## JOURNEY RISK MANAGEMENT (JRM) STUDY

### Salem Terminal to VIYAN FUELS

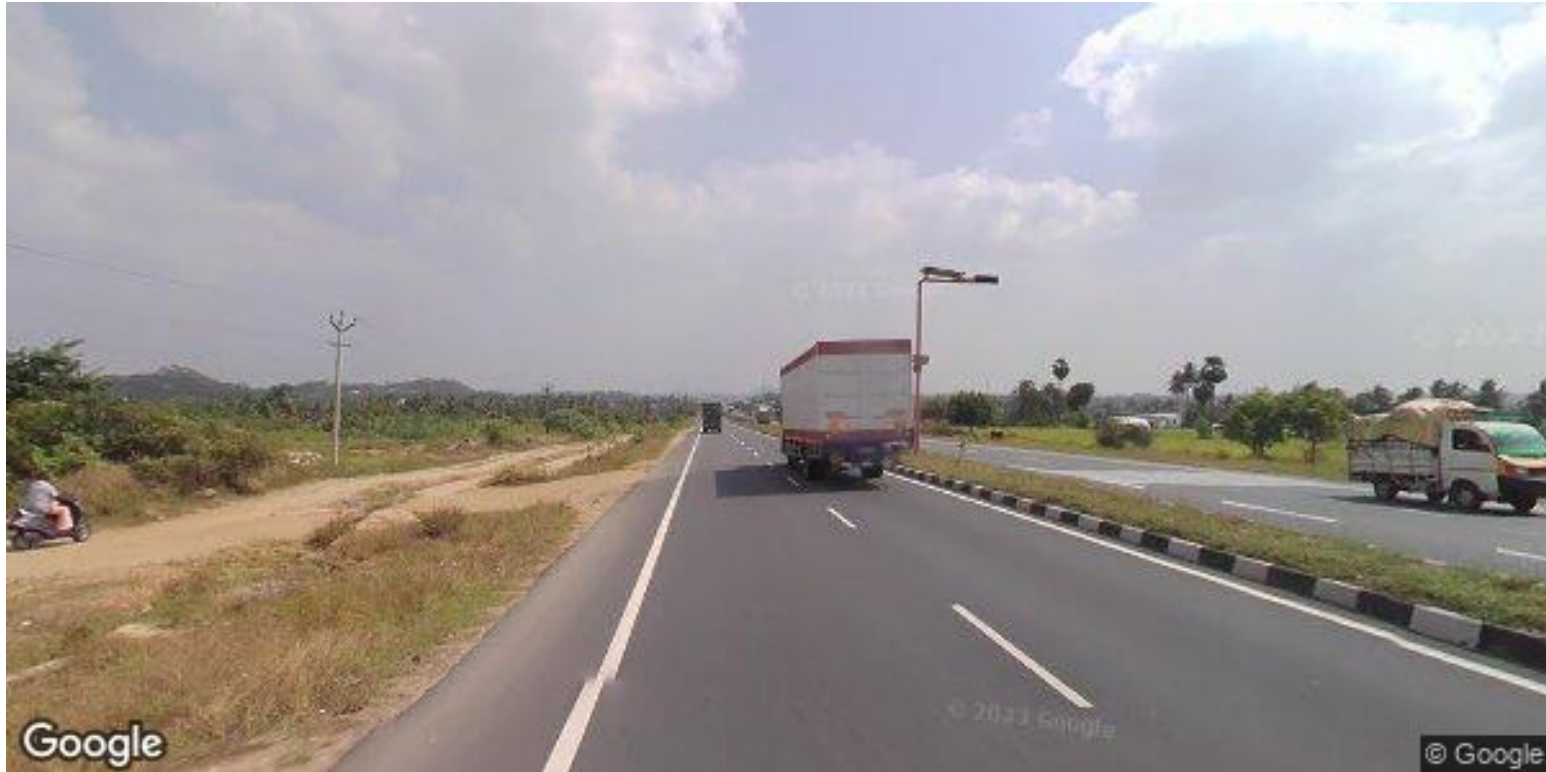
**Risk Type:** Turn  
**Risk Level:** High  
**Speed Limit:** 15 KM/Hr  
**Coordinates:** 11.49409, 77.88004

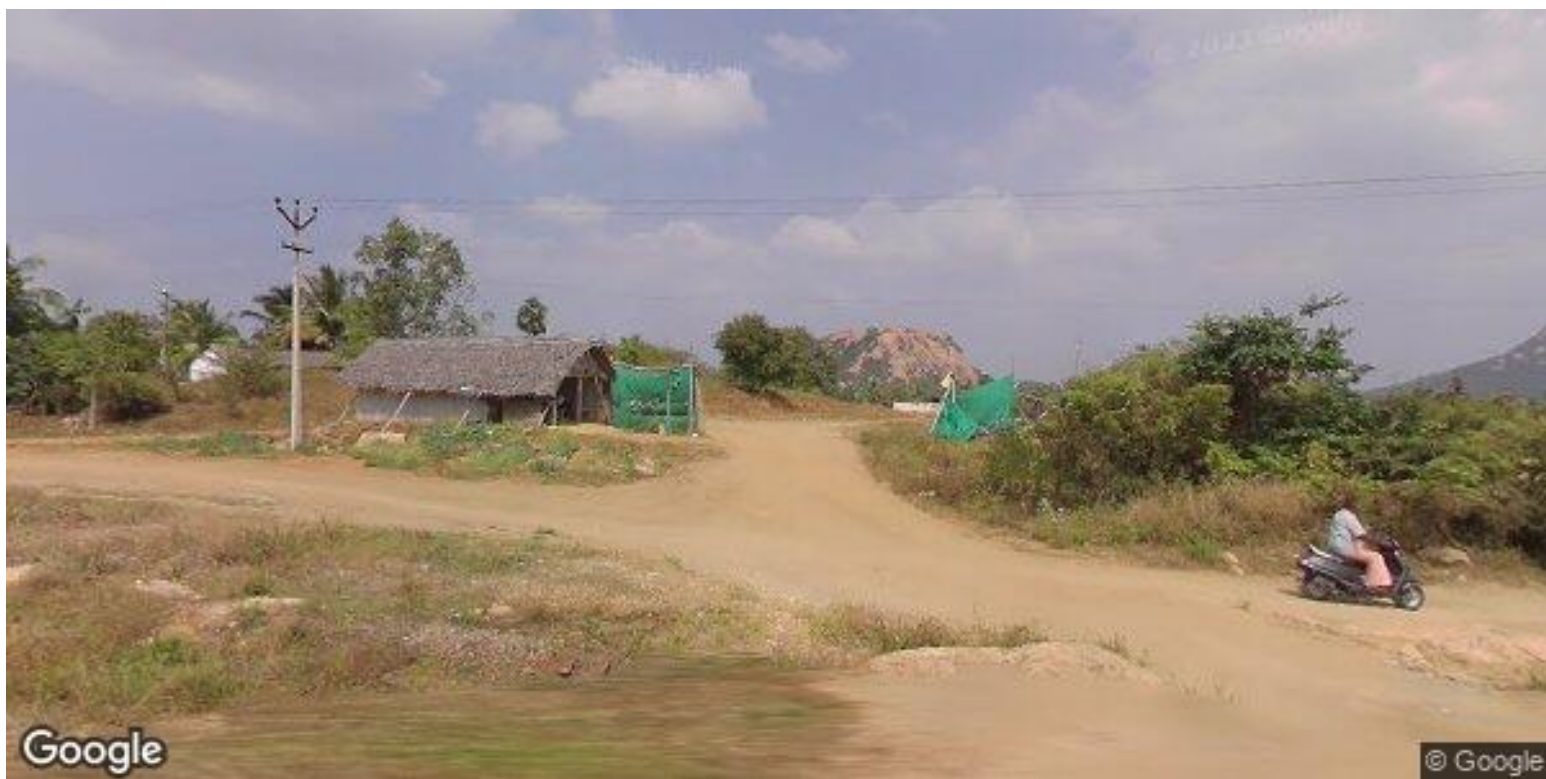
**Risk Type:** Turn  
**Risk Level:** Medium  
**Speed Limit:** 30 KM/Hr  
**Coordinates:** 11.49420, 77.88016

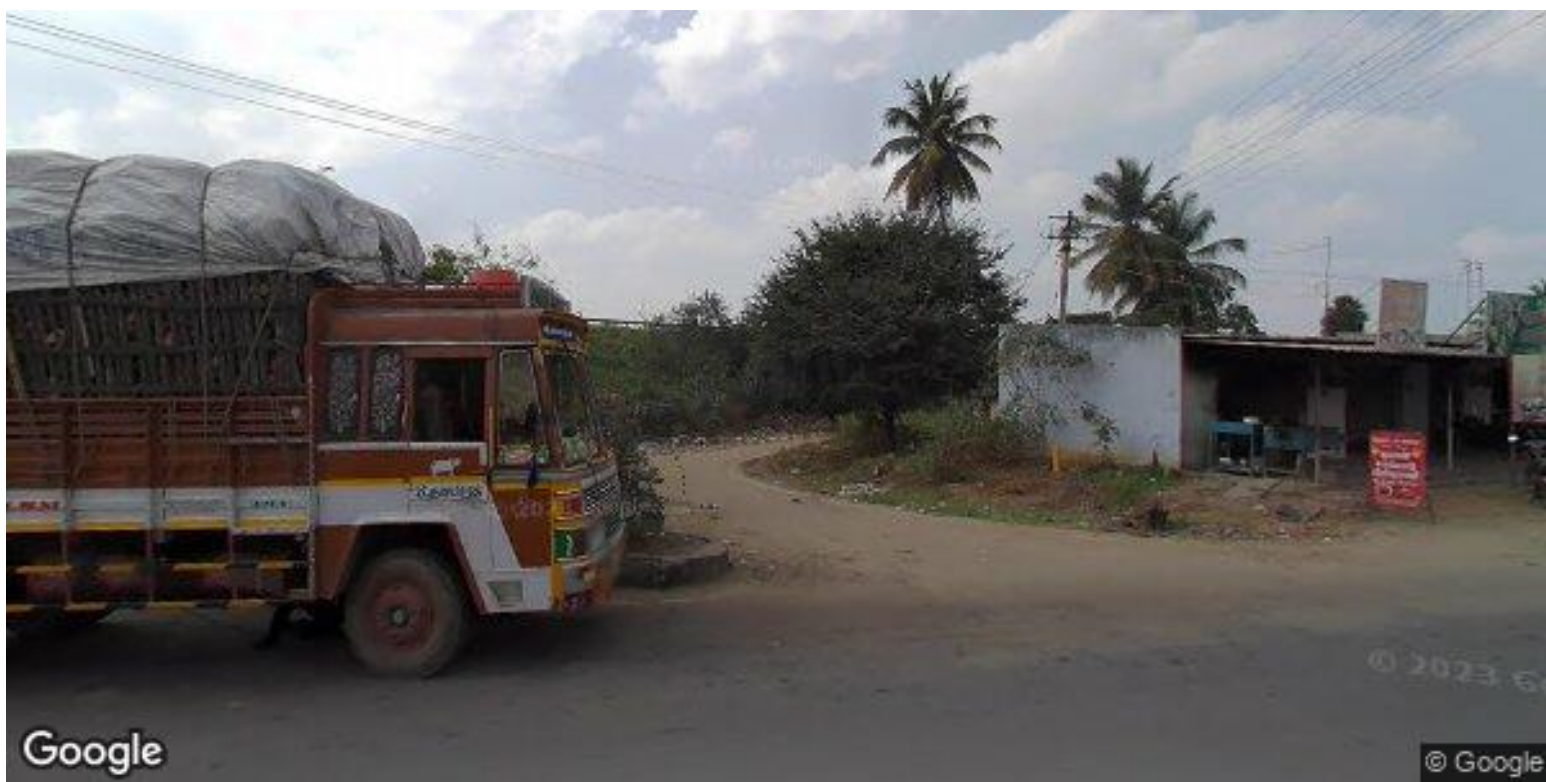
**Coordinates:** 11.49383, 77.88526

**Risk Type:** Turn

**Risk Level:** High

**Speed Limit:** 15 KM/Hr

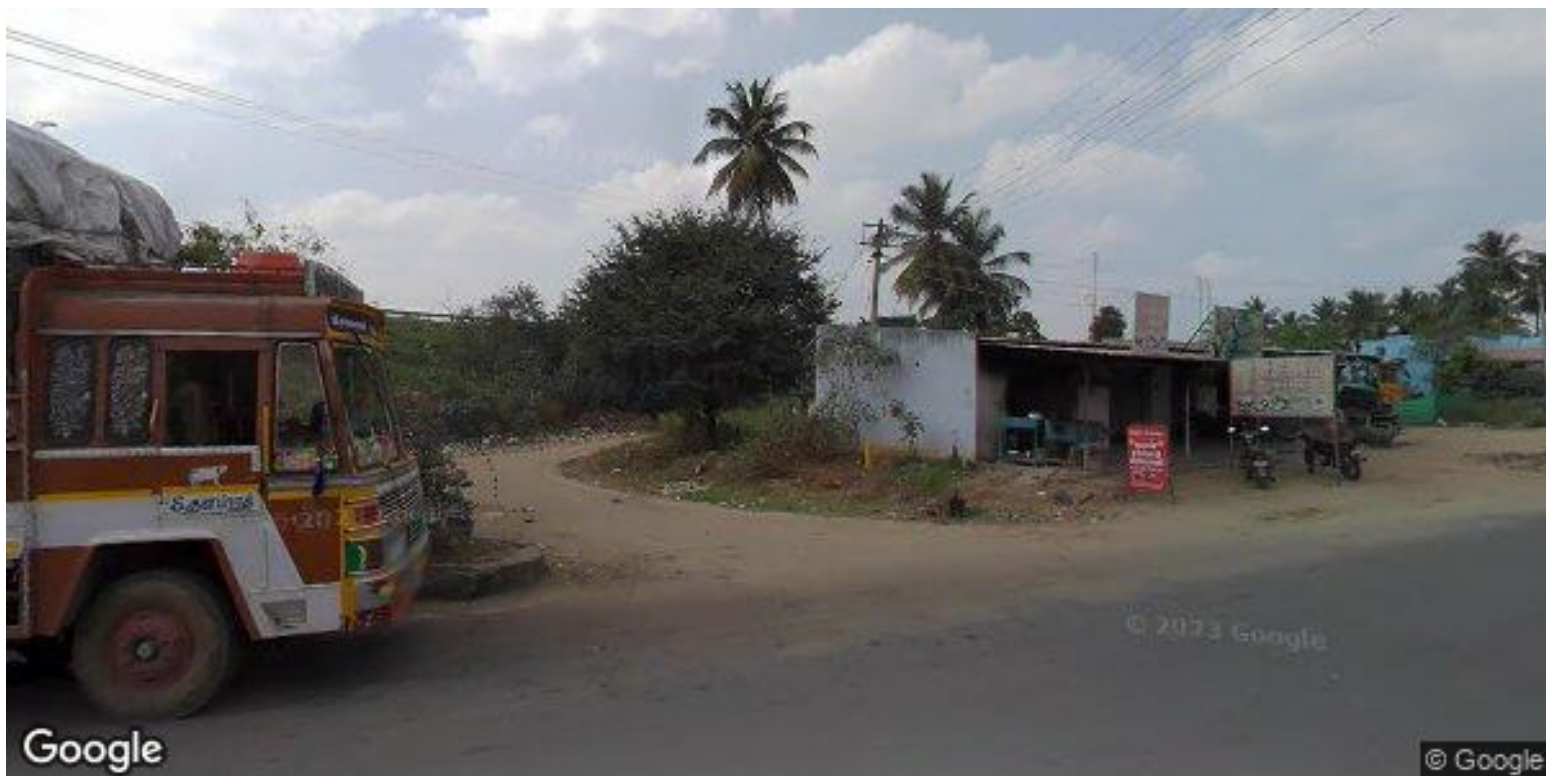
**Coordinates:** 11.49395, 77.88537

**Risk Type:** Turn

**Risk Level:** High

**Speed Limit:** 15 KM/Hr

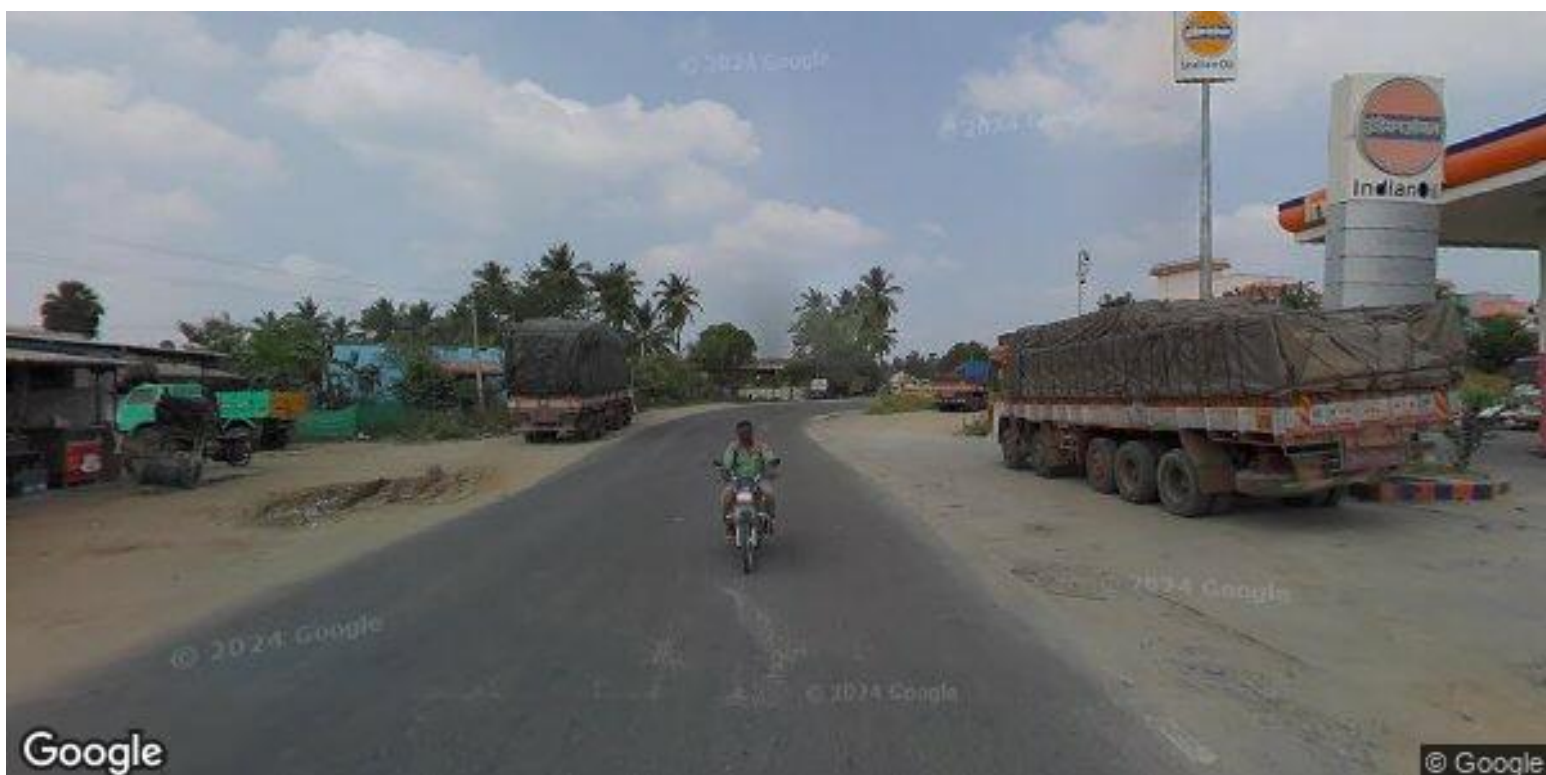
**Risk Type:** Turn  
**Risk Level:** High  
**Speed Limit:** 15 KM/Hr  
**Coordinates:** 11.49409, 77.88536

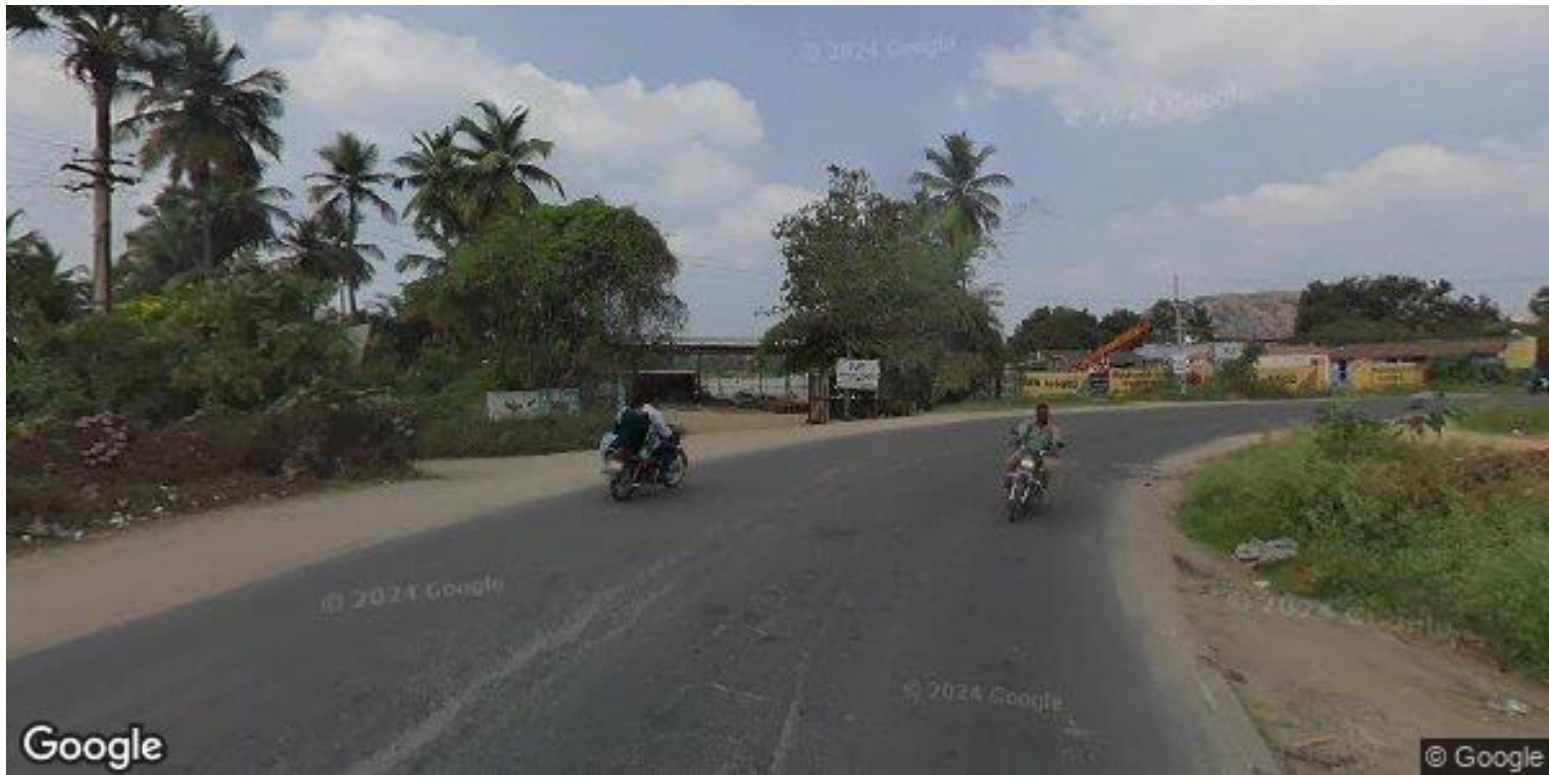
**Risk Type:** Turn  
**Risk Level:** Medium  
**Speed Limit:** 30 KM/Hr  
**Coordinates:** 11.49435, 77.88499

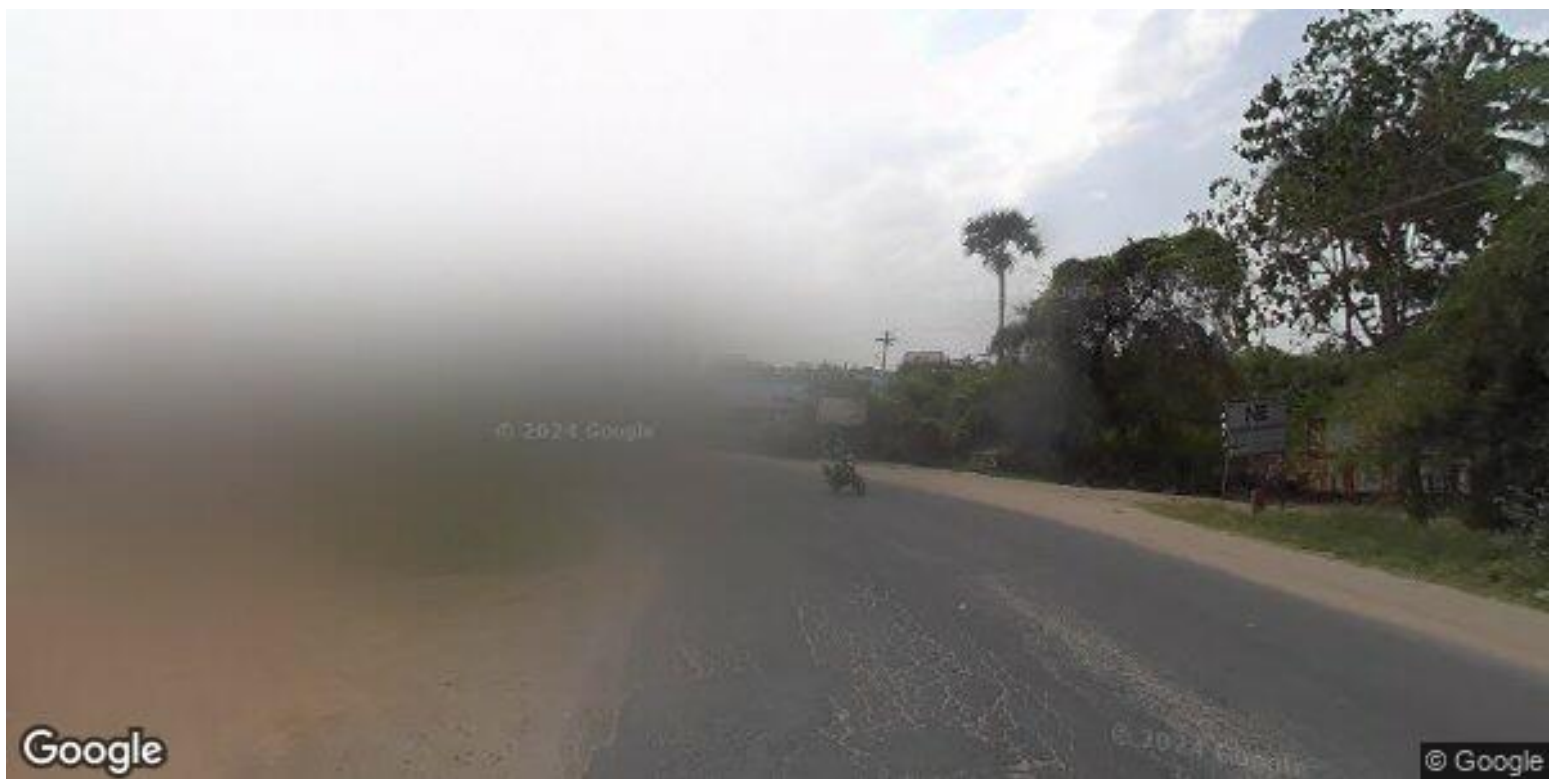
**Risk Type:** Turn  
**Risk Level:** Medium  
**Speed Limit:** 30 KM/Hr  
**Coordinates:** 11.49465, 77.88488

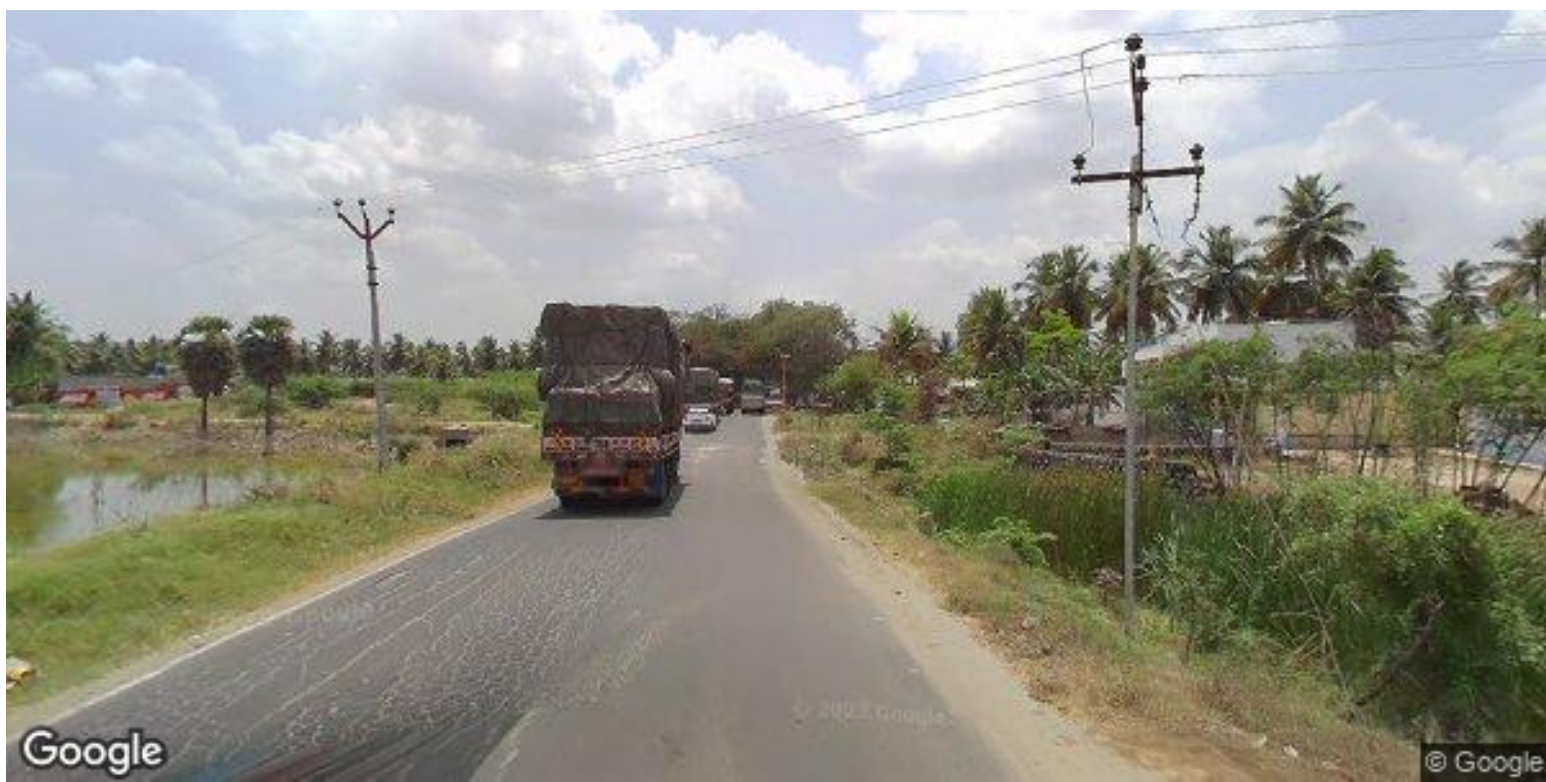
**Coordinates:** 11.56072, 77.89919

**Risk Type:** Turn

**Risk Level:** Medium

**Speed Limit:** 30 KM/Hr

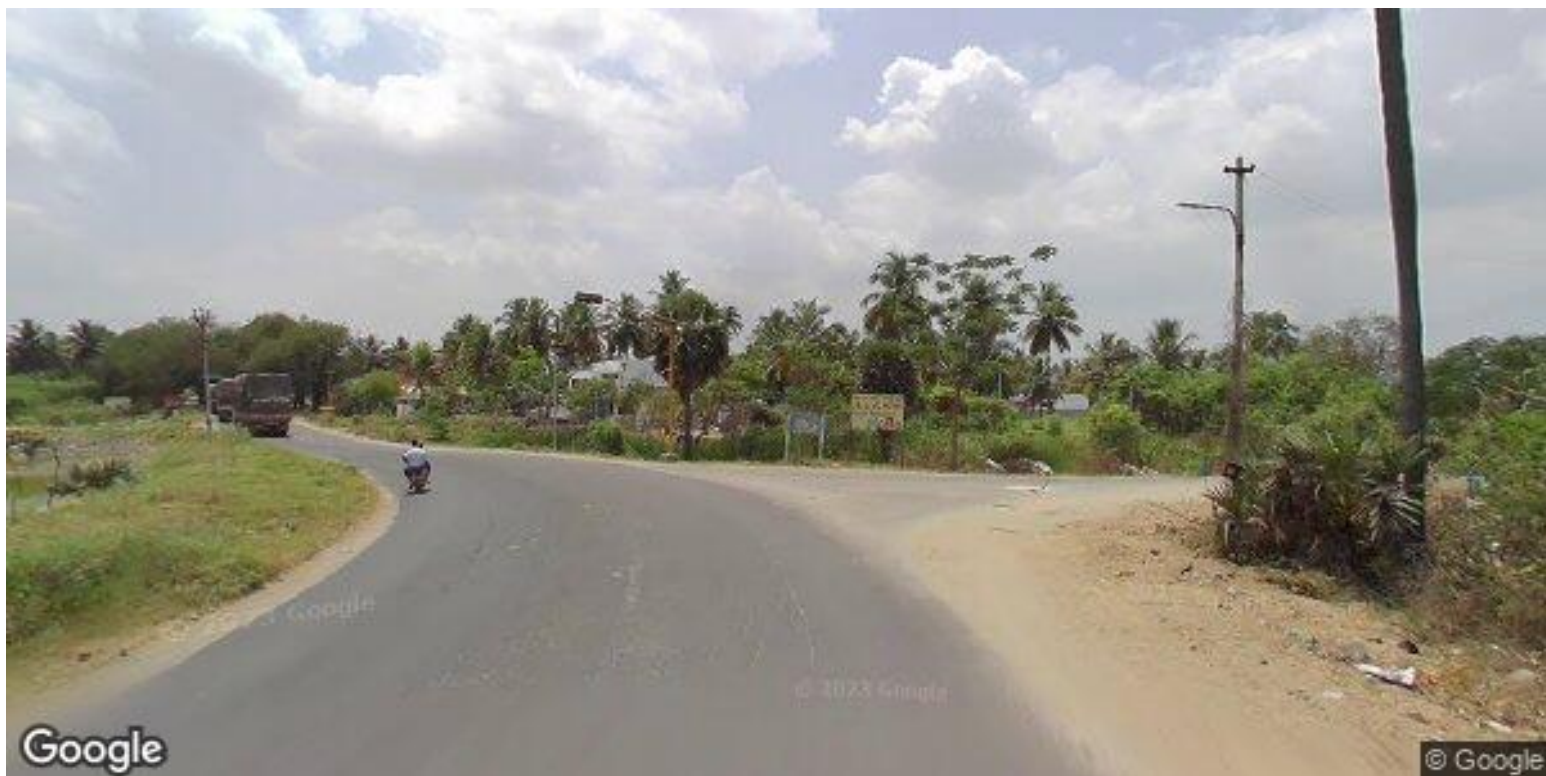
**Coordinates:** 11.56096, 77.89931

**Risk Type:** Turn

**Risk Level:** Medium

**Speed Limit:** 30 KM/Hr

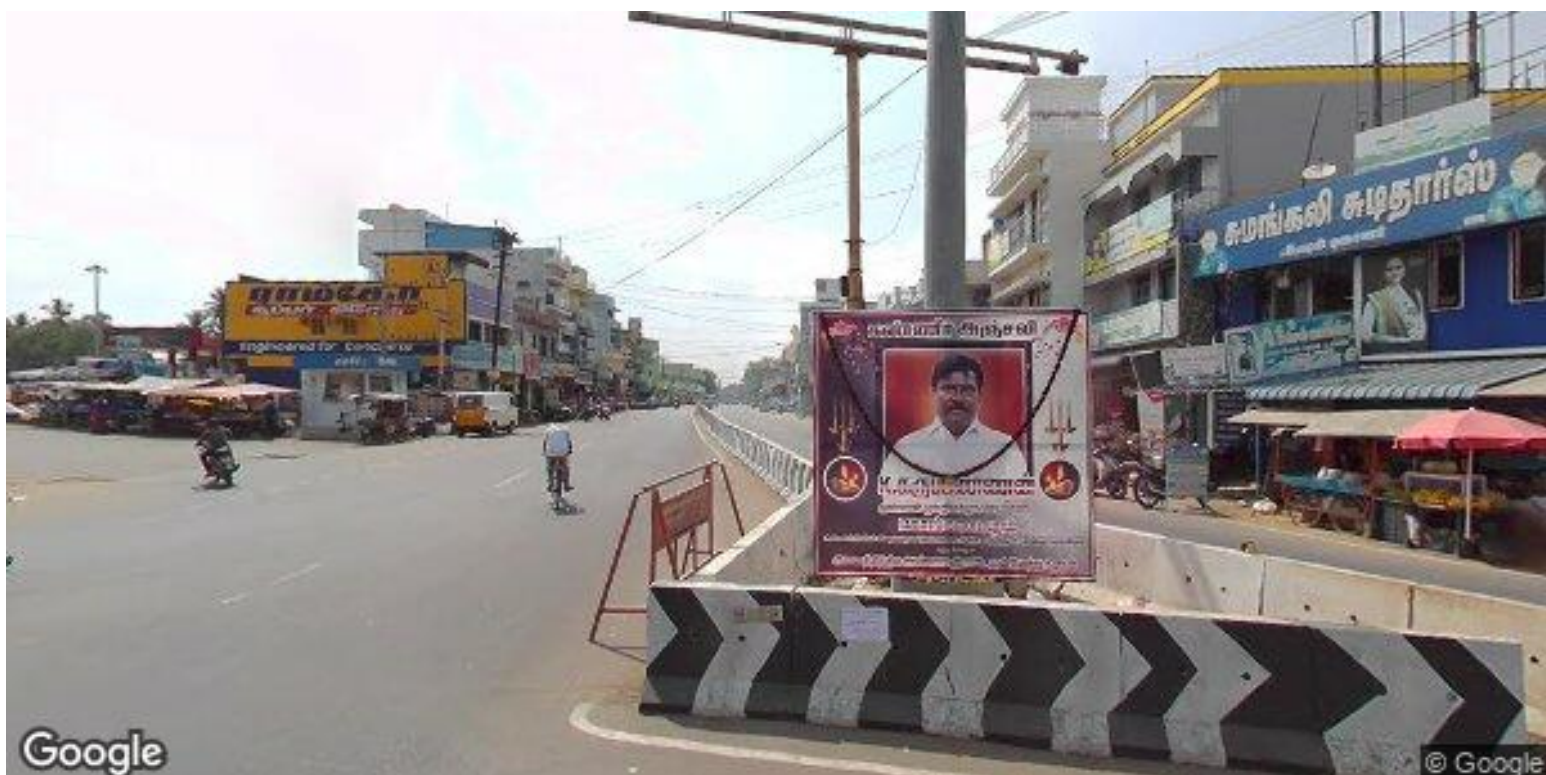
**Coordinates:** 11.57035, 77.90223

**Risk Type:** Turn

**Risk Level:** High

**Speed Limit:** 15 KM/Hr

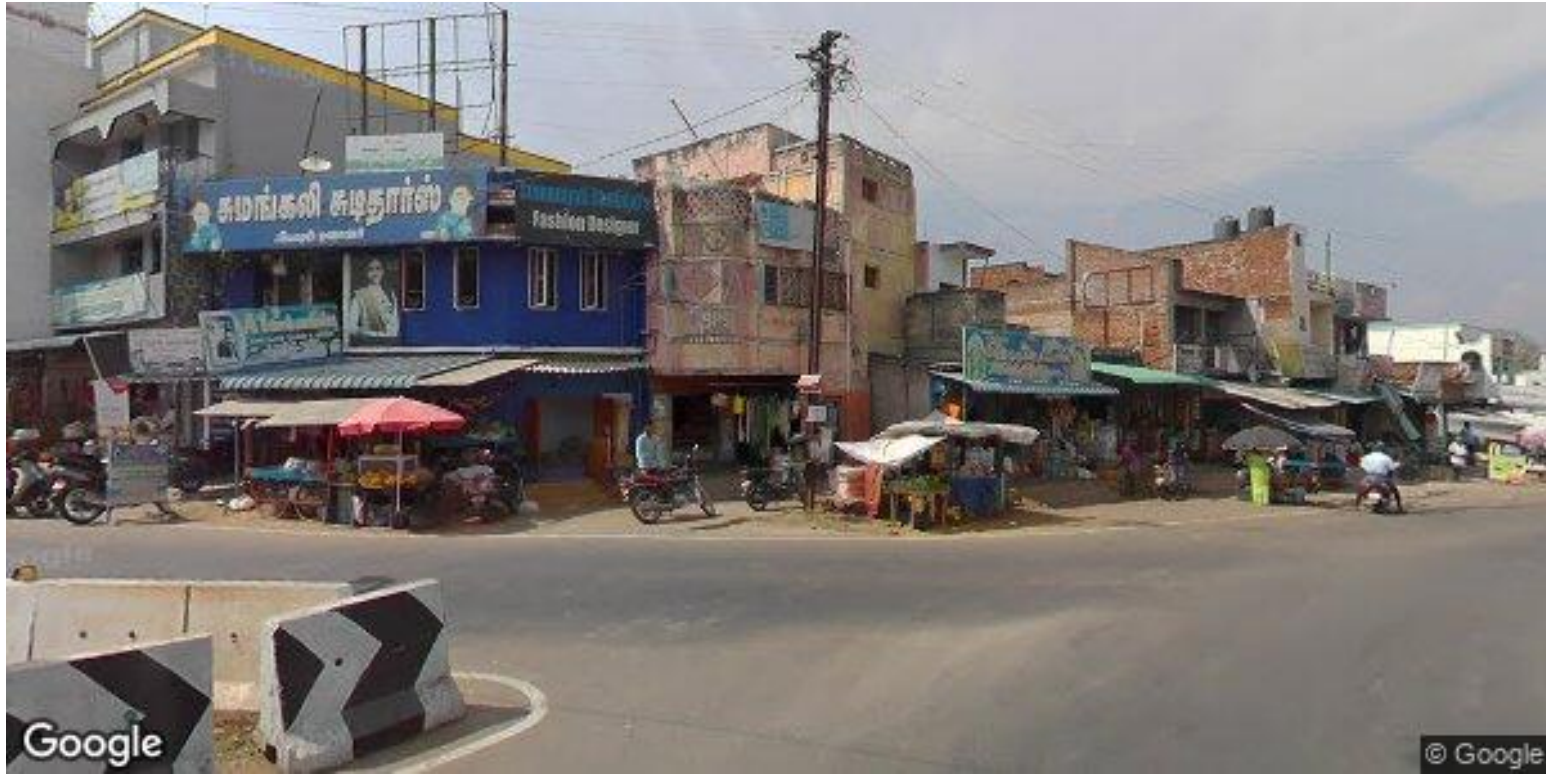
**Coordinates:** 11.57041, 77.90221

**Risk Type:** Turn

**Risk Level:** Medium

**Speed Limit:** 30 KM/Hr

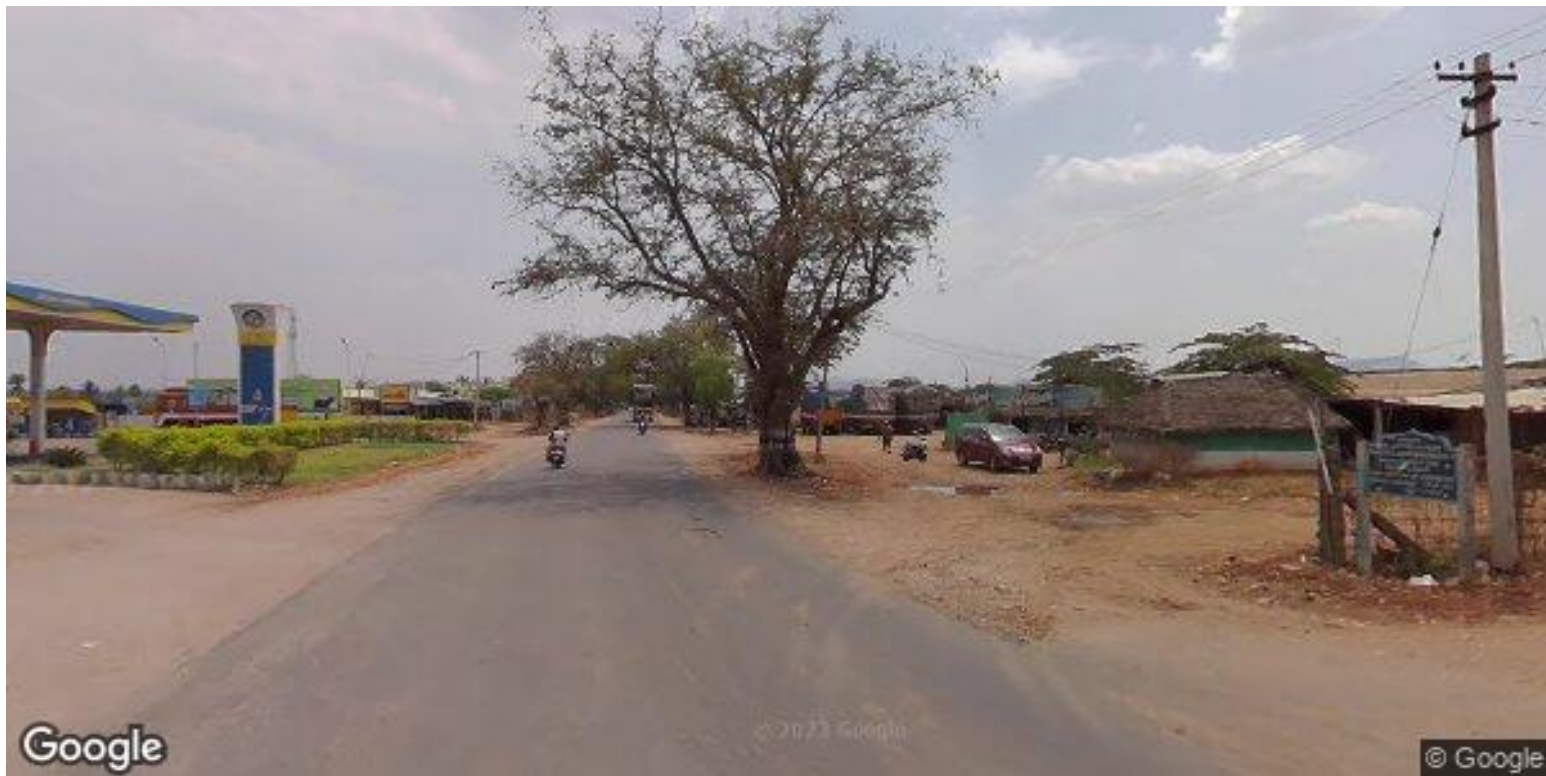
**Coordinates:** 11.58279, 77.90658

**Risk Type:** Turn

**Risk Level:** Medium

**Speed Limit:** 30 KM/Hr

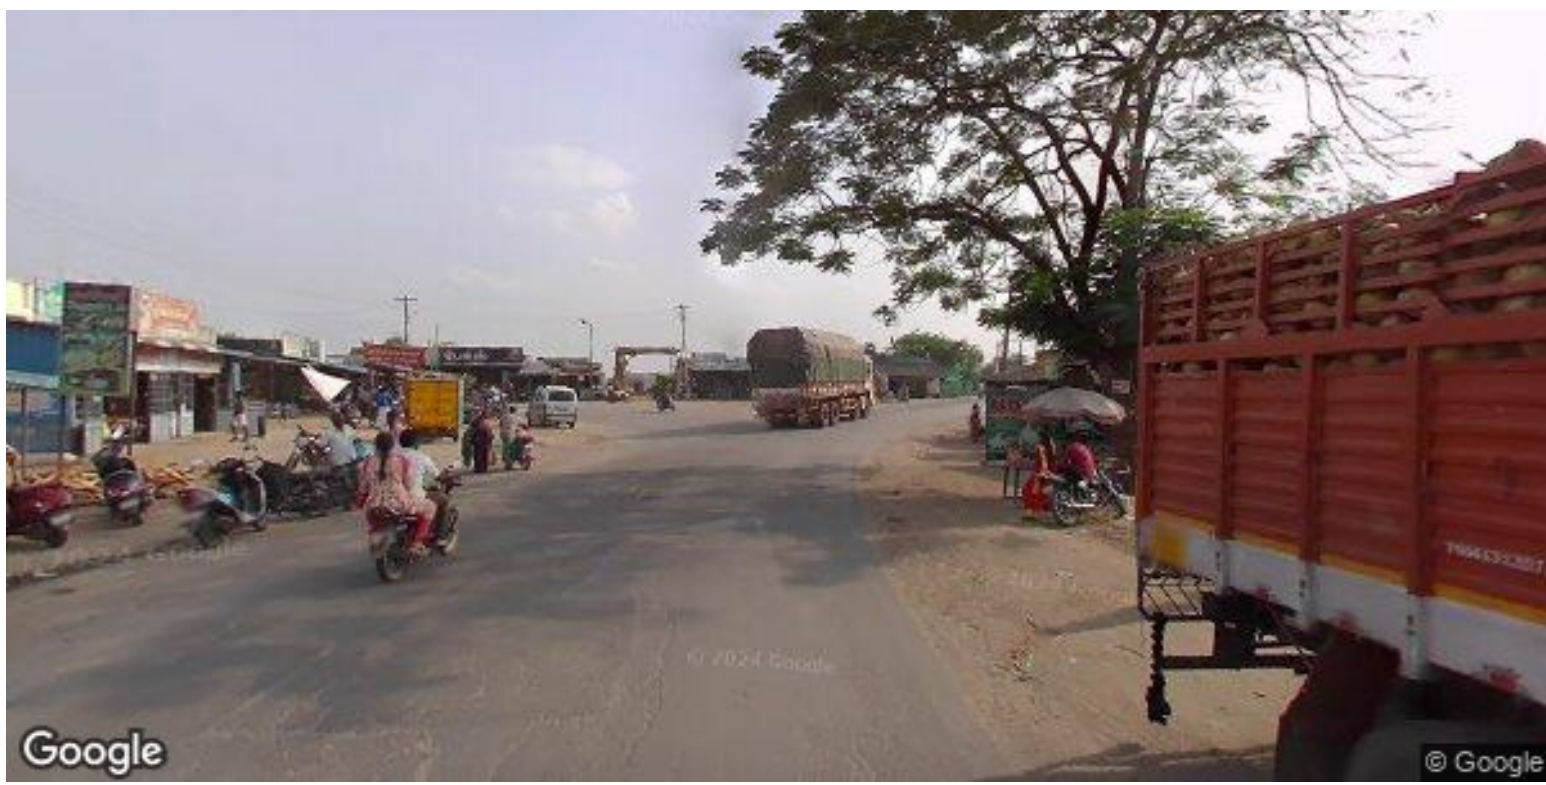
**Coordinates:** 11.64197, 77.95197

**Risk Type:** Turn

**Risk Level:** Medium

**Speed Limit:** 30 KM/Hr

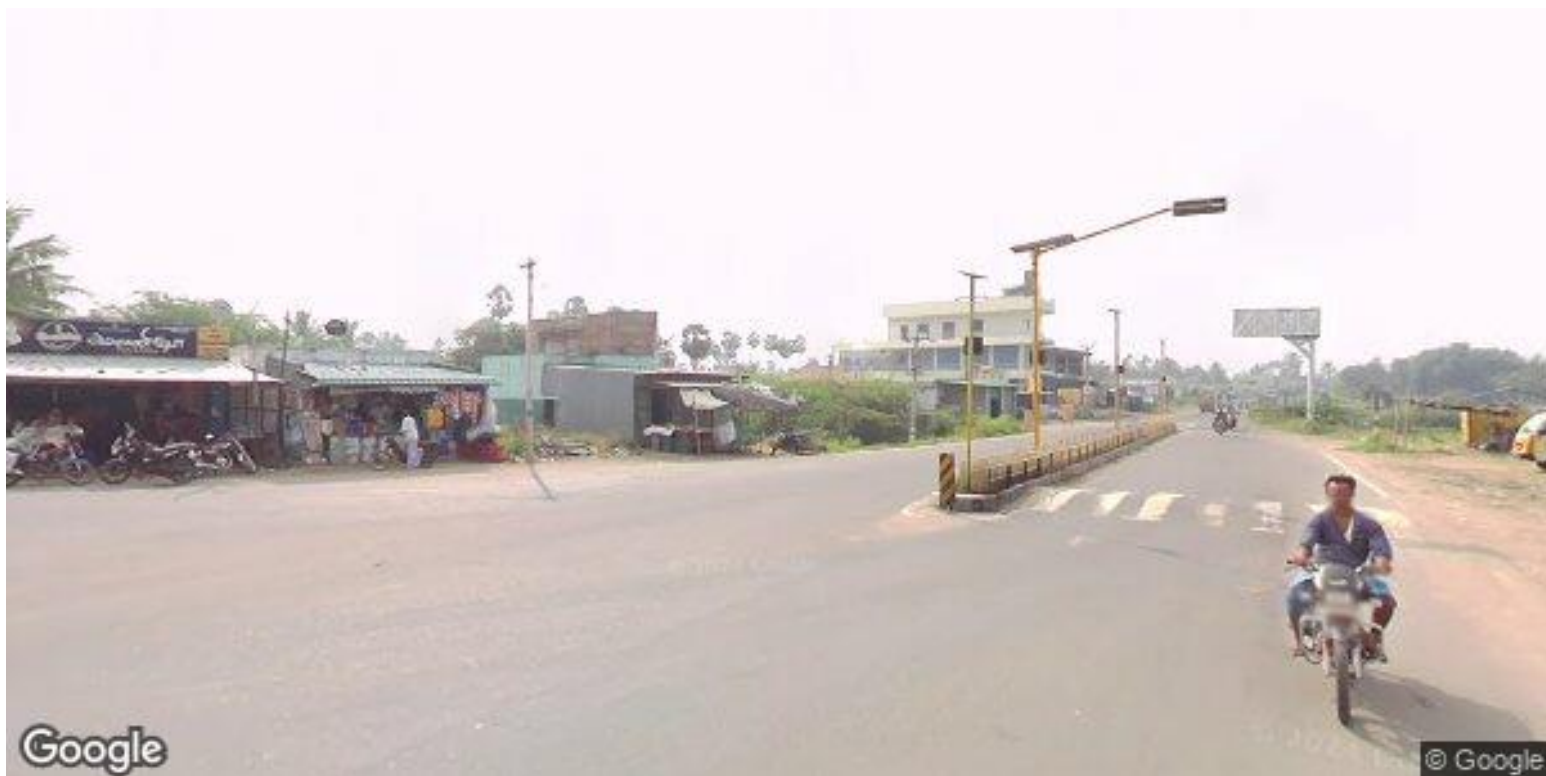
**Coordinates:** 11.67868, 77.96836

**Risk Type:** Turn

**Risk Level:** High

**Speed Limit:** 15 KM/Hr

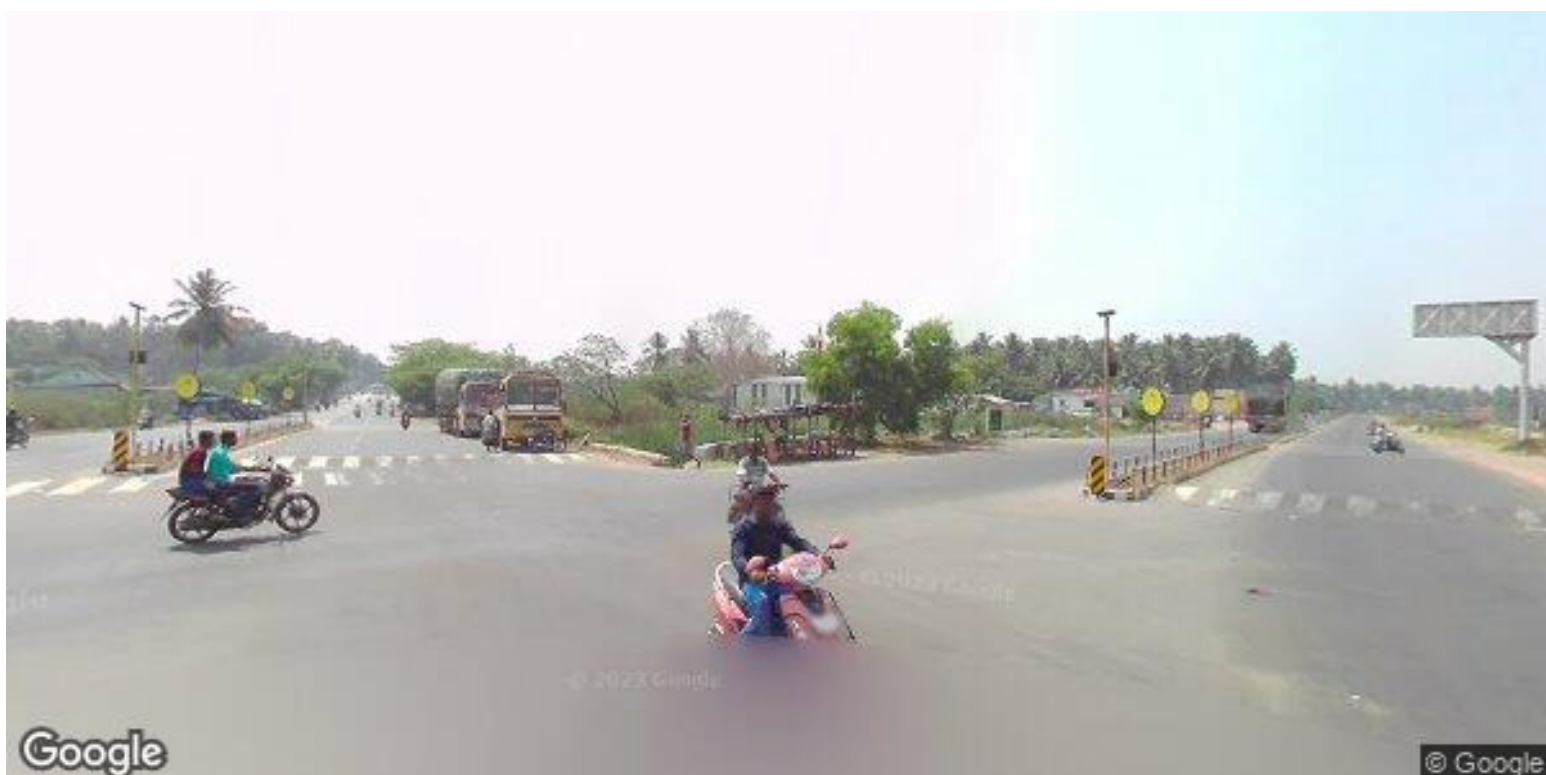
**Risk Type:** Turn  
**Risk Level:** Medium  
**Speed Limit:** 30 KM/Hr  
**Coordinates:** 11.68904, 77.97736

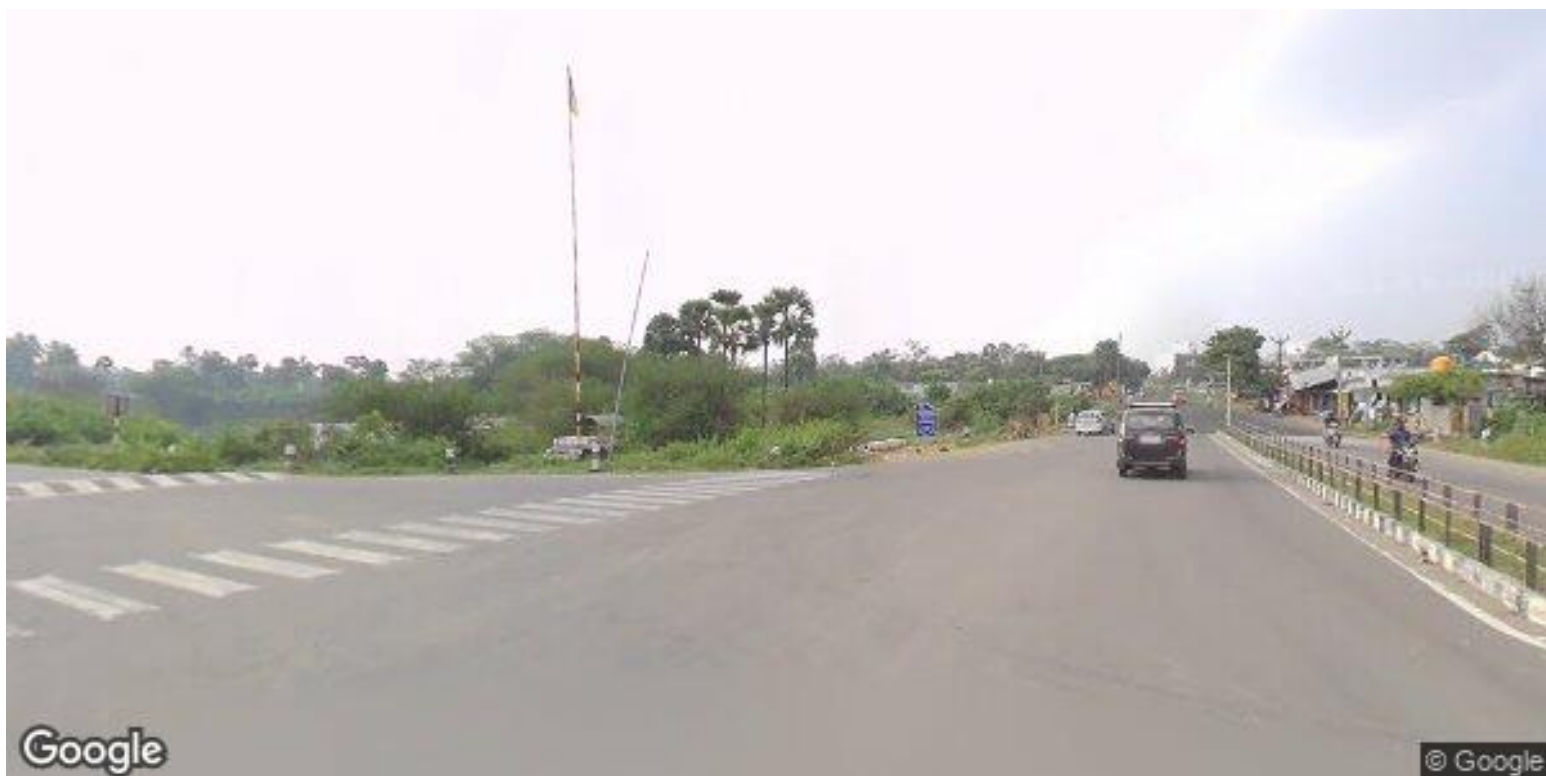
**Risk Type:** Turn  
**Risk Level:** Medium  
**Speed Limit:** 30 KM/Hr  
**Coordinates:** 11.70218, 77.97866

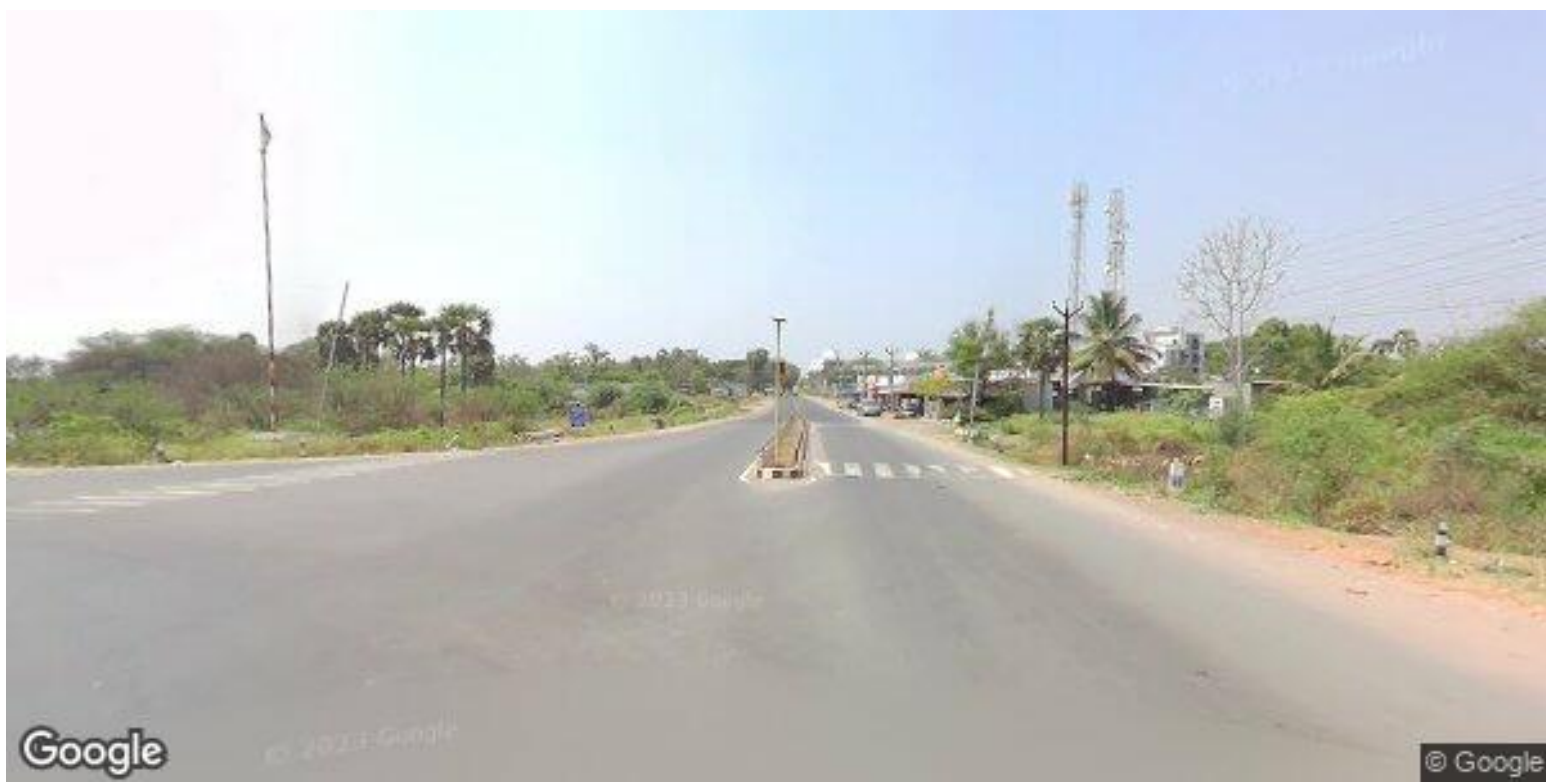
**Coordinates:** 11.70227, 77.97864

**Risk Type:** Turn

**Risk Level:** High

**Speed Limit:** 15 KM/Hr

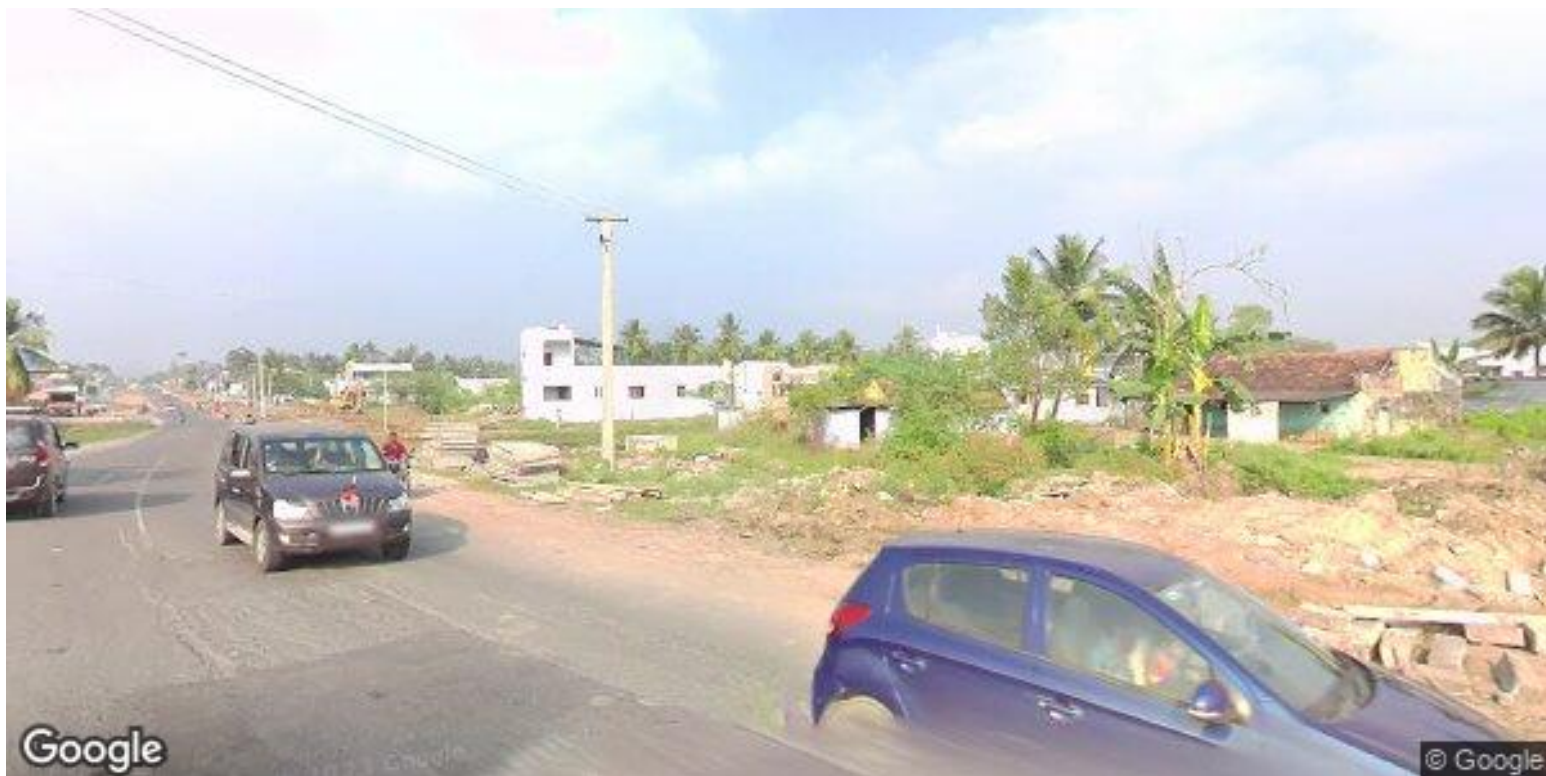
**Coordinates:** 11.71921, 78.01133

**Risk Type:** Turn

**Risk Level:** Medium

**Speed Limit:** 30 KM/Hr

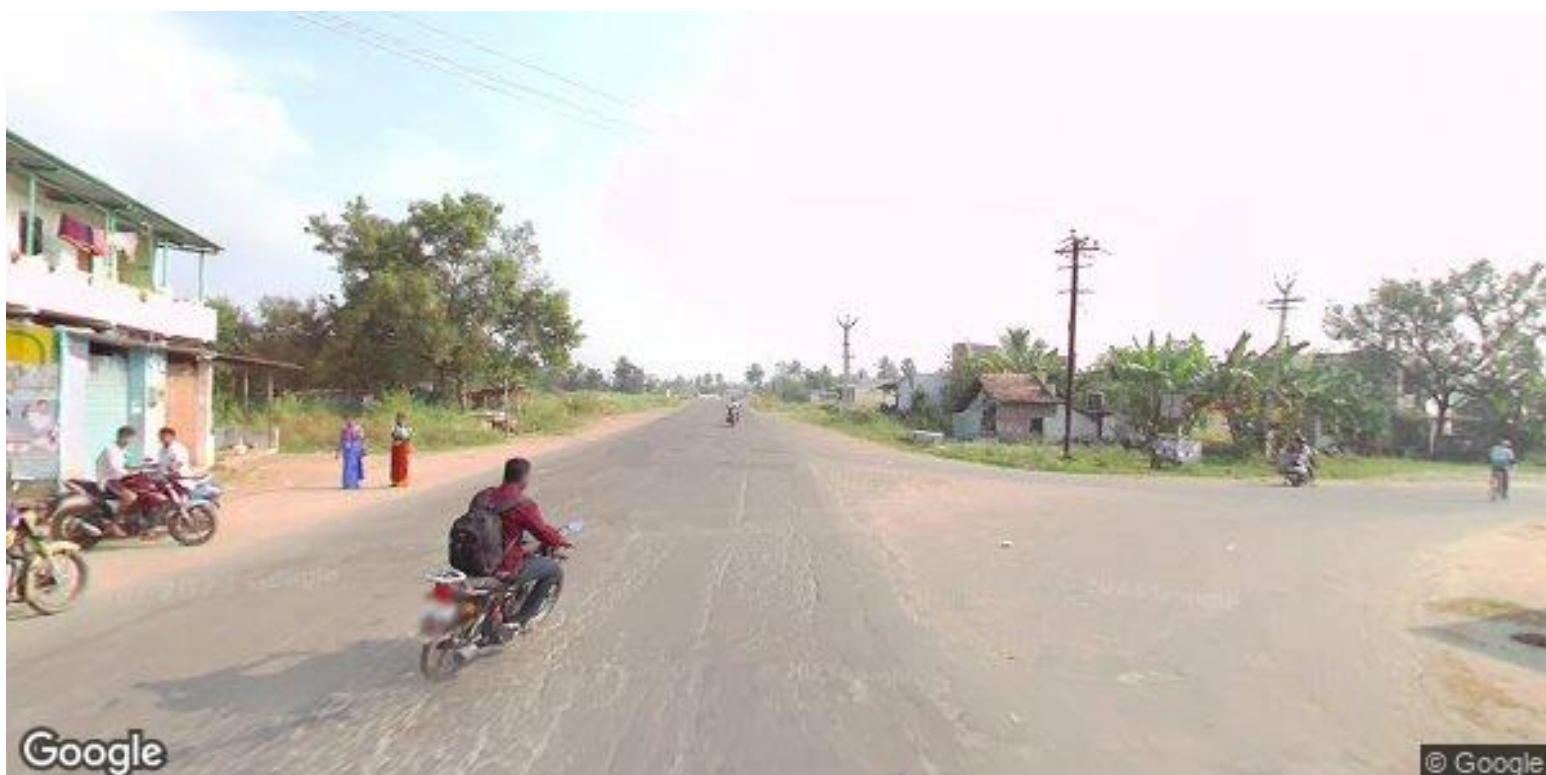
**Coordinates:** 11.72035, 78.01270

**Risk Type:** Turn

**Risk Level:** High

**Speed Limit:** 15 KM/Hr
