# IndianOil

## JOURNEY RISK MANAGEMENT (JRM) STUDY

### Salem Terminal to TAMILARASI FUELS

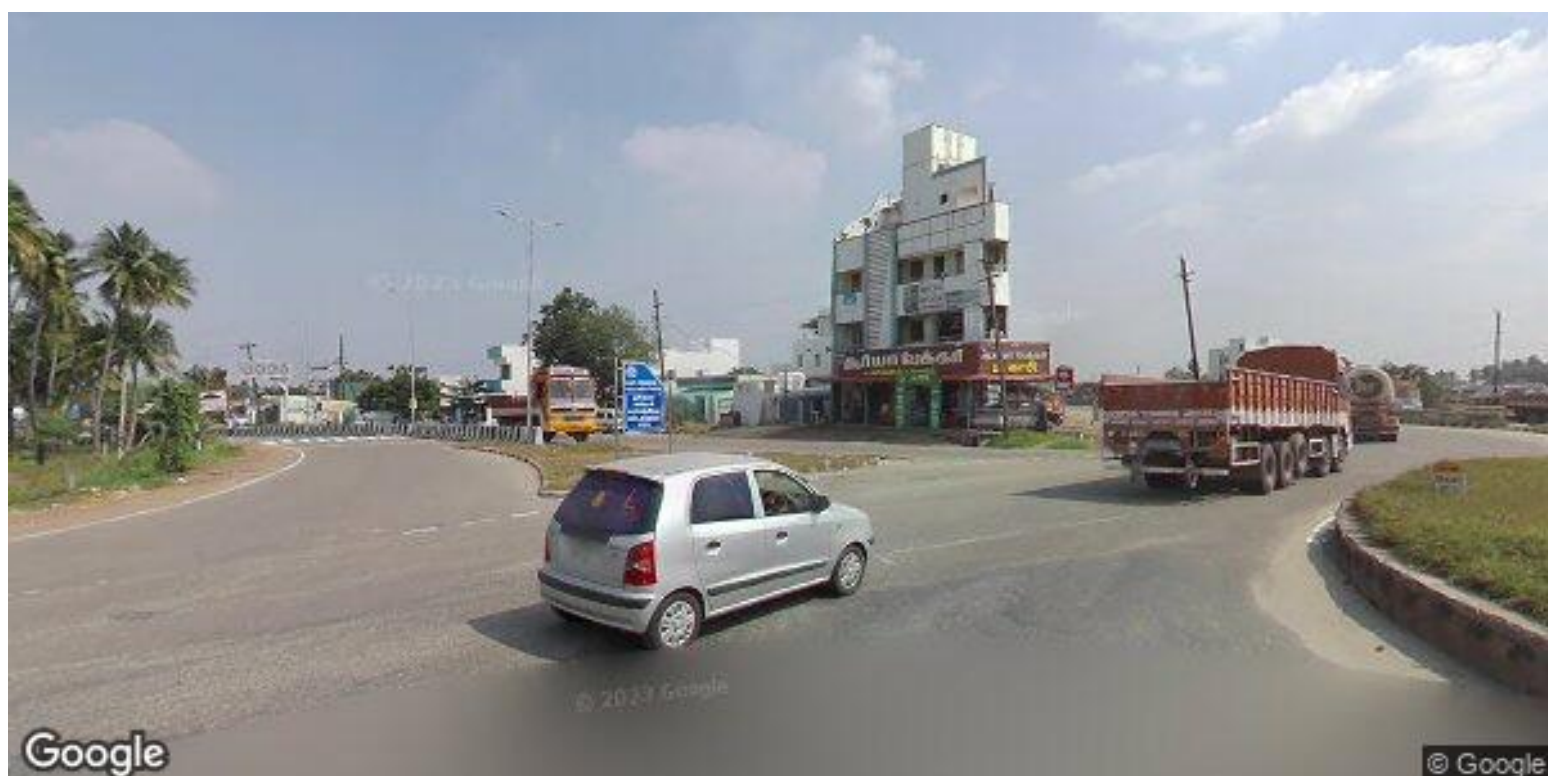
**Risk Type:** Roundabout

**Risk Level:** High

**Speed Limit: 15 KM/Hr**  
**Coordinates: 10.92958, 78.05452**

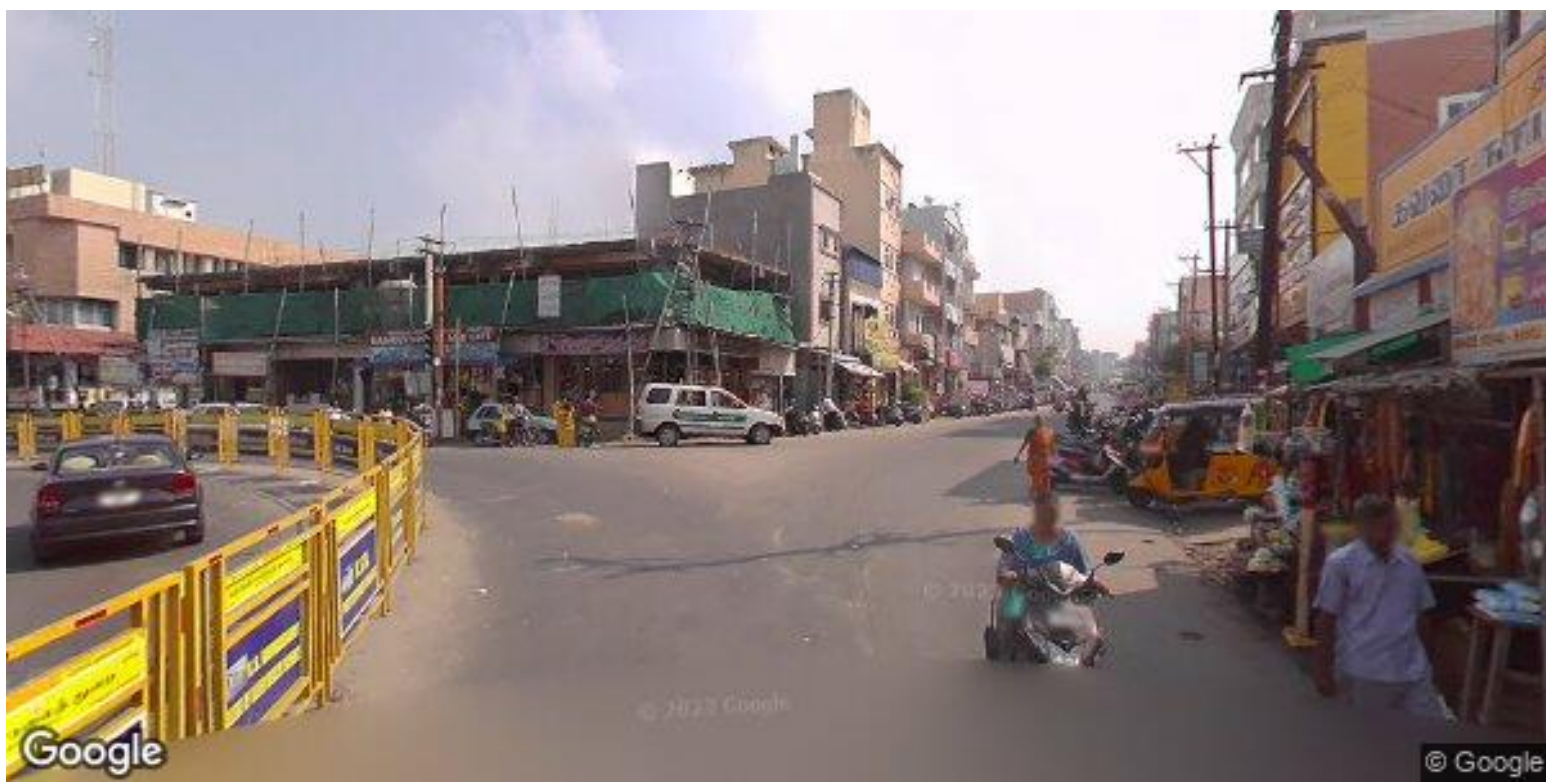
**Coordinates:** 11.37862, 77.89488

**Risk Type:** Turn

**Risk Level:** High

**Speed Limit:** 15 KM/Hr

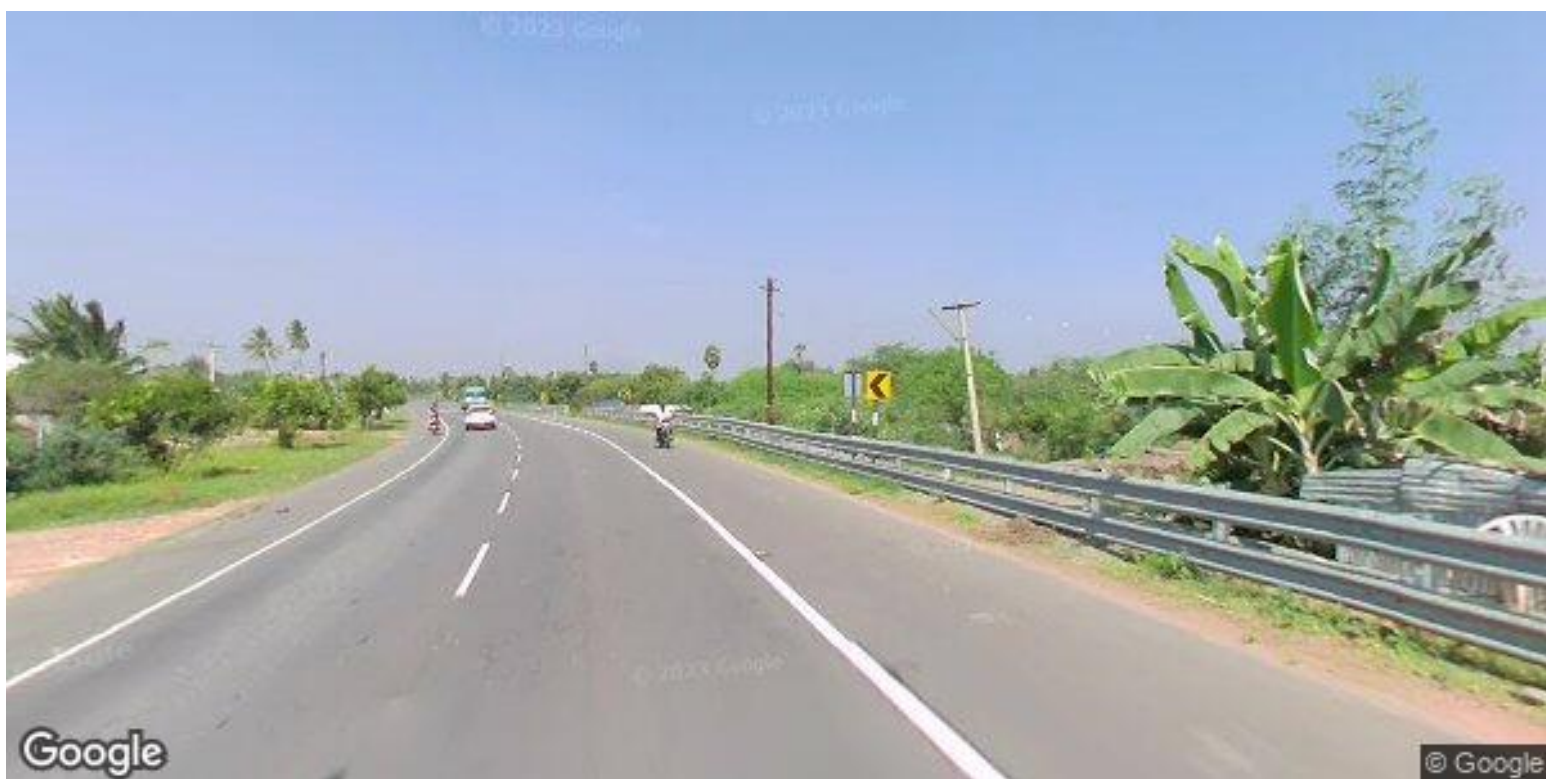
**Coordinates:** 11.16950, 78.01544

**Risk Type:** Turn

**Risk Level:** Medium

**Speed Limit:** 30 KM/Hr

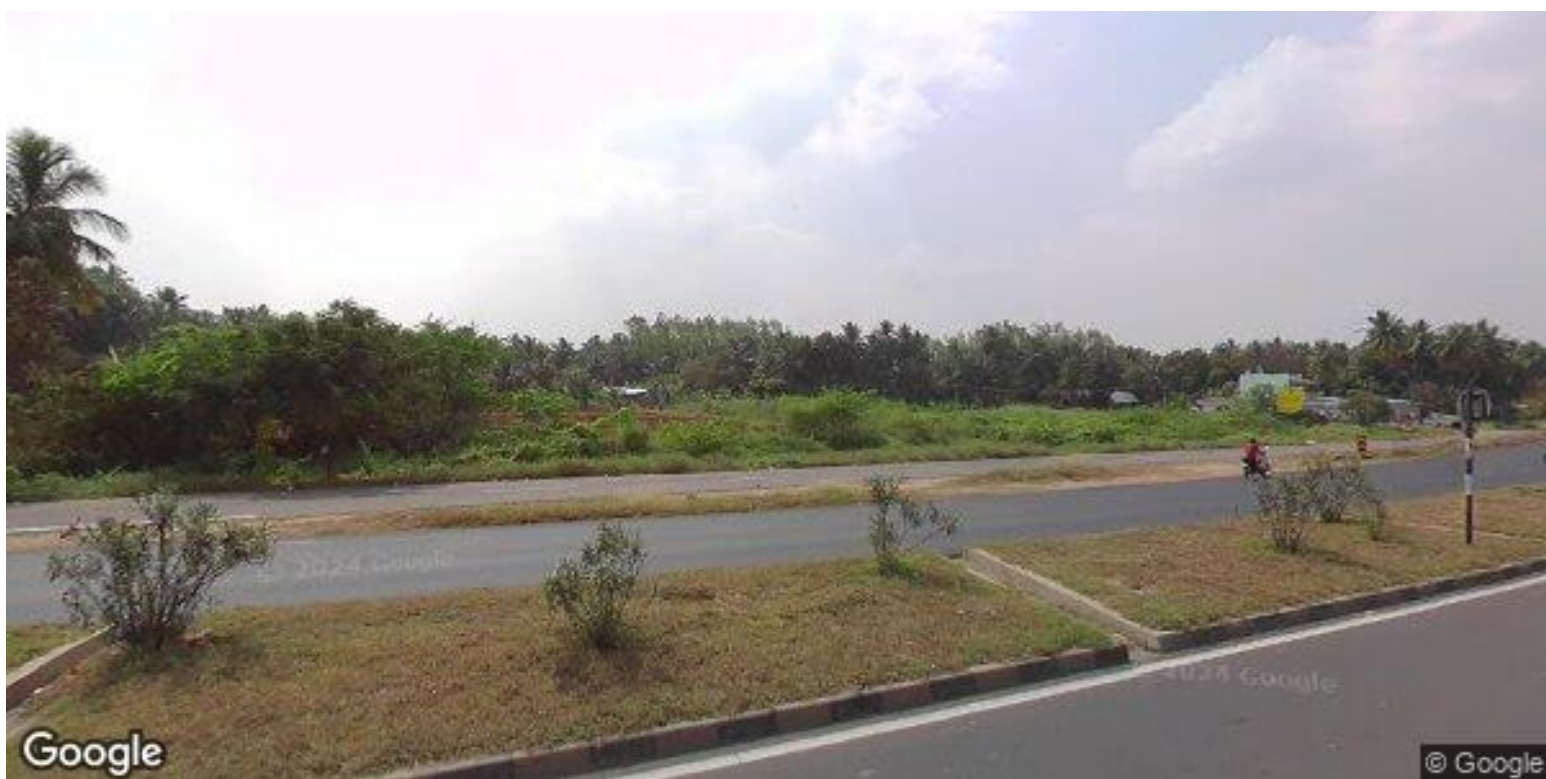
**Risk Type:** Turn  
**Risk Level:** Medium  
**Speed Limit:** 30 KM/Hr  
**Coordinates:** 11.05261, 78.05138

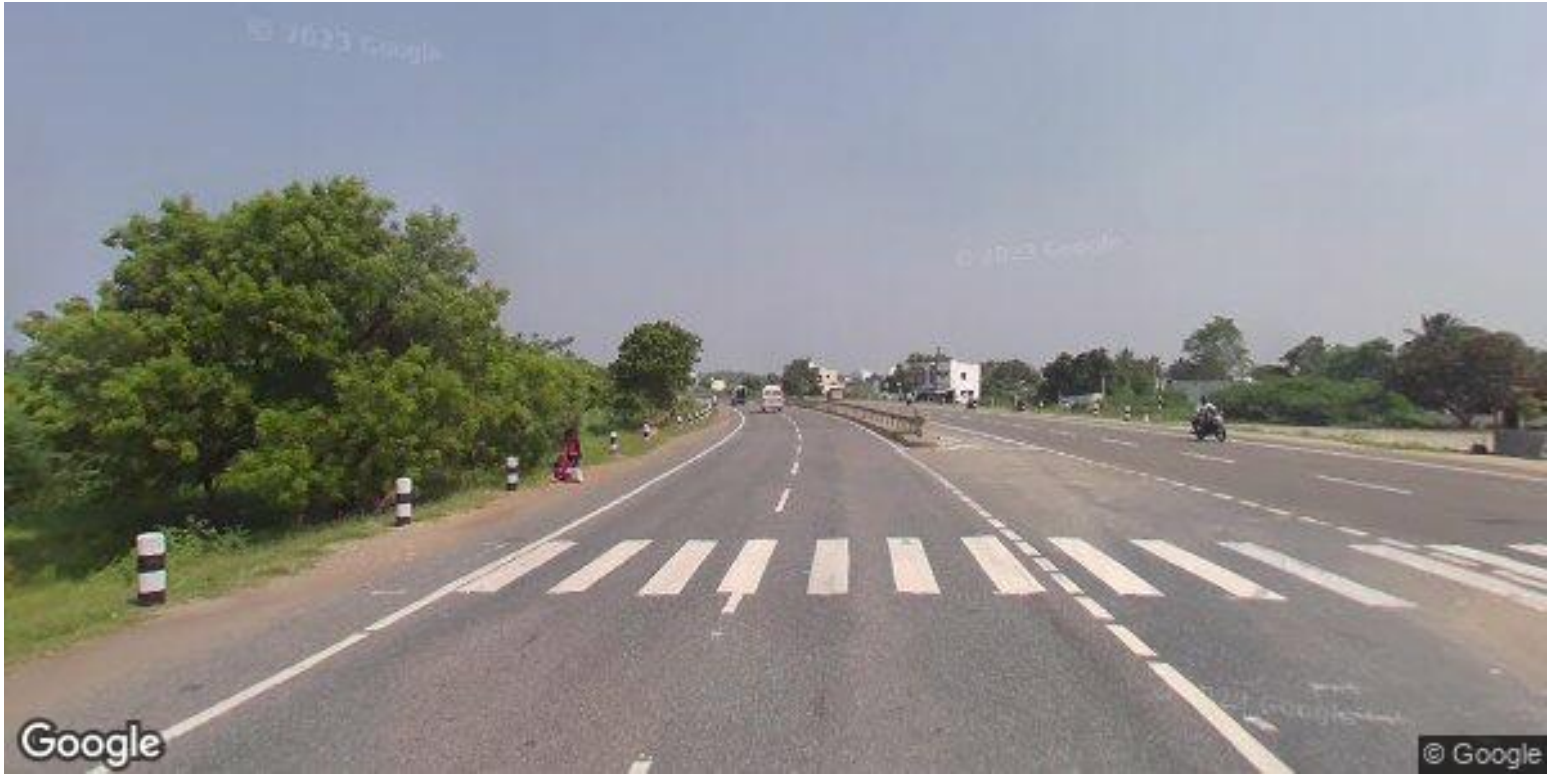
**Risk Type:** Turn  
**Risk Level:** High  
**Speed Limit:** 15 KM/Hr  
**Coordinates:** 10.93631, 78.22884

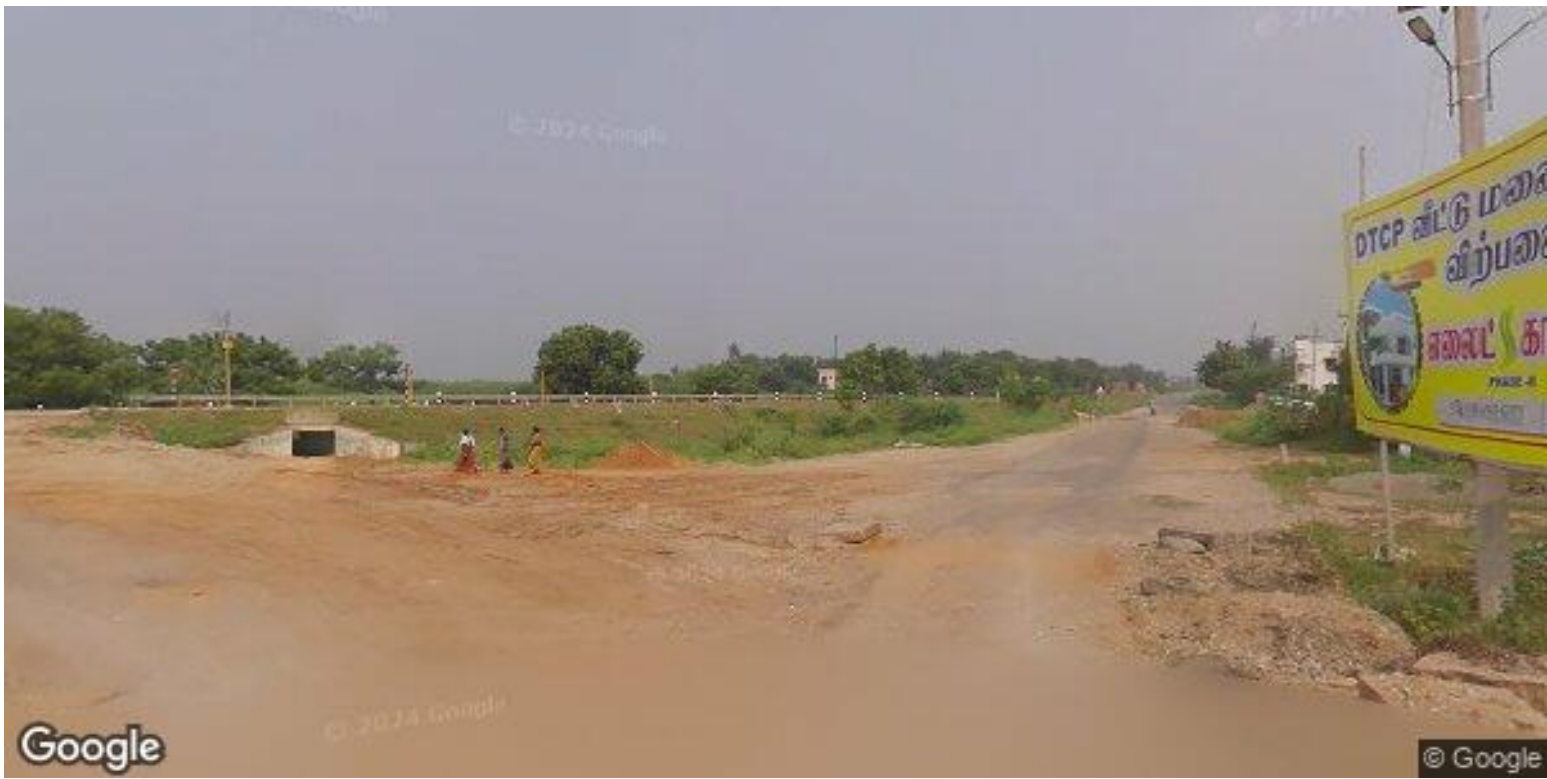
**Risk Type:** Turn  
**Risk Level:** Medium  
**Speed Limit:** 30 KM/Hr  
**Coordinates:** 10.93602, 78.22945

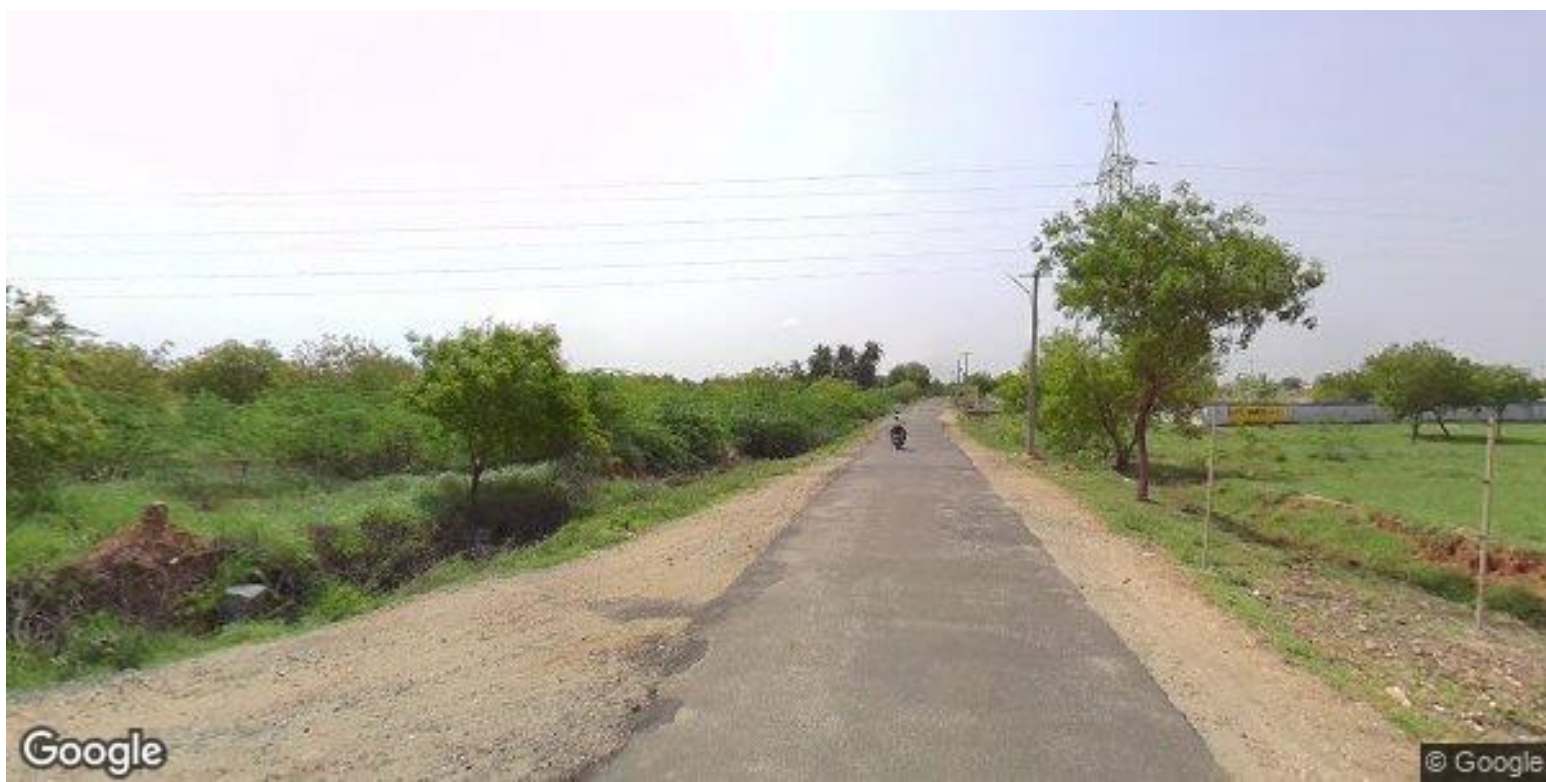
**Coordinates:** 10.93152, 78.23153

**Risk Type:** Turn

**Risk Level:** Medium

**Speed Limit:** 30 KM/Hr

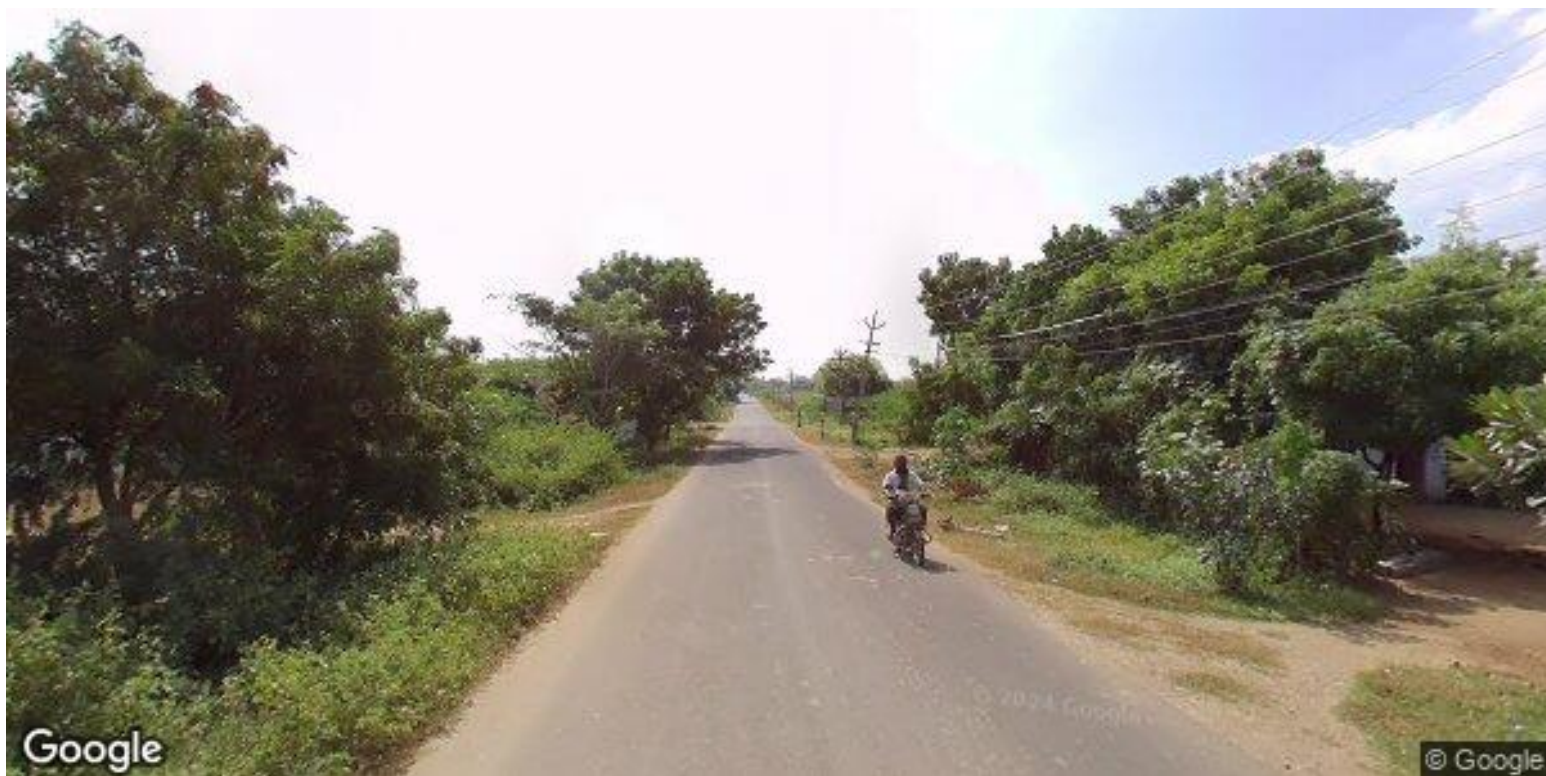
**Coordinates:** 10.92819, 78.23743

**Risk Type:** Turn

**Risk Level:** Medium

**Speed Limit:** 30 KM/Hr

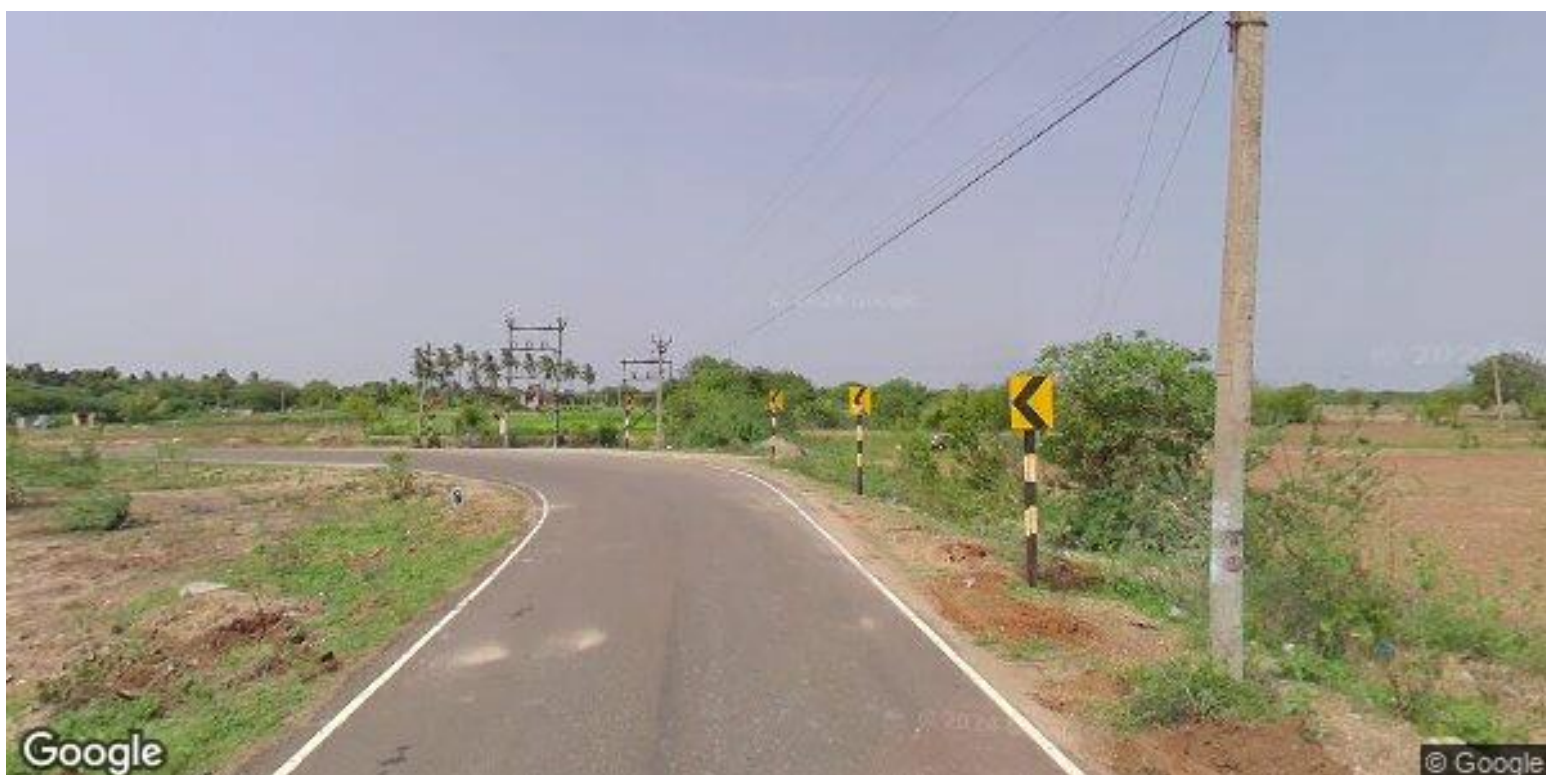
**Risk Type:** Turn  
**Risk Level:** High  
**Speed Limit:** 15 KM/Hr  
**Coordinates:** 10.91798, 78.23849

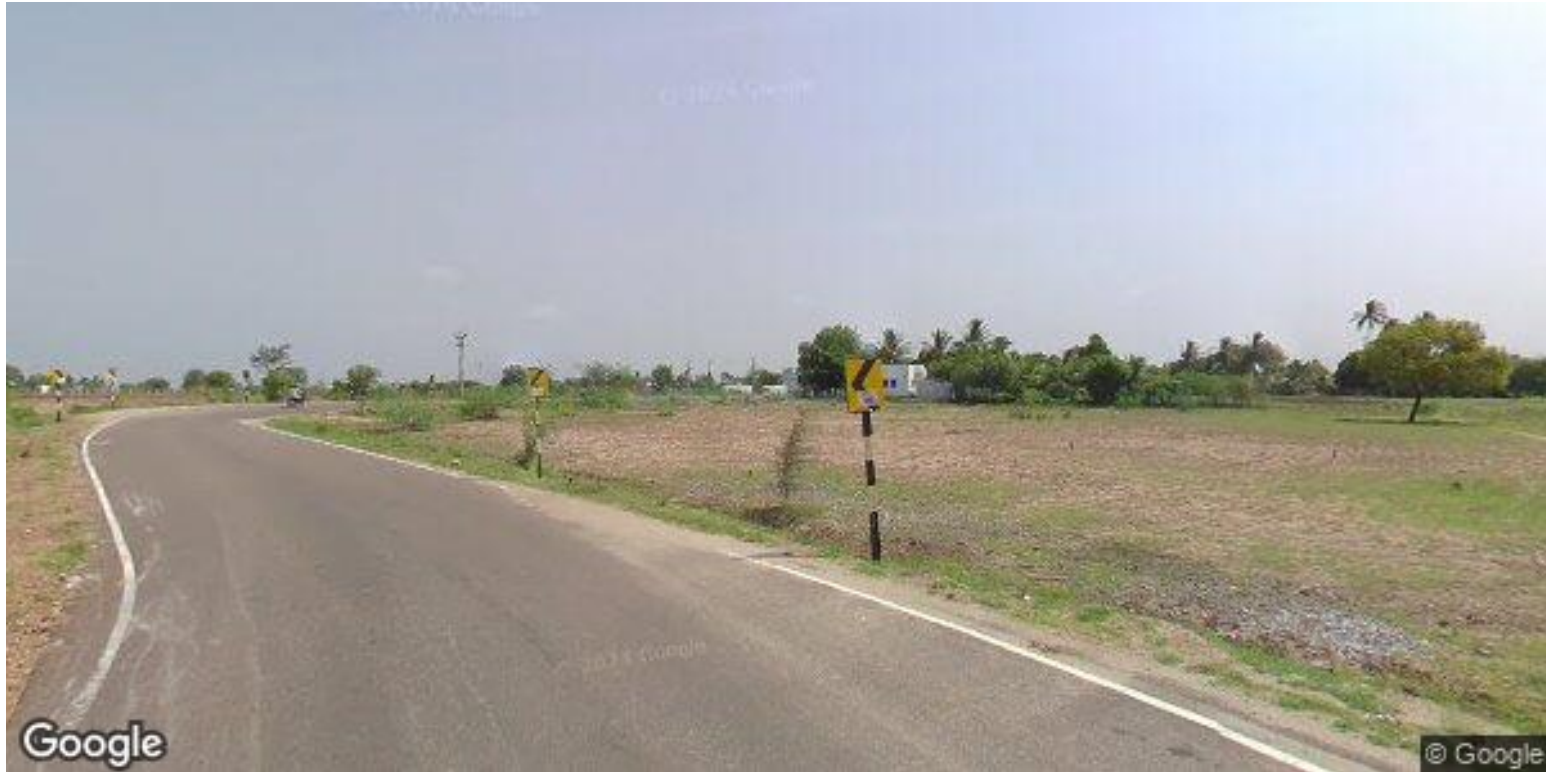
**Risk Type:** Turn  
**Risk Level:** Medium  
**Speed Limit:** 30 KM/Hr  
**Coordinates:** 10.91738, 78.23888

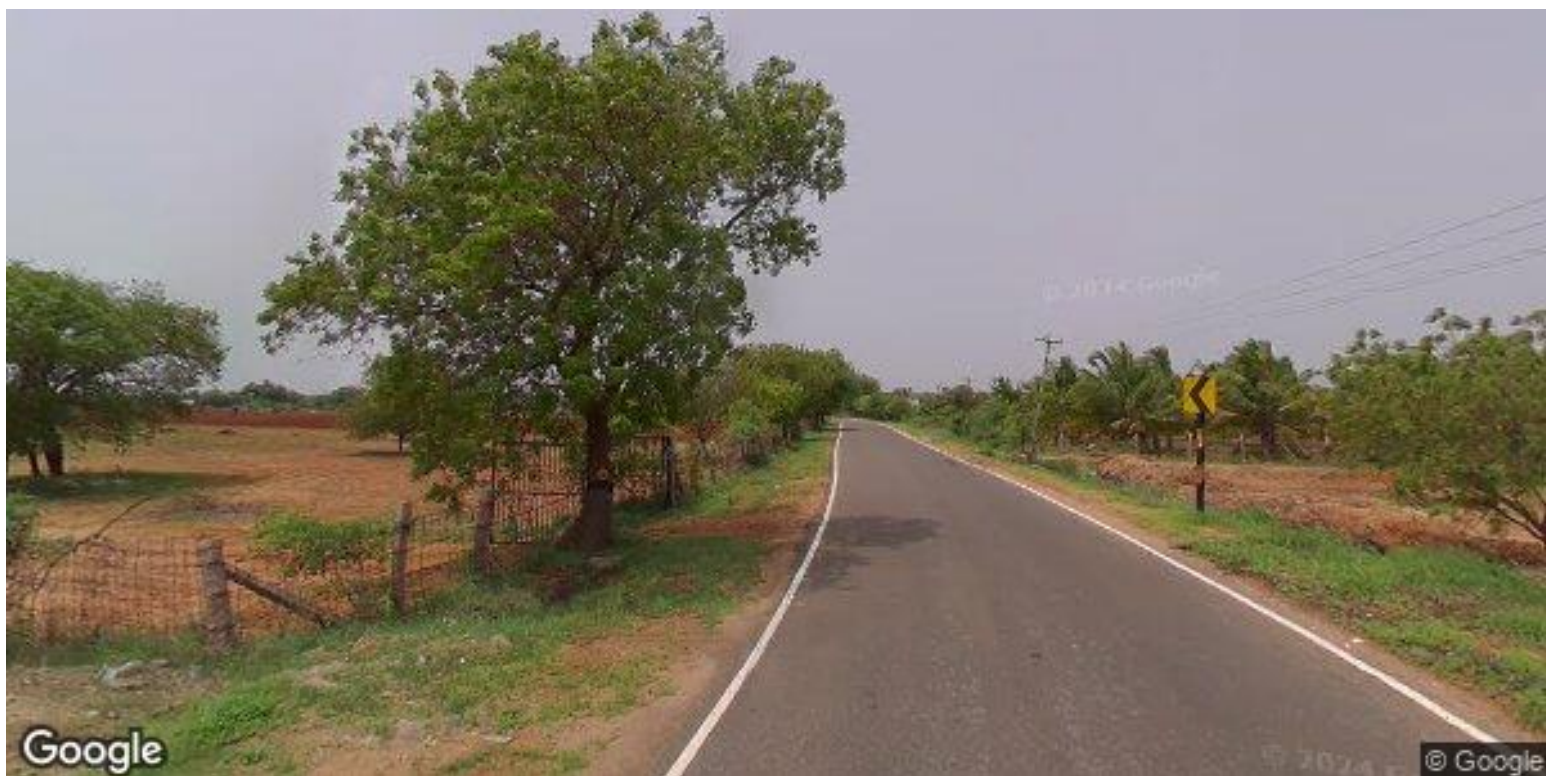
**Risk Type:** Turn  
**Risk Level:** Medium  
**Speed Limit:** 30 KM/Hr  
**Coordinates:** 10.90078, 78.23917

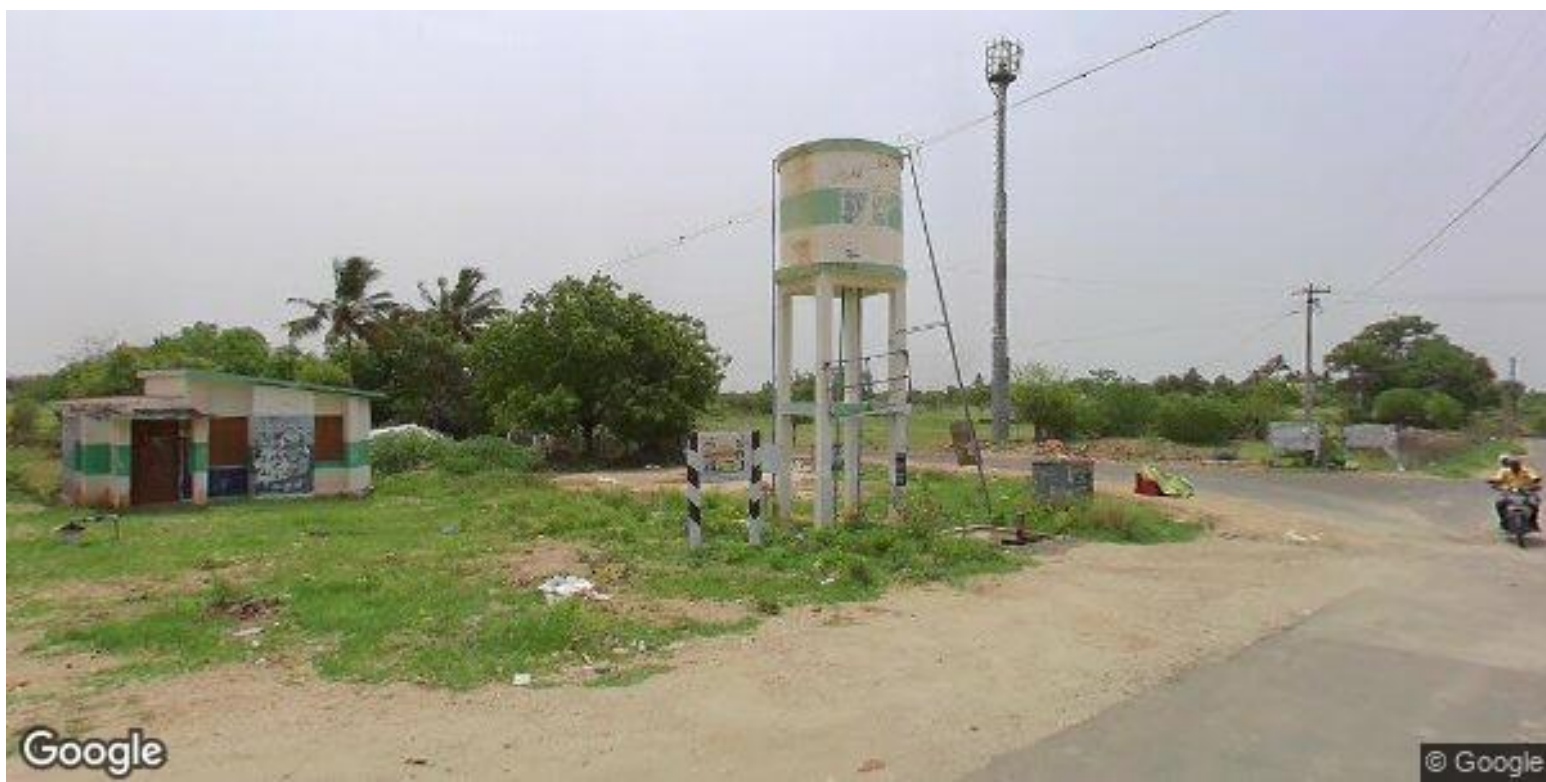
**Coordinates:** 10.89479, 78.24318

**Risk Type:** Turn

**Risk Level:** High

**Speed Limit:** 15 KM/Hr

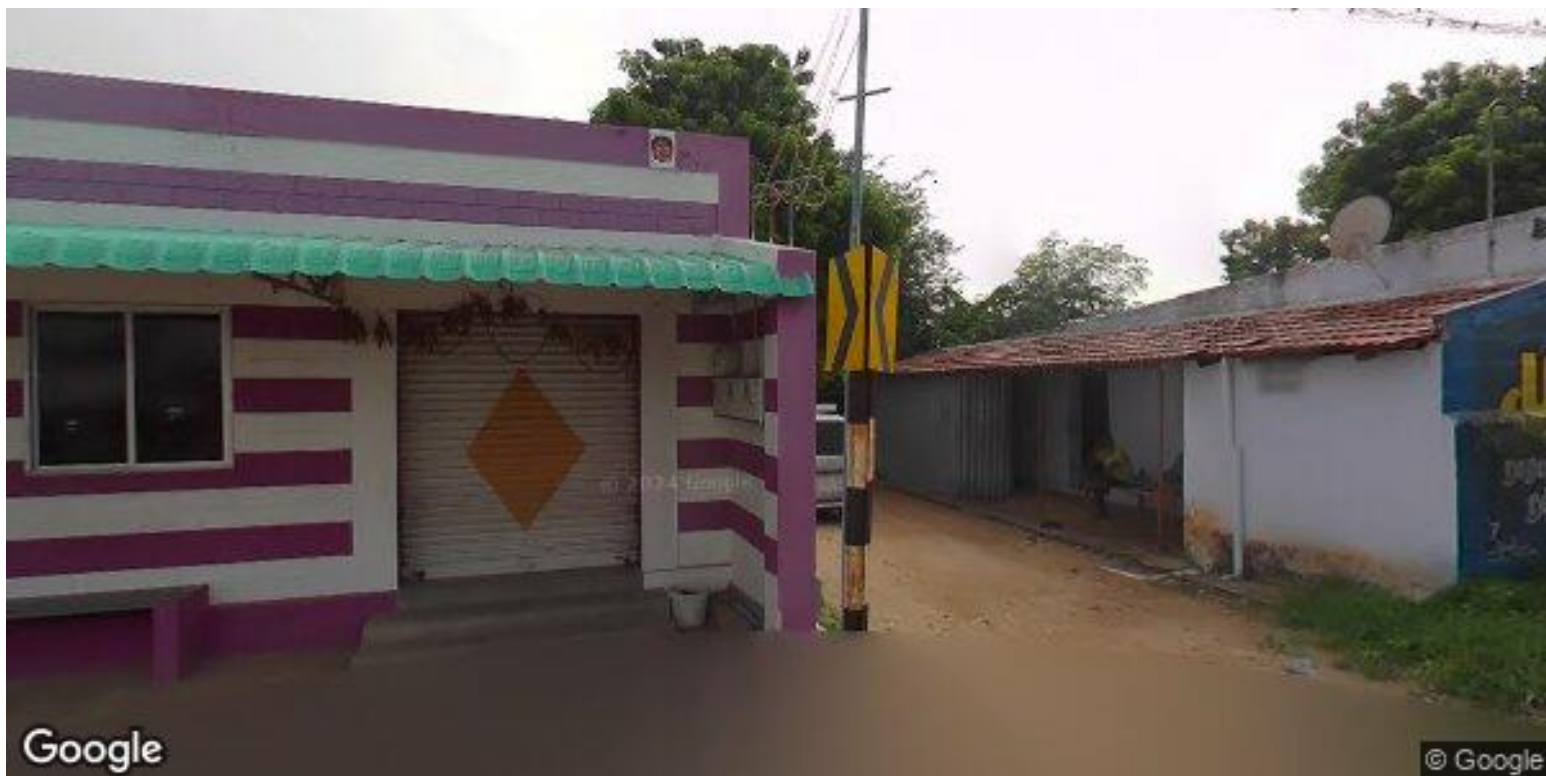
**Coordinates:** 10.89054, 78.24320

**Risk Type:** Turn

**Risk Level:** Medium

**Speed Limit:** 30 KM/Hr

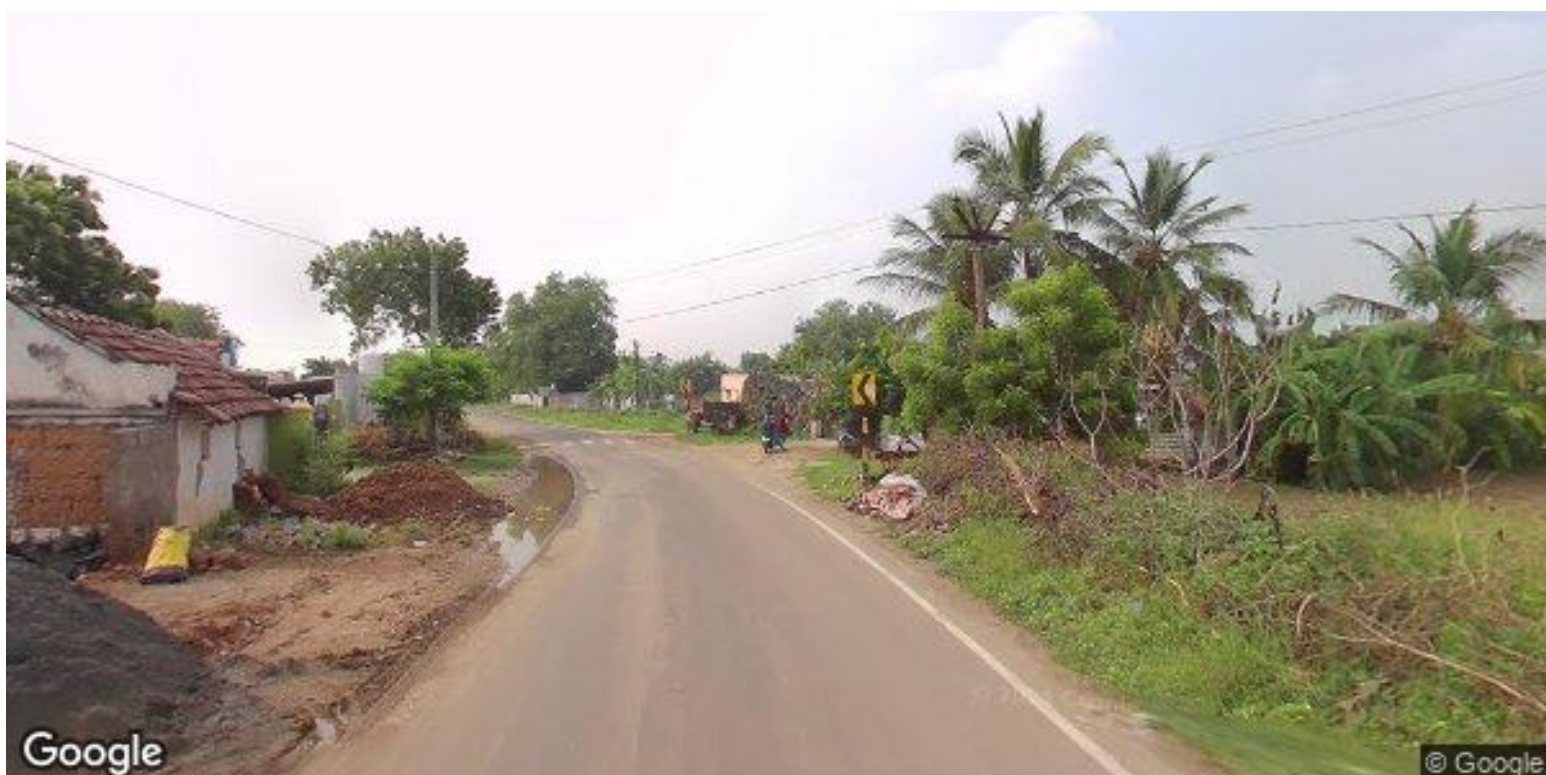
**Risk Type:** Turn  
**Risk Level:** Medium  
**Speed Limit:** 30 KM/Hr  
**Coordinates:** 10.88989, 78.24281

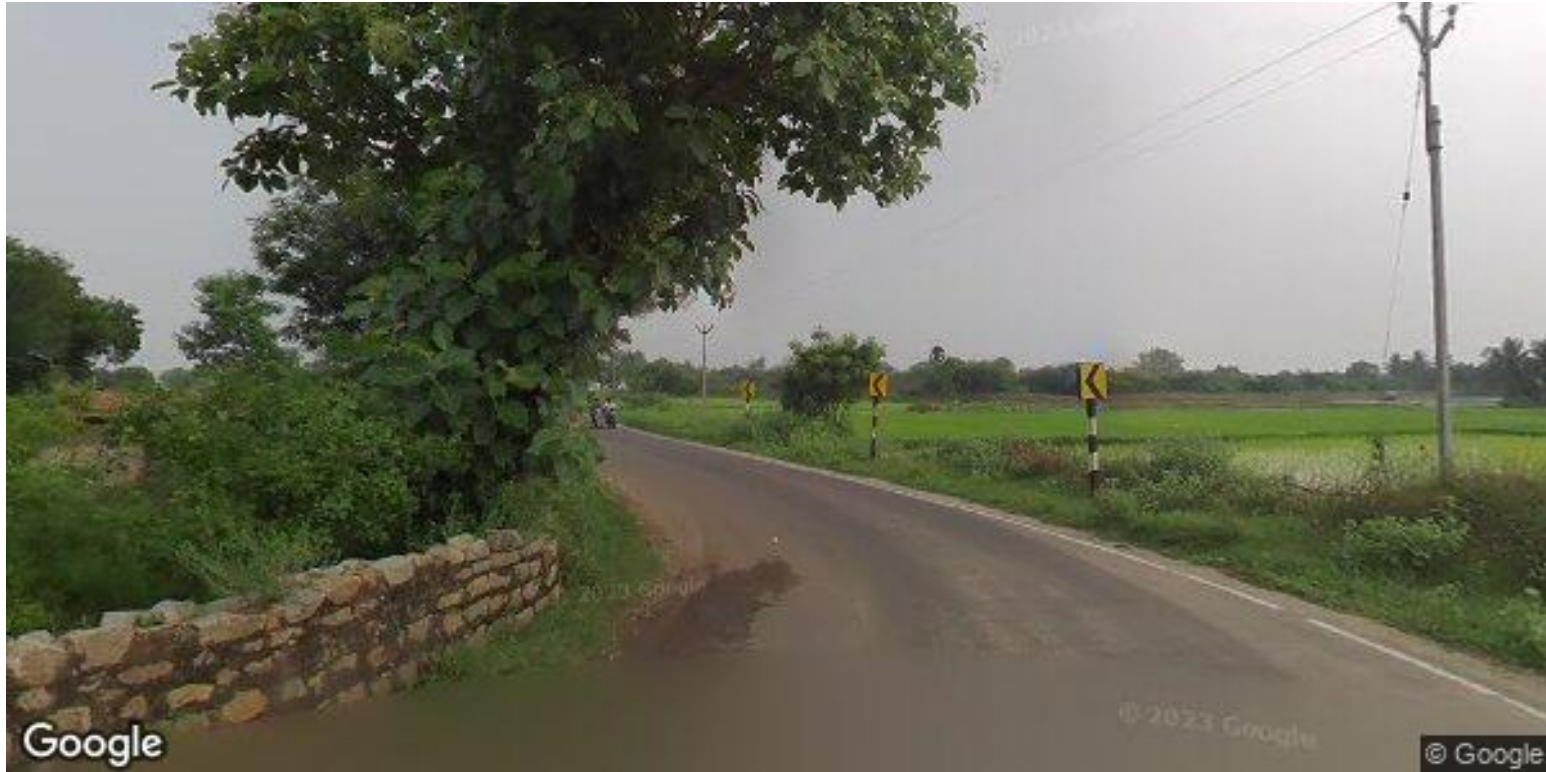
**Risk Type:** Turn  
**Risk Level:** High  
**Speed Limit:** 15 KM/Hr  
**Coordinates:** 10.88000, 78.24306

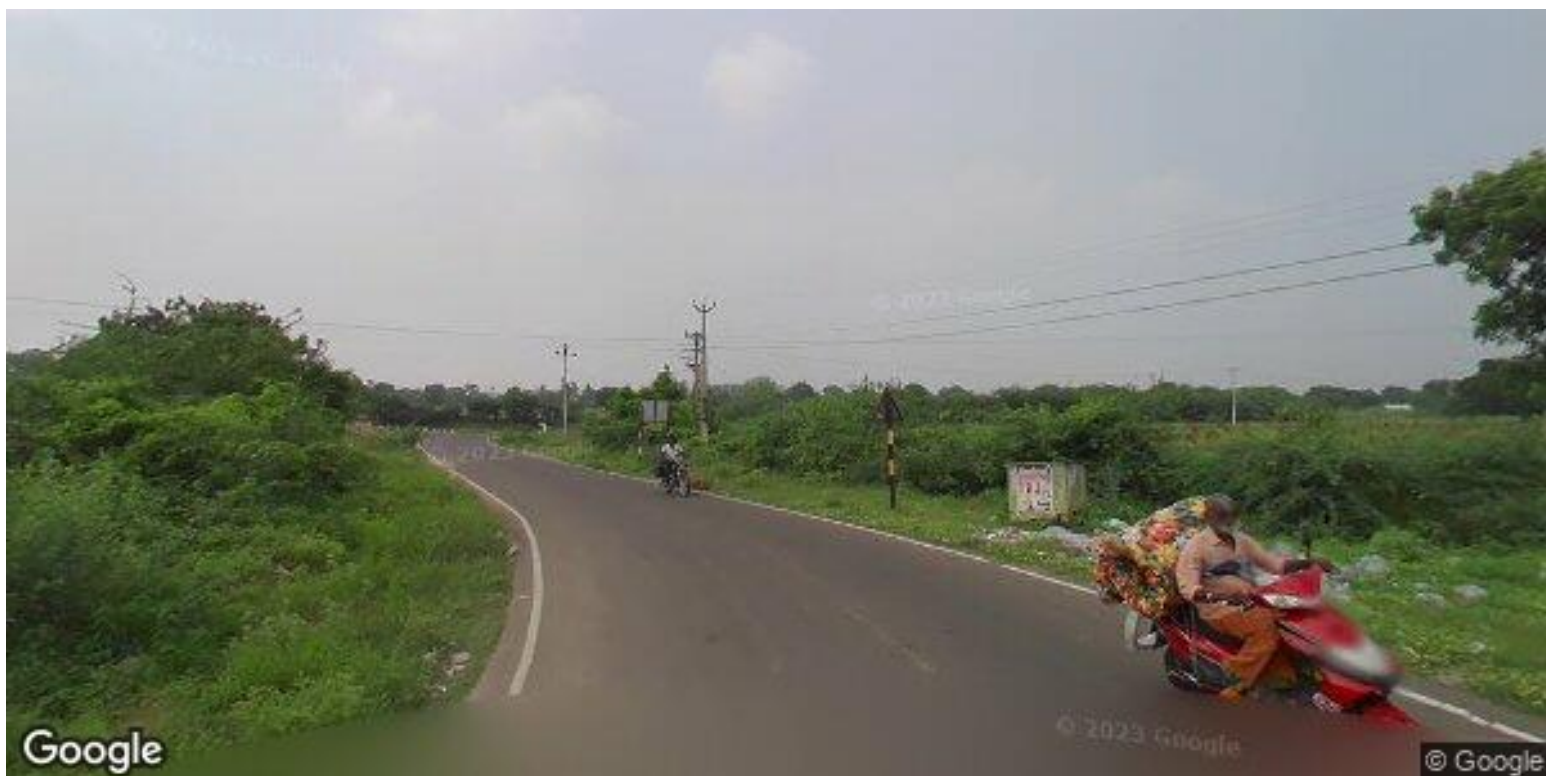
**Risk Type:** Turn  
**Risk Level:** High  
**Speed Limit:** 15 KM/Hr  
**Coordinates:** 10.87955, 78.24645

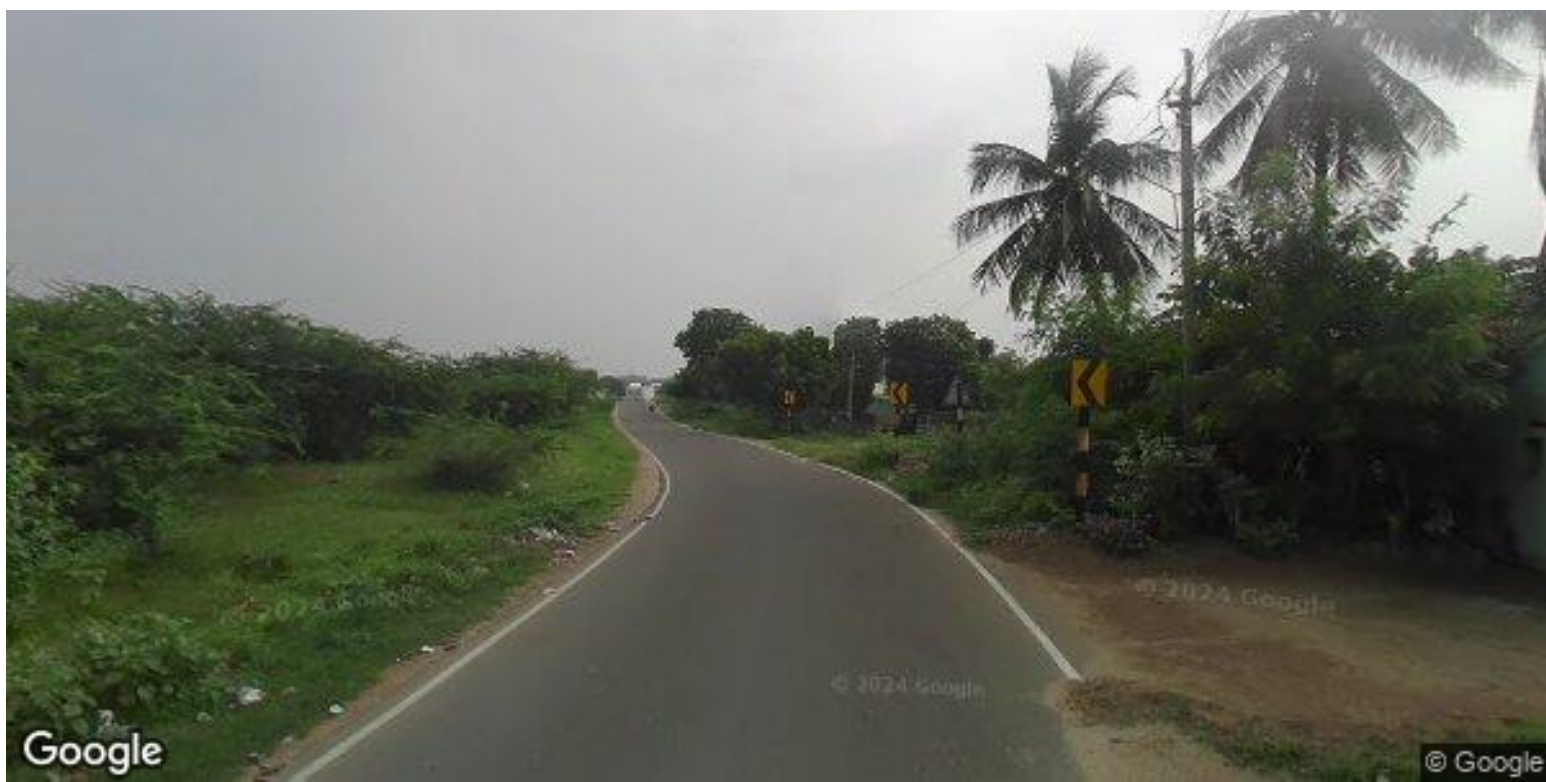
**Coordinates:** 10.87709, 78.24676

**Risk Type:** Turn

**Risk Level:** Medium

**Speed Limit:** 30 KM/Hr

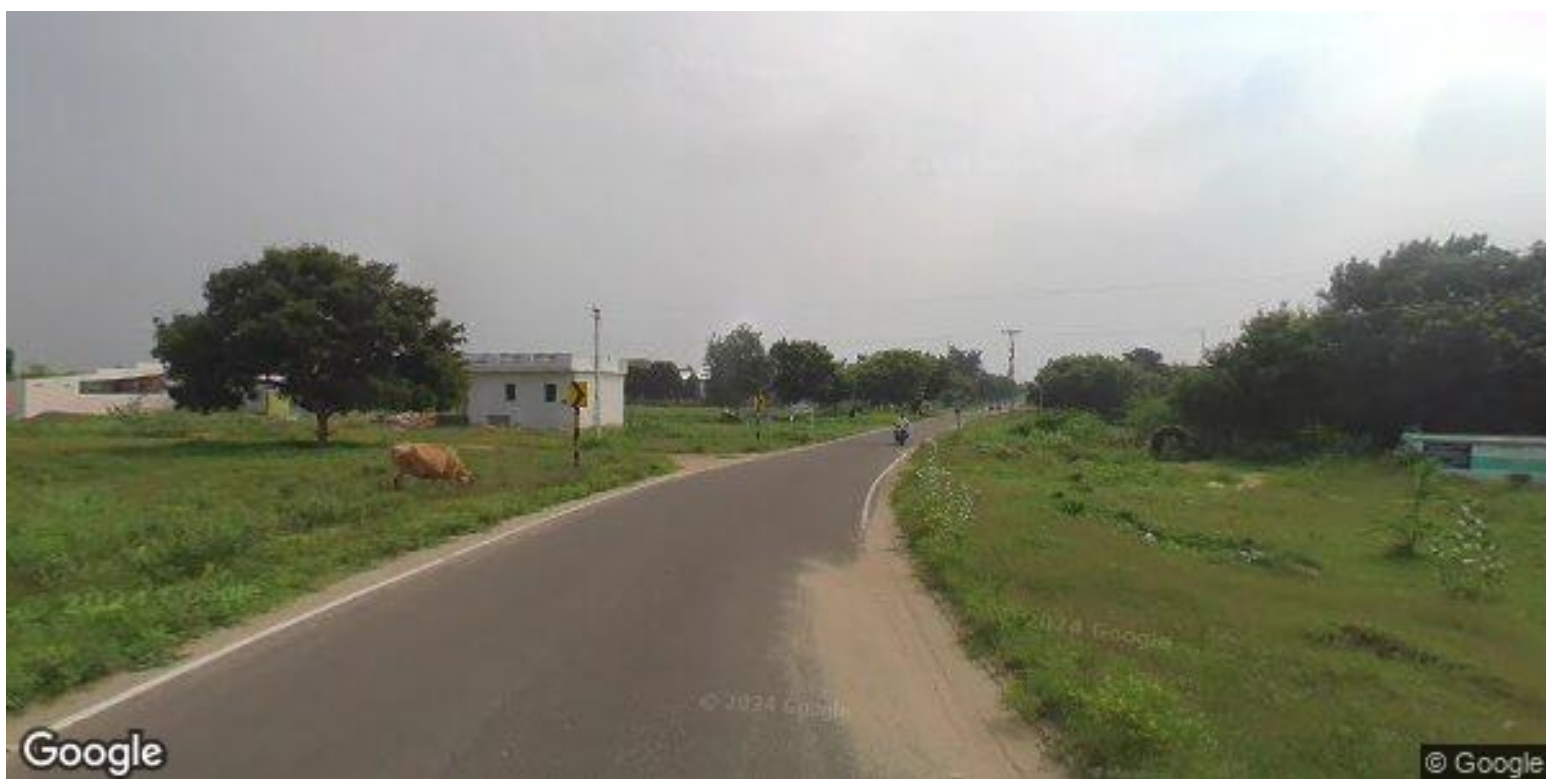
**Coordinates:** 10.87552, 78.24781

**Risk Type:** Turn

**Risk Level:** Medium

**Speed Limit:** 30 KM/Hr
