# IndianOil

## JOURNEY RISK MANAGEMENT (JRM) STUDY

### Salem Terminal to TAMILARASI FUELS

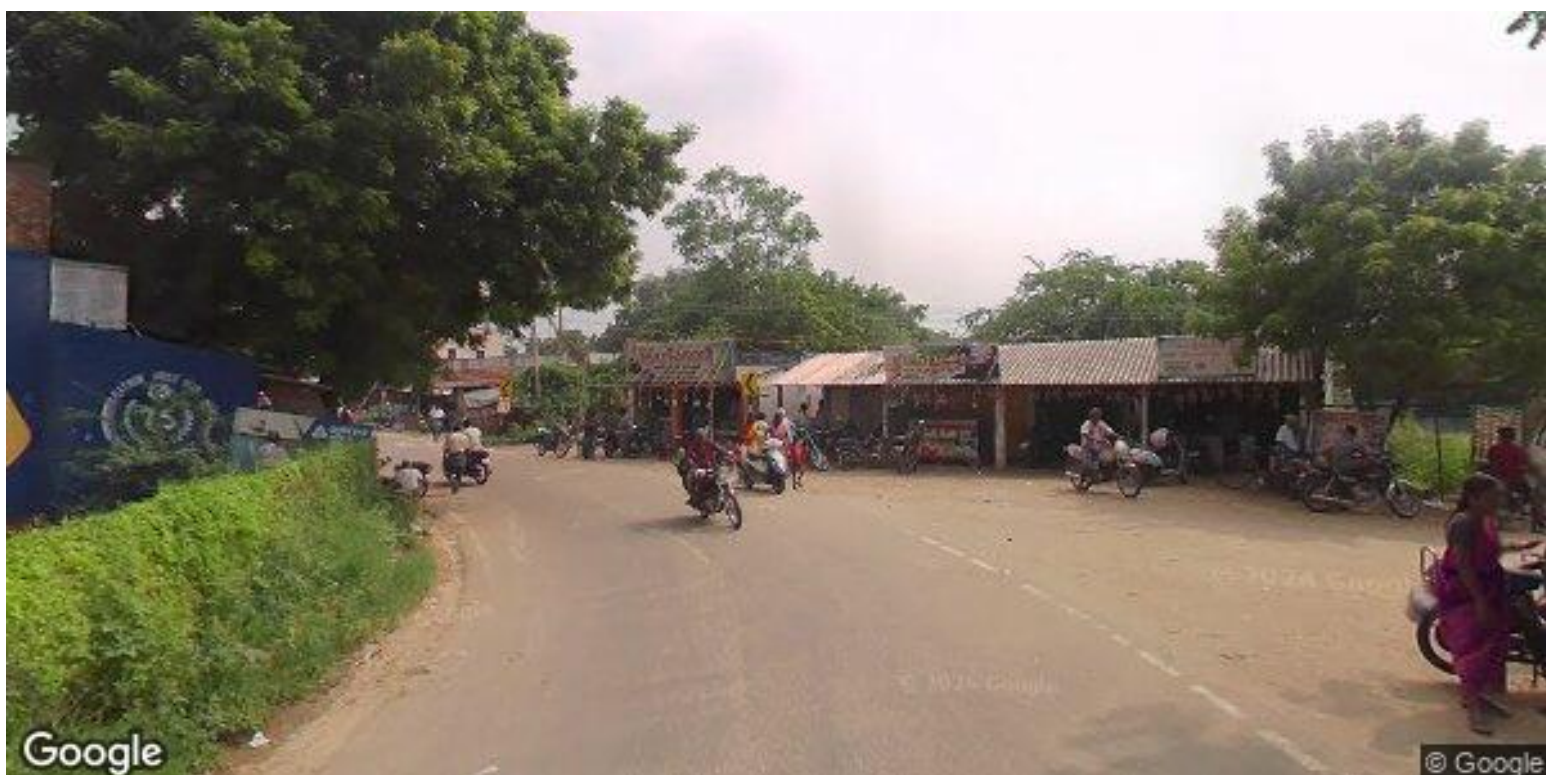
**Risk Type:** Turn  
**Risk Level:** High  
**Speed Limit:** 15 KM/Hr  
**Coordinates:** 10.86831, 78.24800

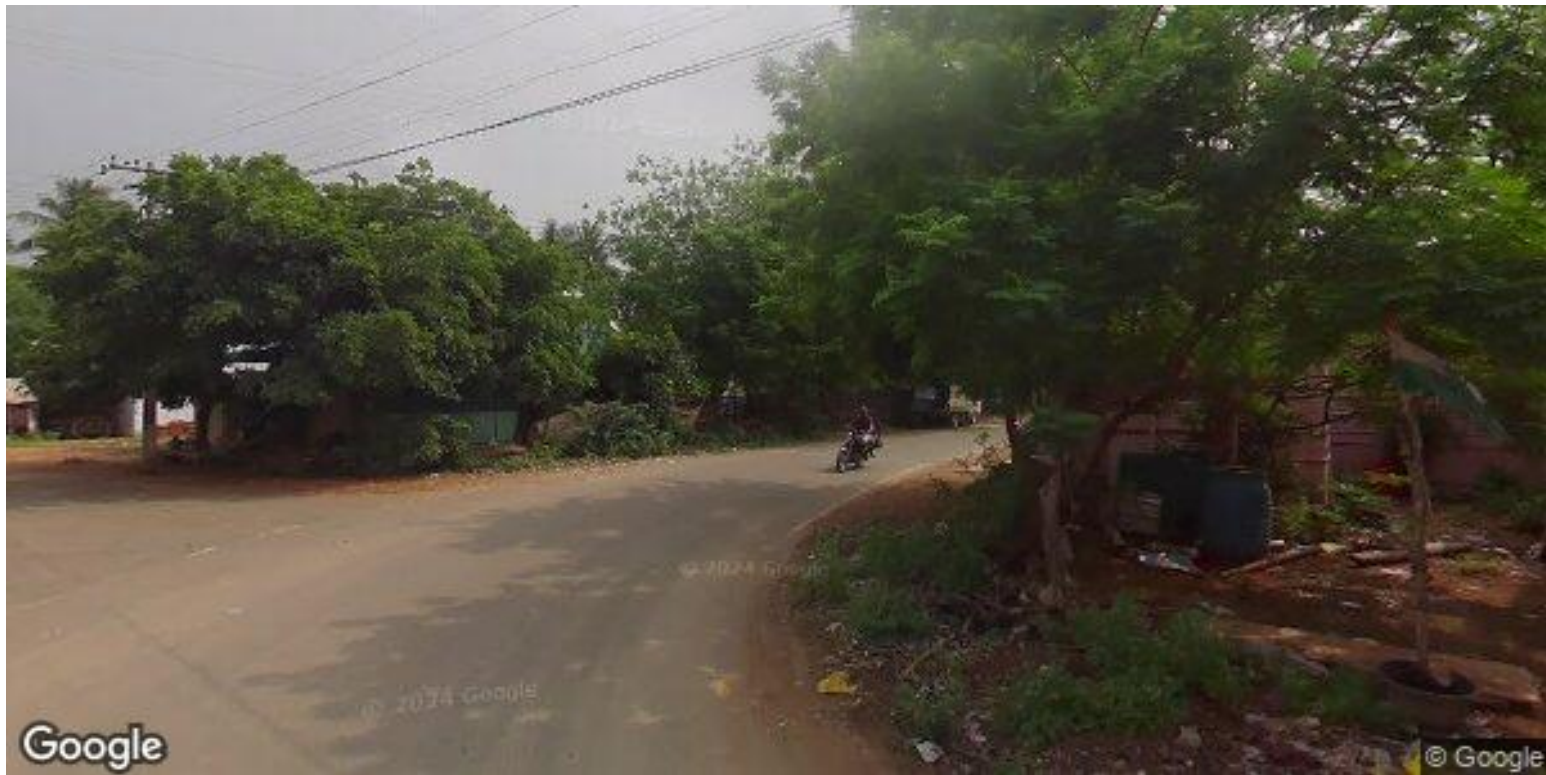
**Risk Type:** Turn  
**Risk Level:** High  
**Speed Limit:** 15 KM/Hr  
**Coordinates:** 10.86764, 78.25008

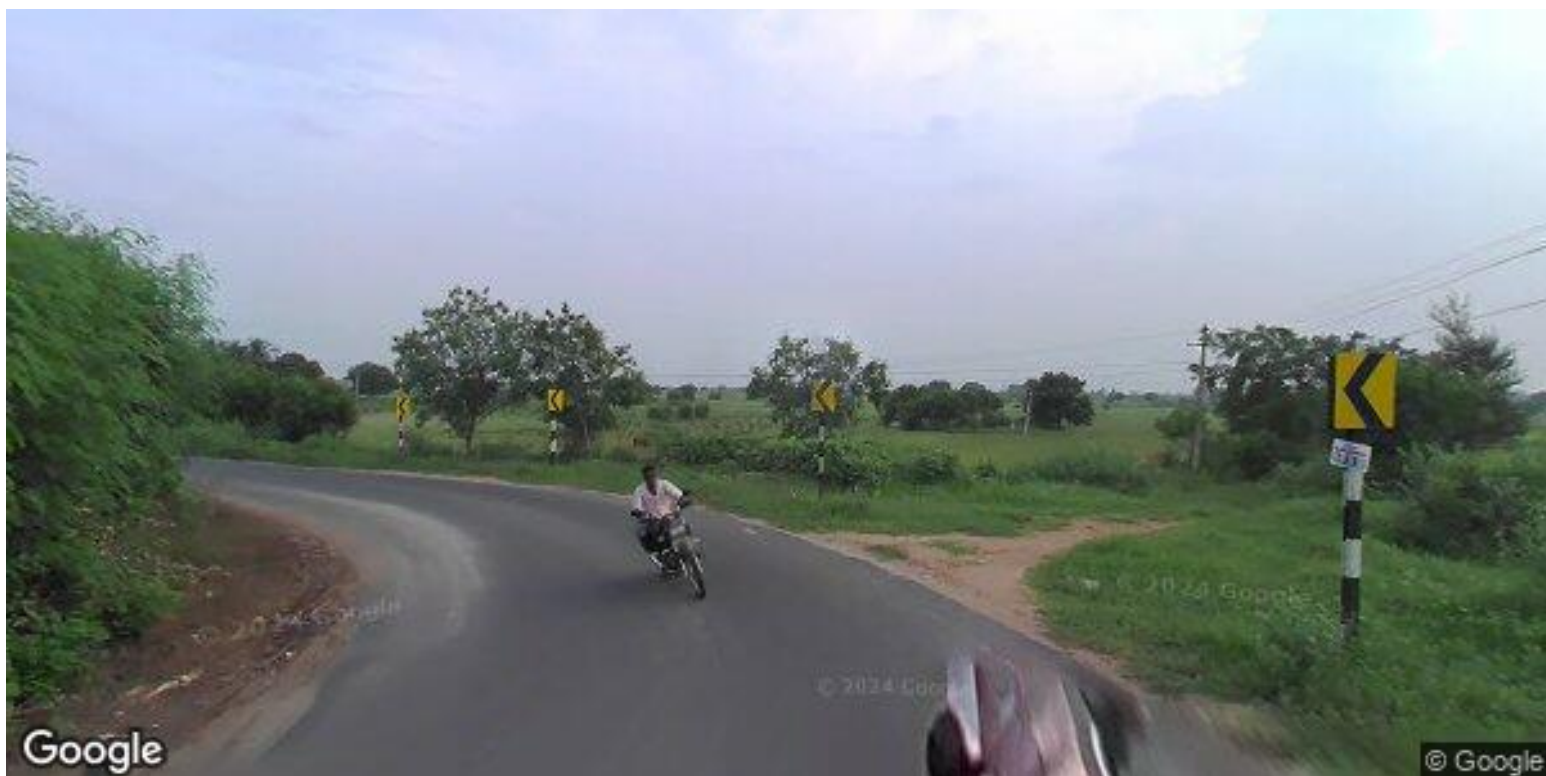
**Risk Type:** Turn  
**Risk Level:** High  
**Speed Limit:** 15 KM/Hr  
**Coordinates:** 10.86378, 78.24971

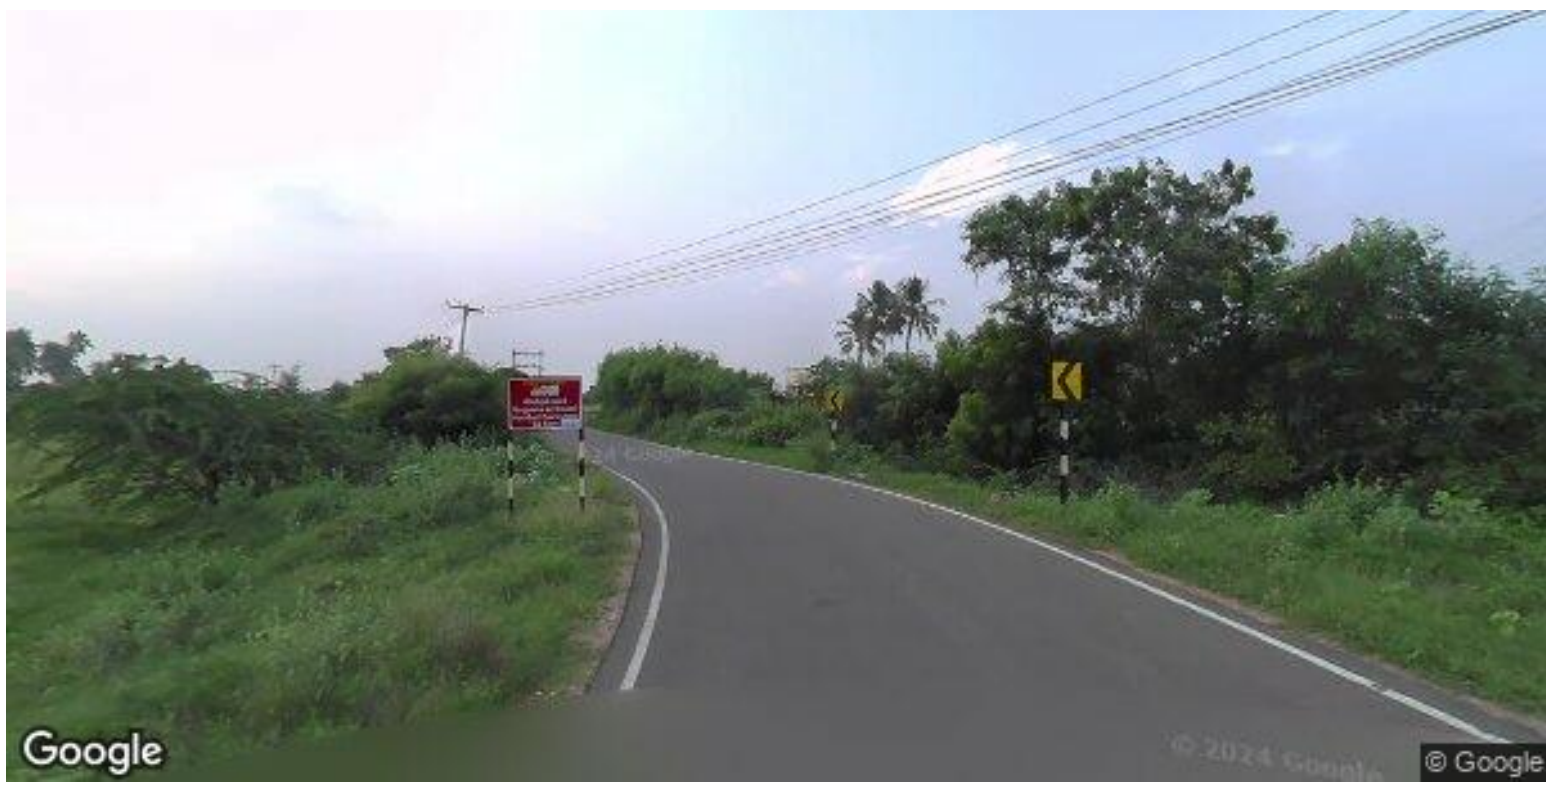
**Coordinates:** 10.86348, 78.25042

**Risk Type:** Turn

**Risk Level:** High

**Speed Limit:** 15 KM/Hr

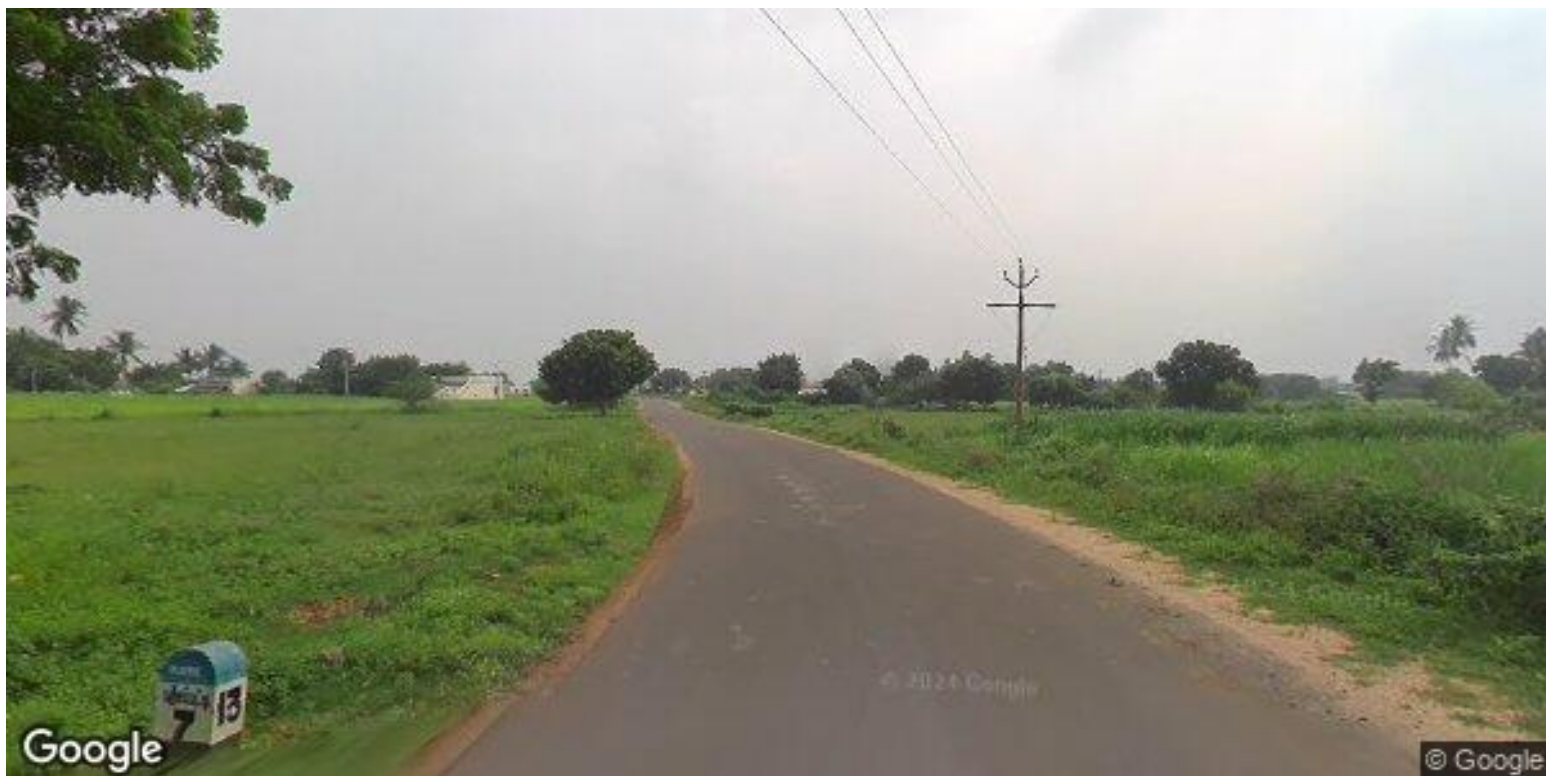
**Coordinates:** 10.85148, 78.25293

**Risk Type:** Turn

**Risk Level:** Medium

**Speed Limit:** 30 KM/Hr

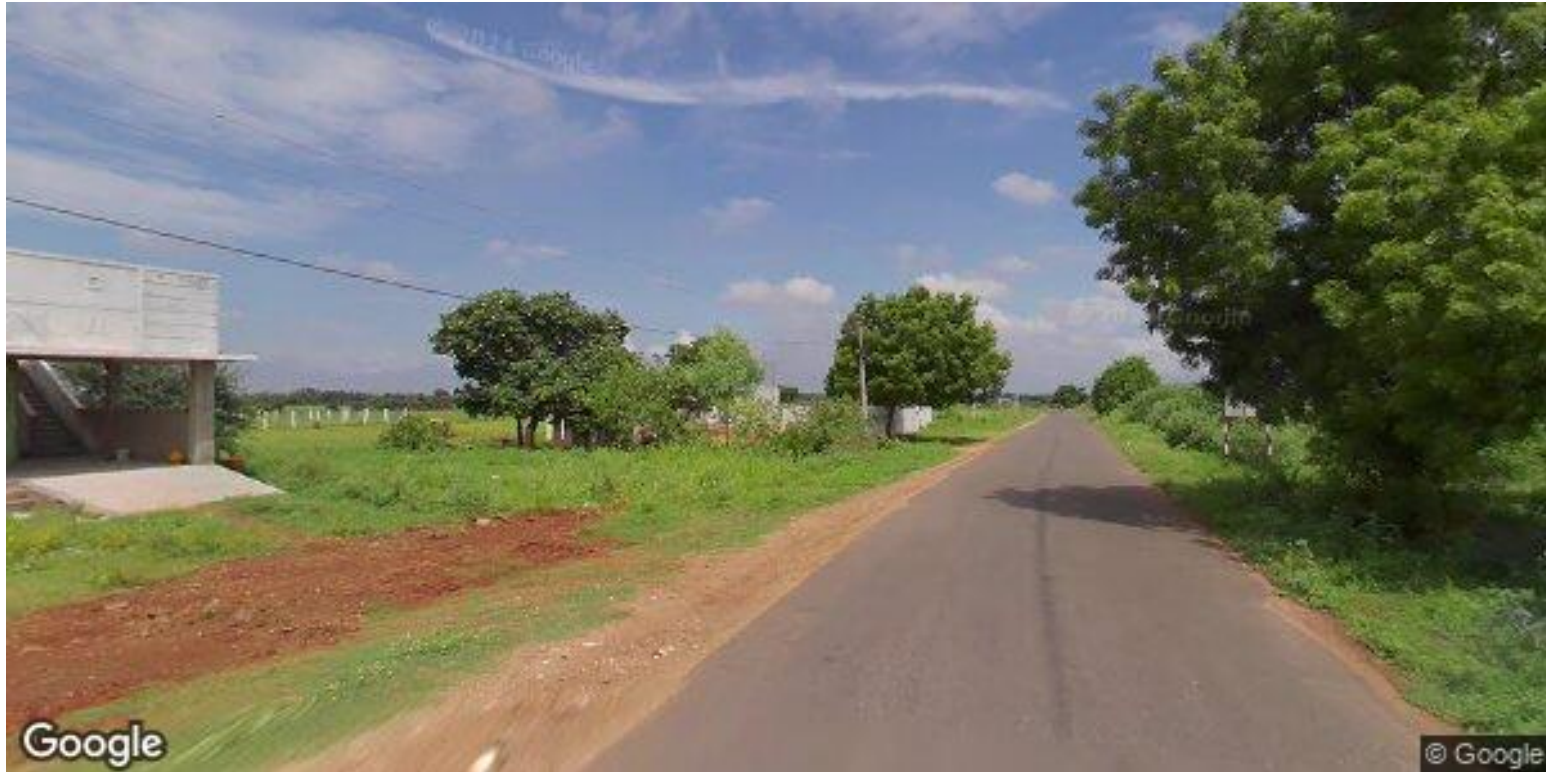
**Risk Type:** Turn  
**Risk Level:** Medium  
**Speed Limit:** 30 KM/Hr  
**Coordinates:** 10.84294, 78.25857

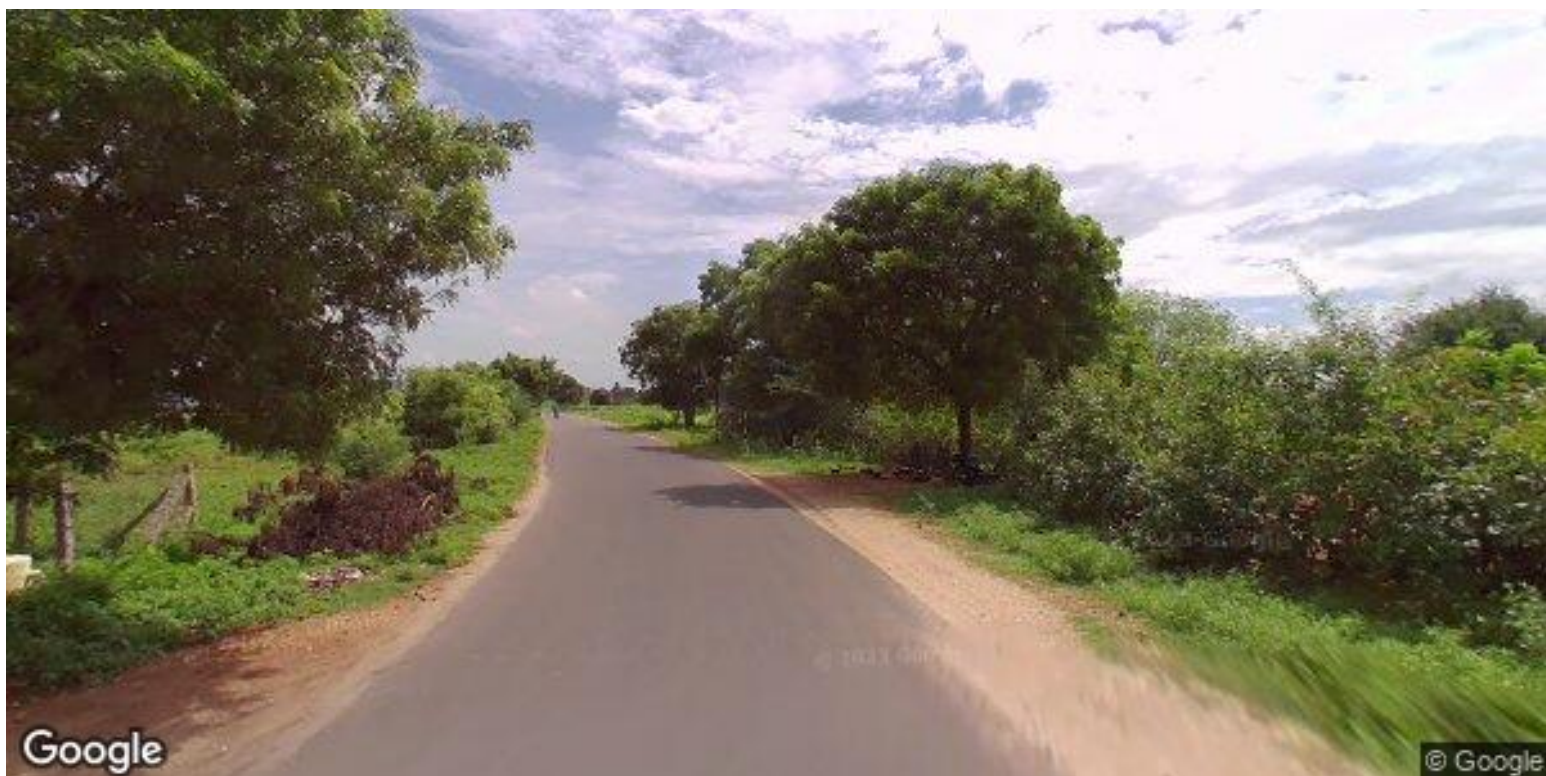
**Risk Type:** Turn  
**Risk Level:** High  
**Speed Limit:** 15 KM/Hr  
**Coordinates:** 10.84262, 78.25876

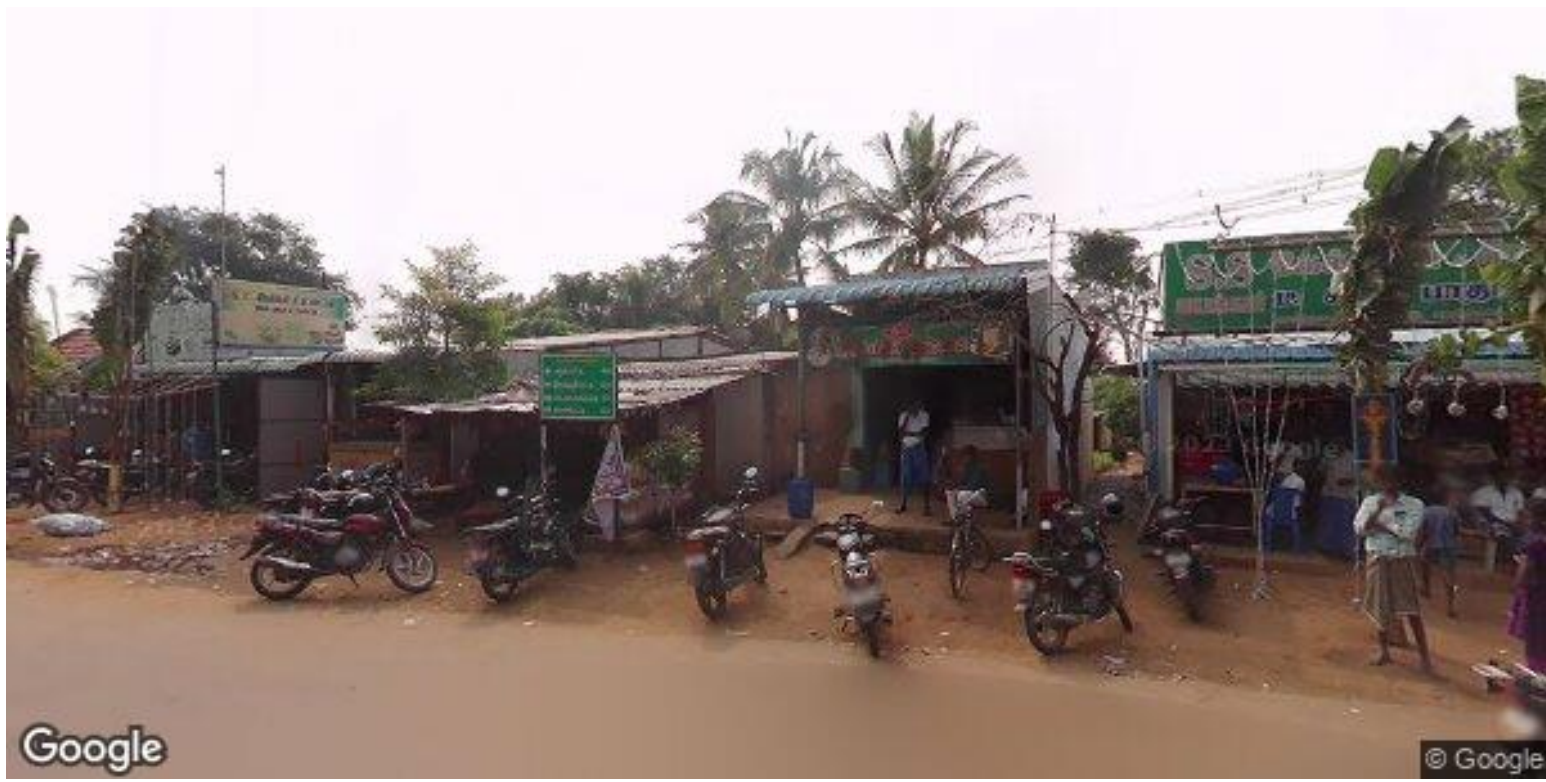
**Coordinates:** 10.83209, 78.27386

**Risk Type:** Turn

**Risk Level:** High

**Speed Limit:** 15 KM/Hr

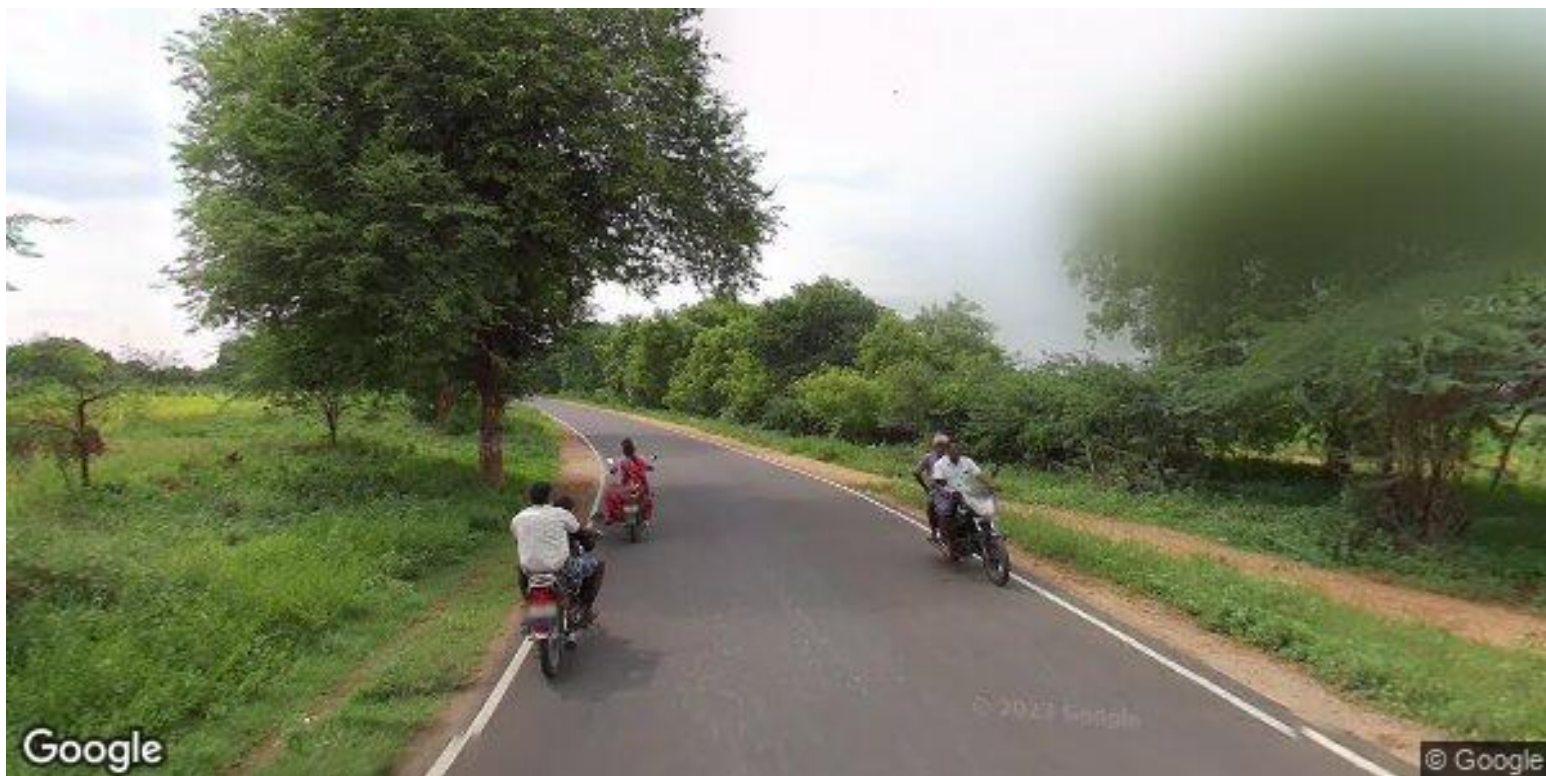
**Coordinates:** 10.83268, 78.27737

**Risk Type:** Turn

**Risk Level:** Medium

**Speed Limit:** 30 KM/Hr

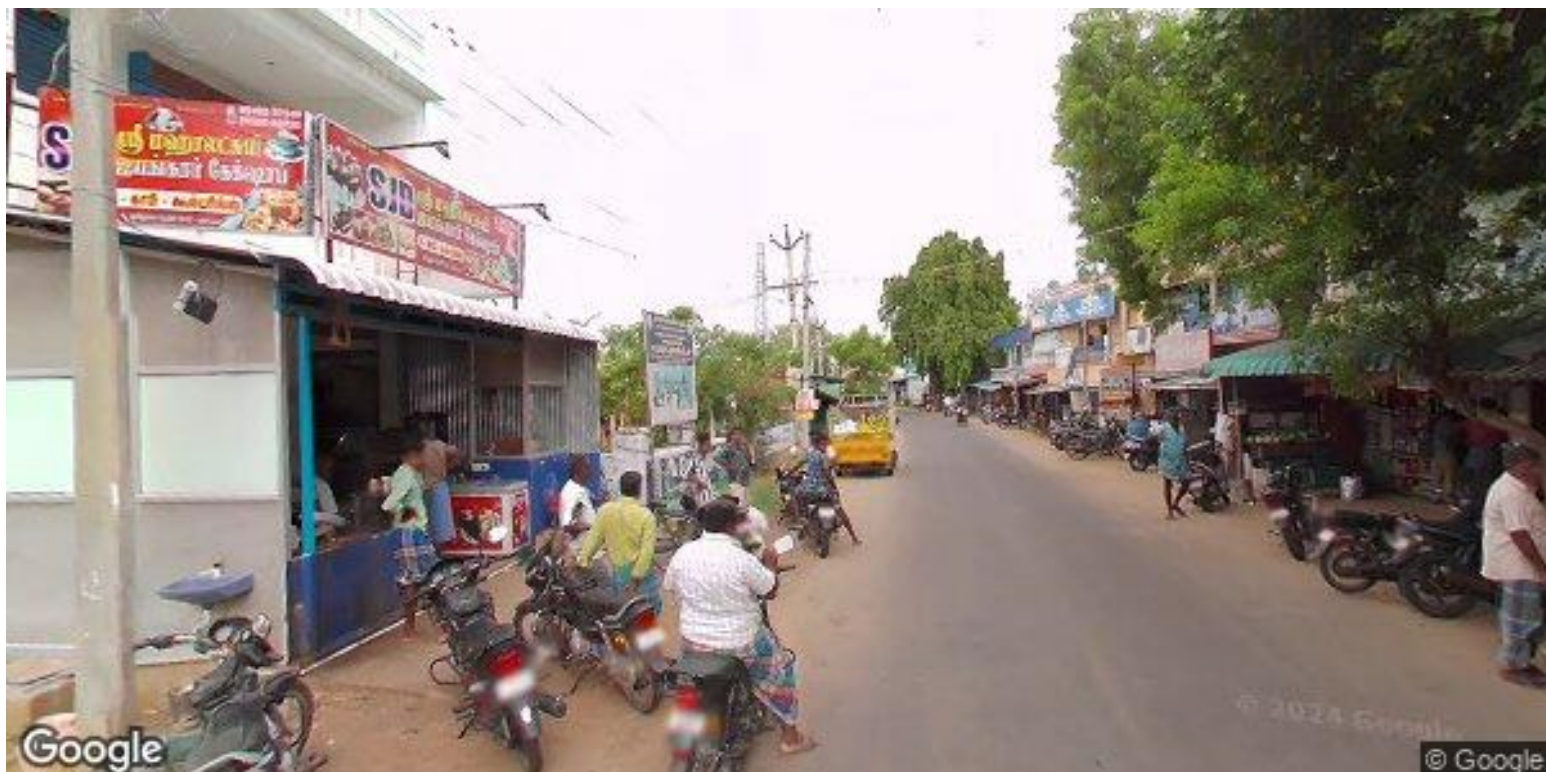
**Risk Type:** Turn  
**Risk Level:** Medium  
**Speed Limit:** 30 KM/Hr  
**Coordinates:** 10.82937, 78.30703

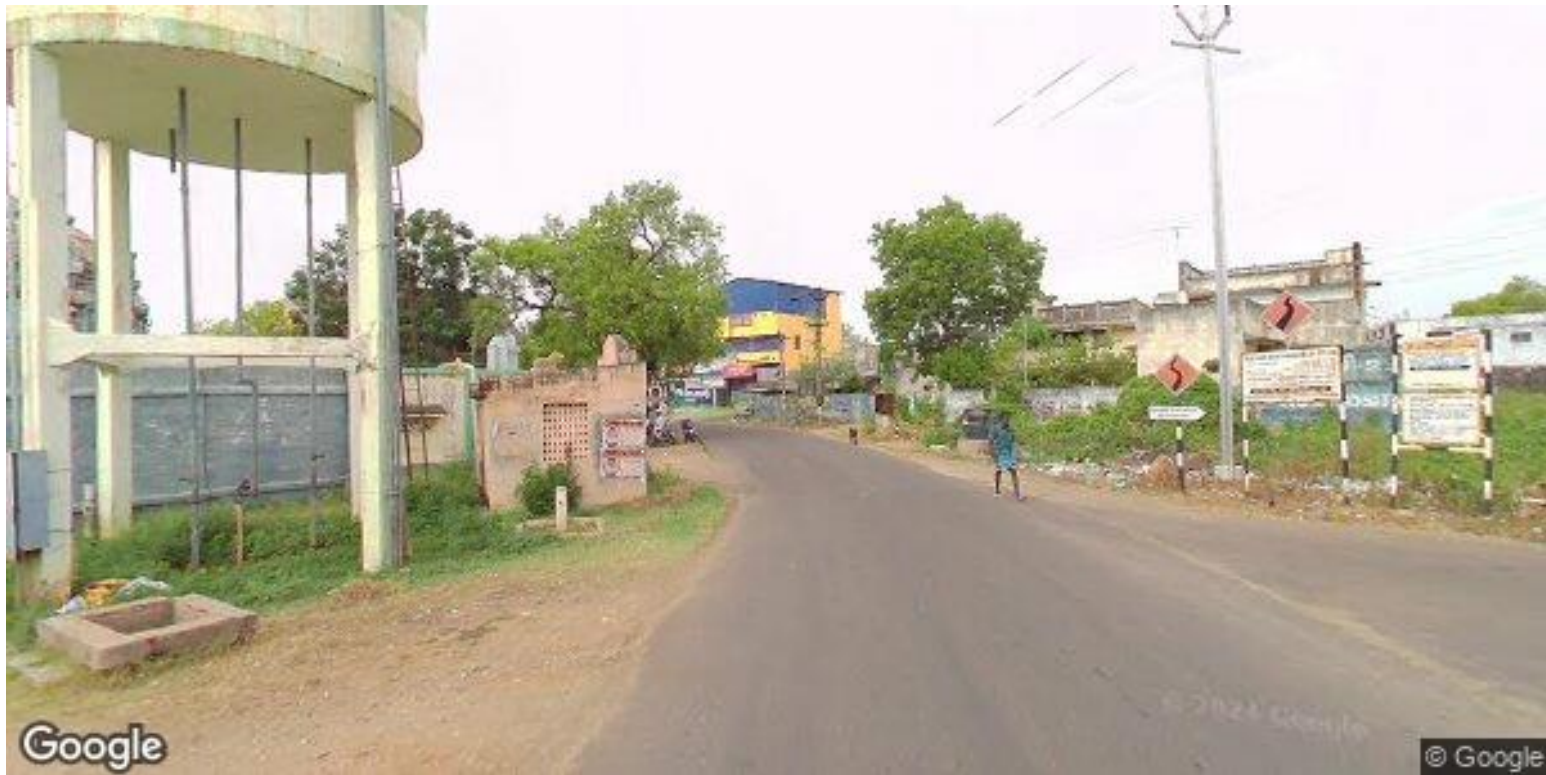
**Risk Type:** Turn  
**Risk Level:** High  
**Speed Limit:** 15 KM/Hr  
**Coordinates:** 10.82922, 78.30825

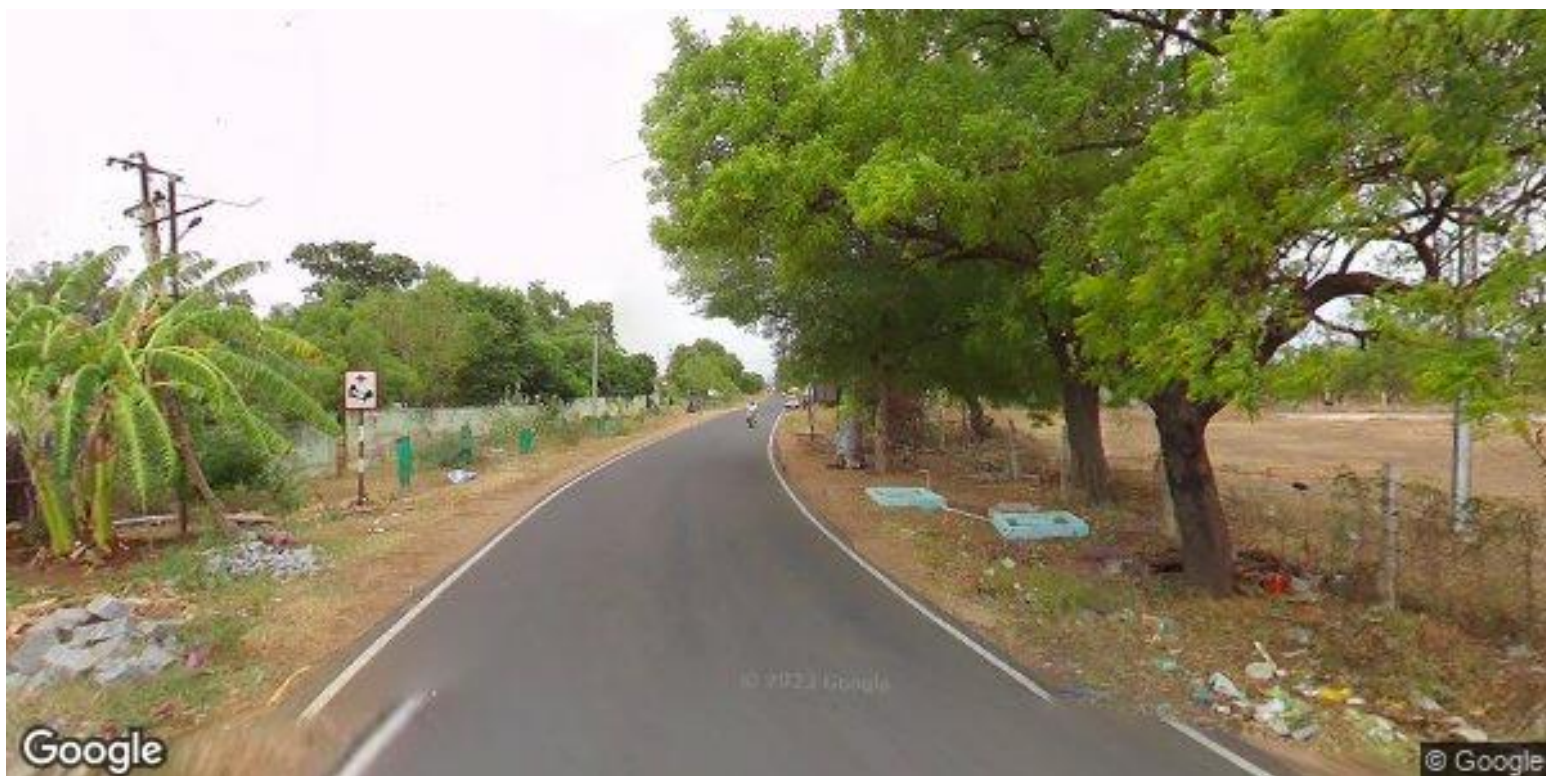
**Risk Type:** Turn  
**Risk Level:** High  
**Speed Limit:** 15 KM/Hr  
**Coordinates:** 10.83059, 78.30942

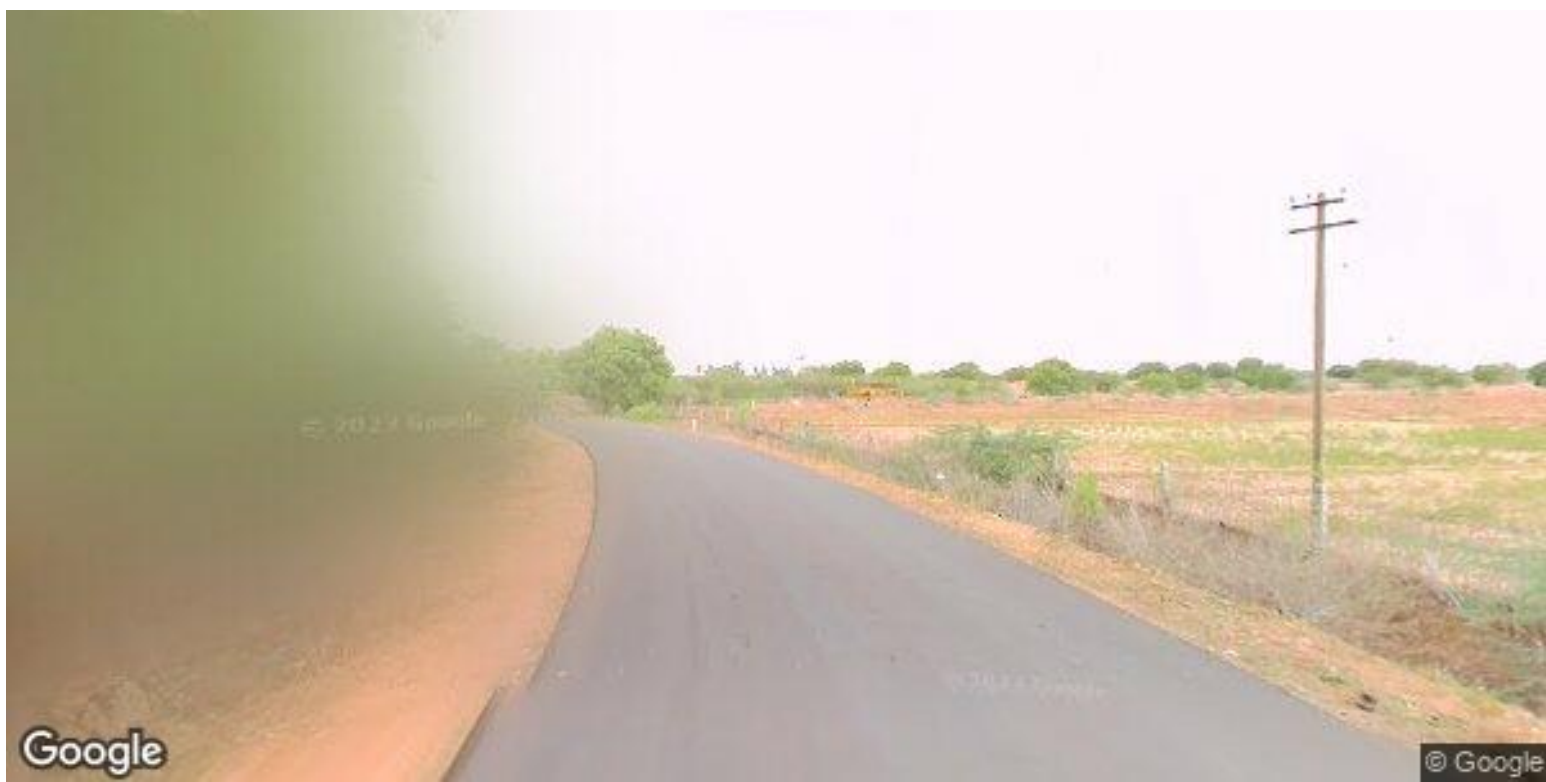
**Coordinates:** 10.83149, 78.32134

**Risk Type:** Turn

**Risk Level:** Medium

**Speed Limit:** 30 KM/Hr

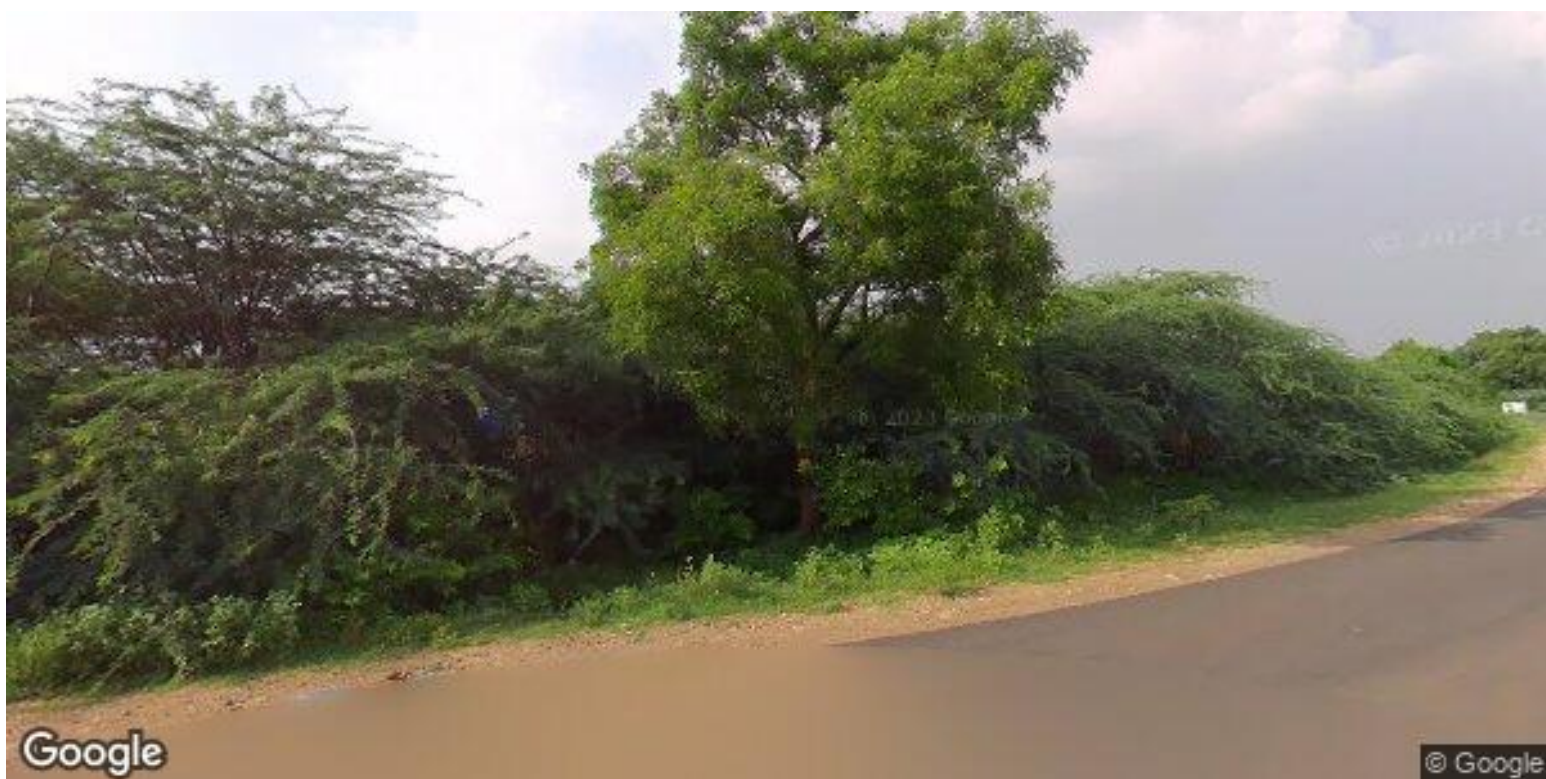
**Coordinates:** 10.83174, 78.32242

**Risk Type:** Turn

**Risk Level:** Medium

**Speed Limit:** 30 KM/Hr

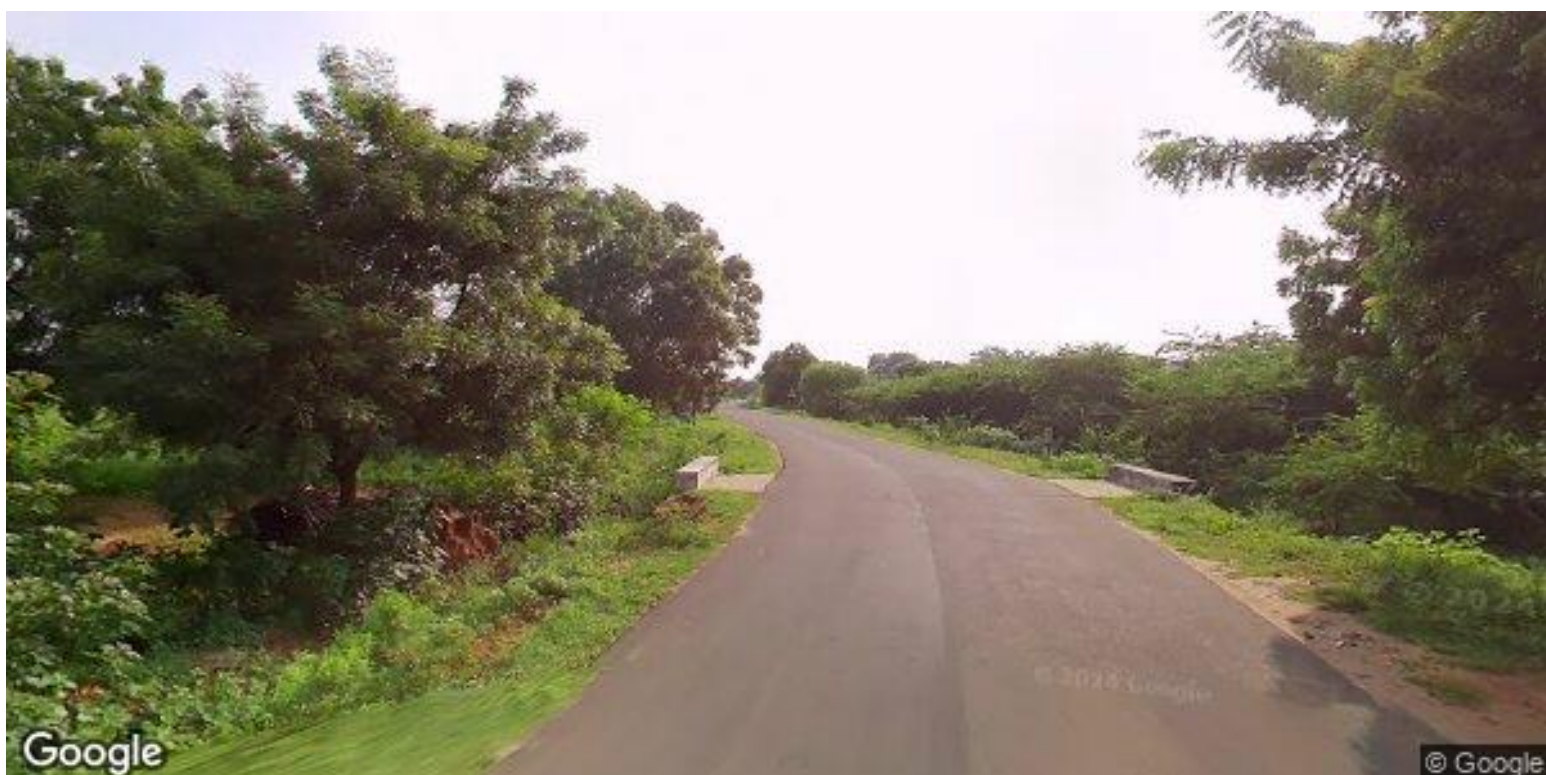
**Risk Type:** Turn  
**Risk Level:** High  
**Speed Limit:** 15 KM/Hr  
**Coordinates:** 10.83317, 78.32326

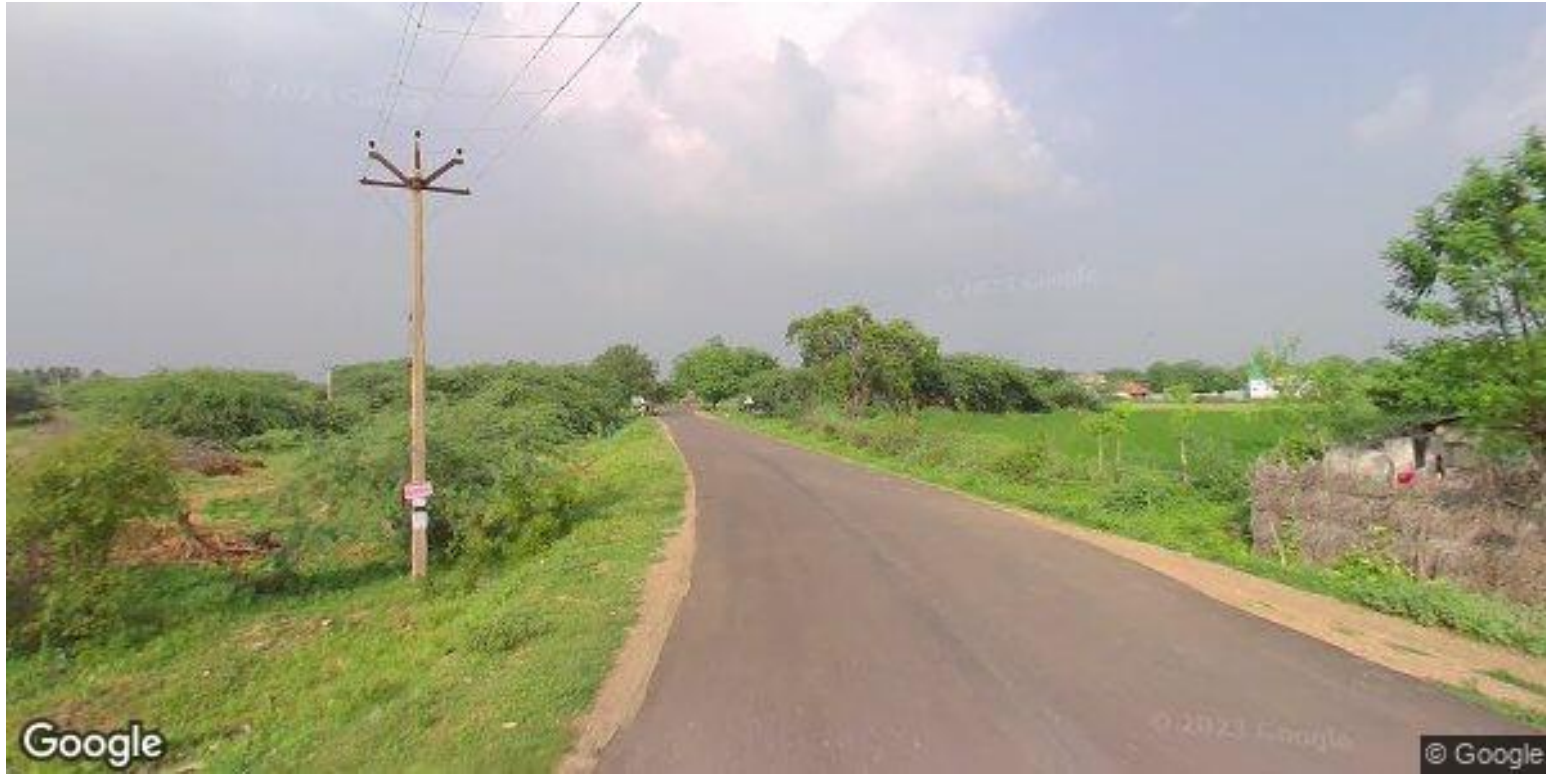
**Risk Type:** Turn  
**Risk Level:** Medium  
**Speed Limit:** 30 KM/Hr  
**Coordinates:** 10.83451, 78.32852

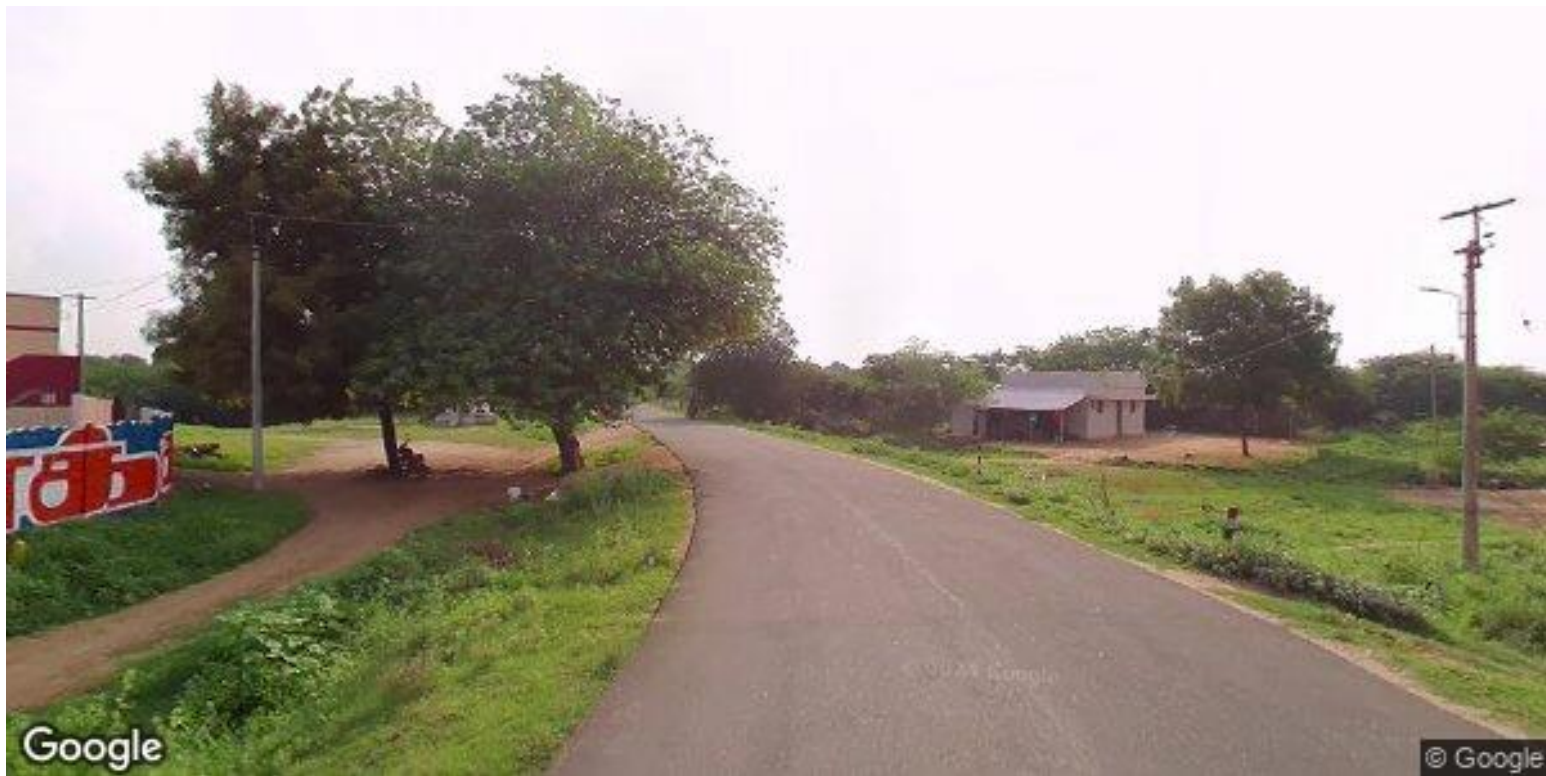
**Risk Type:** Turn  
**Risk Level:** Medium  
**Speed Limit:** 30 KM/Hr  
**Coordinates:** 10.83567, 78.32940

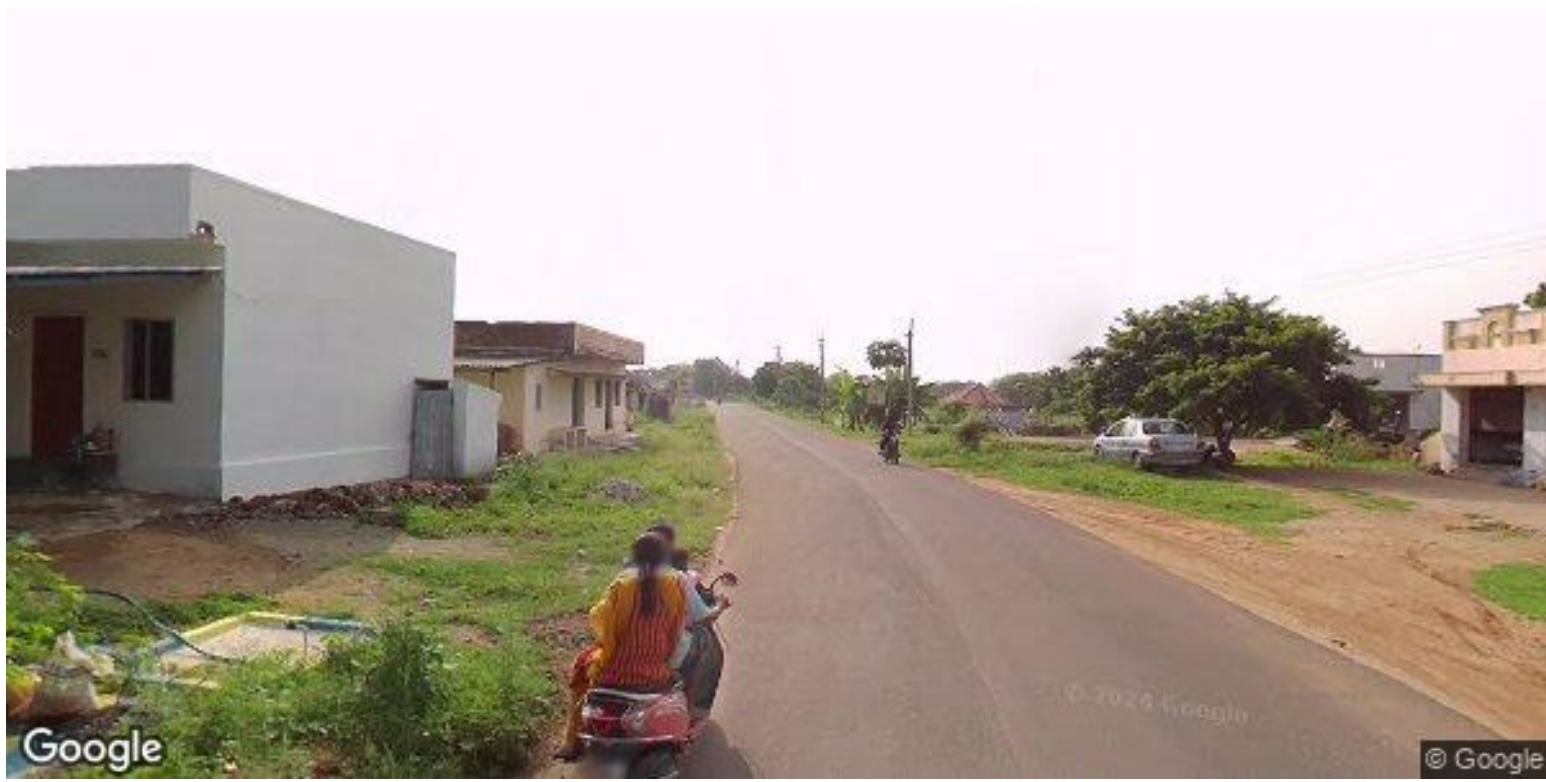
**Coordinates:** 10.83598, 78.33039

**Risk Type:** Turn

**Risk Level:** Medium

**Speed Limit:** 30 KM/Hr
