# IndianOil

## **JOURNEY RISK MANAGEMENT (JRM) STUDY**

### **Salem Terminal to SRI SELVA NITHI AGENCIES**

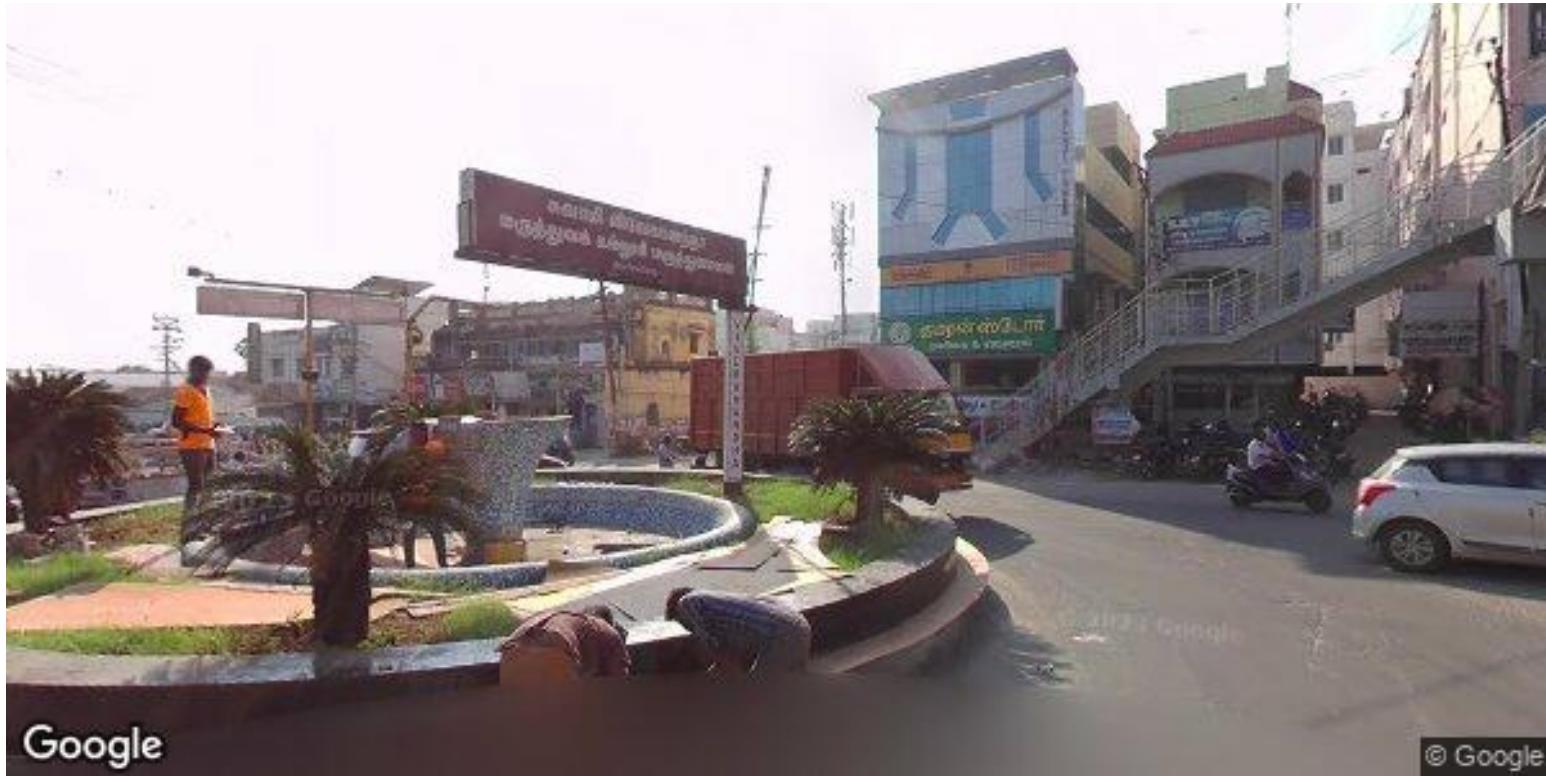
**Coordinates:** 11.38395, 77.89480

**Risk Type:** Roundabout

**Risk Level:** High

**Speed Limit:** 15 KM/Hr

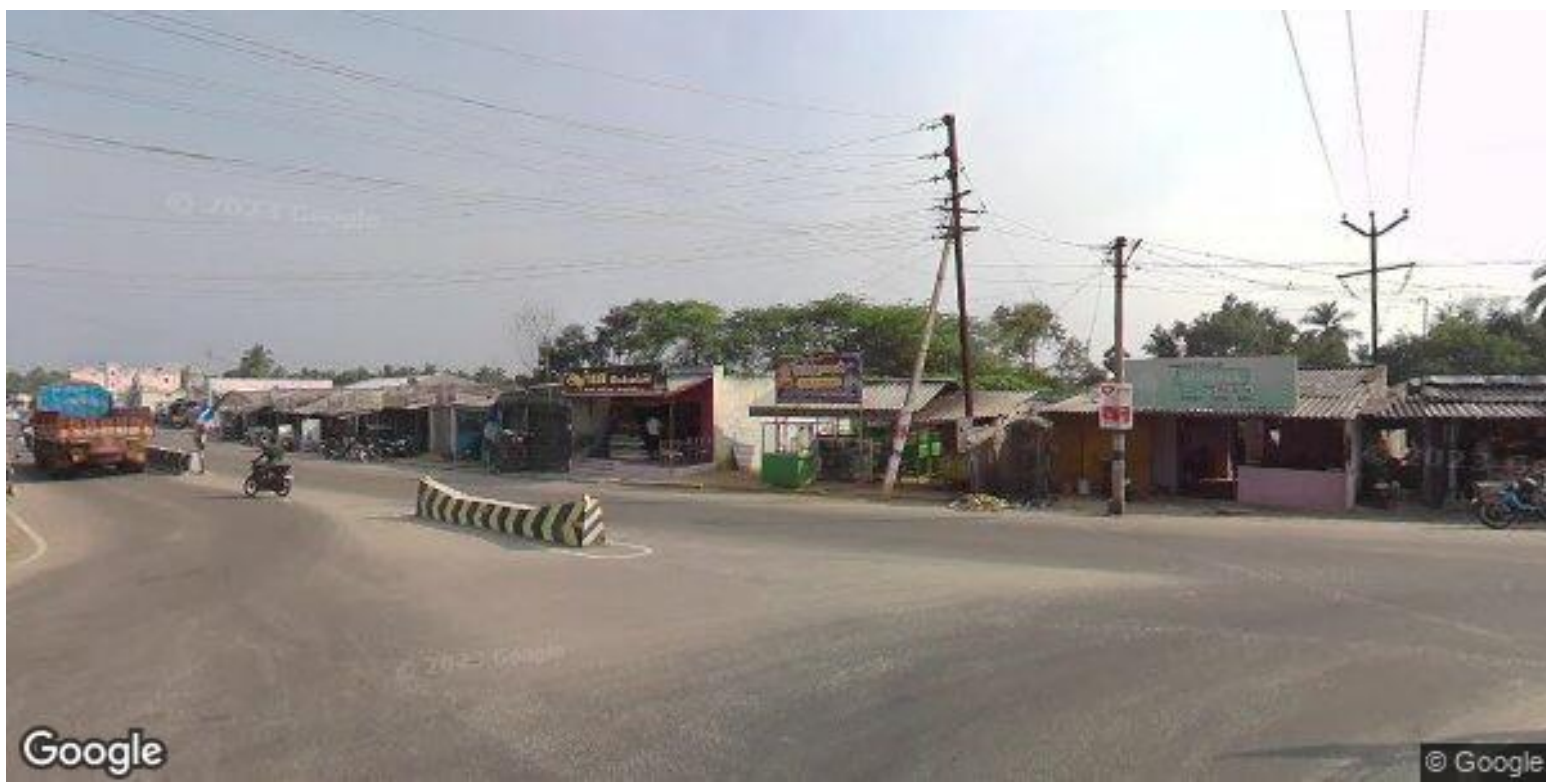
**Coordinates:** 11.04637, 77.73761

**Risk Type:** Roundabout

**Risk Level:** High

**Speed Limit:** 15 KM/Hr

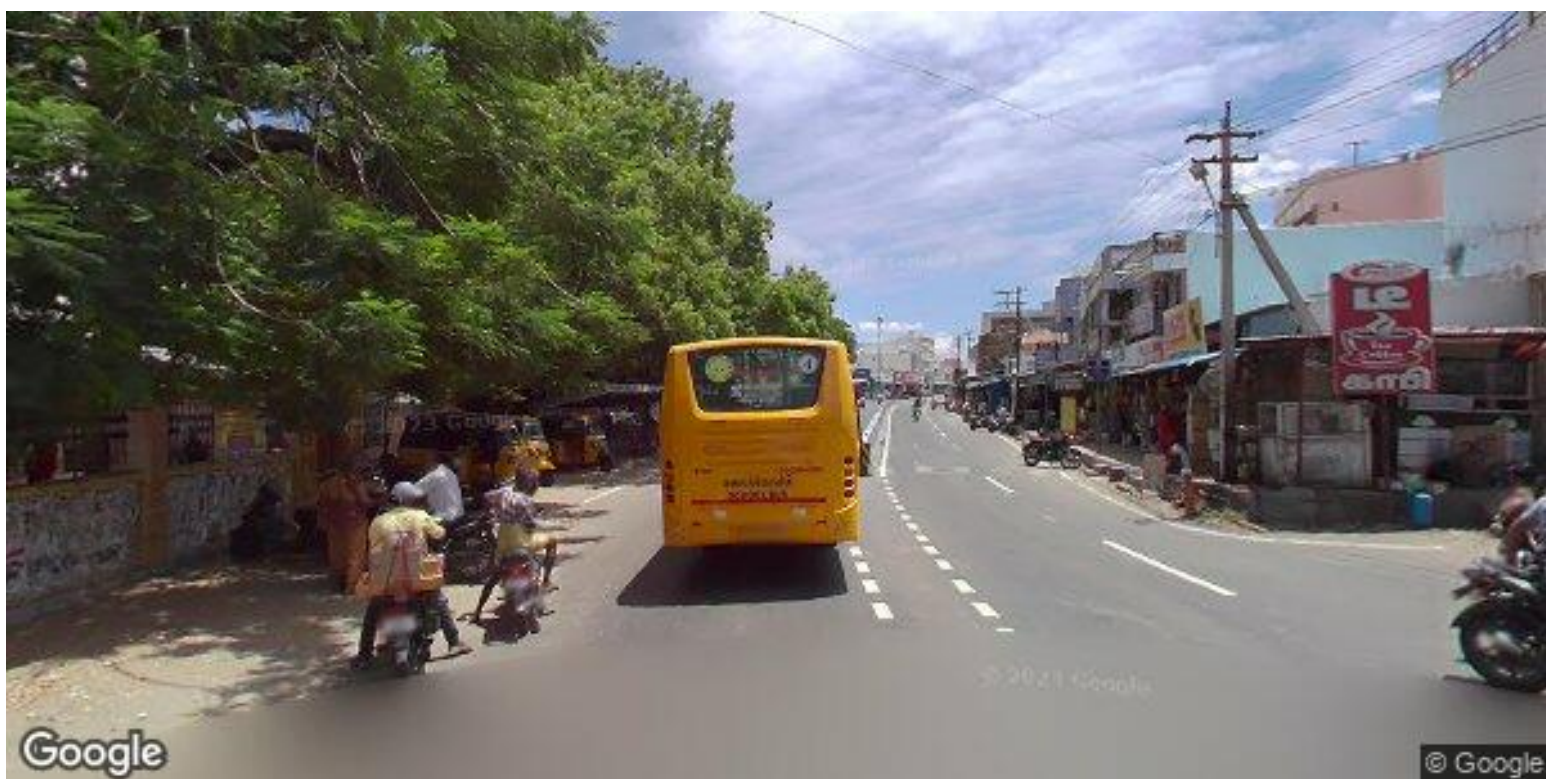
**Coordinates:** 10.7948656, 77.7097512

**Risk Type:** U-Turn

**Risk Level:** High

**Speed Limit:** 10 KM/Hr

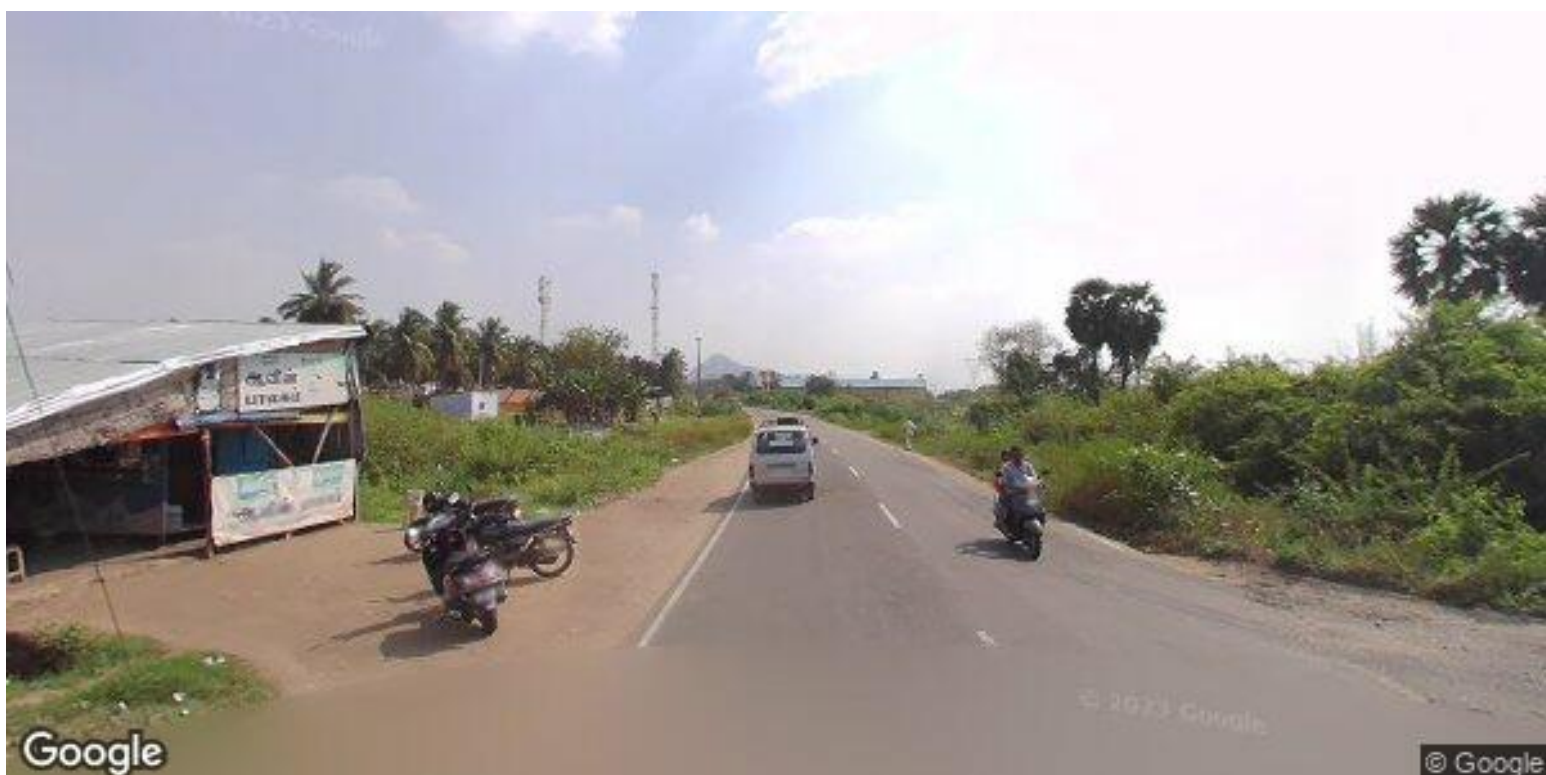
**Risk Type:** Turn  
**Risk Level:** High  
**Speed Limit:** 15 KM/Hr  
**Coordinates:** 11.44022, 77.87546

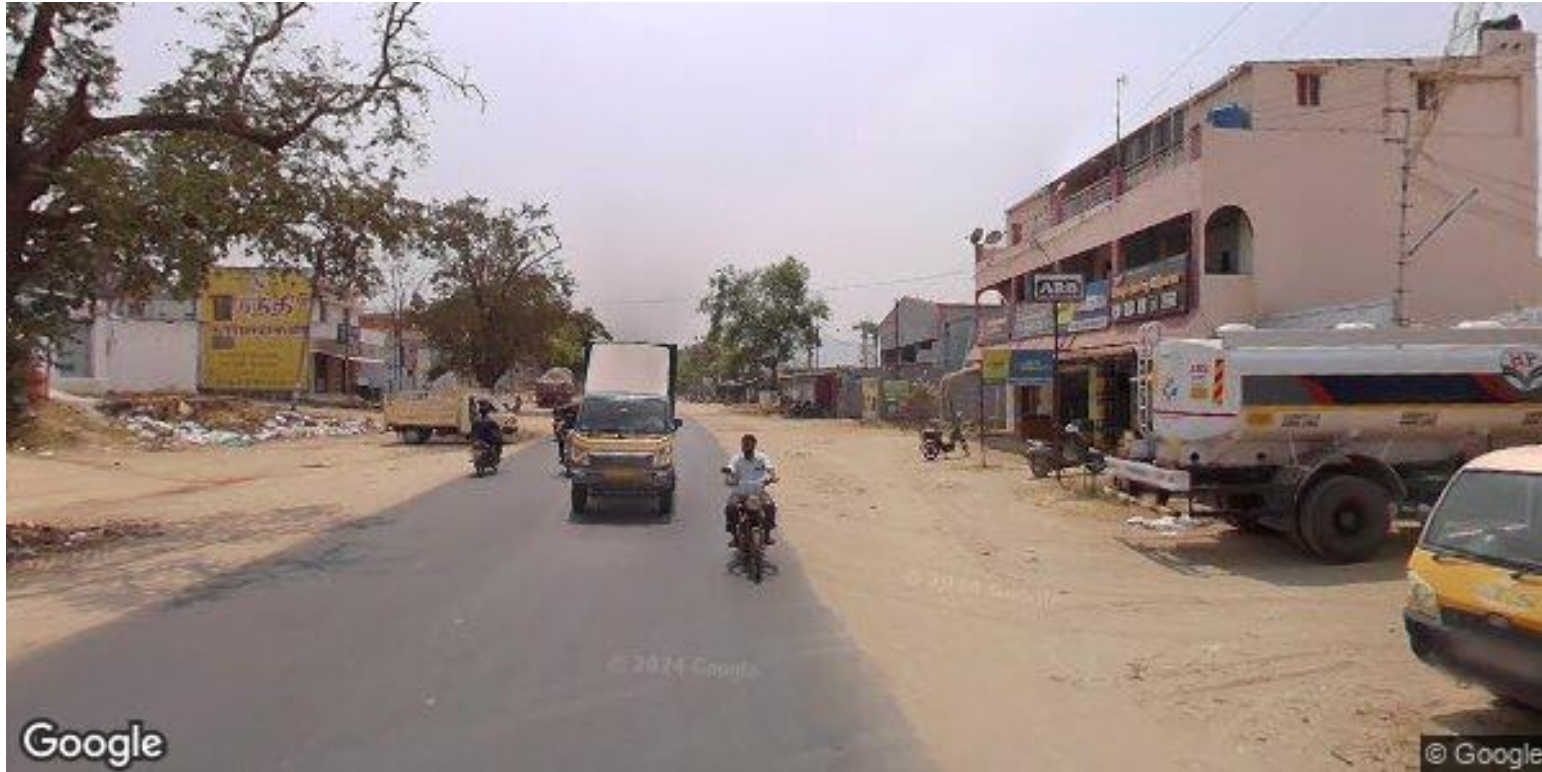
**Risk Type:** Turn  
**Risk Level:** Medium  
**Speed Limit:** 30 KM/Hr  
**Coordinates:** 11.39976, 77.88382

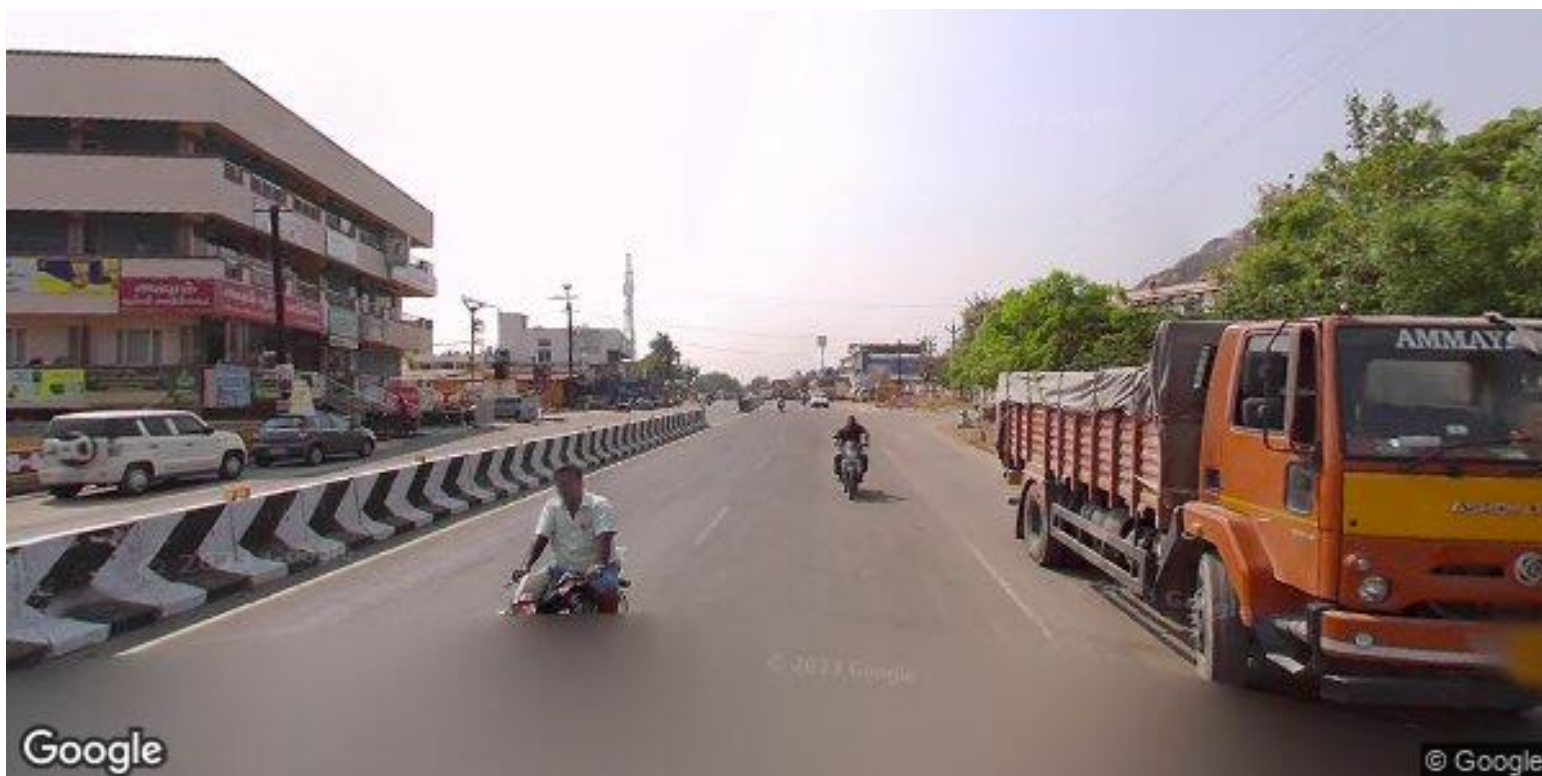
**Risk Type:** Turn  
**Risk Level:** Medium  
**Speed Limit:** 30 KM/Hr  
**Coordinates:** 11.39690, 77.88852

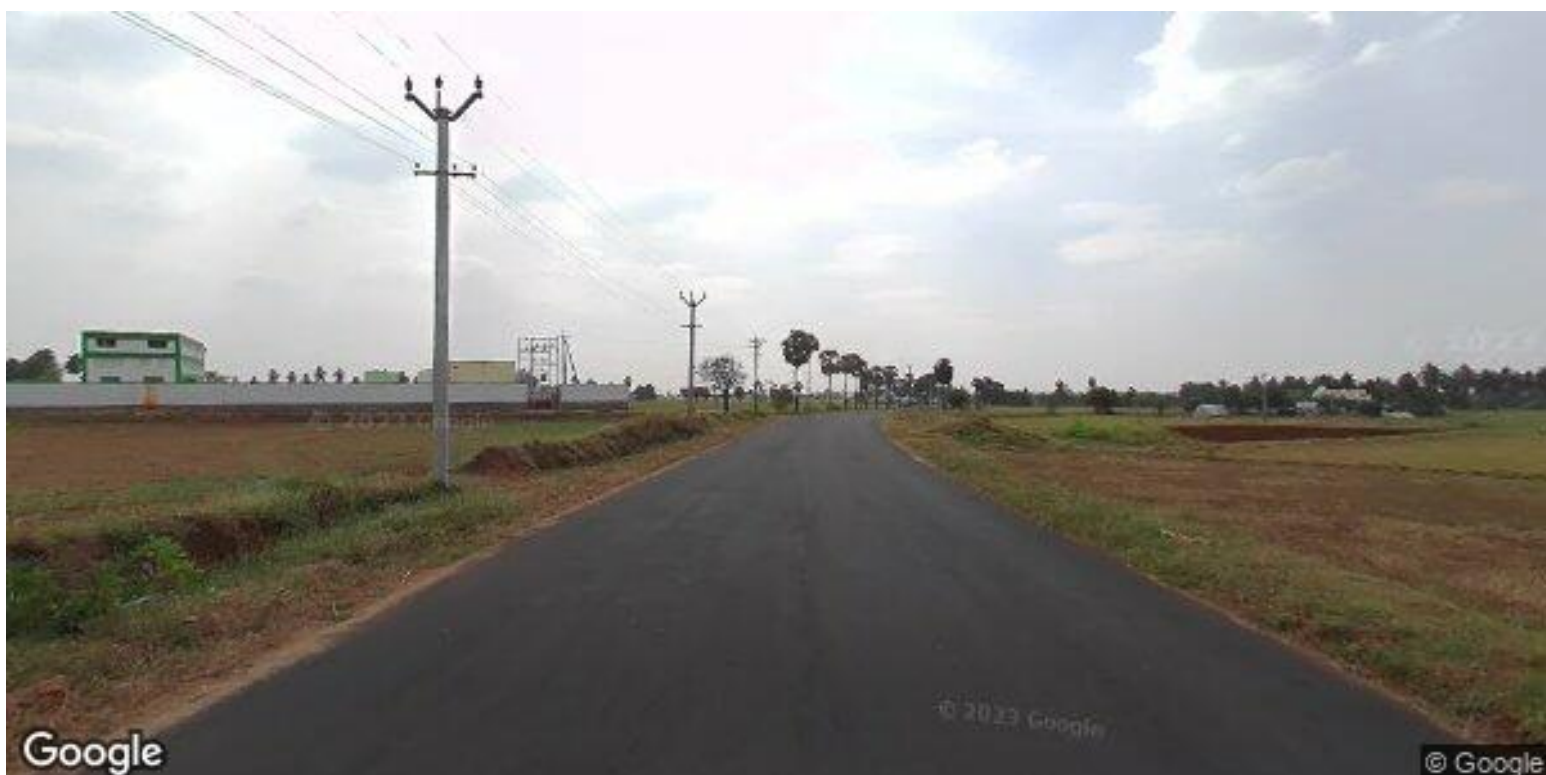
**Risk Type:** Turn  
**Risk Level:** Medium  
**Speed Limit:** 30 KM/Hr  
**Coordinates:** 11.27824, 77.91270

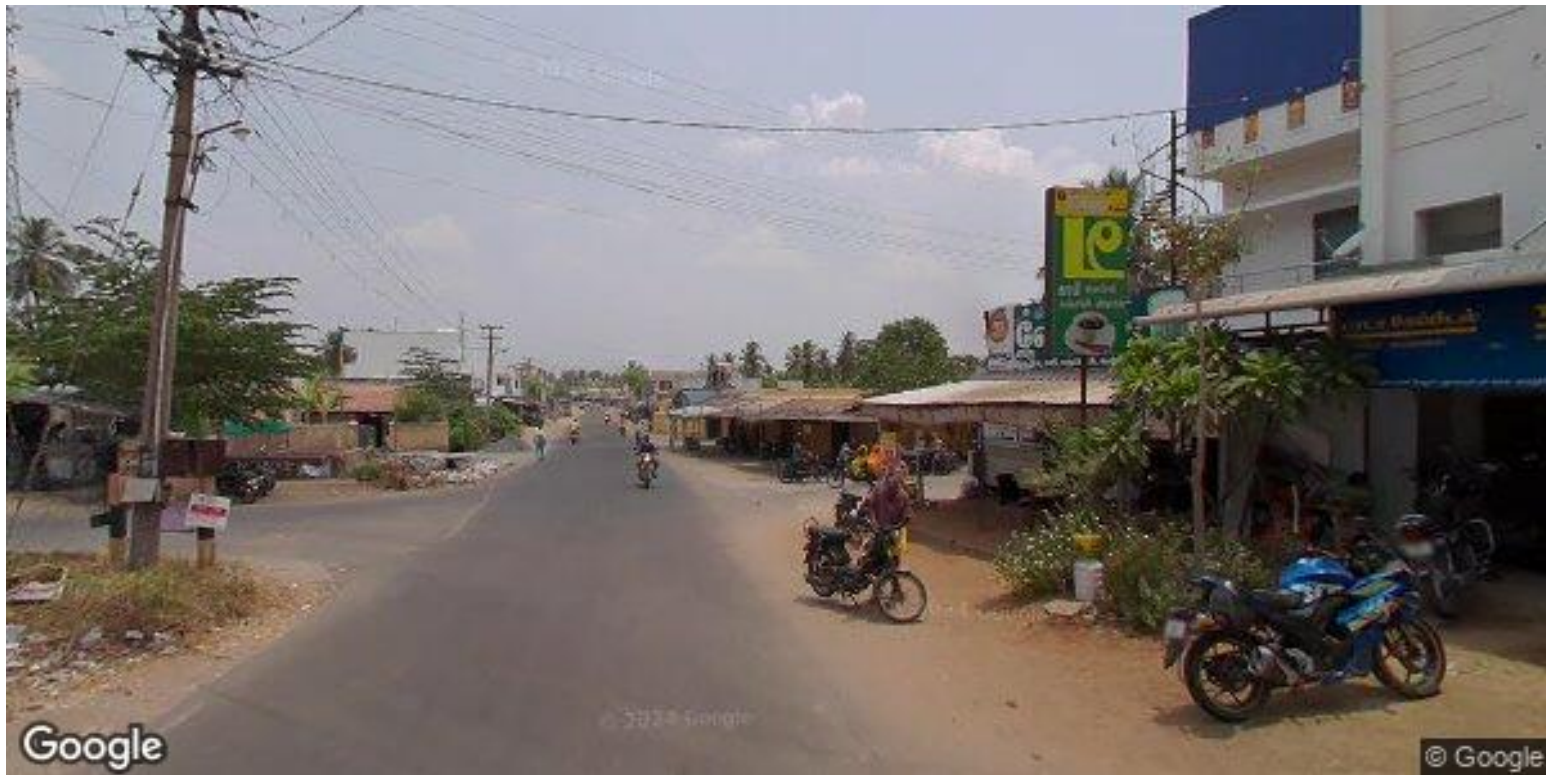
**Risk Type:** Turn  
**Risk Level:** Medium  
**Speed Limit:** 30 KM/Hr  
**Coordinates:** 11.24409, 77.87526

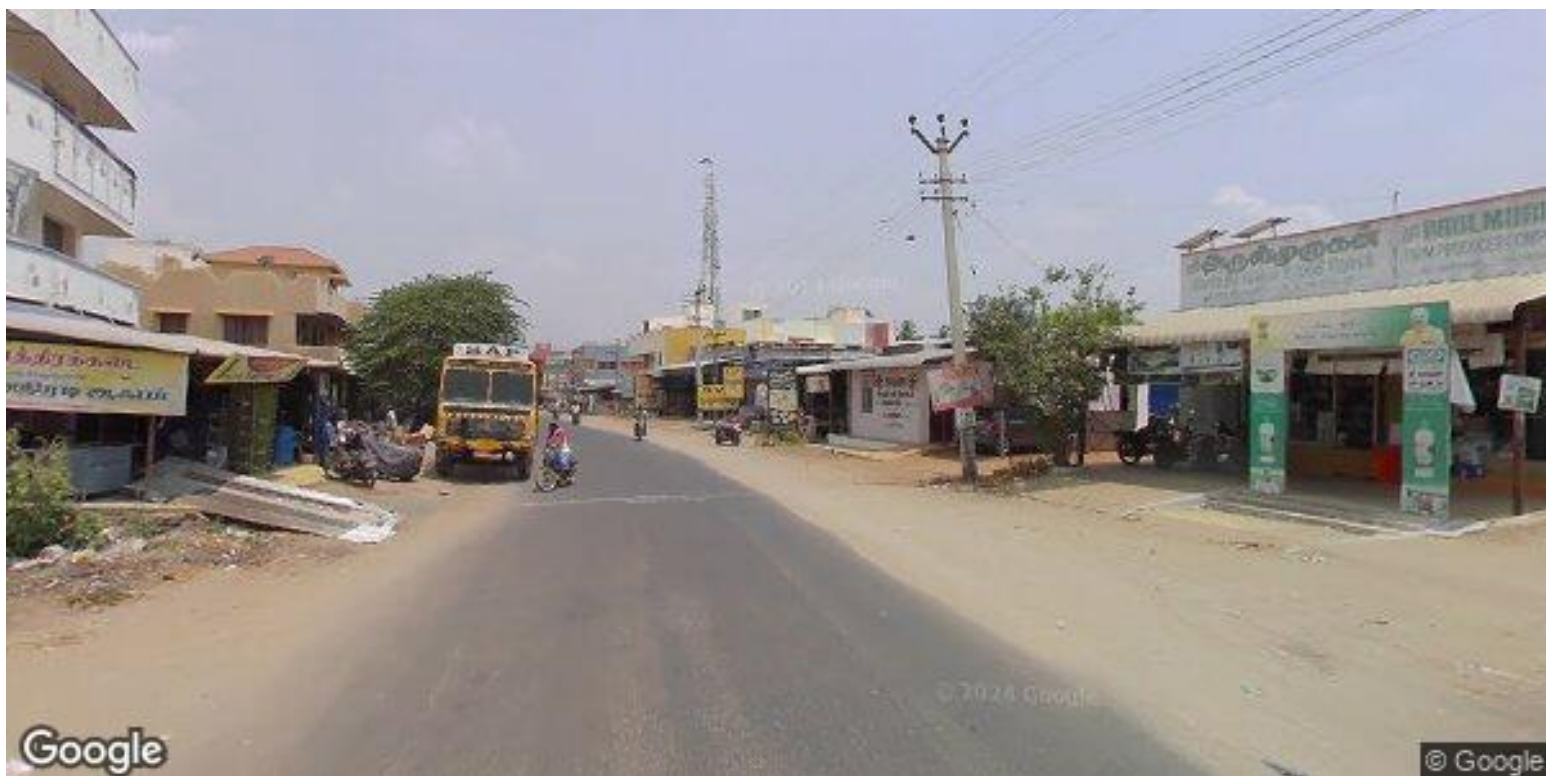
**Risk Type:** Turn  
**Risk Level:** Medium  
**Speed Limit:** 30 KM/Hr  
**Coordinates:** 11.24172, 77.87357

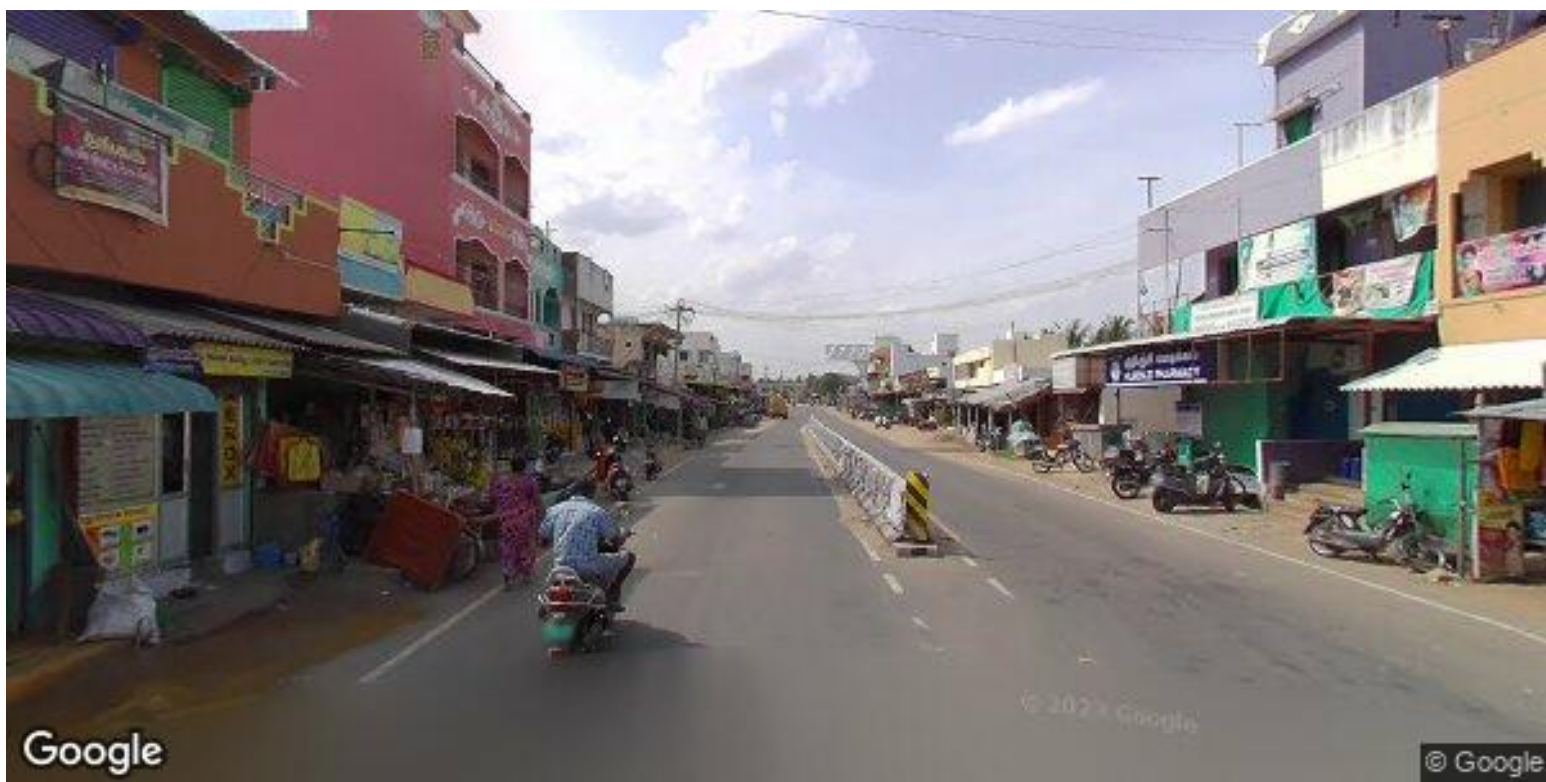
**Coordinates:** 11.24000, 77.87363

**Risk Type:** Turn

**Risk Level:** High

**Speed Limit:** 15 KM/Hr

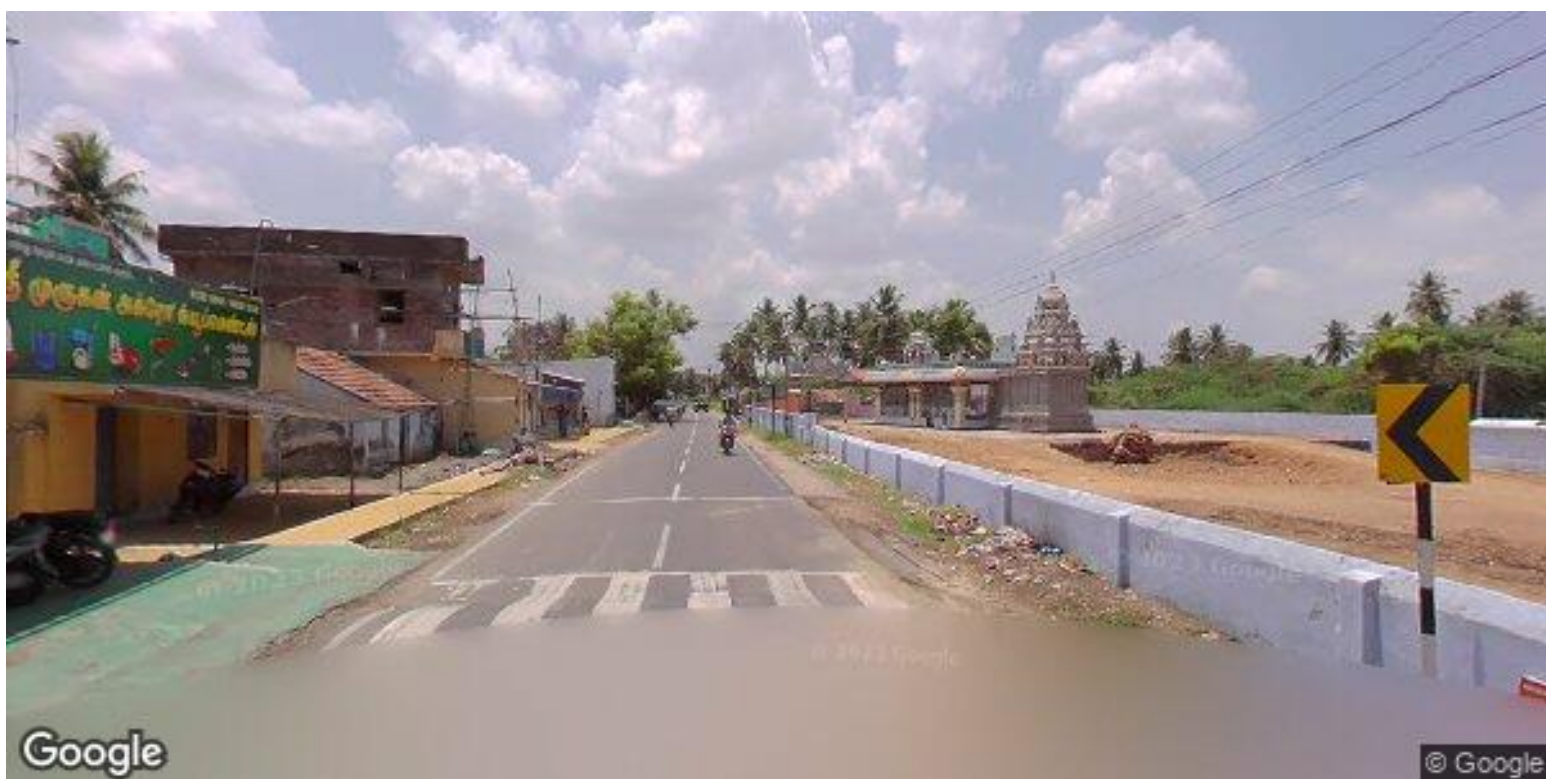
**Coordinates:** 11.24041, 77.86919

**Risk Type:** Turn

**Risk Level:** Medium

**Speed Limit:** 30 KM/Hr

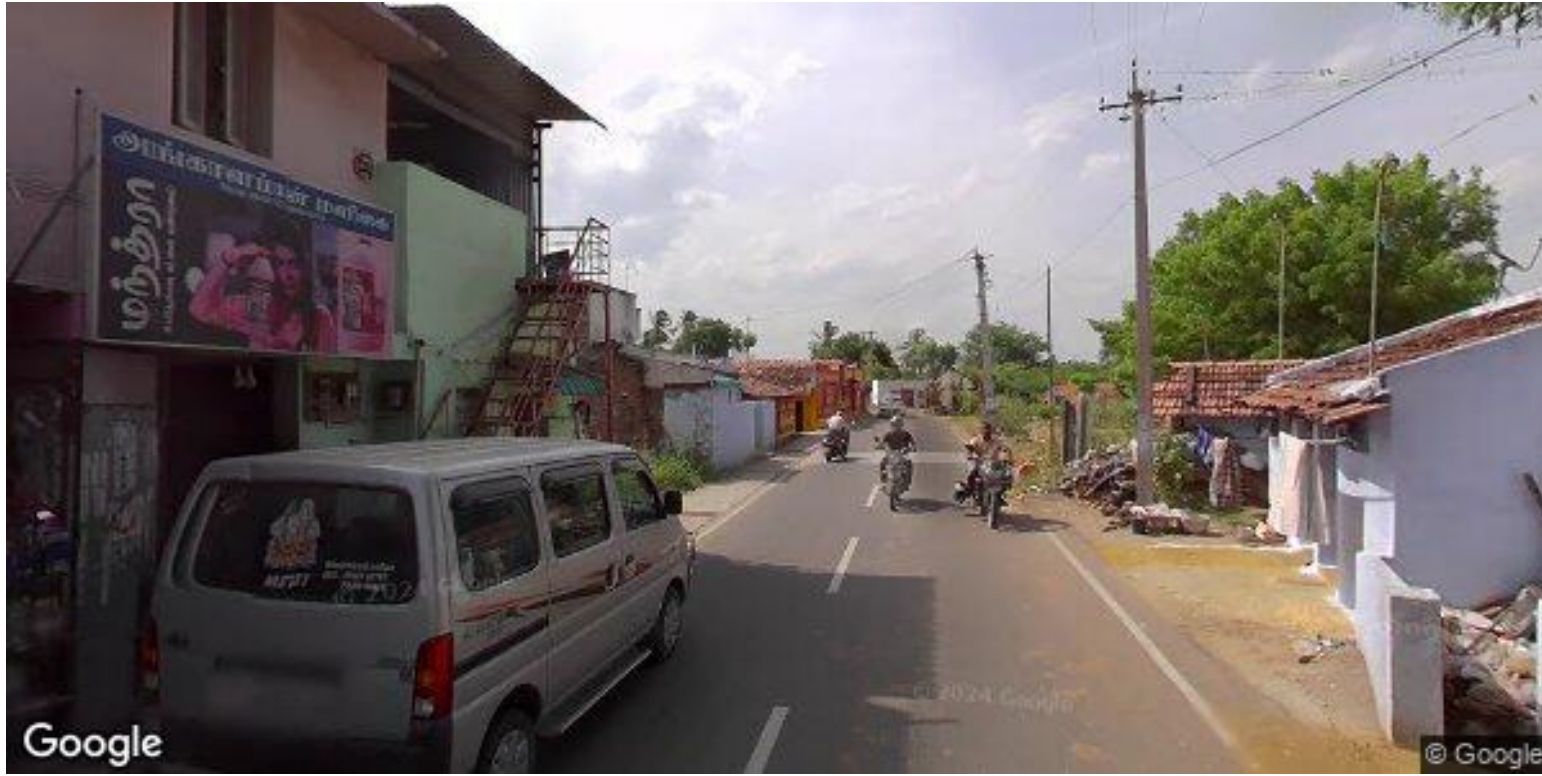
**Coordinates:** 11.24170, 77.86842

**Risk Type:** Turn

**Risk Level:** High

**Speed Limit:** 15 KM/Hr

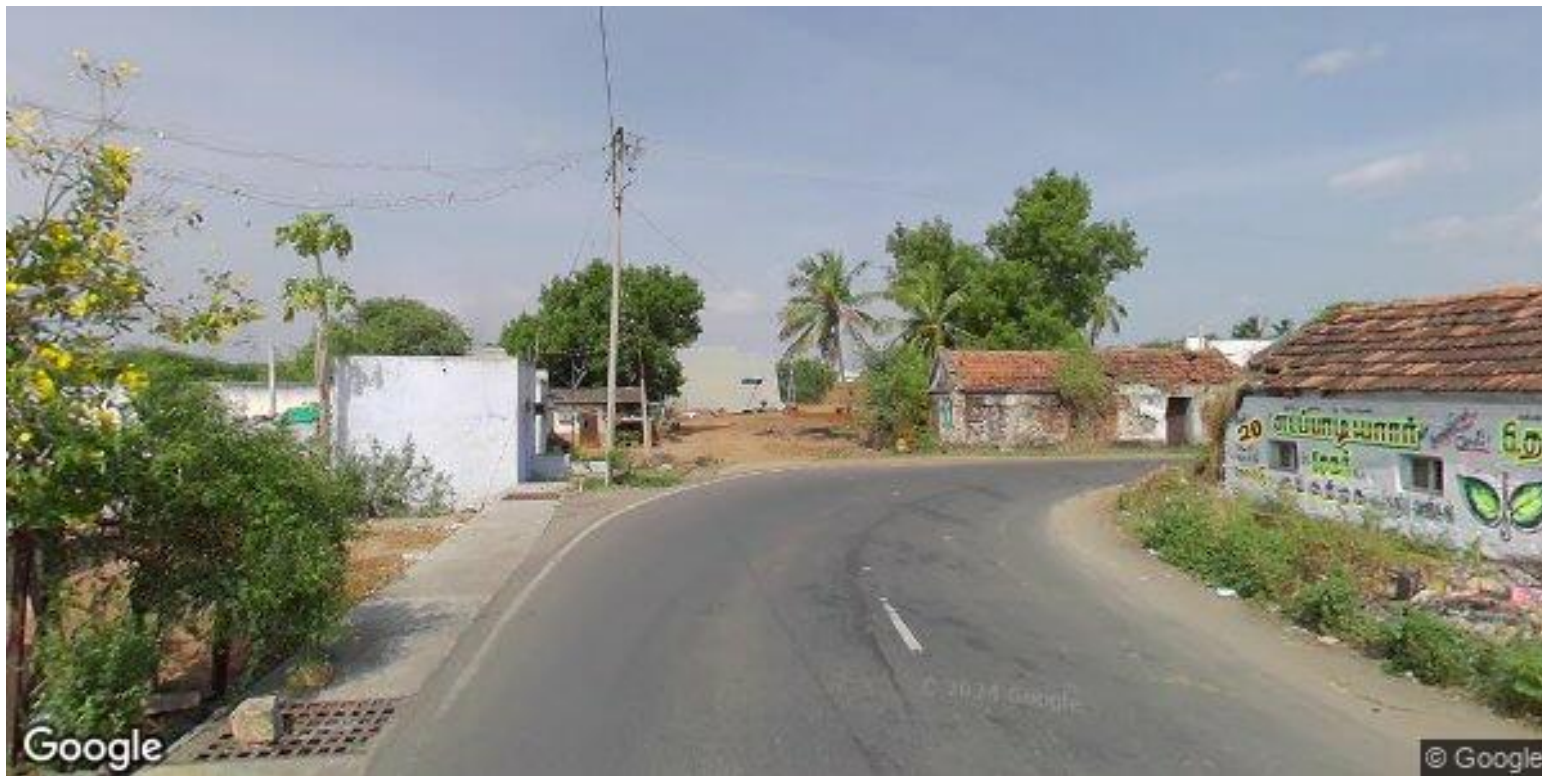
**Coordinates:** 11.24248, 77.86829

**Risk Type:** Turn

**Risk Level:** High

**Speed Limit:** 15 KM/Hr

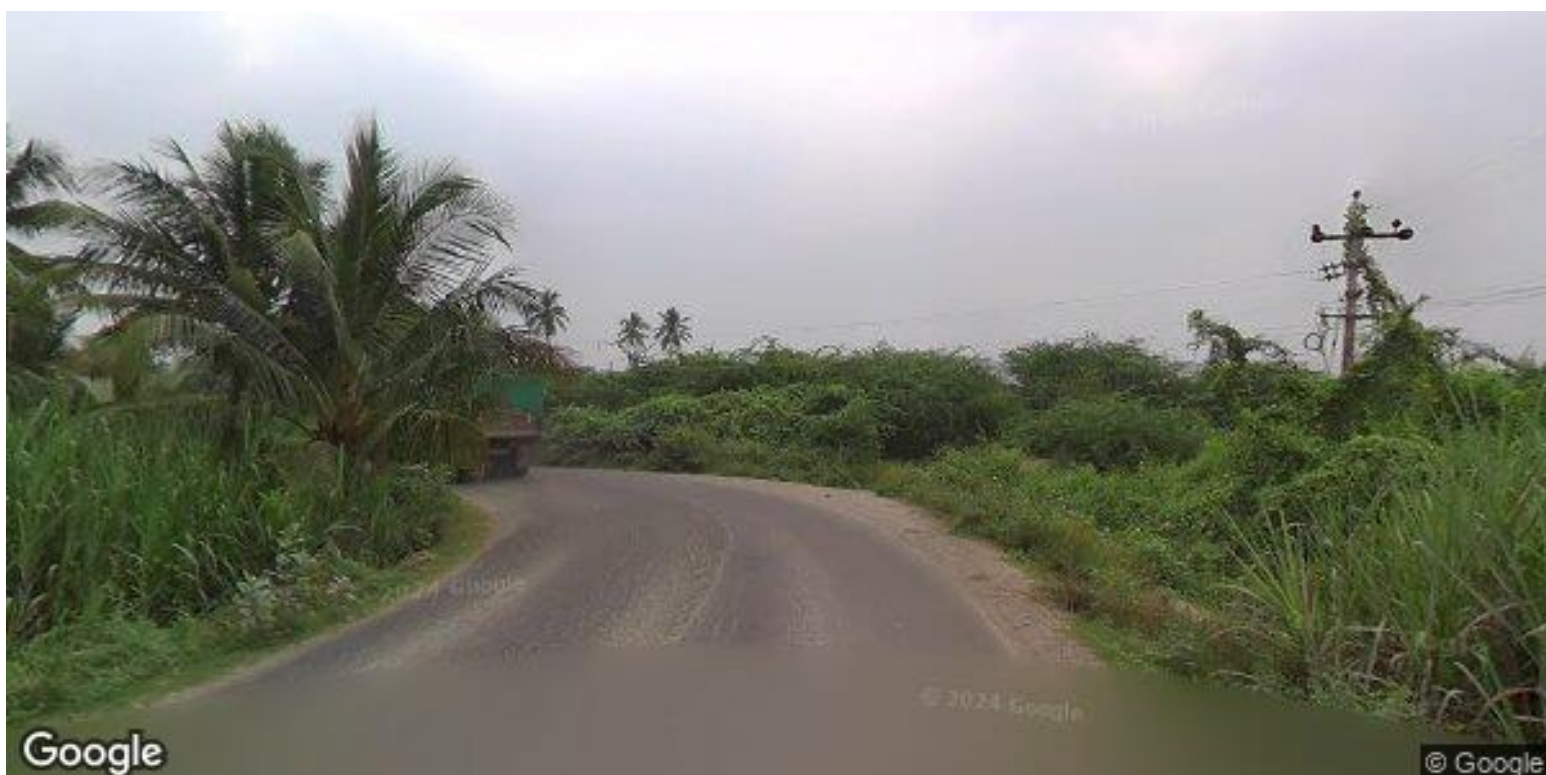
**Risk Type:** Turn  
**Risk Level:** High  
**Speed Limit:** 15 KM/Hr  
**Coordinates:** 11.24103, 77.86020

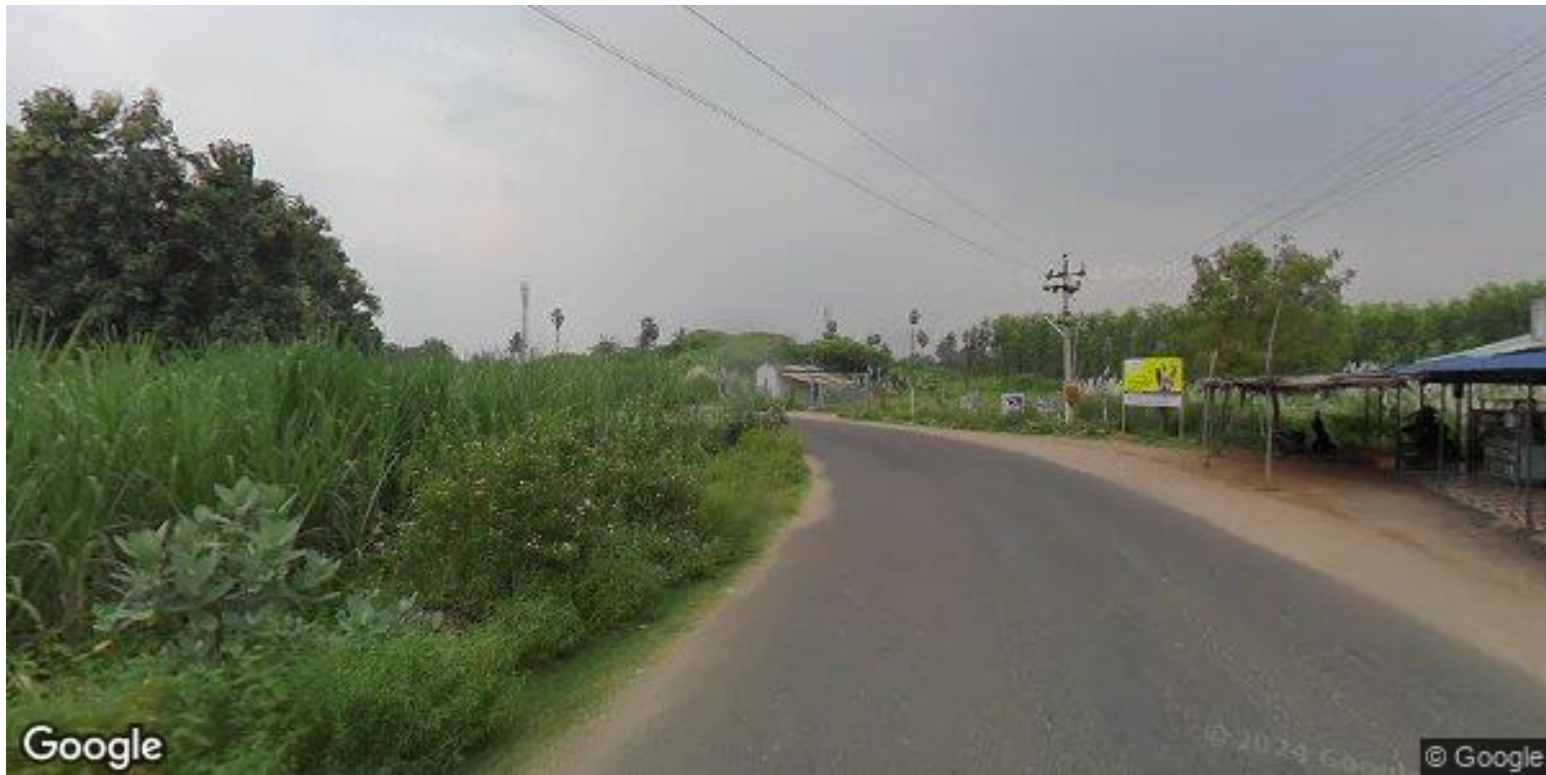
**Risk Type:** Turn  
**Risk Level:** High  
**Speed Limit:** 15 KM/Hr  
**Coordinates:** 11.24200, 77.85882

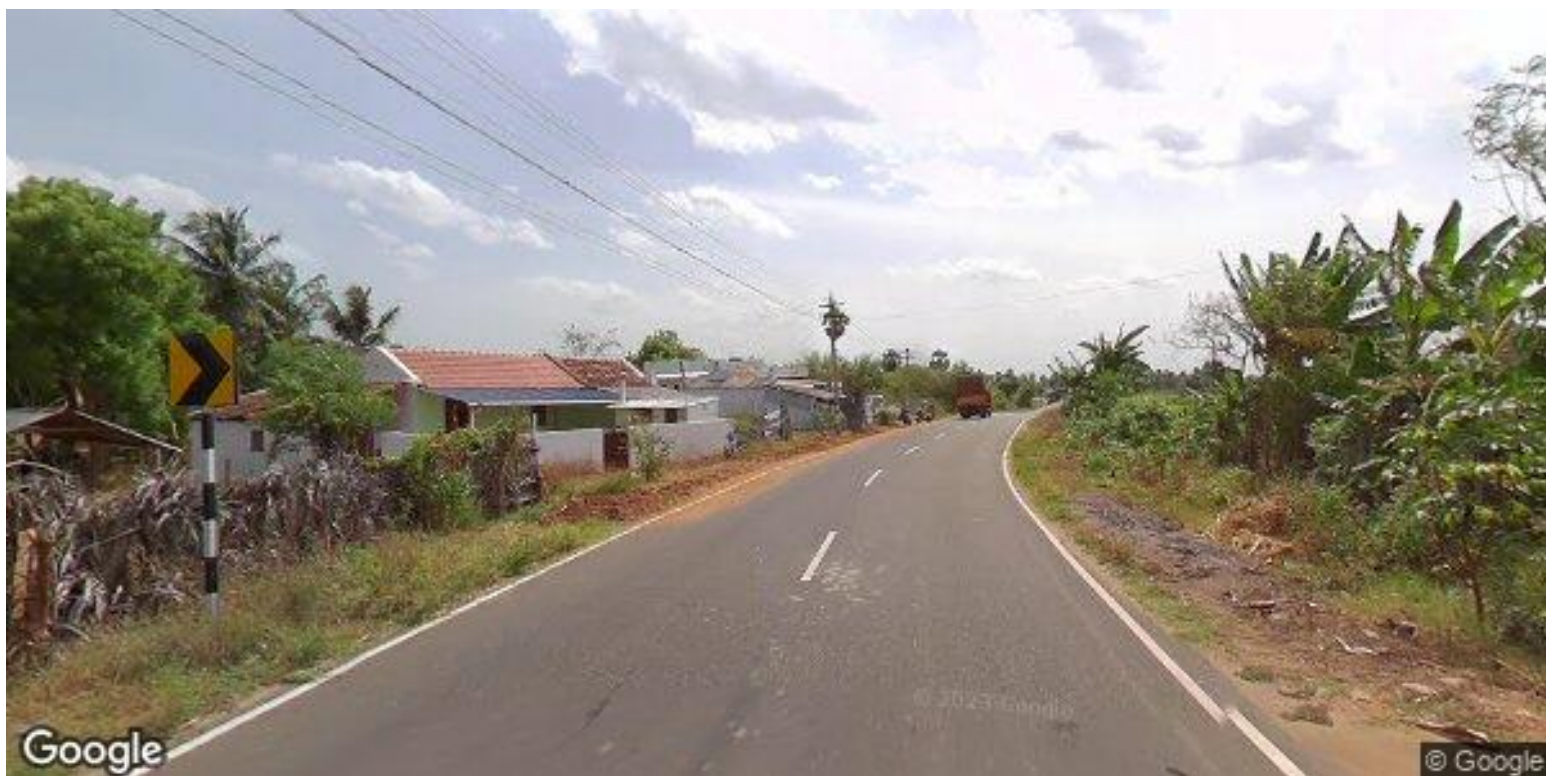
**Risk Type:** Turn  
**Risk Level:** Medium  
**Speed Limit:** 30 KM/Hr  
**Coordinates:** 11.21415, 77.81760

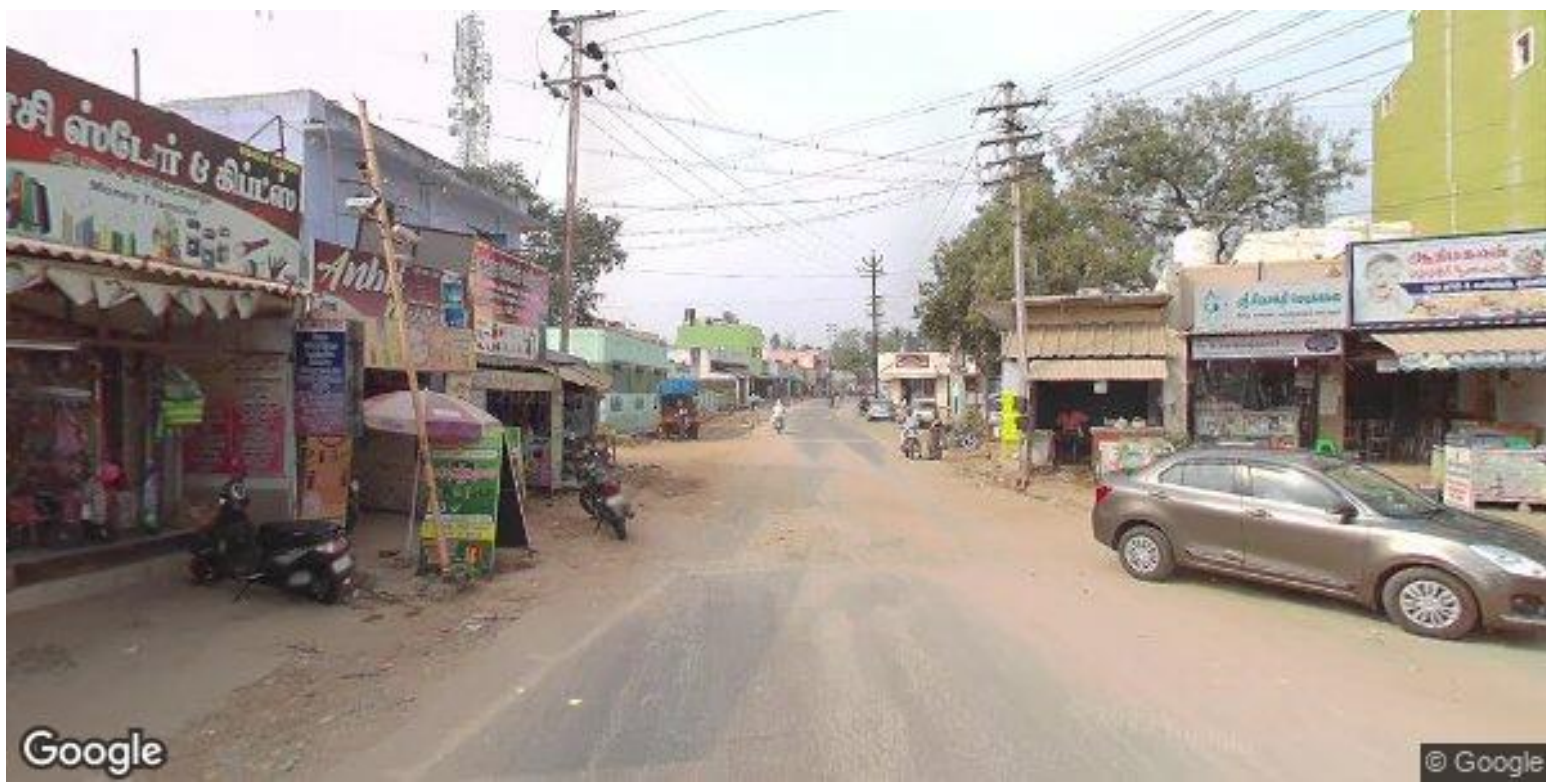
**Coordinates:** 11.18856, 77.77110

**Risk Type:** Turn

**Risk Level:** High

**Speed Limit:** 15 KM/Hr

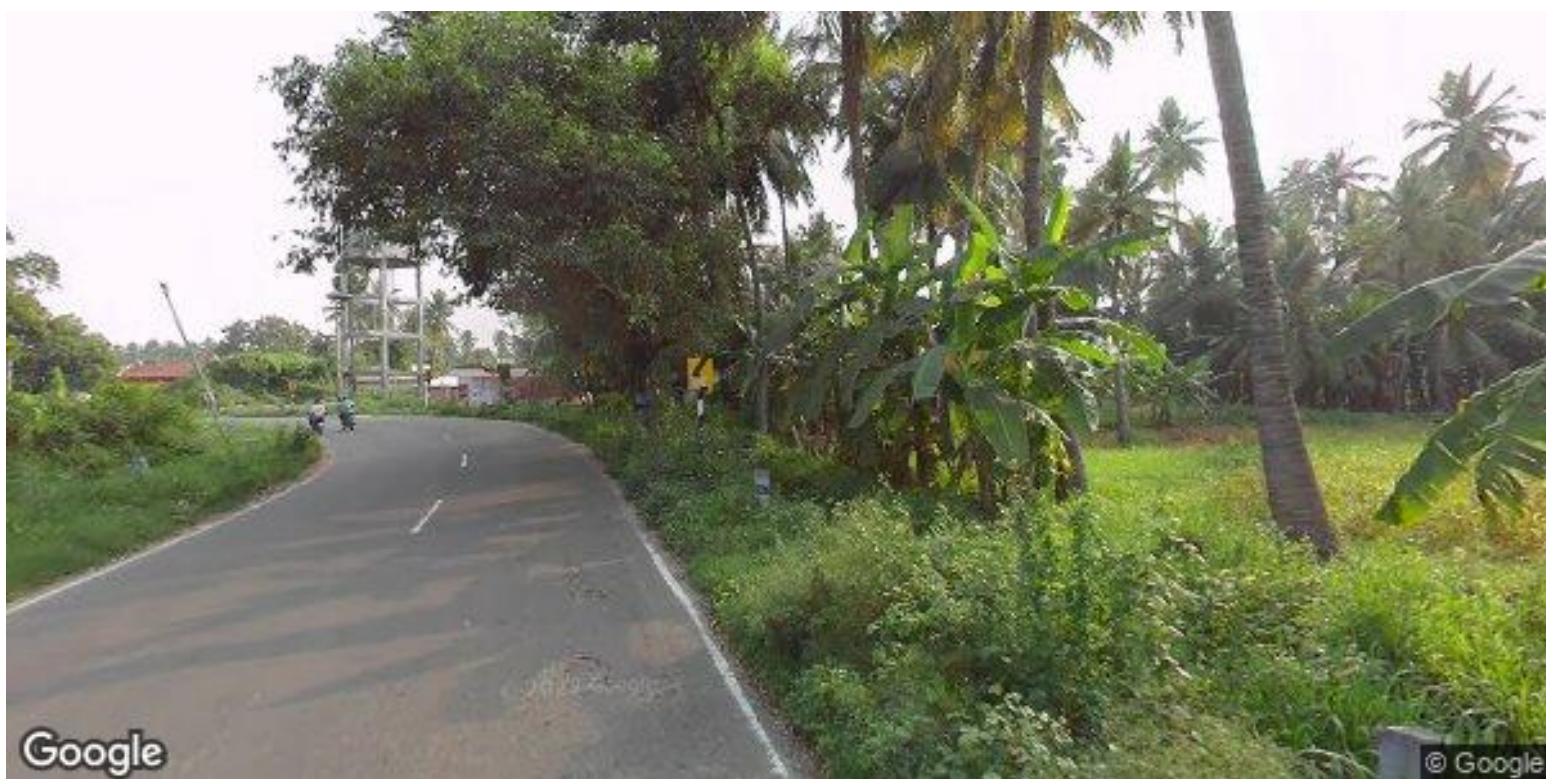
**Coordinates:** 11.16441, 77.77358

**Risk Type:** Turn

**Risk Level:** Medium

**Speed Limit:** 30 KM/Hr

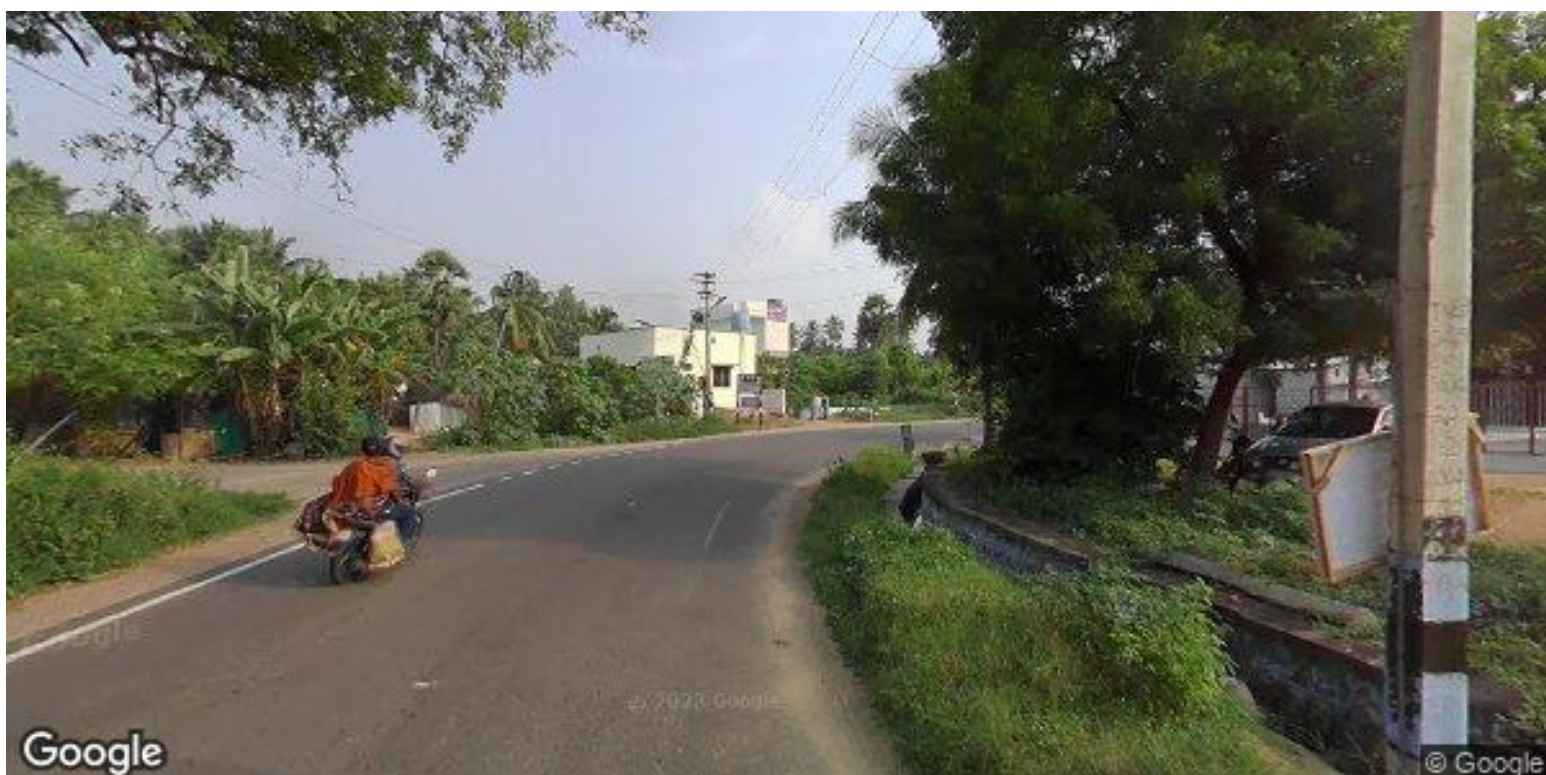
**Coordinates:** 11.16377, 77.77421

**Risk Type:** Turn

**Risk Level:** Medium

**Speed Limit:** 30 KM/Hr
