# IndianOil

## **JOURNEY RISK MANAGEMENT (JRM) STUDY**

### **Salem Terminal to SRI SELVA NITHI AGENCIES**

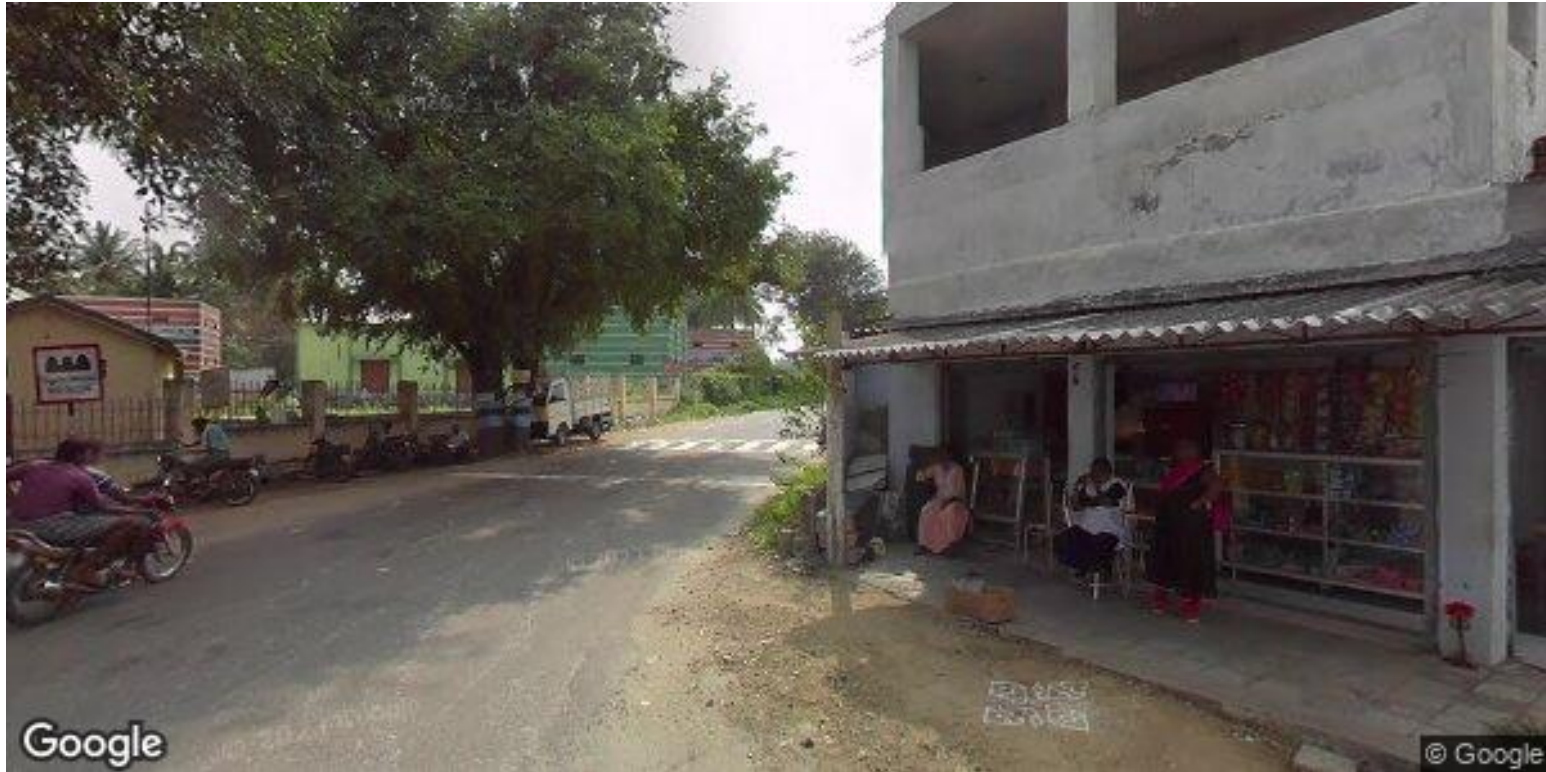
**Coordinates:** 11.13664, 77.76524

**Risk Type:** Turn

**Risk Level:** Medium

**Speed Limit:** 30 KM/Hr

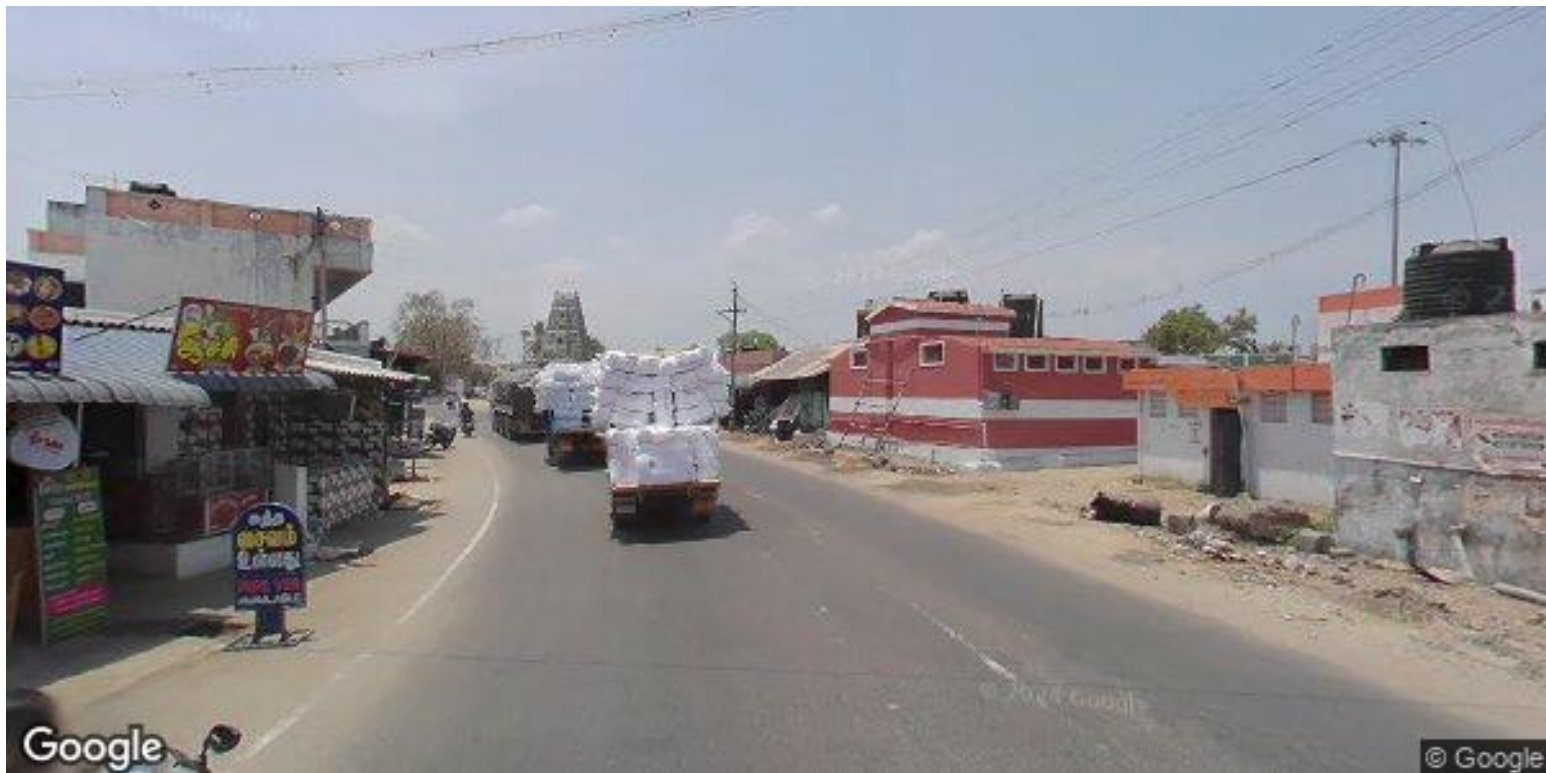
**Coordinates:** 11.04616, 77.73711

**Risk Type:** Turn

**Risk Level:** Medium

**Speed Limit:** 30 KM/Hr

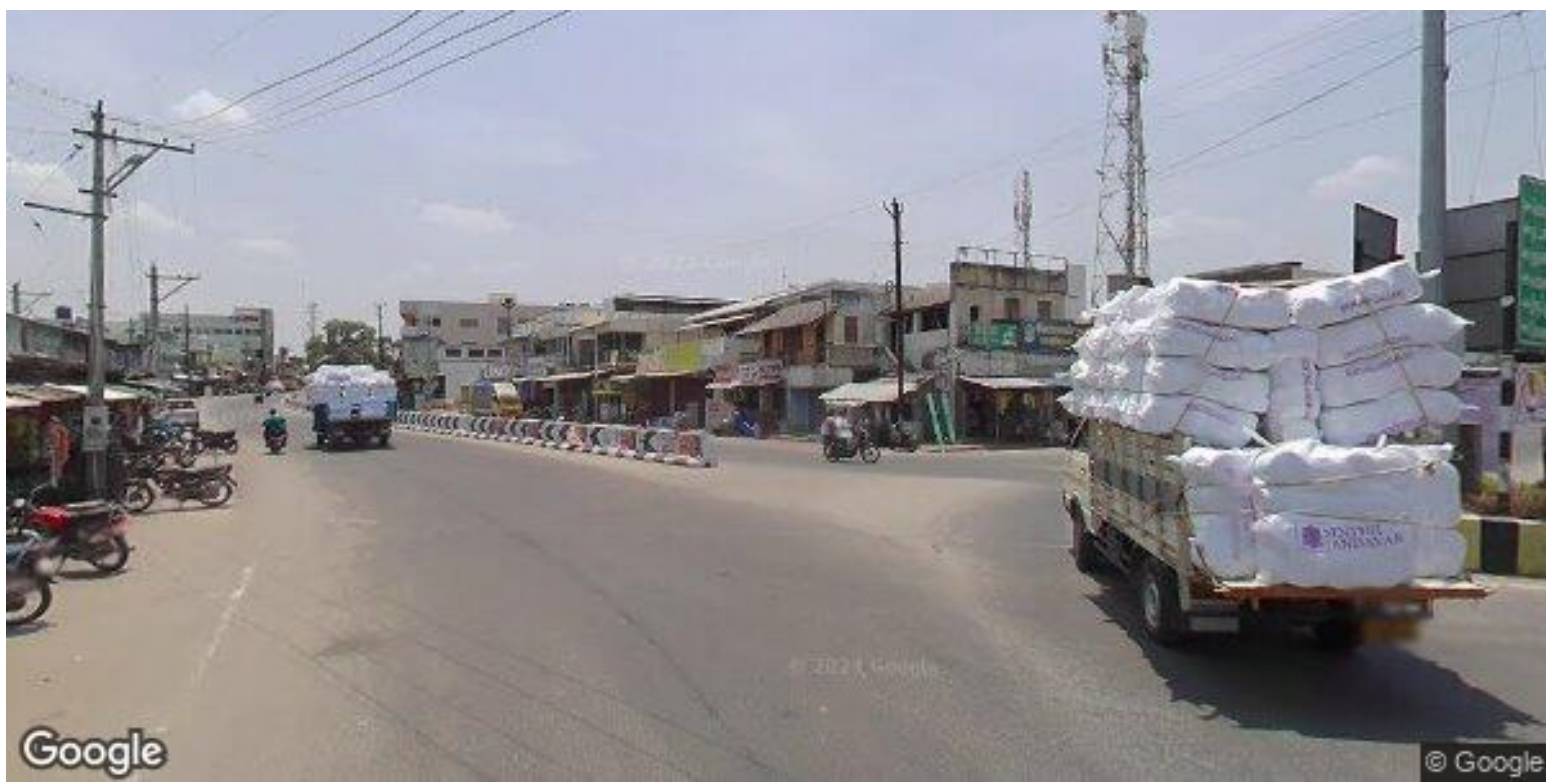
**Coordinates:** 11.04515, 77.73621

**Risk Type:** Turn

**Risk Level:** High

**Speed Limit:** 15 KM/Hr

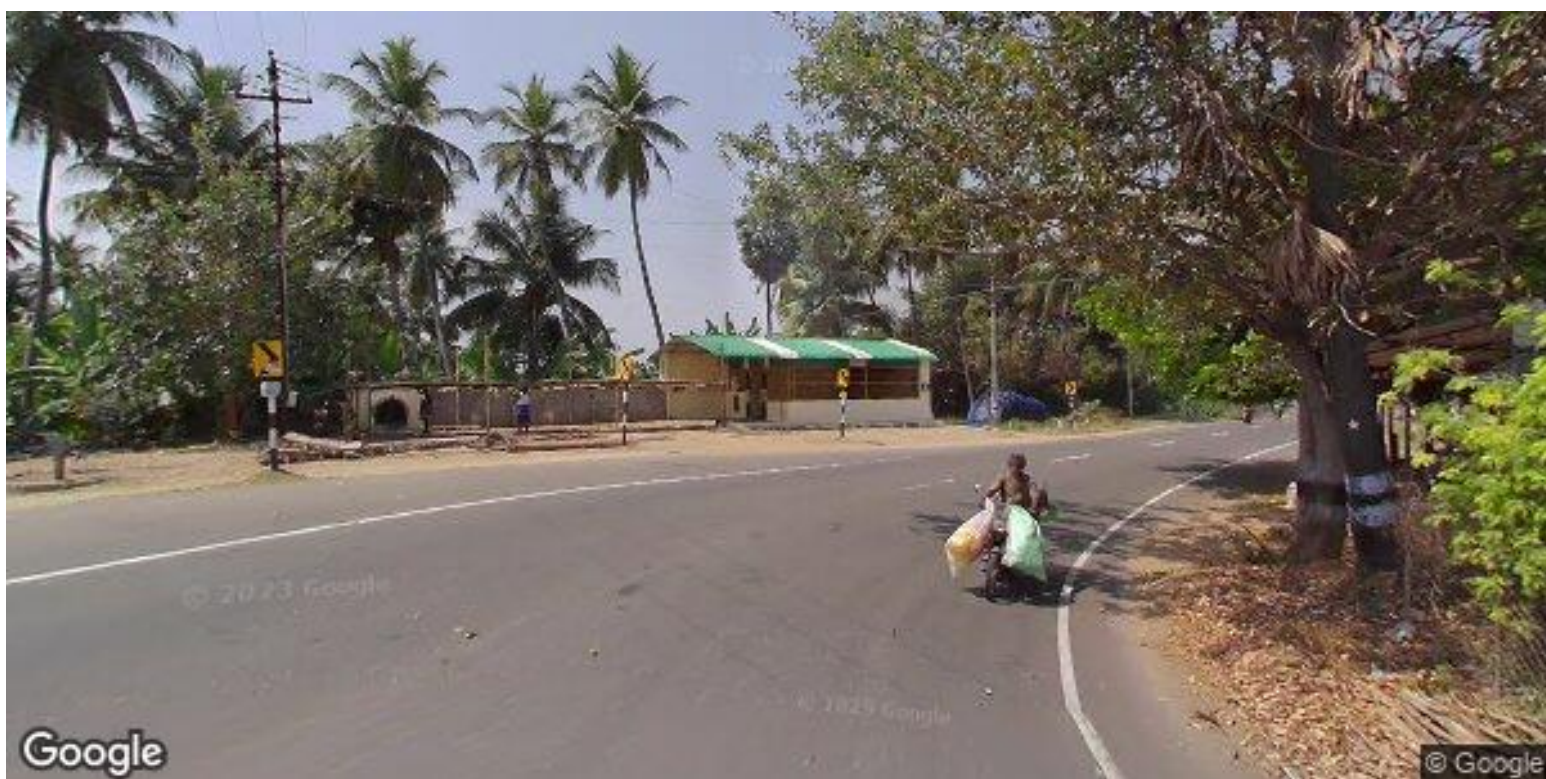
**Coordinates:** 10.99026, 77.72511

**Risk Type:** Turn

**Risk Level:** High

**Speed Limit:** 15 KM/Hr

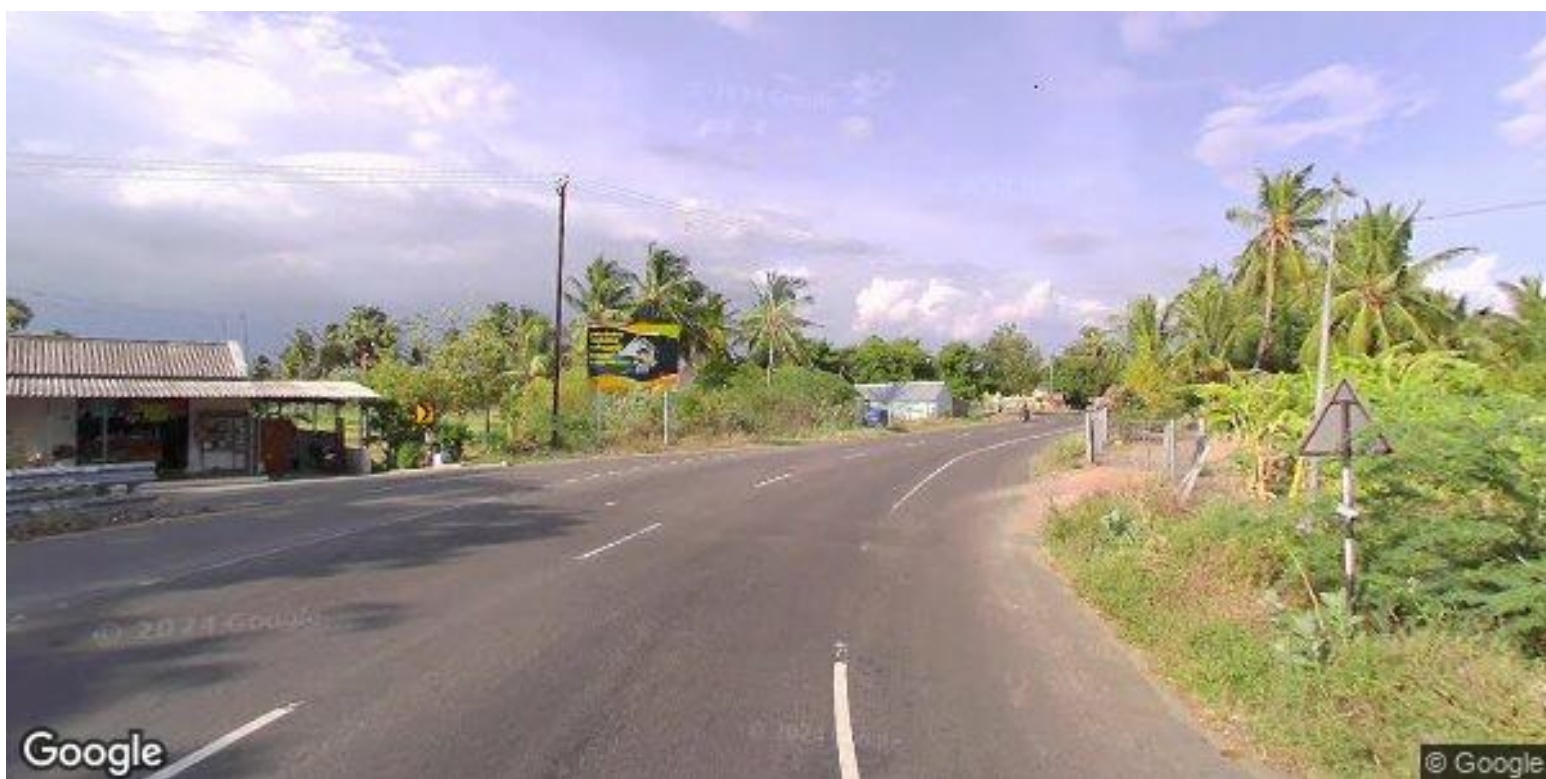
**Risk Type:** Turn  
**Risk Level:** High  
**Speed Limit:** 15 KM/Hr  
**Coordinates:** 10.98974, 77.72388

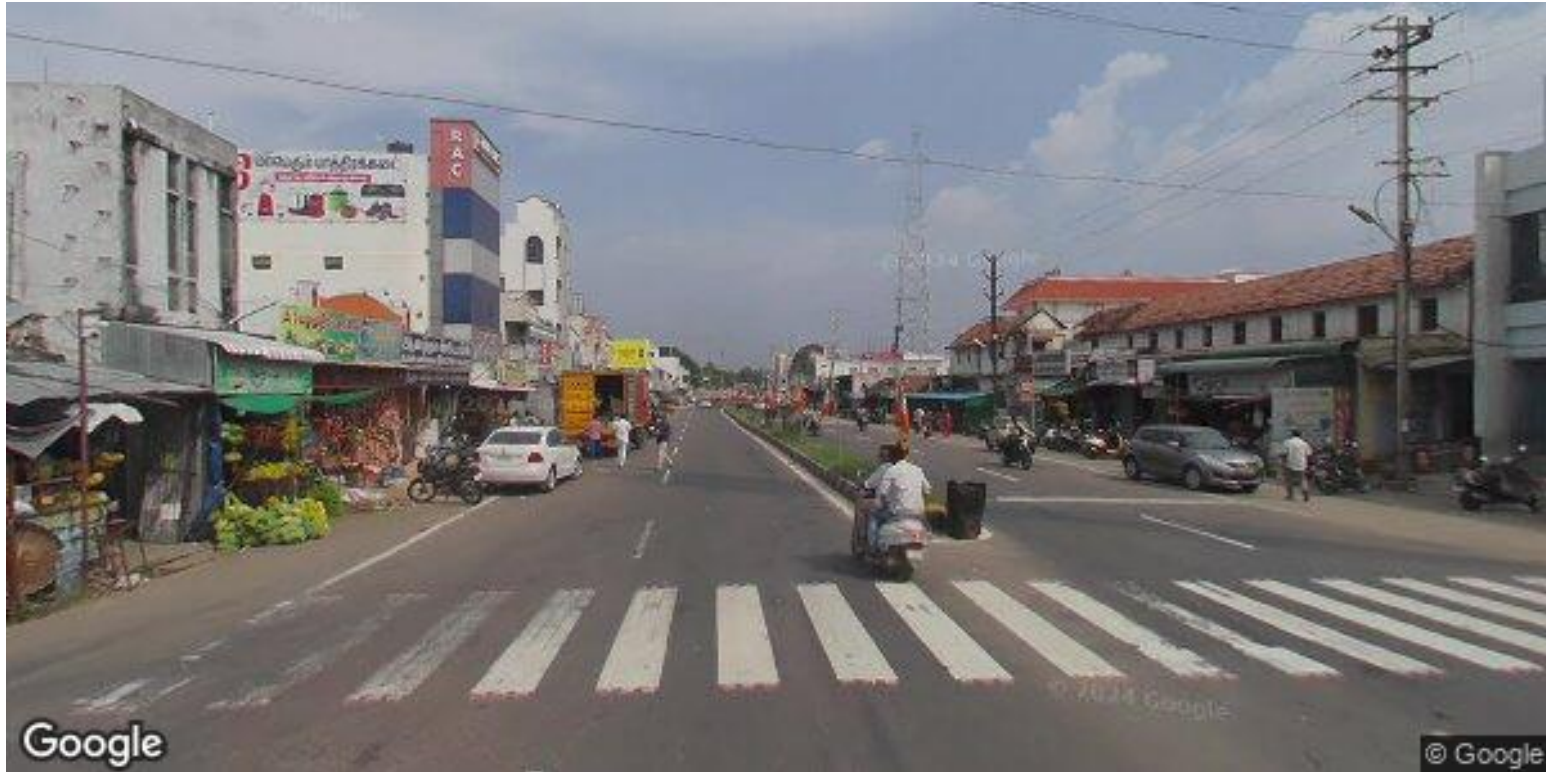
**Risk Type:** Blind Spot  
**Risk Level:** Blind Spot  
**Speed Limit:** 10 KM/Hr  
**Coordinates:** 10.94597, 77.71319

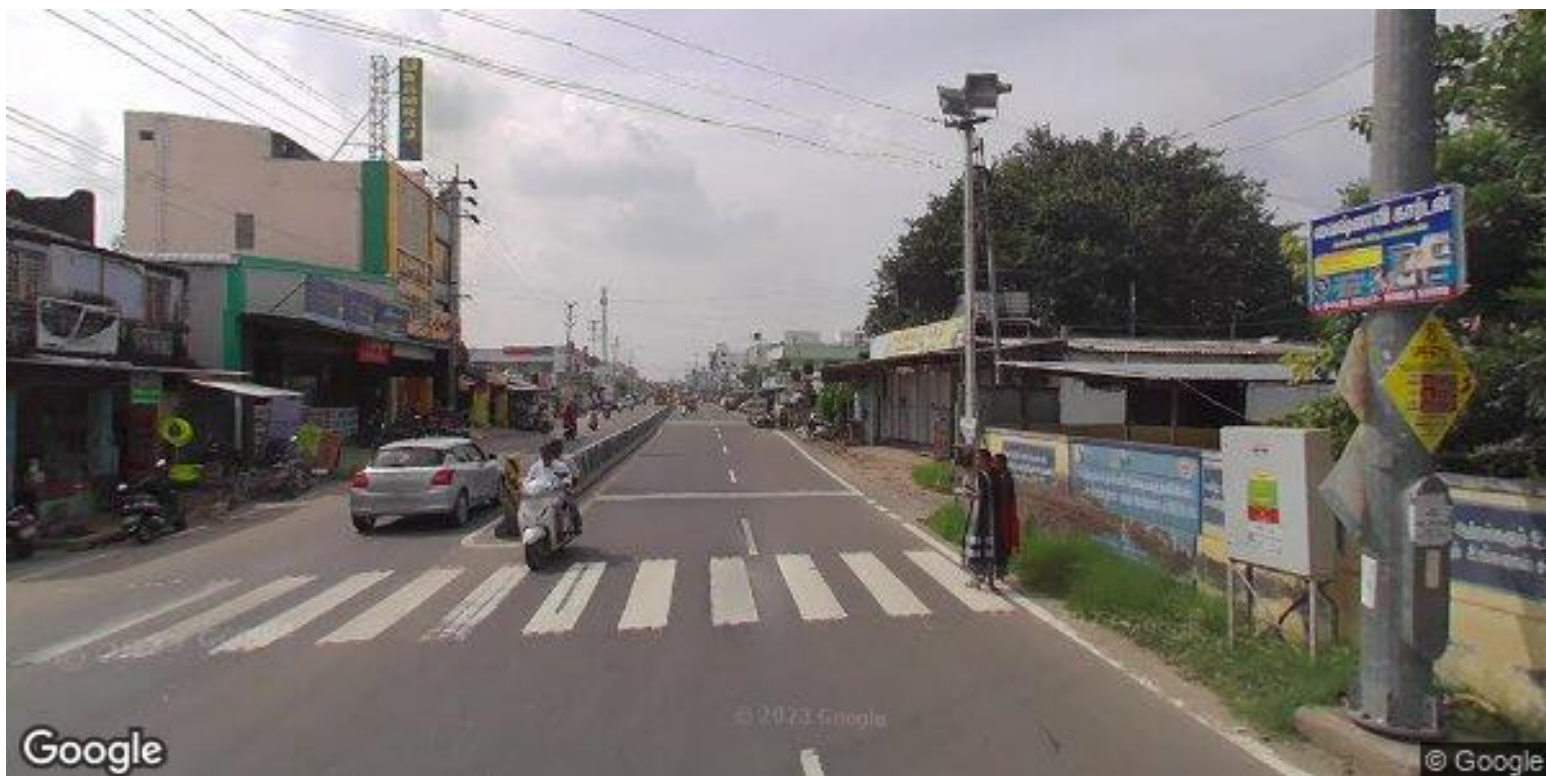
**Risk Type:** Turn  
**Risk Level:** High  
**Speed Limit:** 15 KM/Hr  
**Coordinates:** 10.94571, 77.71574

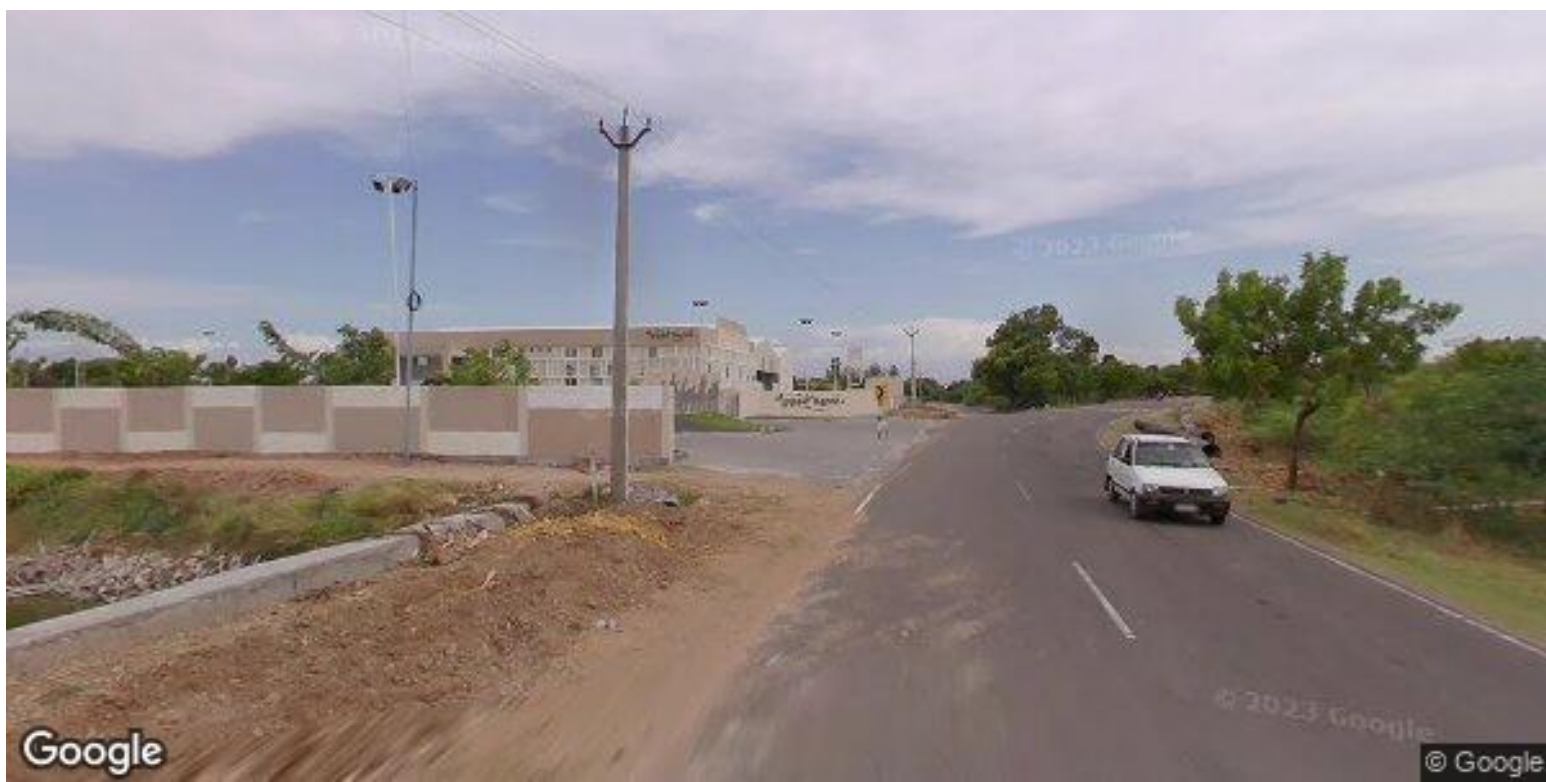
**Coordinates:** 10.92251, 77.72391

**Risk Type:** Turn

**Risk Level:** Medium

**Speed Limit:** 30 KM/Hr

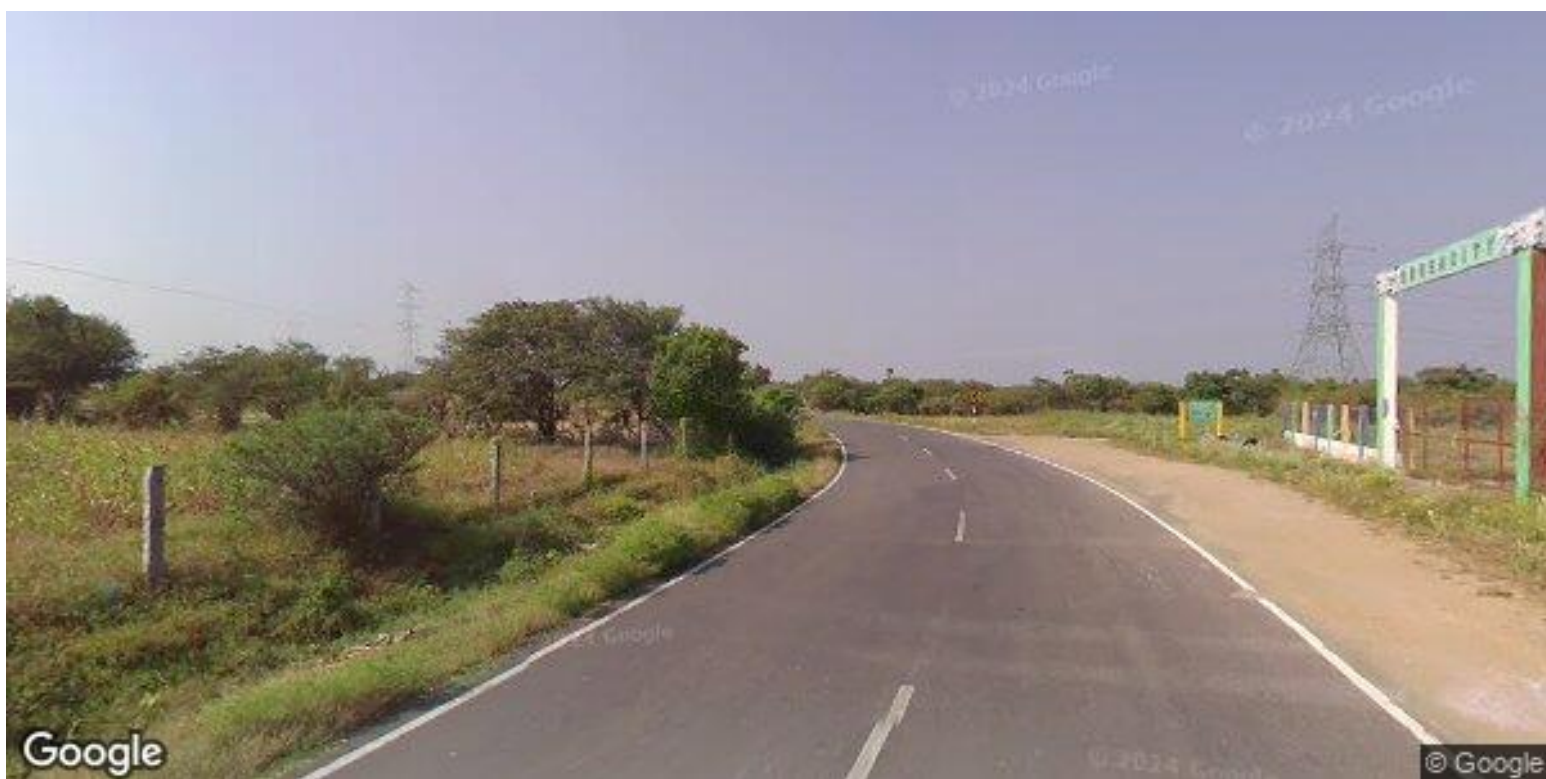
**Coordinates:** 10.87191, 77.72259

**Risk Type:** Turn

**Risk Level:** Medium

**Speed Limit:** 30 KM/Hr

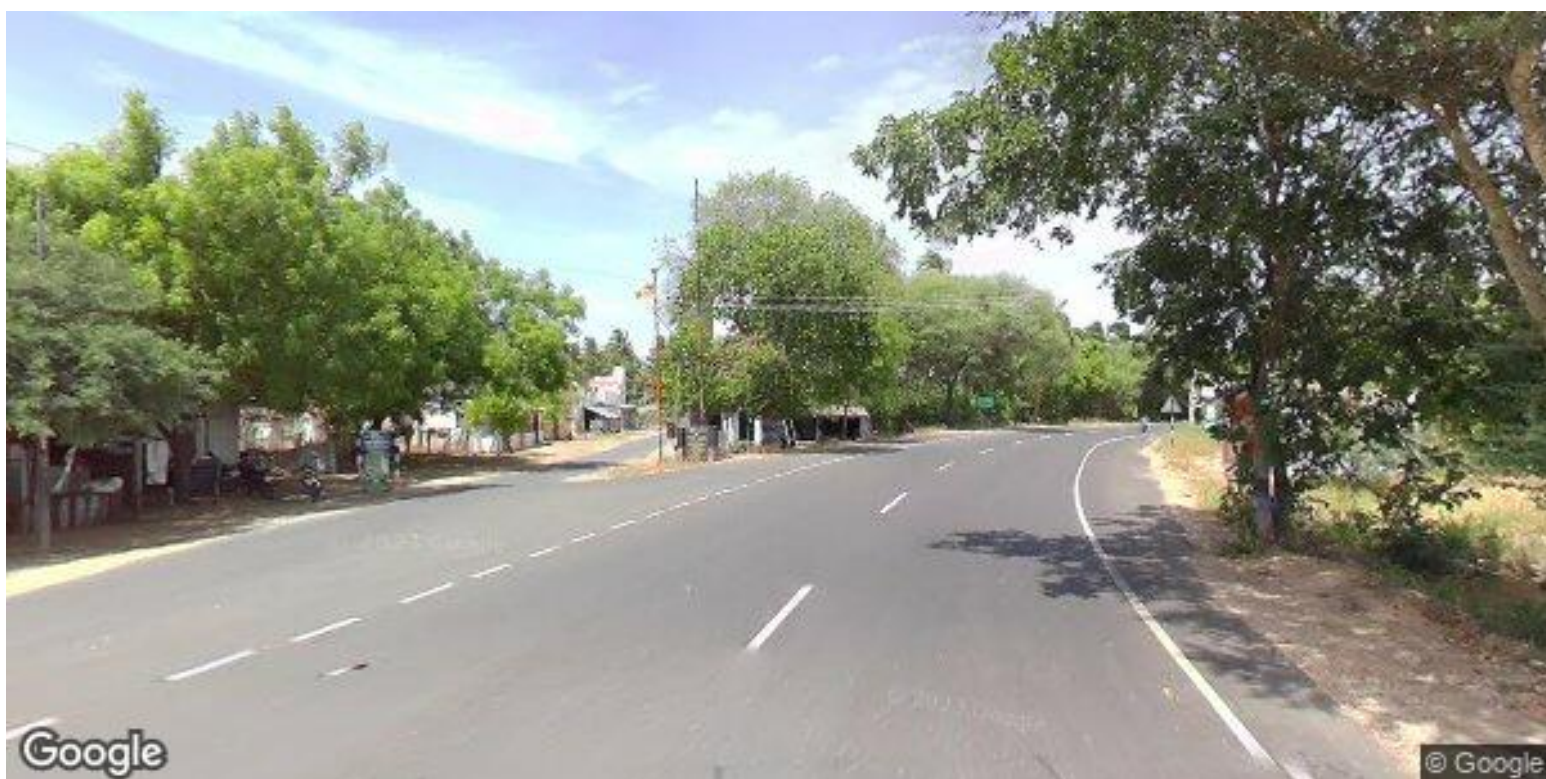
**Risk Type:** Turn  
**Risk Level:** High  
**Speed Limit:** 15 KM/Hr  
**Coordinates:** 10.86296, 77.72154

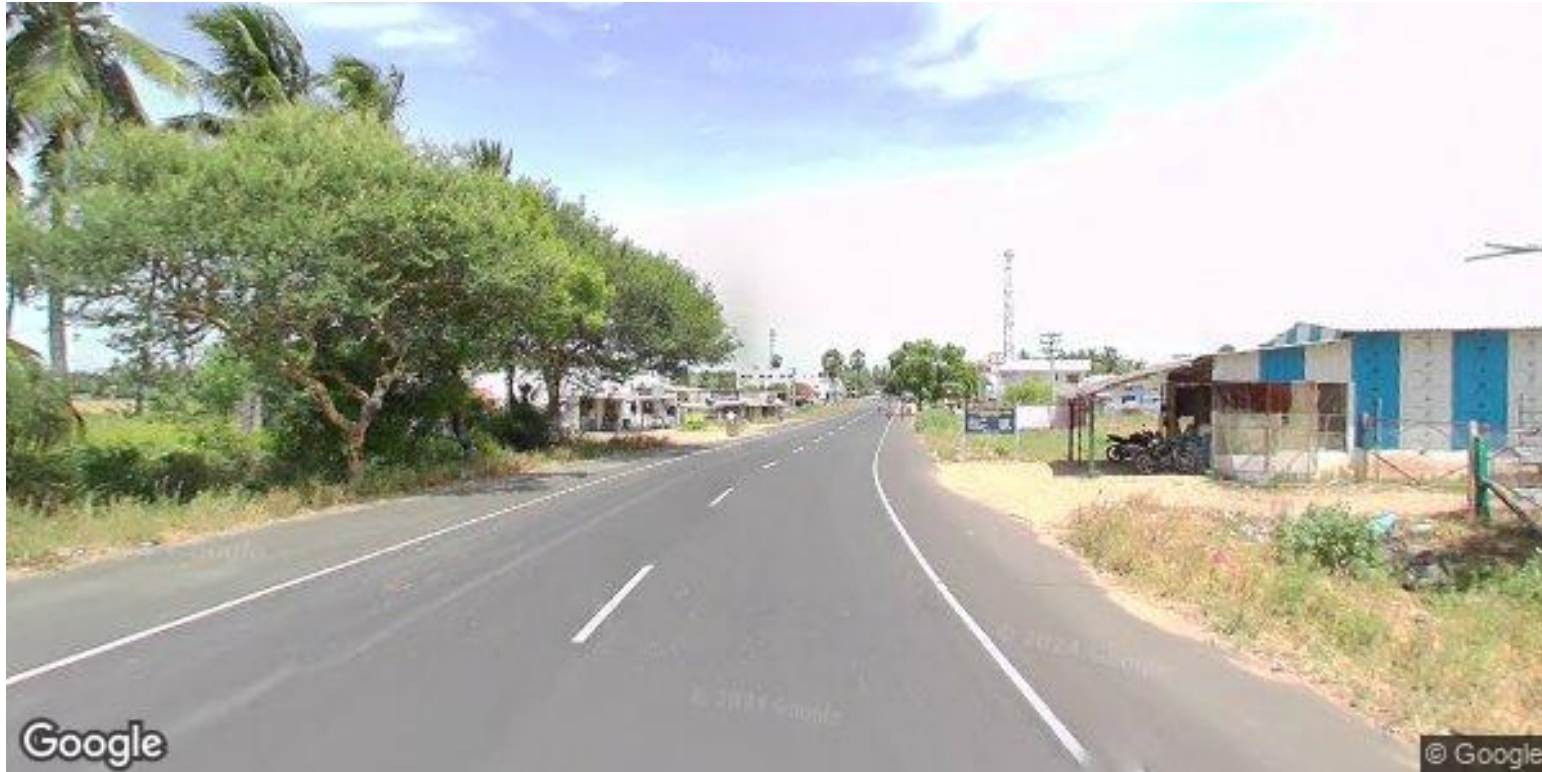
**Risk Type:** Turn  
**Risk Level:** Medium  
**Speed Limit:** 30 KM/Hr  
**Coordinates:** 10.86198, 77.72038

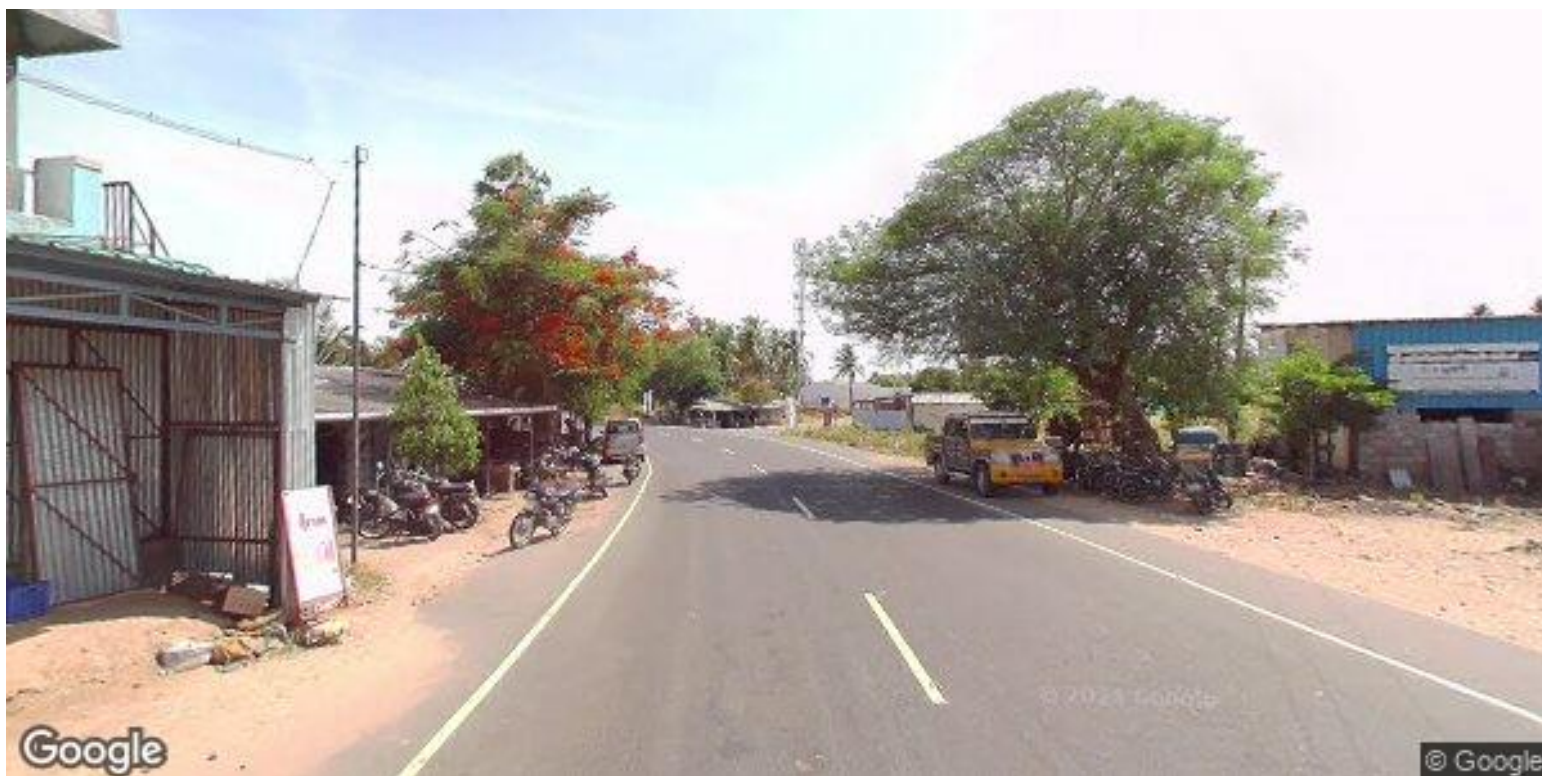
**Risk Type:** Turn  
**Risk Level:** Medium  
**Speed Limit:** 30 KM/Hr  
**Coordinates:** 10.86169, 77.71783

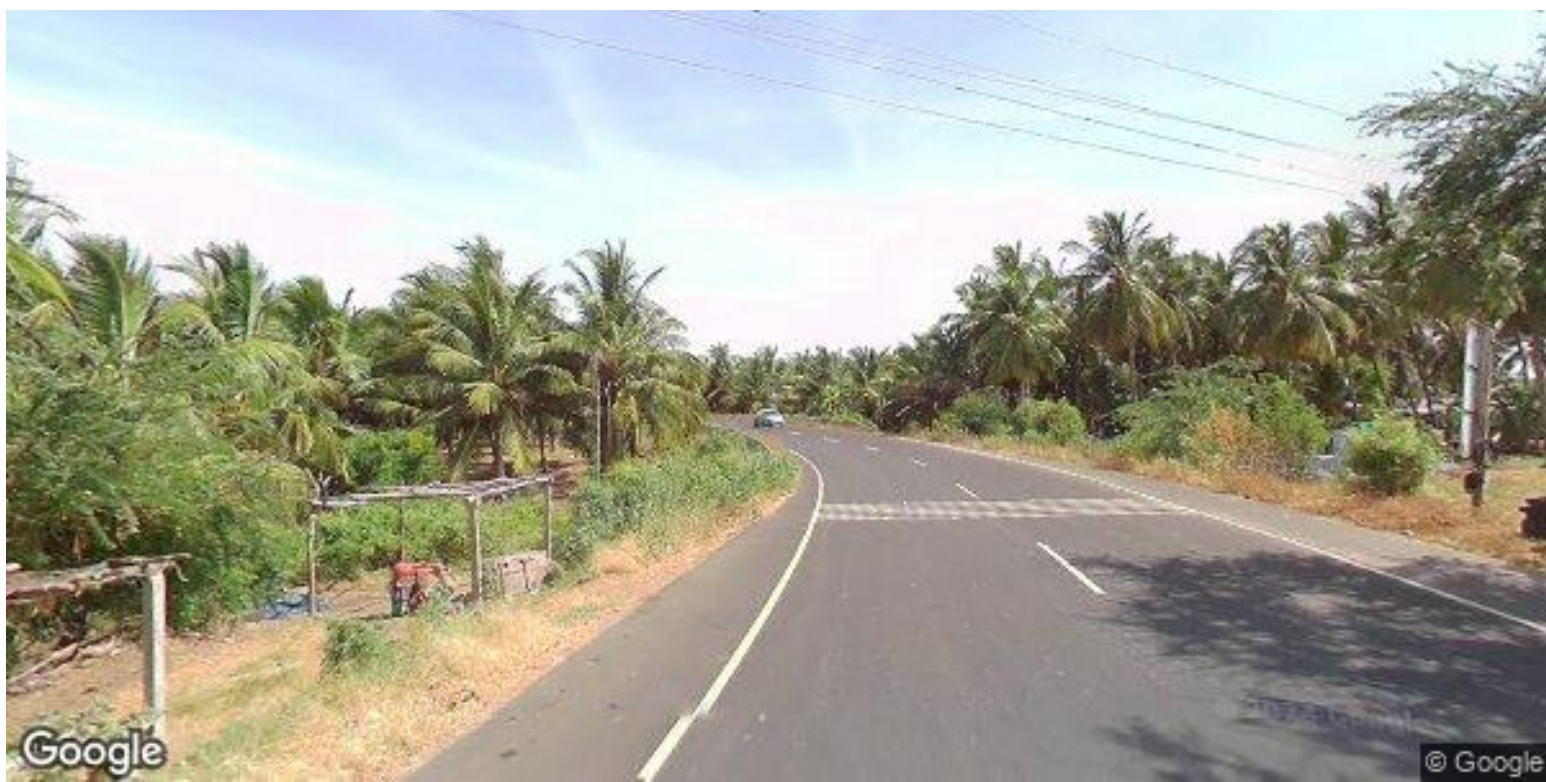
**Coordinates:** 10.86129, 77.71735

**Risk Type:** Turn

**Risk Level:** Medium

**Speed Limit:** 30 KM/Hr

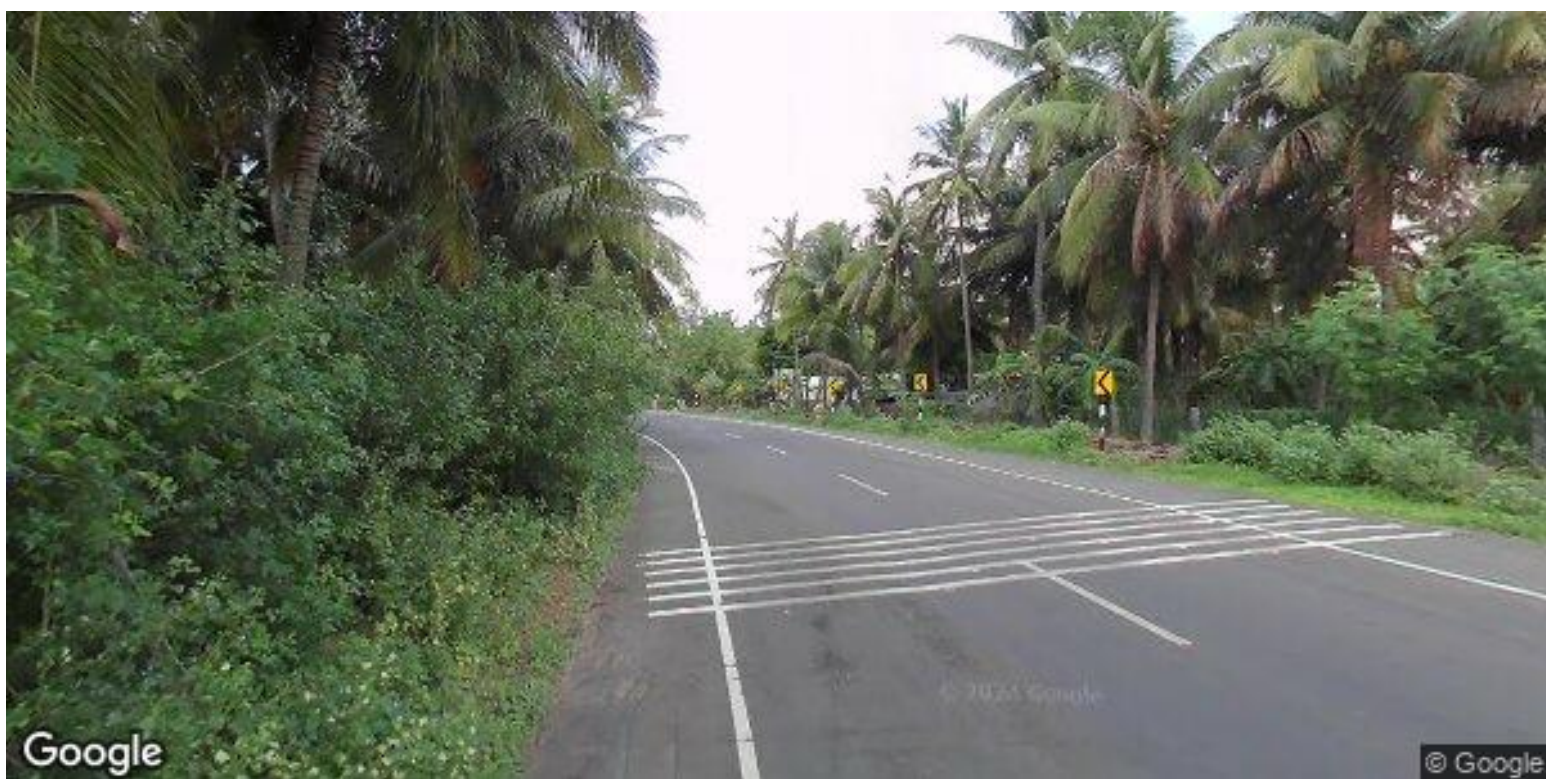
**Coordinates:** 10.85622, 77.71783

**Risk Type:** Turn

**Risk Level:** Medium

**Speed Limit:** 30 KM/Hr

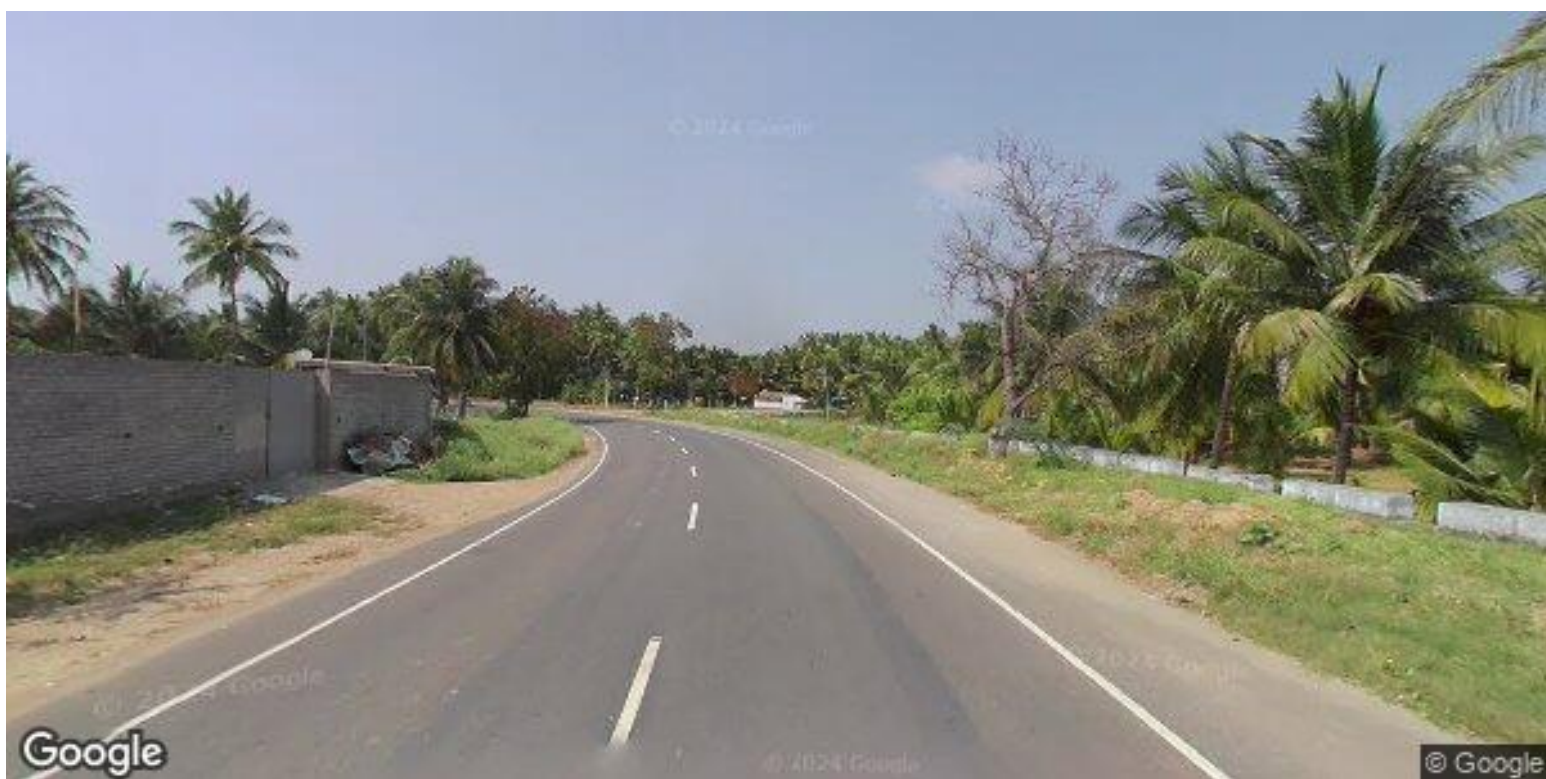
**Risk Type:** Turn  
**Risk Level:** Medium  
**Speed Limit:** 30 KM/Hr  
**Coordinates:** 10.85474, 77.72055

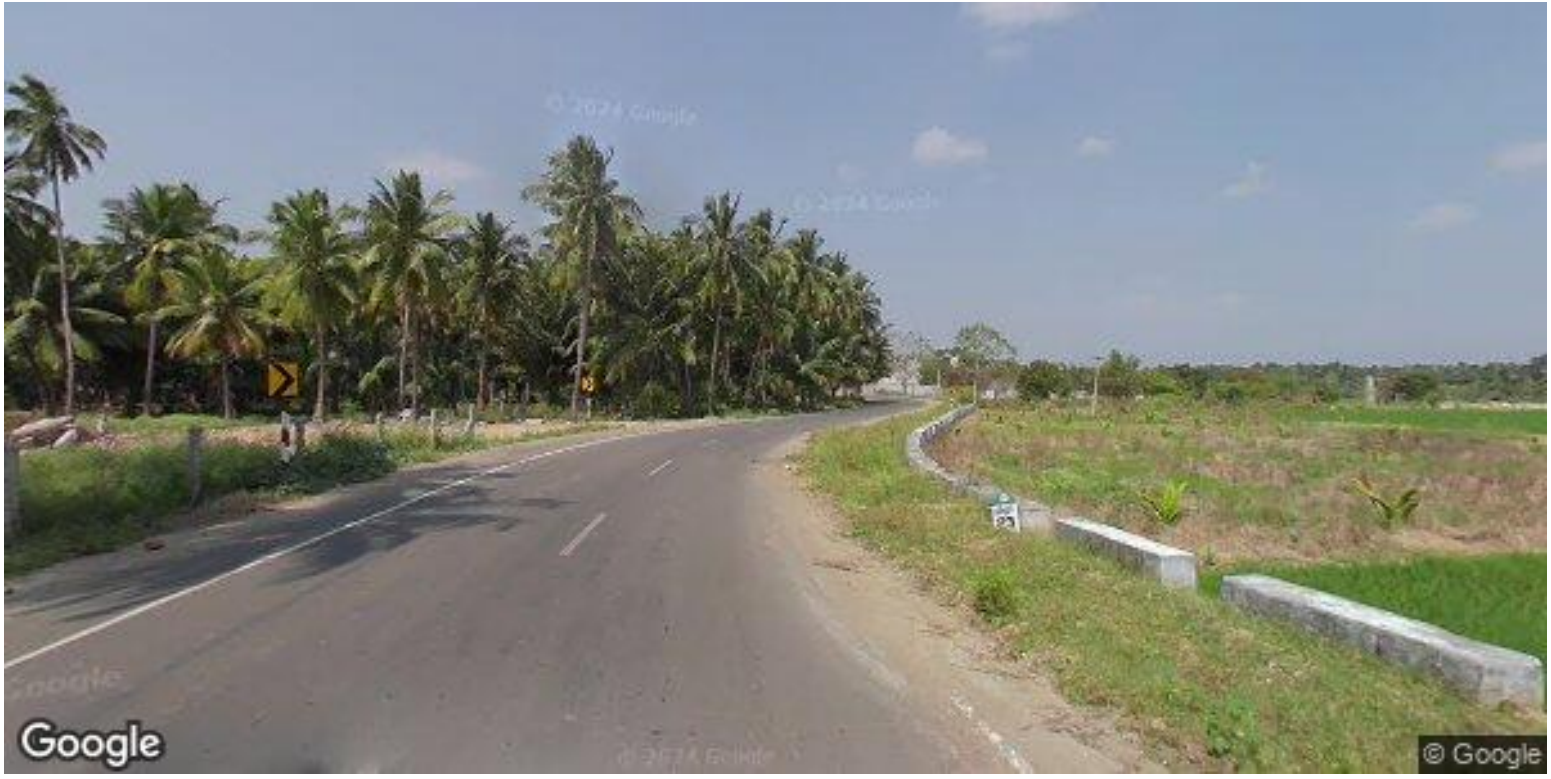
**Risk Type:** Turn  
**Risk Level:** Medium  
**Speed Limit:** 30 KM/Hr  
**Coordinates:** 10.85089, 77.72068

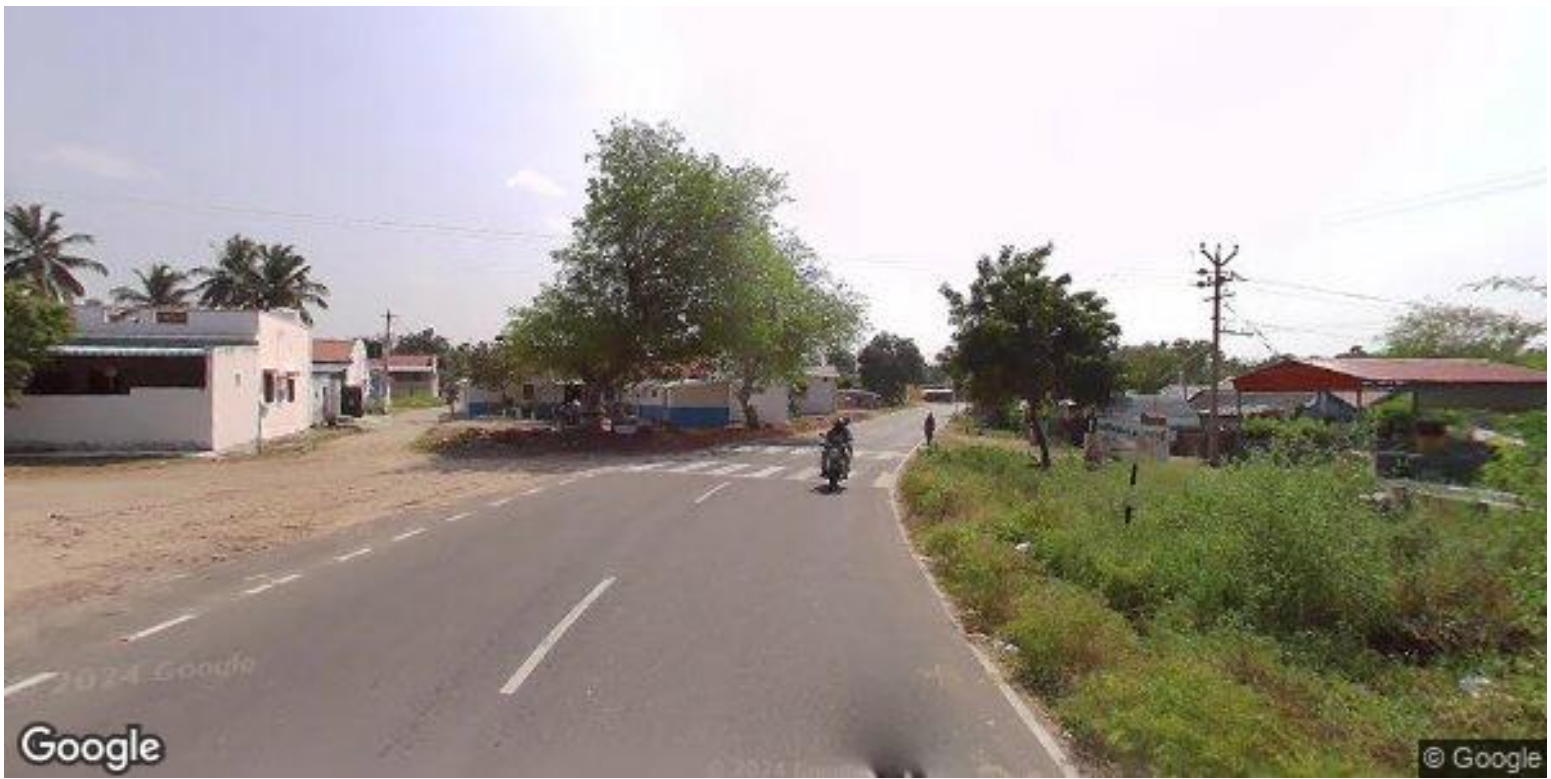
**Risk Type:** Turn  
**Risk Level:** Medium  
**Speed Limit:** 30 KM/Hr  
**Coordinates:** 10.82293, 77.72030

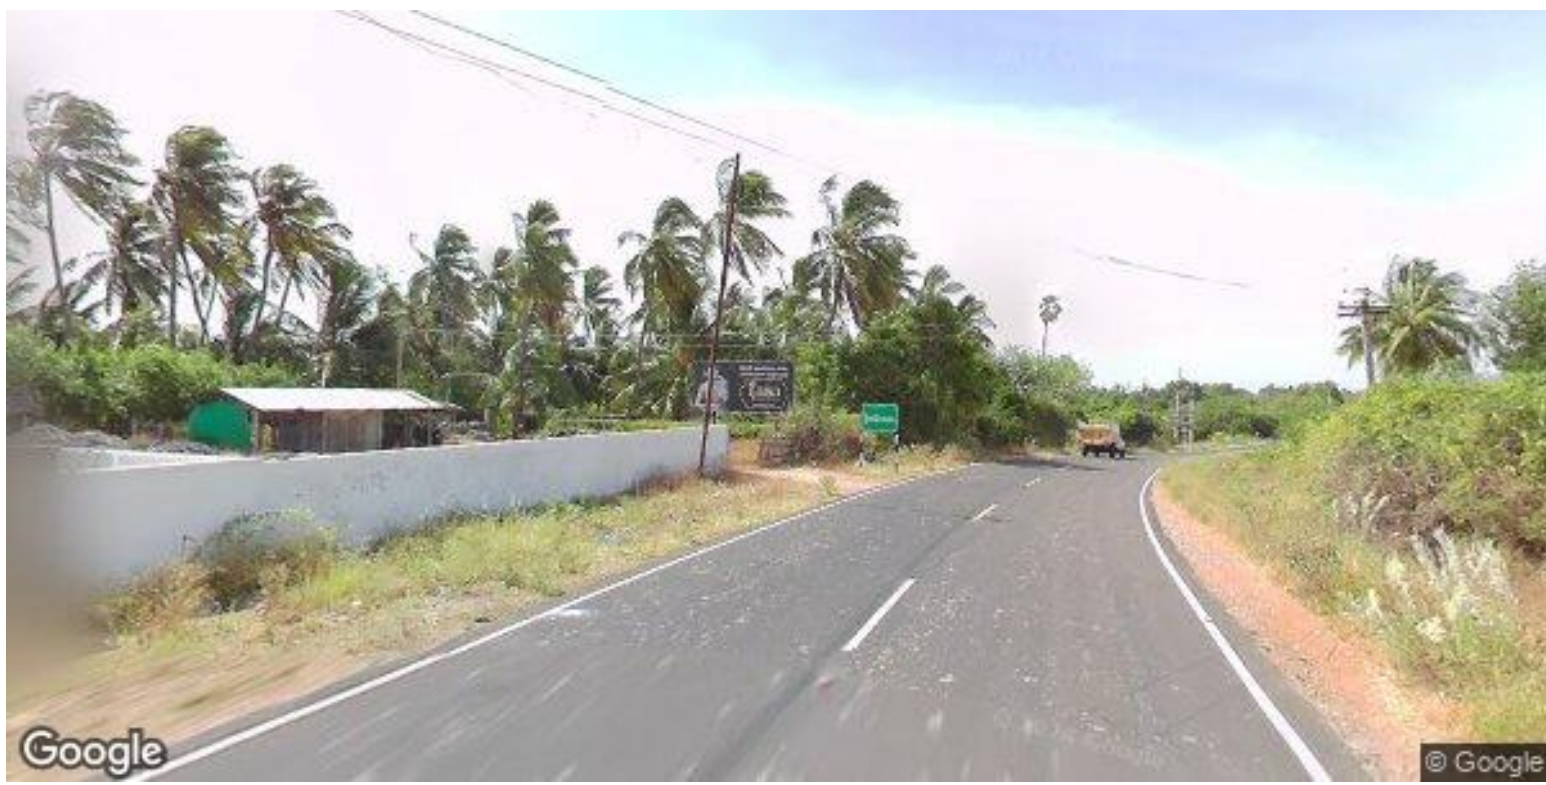
**Coordinates:** 10.82060, 77.71866

**Risk Type:** Turn

**Risk Level:** Medium

**Speed Limit:** 30 KM/Hr
