# IndianOil

## **JOURNEY RISK MANAGEMENT (JRM) STUDY**

### **Salem Terminal to SRI SELVA NITHI AGENCIES**

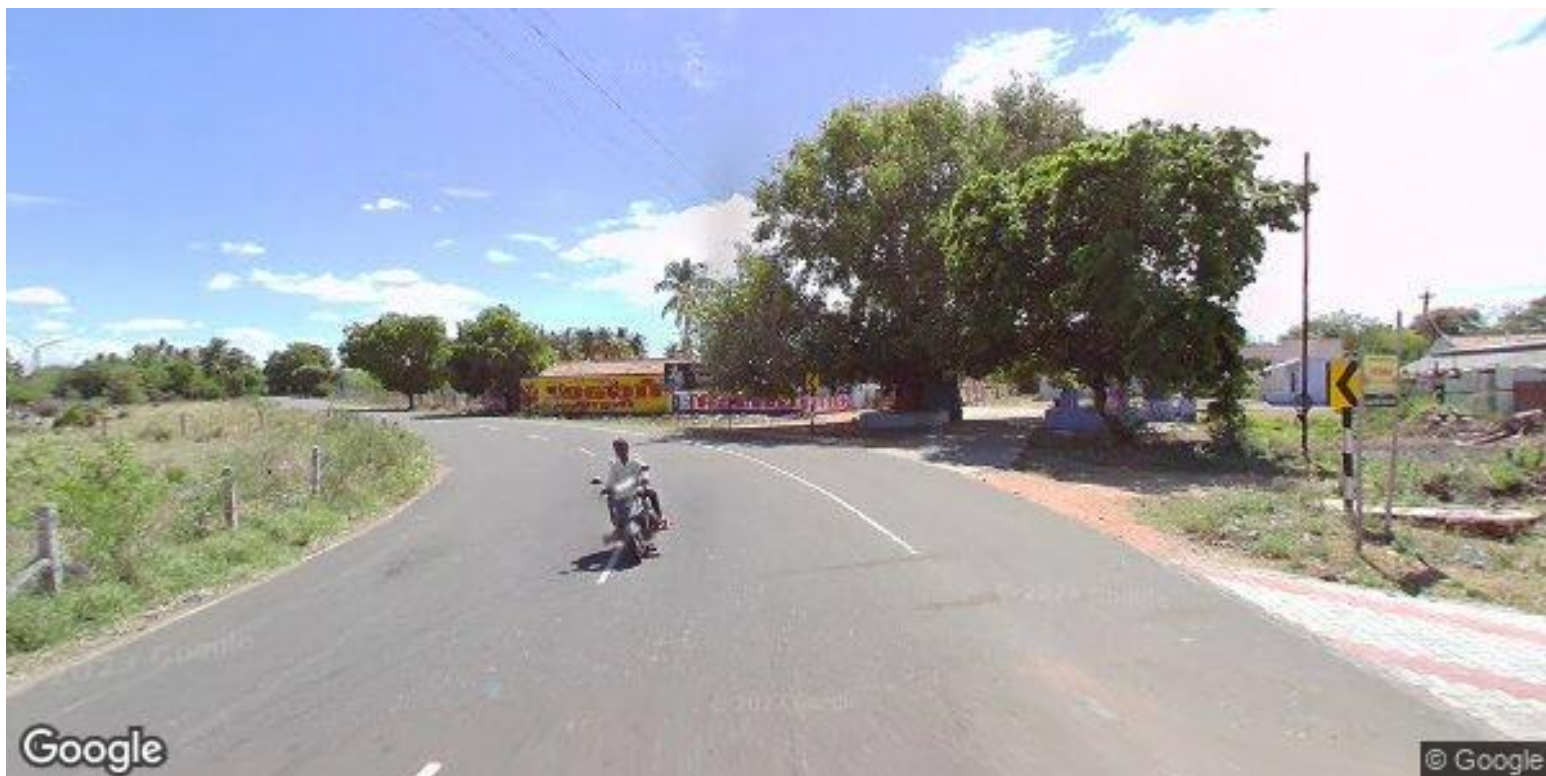
**Coordinates:** 10.80297, 77.71447

**Risk Type:** Turn

**Risk Level:** Medium

**Speed Limit:** 30 KM/Hr

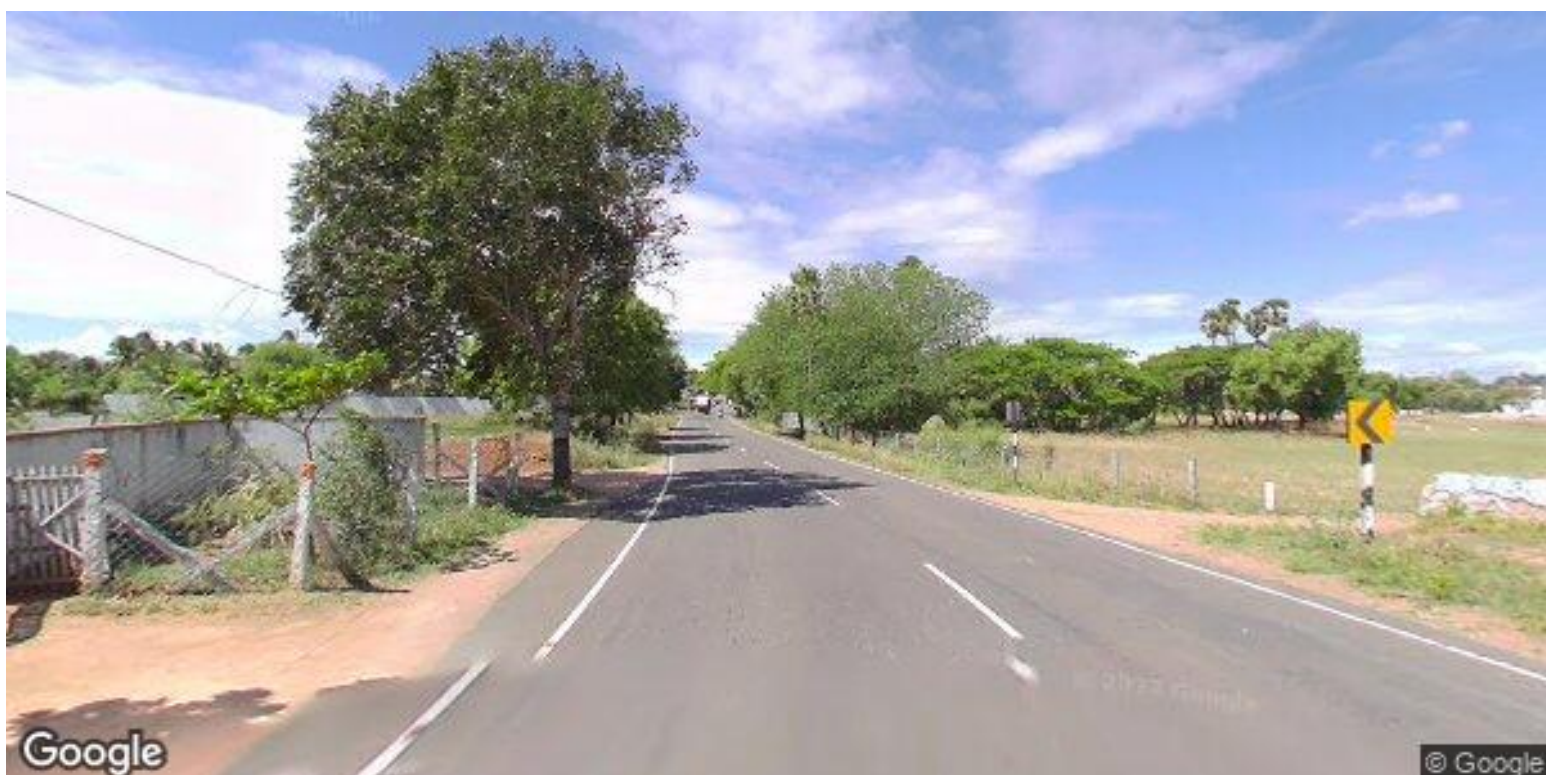
**Coordinates:** 10.80273, 77.71333

**Risk Type:** Turn

**Risk Level:** Medium

**Speed Limit:** 30 KM/Hr

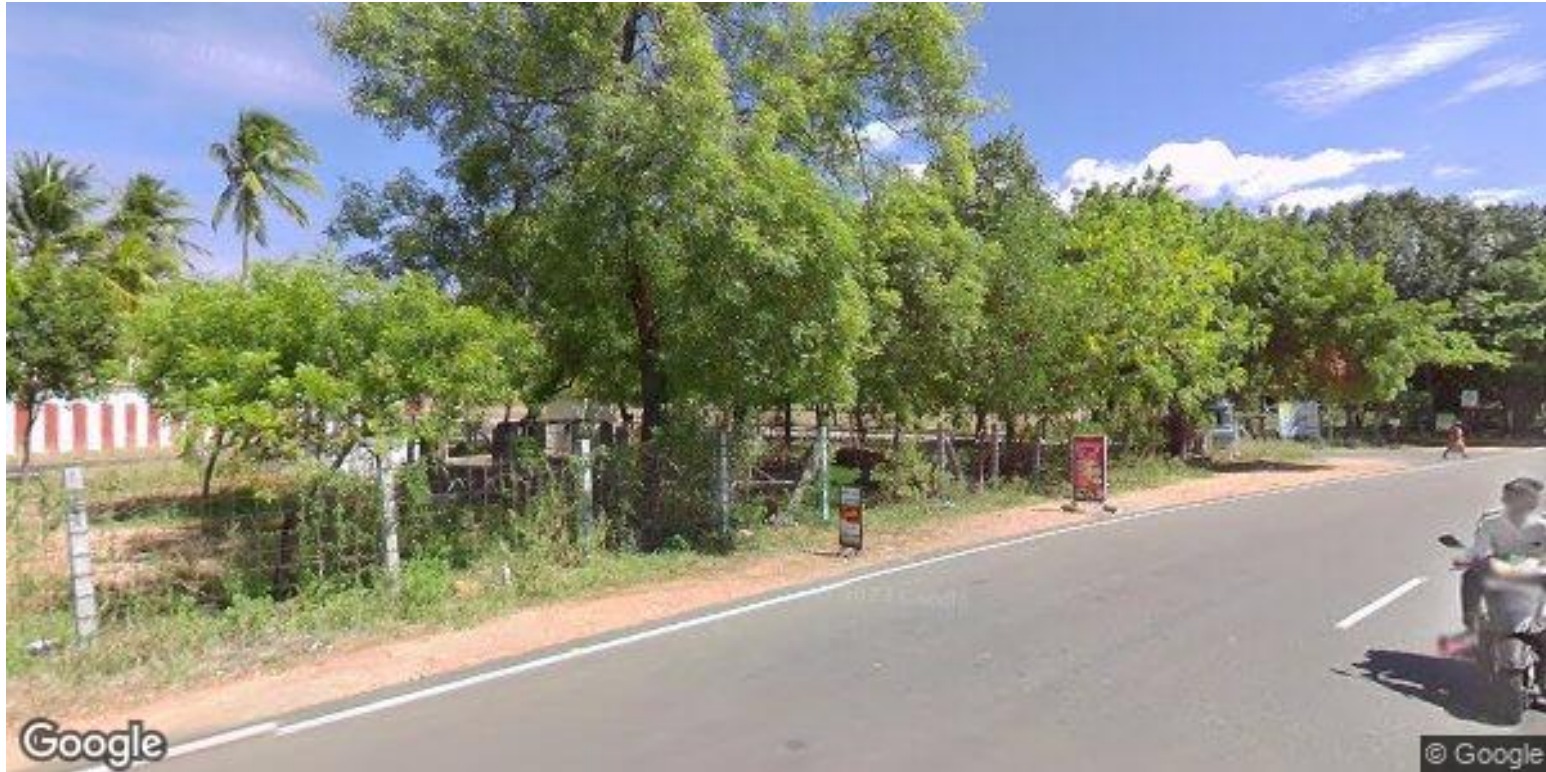
**Coordinates:** 10.80127, 77.71215

**Risk Type:** Turn

**Risk Level:** Medium

**Speed Limit:** 30 KM/Hr

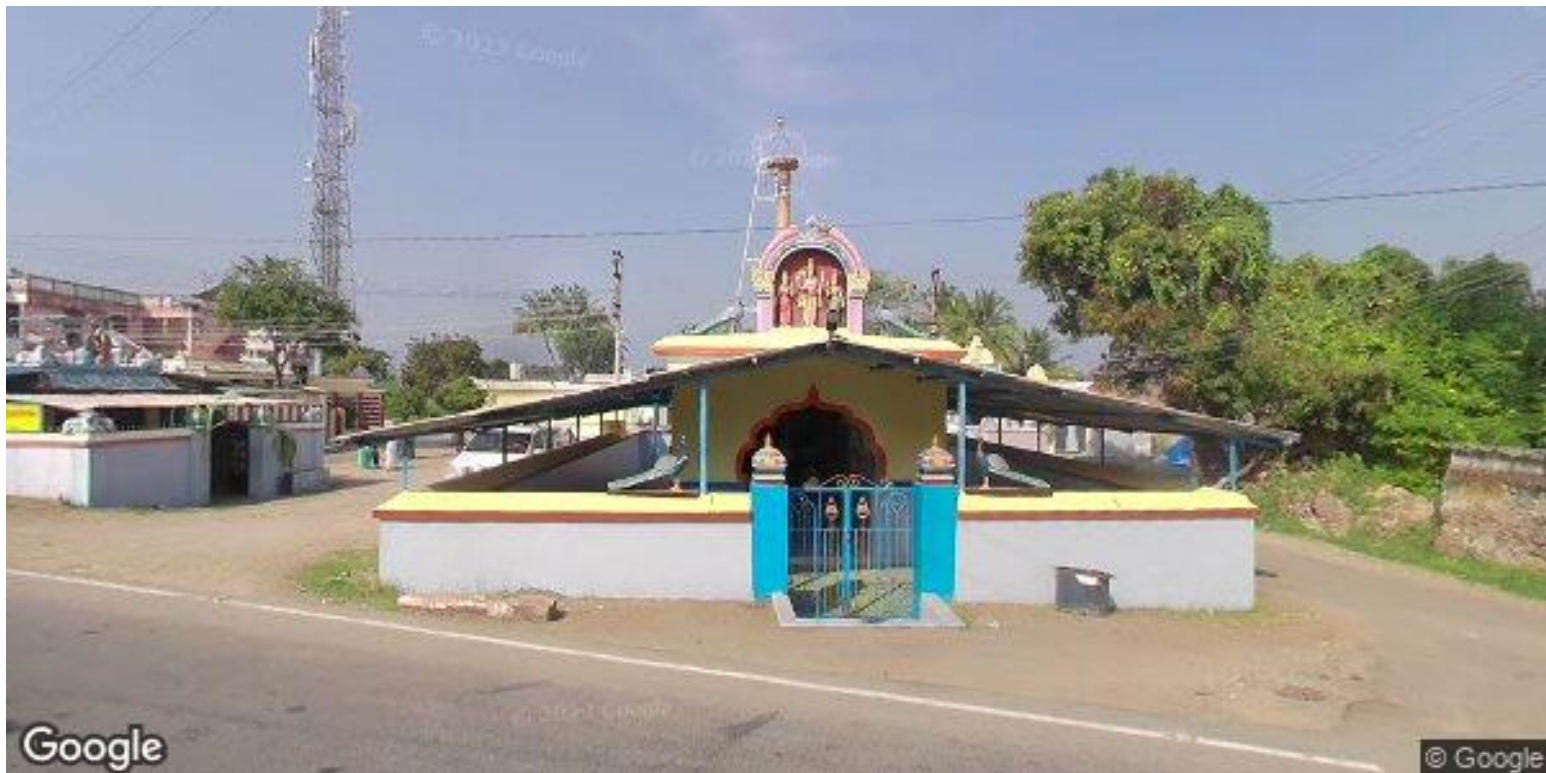
**Coordinates:** 10.79654, 77.71111

**Risk Type:** Turn

**Risk Level:** High

**Speed Limit:** 15 KM/Hr

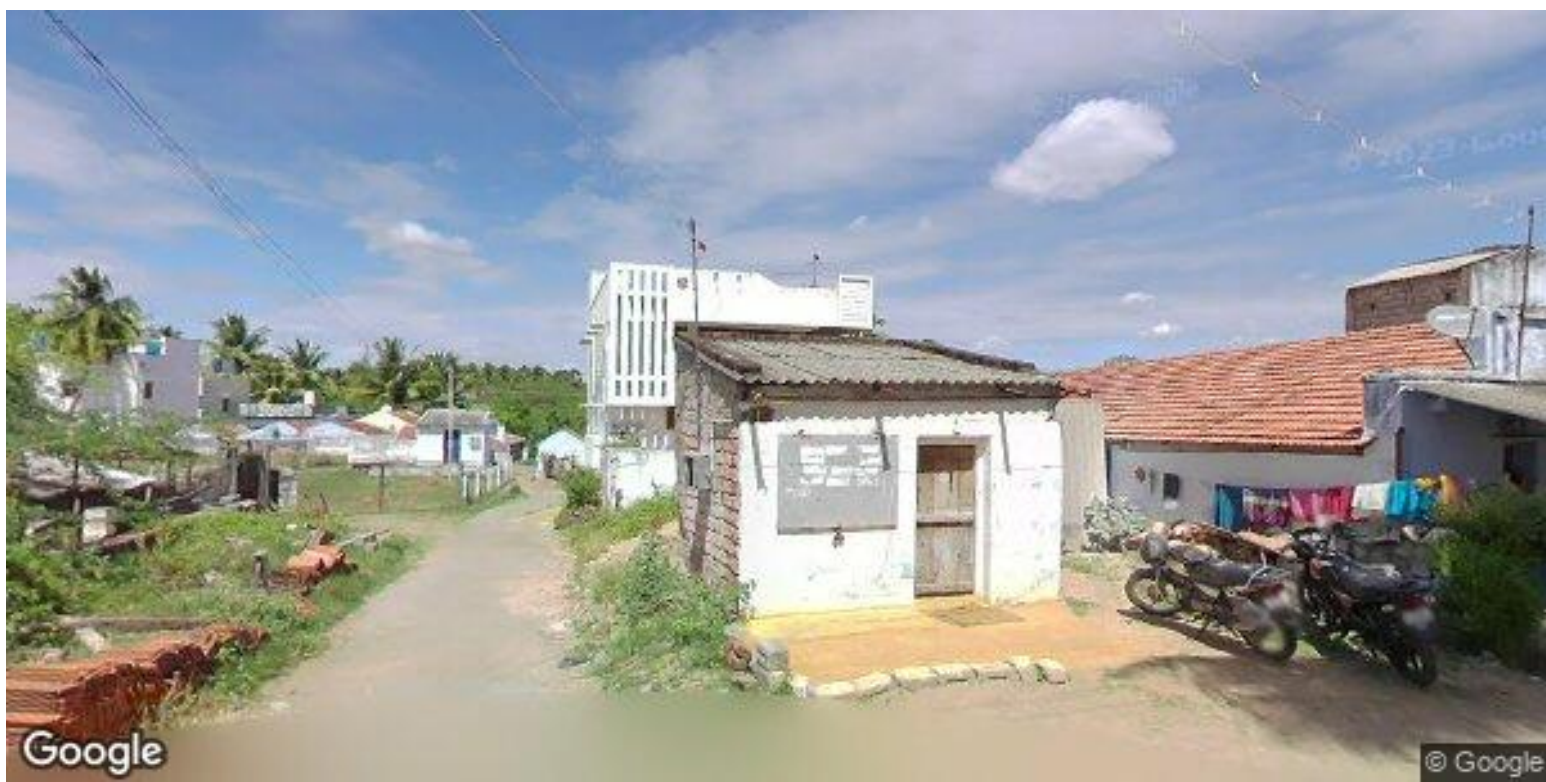
**Coordinates:** 10.79642, 77.71008

**Risk Type:** Turn

**Risk Level:** High

**Speed Limit:** 15 KM/Hr

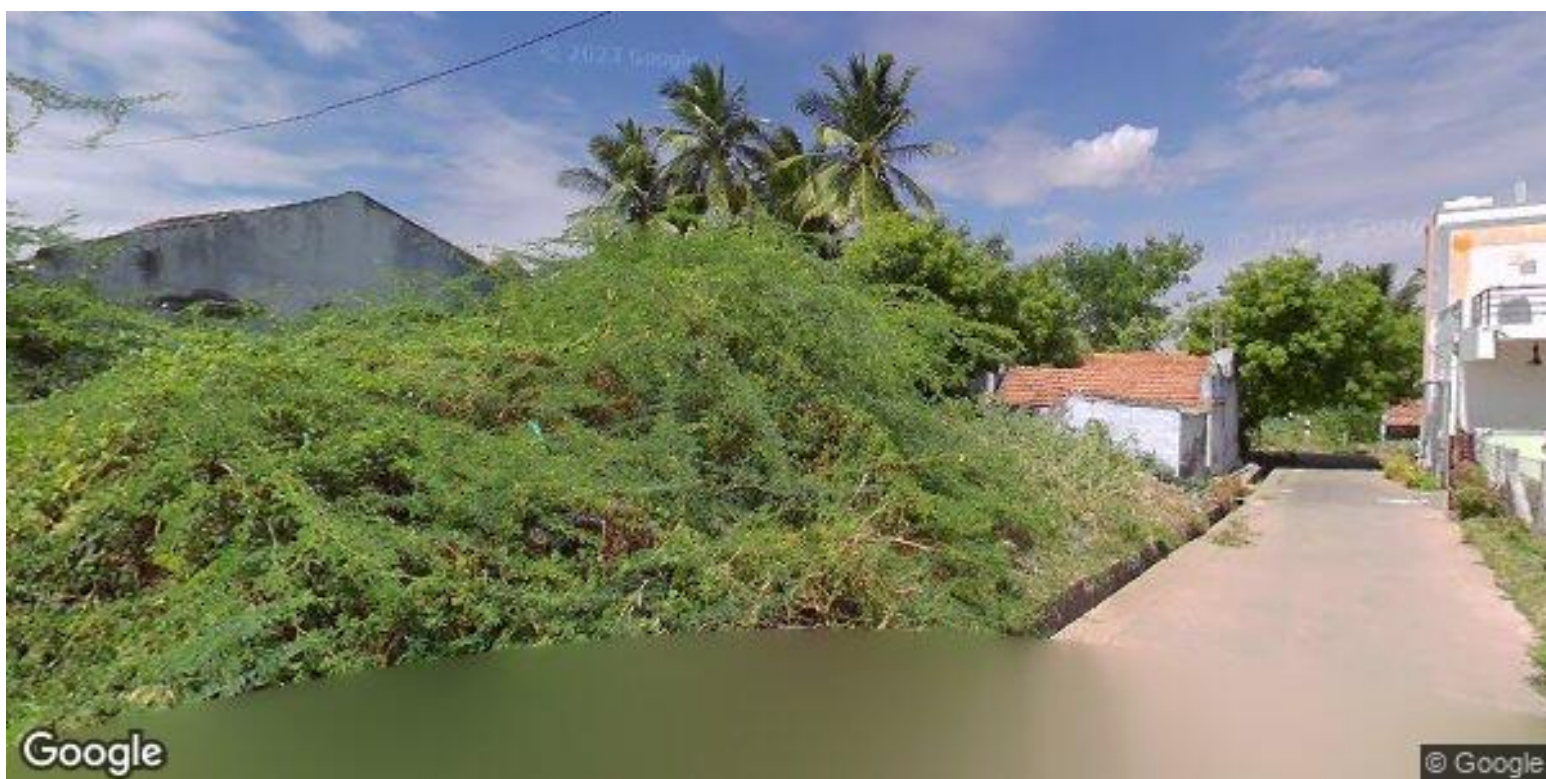
**Coordinates:** 10.79721, 77.71008

**Risk Type:** Turn

**Risk Level:** High

**Speed Limit:** 15 KM/Hr

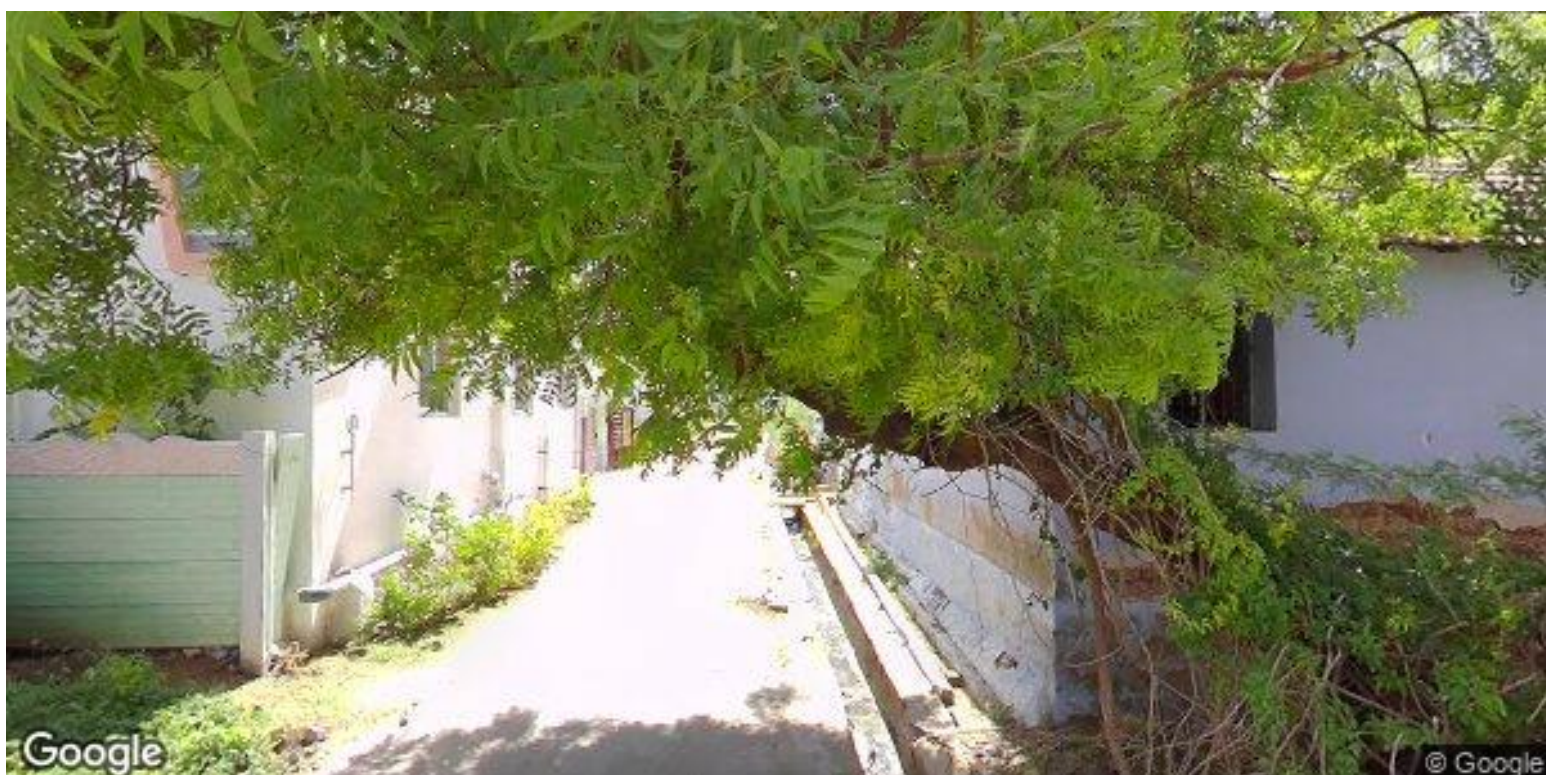
**Risk Type:** Turn  
**Risk Level:** High  
**Speed Limit:** 15 KM/Hr  
**Coordinates:** 10.79724, 77.70972

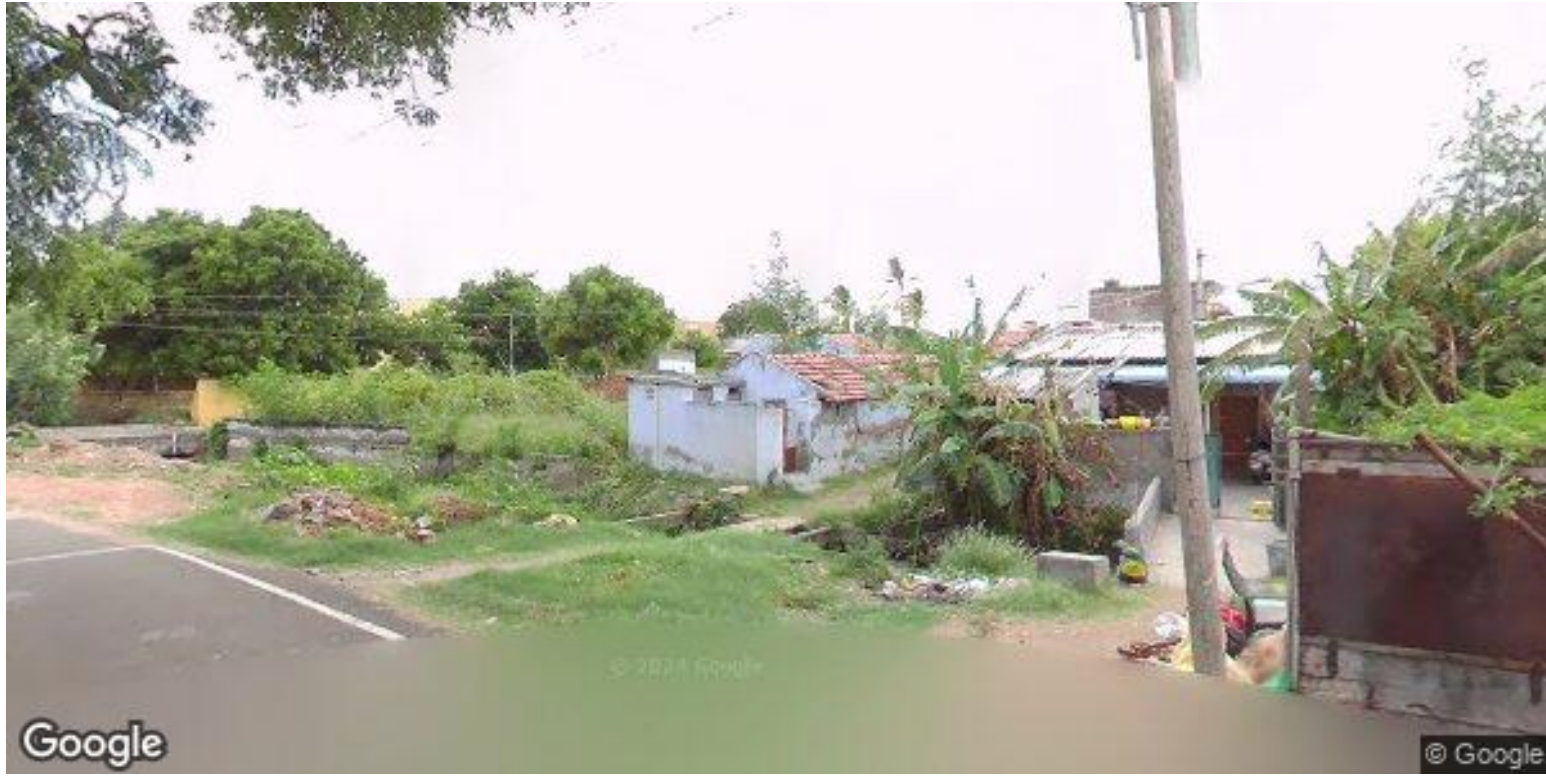
**Risk Type:** Turn  
**Risk Level:** Medium  
**Speed Limit:** 30 KM/Hr  
**Coordinates:** 10.79547, 77.70929

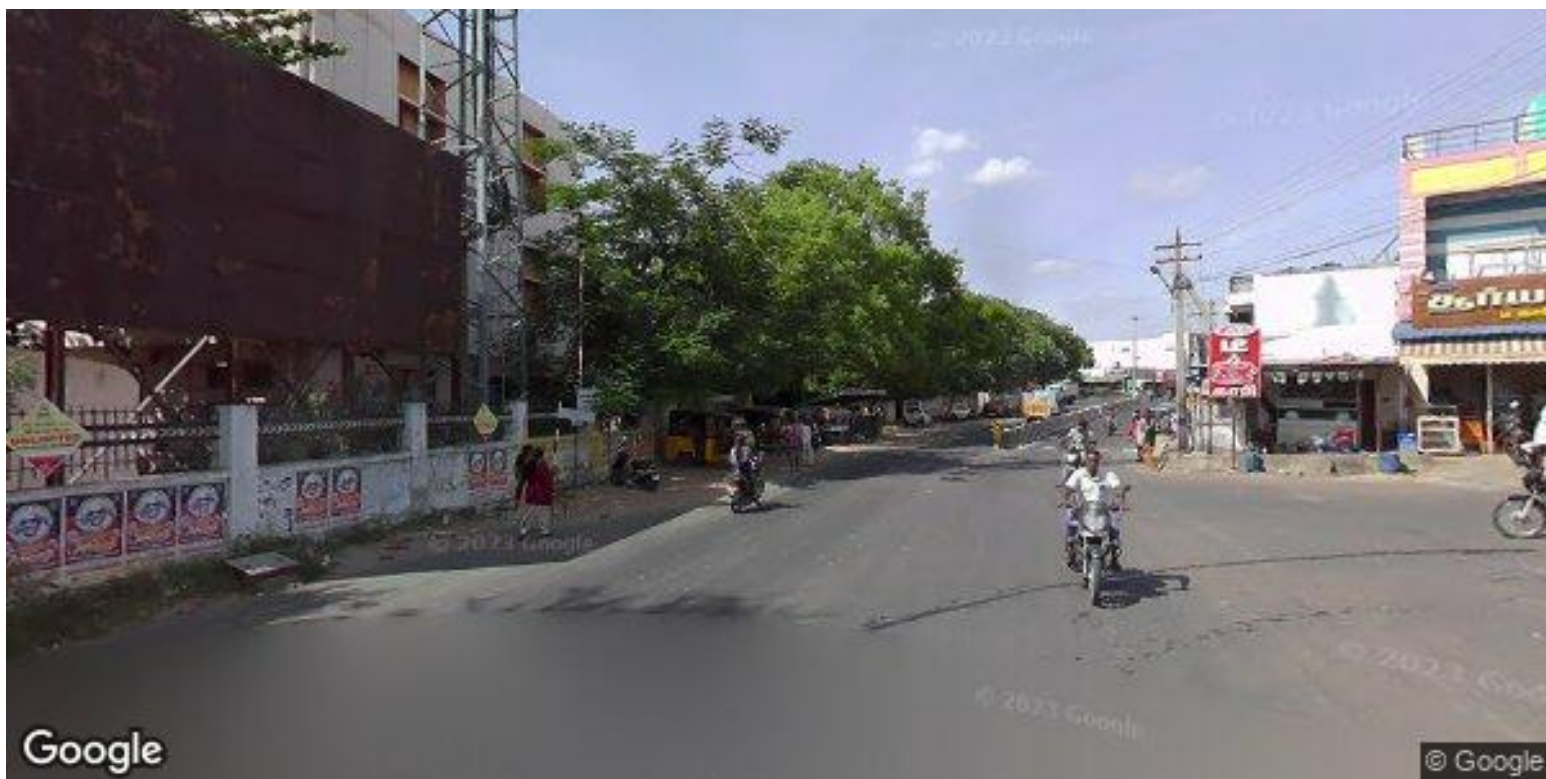
**Risk Type:** Turn  
**Risk Level:** High  
**Speed Limit:** 15 KM/Hr  
**Coordinates:** 10.79476, 77.70965
