# IndianOil

## JOURNEY RISK MANAGEMENT (JRM) STUDY

### Salem Terminal TO NAGUL ENERGY SUPPLYIES

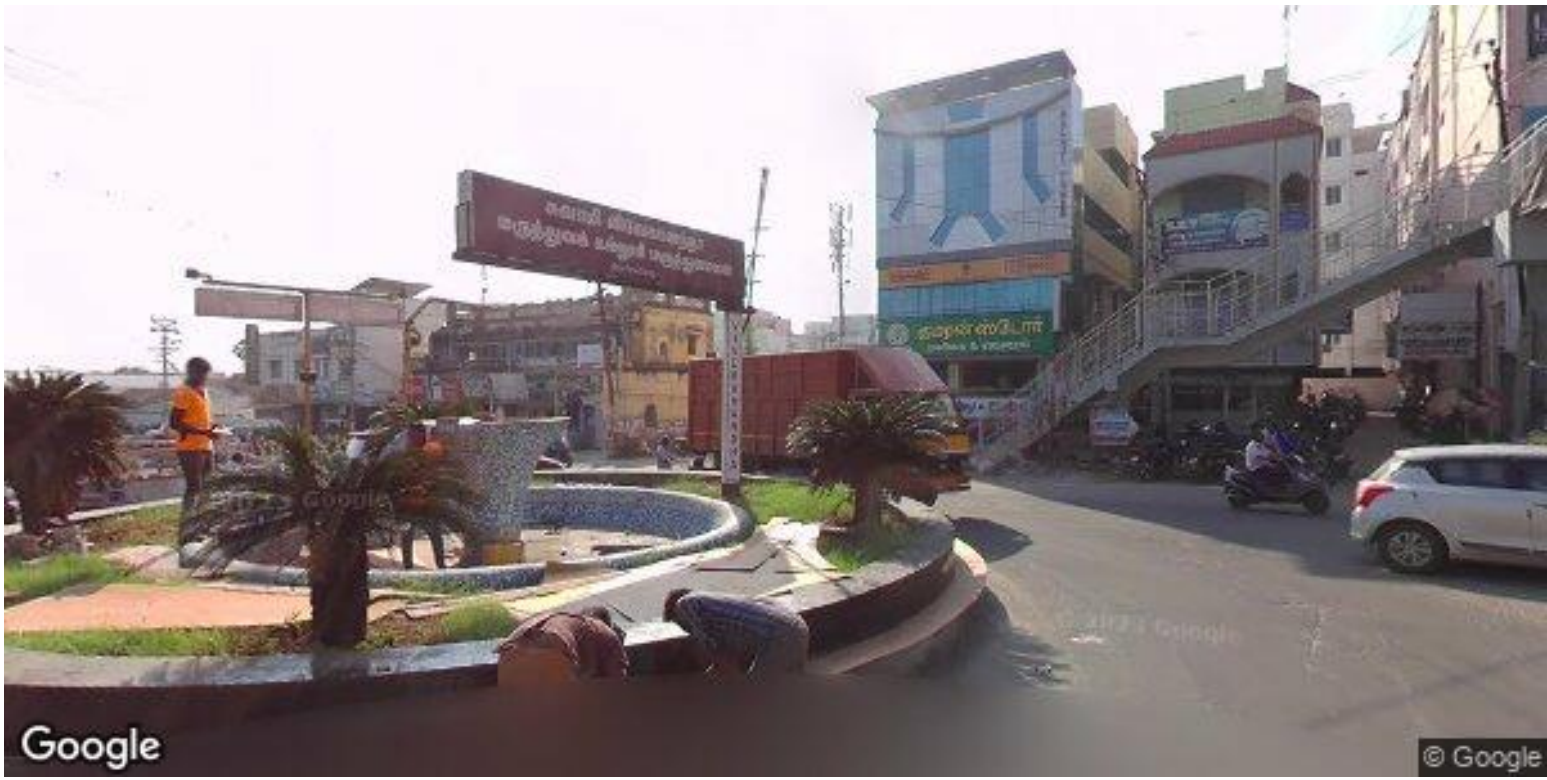
**Coordinates:** 11.38395, 77.89480

**Risk Type:** Roundabout

**Risk Level:** High

**Speed Limit:** 15 KM/Hr

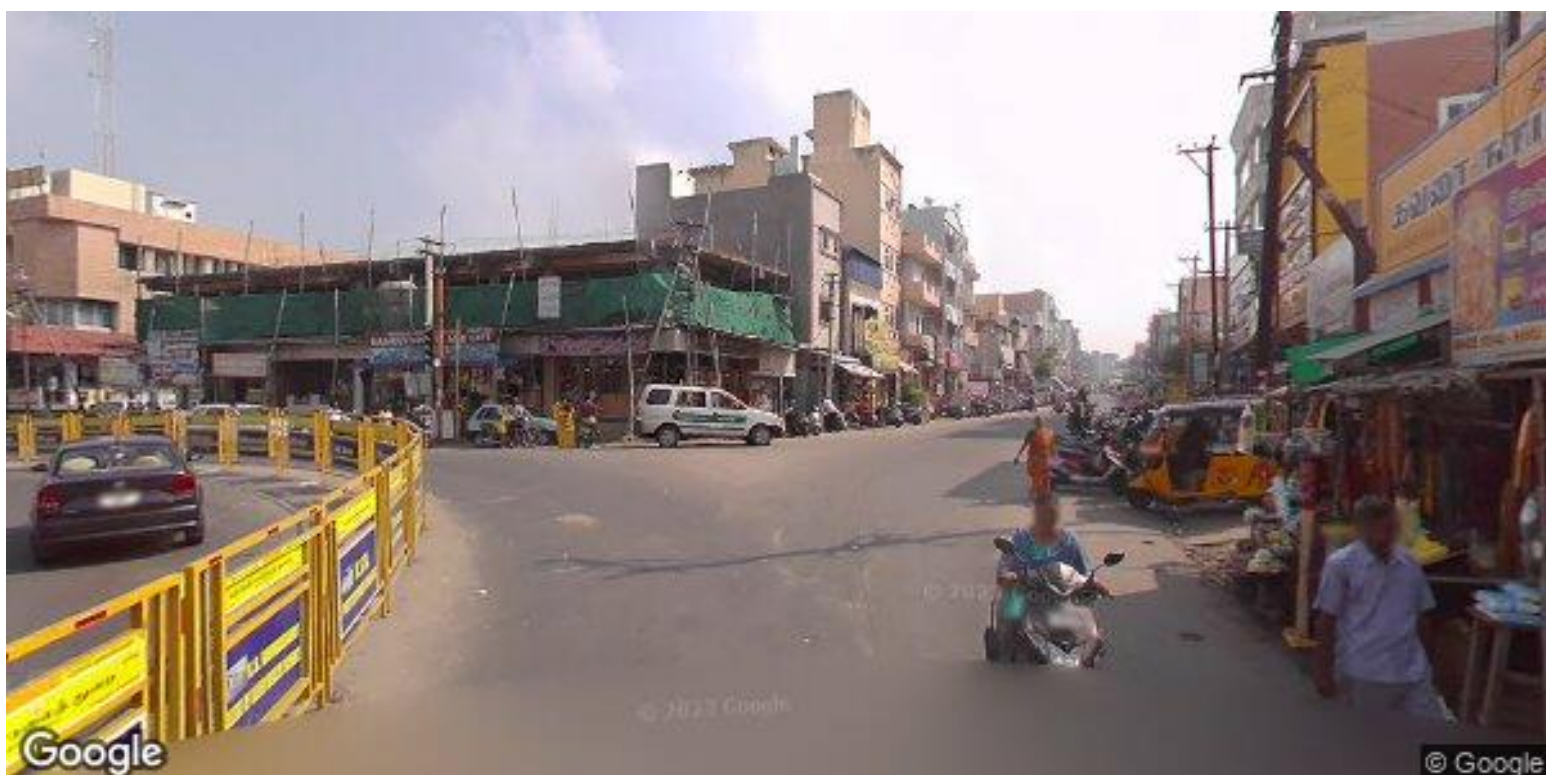
**Coordinates:** 11.37862, 77.89488

**Risk Type:** Turn

**Risk Level:** High

**Speed Limit:** 15 KM/Hr

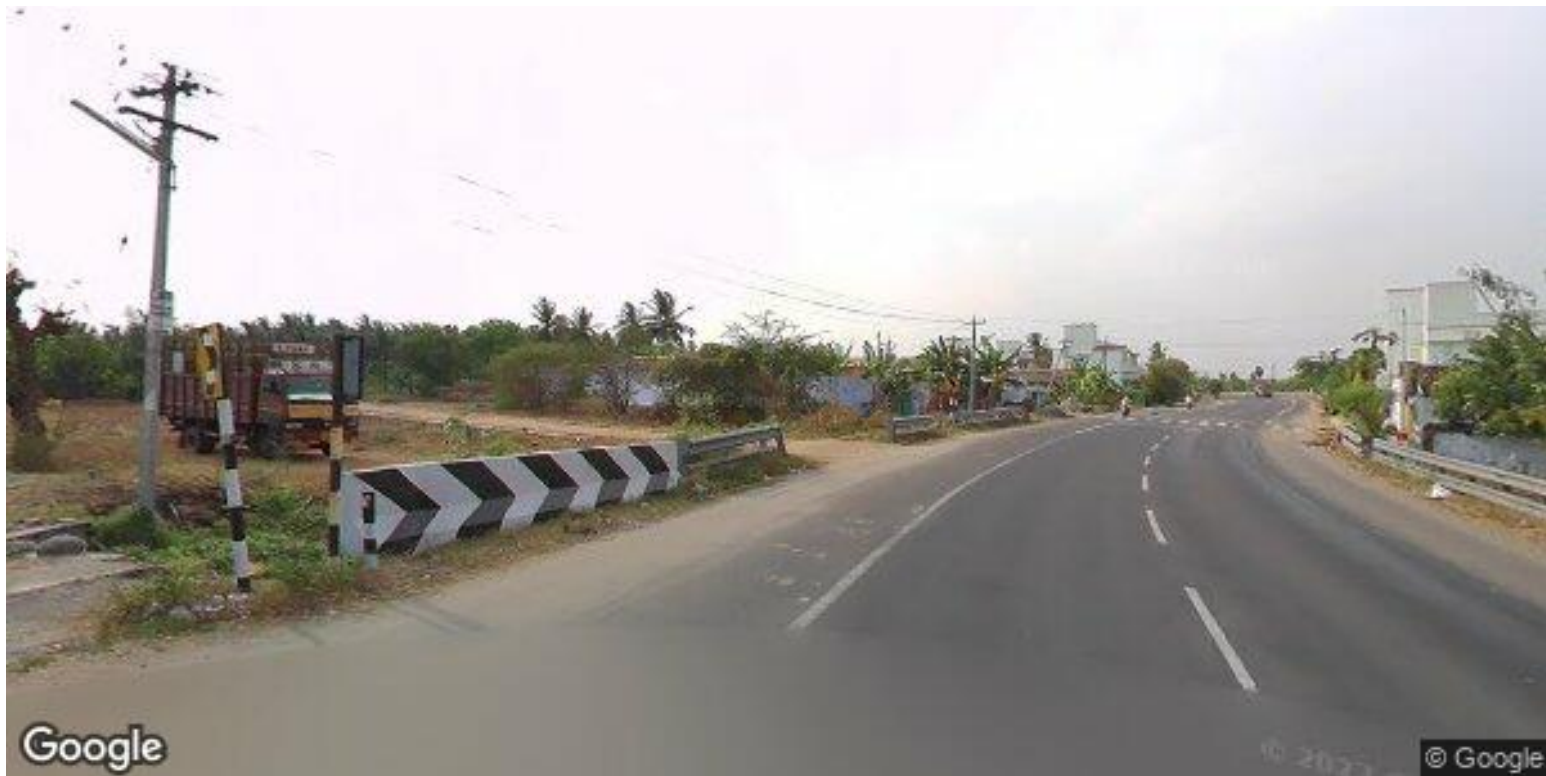
**Coordinates:** 11.16755, 78.01568

**Risk Type:** Turn

**Risk Level:** Medium

**Speed Limit:** 30 KM/Hr

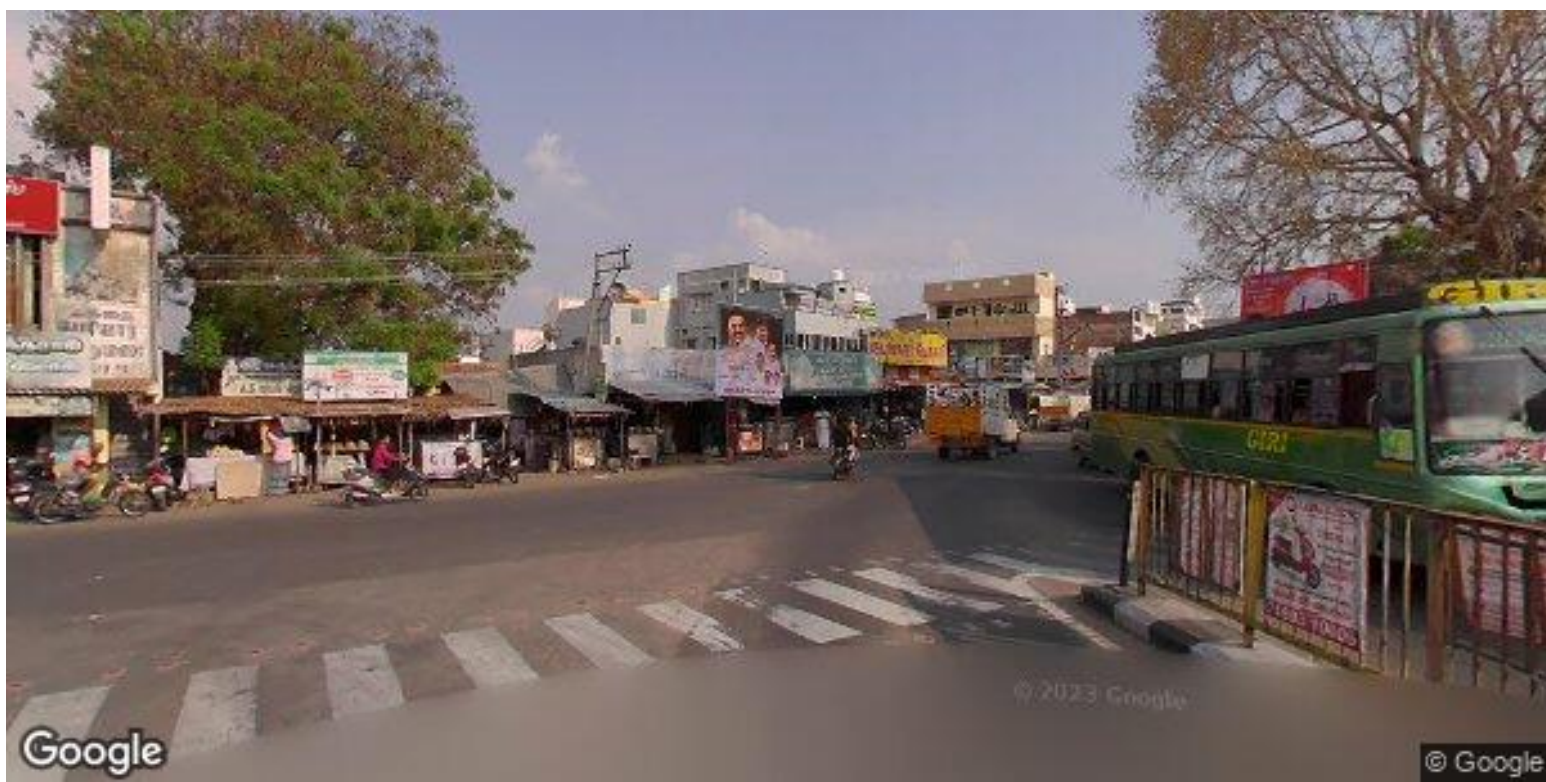
**Coordinates:** 11.15579, 78.02169

**Risk Type:** Turn

**Risk Level:** Medium

**Speed Limit:** 30 KM/Hr

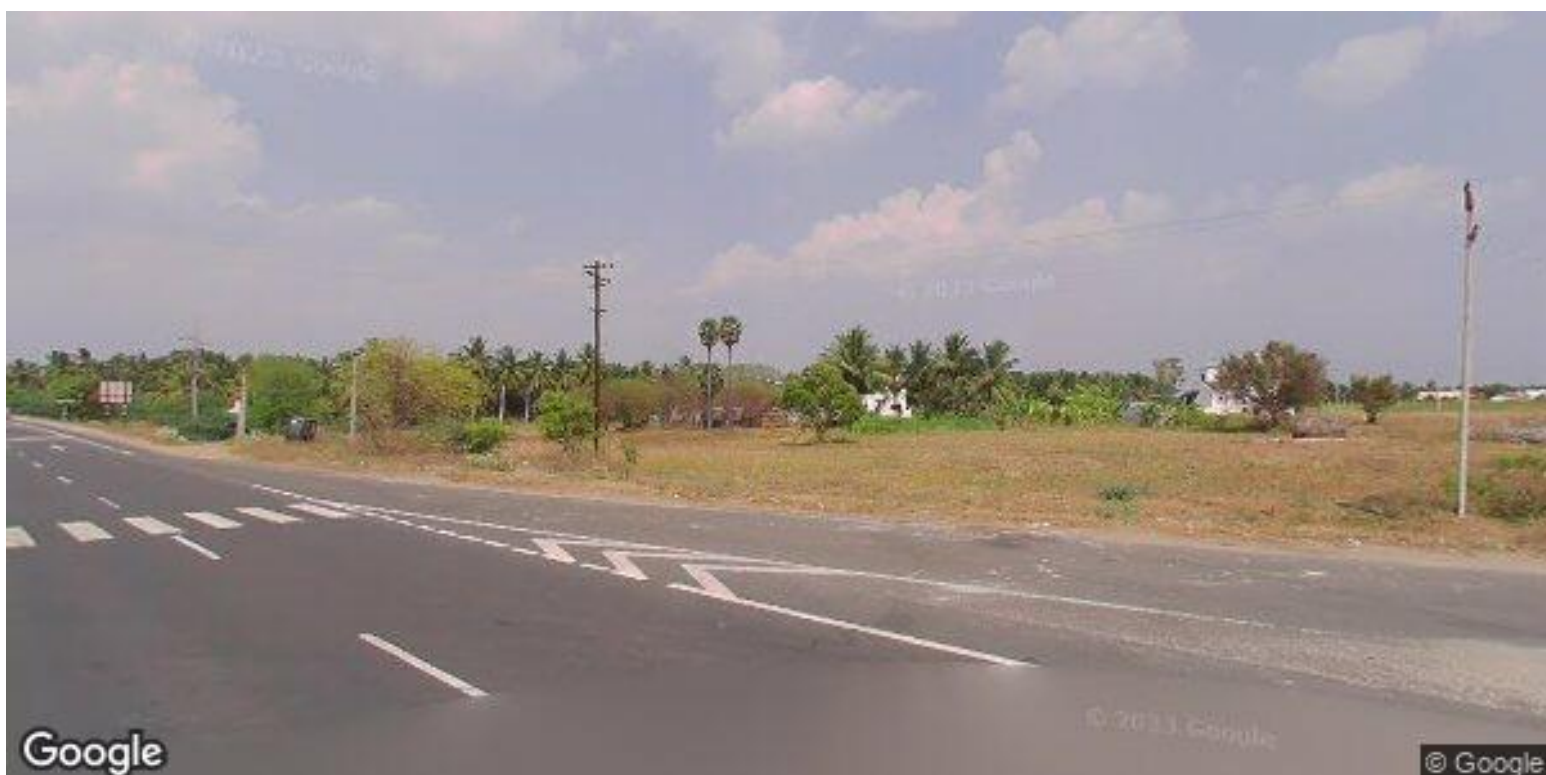
**Risk Type:** Turn  
**Risk Level:** High  
**Speed Limit:** 15 KM/Hr  
**Coordinates:** 11.14480, 78.02291

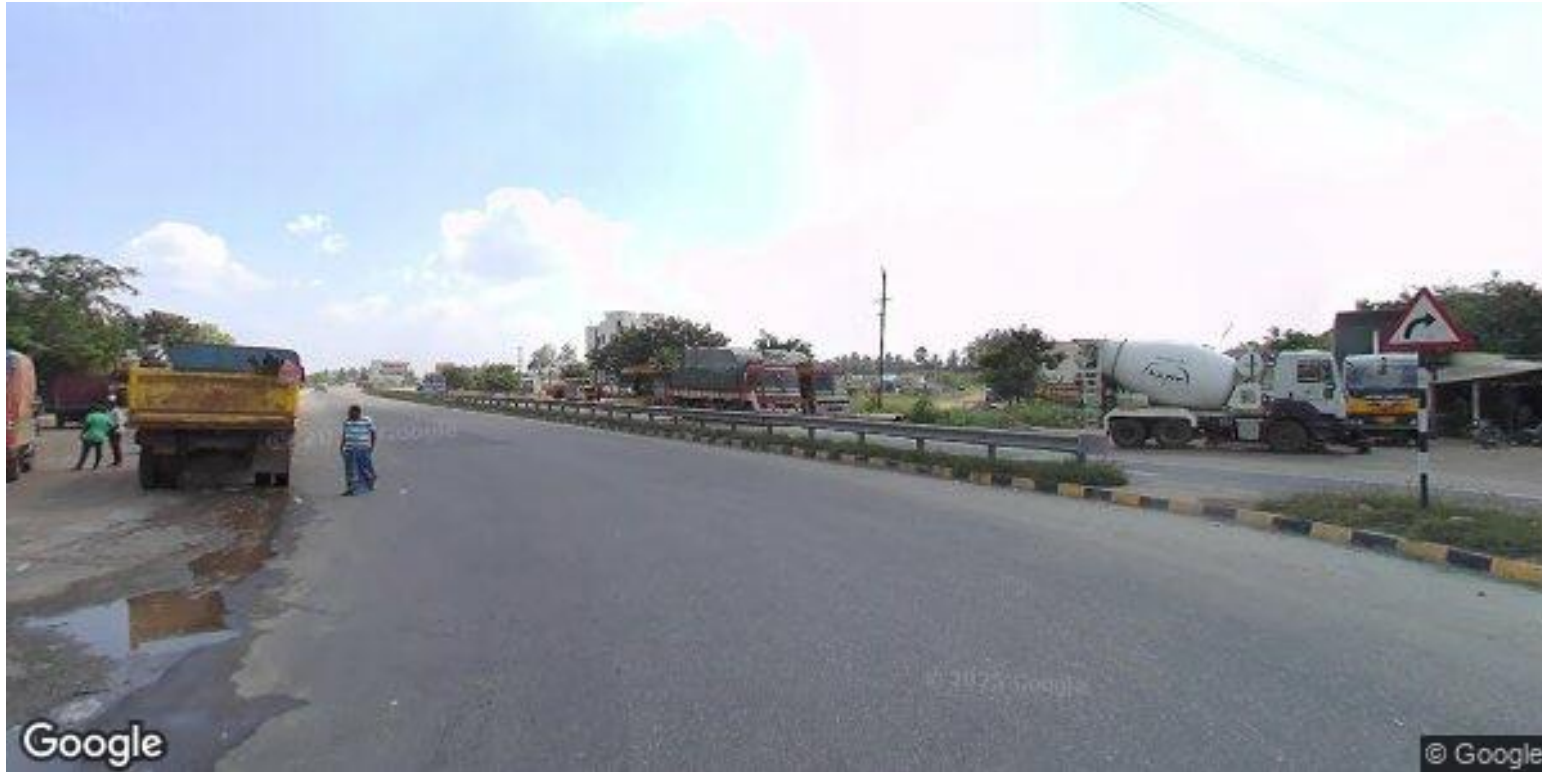
**Risk Type:** Turn  
**Risk Level:** Medium  
**Speed Limit:** 30 KM/Hr  
**Coordinates:** 10.92922, 78.05481

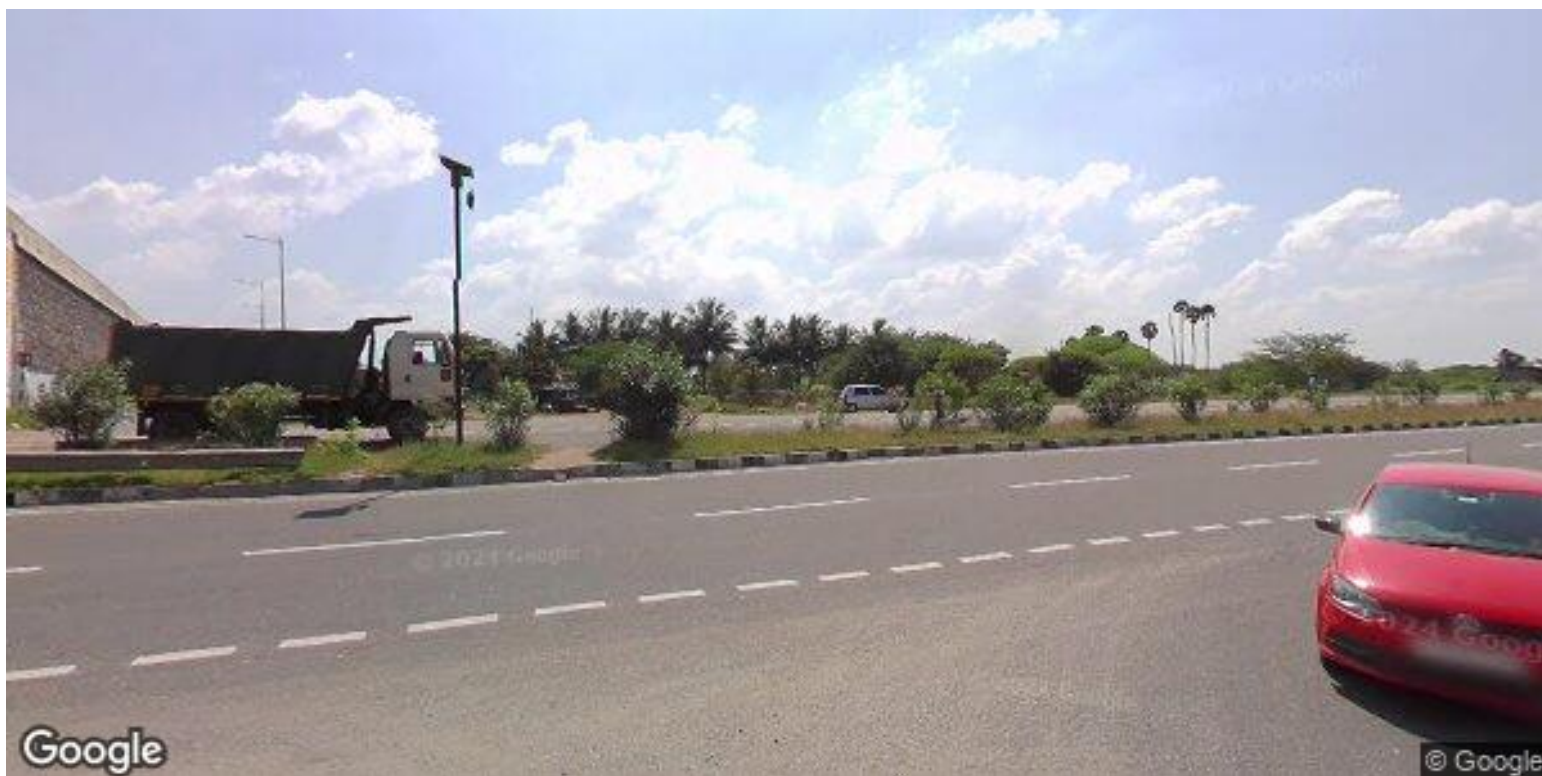
**Risk Type:** Turn  
**Risk Level:** High  
**Speed Limit:** 15 KM/Hr  
**Coordinates:** 10.90784, 78.09916
