## JOURNEY RISK MANAGEMENT (JRM) STUDY

### Salem Terminal TO RAN FUELS

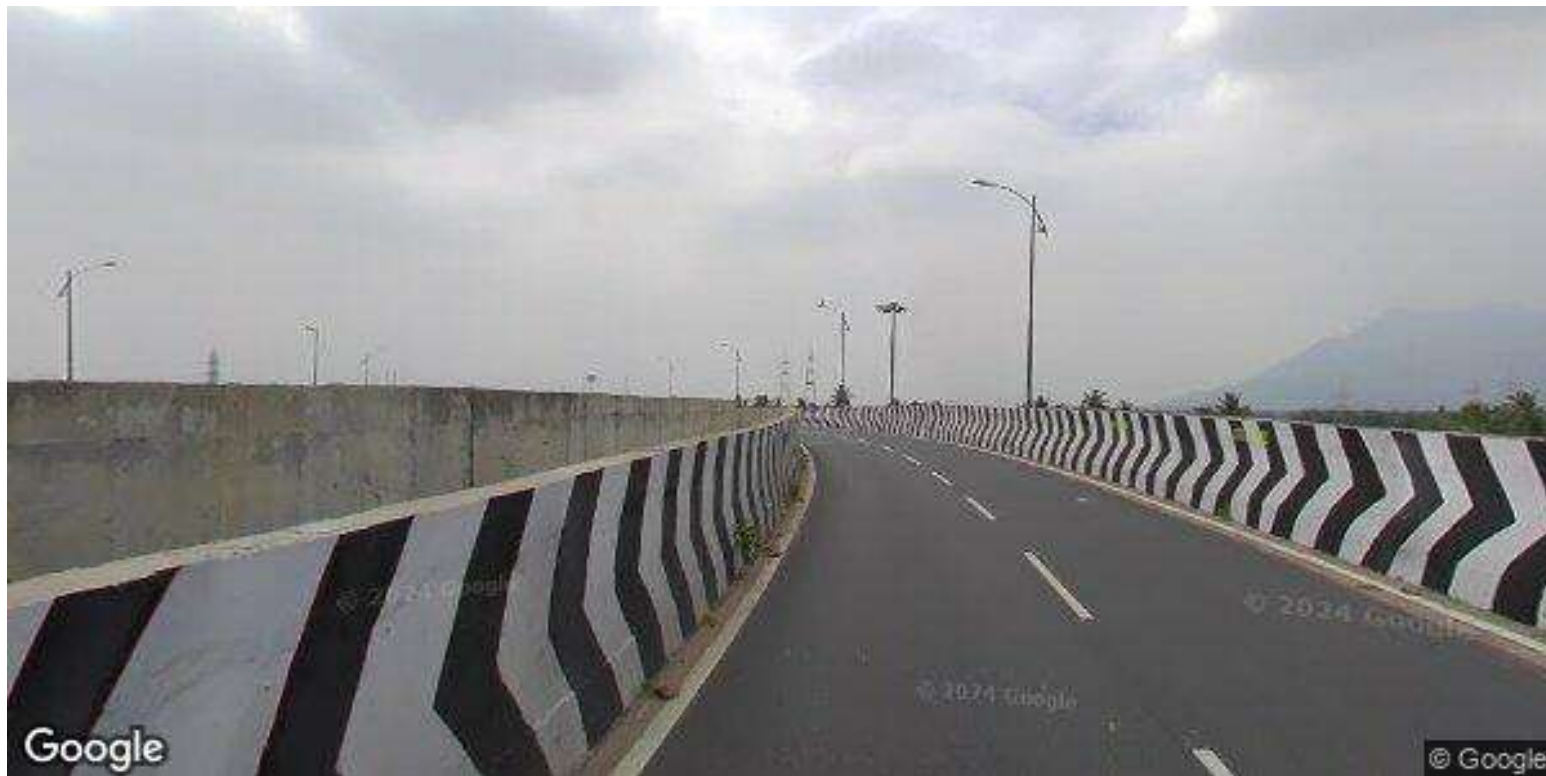
**Coordinates: 11.64180, 78.11808**

**Risk Type: Turn**

**Risk Level: Medium**

**Speed Limit: 30 KM/Hr**

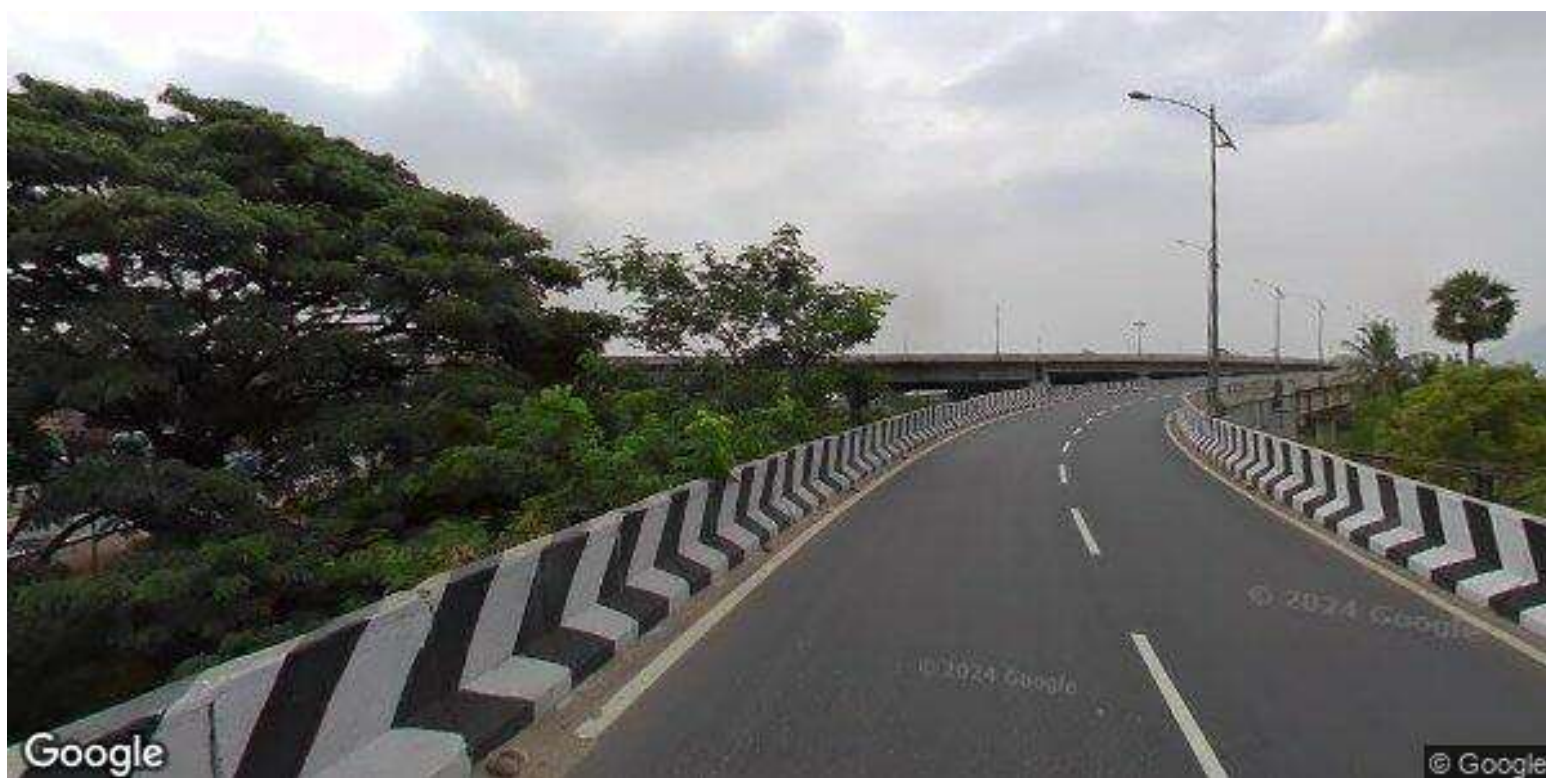
**Coordinates: 11.64325, 78.11993**

**Risk Type: Turn**

**Risk Level: Medium**

**Speed Limit: 30 KM/Hr**

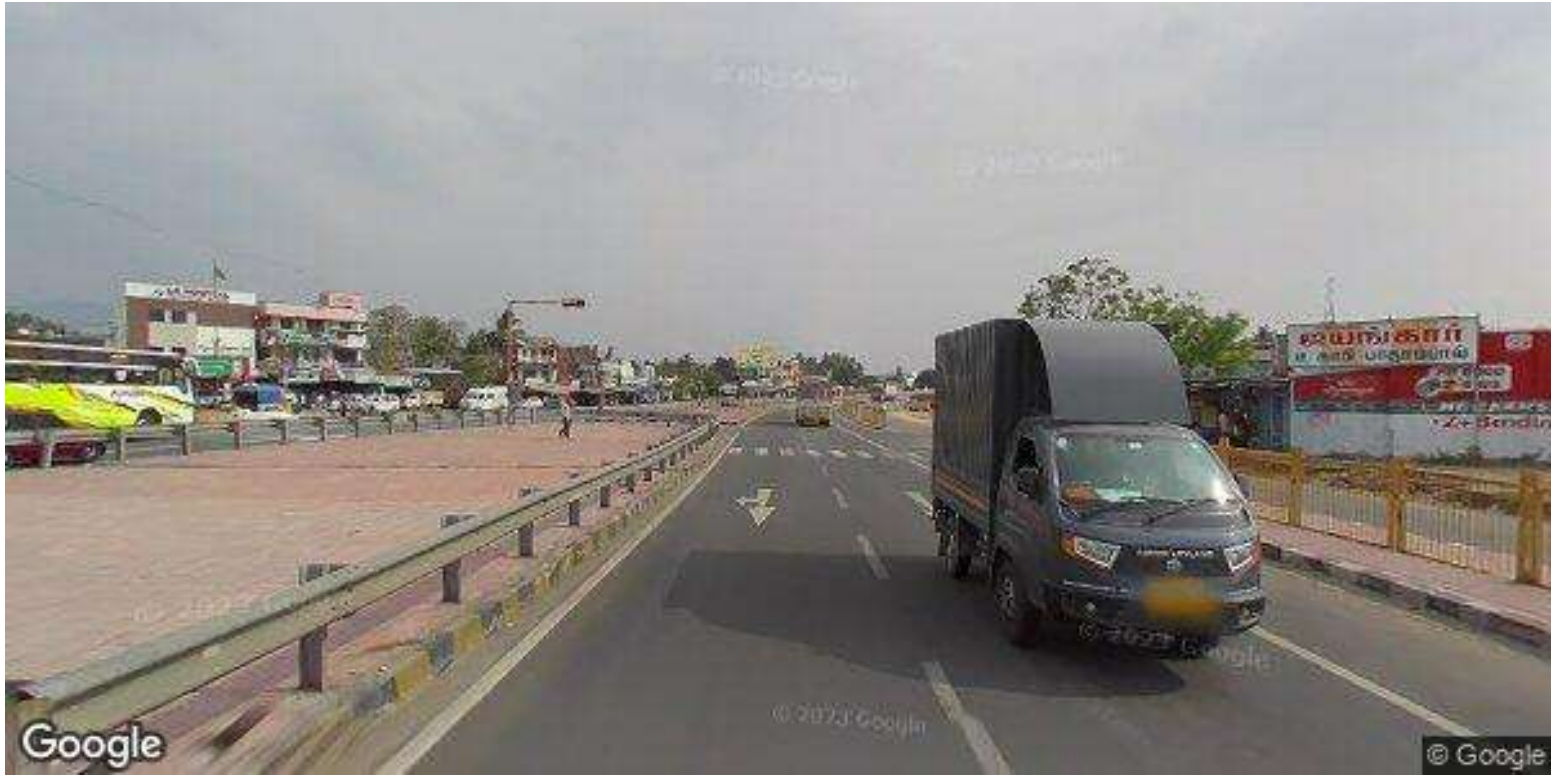
**Risk Type:** Turn  
**Risk Level:** High  
**Speed Limit:** 15 KM/Hr  
**Coordinates:** 11.87086, 78.08362

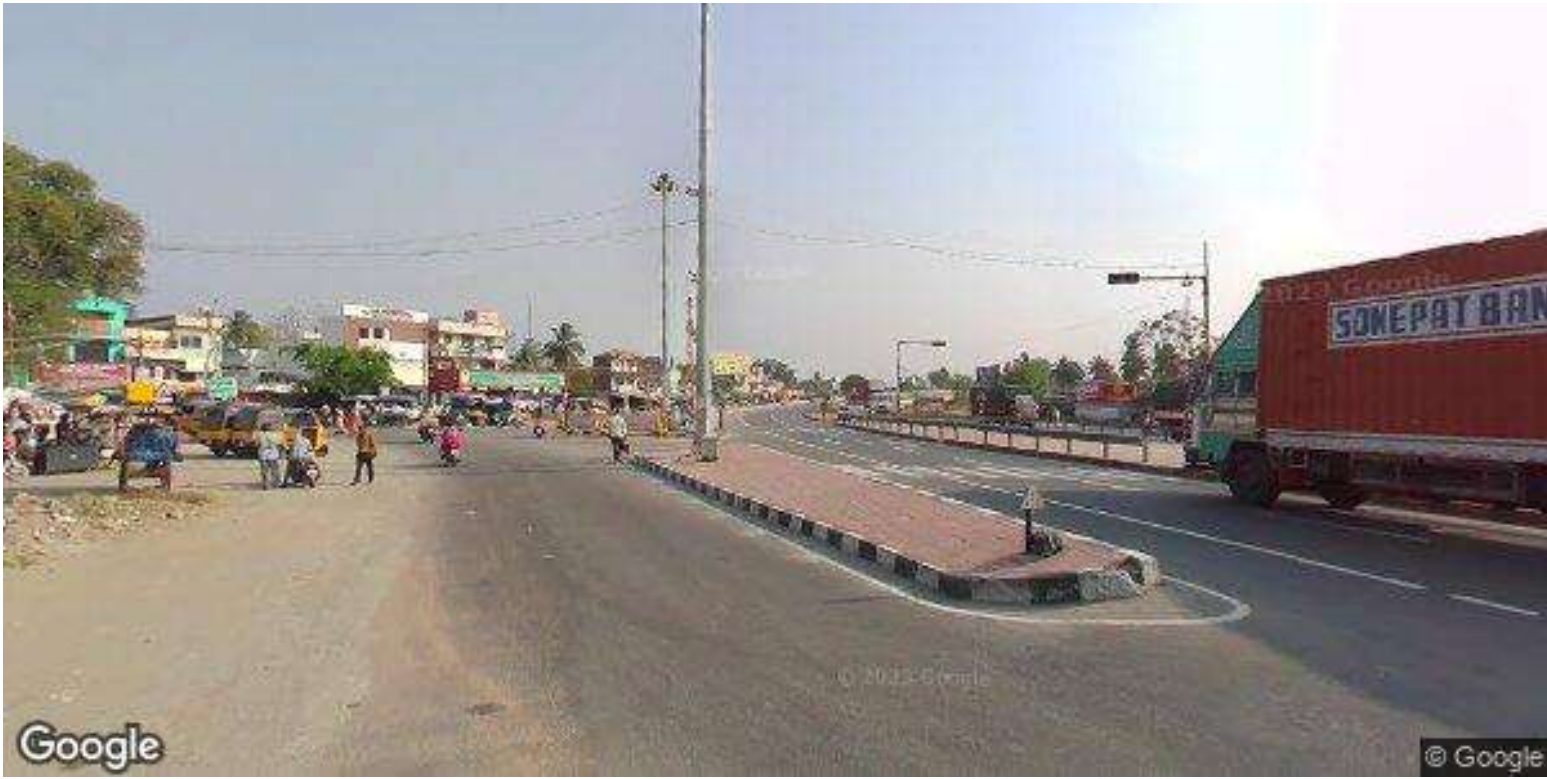
**Risk Type:** Turn  
**Risk Level:** High  
**Speed Limit:** 15 KM/Hr  
**Coordinates:** 11.87111, 78.08382

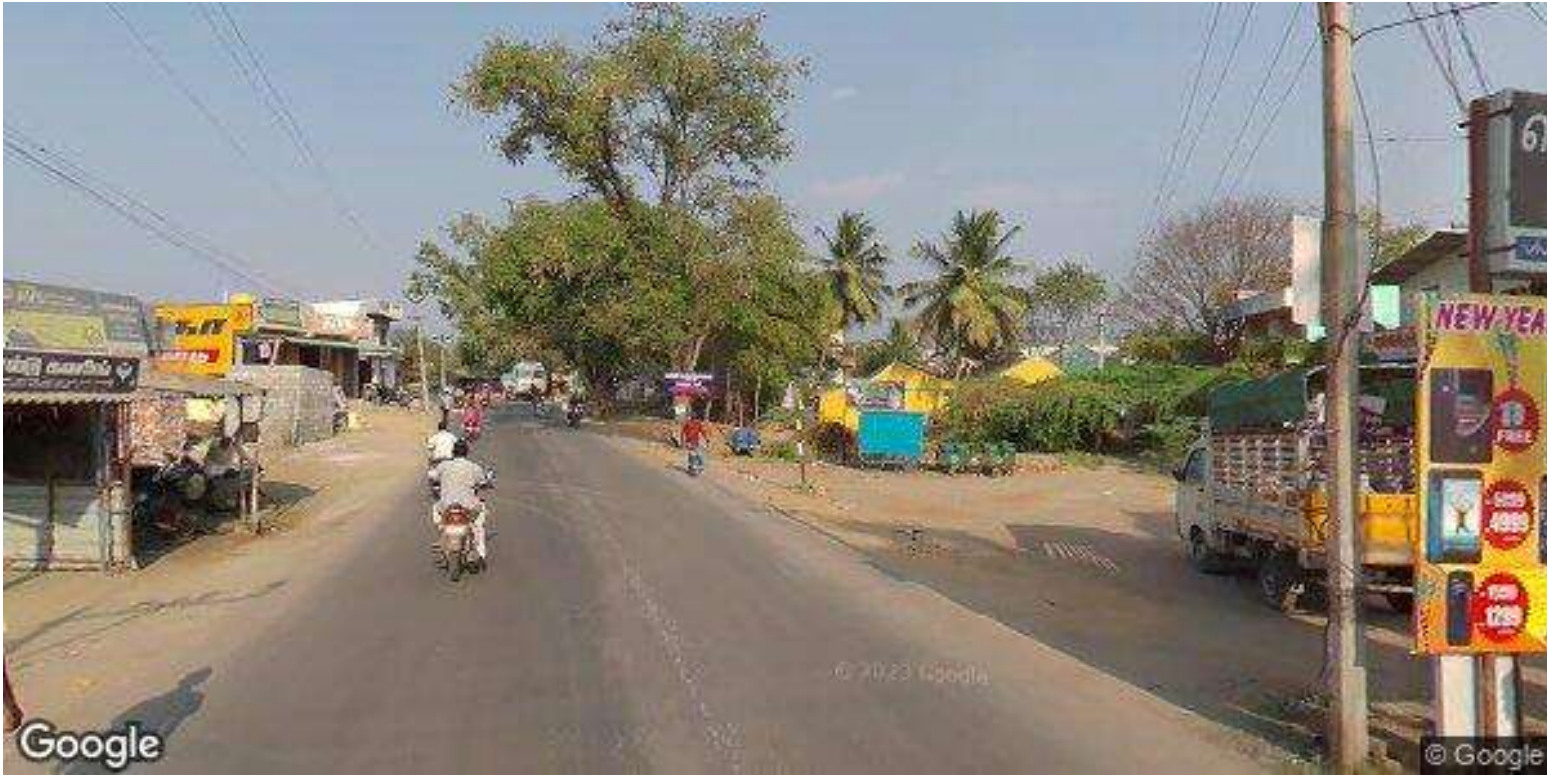
**Risk Type:** Turn  
**Risk Level:** Medium  
**Speed Limit:** 30 KM/Hr  
**Coordinates:** 11.87070, 78.08484

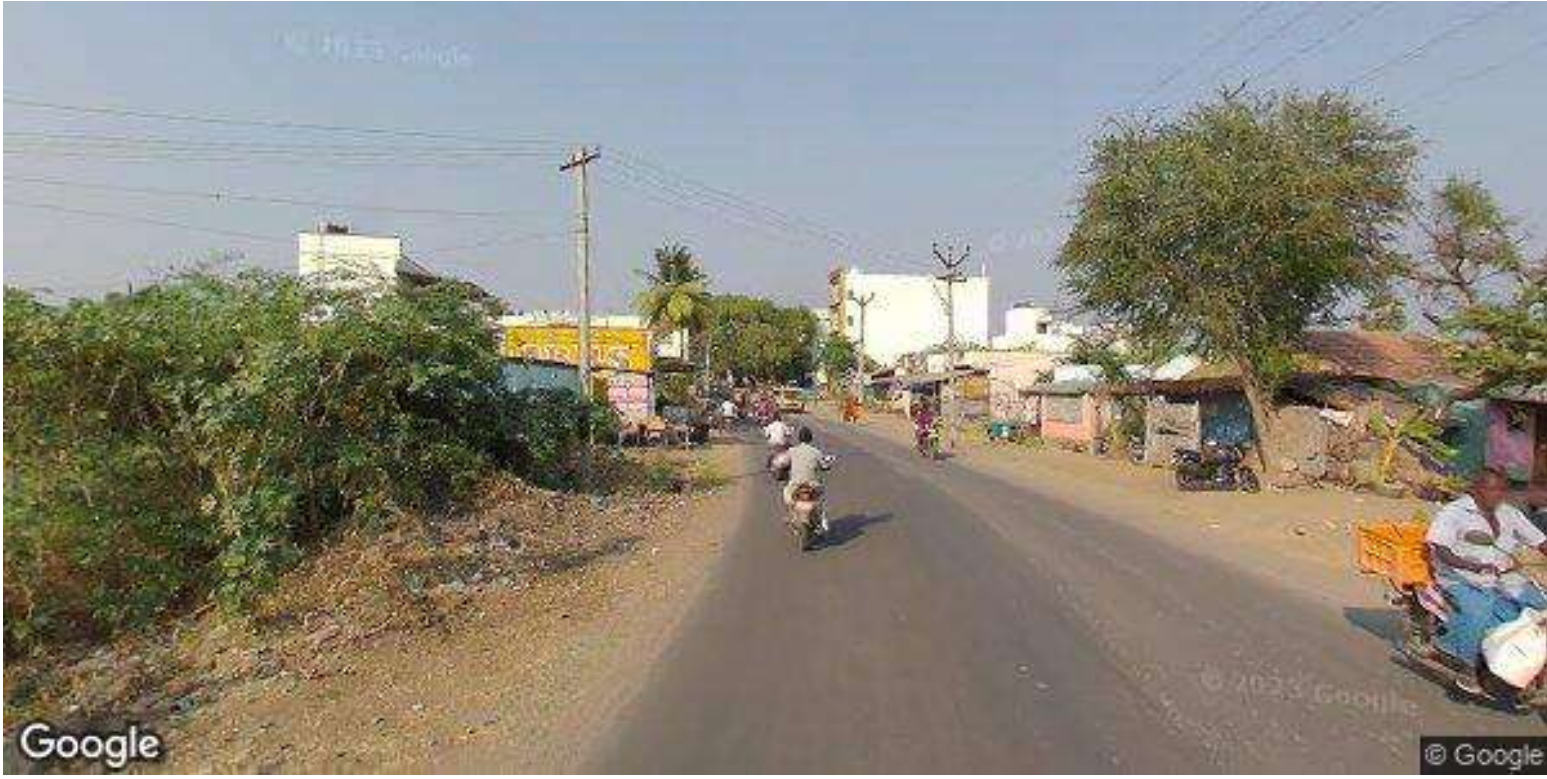
**Risk Type:** Turn  
**Risk Level:** Medium  
**Speed Limit:** 30 KM/Hr  
**Coordinates:** 11.87098, 78.08571

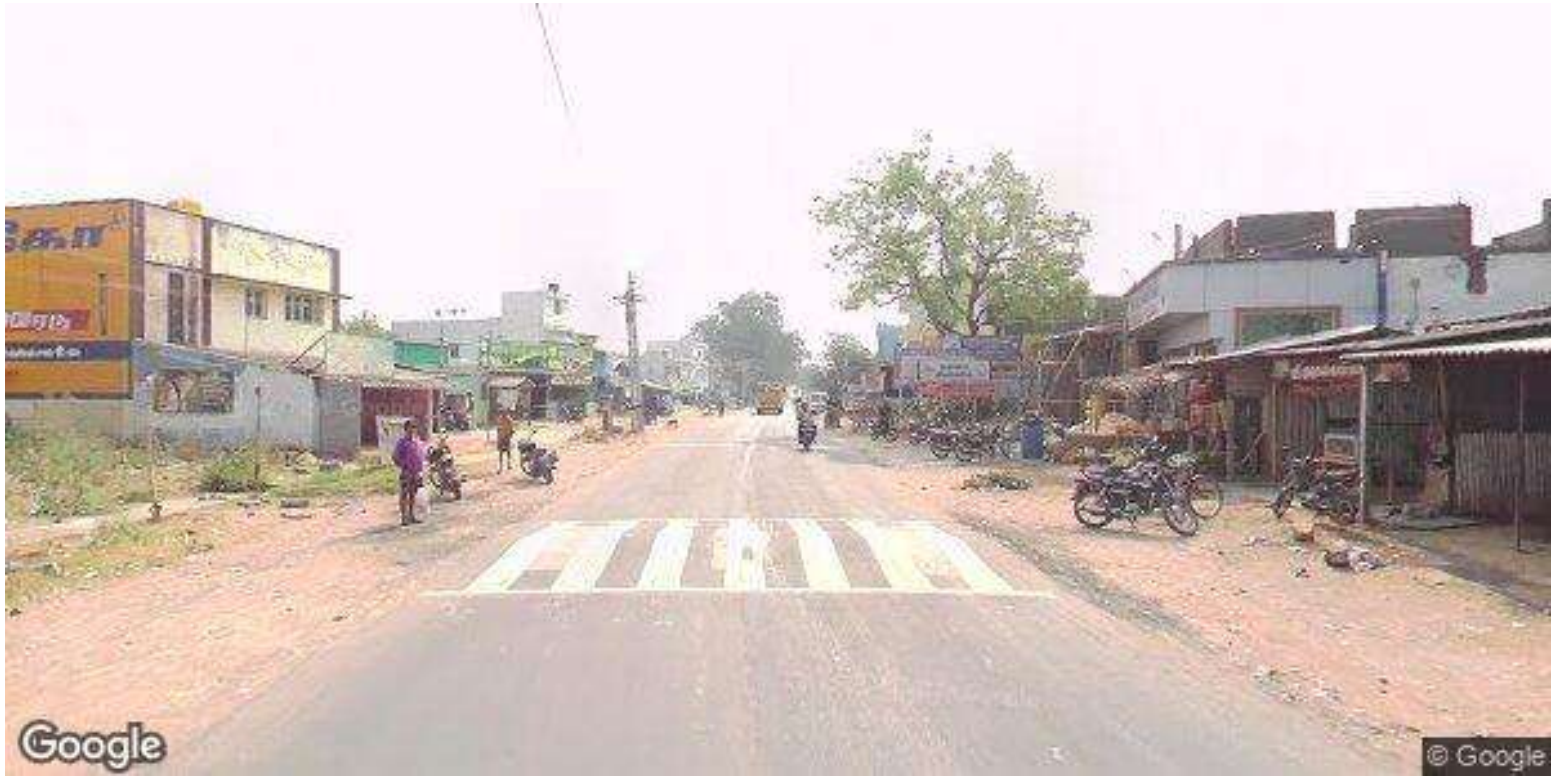
**Risk Type:** Turn  
**Risk Level:** High  
**Speed Limit:** 15 KM/Hr  
**Coordinates:** 11.87255, 78.08723

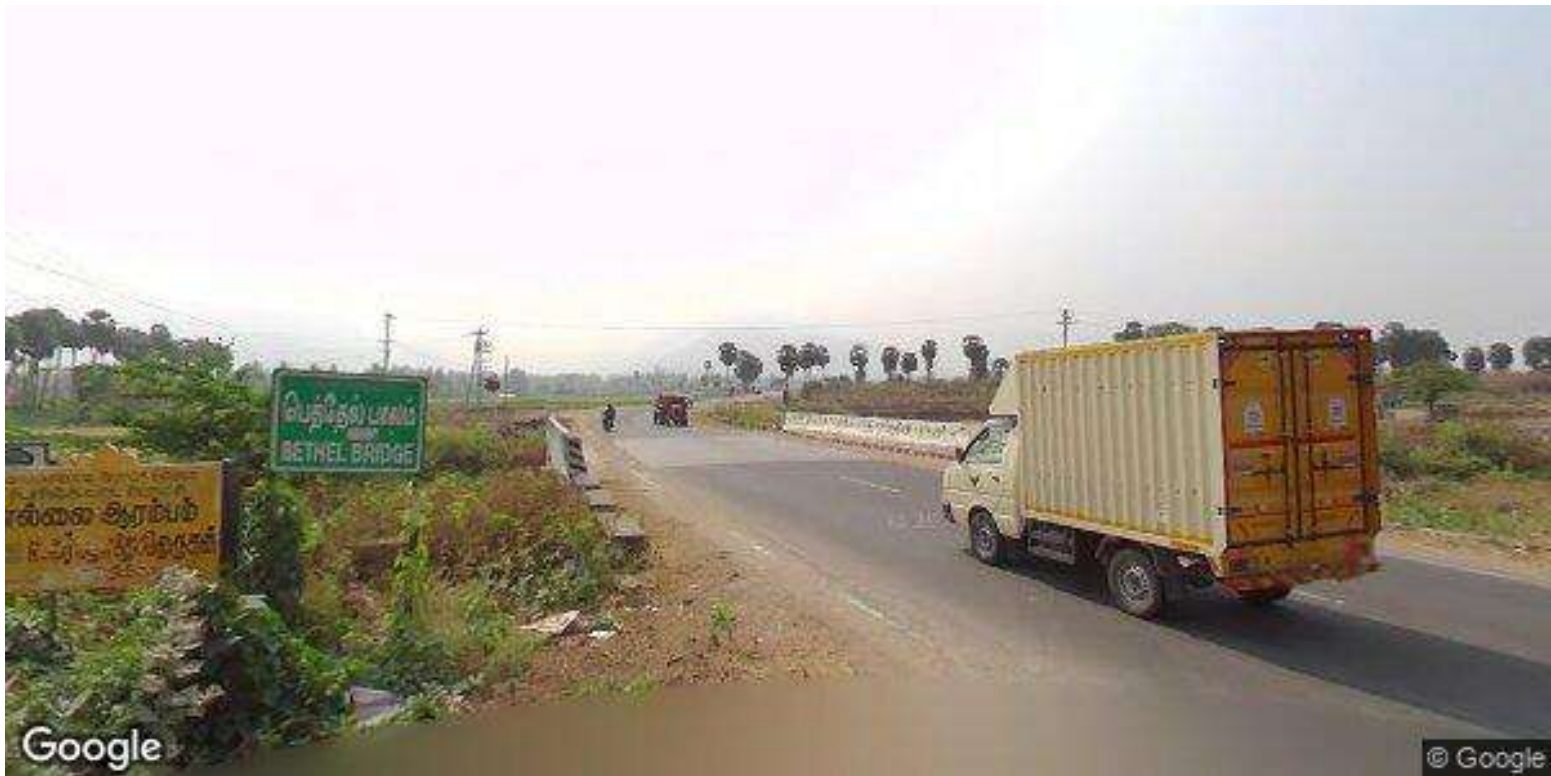
**Risk Type:** Turn  
**Risk Level:** Medium  
**Speed Limit:** 30 KM/Hr  
**Coordinates:** 11.86873, 78.12120

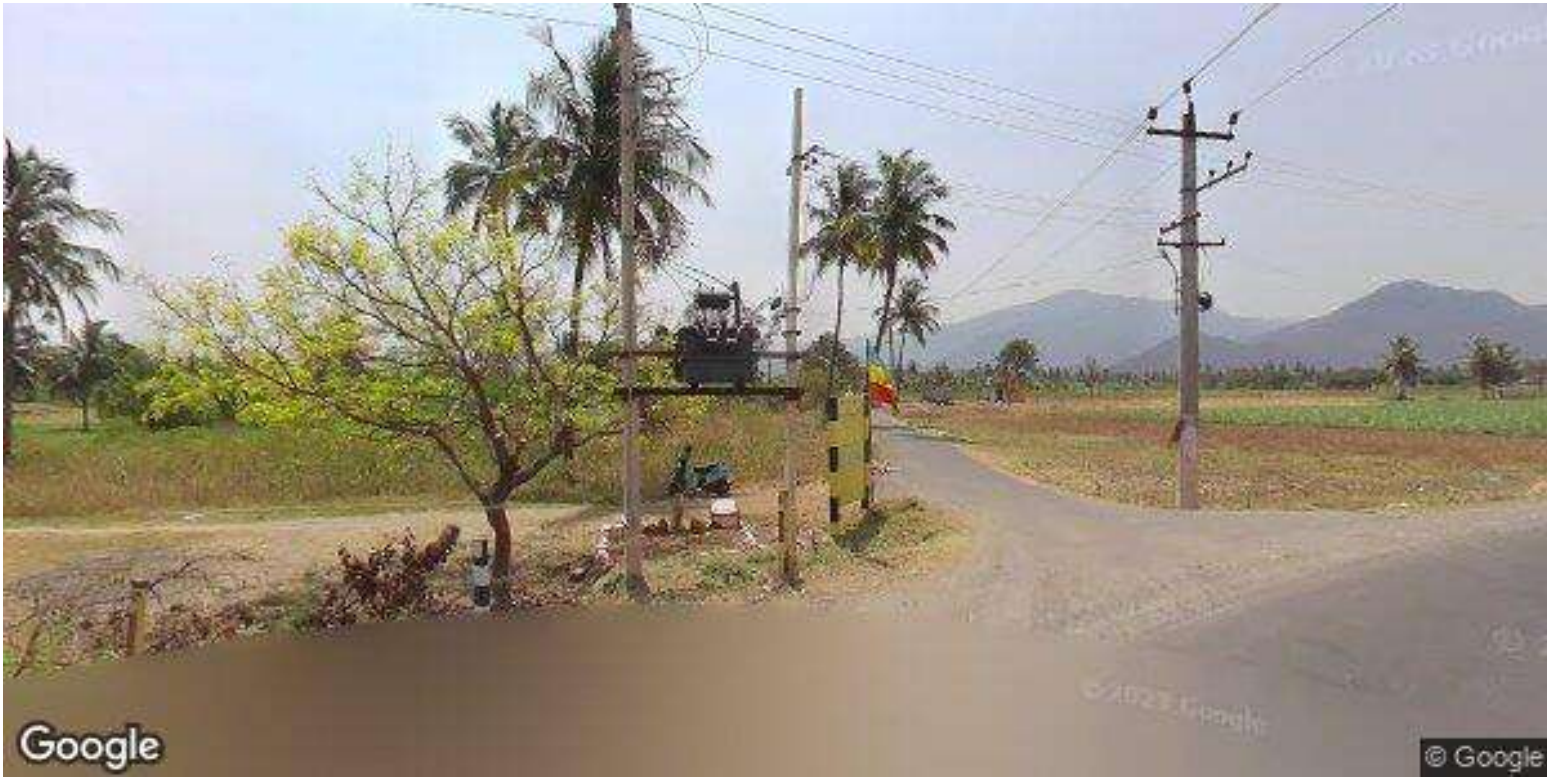
**Risk Type:** Turn  
**Risk Level:** High  
**Speed Limit:** 15 KM/Hr  
**Coordinates:** 11.97325, 78.23714

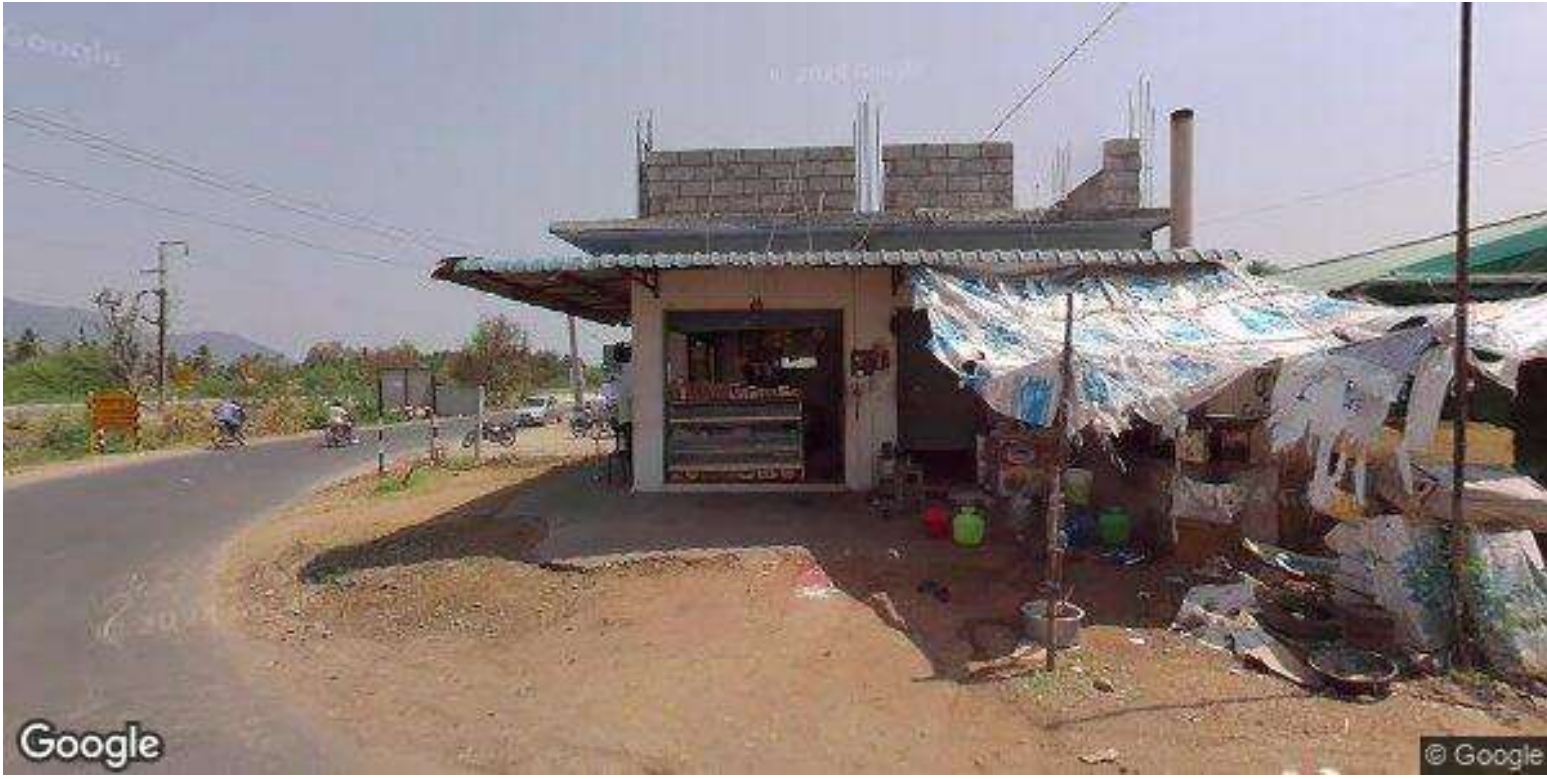
**Risk Type:** Turn  
**Risk Level:** High  
**Speed Limit:** 15 KM/Hr  
**Coordinates:** 11.97747, 78.23549

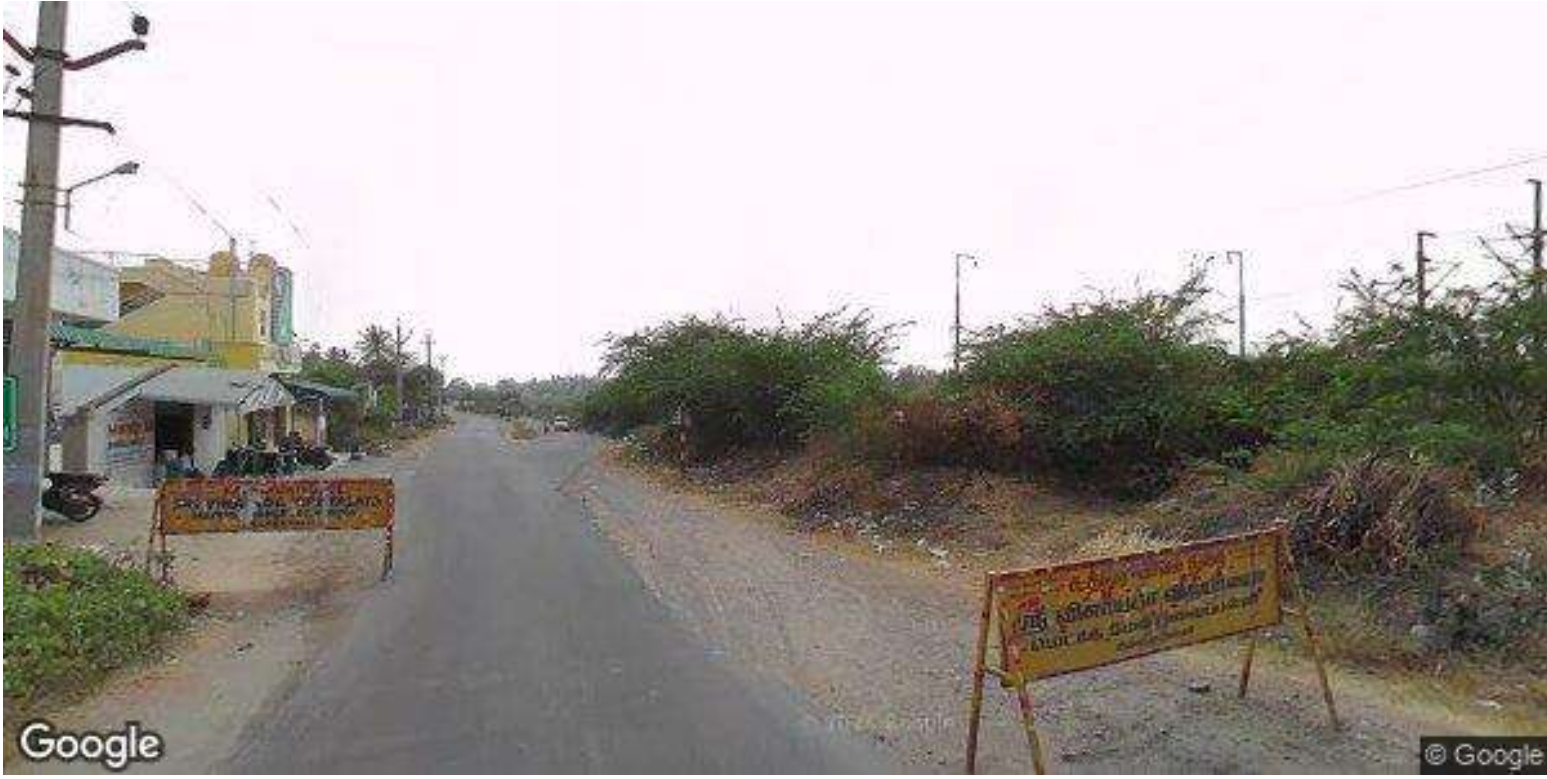
**Risk Type:** Turn  
**Risk Level:** High  
**Speed Limit:** 15 KM/Hr  
**Coordinates:** 11.98245, 78.24301

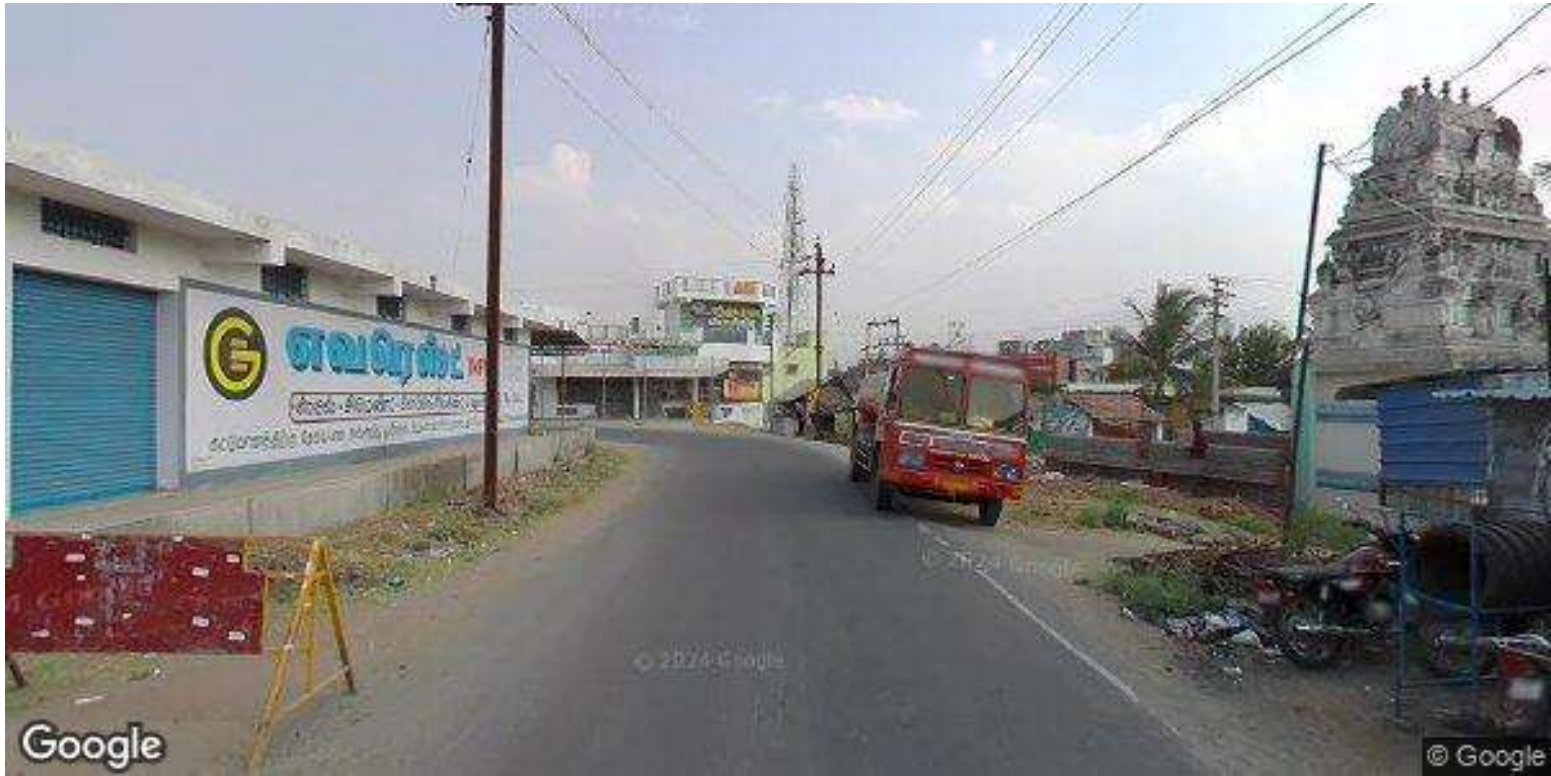
**Risk Type:** Turn  
**Risk Level:** High  
**Speed Limit:** 15 KM/Hr  
**Coordinates:** 11.98222, 78.24321

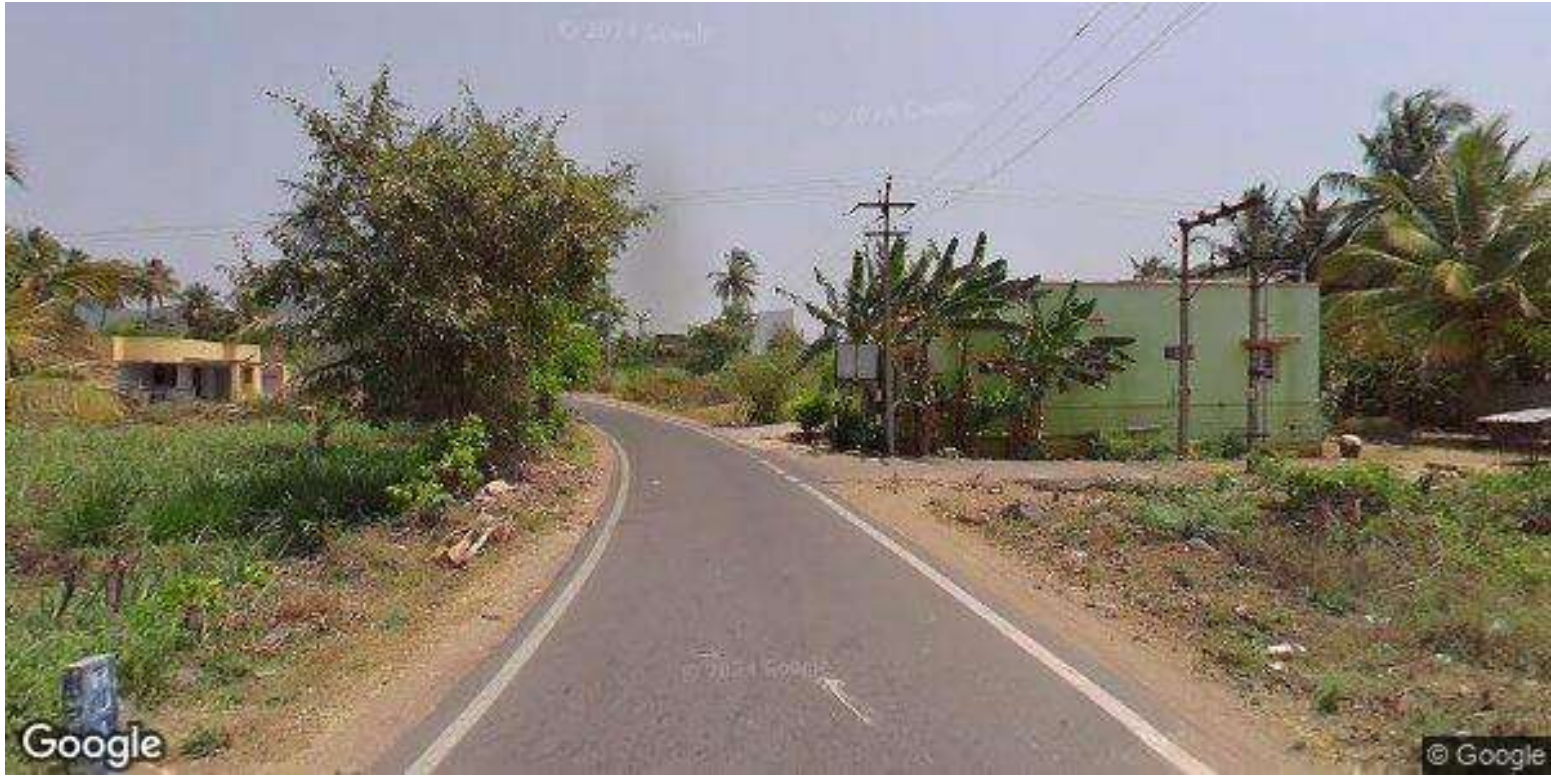
**Risk Type:** Turn  
**Risk Level:** High  
**Speed Limit:** 15 KM/Hr  
**Coordinates:** 11.99210, 78.25772

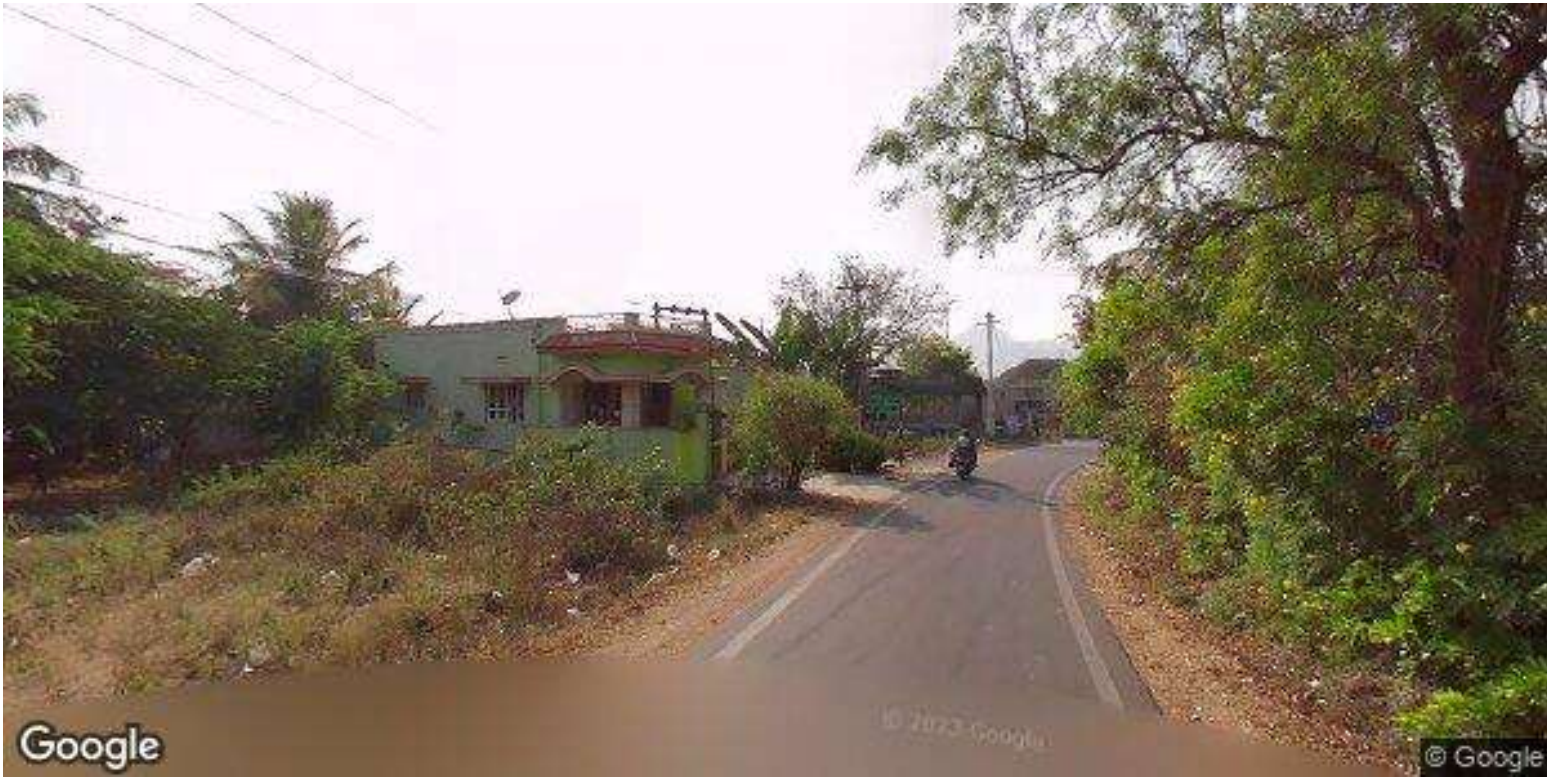
**Risk Type:** Turn  
**Risk Level:** Medium  
**Speed Limit:** 30 KM/Hr  
**Coordinates:** 11.99188, 78.25802

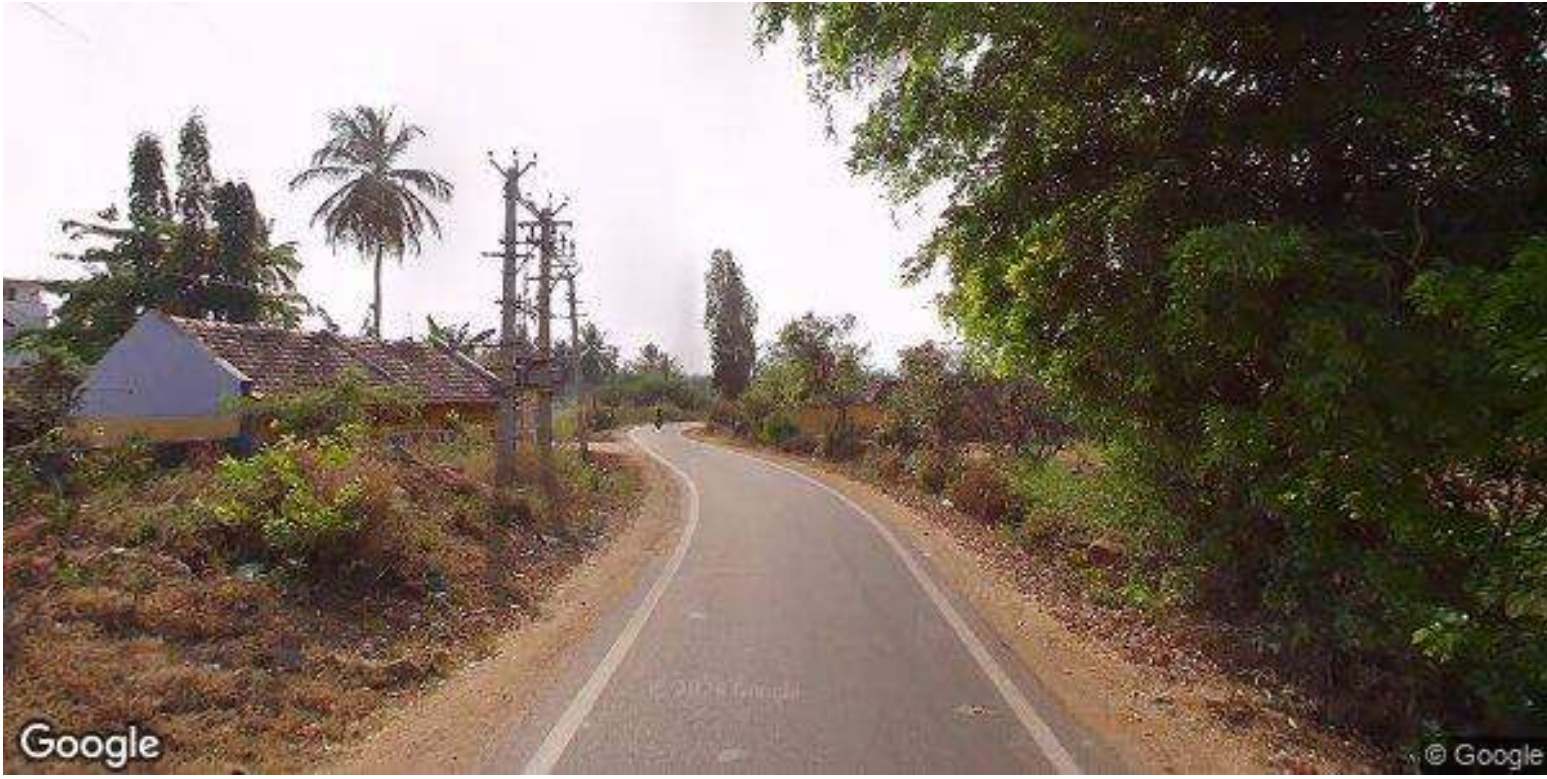
**Risk Type:** Turn  
**Risk Level:** High  
**Speed Limit:** 15 KM/Hr  
**Coordinates:** 11.99183, 78.25890

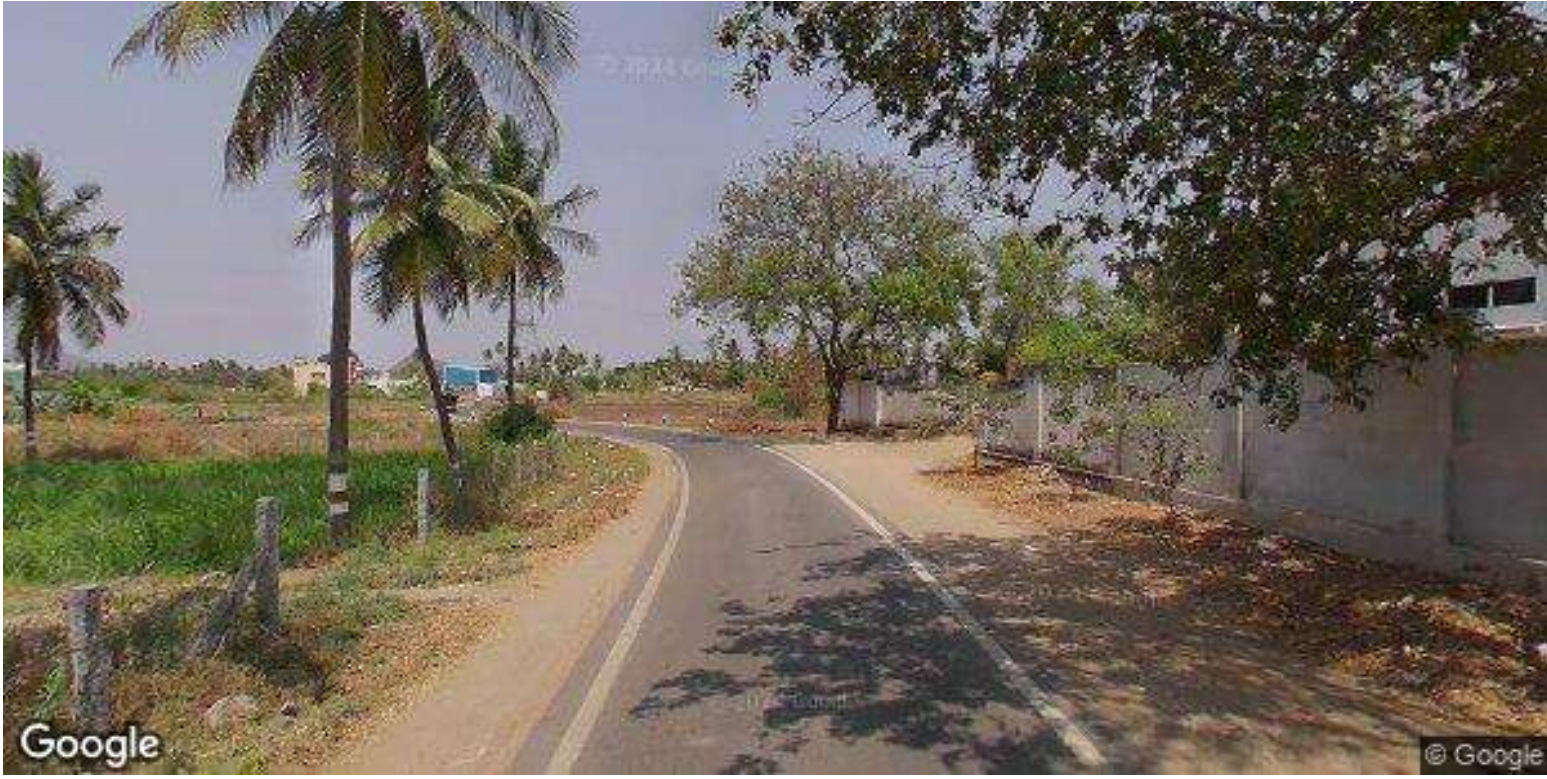
**Risk Type:** Turn  
**Risk Level:** Medium  
**Speed Limit:** 30 KM/Hr  
**Coordinates:** 11.99287, 78.26006

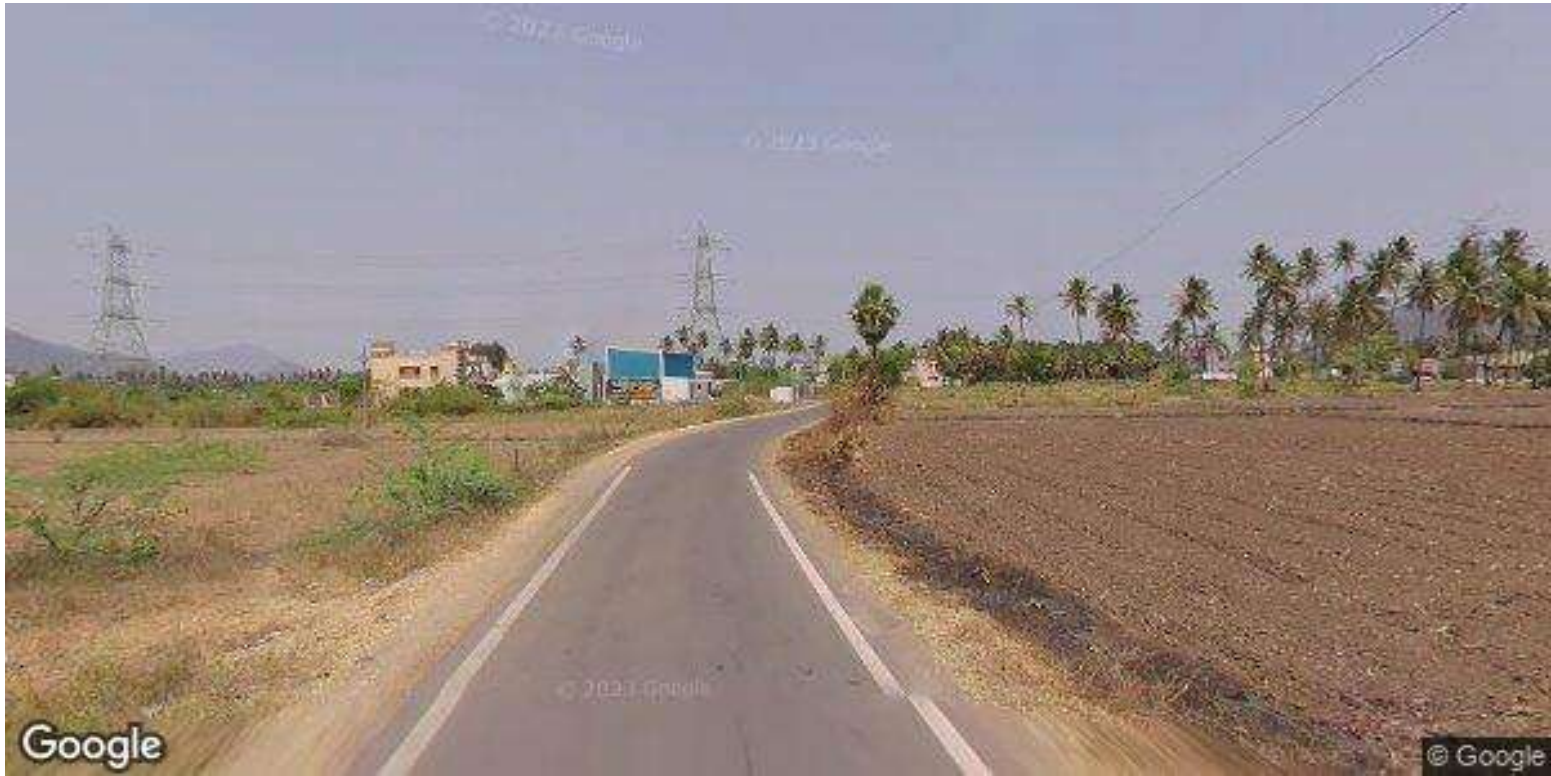
**Risk Type:** Turn  
**Risk Level:** Medium  
**Speed Limit:** 30 KM/Hr  
**Coordinates:** 11.99367, 78.26036

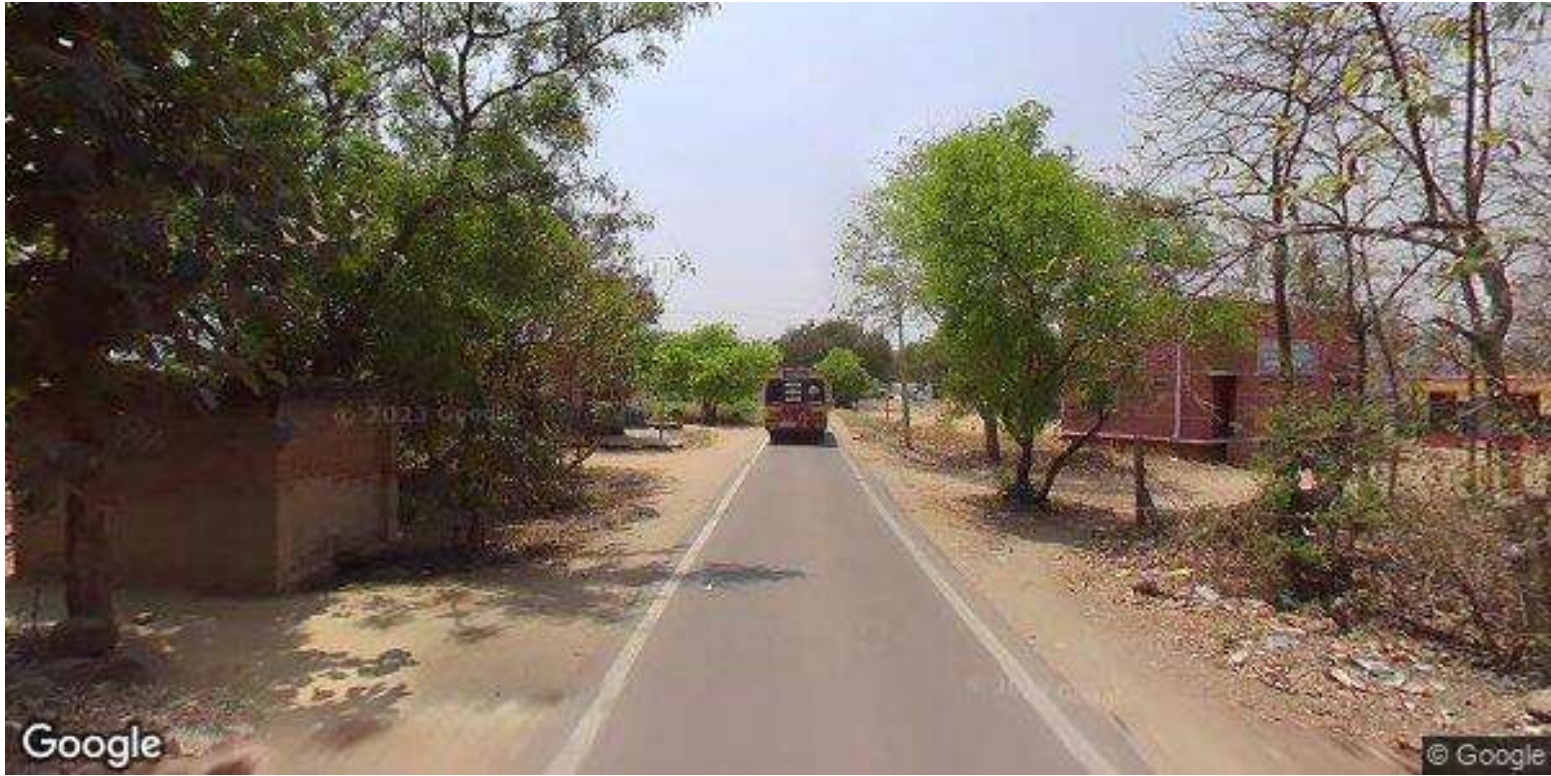
**Risk Type:** Turn  
**Risk Level:** Medium  
**Speed Limit:** 30 KM/Hr  
**Coordinates:** 11.99939, 78.27157
