## JOURNEY RISK MANAGEMENT (JRM) STUDY

### Salem Terminal TO RAN FUELS

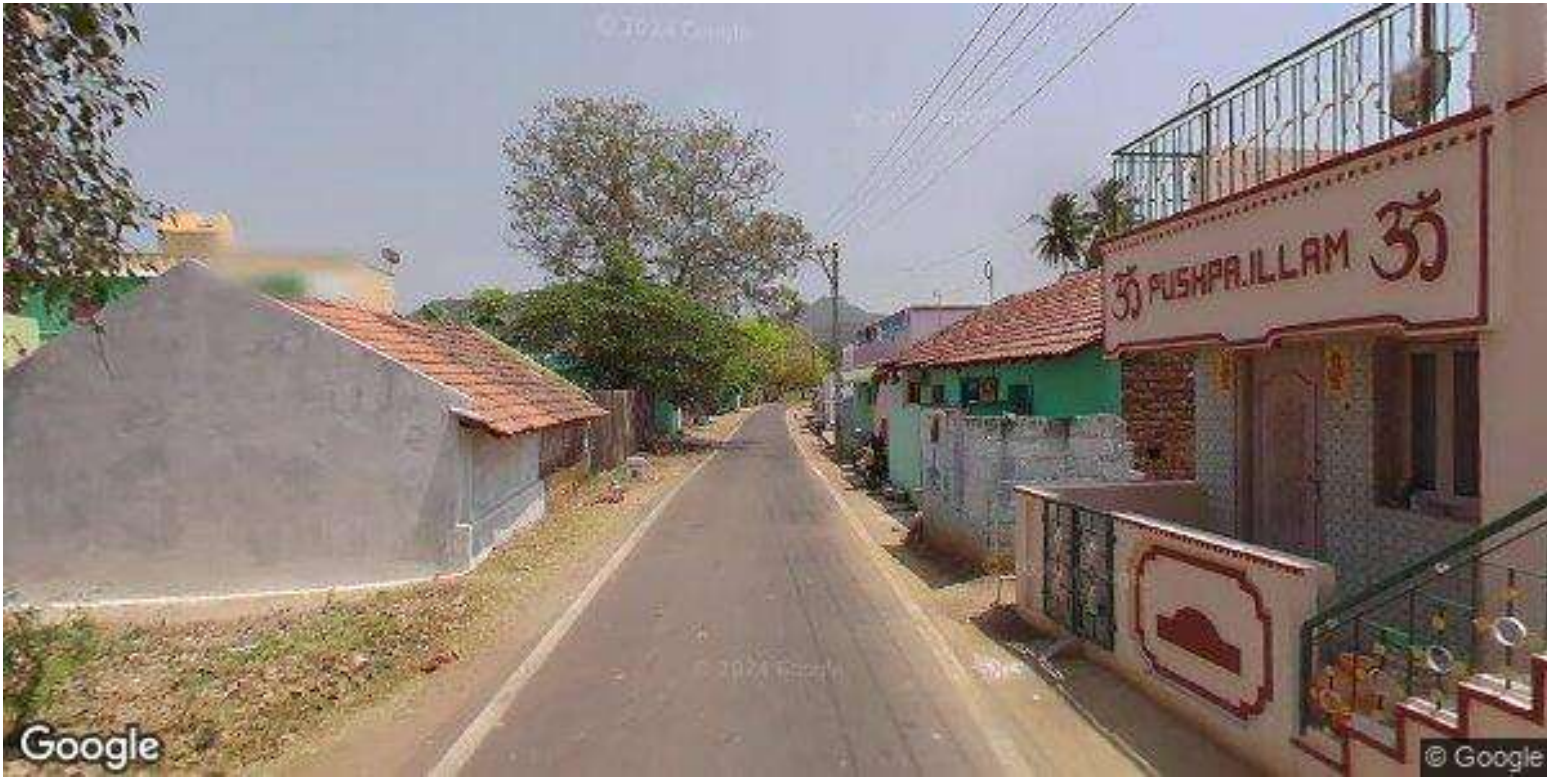
**Risk Type:** Turn  
**Risk Level:** Medium  
**Speed Limit:** 30 KM/Hr  
**Coordinates:** 11.99924, 78.27272

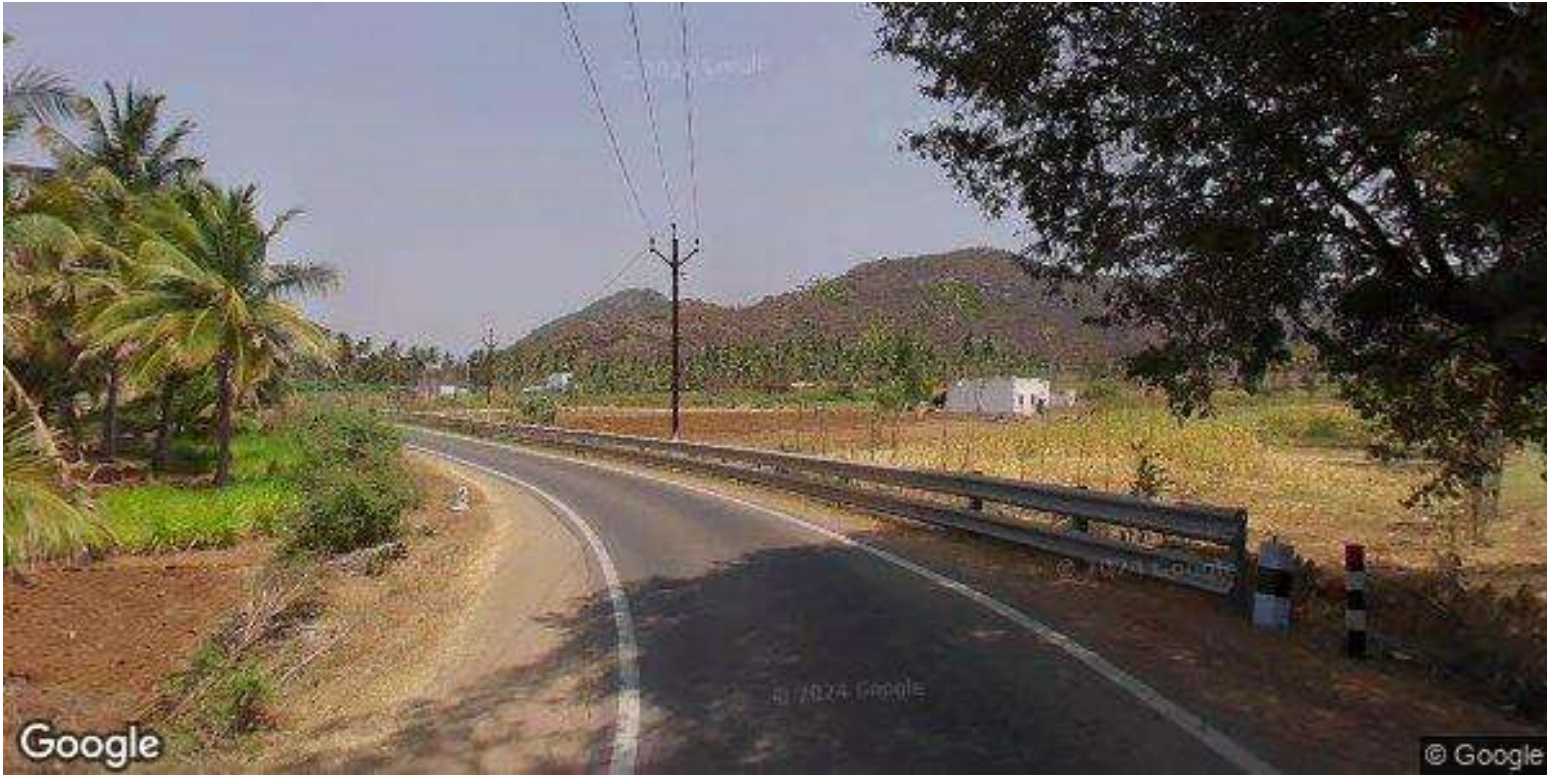
**Risk Type:** Turn  
**Risk Level:** High  
**Speed Limit:** 15 KM/Hr  
**Coordinates:** 11.99674, 78.27753

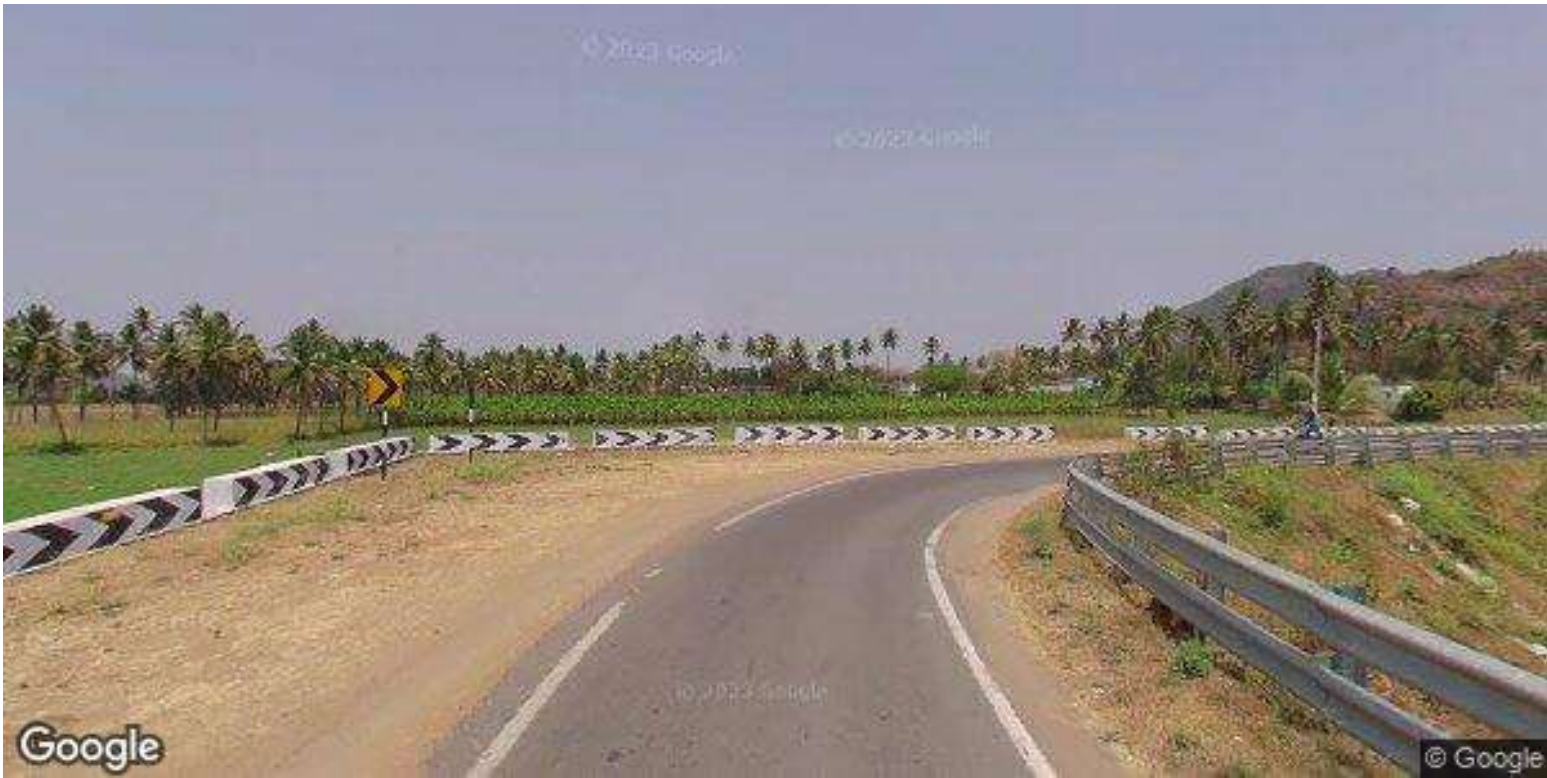
**Coordinates: 11.99812, 78.27825**

**Risk Type: Turn**

**Risk Level: High**

**Speed Limit: 15 KM/Hr**

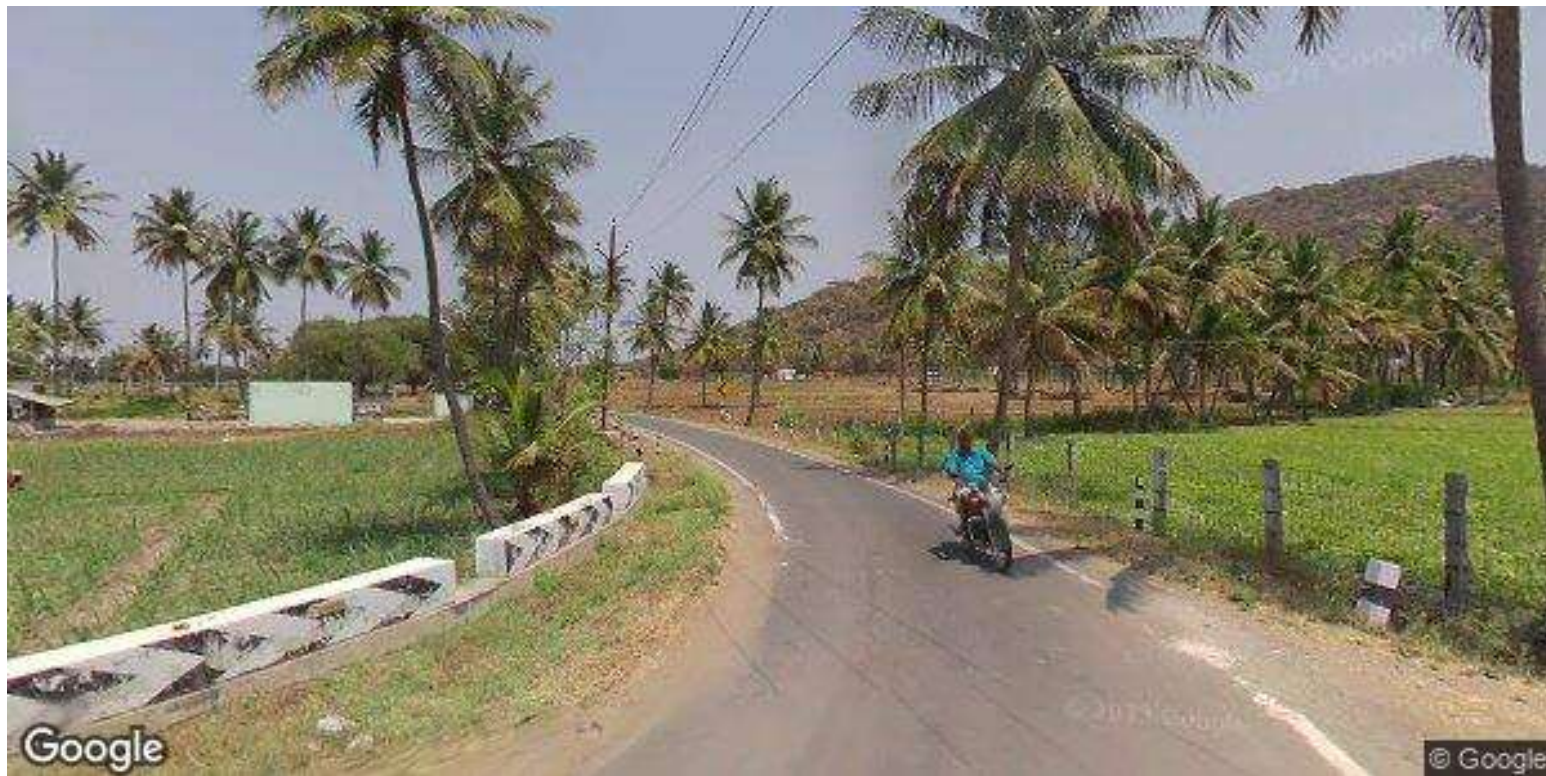
**Coordinates: 11.99800, 78.27978**

**Risk Type: Turn**

**Risk Level: High**

**Speed Limit: 15 KM/Hr**

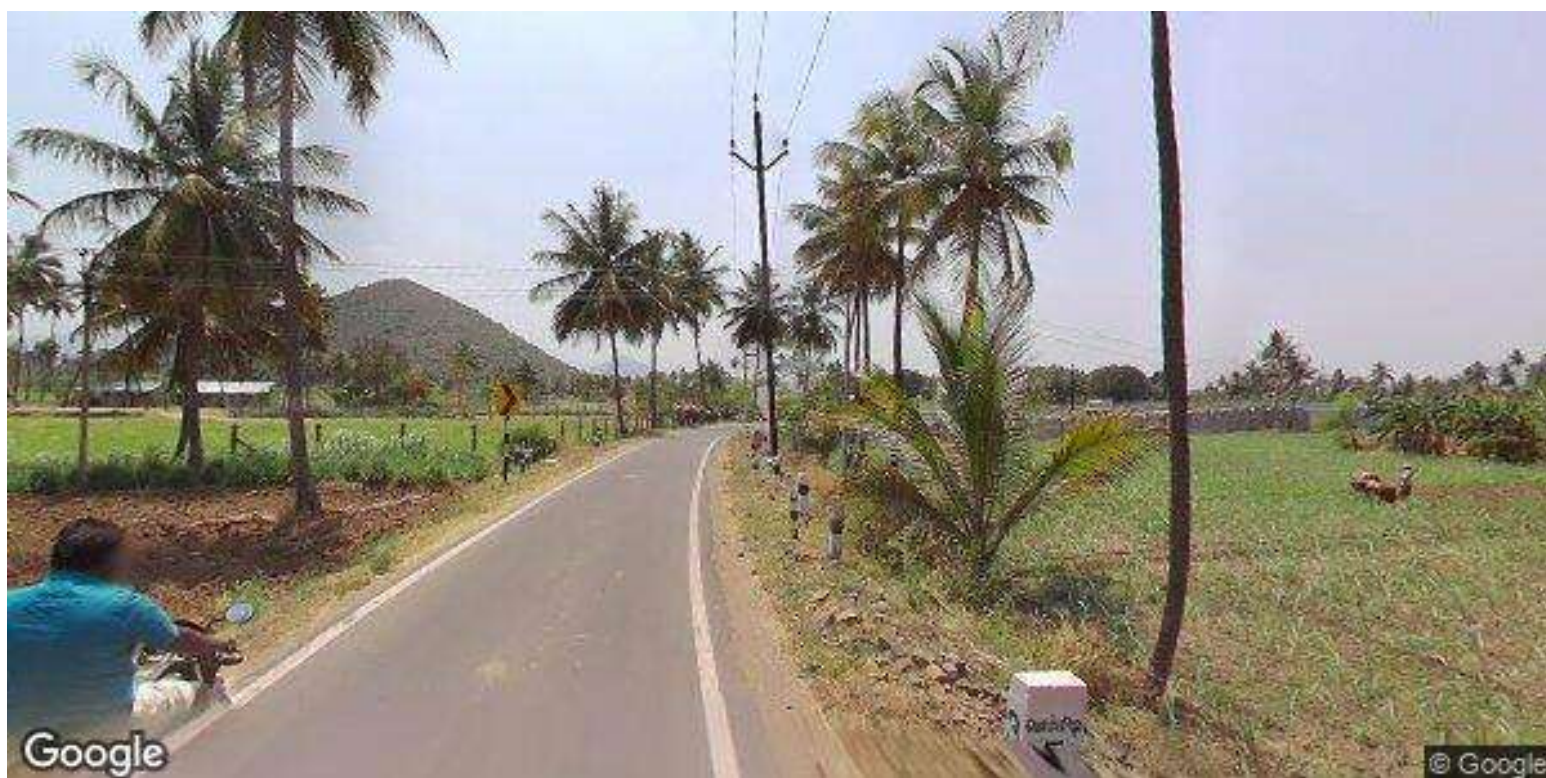
**Coordinates: 11.99835, 78.28018**

**Risk Type: Turn**

**Risk Level: Medium**

**Speed Limit: 30 KM/Hr**

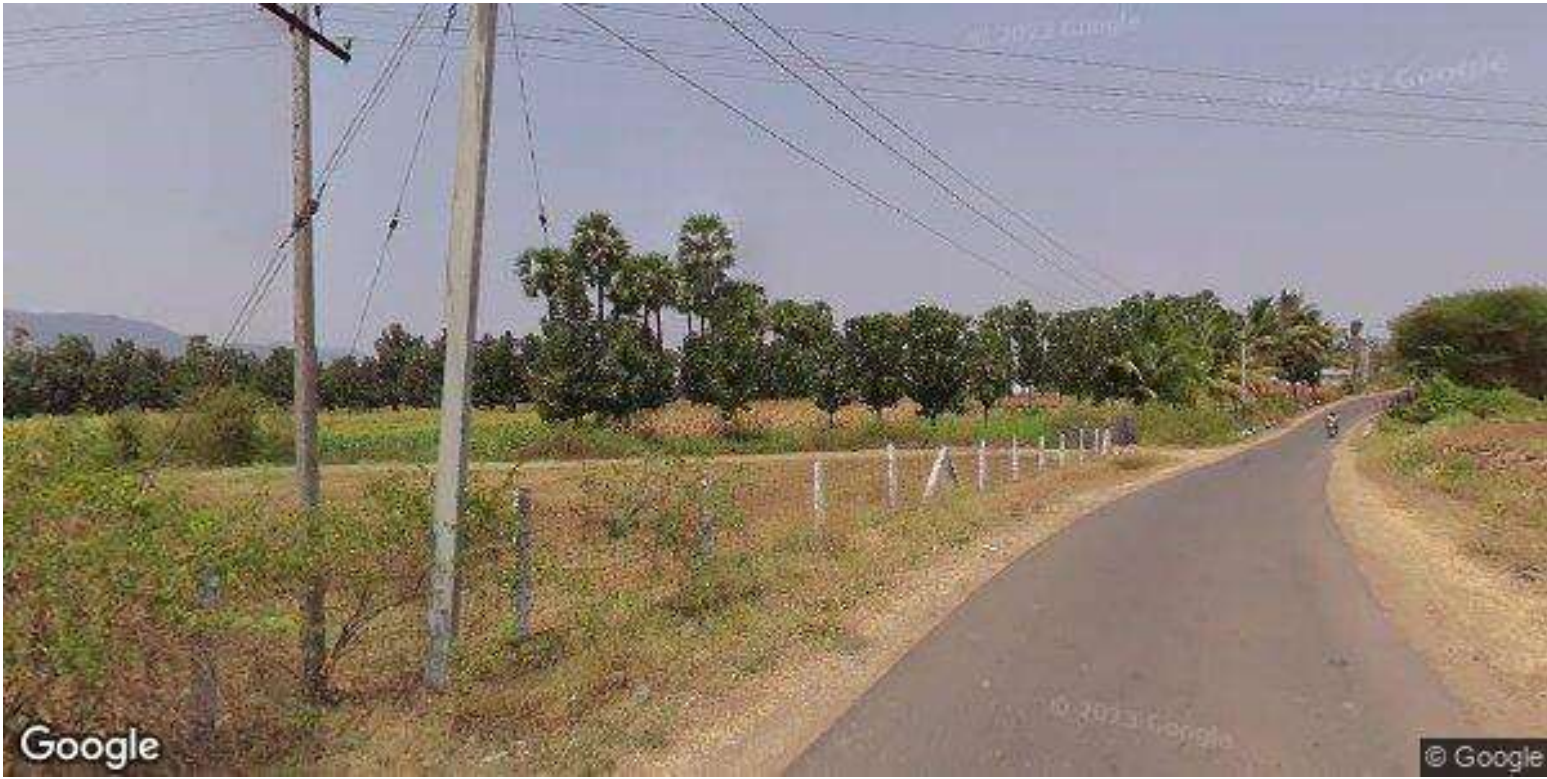
**Risk Type:** Turn  
**Risk Level:** Medium  
**Speed Limit:** 30 KM/Hr  
**Coordinates:** 12.00120, 78.28087

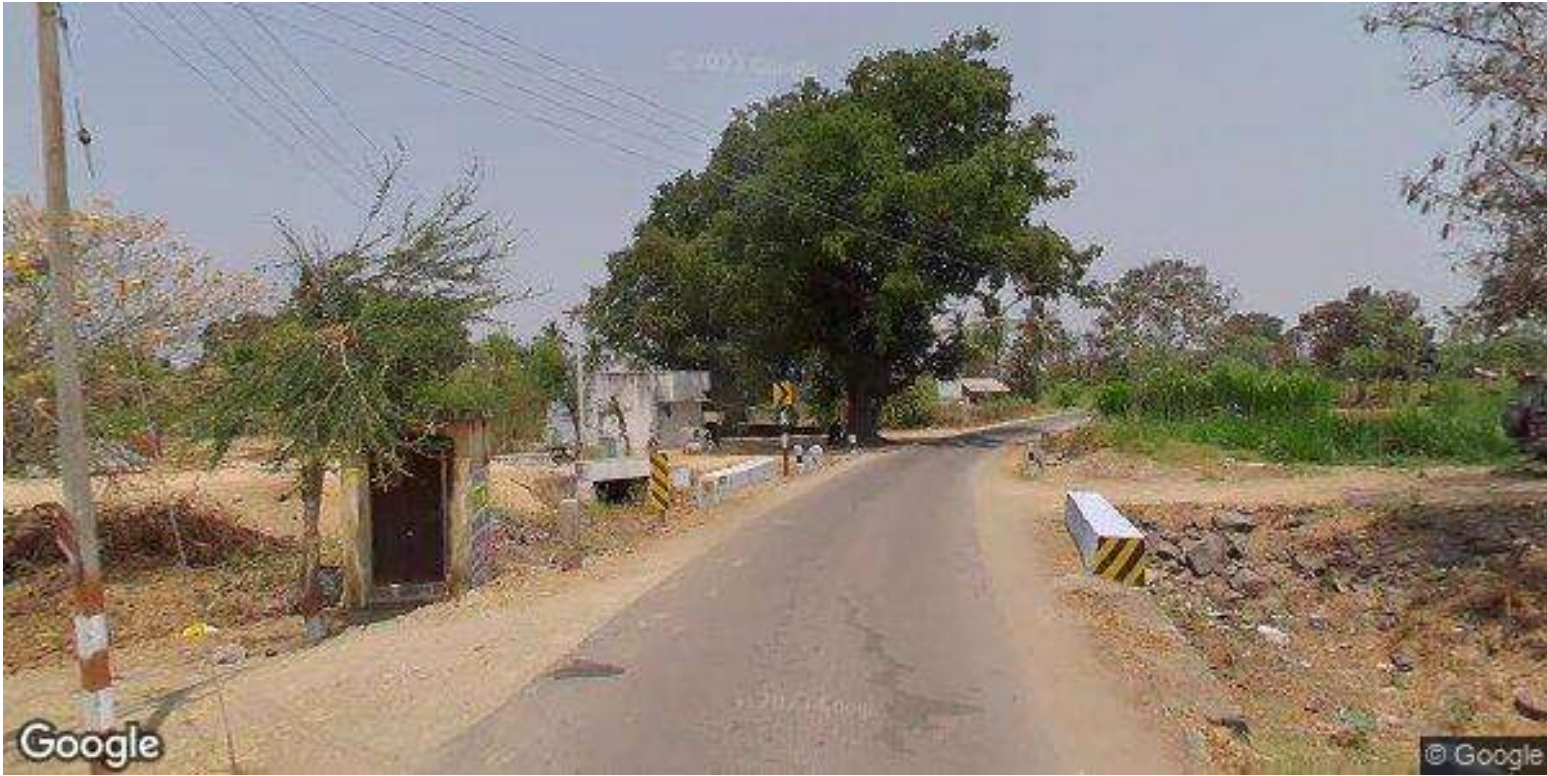
**Risk Type:** Turn  
**Risk Level:** Medium  
**Speed Limit:** 30 KM/Hr  
**Coordinates:** 12.01914, 78.29621

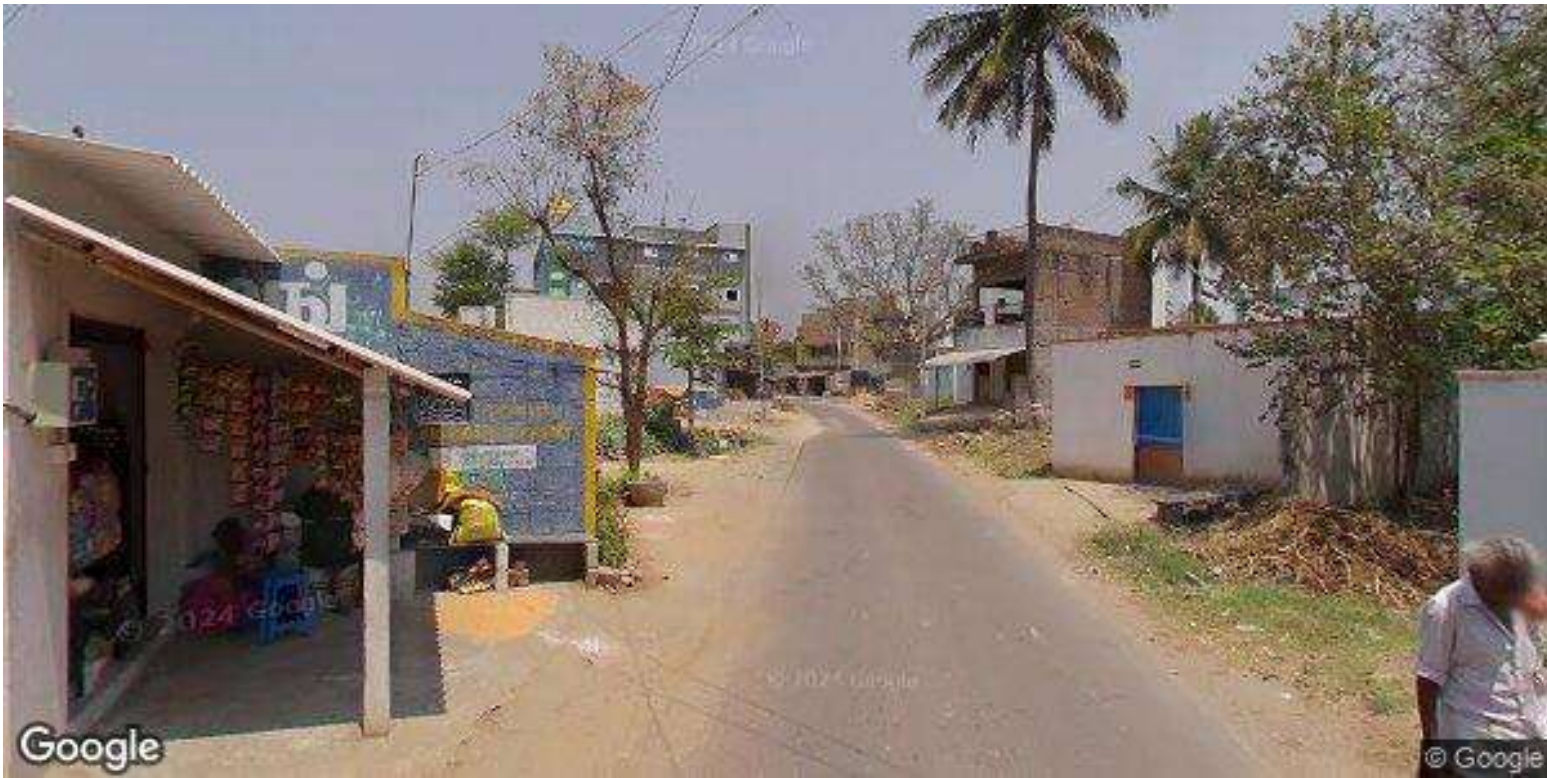
**Risk Type:** Turn  
**Risk Level:** Medium  
**Speed Limit:** 30 KM/Hr  
**Coordinates:** 12.02046, 78.30108

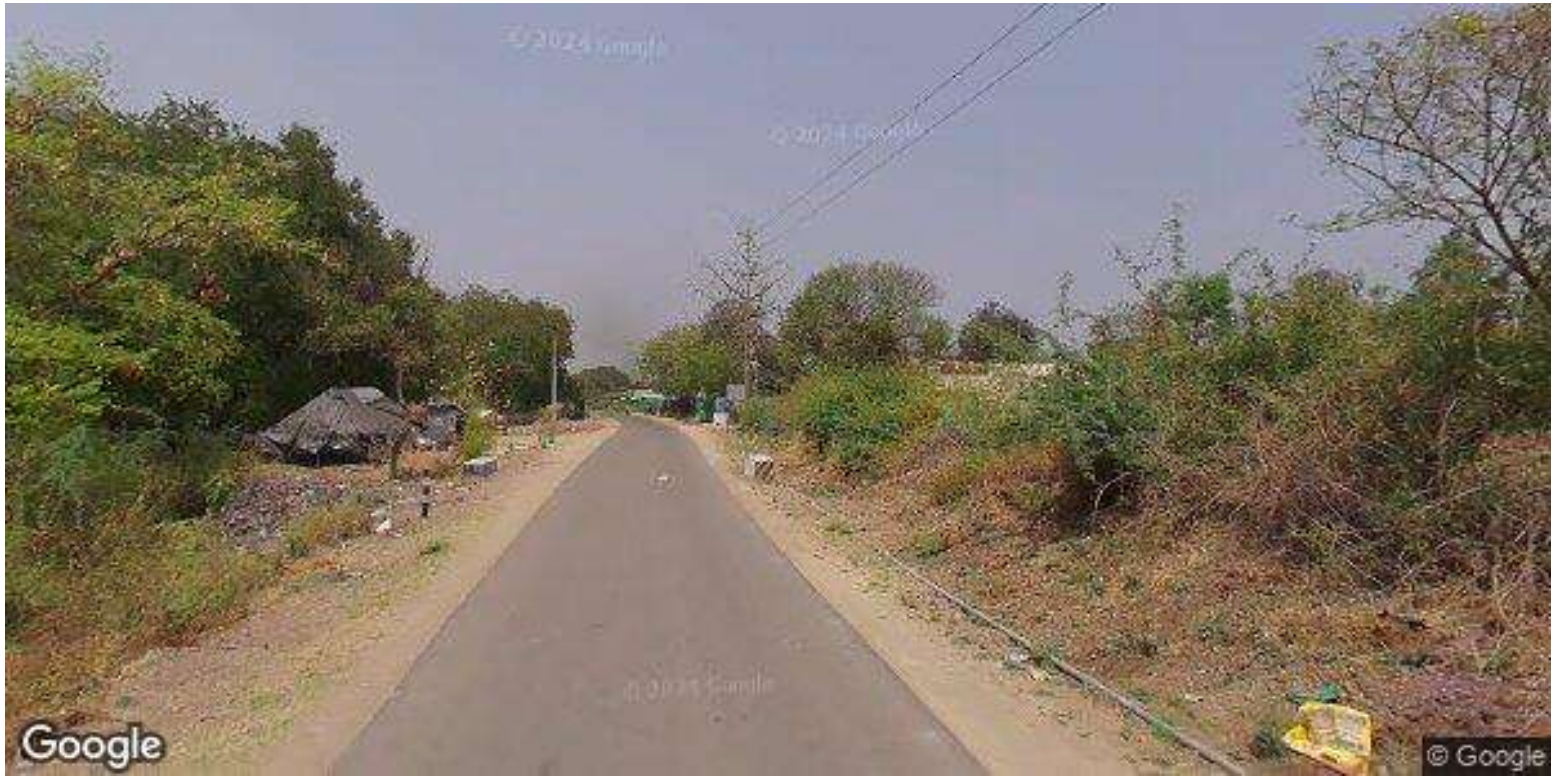
**Risk Type:** Turn  
**Risk Level:** Medium  
**Speed Limit:** 30 KM/Hr  
**Coordinates:** 12.02240, 78.30274

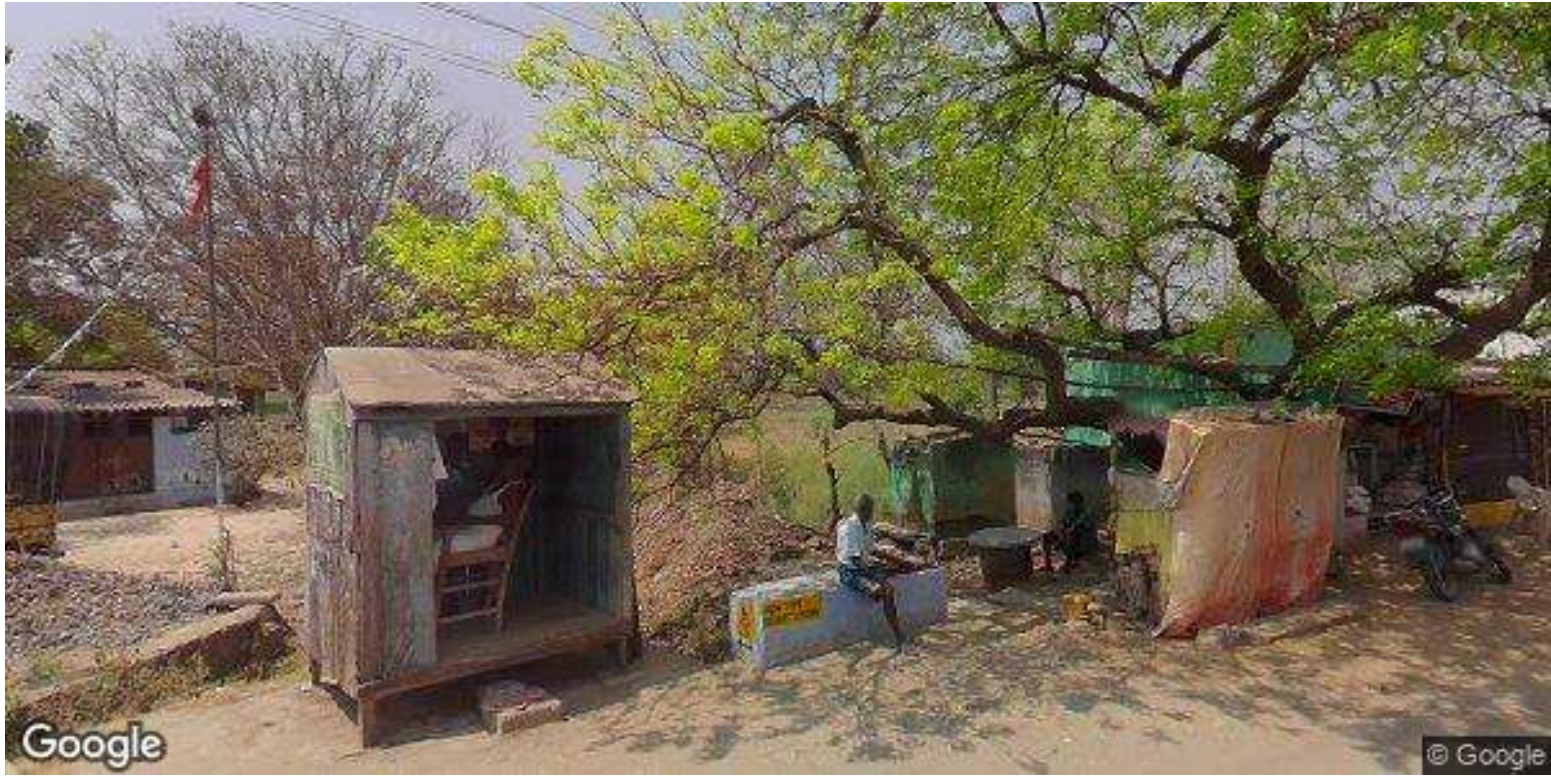
**Risk Type:** Turn  
**Risk Level:** Medium  
**Speed Limit:** 30 KM/Hr  
**Coordinates:** 12.02850, 78.30342

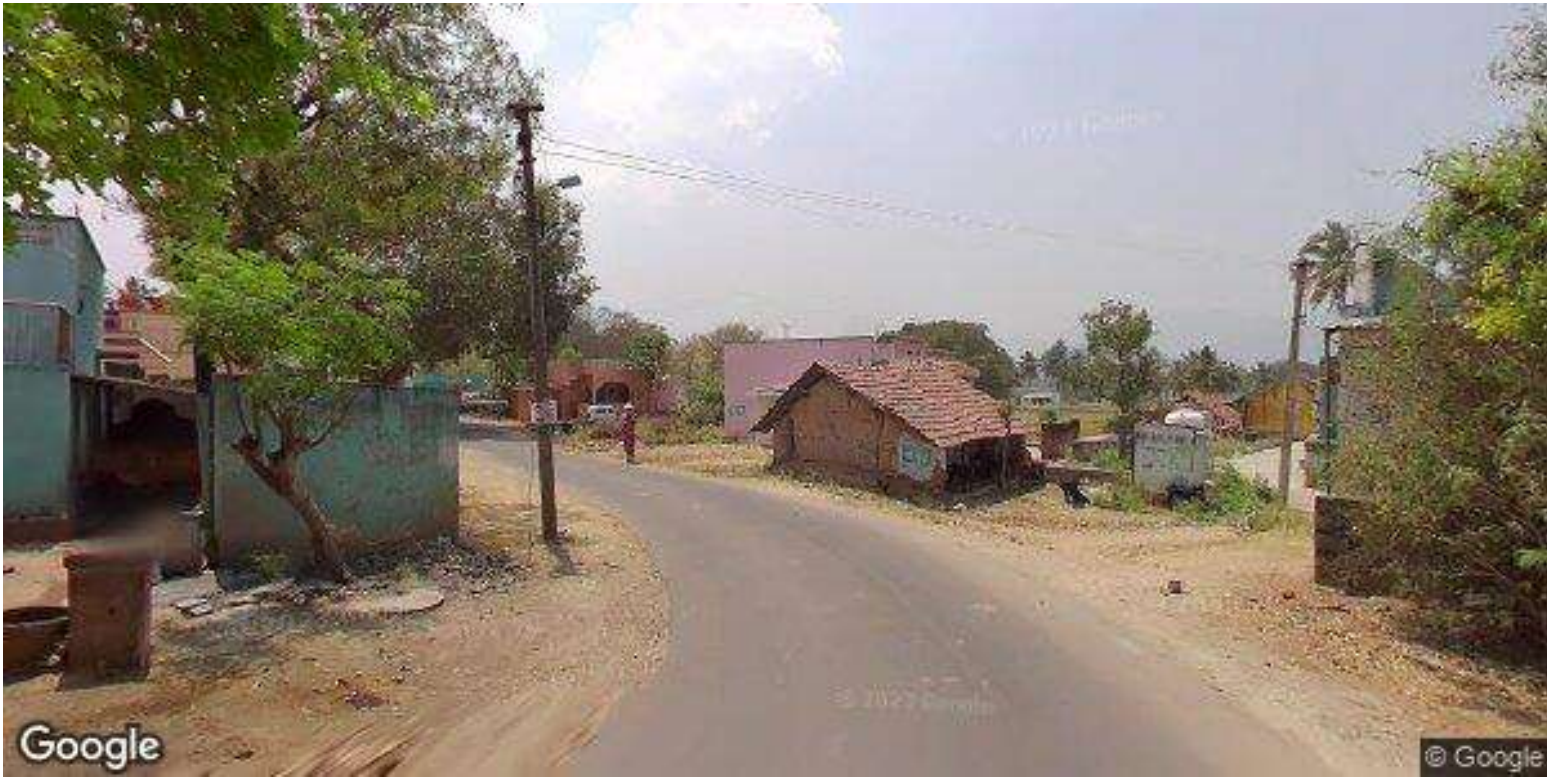
**Risk Type:** Turn  
**Risk Level:** High  
**Speed Limit:** 15 KM/Hr  
**Coordinates:** 12.02936, 78.30415

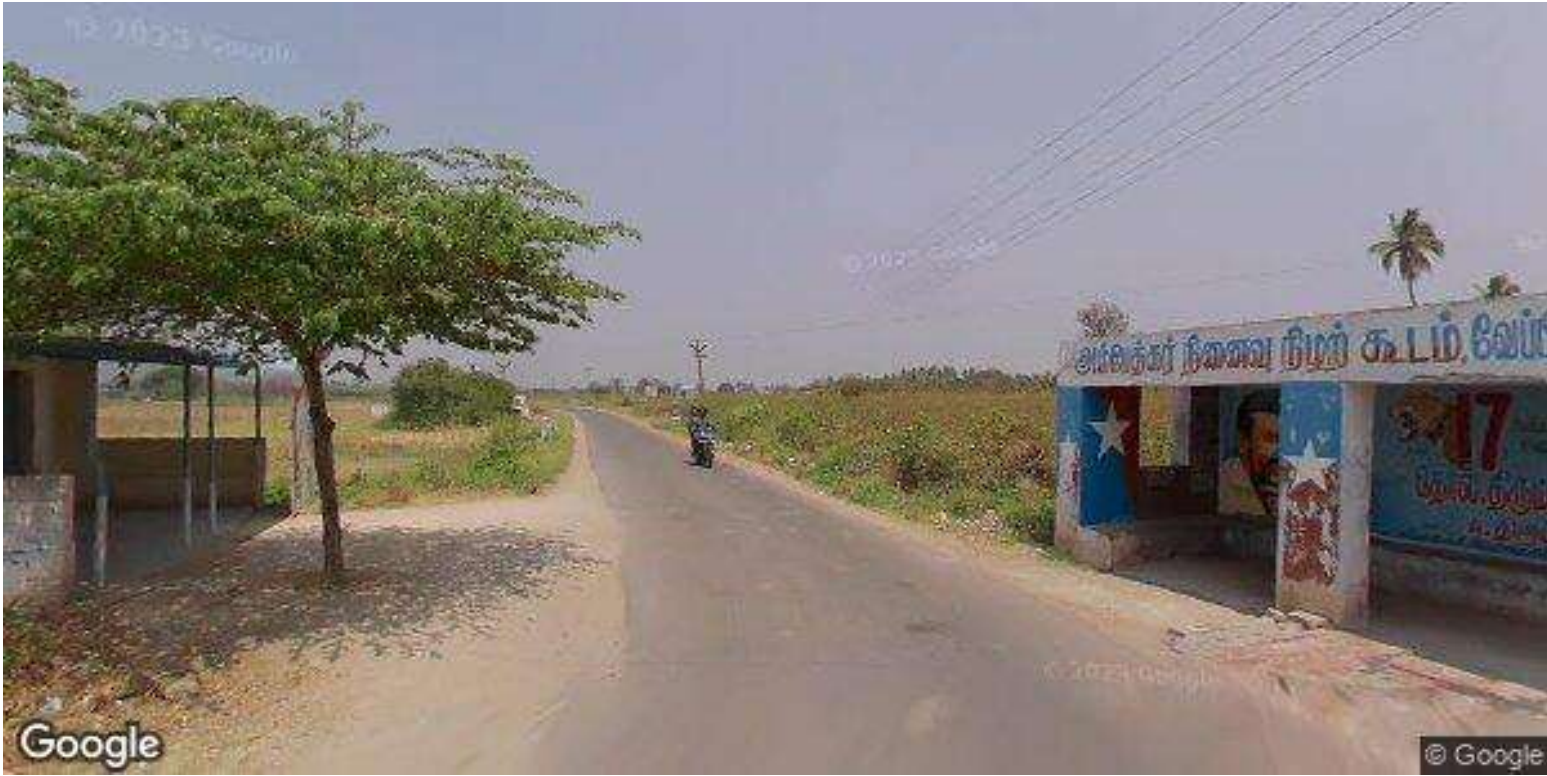
**Risk Type:** Turn  
**Risk Level:** High  
**Speed Limit:** 15 KM/Hr  
**Coordinates:** 12.02905, 78.30515

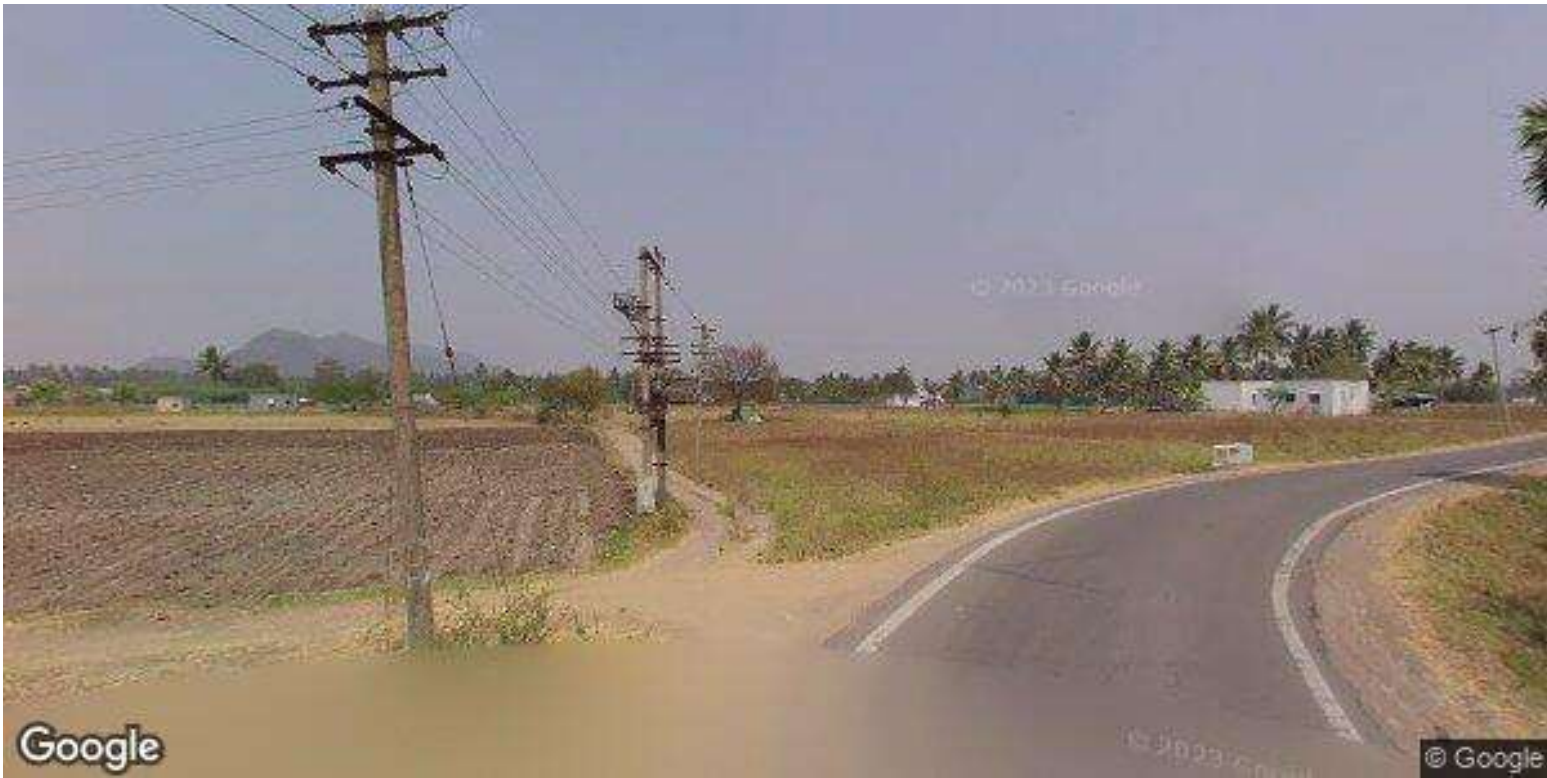
Coordinates: 12.03610, 78.31161

Risk Type: Turn

Risk Level: High

Speed Limit: 15 KM/Hr
