# IndianOil

## JOURNEY RISK MANAGEMENT (JRM) STUDY

### Salem Terminal TO RL AGENCY

Route Safety Analysis Report: CVQF+23W, Sangagiri to JMWJ+6P8, Guruvareddiur

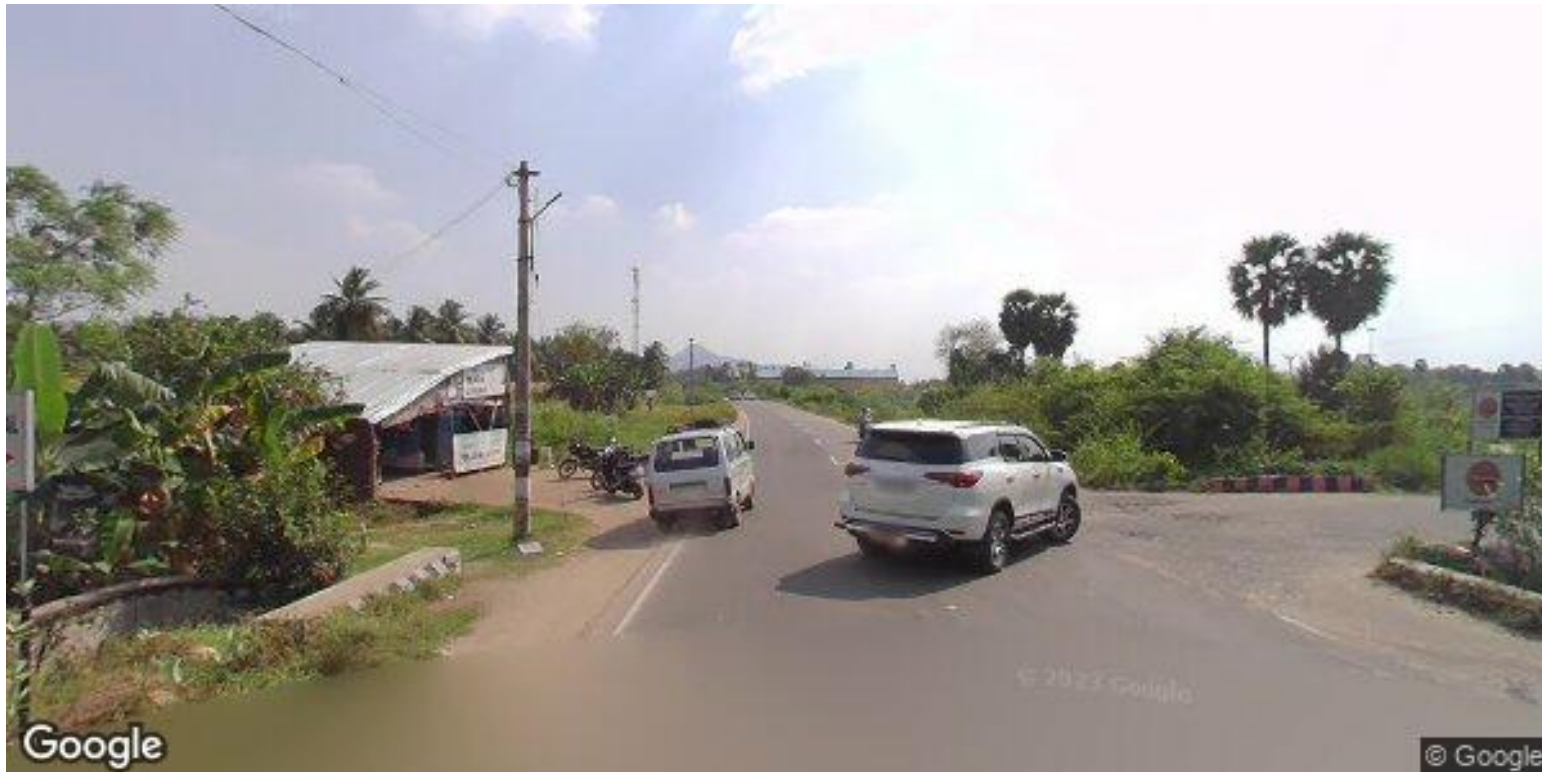
**Coordinates:** 11.44029, 77.87544

**Risk Type:** Turn

**Risk Level:** High

**Speed Limit:** 15 KM/Hr

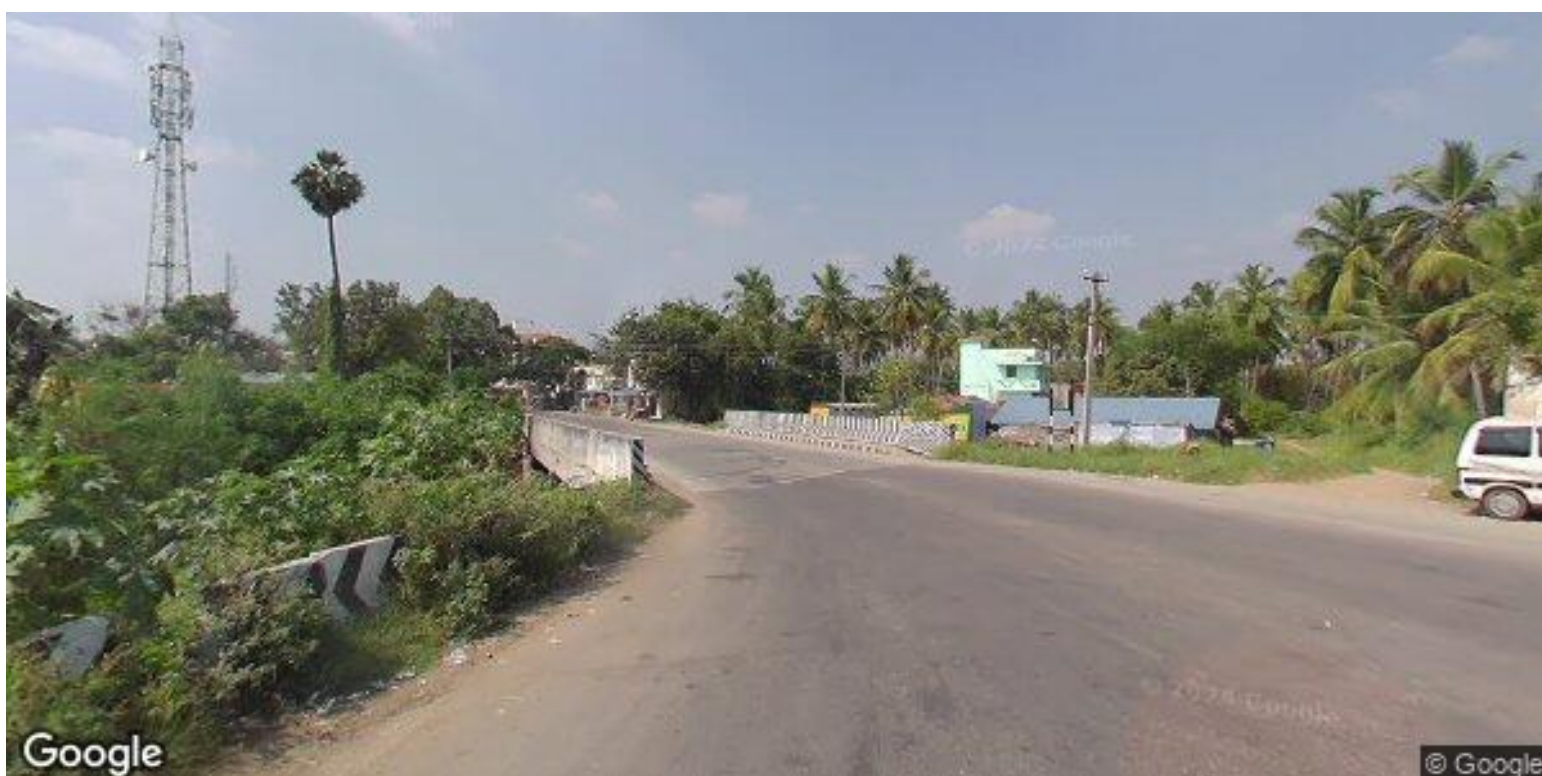
**Coordinates:** 11.44893, 77.87413

**Risk Type:** Turn

**Risk Level:** Medium

**Speed Limit:** 30 KM/Hr

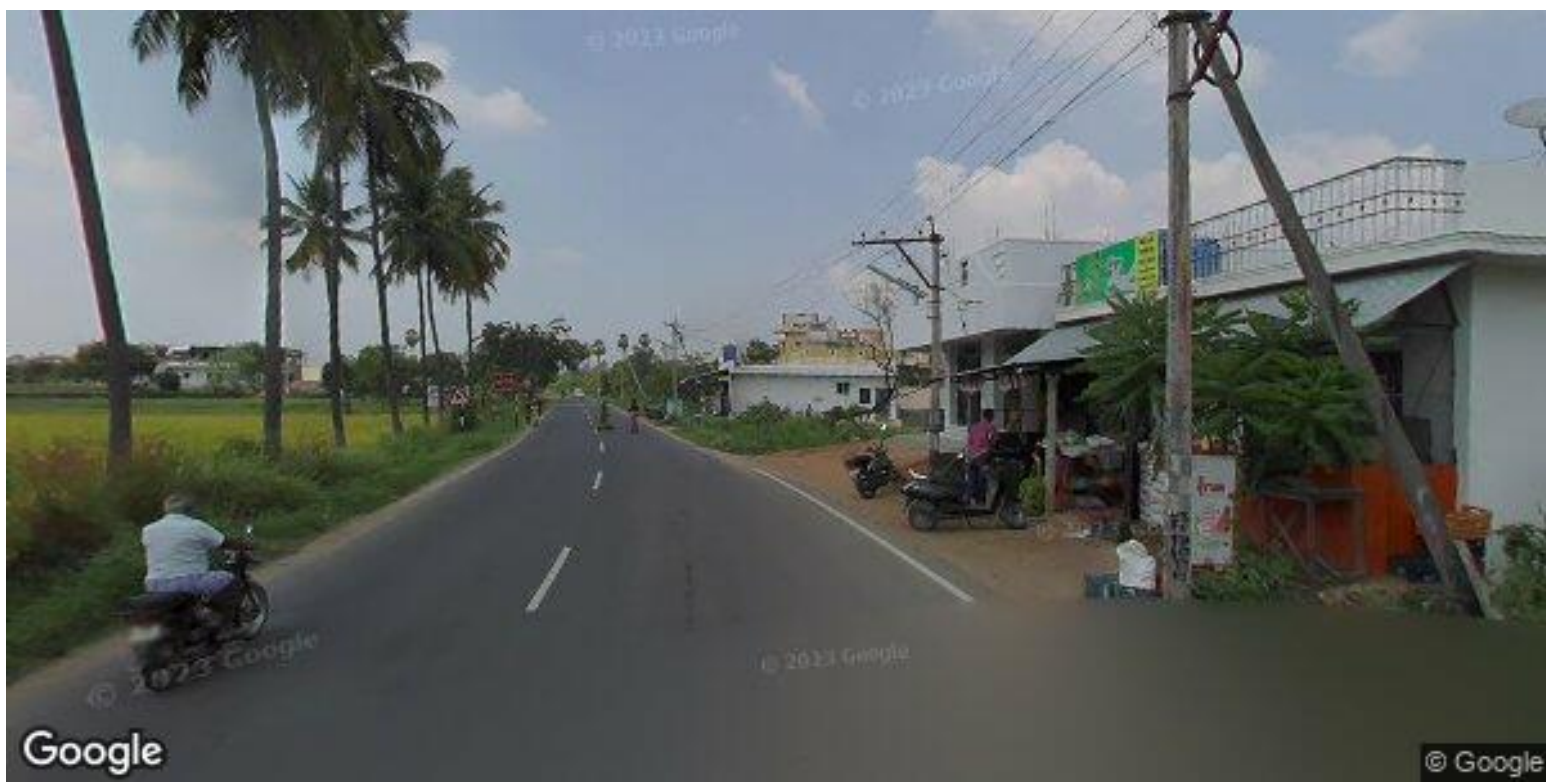
**Coordinates:** 11.45127, 77.86734

**Risk Type:** Turn

**Risk Level:** Medium

**Speed Limit:** 30 KM/Hr

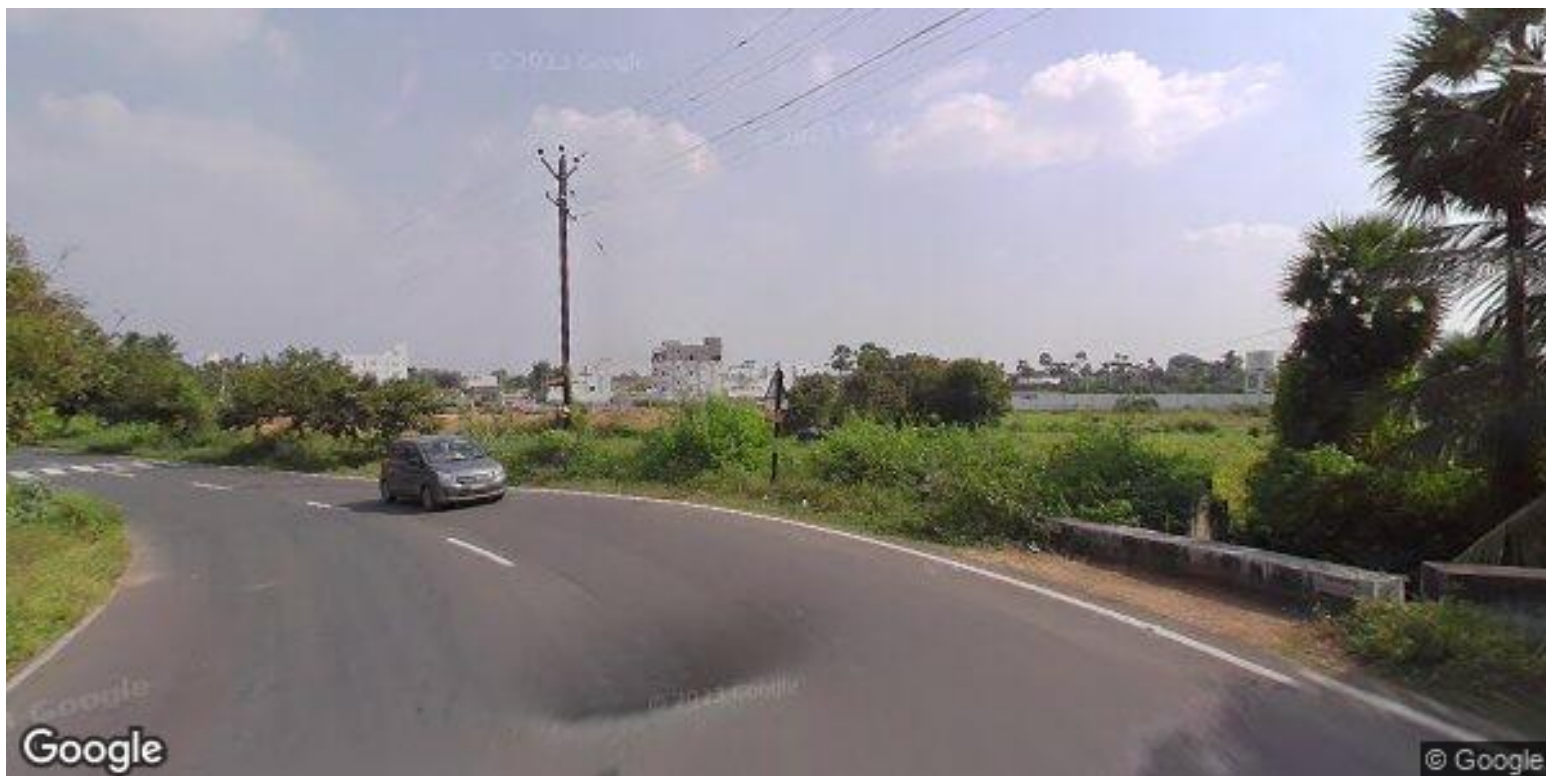
**Coordinates:** 11.45350, 77.85700

**Risk Type:** Turn

**Risk Level:** High

**Speed Limit:** 15 KM/Hr

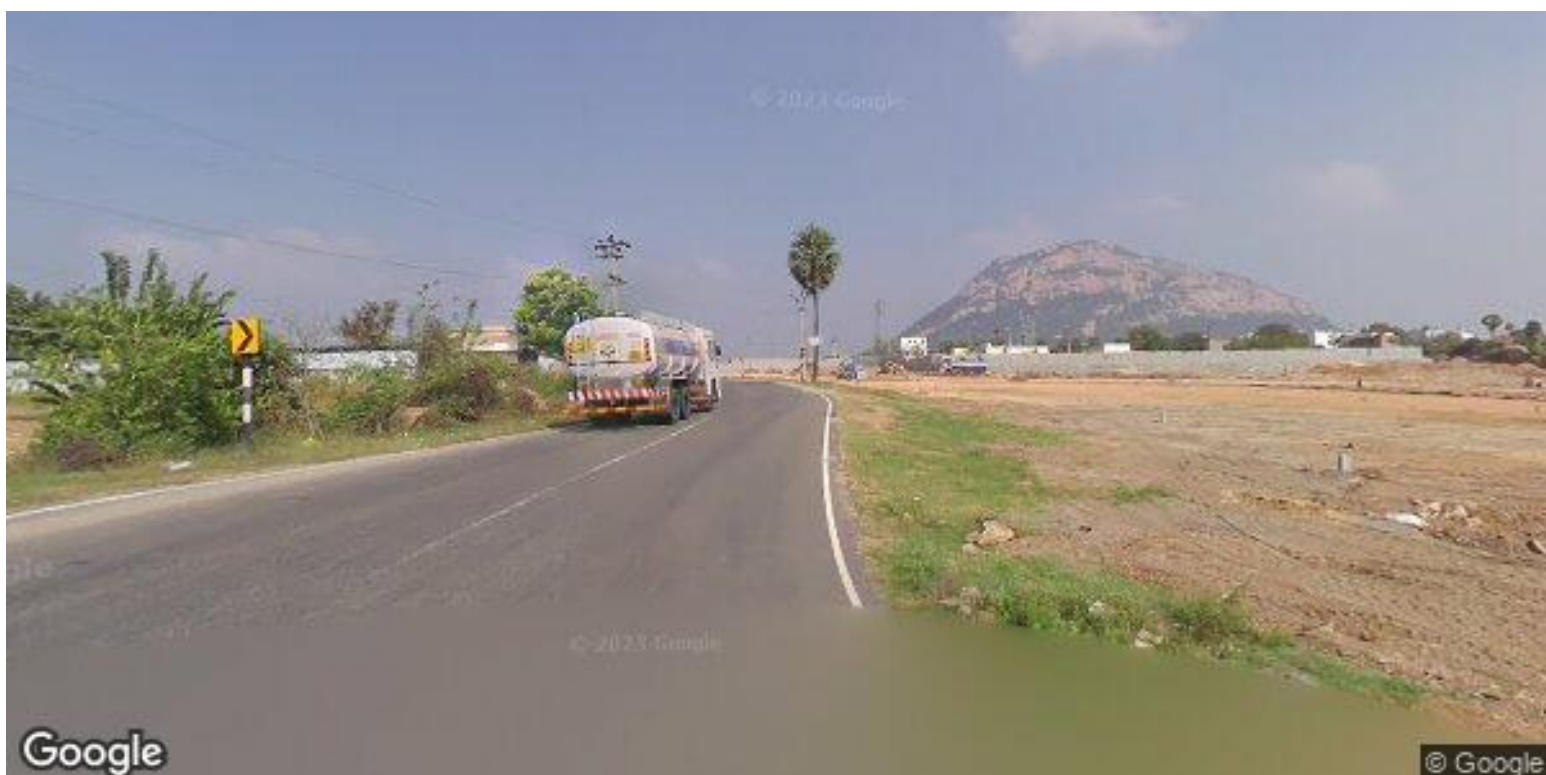
**Risk Type:** Turn  
**Risk Level:** Medium  
**Speed Limit:** 30 KM/Hr  
**Coordinates:** 11.45845, 77.85141

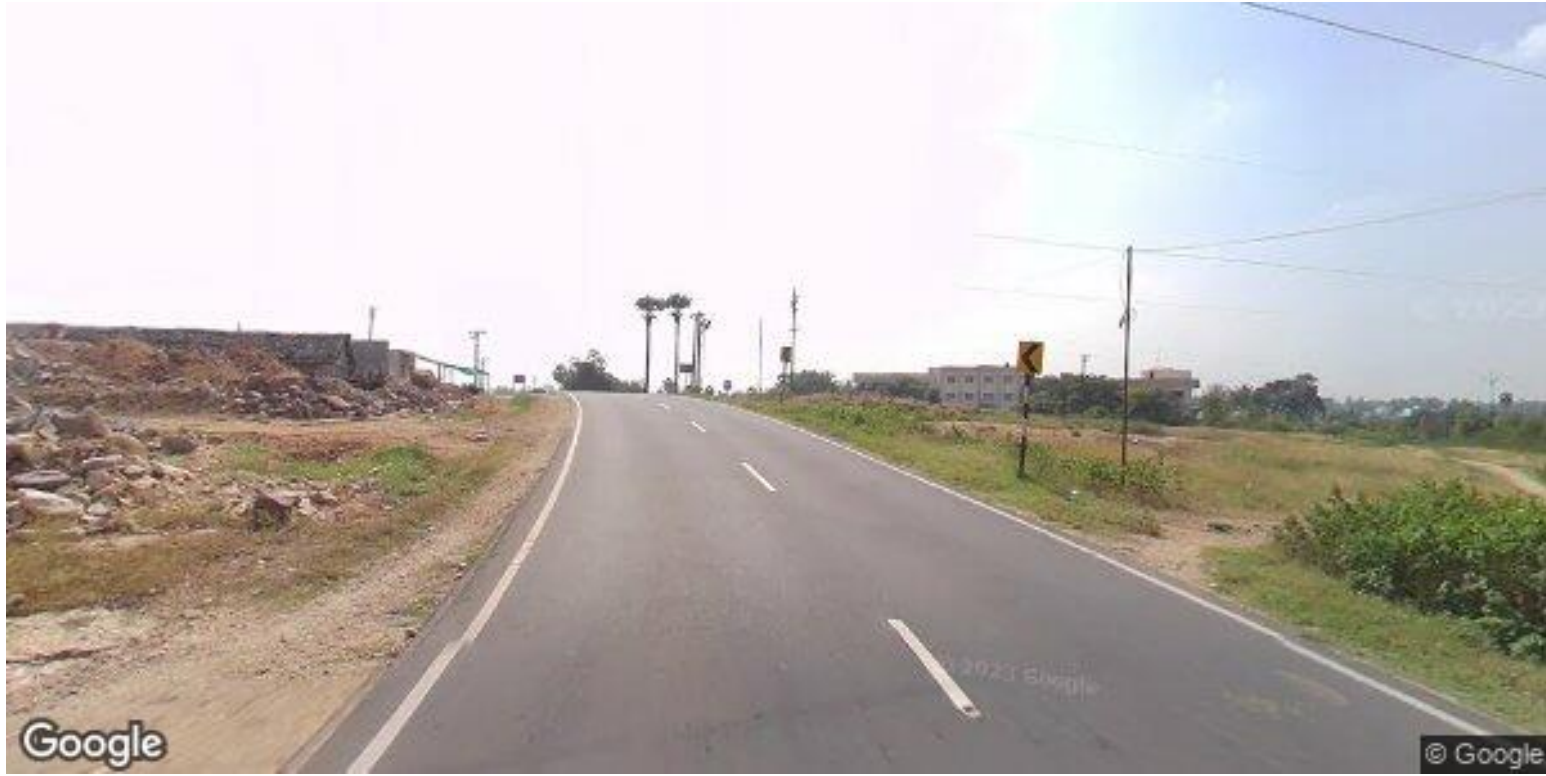
**Risk Type:** Turn  
**Risk Level:** Medium  
**Speed Limit:** 30 KM/Hr  
**Coordinates:** 11.46046, 77.85037

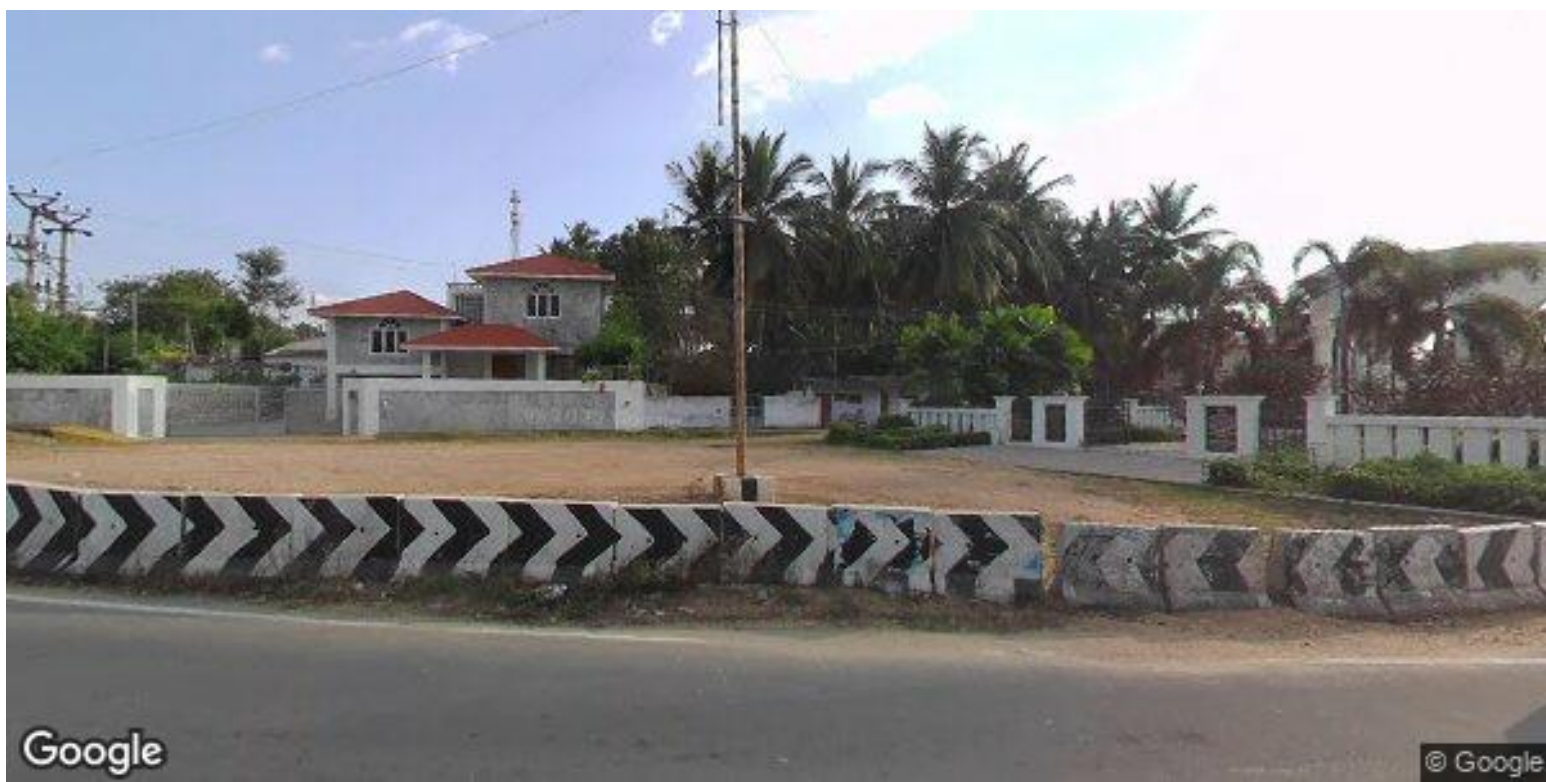
**Coordinates:** 11.46316, 77.84921

**Risk Type:** Turn

**Risk Level:** Medium

**Speed Limit:** 30 KM/Hr

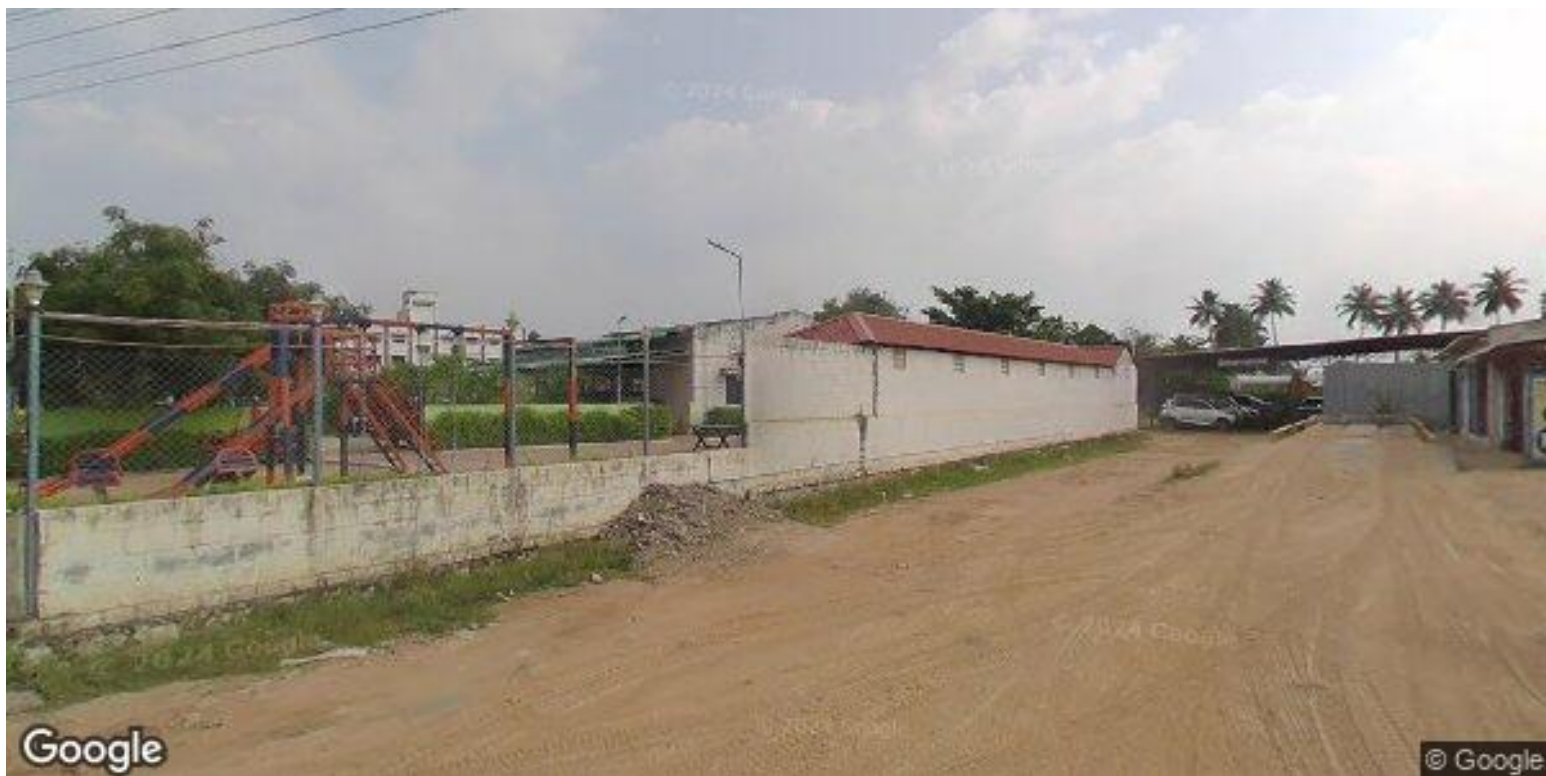
**Coordinates:** 11.44377, 77.71562

**Risk Type:** Turn

**Risk Level:** High

**Speed Limit:** 15 KM/Hr

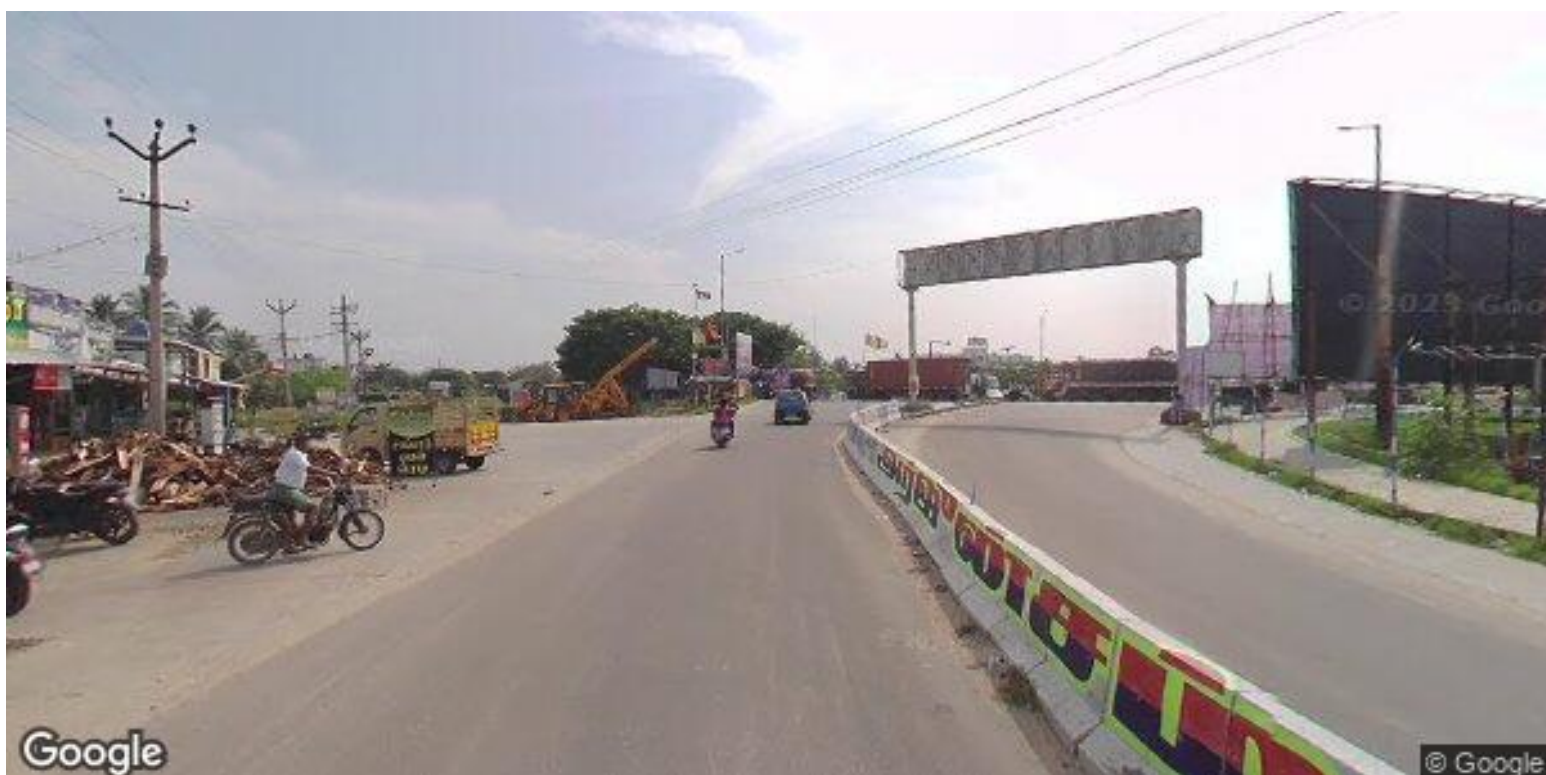
**Coordinates:** 11.44438, 77.71501

**Risk Type:** Turn

**Risk Level:** Medium

**Speed Limit:** 30 KM/Hr

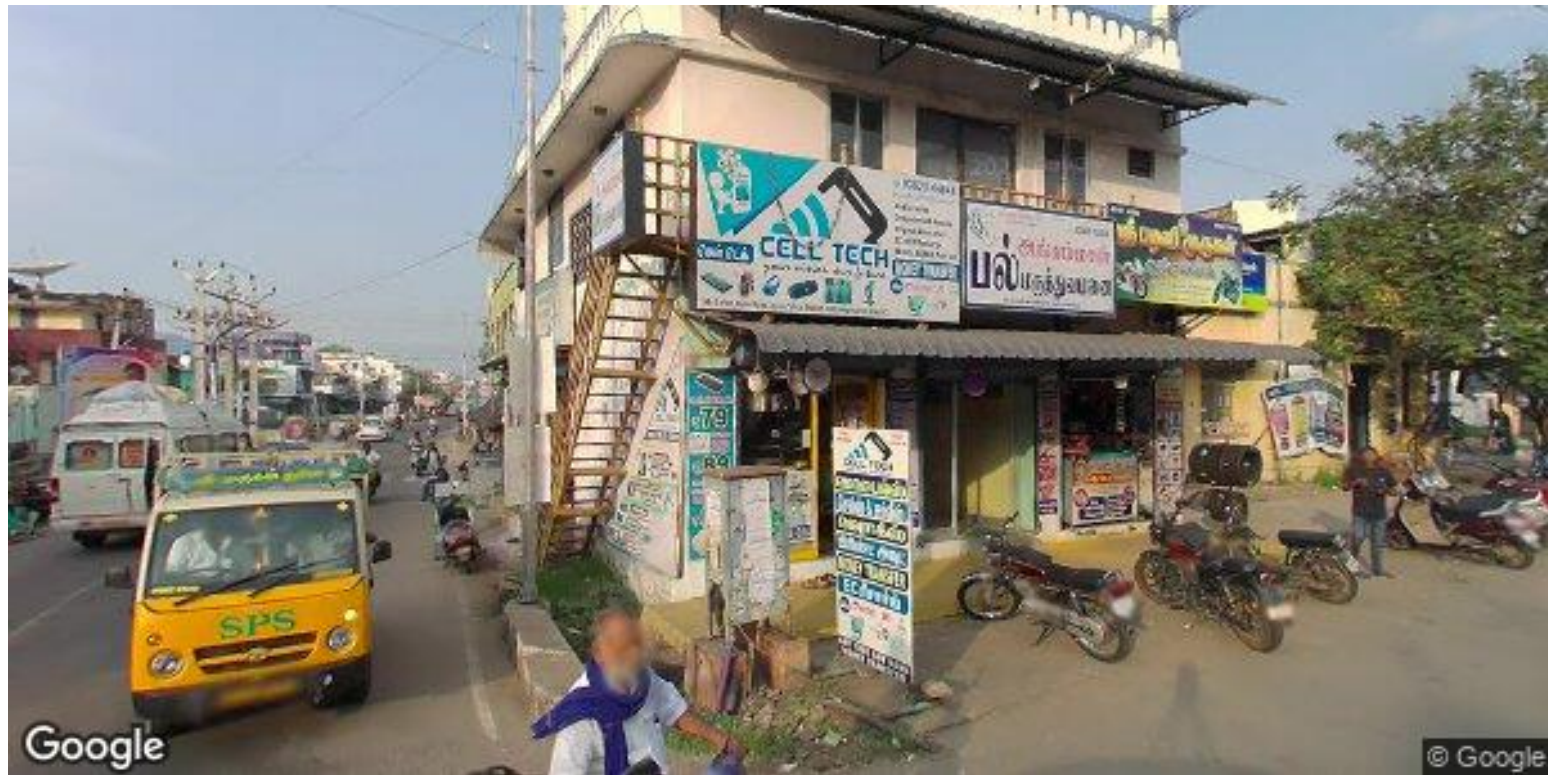
**Coordinates:** 11.44111, 77.69331

**Risk Type:** Turn

**Risk Level:** High

**Speed Limit:** 15 KM/Hr

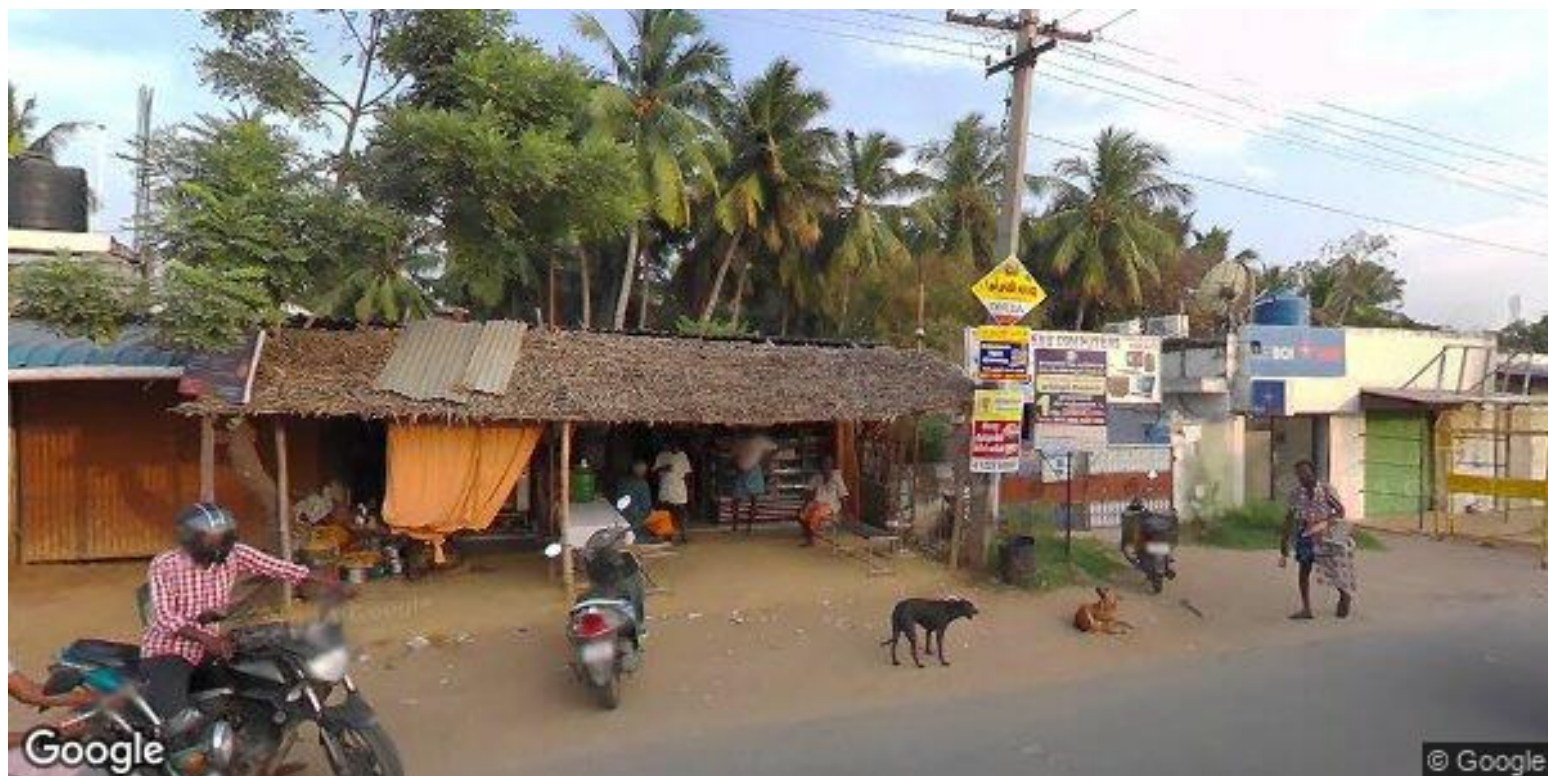
**Coordinates:** 11.44985, 77.69520

**Risk Type:** Turn

**Risk Level:** High

**Speed Limit:** 15 KM/Hr

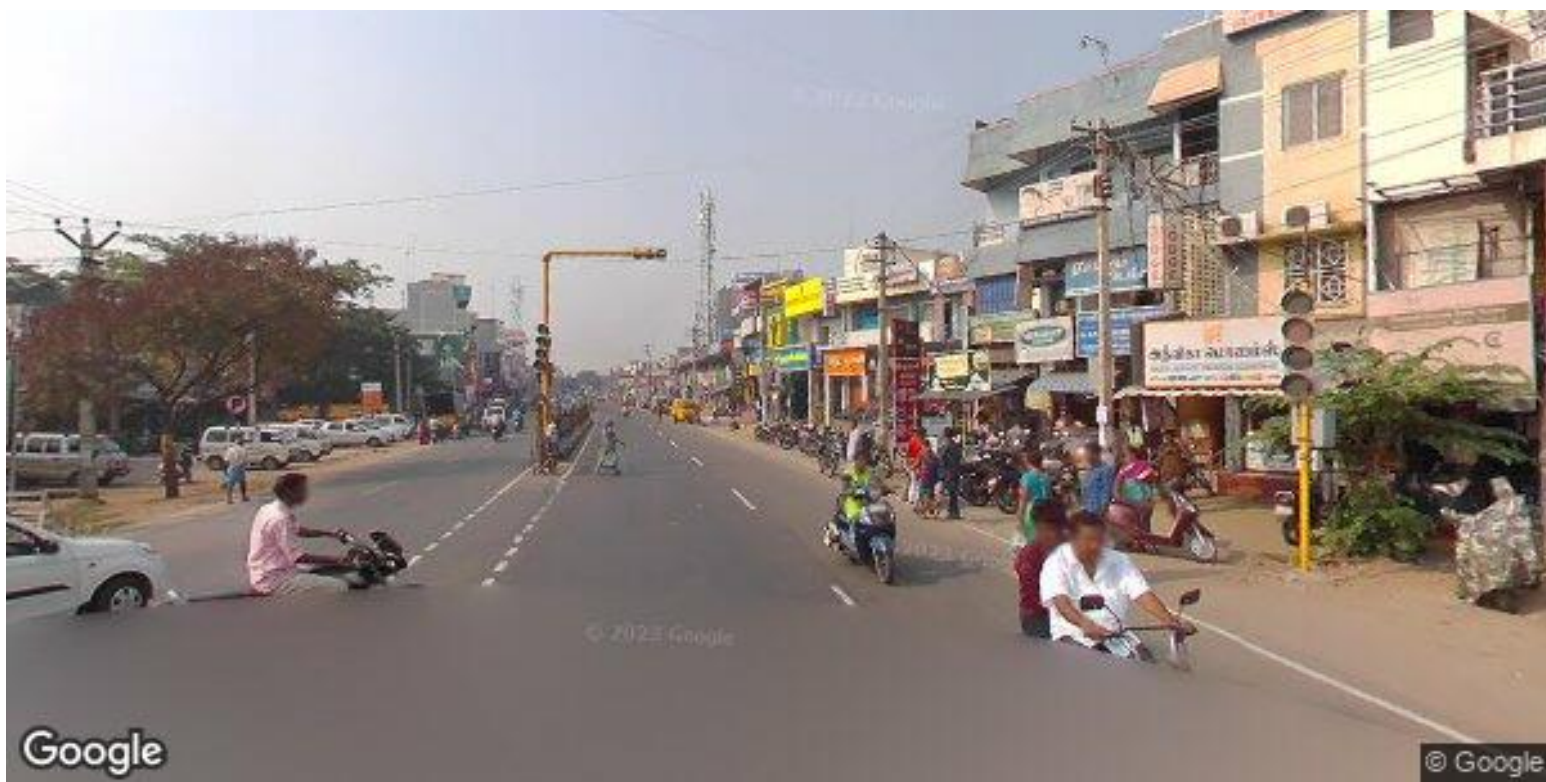
**Coordinates:** 11.45331, 77.68803

**Risk Type:** Turn

**Risk Level:** High

**Speed Limit:** 15 KM/Hr

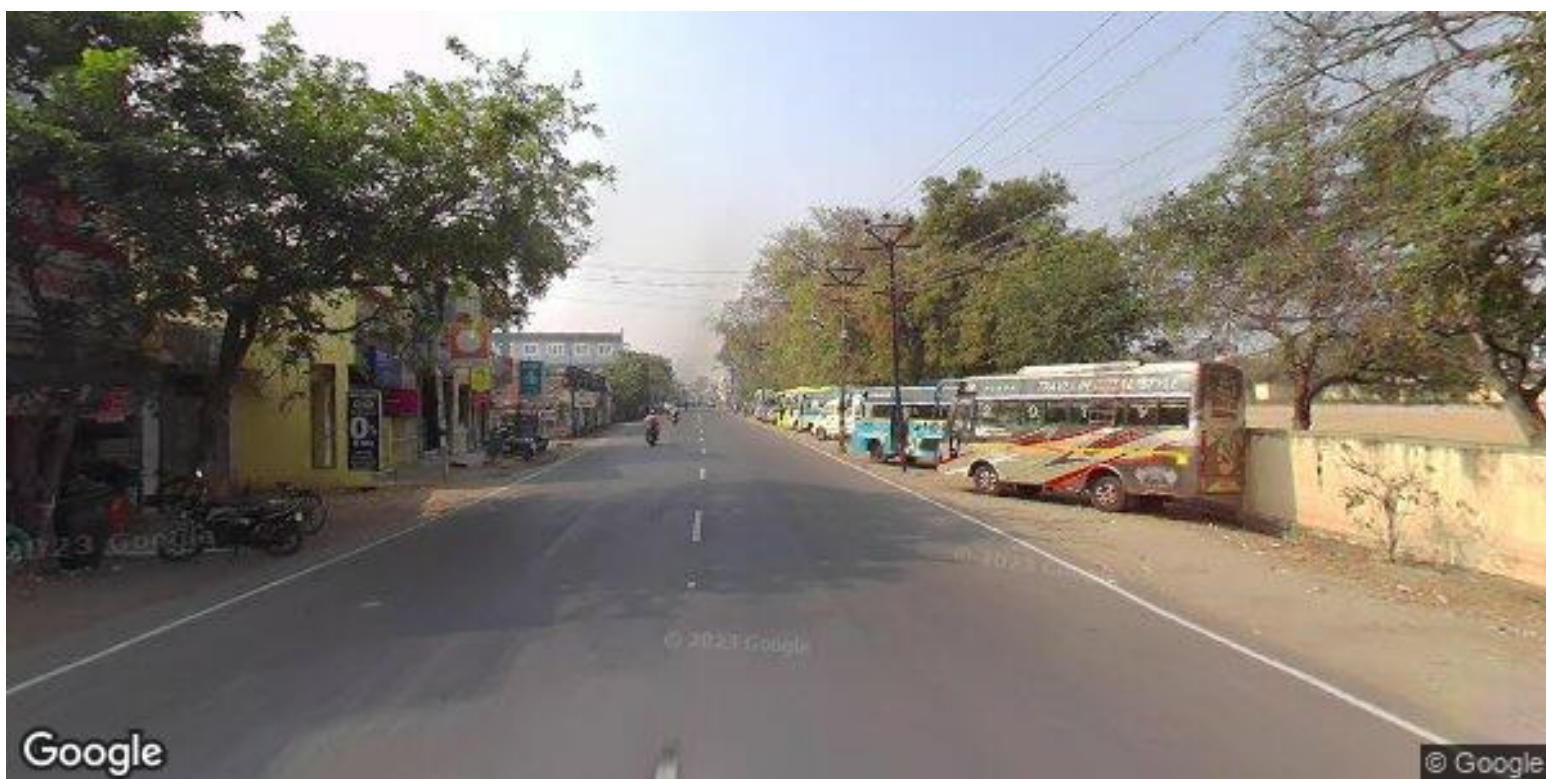
**Coordinates:** 11.44979, 77.68549

**Risk Type:** Blind Spot

**Risk Level:** Blind Spot

**Speed Limit:** 10 KM/Hr

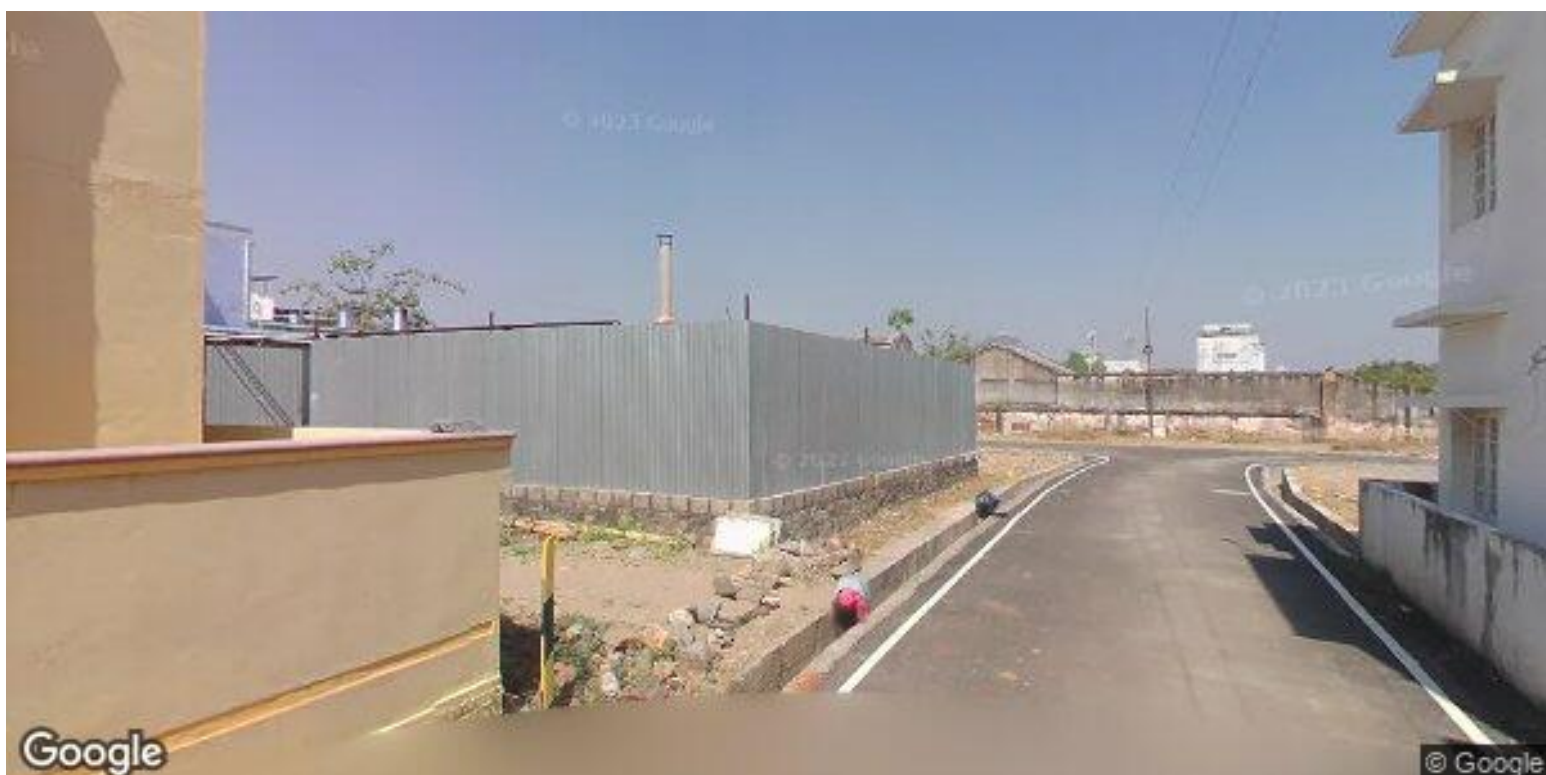
**Coordinates:** 11.44948, 77.68645

**Risk Type:** Turn

**Risk Level:** High

**Speed Limit:** 15 KM/Hr

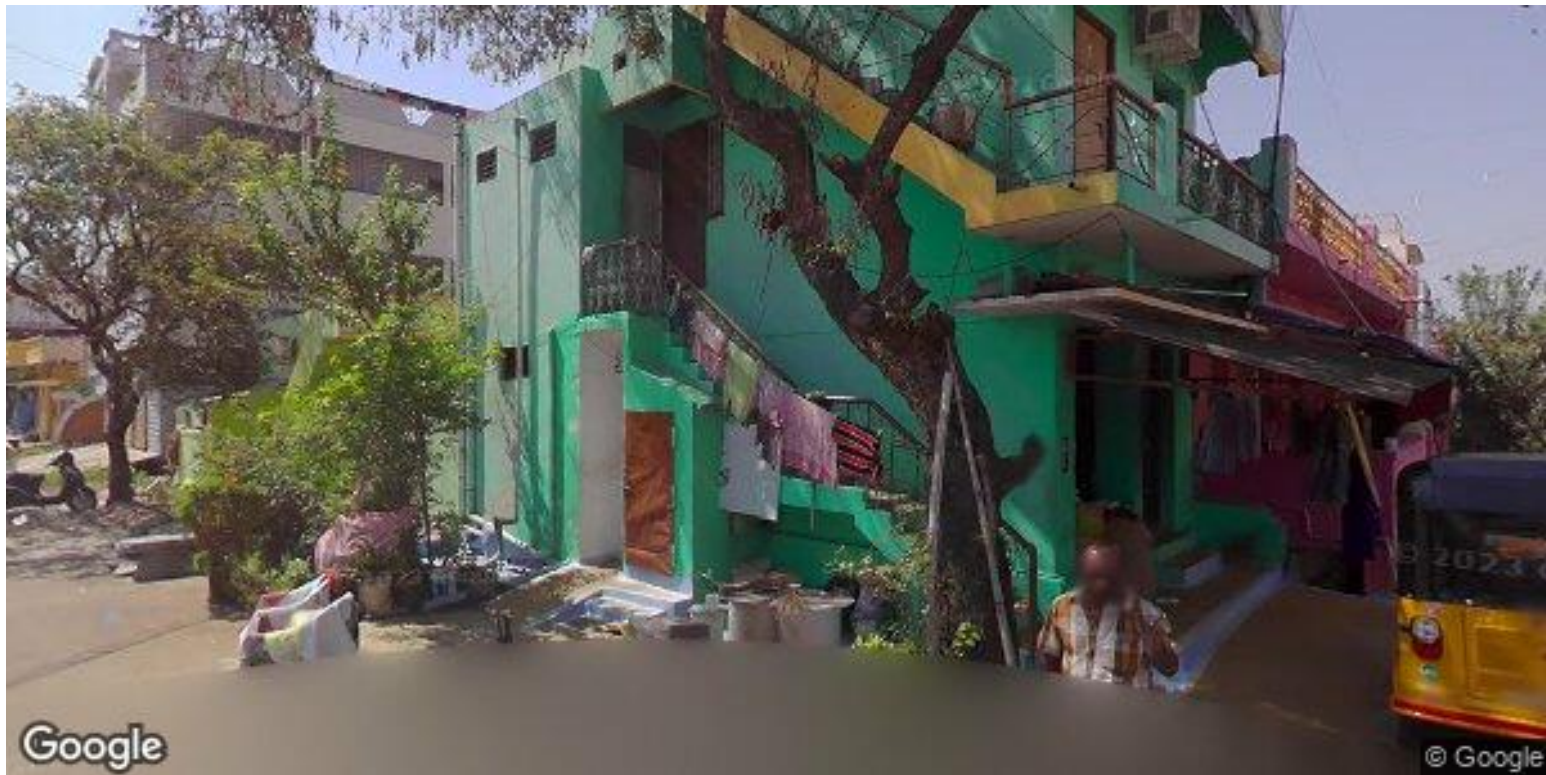
**Coordinates:** 11.44801, 77.68596

**Risk Type:** Turn

**Risk Level:** High

**Speed Limit:** 15 KM/Hr

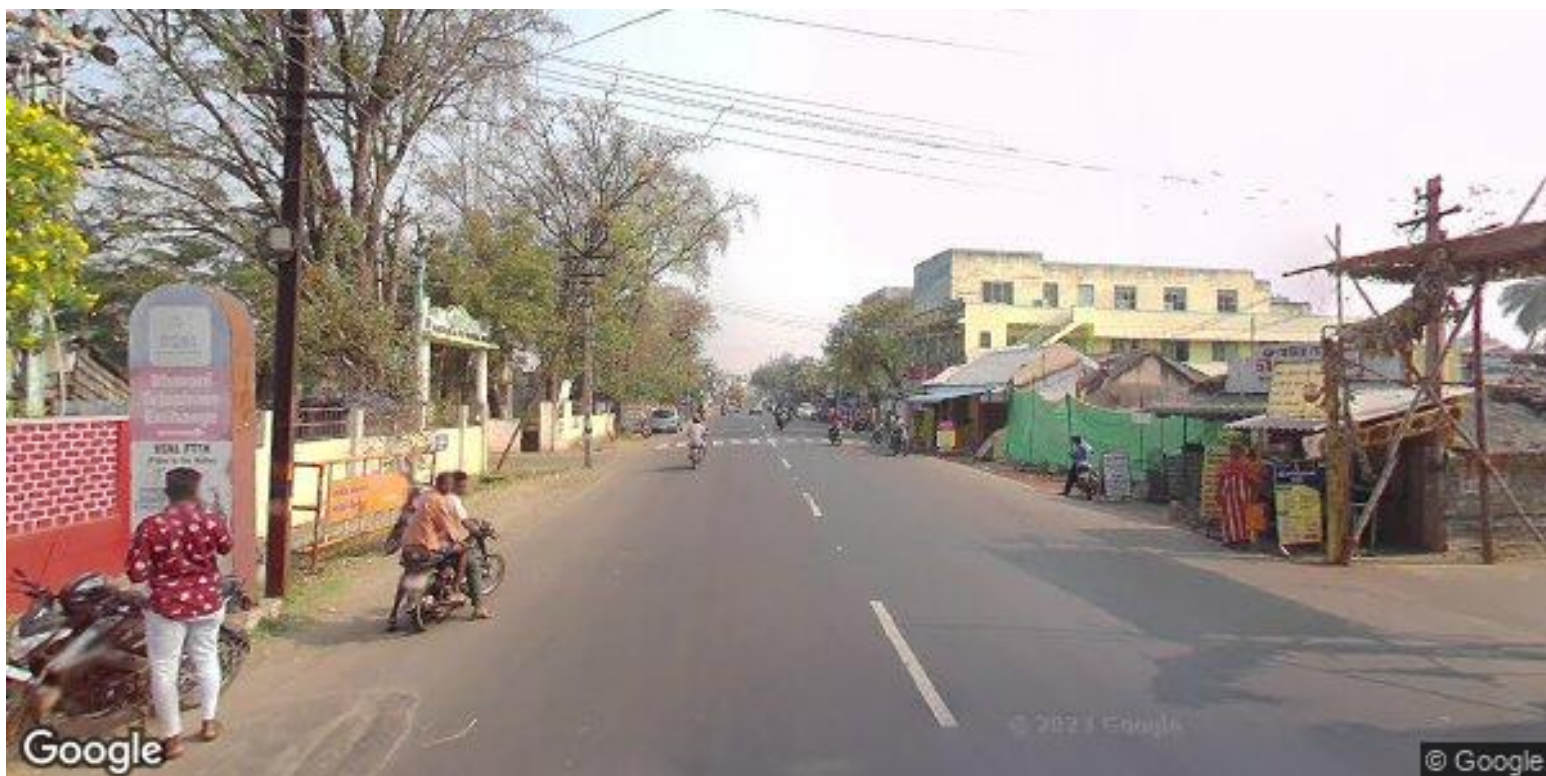
**Coordinates:** 11.44842, 77.68473

**Risk Type:** Blind Spot

**Risk Level:** Blind Spot

**Speed Limit:** 10 KM/Hr

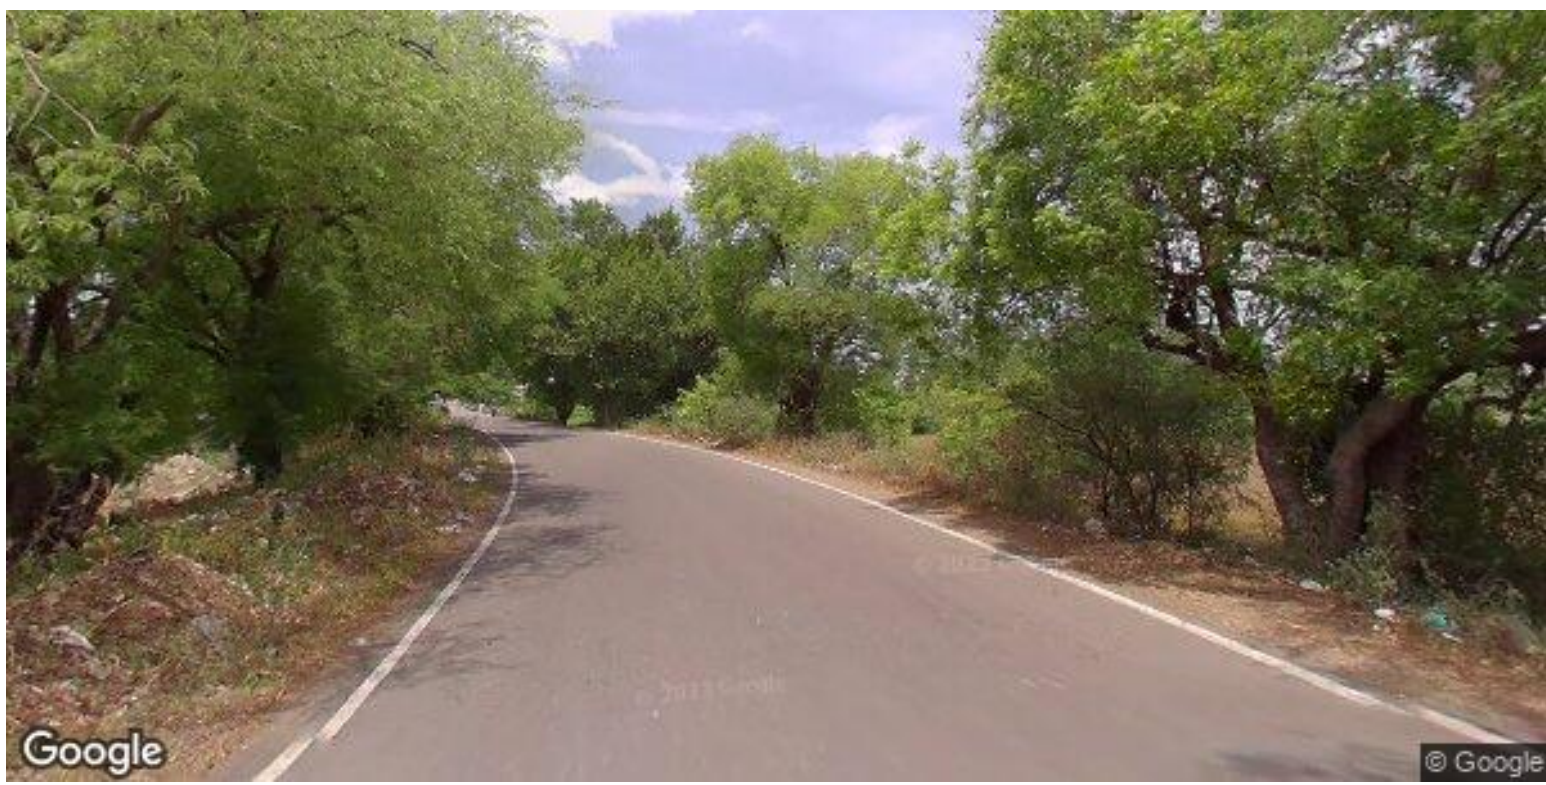
**Coordinates:** 11.55440, 77.71815

**Risk Type:** Turn

**Risk Level:** Medium

**Speed Limit:** 30 KM/Hr

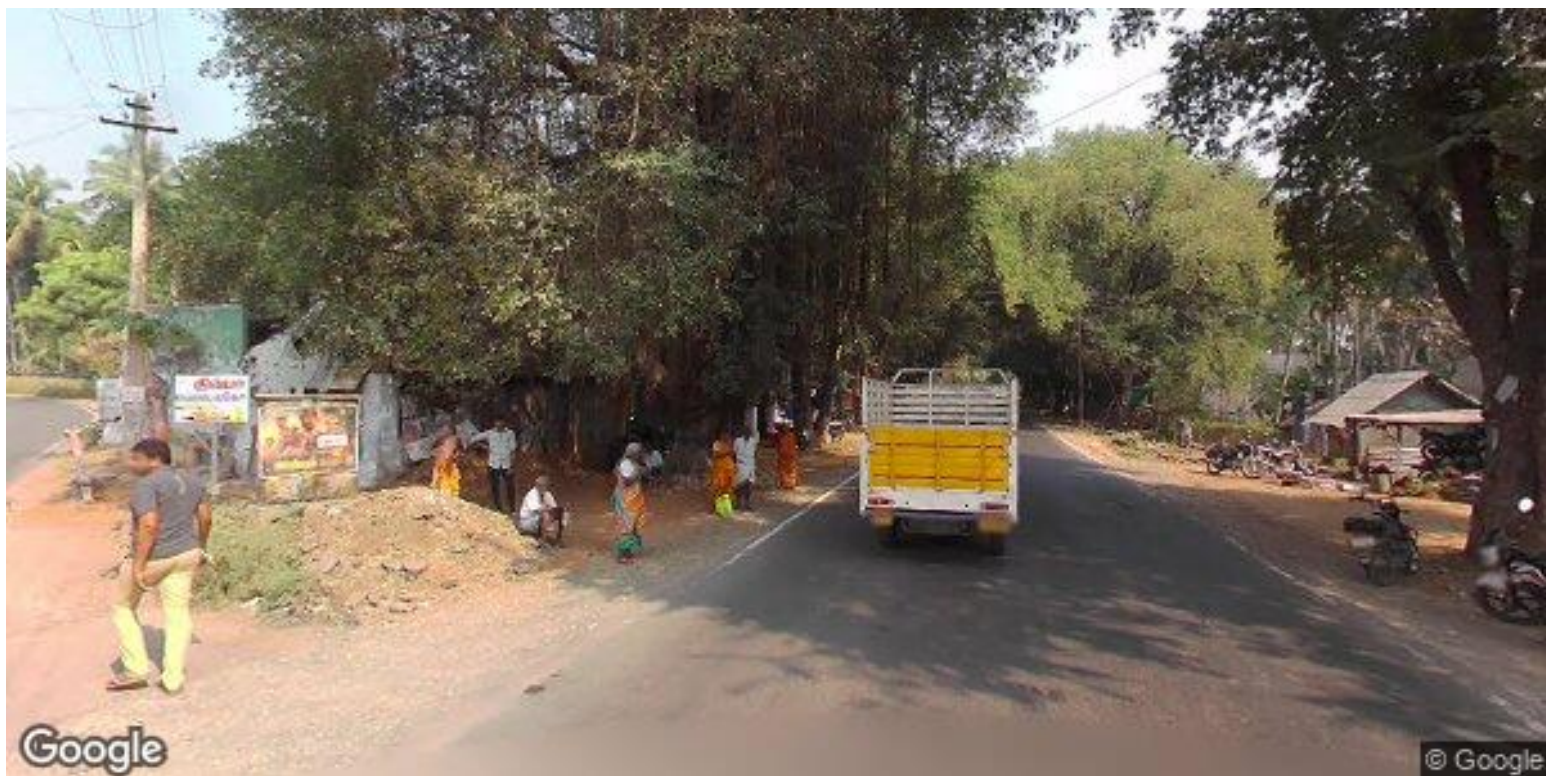
**Coordinates:** 11.59946, 77.73130

**Risk Type:** Turn

**Risk Level:** High

**Speed Limit:** 15 KM/Hr

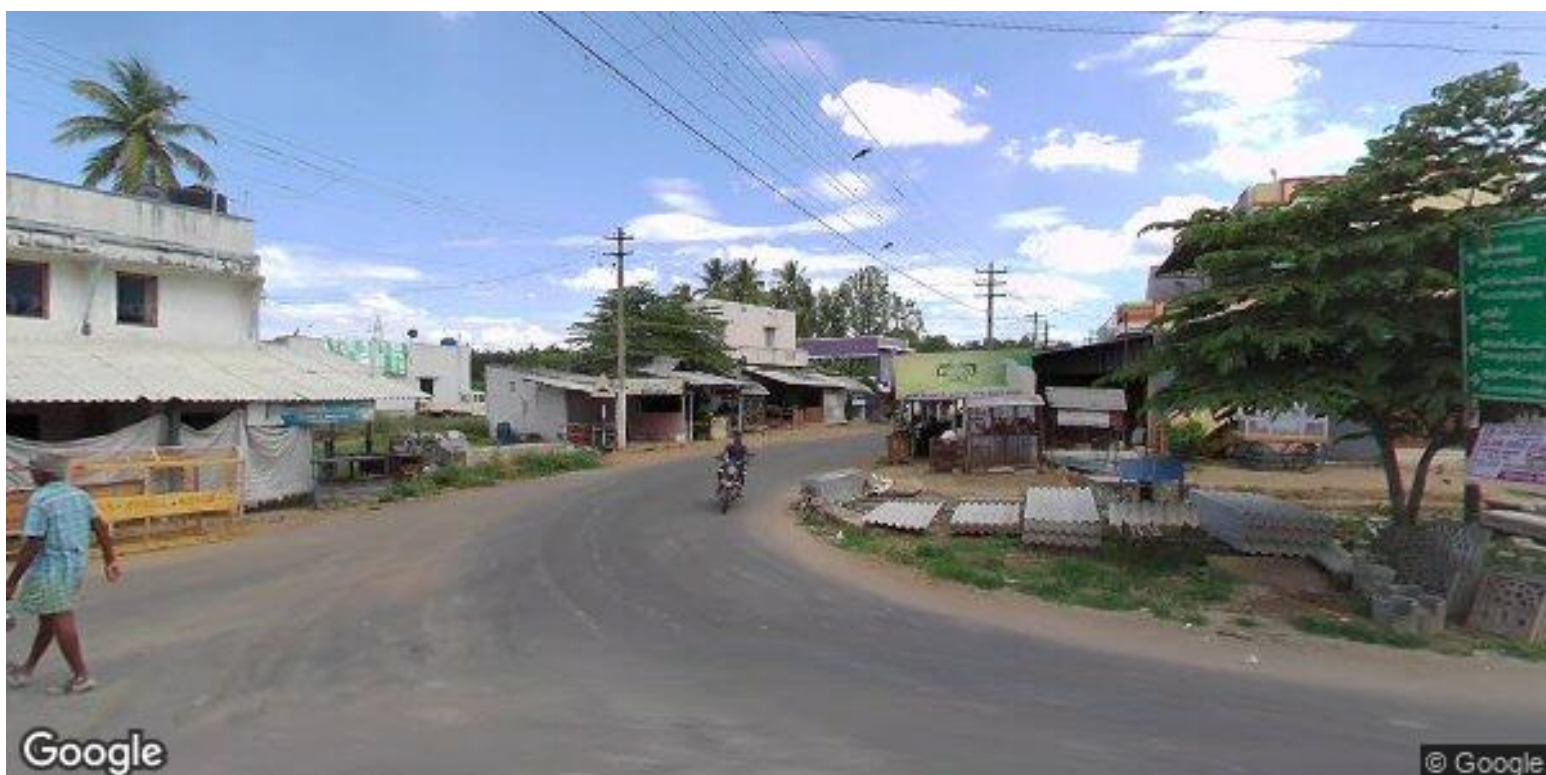
**Coordinates:** 11.61011, 77.71752

**Risk Type:** Turn

**Risk Level:** Medium

**Speed Limit:** 30 KM/Hr
