# IndianOil

## JOURNEY RISK MANAGEMENT (JRM) STUDY

### Salem Terminal TO RL AGENCY

Route Safety Analysis Report: CVQF+23W, Sangagiri to JMWJ+6P8, Guruvareddiur

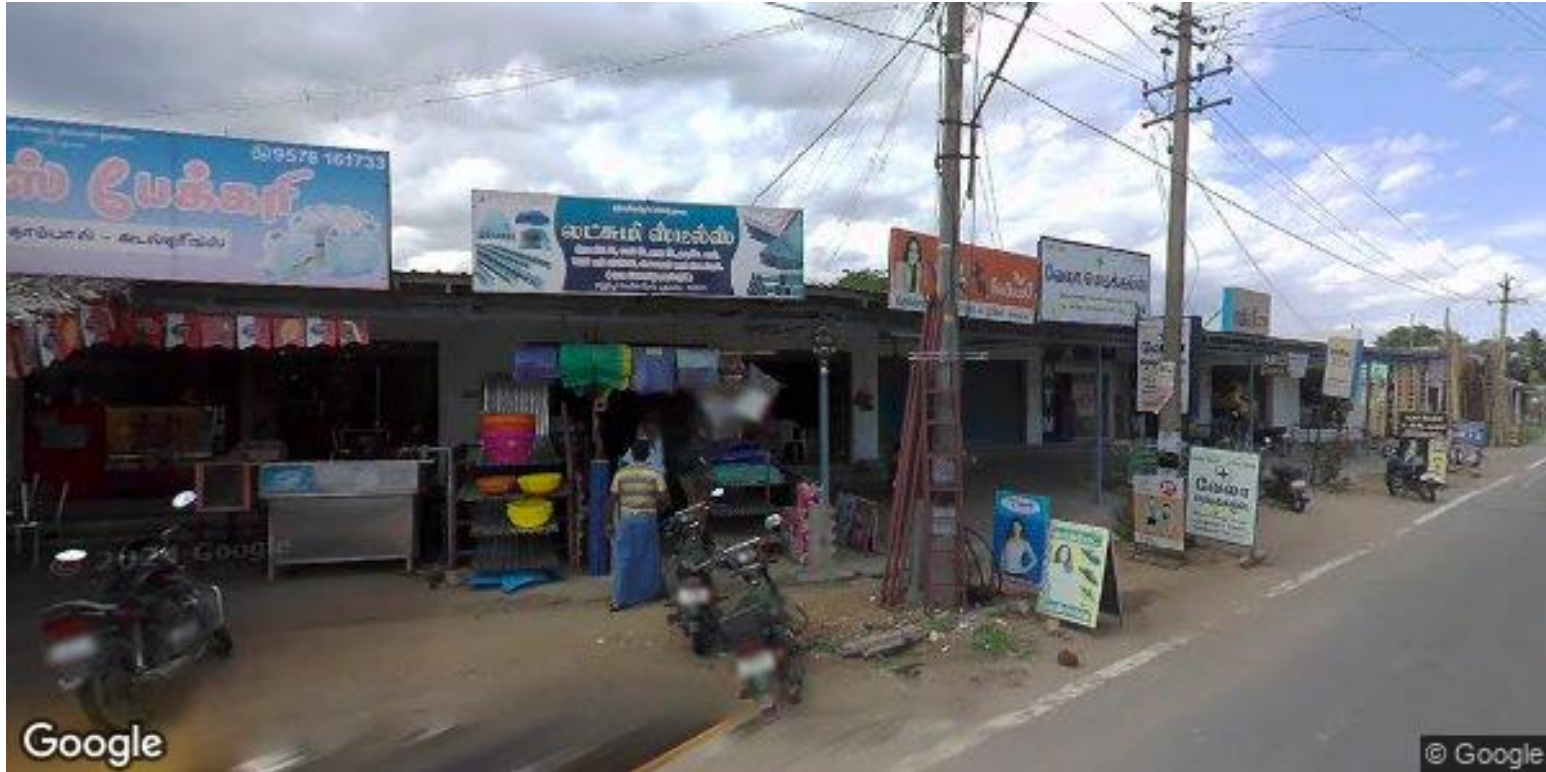
**Coordinates:** 11.61026, 77.71748

**Risk Type:** Blind Spot

**Risk Level:** Blind Spot

**Speed Limit:** 10 KM/Hr

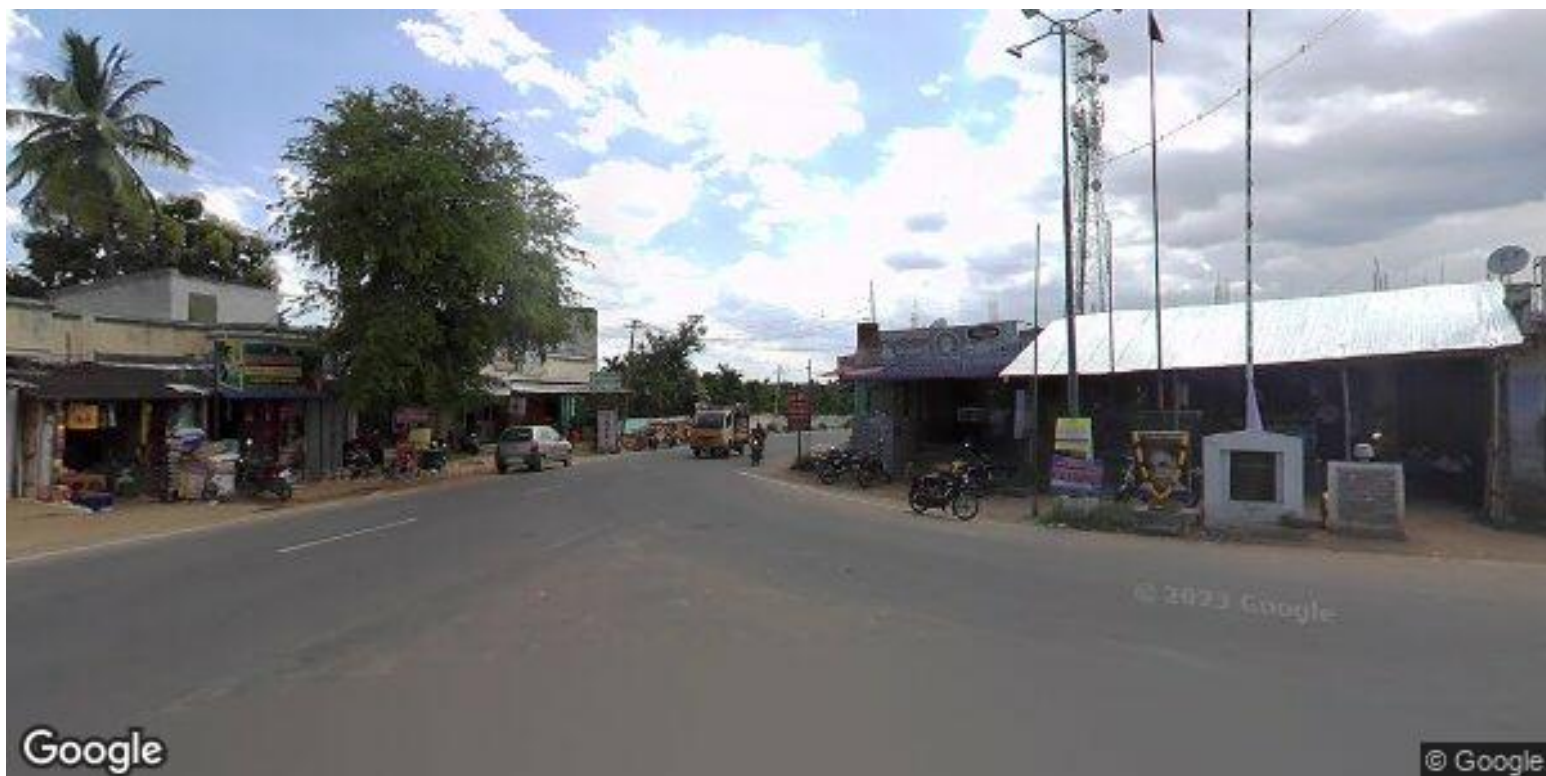
**Coordinates:** 11.60985, 77.71617

**Risk Type:** Turn

**Risk Level:** High

**Speed Limit:** 15 KM/Hr

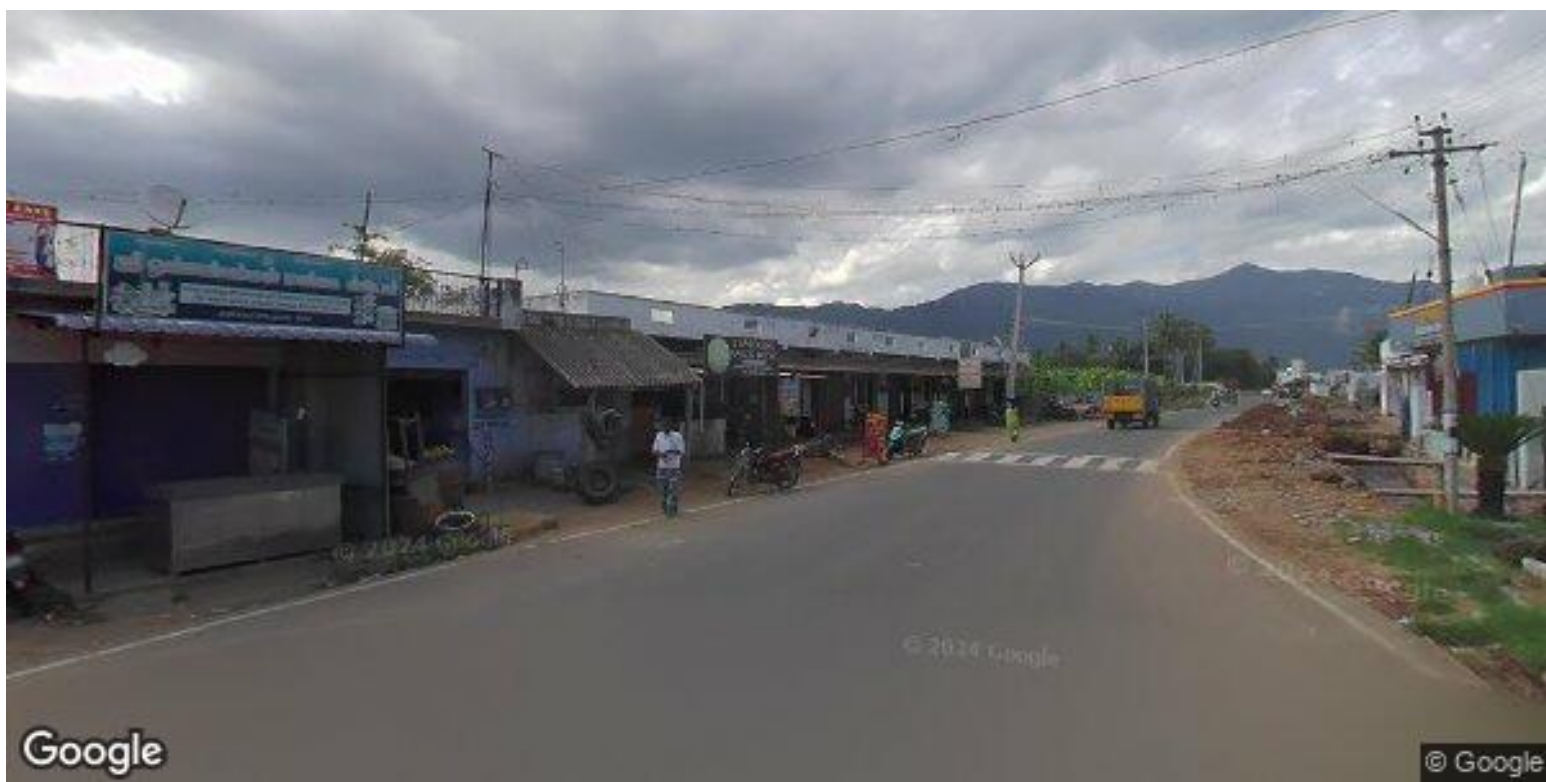
**Coordinates:** 11.60999, 77.71606

**Risk Type:** Turn

**Risk Level:** High

**Speed Limit:** 15 KM/Hr

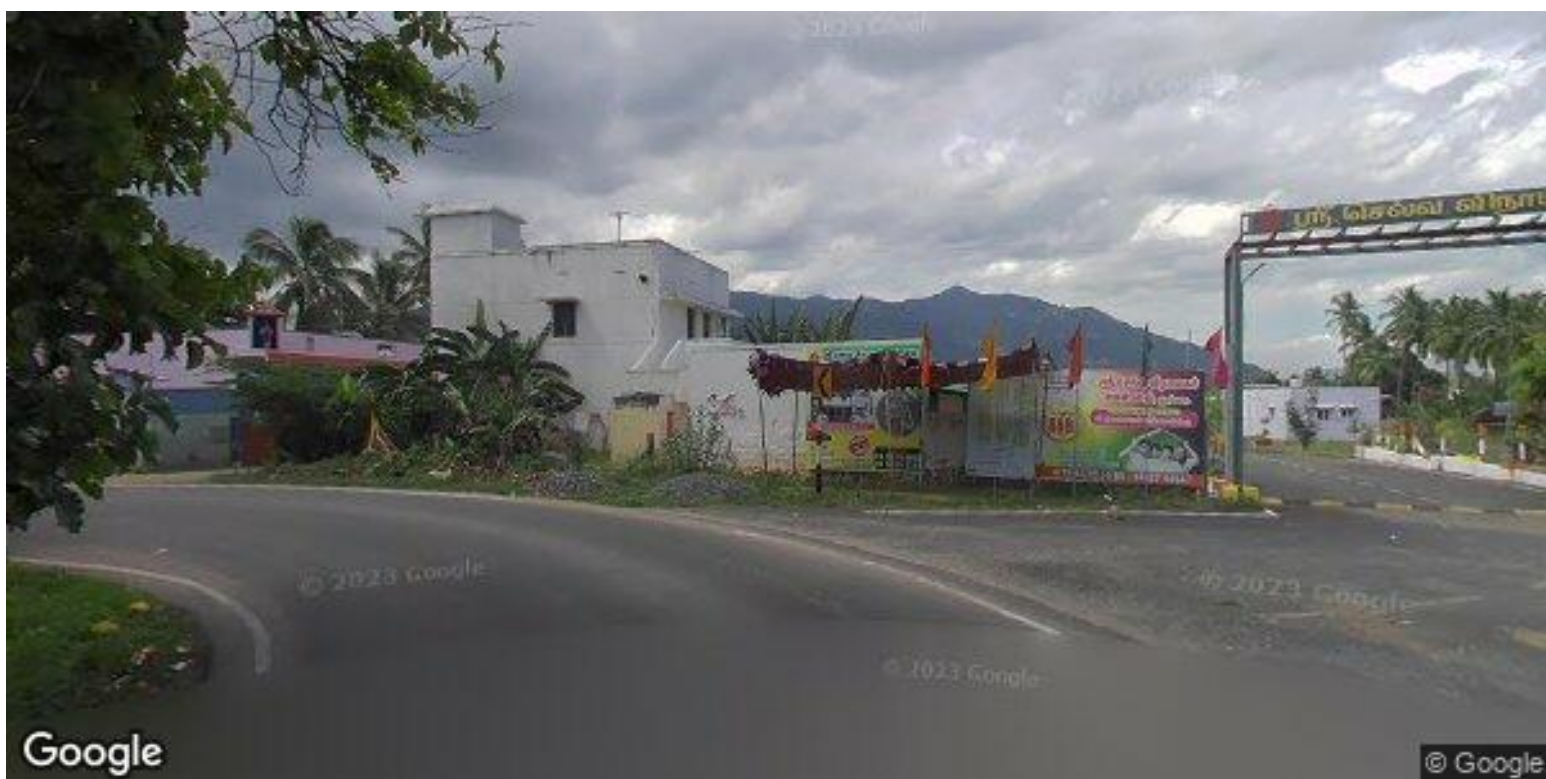
**Coordinates:** 11.61277, 77.71687

**Risk Type:** Turn

**Risk Level:** High

**Speed Limit:** 15 KM/Hr

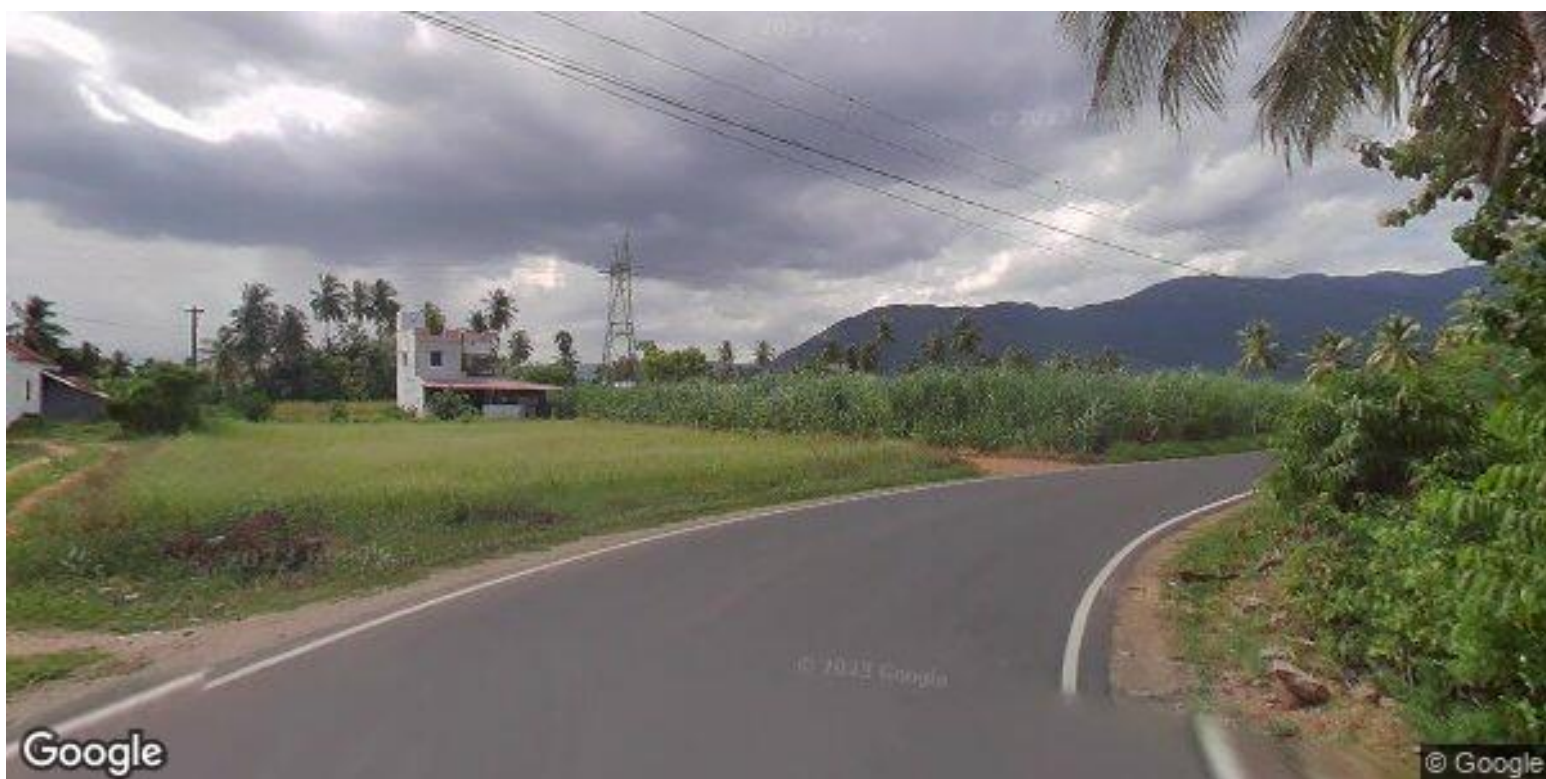
**Risk Type:** Turn  
**Risk Level:** High  
**Speed Limit:** 15 KM/Hr  
**Coordinates:** 11.61330, 77.71567

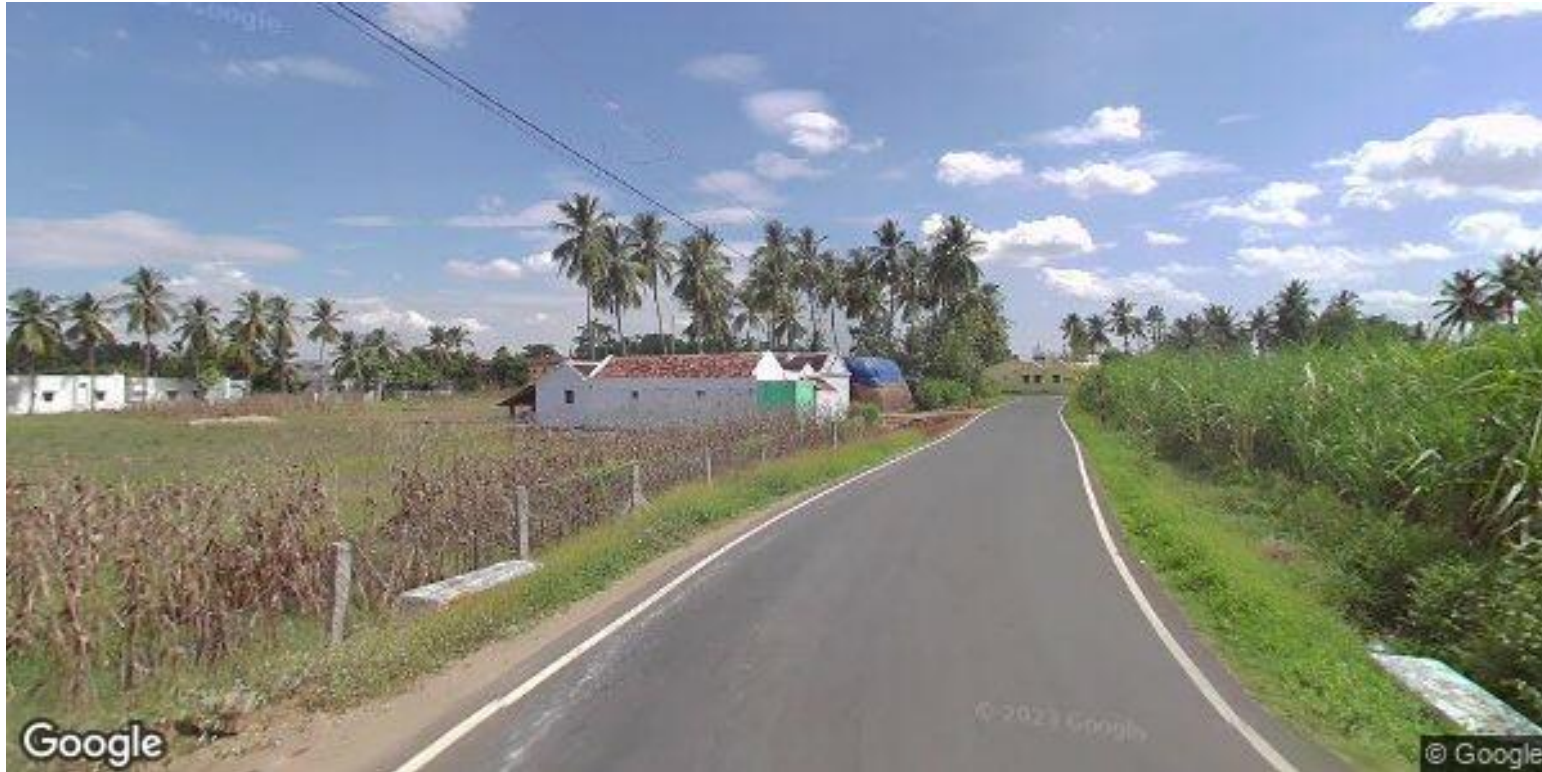
**Risk Type:** Turn  
**Risk Level:** High  
**Speed Limit:** 15 KM/Hr  
**Coordinates:** 11.61424, 77.71584

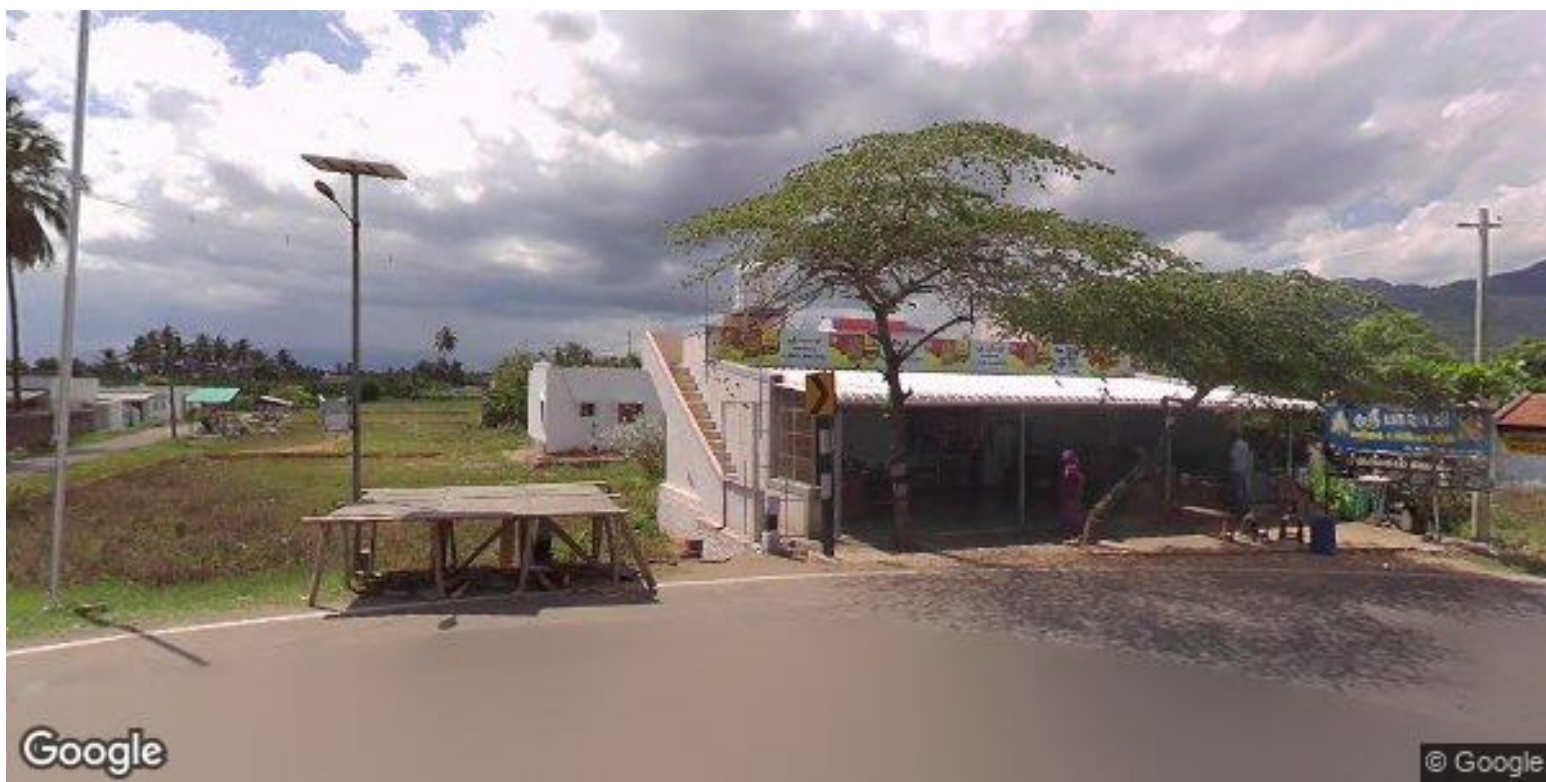
**Coordinates:** 11.61537, 77.71369

**Risk Type:** Turn

**Risk Level:** High

**Speed Limit:** 15 KM/Hr

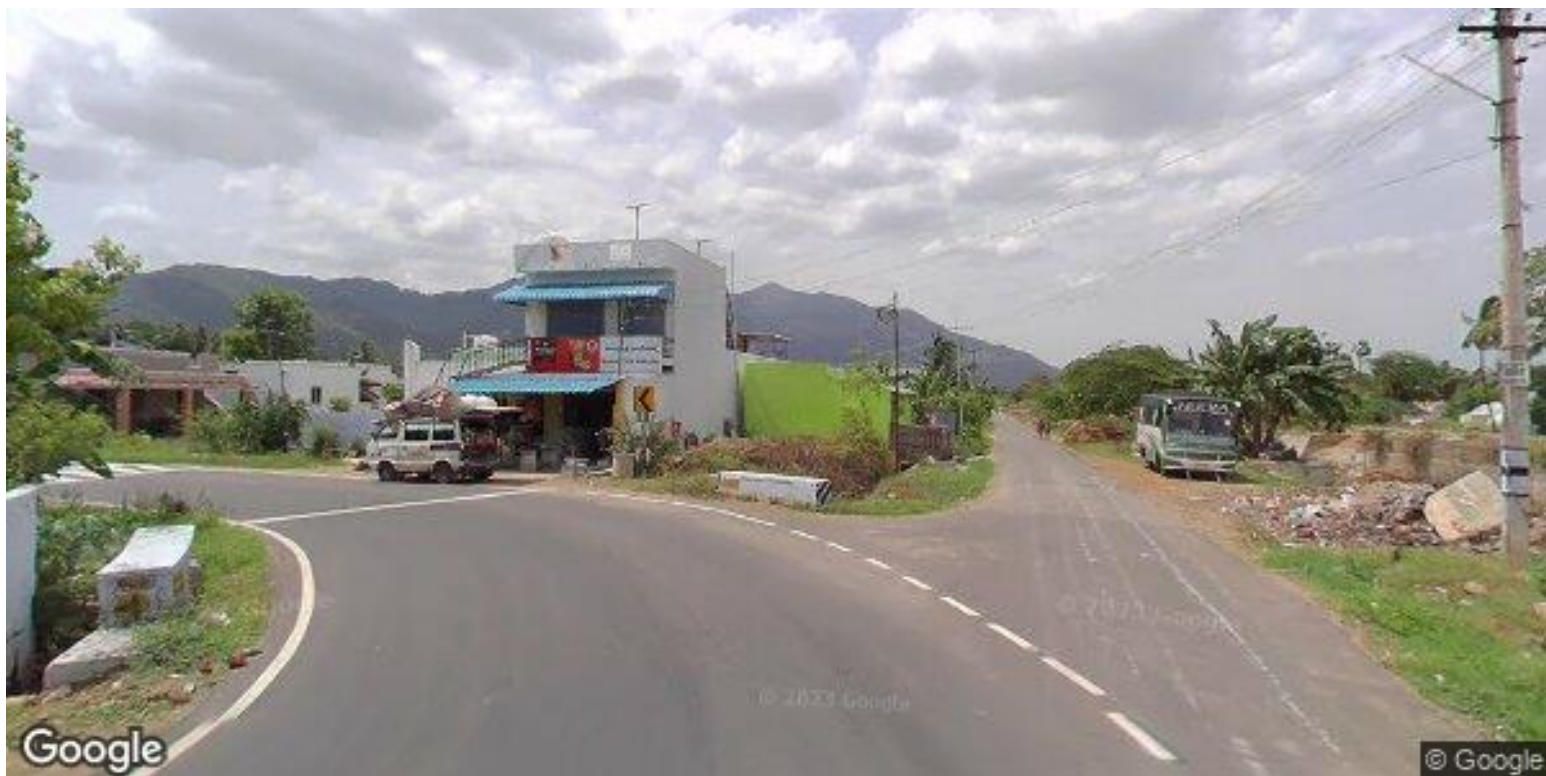
**Coordinates:** 11.61584, 77.71389

**Risk Type:** Turn

**Risk Level:** Medium

**Speed Limit:** 30 KM/Hr

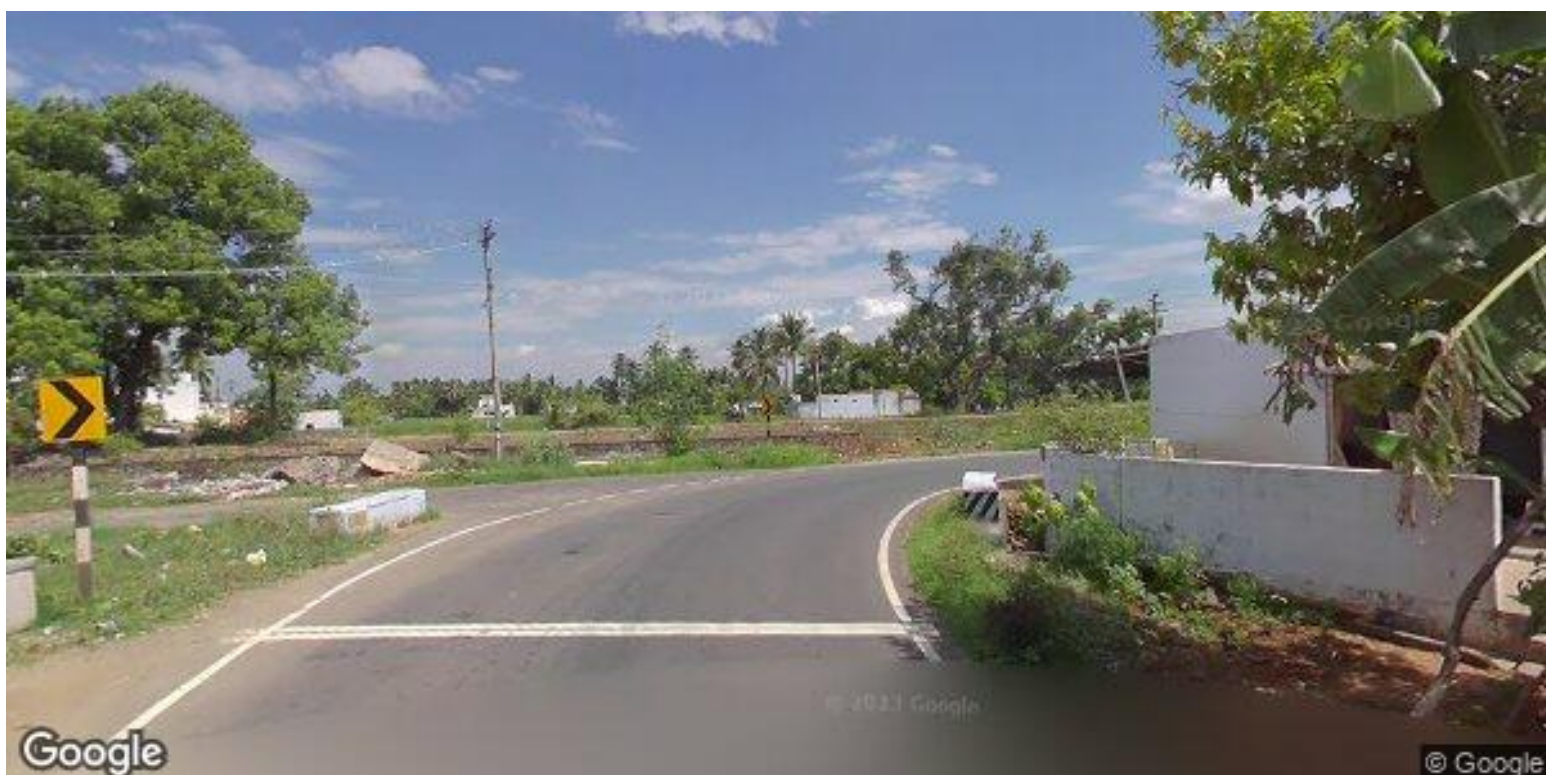
**Risk Type:** Turn  
**Risk Level:** Medium  
**Speed Limit:** 30 KM/Hr  
**Coordinates:** 11.61597, 77.71385

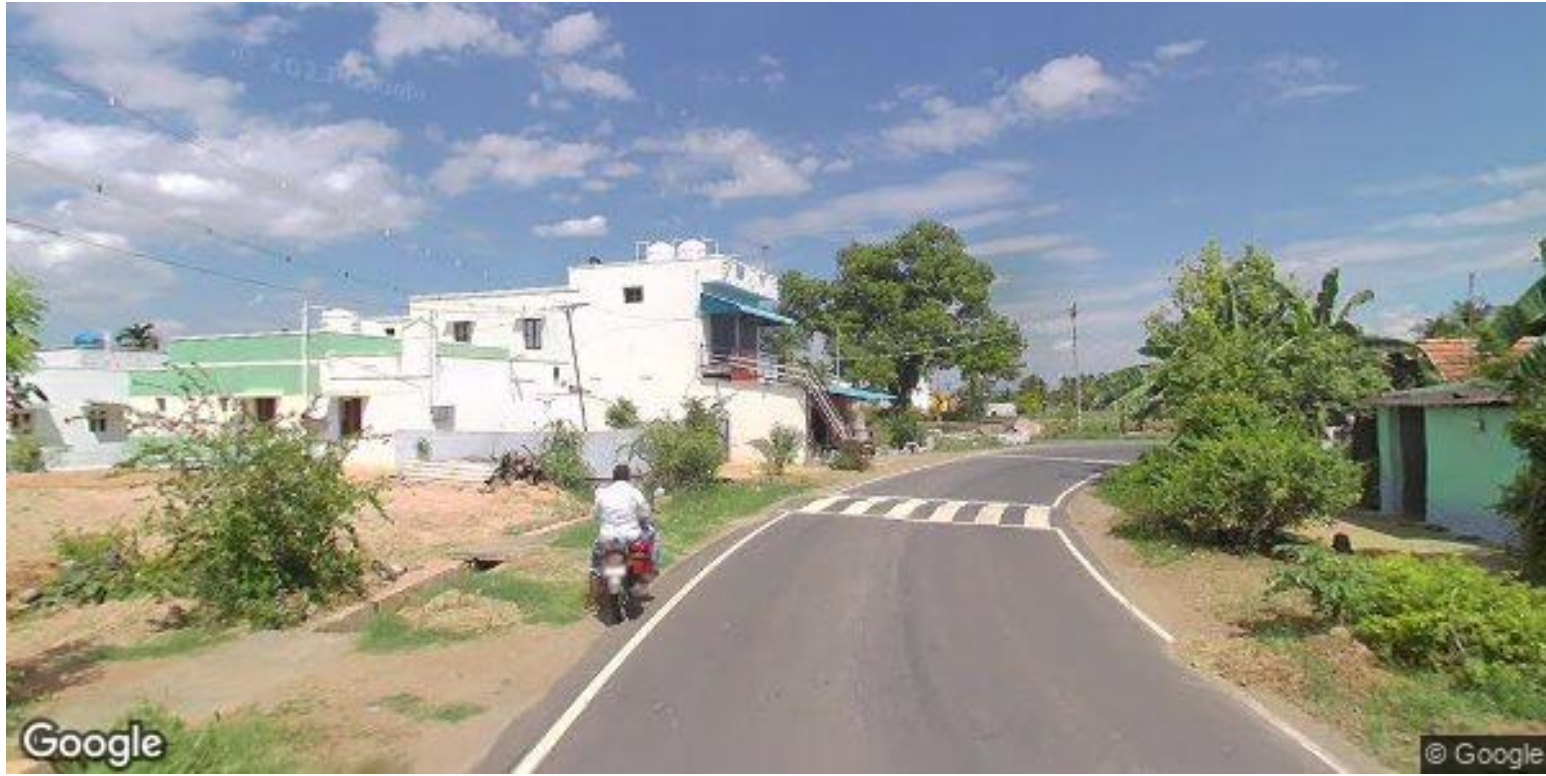
**Risk Type:** Turn  
**Risk Level:** Medium  
**Speed Limit:** 30 KM/Hr  
**Coordinates:** 11.61608, 77.71371

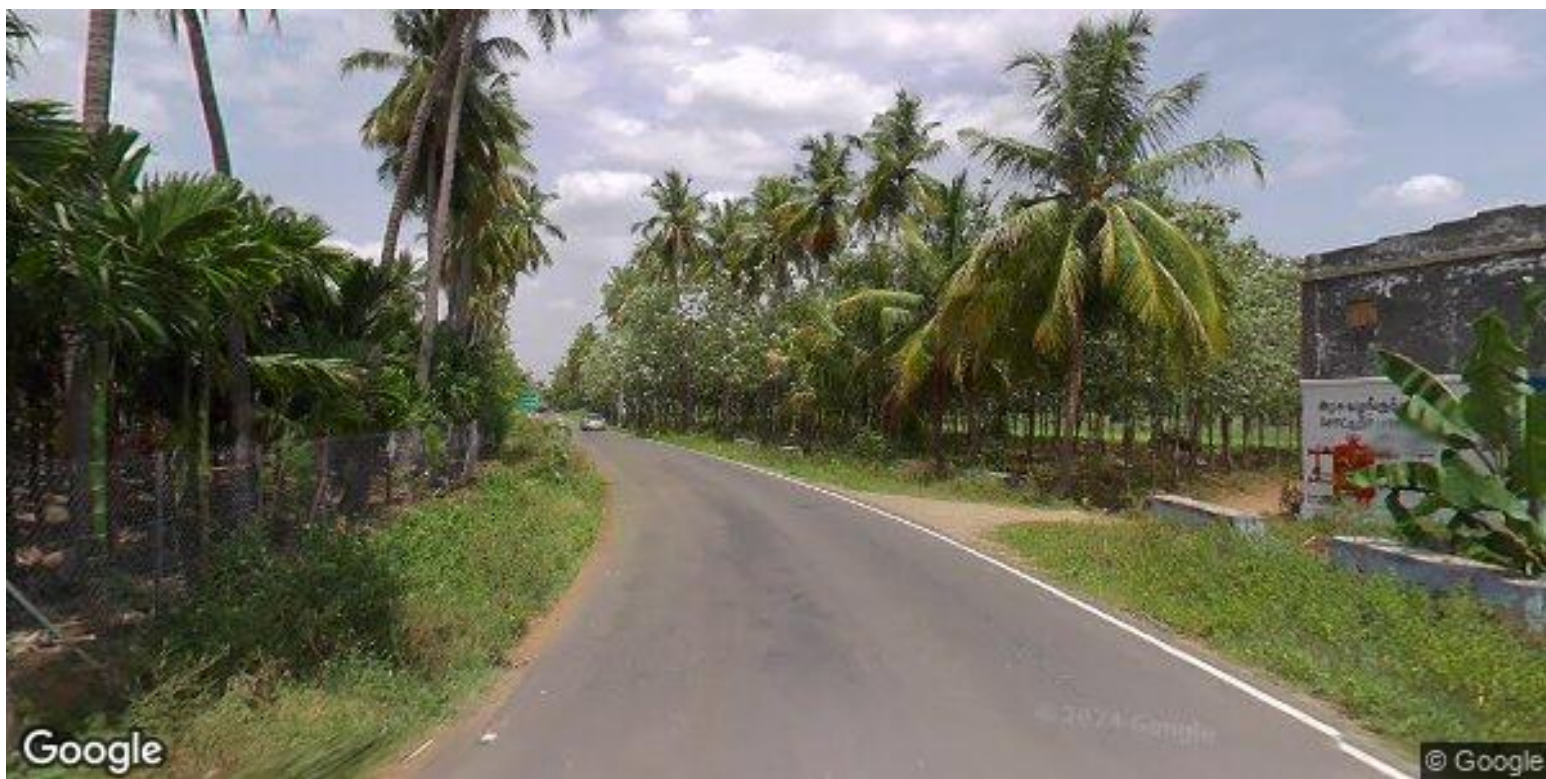
**Risk Type:** Turn  
**Risk Level:** Medium  
**Speed Limit:** 30 KM/Hr  
**Coordinates:** 11.61792, 77.71017

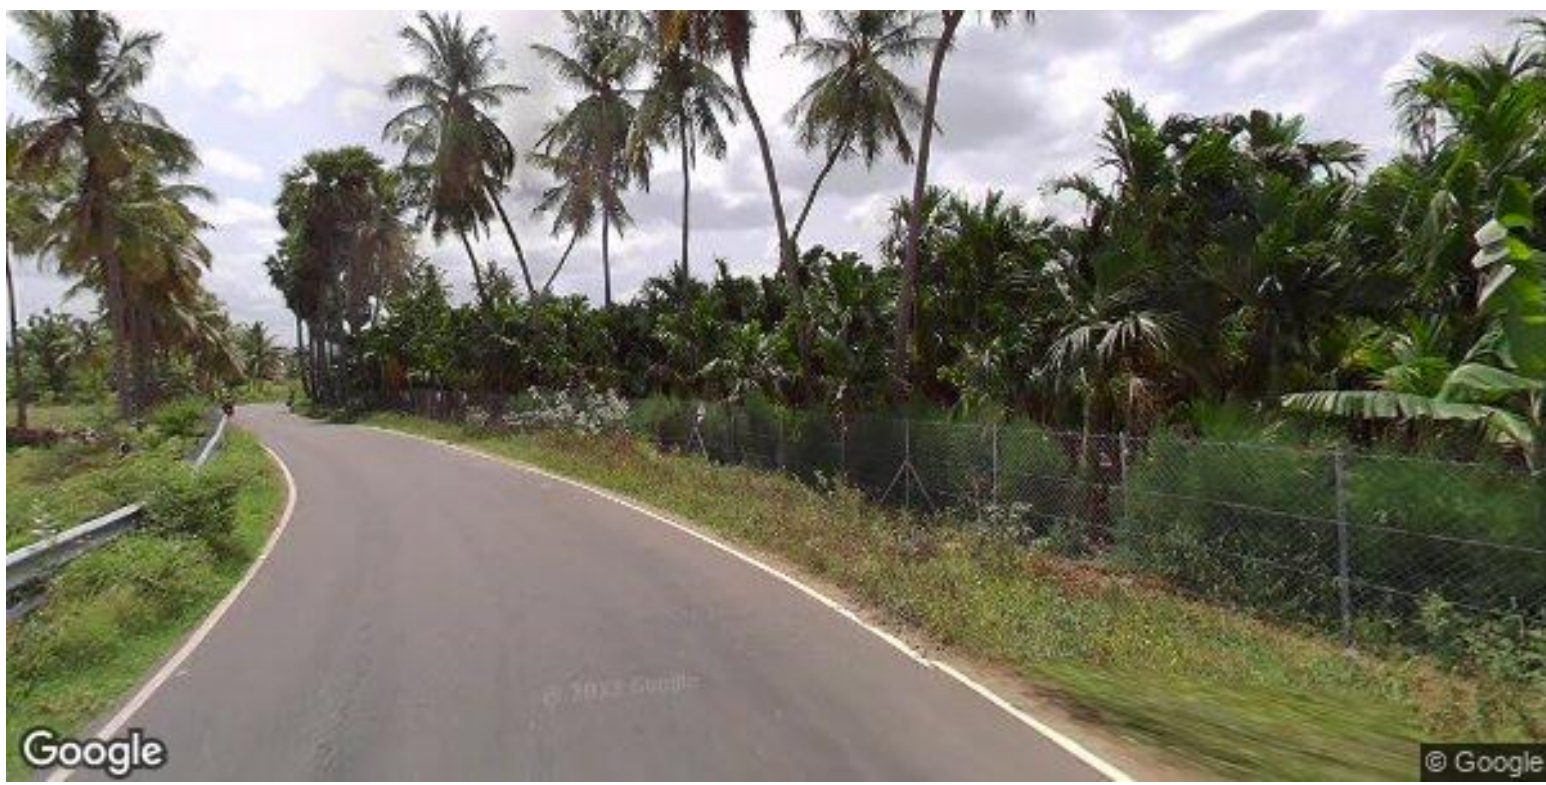
**Coordinates:** 11.61875, 77.70972

**Risk Type:** Turn

**Risk Level:** Medium

**Speed Limit:** 30 KM/Hr

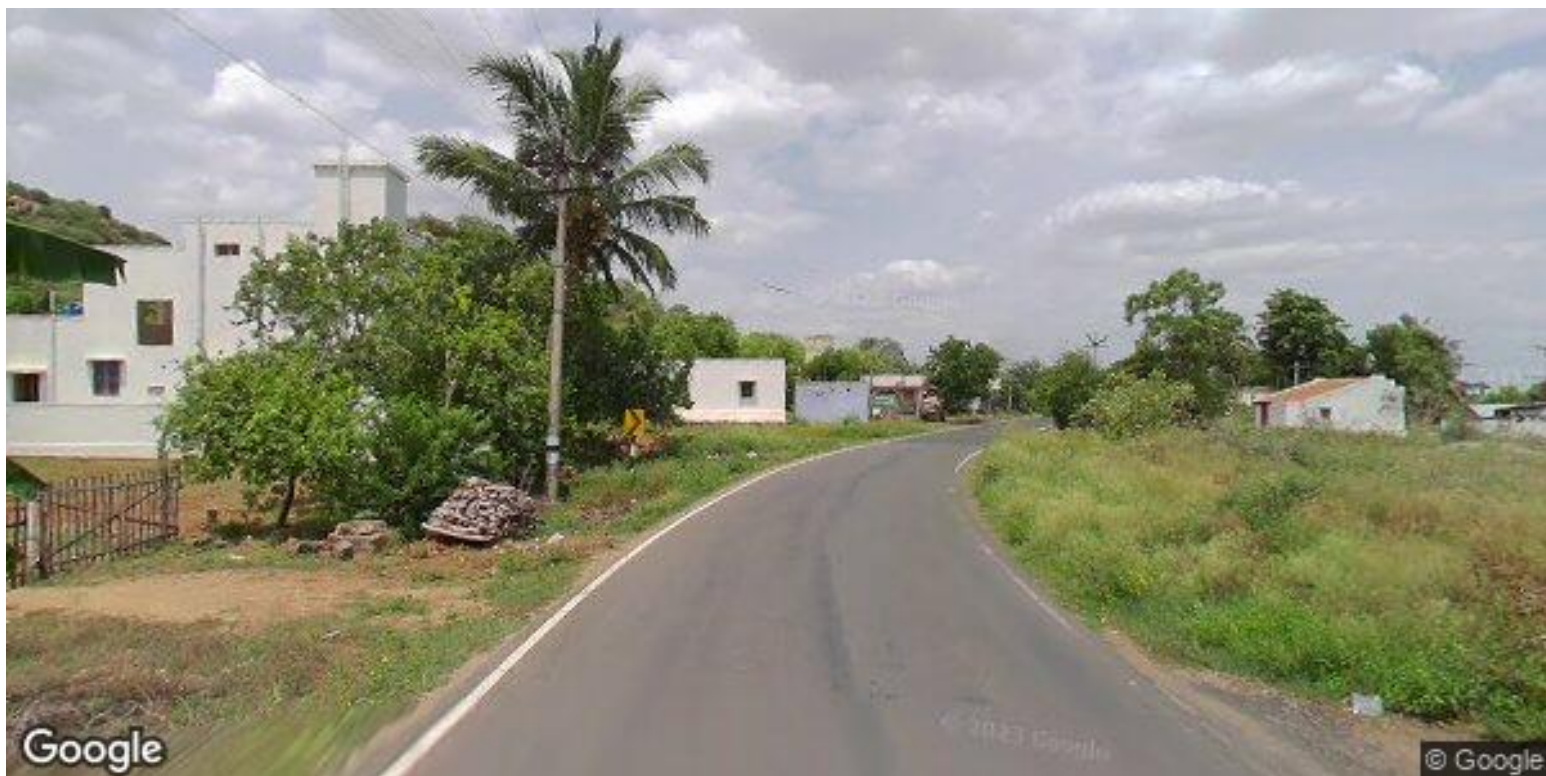
**Coordinates:** 11.63368, 77.69795

**Risk Type:** Turn

**Risk Level:** Medium

**Speed Limit:** 30 KM/Hr

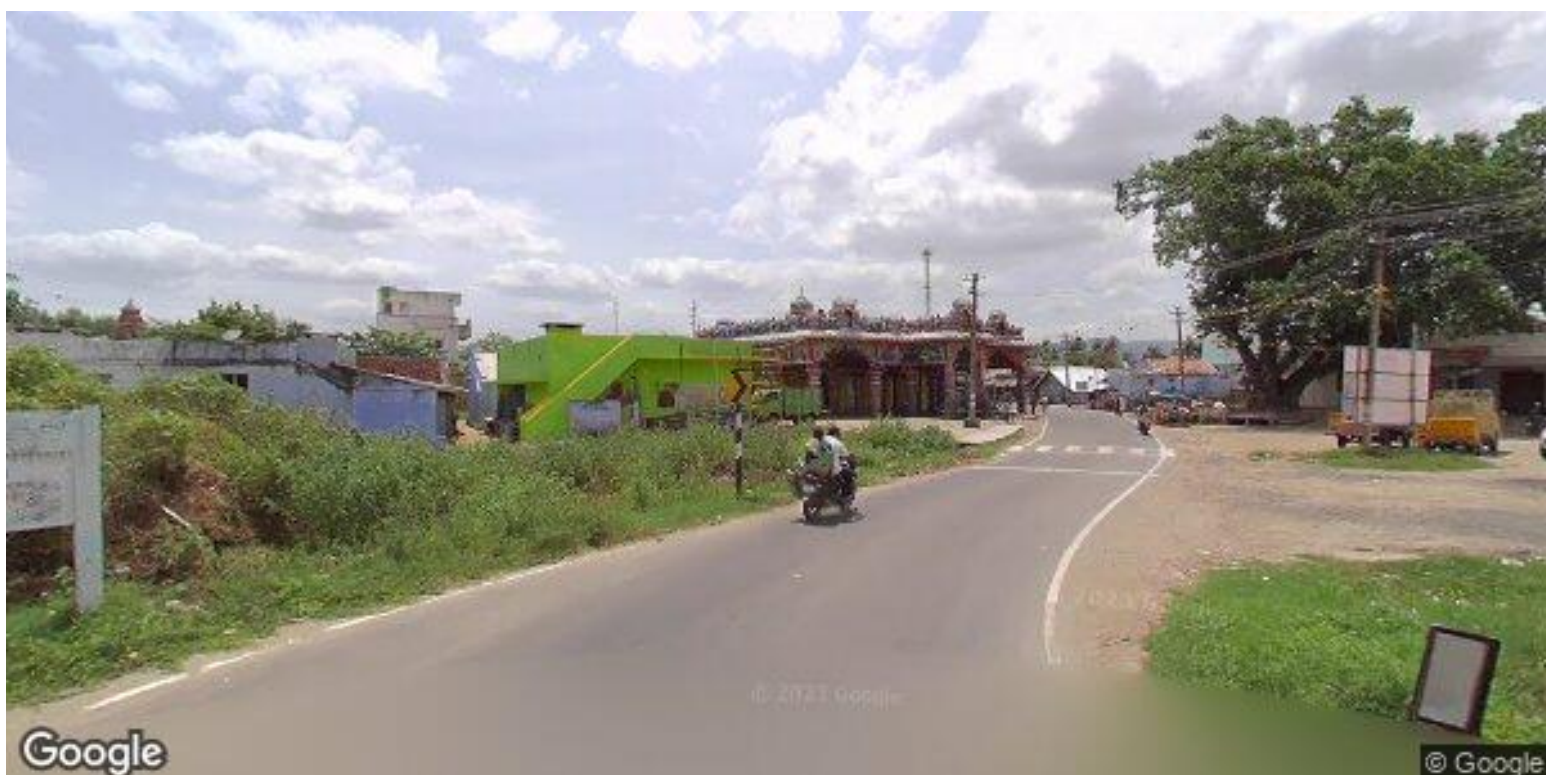
**Risk Type:** Turn  
**Risk Level:** High  
**Speed Limit:** 15 KM/Hr  
**Coordinates:** 11.63946, 77.68505

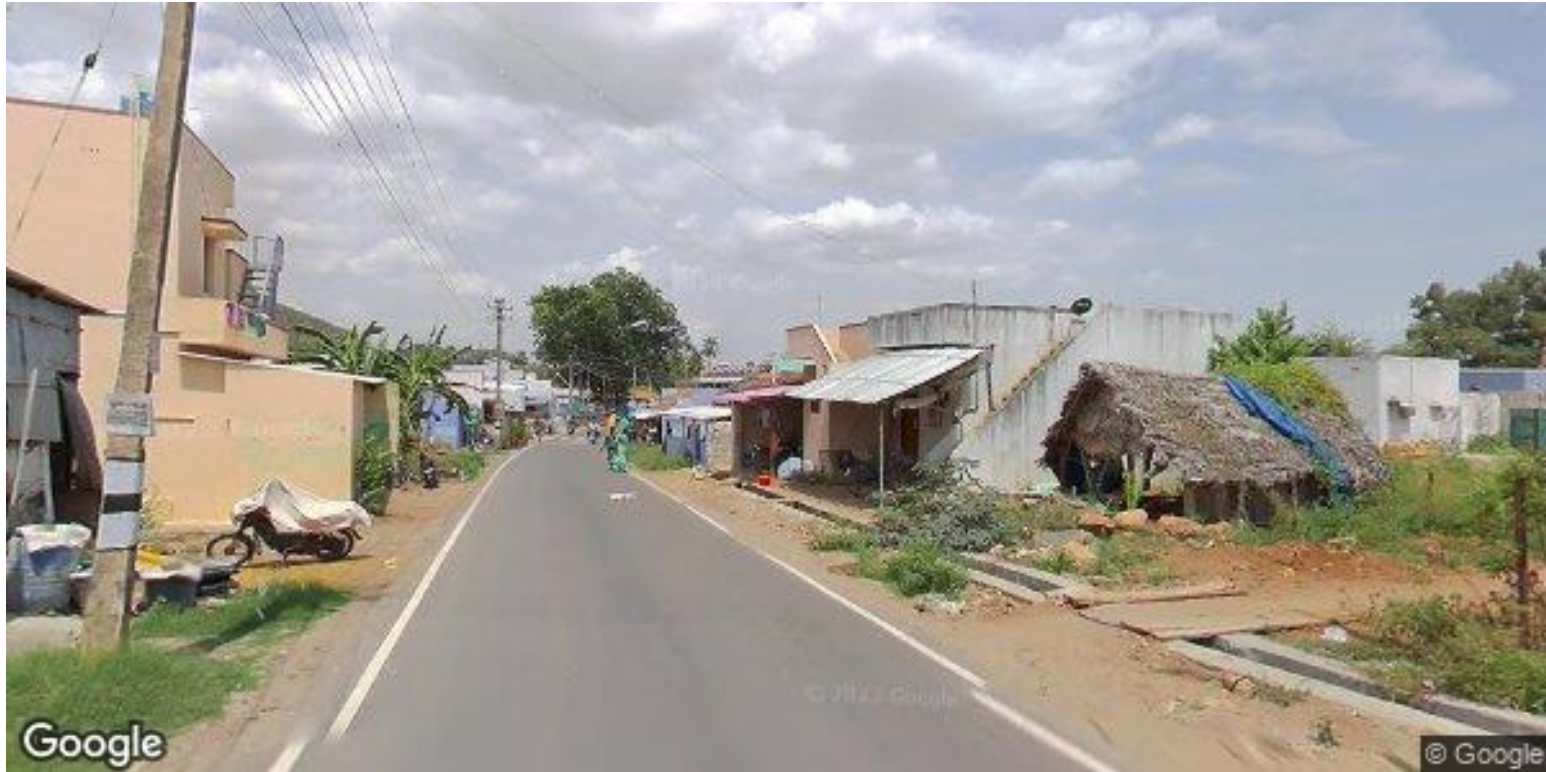
**Risk Type:** Turn  
**Risk Level:** Medium  
**Speed Limit:** 30 KM/Hr  
**Coordinates:** 11.64030, 77.68399

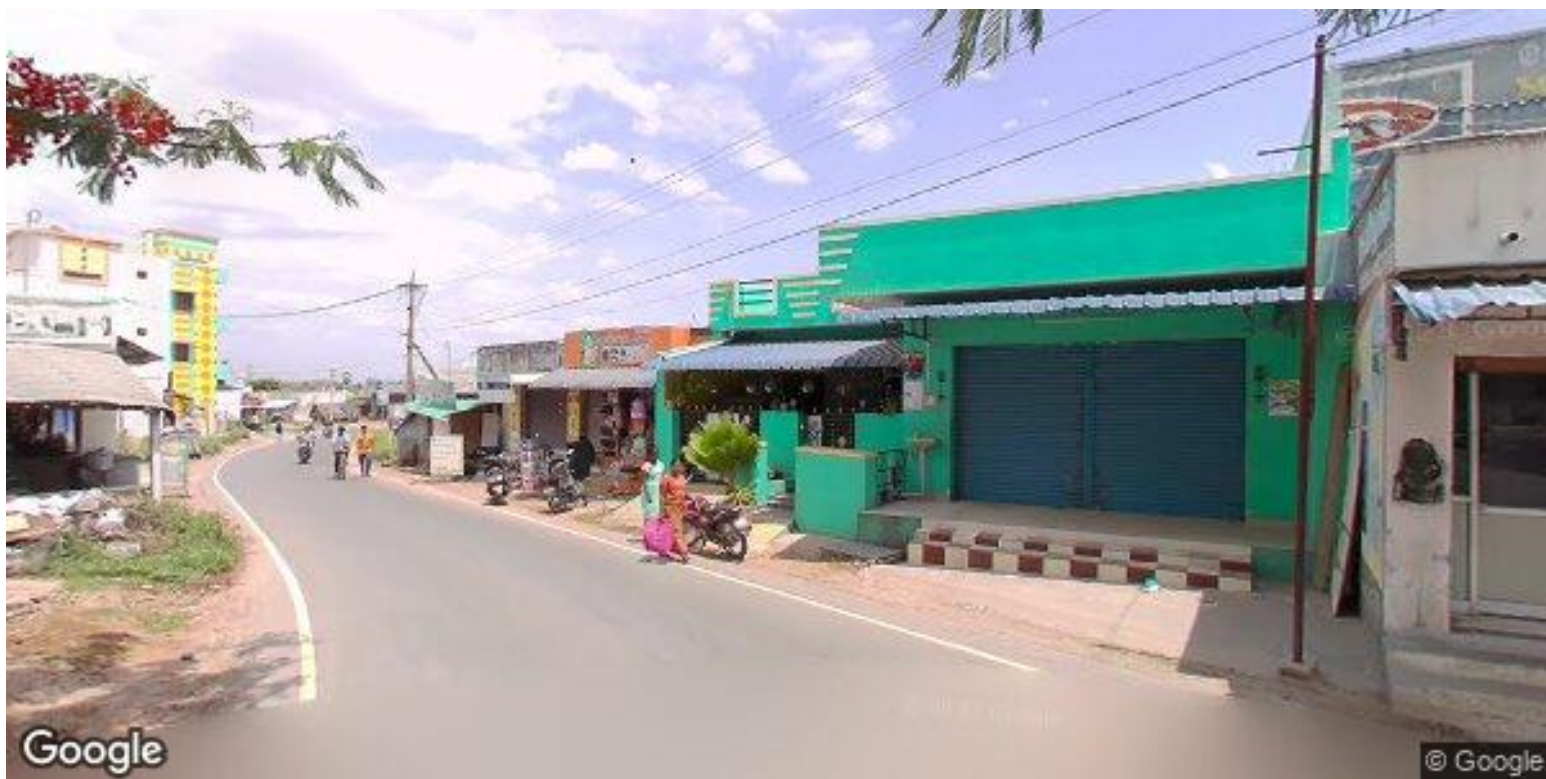
**Risk Type:** Turn  
**Risk Level:** Medium  
**Speed Limit:** 30 KM/Hr  
**Coordinates:** 11.64093, 77.68331

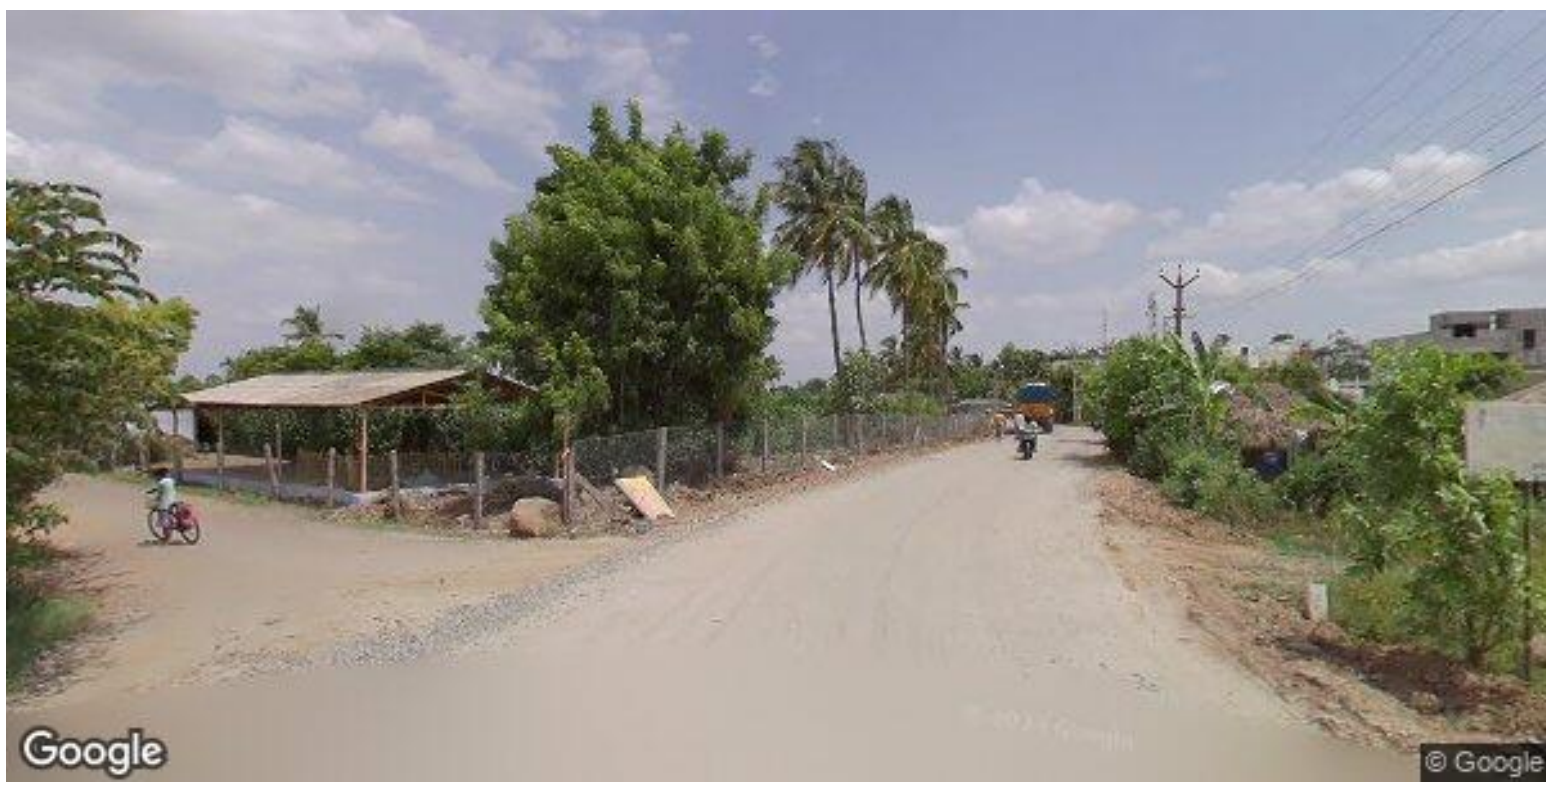
**Coordinates:** 11.64348, 77.68342

**Risk Type:** Turn

**Risk Level:** Medium

**Speed Limit:** 30 KM/Hr
