# IndianOil

## JOURNEY RISK MANAGEMENT (JRM) STUDY

### Salem Terminal TO RL AGENCY

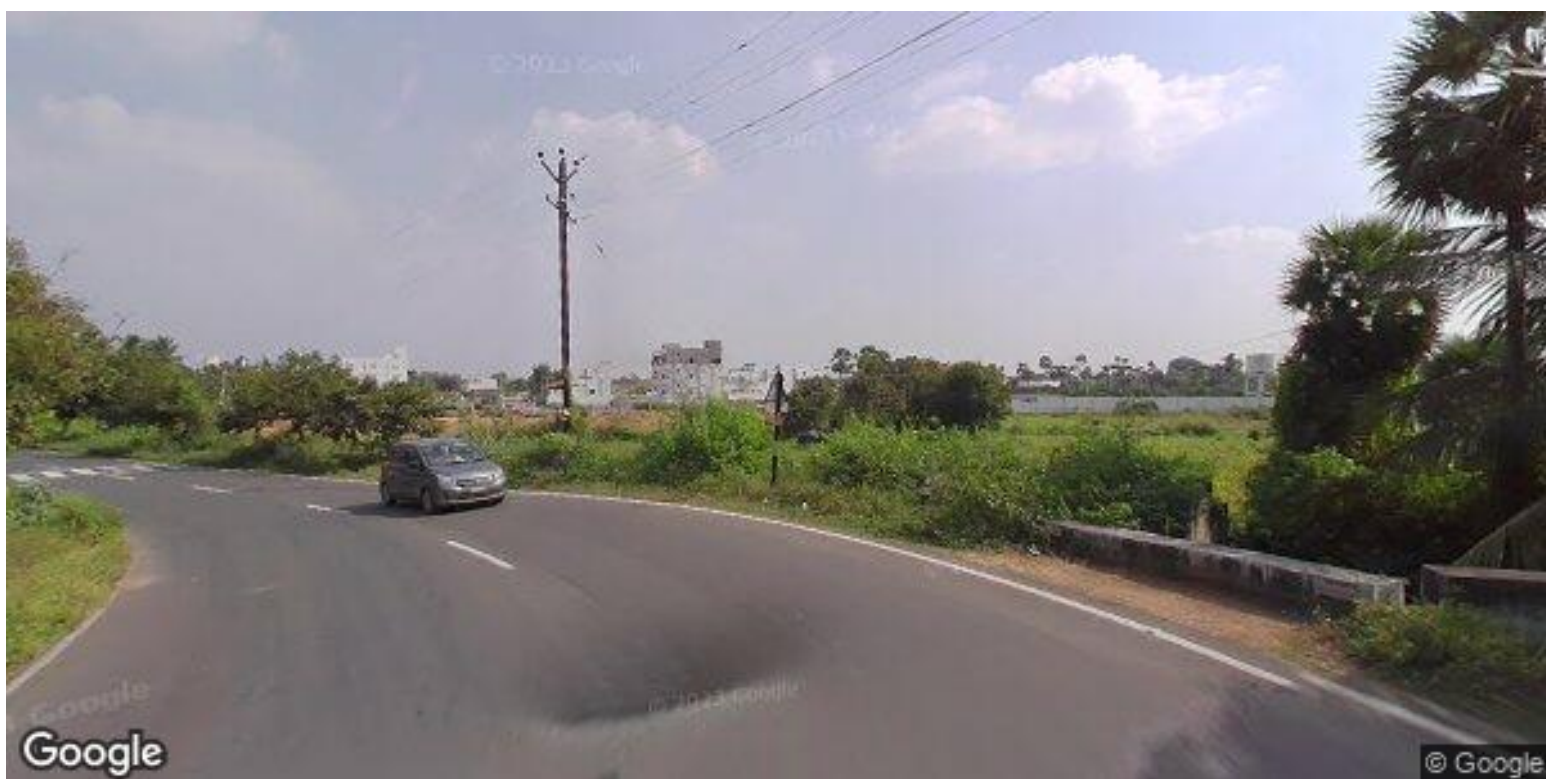
**Coordinates:** 11.45350, 77.85700

**Risk Type:** Turn

**Risk Level:** High

**Speed Limit:** 15 KM/Hr

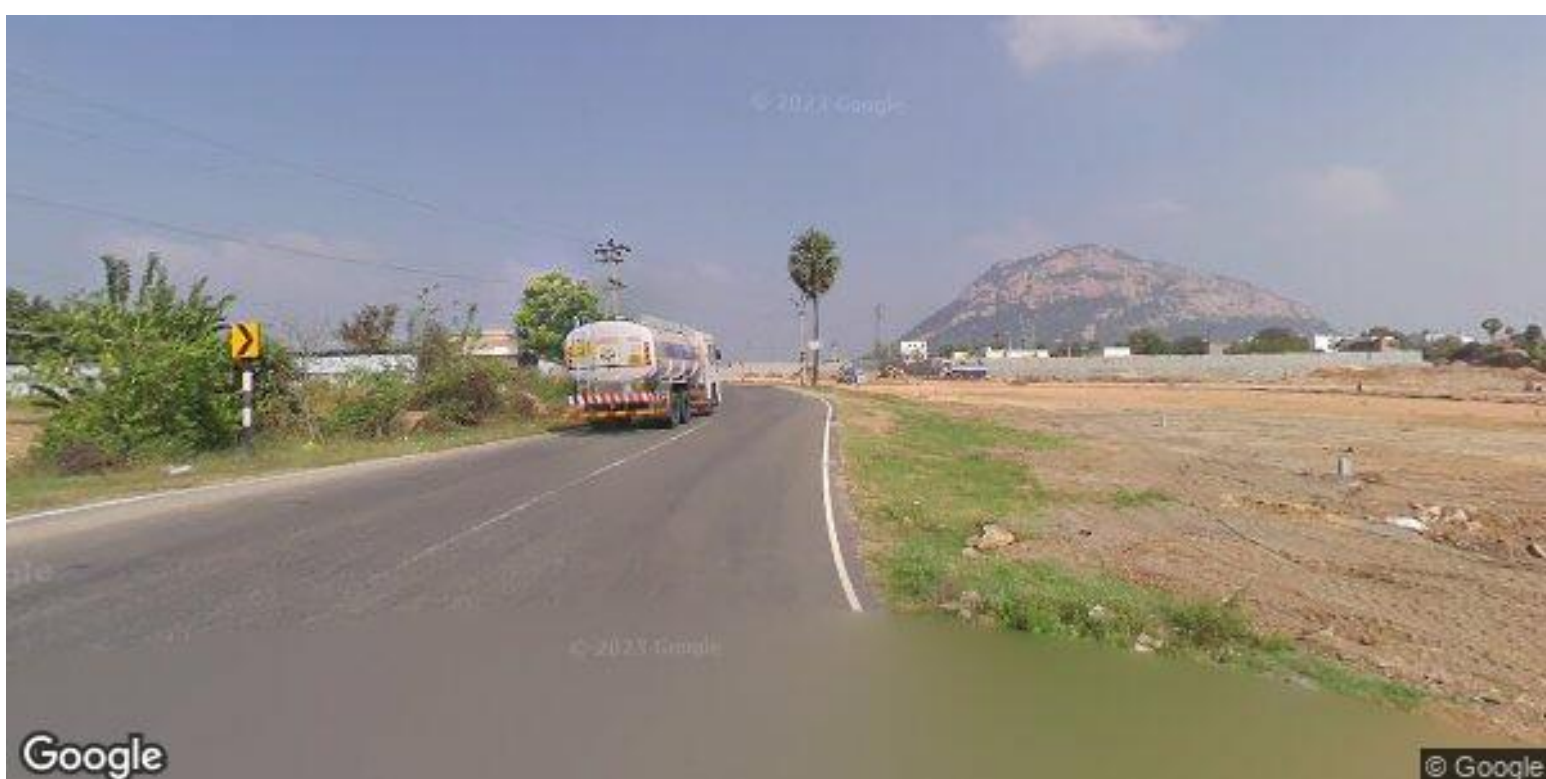
**Risk Type:** Turn  
**Risk Level:** Medium  
**Speed Limit:** 30 KM/Hr  
**Coordinates:** 11.45845, 77.85141

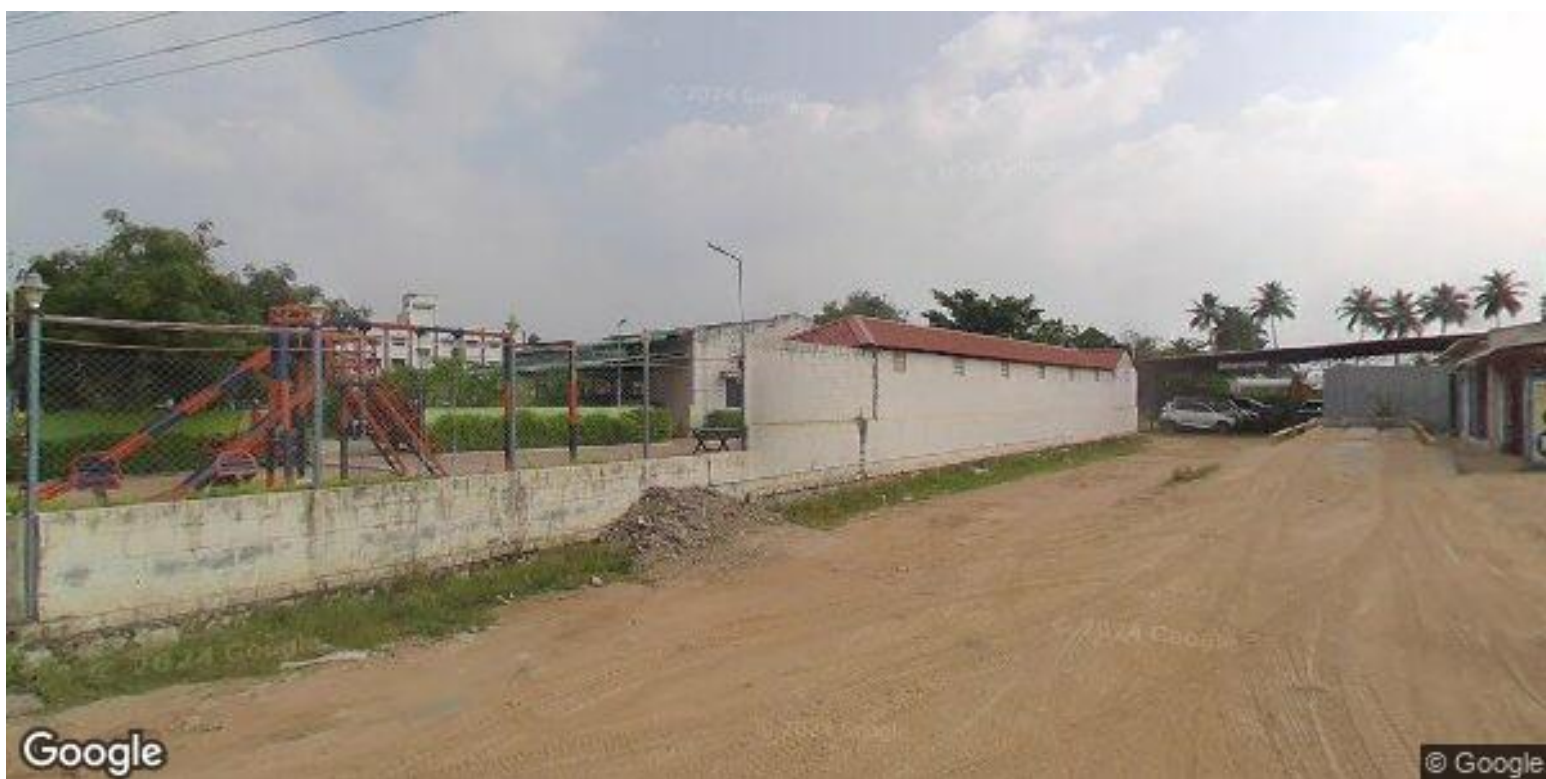
**Coordinates:** 11.44377, 77.71562

**Risk Type:** Turn

**Risk Level:** High

**Speed Limit:** 15 KM/Hr

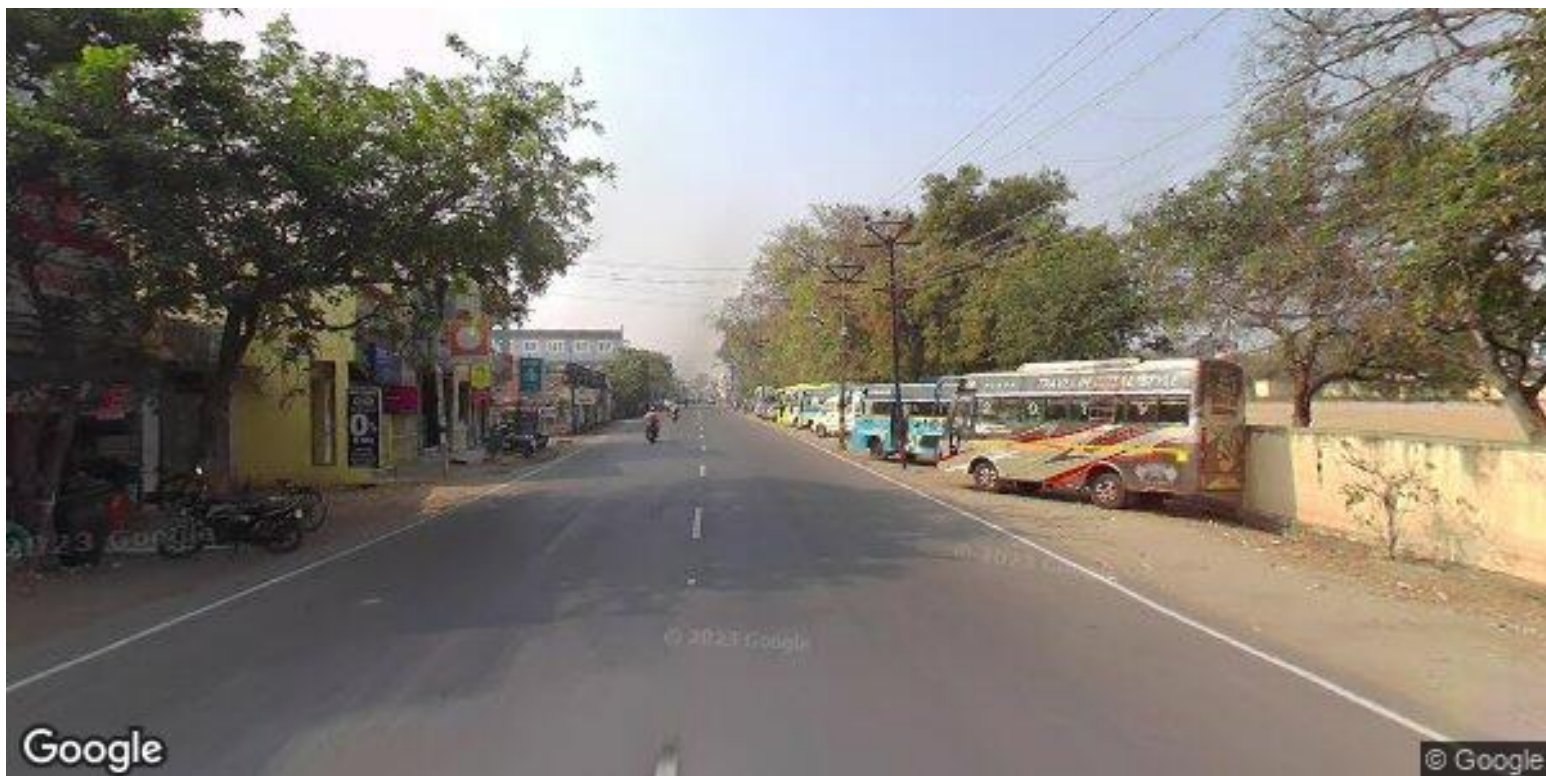
**Coordinates:** 11.44979, 77.68549

**Risk Type:** Blind Spot

**Risk Level:** Blind Spot

**Speed Limit:** 10 KM/Hr

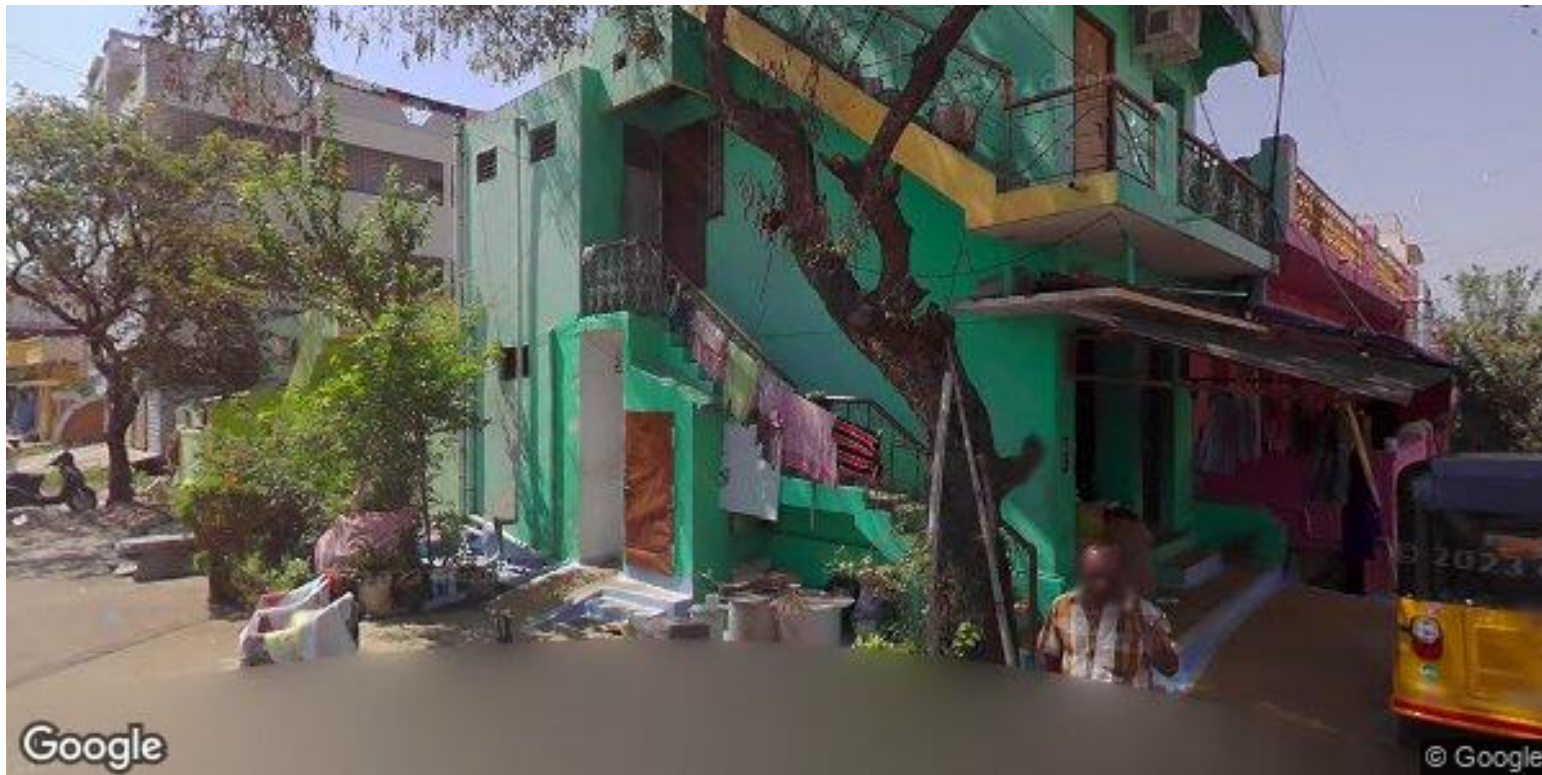
**Coordinates:** 11.44801, 77.68596

**Risk Type:** Turn

**Risk Level:** High

**Speed Limit:** 15 KM/Hr

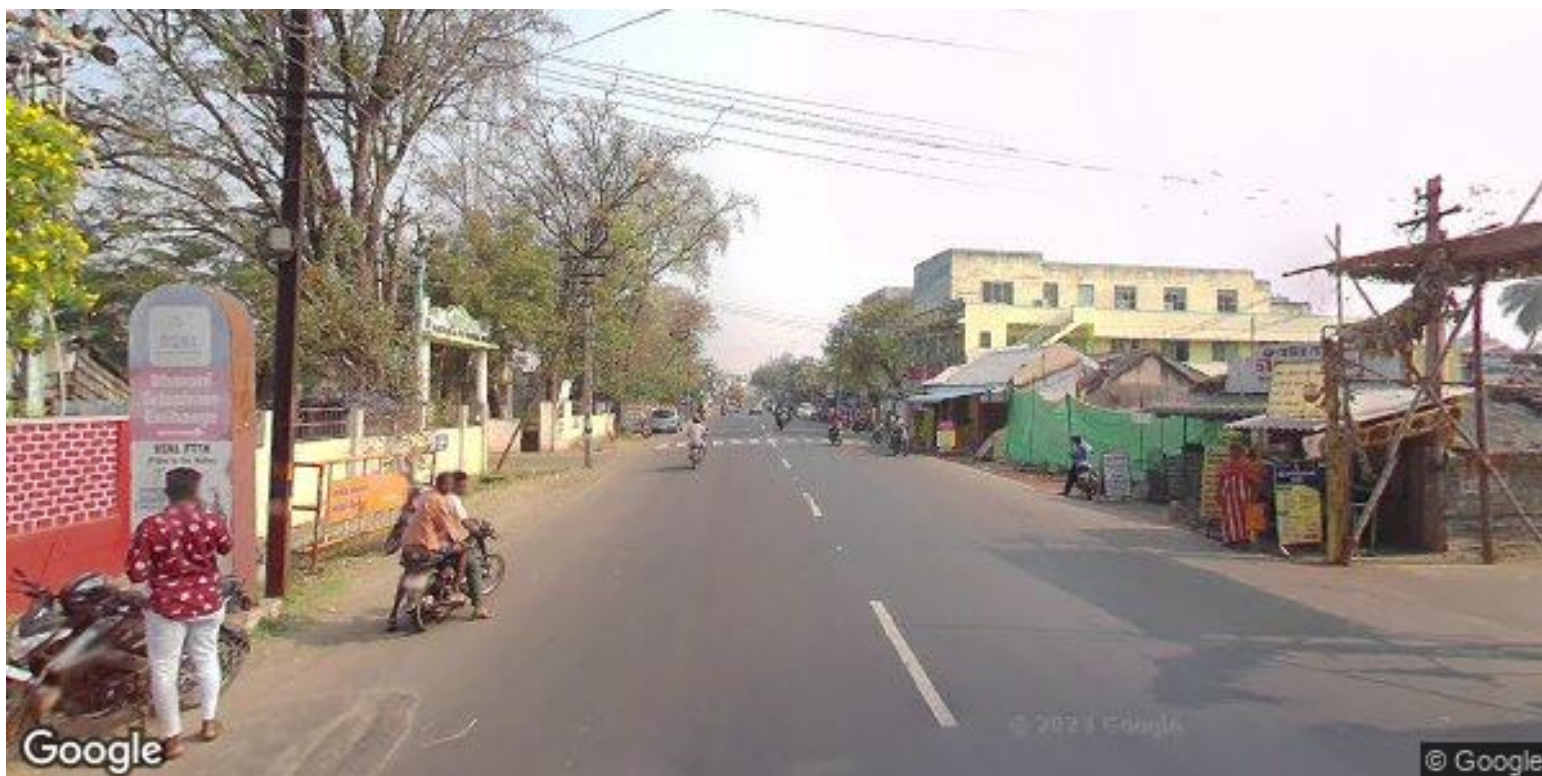
**Coordinates:** 11.44842, 77.68473

**Risk Type:** Blind Spot

**Risk Level:** Blind Spot

**Speed Limit:** 10 KM/Hr

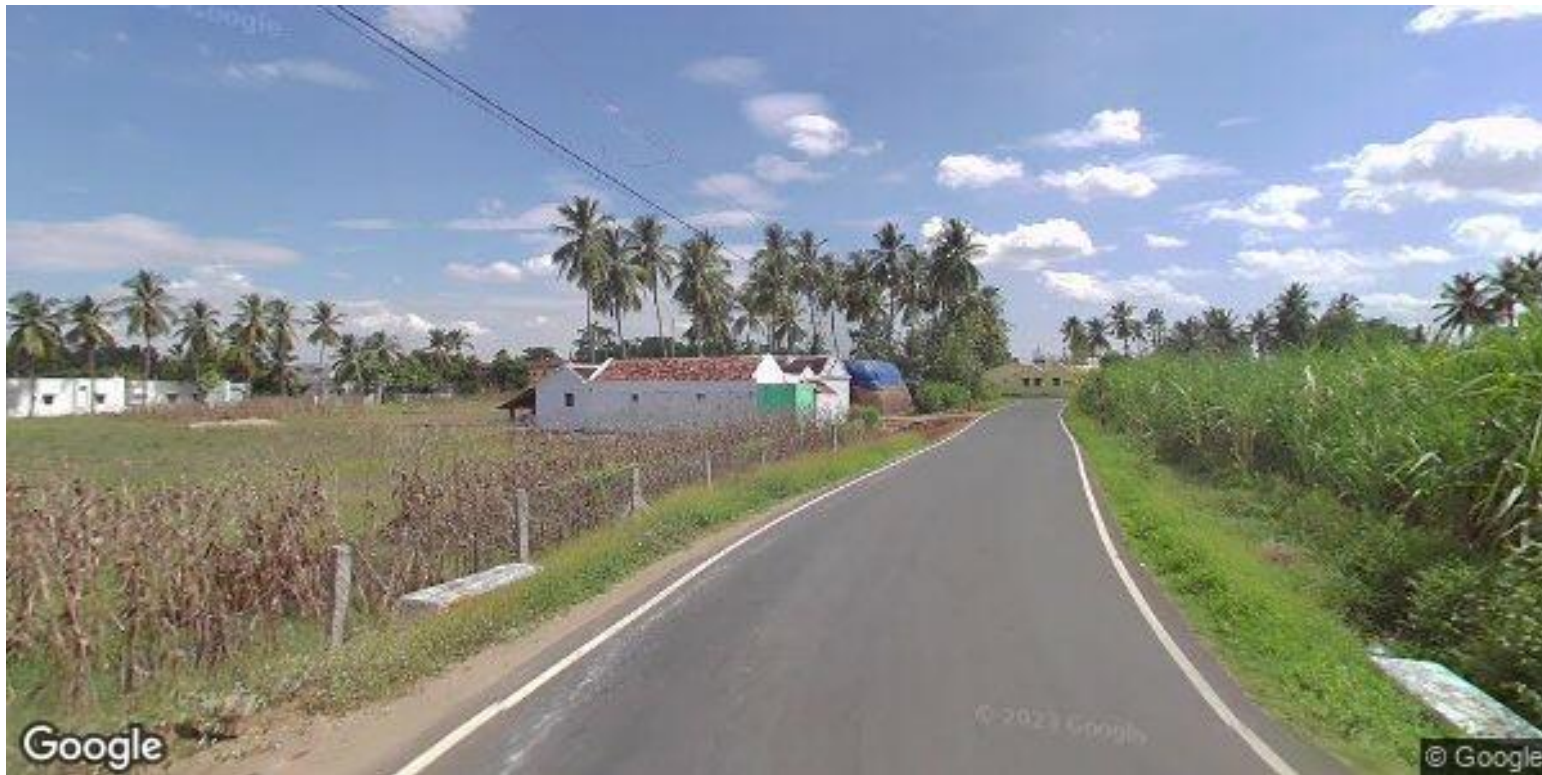
**Coordinates:** 11.61424, 77.71584

**Risk Type:** Turn

**Risk Level:** High

**Speed Limit:** 15 KM/Hr

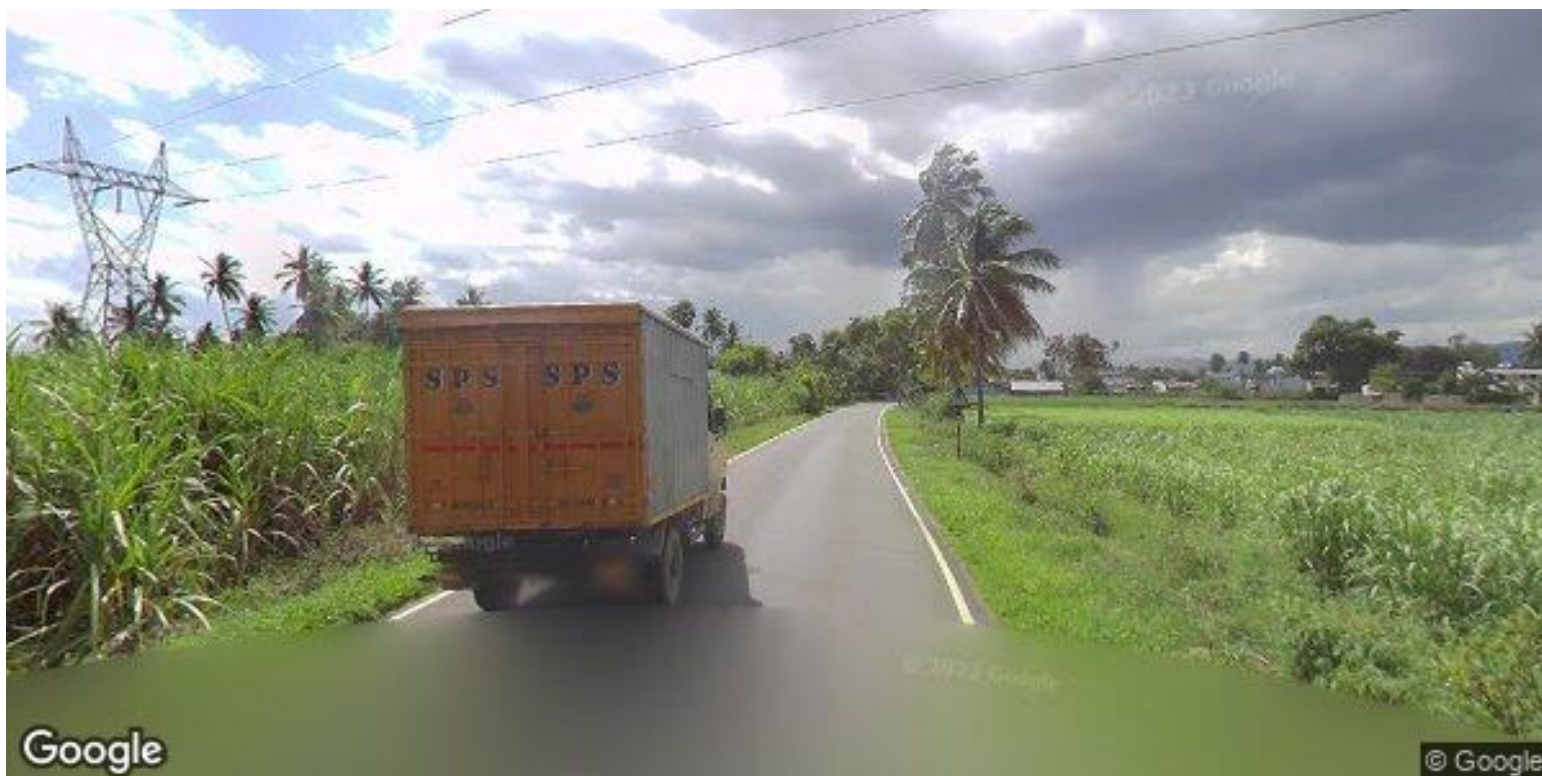
**Coordinates:** 11.61439, 77.71570

**Risk Type:** Turn

**Risk Level:** Medium

**Speed Limit:** 30 KM/Hr

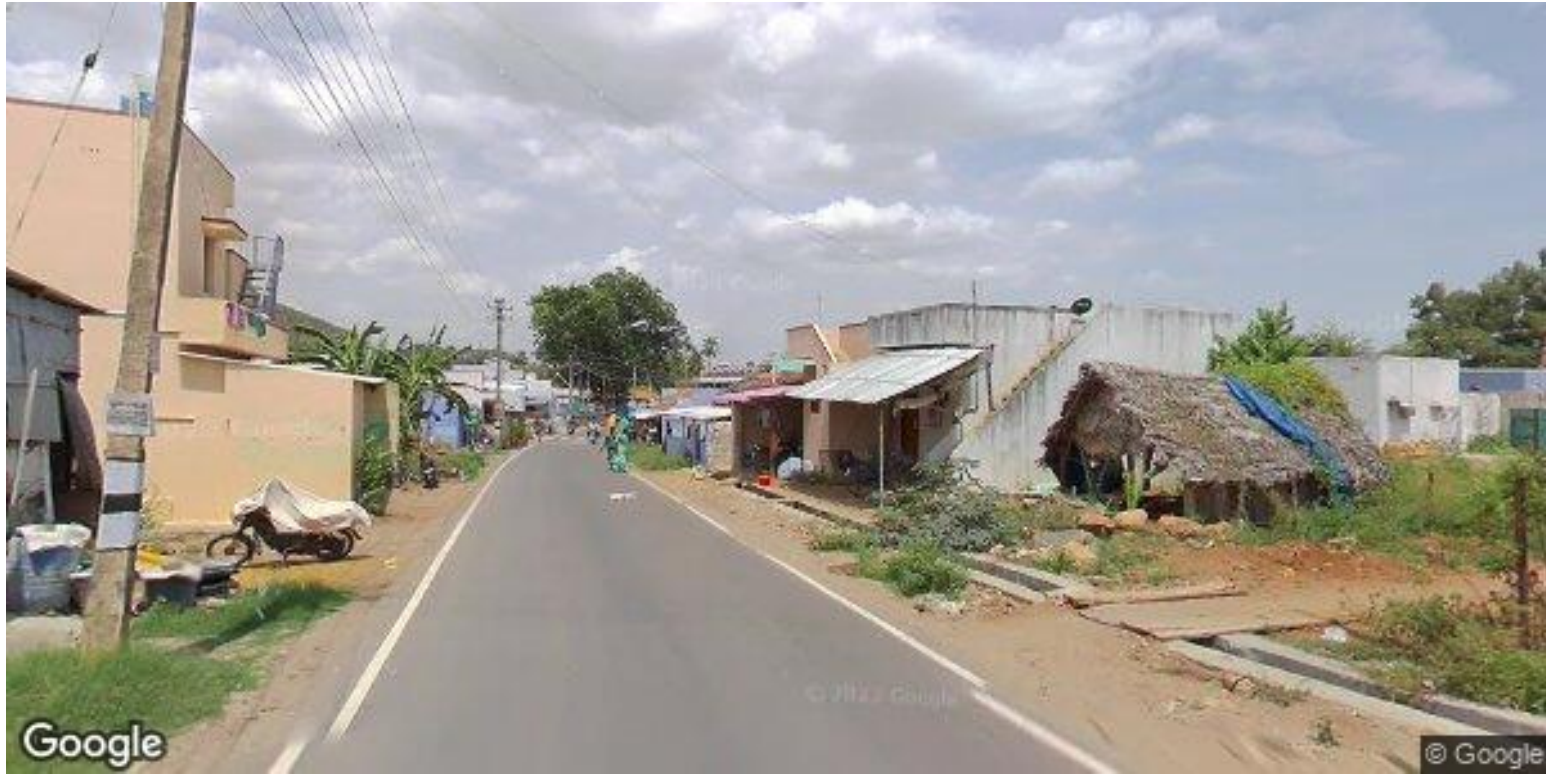
**Risk Type:** Turn  
**Risk Level:** Medium  
**Speed Limit:** 30 KM/Hr  
**Coordinates:** 11.64030, 77.68399

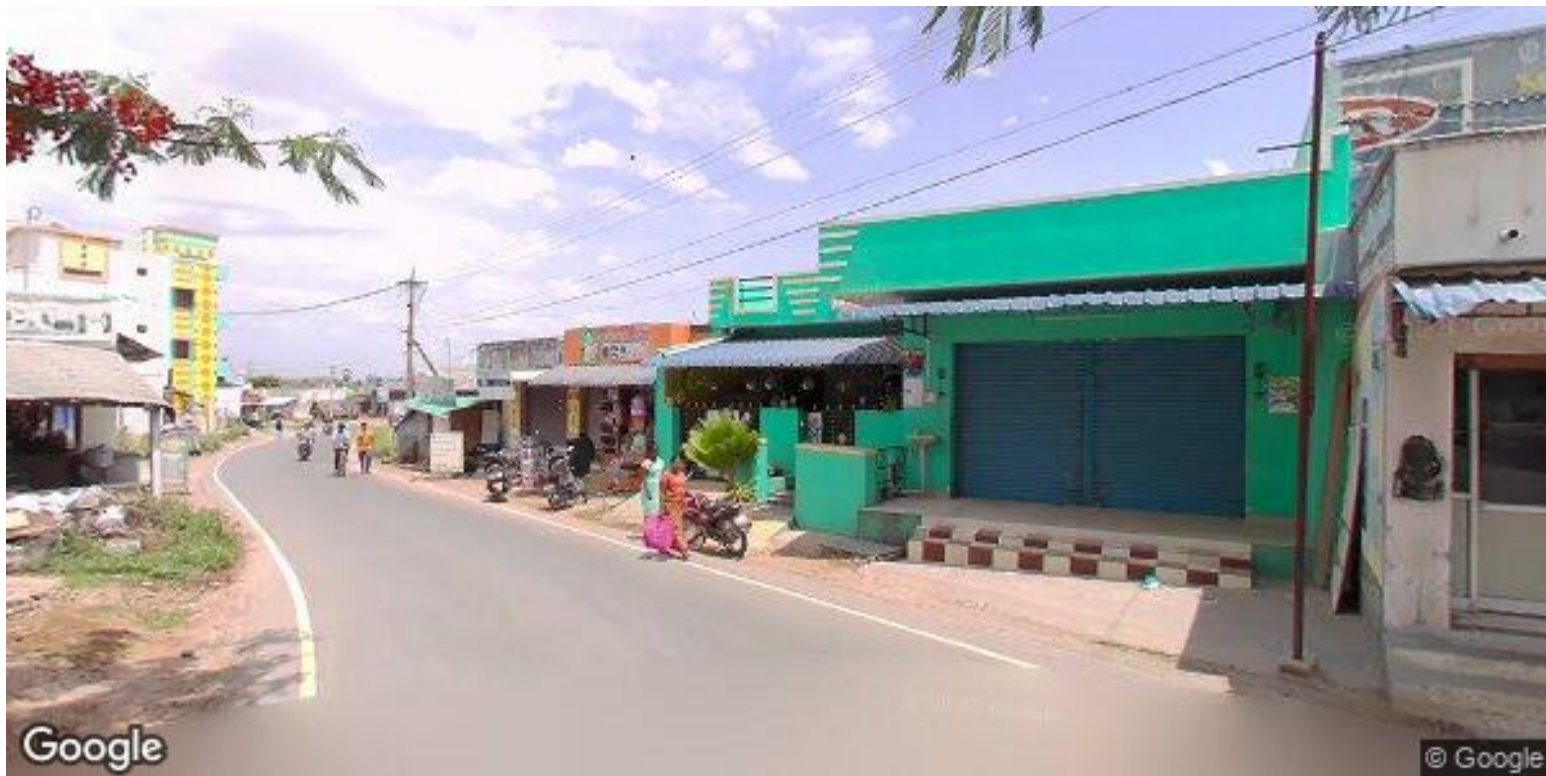
**Risk Type:** Turn  
**Risk Level:** Medium  
**Speed Limit:** 30 KM/Hr  
**Coordinates:** 11.64093, 77.68331
