# IndianOil

## JOURNEY RISK MANAGEMENT (JRM) STUDY

### Salem Terminal to ARUL MURUGAN AGENCIES

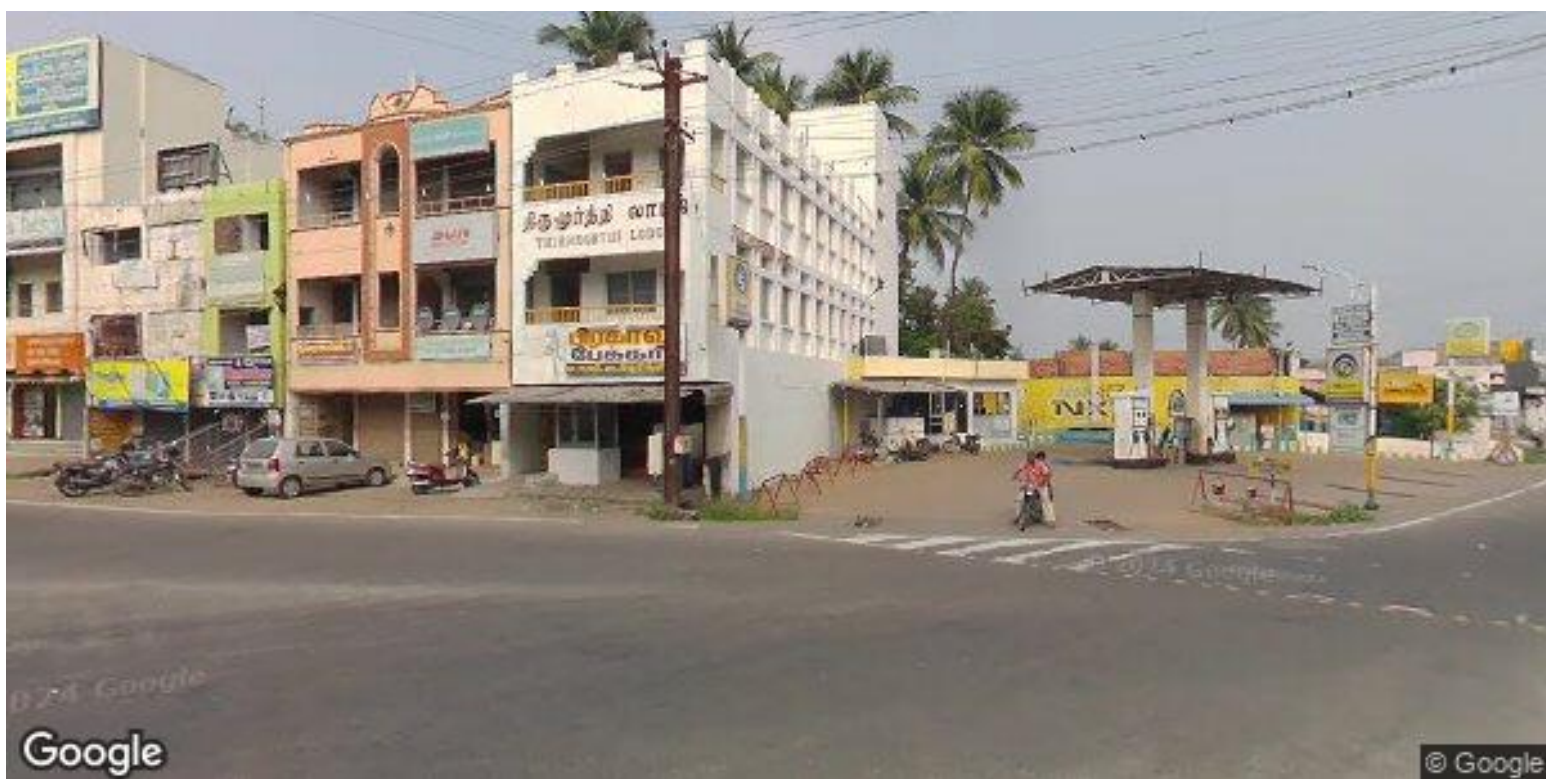
**Coordinates:** 11.00172, 77.56268

**Risk Type:** Roundabout

**Risk Level:** High

**Speed Limit:** 15 KM/Hr

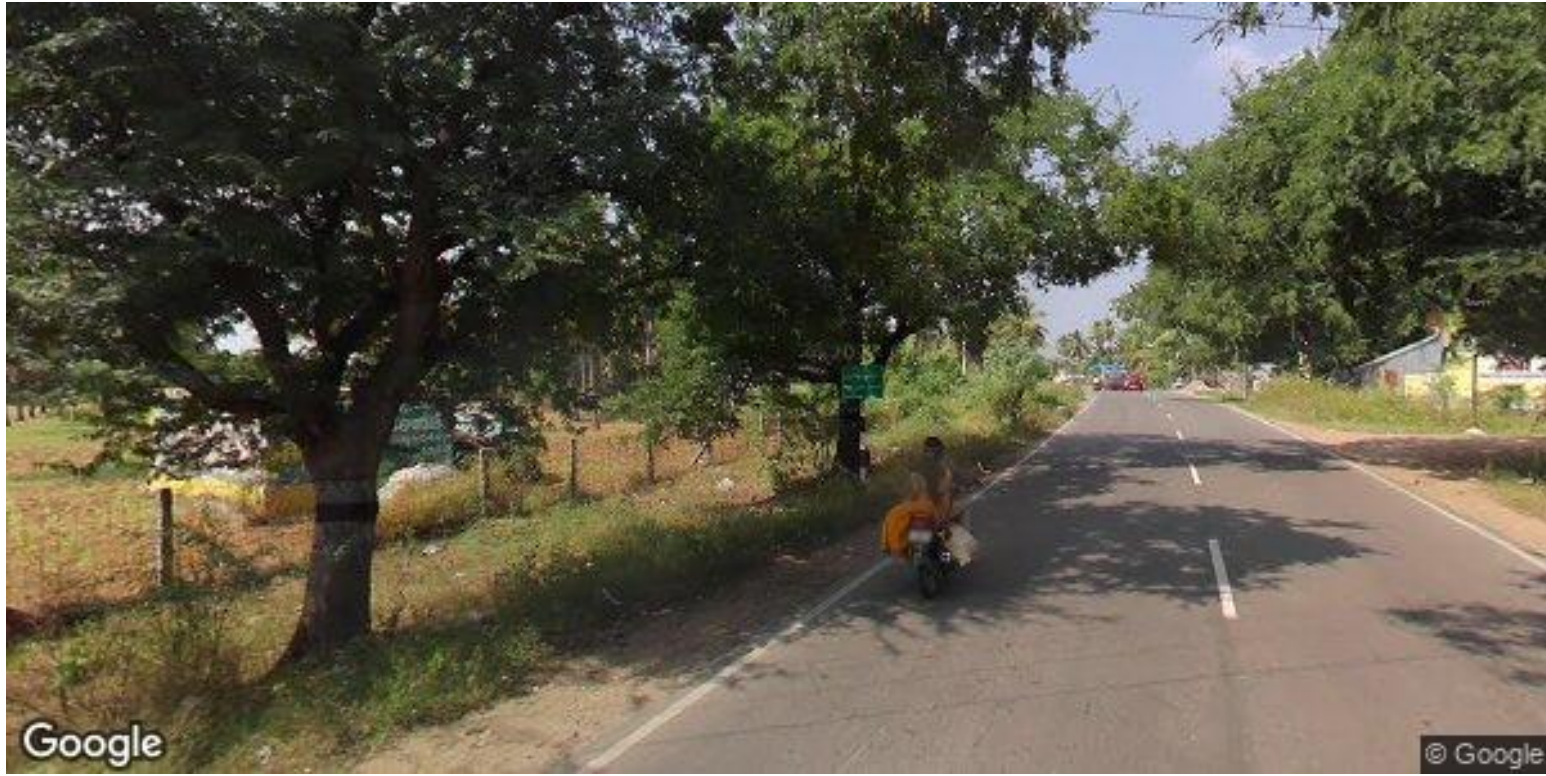
**Risk Type:** Turn  
**Risk Level:** Medium  
**Speed Limit:** 30 KM/Hr  
**Coordinates:** 11.43107, 77.88171

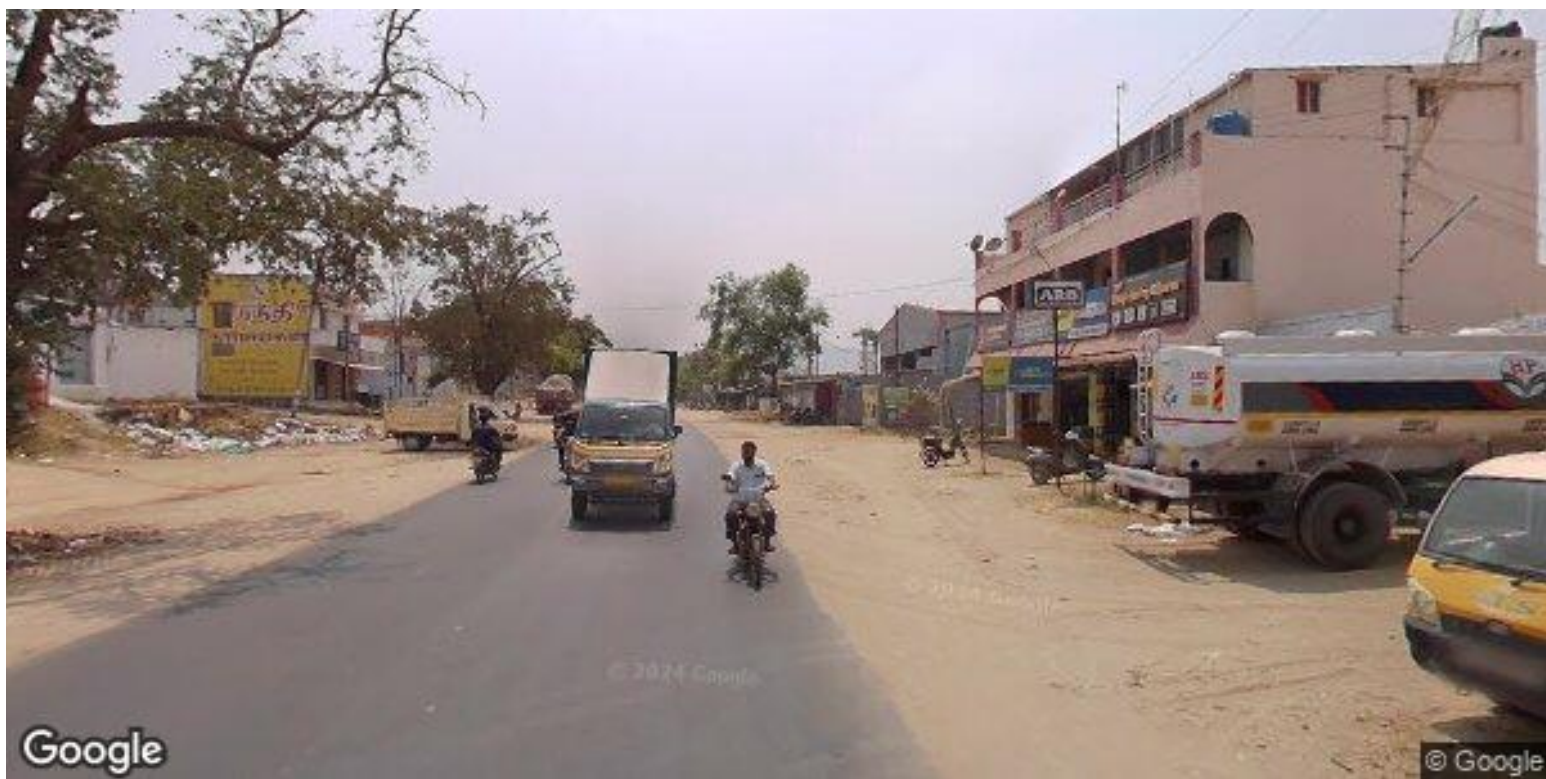
**Risk Type:** Turn  
**Risk Level:** Medium  
**Speed Limit:** 30 KM/Hr  
**Coordinates:** 11.39976, 77.88382

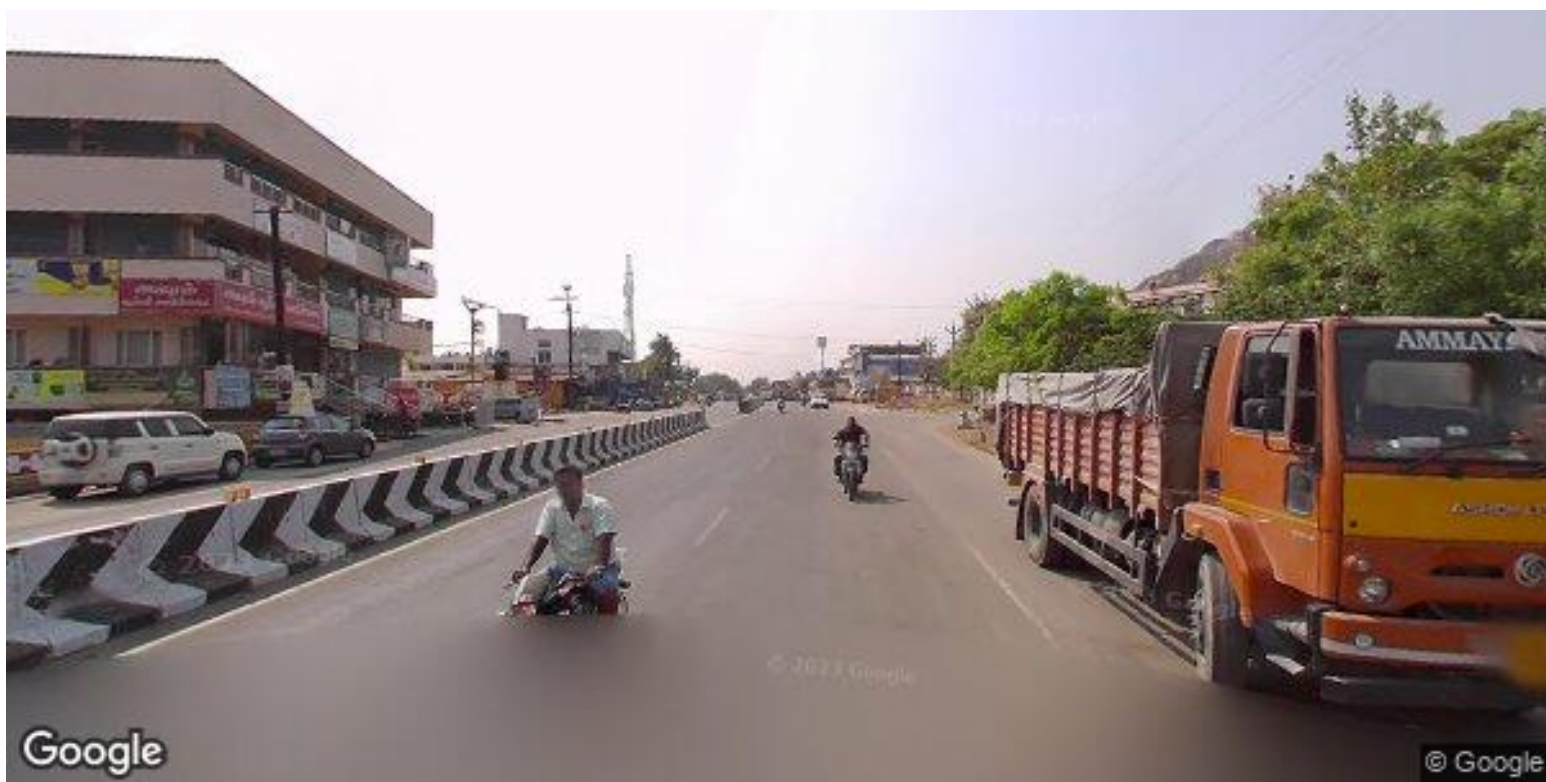
**Coordinates:** 11.39690, 77.88852

**Risk Type:** Turn

**Risk Level:** Medium

**Speed Limit:** 30 KM/Hr

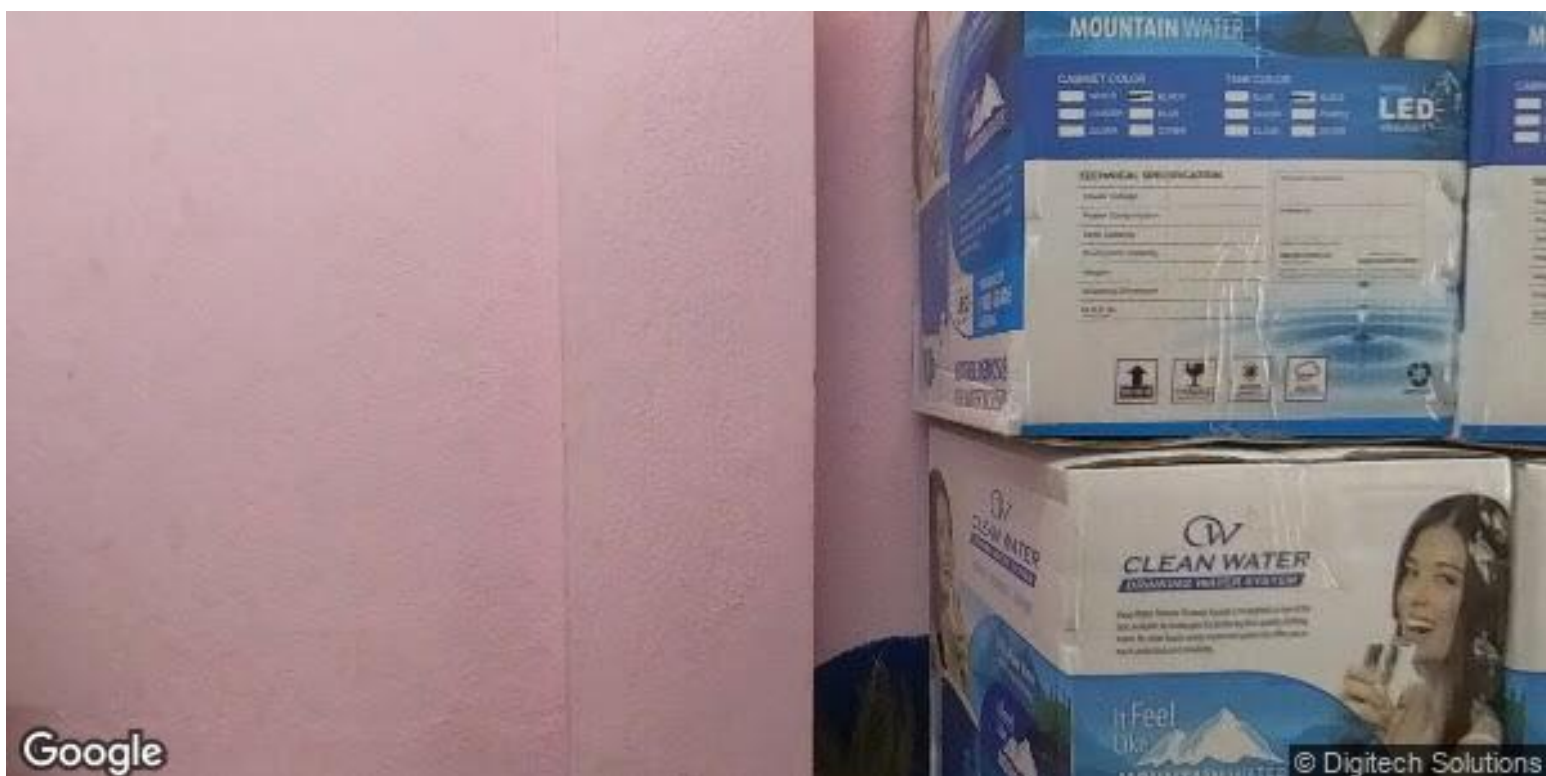
**Coordinates:** 11.37862, 77.89530

**Risk Type:** Turn

**Risk Level:** High

**Speed Limit:** 15 KM/Hr

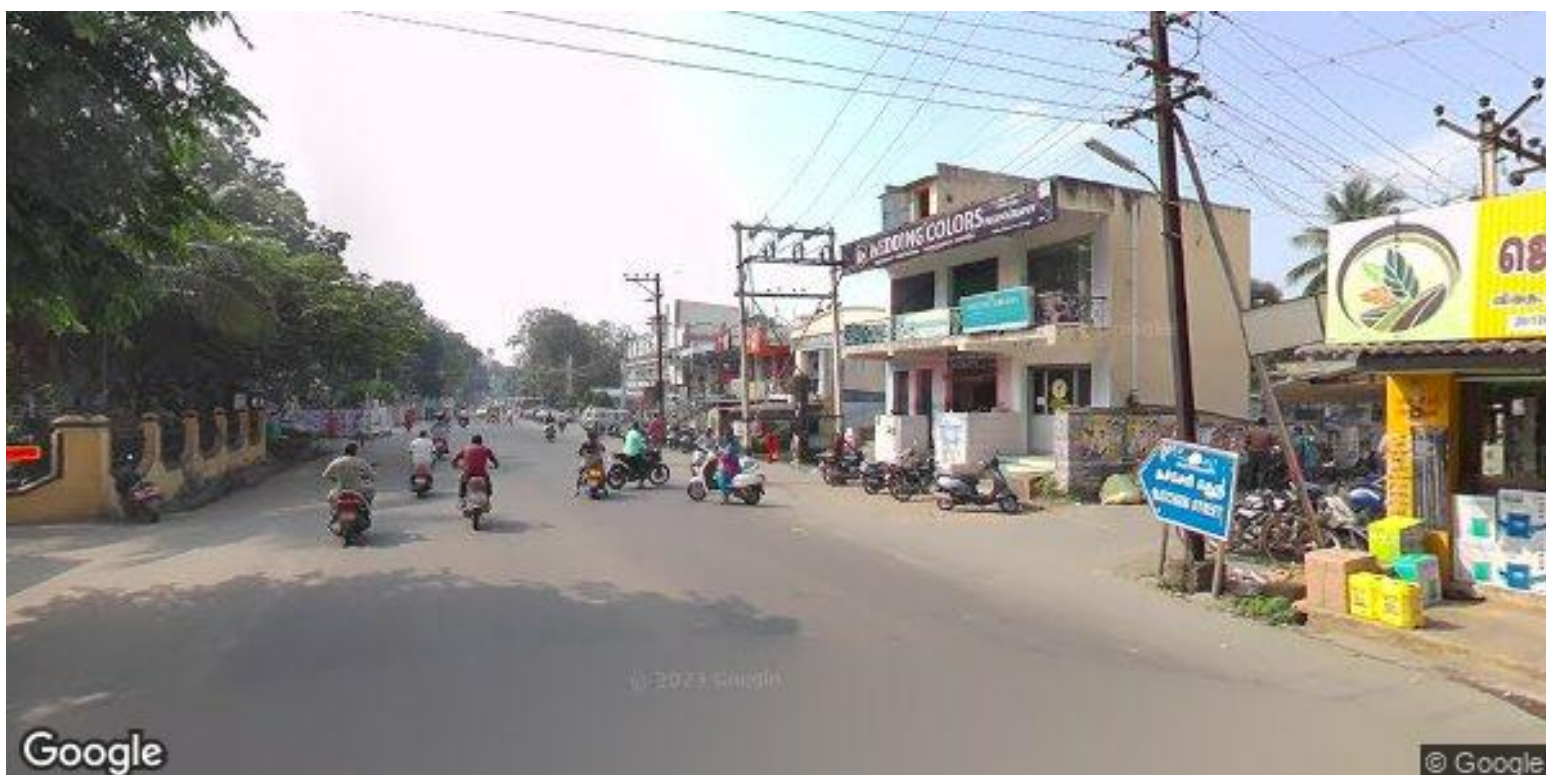
**Risk Type:** Turn  
**Risk Level:** High  
**Speed Limit:** 15 KM/Hr  
**Coordinates:** 11.37820, 77.89447

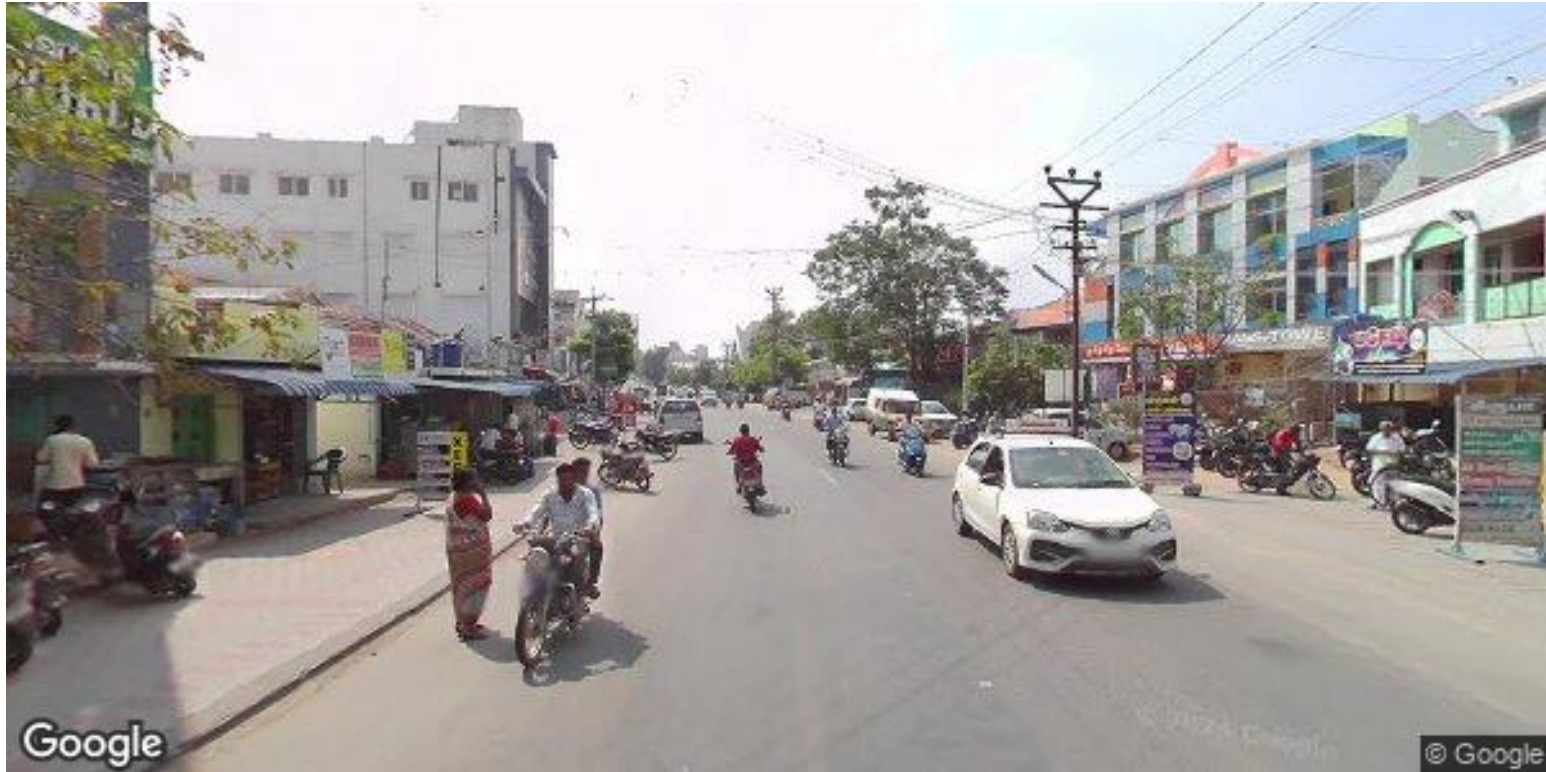
**Risk Type:** Turn  
**Risk Level:** Medium  
**Speed Limit:** 30 KM/Hr  
**Coordinates:** 11.36919, 77.88934

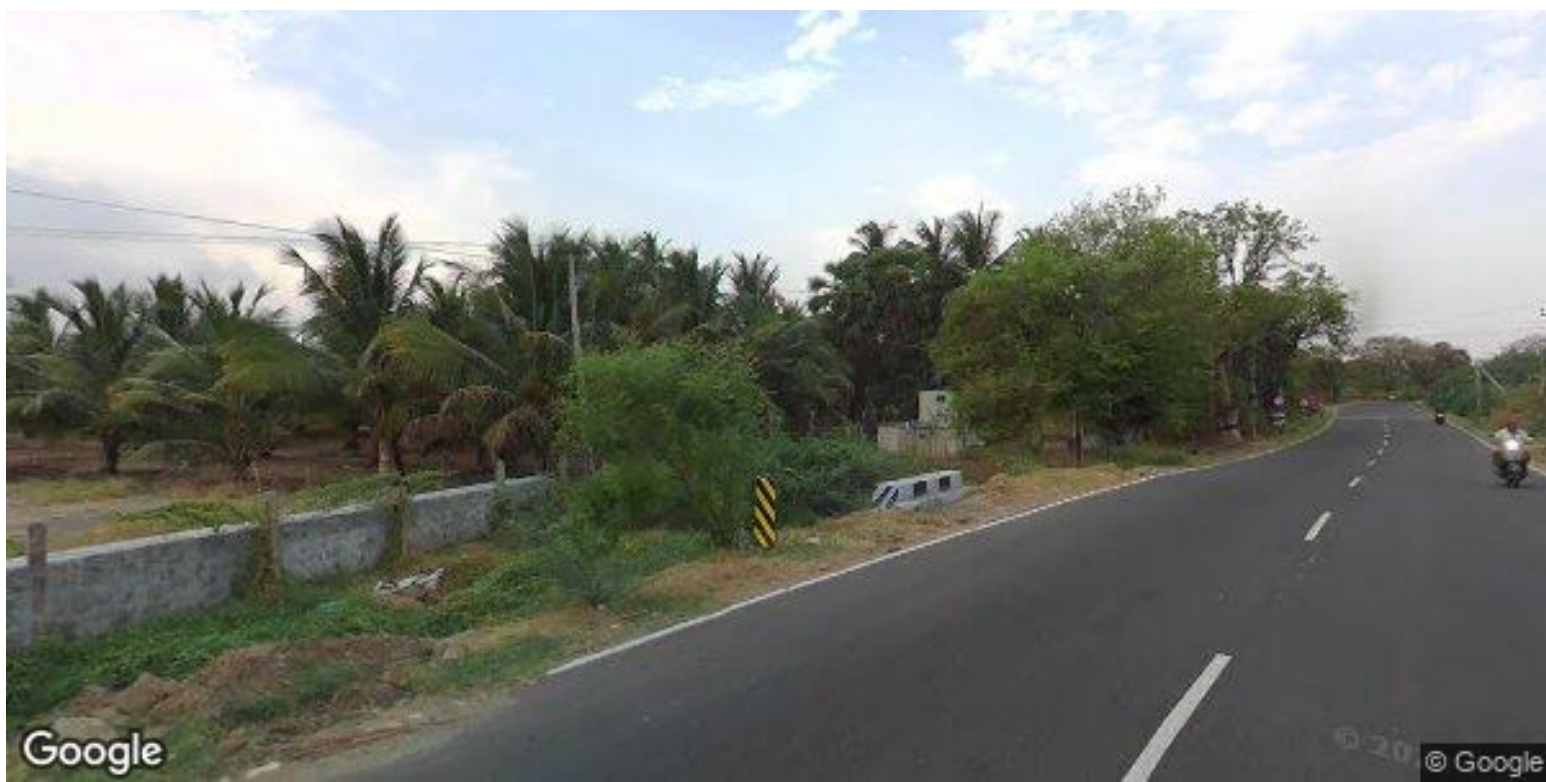
**Coordinates:** 11.33949, 77.86263

**Risk Type:** Turn

**Risk Level:** Medium

**Speed Limit:** 30 KM/Hr

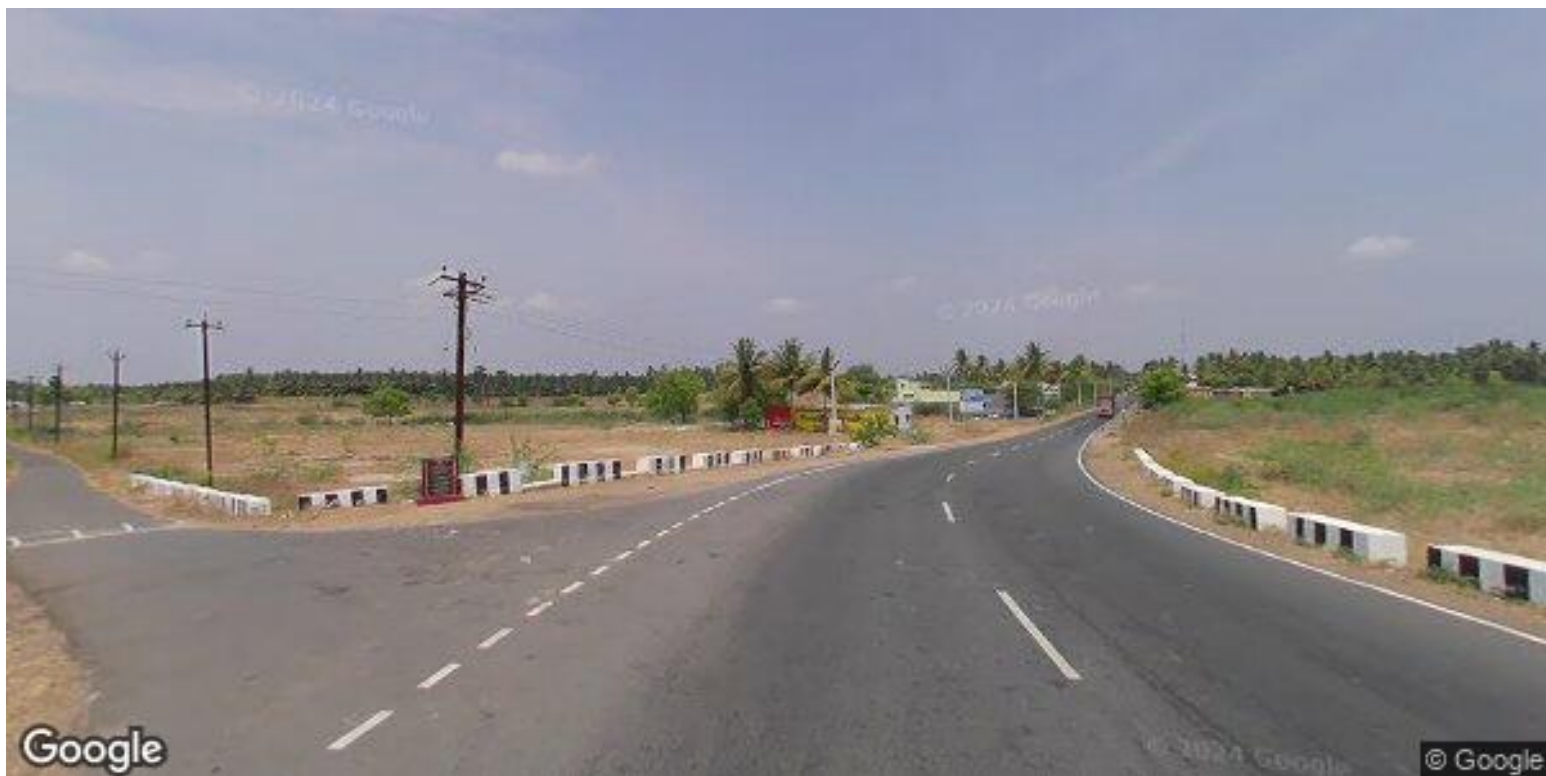
**Coordinates:** 11.31752, 77.84260

**Risk Type:** Turn

**Risk Level:** Medium

**Speed Limit:** 30 KM/Hr

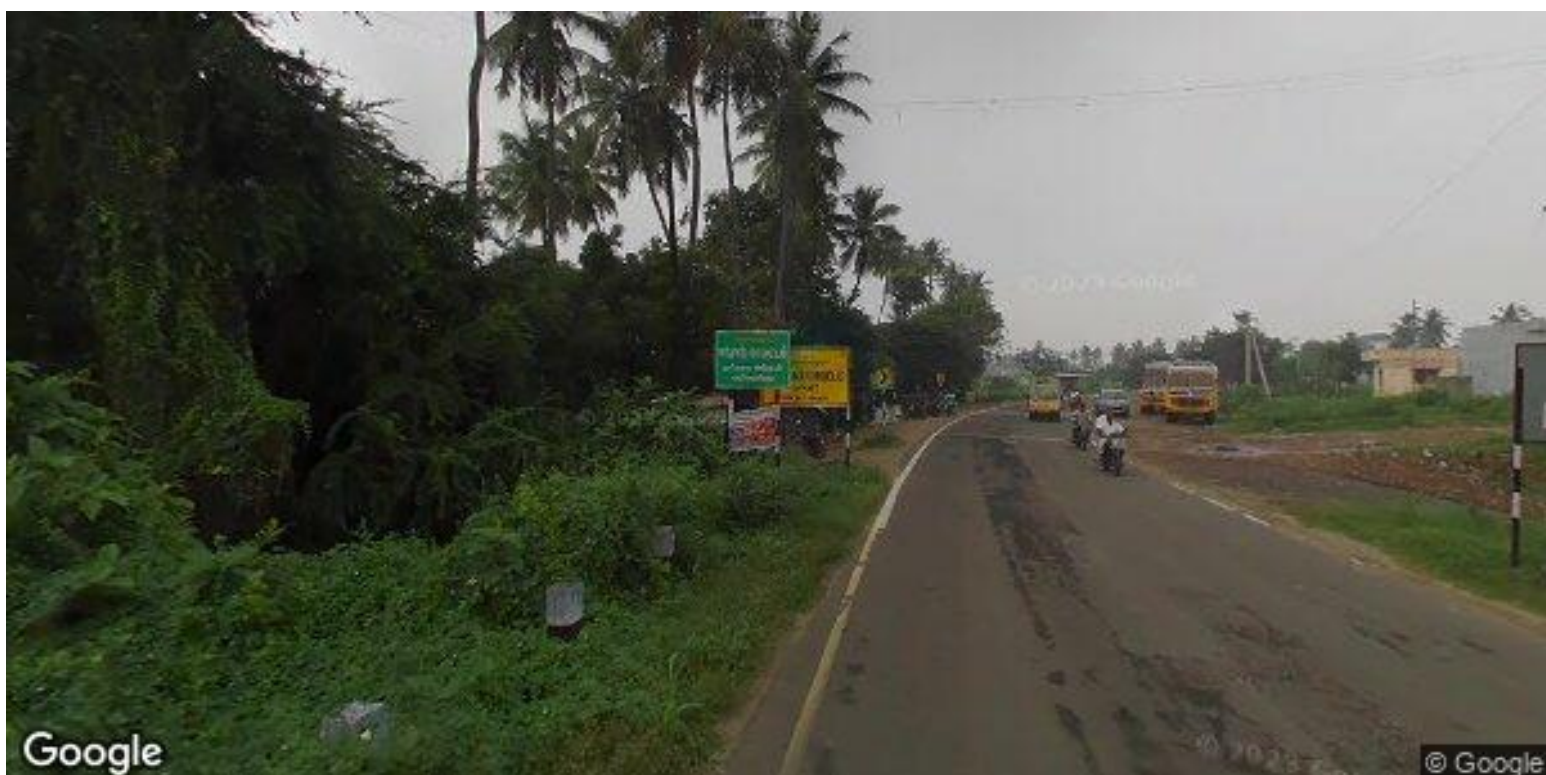
**Risk Type:** Turn  
**Risk Level:** Medium  
**Speed Limit:** 30 KM/Hr  
**Coordinates:** 11.30955, 77.77637

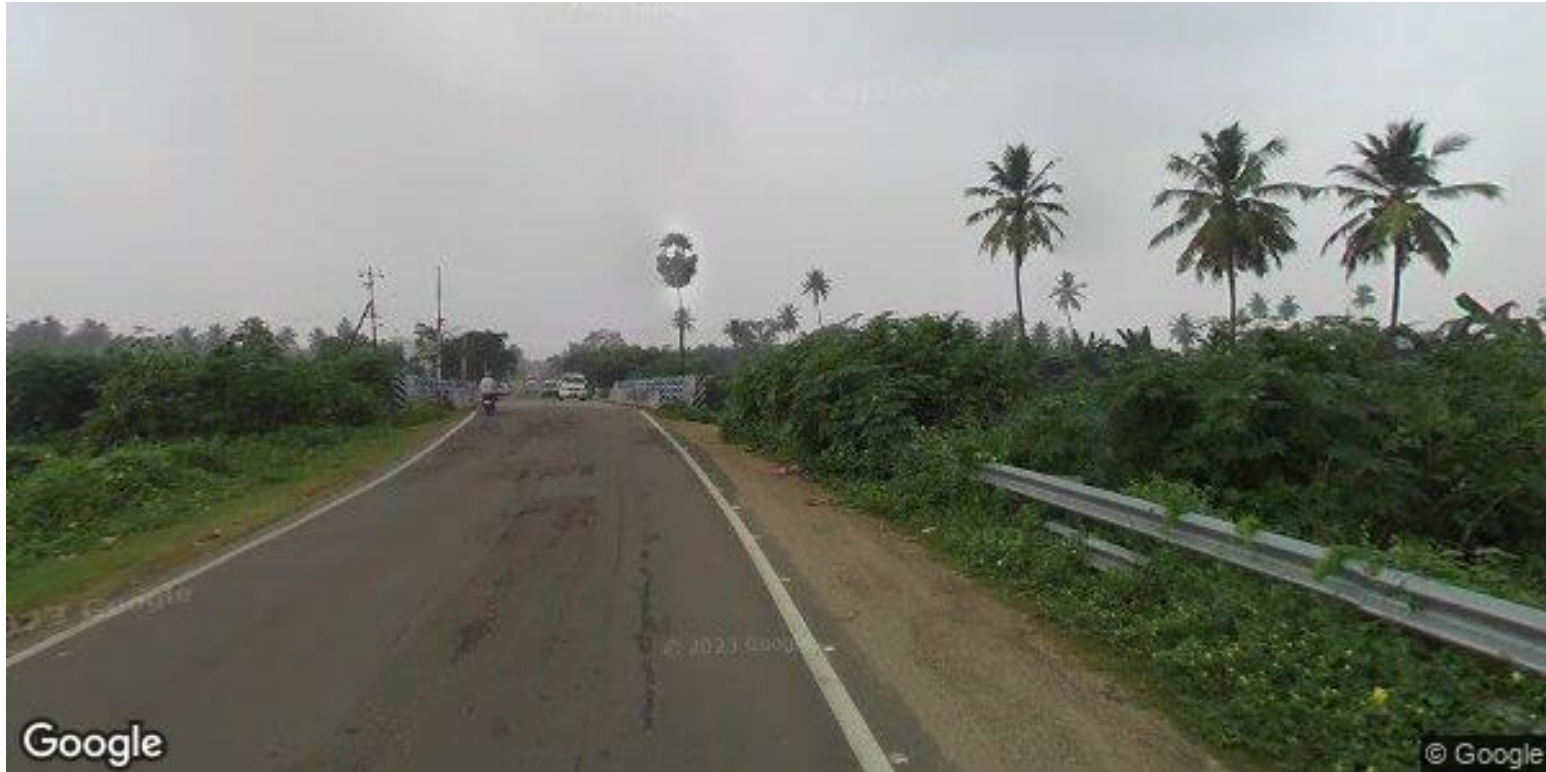
**Risk Type:** Turn  
**Risk Level:** Medium  
**Speed Limit:** 30 KM/Hr  
**Coordinates:** 11.31115, 77.77102

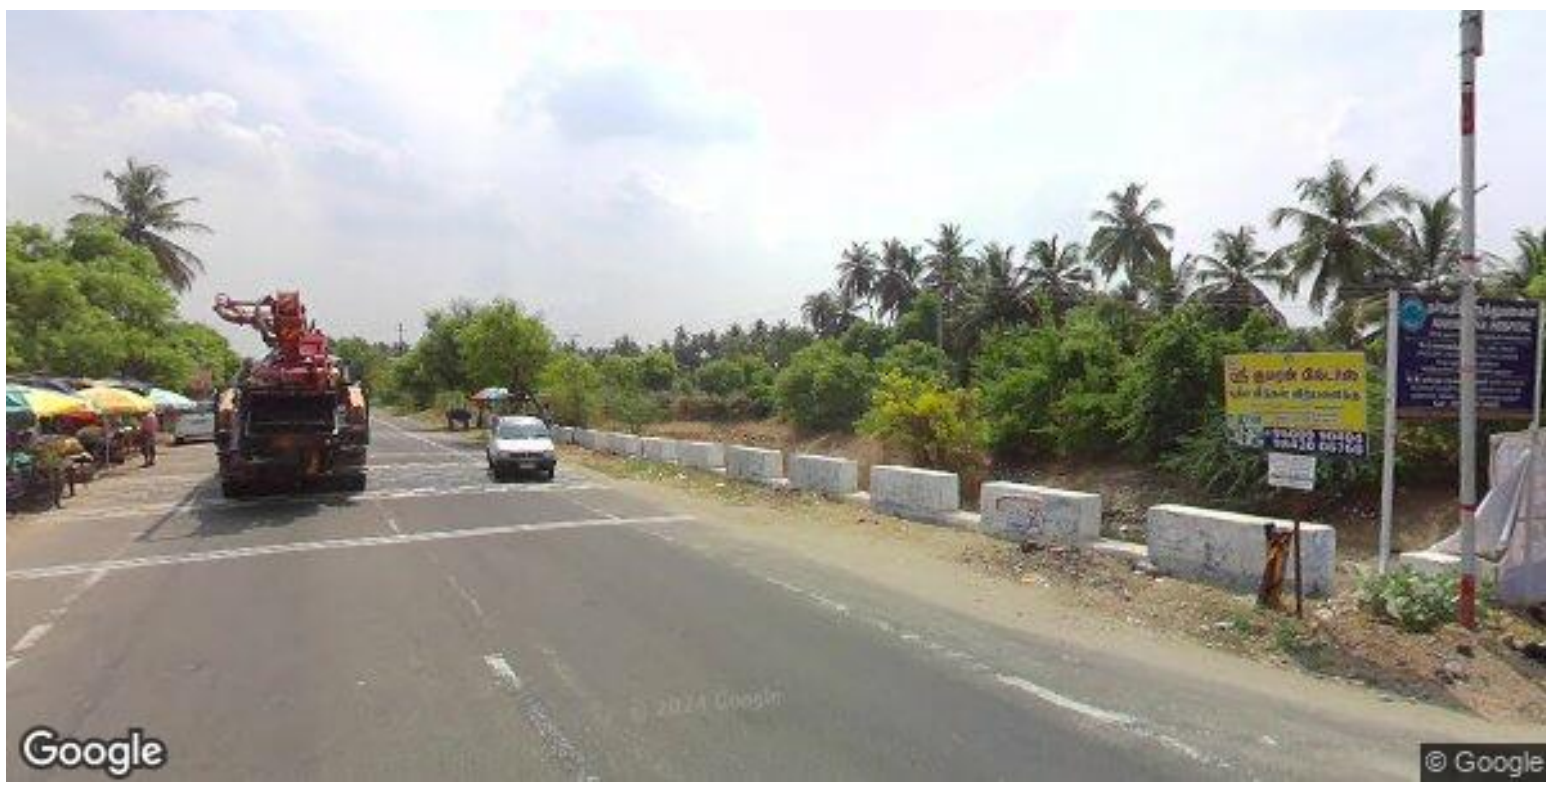
**Coordinates:** 11.29490, 77.74685

**Risk Type:** Turn

**Risk Level:** High

**Speed Limit:** 15 KM/Hr

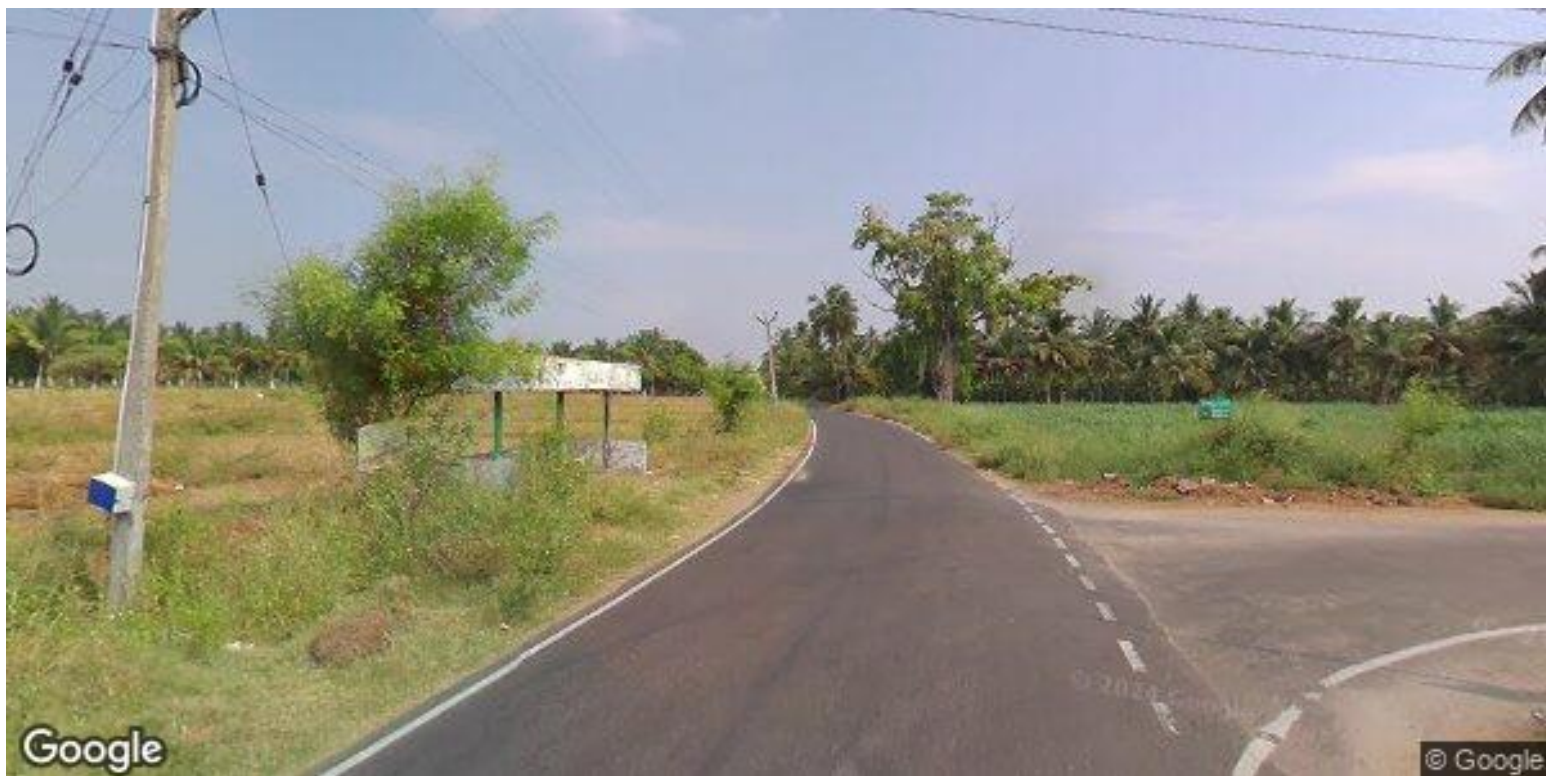
**Coordinates:** 11.29141, 77.74662

**Risk Type:** Turn

**Risk Level:** High

**Speed Limit:** 15 KM/Hr

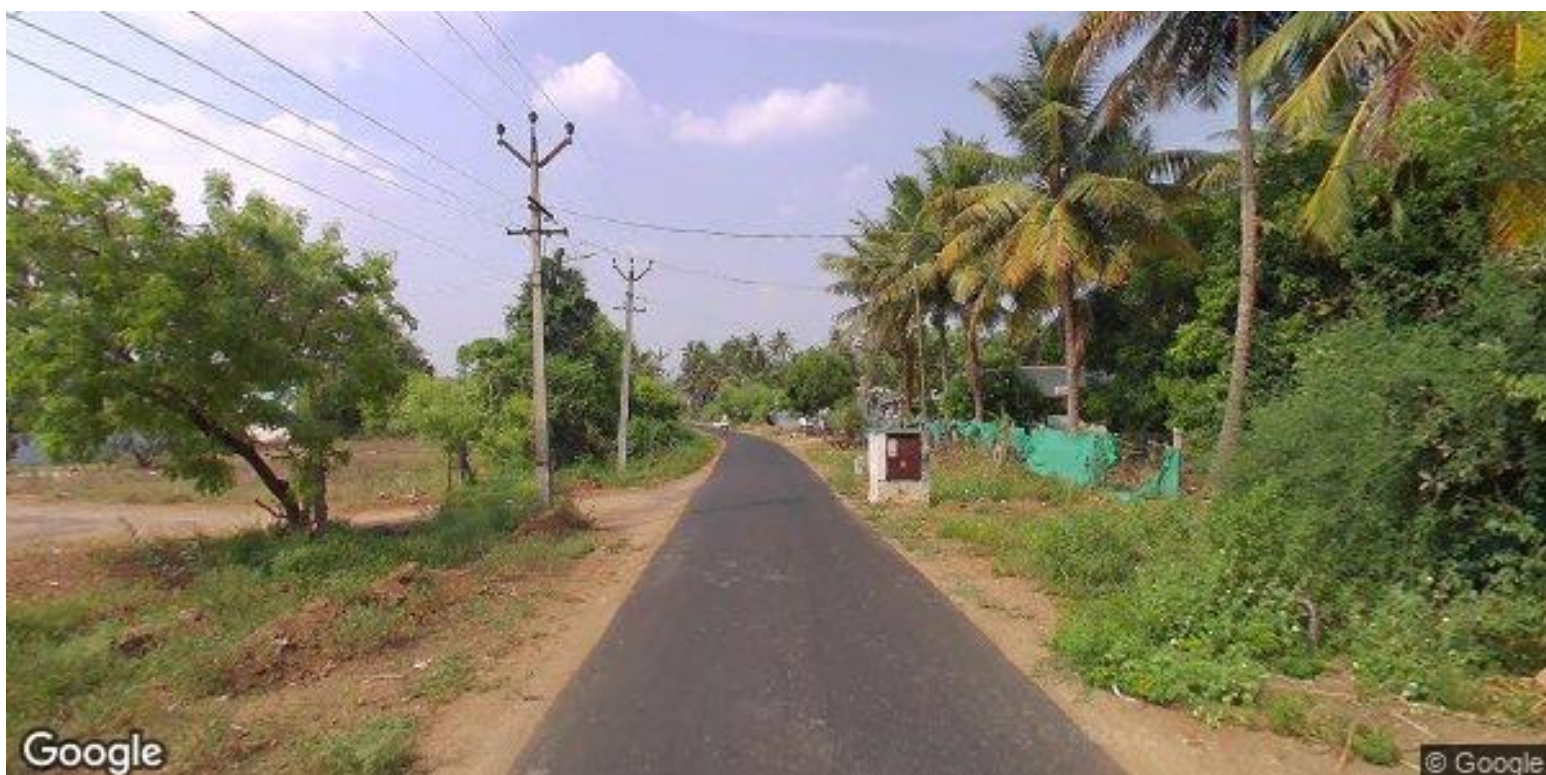
**Risk Type:** Turn  
**Risk Level:** Medium  
**Speed Limit:** 30 KM/Hr  
**Coordinates:** 11.28908, 77.74368

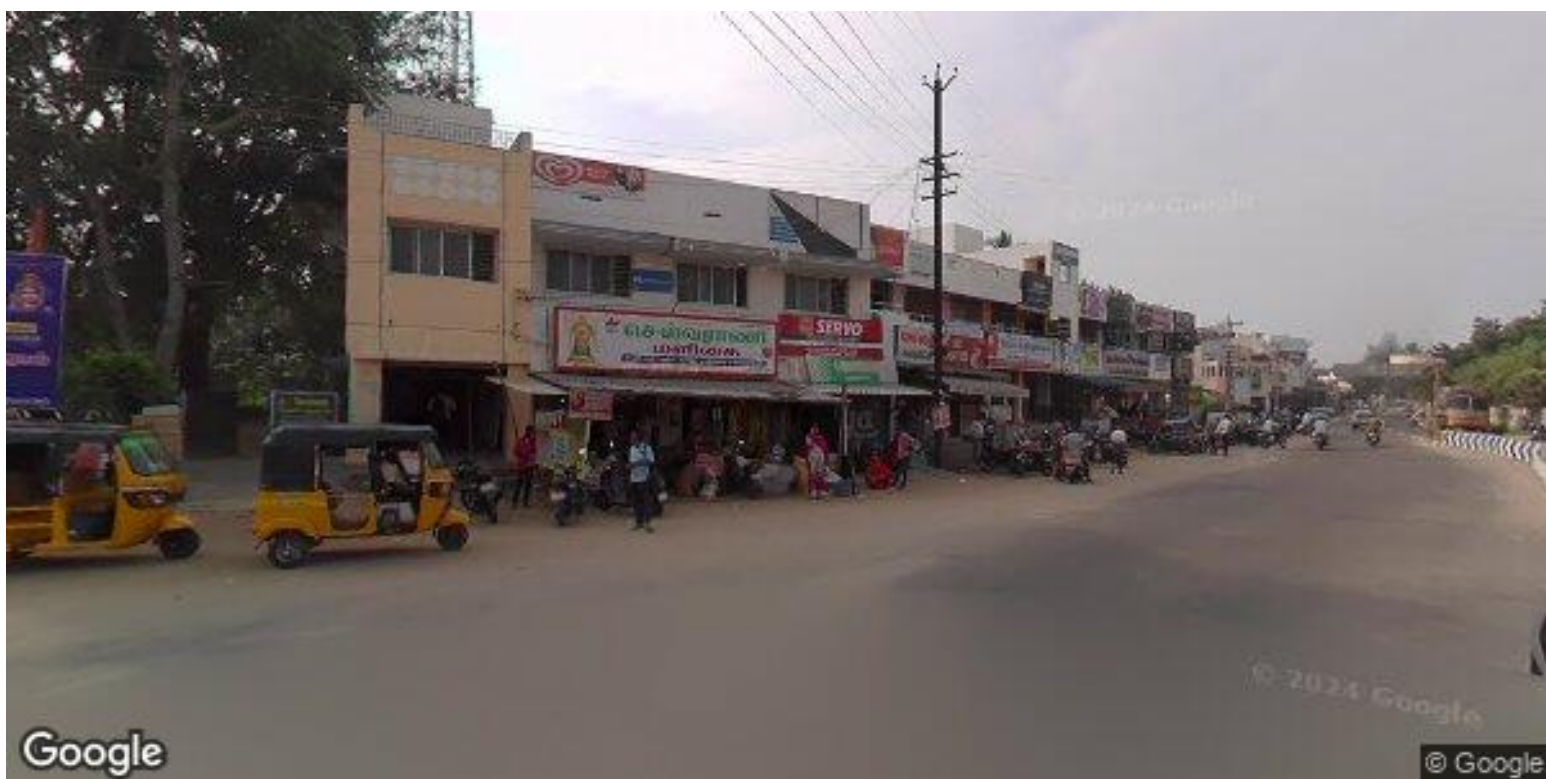
**Risk Type:** Turn  
**Risk Level:** Medium  
**Speed Limit:** 30 KM/Hr  
**Coordinates:** 11.15944, 77.70068

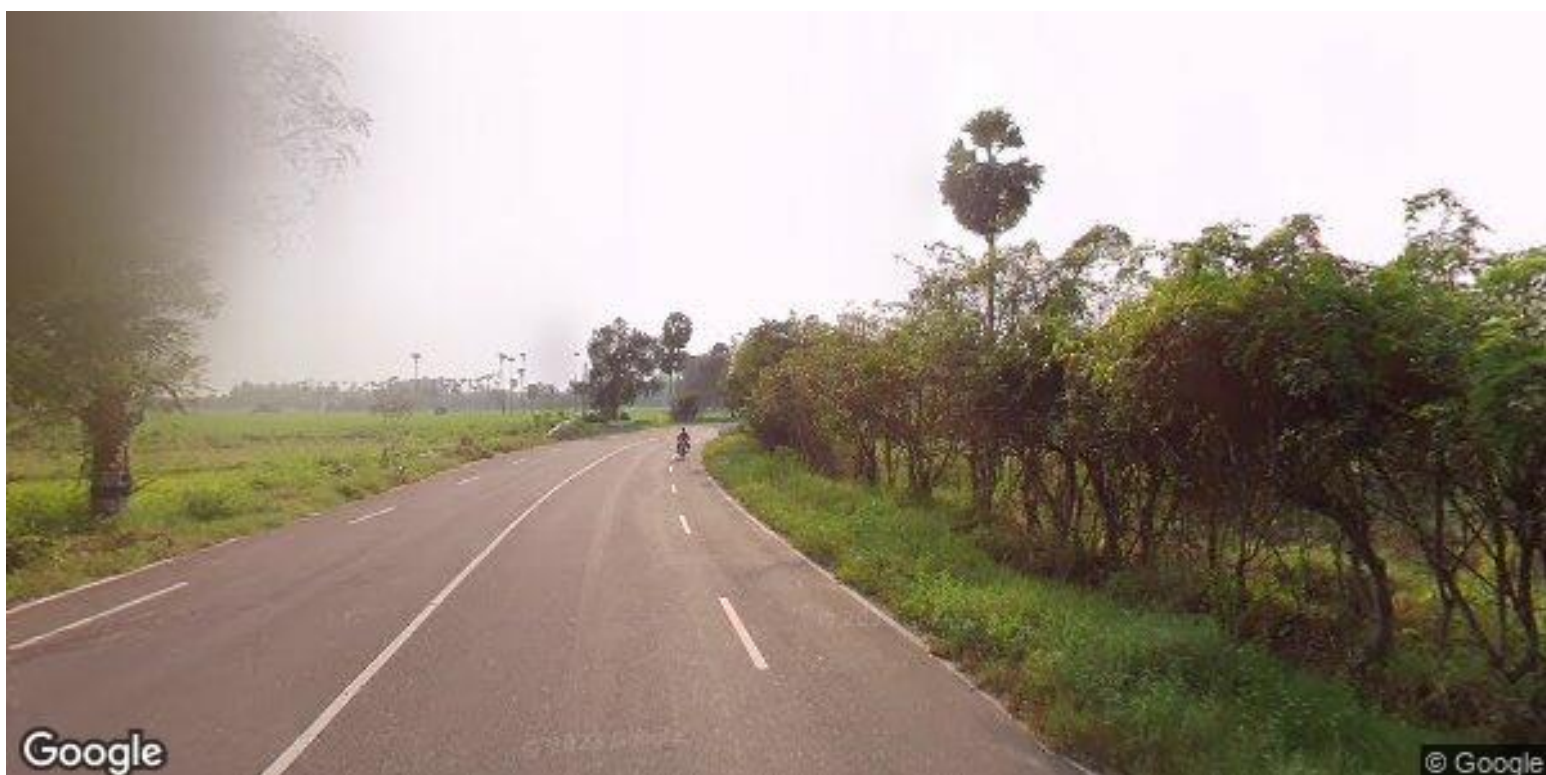
**Coordinates:** 11.11962, 77.67818

**Risk Type:** Turn

**Risk Level:** Medium

**Speed Limit:** 30 KM/Hr

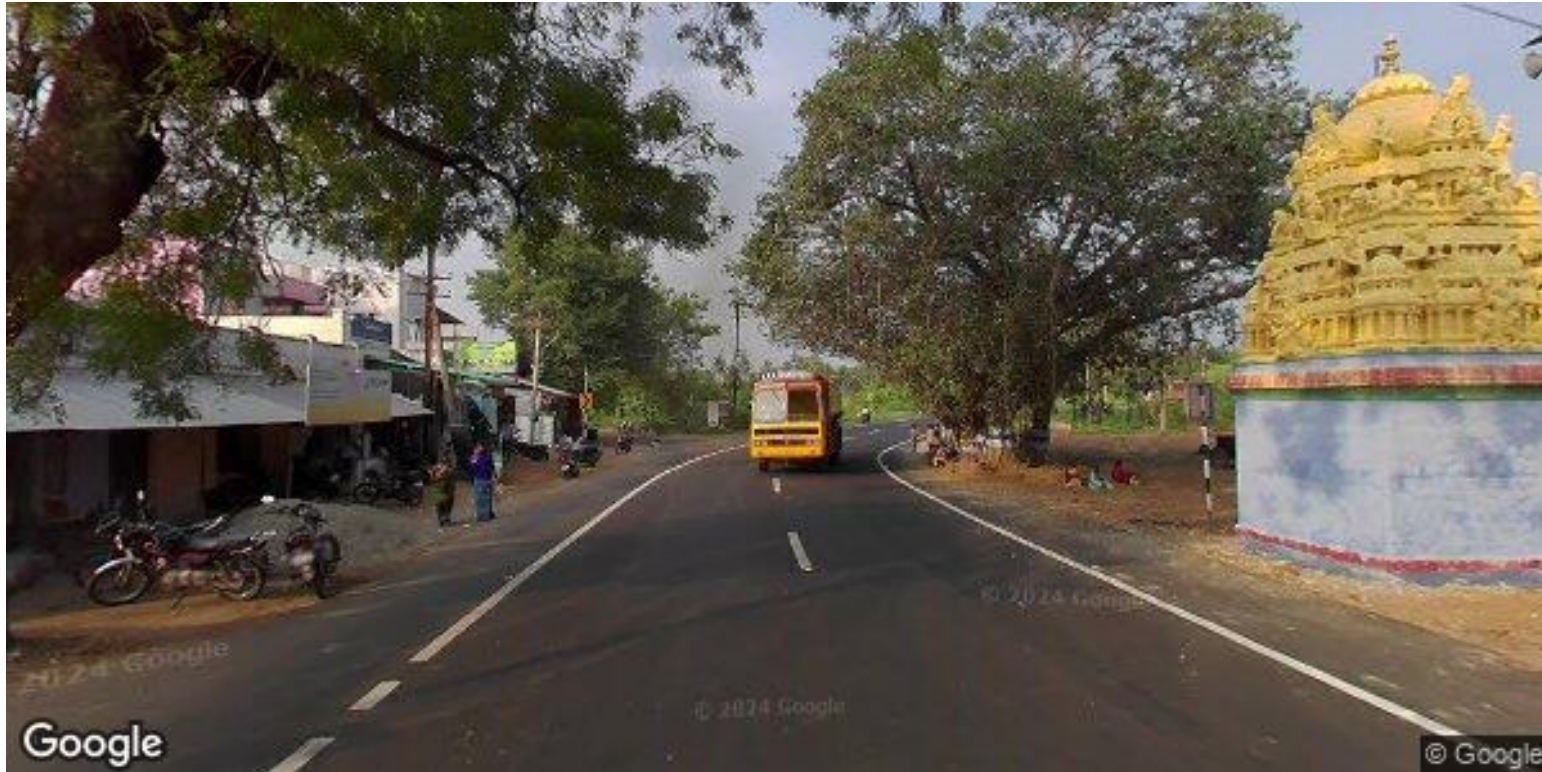
**Coordinates:** 11.11683, 77.67168

**Risk Type:** Turn

**Risk Level:** High

**Speed Limit:** 15 KM/Hr

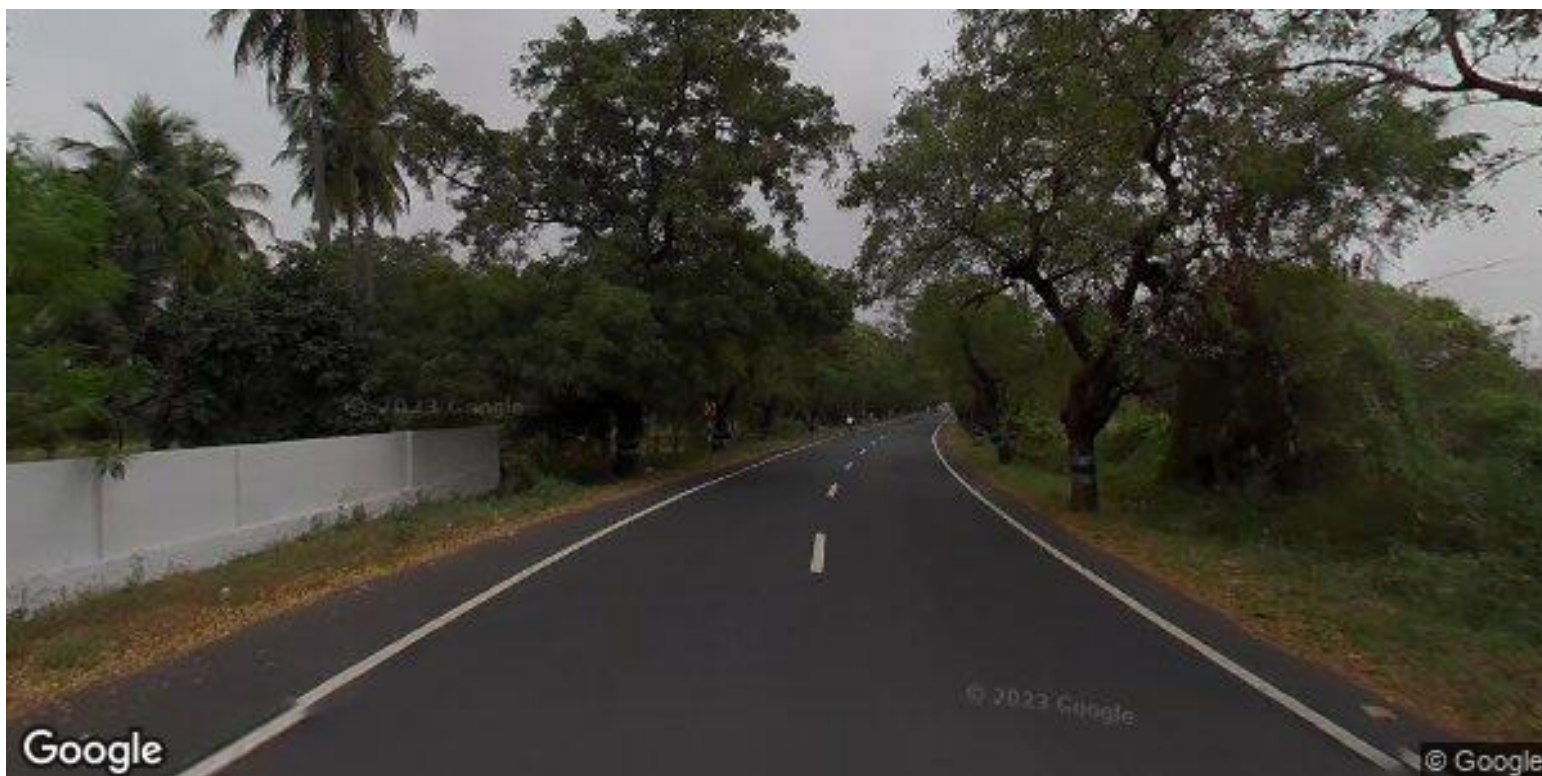
**Coordinates:** 11.10481, 77.67060

**Risk Type:** Turn

**Risk Level:** Medium

**Speed Limit:** 30 KM/Hr

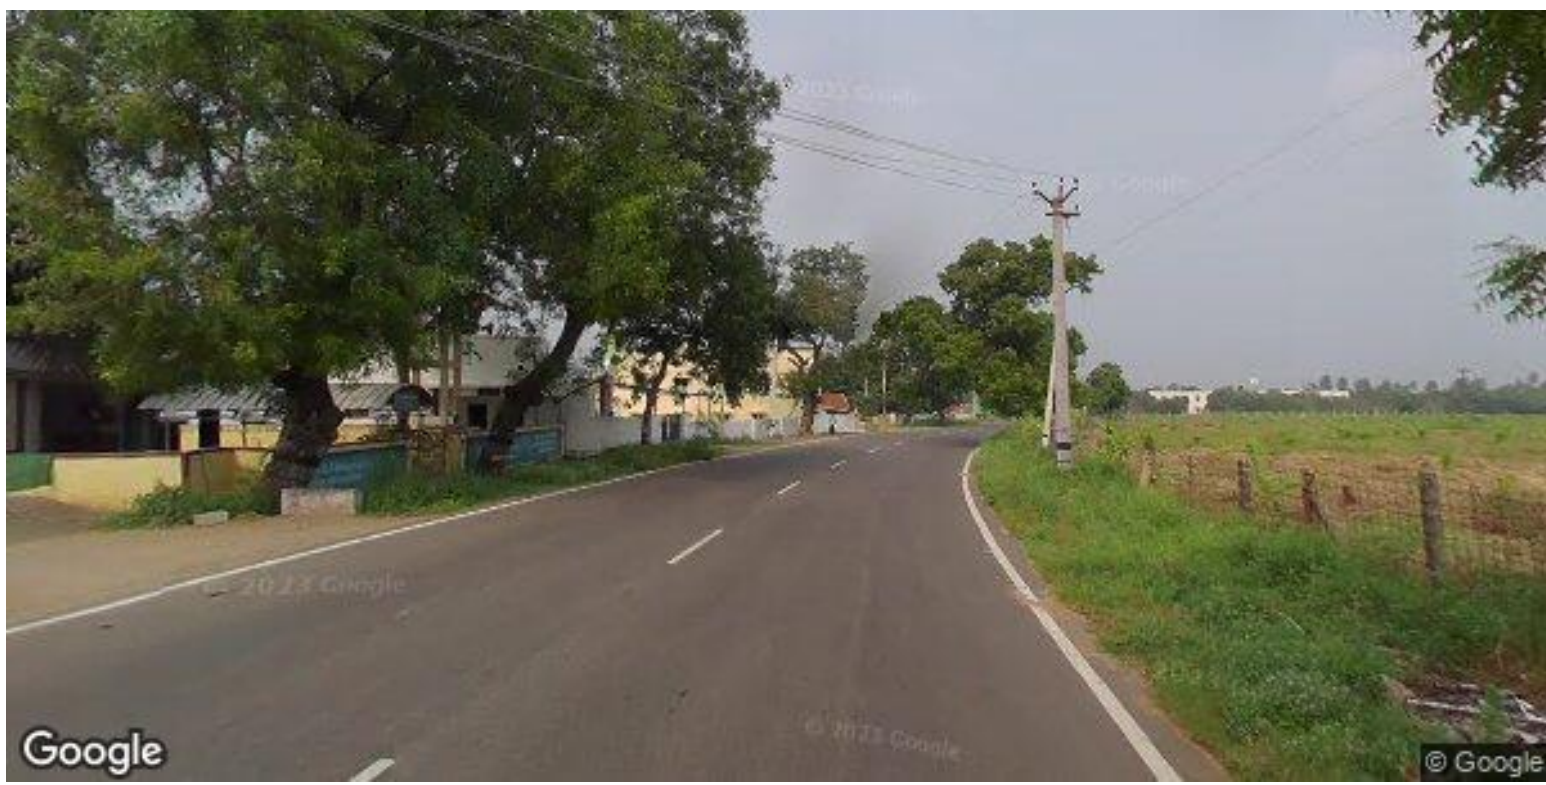
**Coordinates:** 11.09509, 77.66612

**Risk Type:** Turn

**Risk Level:** Medium

**Speed Limit:** 30 KM/Hr
