# IndianOil

## JOURNEY RISK MANAGEMENT (JRM) STUDY

### Salem Terminal to ARUL MURUGAN AGENCIES

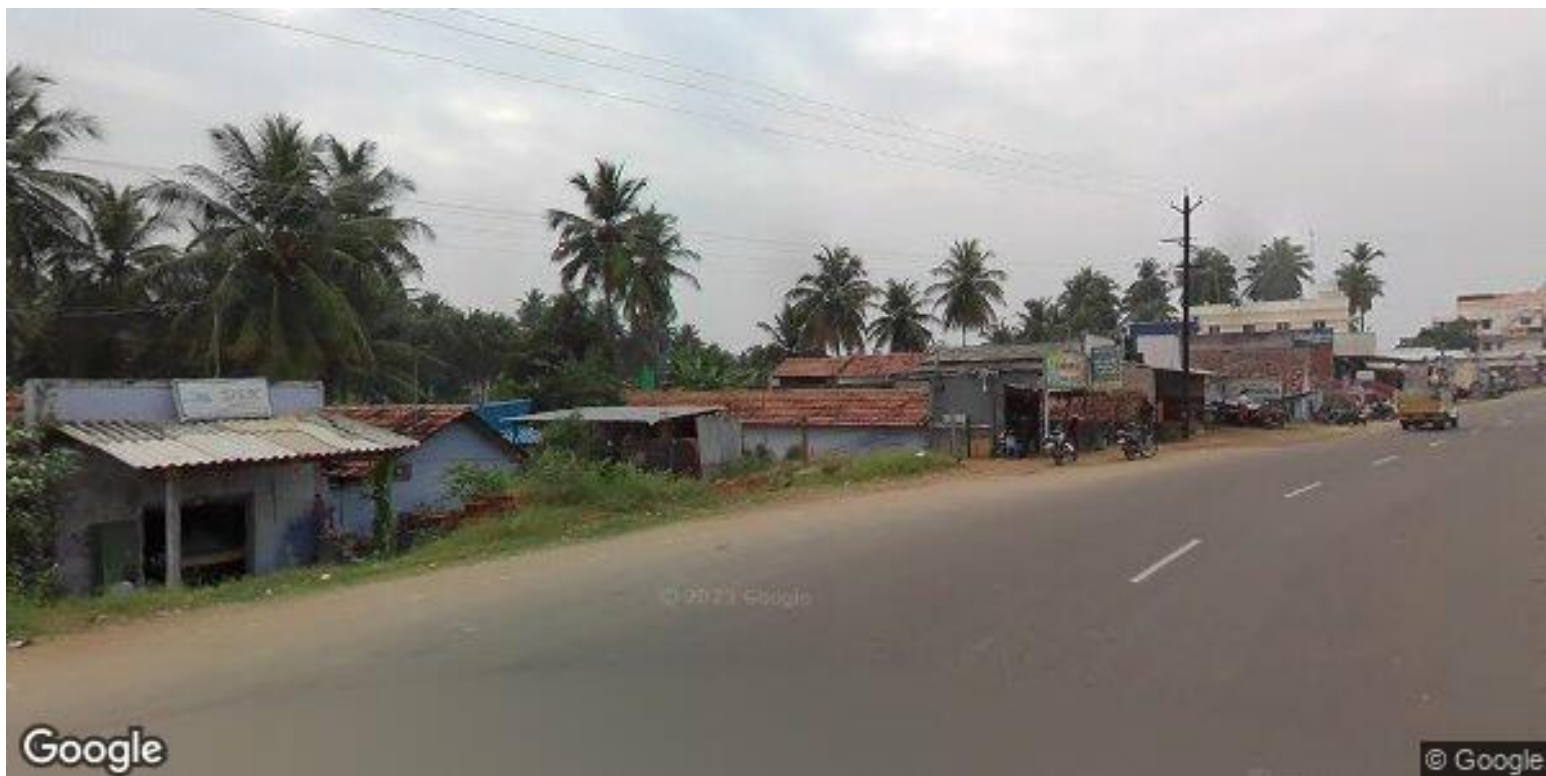
**Coordinates:** 11.08730, 77.66436

**Risk Type:** Turn

**Risk Level:** Medium

**Speed Limit:** 30 KM/Hr

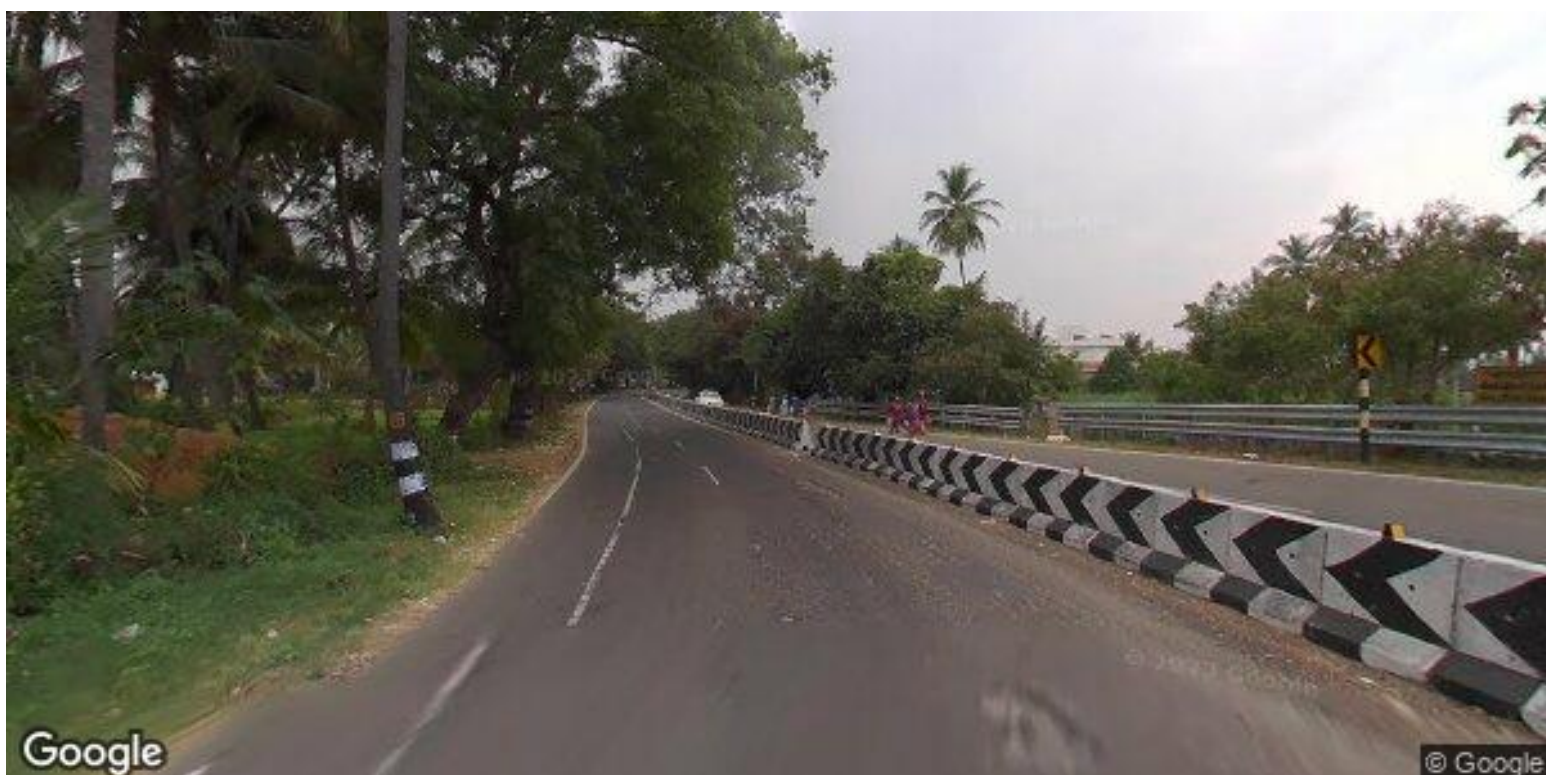
**Risk Type:** Turn  
**Risk Level:** Medium  
**Speed Limit:** 30 KM/Hr  
**Coordinates:** 11.08282, 77.65837

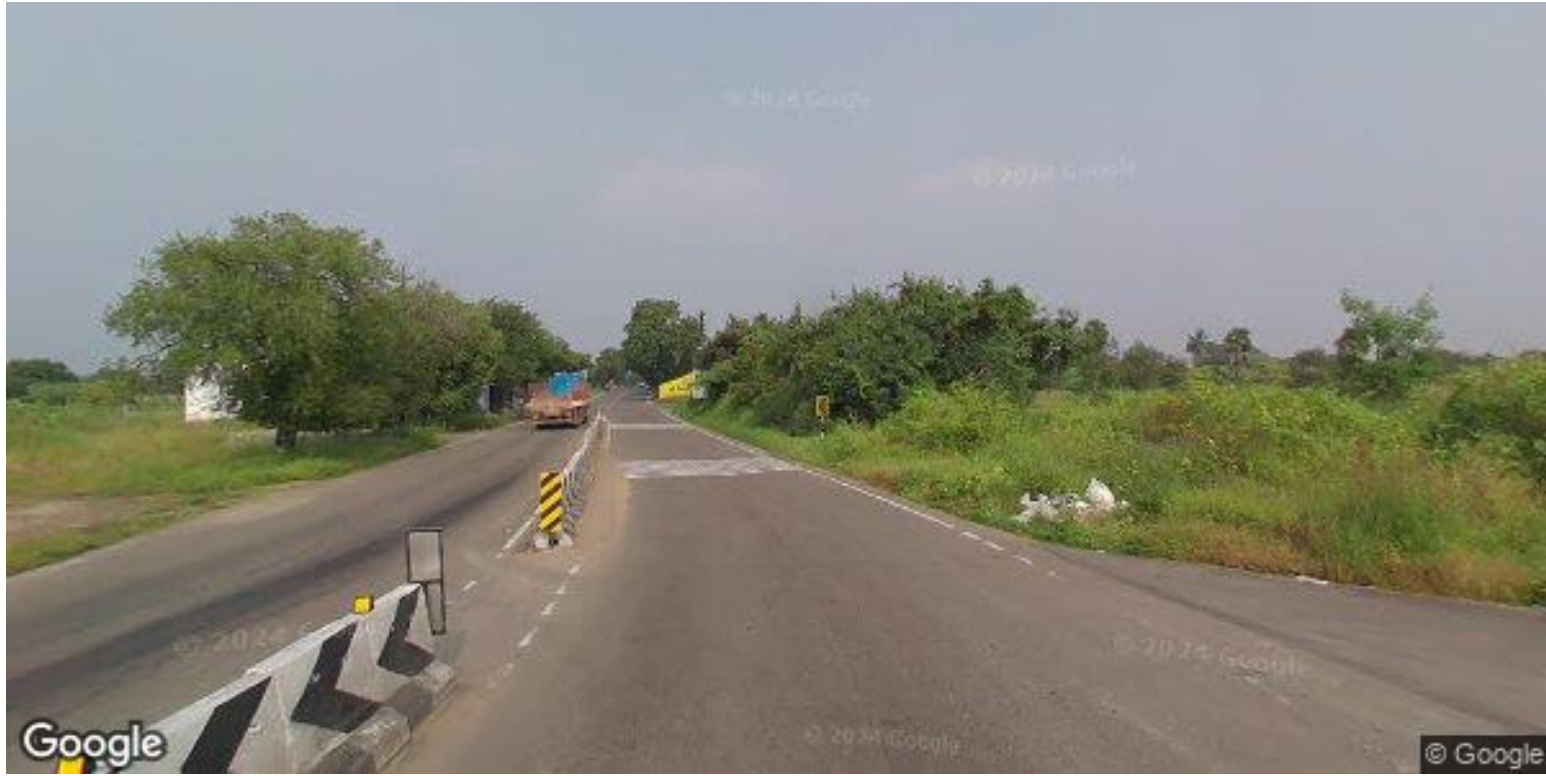
**Risk Type:** Turn  
**Risk Level:** High  
**Speed Limit:** 15 KM/Hr  
**Coordinates:** 11.06189, 77.63943

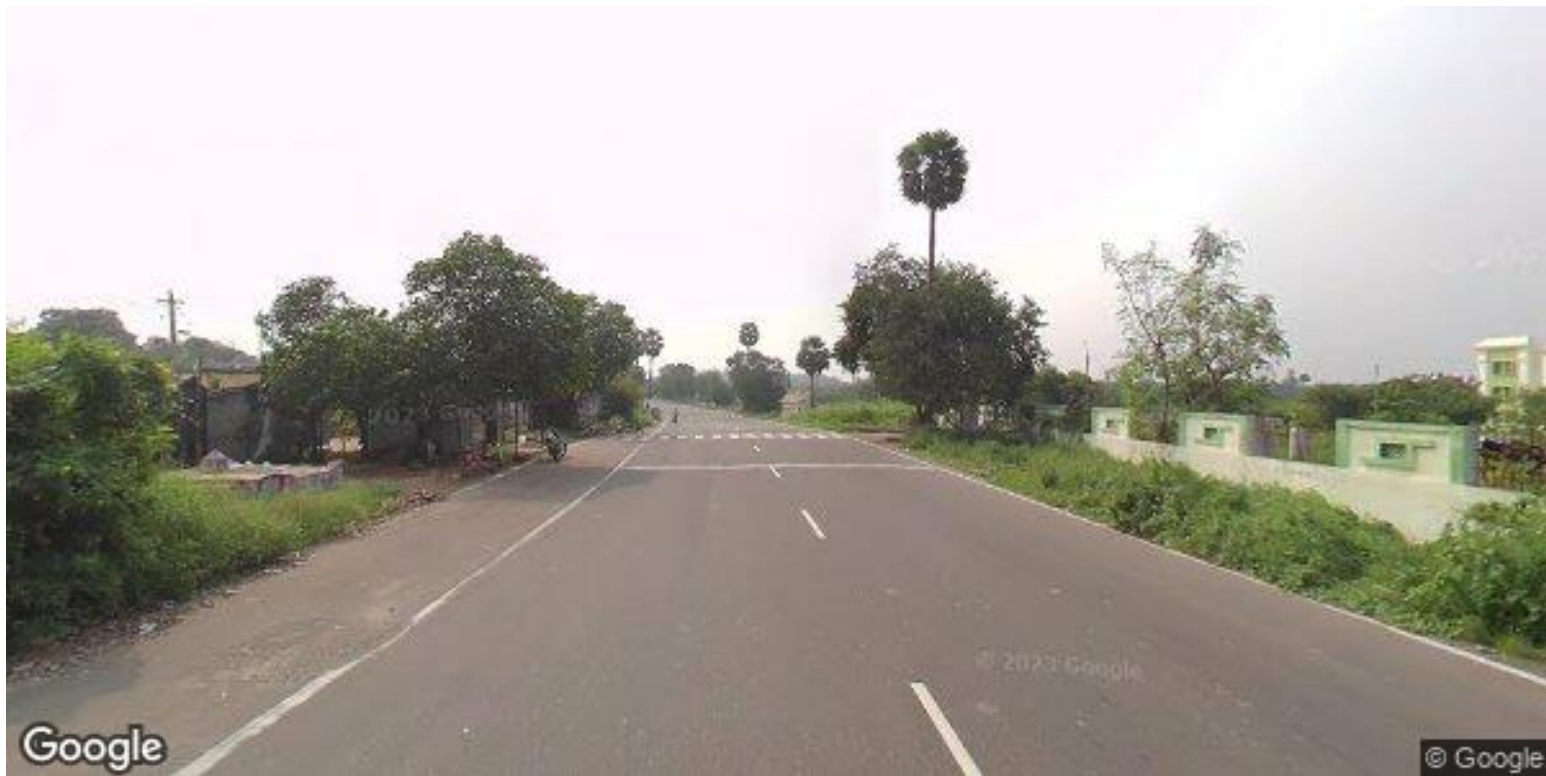
**Risk Type:** Turn  
**Risk Level:** Medium  
**Speed Limit:** 30 KM/Hr  
**Coordinates:** 11.06183, 77.63626

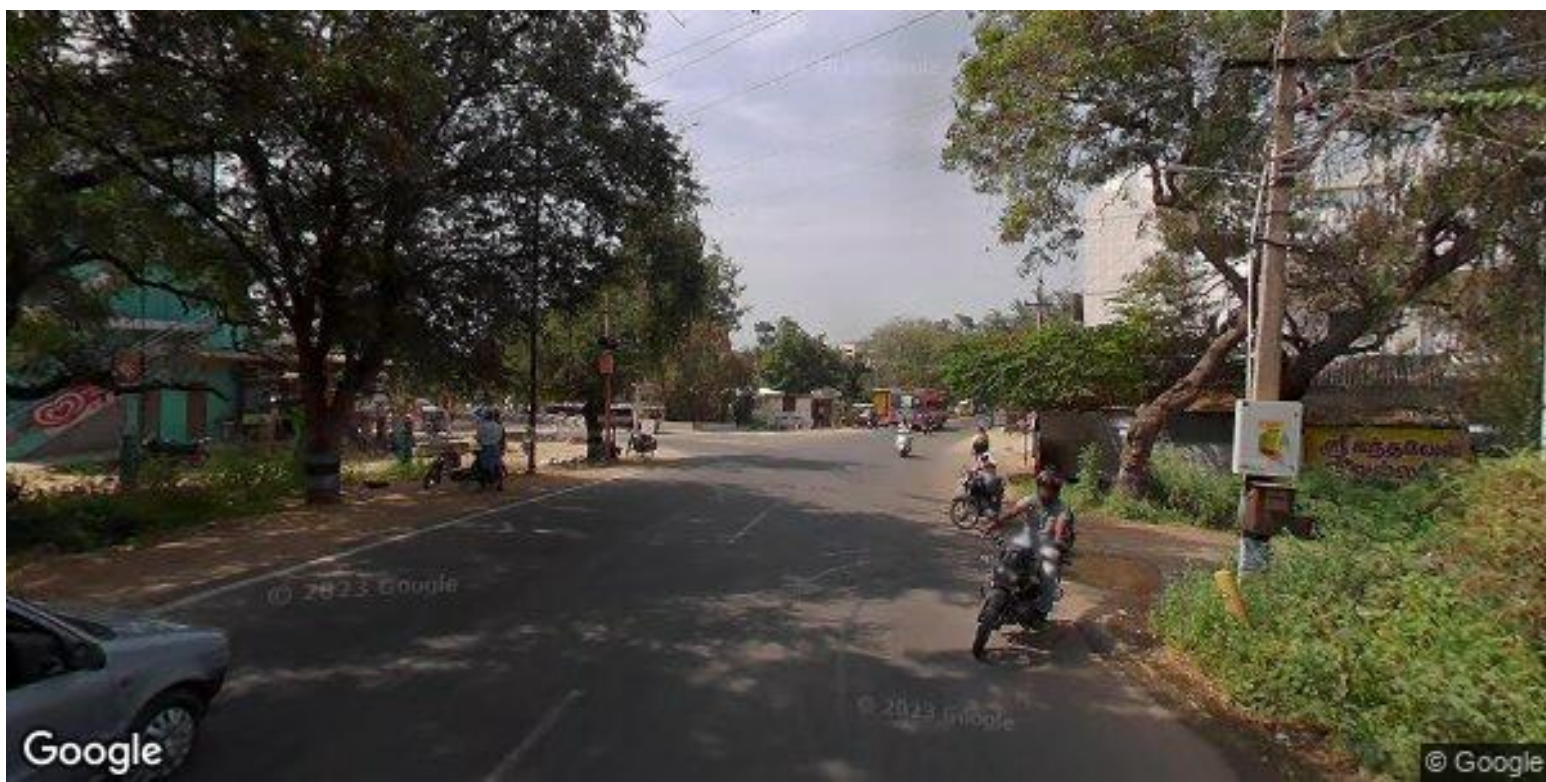
**Coordinates:** 11.00852, 77.56992

**Risk Type:** Turn

**Risk Level:** Medium

**Speed Limit:** 30 KM/Hr

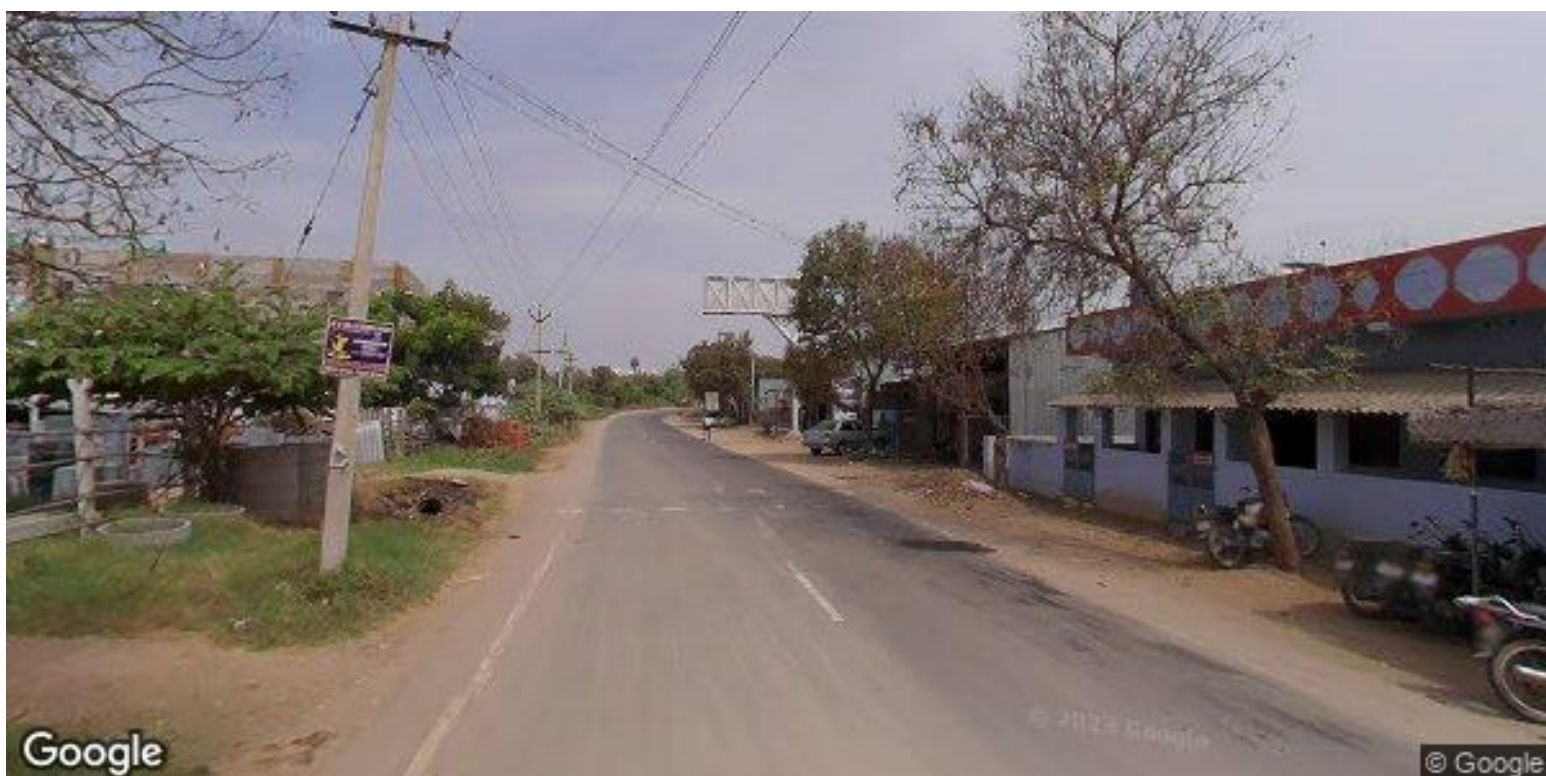
**Coordinates:** 11.00090, 77.56888

**Risk Type:** Turn

**Risk Level:** High

**Speed Limit:** 15 KM/Hr

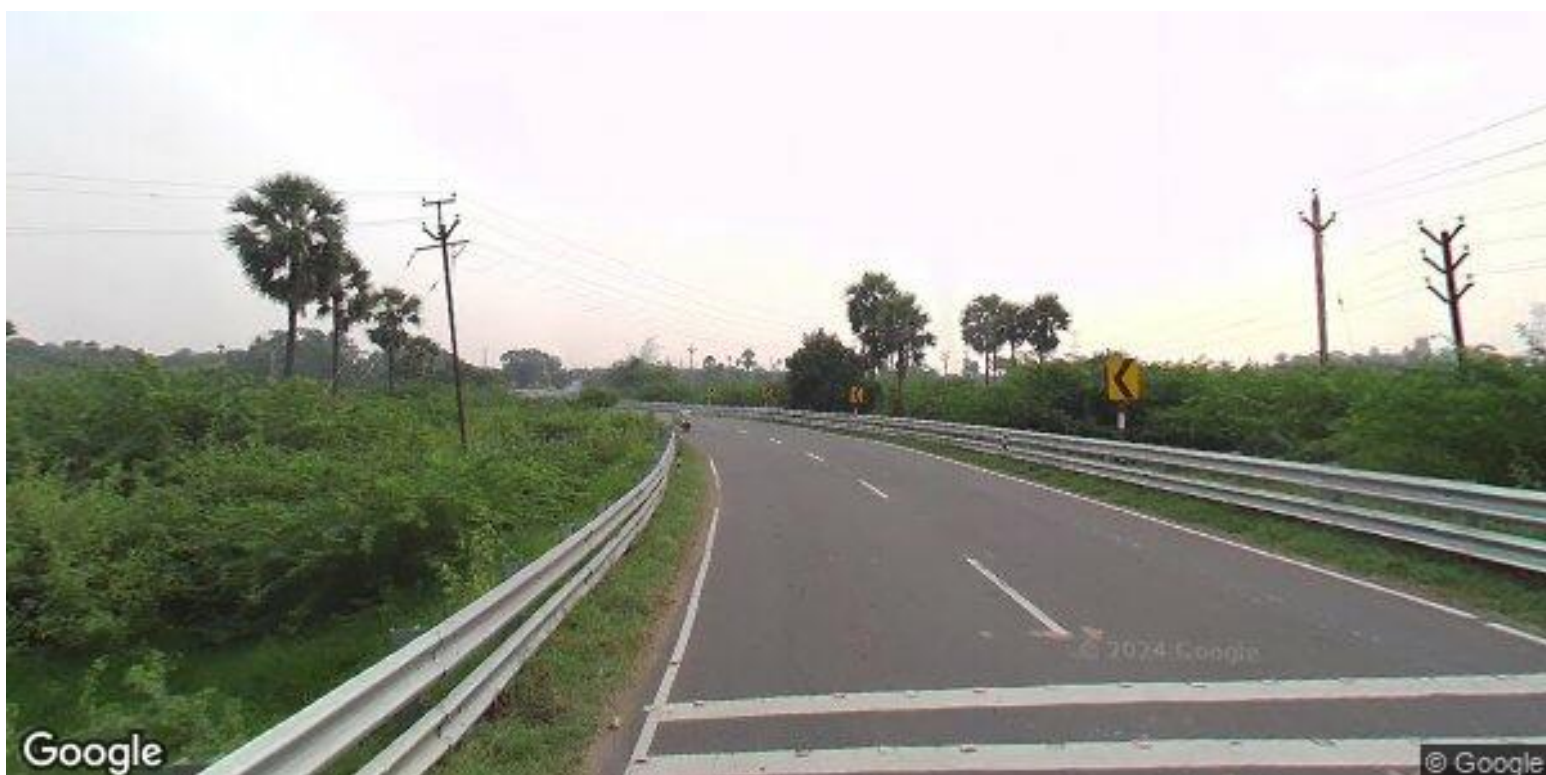
**Risk Type:** Turn  
**Risk Level:** Medium  
**Speed Limit:** 30 KM/Hr  
**Coordinates:** 10.94900, 77.54681

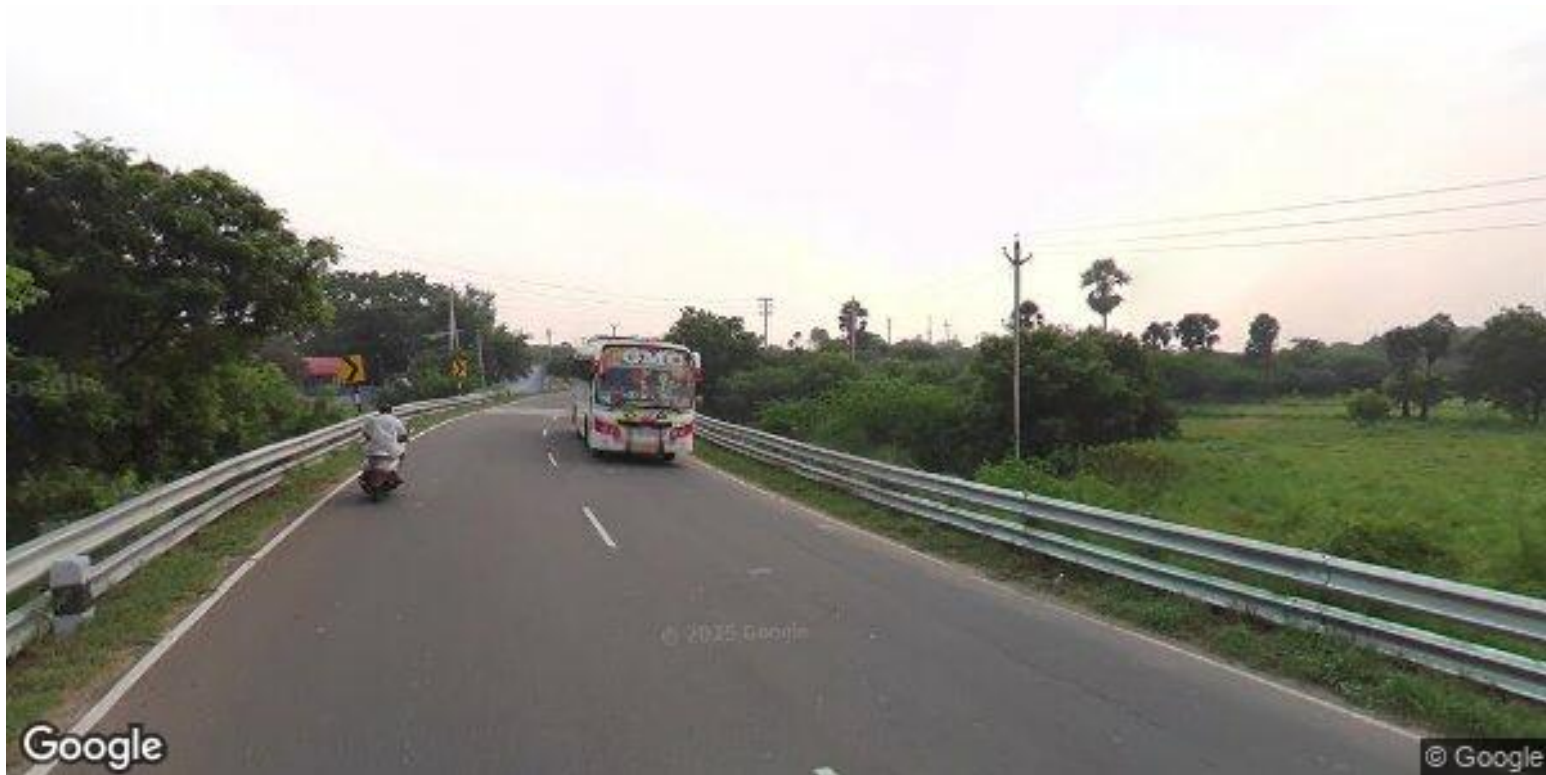
**Risk Type:** Turn  
**Risk Level:** Medium  
**Speed Limit:** 30 KM/Hr  
**Coordinates:** 10.94764, 77.54709

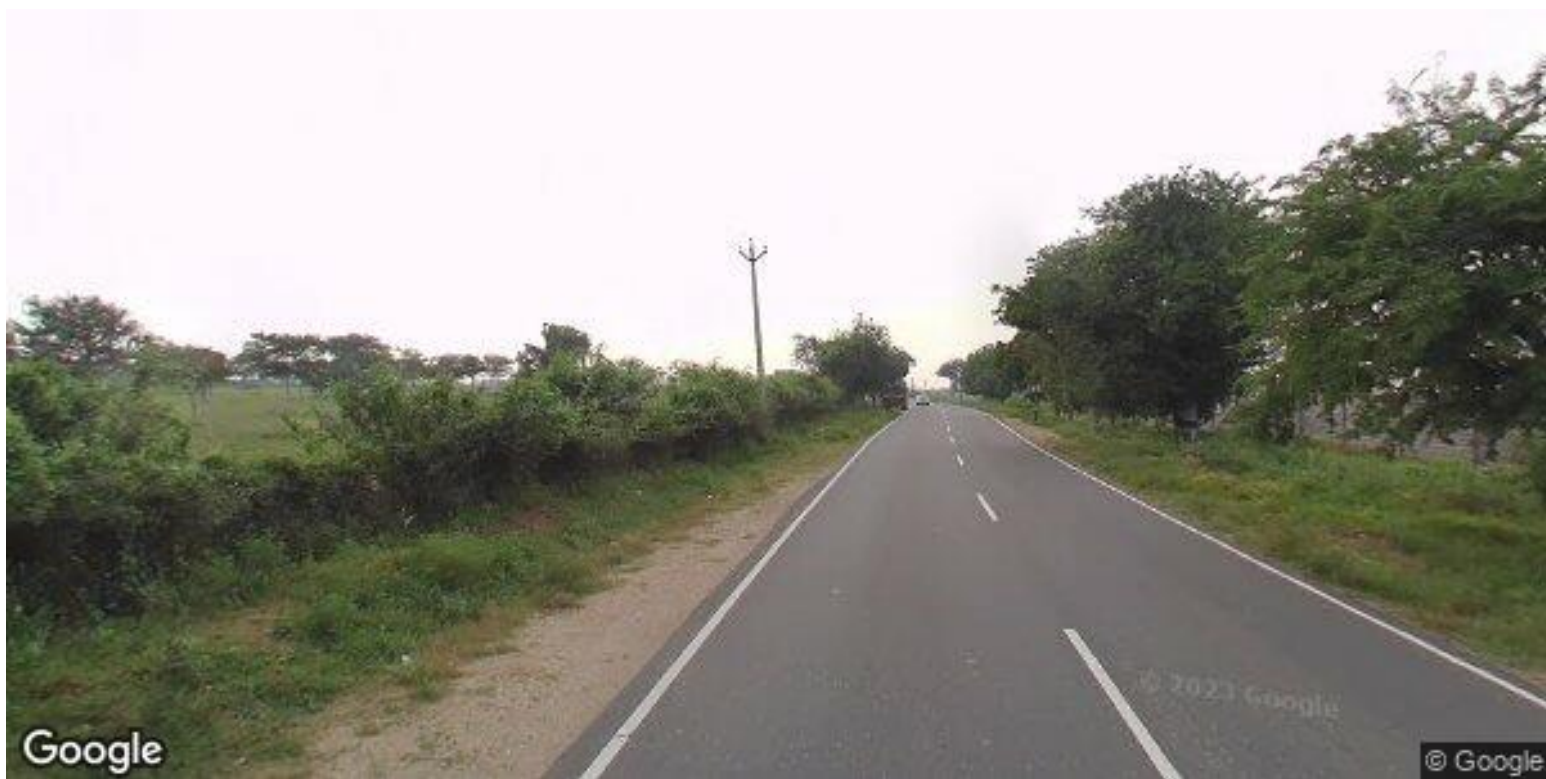
**Risk Type:** Turn  
**Risk Level:** Medium  
**Speed Limit:** 30 KM/Hr  
**Coordinates:** 10.93853, 77.53921

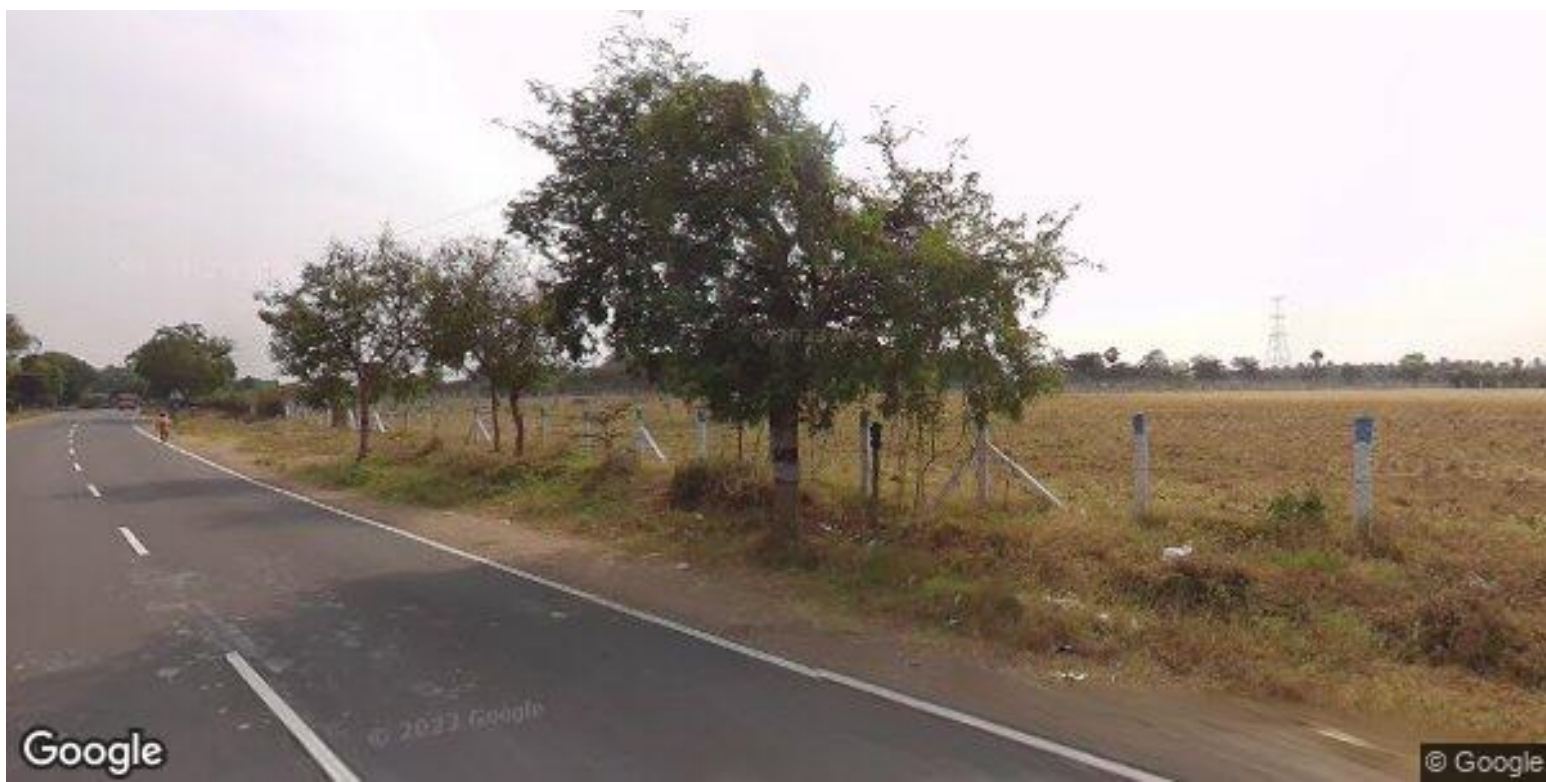
**Coordinates:** 10.93794, 77.53764

**Risk Type:** Turn

**Risk Level:** Medium

**Speed Limit:** 30 KM/Hr

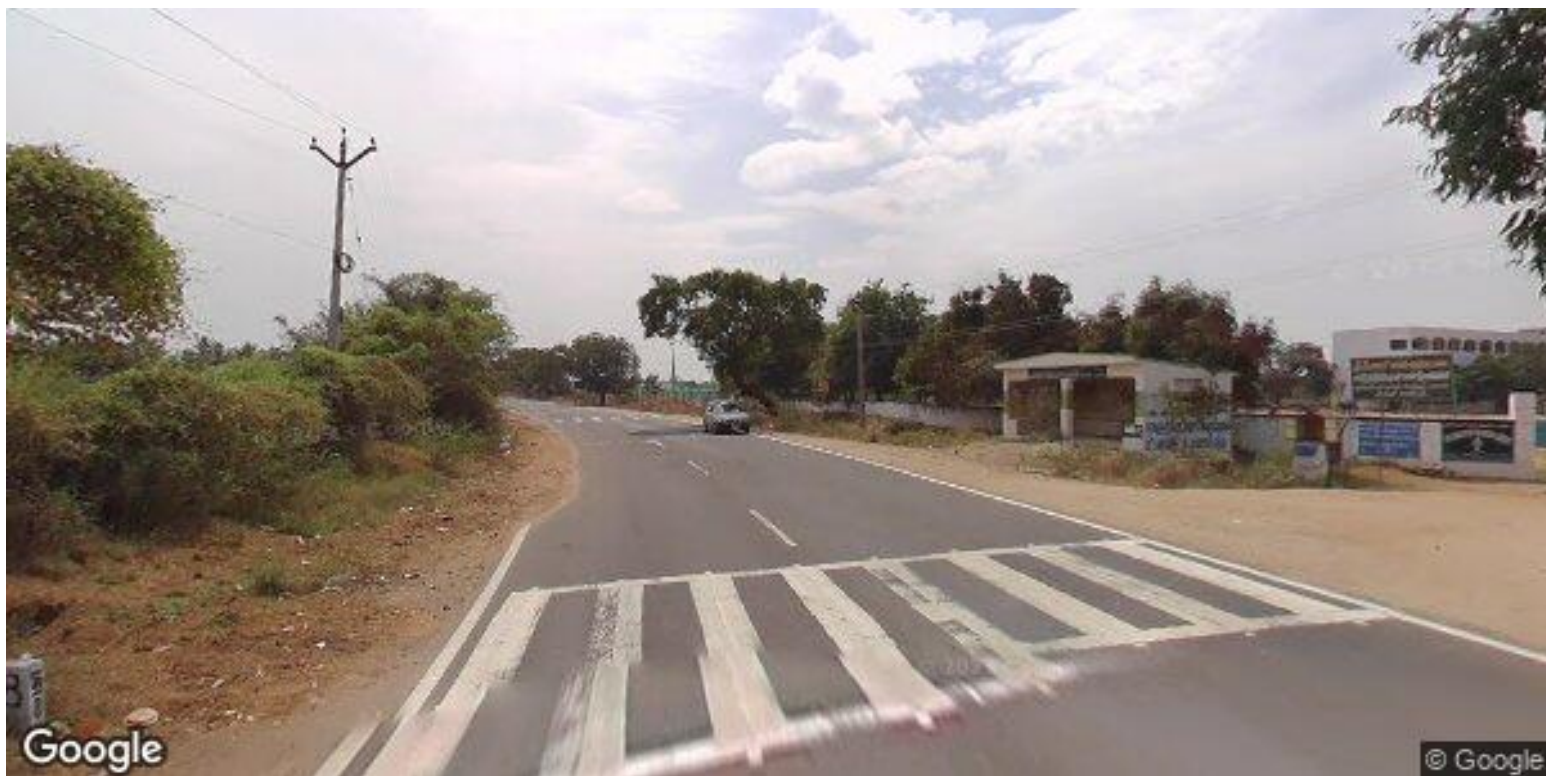
**Coordinates:** 10.93006, 77.53262

**Risk Type:** Turn

**Risk Level:** High

**Speed Limit:** 15 KM/Hr

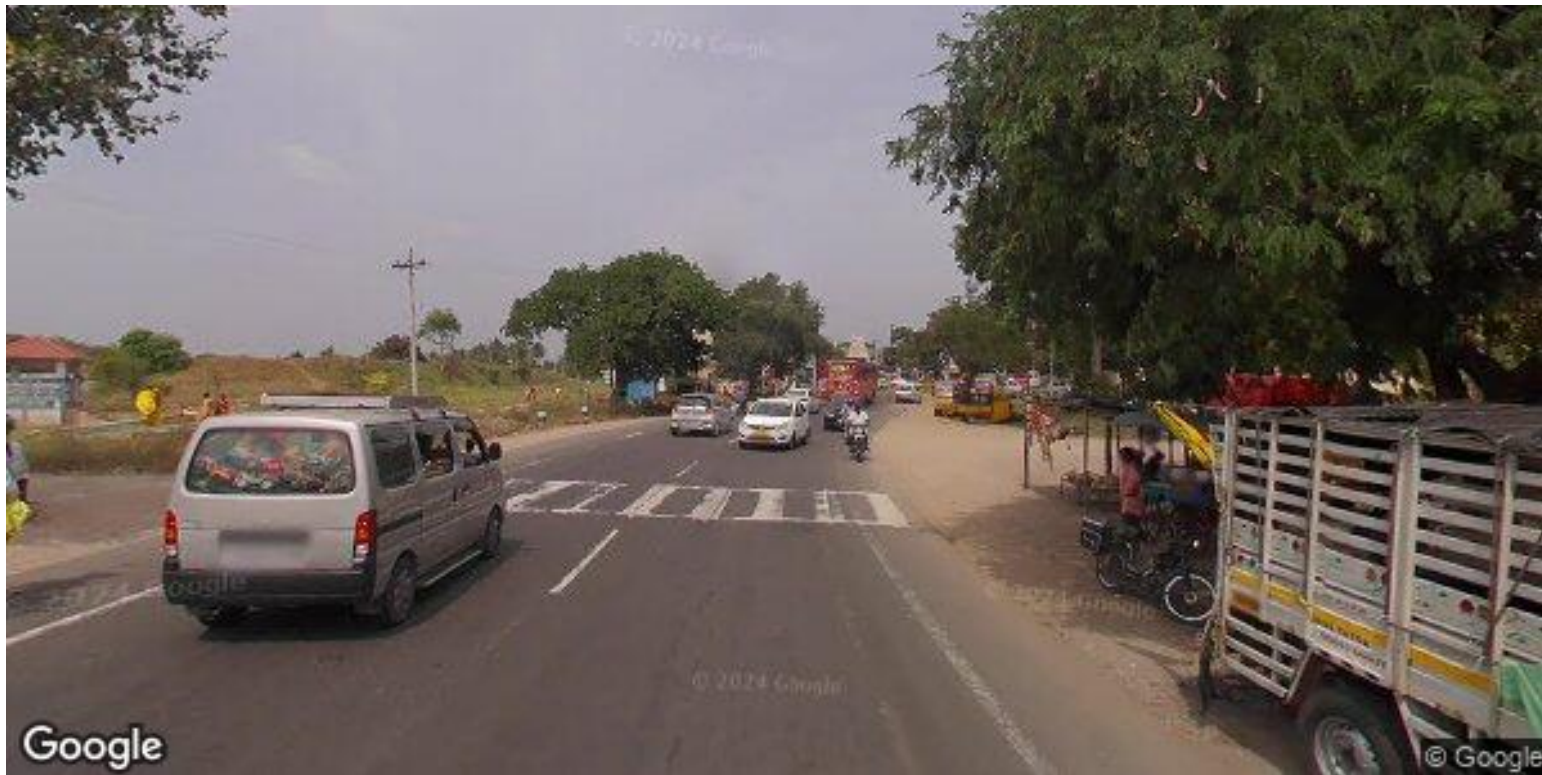
**Risk Type:** Turn  
**Risk Level:** Medium  
**Speed Limit:** 30 KM/Hr  
**Coordinates:** 10.89172, 77.52640

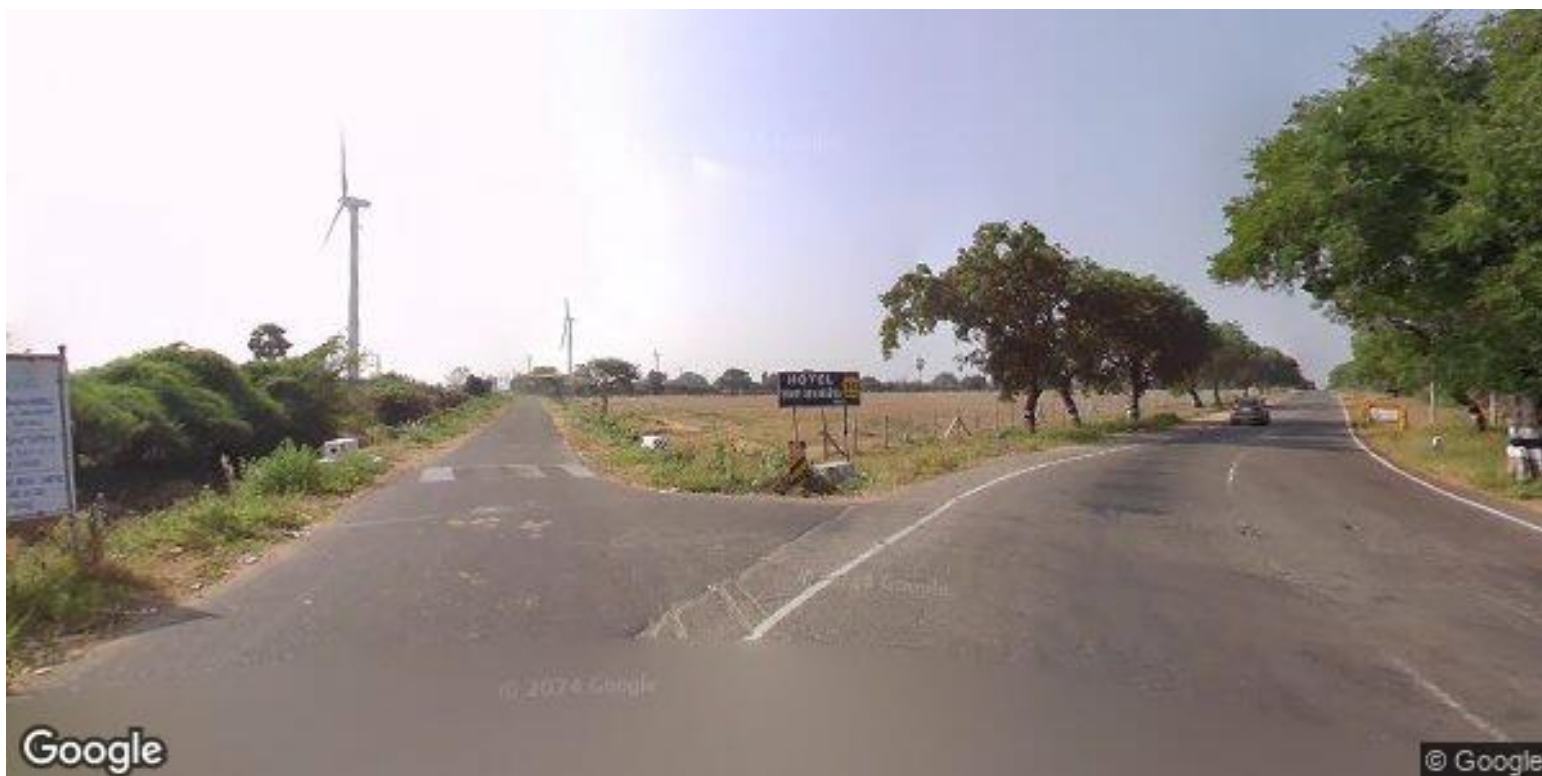
**Risk Type:** Turn  
**Risk Level:** Medium  
**Speed Limit:** 30 KM/Hr  
**Coordinates:** 10.83409, 77.52932

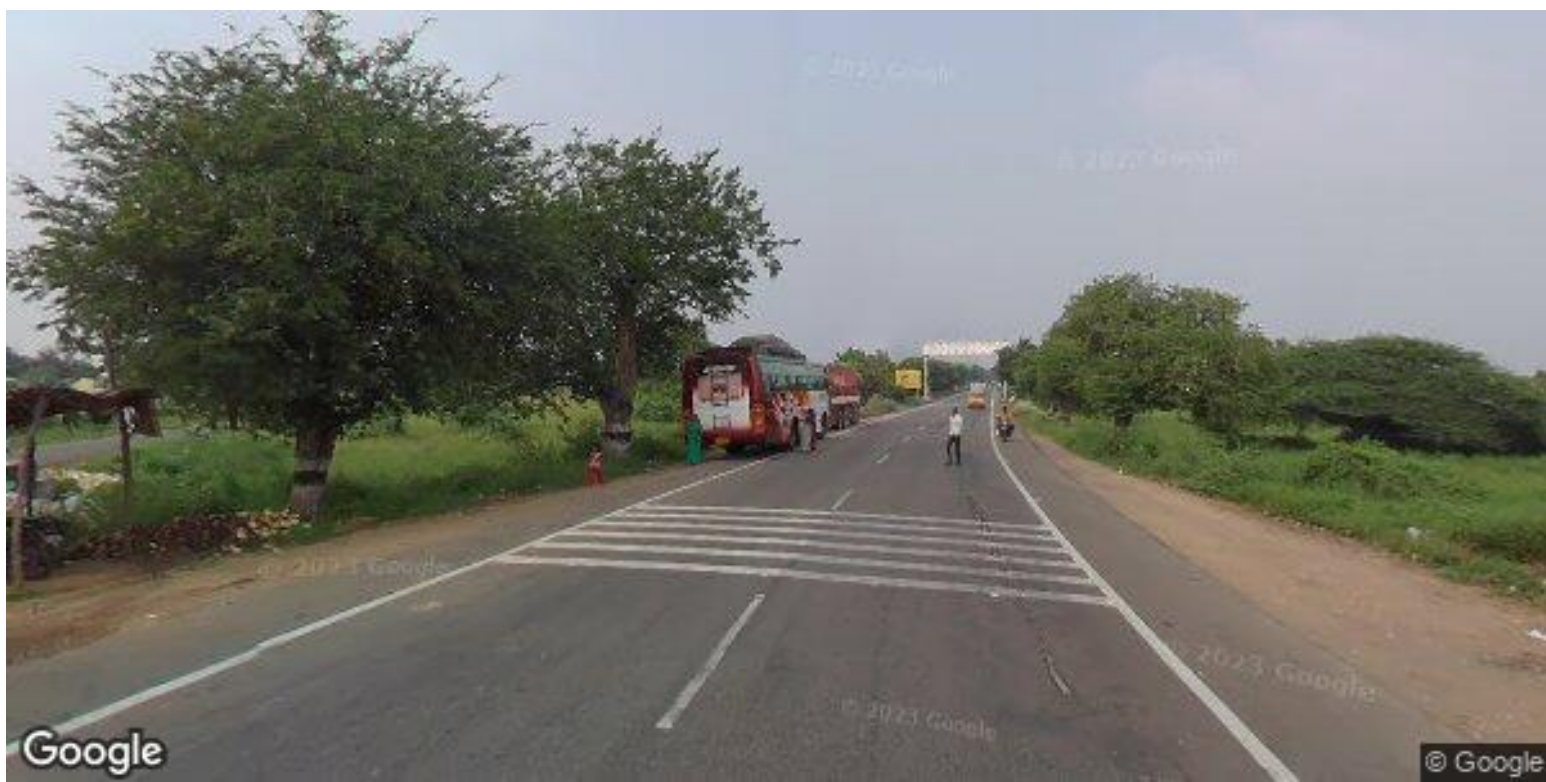
**Coordinates:** 10.77676, 77.50724

**Risk Type:** Turn

**Risk Level:** Medium

**Speed Limit:** 30 KM/Hr

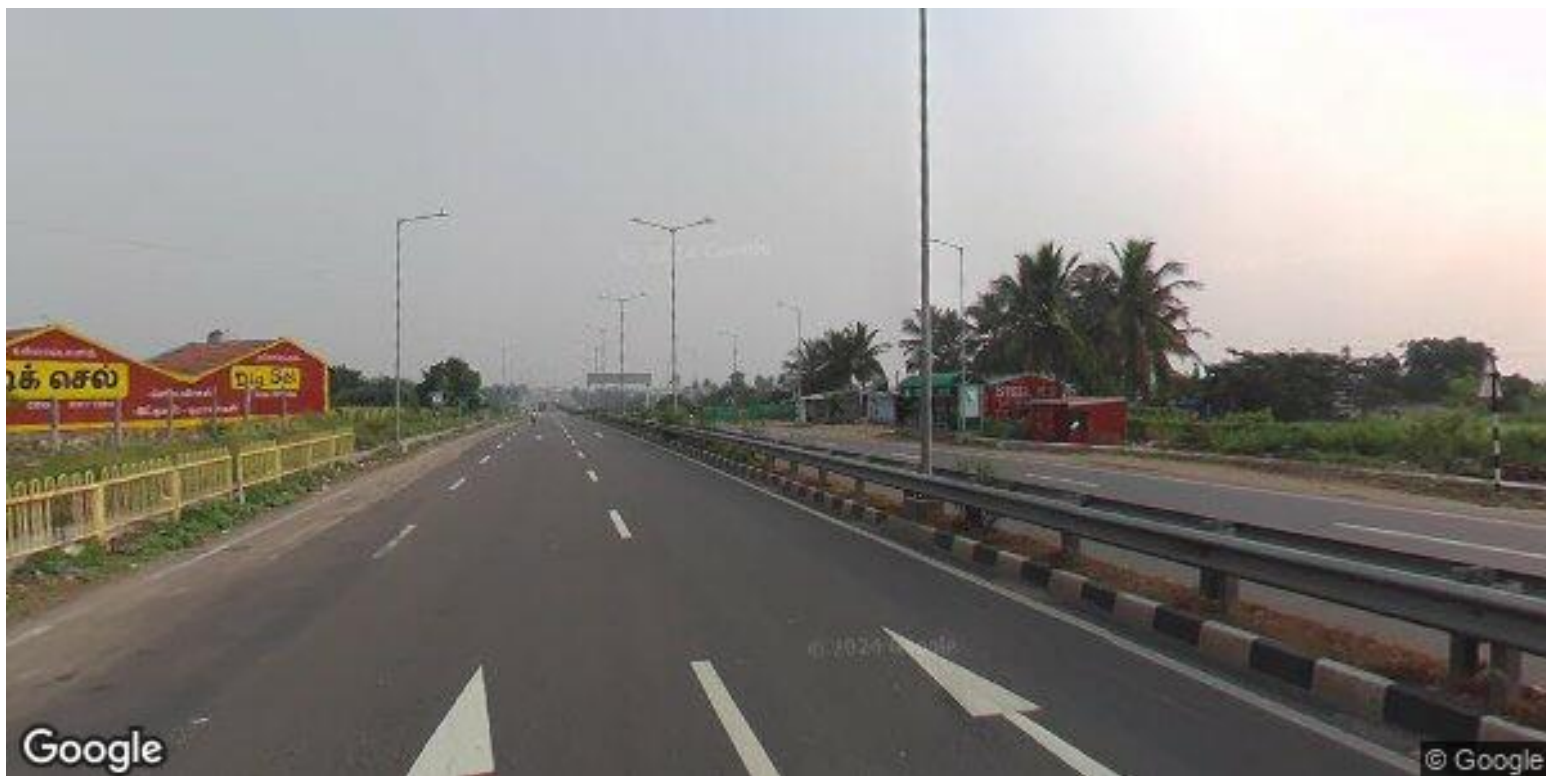
**Coordinates:** 10.77580, 77.50724

**Risk Type:** Turn

**Risk Level:** Medium

**Speed Limit:** 30 KM/Hr

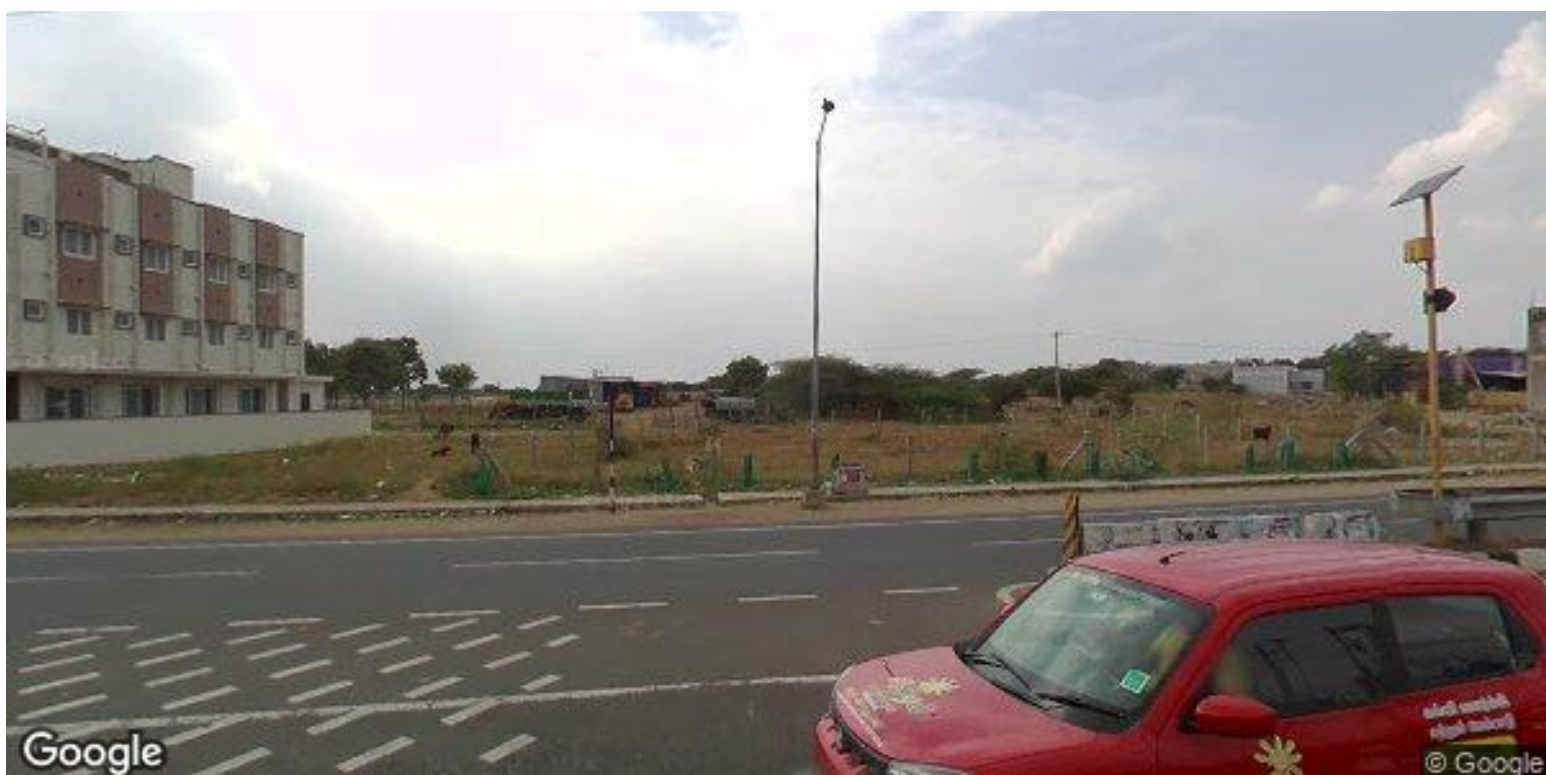
**Risk Type:** Turn  
**Risk Level:** High  
**Speed Limit:** 15 KM/Hr  
**Coordinates:** 10.75791, 77.51938

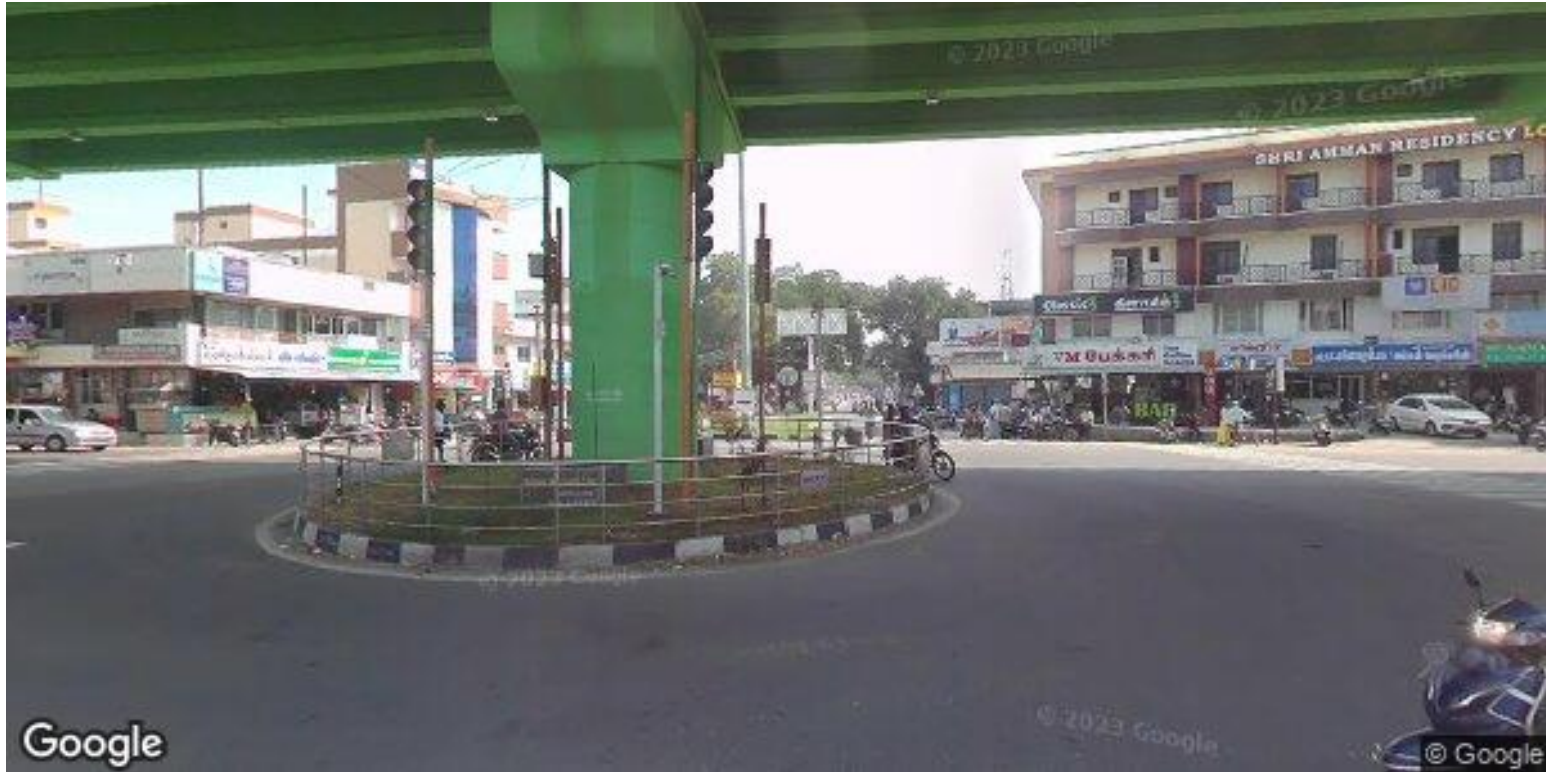
**Risk Type:** Turn  
**Risk Level:** High  
**Speed Limit:** 15 KM/Hr  
**Coordinates:** 10.73533, 77.51739

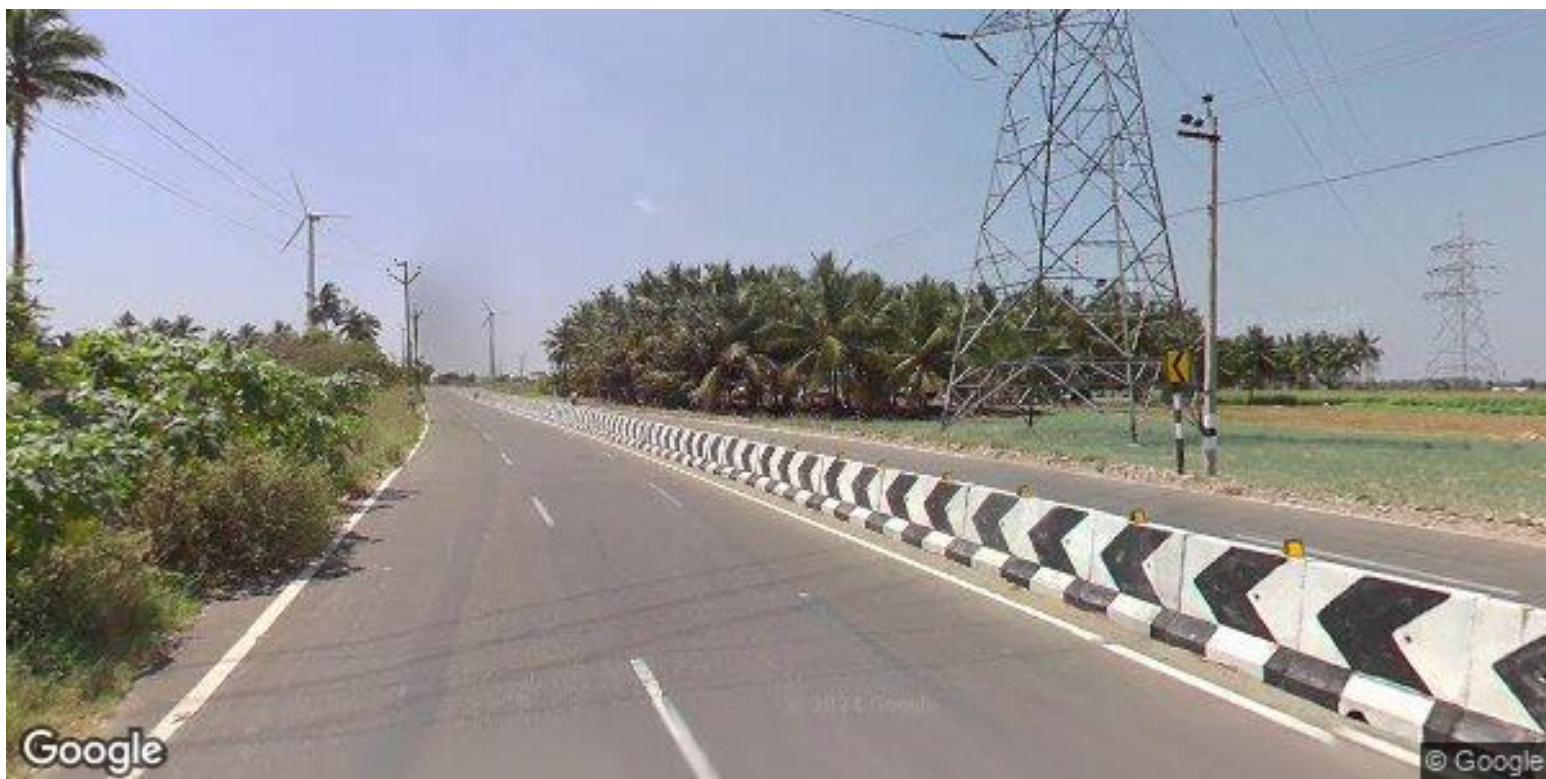
**Risk Type:** Turn  
**Risk Level:** Medium  
**Speed Limit:** 30 KM/Hr  
**Coordinates:** 10.70318, 77.39789

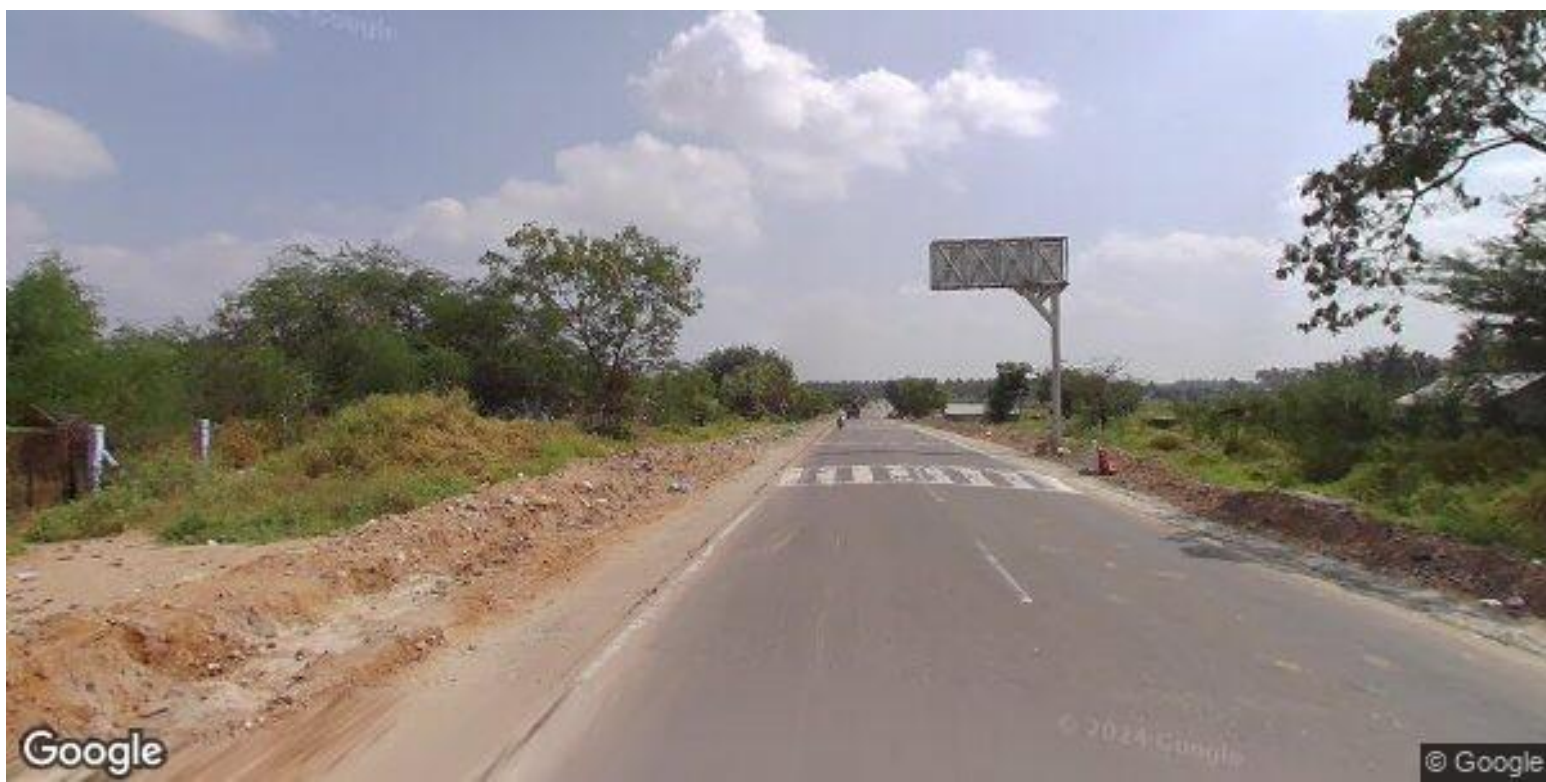
**Coordinates:** 10.68901, 77.28244

**Risk Type:** Turn

**Risk Level:** Medium

**Speed Limit:** 30 KM/Hr
