# IndianOil

## JOURNEY RISK MANAGEMENT (JRM) STUDY

### Salem Terminal to ARUL MURUGAN AGENCIES

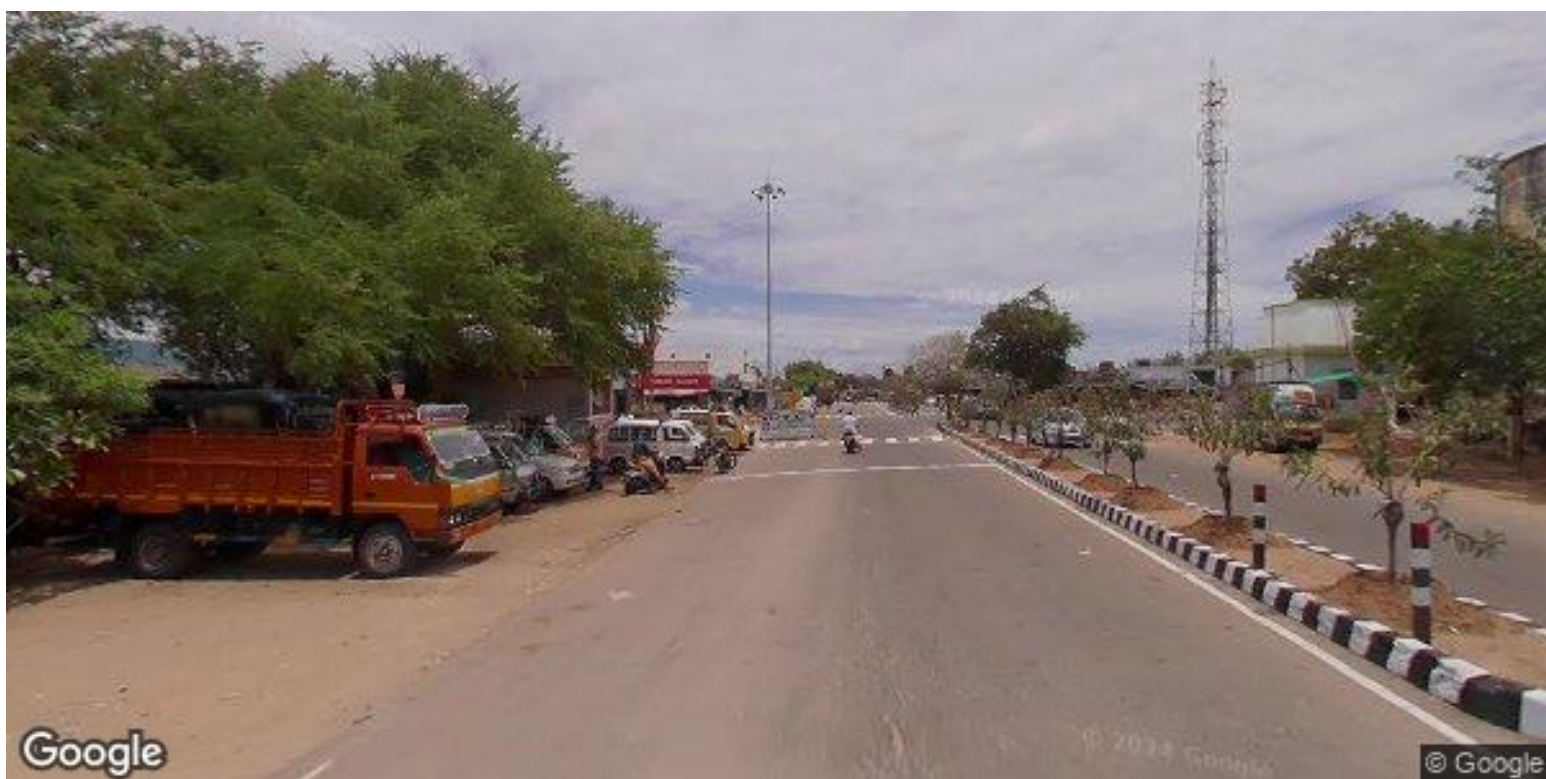
**Coordinates:** 10.68872, 77.28115

**Risk Type:** Turn

**Risk Level:** High

**Speed Limit:** 15 KM/Hr

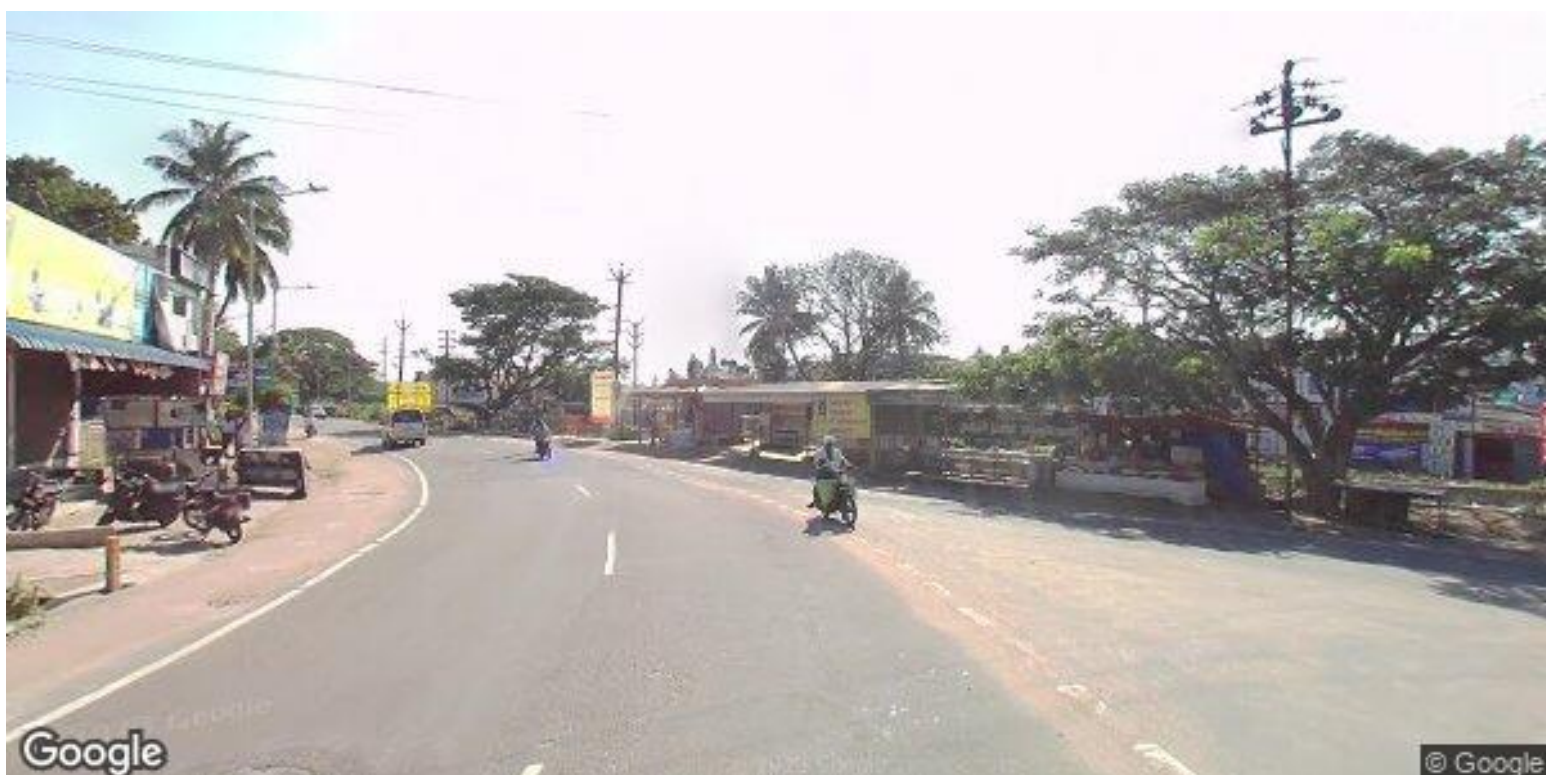
**Risk Type:** Turn  
**Risk Level:** High  
**Speed Limit:** 15 KM/Hr  
**Coordinates:** 10.59566, 77.24559

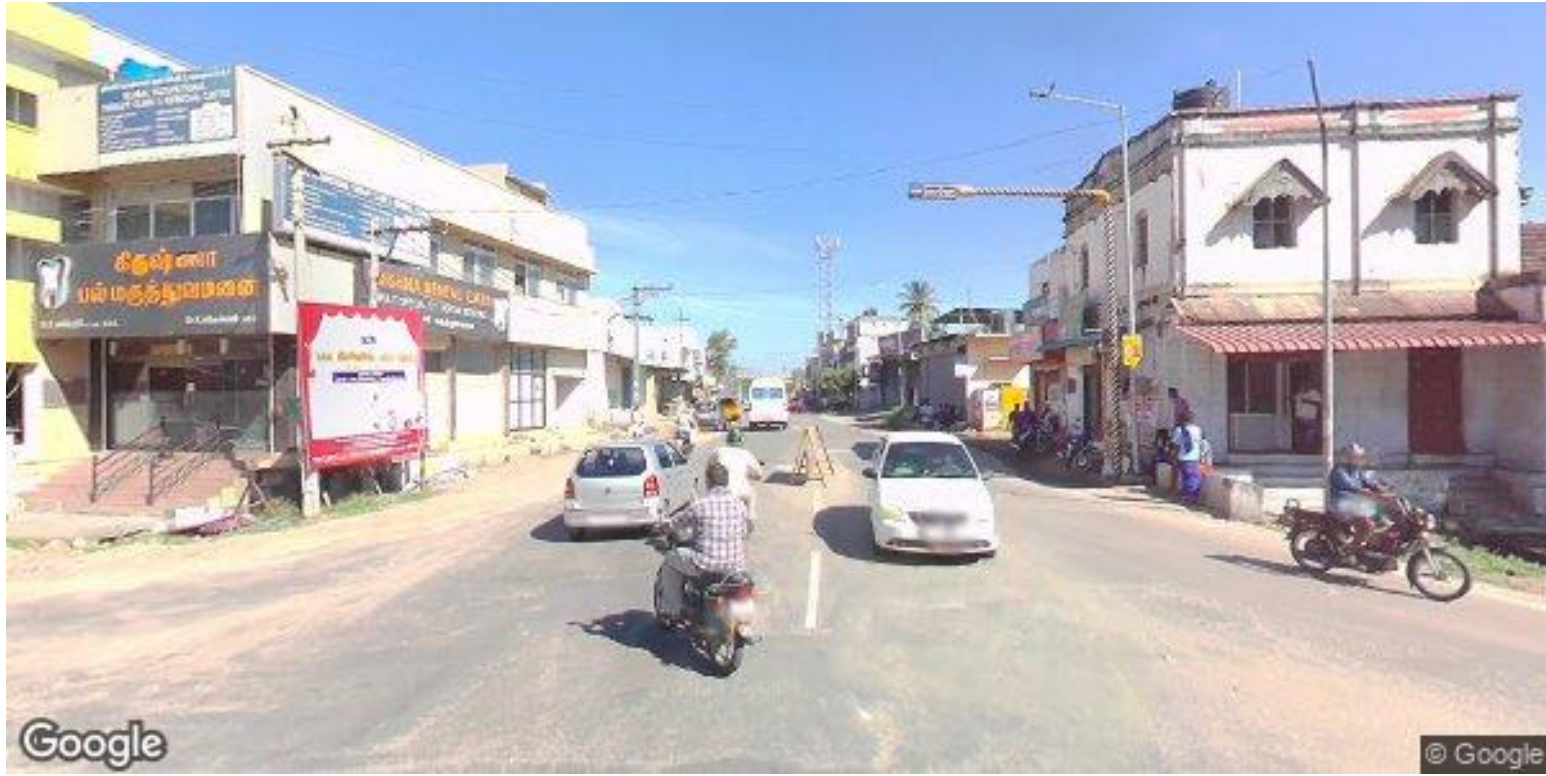
**Risk Type:** Turn  
**Risk Level:** High  
**Speed Limit:** 15 KM/Hr  
**Coordinates:** 10.58828, 77.24496

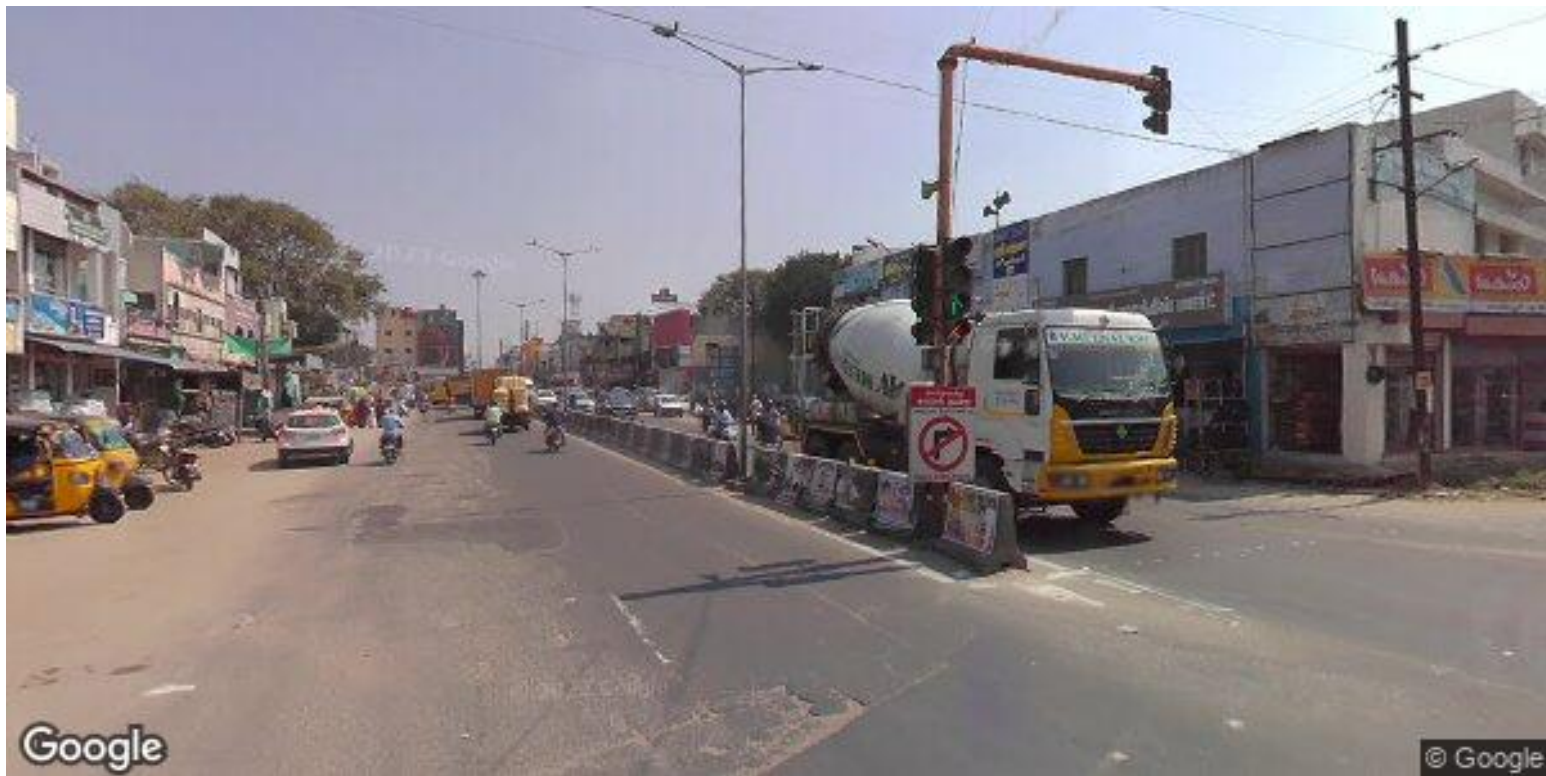
**Risk Type:** Blind Spot  
**Risk Level:** Blind Spot  
**Speed Limit:** 10 KM/Hr  
**Coordinates:** 10.58797, 77.24603

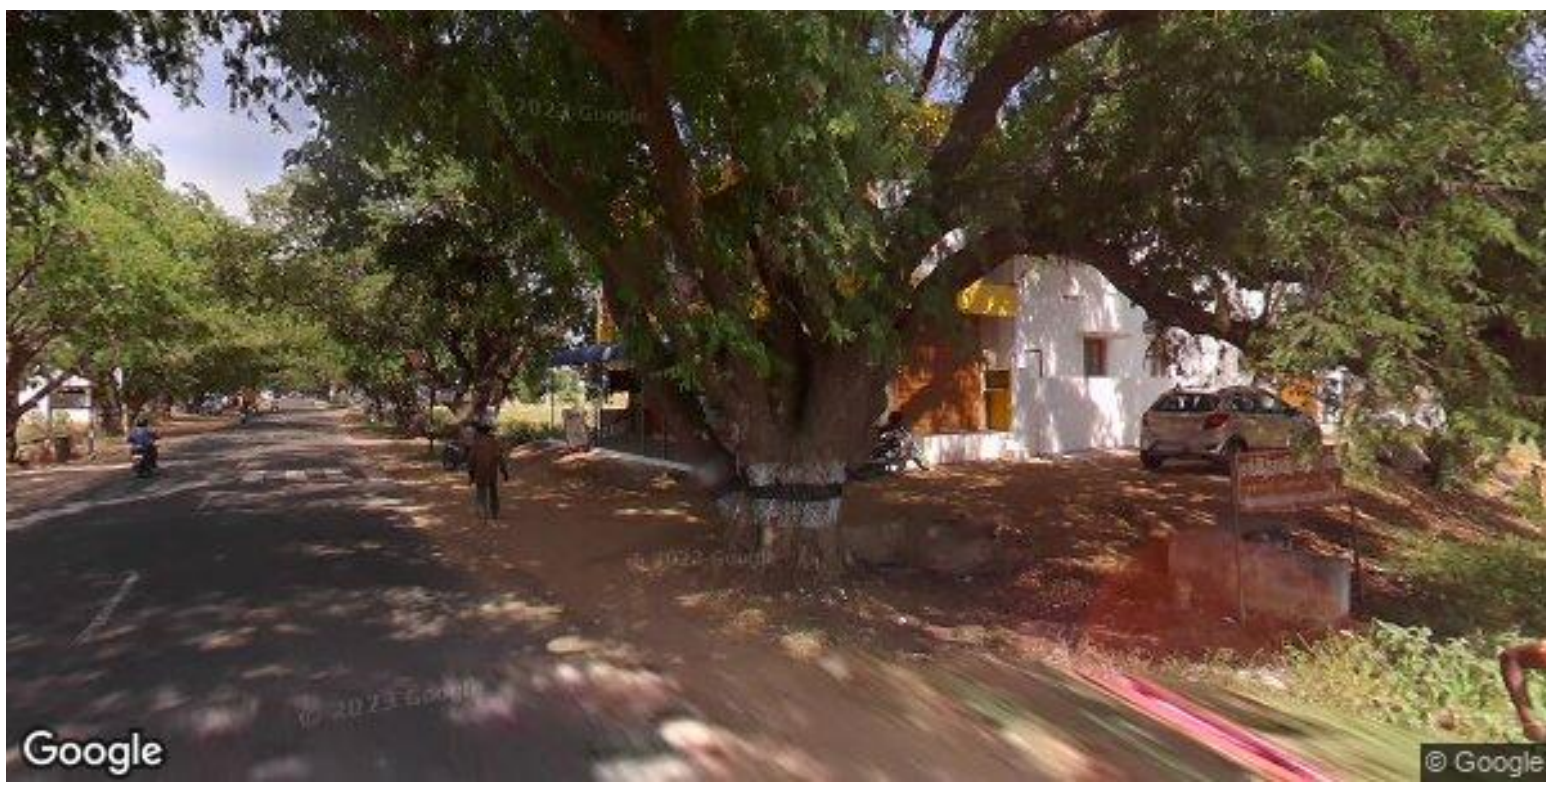
**Coordinates:** 10.53874, 77.22421

**Risk Type:** Turn

**Risk Level:** Medium

**Speed Limit:** 30 KM/Hr

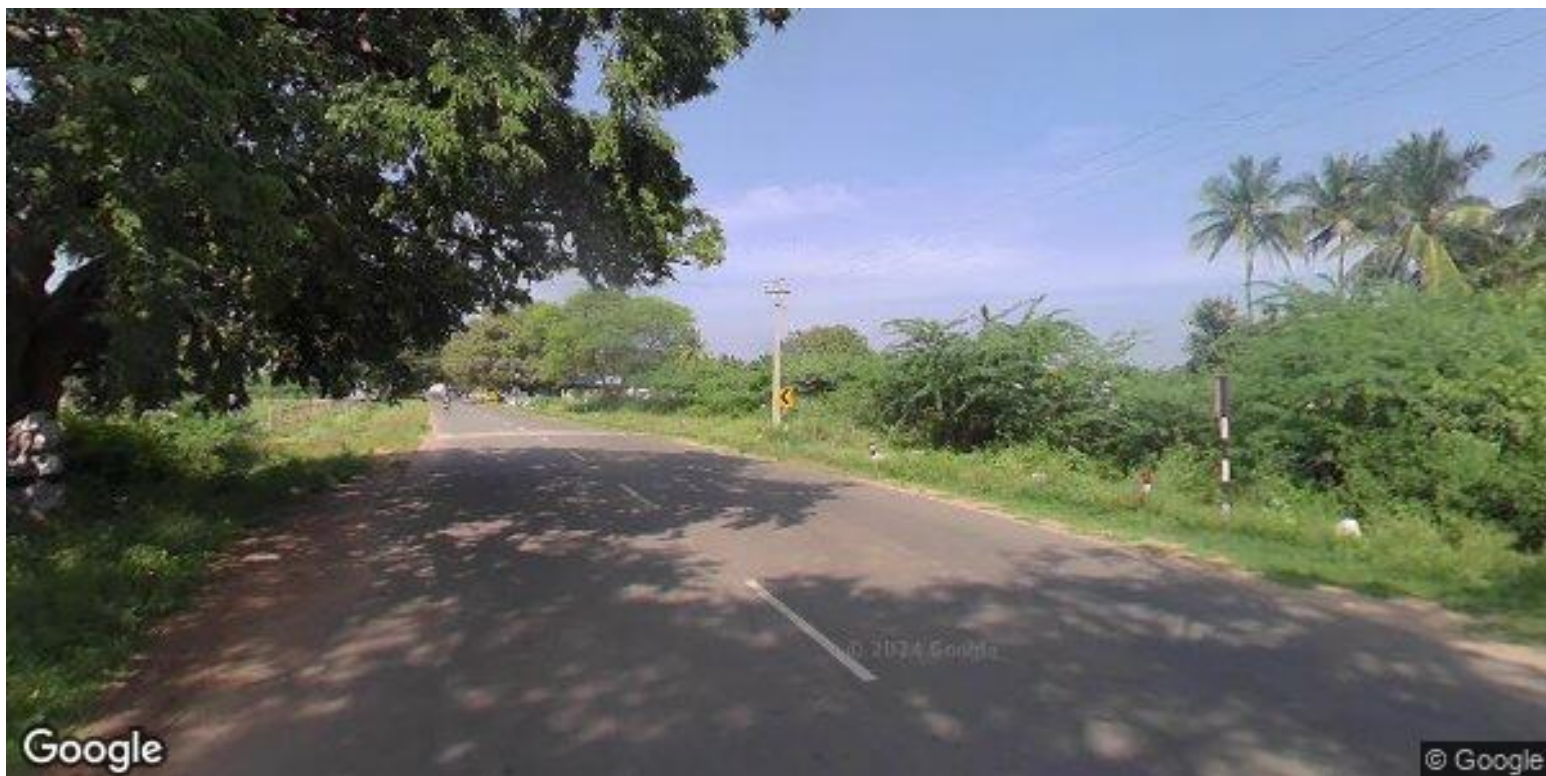
**Coordinates:** 10.53483, 77.22429

**Risk Type:** Turn

**Risk Level:** High

**Speed Limit:** 15 KM/Hr

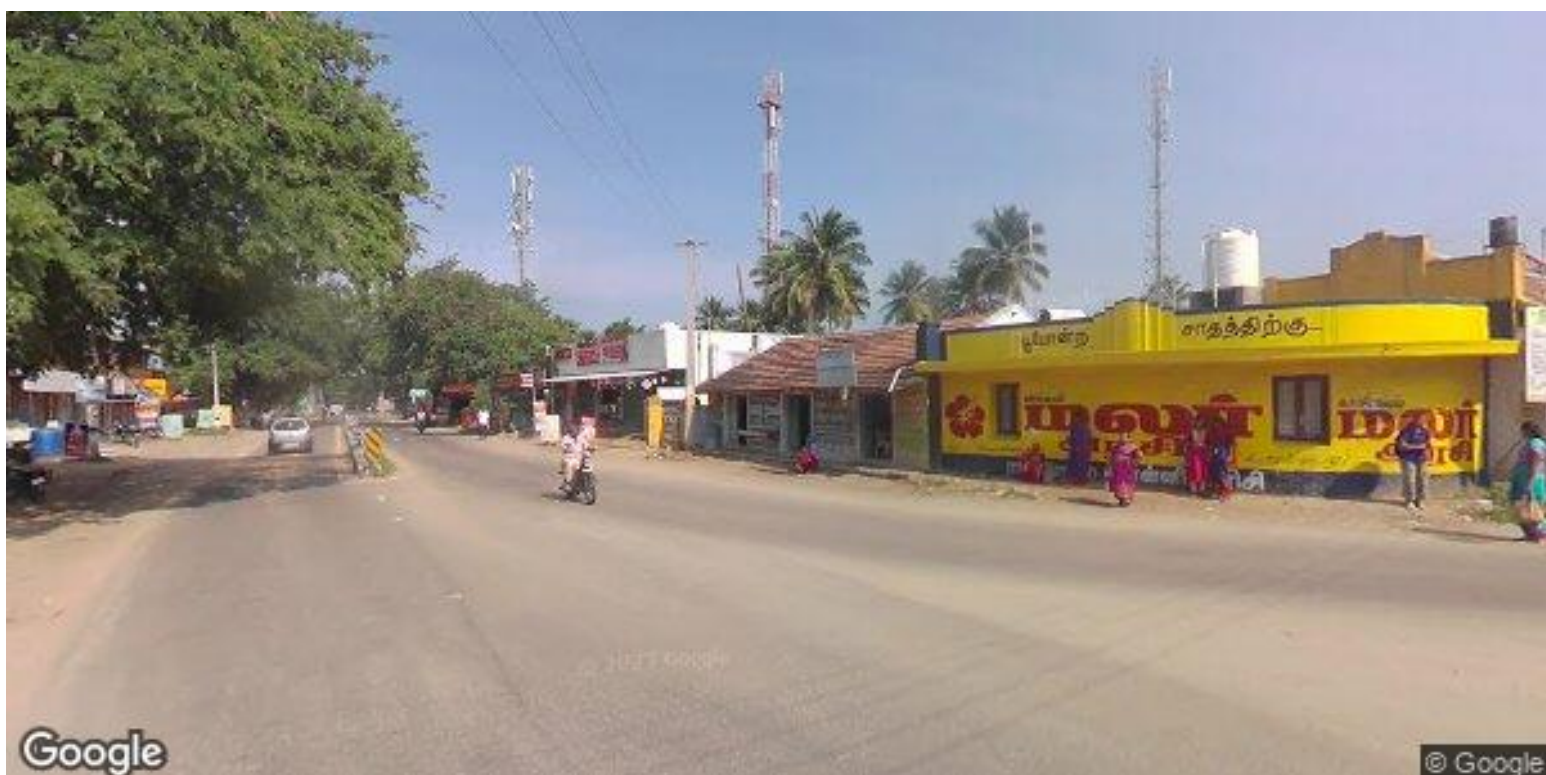
**Risk Type:** Blind Spot  
**Risk Level:** Blind Spot  
**Speed Limit:** 10 KM/Hr  
**Coordinates:** 10.53104, 77.22003

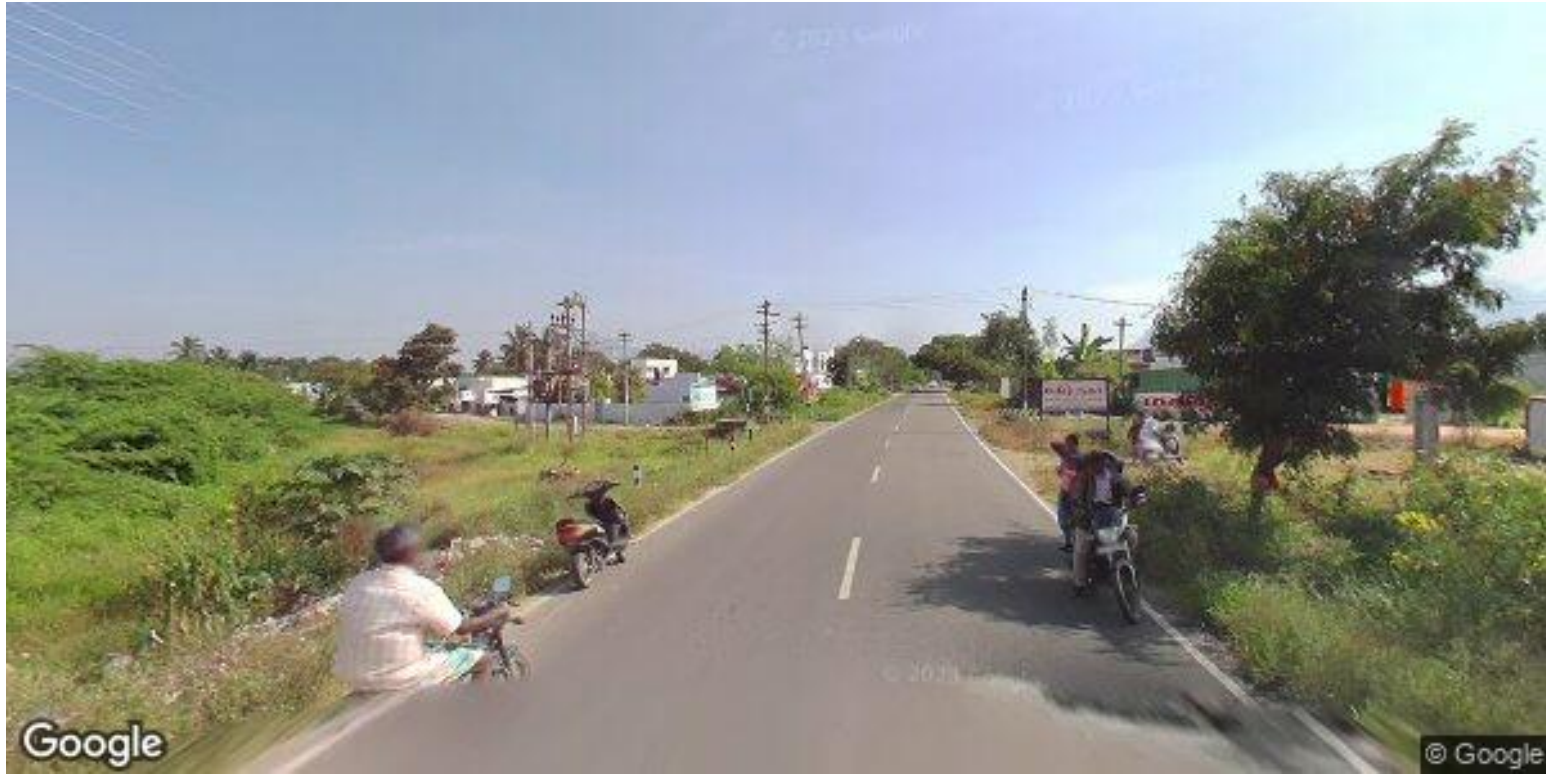
**Risk Type:** Turn  
**Risk Level:** Medium  
**Speed Limit:** 30 KM/Hr  
**Coordinates:** 10.52368, 77.22684

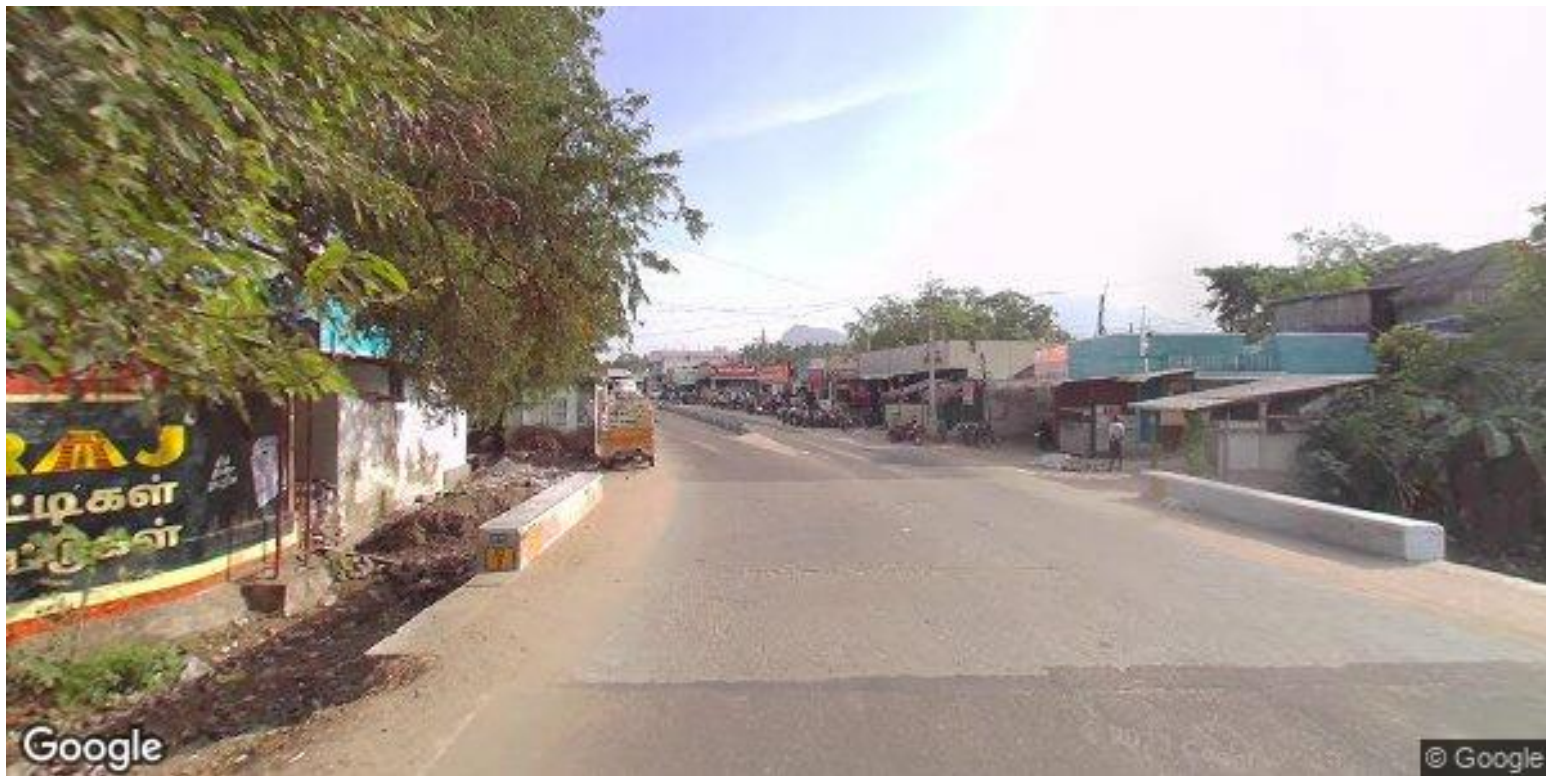
**Risk Type:** Turn  
**Risk Level:** Medium  
**Speed Limit:** 30 KM/Hr  
**Coordinates:** 10.50851, 77.22699

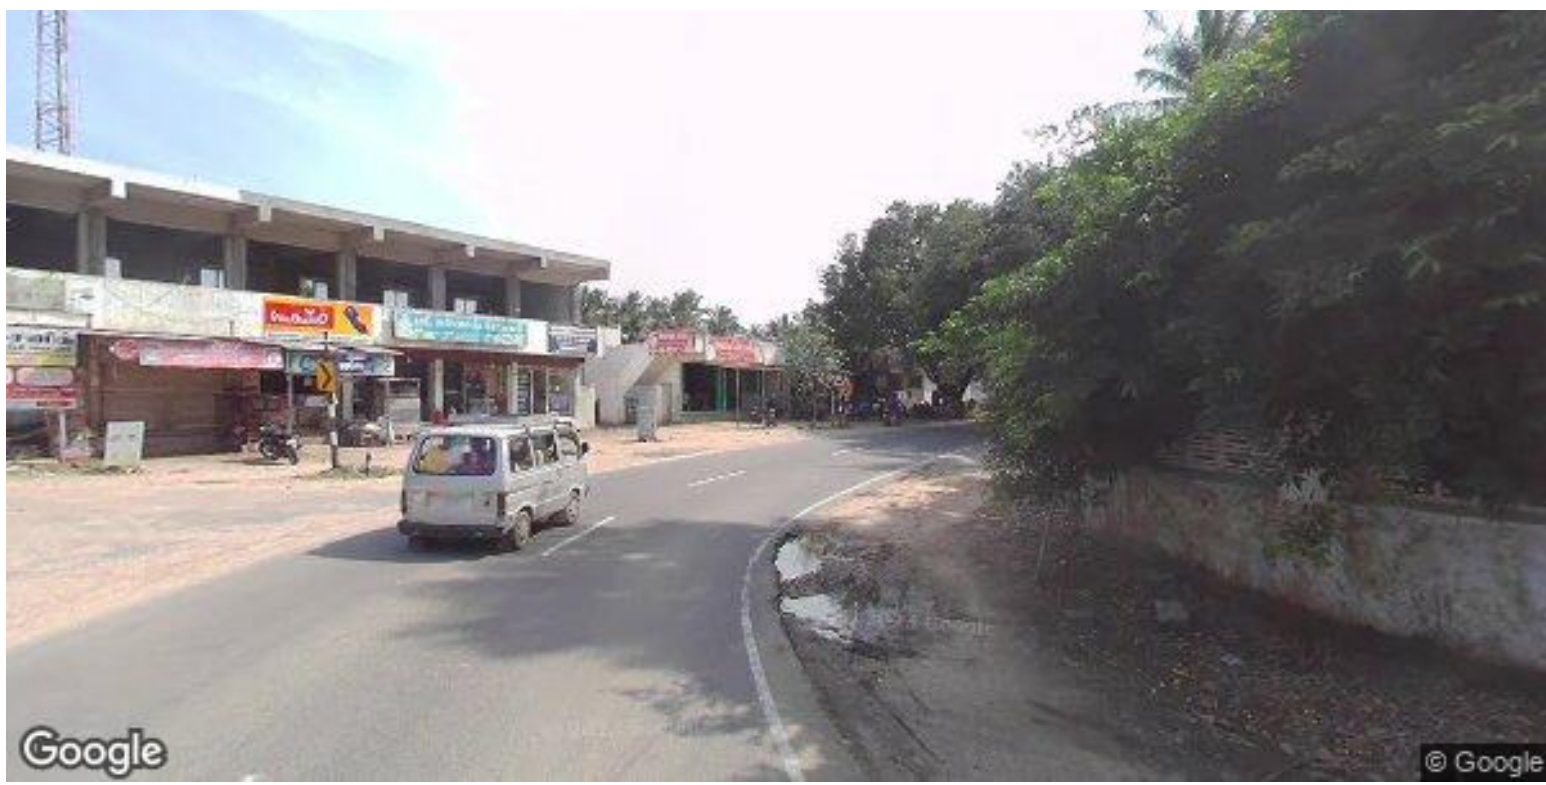
**Coordinates:** 10.49231, 77.24037

**Risk Type:** Turn

**Risk Level:** High

**Speed Limit:** 15 KM/Hr
