# IndianOil

## JOURNEY RISK MANAGEMENT (JRM) STUDY

### Salem Terminal TO AS PETROLEUM

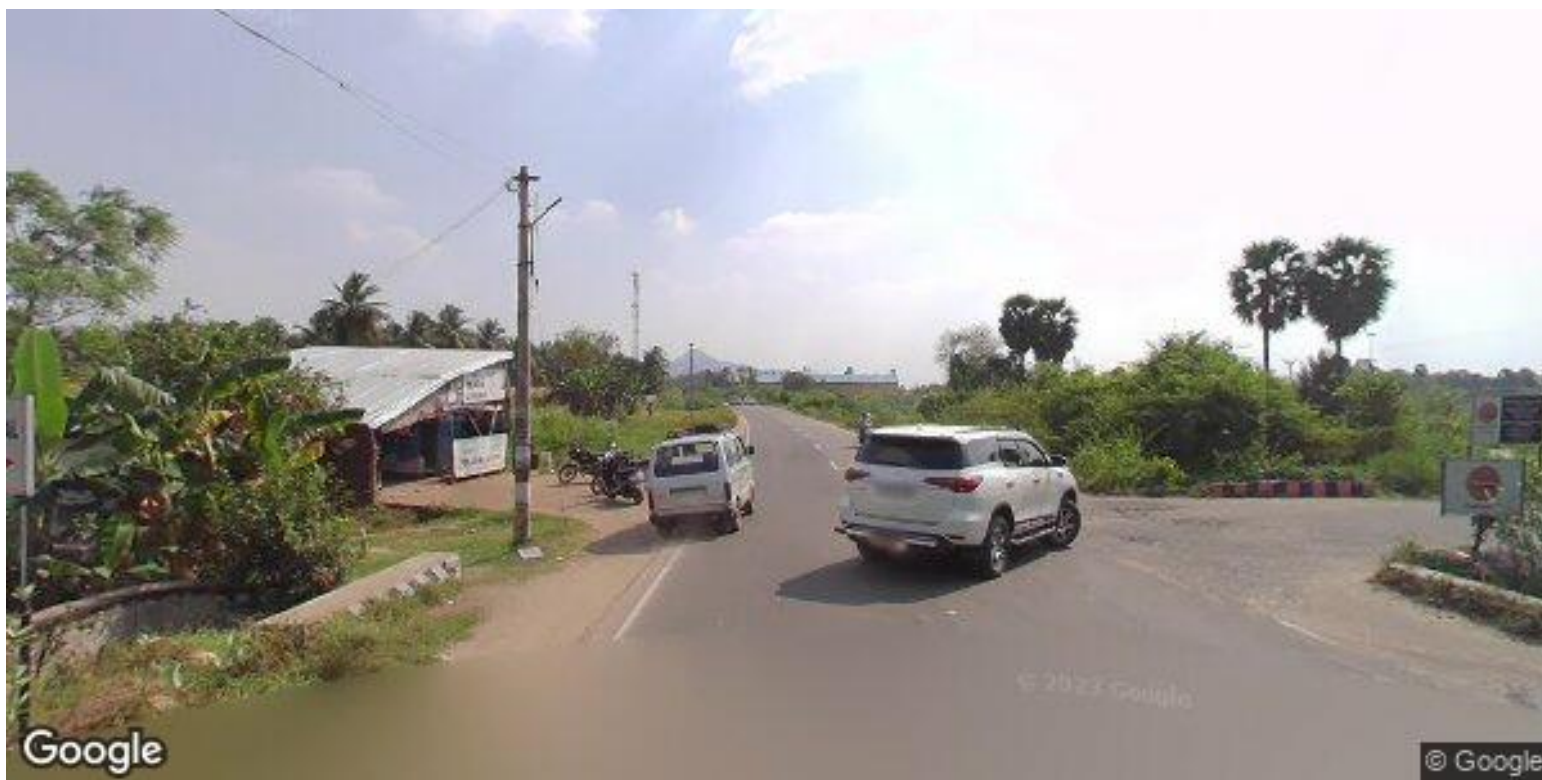
**Coordinates:** 11.44029, 77.87544

**Risk Type:** Turn

**Risk Level:** High

**Speed Limit:** 15 KM/Hr

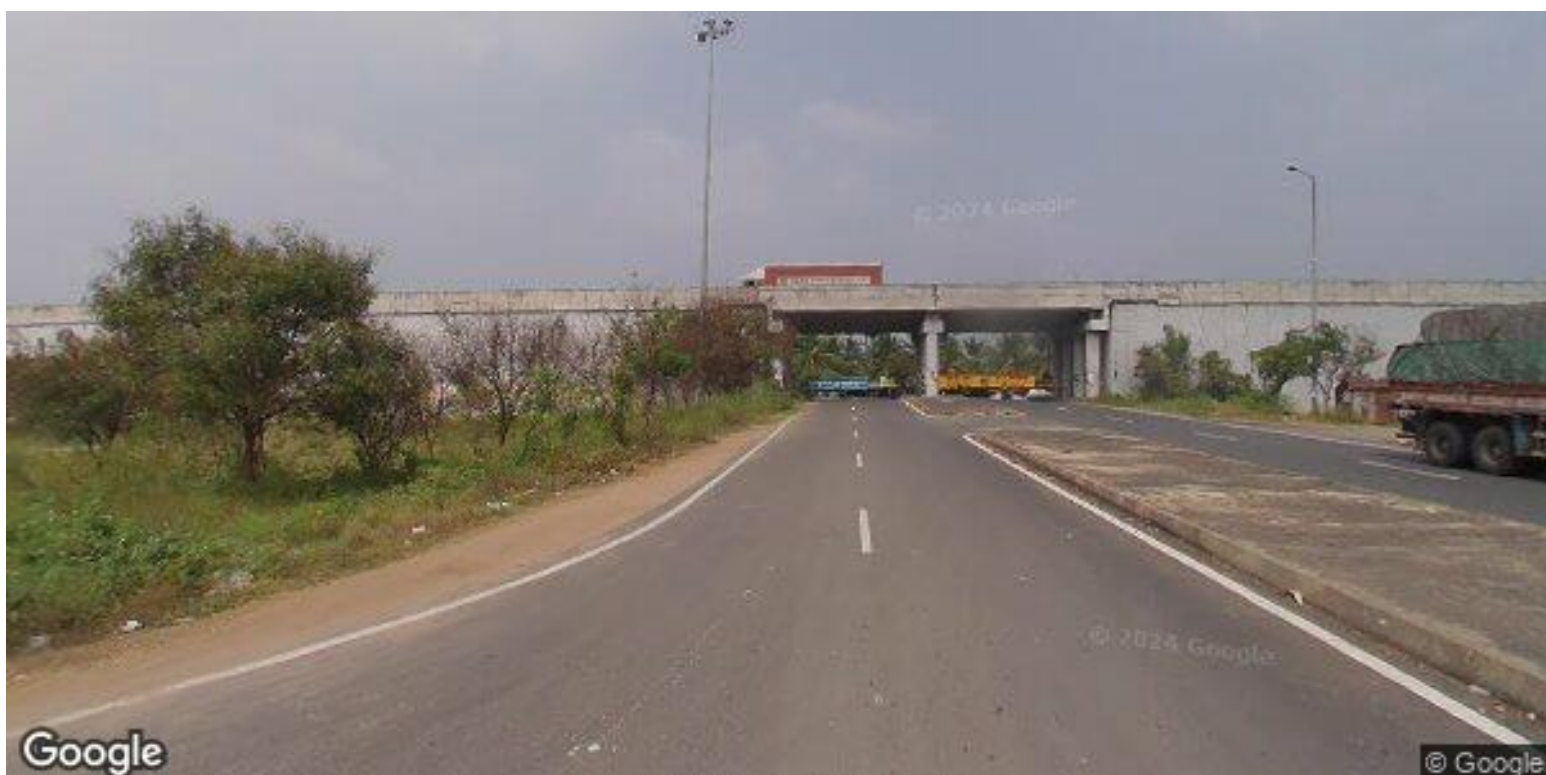
**Coordinates: 11.45563, 77.81708**

**Risk Type: Turn**

**Risk Level: Medium**

**Speed Limit: 30 KM/Hr**

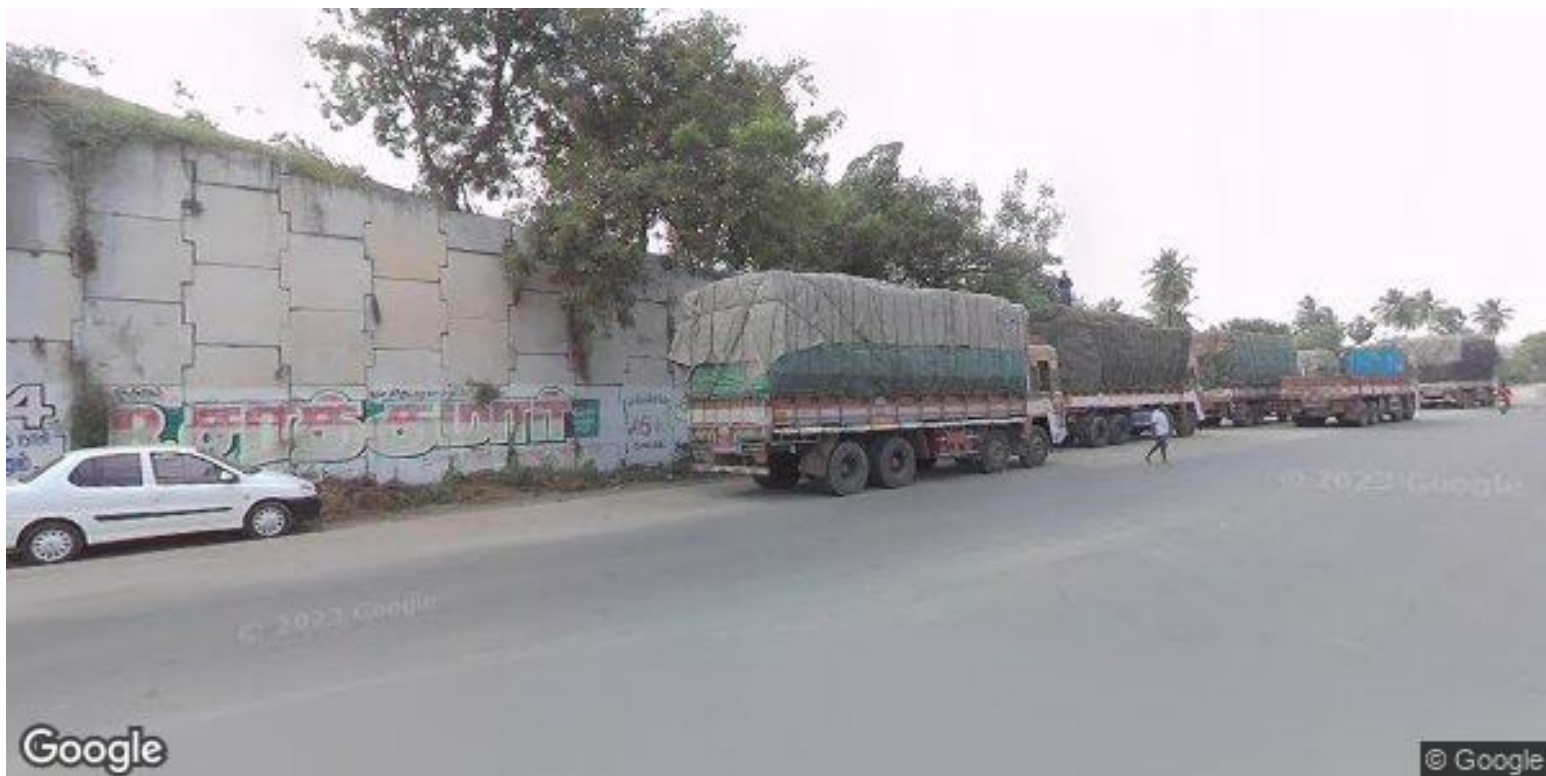
**Coordinates:** 11.49365, 77.88596

**Risk Type:** Turn

**Risk Level:** Medium

**Speed Limit:** 30 KM/Hr

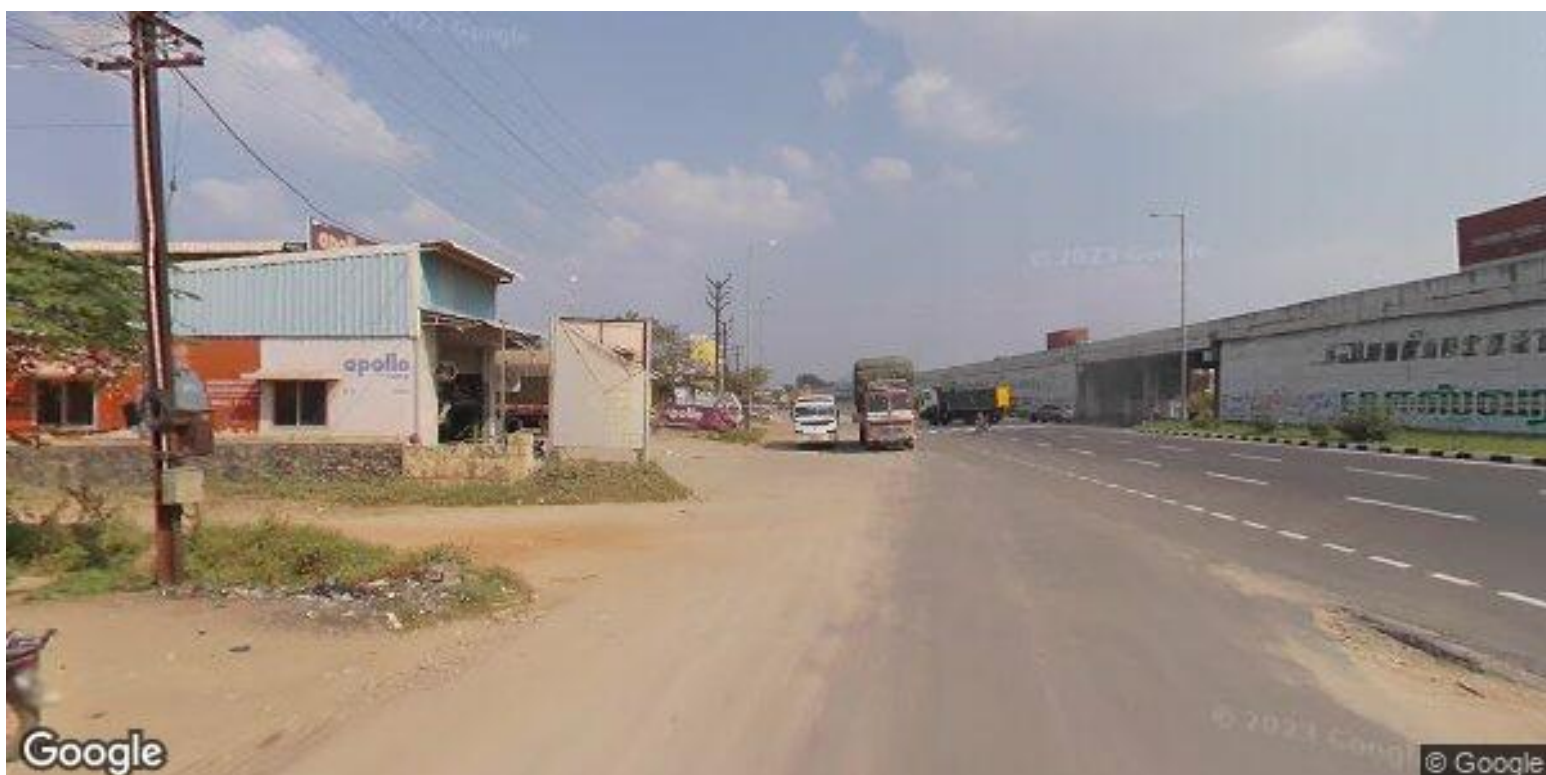
**Risk Type:** Turn  
**Risk Level:** High  
**Speed Limit:** 15 KM/Hr  
**Coordinates:** 11.49236, 77.89552

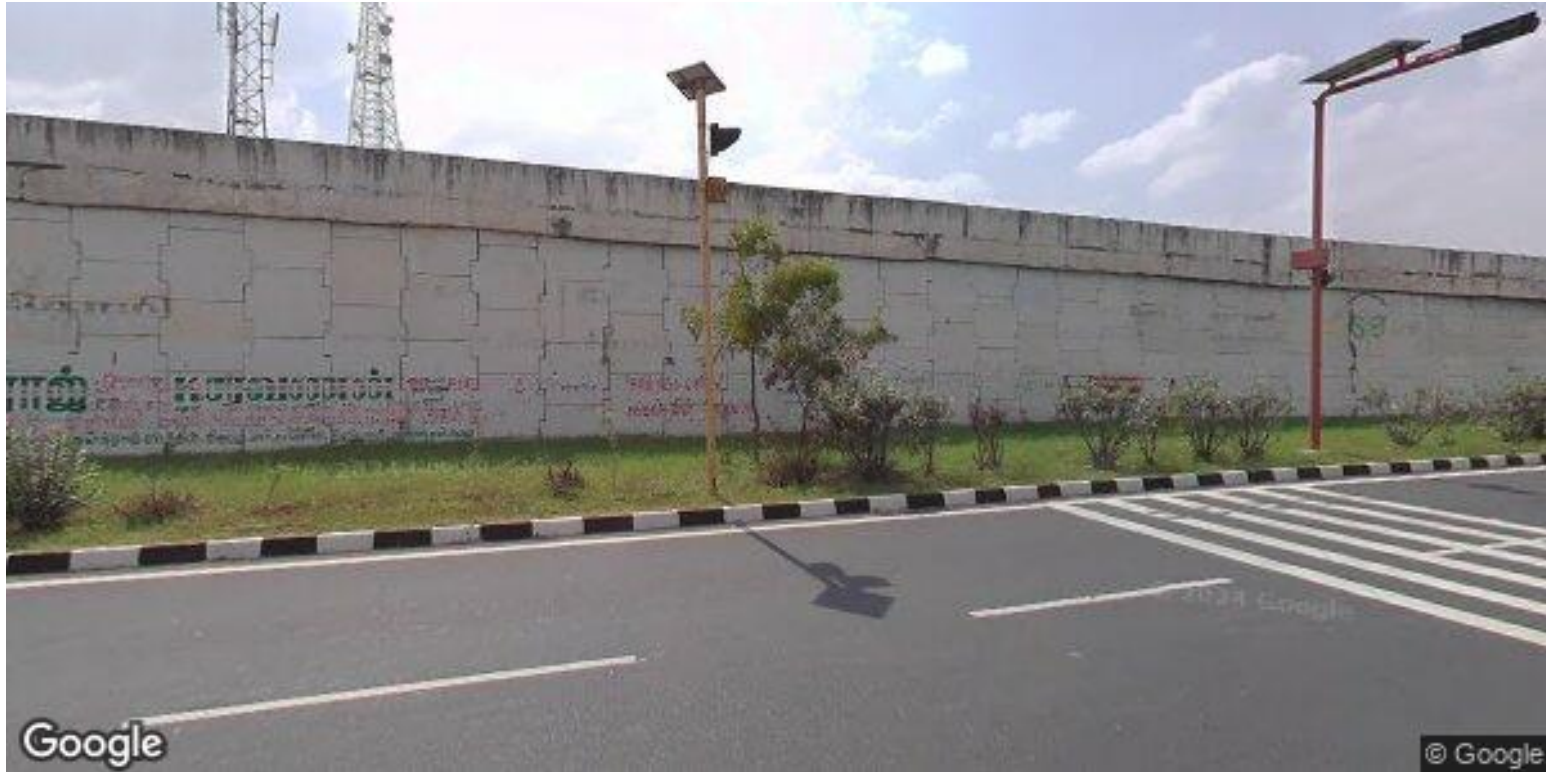
**Risk Type:** Turn  
**Risk Level:** High  
**Speed Limit:** 15 KM/Hr  
**Coordinates:** 11.49225, 77.89560

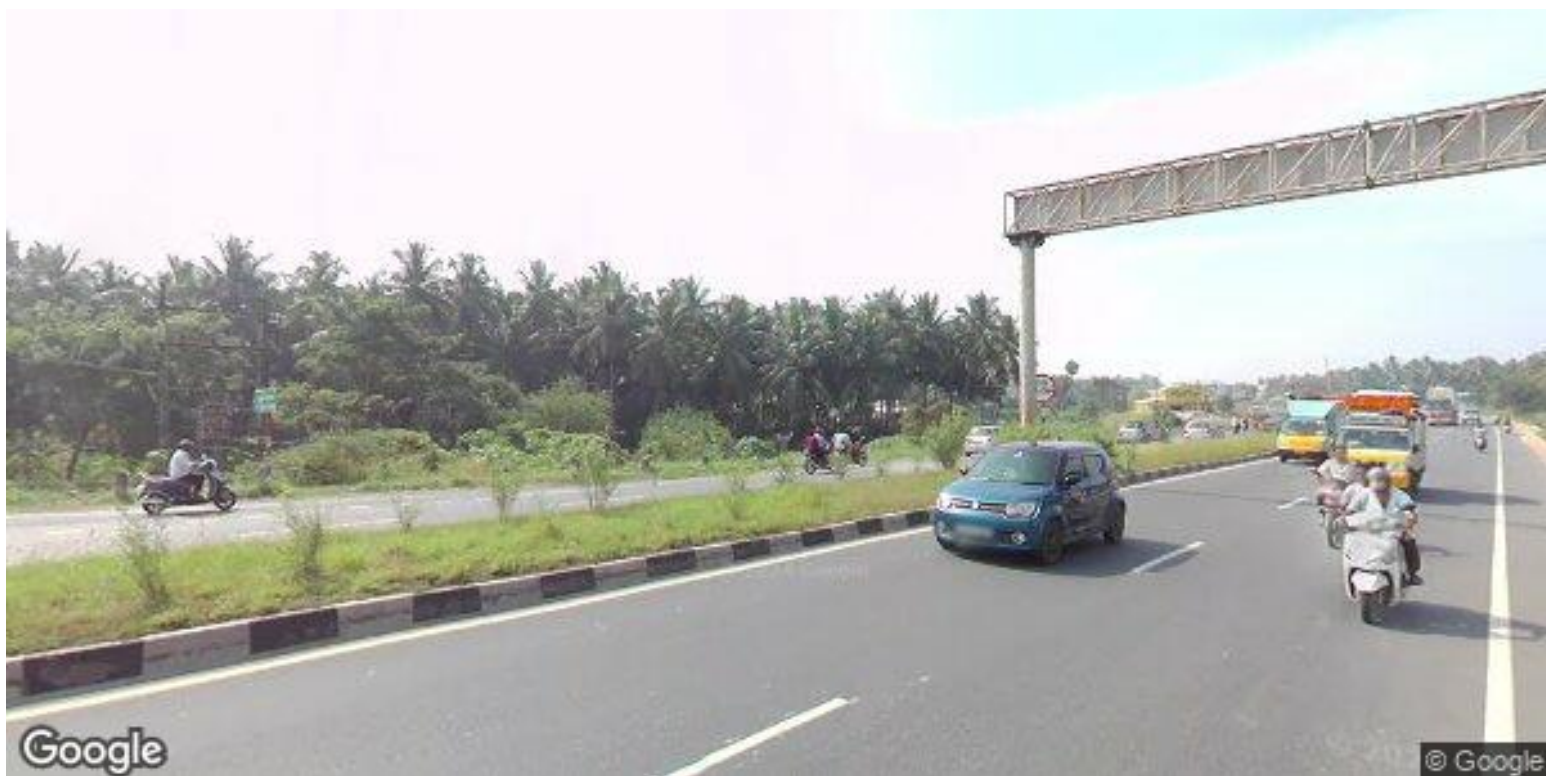
**Risk Type:** Turn  
**Risk Level:** Medium  
**Speed Limit:** 30 KM/Hr  
**Coordinates:** 11.60942, 78.10056

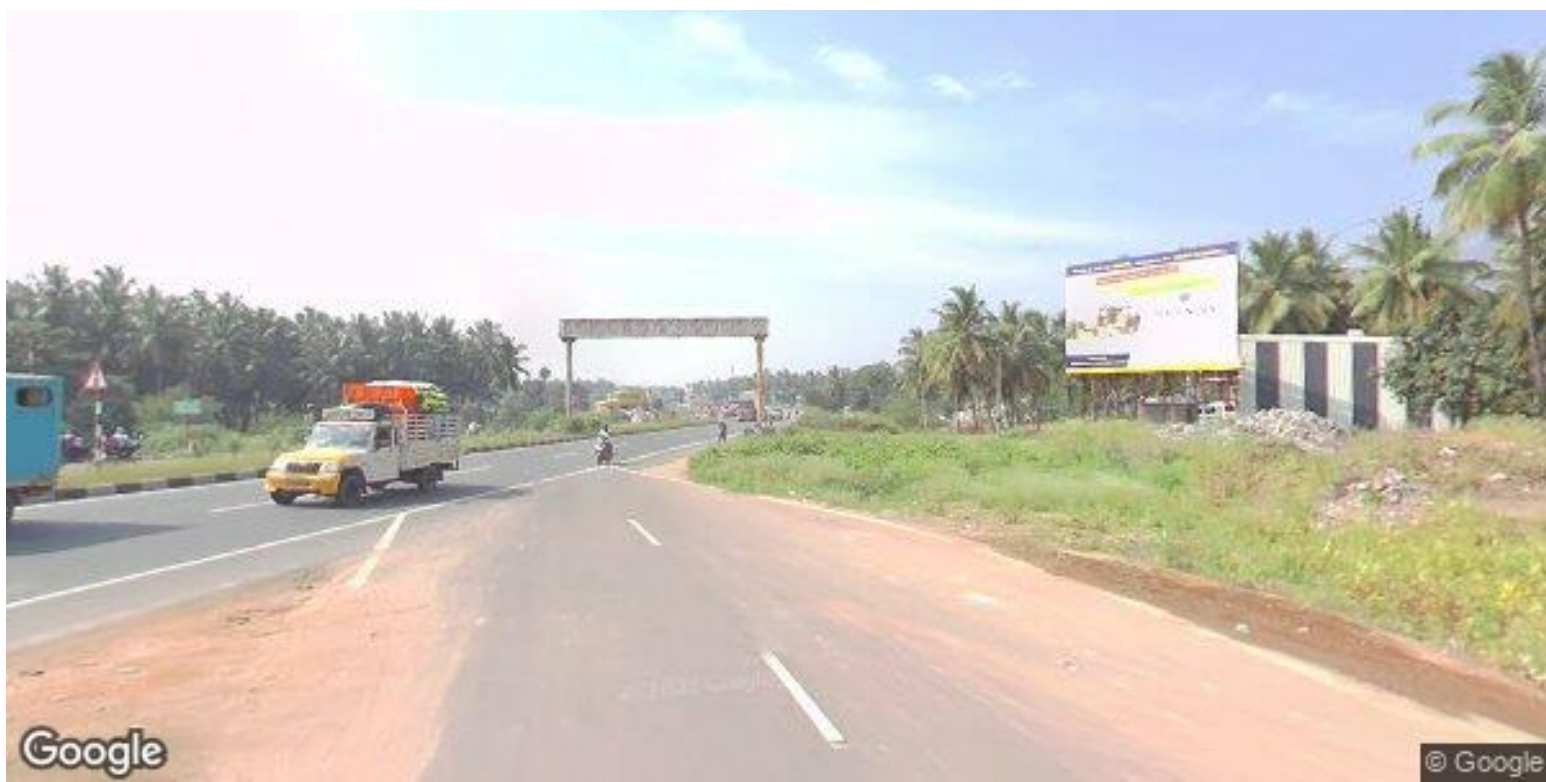
**Coordinates:** 11.60965, 78.10070

**Risk Type:** Turn

**Risk Level:** Medium

**Speed Limit:** 30 KM/Hr

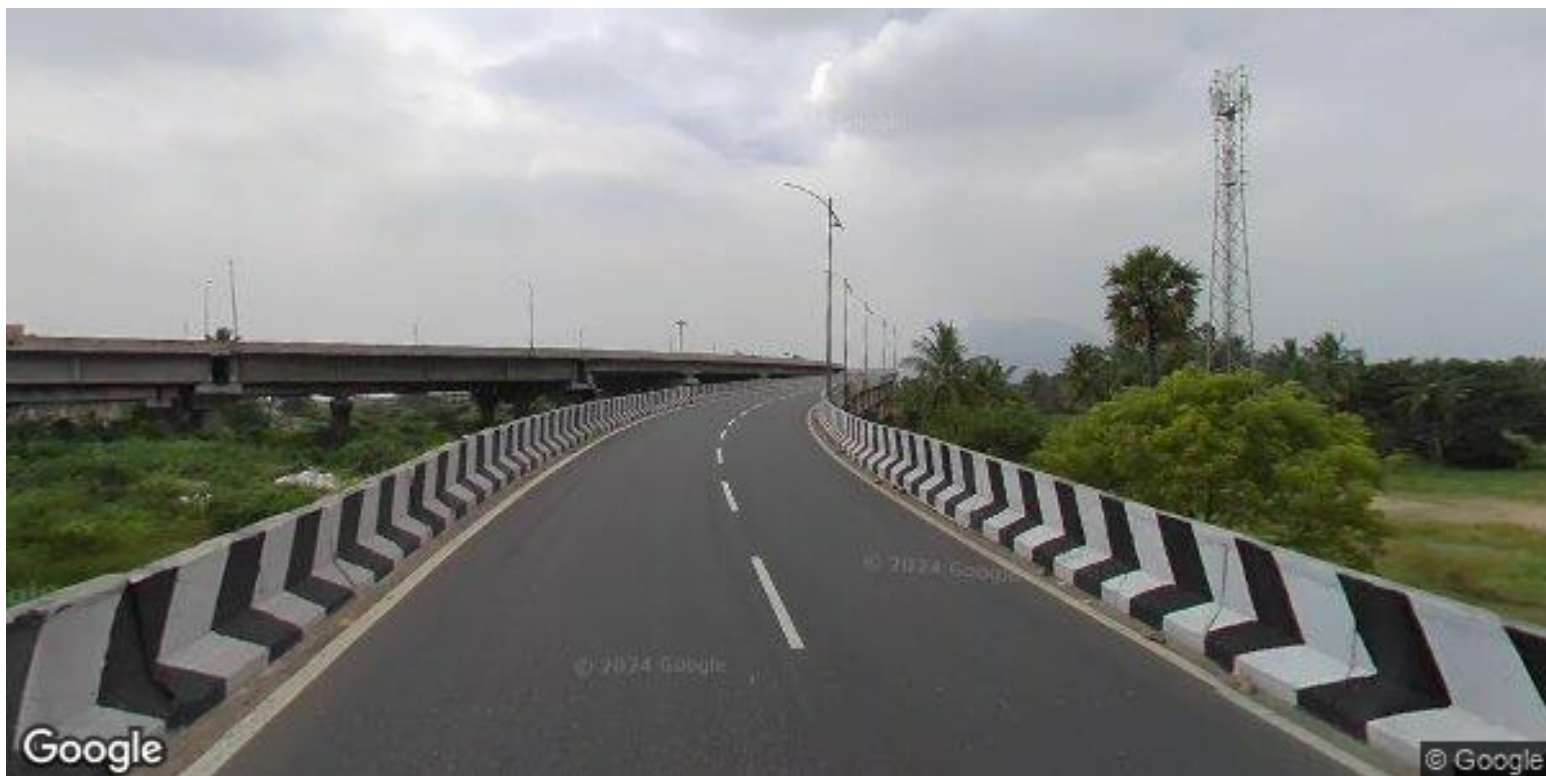
**Coordinates:** 11.64310, 78.11982

**Risk Type:** Turn

**Risk Level:** Medium

**Speed Limit:** 30 KM/Hr

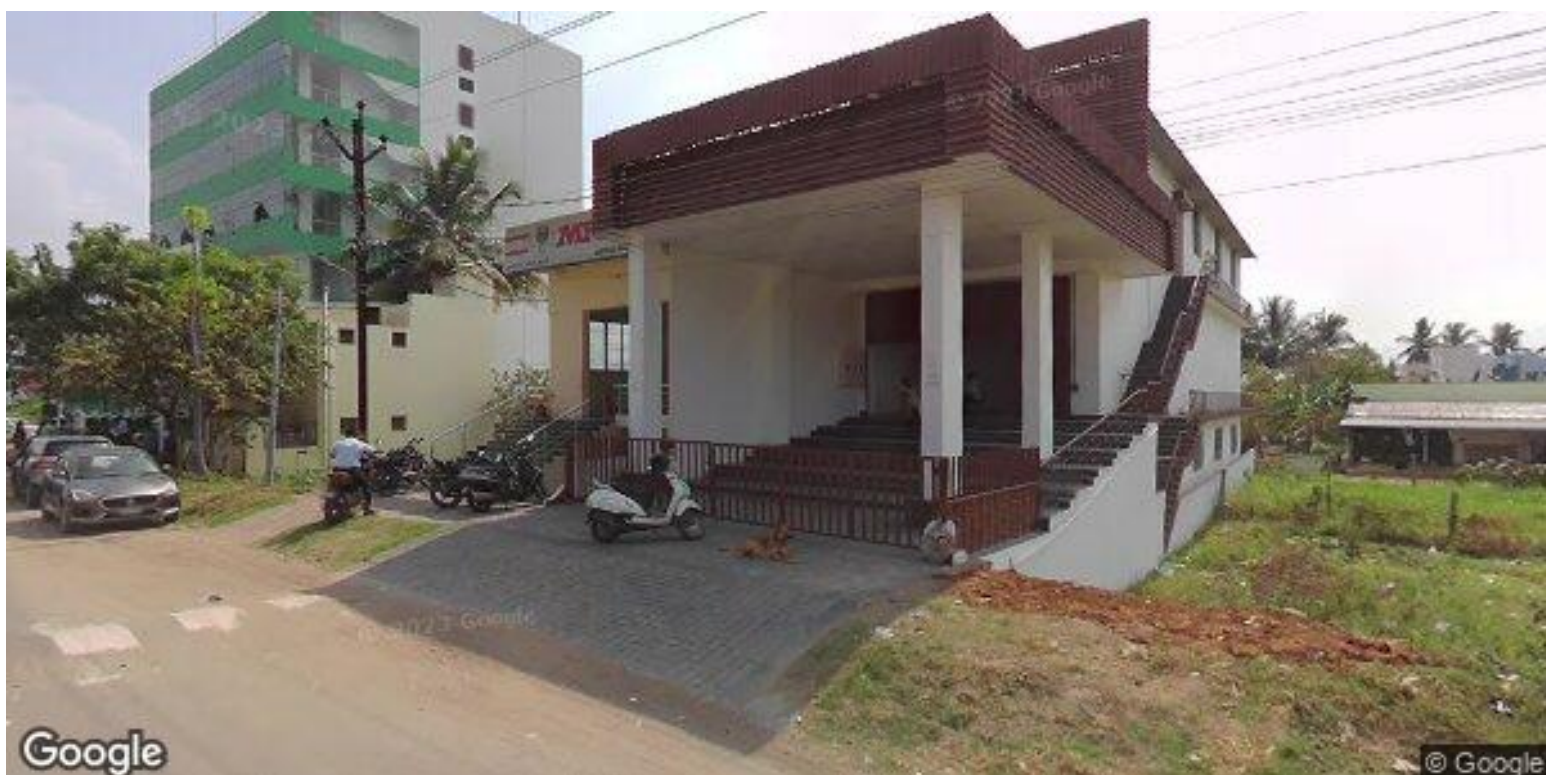
**Coordinates:** 11.69388, 78.10965

**Risk Type:** Turn

**Risk Level:** High

**Speed Limit:** 15 KM/Hr

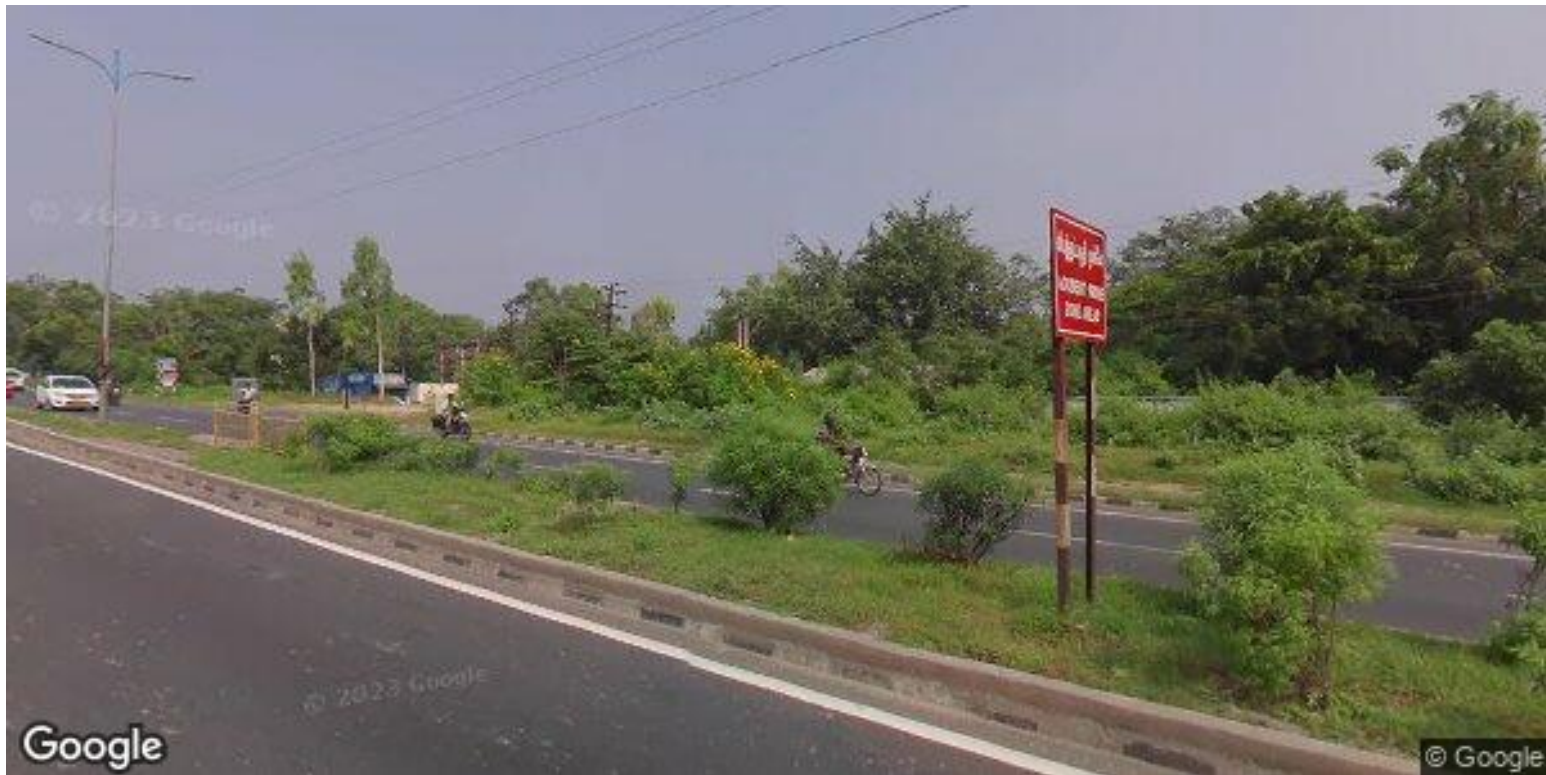
**Coordinates:** 11.69400, 78.10963

**Risk Type:** Turn

**Risk Level:** High

**Speed Limit:** 15 KM/Hr

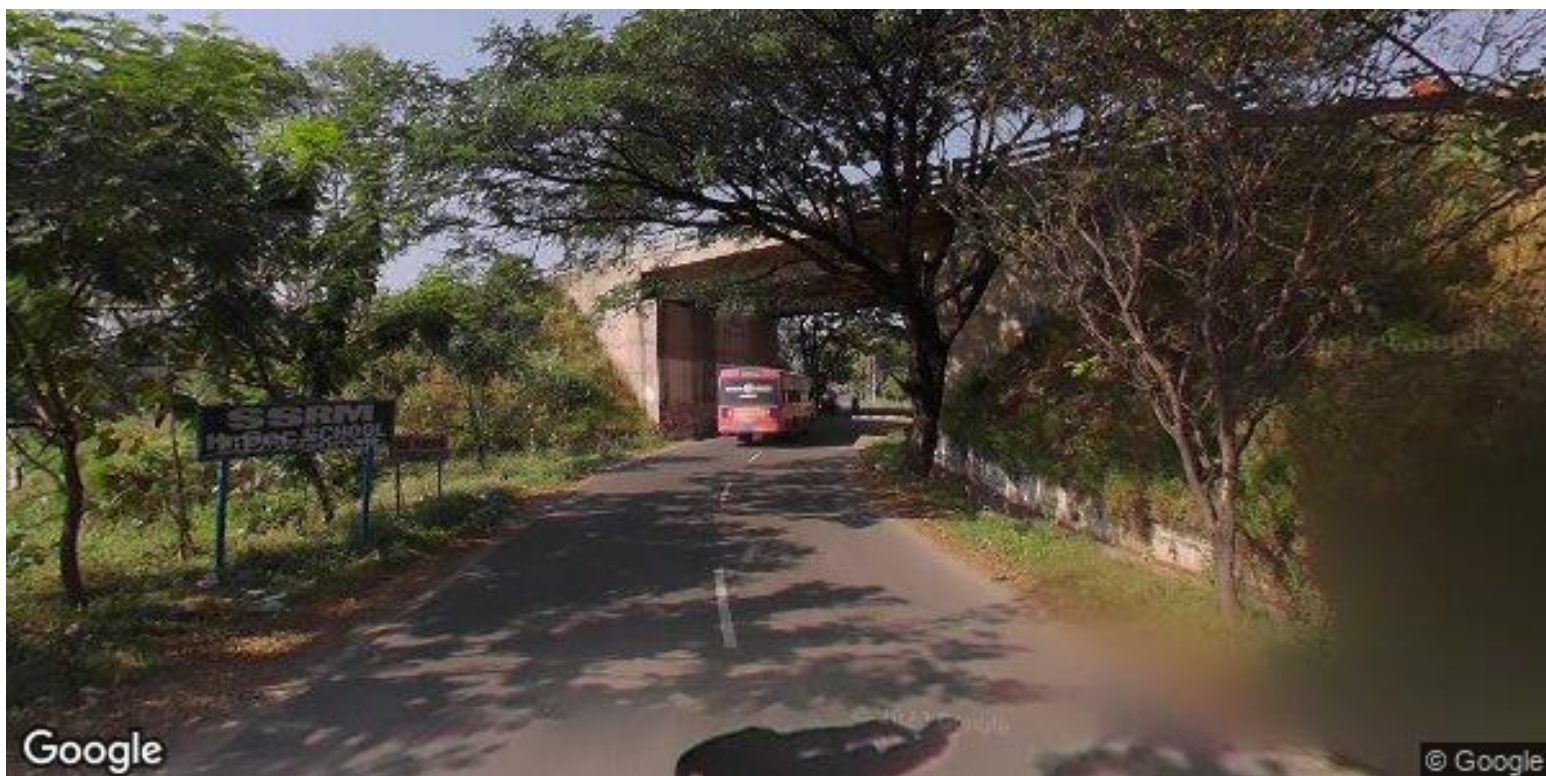
**Coordinates:** 11.70757, 78.09323

**Risk Type:** Turn

**Risk Level:** Medium

**Speed Limit:** 30 KM/Hr

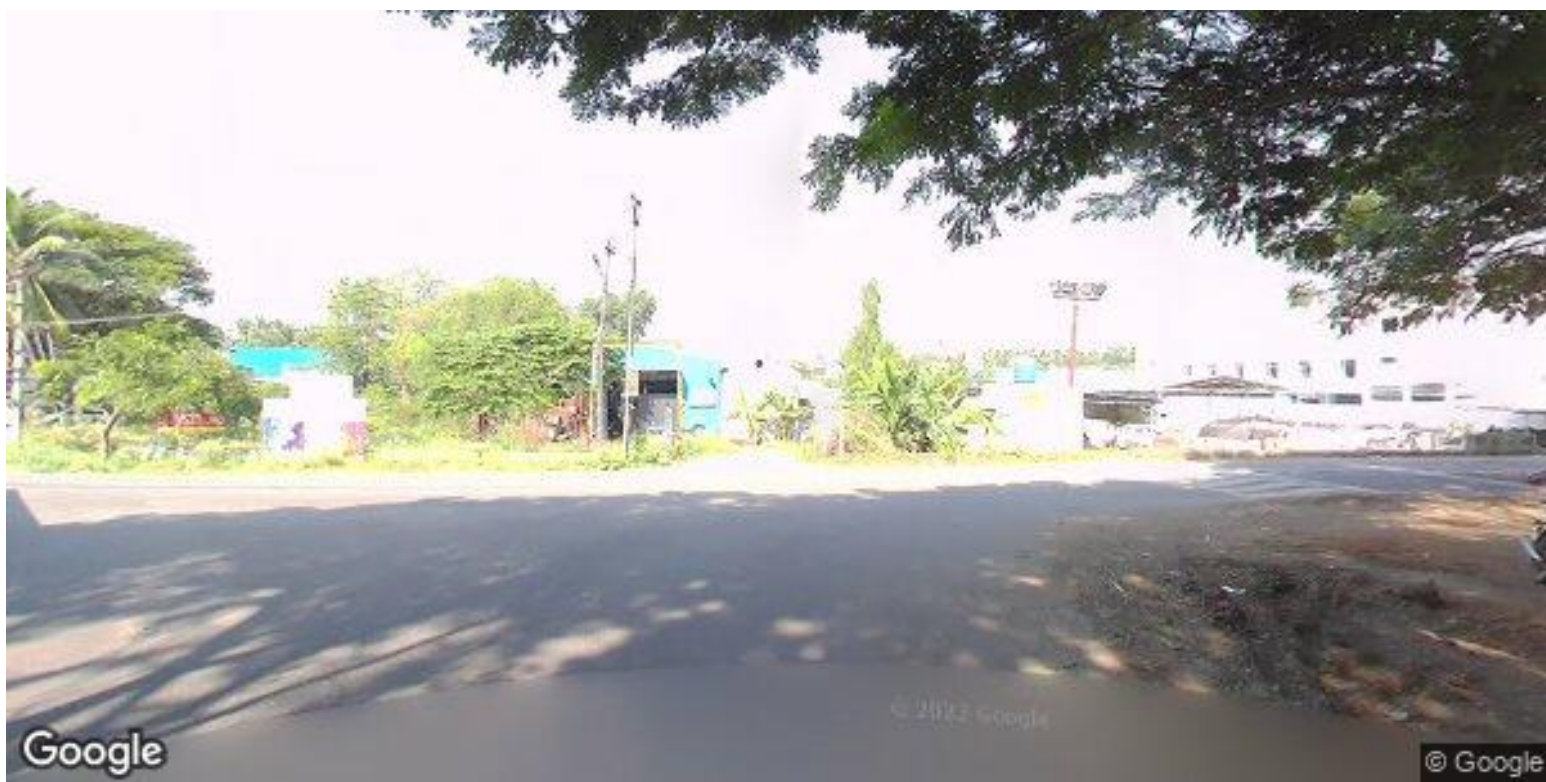
**Coordinates:** 11.70821, 78.09318

**Risk Type:** Turn

**Risk Level:** Medium

**Speed Limit:** 30 KM/Hr

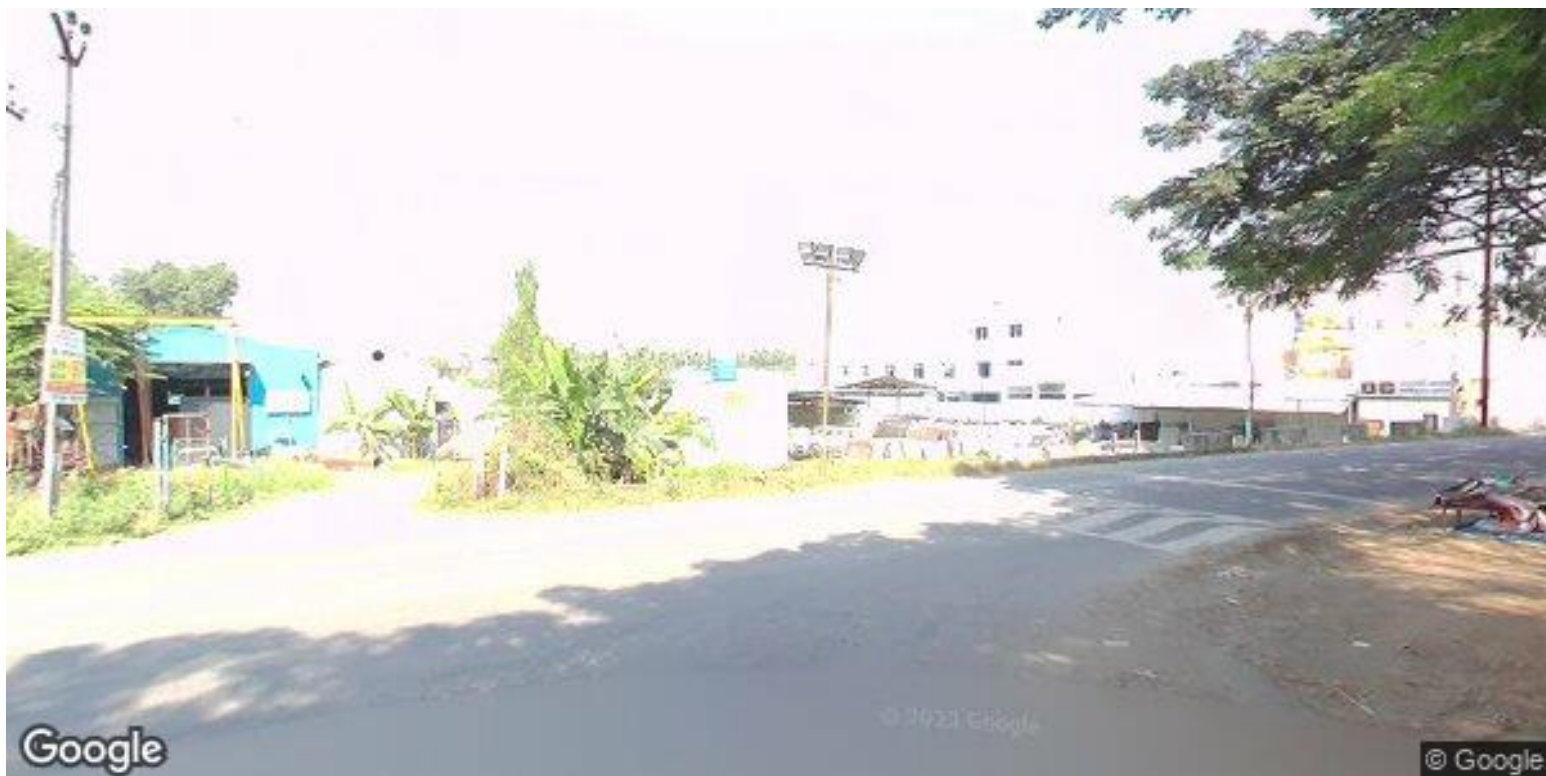
**Coordinates:** 11.70828, 78.09323

**Risk Type:** Turn

**Risk Level:** High

**Speed Limit:** 15 KM/Hr

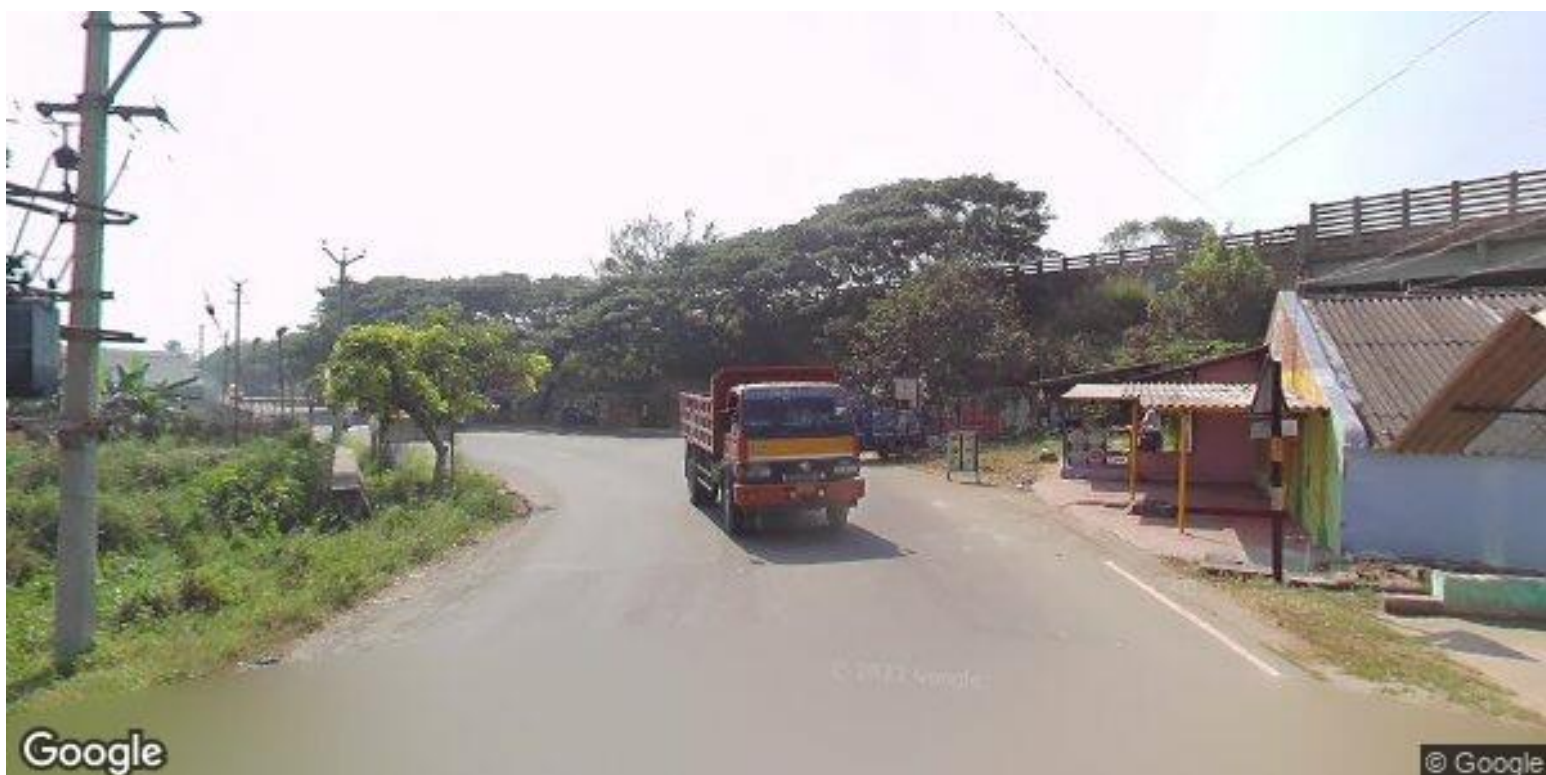
**Risk Type:** Turn  
**Risk Level:** Medium  
**Speed Limit:** 30 KM/Hr  
**Coordinates:** 11.70855, 78.09304

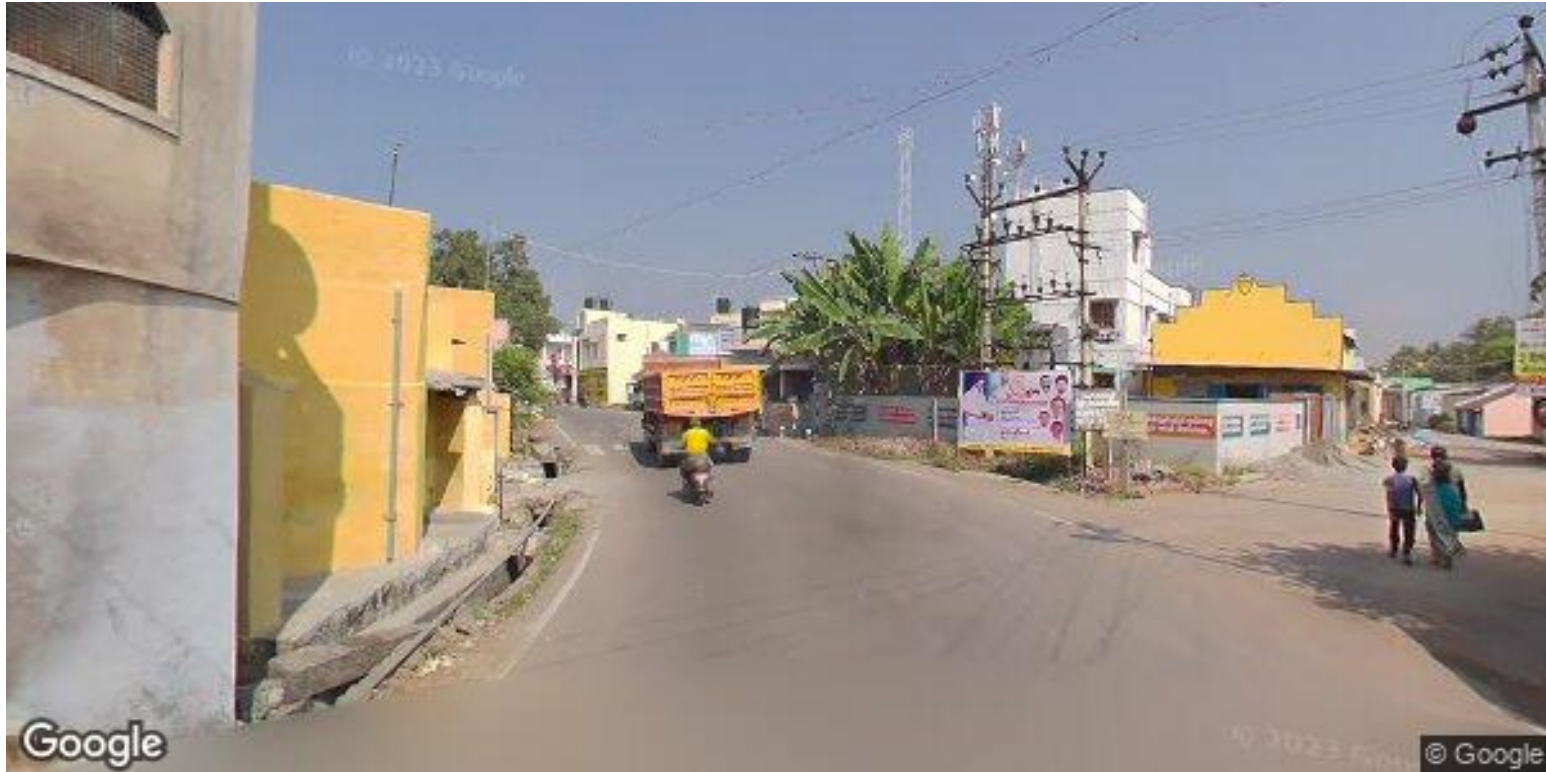
**Risk Type:** Turn  
**Risk Level:** Medium  
**Speed Limit:** 30 KM/Hr  
**Coordinates:** 11.71616, 78.09287

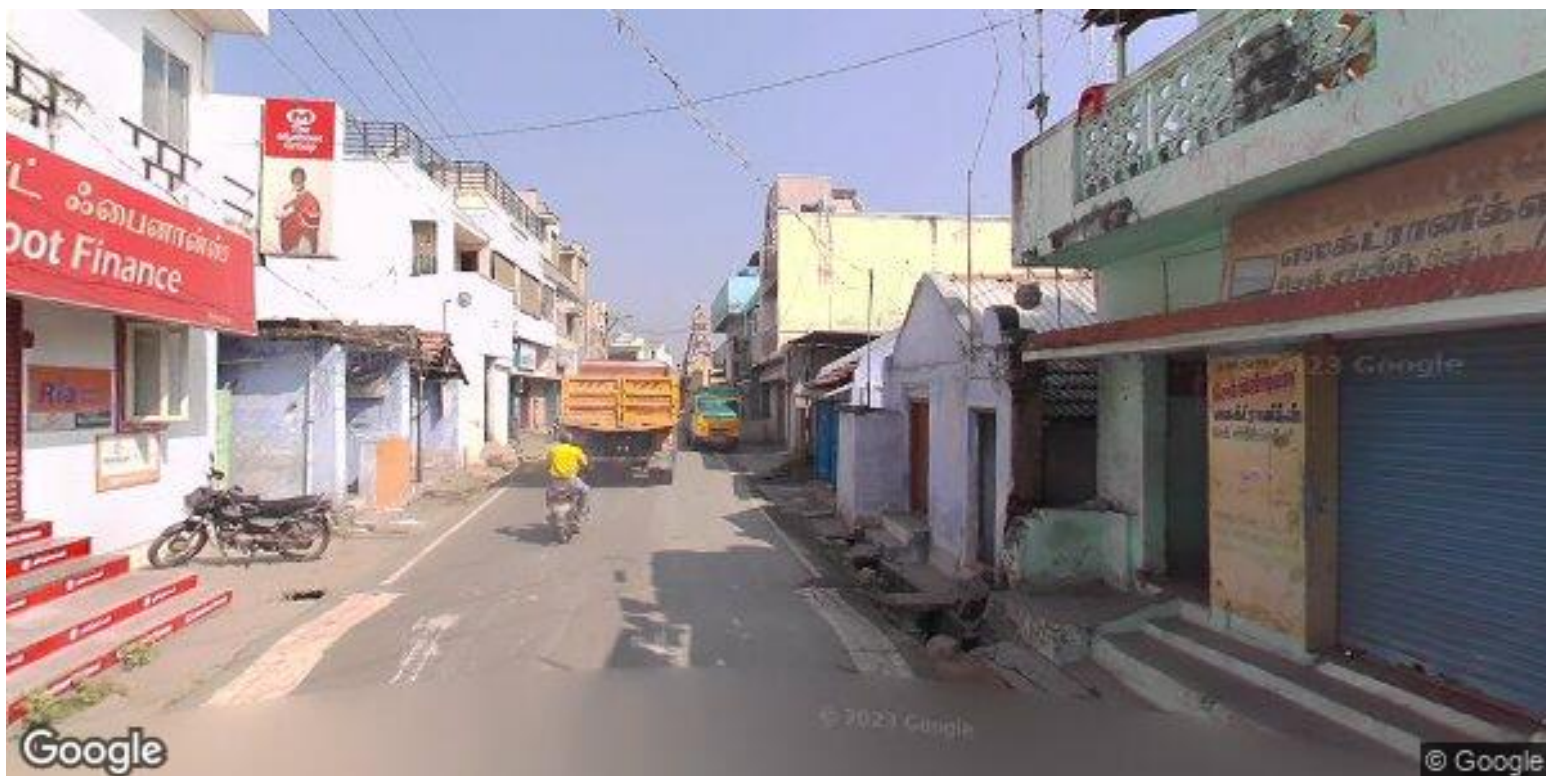
**Risk Type:** Turn  
**Risk Level:** High  
**Speed Limit:** 15 KM/Hr  
**Coordinates:** 11.71690, 78.09240

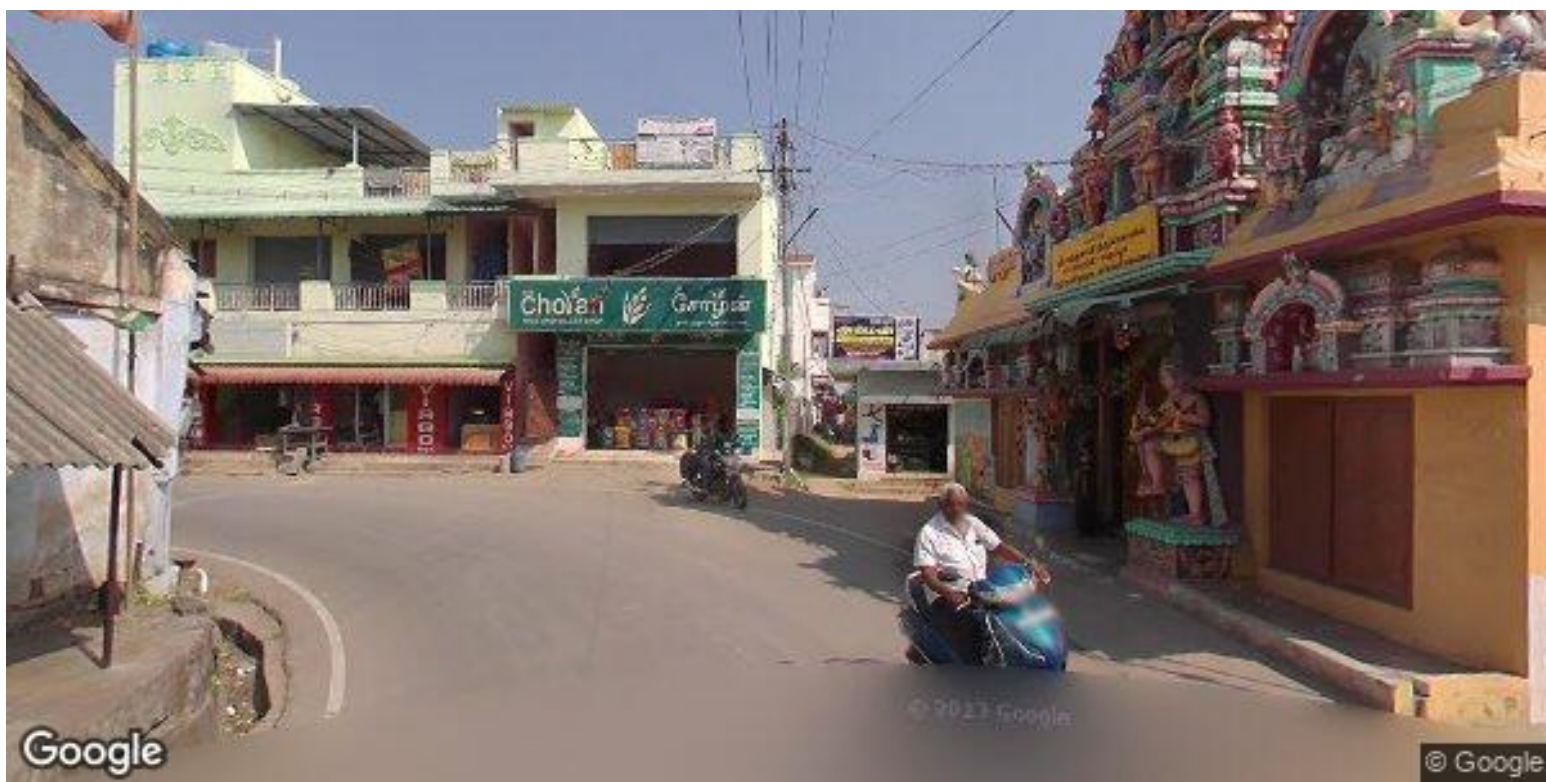
**Coordinates:** 11.71755, 78.09256

**Risk Type:** Turn

**Risk Level:** High

**Speed Limit:** 15 KM/Hr

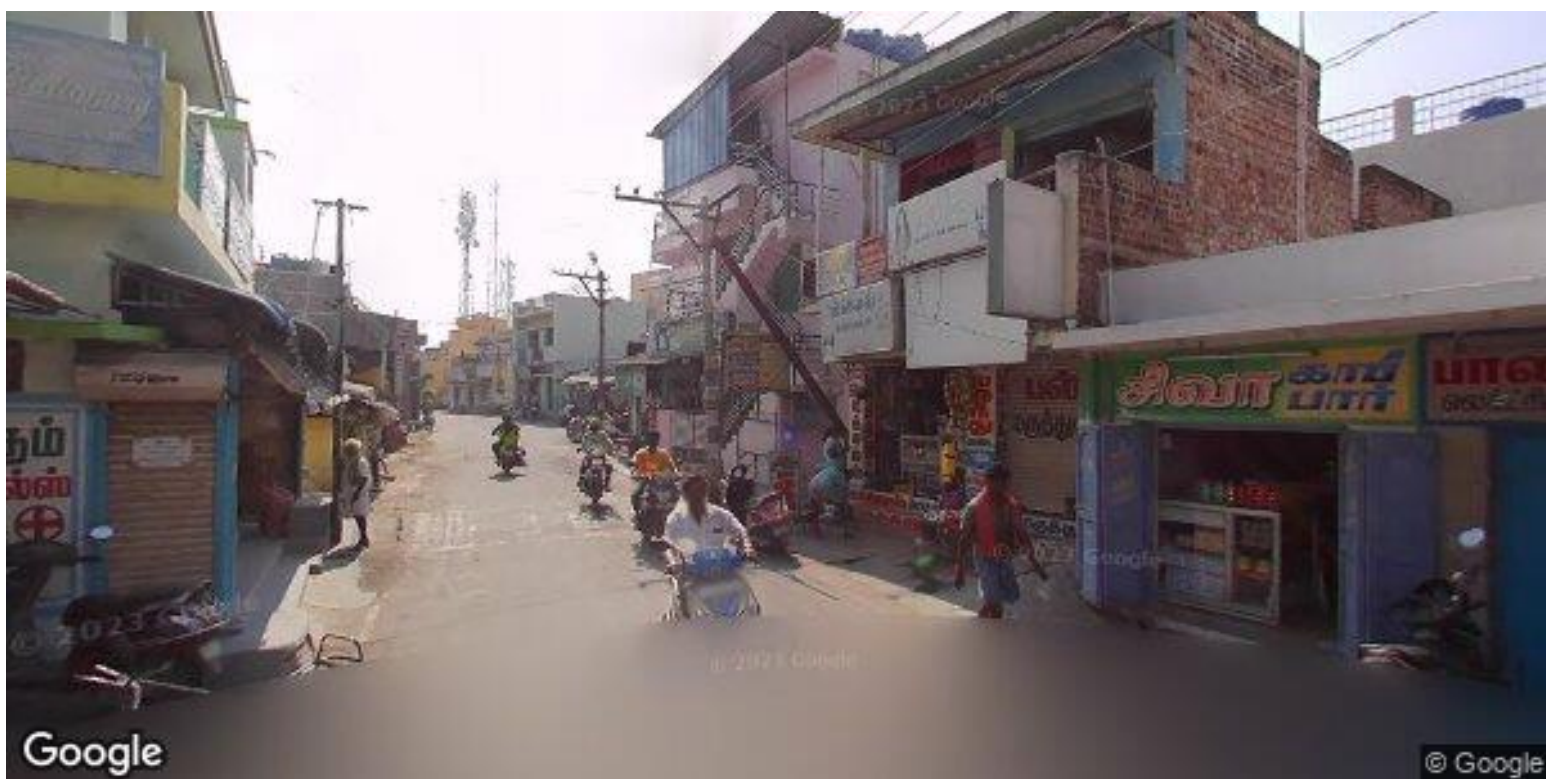
**Coordinates:** 11.71816, 78.09185

**Risk Type:** Turn

**Risk Level:** Medium

**Speed Limit:** 30 KM/Hr

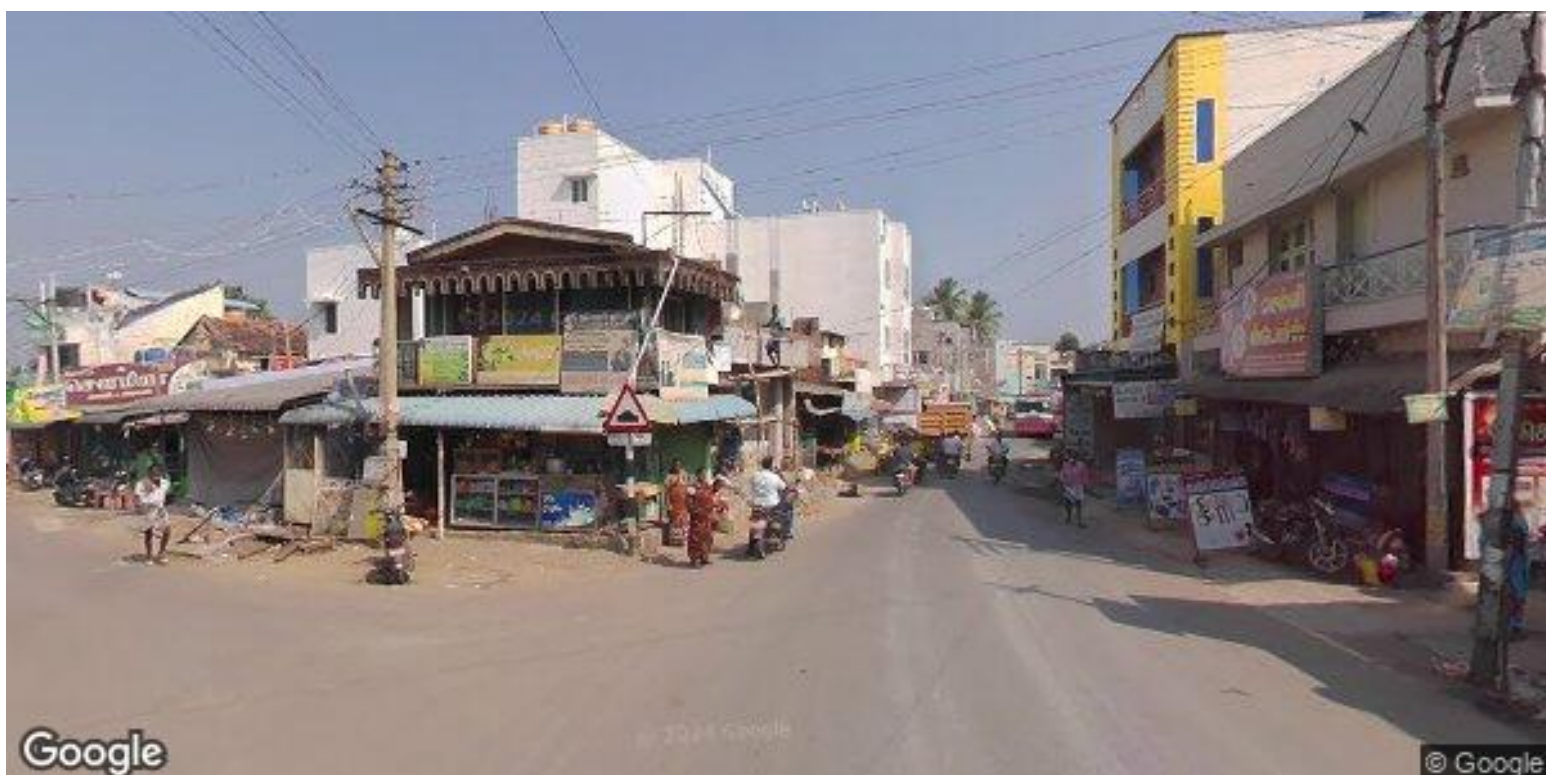
**Coordinates:** 11.71829, 78.09183

**Risk Type:** Turn

**Risk Level:** Medium

**Speed Limit:** 30 KM/Hr
