# IndianOil

## JOURNEY RISK MANAGEMENT (JRM) STUDY

### Salem Terminal TO AS PETROLEUM

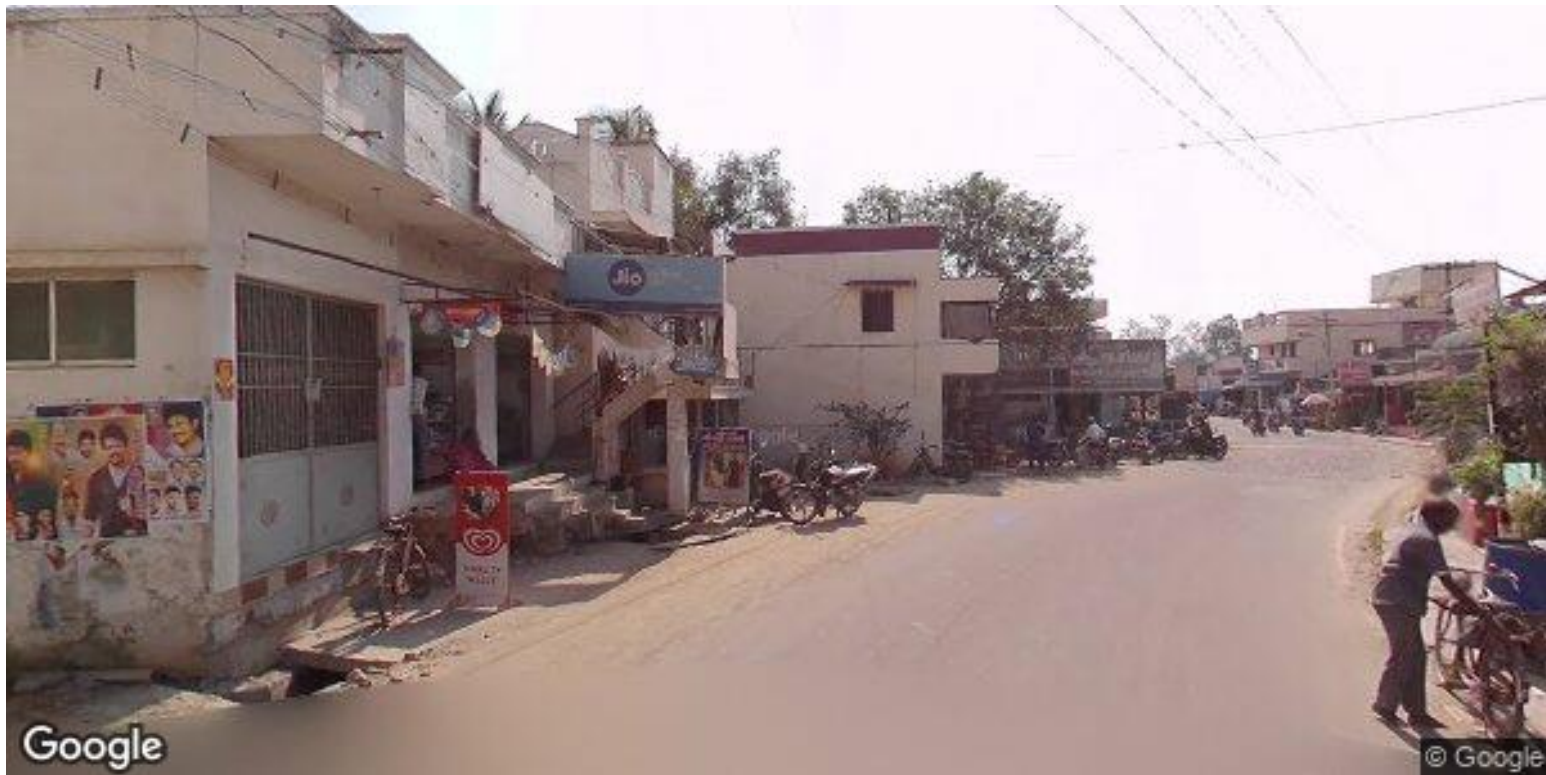
**Coordinates:** 11.72096, 78.09477

**Risk Type:** Turn

**Risk Level:** High

**Speed Limit:** 15 KM/Hr

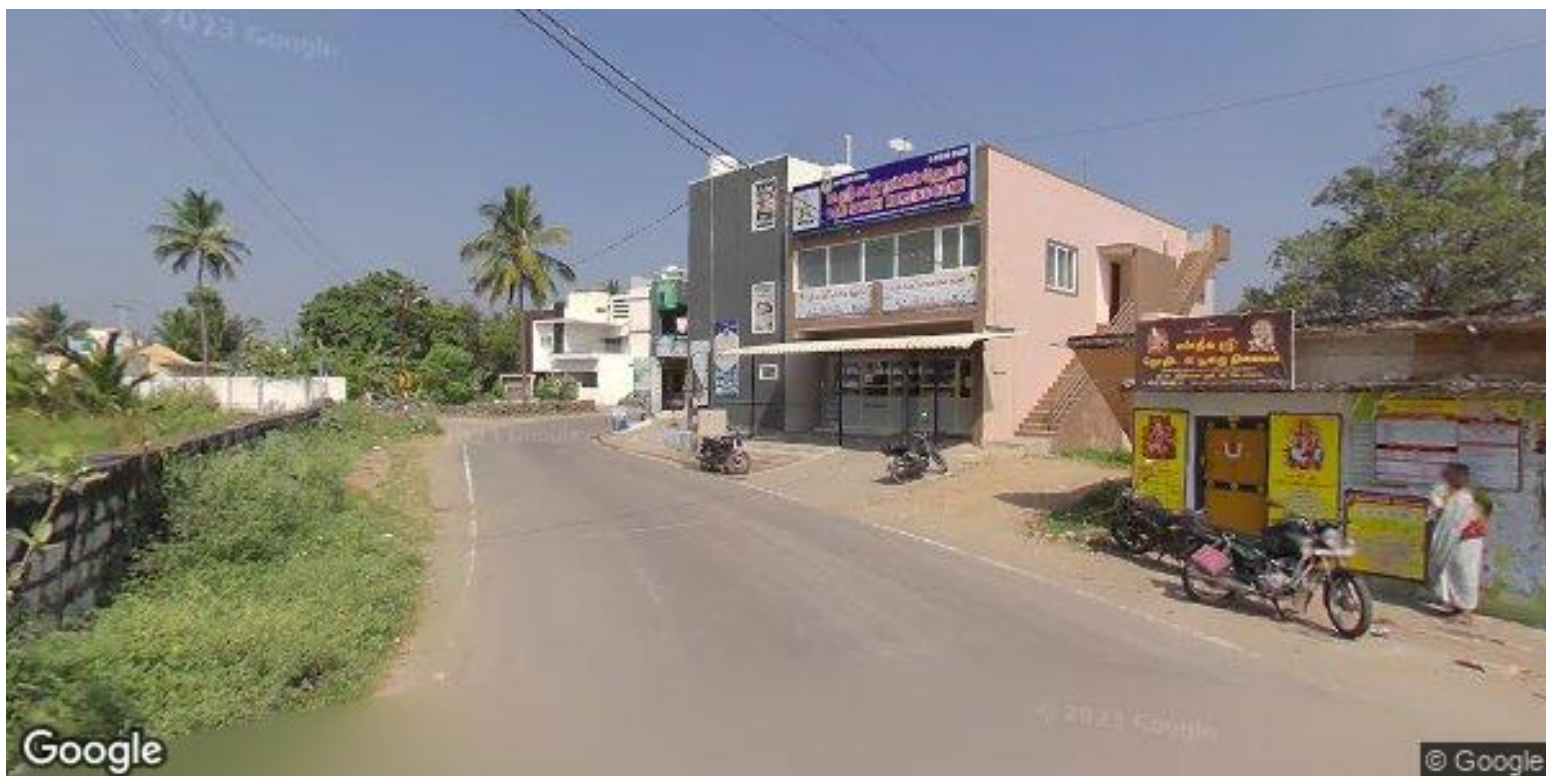
**Coordinates:** 11.72215, 78.09520

**Risk Type:** Turn

**Risk Level:** Medium

**Speed Limit:** 30 KM/Hr

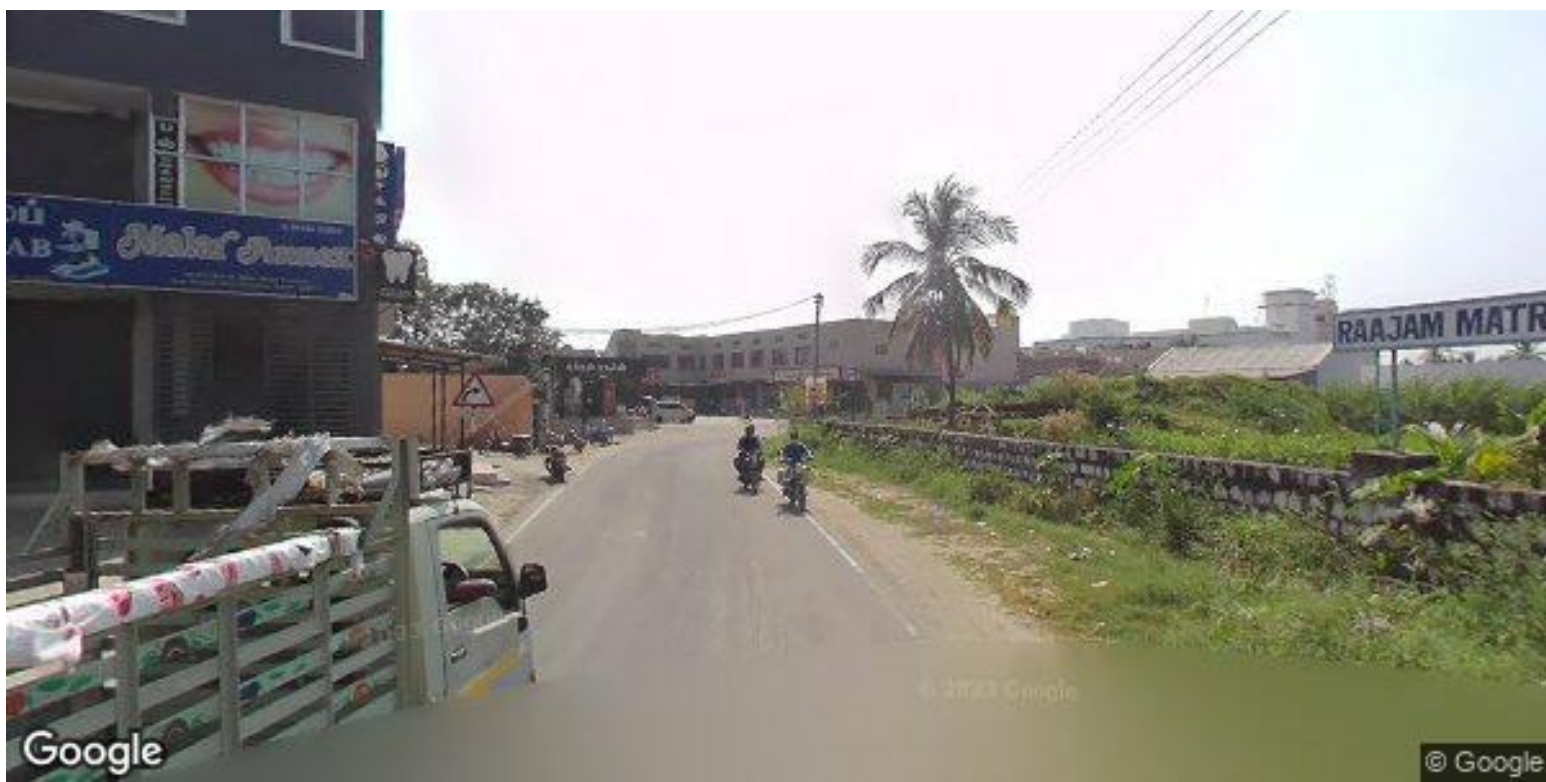
**Coordinates:** 11.72240, 78.09501

**Risk Type:** Turn

**Risk Level:** High

**Speed Limit:** 15 KM/Hr

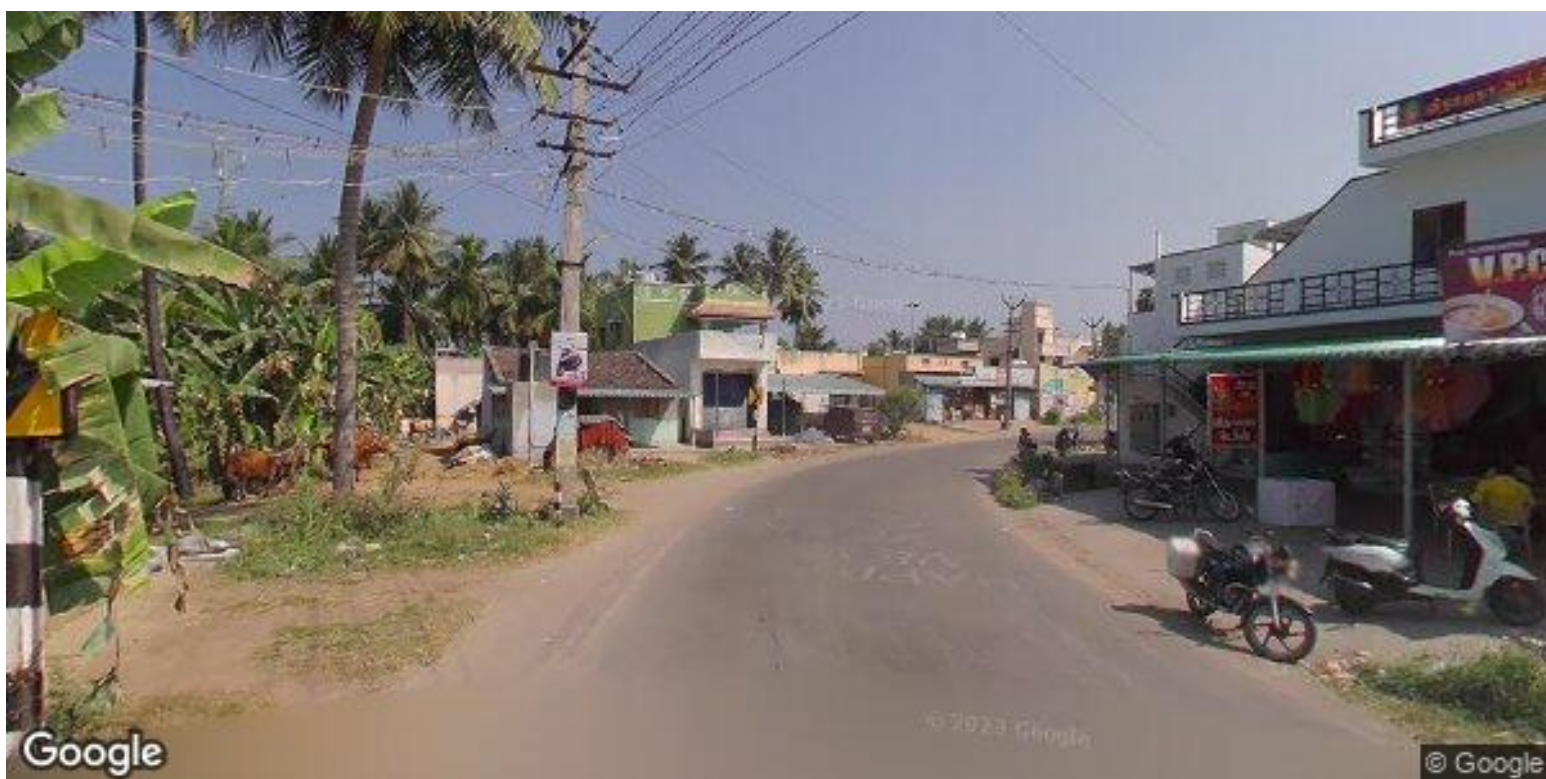
**Coordinates:** 11.73016, 78.09877

**Risk Type:** Turn

**Risk Level:** Medium

**Speed Limit:** 30 KM/Hr

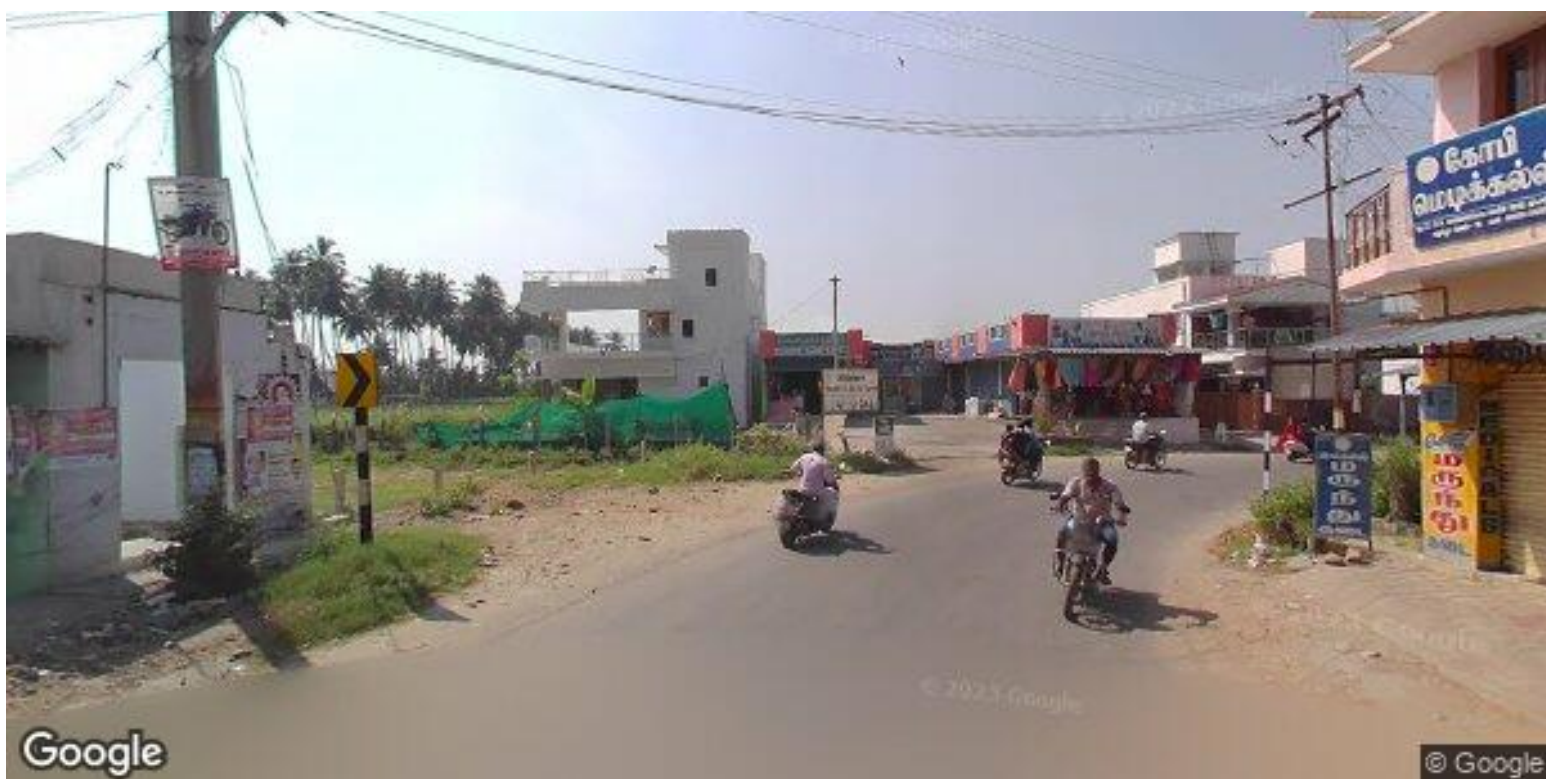
**Risk Type:** Turn  
**Risk Level:** High  
**Speed Limit:** 15 KM/Hr  
**Coordinates:** 11.73046, 78.09949

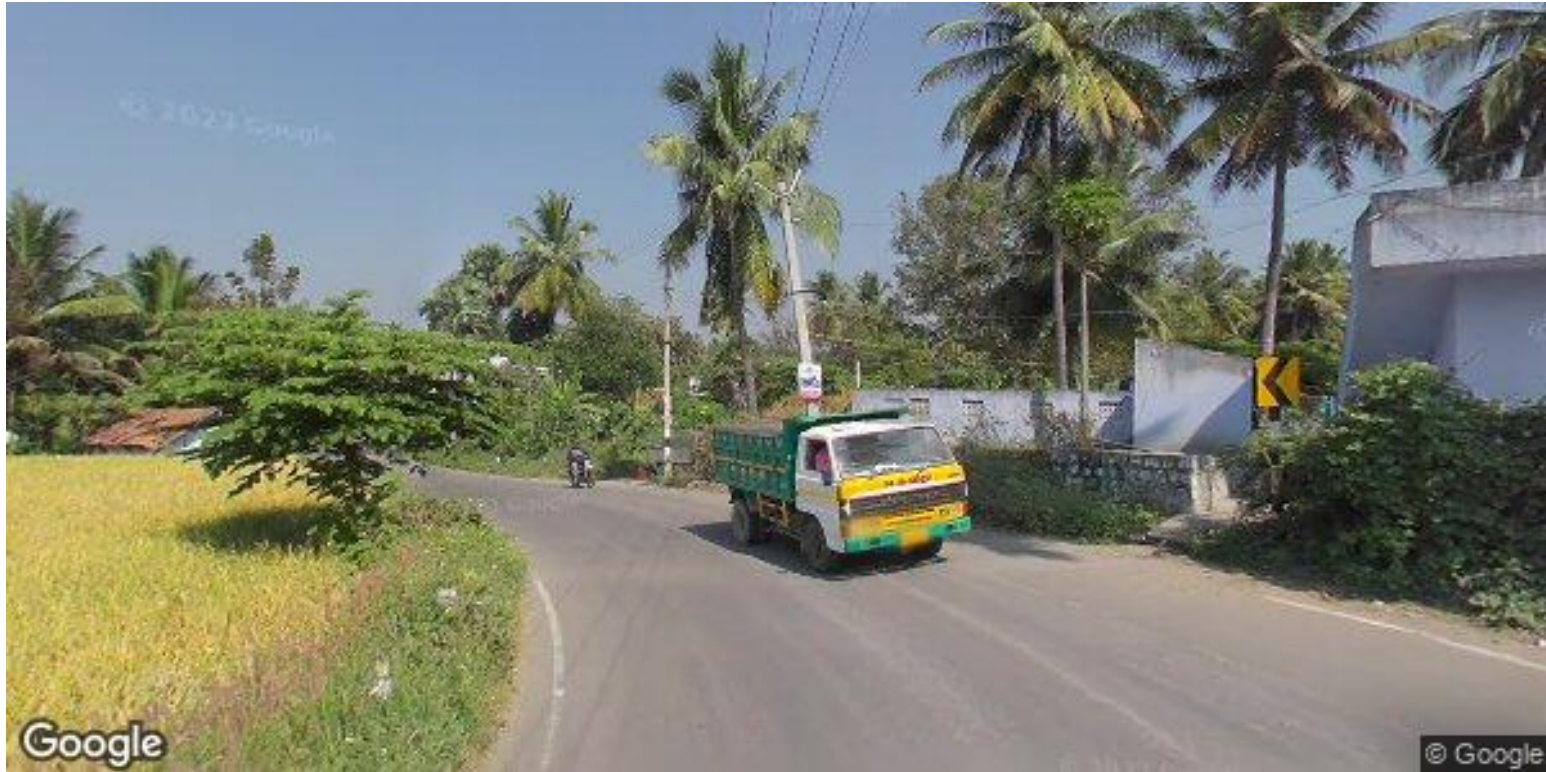
**Risk Type:** Turn  
**Risk Level:** High  
**Speed Limit:** 15 KM/Hr  
**Coordinates:** 11.73670, 78.10229

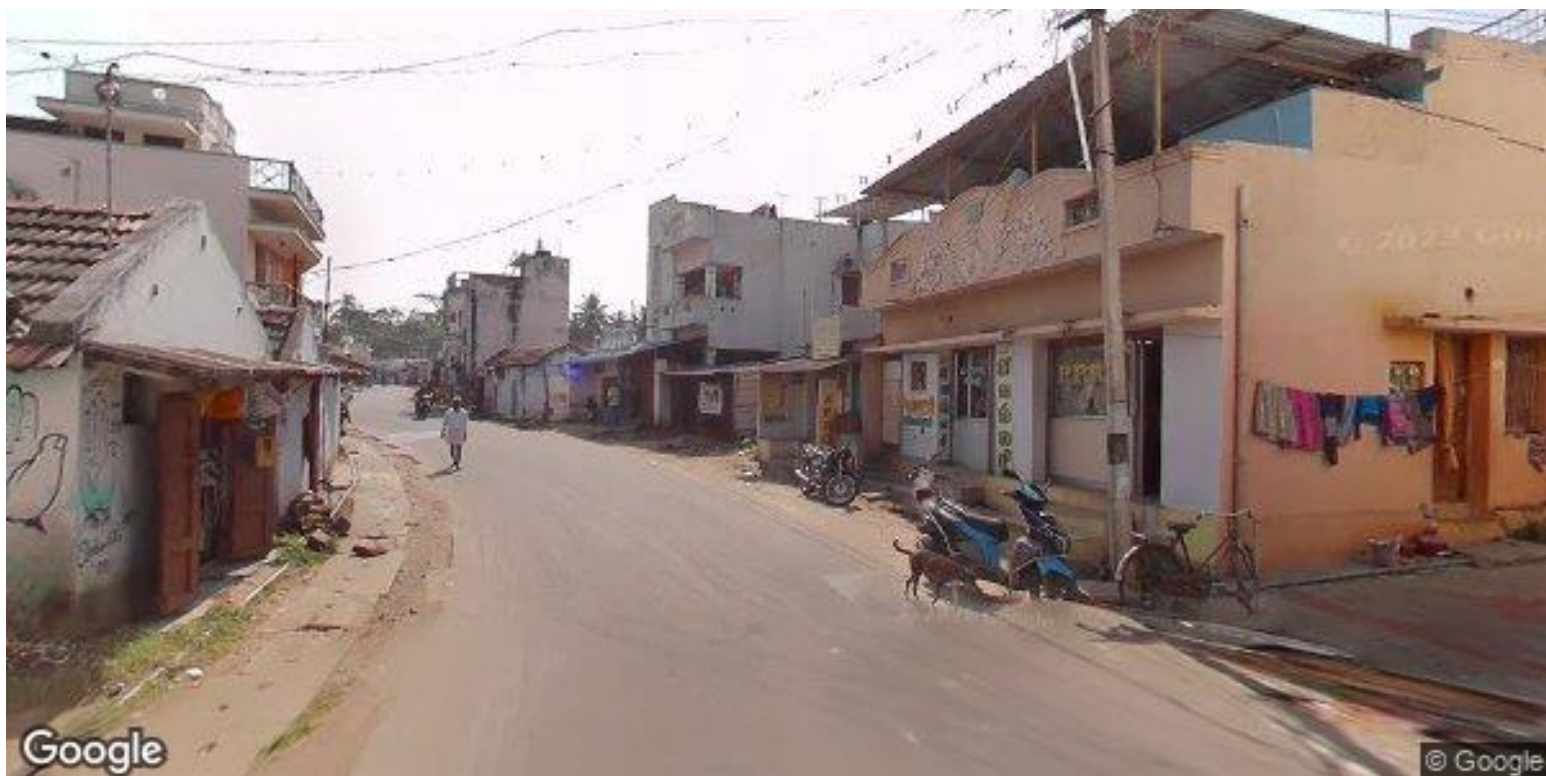
**Risk Type:** Turn  
**Risk Level:** Medium  
**Speed Limit:** 30 KM/Hr  
**Coordinates:** 11.74803, 78.10069

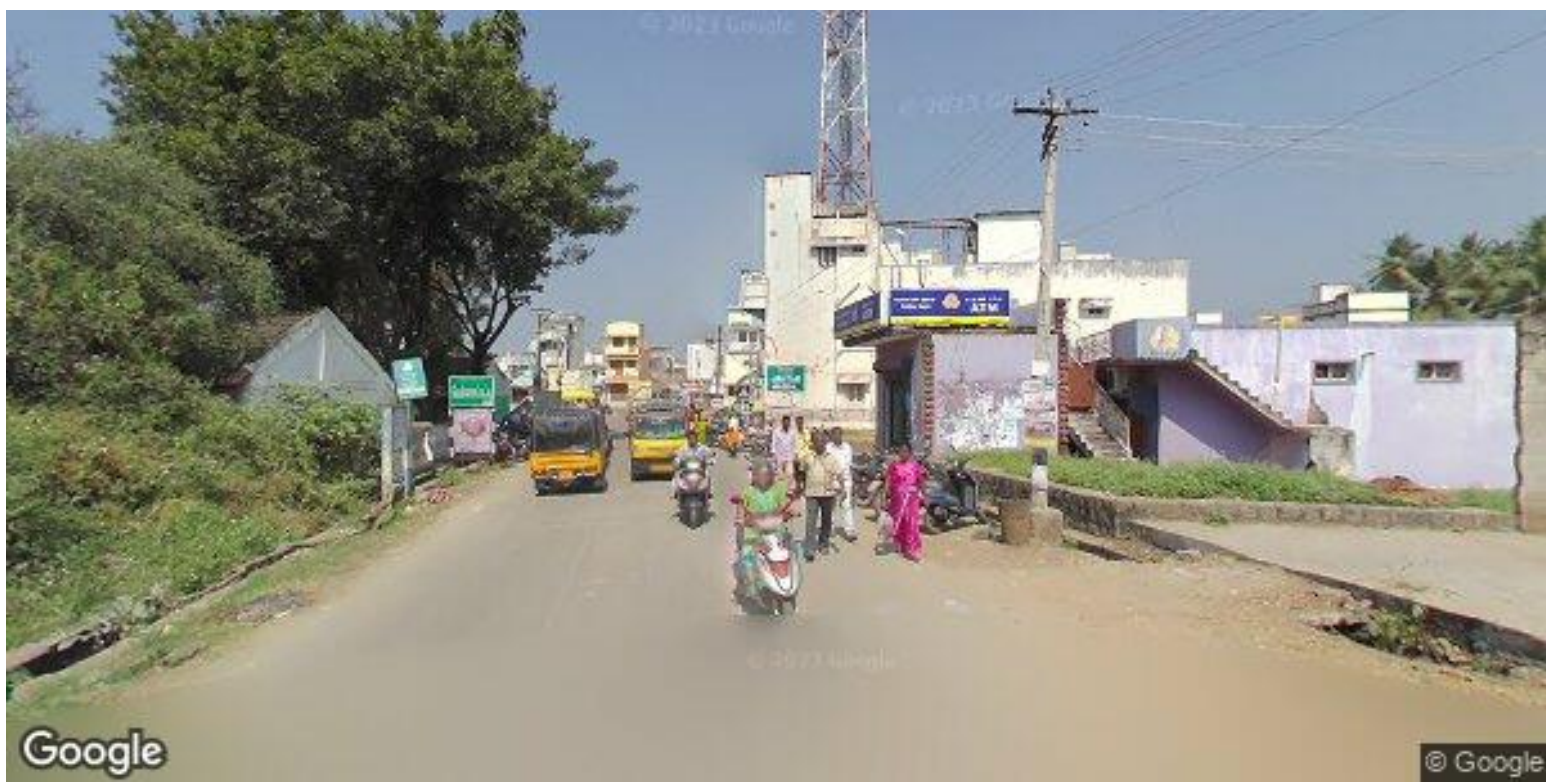
**Coordinates:** 11.74967, 78.10232

**Risk Type:** Turn

**Risk Level:** Medium

**Speed Limit:** 30 KM/Hr

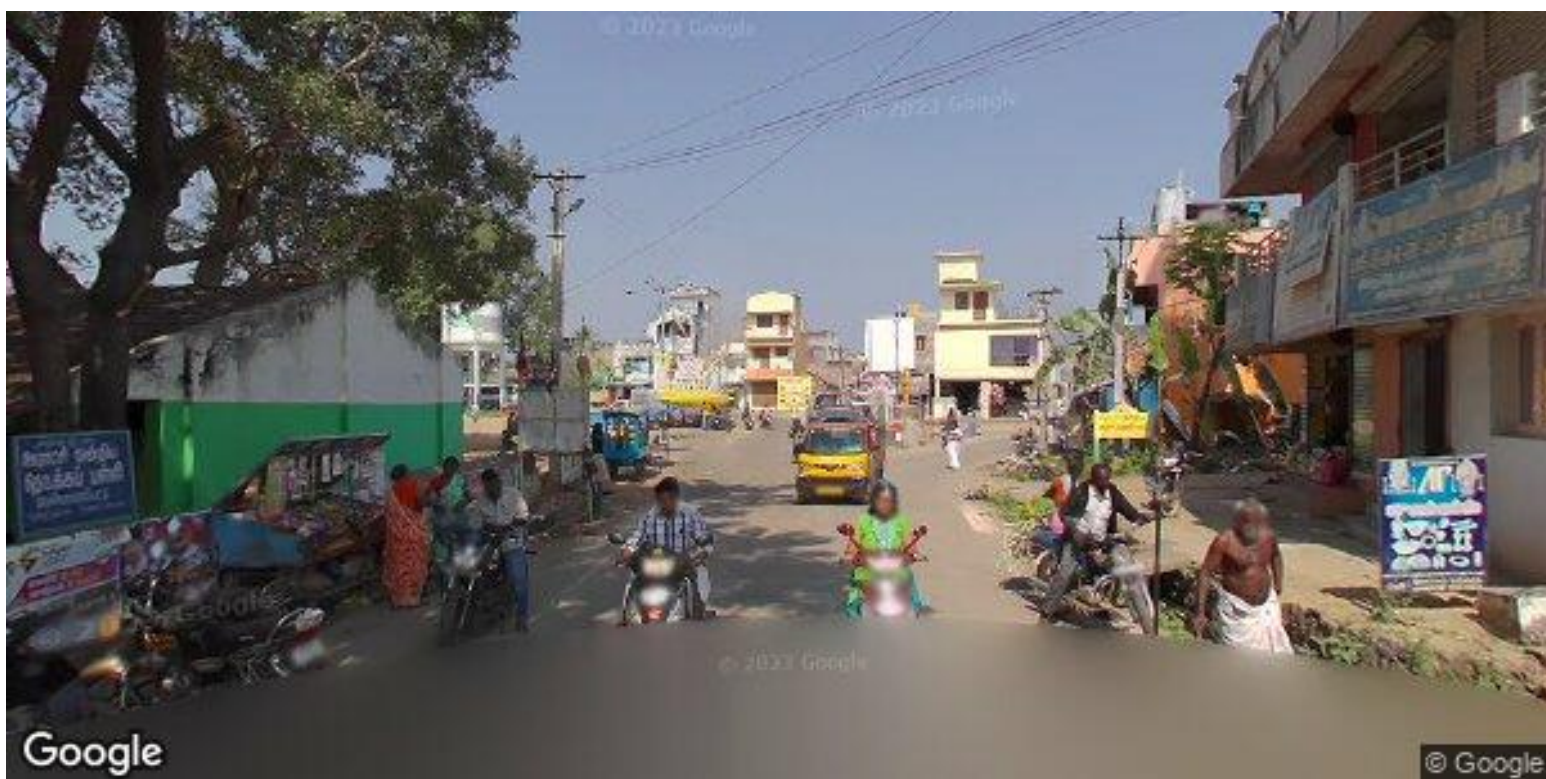
**Coordinates:** 11.74996, 78.10236

**Risk Type:** Turn

**Risk Level:** Medium

**Speed Limit:** 30 KM/Hr

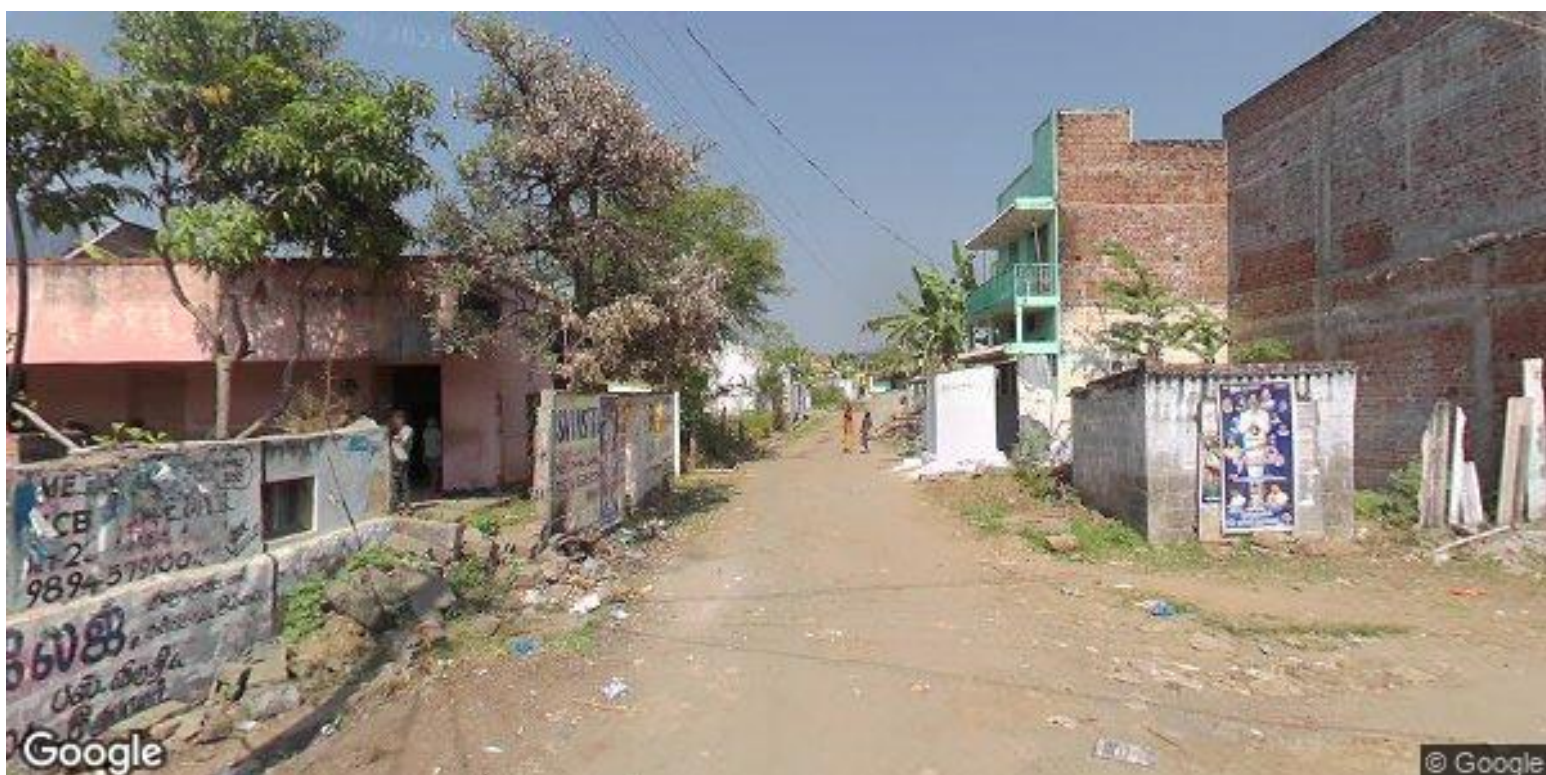
**Coordinates:** 11.75058, 78.10279

**Risk Type:** Turn

**Risk Level:** High

**Speed Limit:** 15 KM/Hr
