# IndianOil

## JOURNEY RISK MANAGEMENT (JRM) STUDY

### Salem Terminal to Sakthi Fuels Unit II

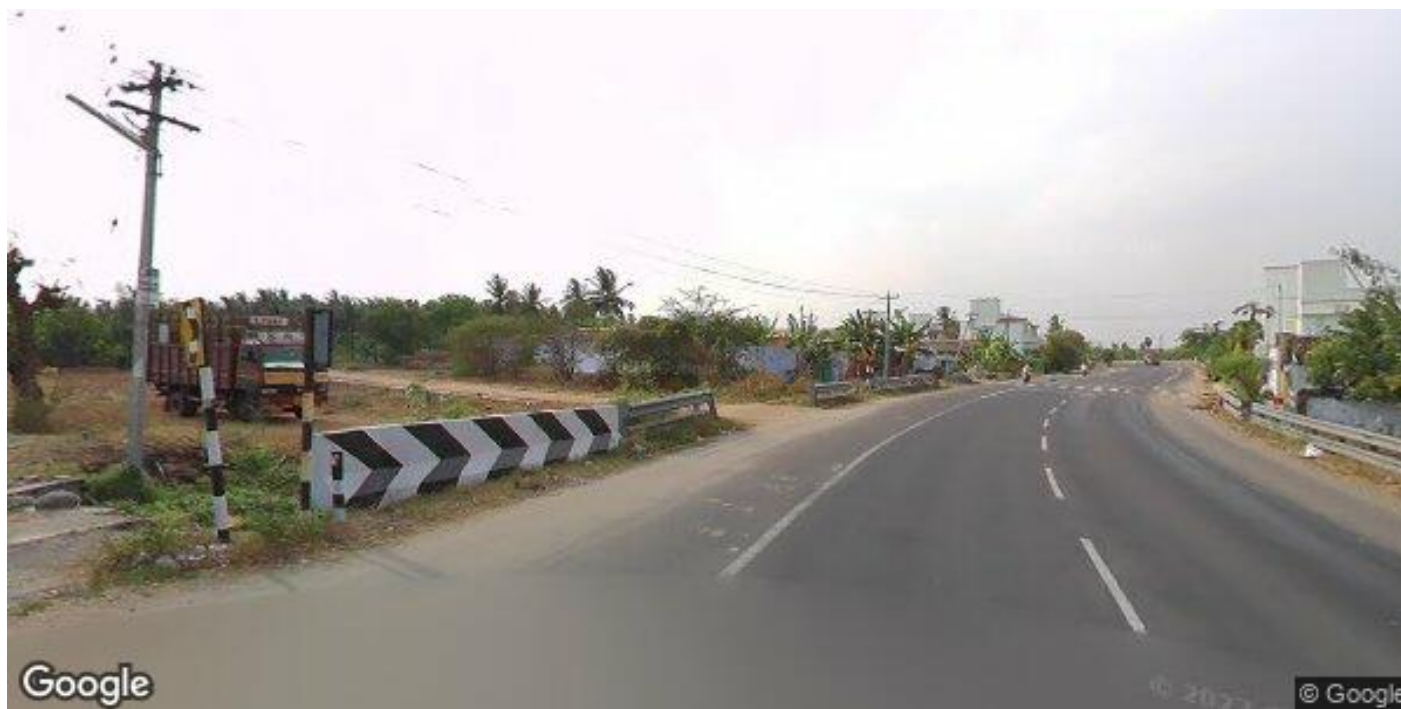
**Risk Type:** Turn  
**Risk Level:** Medium  
**Speed Limit:** 30 KM/Hr  
**Coordinates:** 11.16755, 78.01568

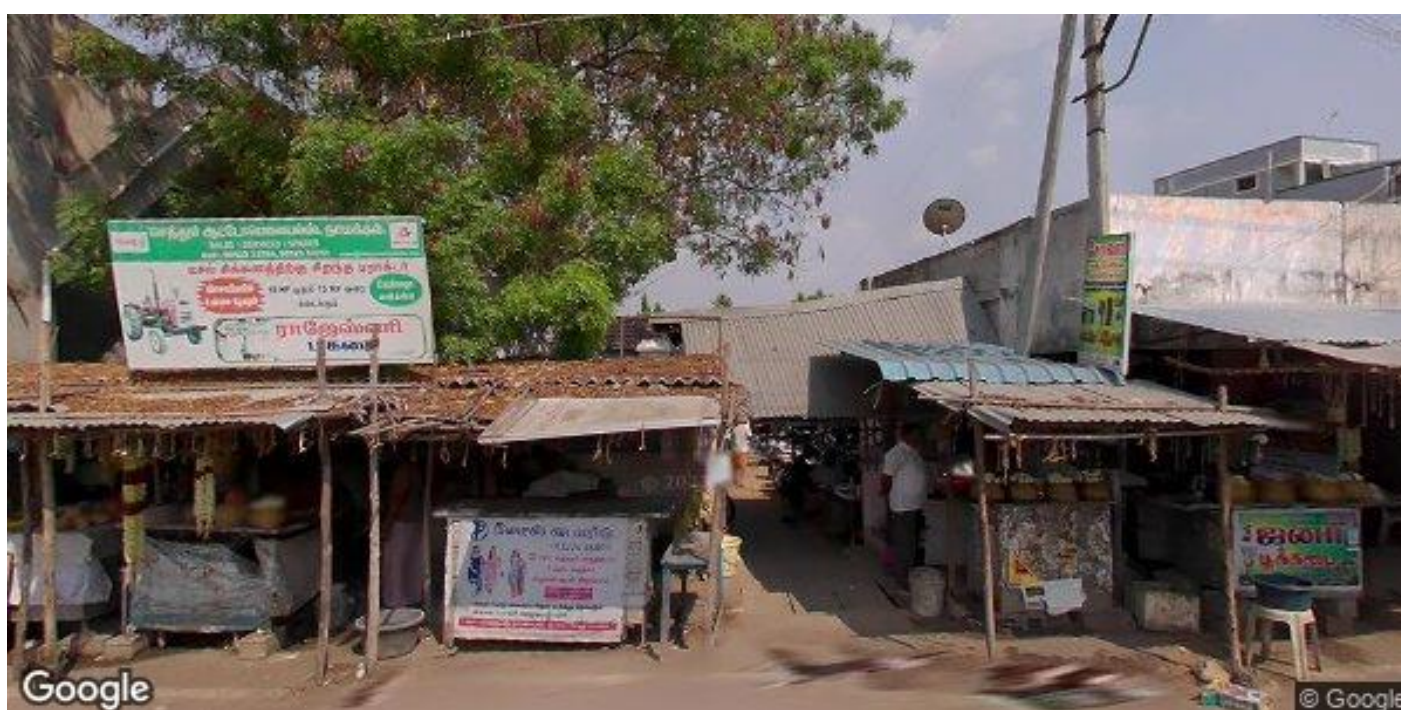
**Risk Type:** Turn  
**Risk Level:** High  
**Speed Limit:** 15 KM/Hr  
**Coordinates:** 11.15573, 78.02176

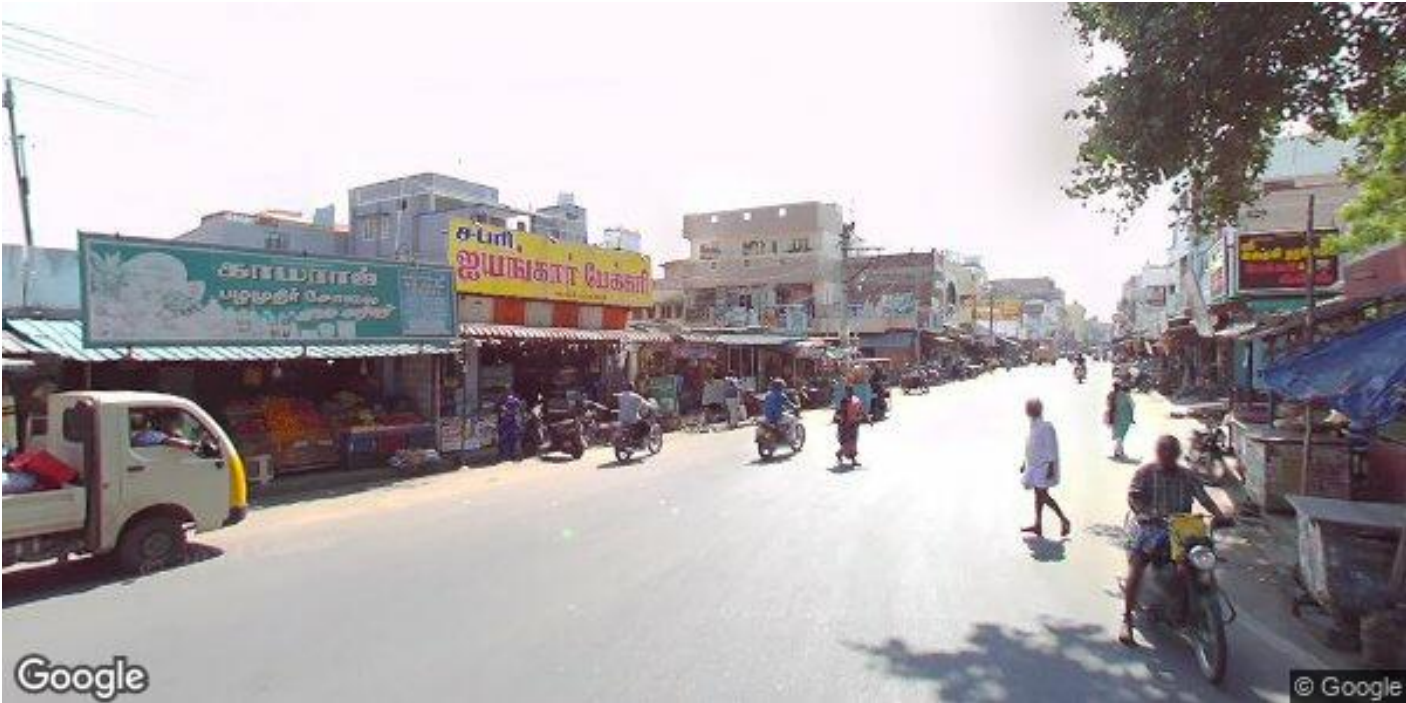
**Risk Type:** Turn  
**Risk Level:** Medium  
**Speed Limit:** 30 KM/Hr  
**Coordinates:** 11.15565, 78.02171

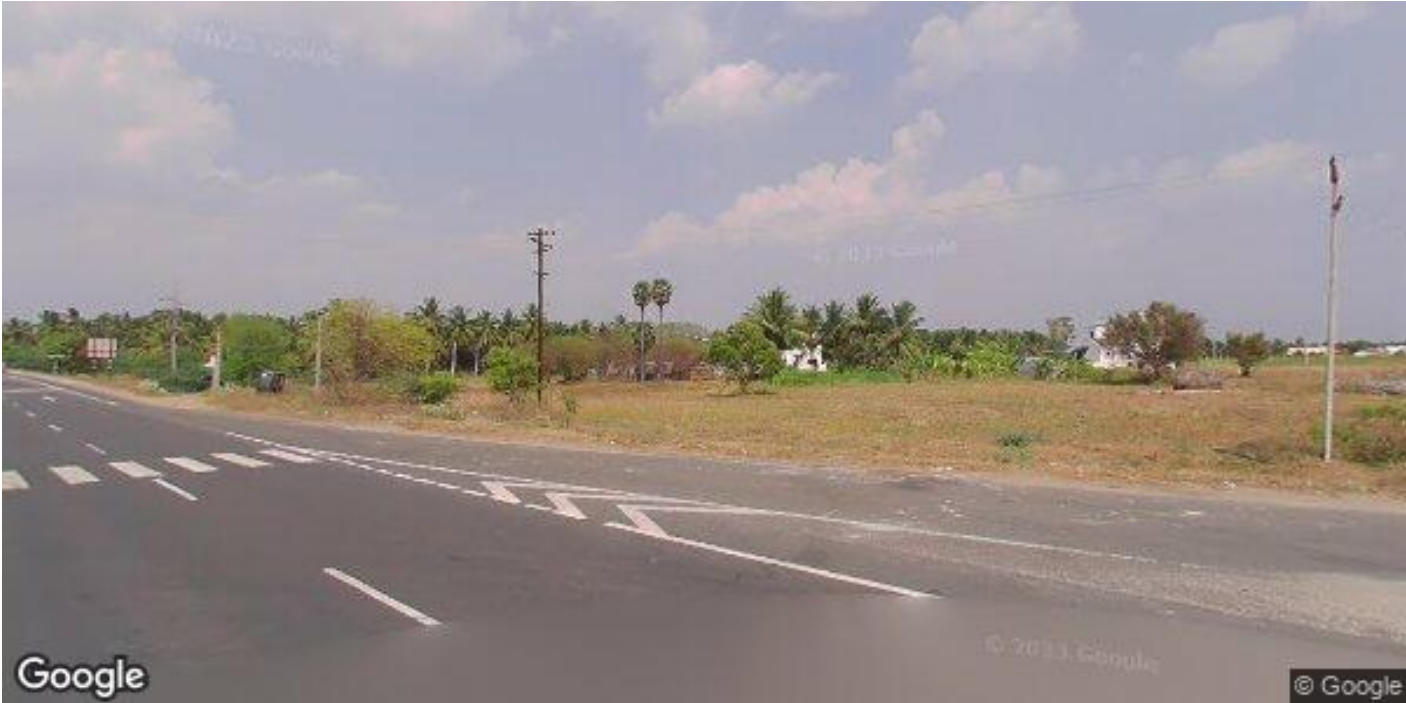
**Risk Type:** Blind Spot  
**Risk Level:** Blind Spot  
**Speed Limit:** 10 KM/Hr  
**Coordinates:** 11.14480, 78.02291

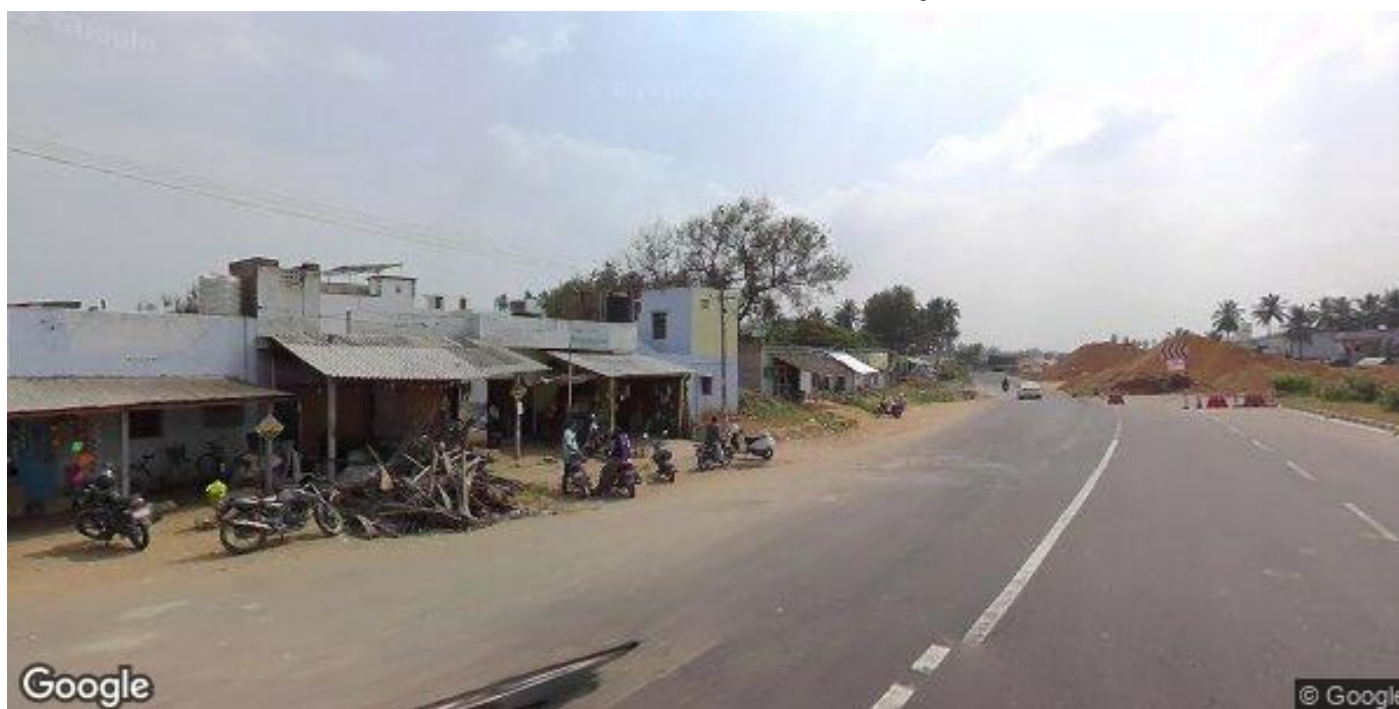
**Risk Type:** Blind Spot  
**Risk Level:** Blind Spot  
**Speed Limit:** 10 KM/Hr  
**Coordinates:** 11.09003, 78.00251

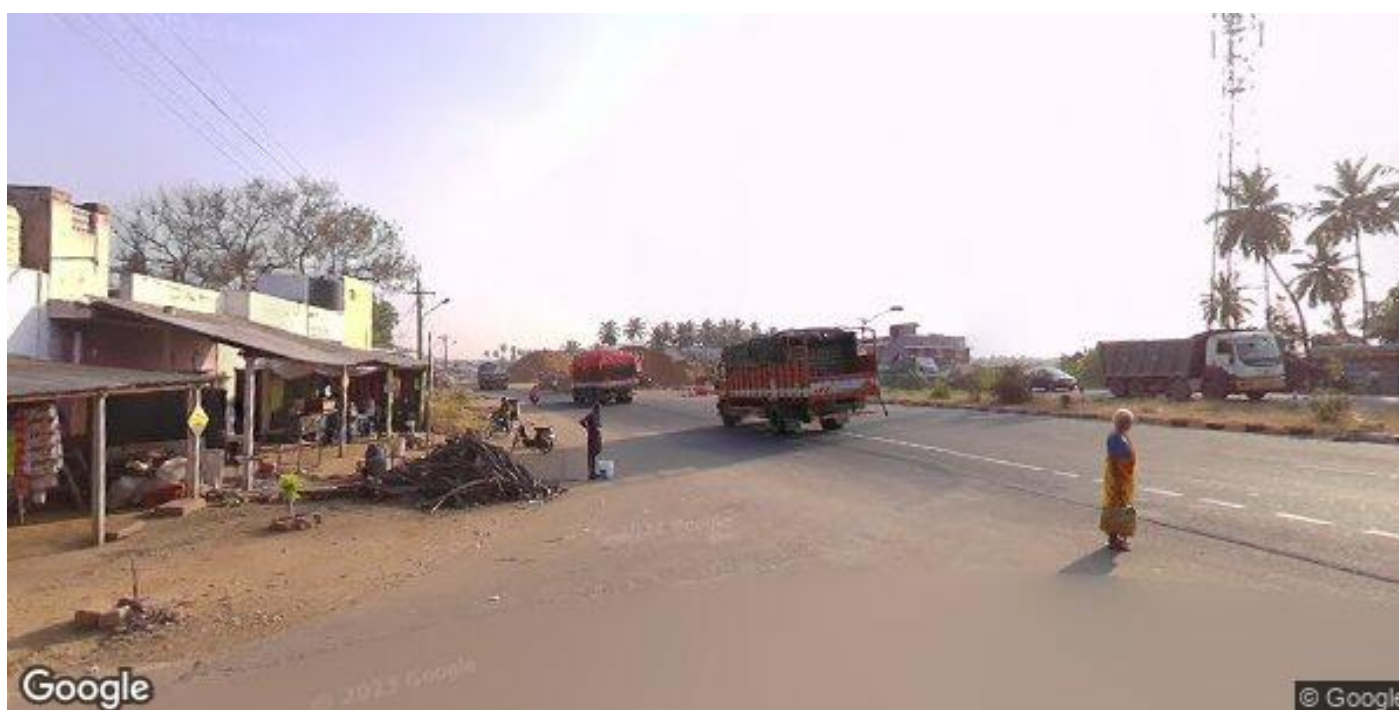
**Risk Type:** Blind Spot  
**Risk Level:** Blind Spot  
**Speed Limit:** 10 KM/Hr  
**Coordinates:** 11.09005, 78.00260

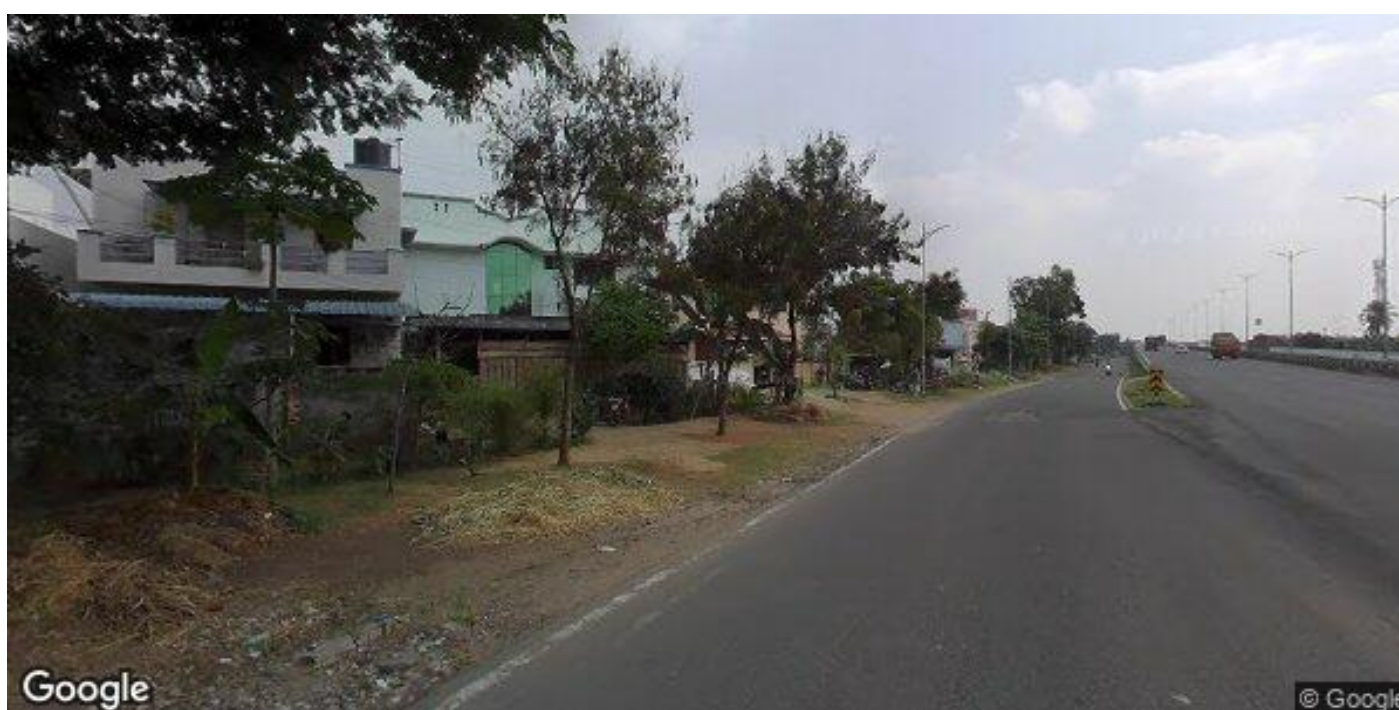
**Risk Type:** Turn  
**Risk Level:** Medium  
**Speed Limit:** 30 KM/Hr  
**Coordinates:** 11.08001, 78.00539

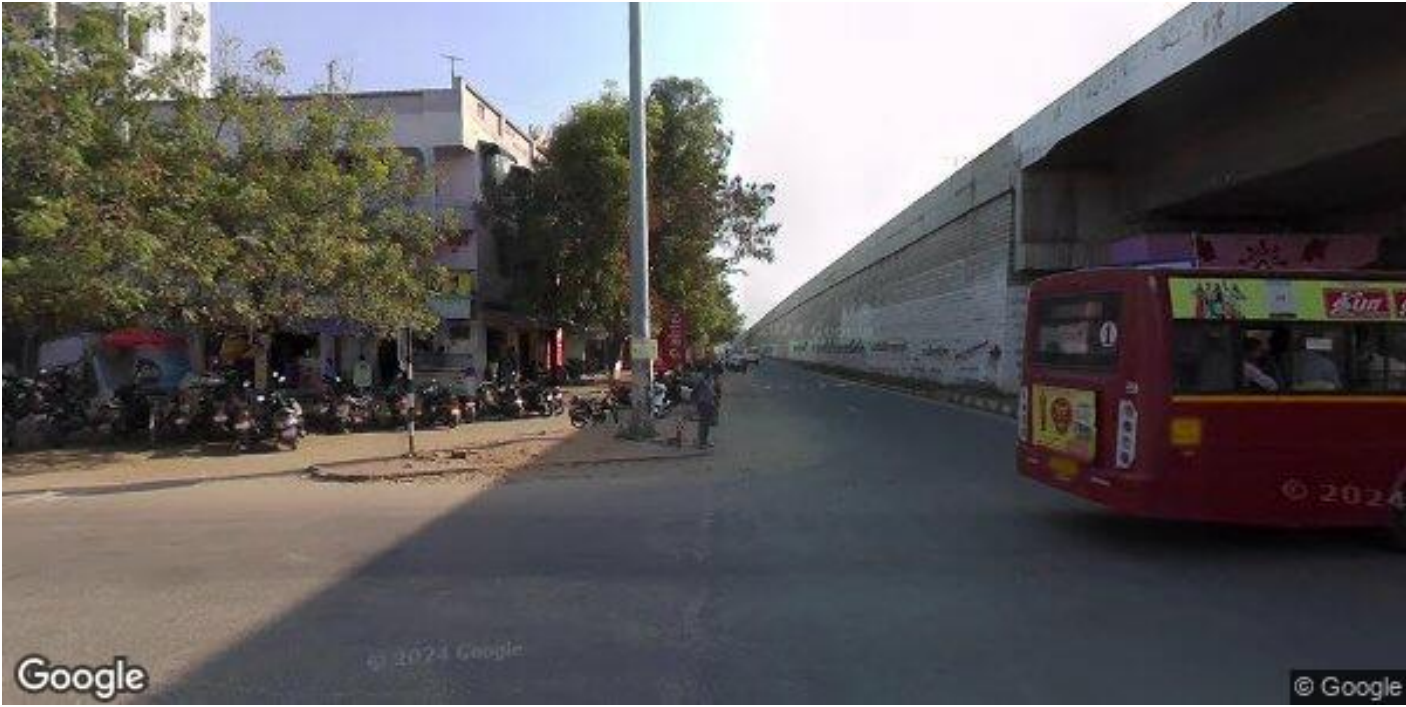
**Risk Type:** Blind Spot  
**Risk Level:** Blind Spot  
**Speed Limit:** 10 KM/Hr  
**Coordinates:** 11.07467, 78.00842

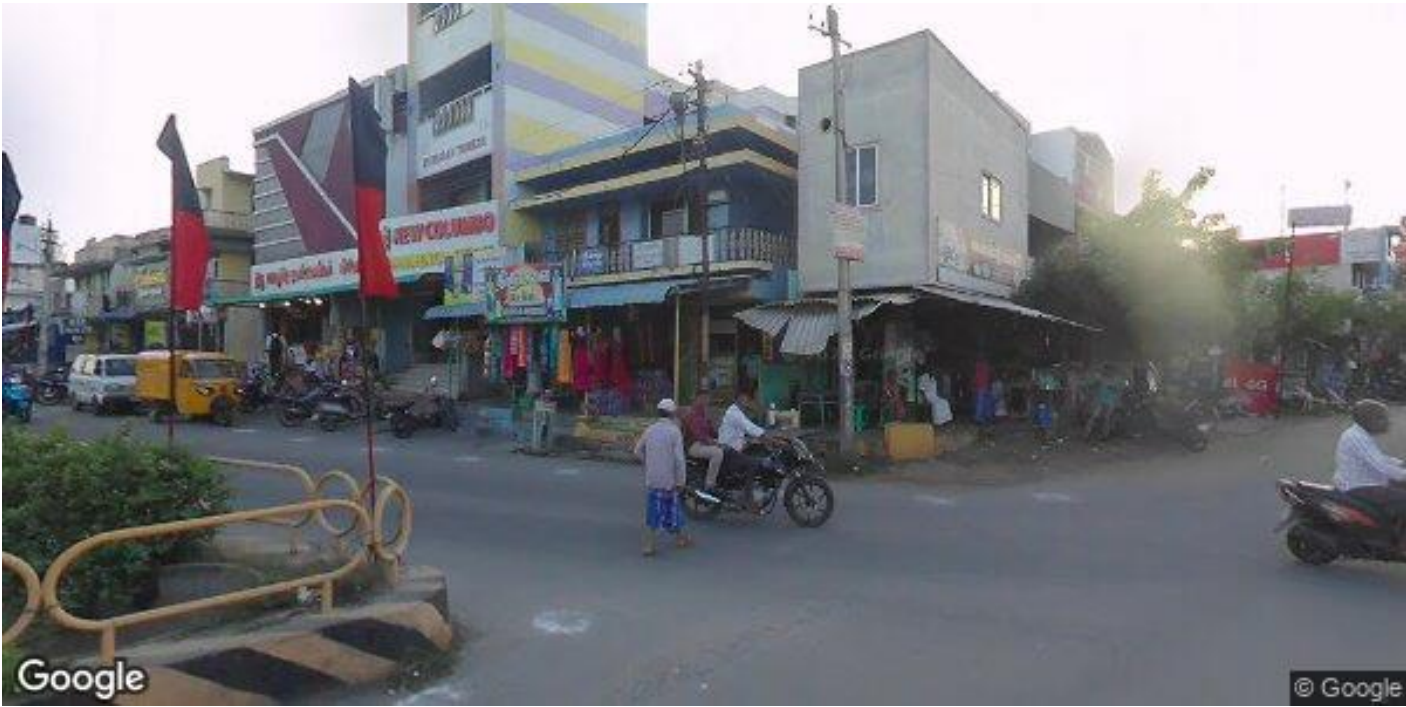
**Risk Type:** Blind Spot  
**Risk Level:** Blind Spot  
**Speed Limit:** 10 KM/Hr  
**Coordinates:** 11.07476, 78.00192
