## **JOURNEY RISK MANAGEMENT (JRM) STUDY**

### **Salem Terminal To SRI KALYAN PERUMAL FUELS**

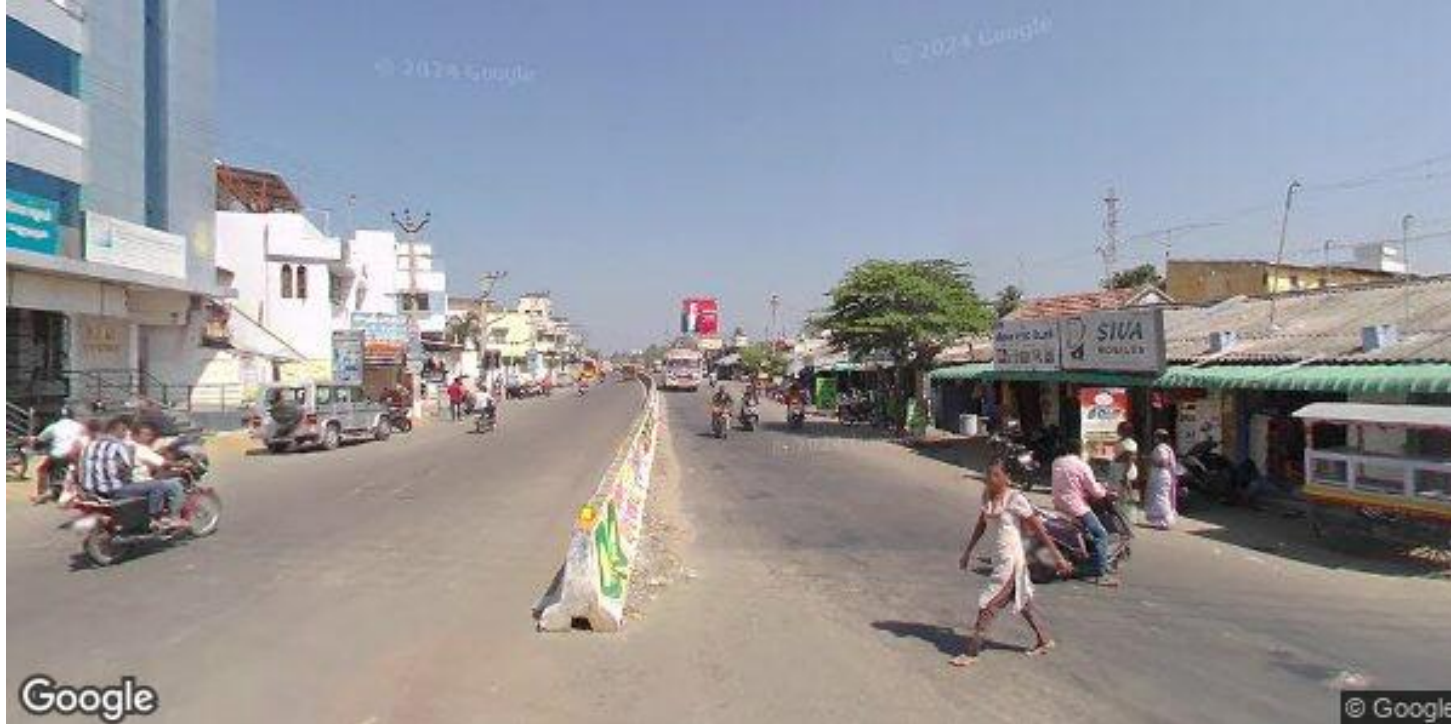
**Risk Type:** Roundabout  
**Risk Level:** High  
**Speed Limit:** 15 KM/Hr  
**Coordinates:** 11.37086, 77.74828

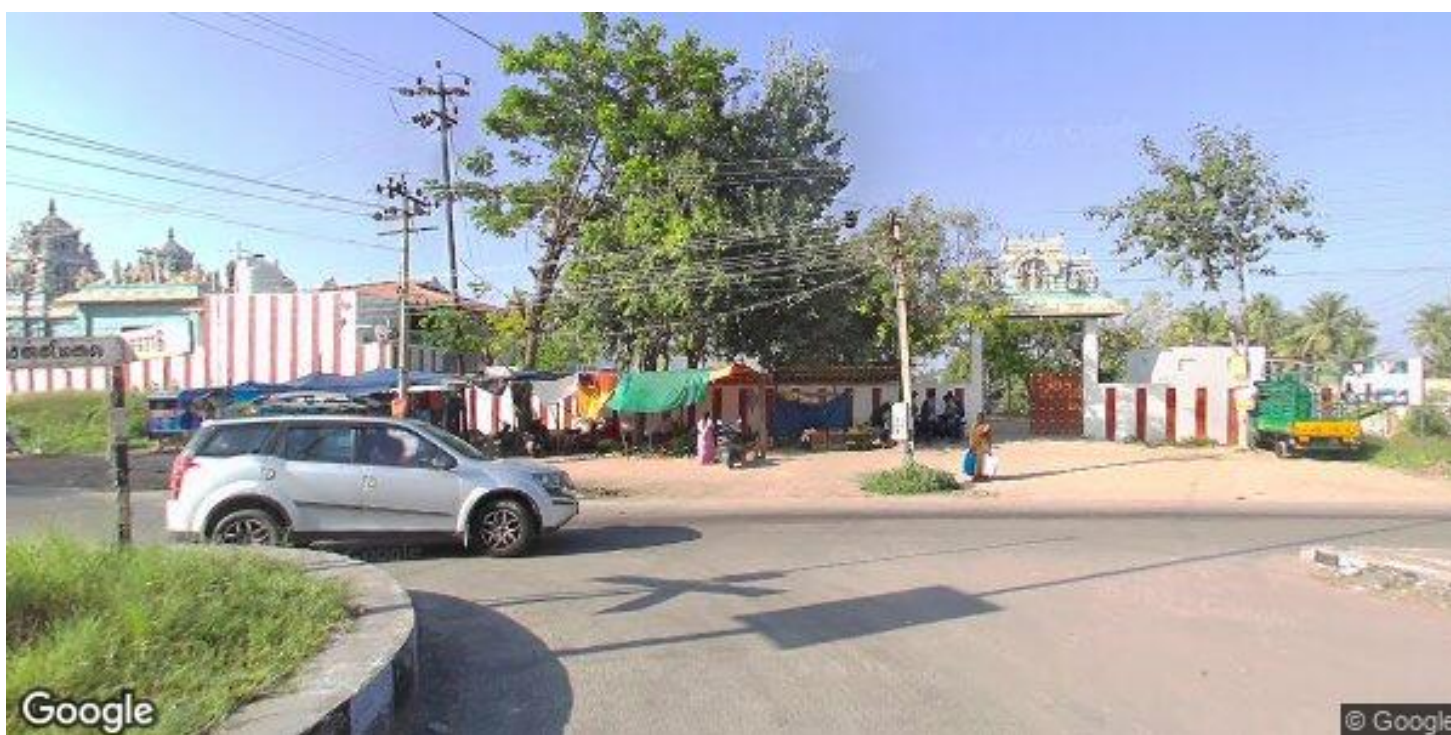
**Risk Type:** Roundabout  
**Risk Level:** High  
**Speed Limit:** 15 KM/Hr  
**Coordinates:** 11.23678, 77.65868

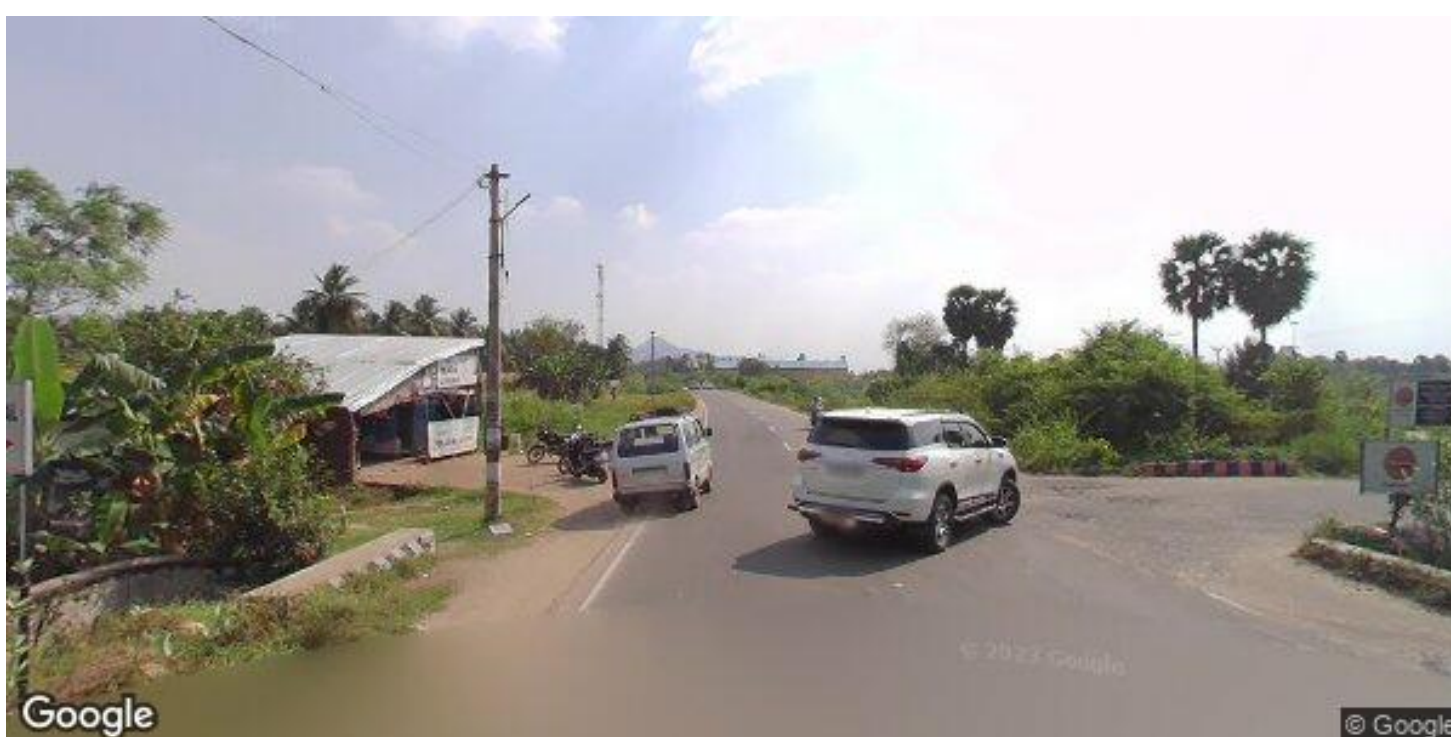
**Coordinates: 11.44029, 77.87544**

**Risk Type:** Turn  
**Risk Level:** High

**Speed Limit: 15 KM/Hr**

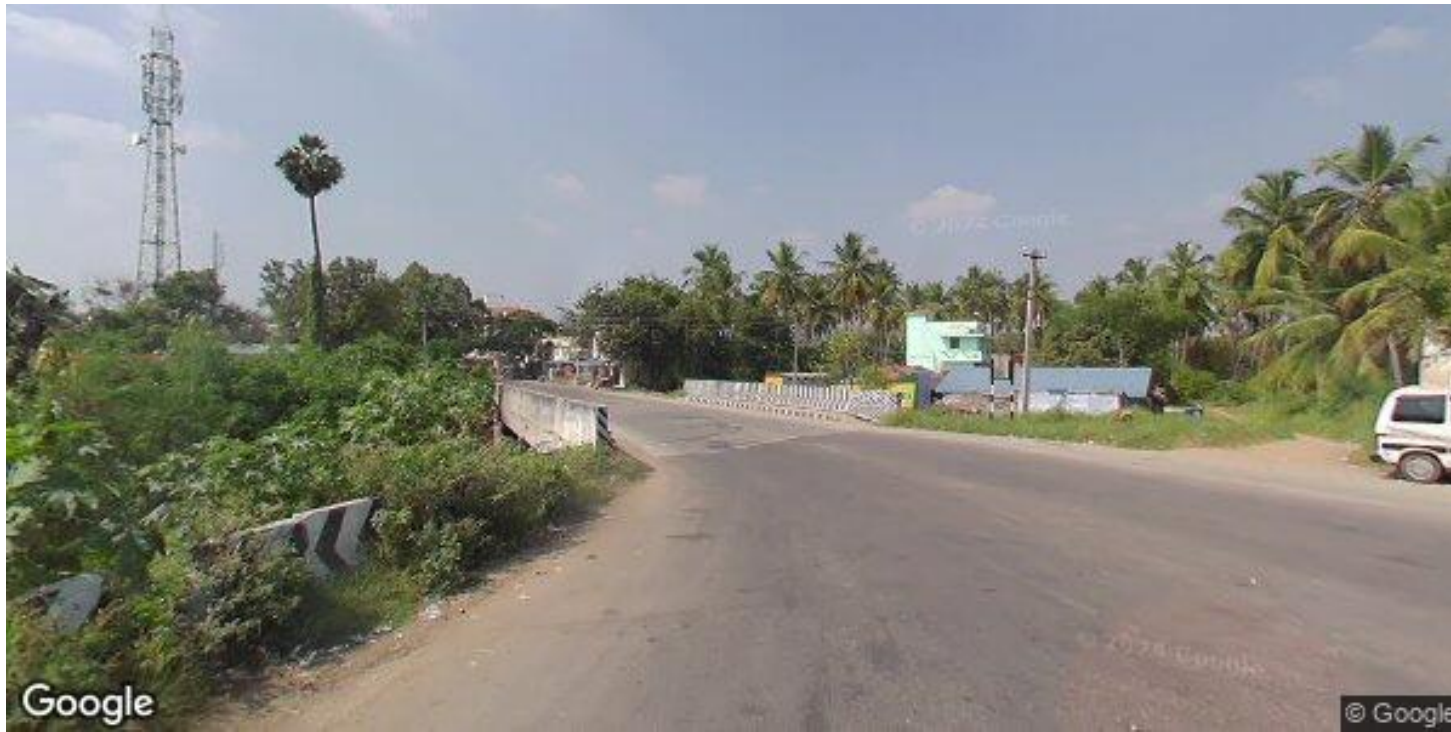
**Coordinates: 11.44893, 77.87413**

**Risk Type: Turn**

**Risk Level: Medium**

**Speed Limit: 30 KM/Hr**

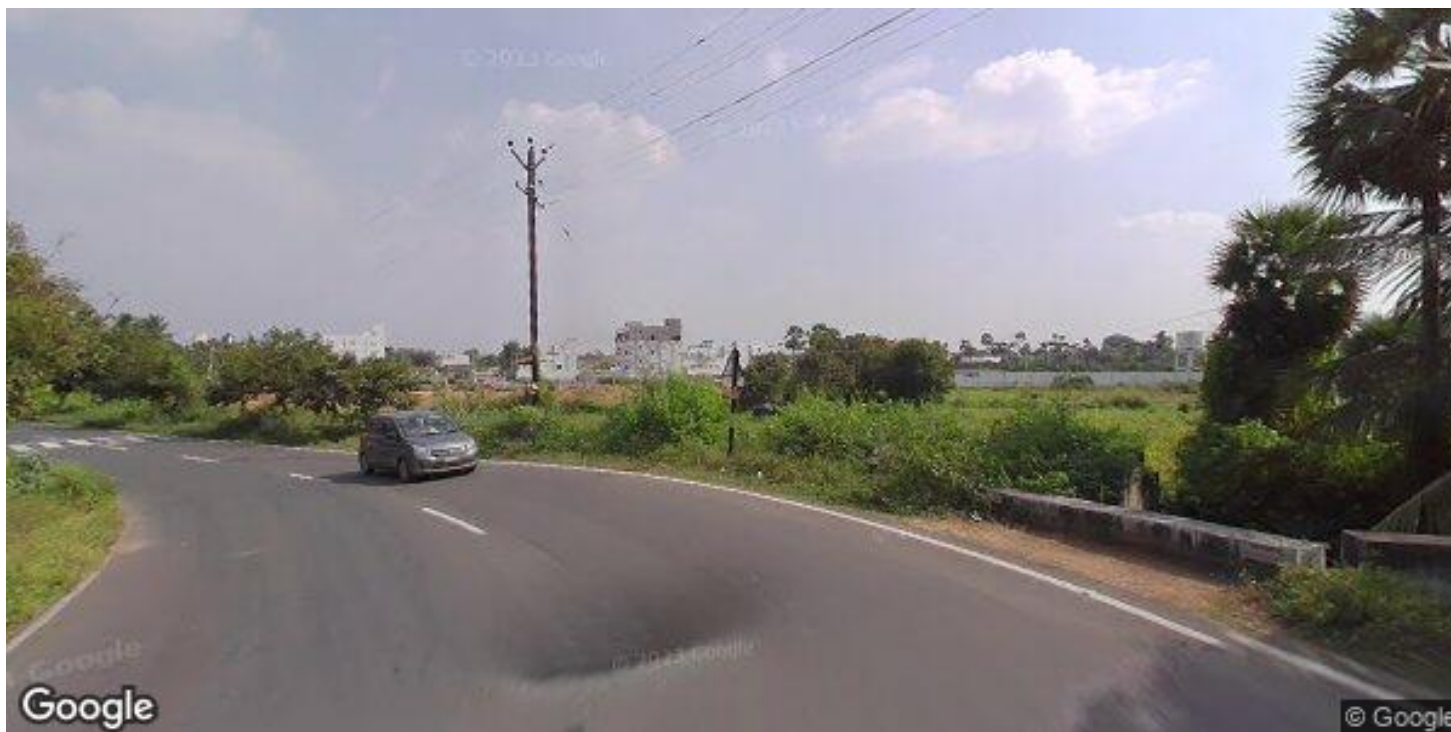
**Coordinates: 11.45350, 77.85700**

**Risk Type: Turn**

**Risk Level: High**

**Speed Limit: 15 KM/Hr**

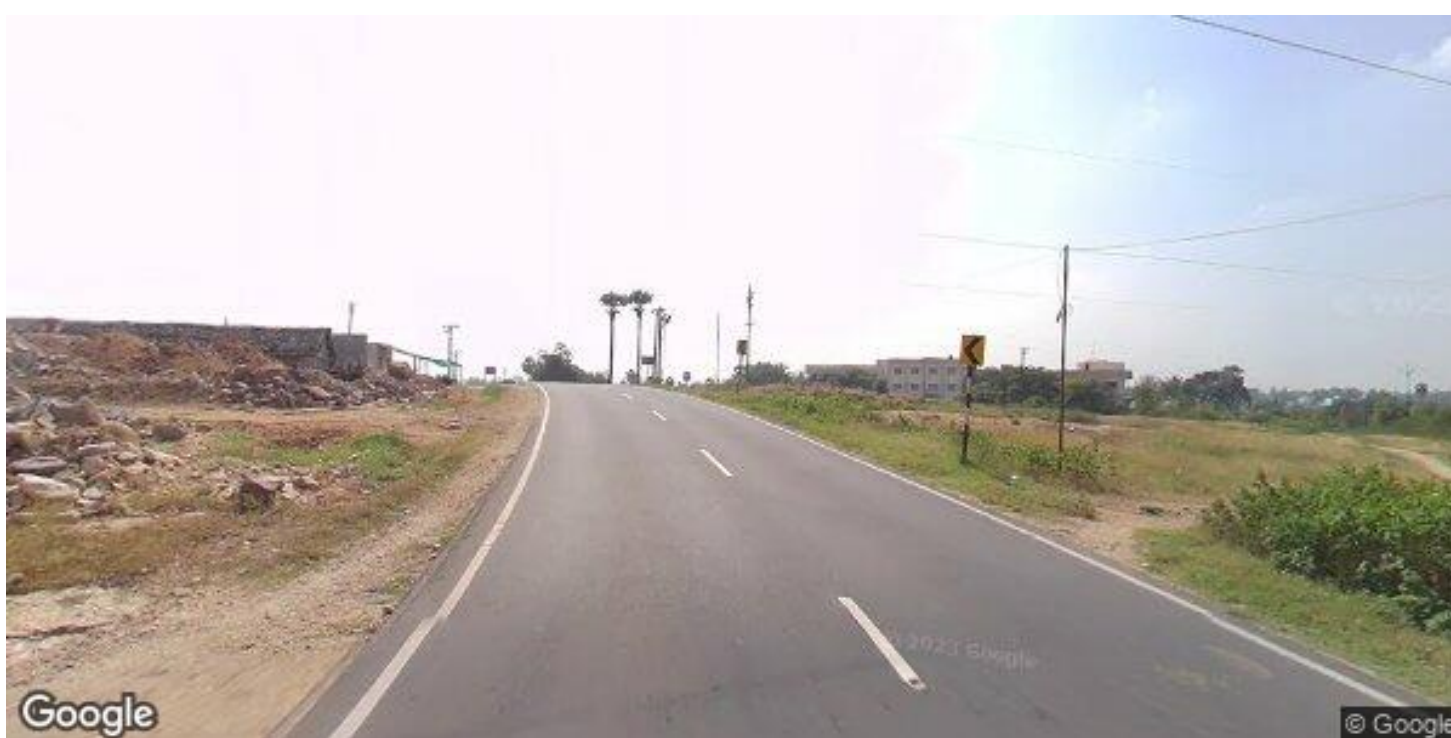
**Coordinates:** 11.46046, 77.85037

**Risk Type:** Turn

**Risk Level:** Medium

**Speed Limit:** 30 KM/Hr

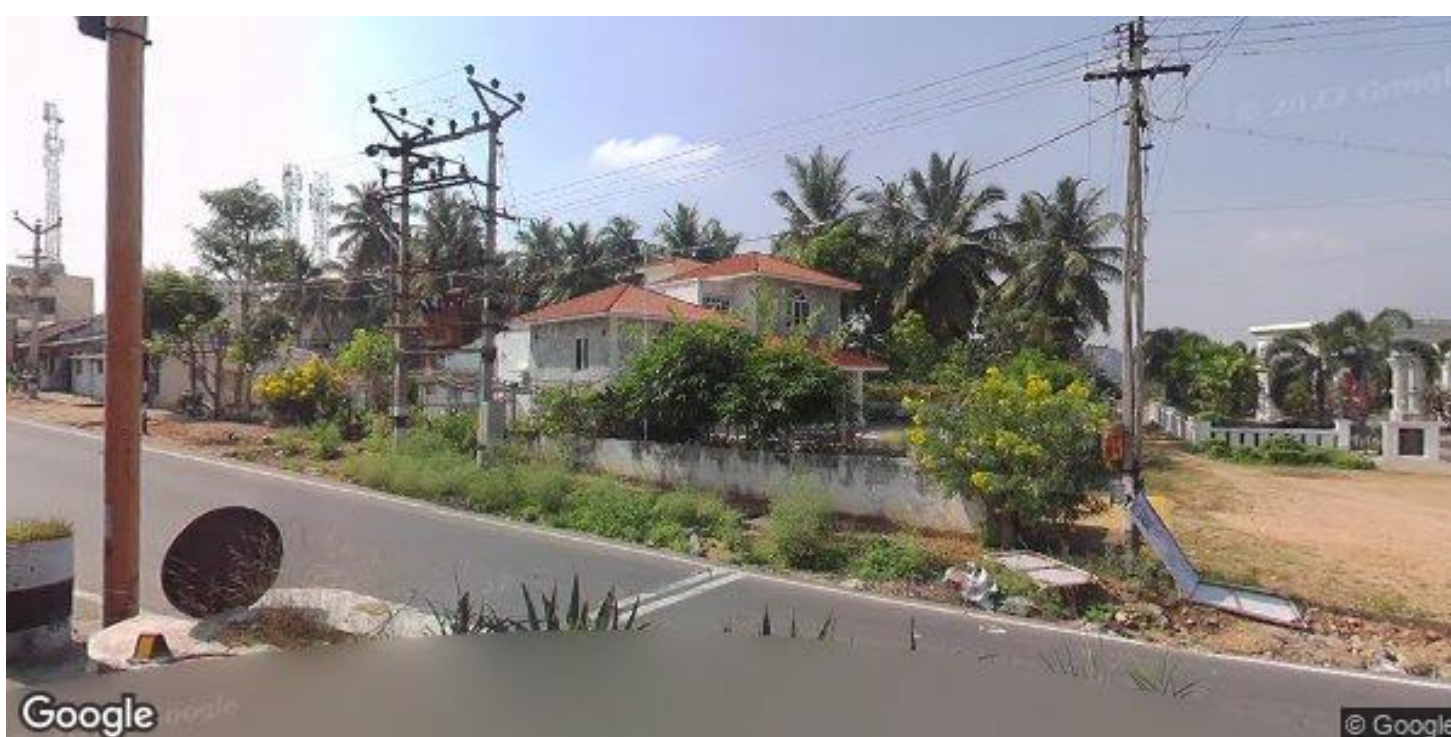
**Coordinates: 11.46303, 77.84945**

**Risk Type:** Turn

**Risk Level:** Medium

**Speed Limit: 30 KM/Hr**

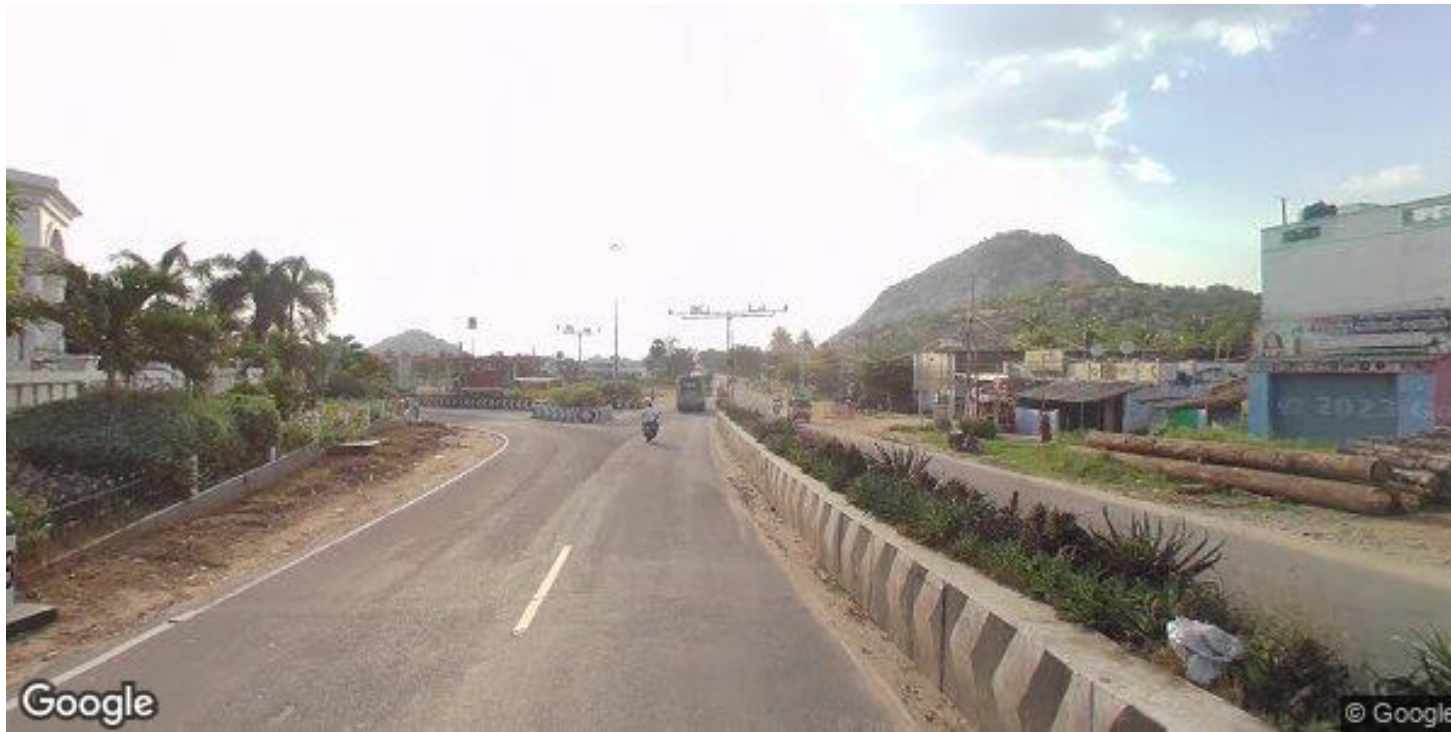
**Coordinates: 11.46317, 77.84906**

**Risk Type: Turn**

**Risk Level: Medium**

**Speed Limit: 30 KM/Hr**

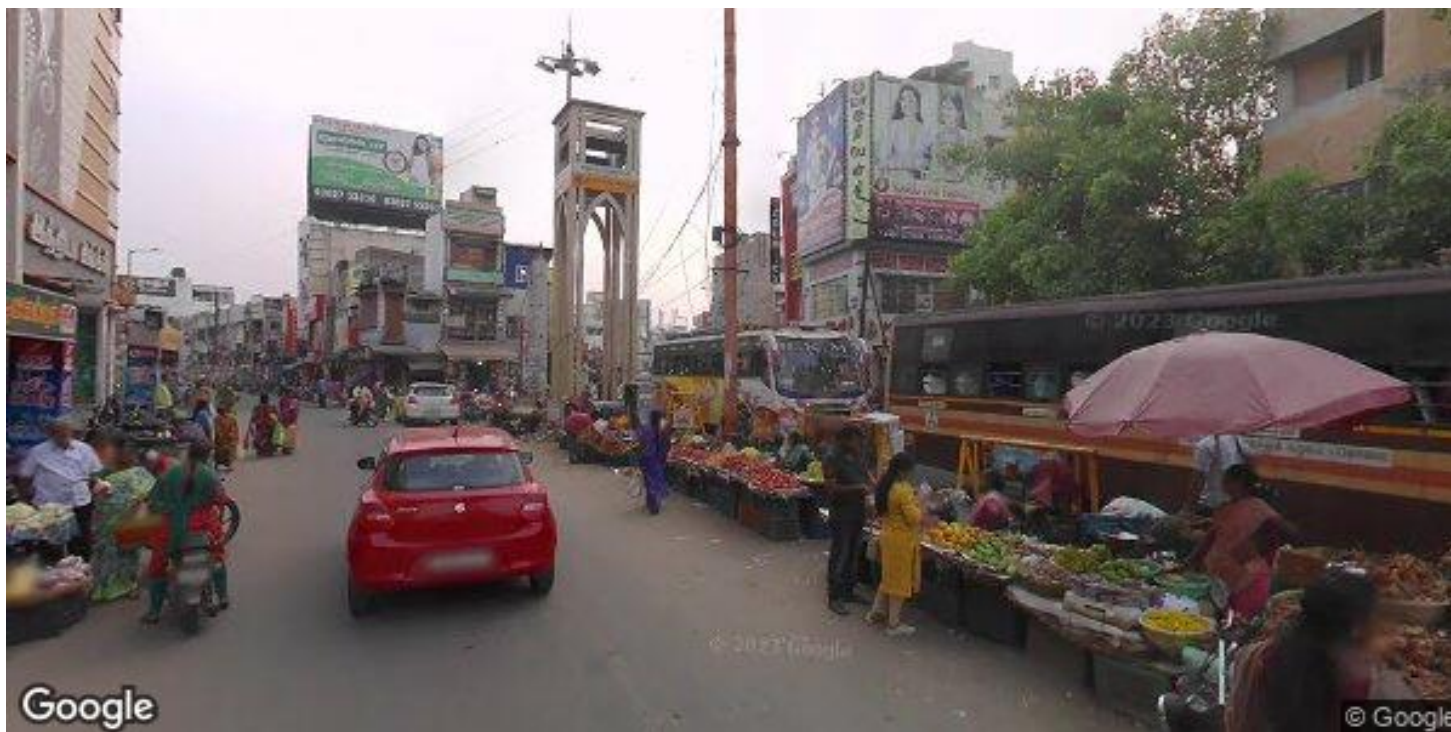
**Coordinates: 11.34192, 77.72824**

**Risk Type: Turn**

**Risk Level: Medium**

**Speed Limit: 30 KM/Hr**

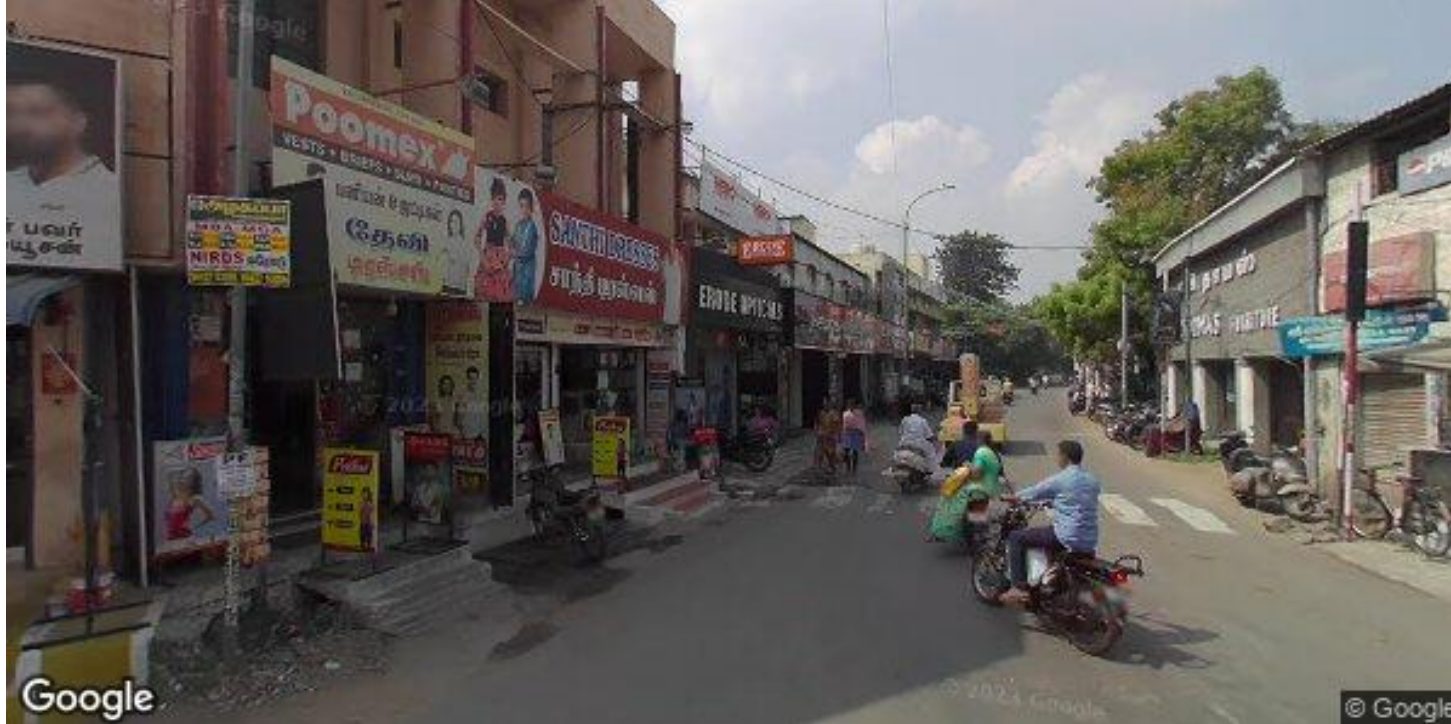
**Risk Type:** Blind Spot  
**Risk Level:** Blind Spot  
**Speed Limit:** 10 KM/Hr  
**Coordinates:** 11.33920, 77.72902

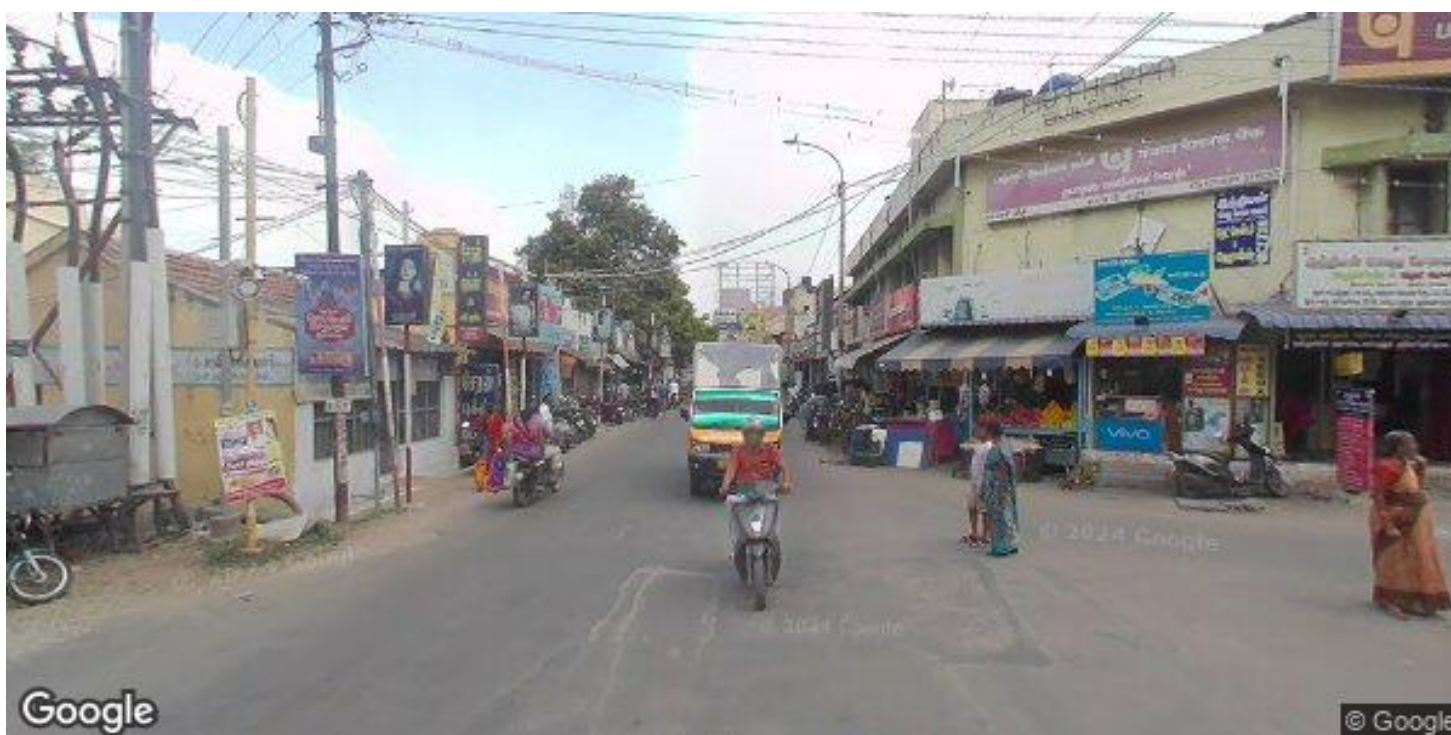
**Risk Type:** Turn  
**Risk Level:** High  
**Speed Limit:** 15 KM/Hr  
**Coordinates:** 11.33913, 77.72832

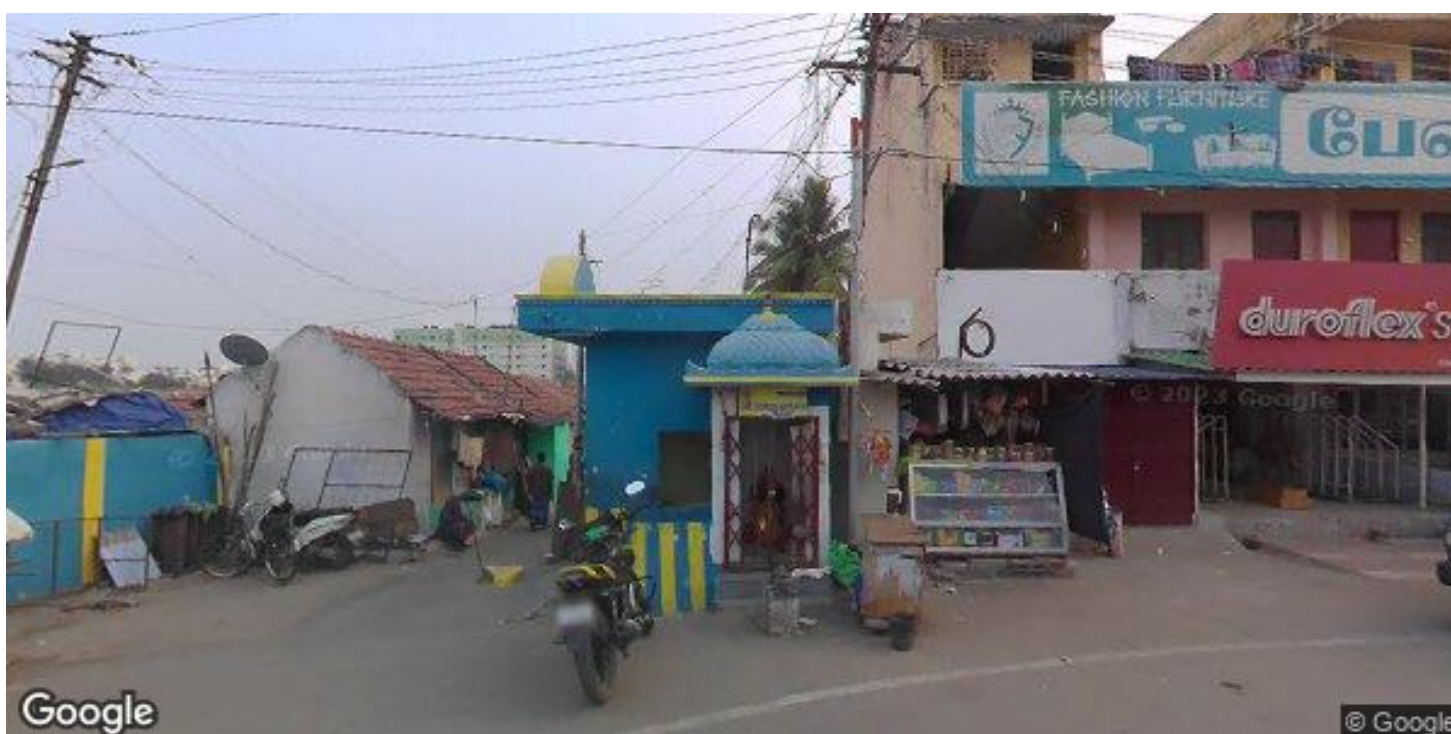
Coordinates: 11.33618, 77.72865

**Risk Type:** Blind Spot  
**Risk Level:** Blind Spot

Speed Limit: 10 KM/Hr

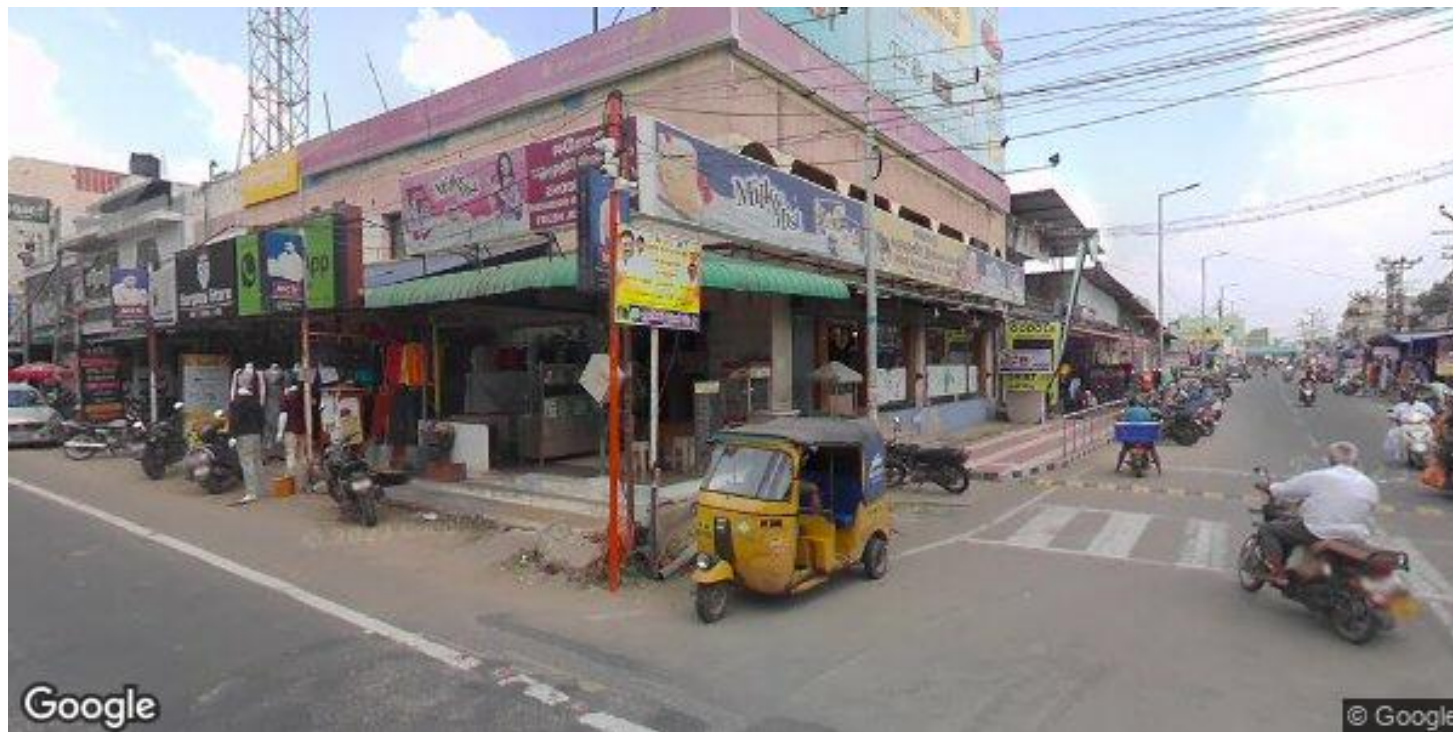
Coordinates: 11.33582, 77.72712

Risk Type: Blind Spot

Risk Level: Blind Spot

Speed Limit: 10 KM/Hr

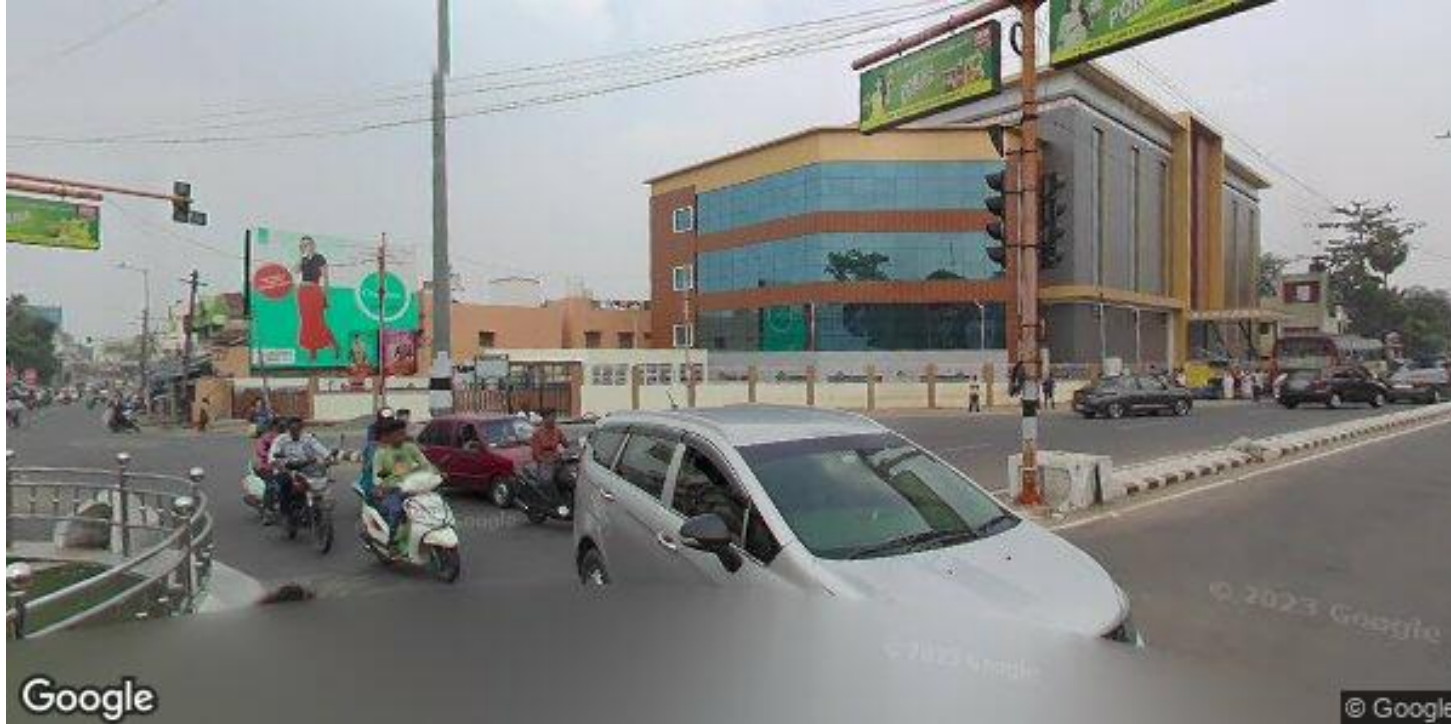
**Coordinates:** 11.33088, 77.72747

**Risk Type:** Turn

**Risk Level:** Medium

**Speed Limit:** 30 KM/Hr

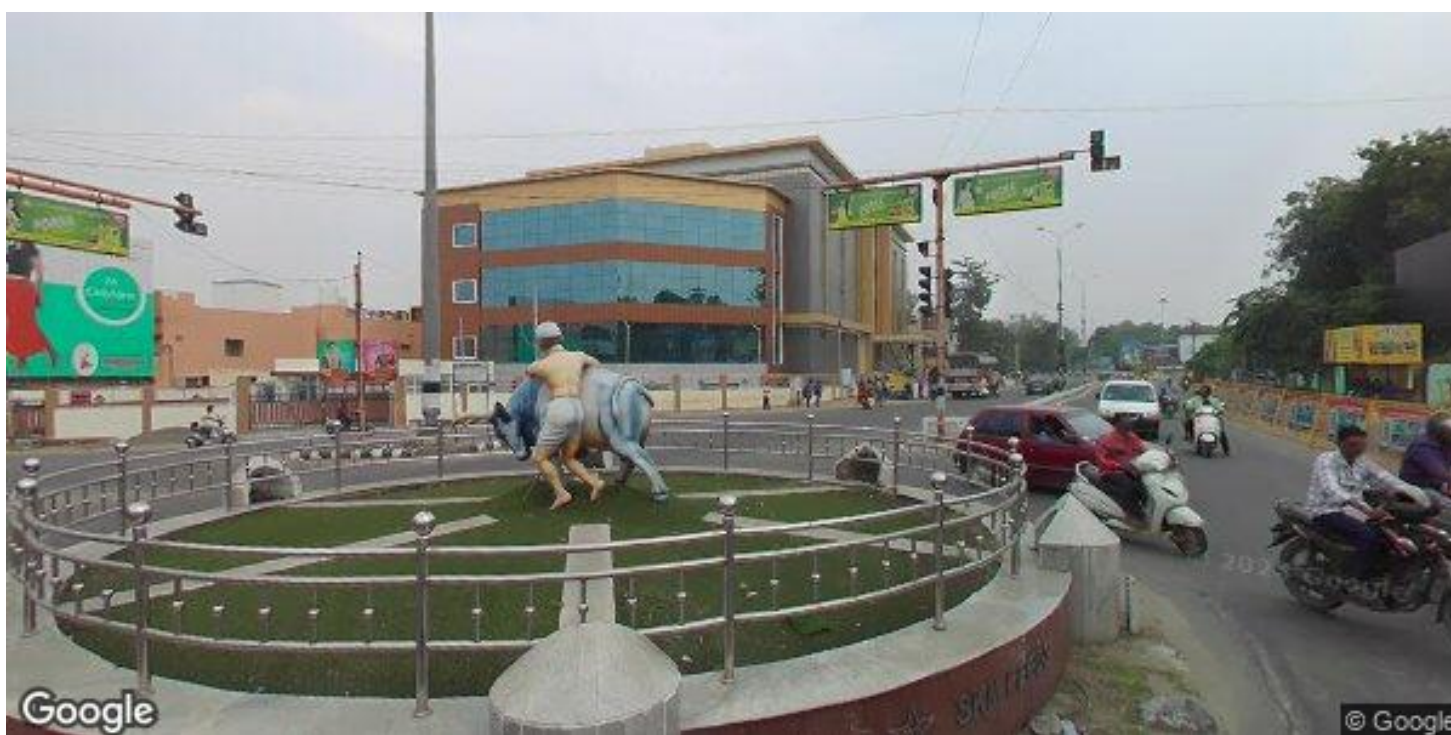
**Coordinates:** 11.33083, 77.72740

**Risk Type:** Turn

**Risk Level:** Medium

**Speed Limit:** 30 KM/Hr

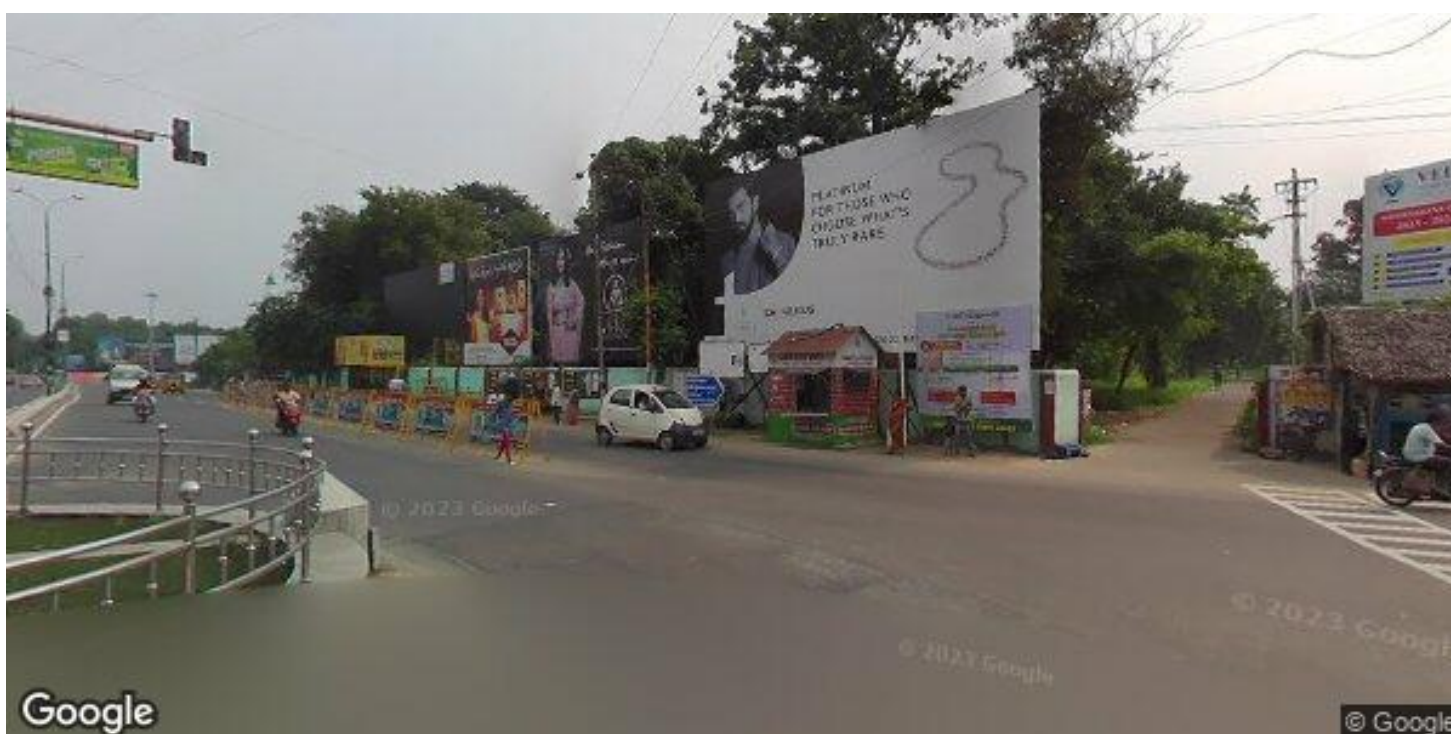
Coordinates: 11.33083, 77.72732

**Risk Type:** Turn

**Risk Level:** Medium

Speed Limit: 30 KM/Hr

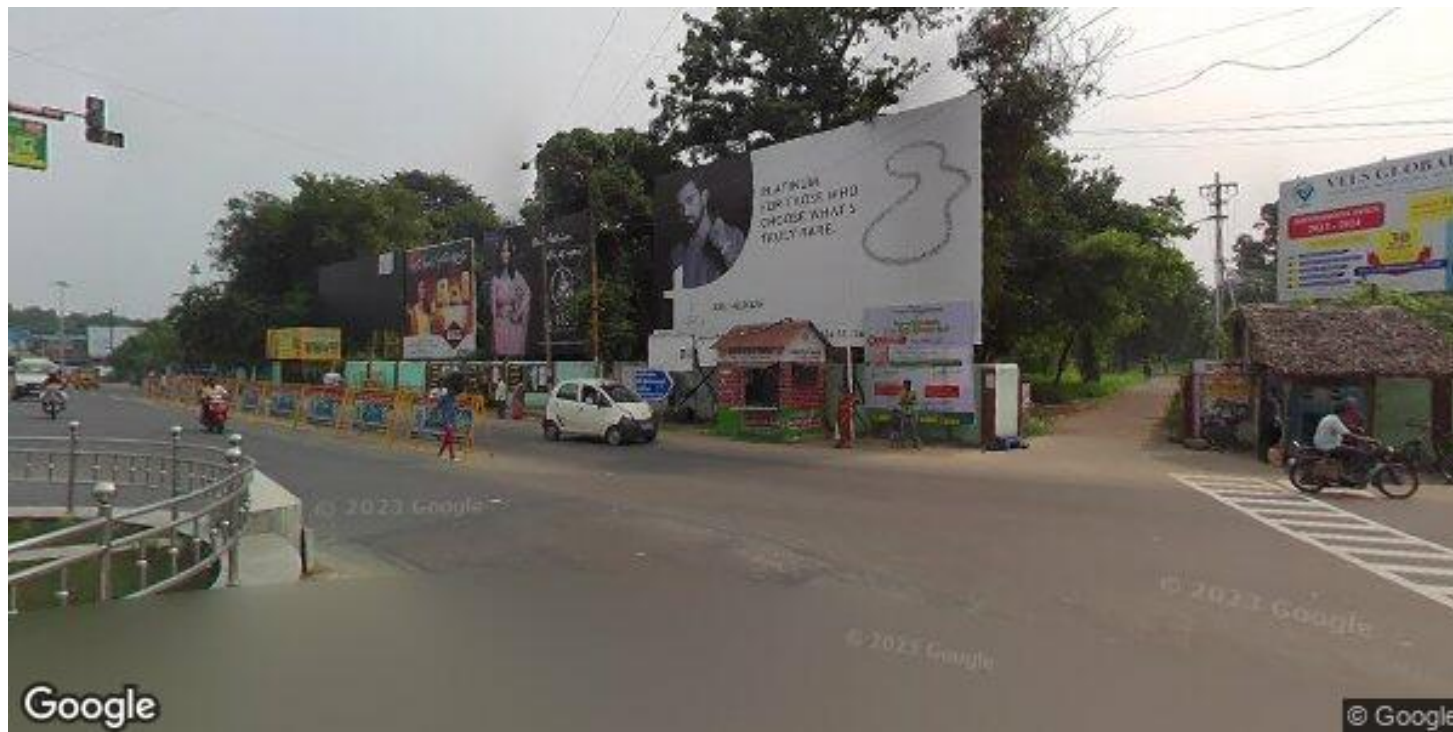
Coordinates: 11.33085, 77.72730

Risk Type: Turn

Risk Level: High

Speed Limit: 15 KM/Hr

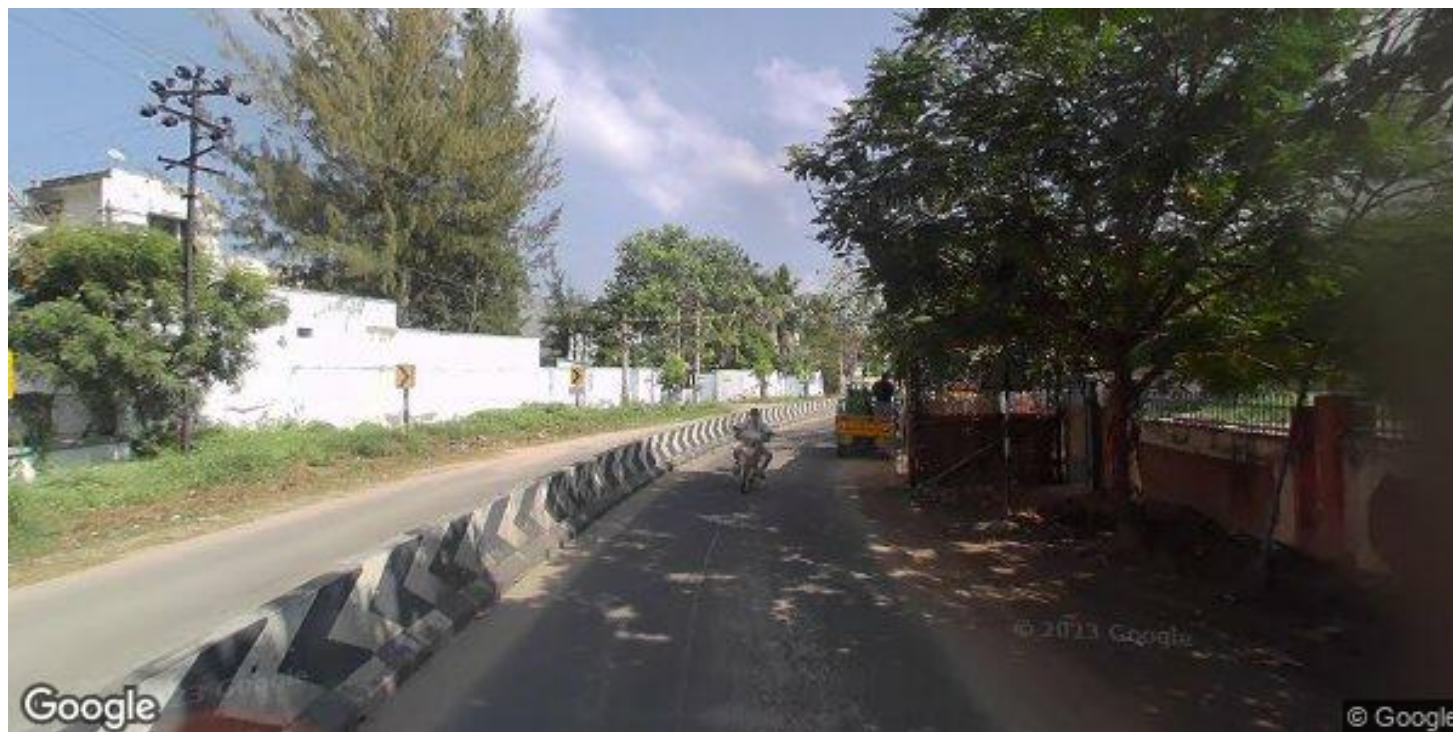
Coordinates: 11.32259, 77.71458

Risk Type: Turn

Risk Level: Medium

Speed Limit: 30 KM/Hr

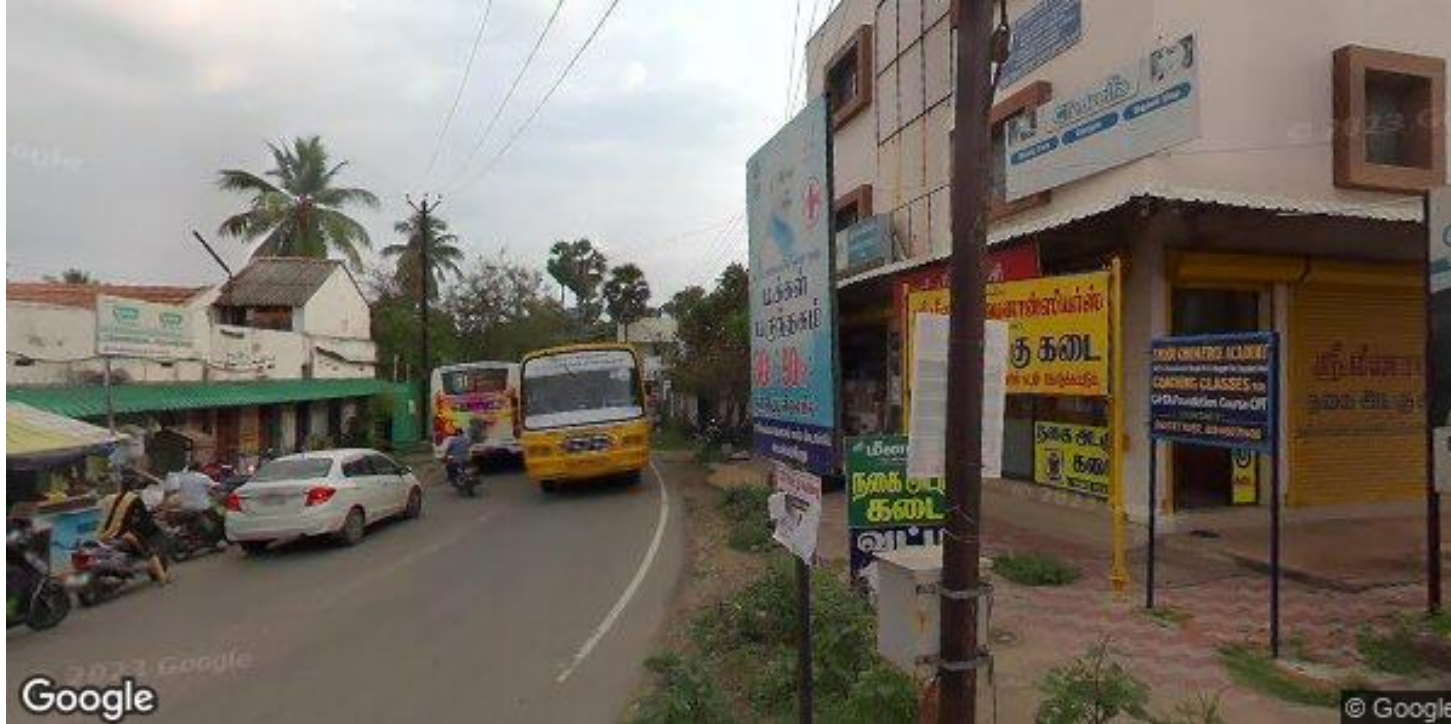
**Coordinates:** 11.31165, 77.70717

**Risk Type:** Turn

**Risk Level:** High

**Speed Limit:** 15 KM/Hr

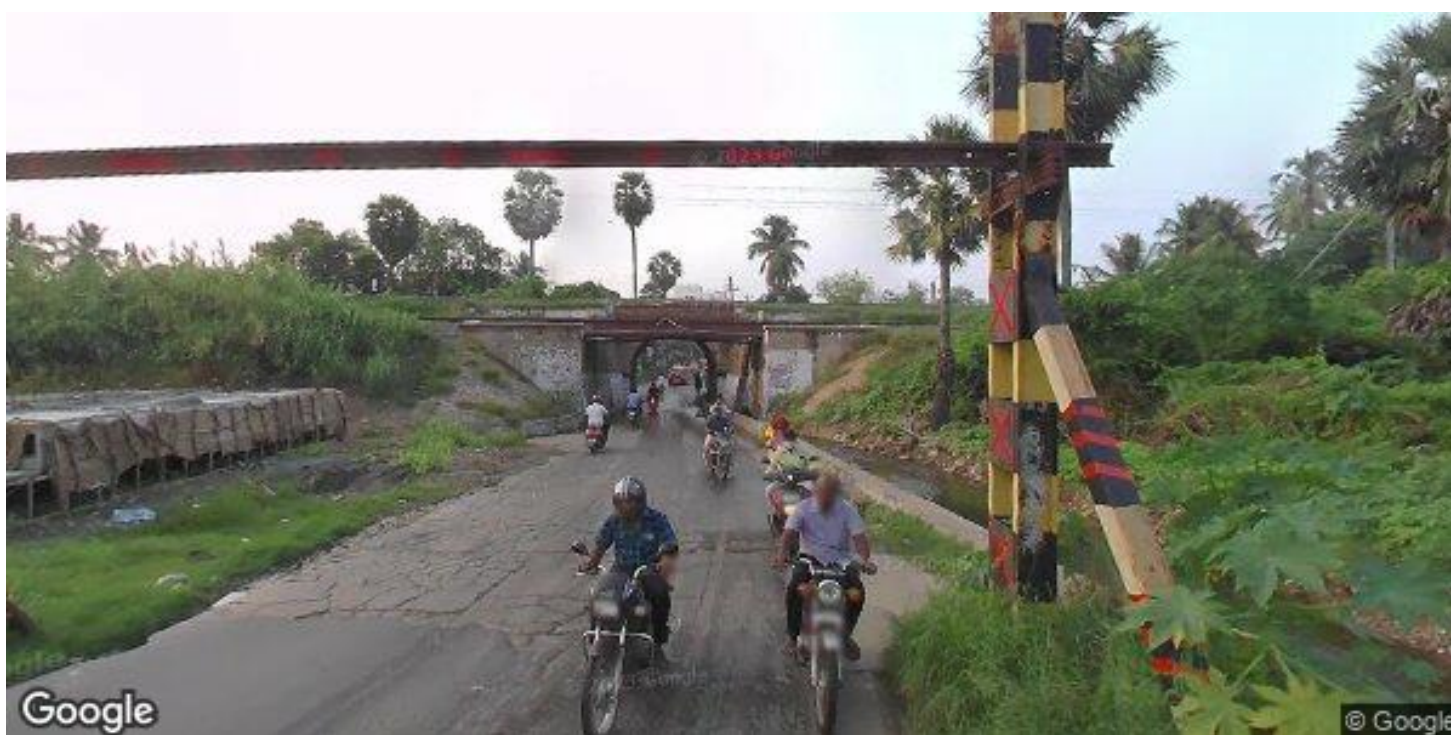
**Coordinates:** 11.31050, 77.70781

**Risk Type:** Turn

**Risk Level:** Medium

**Speed Limit:** 30 KM/Hr

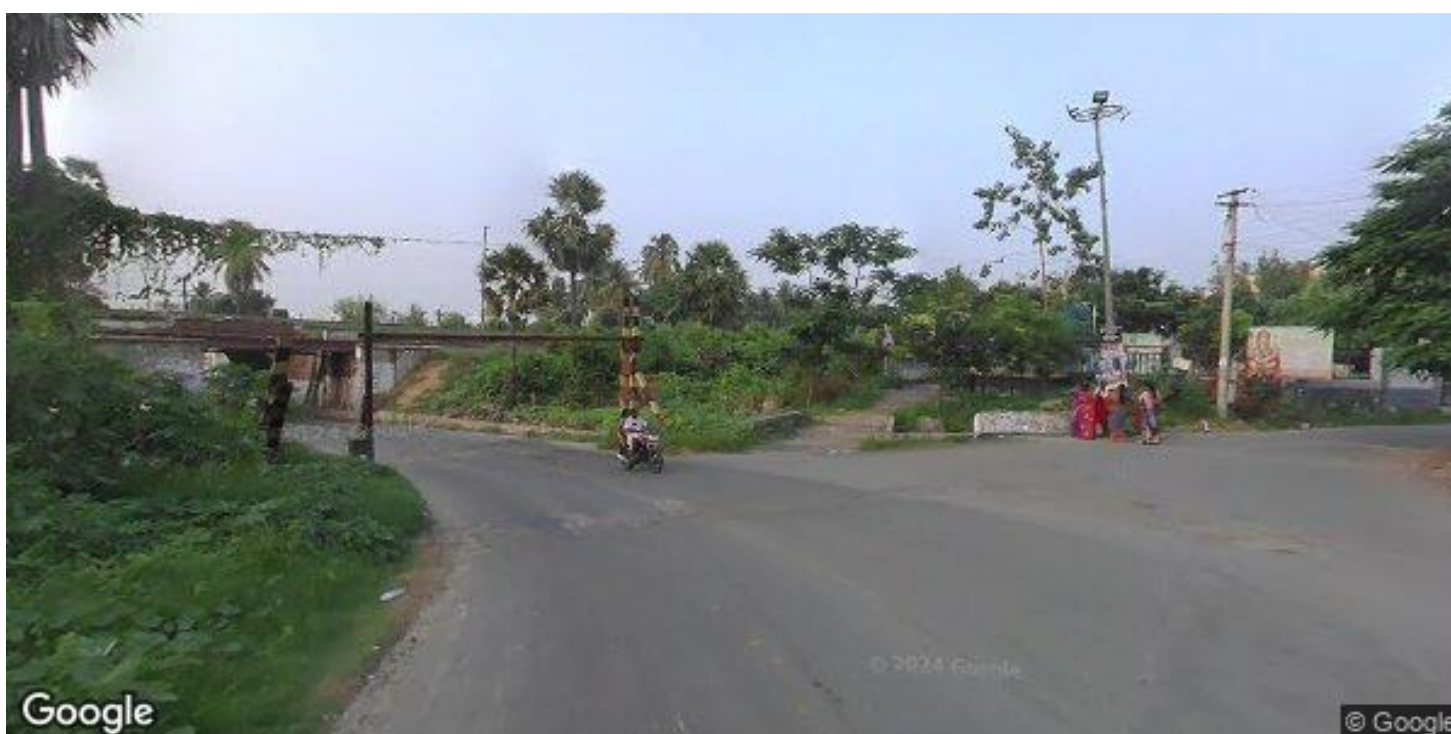
**Coordinates: 11.31032, 77.70783**

**Risk Type:** Turn

**Risk Level:** Medium

**Speed Limit: 30 KM/Hr**
