## **JOURNEY RISK MANAGEMENT (JRM) STUDY**

### **Salem Terminal To SRI KALYAN PERUMAL FUELS**

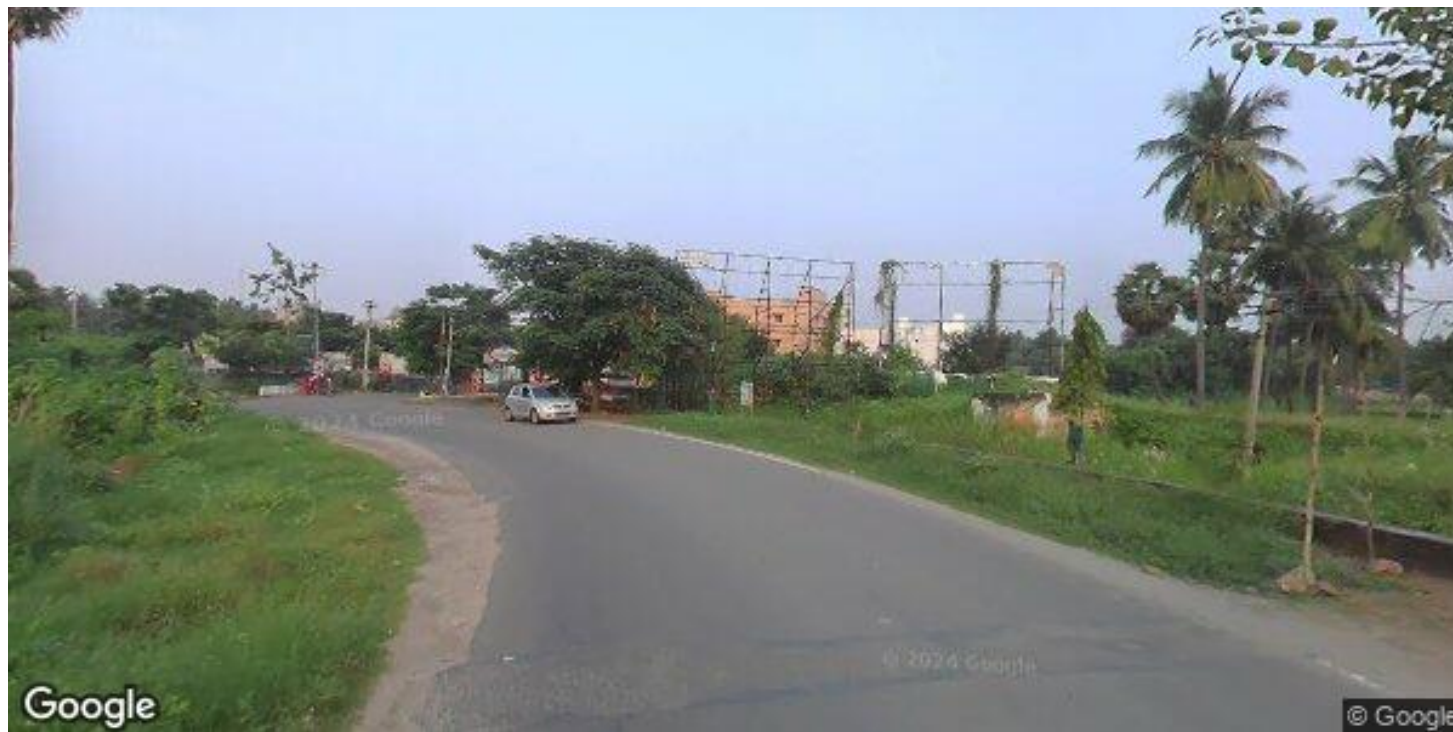
**Coordinates: 11.31003, 77.70761**

**Risk Type: Turn**

**Risk Level: Medium**

**Speed Limit: 30 KM/Hr**

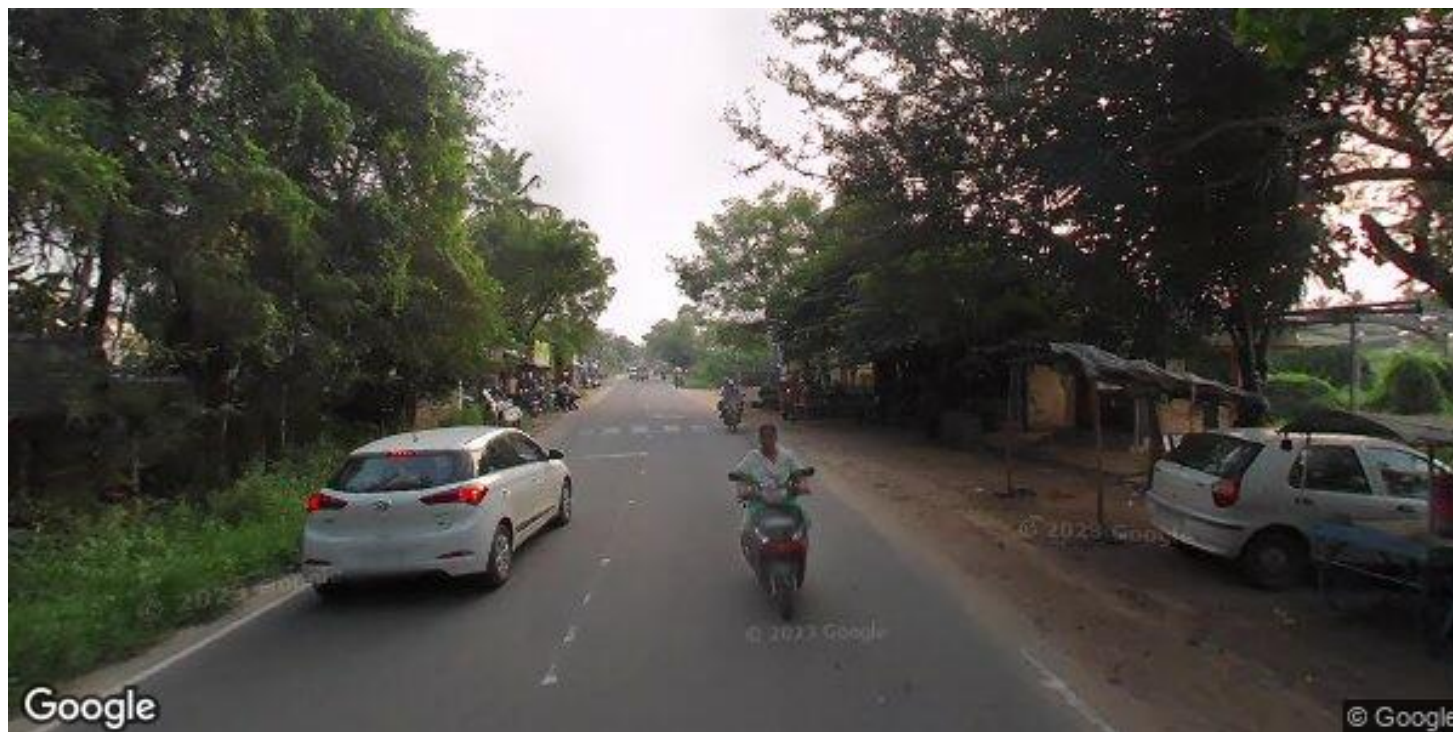
**Coordinates: 11.30807, 77.70415**

**Risk Type: Turn**

**Risk Level: Medium**

**Speed Limit: 30 KM/Hr**

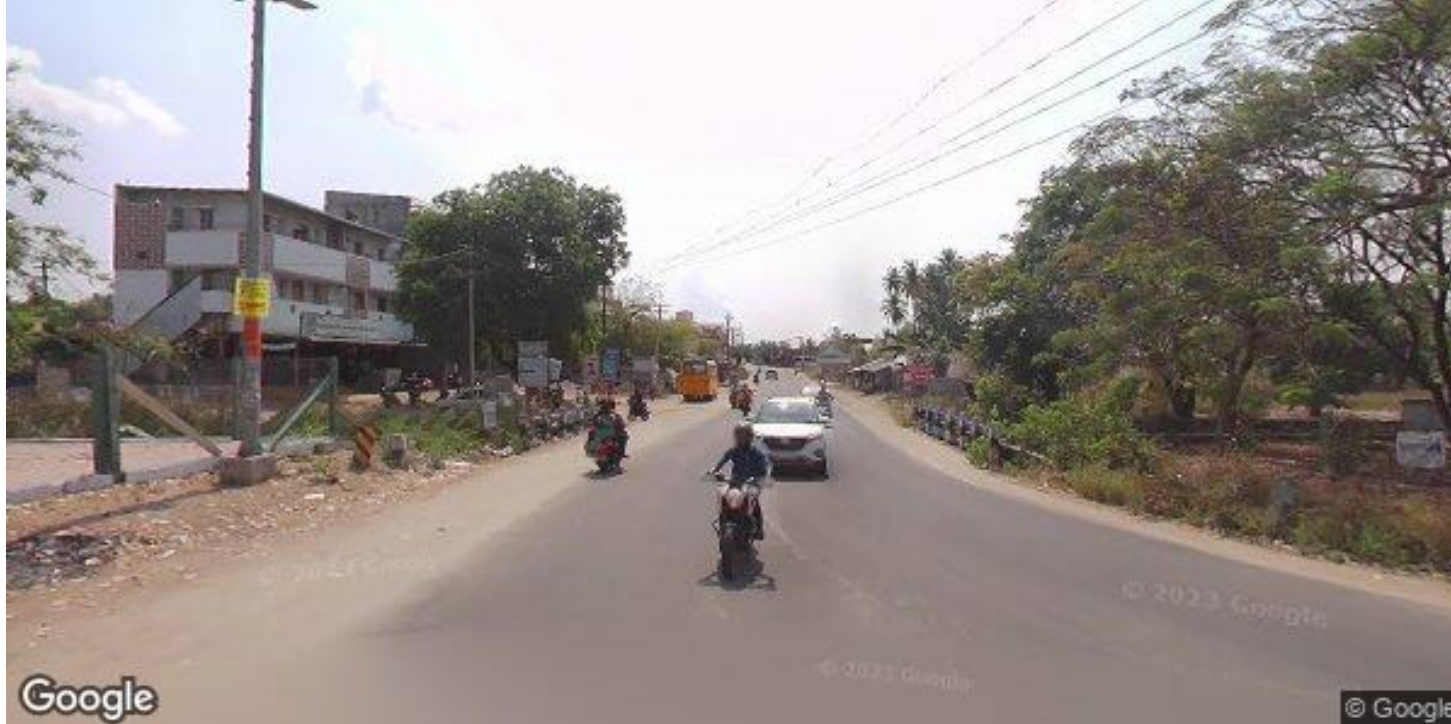
**Risk Type:** Blind Spot  
**Risk Level:** Blind Spot  
**Speed Limit:** 10 KM/Hr  
**Coordinates:** 11.23903, 77.66455

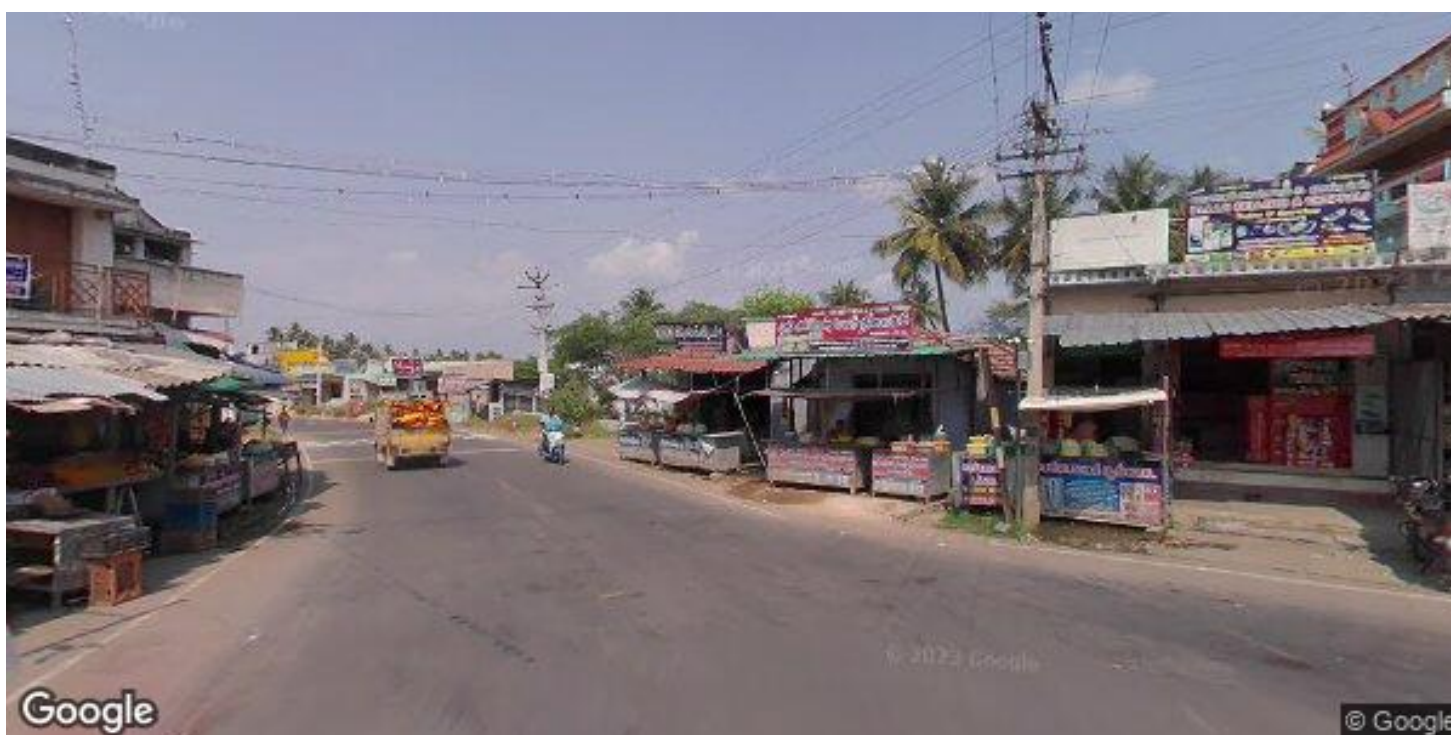
**Risk Type:** Turn  
**Risk Level:** Medium  
**Speed Limit:** 30 KM/Hr  
**Coordinates:** 11.23738, 77.66170

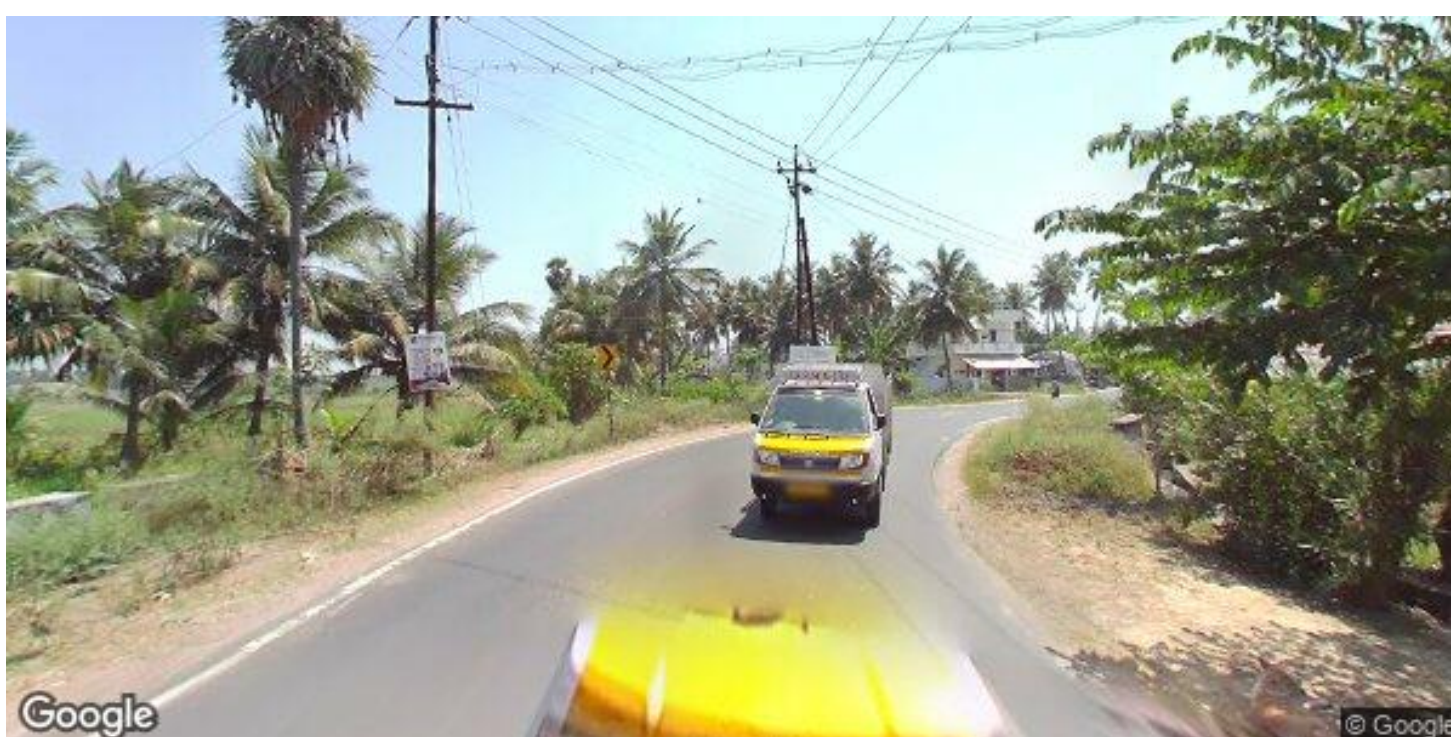
**Risk Type:** Turn  
**Risk Level:** Medium

**Speed Limit:** 30 KM/Hr  
**Coordinates:** 11.23837, 77.65729
