## **JOURNEY RISK MANAGEMENT (JRM) STUDY**

### **Salem Terminal TO SALEM DISTRICT LORRY OWNERS**

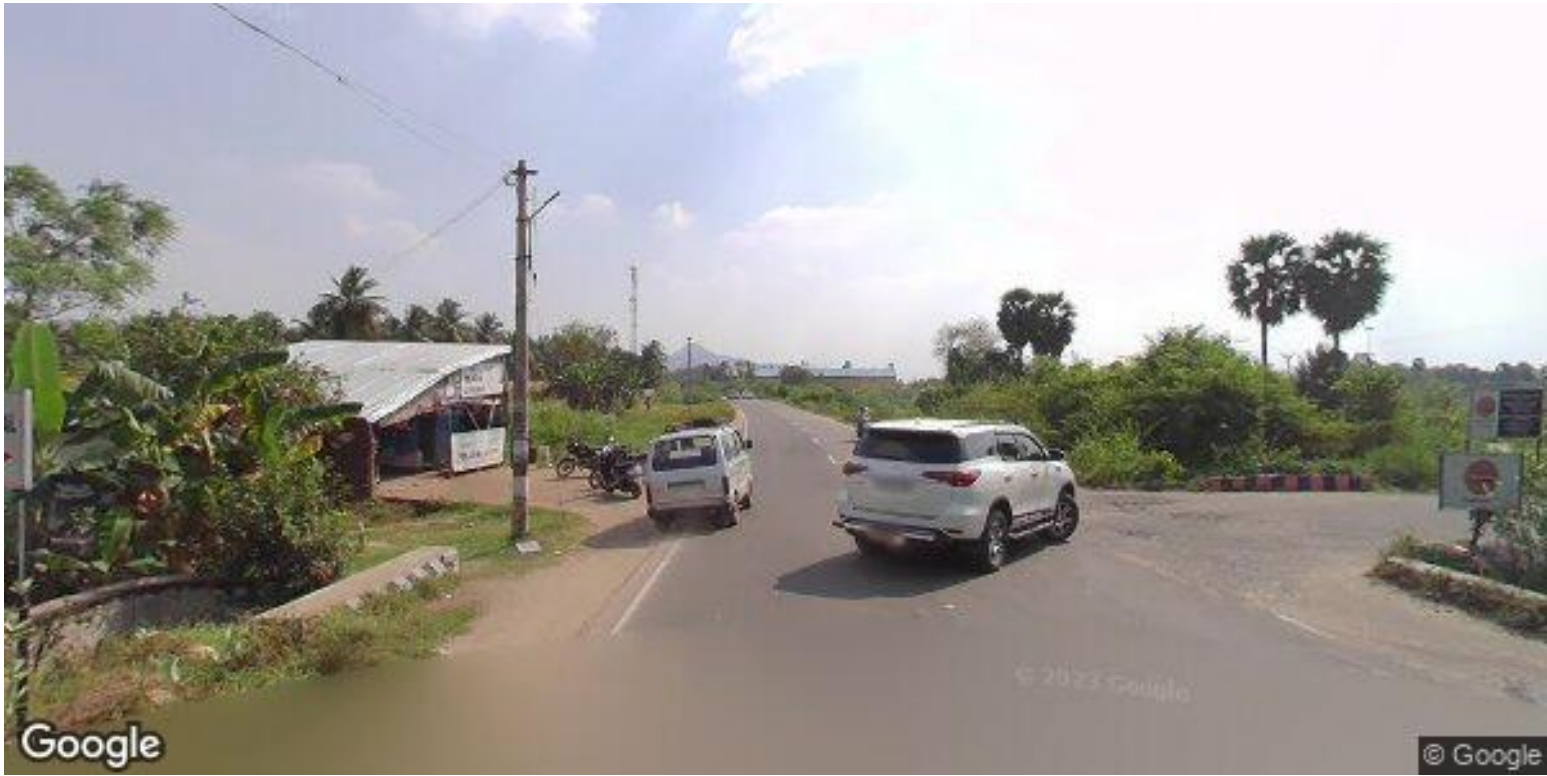
**Coordinates:** 11.44029, 77.87544

**Risk Type:** Turn

**Risk Level:** High

**Speed Limit:** 15 KM/Hr

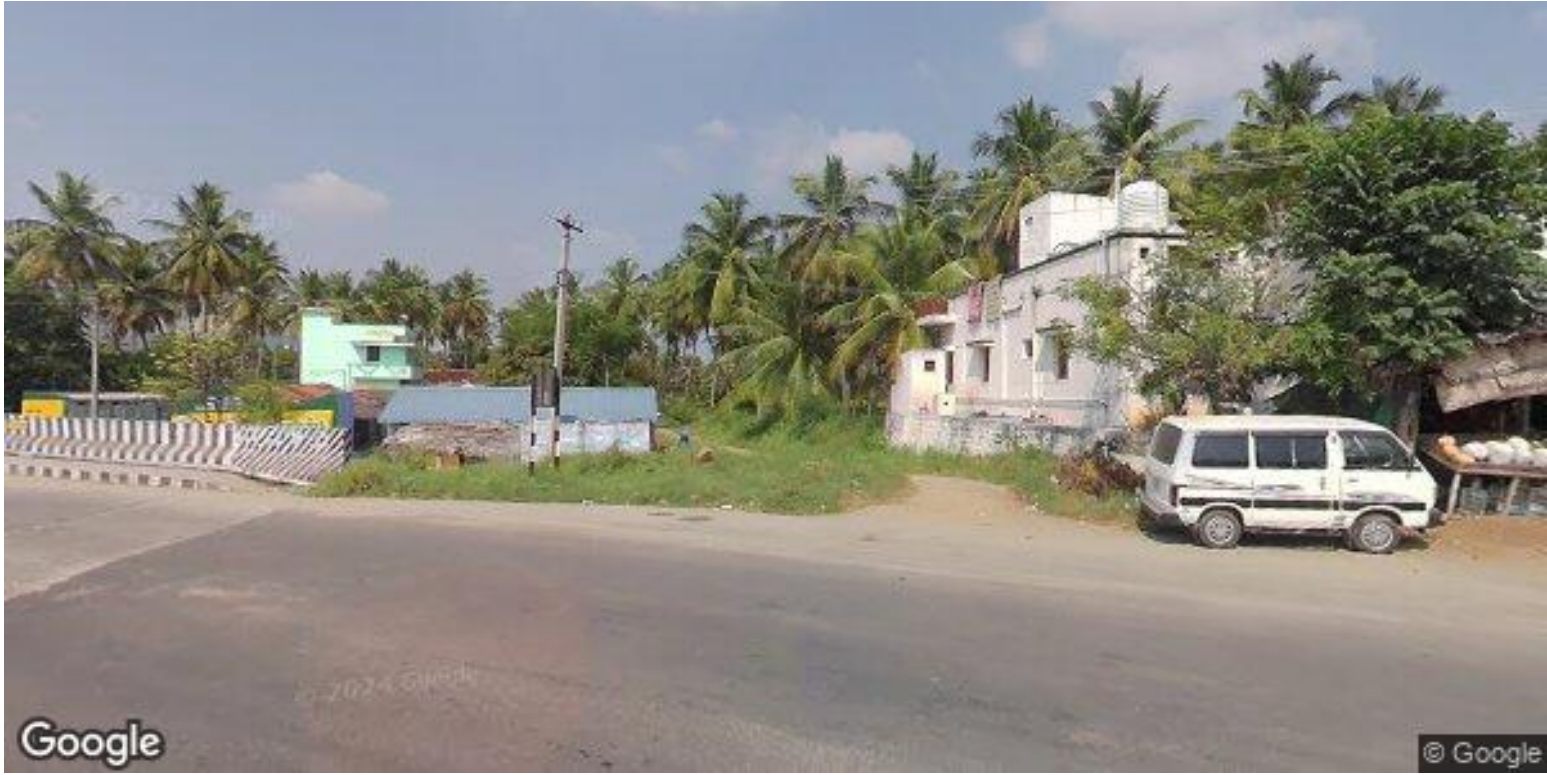
**Risk Type:** Turn  
**Risk Level:** Medium  
**Speed Limit:** 30 KM/Hr  
**Coordinates:** 11.44898, 77.87410

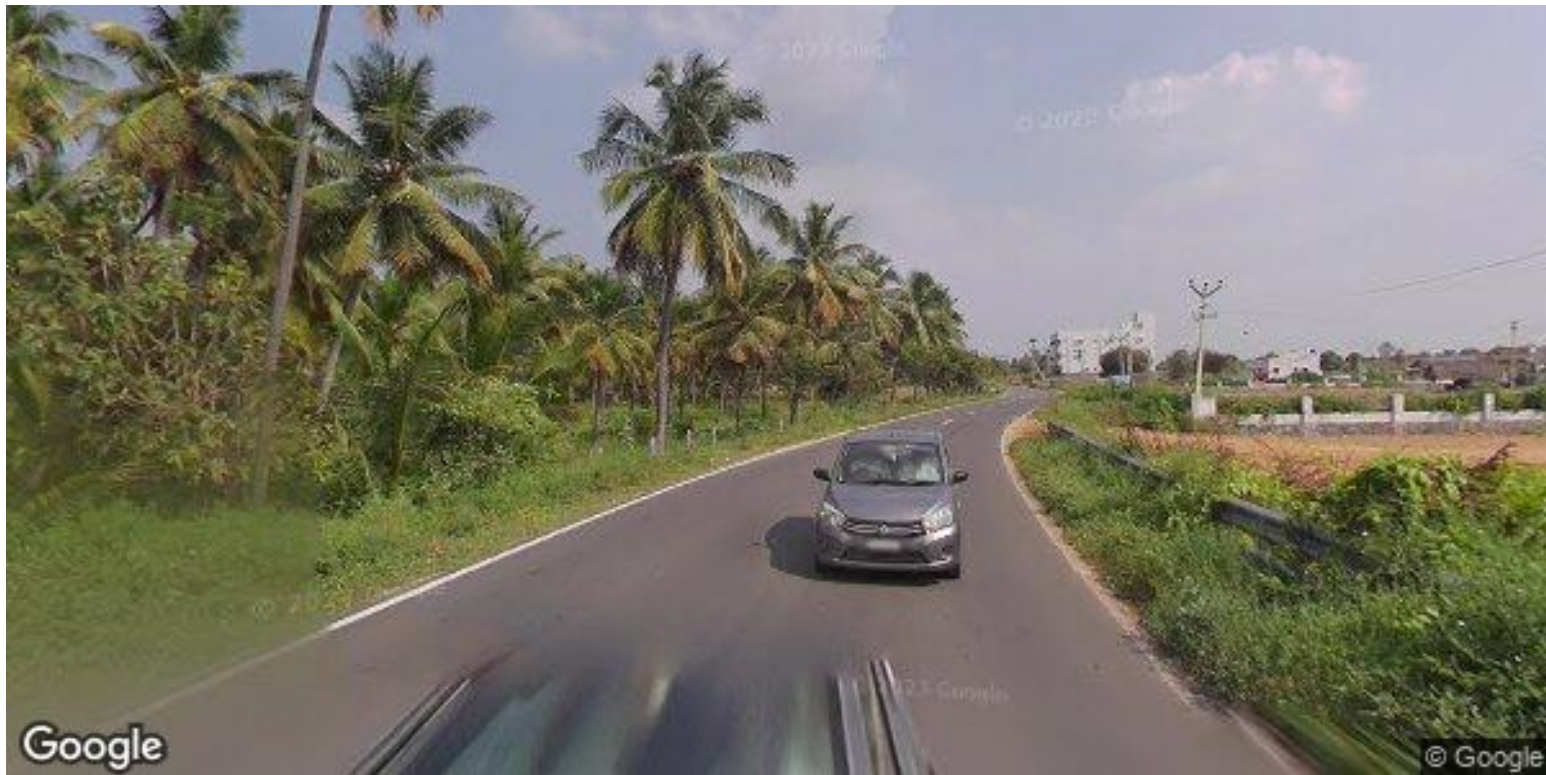
**Risk Type:** Turn  
**Risk Level:** Medium  
**Speed Limit:** 30 KM/Hr  
**Coordinates:** 11.45357, 77.85789

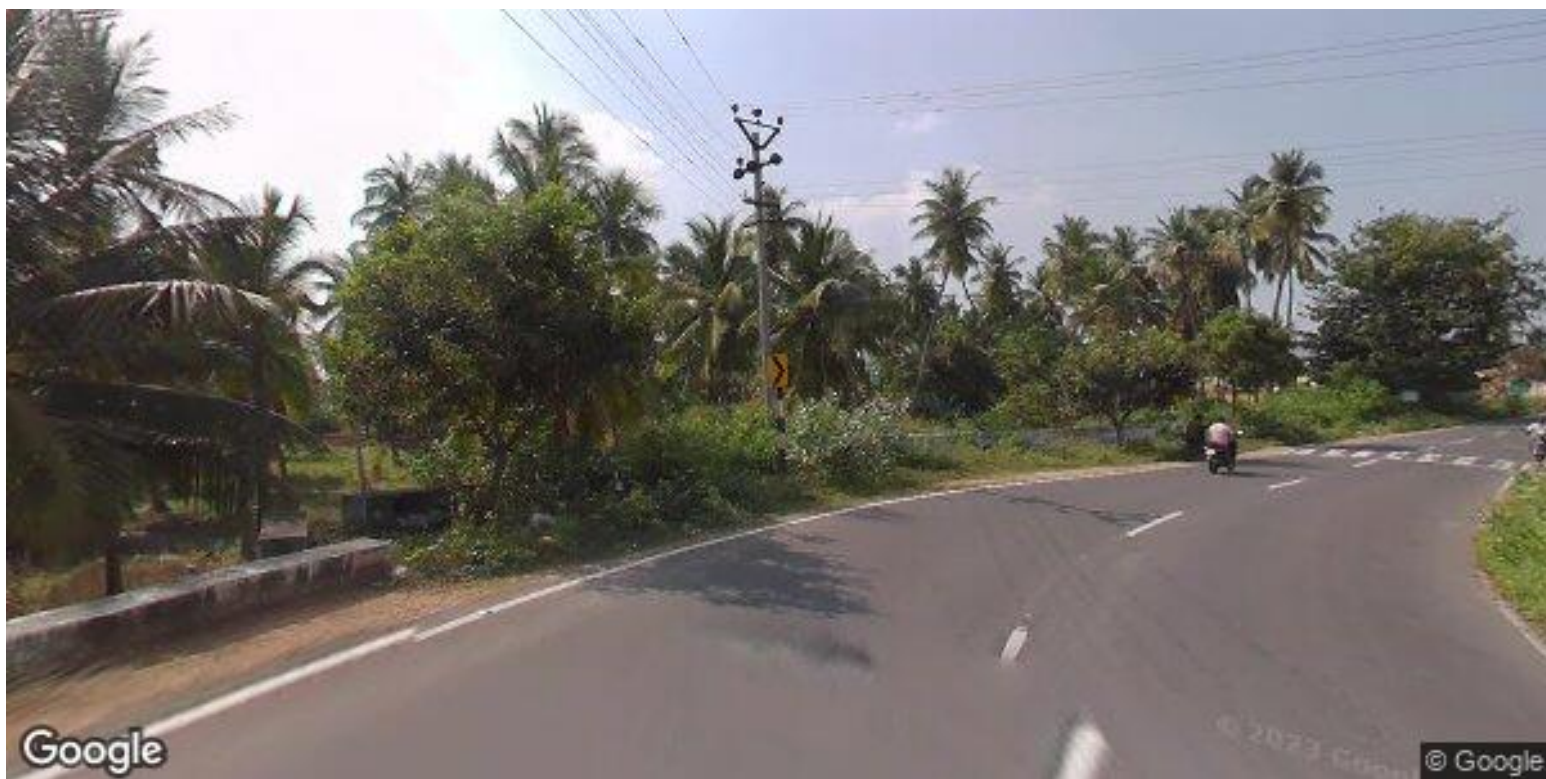
**Risk Type:** Turn  
**Risk Level:** Medium  
**Speed Limit:** 30 KM/Hr  
**Coordinates:** 11.45348, 77.85706

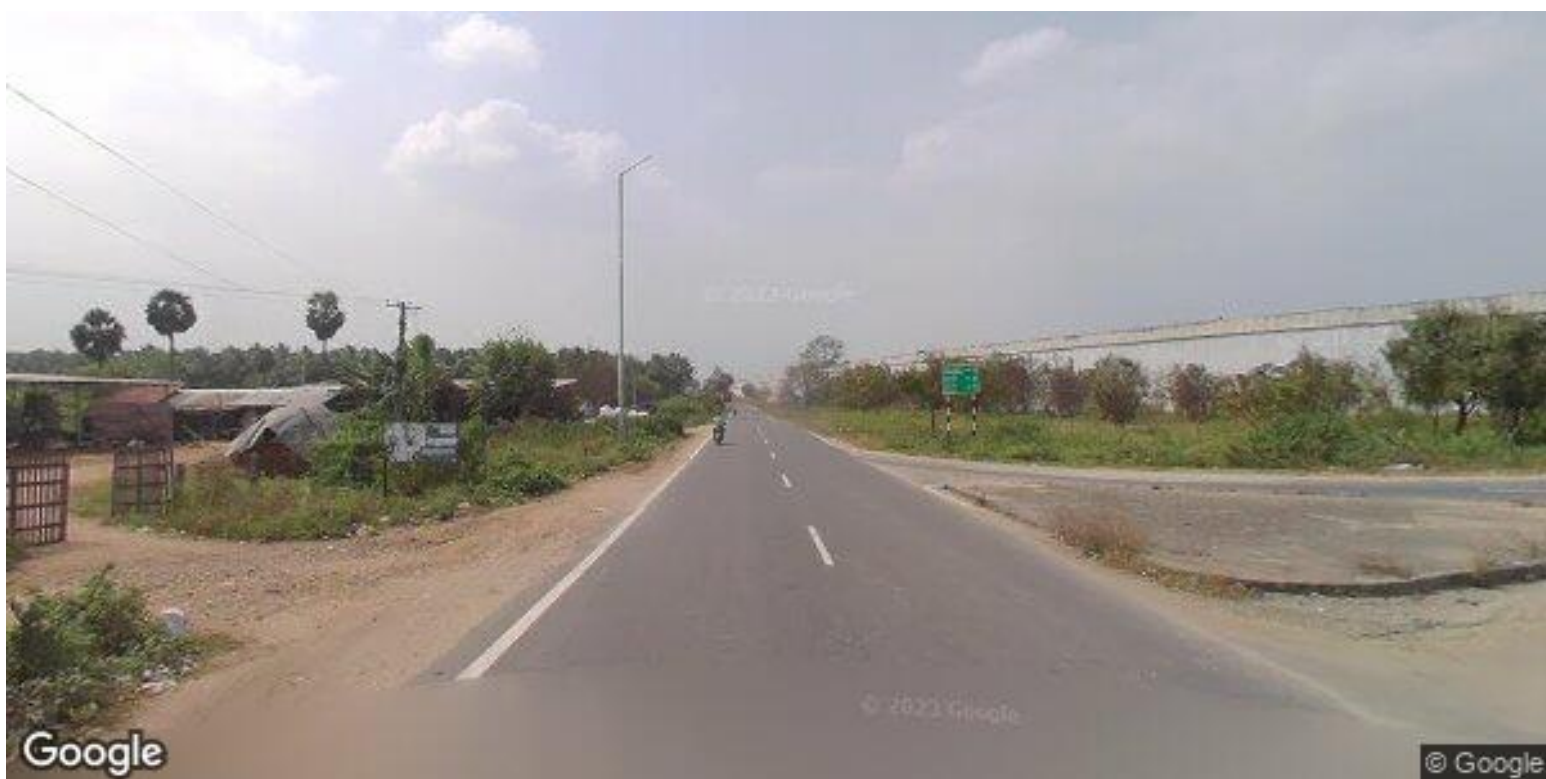
**Risk Type:** Turn  
**Risk Level:** High  
**Speed Limit:** 15 KM/Hr  
**Coordinates:** 11.45542, 77.81725

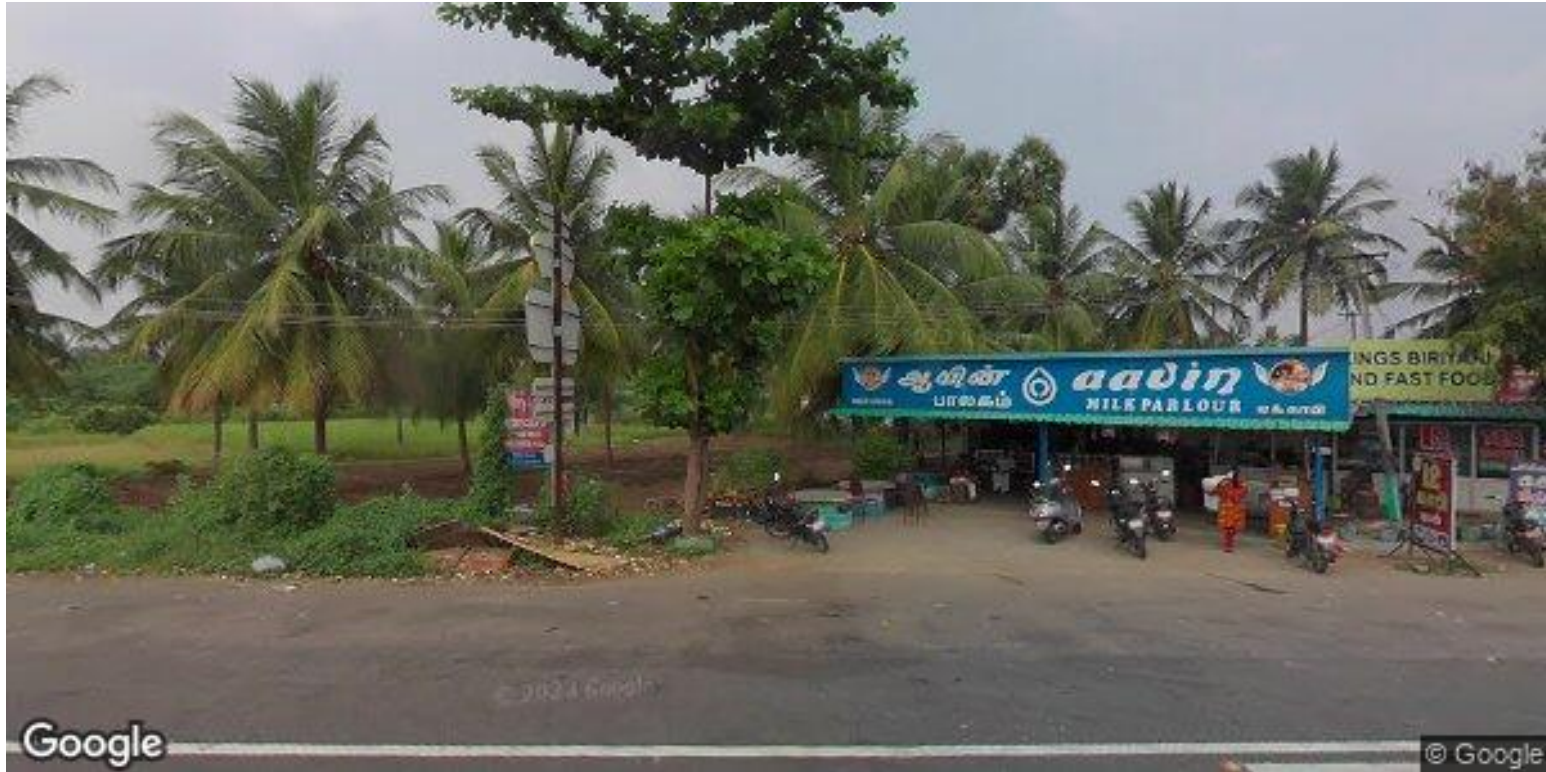
**Risk Type:** Turn  
**Risk Level:** High  
**Speed Limit:** 15 KM/Hr  
**Coordinates:** 11.45631, 77.81668

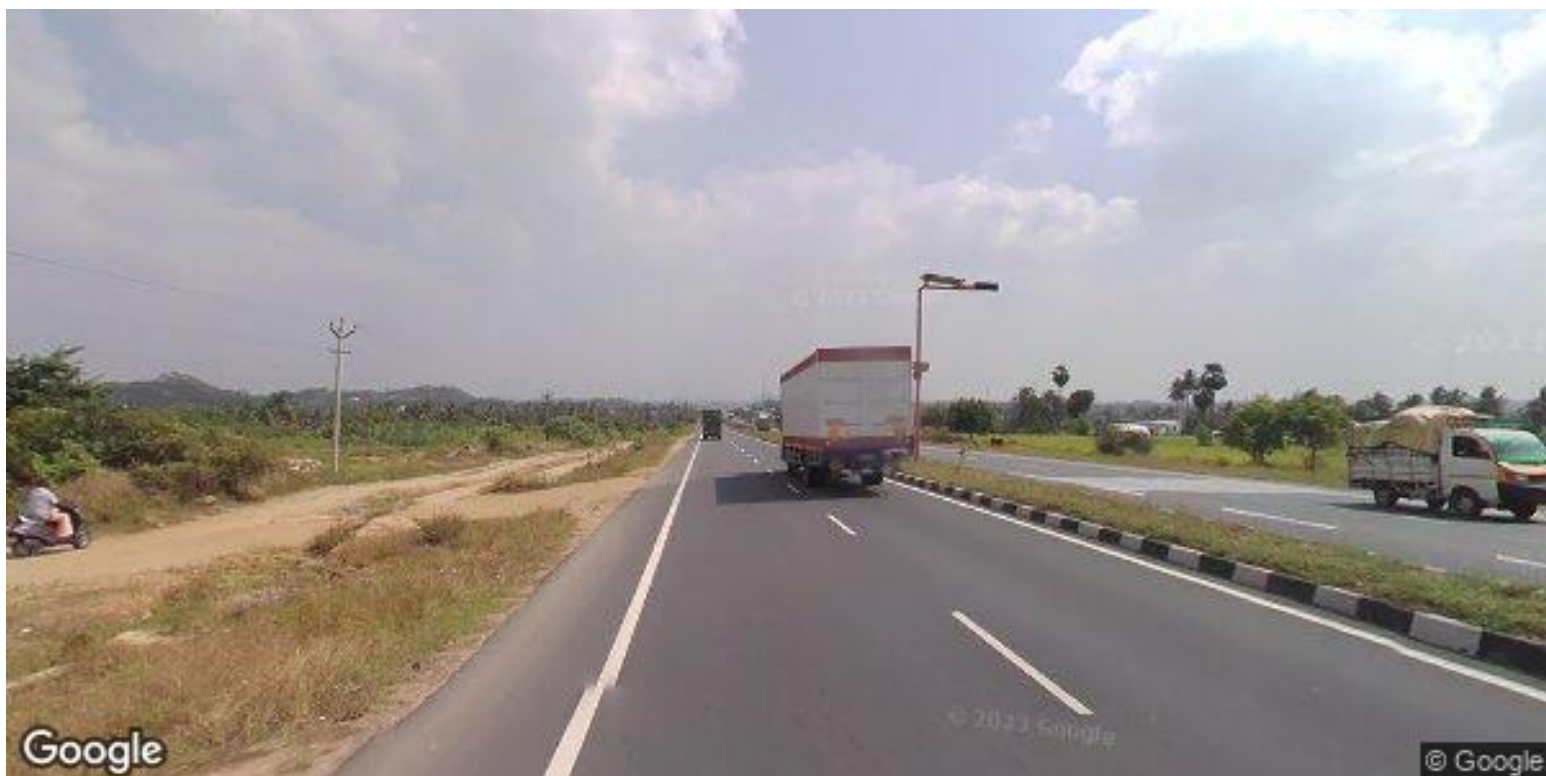
**Risk Type:** Turn  
**Risk Level:** High  
**Speed Limit:** 15 KM/Hr  
**Coordinates:** 11.49409, 77.88004

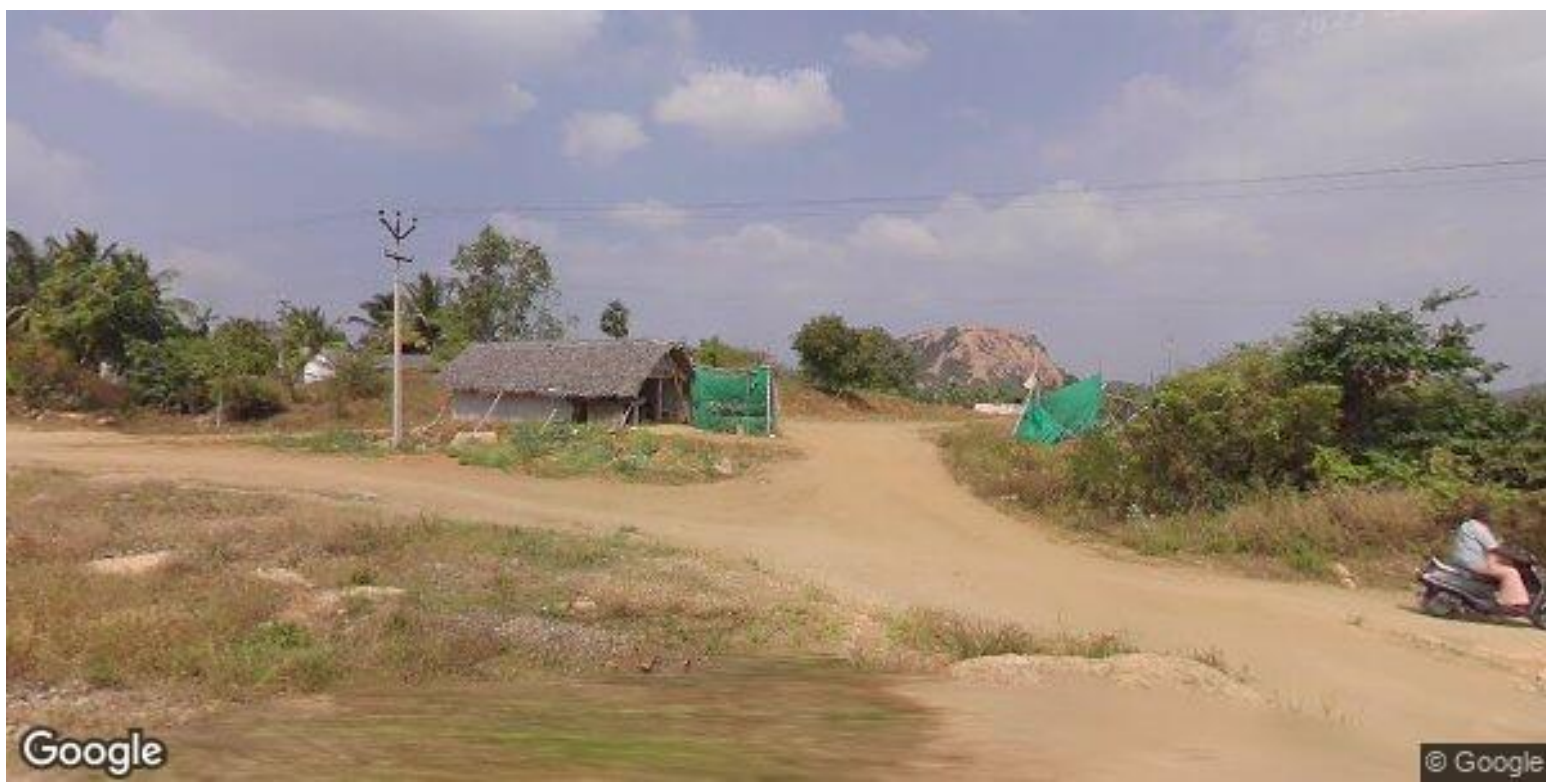
**Coordinates:** 11.49419, 77.88015

**Risk Type:** Turn

**Risk Level:** Medium

**Speed Limit:** 30 KM/Hr

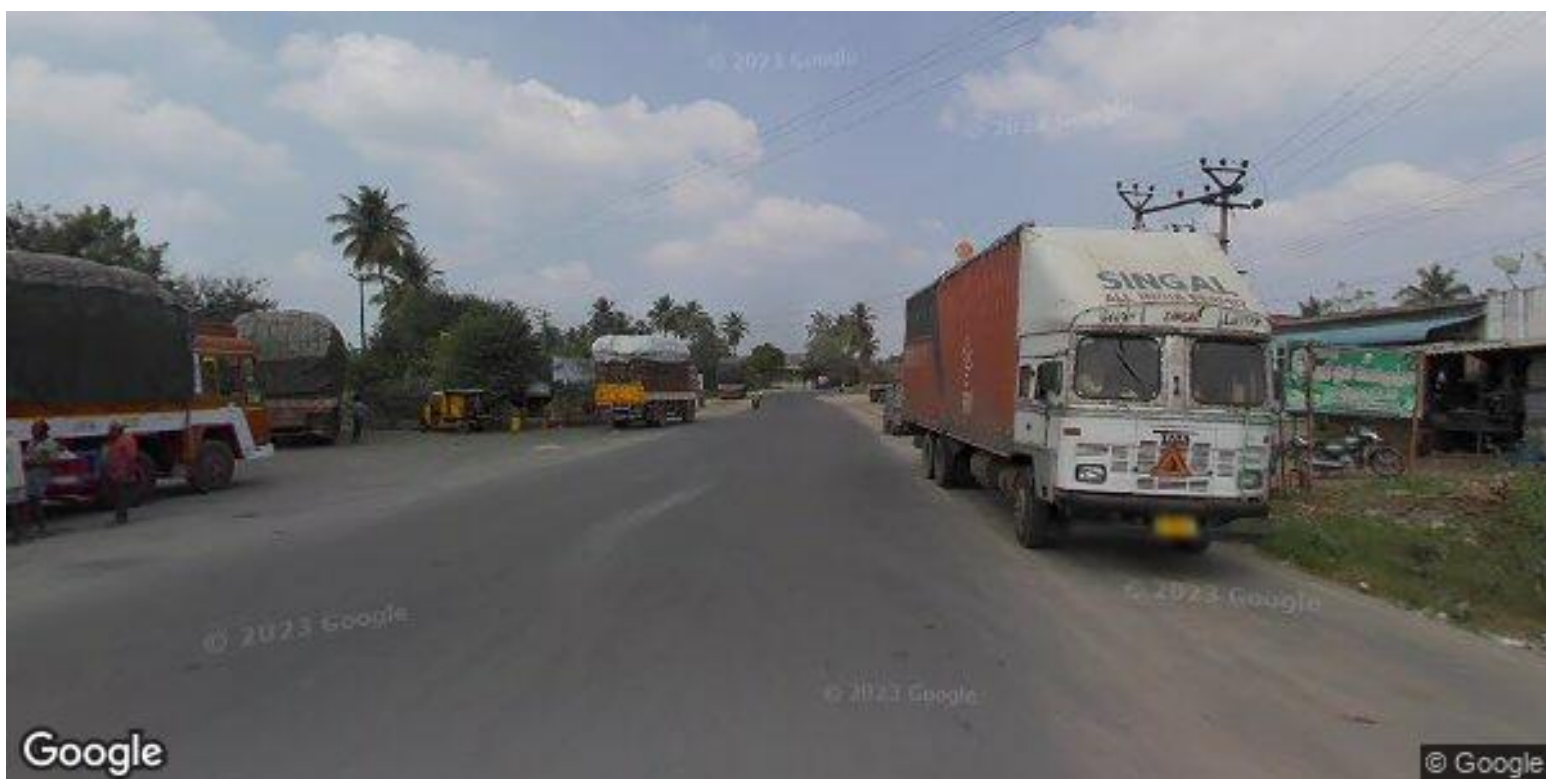
**Coordinates:** 11.49377, 77.88573

**Risk Type:** Turn

**Risk Level:** Medium

**Speed Limit:** 30 KM/Hr

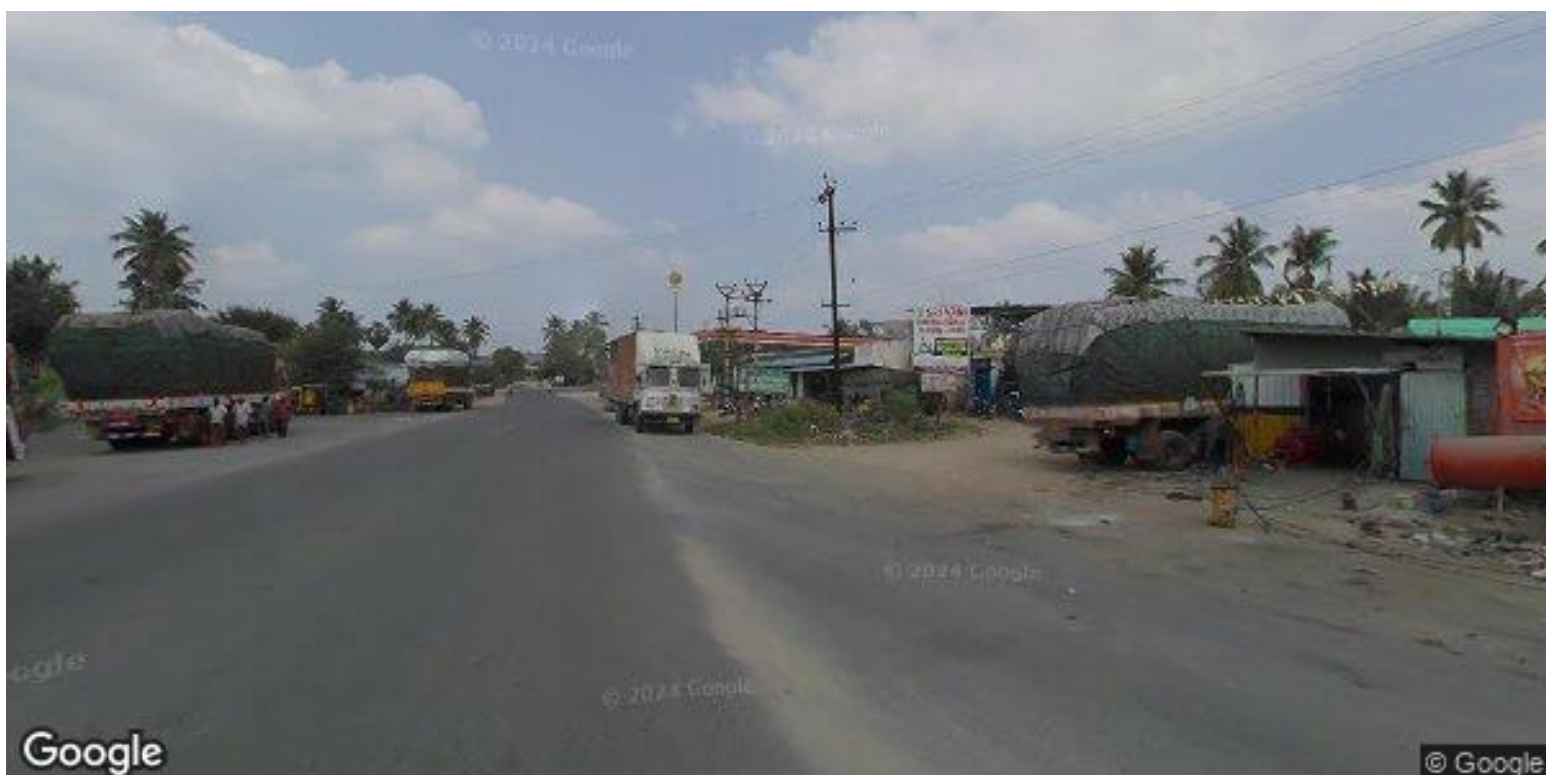
**Risk Type:** Turn  
**Risk Level:** High  
**Speed Limit:** 15 KM/Hr  
**Coordinates:** 11.49363, 77.88590

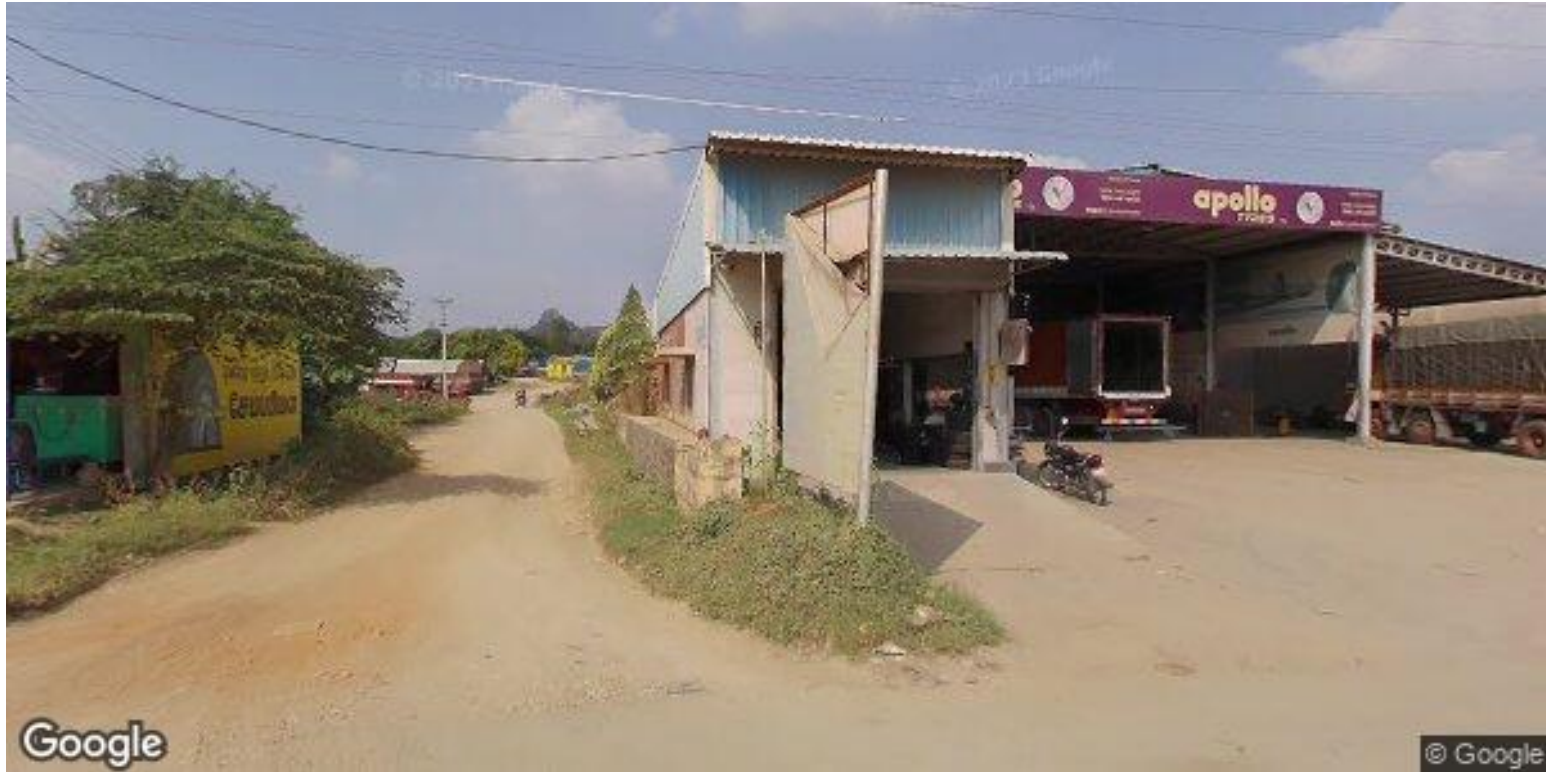
**Risk Type:** Turn  
**Risk Level:** High  
**Speed Limit:** 15 KM/Hr  
**Coordinates:** 11.49235, 77.89561

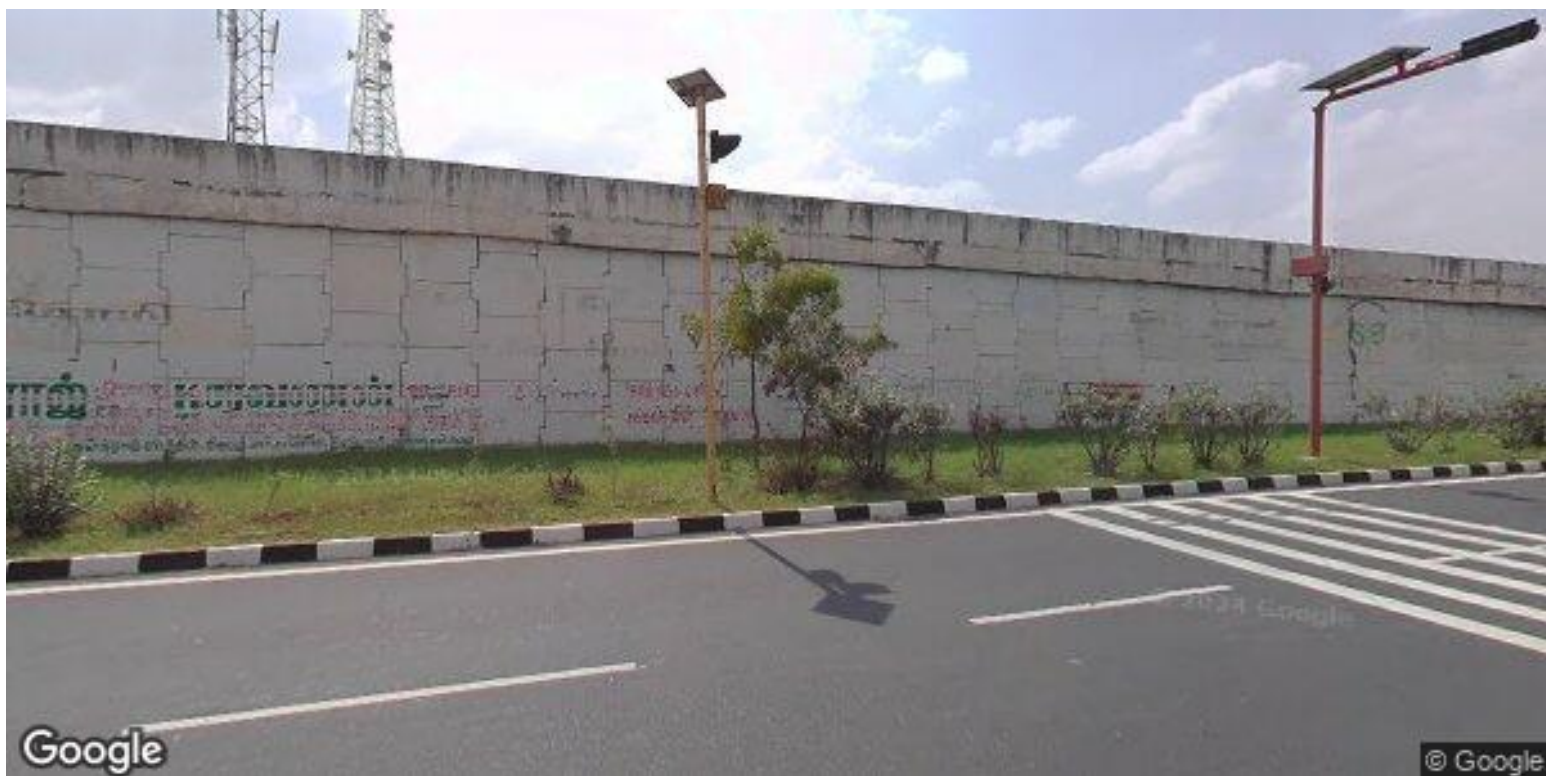
**Risk Type:** Blind Spot  
**Risk Level:** Blind Spot  
**Speed Limit:** 10 KM/Hr  
**Coordinates:** 11.49225, 77.89560

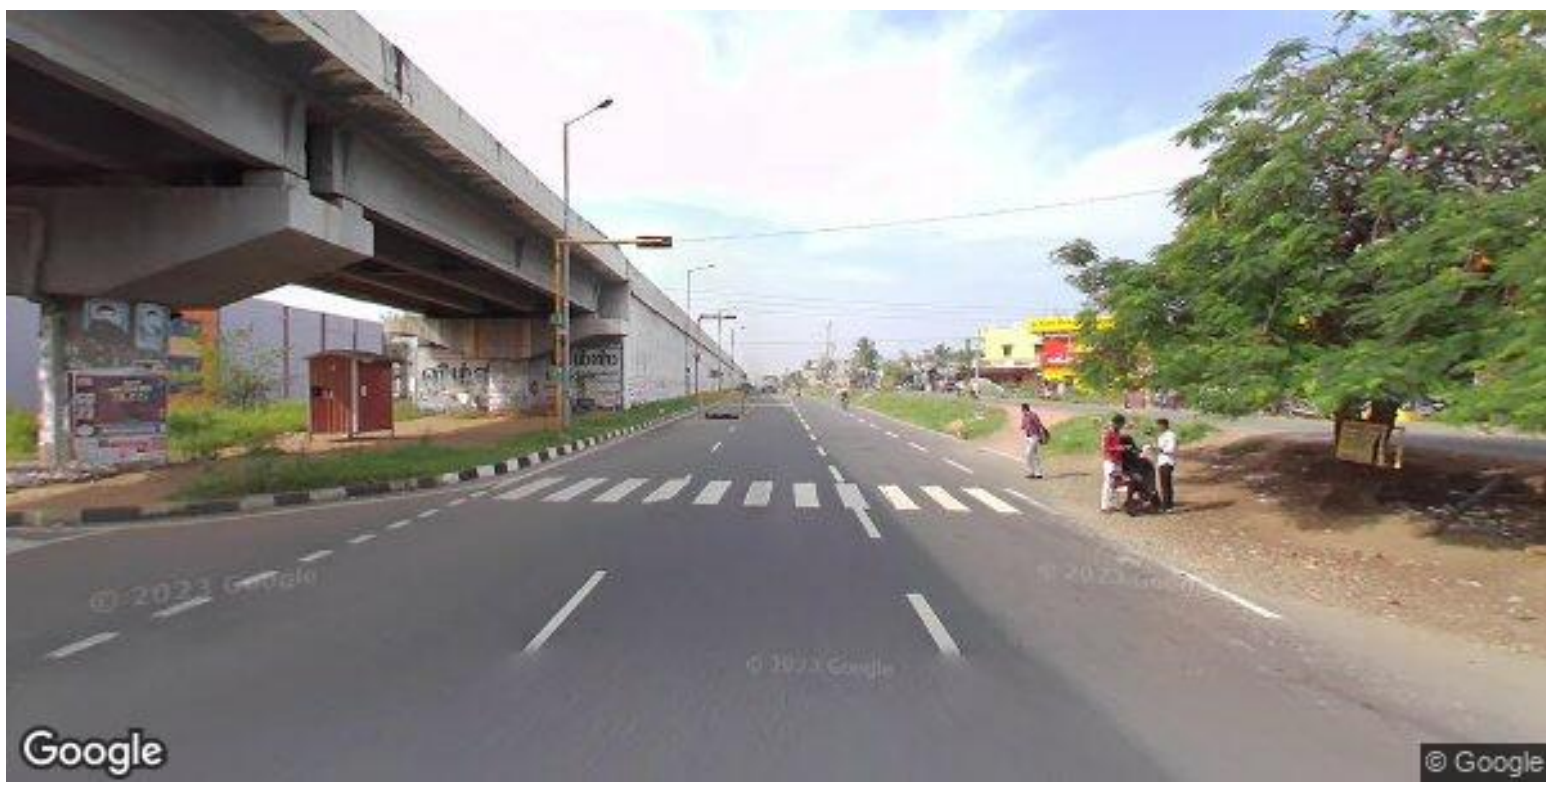
**Coordinates:** 11.58526, 78.06049

**Risk Type:** Blind Spot

**Risk Level:** Blind Spot

**Speed Limit:** 10 KM/Hr

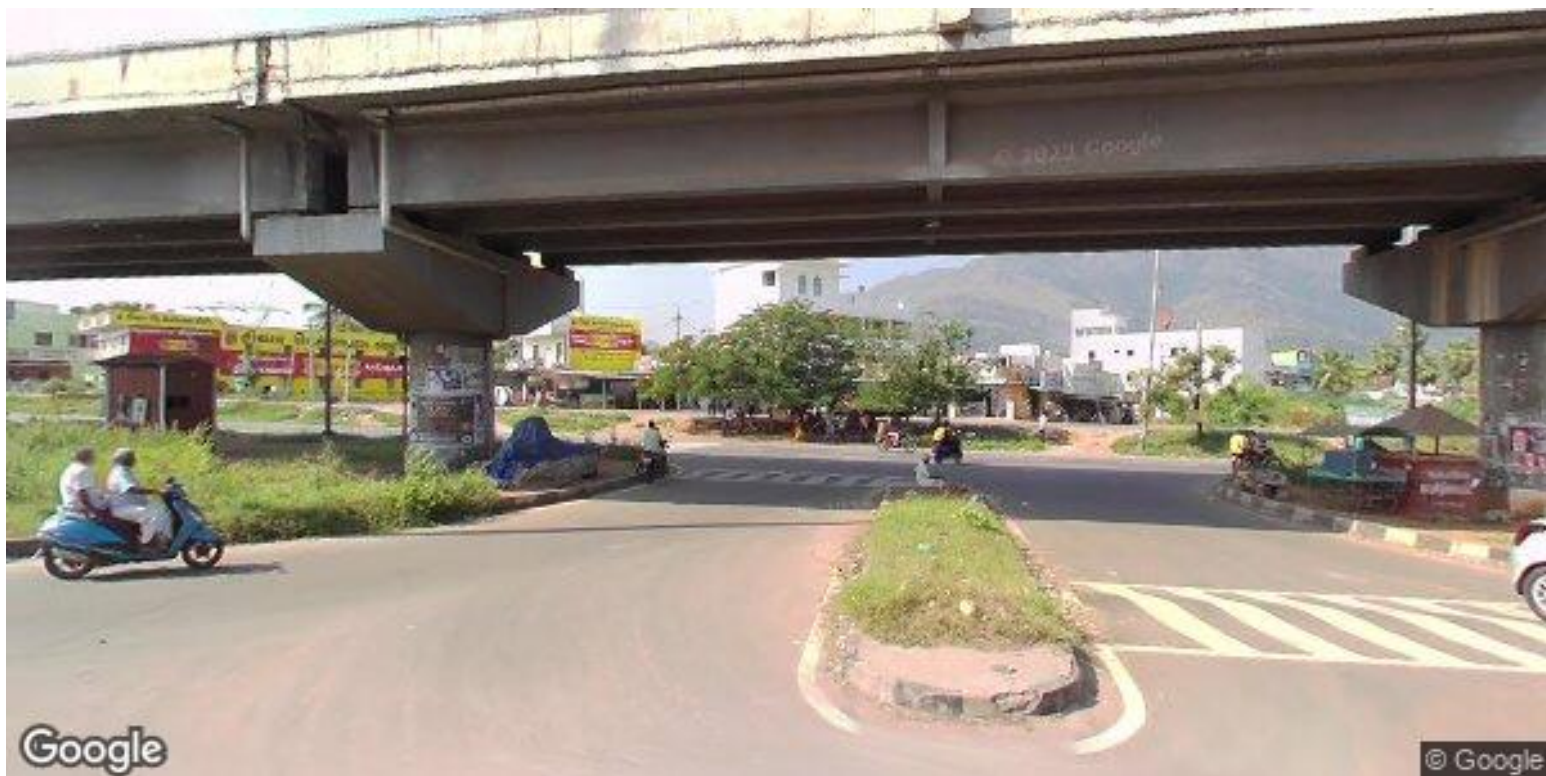
**Coordinates:** 11.58499, 78.06061

**Risk Type:** Blind Spot

**Risk Level:** Blind Spot

**Speed Limit:** 10 KM/Hr
