# IndianOil

## JOURNEY RISK MANAGEMENT (JRM) STUDY

### Salem Terminal TO VELAVAN FUELS

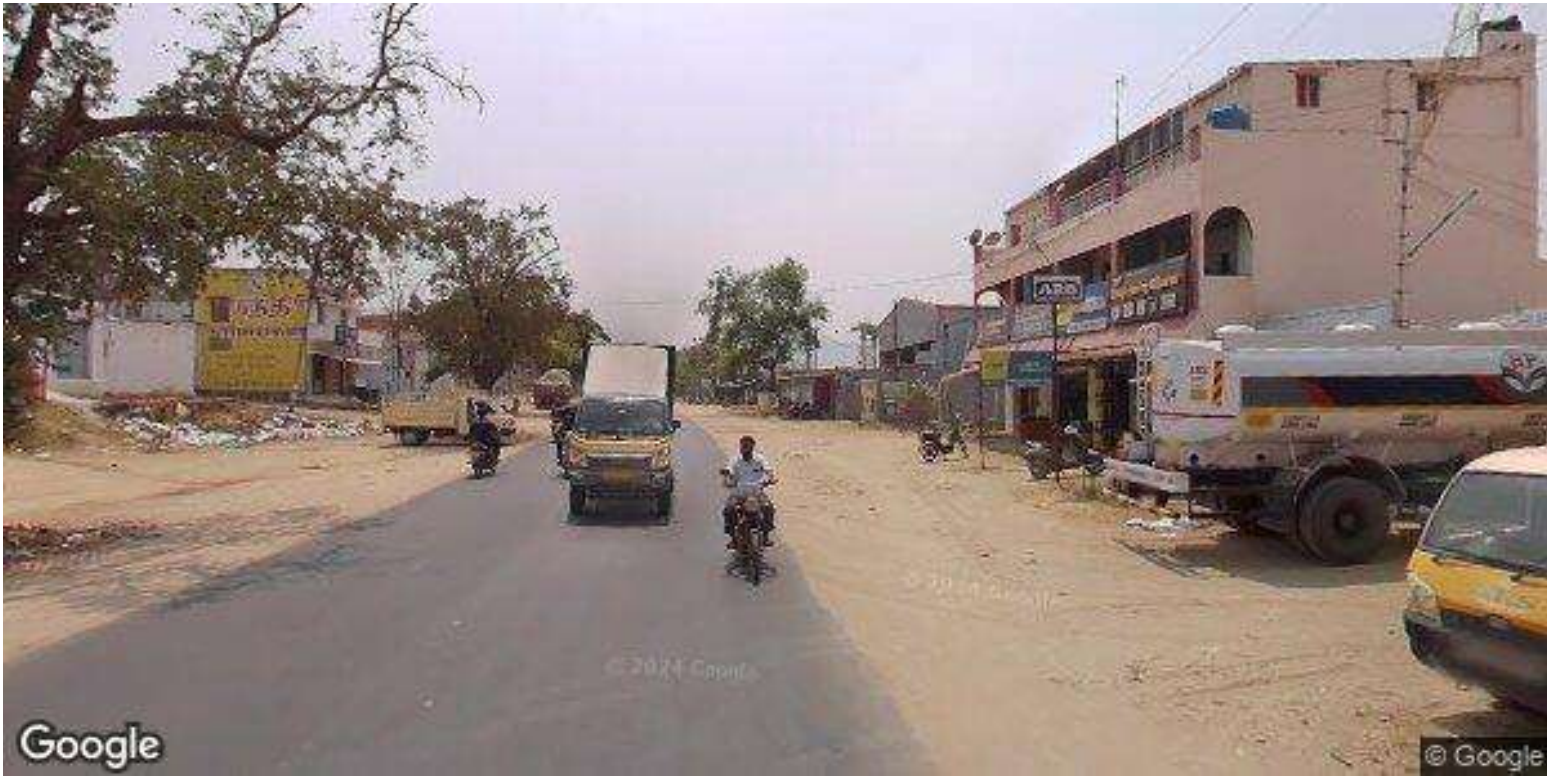
**Risk Type:** Turn  
**Risk Level:** Medium  
**Speed Limit:** 30 KM/Hr  
**Coordinates:** 11.39976, 77.88382

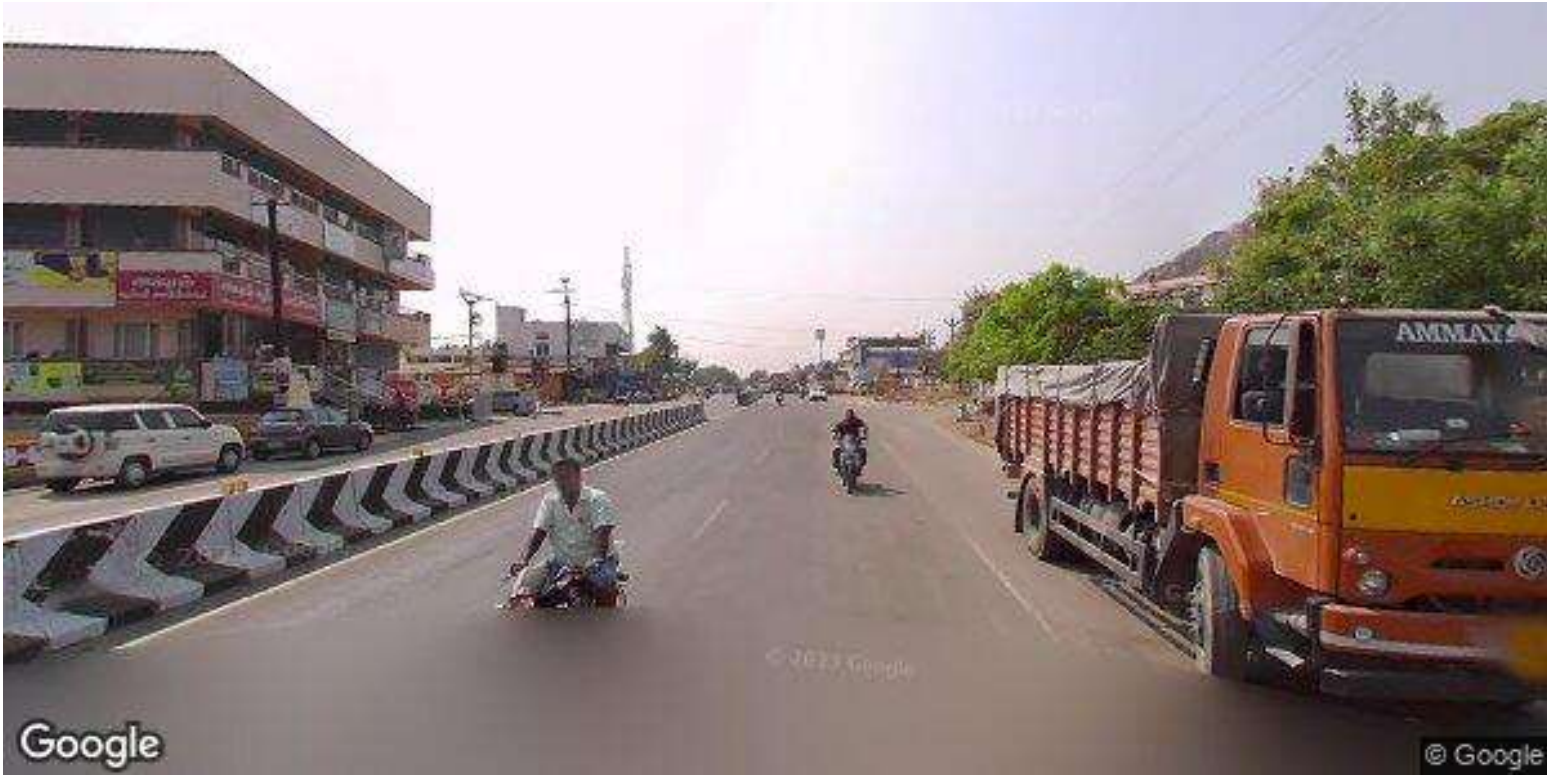
**Risk Type:** Turn  
**Risk Level:** Medium  
**Speed Limit:** 30 KM/Hr  
**Coordinates:** 11.39690, 77.88852

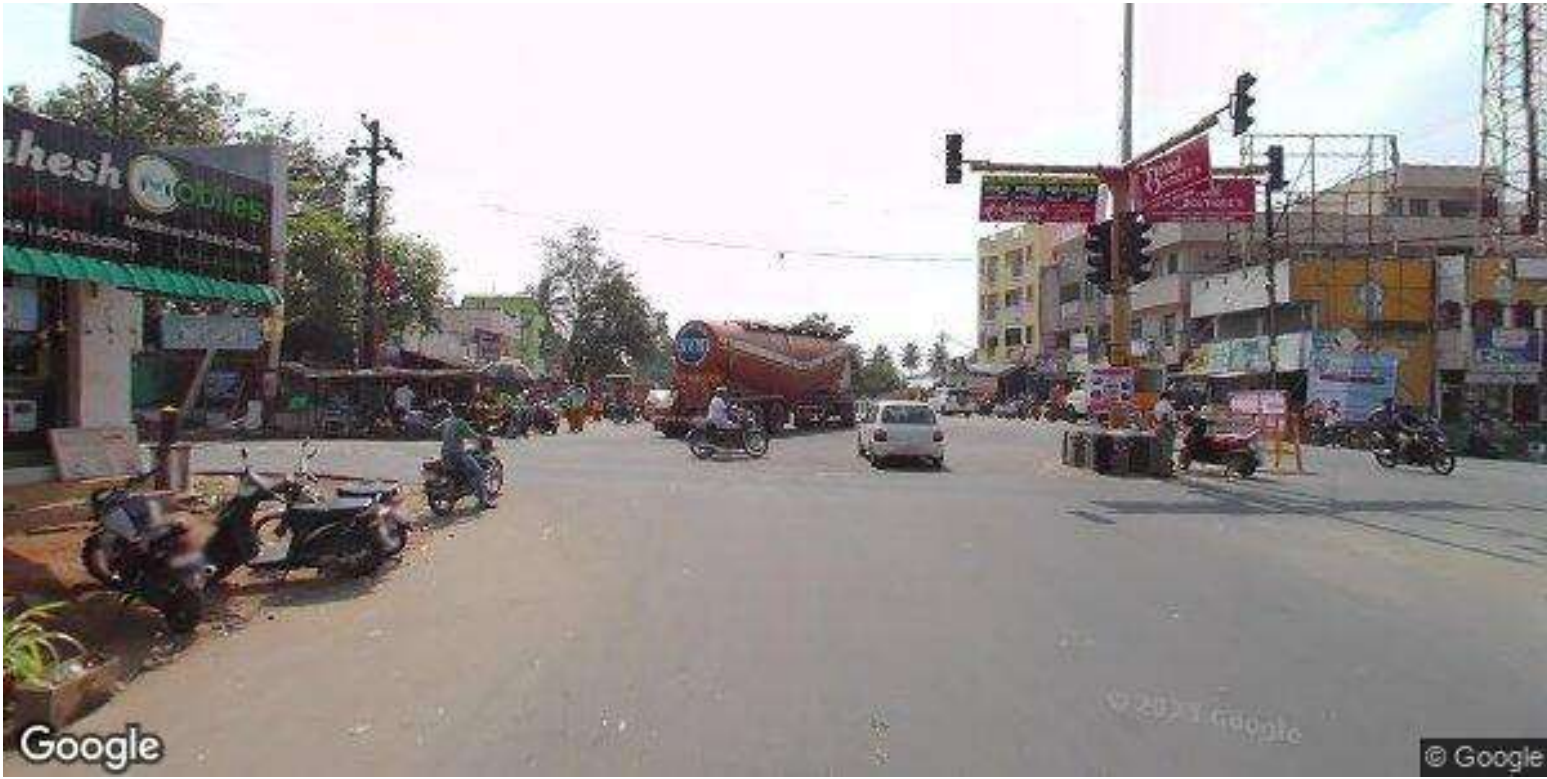
**Risk Type:** Turn  
**Risk Level:** High  
**Speed Limit:** 15 KM/Hr  
**Coordinates:** 11.36616, 77.88885

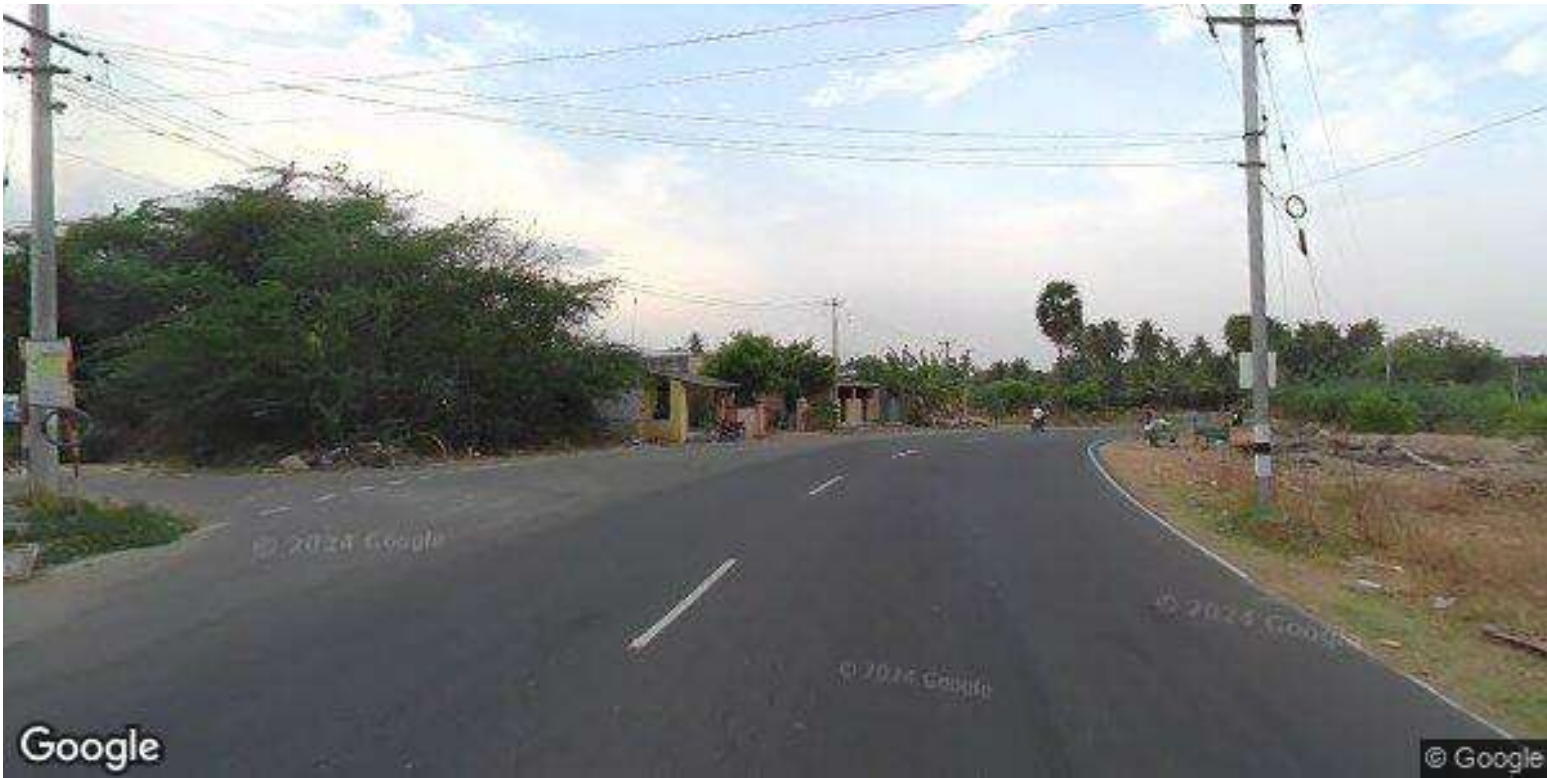
**Risk Type: Turn**

**Risk Level: High**

**Speed Limit: 15 KM/Hr**

**Coordinates: 11.33854, 77.86216**

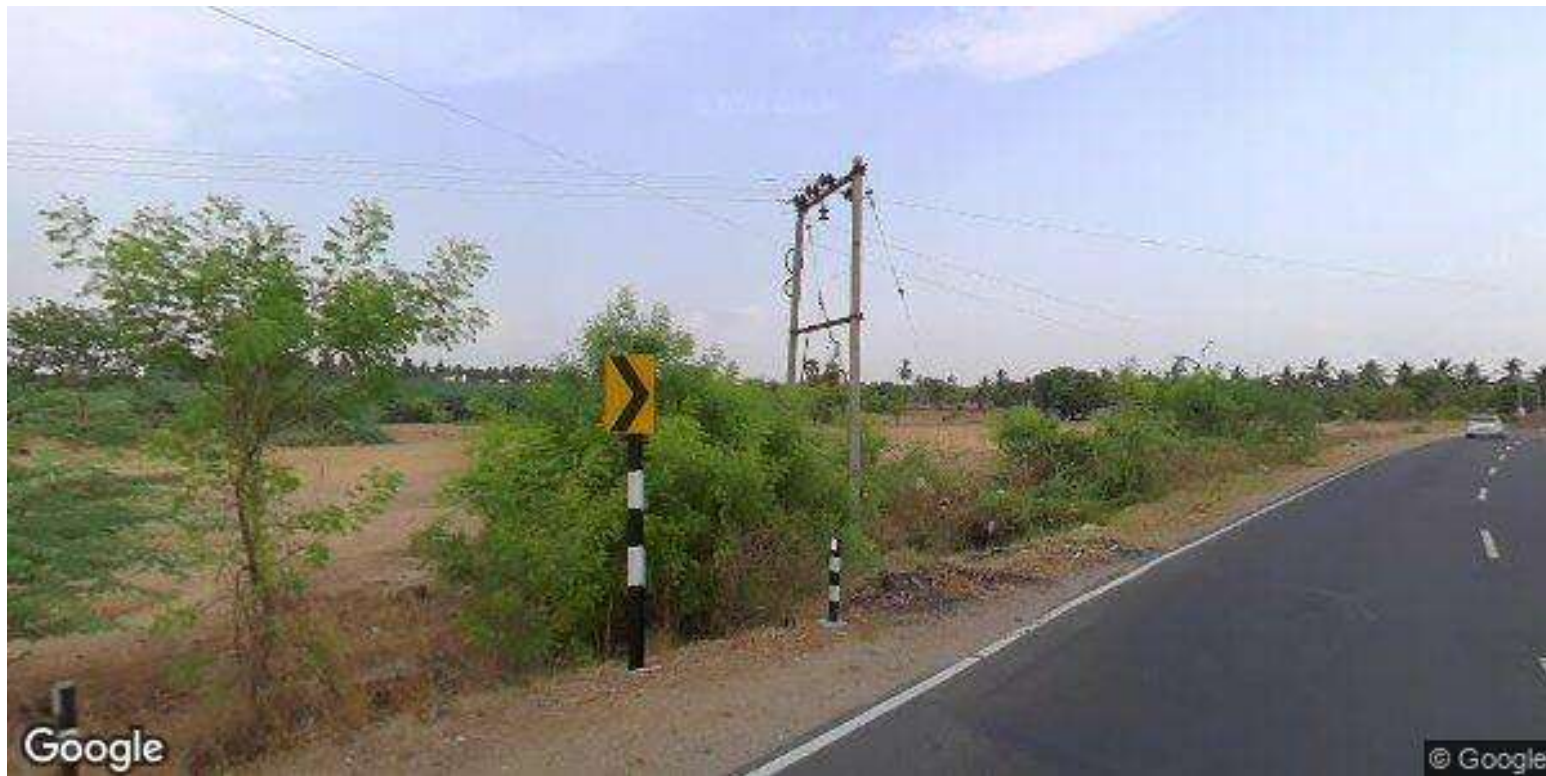
**Risk Type: Turn**

**Risk Level: Medium**

**Speed Limit: 30 KM/Hr**

**Coordinates: 11.33778, 77.86236**

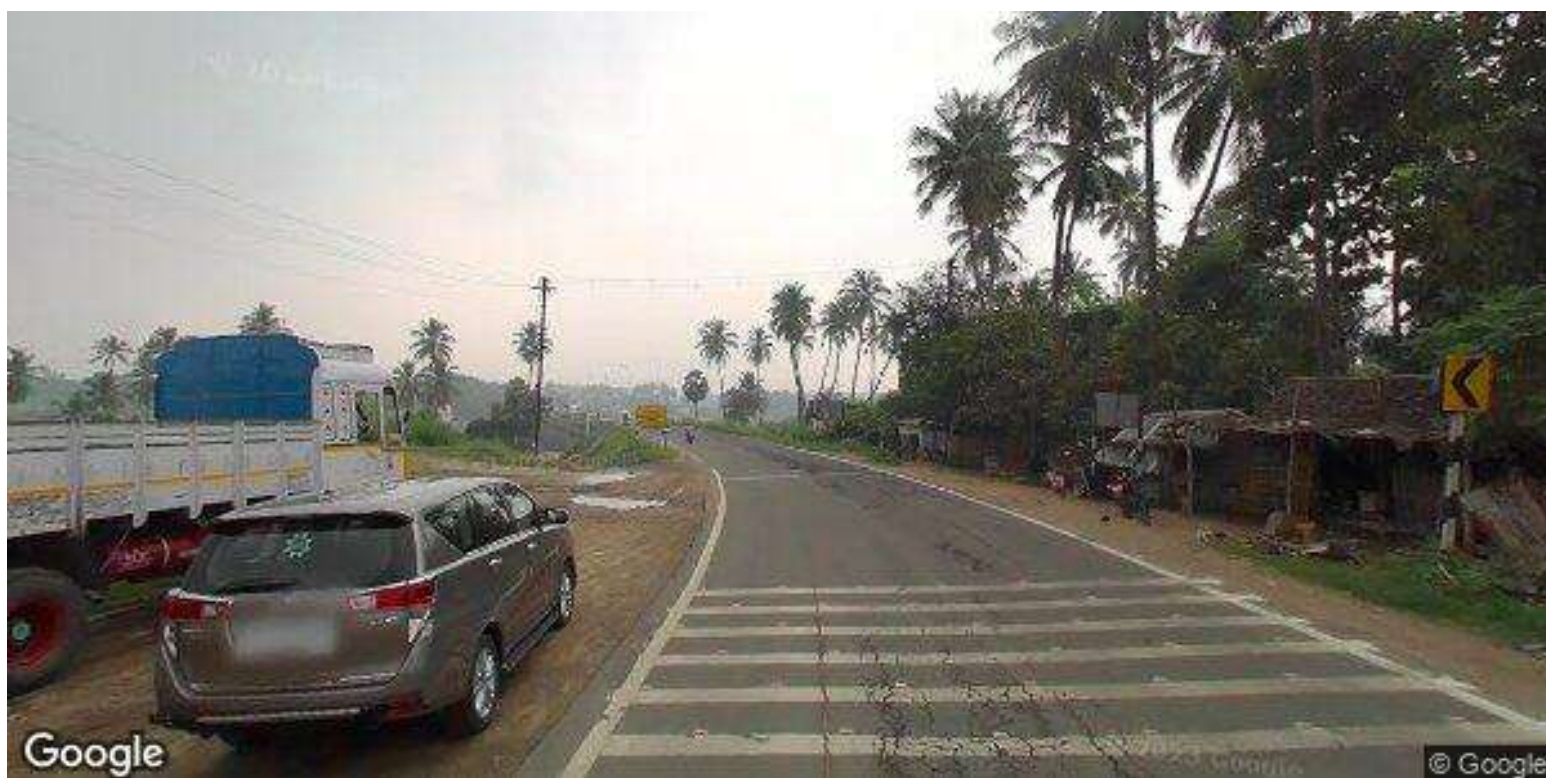
**Risk Type: Turn**

**Risk Level: Medium**

**Speed Limit: 30 KM/Hr**

**Coordinates: 11.30952, 77.77587**

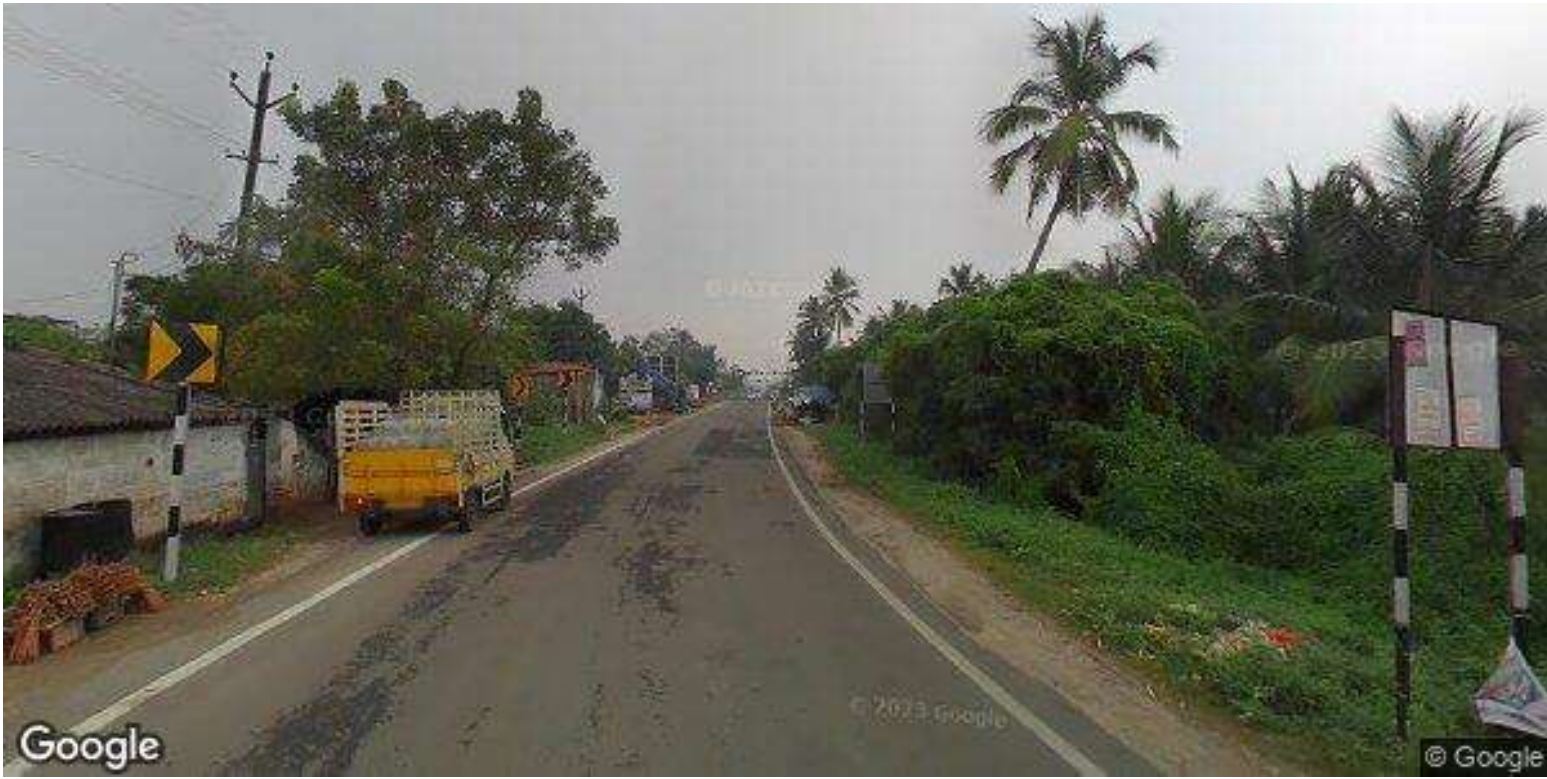
**Risk Type:** Turn  
**Risk Level:** Medium  
**Speed Limit:** 30 KM/Hr  
**Coordinates:** 11.30973, 77.76712

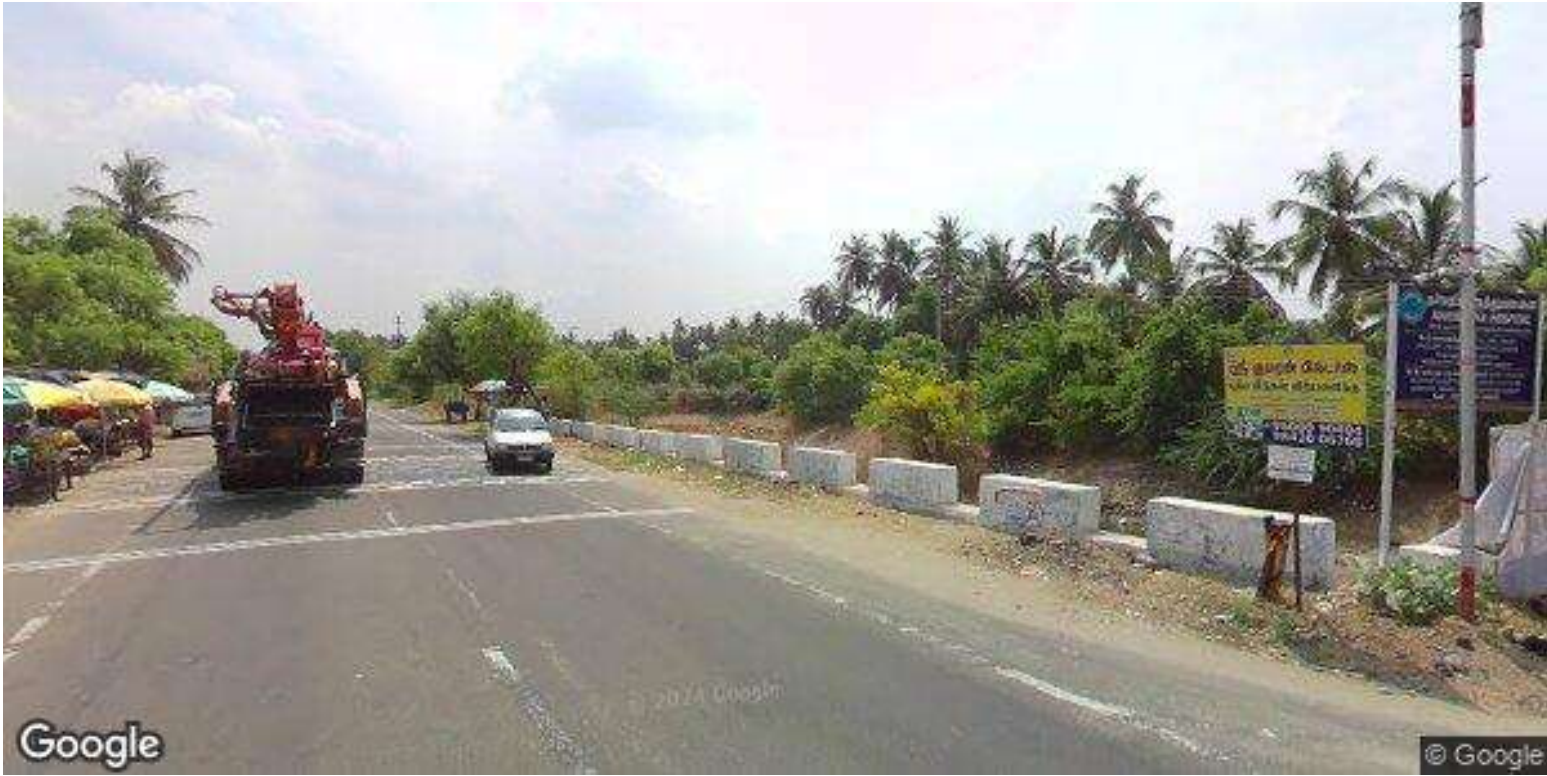
**Risk Type:** Turn  
**Risk Level:** High  
**Speed Limit:** 15 KM/Hr  
**Coordinates:** 11.29490, 77.74685

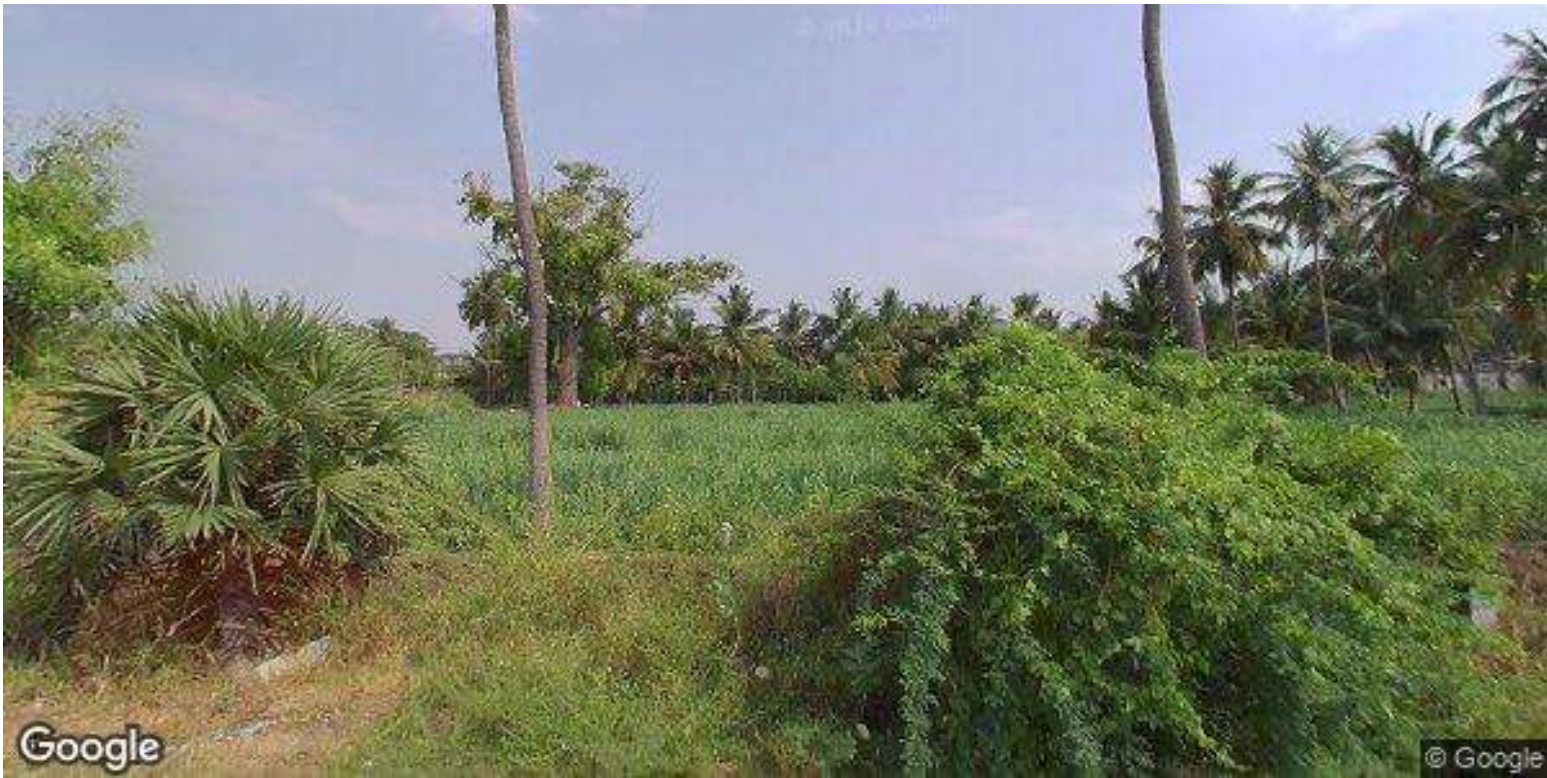
**Risk Type:** Turn  
**Risk Level:** High  
**Speed Limit:** 15 KM/Hr  
**Coordinates:** 11.29125, 77.74646

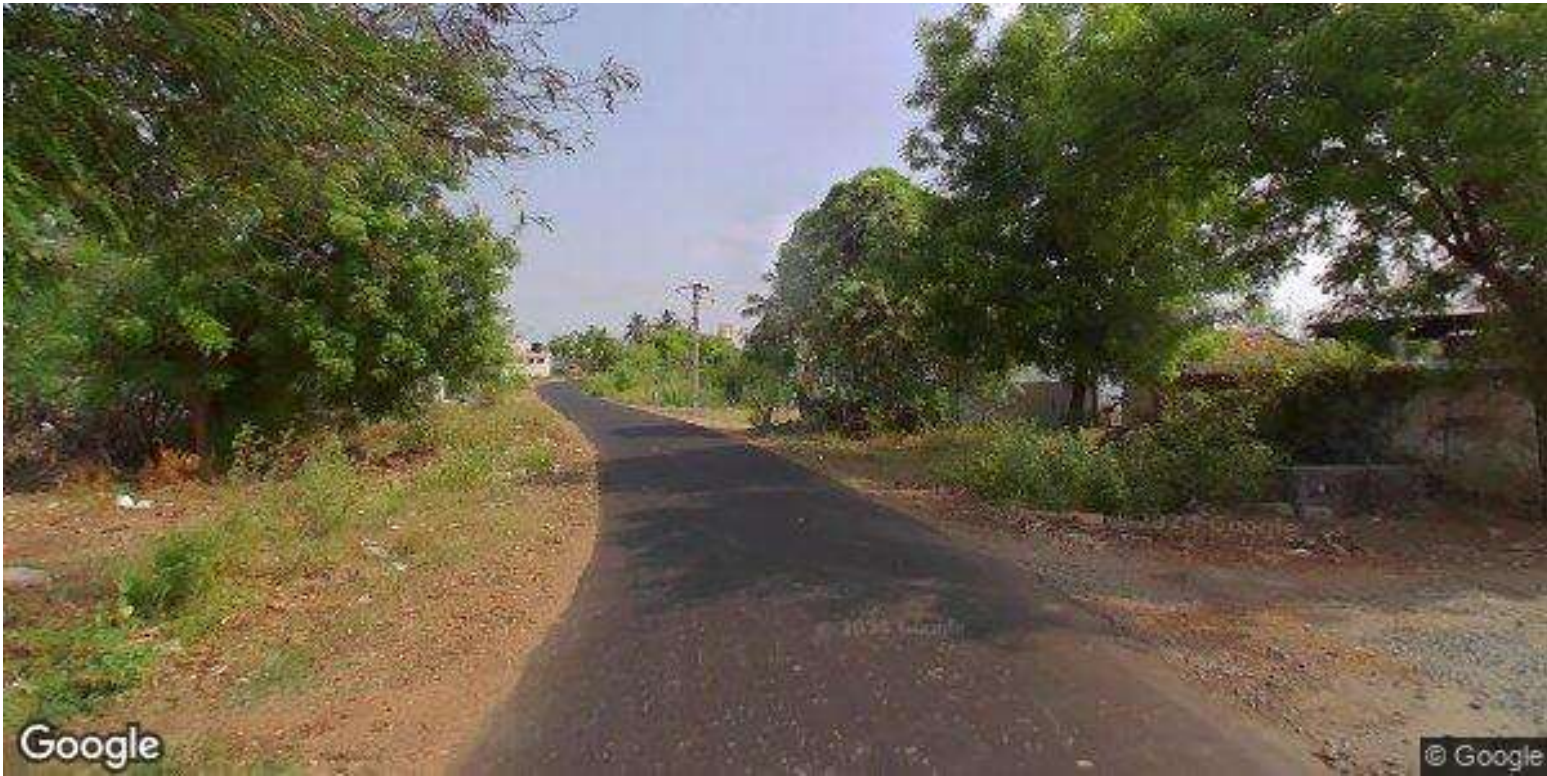
**Risk Type:** Turn  
**Risk Level:** Medium  
**Speed Limit:** 30 KM/Hr  
**Coordinates:** 11.28844, 77.74319

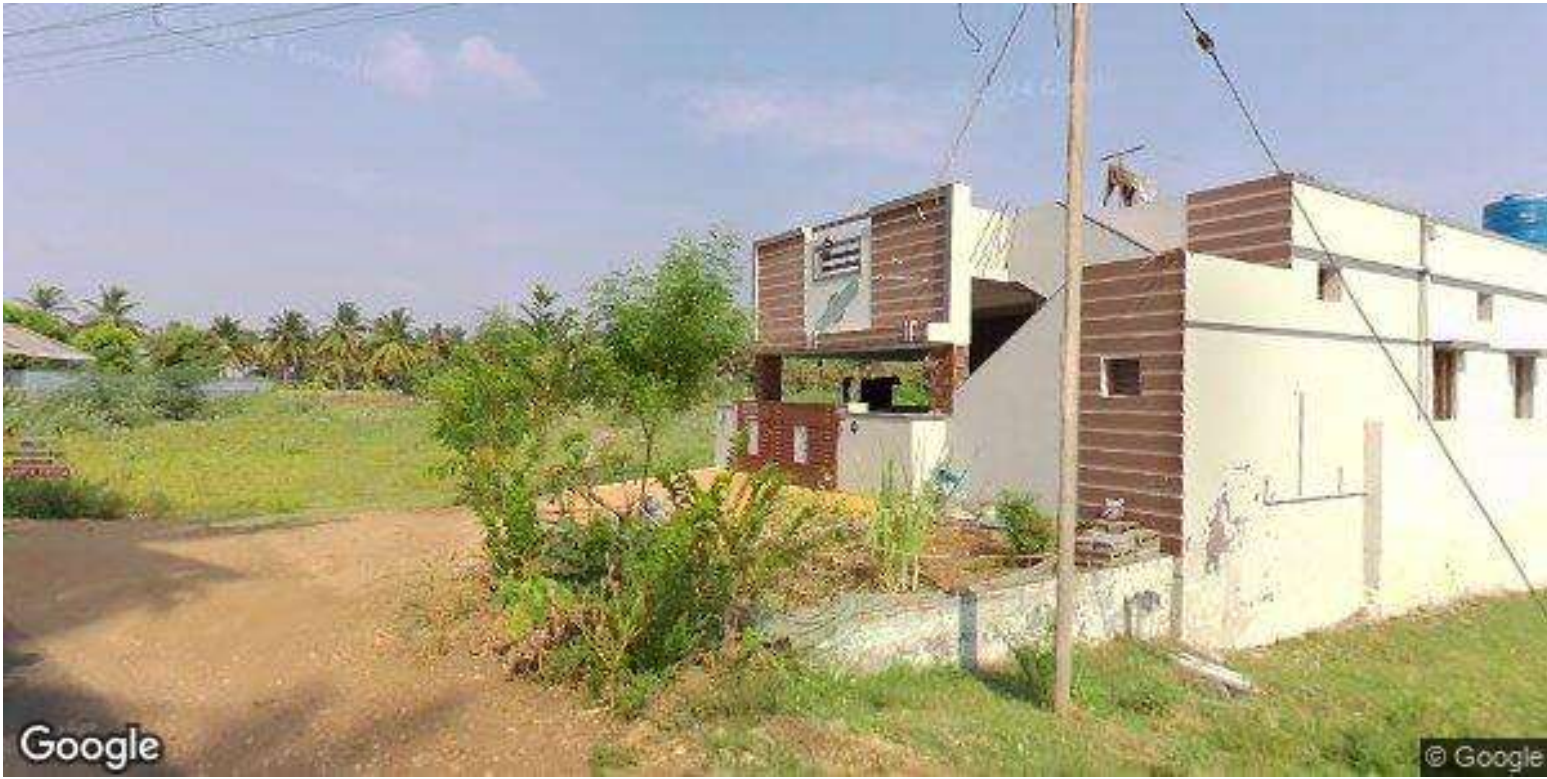
**Risk Type:** Turn  
**Risk Level:** High  
**Speed Limit:** 15 KM/Hr  
**Coordinates:** 11.27319, 77.72981

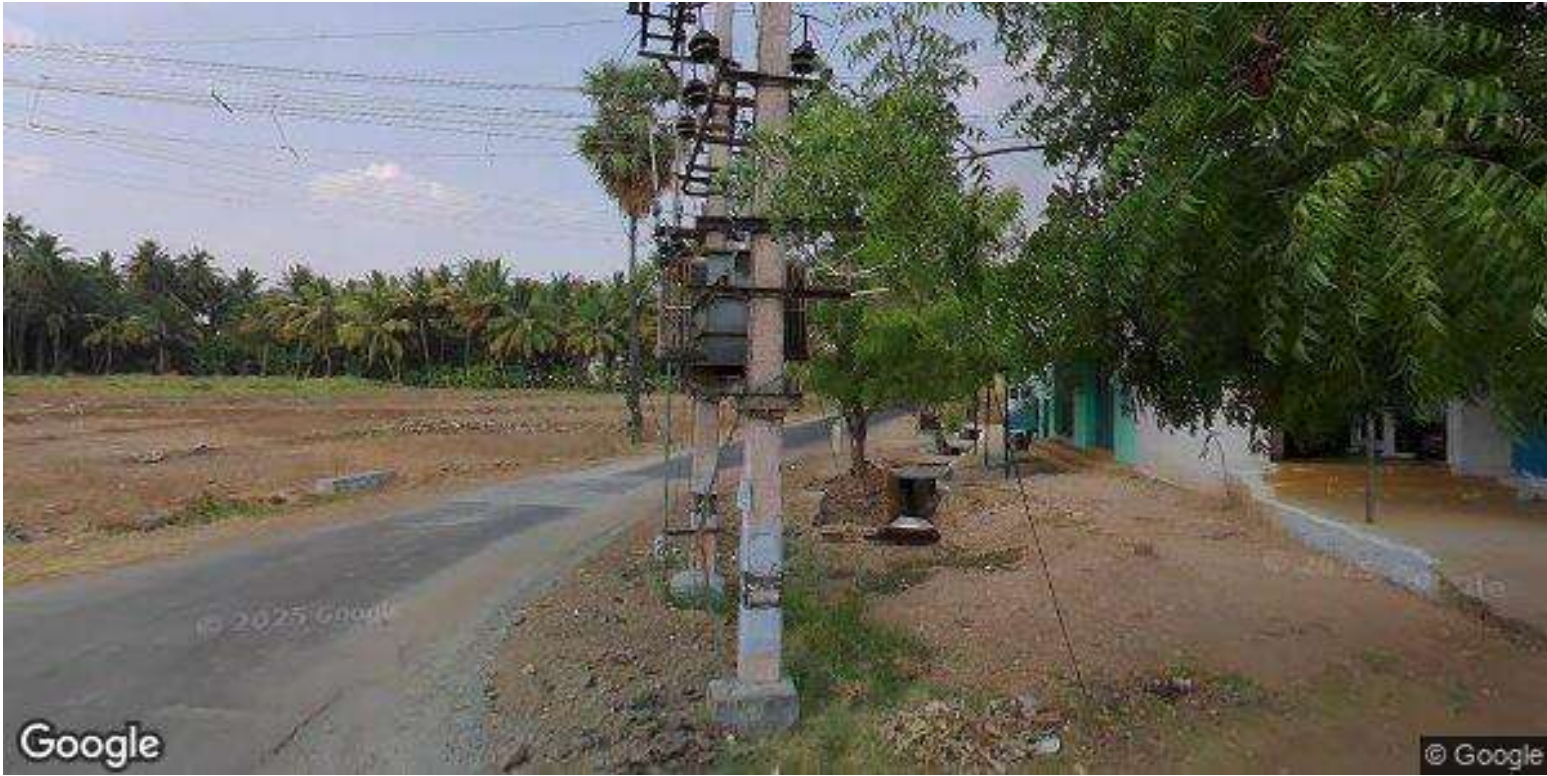
**Risk Type:** Blind Spot  
**Risk Level:** Blind Spot  
**Speed Limit:** 10 KM/Hr  
**Coordinates:** 11.27330, 77.72715

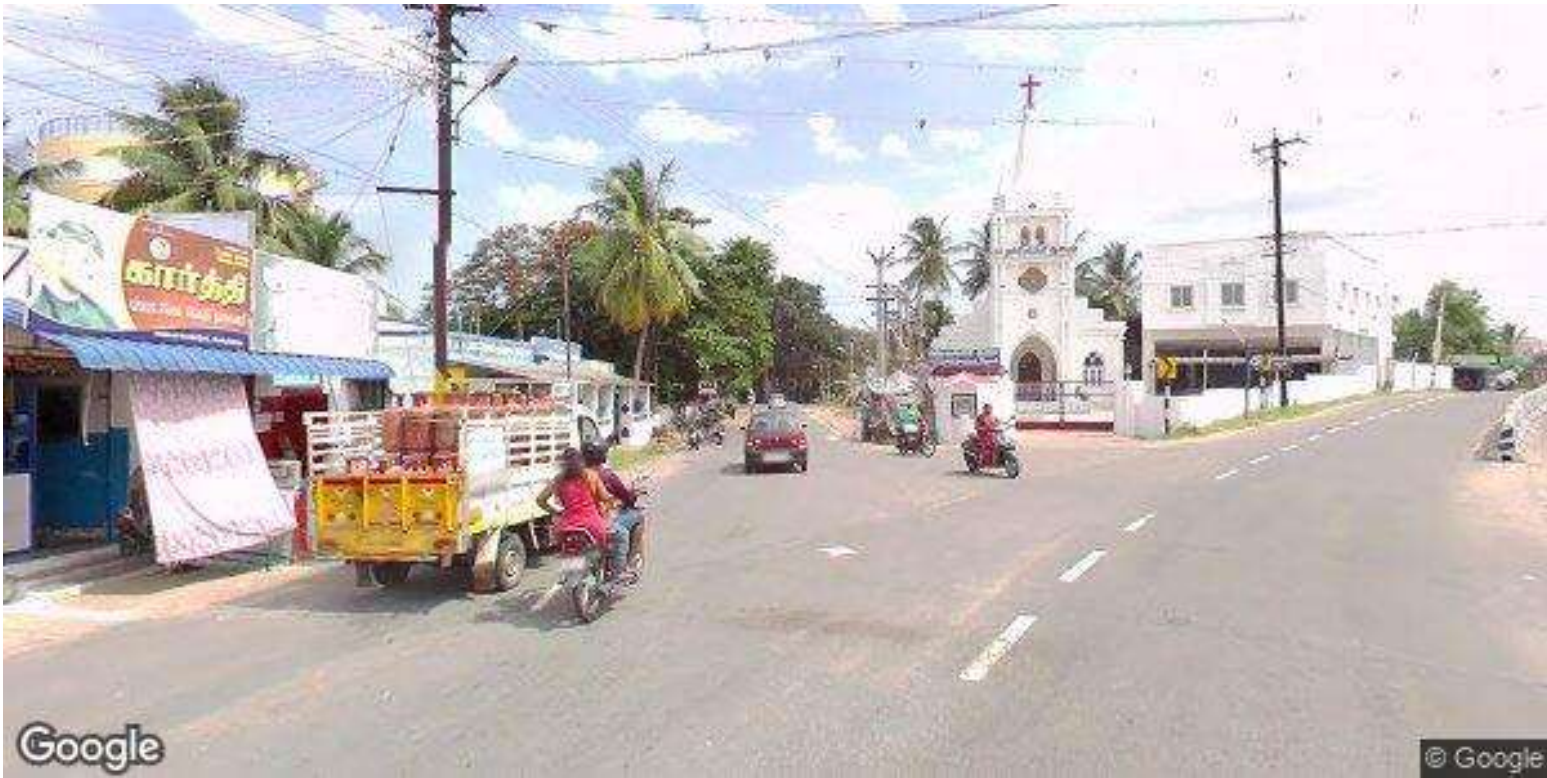
**Risk Type:** Turn  
**Risk Level:** Medium  
**Speed Limit:** 30 KM/Hr  
**Coordinates:** 11.23054, 77.71796

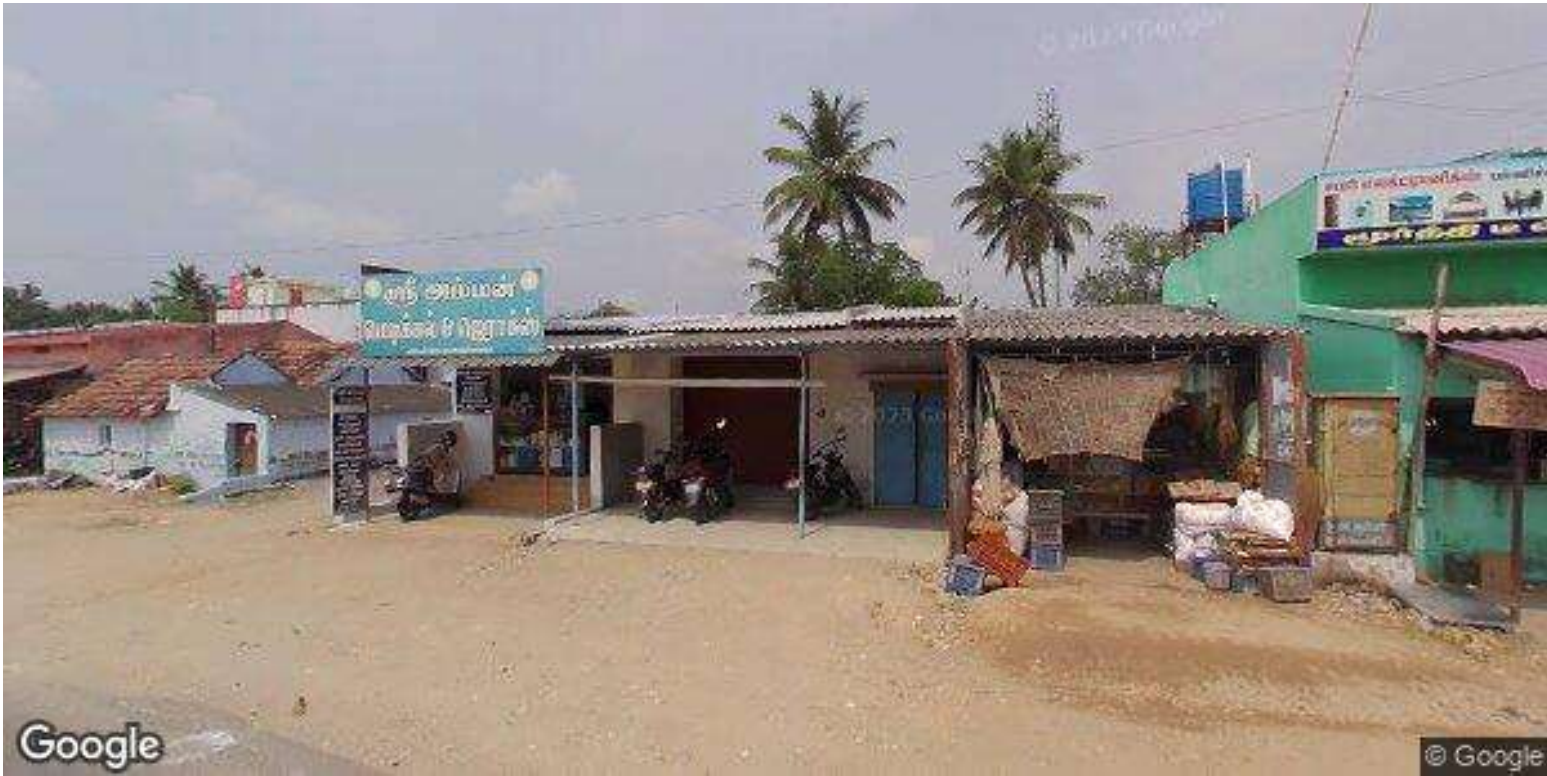
**Risk Type:** Turn  
**Risk Level:** Medium  
**Speed Limit:** 30 KM/Hr  
**Coordinates:** 11.20776, 77.70916

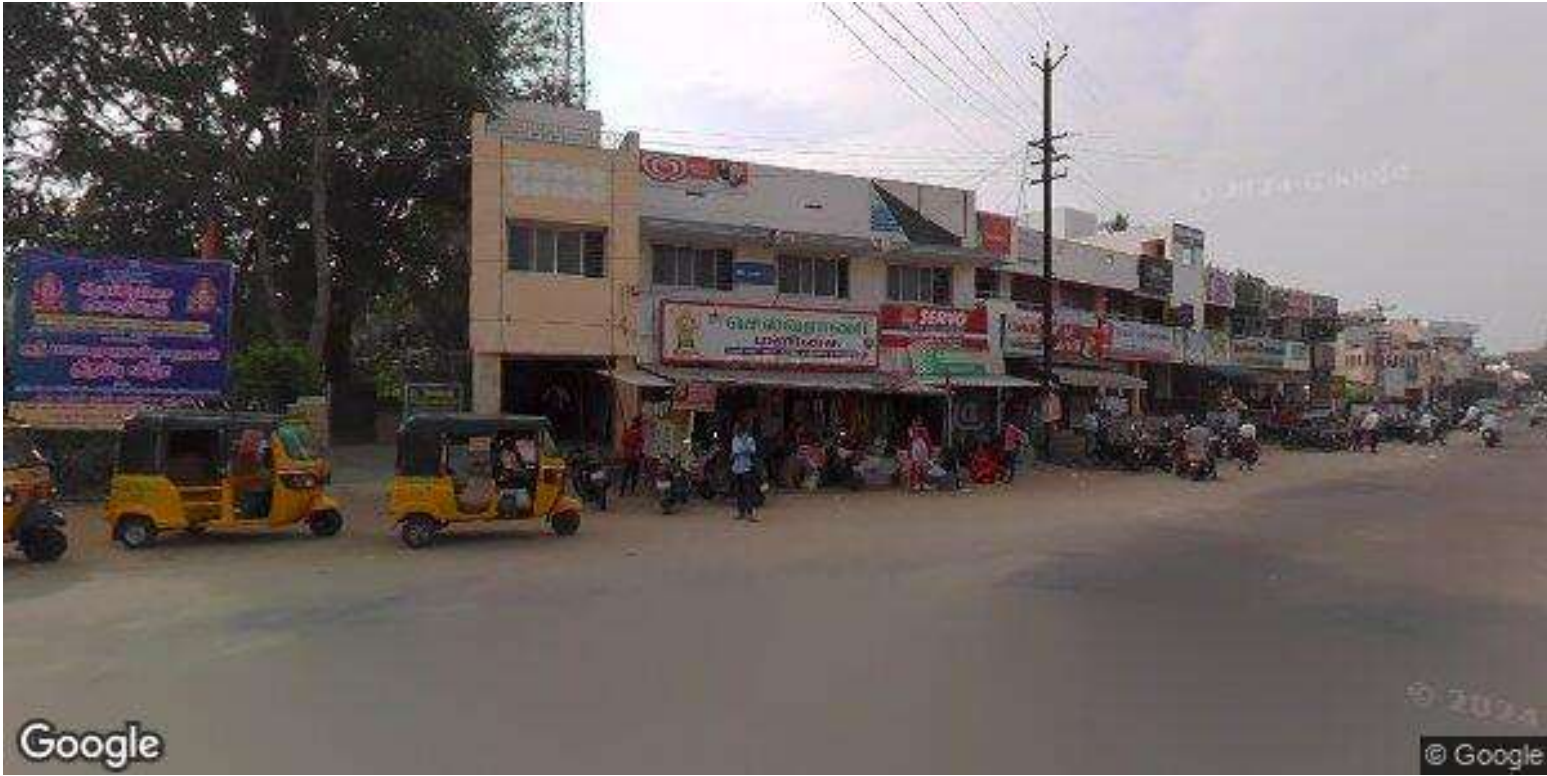
**Risk Type:** Turn  
**Risk Level:** Medium  
**Speed Limit:** 30 KM/Hr  
**Coordinates:** 11.15942, 77.70068

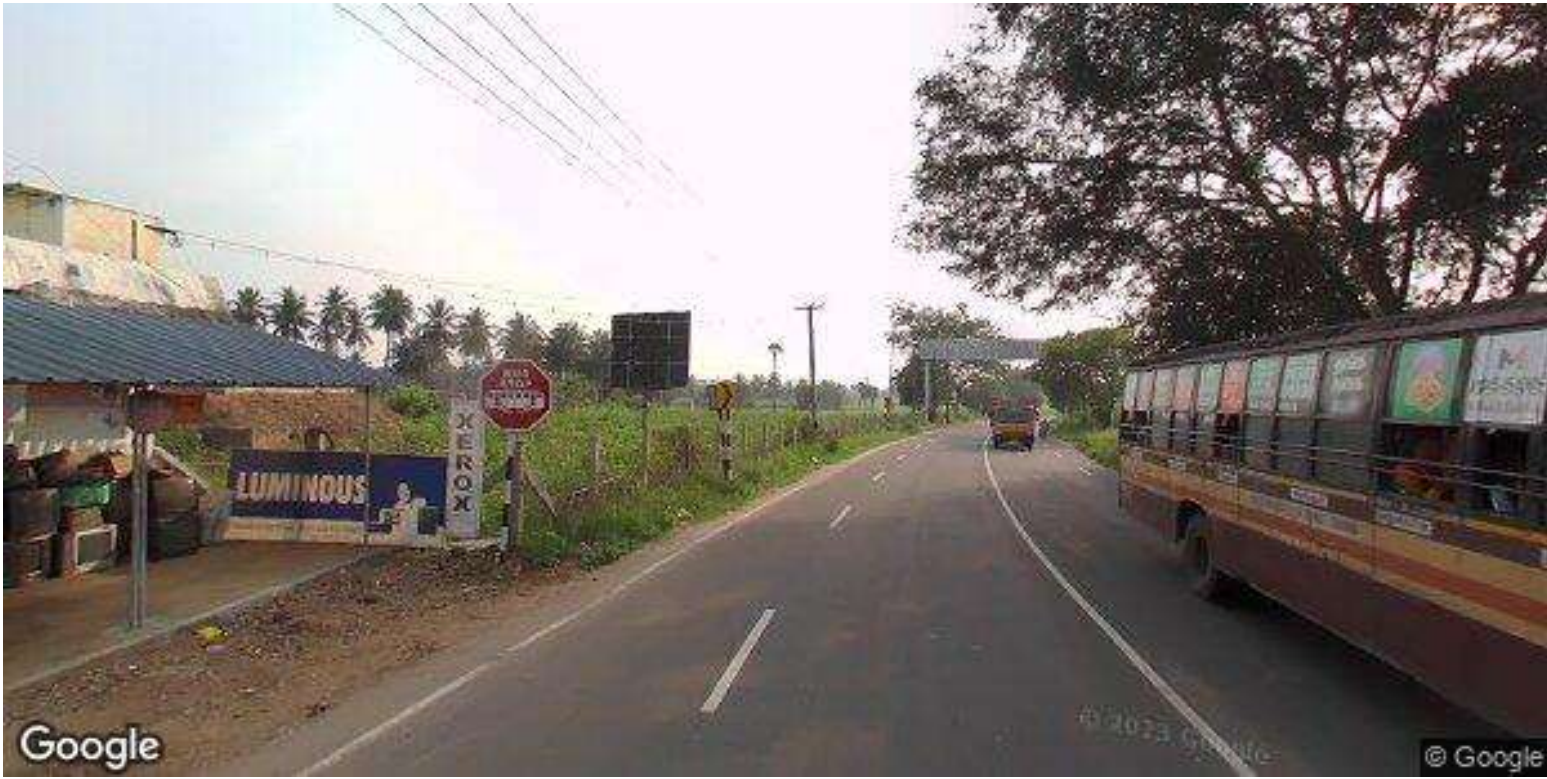
**Risk Type:** Turn  
**Risk Level:** Medium  
**Speed Limit:** 30 KM/Hr  
**Coordinates:** 11.12102, 77.67919

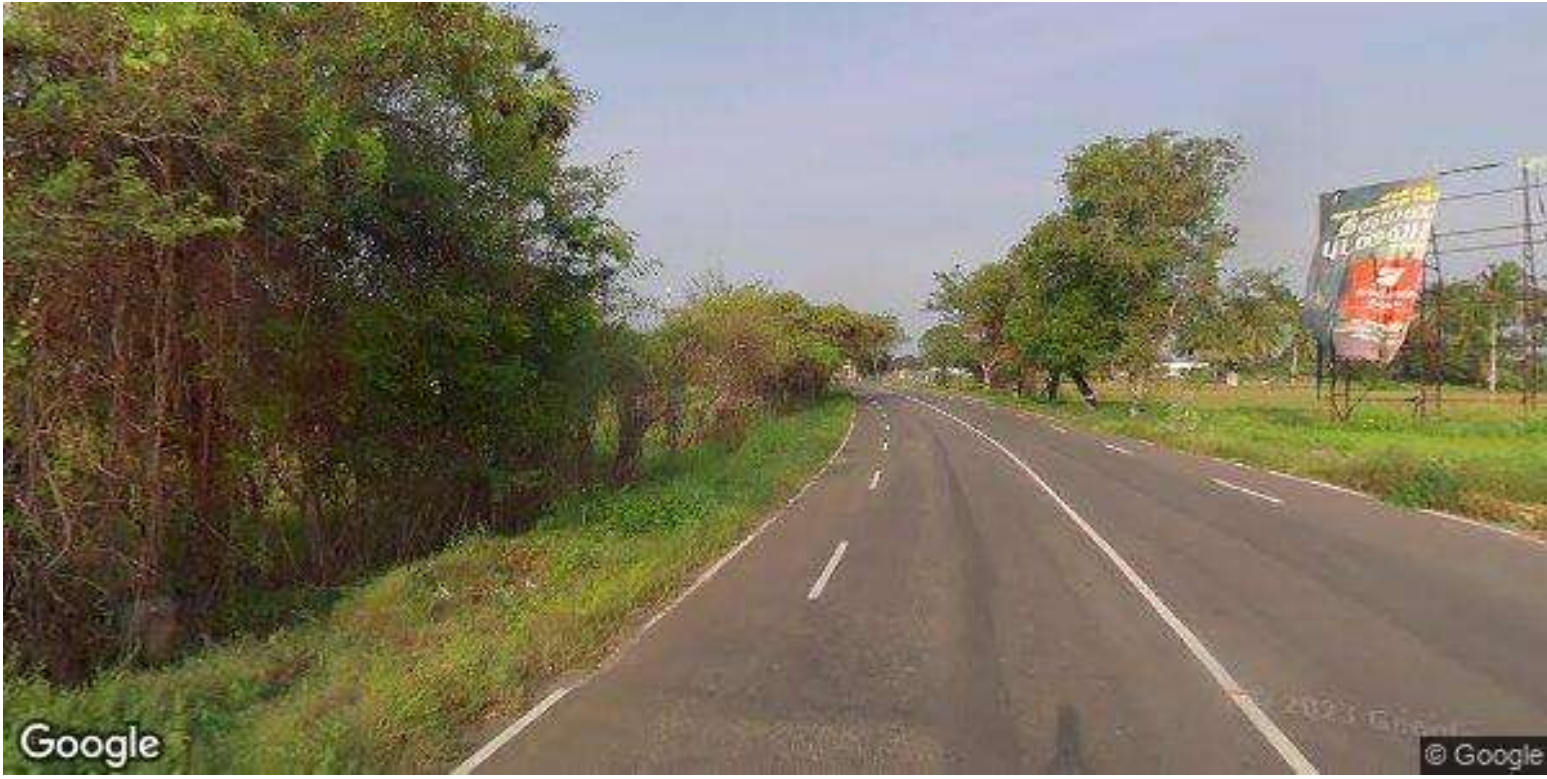
**Risk Type:** Turn  
**Risk Level:** Medium  
**Speed Limit:** 30 KM/Hr  
**Coordinates:** 11.11932, 77.67786

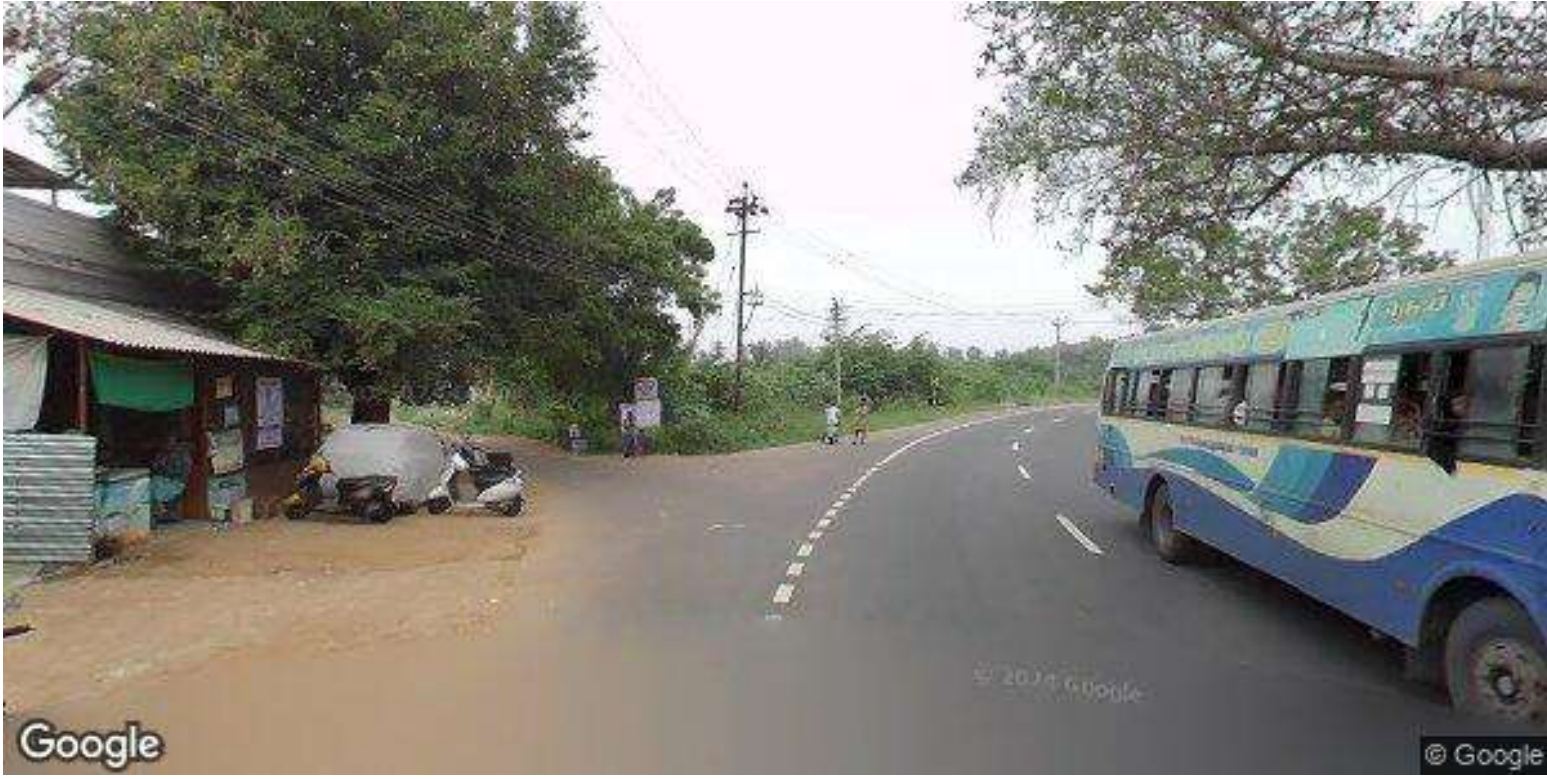
**Risk Type:** Turn  
**Risk Level:** Medium  
**Speed Limit:** 30 KM/Hr  
**Coordinates:** 11.11710, 77.67175
