# IndianOil

## JOURNEY RISK MANAGEMENT (JRM) STUDY

### Salem Terminal TO VELAVAN FUELS

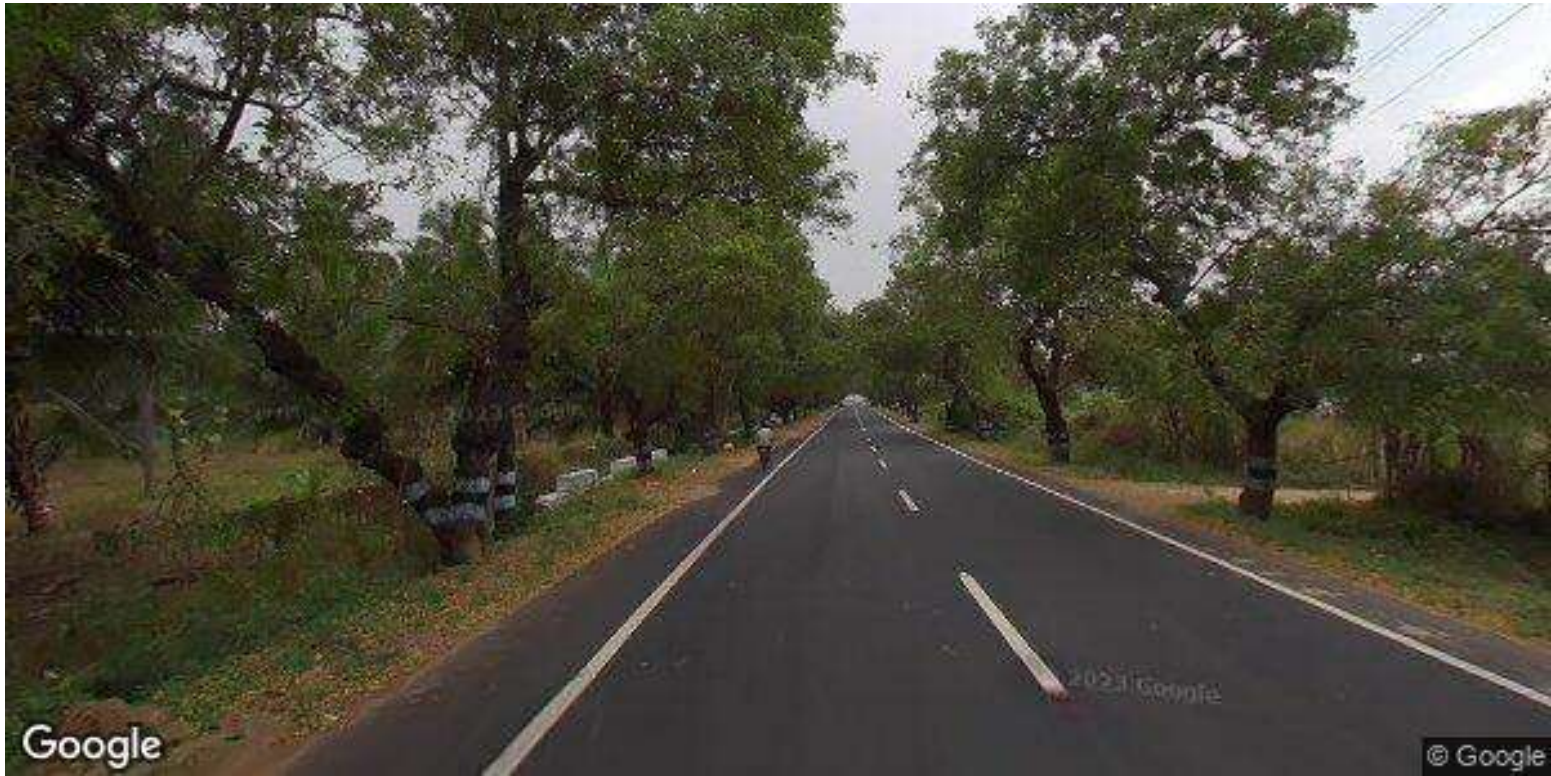
**Risk Type:** Turn  
**Risk Level:** Medium  
**Speed Limit:** 30 KM/Hr  
**Coordinates:** 11.10436, 77.67044

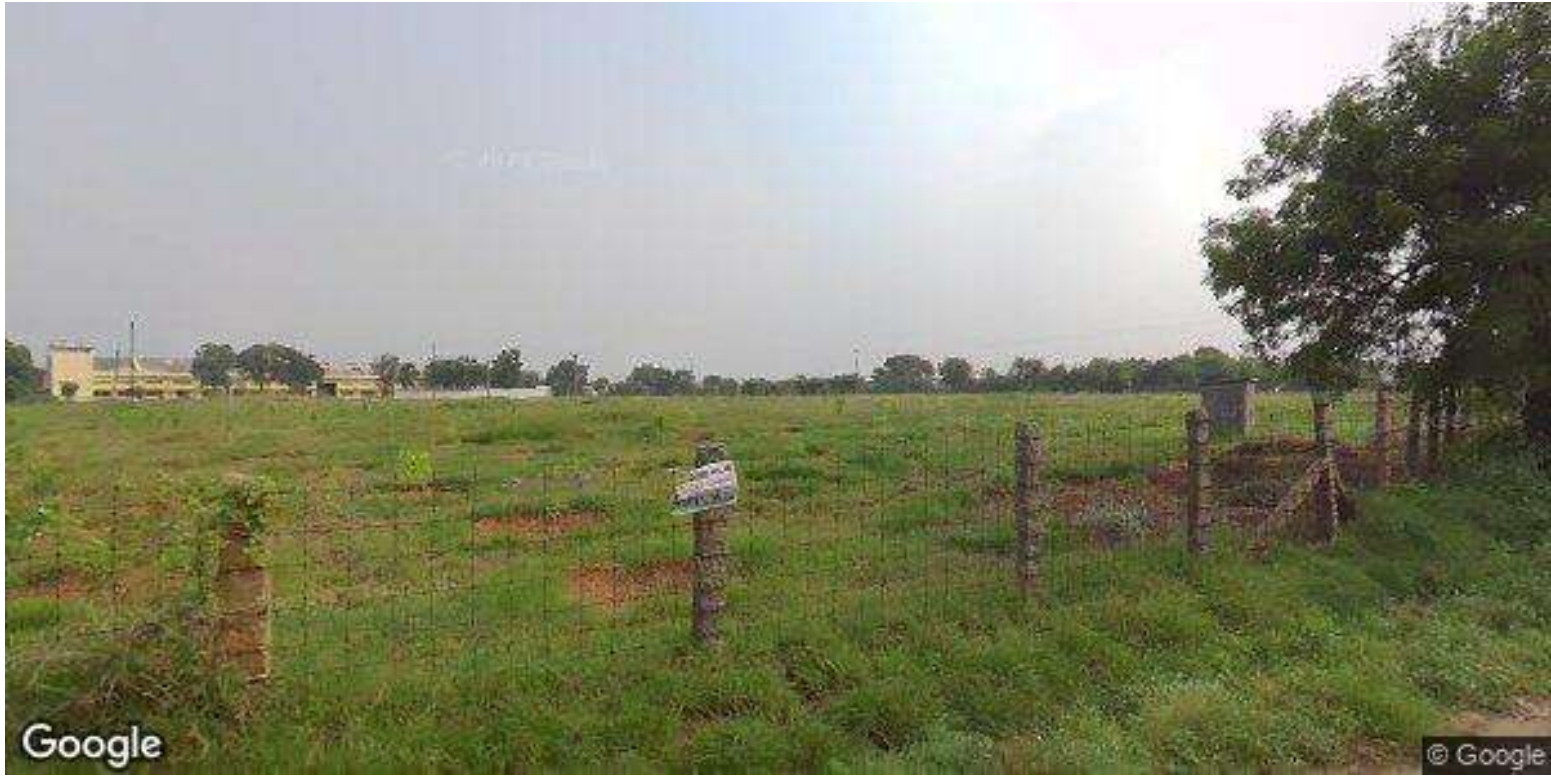
**Risk Type:** Turn  
**Risk Level:** Medium  
**Speed Limit:** 30 KM/Hr  
**Coordinates:** 11.09491, 77.66603

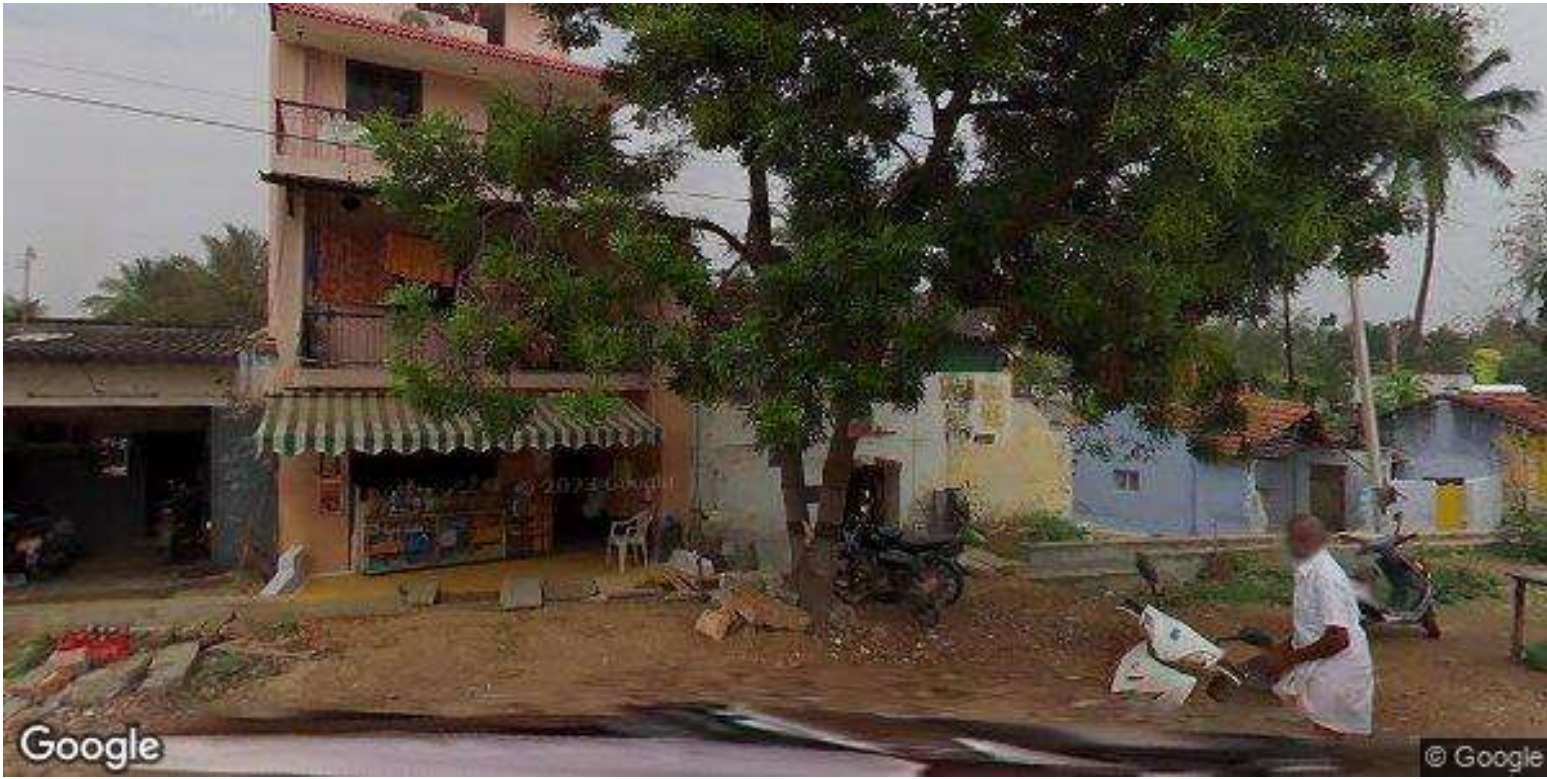
**Risk Type:** Turn  
**Risk Level:** Medium  
**Speed Limit:** 30 KM/Hr  
**Coordinates:** 11.08696, 77.66407

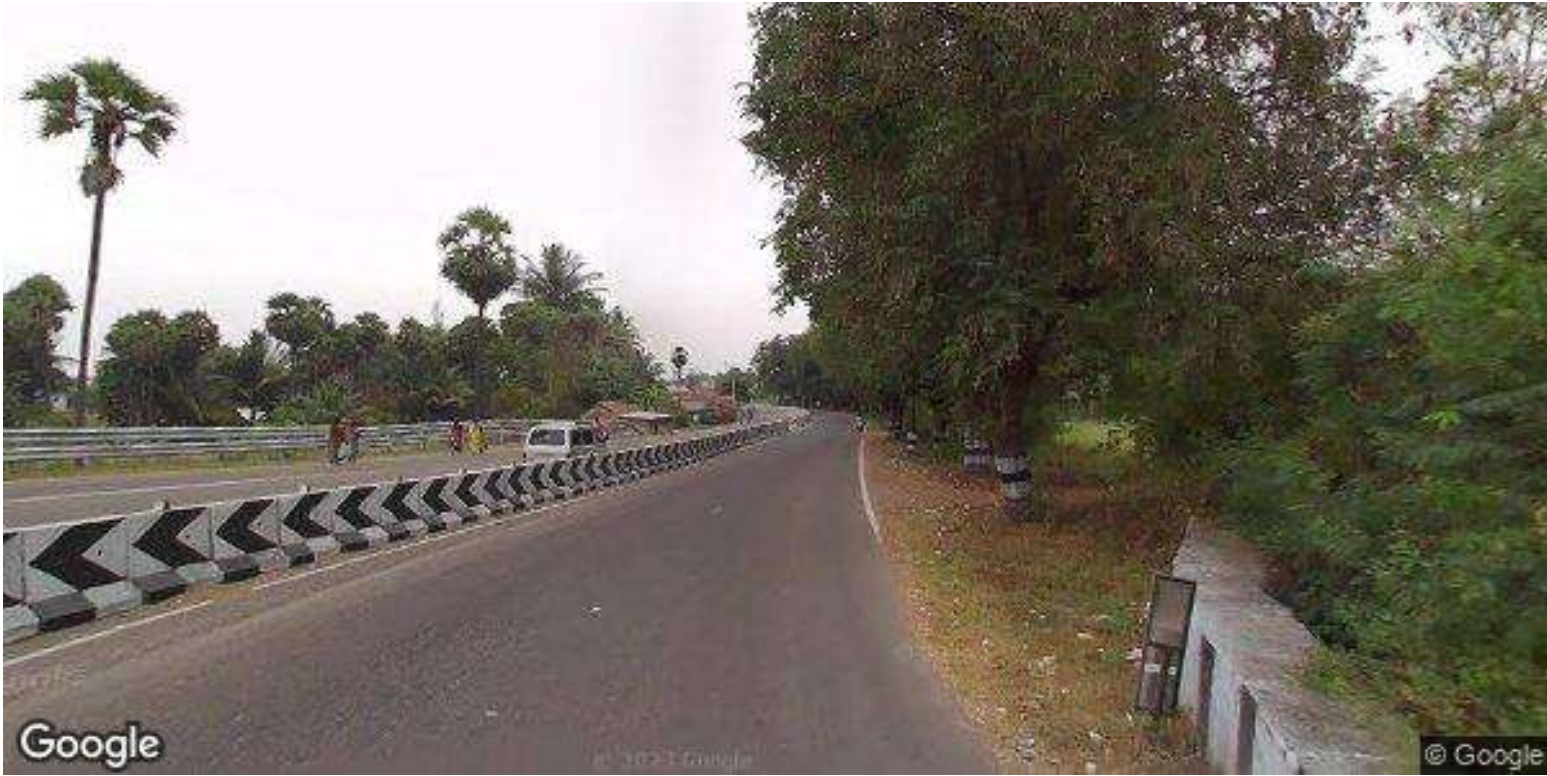
**Risk Type:** Turn  
**Risk Level:** Medium  
**Speed Limit:** 30 KM/Hr  
**Coordinates:** 11.08296, 77.65857

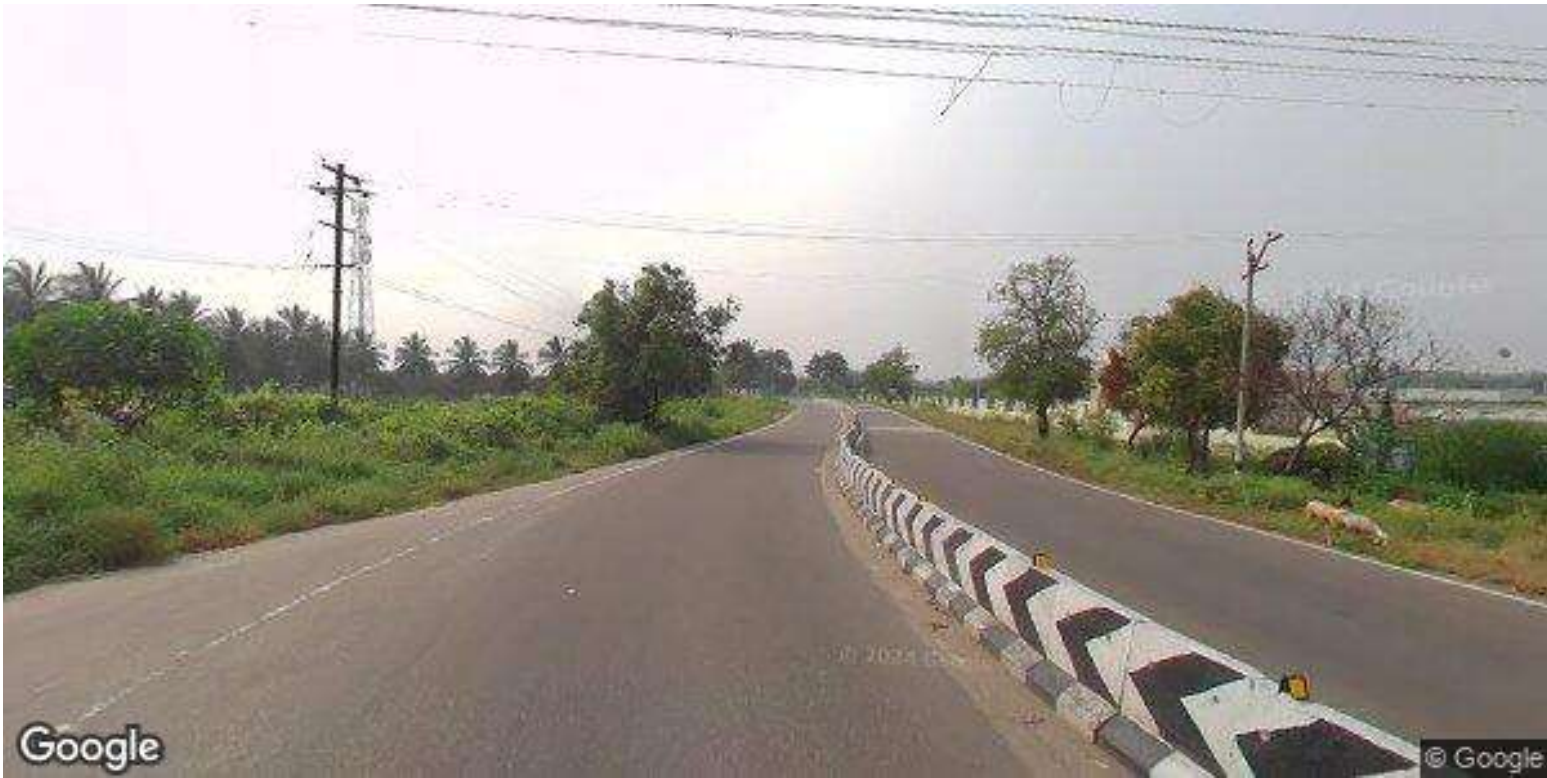
**Risk Type:** Turn  
**Risk Level:** Medium  
**Speed Limit:** 30 KM/Hr  
**Coordinates:** 11.06183, 77.63924

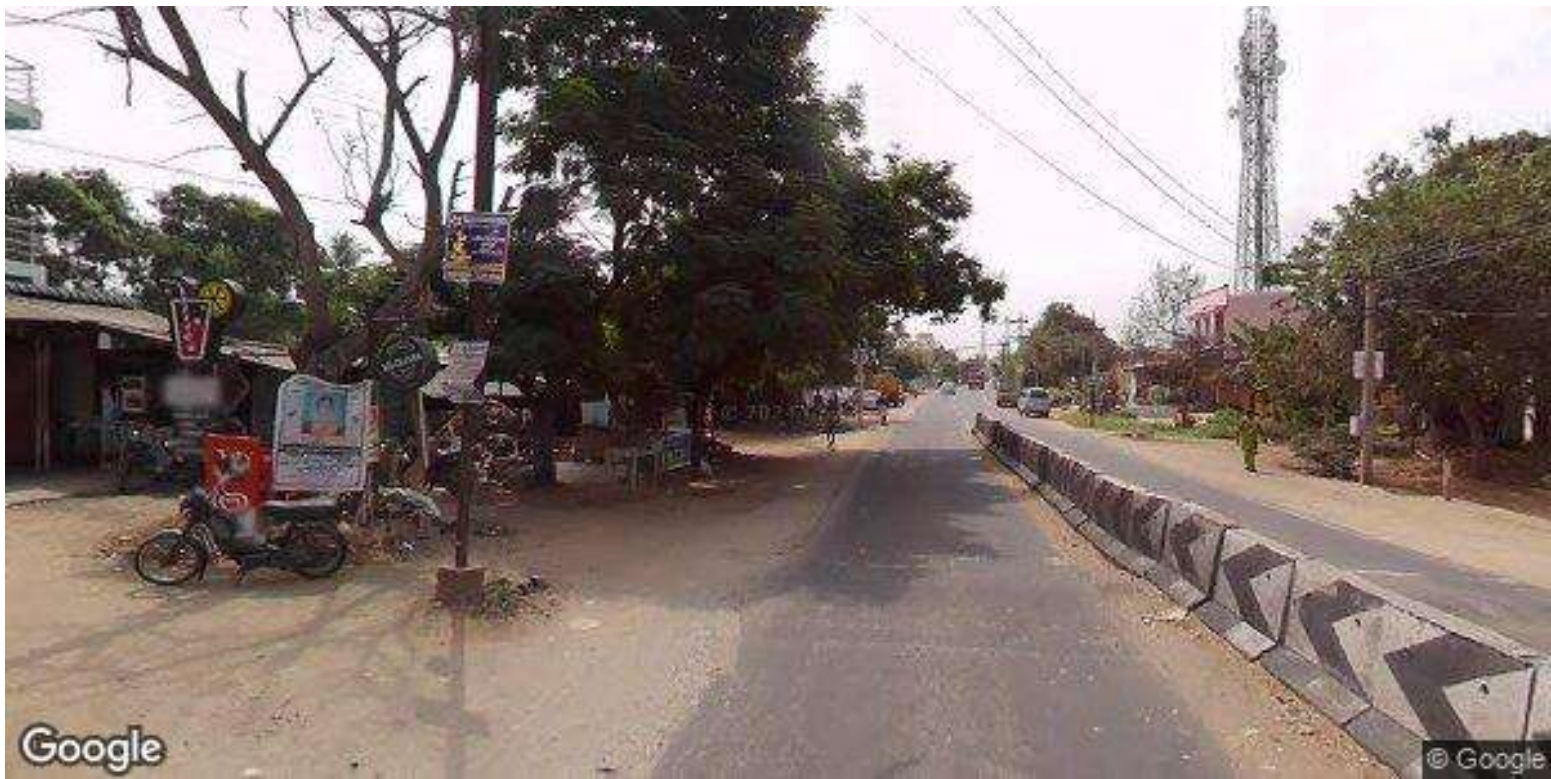
**Risk Type:** Turn  
**Risk Level:** High  
**Speed Limit:** 15 KM/Hr  
**Coordinates:** 11.00826, 77.56962

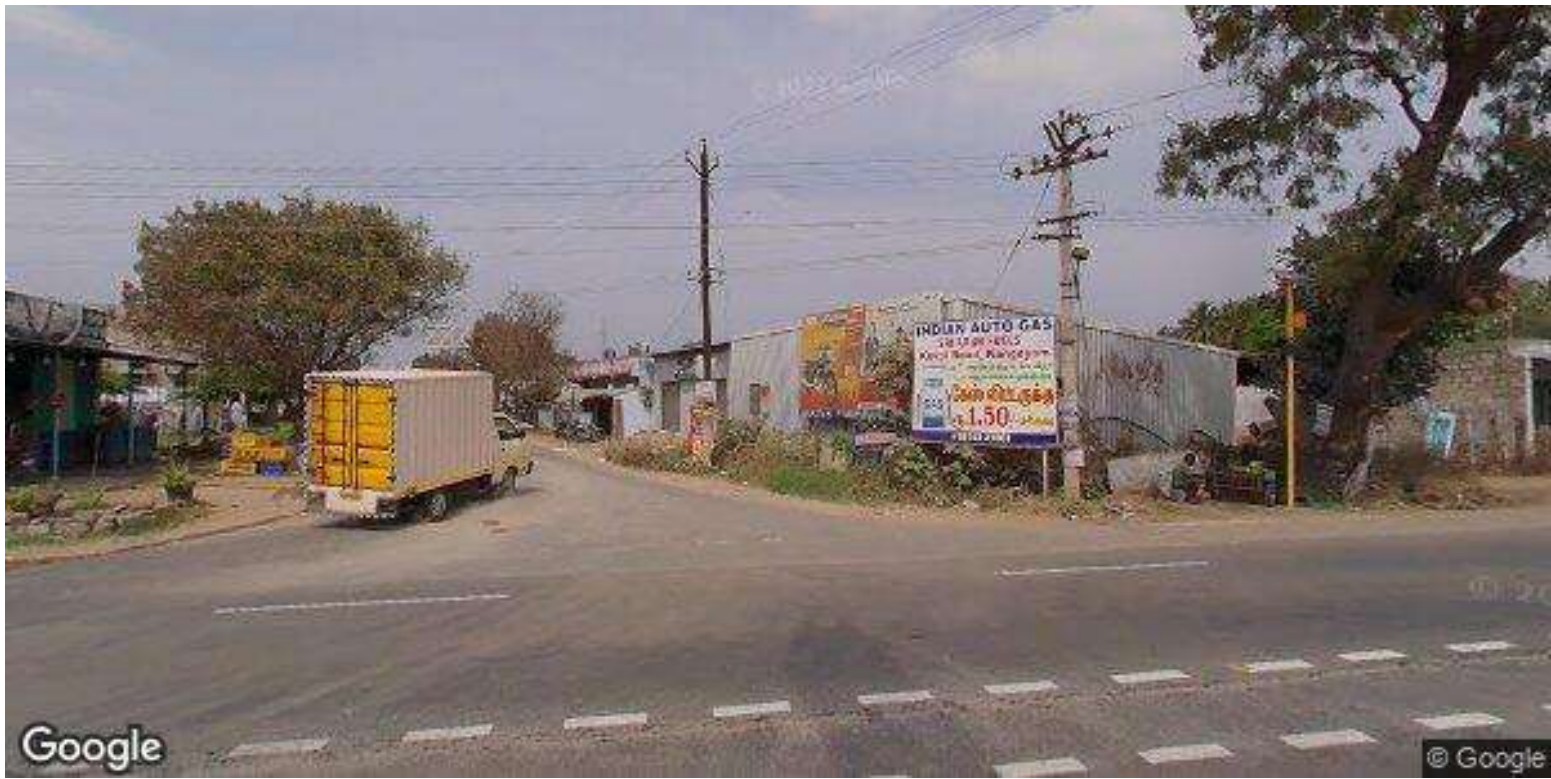
**Risk Type:** Blind Spot  
**Risk Level:** Blind Spot  
**Speed Limit:** 10 KM/Hr  
**Coordinates:** 11.00058, 77.56882

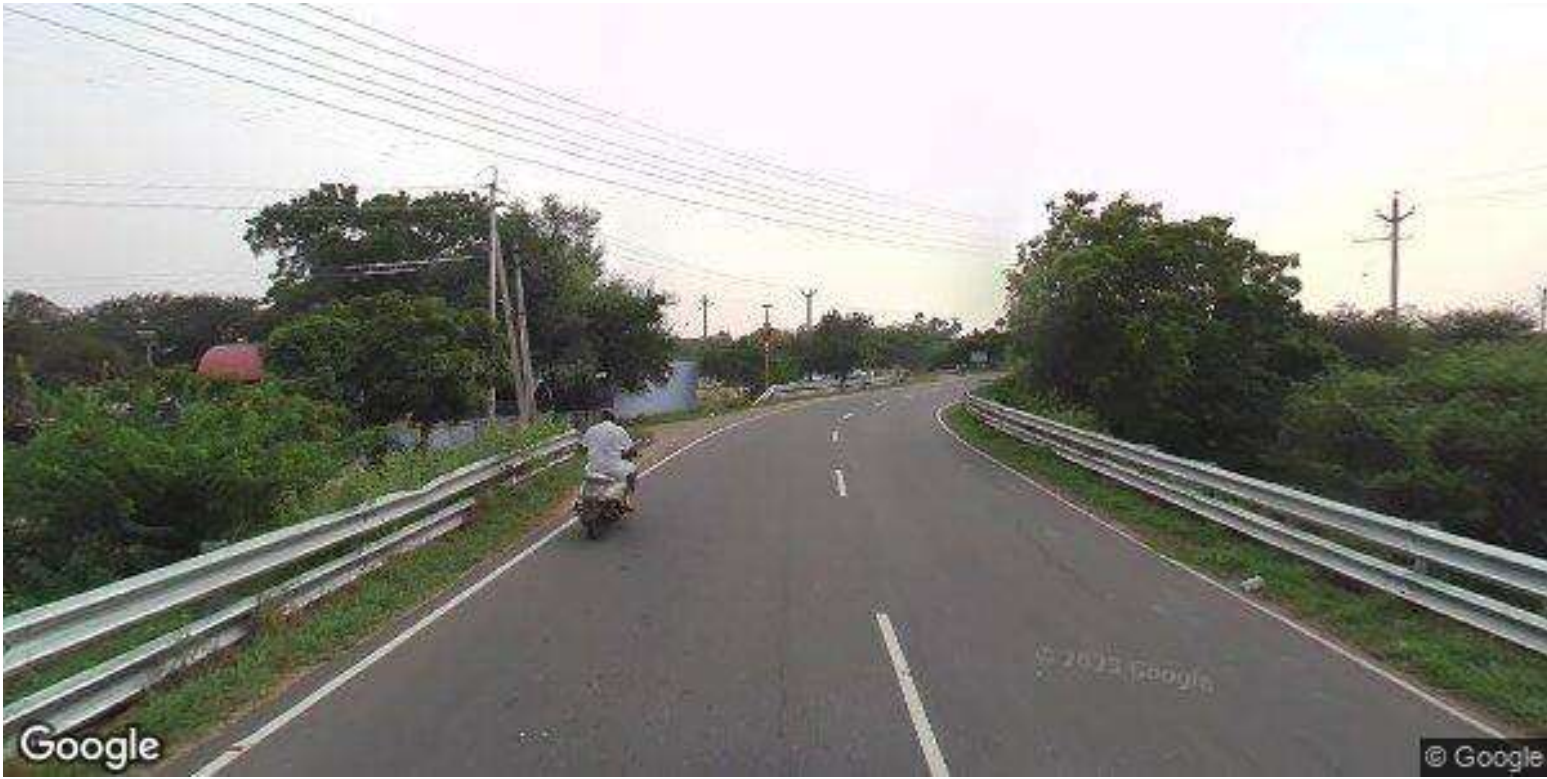
**Risk Type:** Turn  
**Risk Level:** High  
**Speed Limit:** 15 KM/Hr  
**Coordinates:** 10.94722, 77.54709

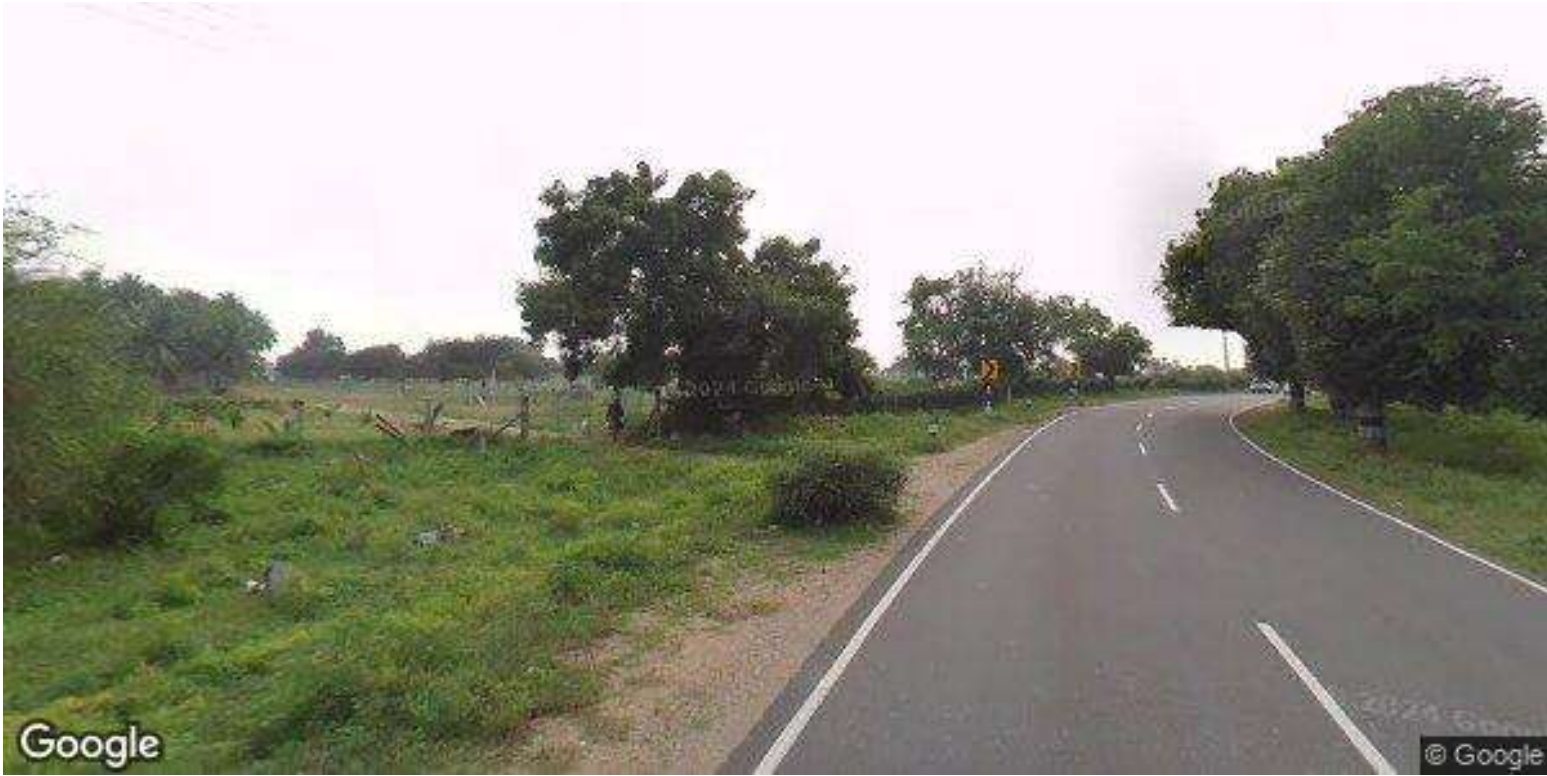
**Risk Type:** Turn  
**Risk Level:** Medium  
**Speed Limit:** 30 KM/Hr  
**Coordinates:** 10.93895, 77.53976

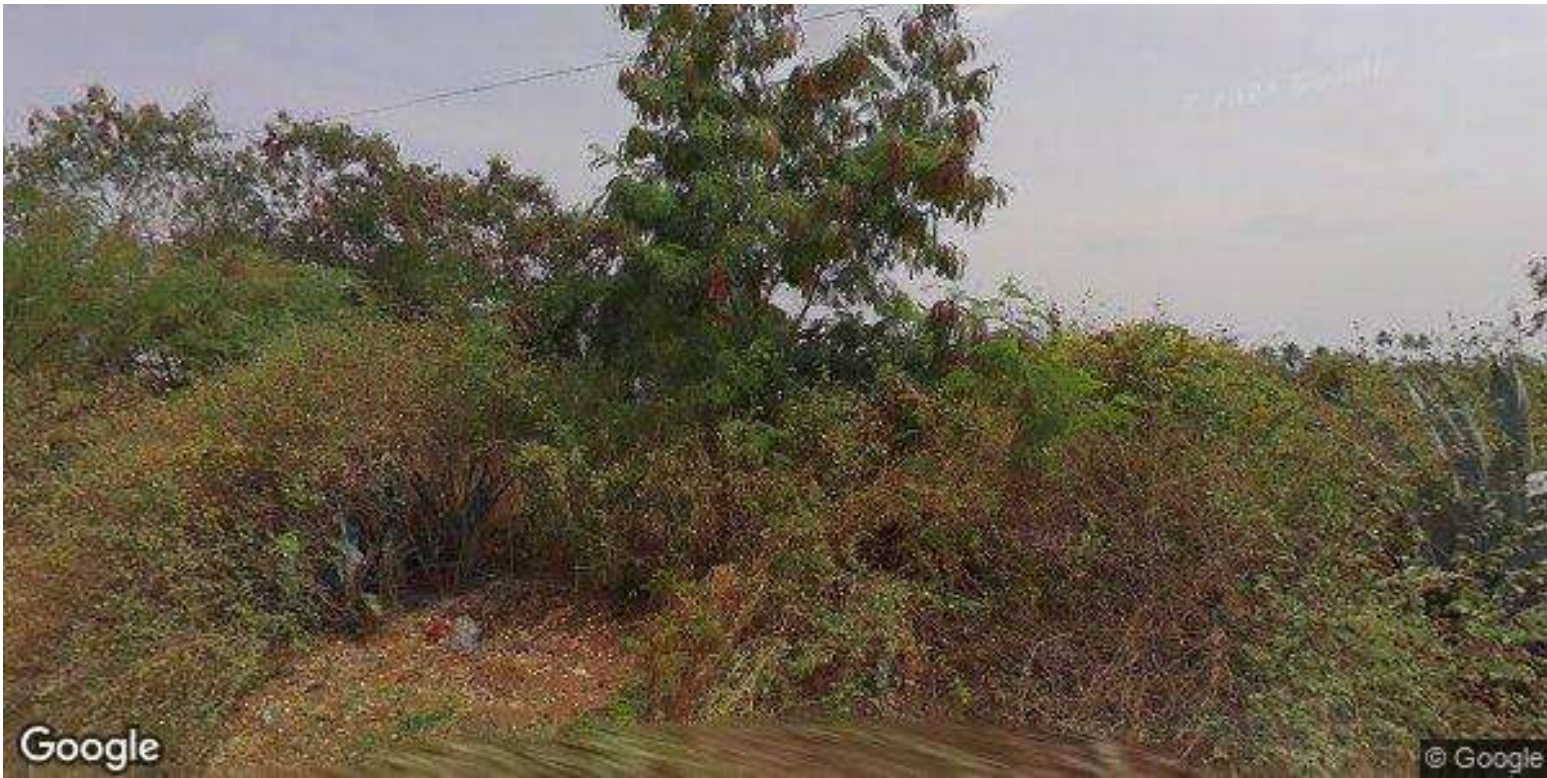
**Risk Type:** Turn  
**Risk Level:** Medium  
**Speed Limit:** 30 KM/Hr  
**Coordinates:** 10.93054, 77.53265

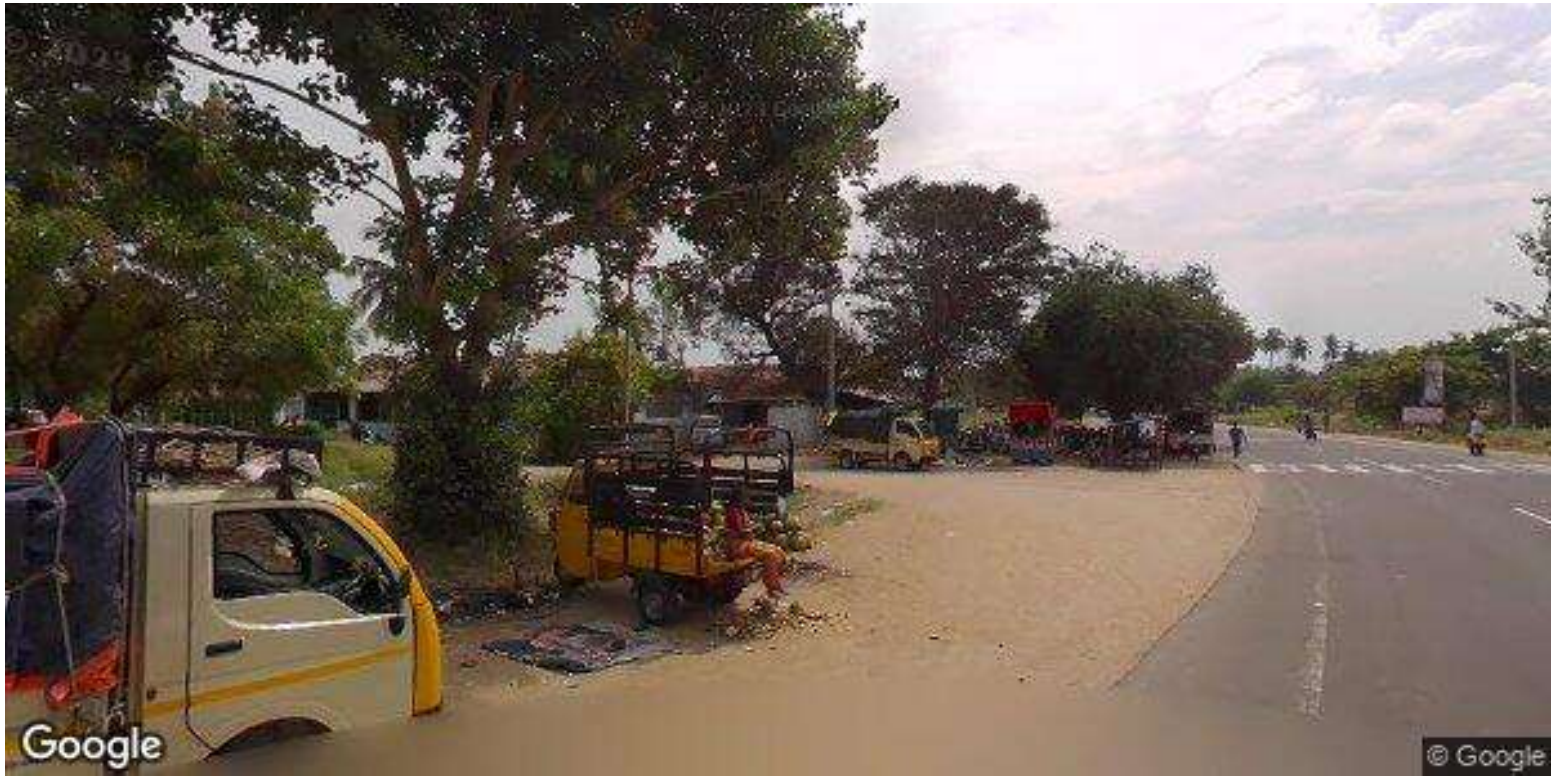
**Risk Type:** Turn  
**Risk Level:** Medium  
**Speed Limit:** 30 KM/Hr  
**Coordinates:** 10.89213, 77.52646

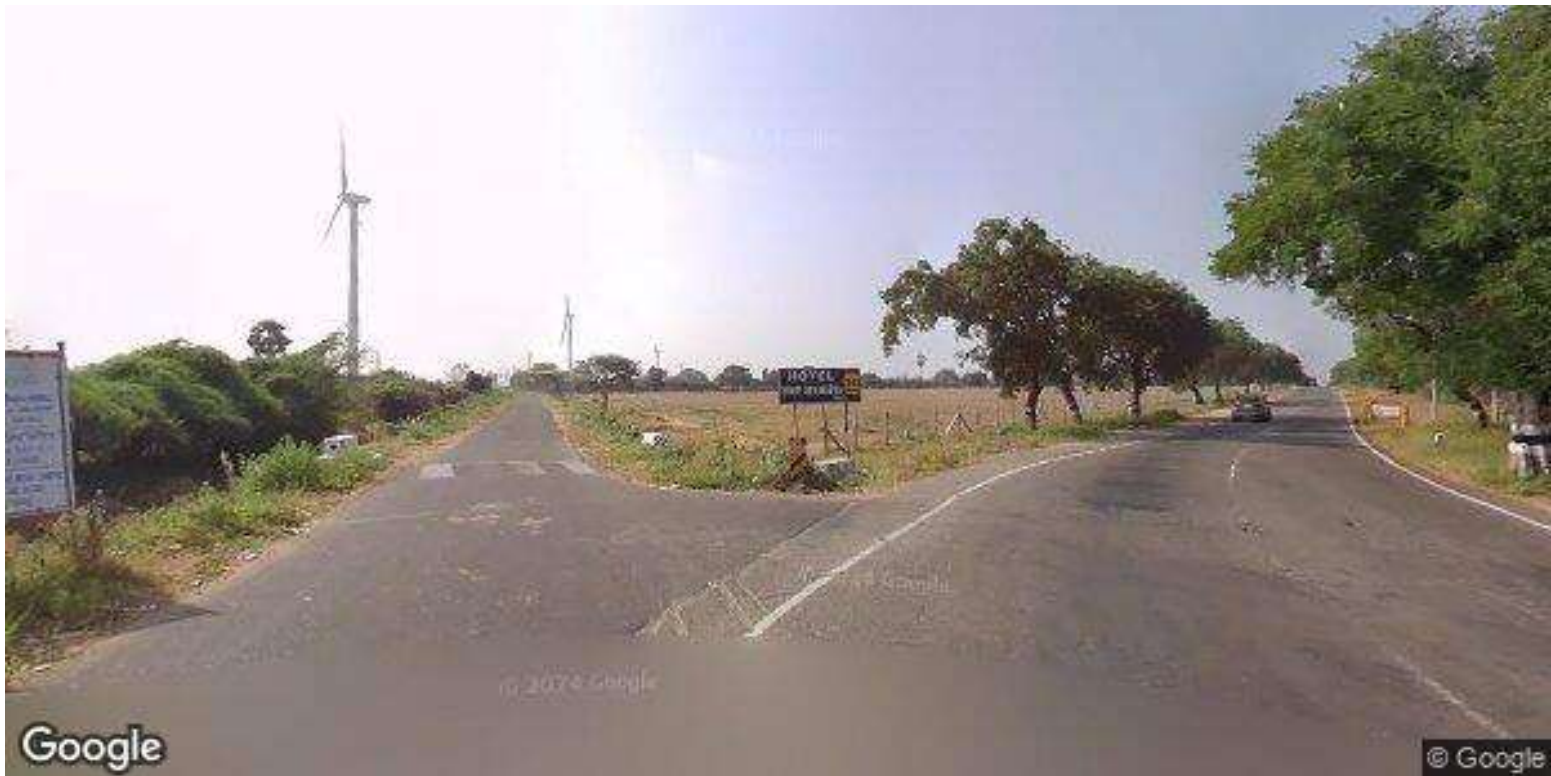
**Risk Type:** Turn  
**Risk Level:** Medium  
**Speed Limit:** 30 KM/Hr  
**Coordinates:** 10.83409, 77.52932

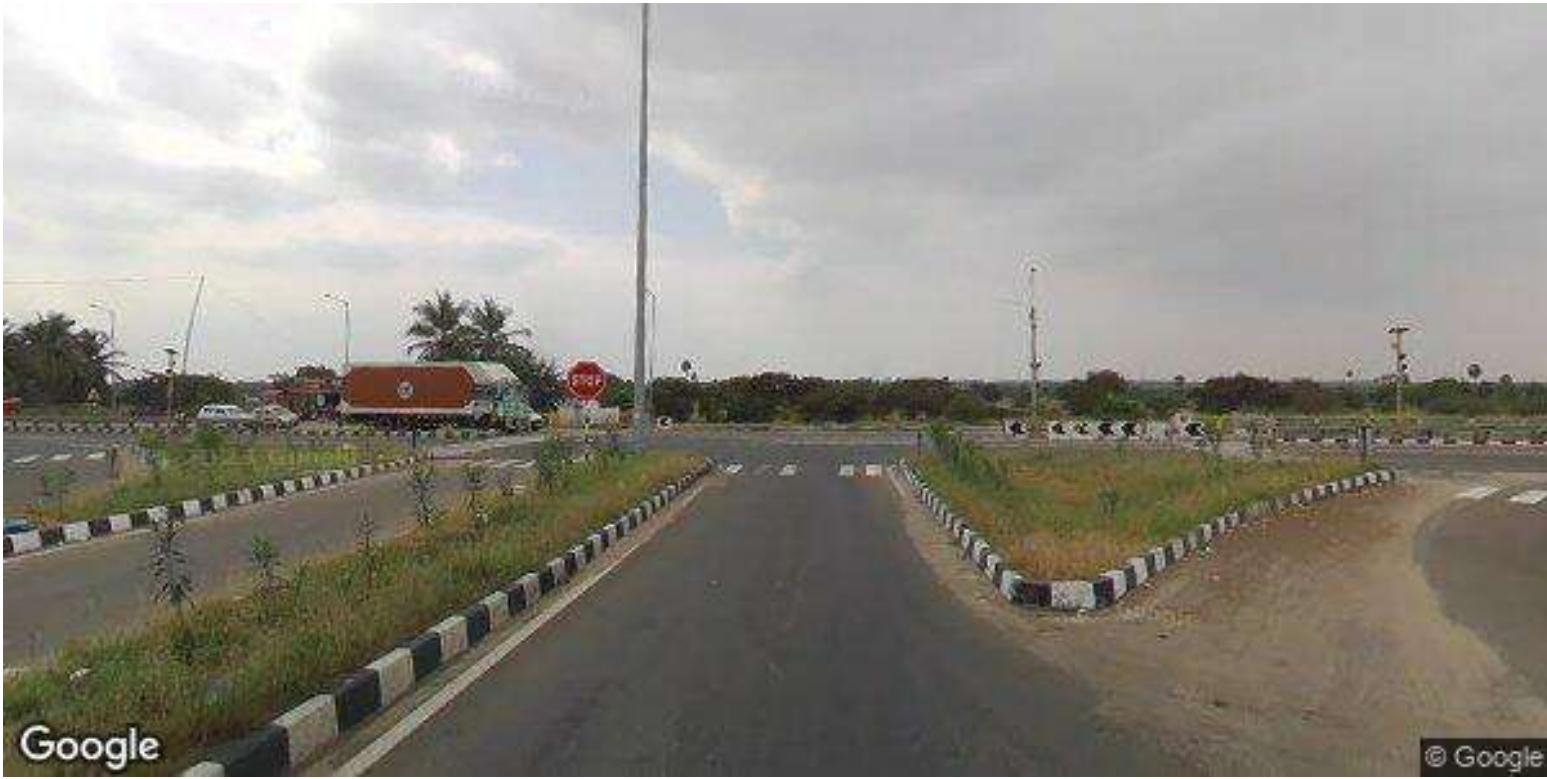
**Risk Type:** Turn  
**Risk Level:** Medium  
**Speed Limit:** 30 KM/Hr  
**Coordinates:** 10.77642, 77.50712

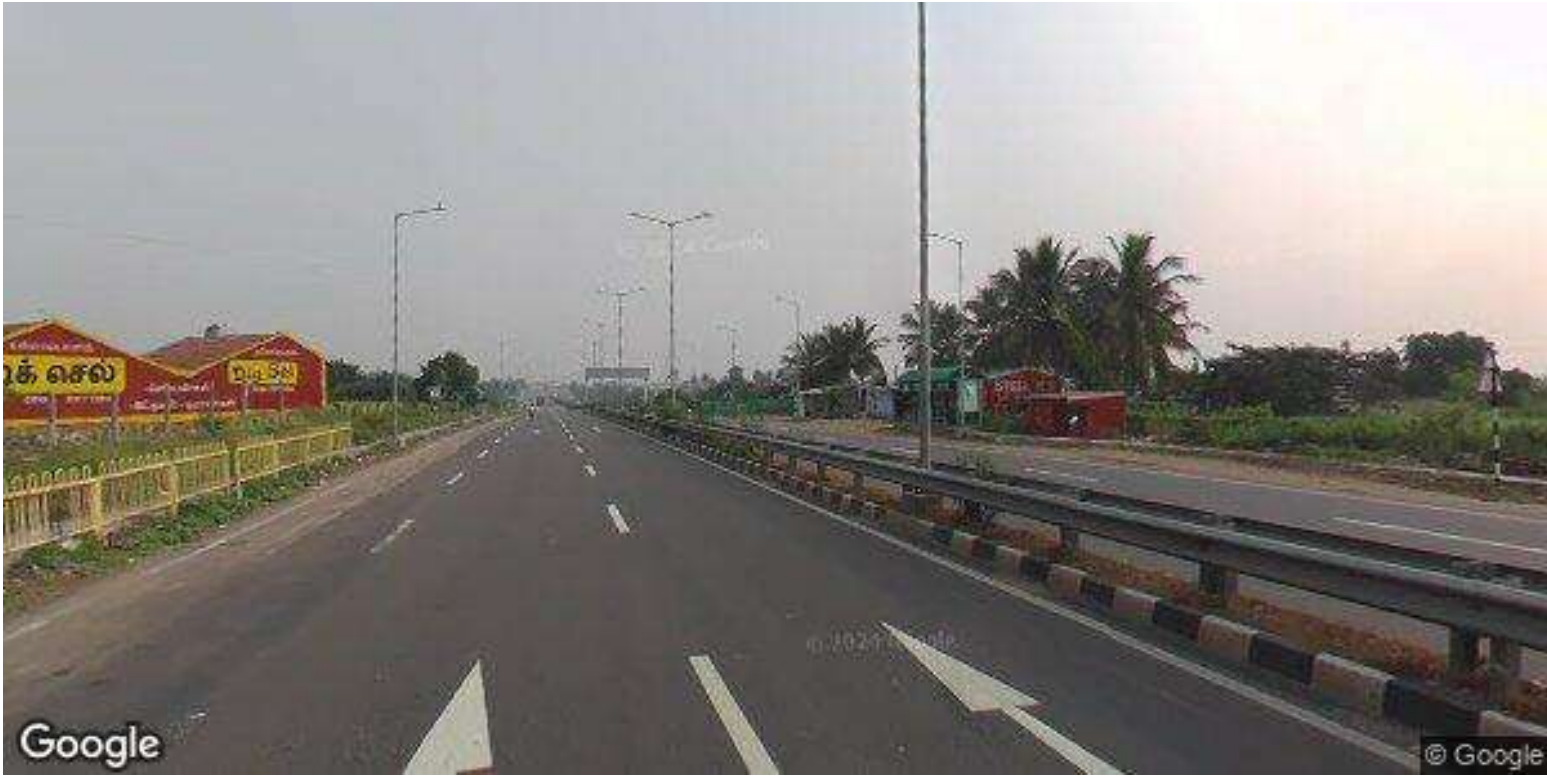
**Risk Type:** Turn  
**Risk Level:** Medium  
**Speed Limit:** 30 KM/Hr  
**Coordinates:** 10.77580, 77.50724

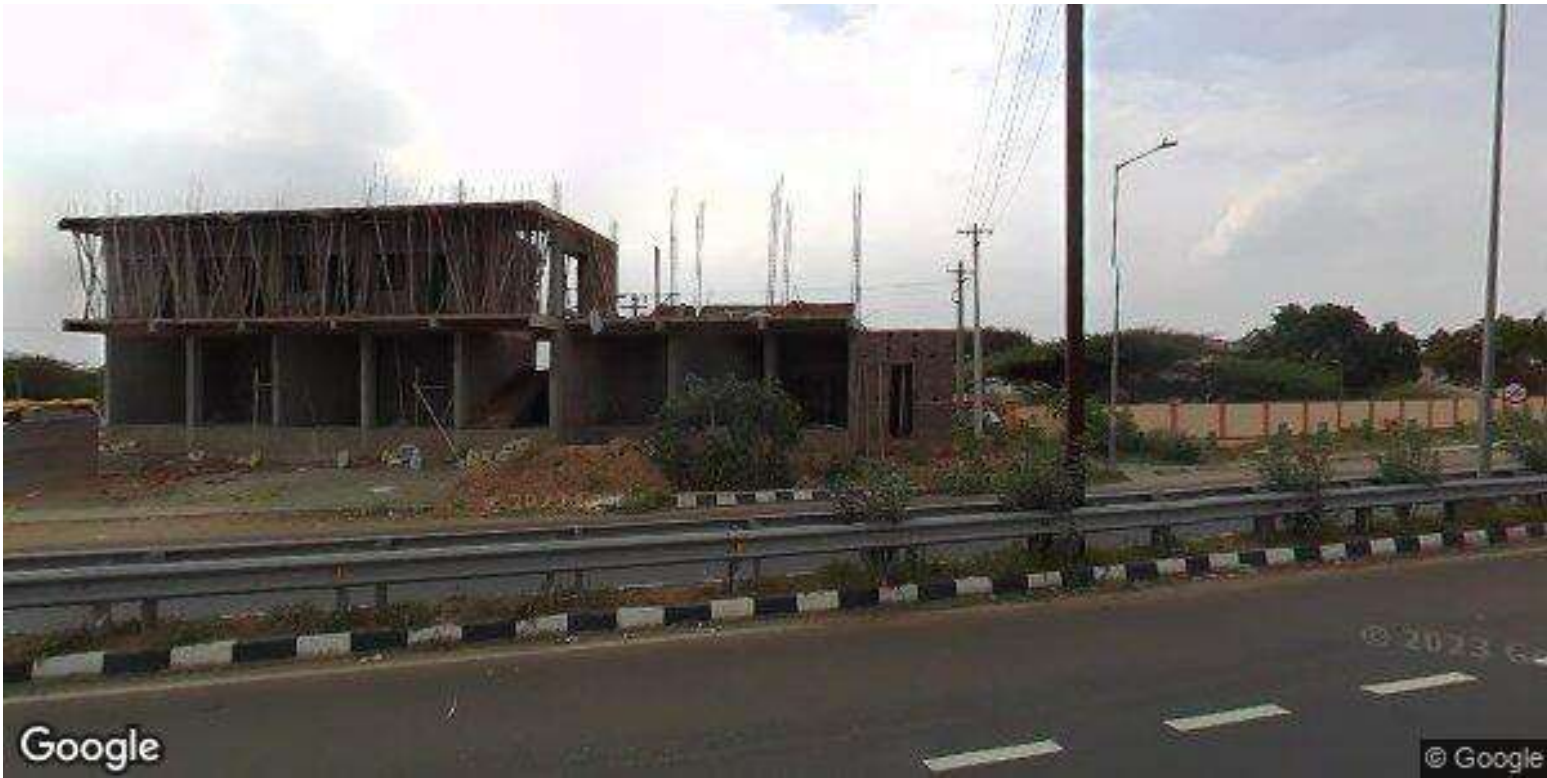
**Risk Type:** Turn  
**Risk Level:** Medium  
**Speed Limit:** 30 KM/Hr  
**Coordinates:** 10.75864, 77.51918

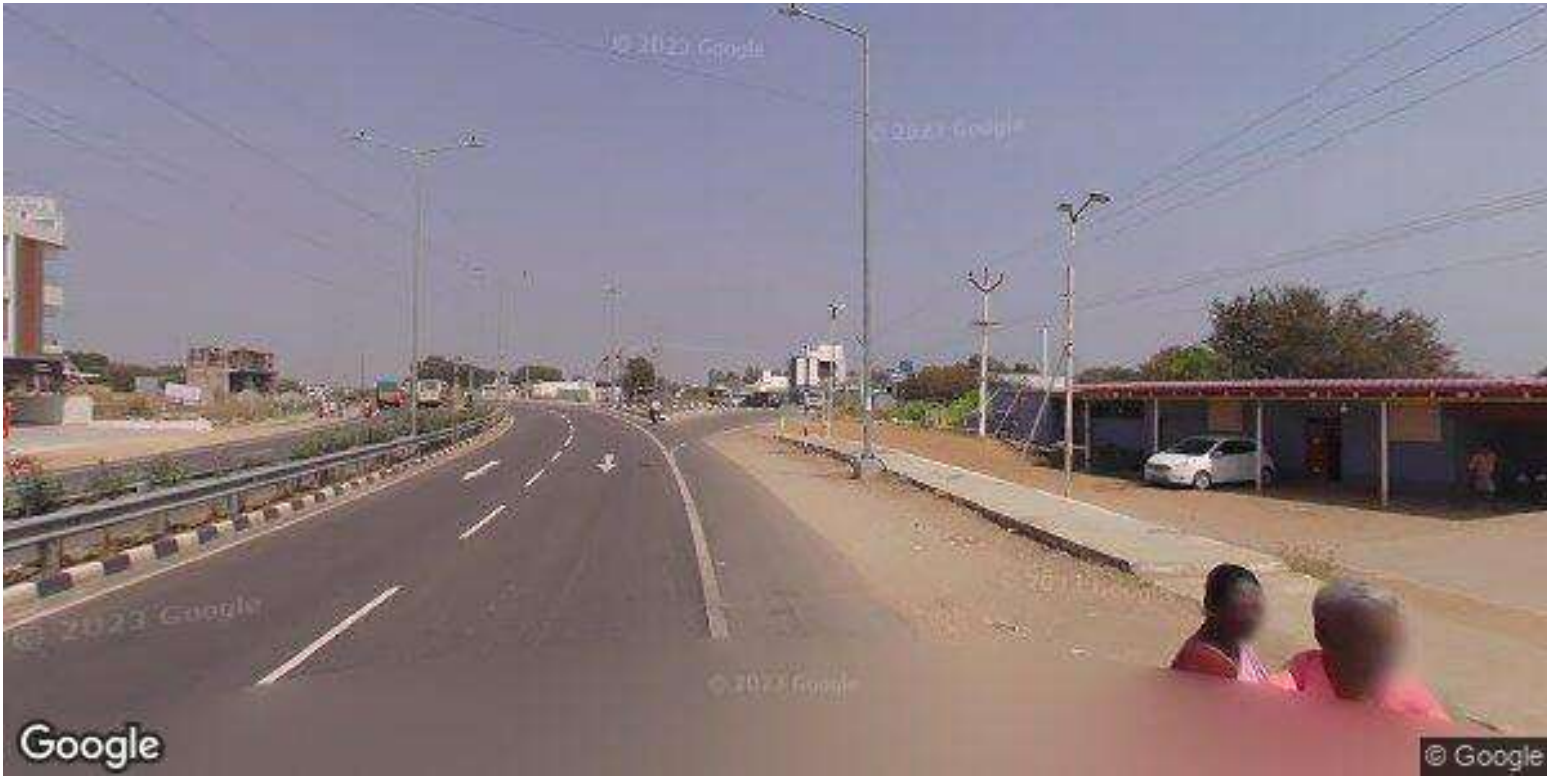
**Risk Type:** Turn  
**Risk Level:** Medium  
**Speed Limit:** 30 KM/Hr  
**Coordinates:** 10.75722, 77.51935

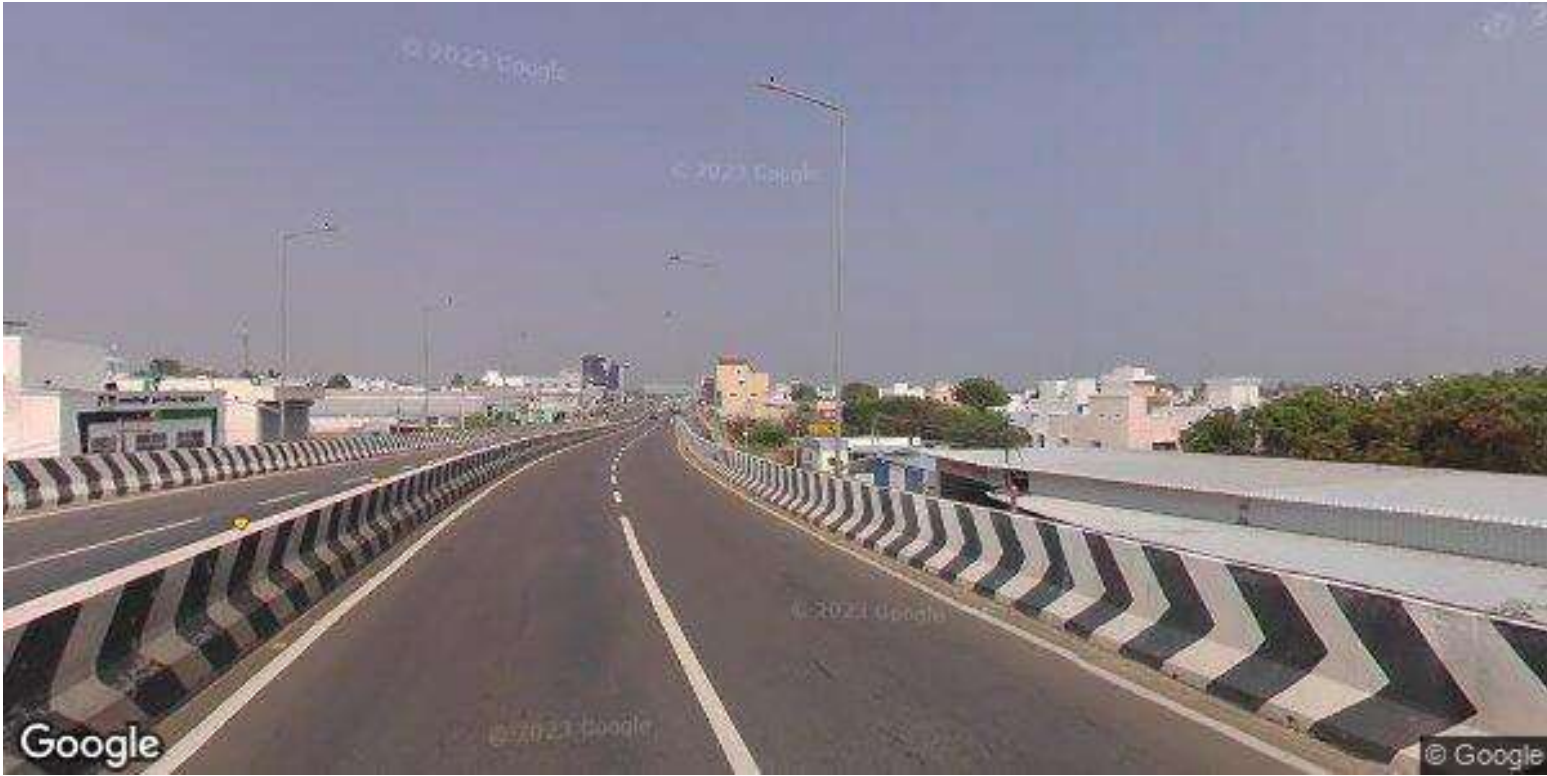
**Risk Type:** Turn  
**Risk Level:** Medium  
**Speed Limit:** 30 KM/Hr  
**Coordinates:** 10.73670, 77.51731

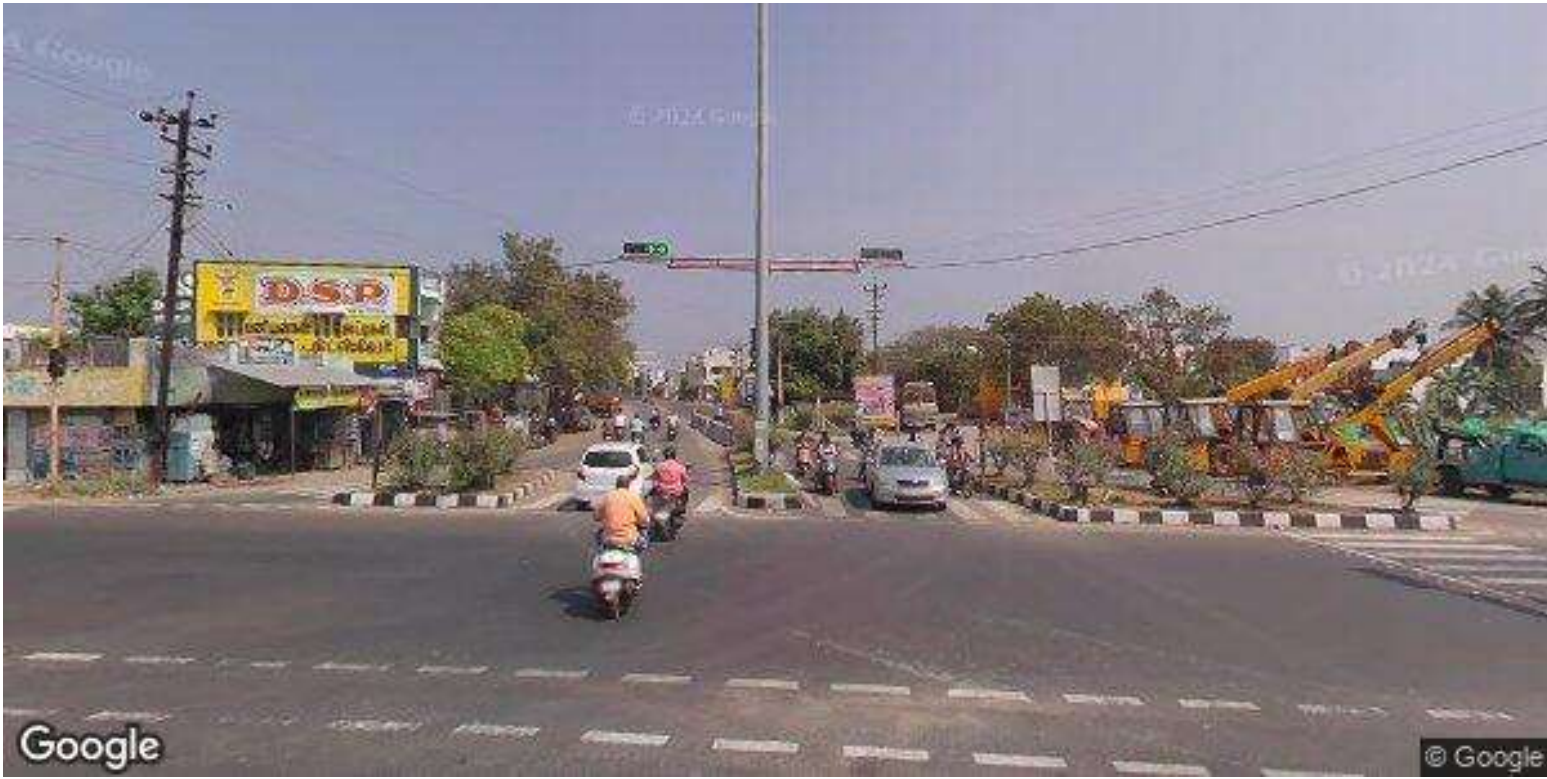
**Risk Type:** Blind Spot

**Risk Level:** Blind Spot

**Speed Limit:** 10 KM/Hr

**Coordinates:** 10.72415, 77.52567
