# IndianOil

## JOURNEY RISK MANAGEMENT (JRM) STUDY

### Salem Terminal TO G A S STAATION

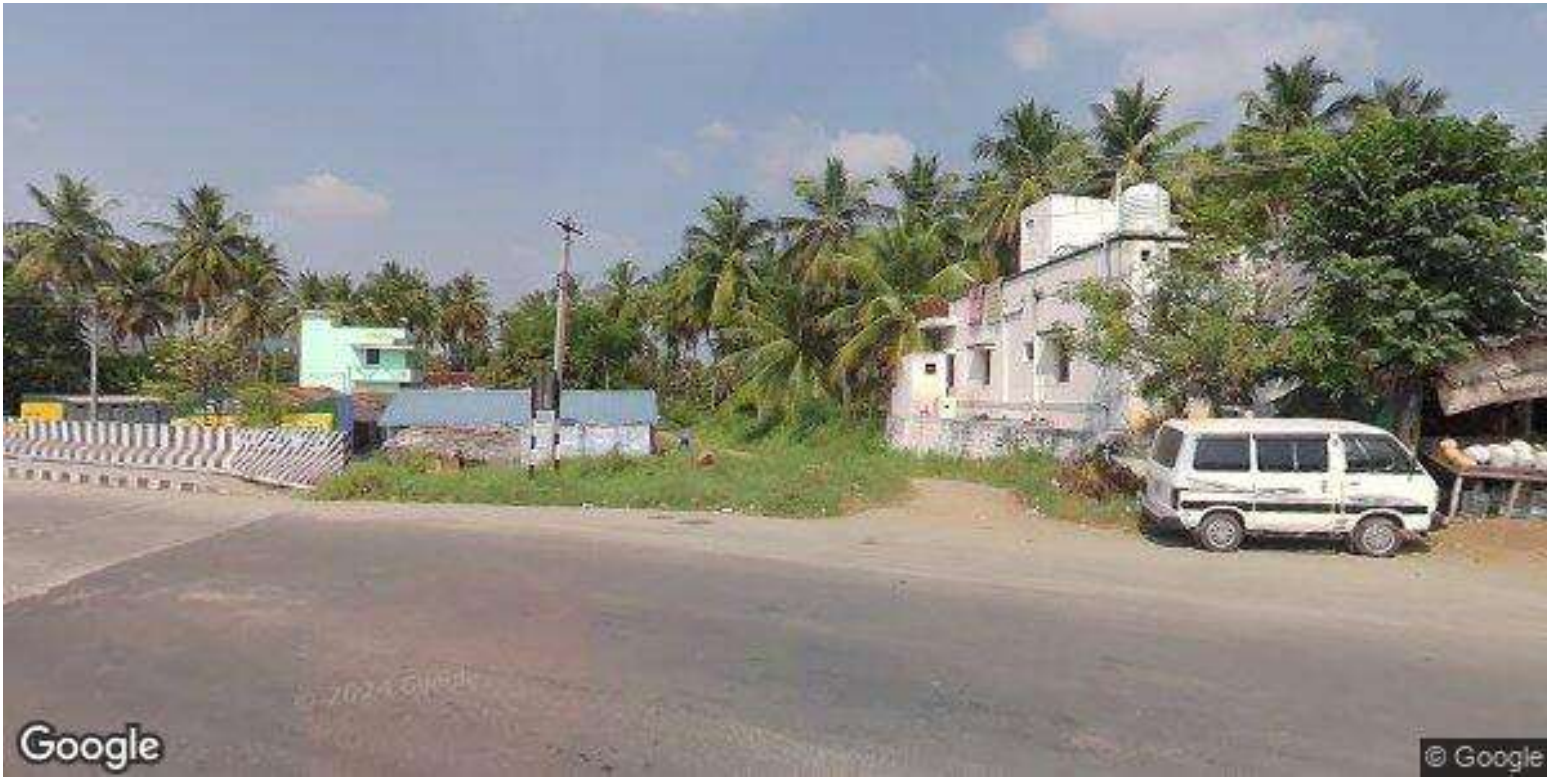
**Risk Type:** Turn  
**Risk Level:** High  
**Speed Limit:** 15 KM/Hr  
**Coordinates:** 11.44898, 77.87410

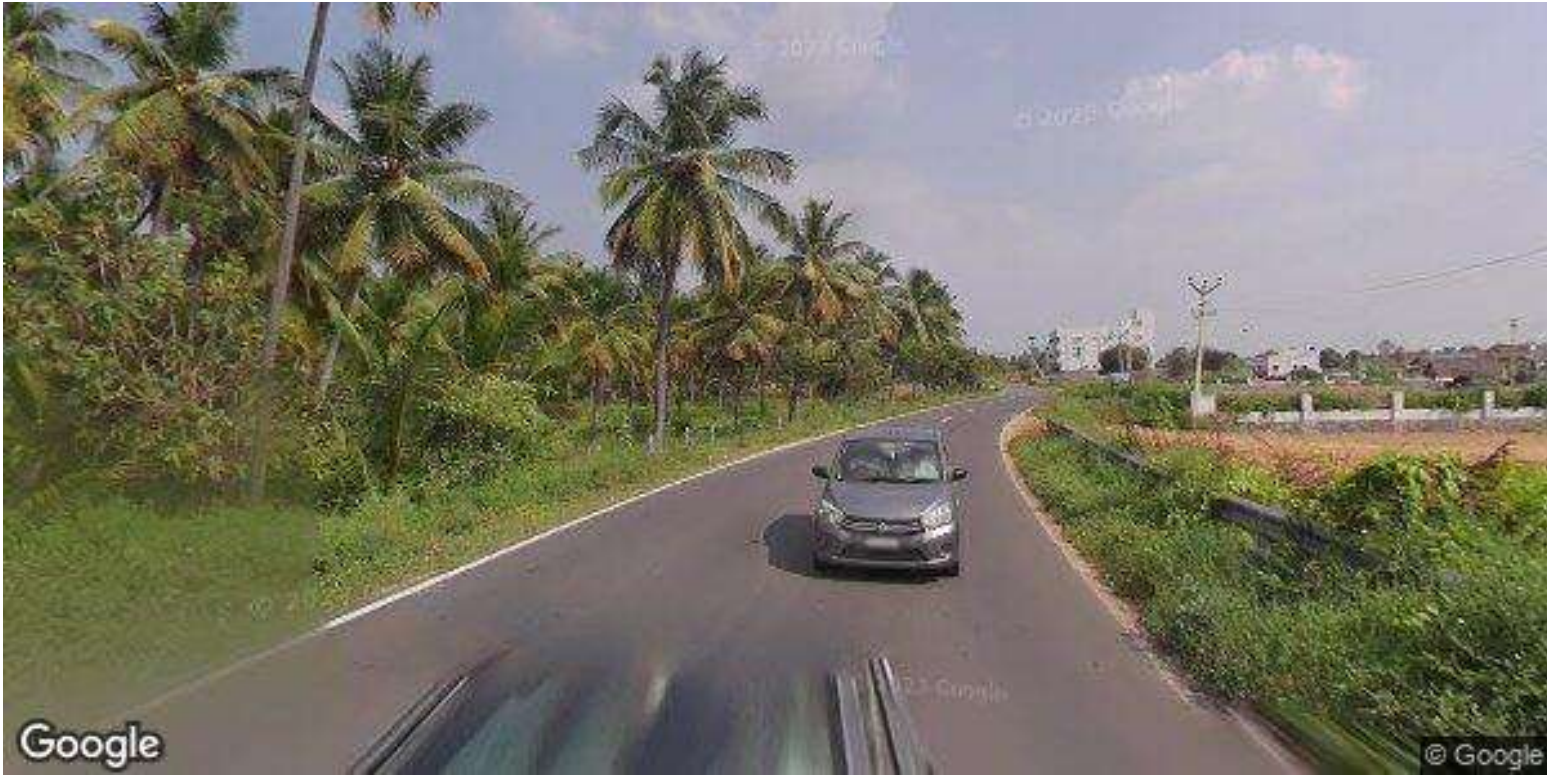
**Risk Type:** Turn  
**Risk Level:** Medium  
**Speed Limit:** 30 KM/Hr  
**Coordinates:** 11.45357, 77.85789

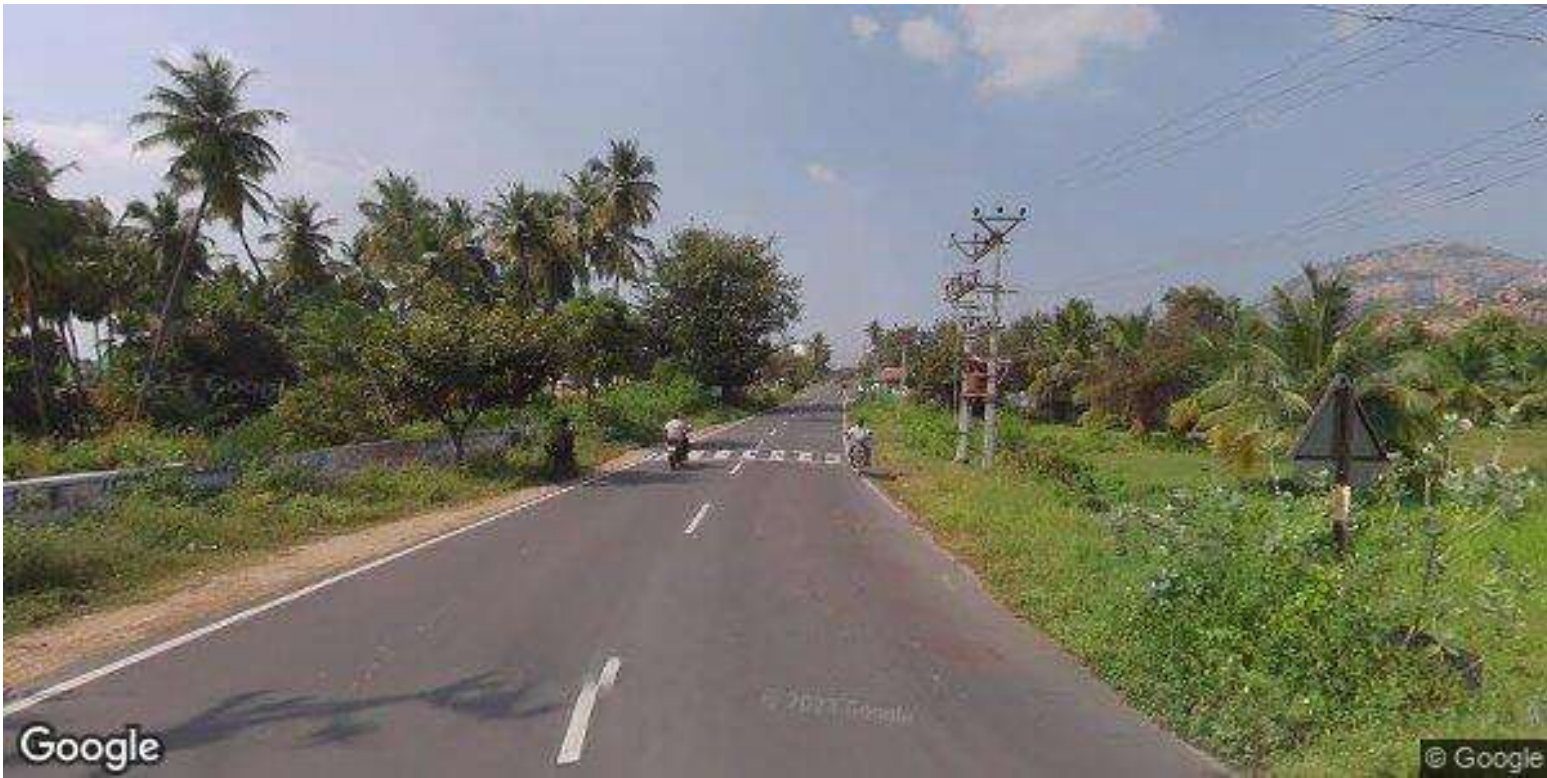
**Risk Type:** Turn  
**Risk Level:** High  
**Speed Limit:** 15 KM/Hr  
**Coordinates:** 11.45352, 77.85698

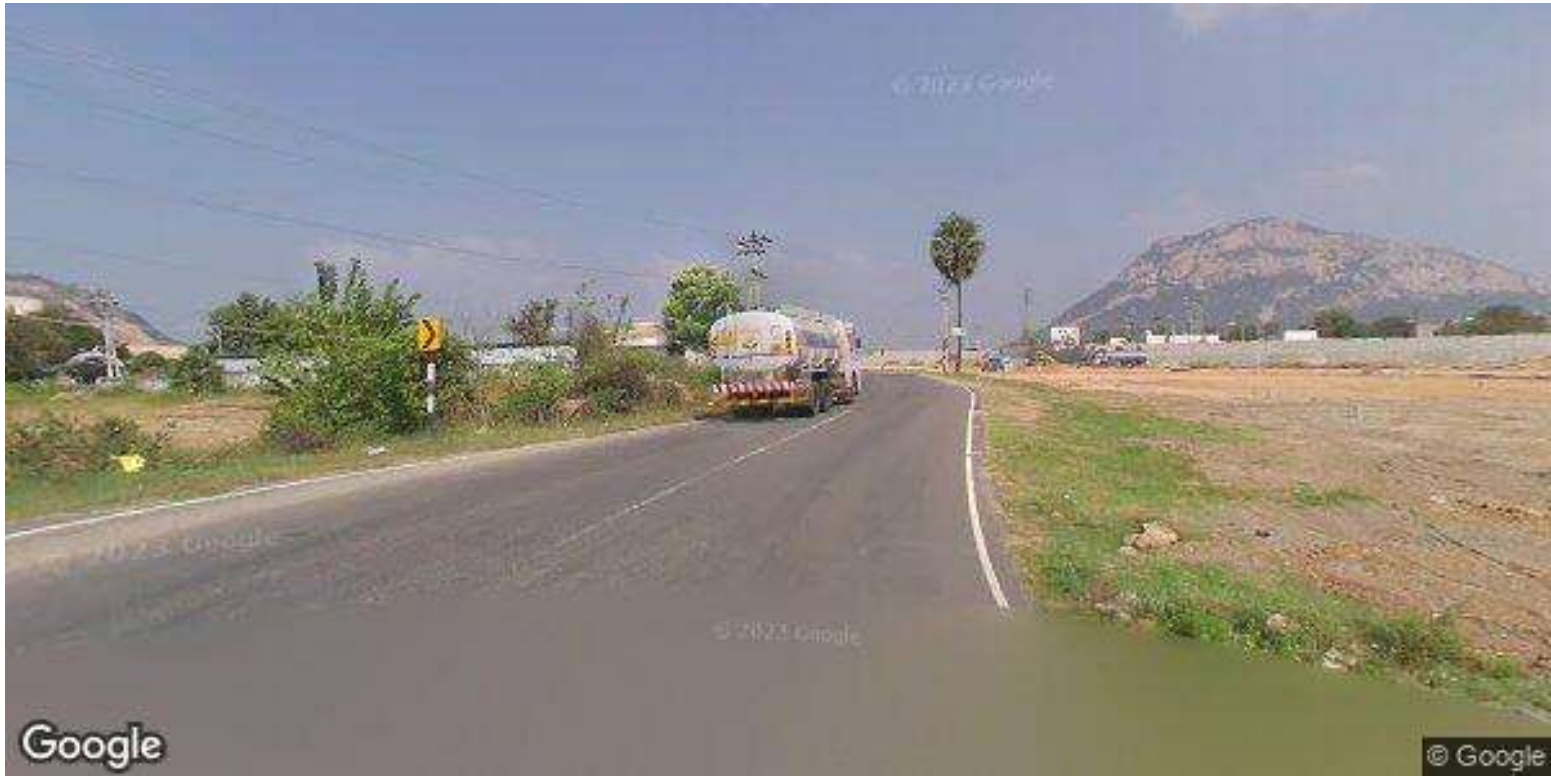
**Risk Type:** Turn  
**Risk Level:** Medium  
**Speed Limit:** 30 KM/Hr  
**Coordinates:** 11.45847, 77.85140

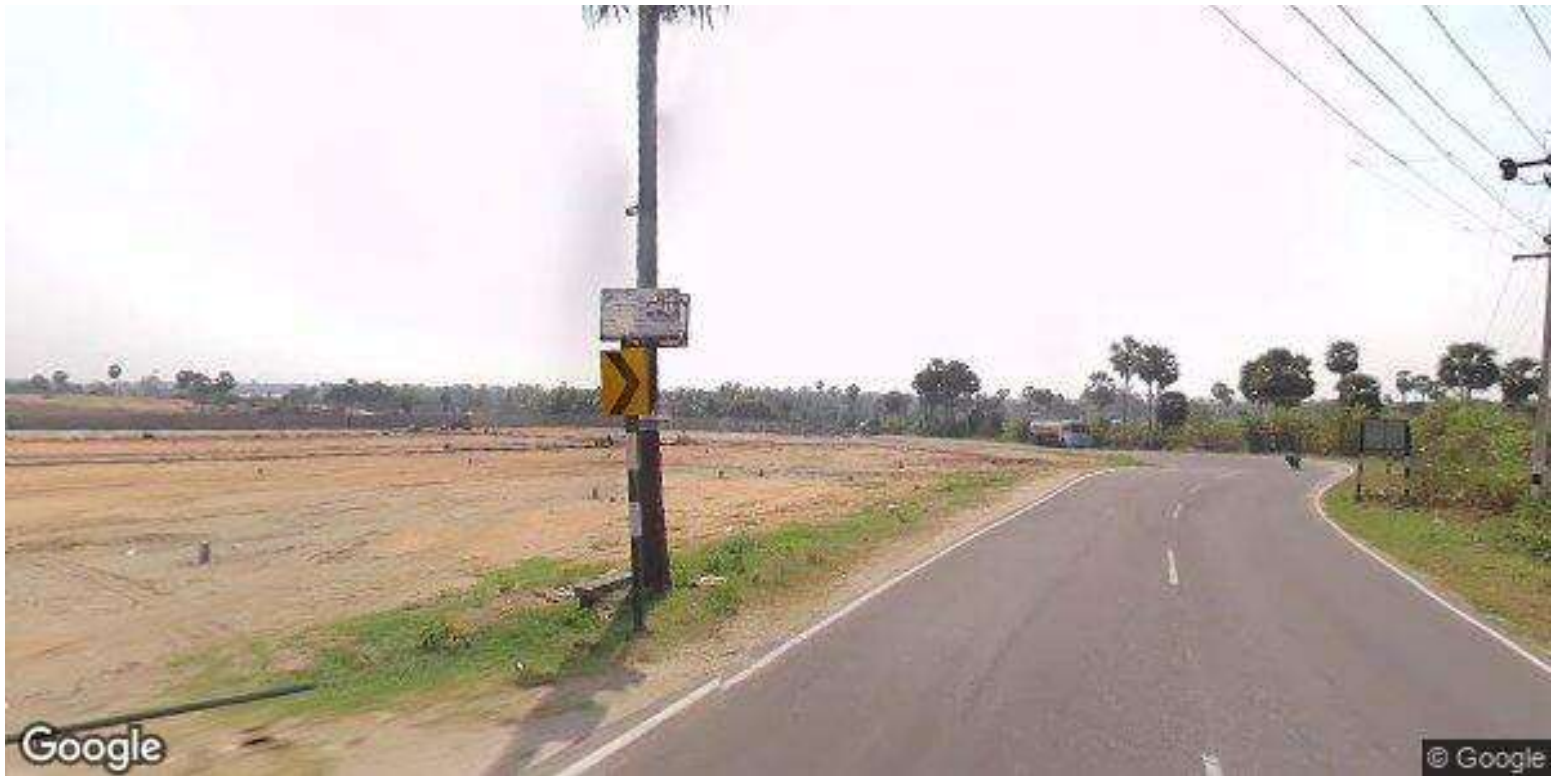
**Risk Type:** Turn  
**Risk Level:** Medium  
**Speed Limit:** 30 KM/Hr  
**Coordinates:** 11.45898, 77.85135

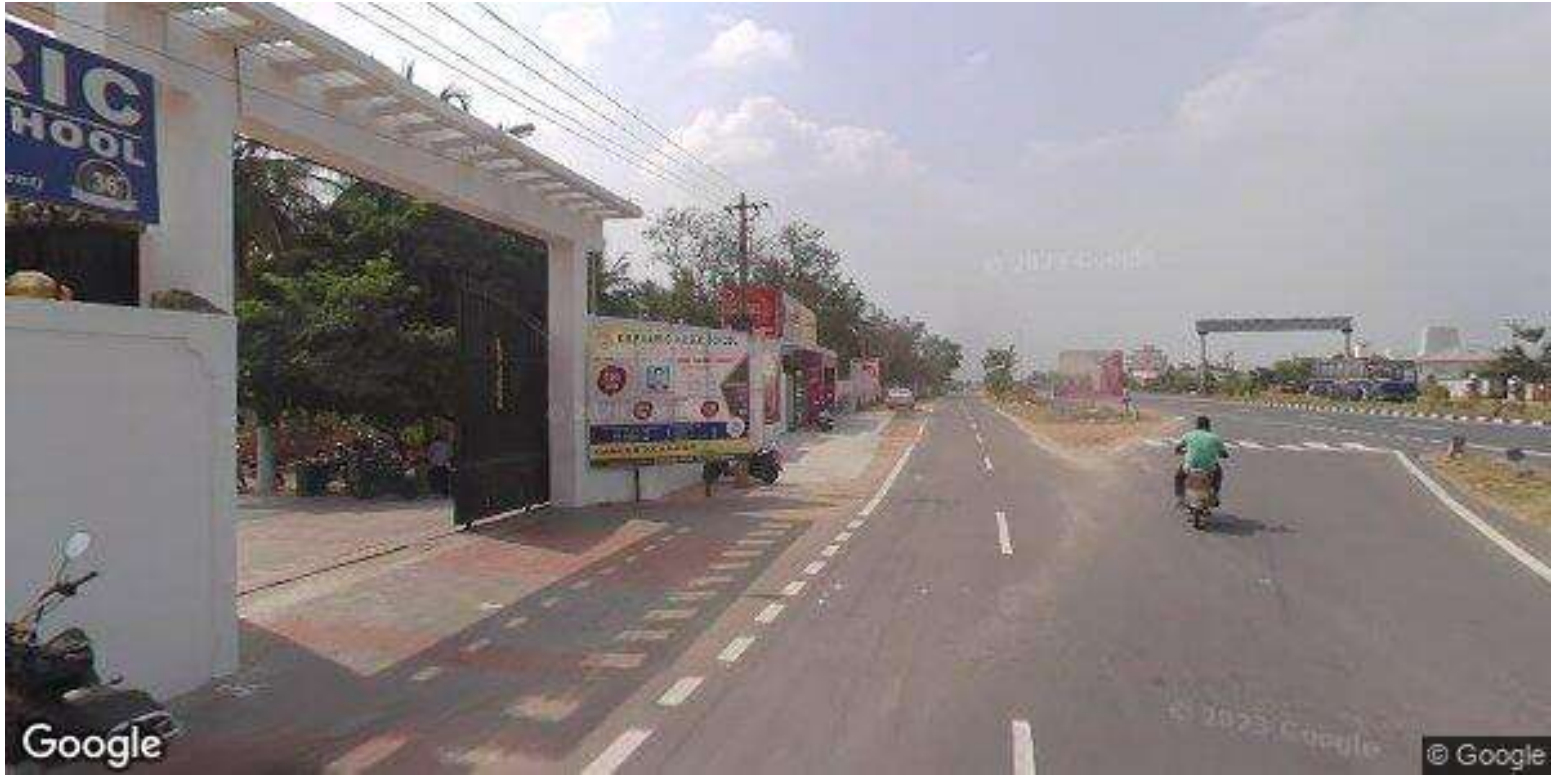
**Risk Type:** Turn  
**Risk Level:** Medium  
**Speed Limit:** 30 KM/Hr  
**Coordinates:** 11.45509, 77.81383

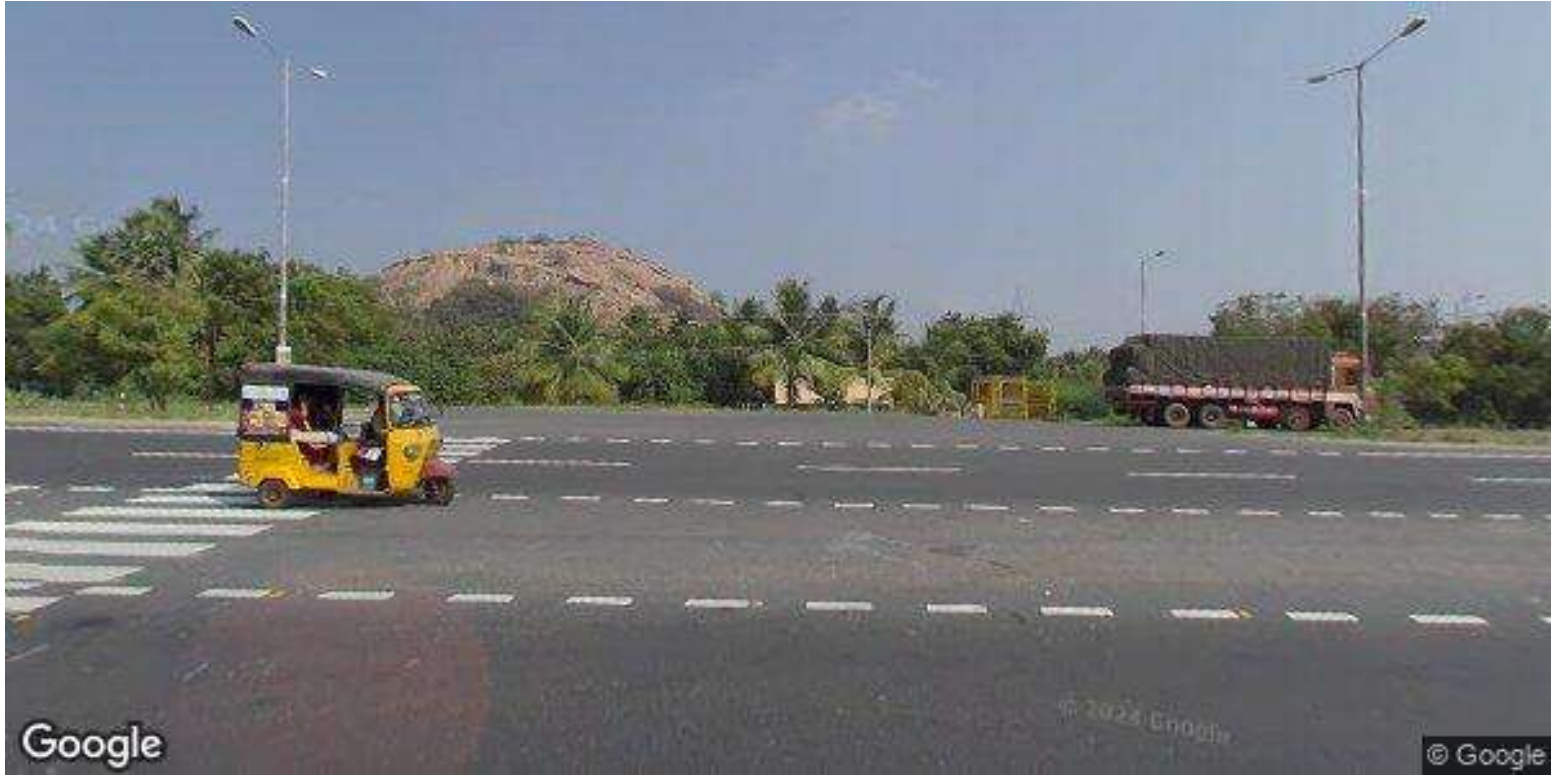
**Risk Type:** Turn  
**Risk Level:** Medium  
**Speed Limit:** 30 KM/Hr  
**Coordinates:** 11.45085, 77.77020

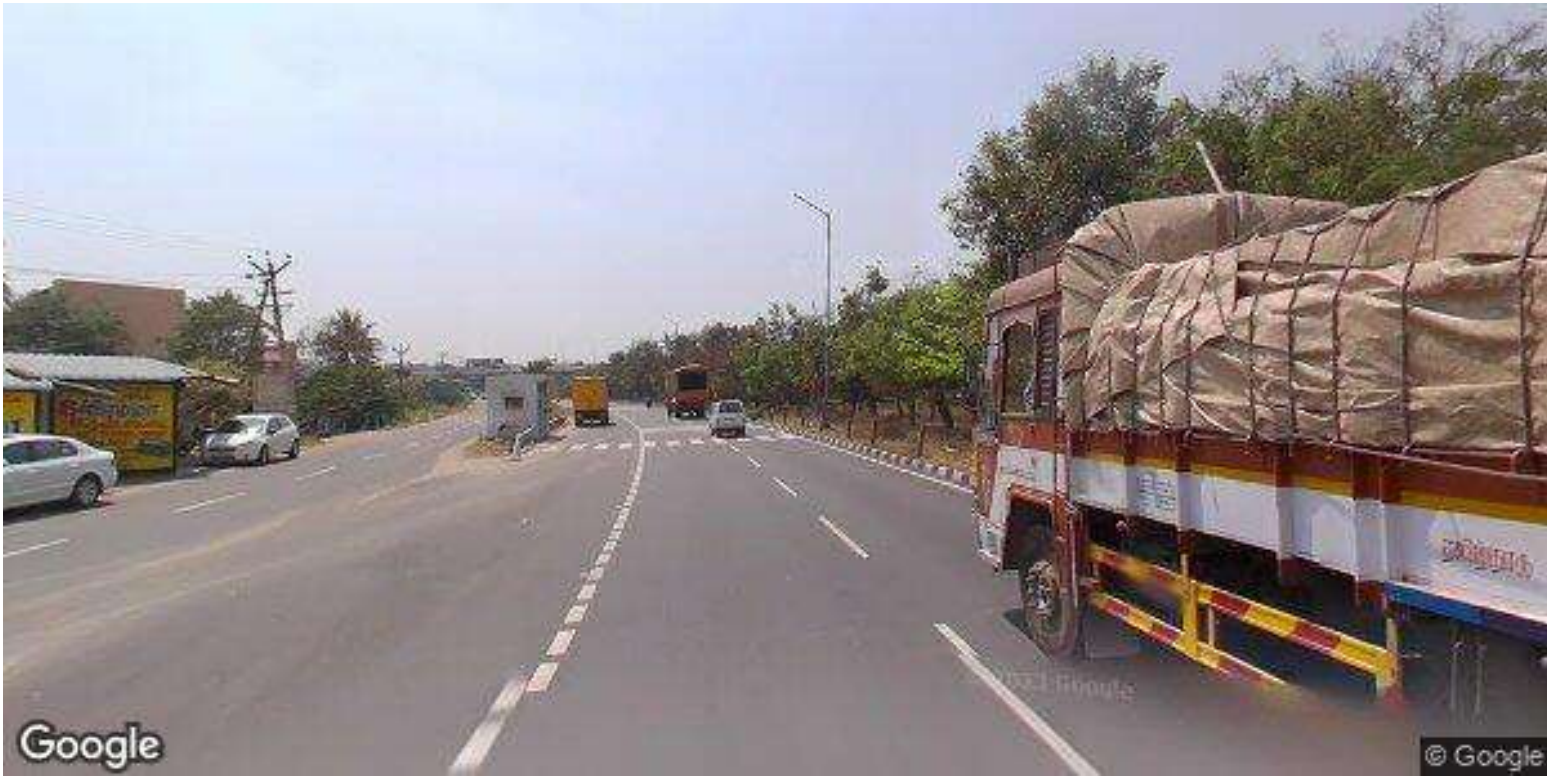
**Risk Type:** Turn  
**Risk Level:** Medium  
**Speed Limit:** 30 KM/Hr  
**Coordinates:** 11.43165, 77.67734

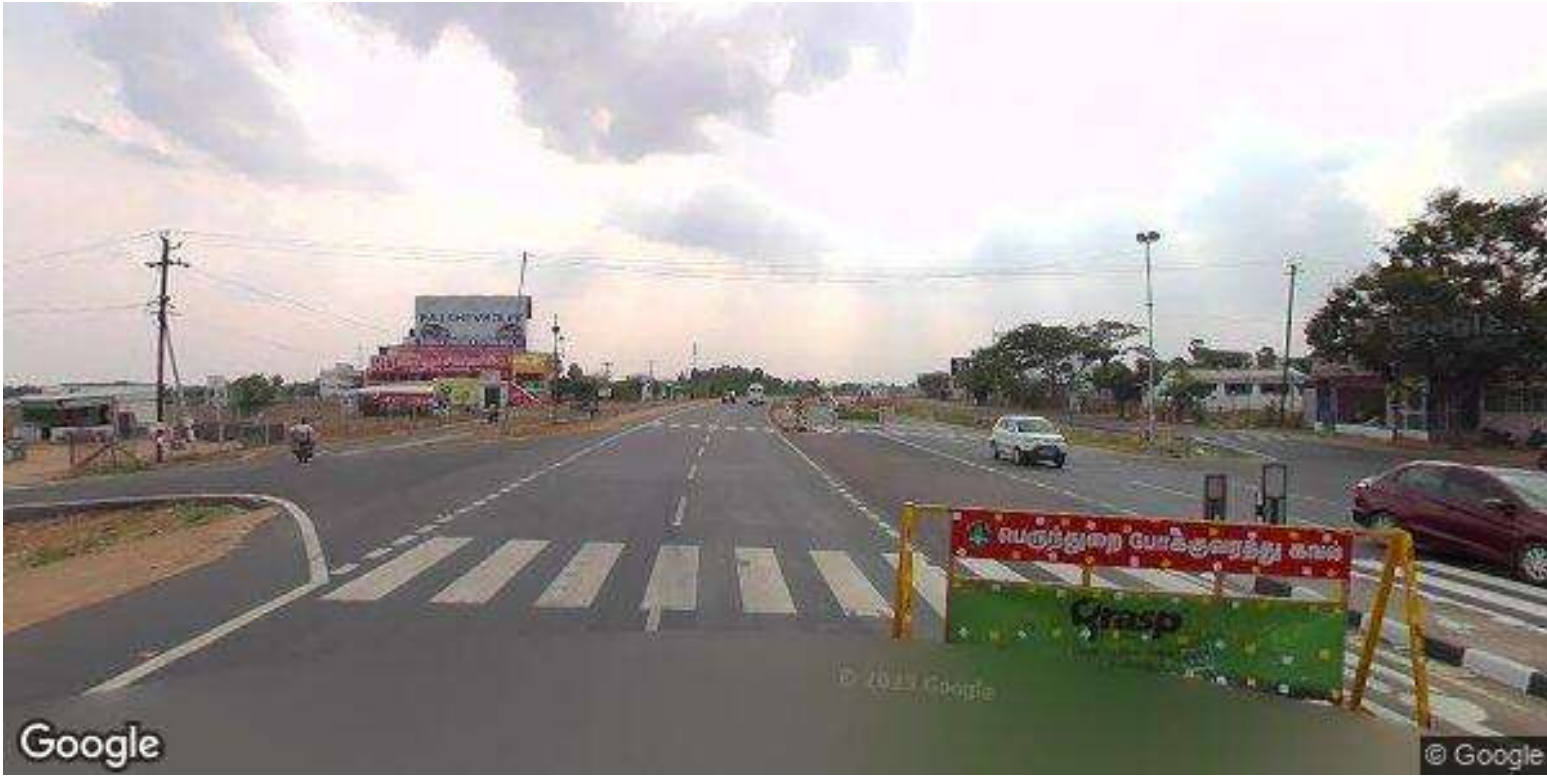
**Risk Type:** Turn  
**Risk Level:** Medium  
**Speed Limit:** 30 KM/Hr  
**Coordinates:** 11.23724, 77.50686

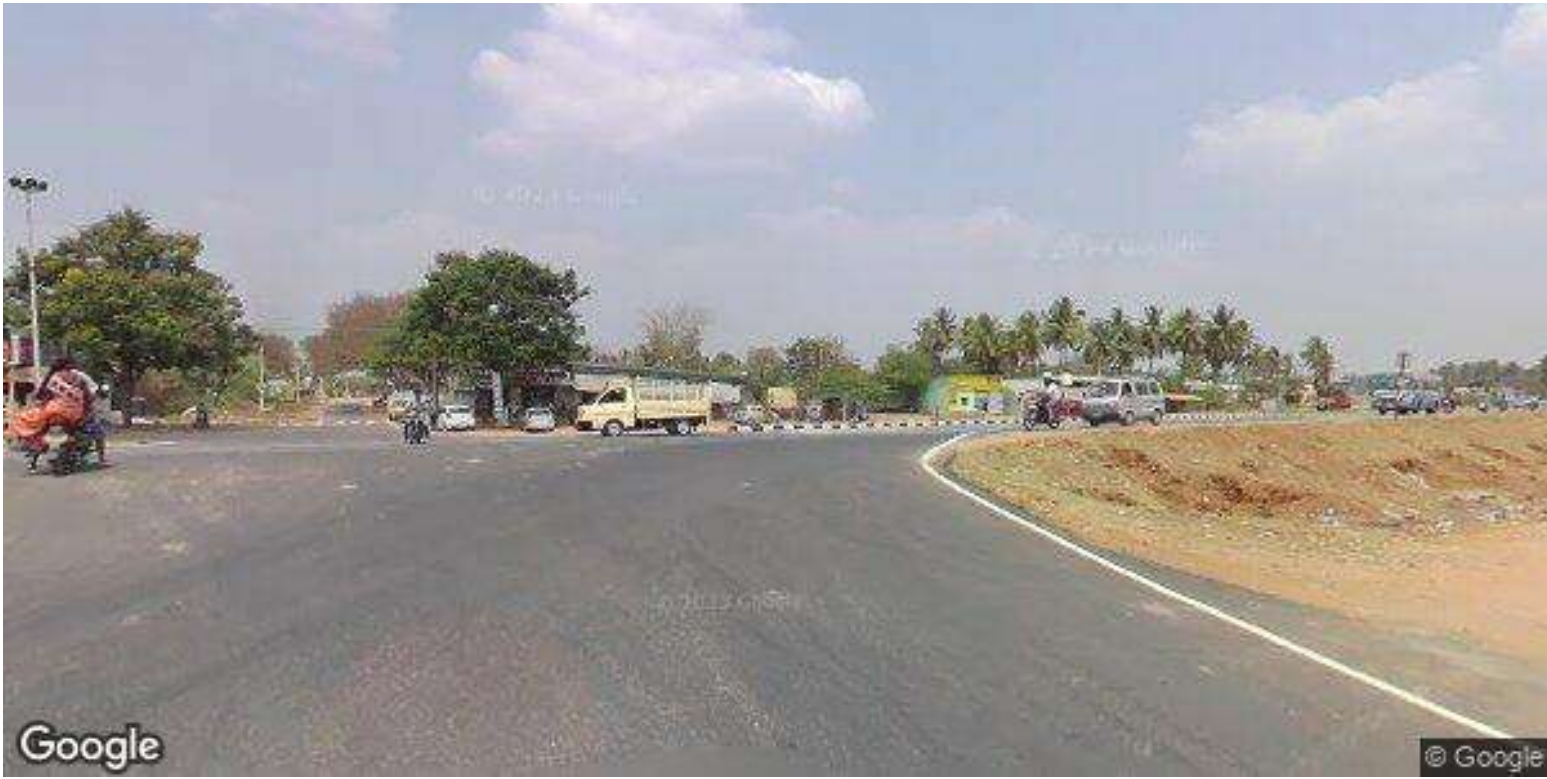
**Risk Type:** Turn  
**Risk Level:** High  
**Speed Limit:** 15 KM/Hr  
**Coordinates:** 11.23704, 77.50676

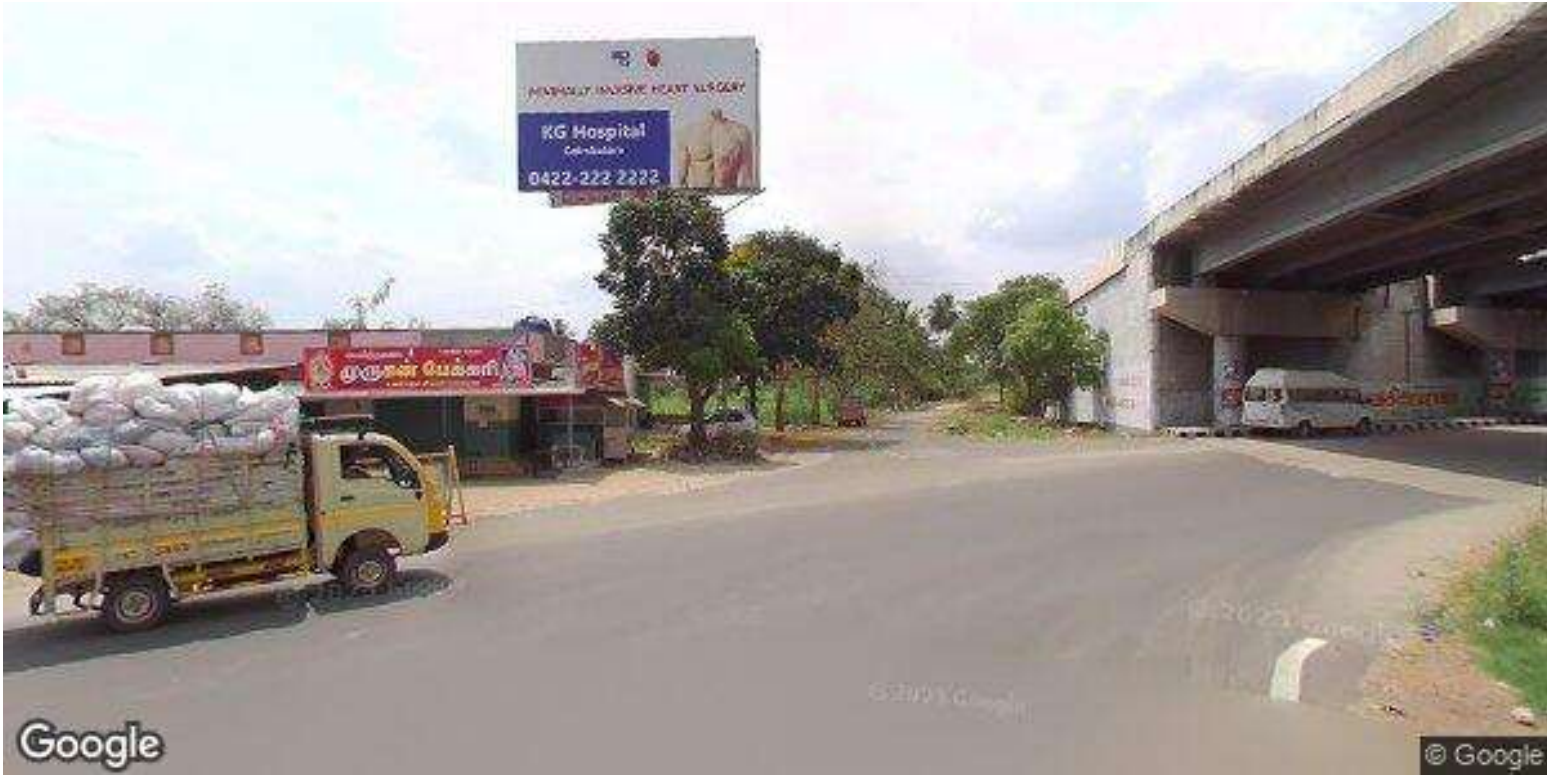
**Risk Type:** Blind Spot  
**Risk Level:** Blind Spot  
**Speed Limit:** 10 KM/Hr  
**Coordinates:** 11.23686, 77.50216

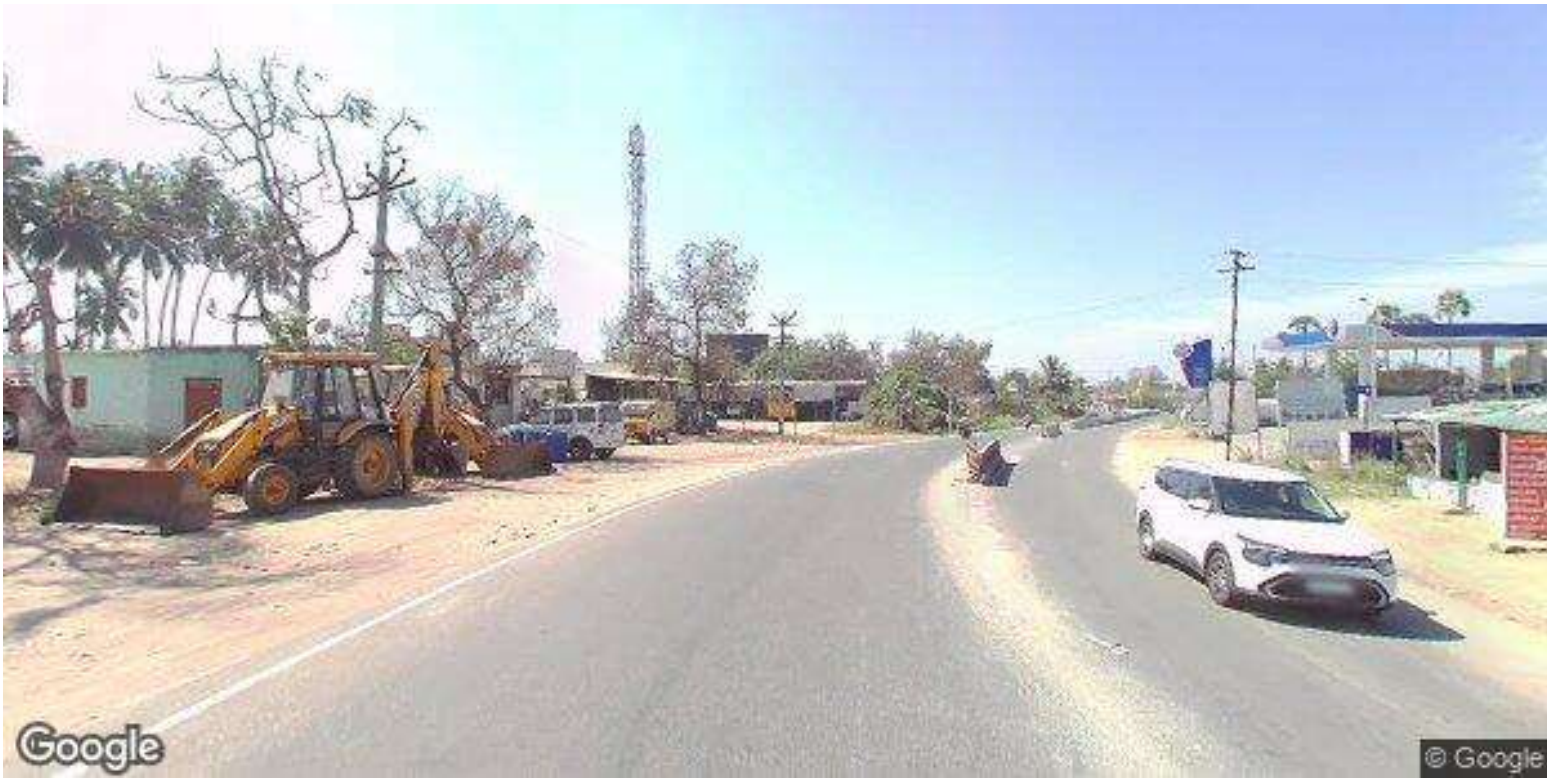
**Risk Type:** Turn  
**Risk Level:** Medium  
**Speed Limit:** 30 KM/Hr  
**Coordinates:** 11.23649, 77.50219

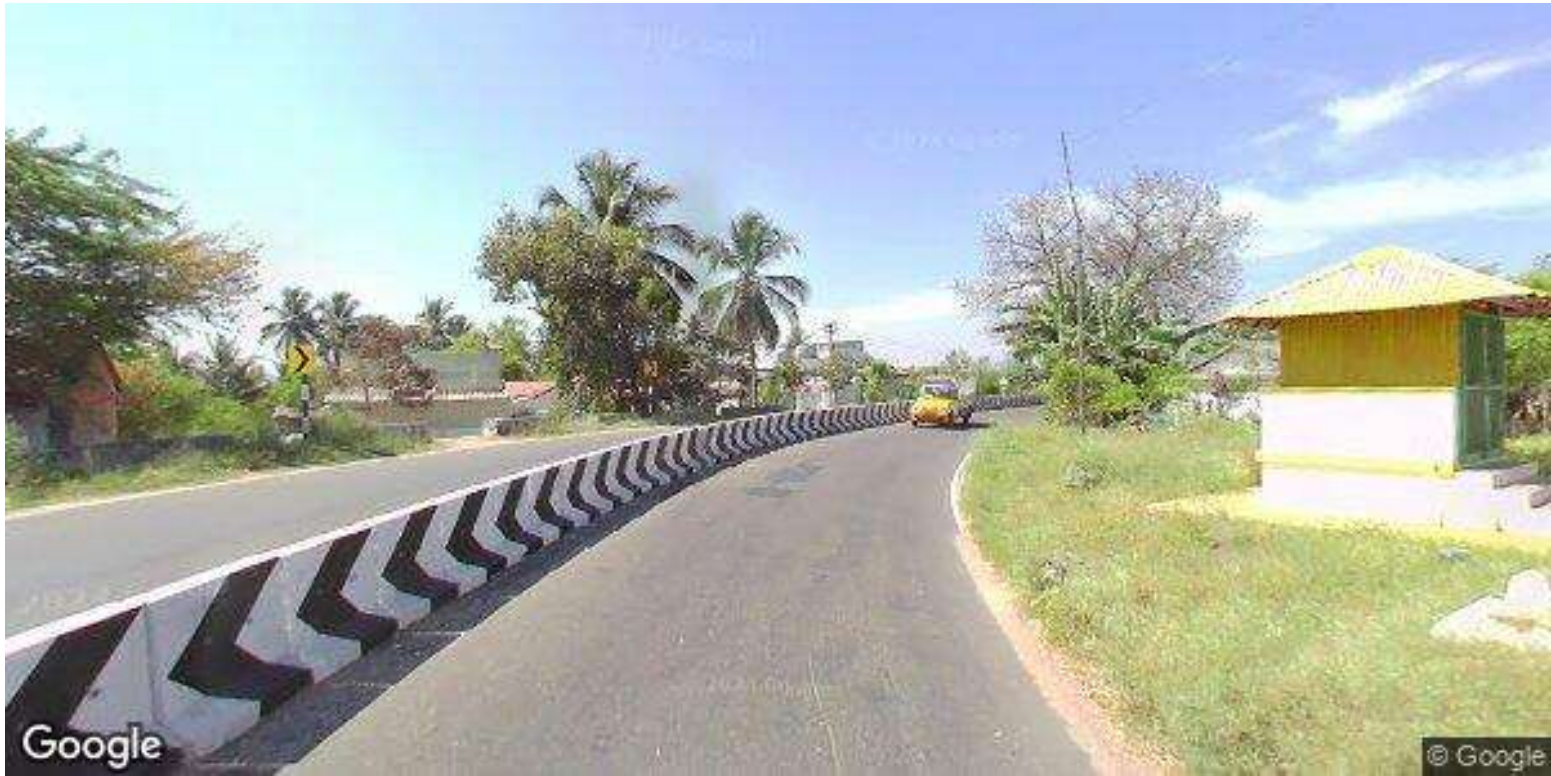
**Risk Type:** Turn  
**Risk Level:** High  
**Speed Limit:** 15 KM/Hr  
**Coordinates:** 11.23396, 77.50105

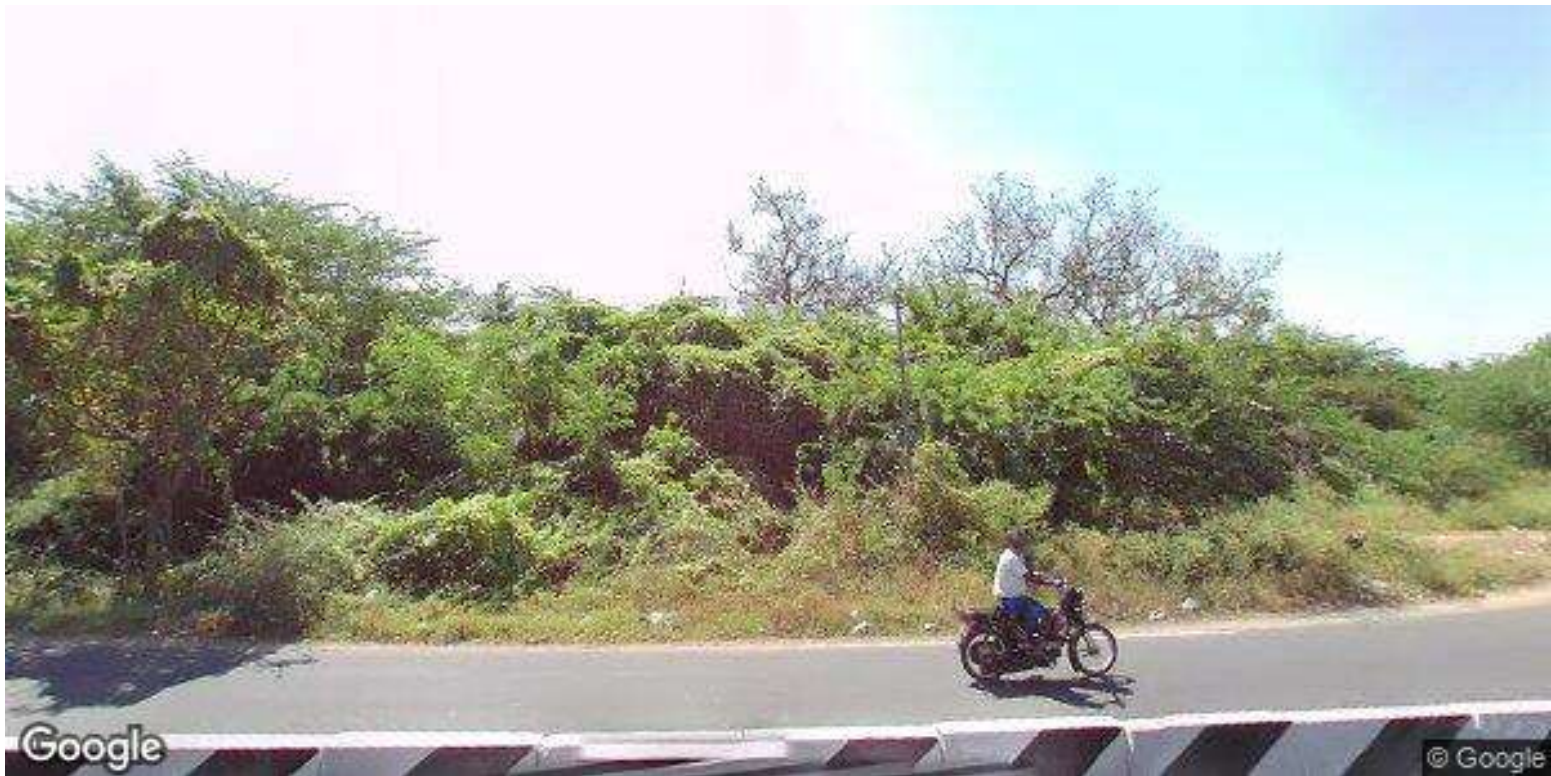
**Risk Type:** Turn  
**Risk Level:** Medium  
**Speed Limit:** 30 KM/Hr  
**Coordinates:** 11.23329, 77.49966

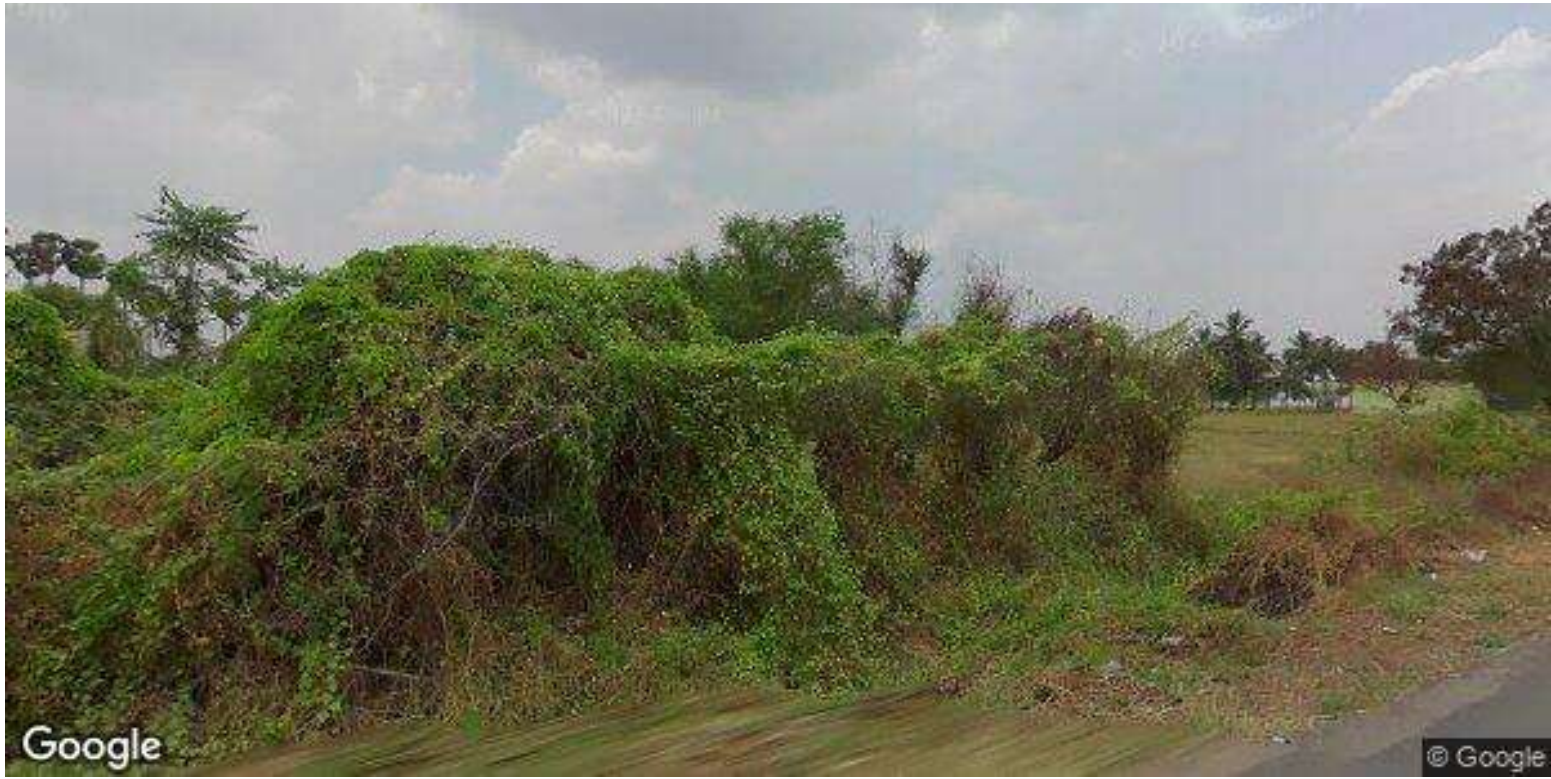
**Risk Type:** Turn  
**Risk Level:** Medium  
**Speed Limit:** 30 KM/Hr  
**Coordinates:** 11.17851, 77.46169

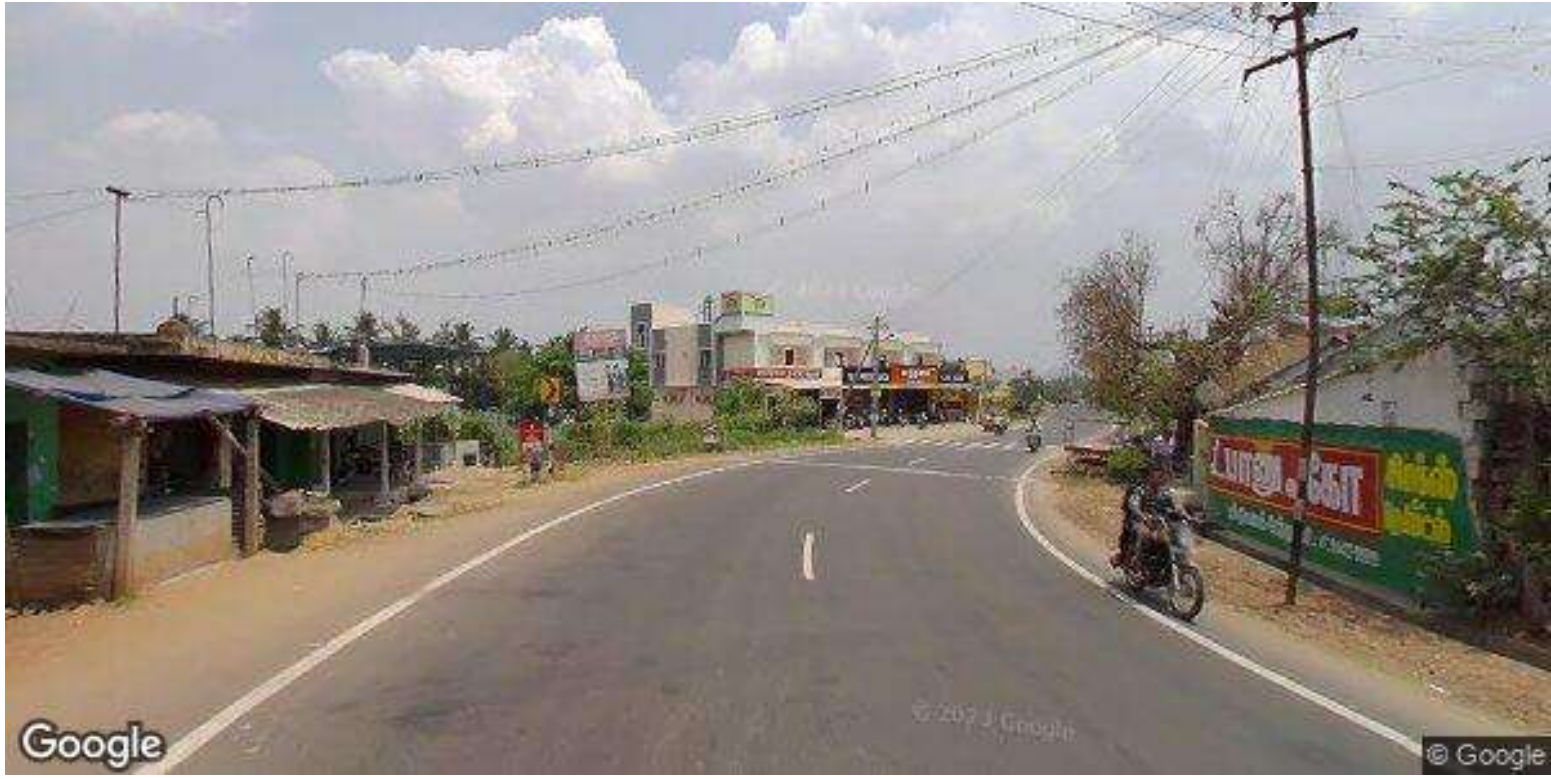
**Risk Type:** Turn  
**Risk Level:** Medium  
**Speed Limit:** 30 KM/Hr  
**Coordinates:** 11.17368, 77.45730

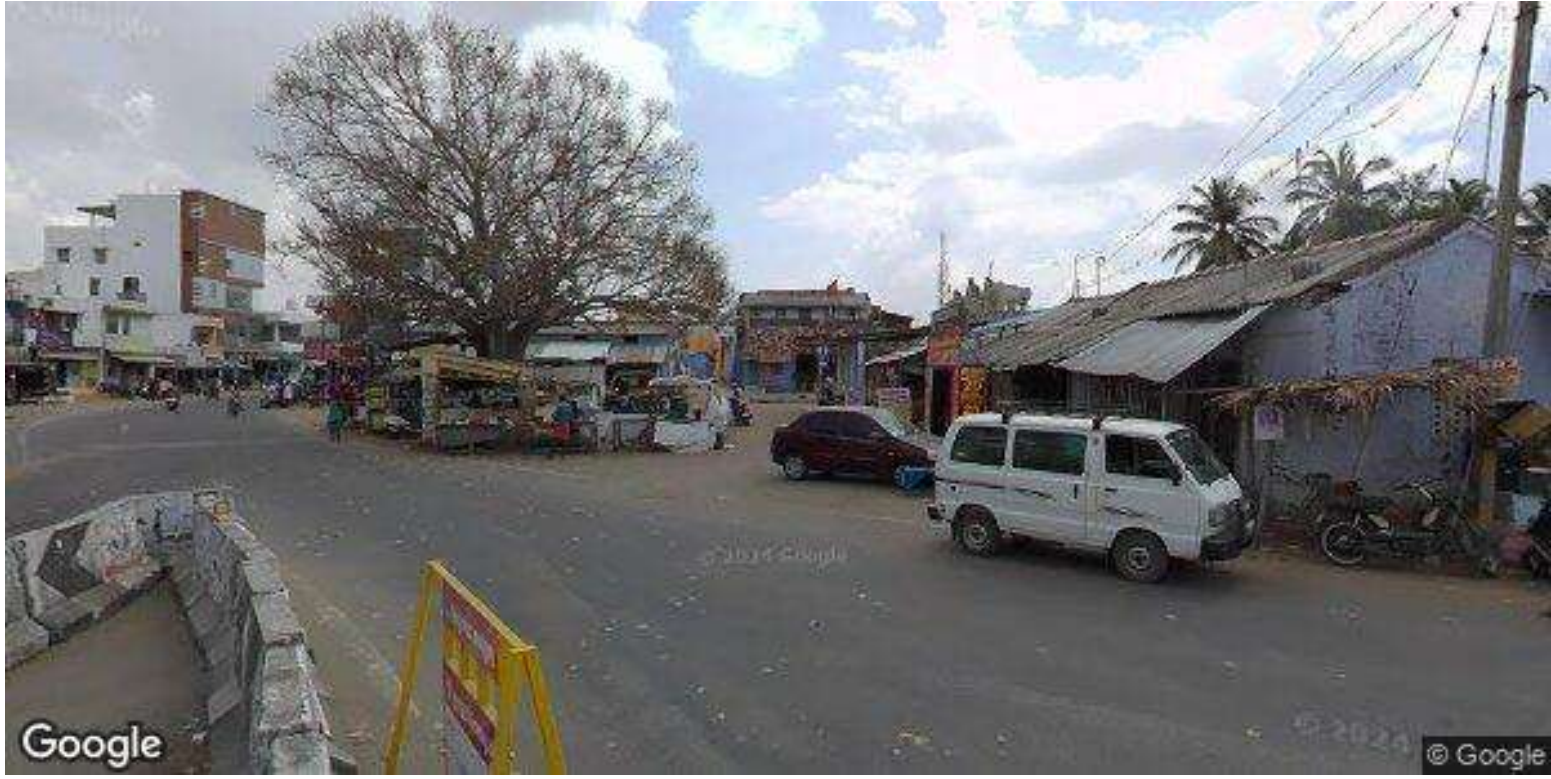
Coordinates: 11.17096, 77.45516

Risk Type: Turn

Risk Level: High

Speed Limit: 15 KM/Hr

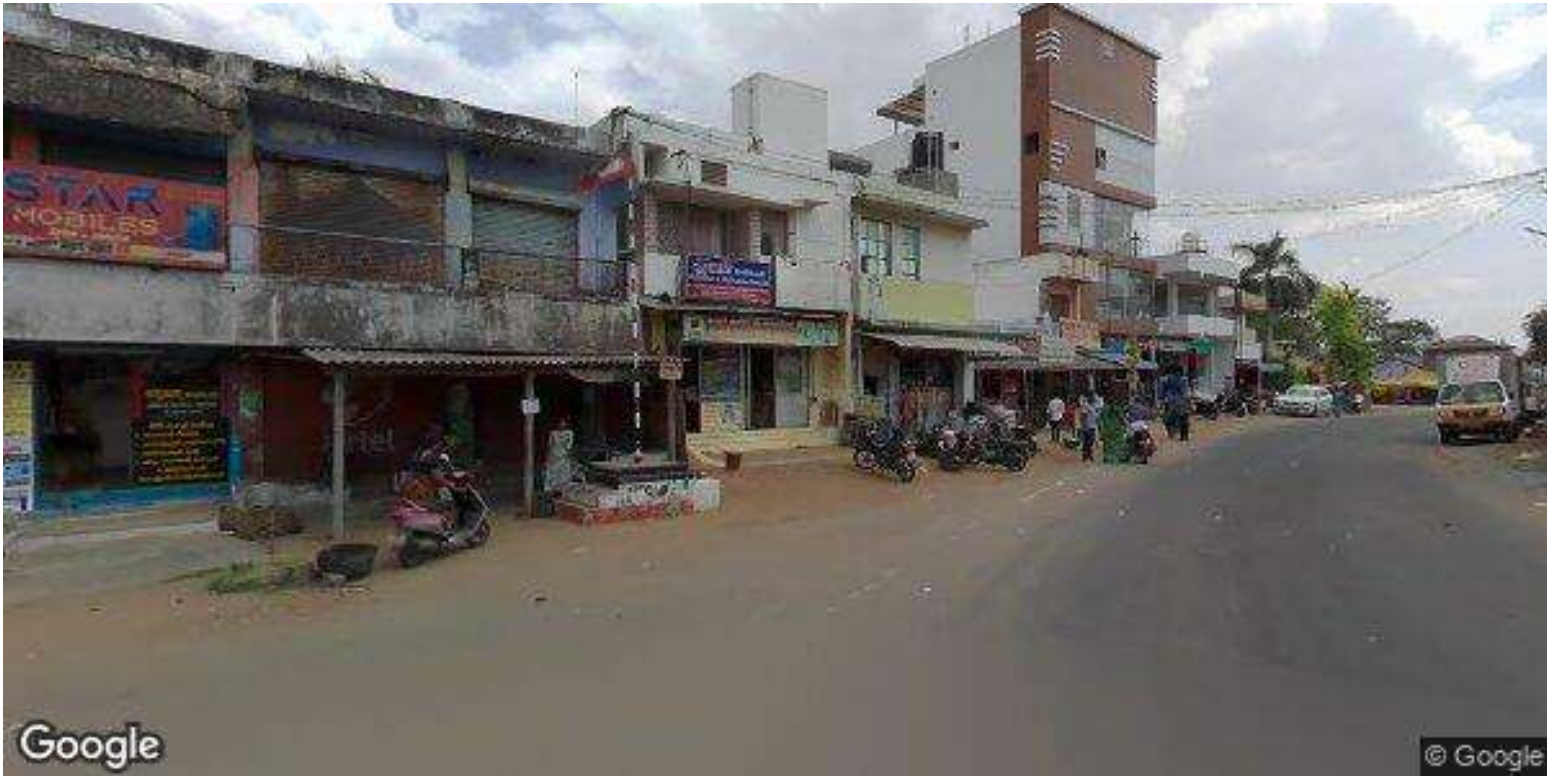
Coordinates: 11.17048, 77.45544

Risk Type: Turn

Risk Level: Medium

Speed Limit: 30 KM/Hr
