# IndianOil

## JOURNEY RISK MANAGEMENT (JRM) STUDY

### Salem Terminal TO G A S STAATION

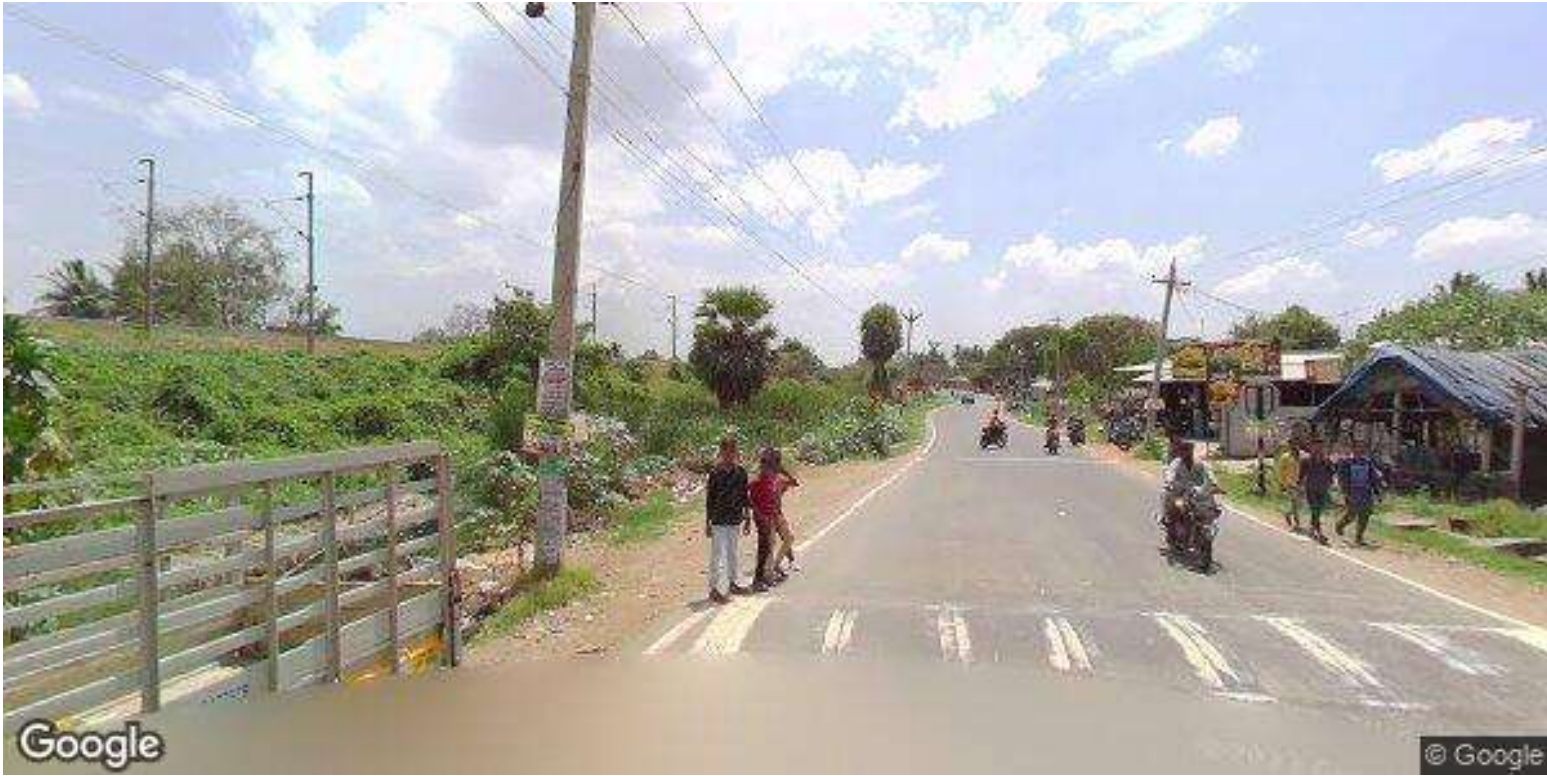
Coordinates: 11.16706, 77.45494

Risk Type: Turn

Risk Level: Medium

Speed Limit: 30 KM/Hr

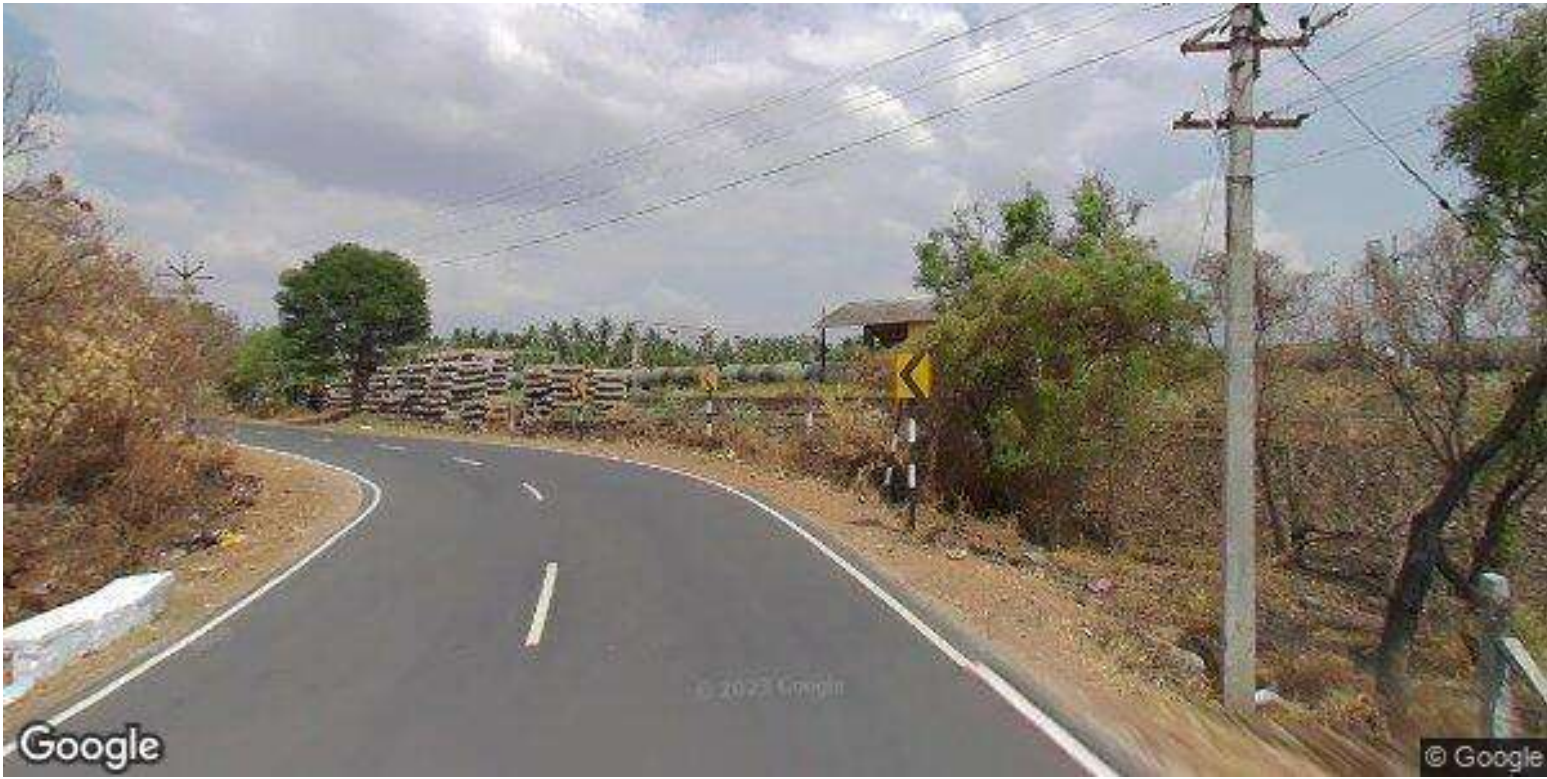
**Risk Type:** Turn  
**Risk Level:** High  
**Speed Limit:** 15 KM/Hr  
**Coordinates:** 11.15693, 77.44742

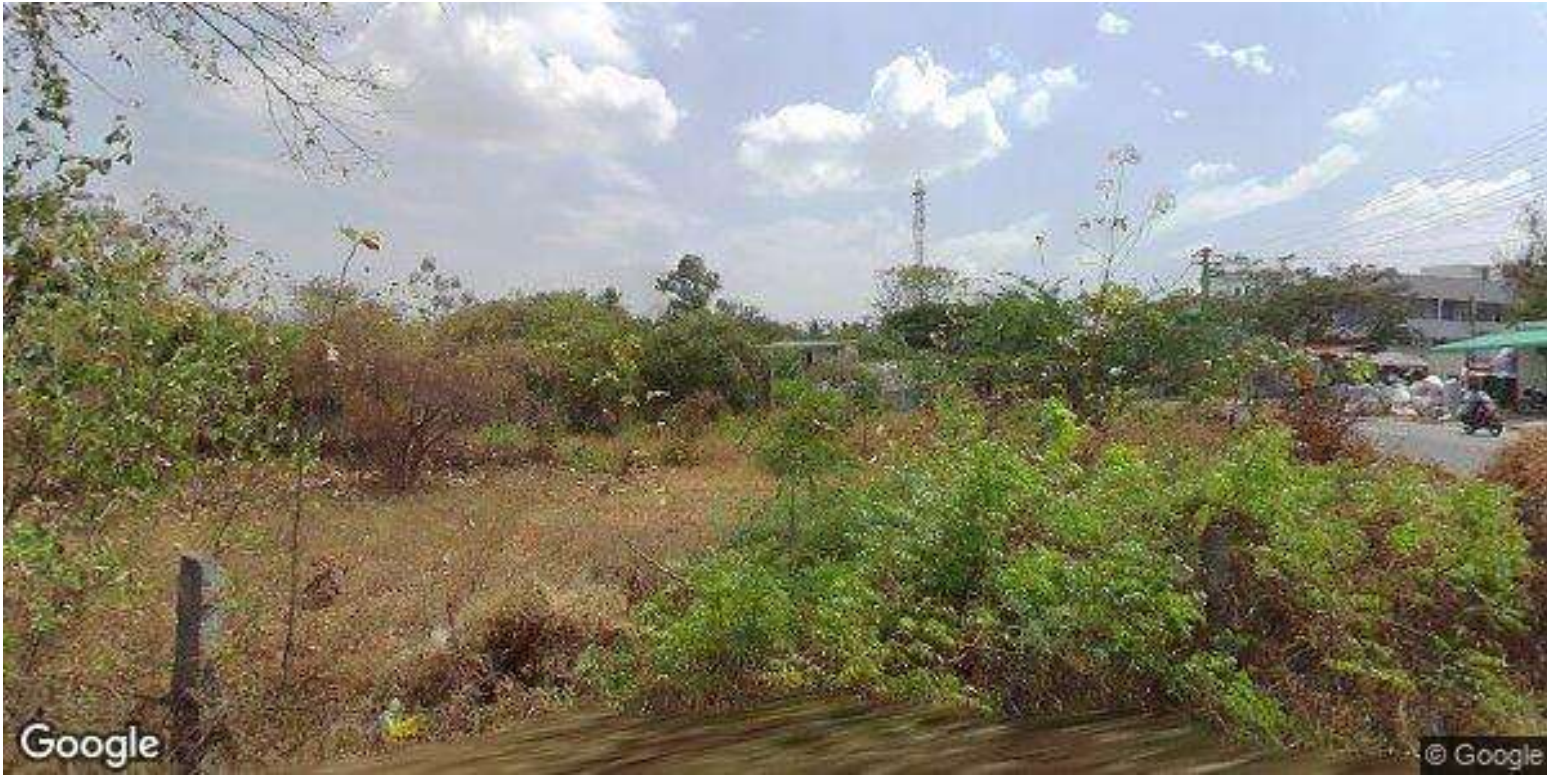
**Risk Type:** Turn  
**Risk Level:** High  
**Speed Limit:** 15 KM/Hr  
**Coordinates:** 11.15727, 77.44546

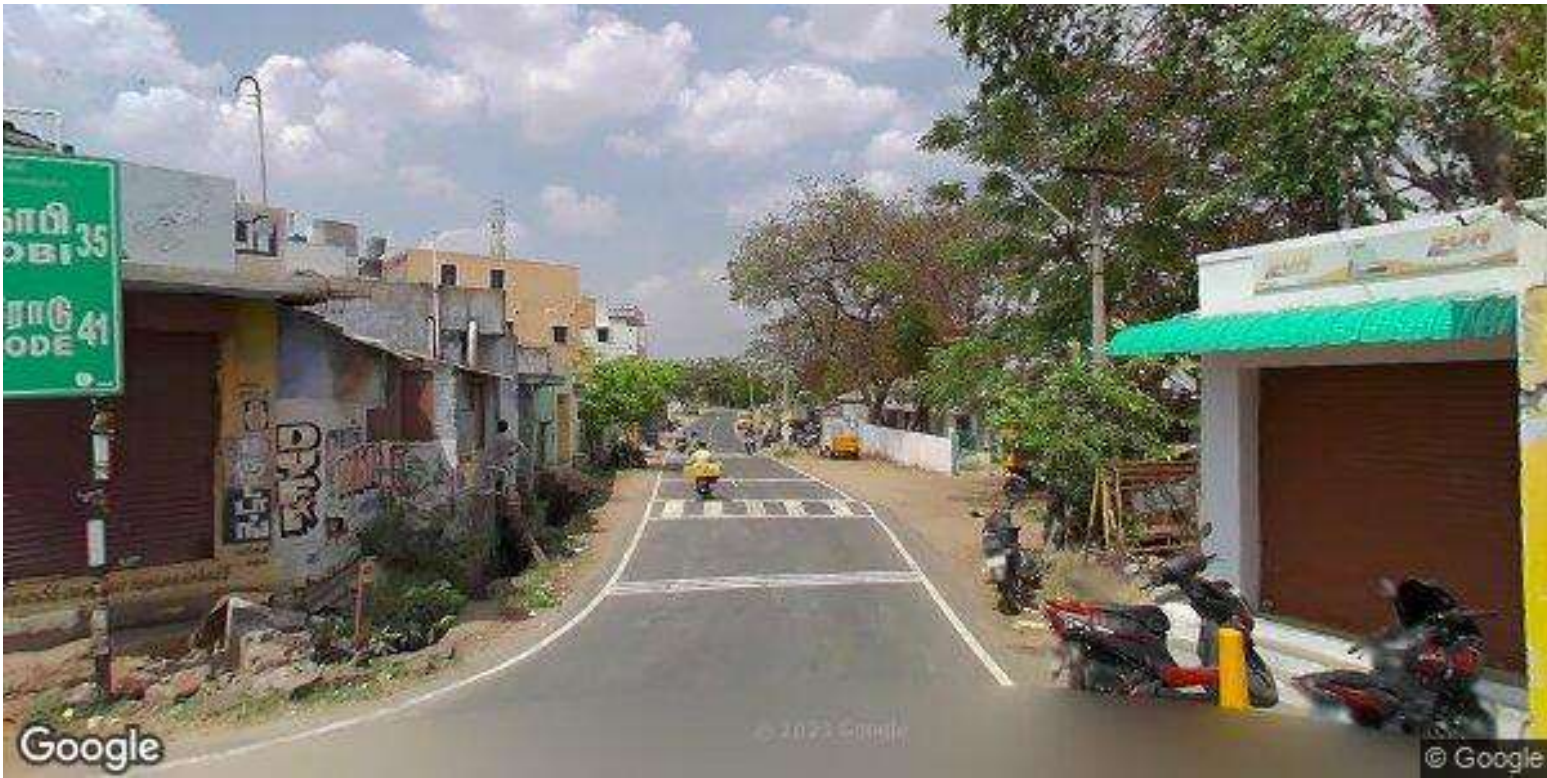
**Risk Type:** Turn  
**Risk Level:** Medium  
**Speed Limit:** 30 KM/Hr  
**Coordinates:** 11.15581, 77.44486

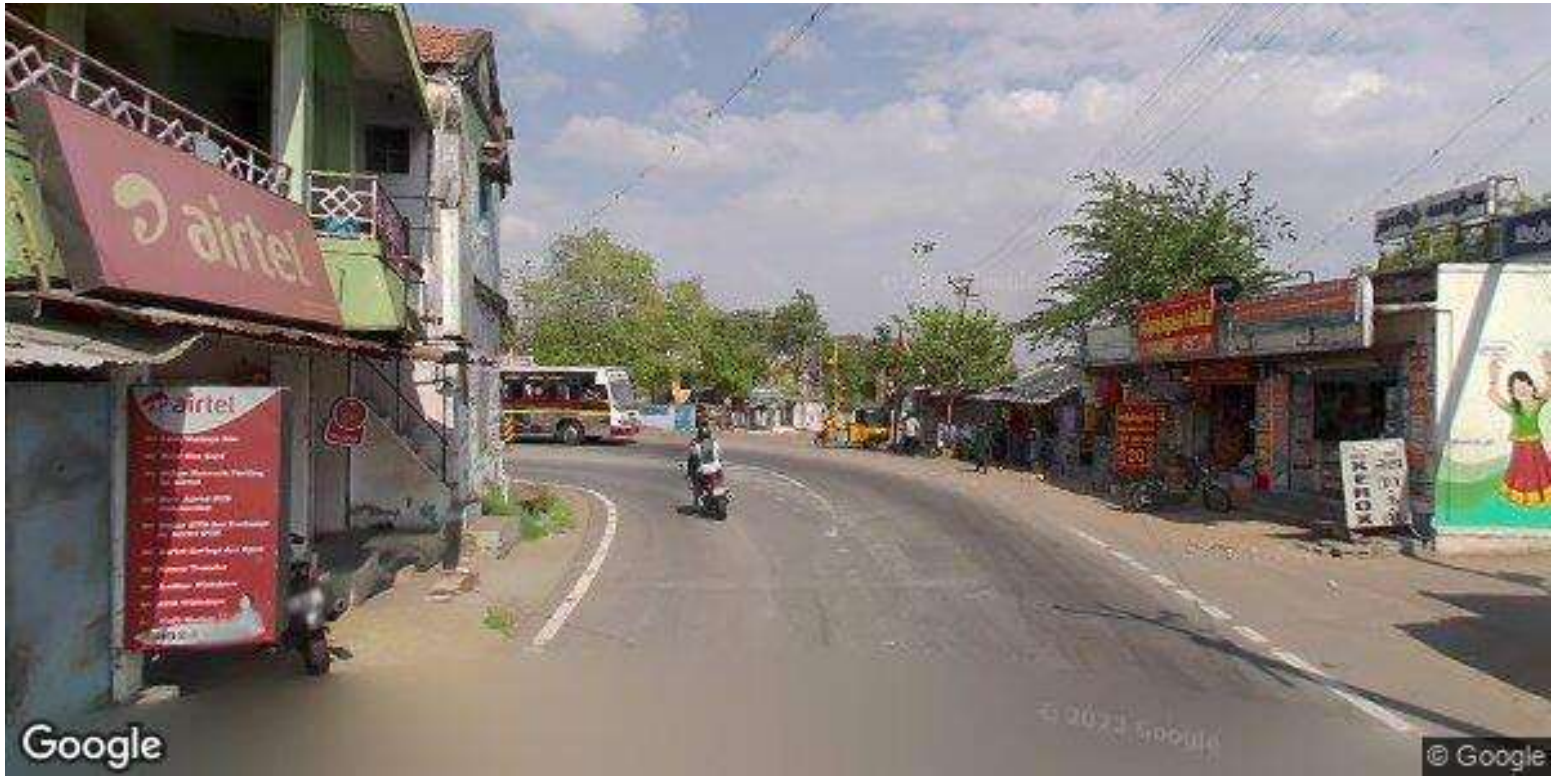
**Risk Type:** Turn  
**Risk Level:** High  
**Speed Limit:** 15 KM/Hr  
**Coordinates:** 11.15553, 77.44454

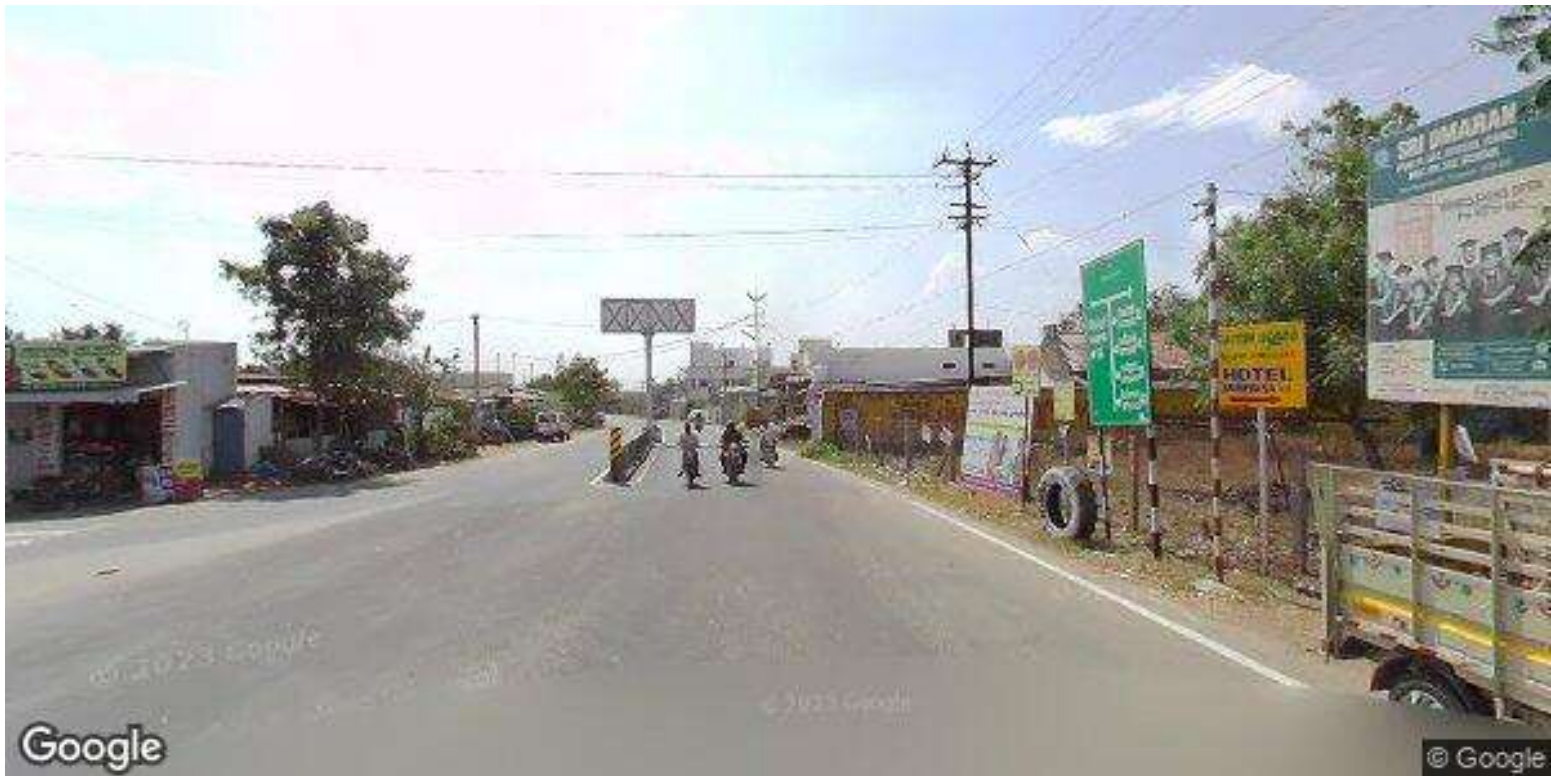
**Risk Type:** Blind Spot  
**Risk Level:** Blind Spot  
**Speed Limit:** 10 KM/Hr  
**Coordinates:** 11.15600, 77.44208

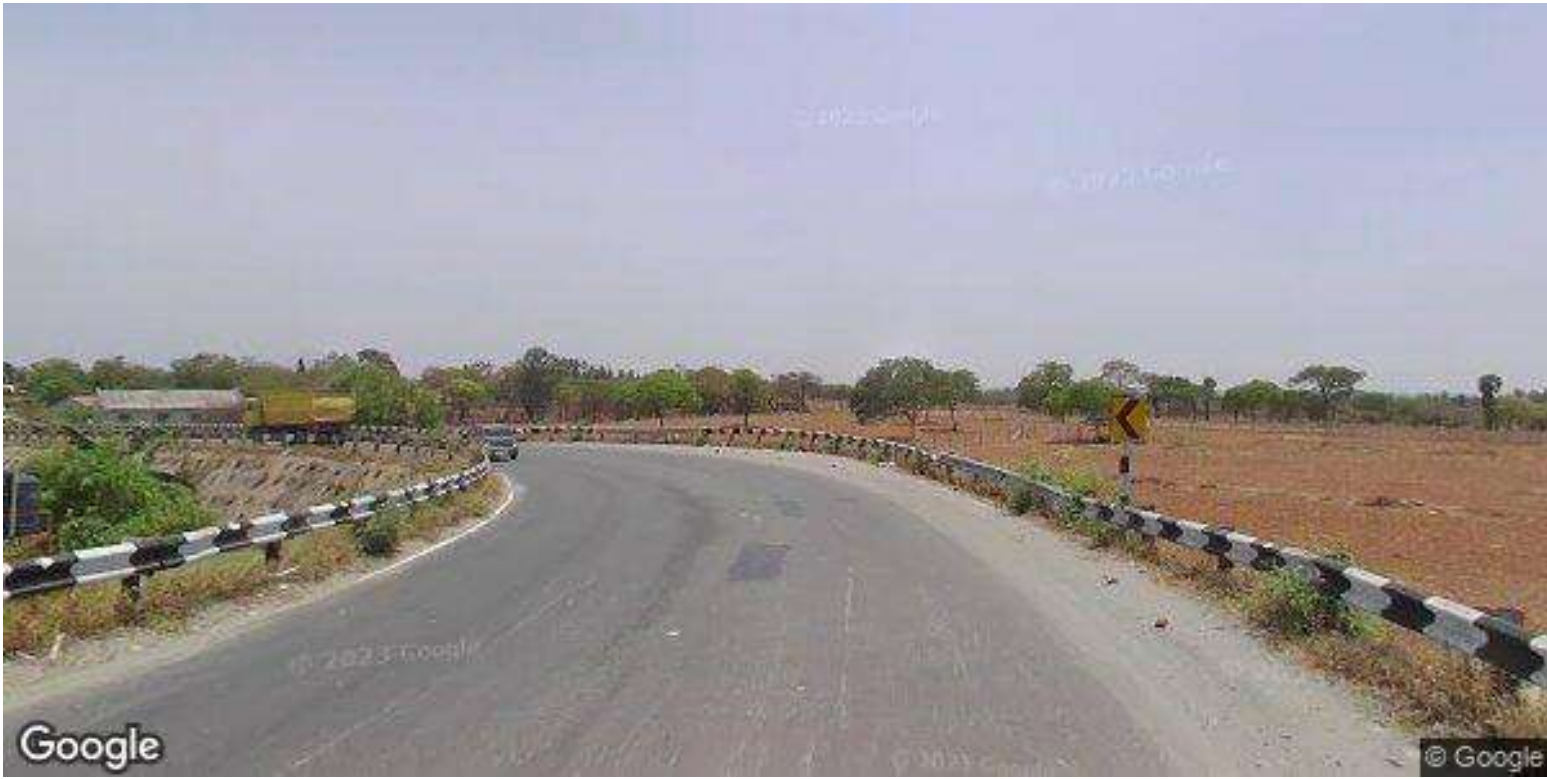
**Risk Type:** Turn  
**Risk Level:** Medium  
**Speed Limit:** 30 KM/Hr  
**Coordinates:** 11.15034, 77.44341

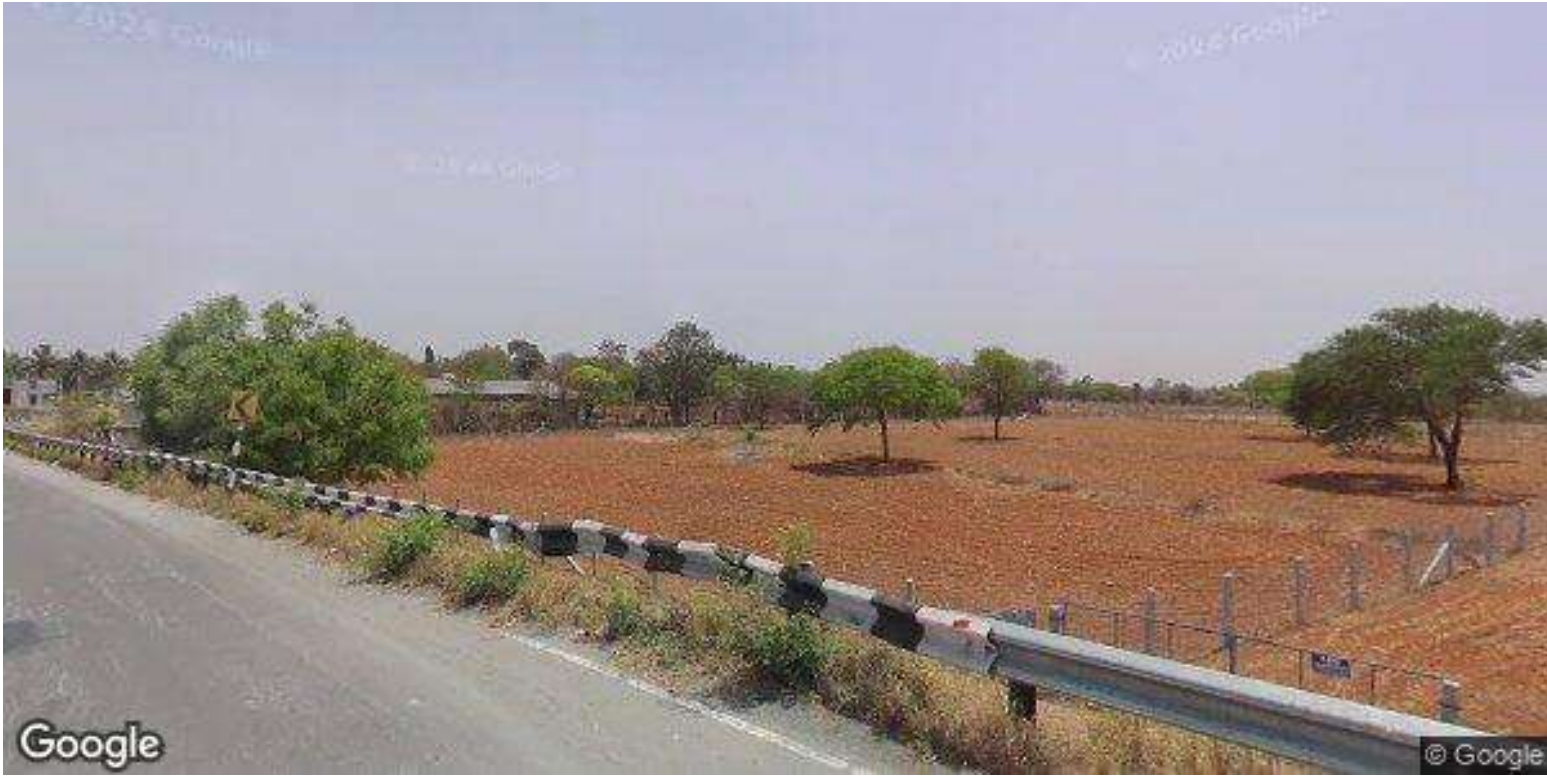
**Risk Type:** Turn  
**Risk Level:** Medium  
**Speed Limit:** 30 KM/Hr  
**Coordinates:** 11.15010, 77.44365

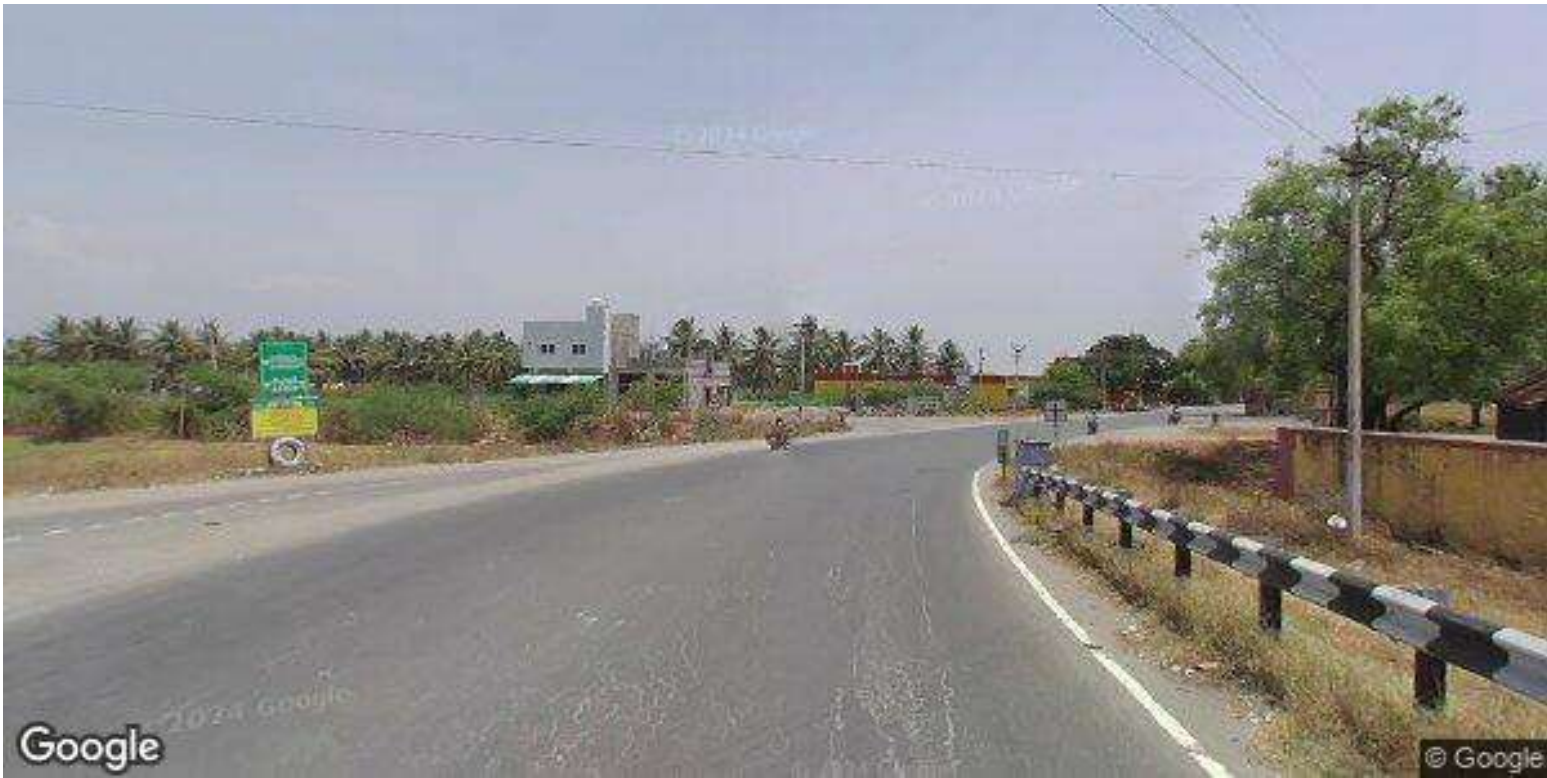
**Risk Type:** Turn  
**Risk Level:** Medium  
**Speed Limit:** 30 KM/Hr  
**Coordinates:** 11.14996, 77.44489

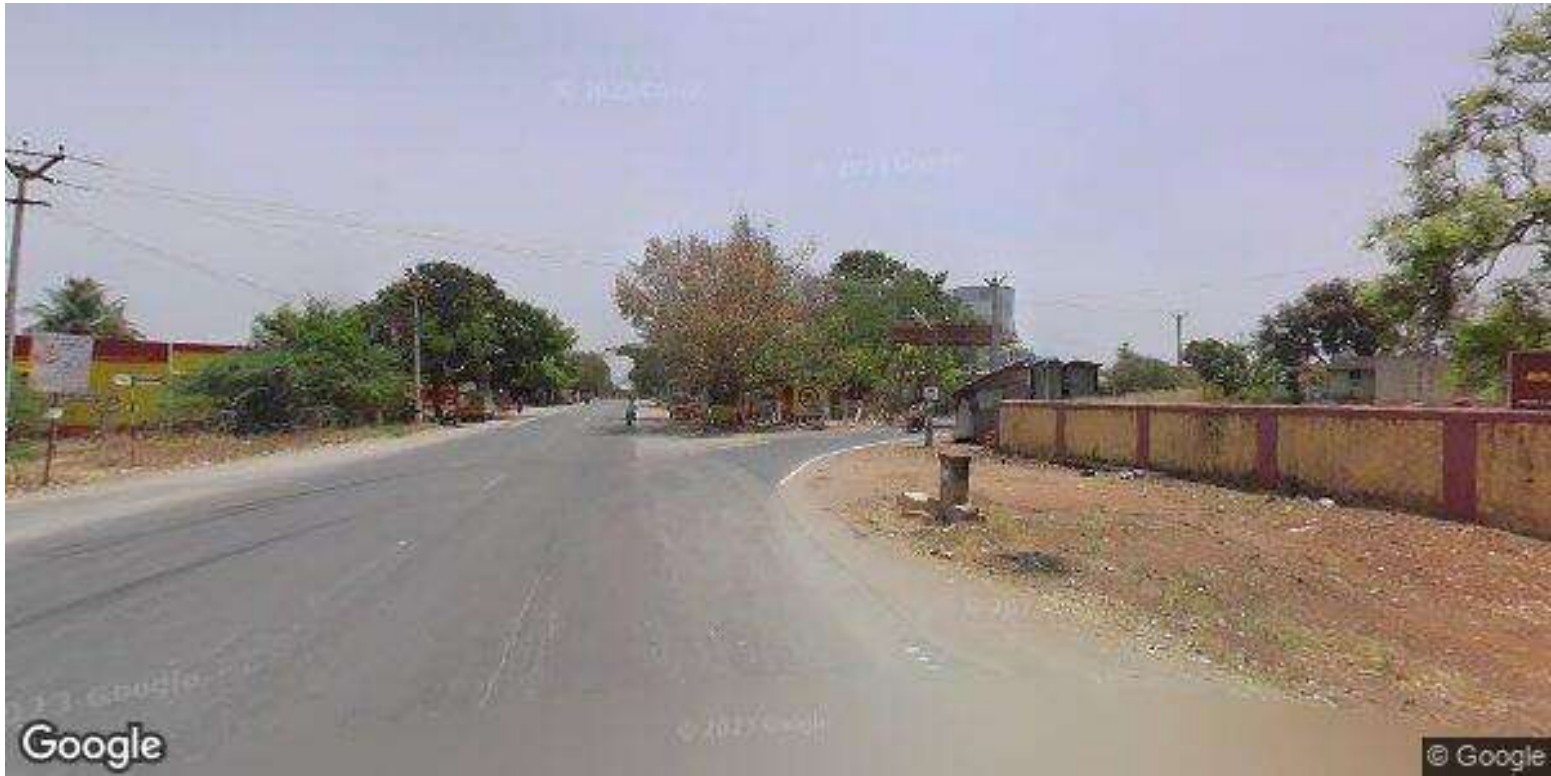
**Risk Type:** Turn  
**Risk Level:** High  
**Speed Limit:** 15 KM/Hr  
**Coordinates:** 11.14957, 77.44526

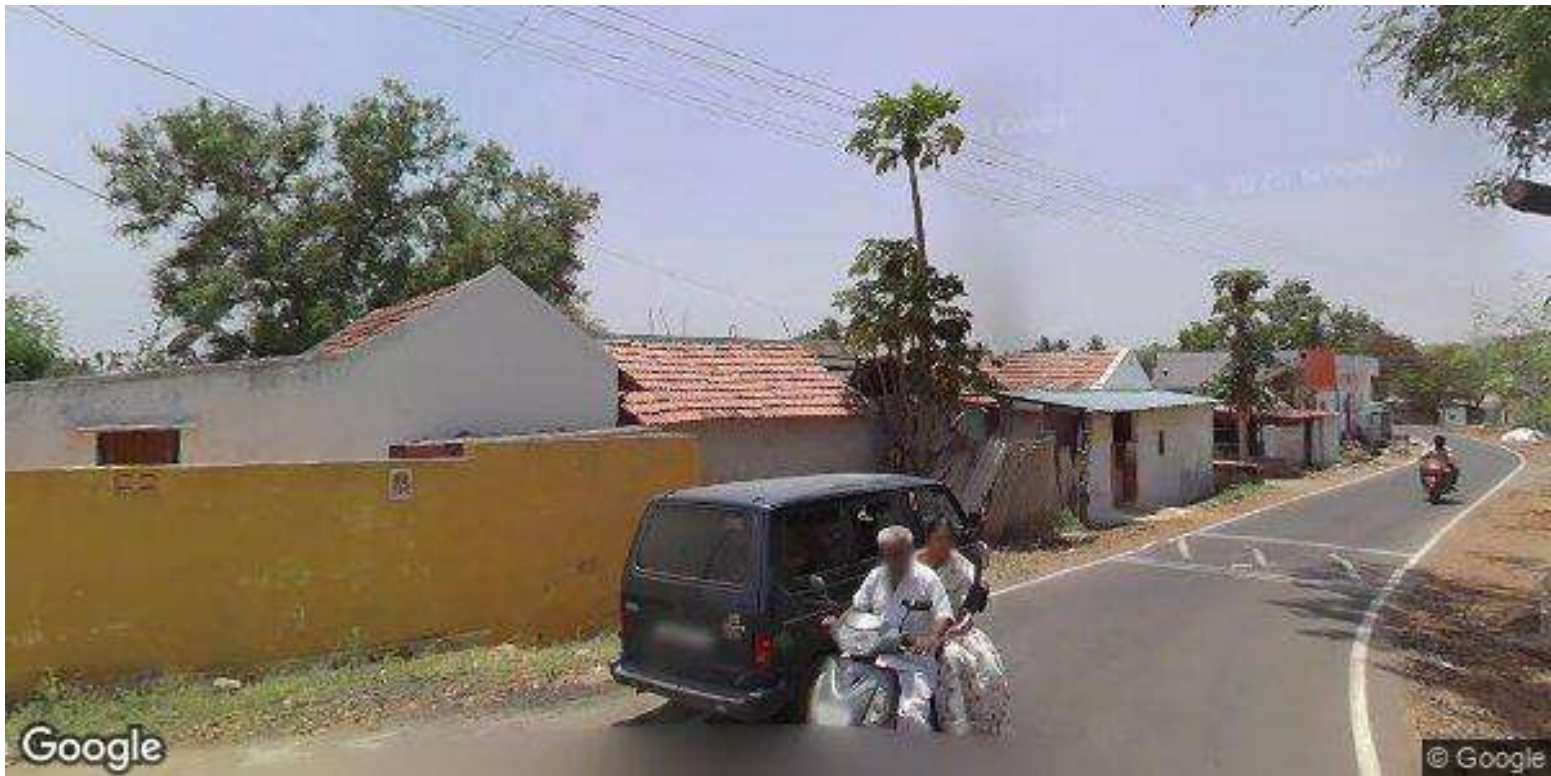
**Risk Type:** Turn  
**Risk Level:** High  
**Speed Limit:** 15 KM/Hr  
**Coordinates:** 11.14479, 77.44350

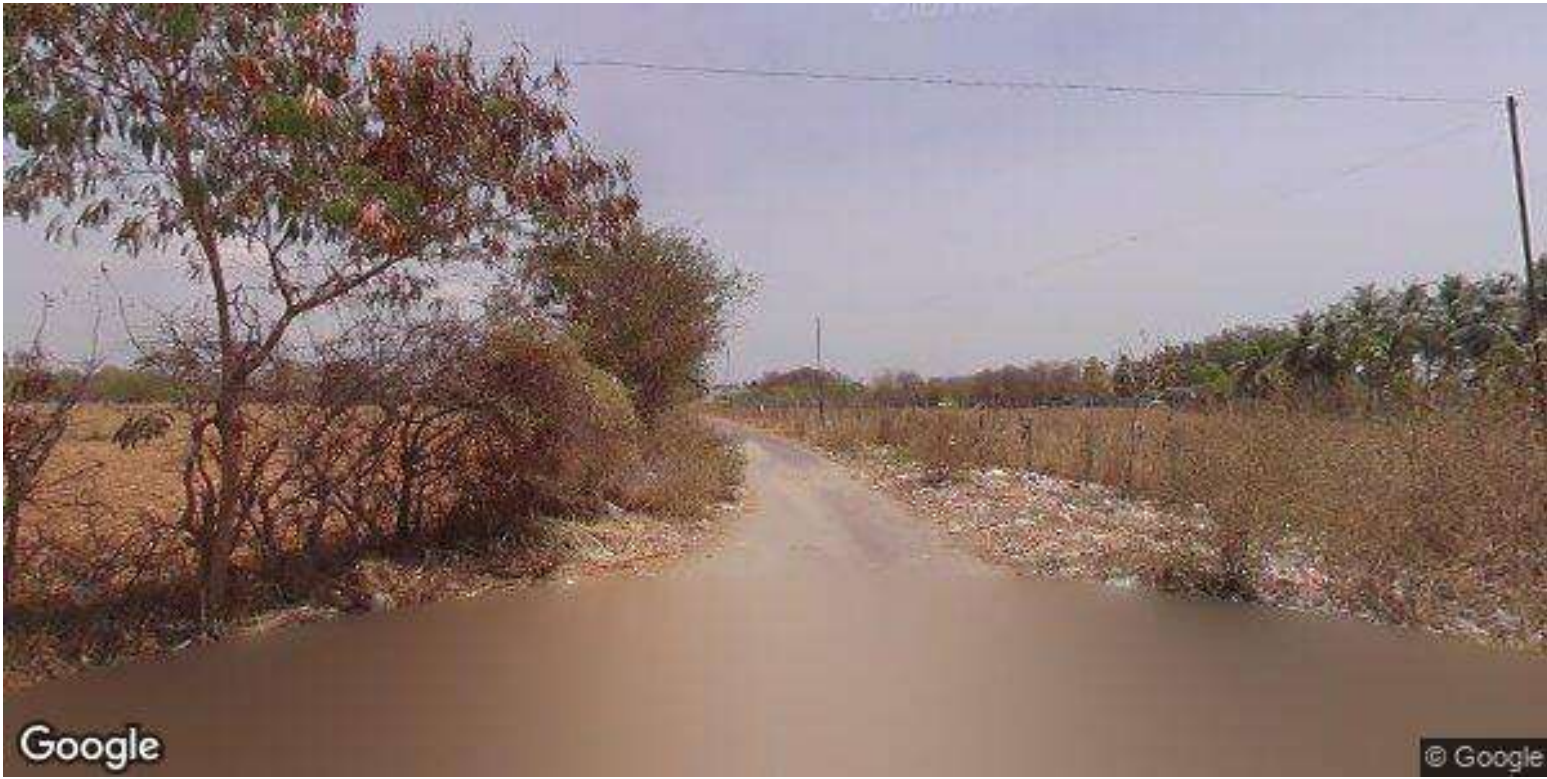
**Risk Type:** Turn  
**Risk Level:** High  
**Speed Limit:** 15 KM/Hr  
**Coordinates:** 11.14525, 77.43906

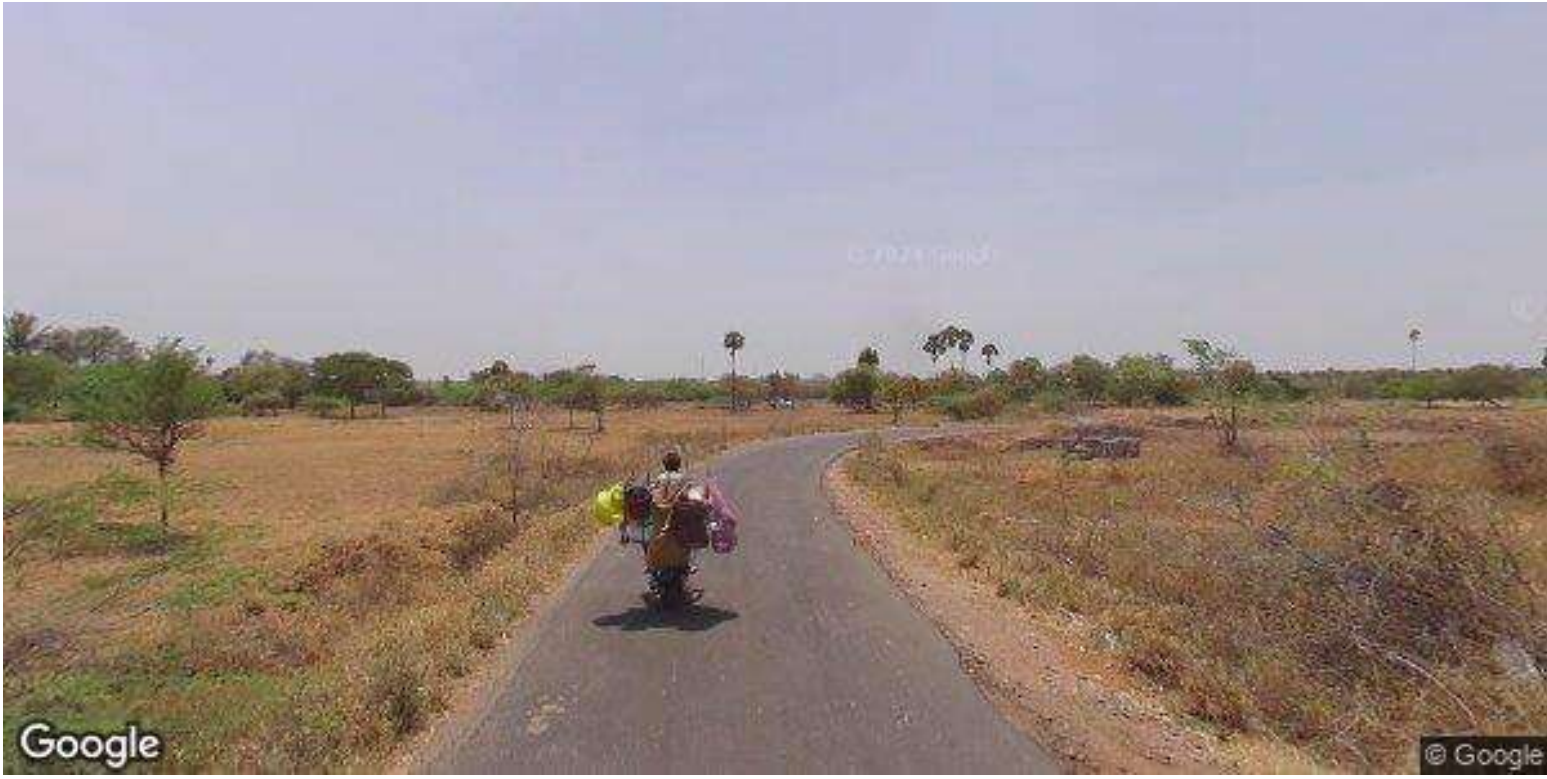
**Risk Type:** Turn  
**Risk Level:** Medium  
**Speed Limit:** 30 KM/Hr  
**Coordinates:** 11.13230, 77.43321

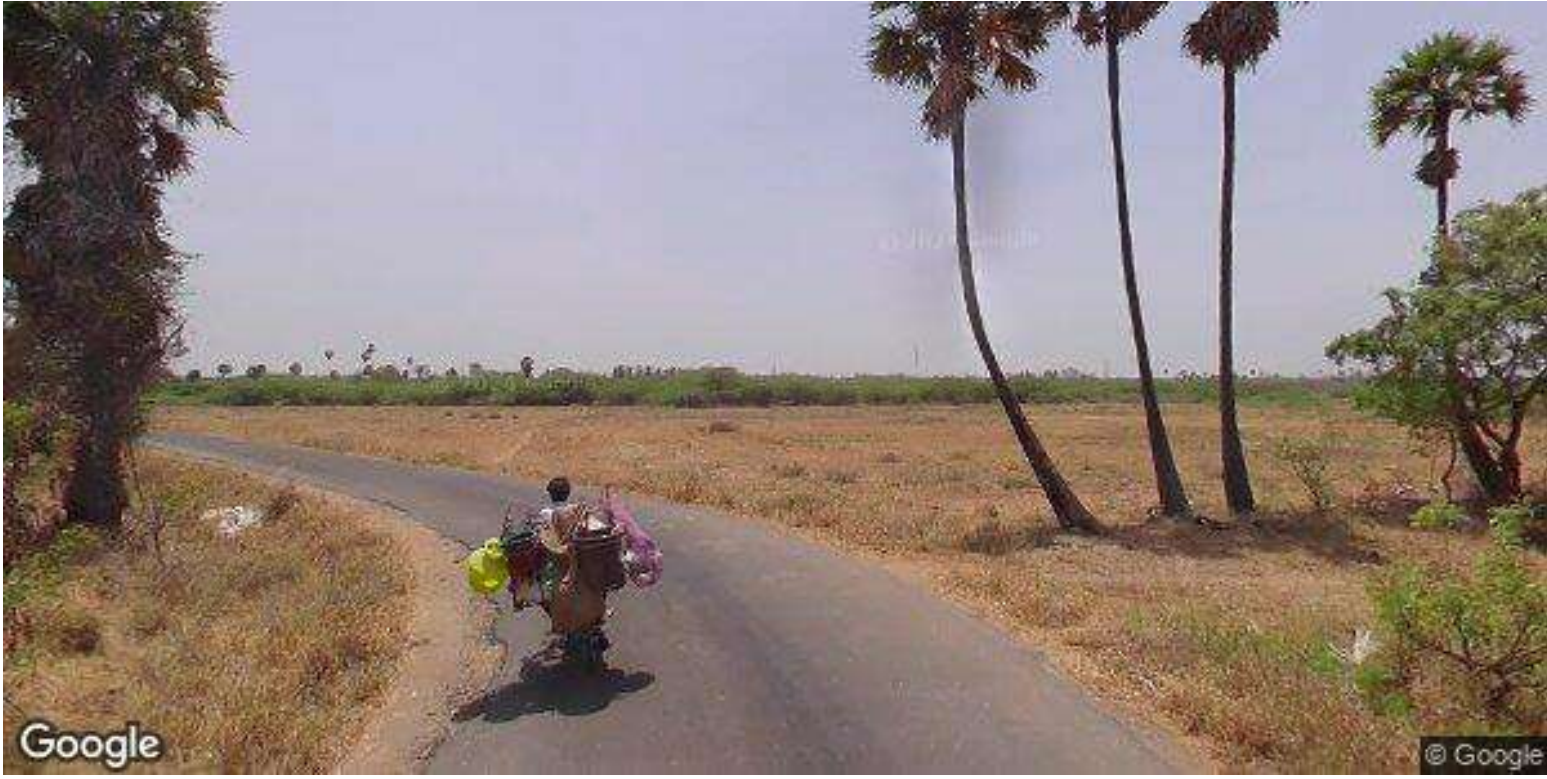
**Risk Type:** Turn  
**Risk Level:** High  
**Speed Limit:** 15 KM/Hr  
**Coordinates:** 11.13163, 77.43254

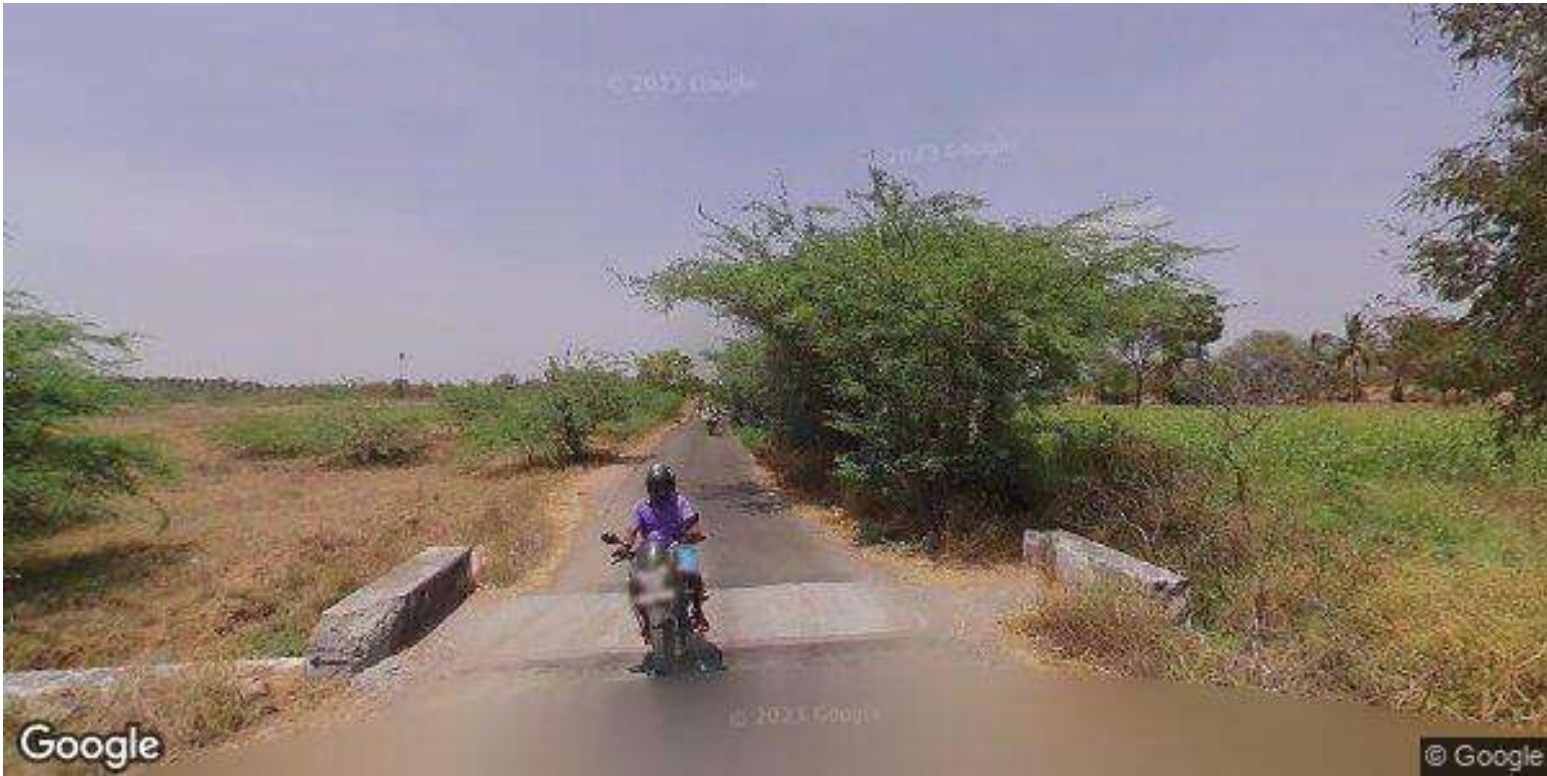
**Risk Type:** Blind Spot  
**Risk Level:** Blind Spot  
**Speed Limit:** 10 KM/Hr  
**Coordinates:** 11.13022, 77.43358

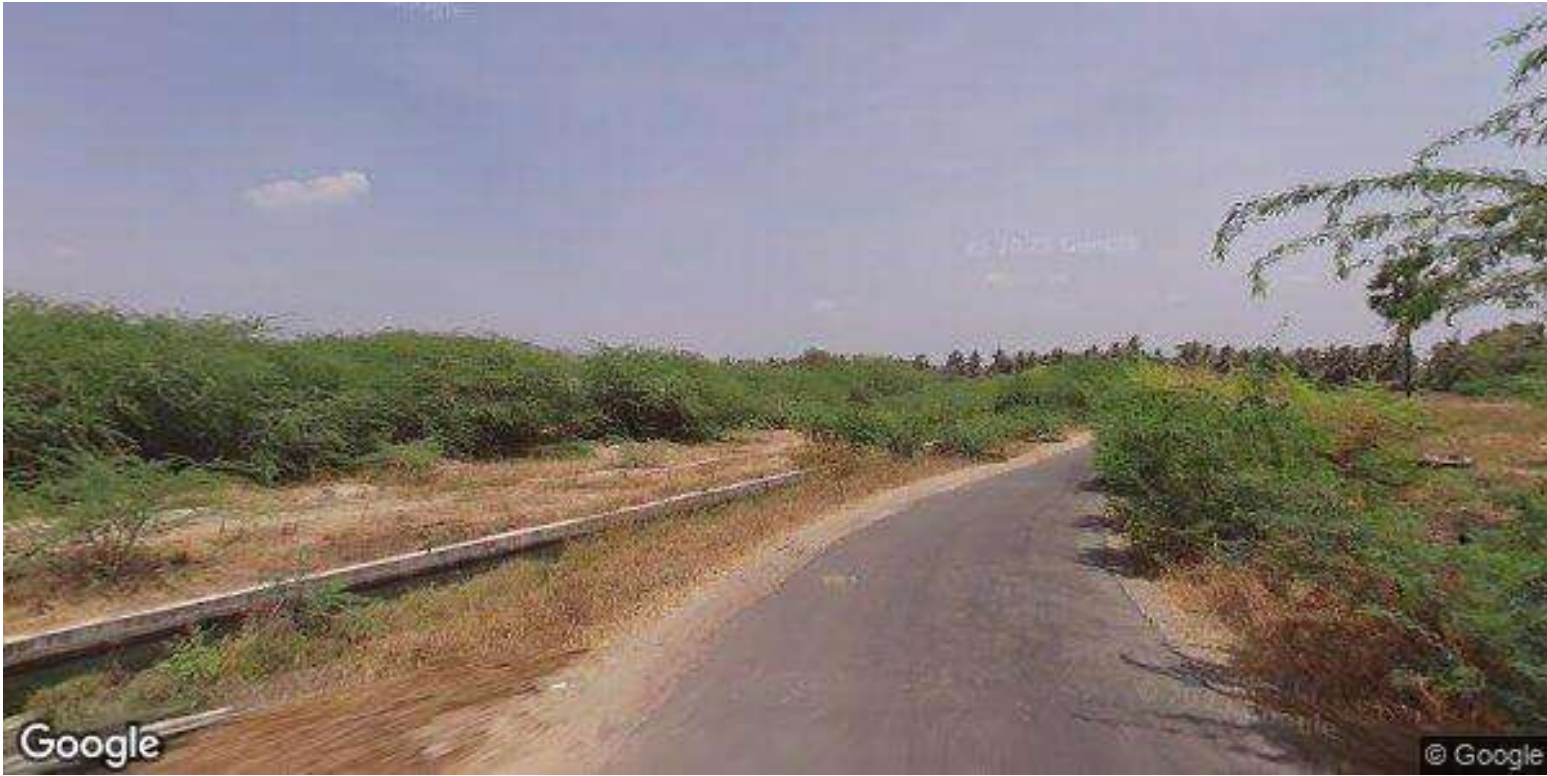
**Risk Type:** Turn  
**Risk Level:** Medium  
**Speed Limit:** 30 KM/Hr  
**Coordinates:** 11.12977, 77.43230

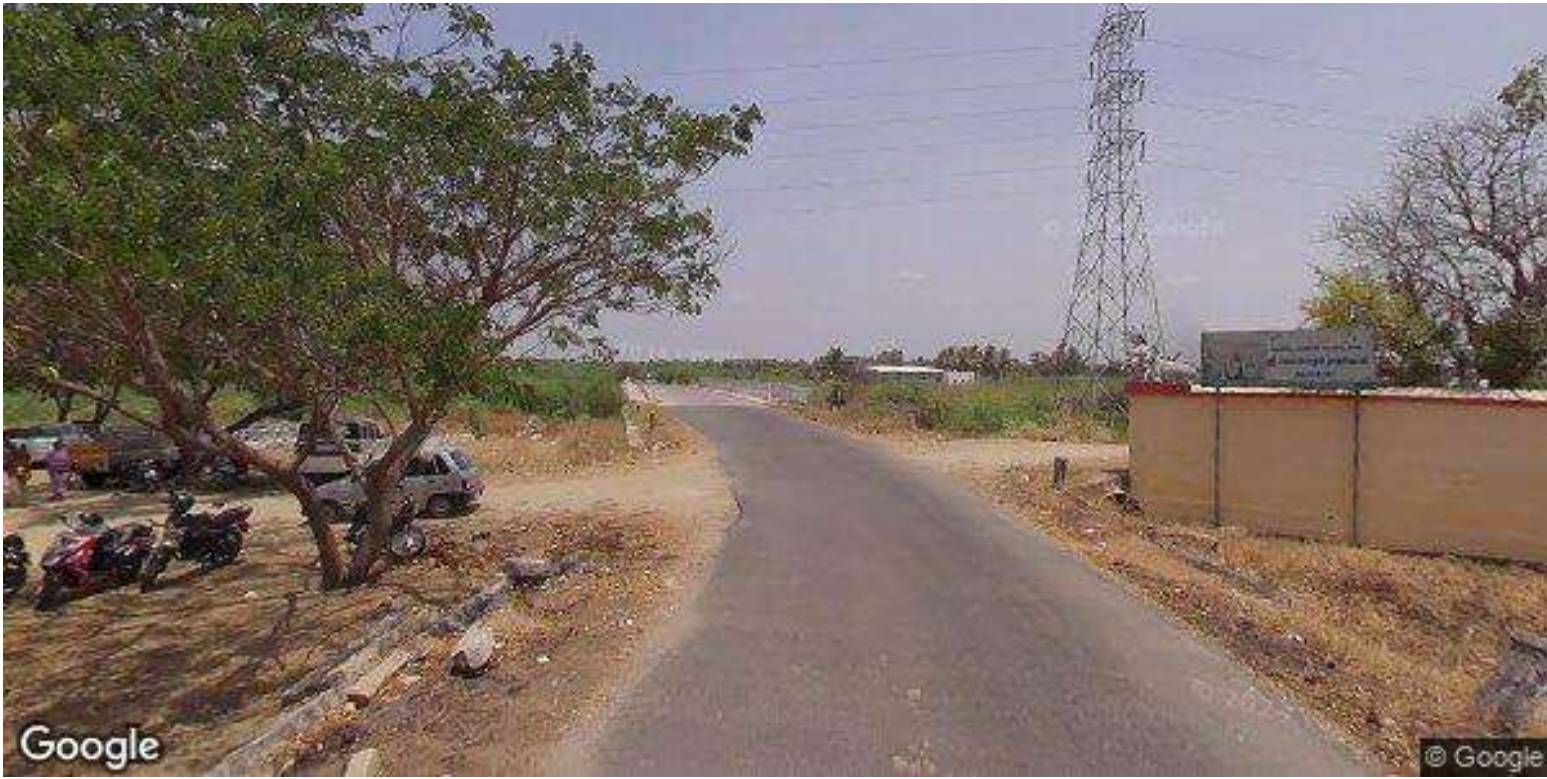
**Risk Type:** Turn  
**Risk Level:** High  
**Speed Limit:** 15 KM/Hr  
**Coordinates:** 11.12744, 77.43053

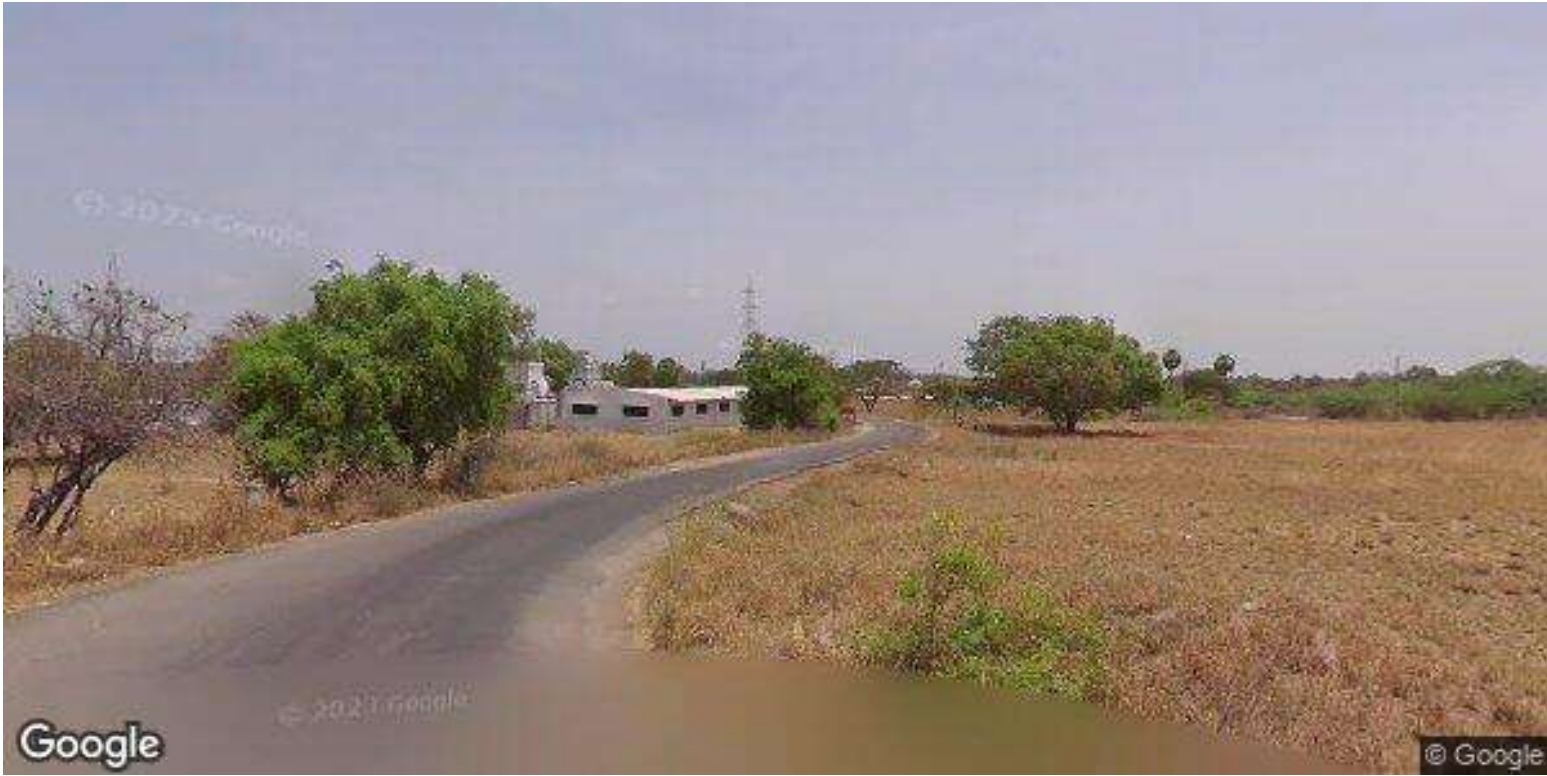
**Risk Type:** Turn  
**Risk Level:** High  
**Speed Limit:** 15 KM/Hr  
**Coordinates:** 11.12731, 77.42945
