# IndianOil

## JOURNEY RISK MANAGEMENT (JRM) STUDY

### Salem Terminal TO G A S STAATION

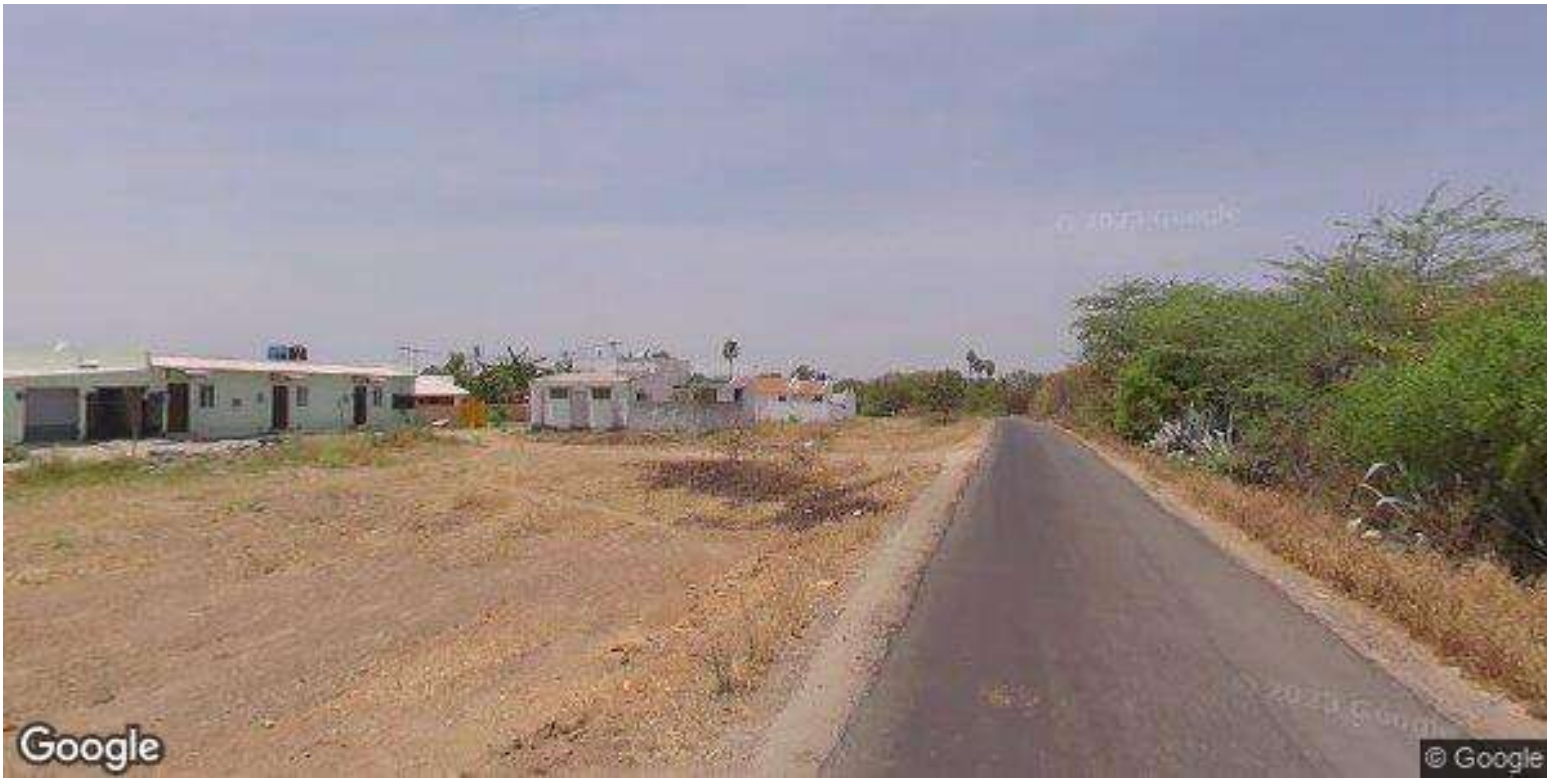
**Risk Type:** Turn  
**Risk Level:** High  
**Speed Limit:** 15 KM/Hr  
**Coordinates:** 11.12638, 77.42910

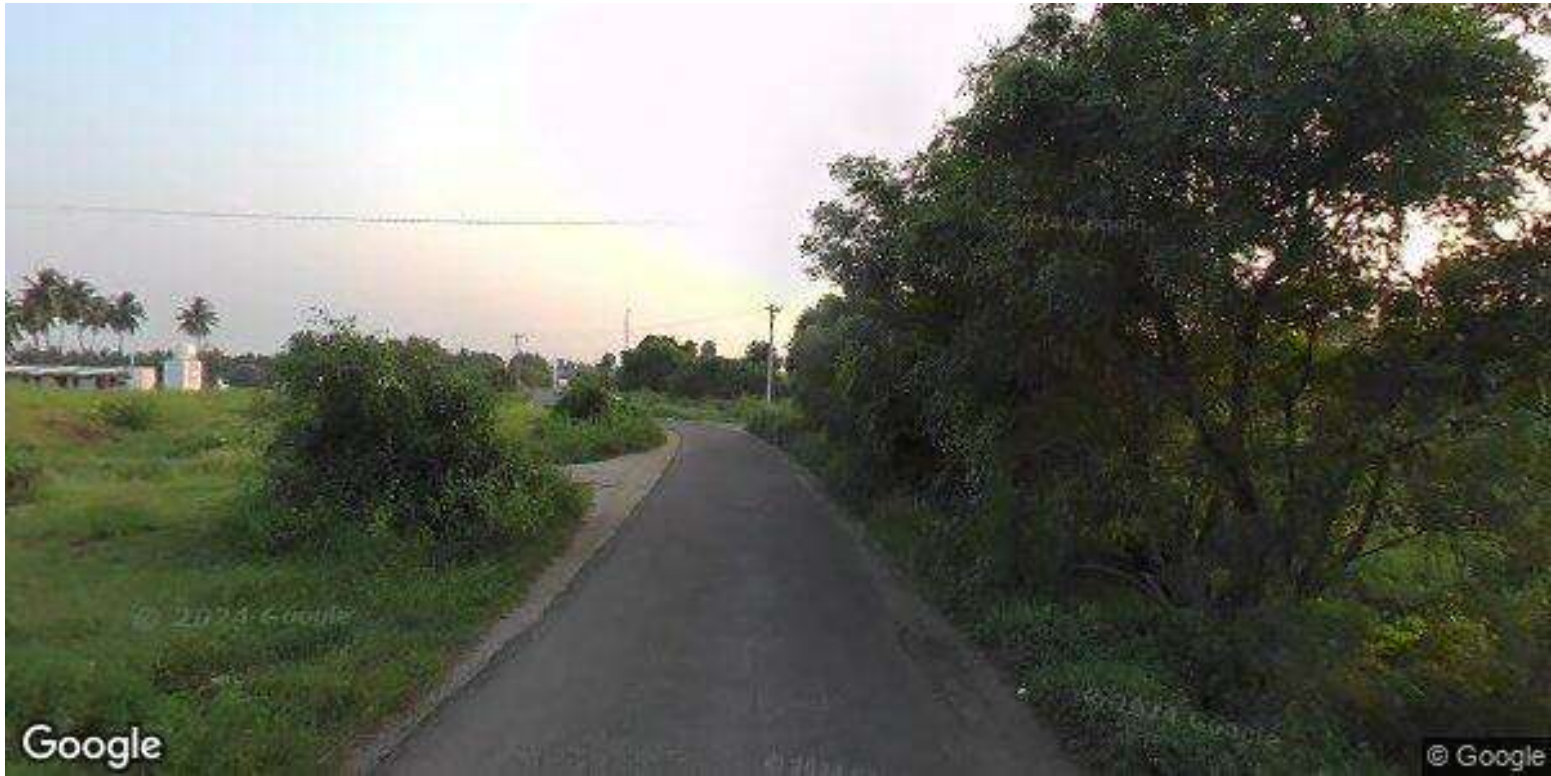
**Risk Type:** Blind Spot  
**Risk Level:** Blind Spot  
**Speed Limit:** 10 KM/Hr  
**Coordinates:** 11.12638, 77.42801

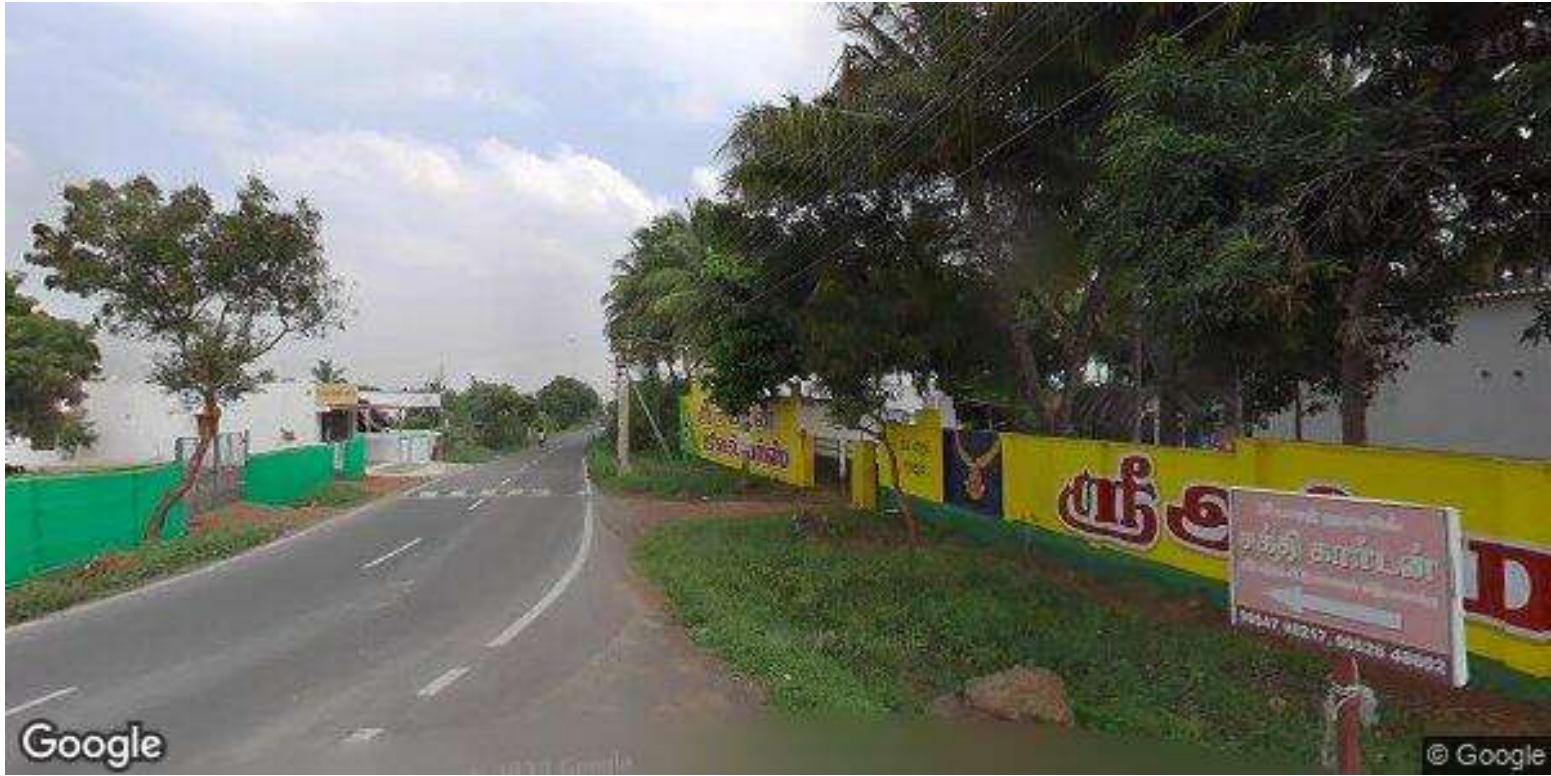
**Risk Type:** Turn  
**Risk Level:** Medium  
**Speed Limit:** 30 KM/Hr  
**Coordinates:** 11.10417, 77.42302

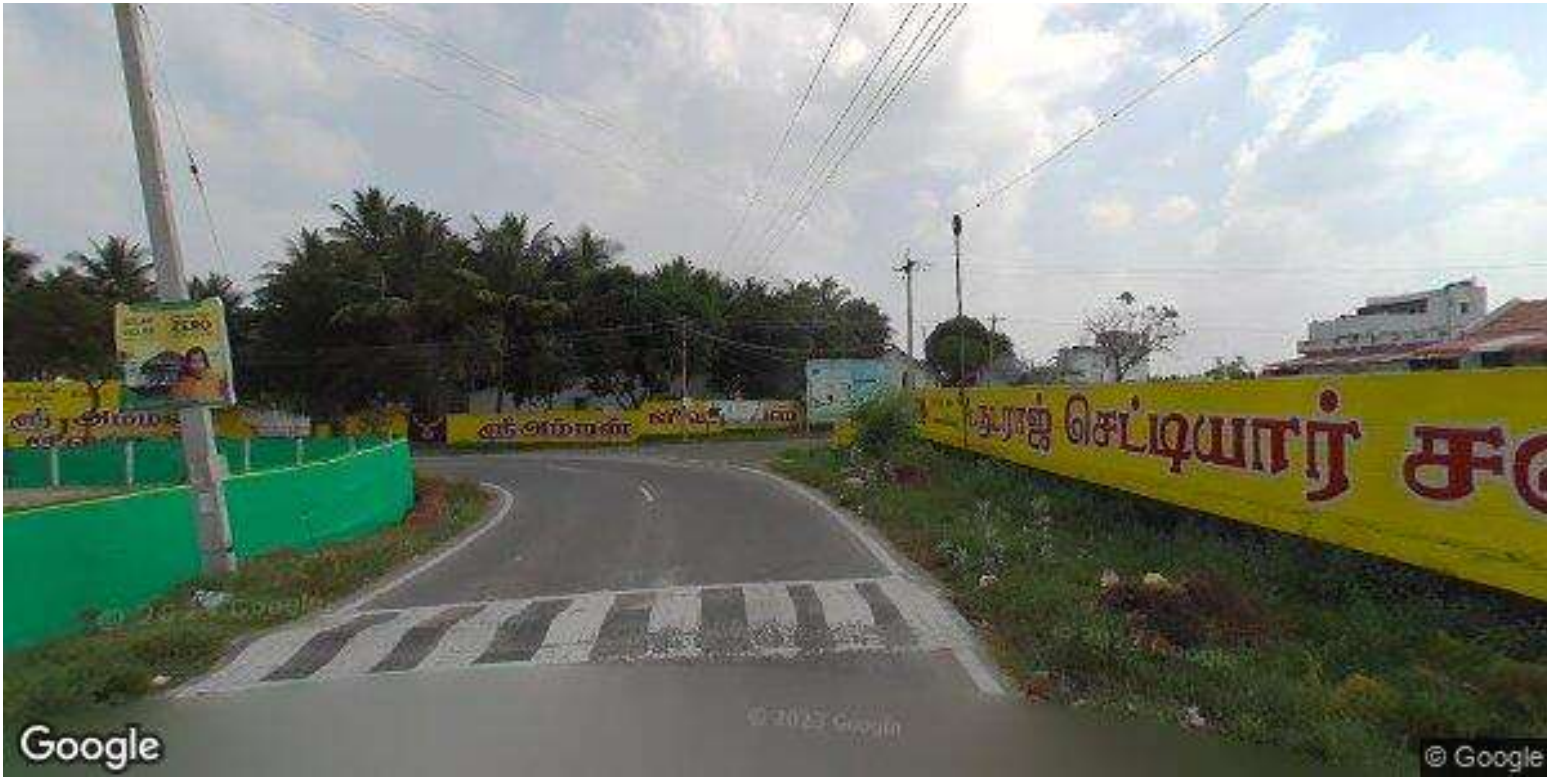
**Risk Type:** Turn  
**Risk Level:** Medium  
**Speed Limit:** 30 KM/Hr  
**Coordinates:** 11.10404, 77.42280

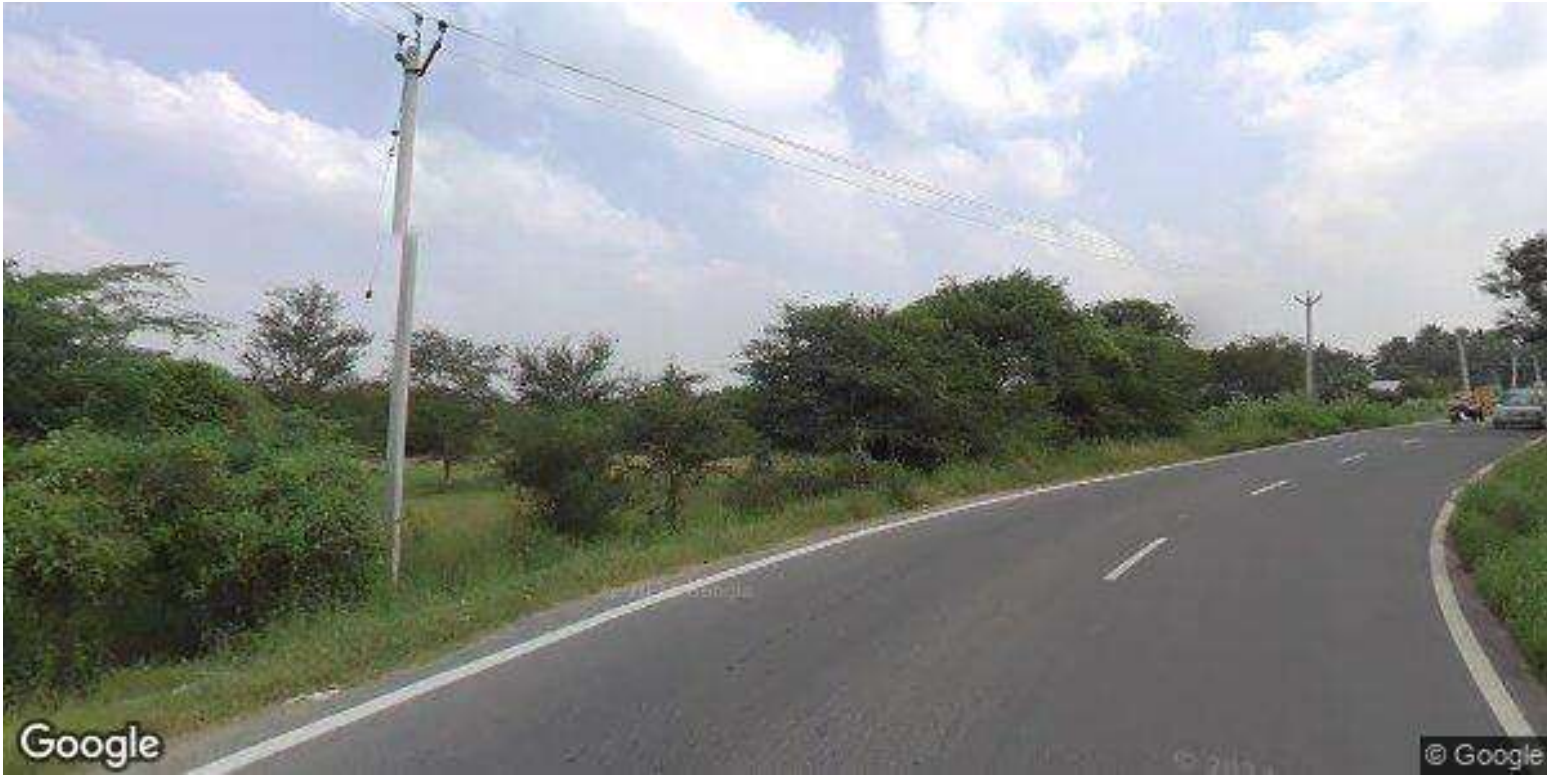
**Risk Type:** Turn  
**Risk Level:** Medium  
**Speed Limit:** 30 KM/Hr  
**Coordinates:** 11.10419, 77.42108

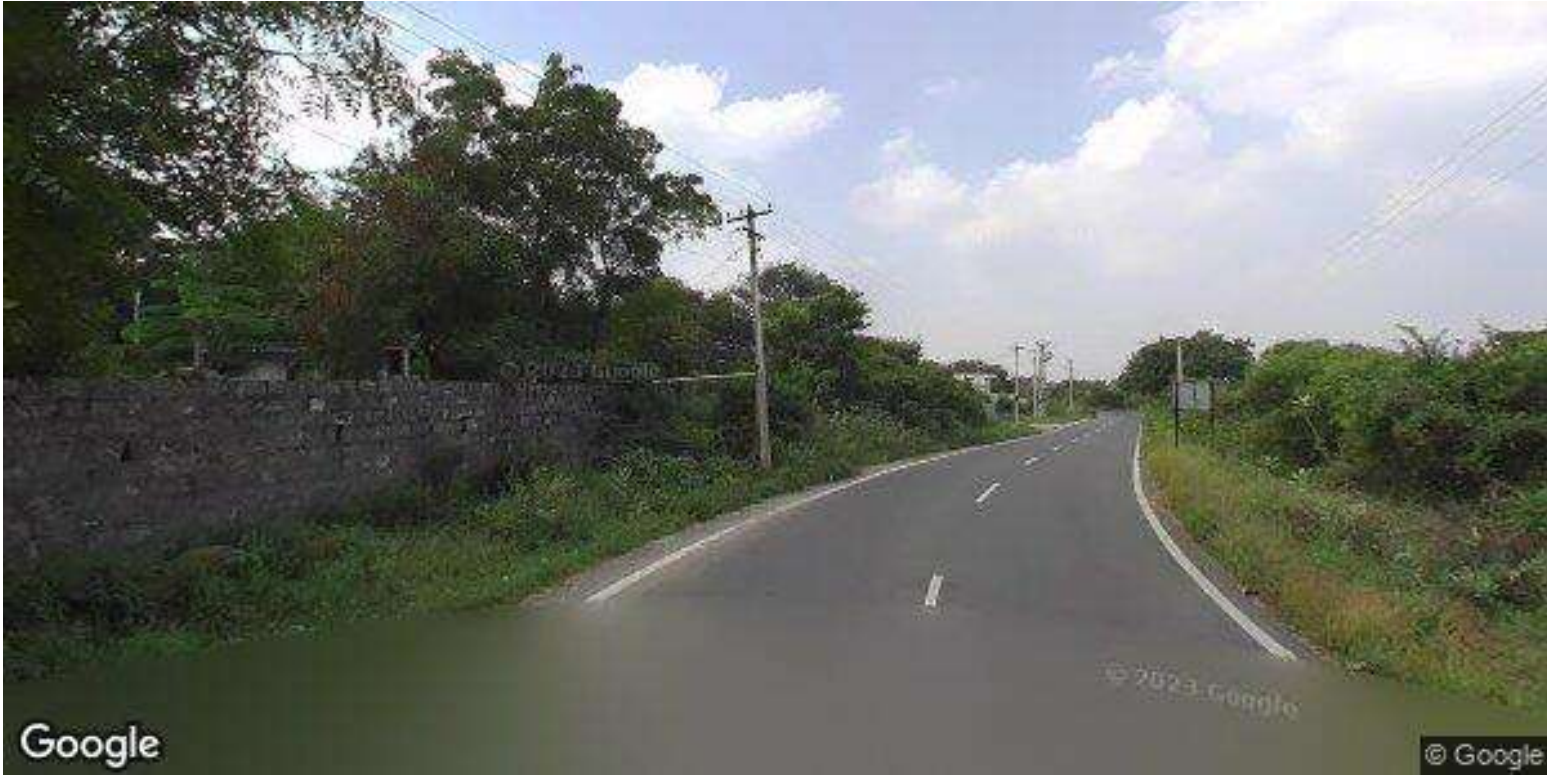
**Risk Type:** Turn  
**Risk Level:** Medium  
**Speed Limit:** 30 KM/Hr  
**Coordinates:** 11.10398, 77.42073

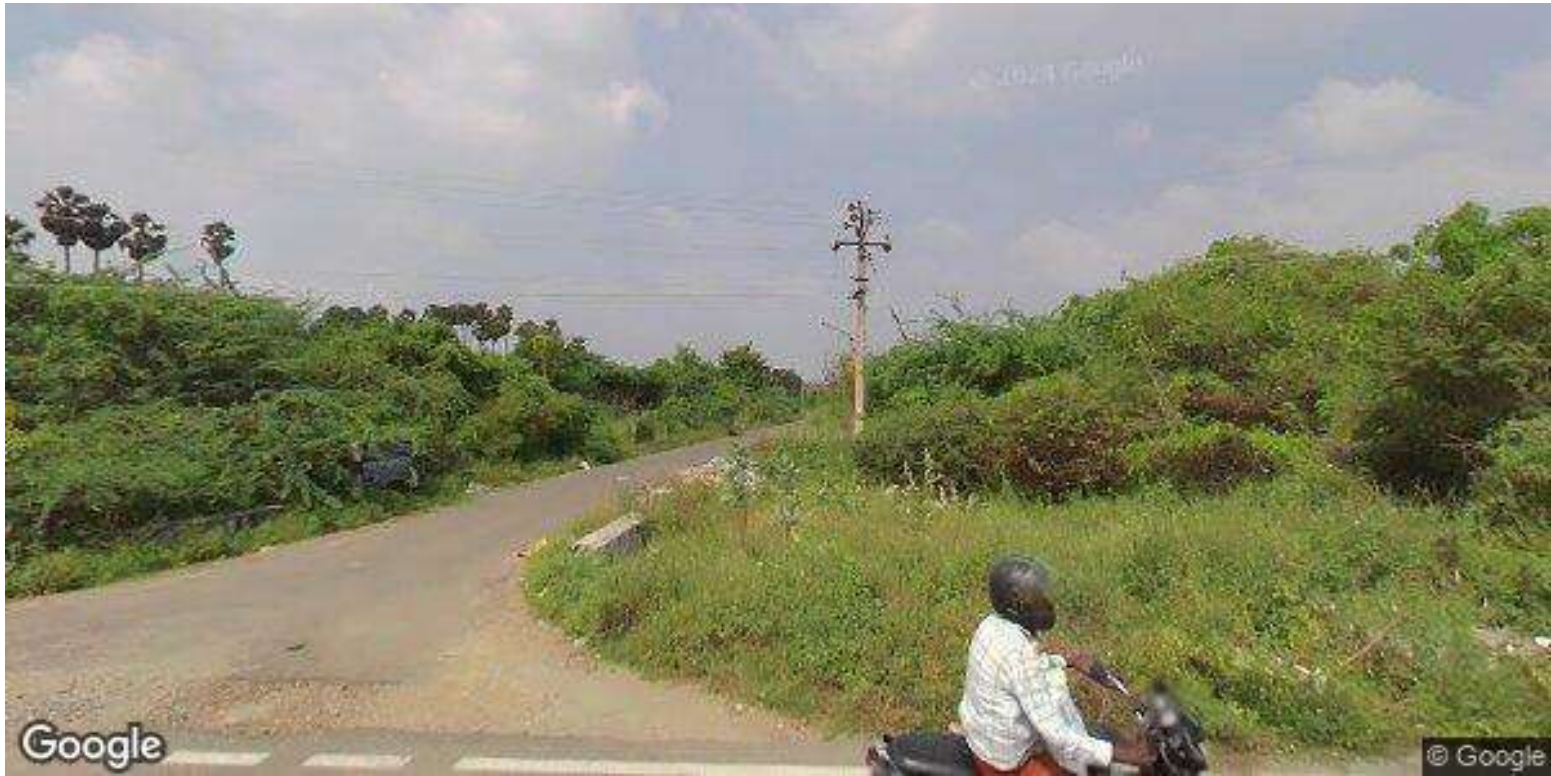
**Risk Type:** Turn  
**Risk Level:** Medium  
**Speed Limit:** 30 KM/Hr  
**Coordinates:** 11.10331, 77.41739

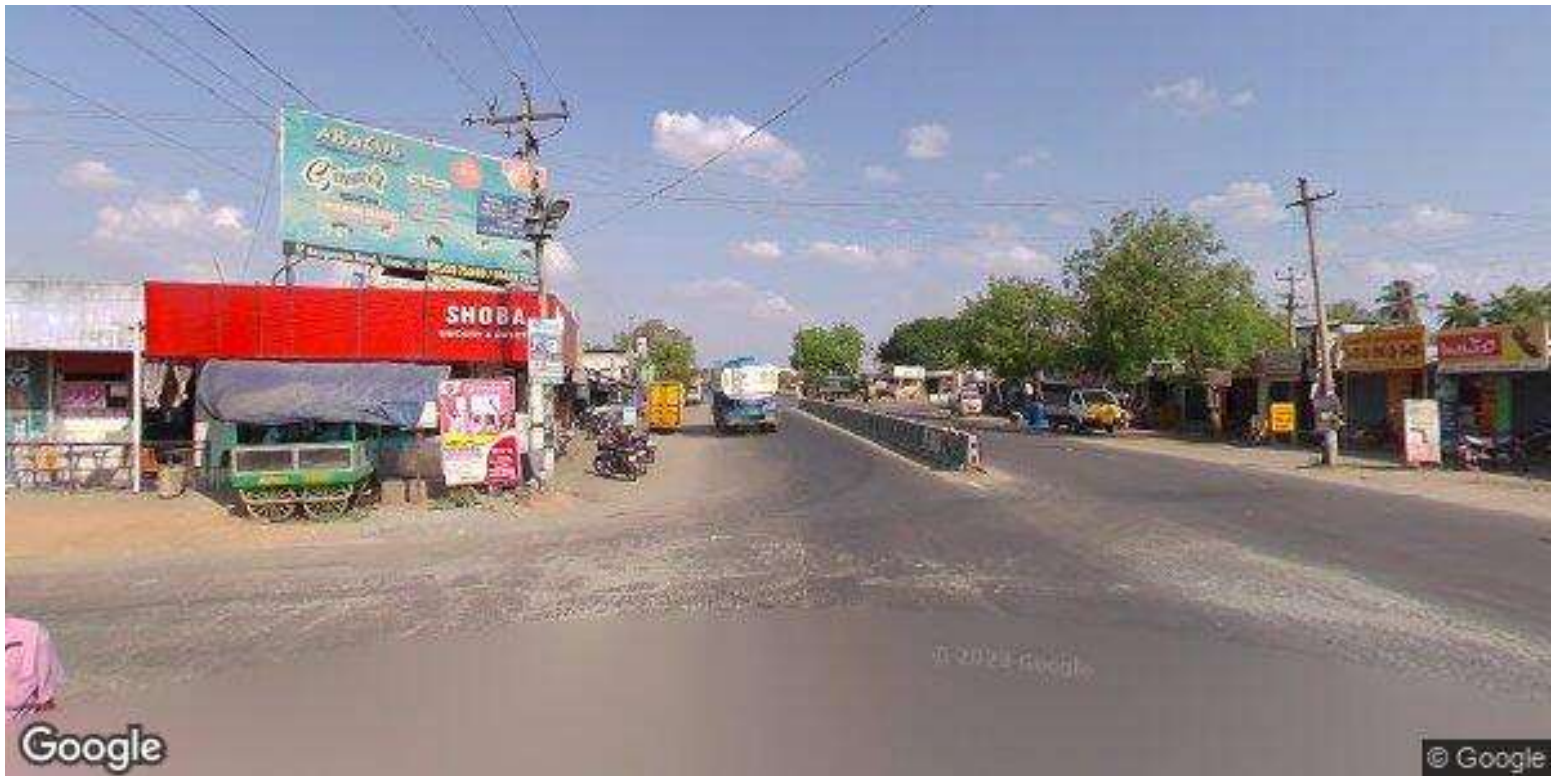
**Risk Type:** Turn  
**Risk Level:** High  
**Speed Limit:** 15 KM/Hr  
**Coordinates:** 11.09148, 77.41646
