## JOURNEY RISK MANAGEMENT (JRM) STUDY

### Salem Terminal to Dhanalakshmi Agencies Adhoc

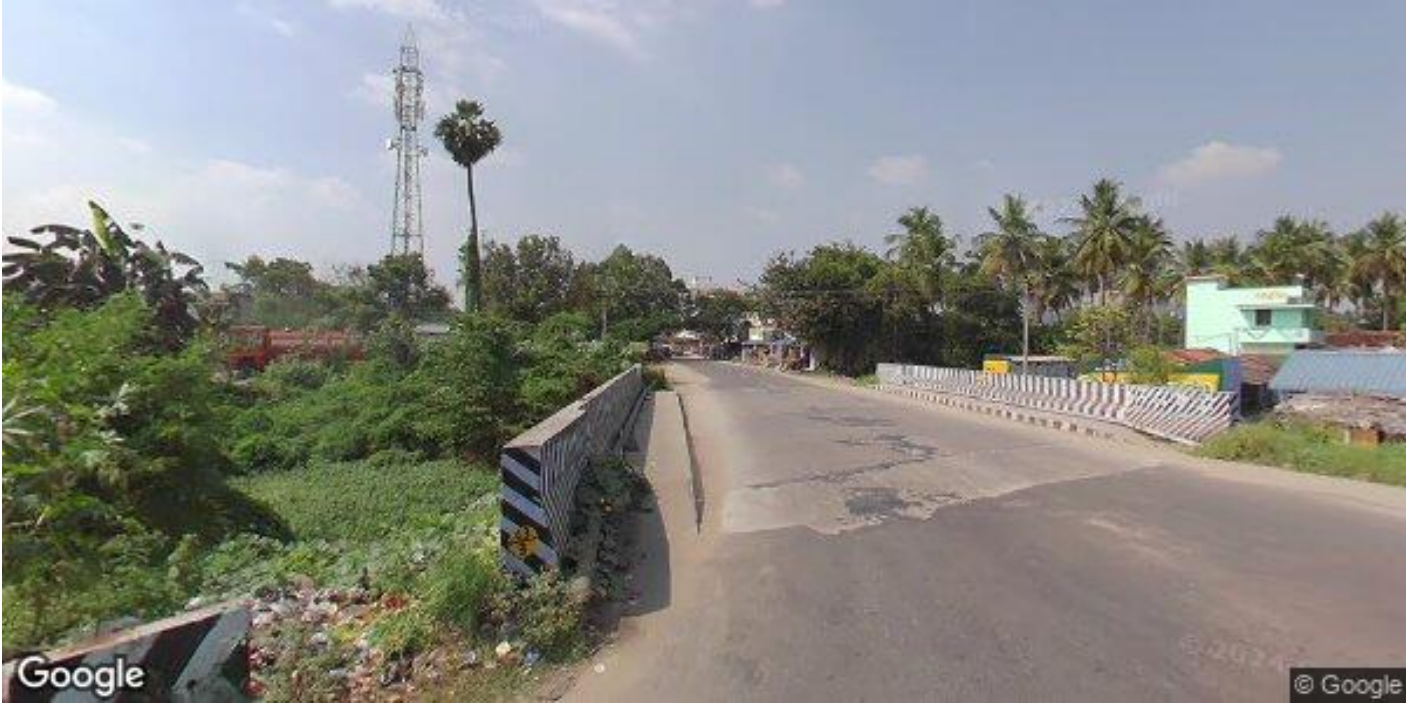
Risk Type: Turn  
Risk Level: Medium

**Speed Limit: 30 KM/Hr**  
**Coordinates: 11.44900, 77.87406**

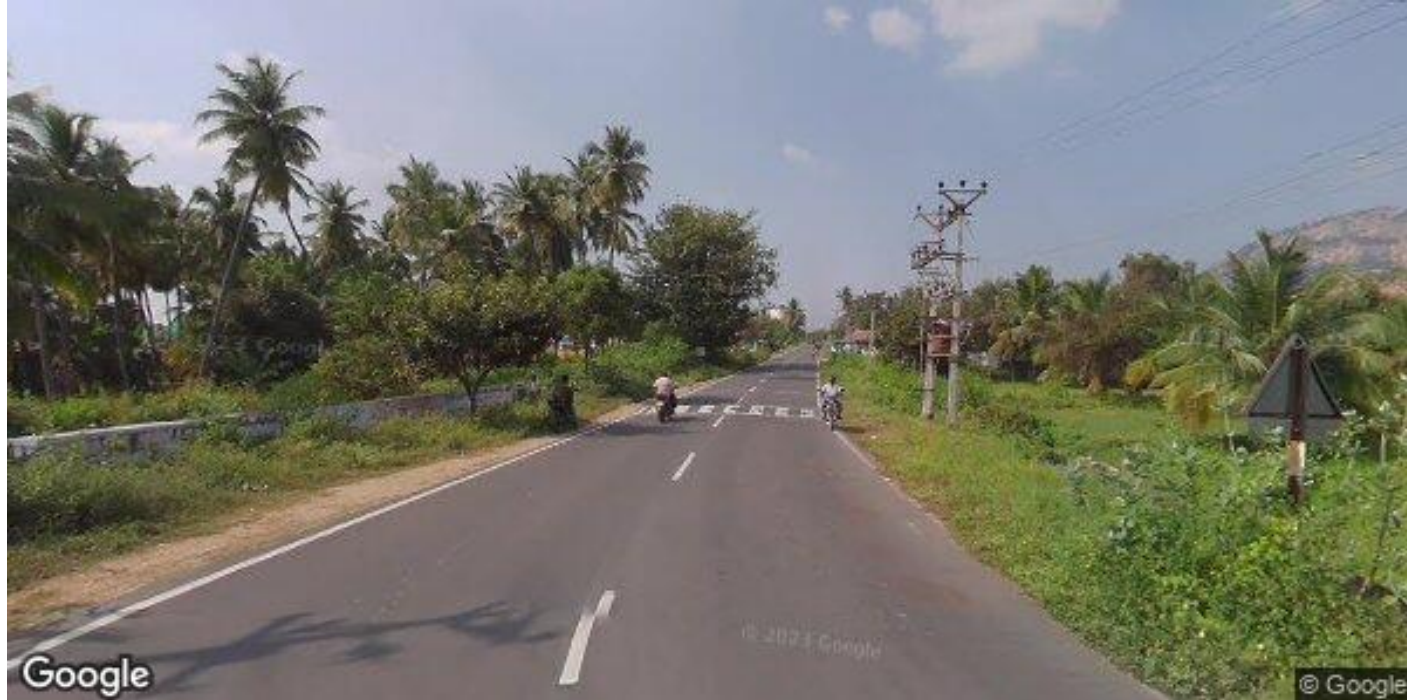
**Risk Type: Turn**  
**Risk Level: High**  
**Speed Limit: 15 KM/Hr**  
**Coordinates: 11.45353, 77.85697**

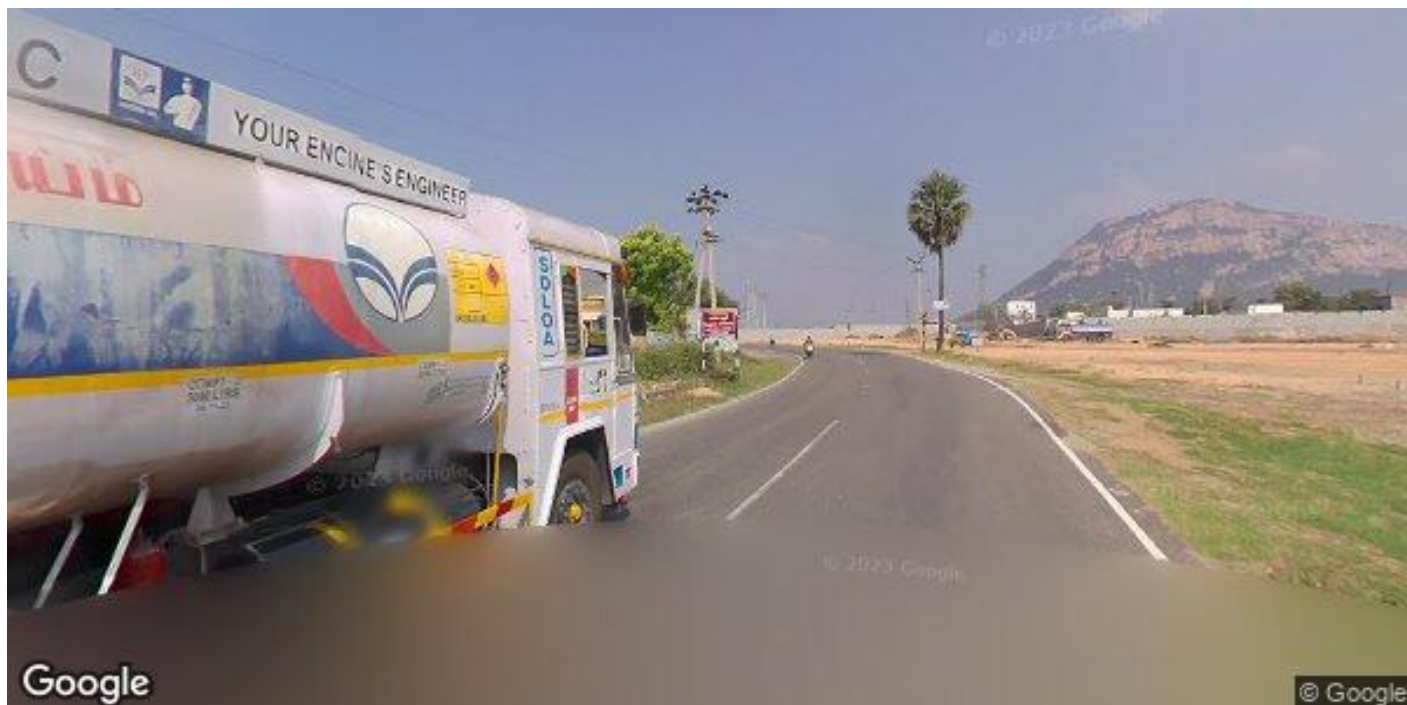
**Risk Type: Turn**  
**Risk Level: Medium**  
**Speed Limit: 30 KM/Hr**  
**Coordinates: 11.45853, 77.85139**

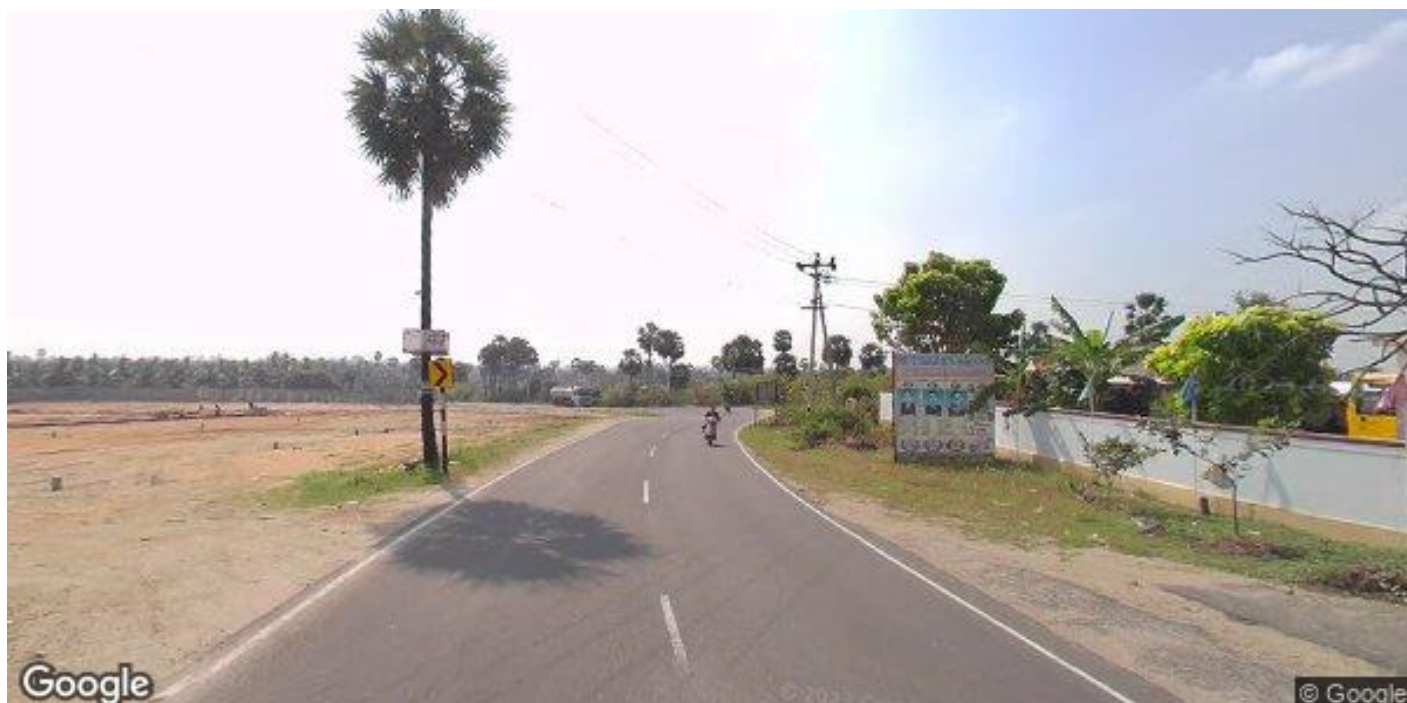
**Risk Type:** Turn  
**Risk Level:** Medium  
**Speed Limit:** 30 KM/Hr  
**Coordinates:** 11.45906, 77.85132

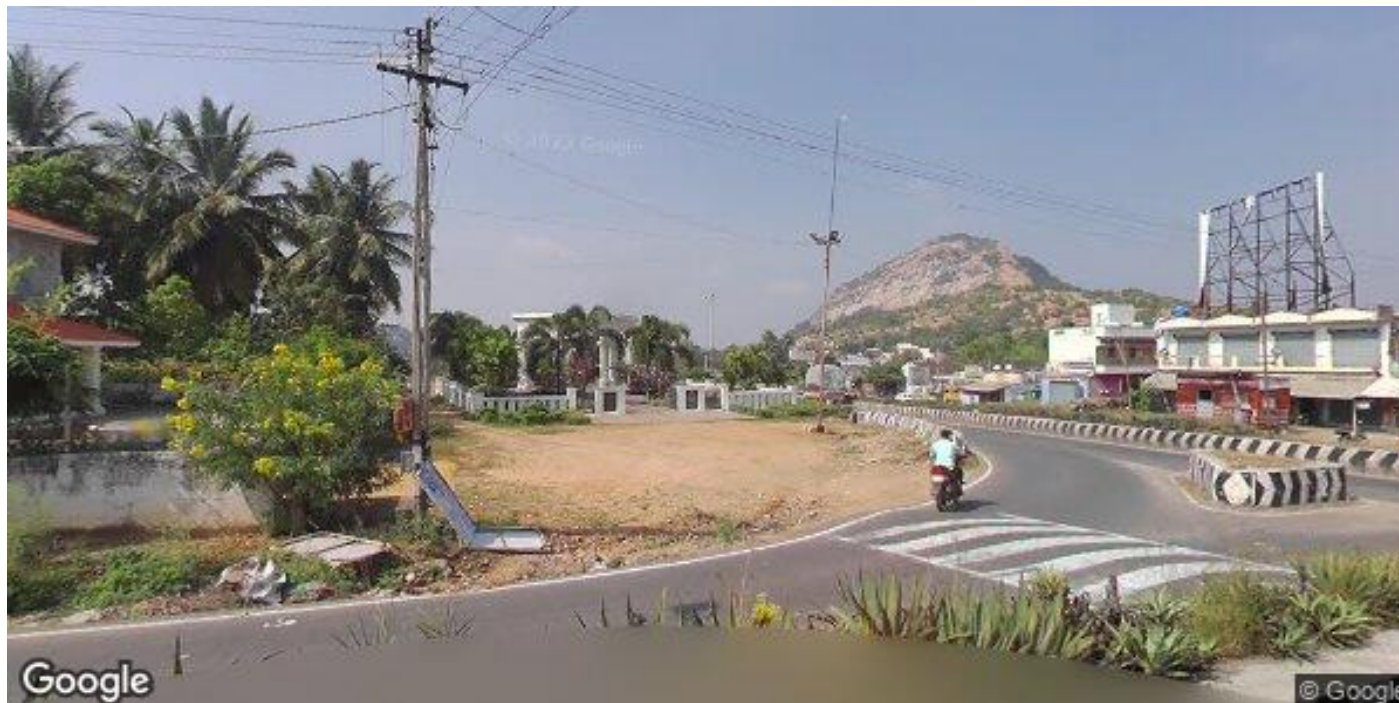
**Risk Type:** Turn  
**Risk Level:** High  
**Speed Limit:** 15 KM/Hr  
**Coordinates:** 11.46307, 77.84941

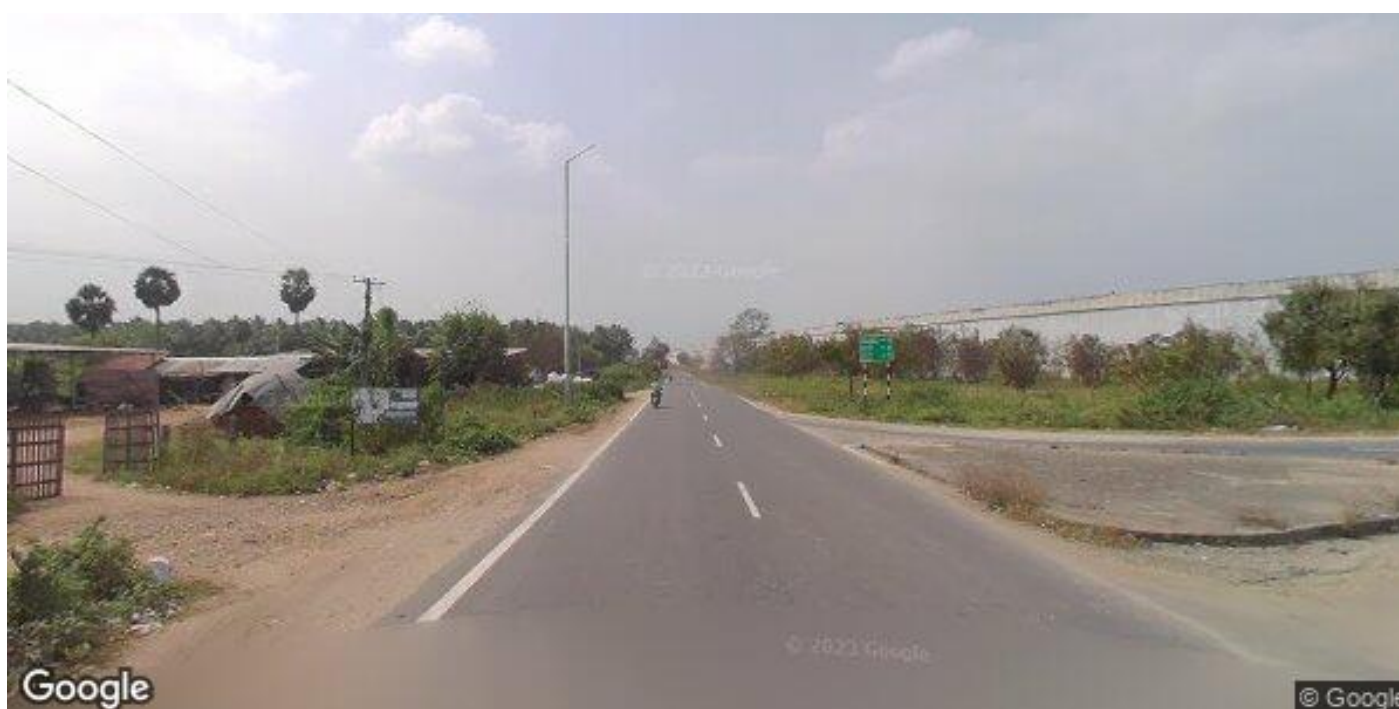
**Risk Type:** Turn  
**Risk Level:** High  
**Speed Limit:** 15 KM/Hr  
**Coordinates:** 11.45542, 77.81725

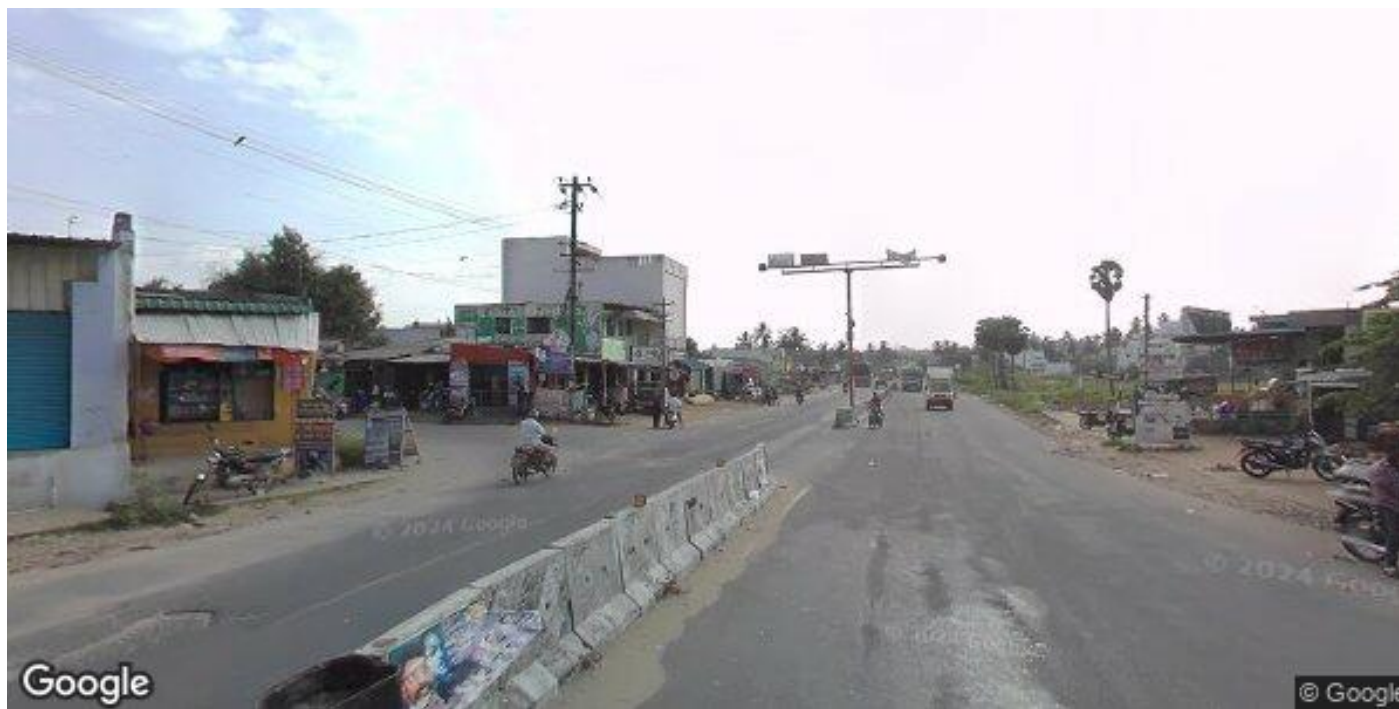
**Risk Type:** Blind Spot  
**Risk Level:** Blind Spot  
**Speed Limit:** 10 KM/Hr  
**Coordinates:** 11.48364, 77.88780

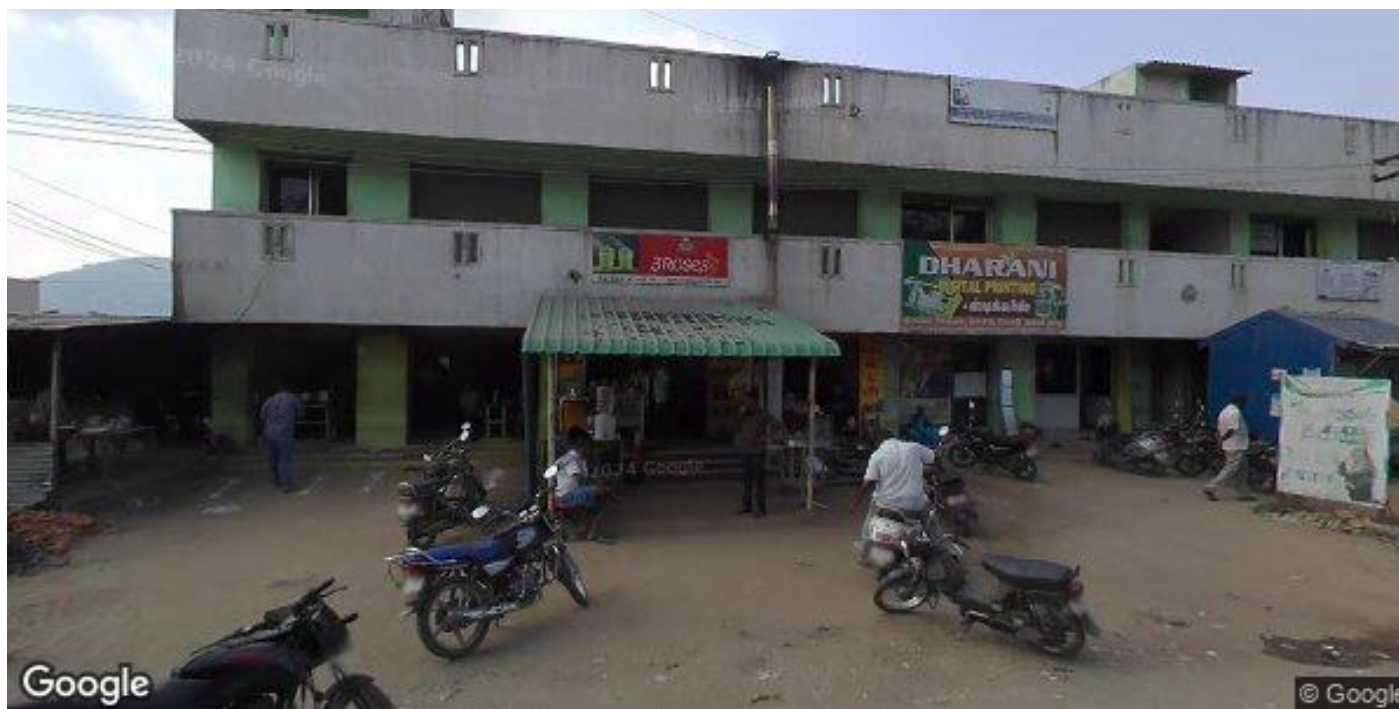
**Risk Type:** Turn  
**Risk Level:** Medium  
**Speed Limit:** 30 KM/Hr  
**Coordinates:** 11.49155, 77.88776

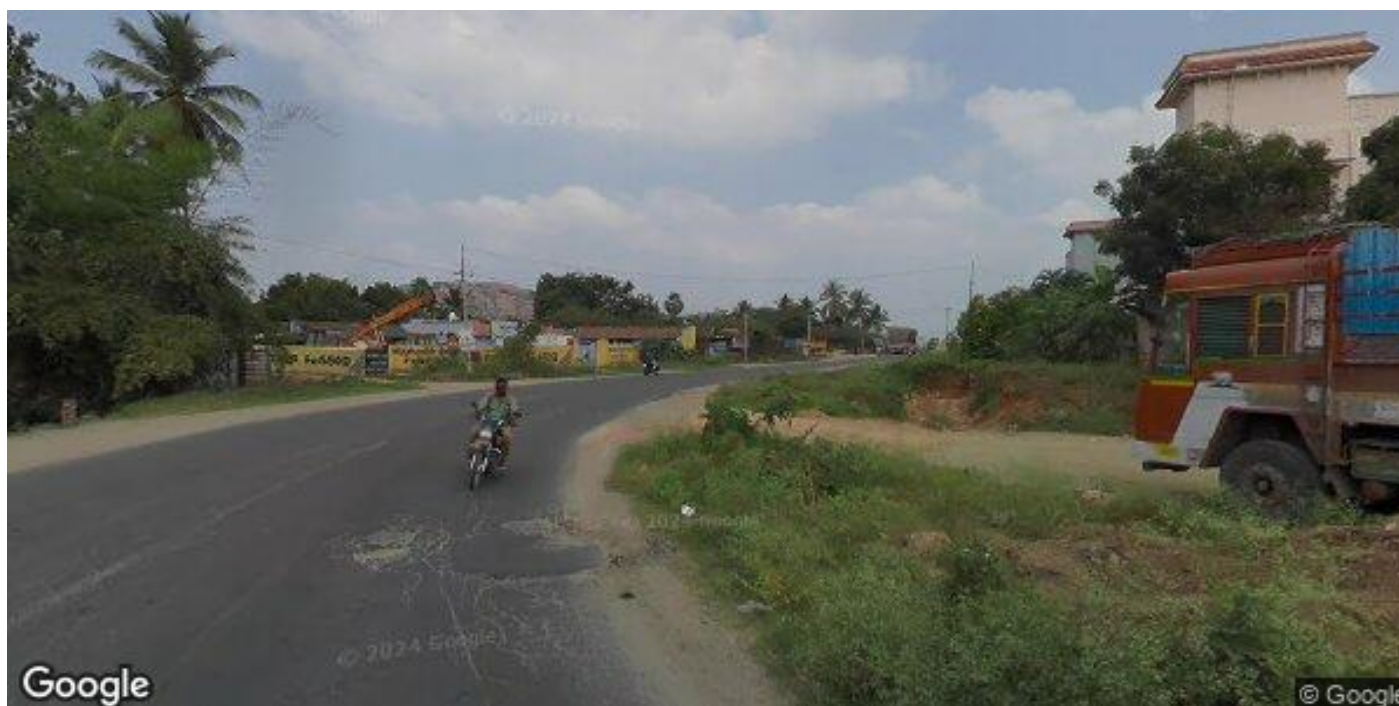
**Risk Type:** Turn  
**Risk Level:** Medium  
**Speed Limit:** 30 KM/Hr  
**Coordinates:** 11.49441, 77.88495

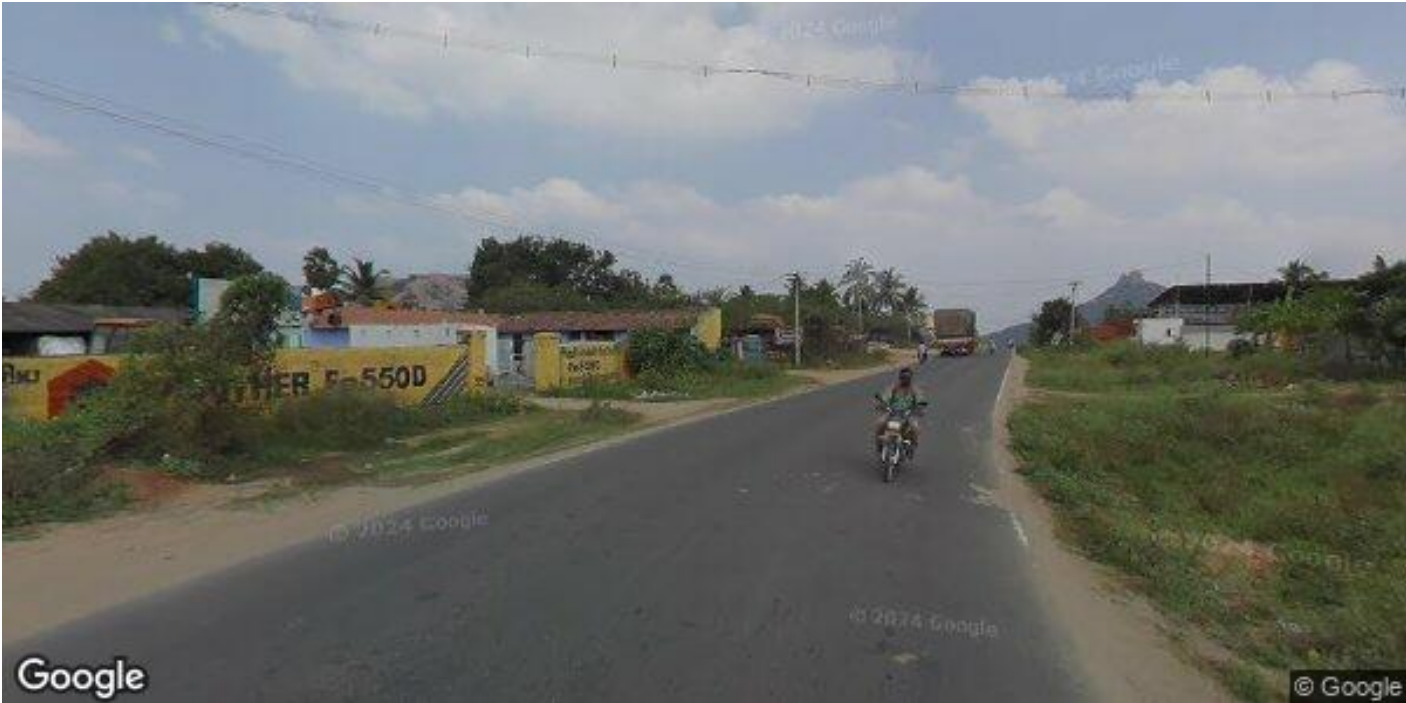
**Risk Type:** Turn  
**Risk Level:** Medium  
**Speed Limit:** 30 KM/Hr  
**Coordinates:** 11.49469, 77.88488

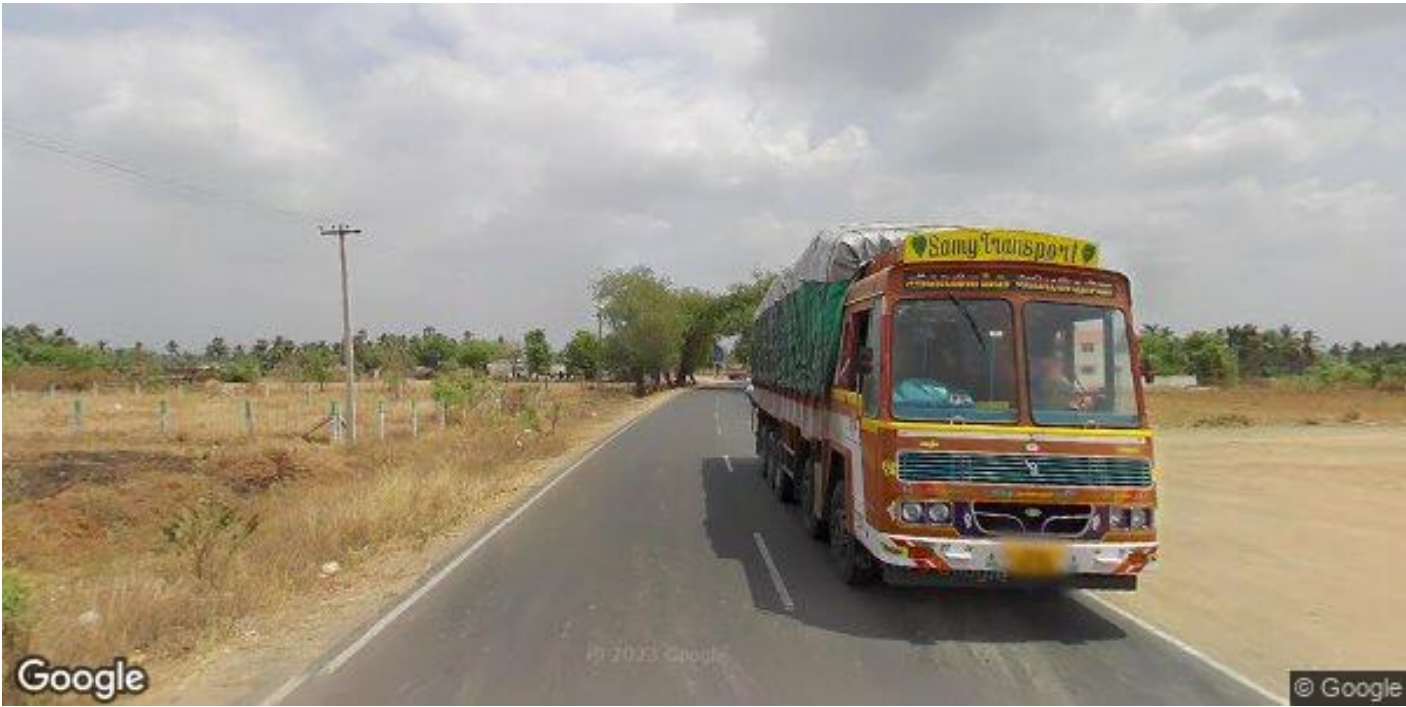
**Risk Type:** Turn  
**Risk Level:** High  
**Speed Limit:** 15 KM/Hr  
**Coordinates:** 11.55614, 77.89764

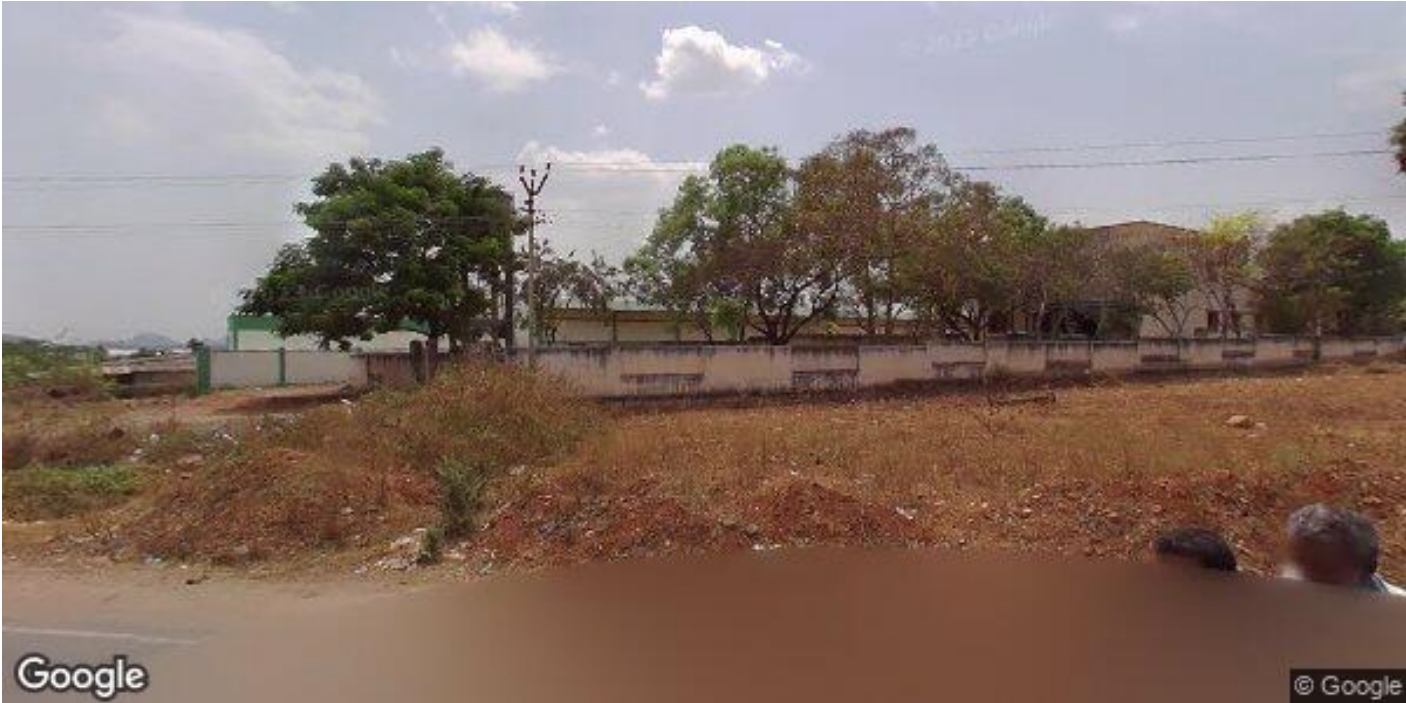
**Risk Type:** Turn  
**Risk Level:** High  
**Speed Limit:** 15 KM/Hr  
**Coordinates:** 11.58330, 77.90642

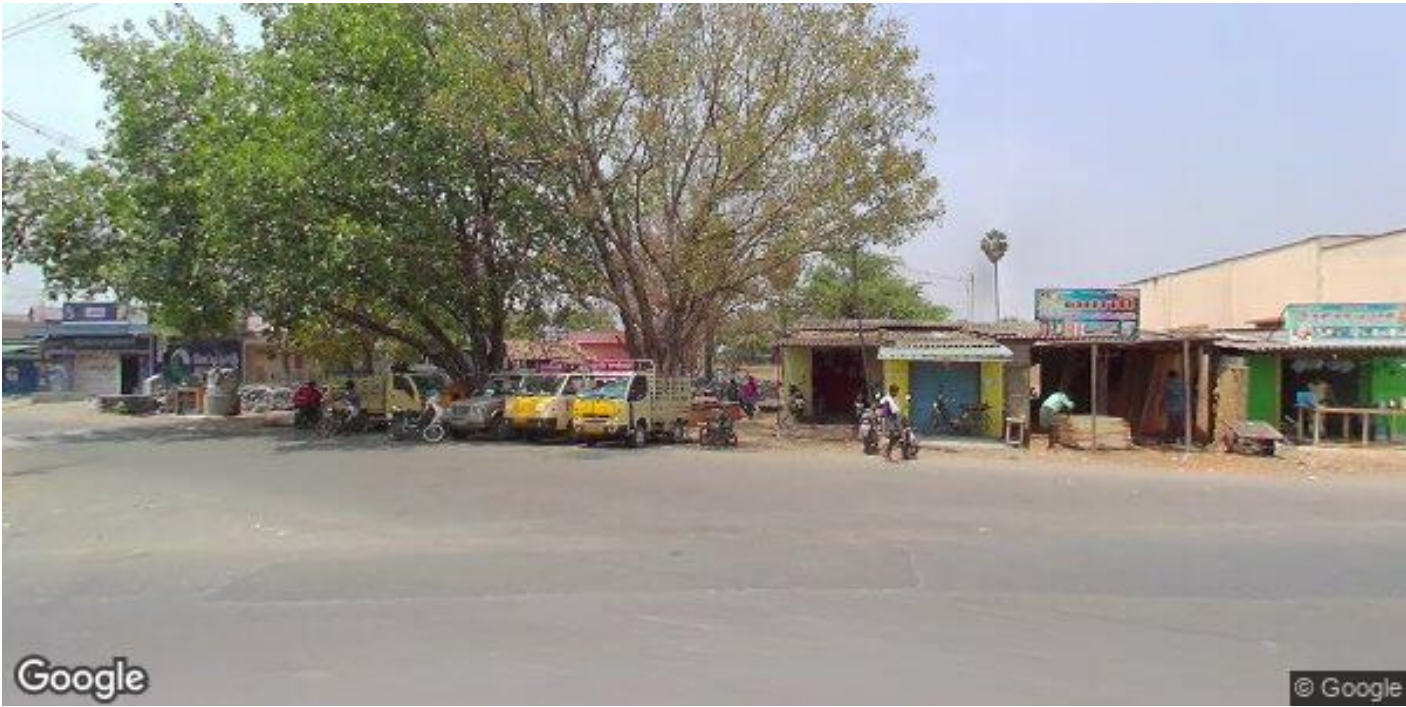
**Risk Type:** Turn  
**Risk Level:** Medium  
**Speed Limit:** 30 KM/Hr  
**Coordinates:** 11.64712, 77.95118

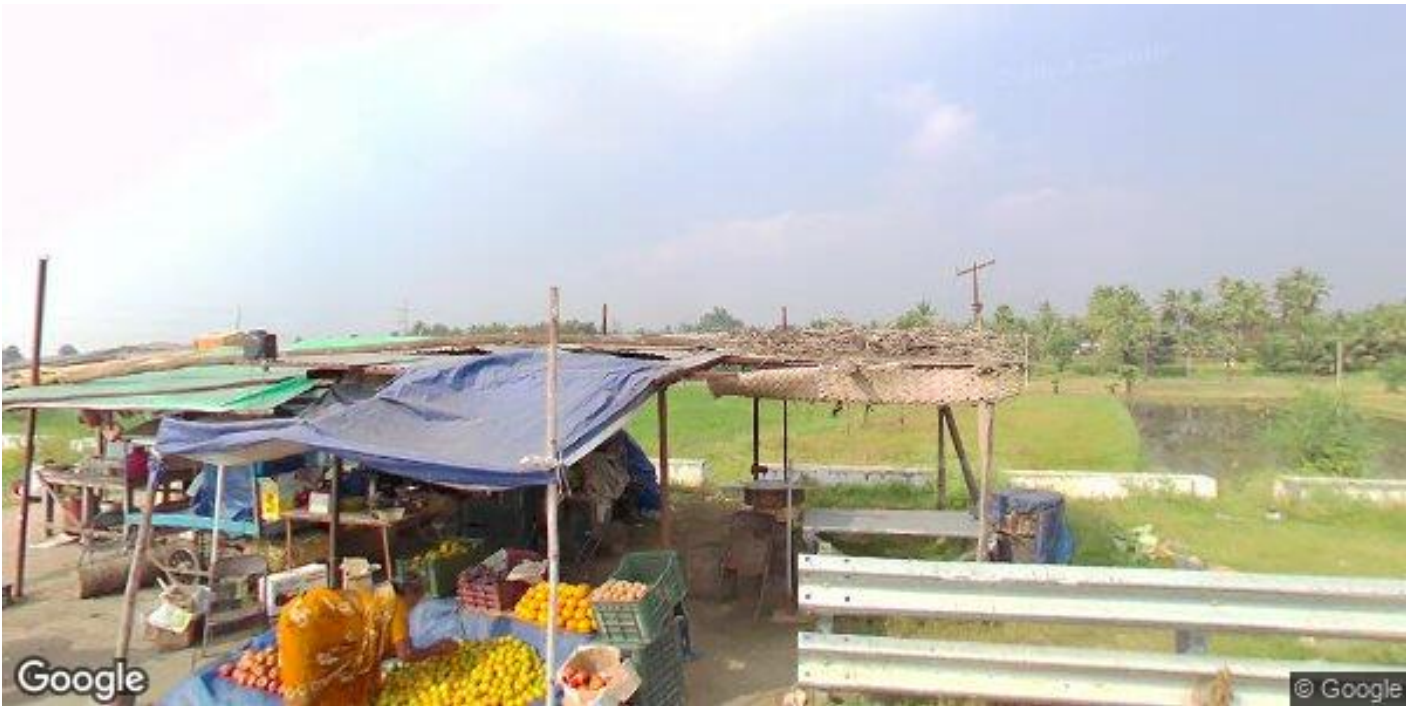
**Risk Type:** Turn  
**Risk Level:** Medium  
**Speed Limit:** 30 KM/Hr  
**Coordinates:** 11.67858, 77.96834

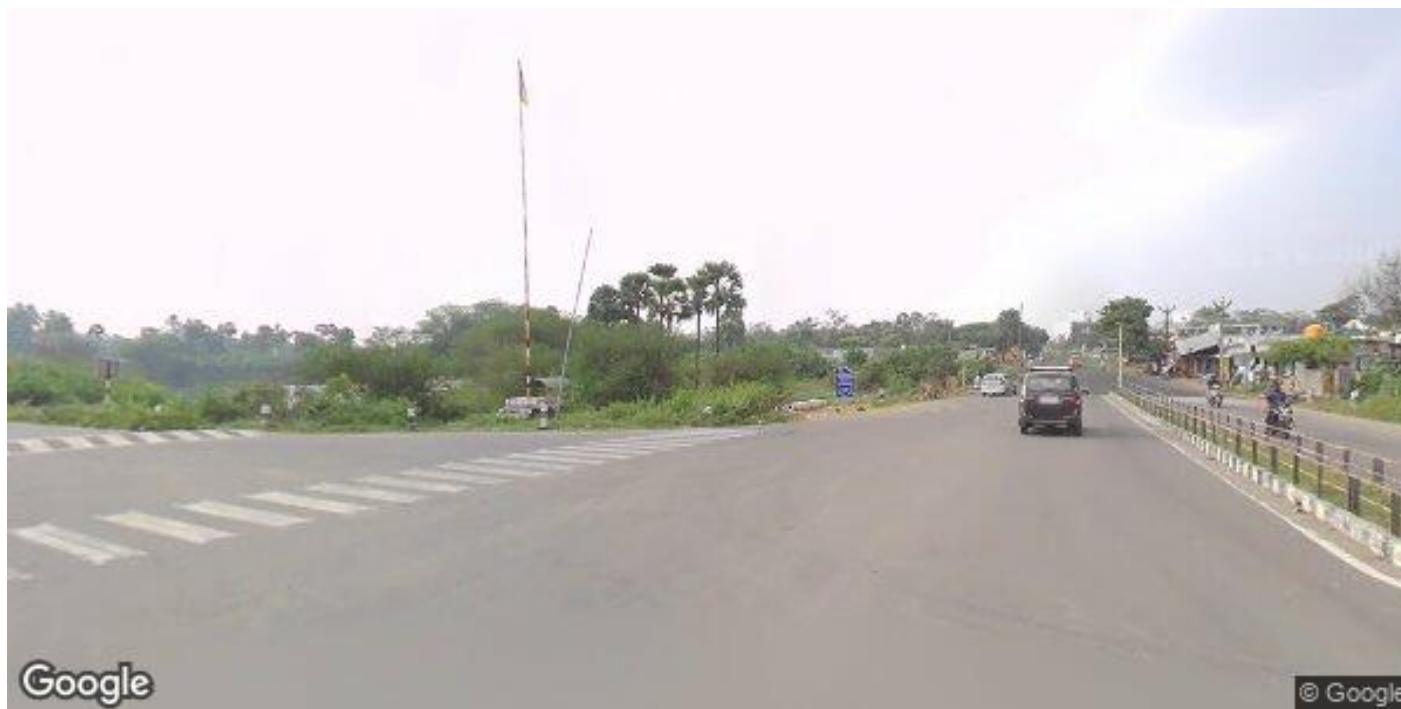
**Risk Type:** Turn  
**Risk Level:** High  
**Speed Limit:** 15 KM/Hr  
**Coordinates:** 11.70218, 77.97866

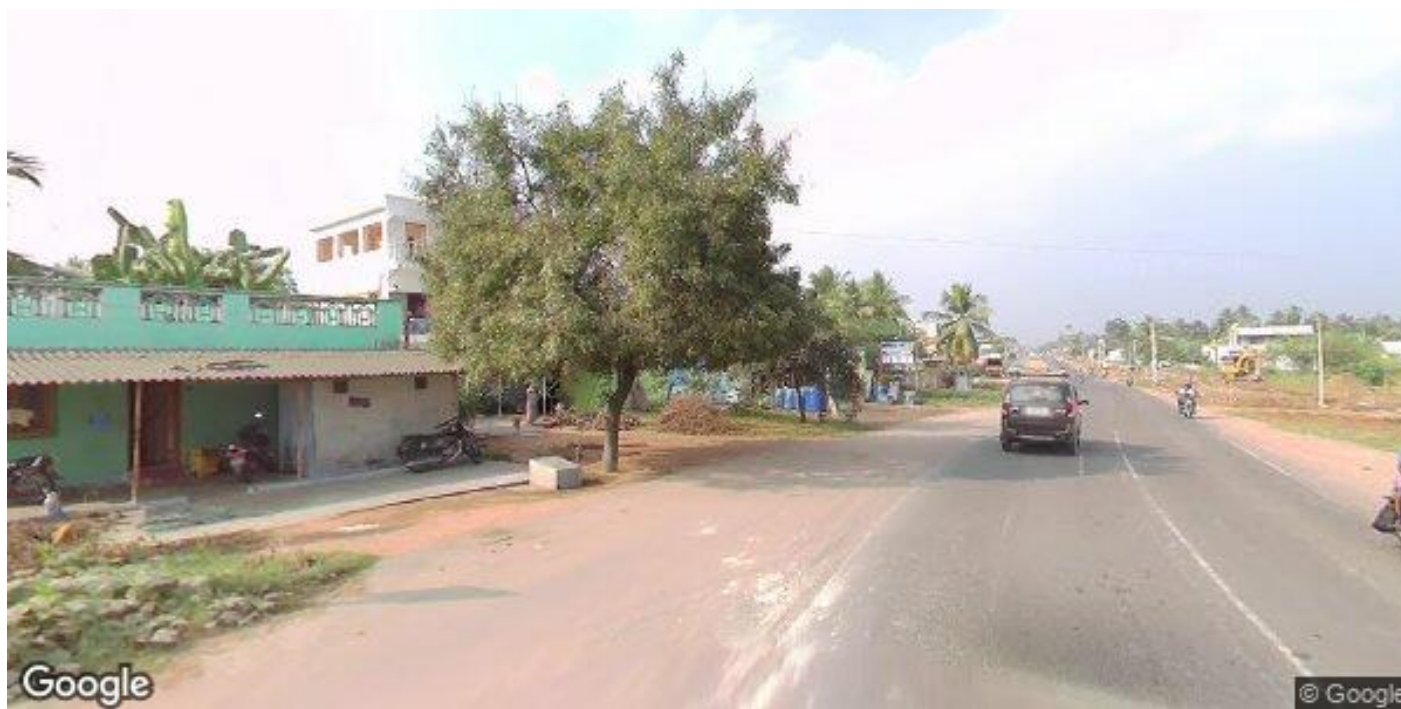
**Risk Type:** Turn  
**Risk Level:** Medium  
**Speed Limit:** 30 KM/Hr  
**Coordinates:** 11.71917, 78.01123

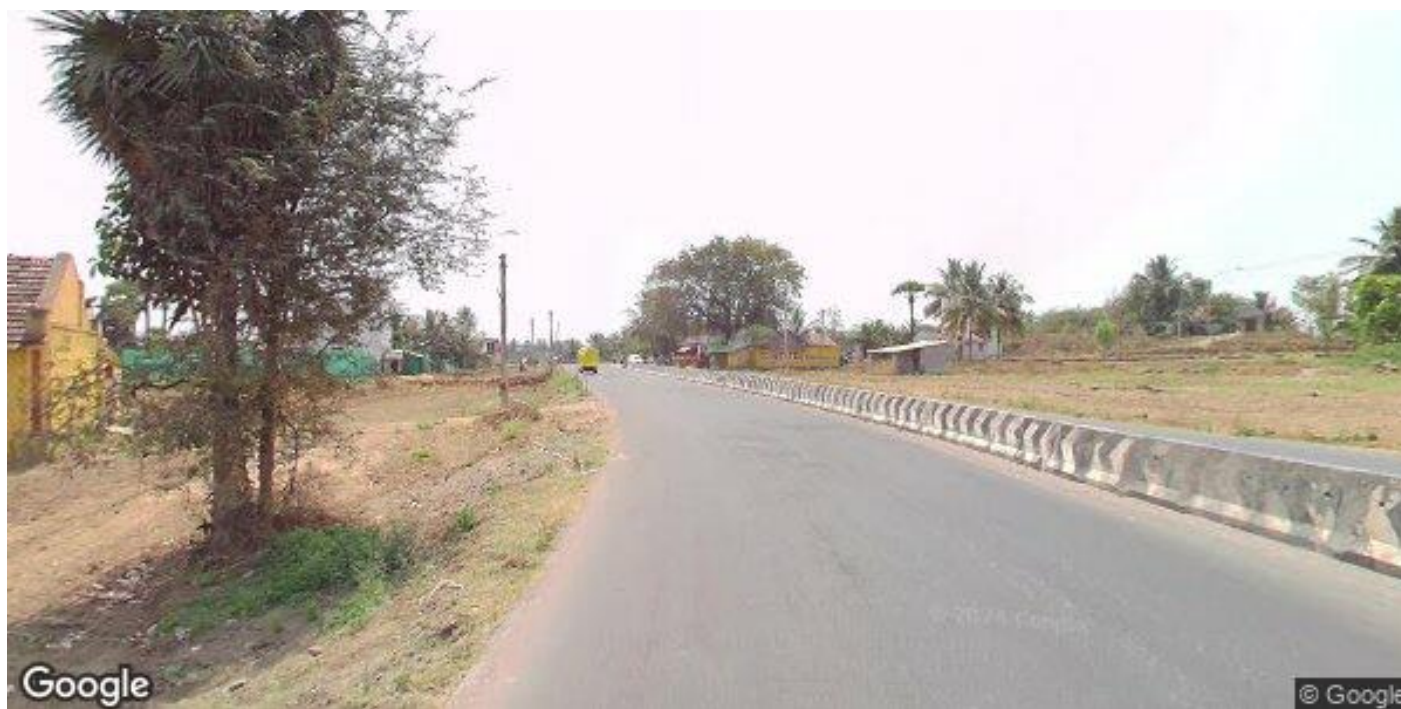
**Risk Type:** Turn  
**Risk Level:** Medium  
**Speed Limit:** 30 KM/Hr  
**Coordinates:** 11.72565, 78.01770

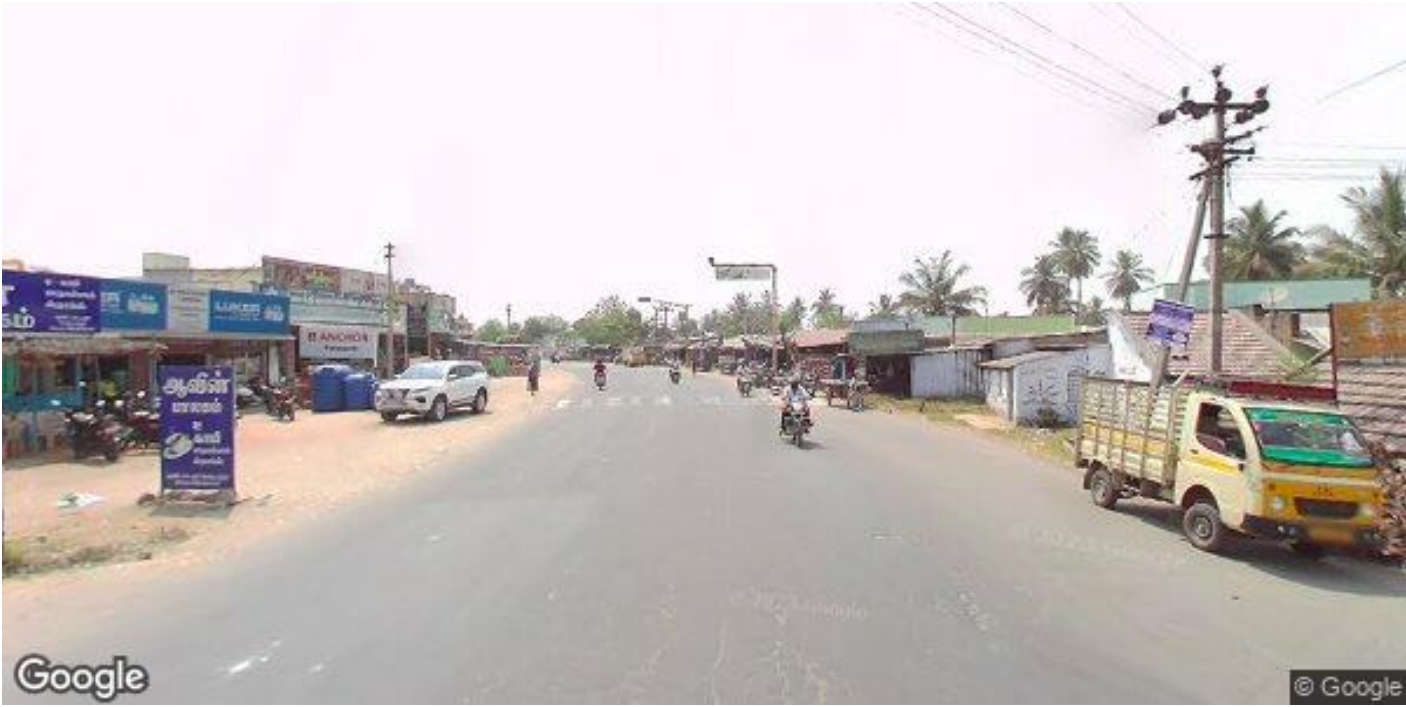
**Risk Type:** Turn  
**Risk Level:** Medium  
**Speed Limit:** 30 KM/Hr  
**Coordinates:** 11.73787, 78.03528

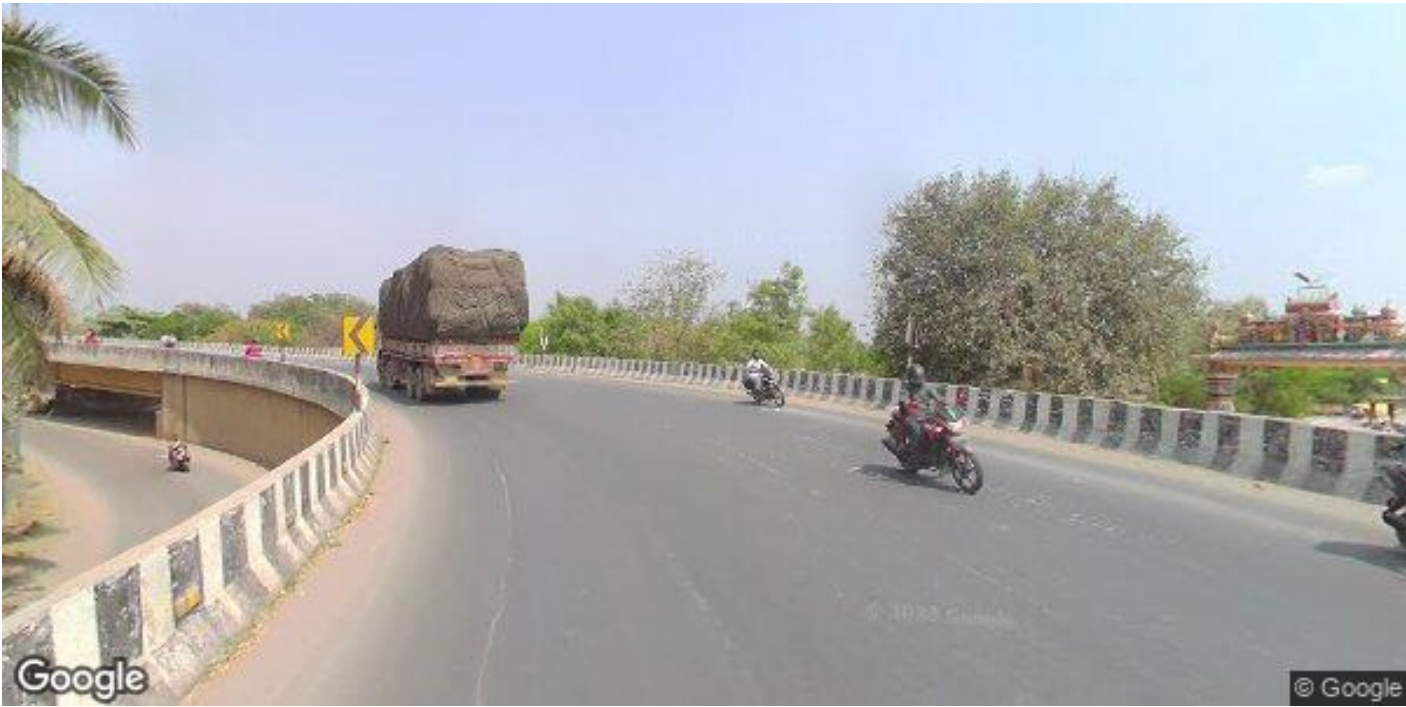
**Risk Type:** Turn  
**Risk Level:** High  
**Speed Limit:** 15 KM/Hr  
**Coordinates:** 11.73651, 78.03868

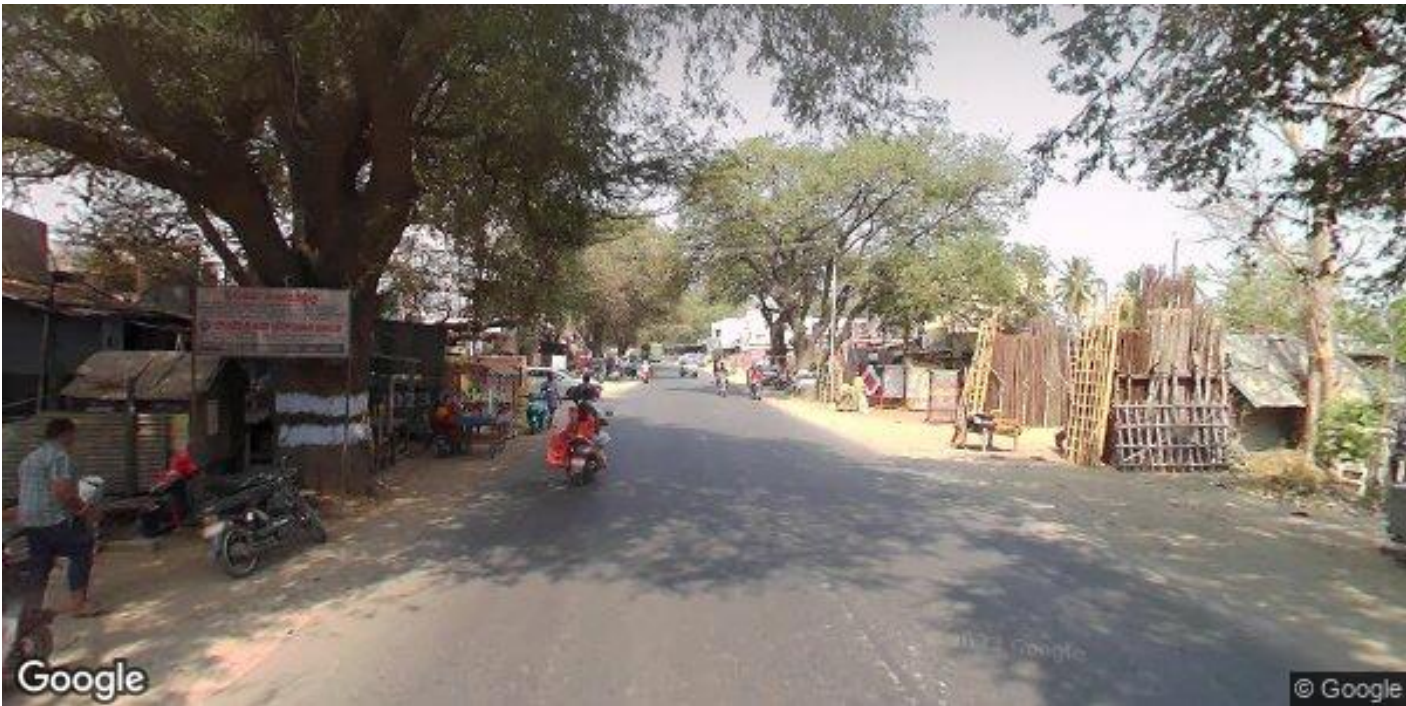
**Risk Type:** Turn  
**Risk Level:** Medium  
**Speed Limit:** 30 KM/Hr  
**Coordinates:** 11.74120, 78.04588

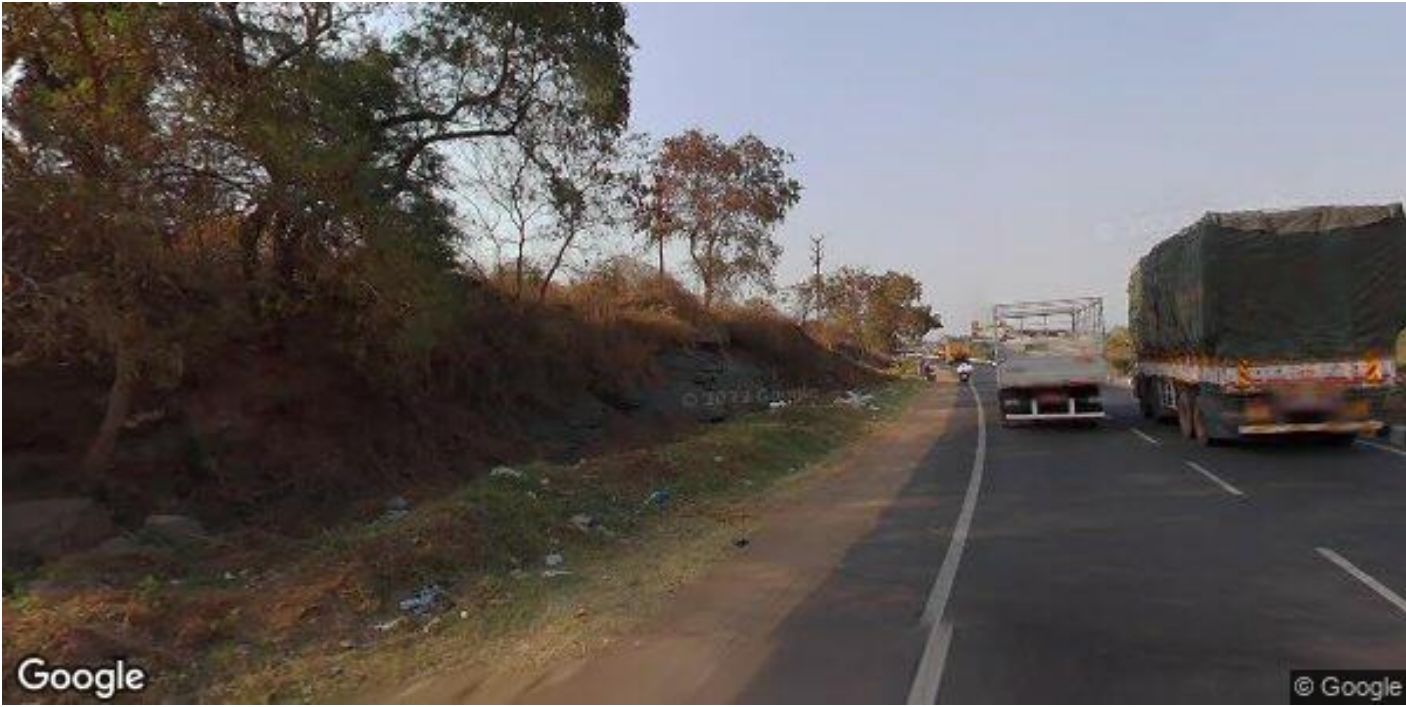
**Risk Type:** Turn  
**Risk Level:** Medium  
**Speed Limit:** 30 KM/Hr  
**Coordinates:** 11.78045, 78.05792

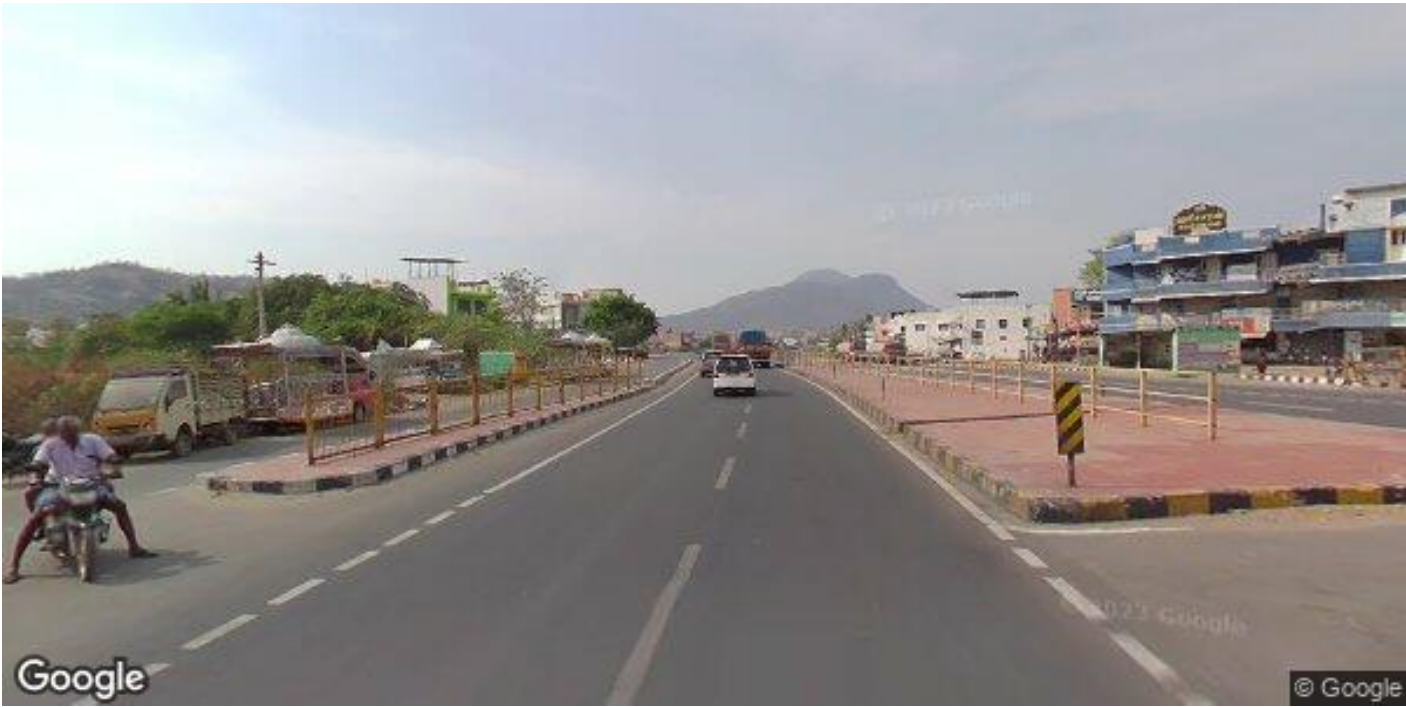
**Risk Type:** Blind Spot  
**Risk Level:** Blind Spot  
**Speed Limit:** 10 KM/Hr  
**Coordinates:** 11.87104, 78.08356
