## JOURNEY RISK MANAGEMENT (JRM) STUDY

### Salem Terminal to Dhanalakshmi Agencies Adhoc

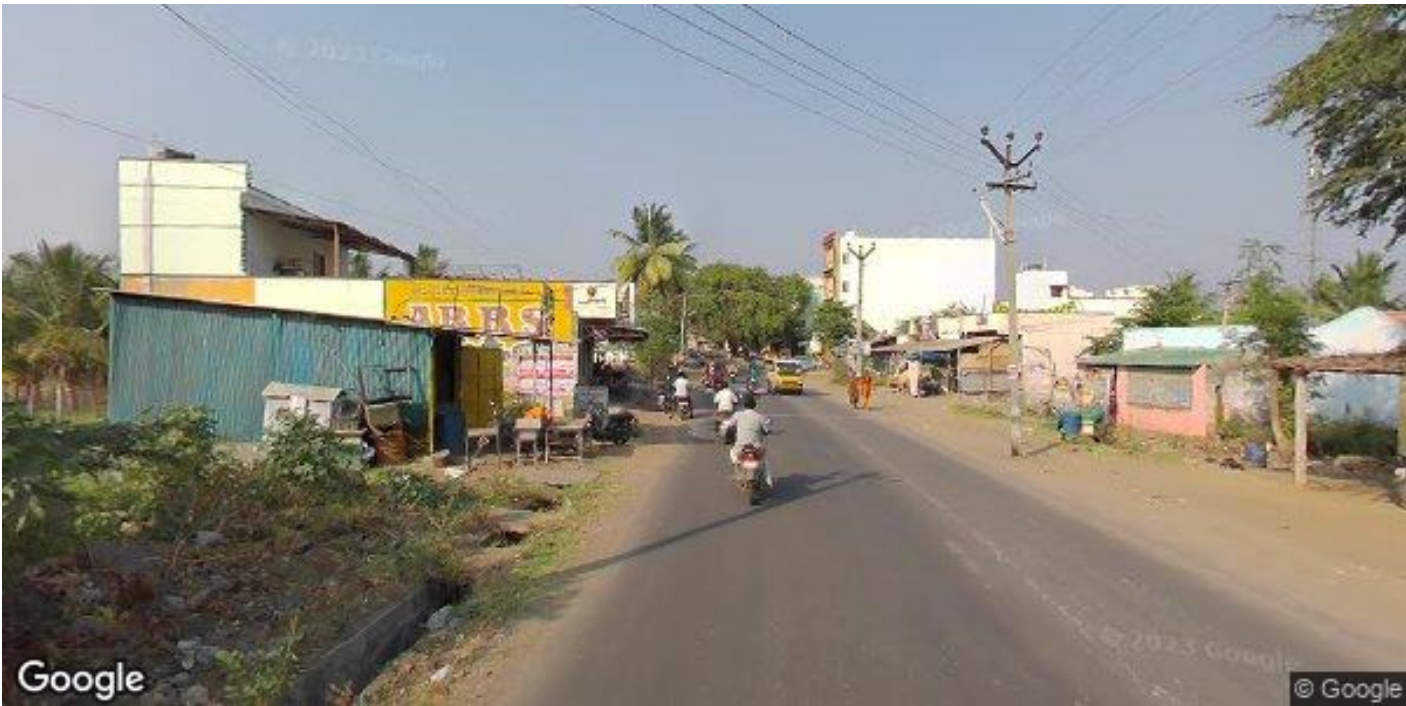
**Risk Type:** Turn  
**Risk Level:** Medium  
**Speed Limit:** 30 KM/Hr  
**Coordinates:** 11.87106, 78.08579

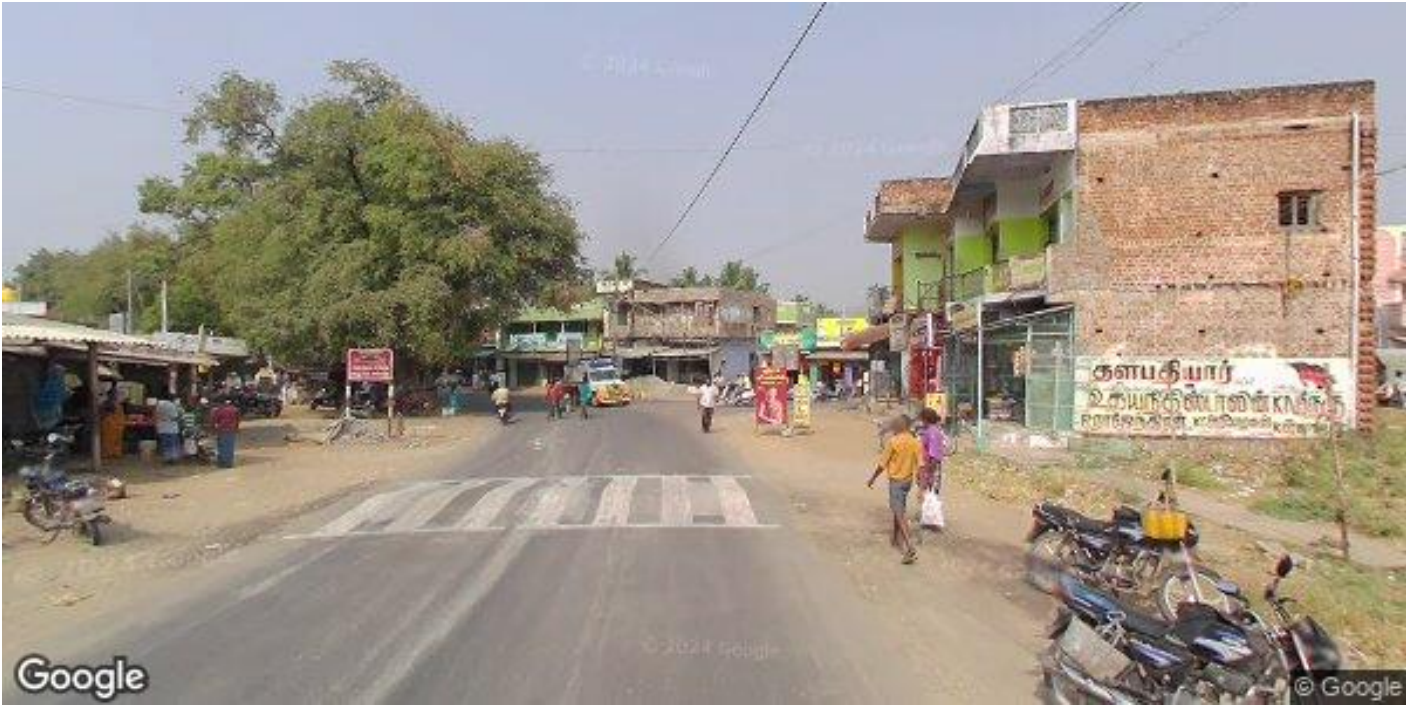
**Risk Type:** Turn  
**Risk Level:** Medium  
**Speed Limit:** 30 KM/Hr  
**Coordinates:** 11.87257, 78.08738

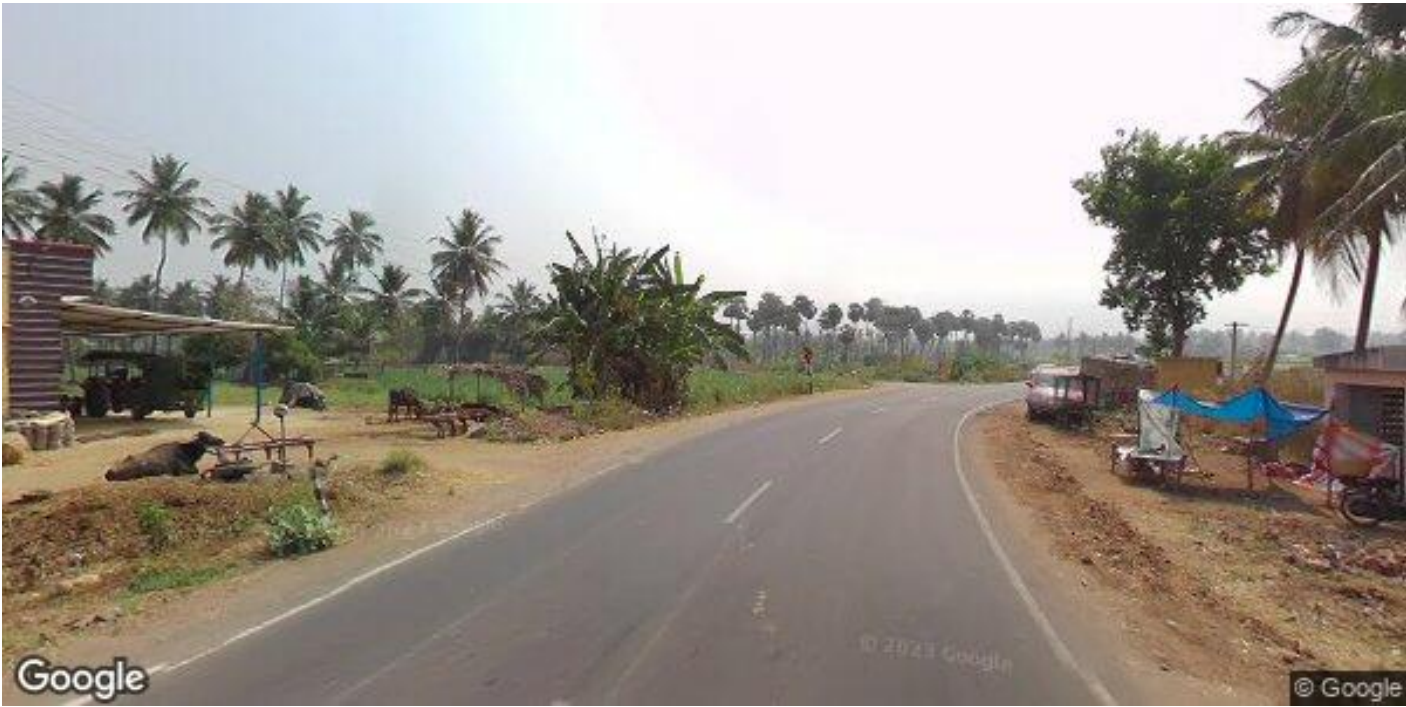
**Risk Type:** Turn  
**Risk Level:** Medium  
**Speed Limit:** 30 KM/Hr  
**Coordinates:** 11.86902, 78.12044
