# IndianOil

## JOURNEY RISK MANAGEMENT (JRM) STUDY

### Salem Terminal to AMBAL FUEL AGENCIES

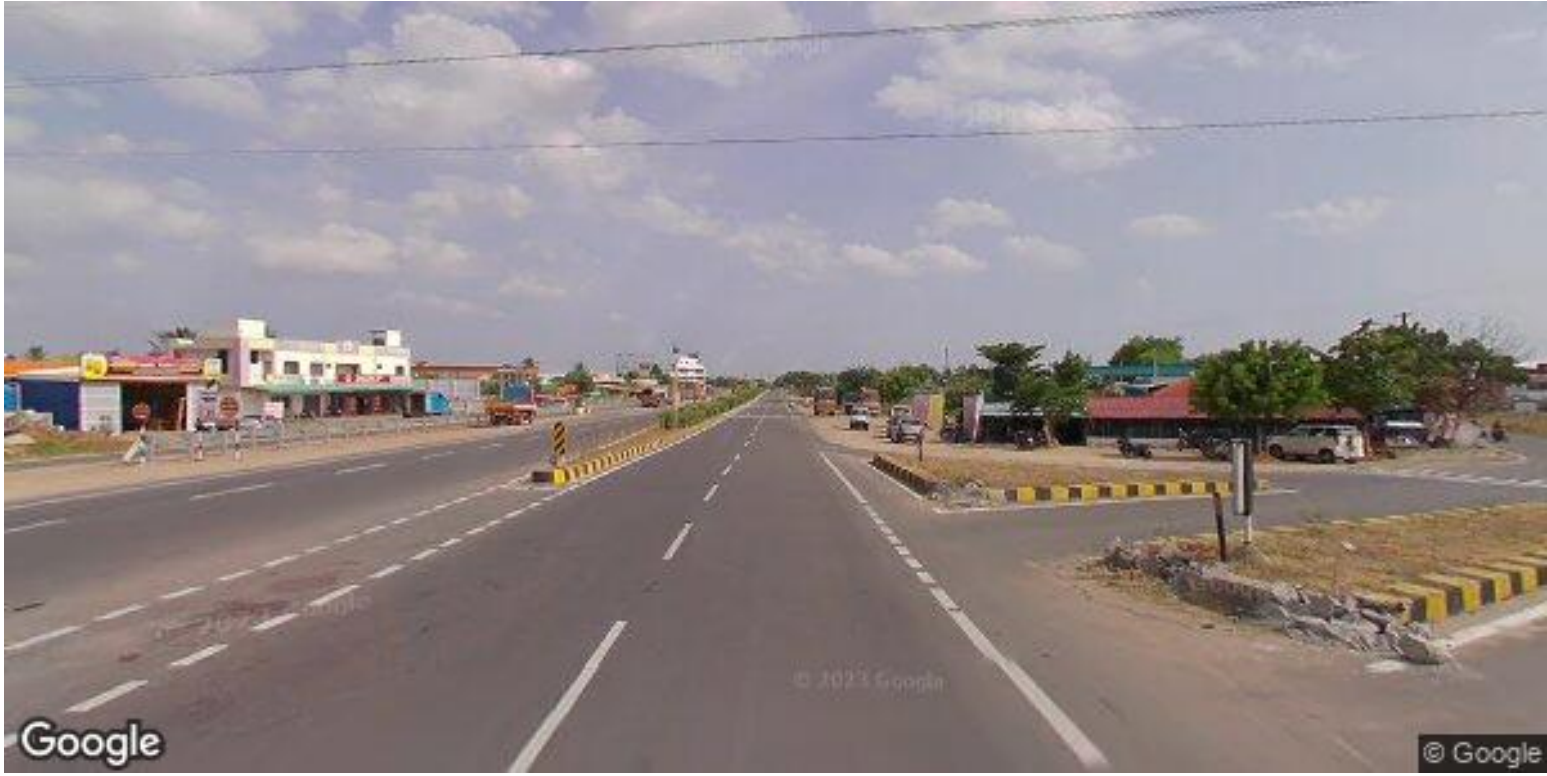
| | Risk Type | Risk Level | Coordinates | Speed Limit |
|---|---|---|---|---|
| 1 | U-Turn | High | 11.3169758, 78.17175879999999 | 10 KM/Hr |

Risk Type: U-Turn  
Risk Level: High  
Speed Limit: 10 KM/Hr  
Coordinates: 11.3169758, 78.17175879999999

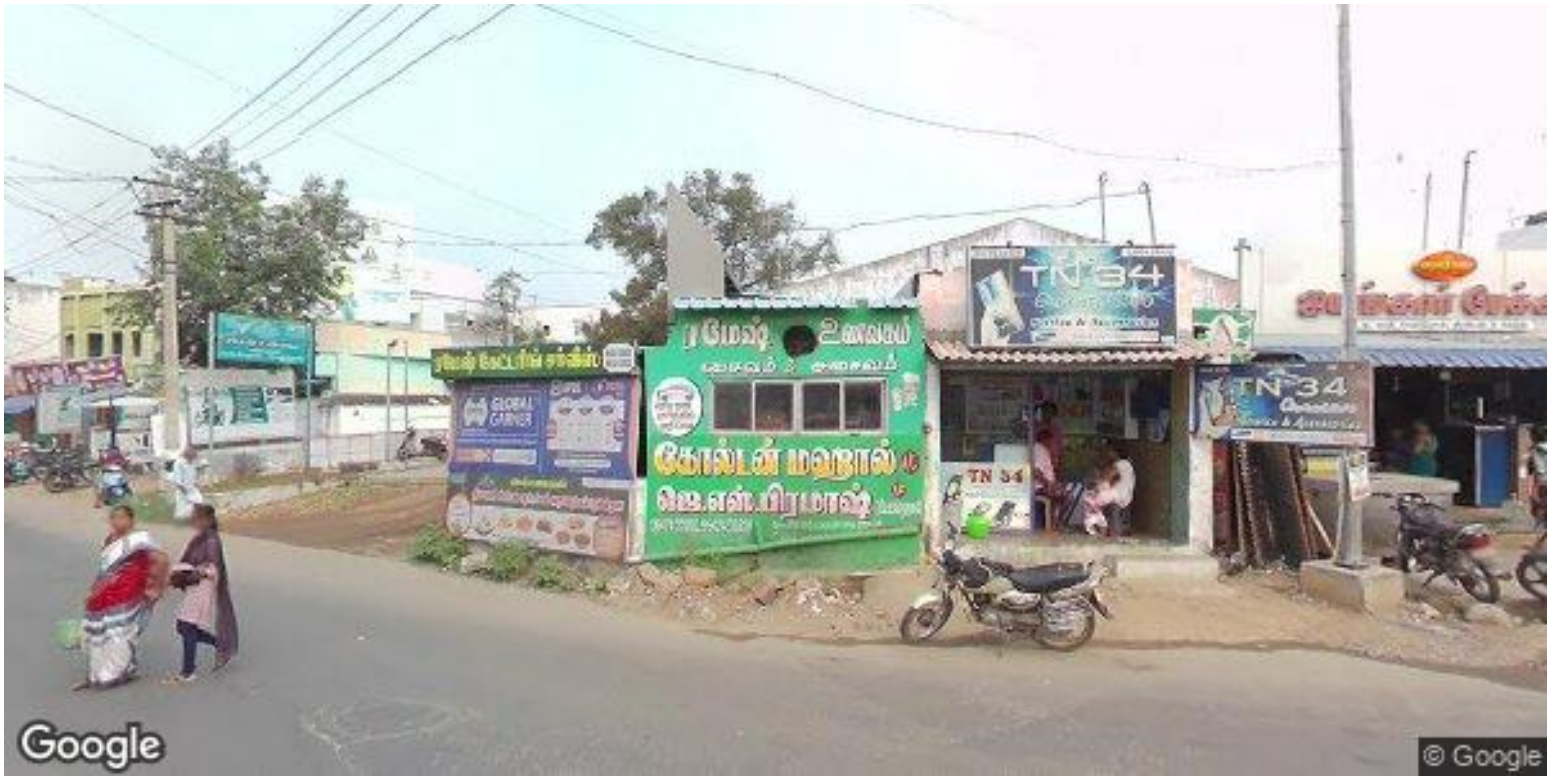
| | Risk Type | Risk Level | Coordinates | Speed Limit |
|---|---|---|---|---|
| 6 | Turn | Medium | 11.38346, 77.89975 | 30 KM/Hr |

**Risk Type:** Turn  
**Risk Level:** Medium  
**Speed Limit:** 30 KM/Hr  
**Coordinates:** 11.38346, 77.89975

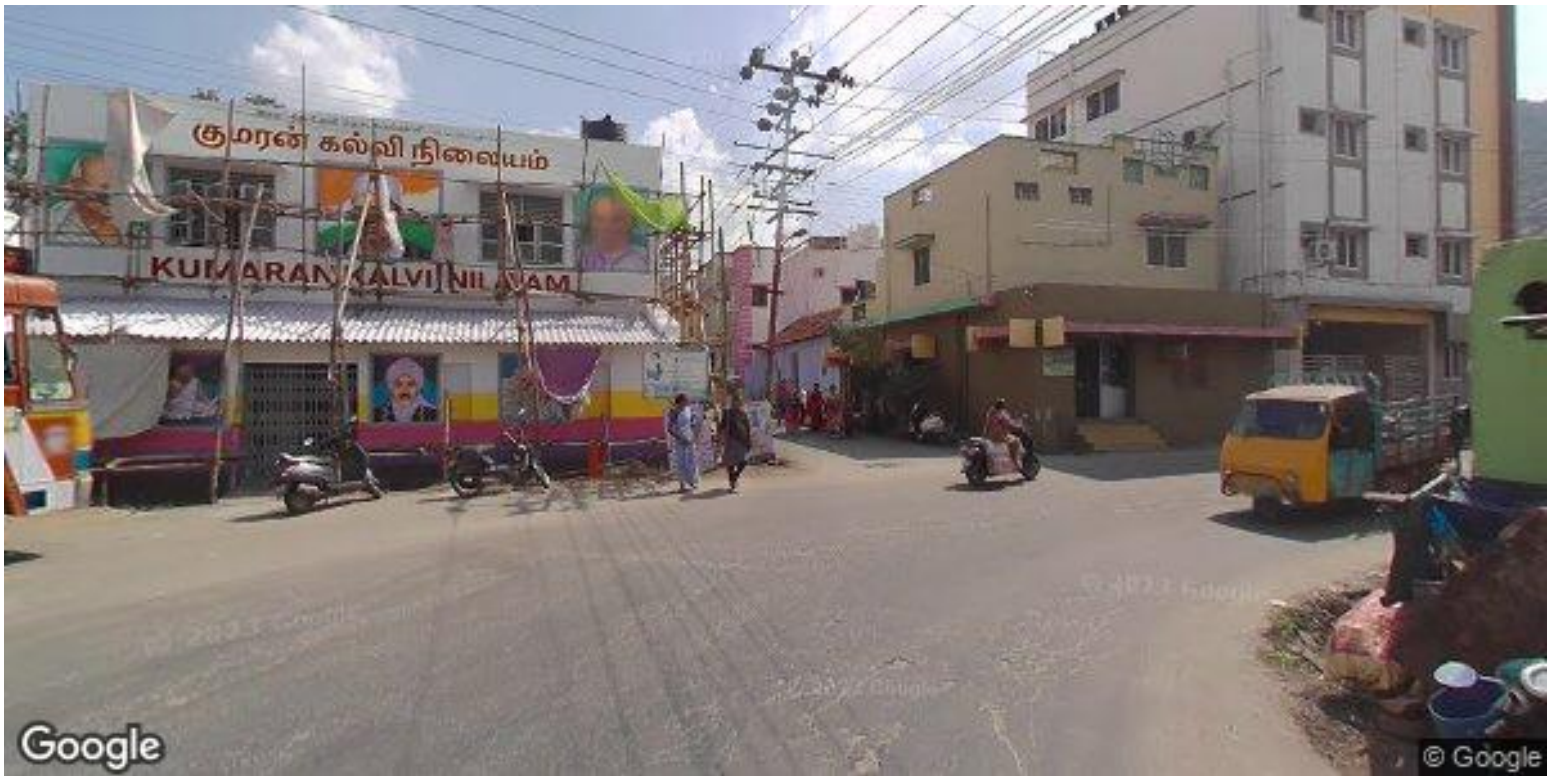
| | Risk Type | Risk Level | Coordinates | Speed Limit |
|---|---|---|---|---|
| 7 | Blind Spot | Blind Spot | 11.38188, 77.90257 | 10 KM/Hr |

**Risk Type:** Blind Spot  
**Risk Level:** Blind Spot  
**Speed Limit:** 10 KM/Hr  
**Coordinates:** 11.38188, 77.90257

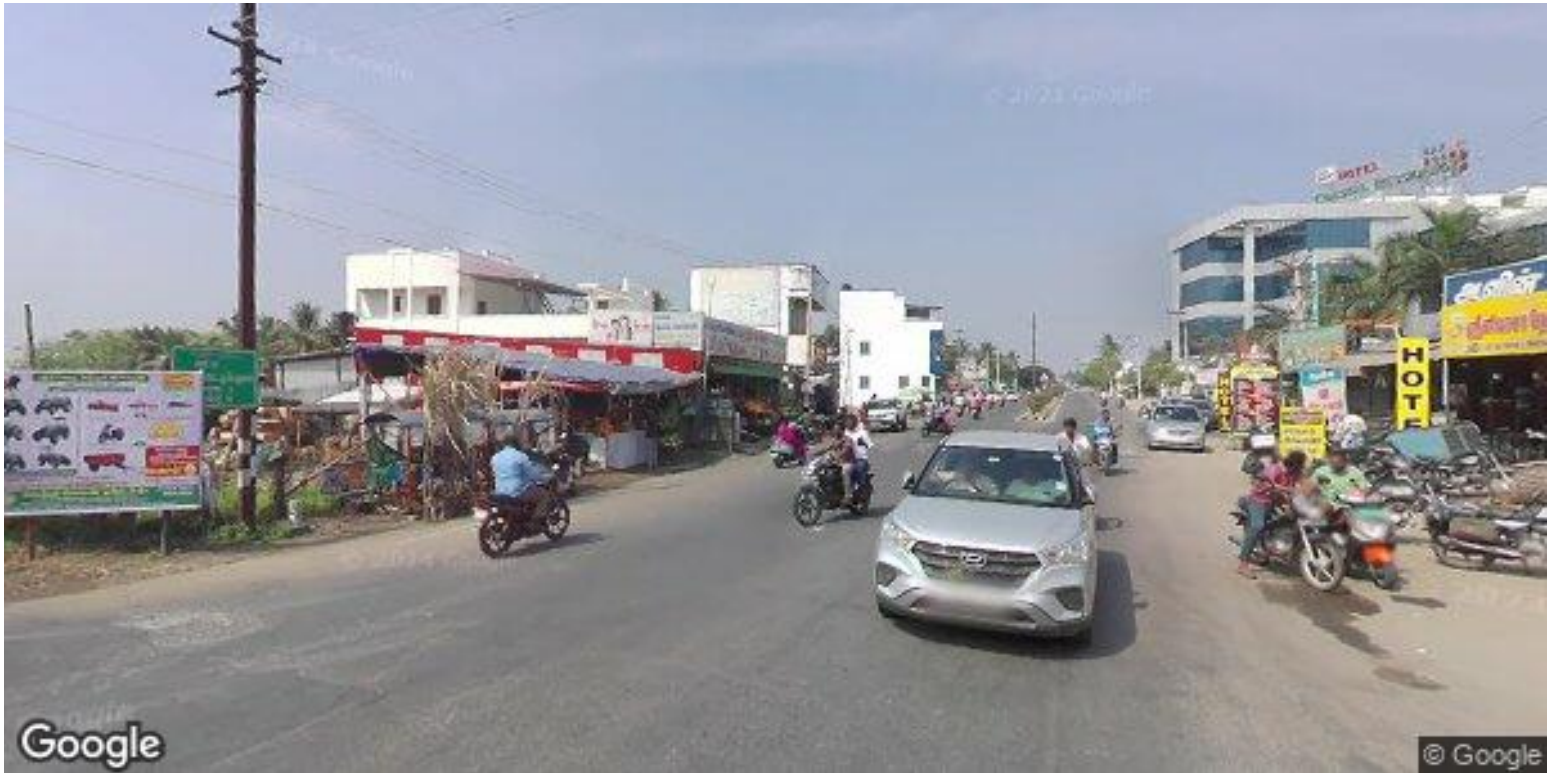
| | Risk Type | Risk Level | Coordinates | Speed Limit |
|---|---|---|---|---|
| 9 | Turn | High | 11.23961, 78.14223 | 15 KM/Hr |

**Risk Type:** Turn  
**Risk Level:** High  
**Speed Limit:** 15 KM/Hr  
**Coordinates:** 11.23961, 78.14223

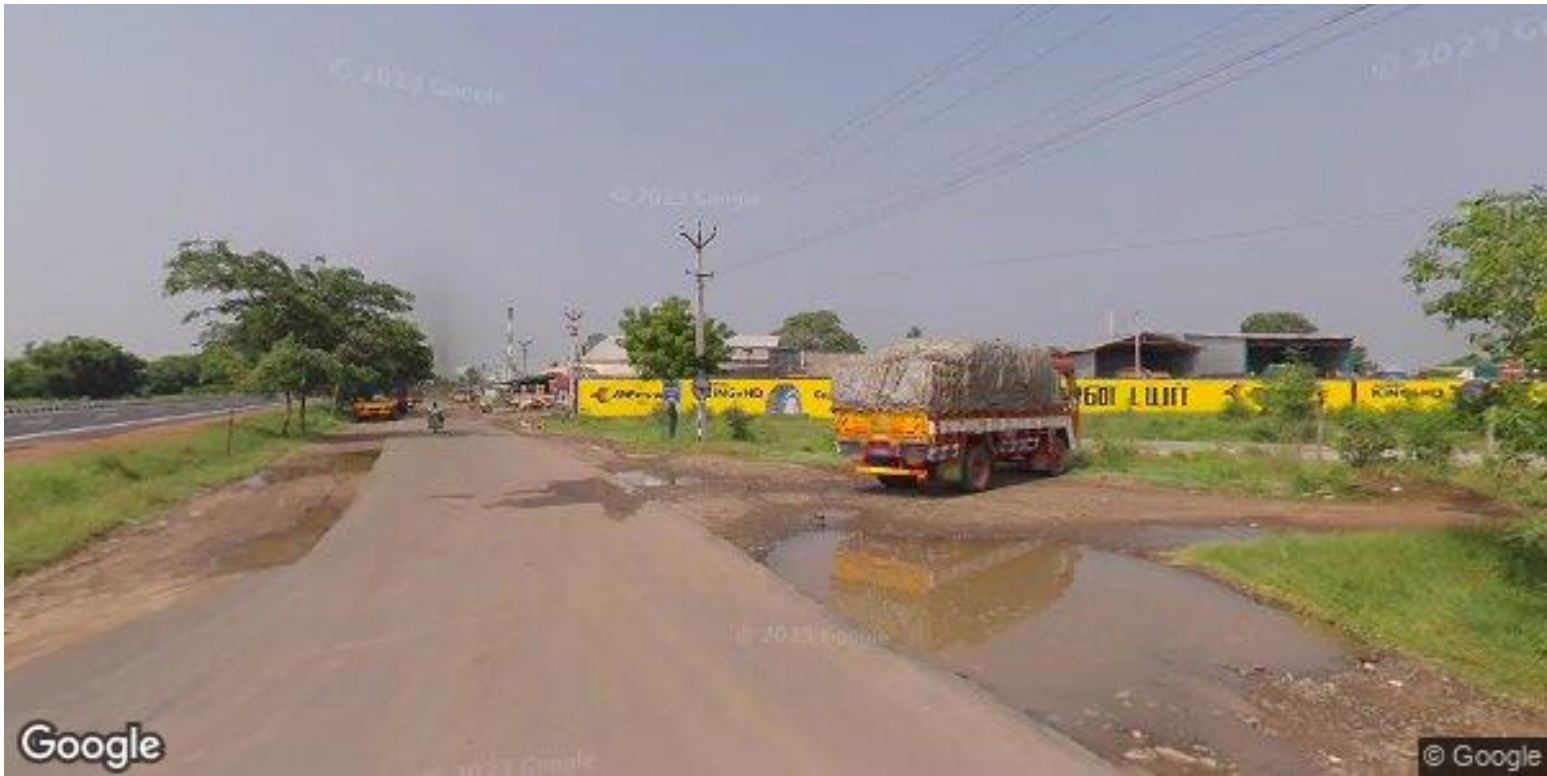
| | Risk Type | Risk Level | Coordinates | Speed Limit |
|---|---|---|---|---|
| 10 | Turn | High | 11.24549, 78.14753 | 15 KM/Hr |

**Risk Type:** Turn  
**Risk Level:** High  
**Speed Limit:** 15 KM/Hr  
**Coordinates:** 11.24549, 78.14753

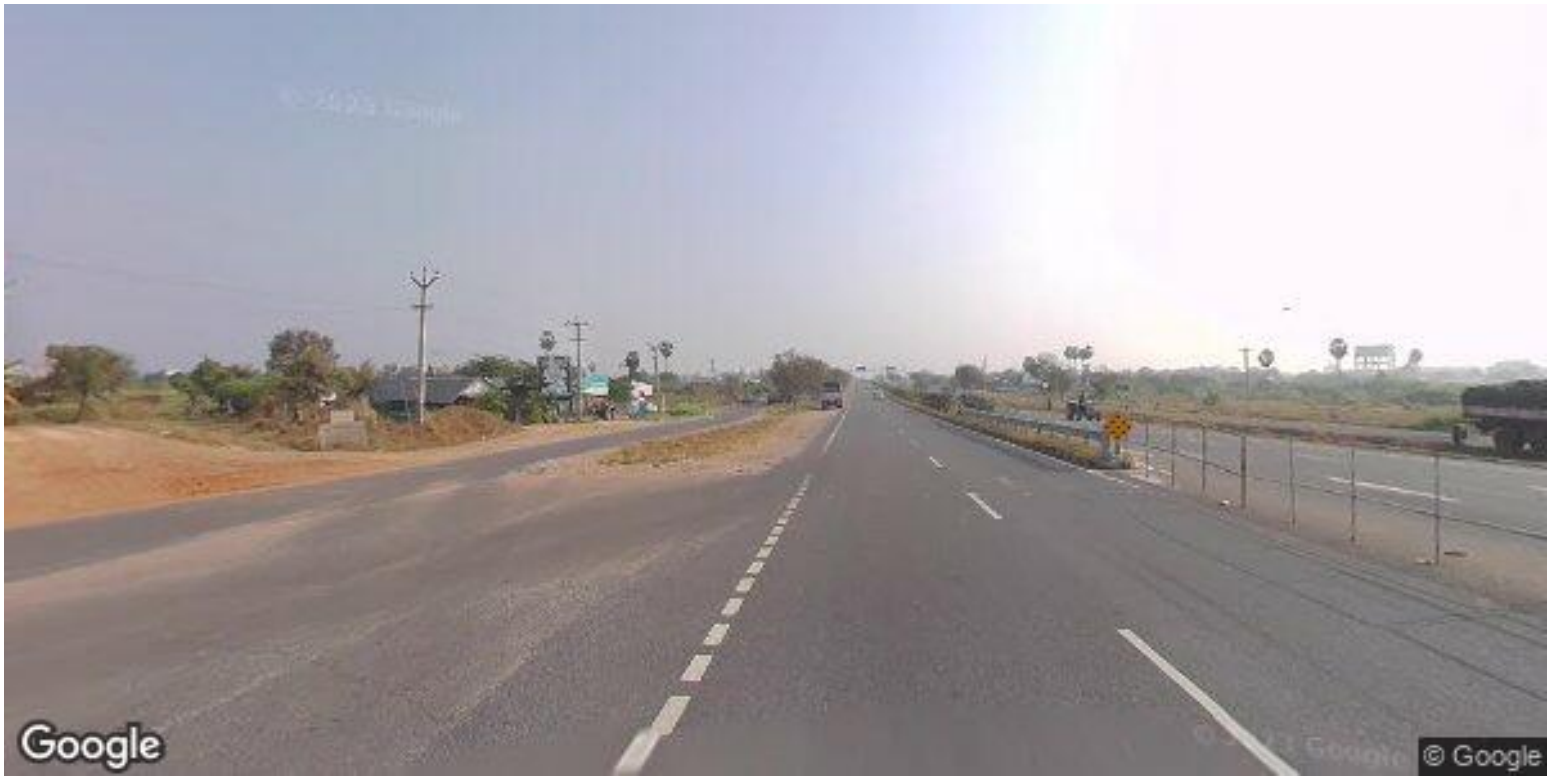
| | Risk Type | Risk Level | Coordinates | Speed Limit |
|---|---|---|---|---|
| 11 | Turn | High | 11.24537, 78.14763 | 15 KM/Hr |

**Risk Type:** Turn  
**Risk Level:** High  
**Speed Limit:** 15 KM/Hr  
**Coordinates:** 11.24537, 78.14763

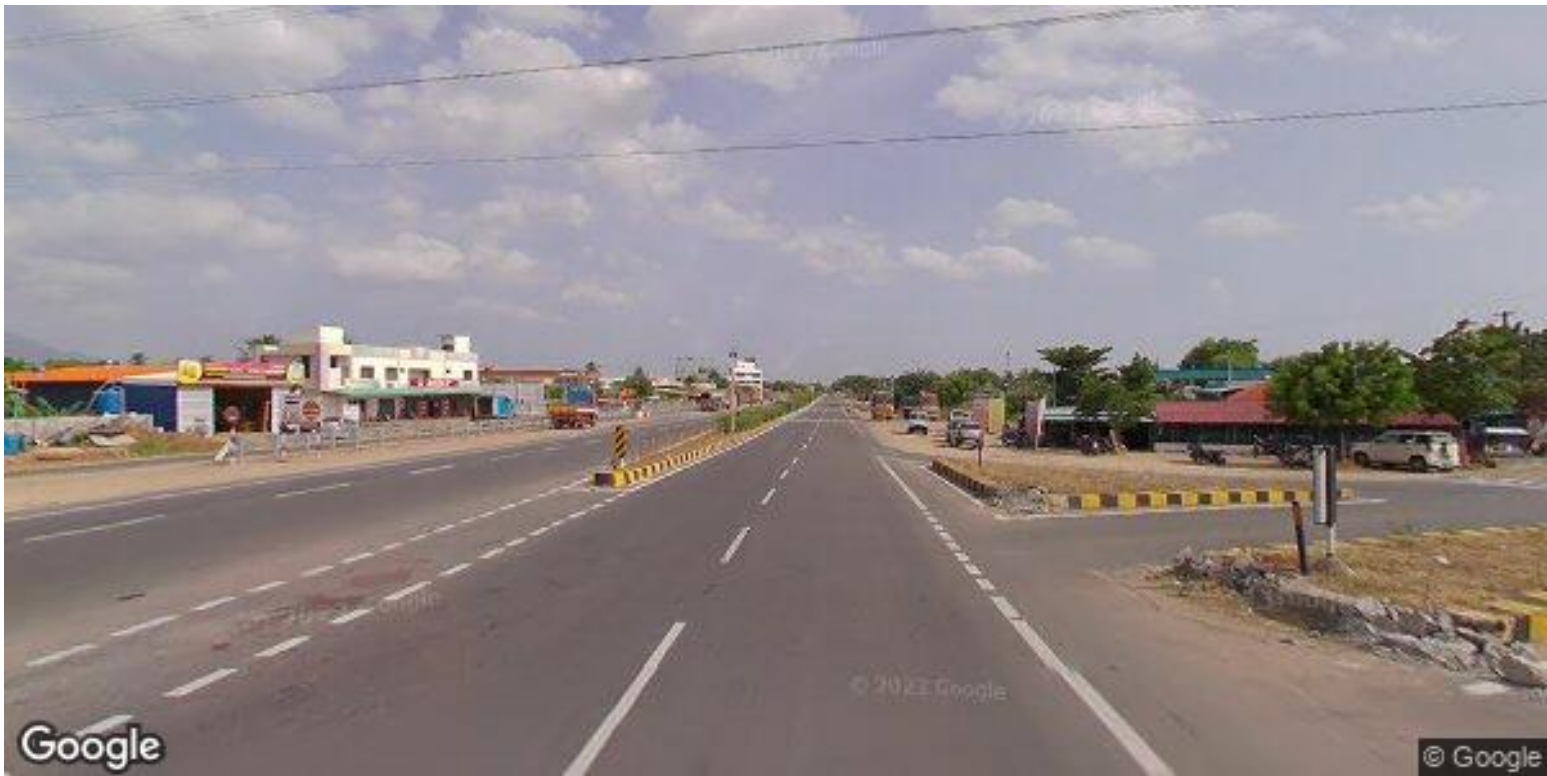
| | Risk Type | Risk Level | Coordinates | Speed Limit |
|---|---|---|---|---|
| 12 | Blind Spot | Blind Spot | 11.31698, 78.17176 | 10 KM/Hr |

**Risk Type:** Blind Spot  
**Risk Level:** Blind Spot  
**Speed Limit:** 10 KM/Hr  
**Coordinates:** 11.31698, 78.17176

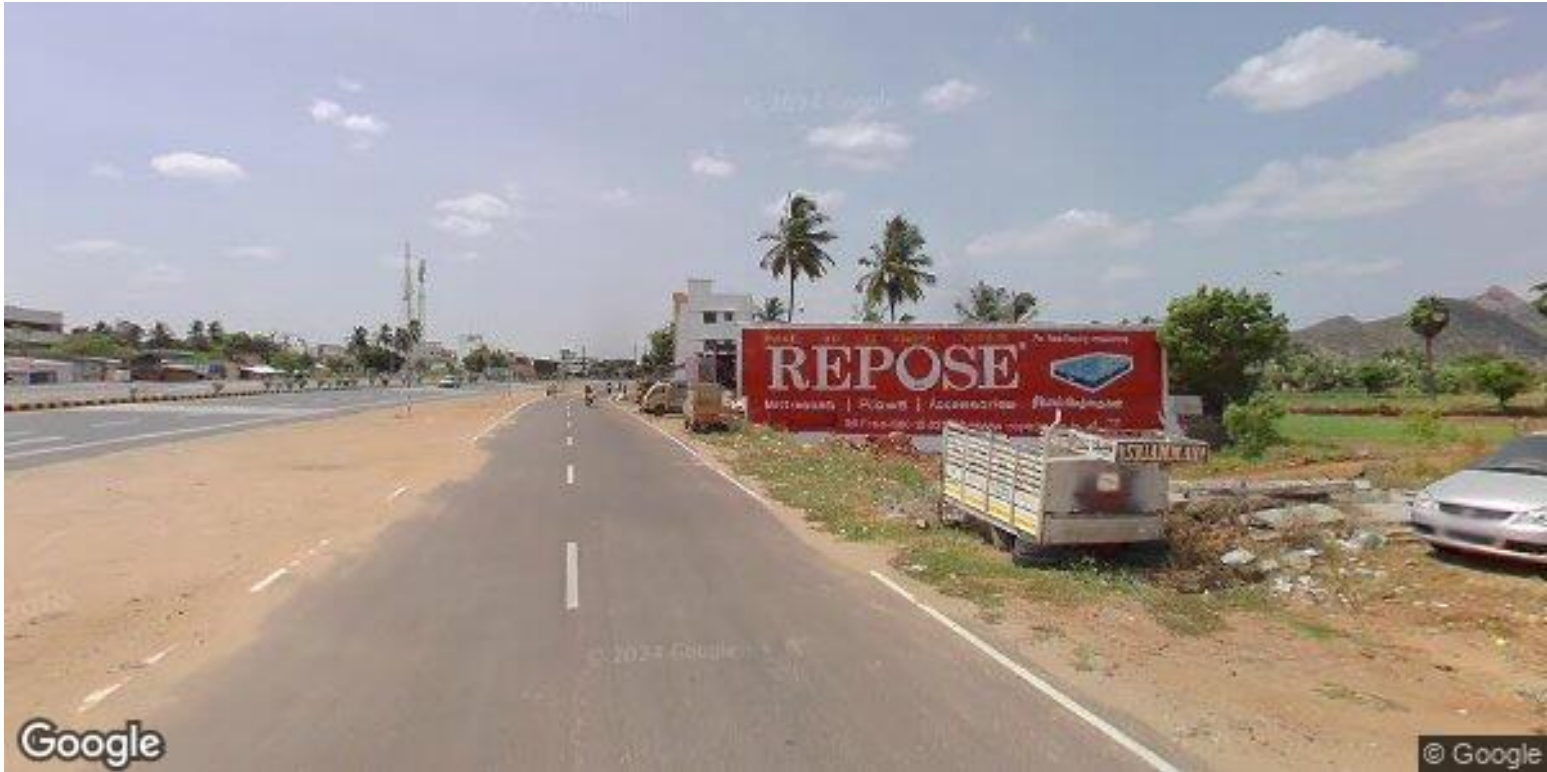
| | Risk Type | Risk Level | Coordinates | Speed Limit |
|---|---|---|---|---|
| 13 | Turn | High | 11.31697, 78.17188 | 15 KM/Hr |

**Risk Type:** Turn  
**Risk Level:** High  
**Speed Limit:** 15 KM/Hr  
**Coordinates:** 11.31697, 78.17188
