## JOURNEY RISK MANAGEMENT (JRM) STUDY

### Salem Terminal TO PALKARAR K. PONNU AGENCIES

**Route Analysis from CVQF+23W, Sangagiri to 438R+HQJ, Vallipuram - Palapatti Road**

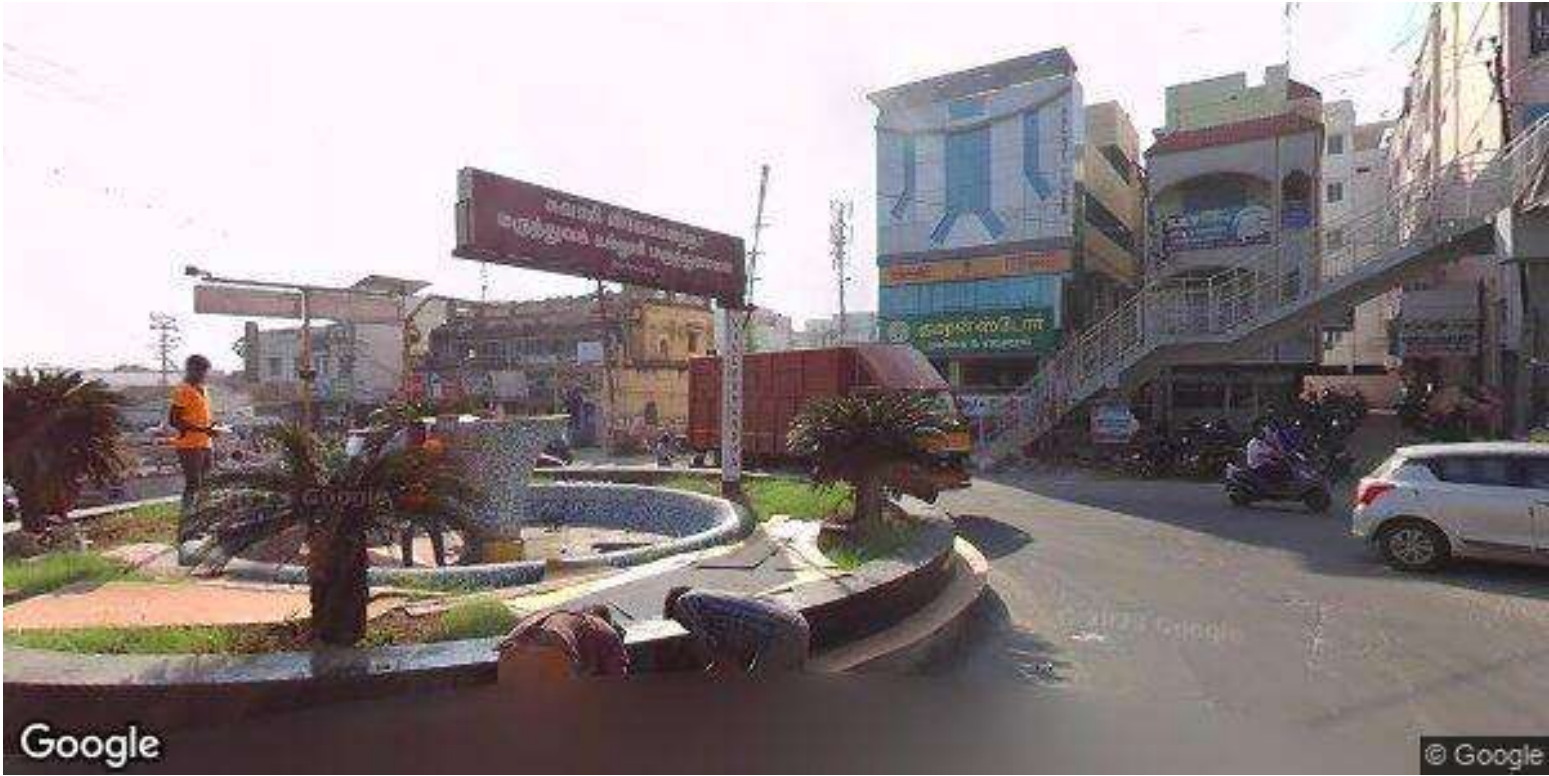
Risk Type: Roundabout

Risk Level: High

Speed Limit: 15 KM/Hr

Coordinates: 11.38395, 77.89480

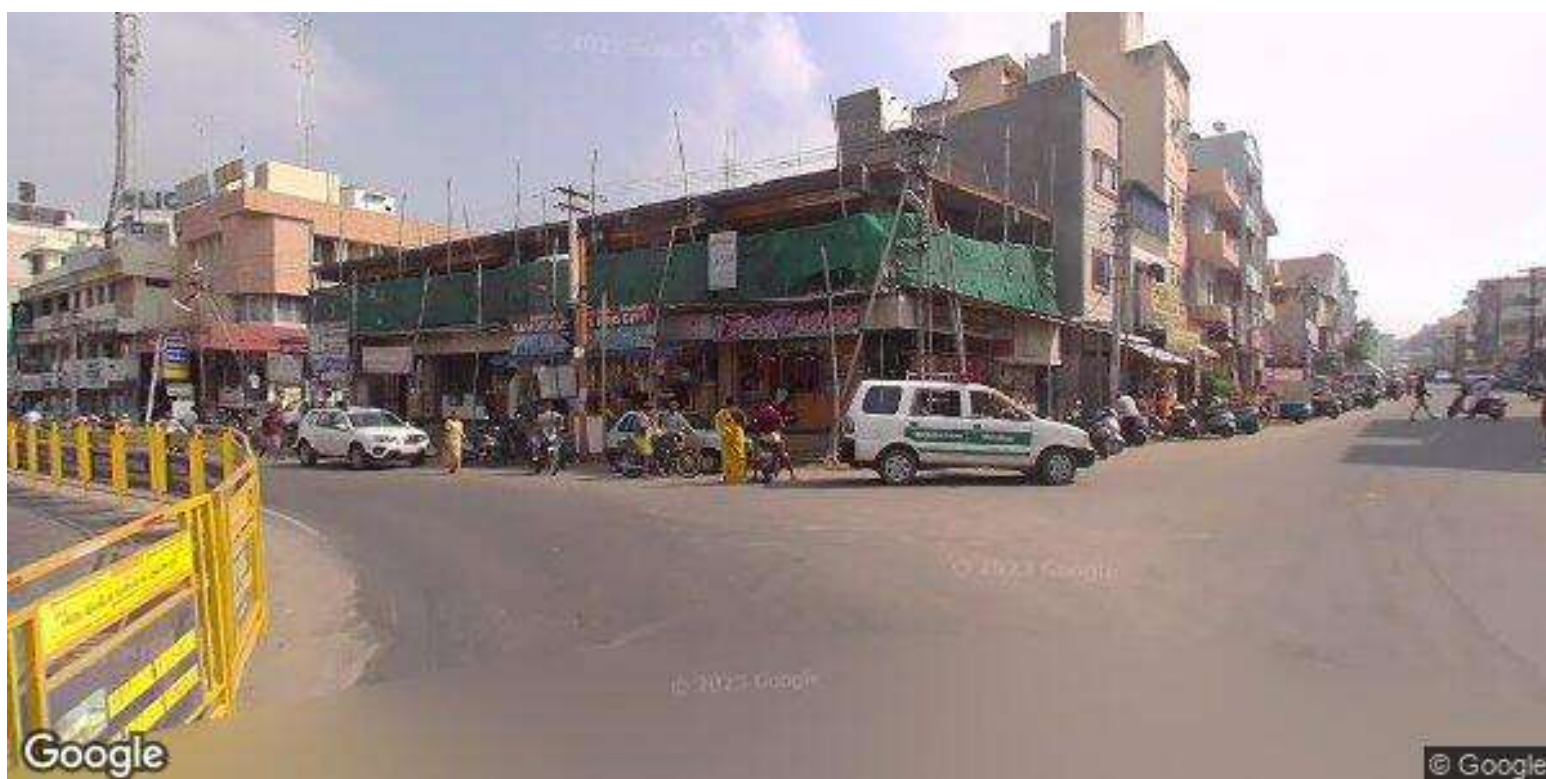
**Risk Type:** Turn

**Risk Level:** High

**Speed Limit:** 15 KM/Hr

**Coordinates:** 11.37868, 77.89498

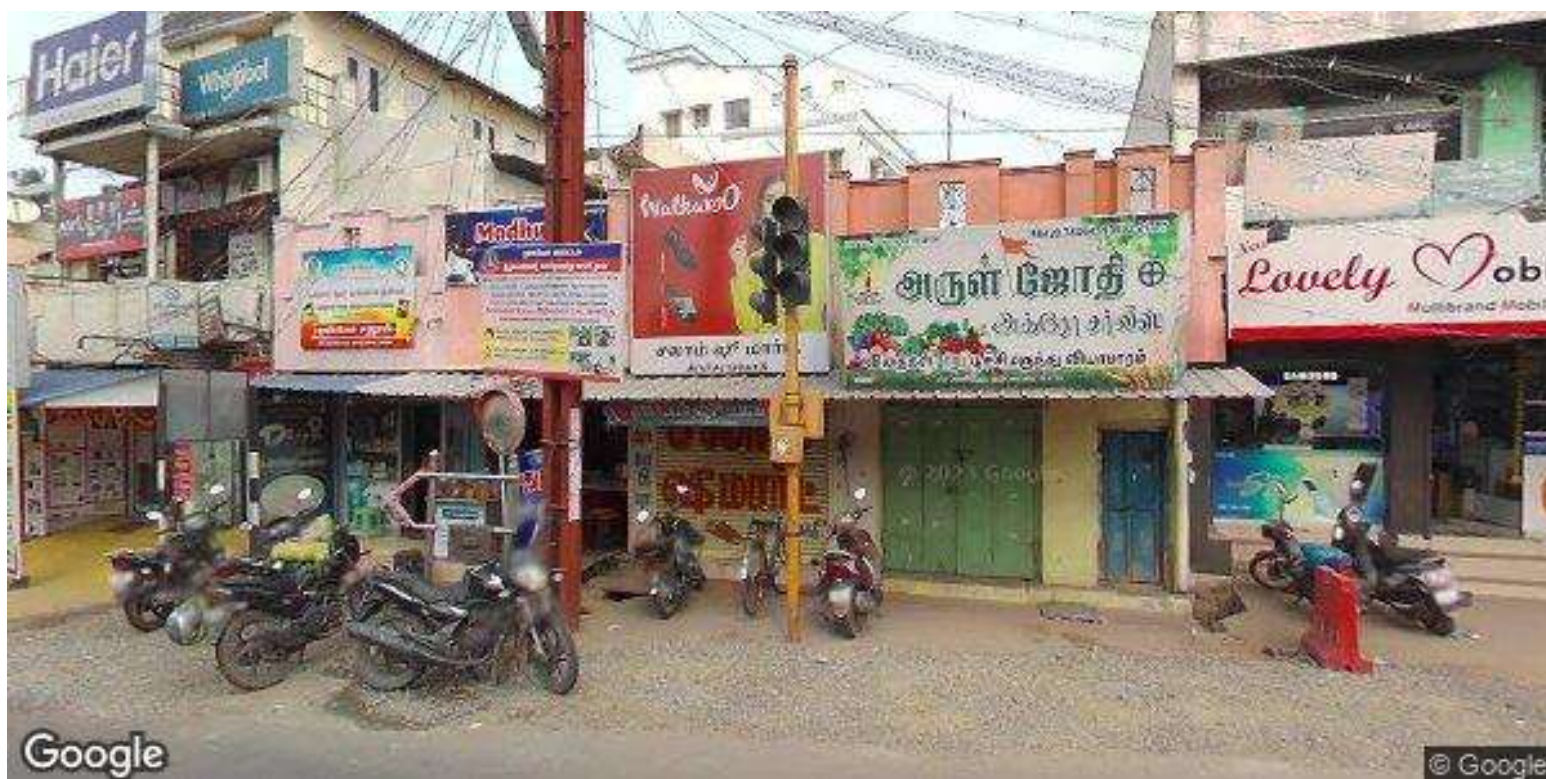
**Risk Type:** Turn  
**Risk Level:** High  
**Speed Limit:** 15 KM/Hr  
**Coordinates:** 11.37850, 77.89453

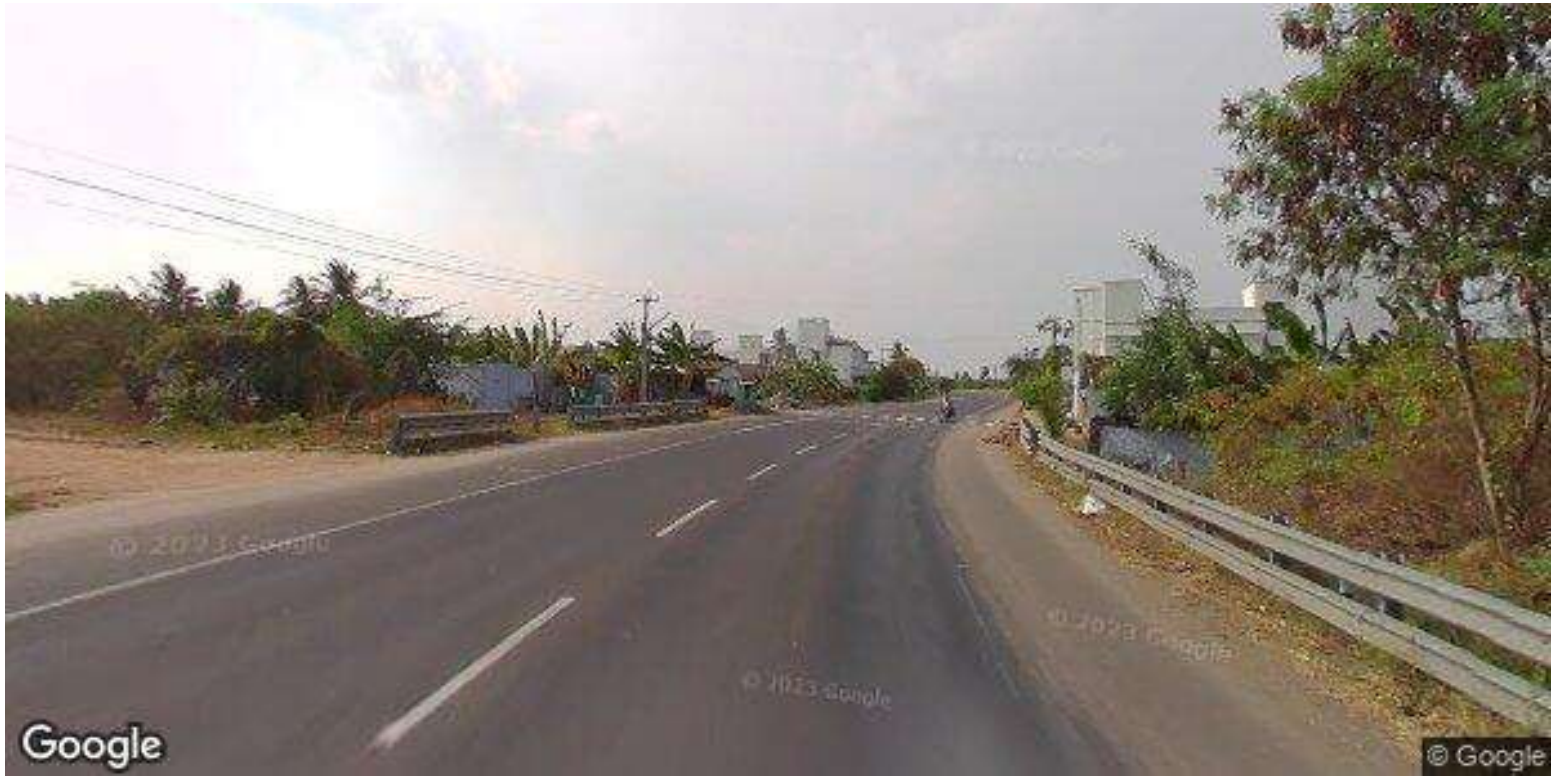
**Risk Type:** Turn  
**Risk Level:** Medium  
**Speed Limit:** 30 KM/Hr  
**Coordinates:** 11.16764, 78.01565

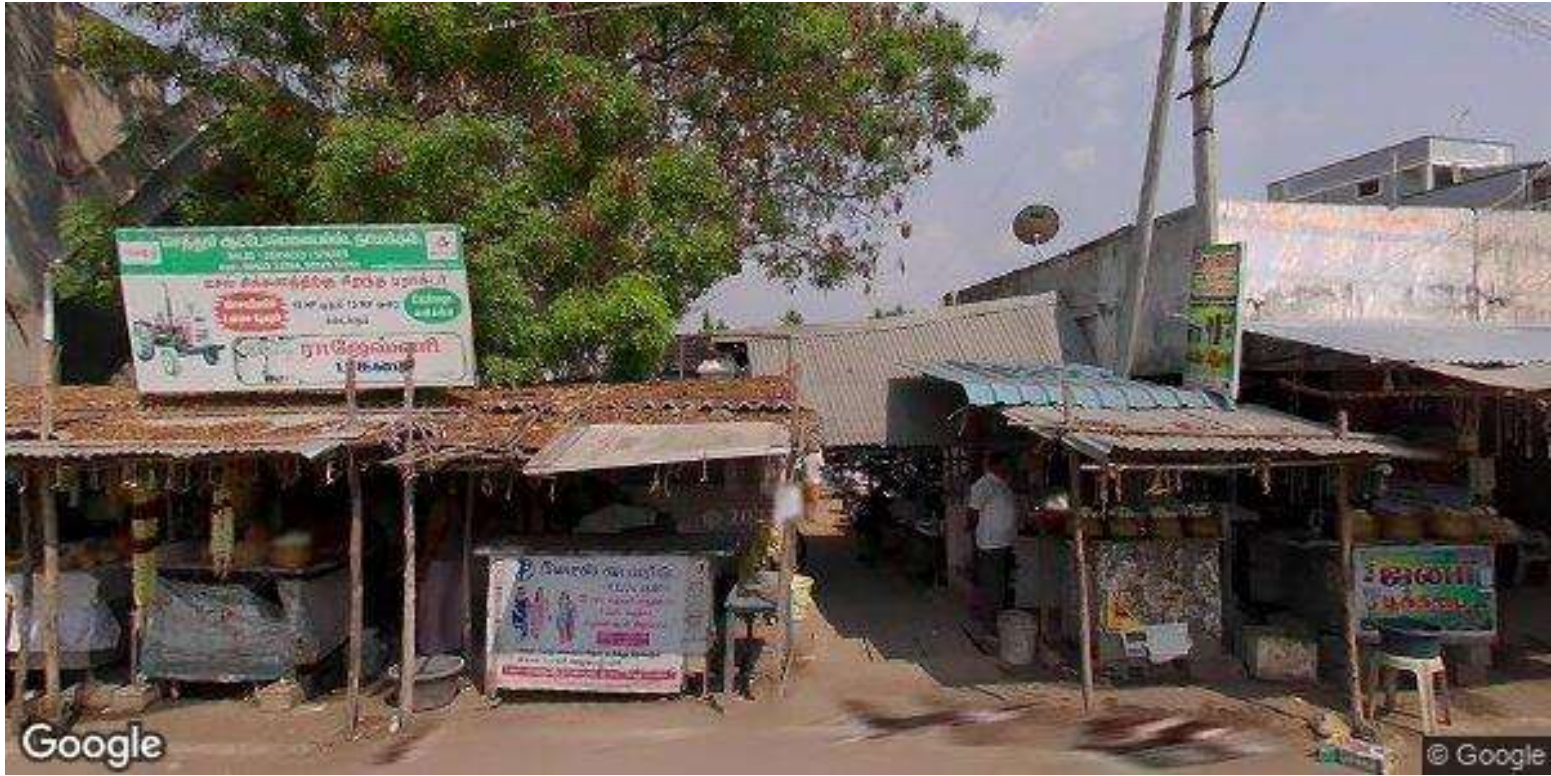
**Risk Type:** Blind Spot  
**Risk Level:** Blind Spot  
**Speed Limit:** 10 KM/Hr  
**Coordinates:** 11.15573, 78.02176

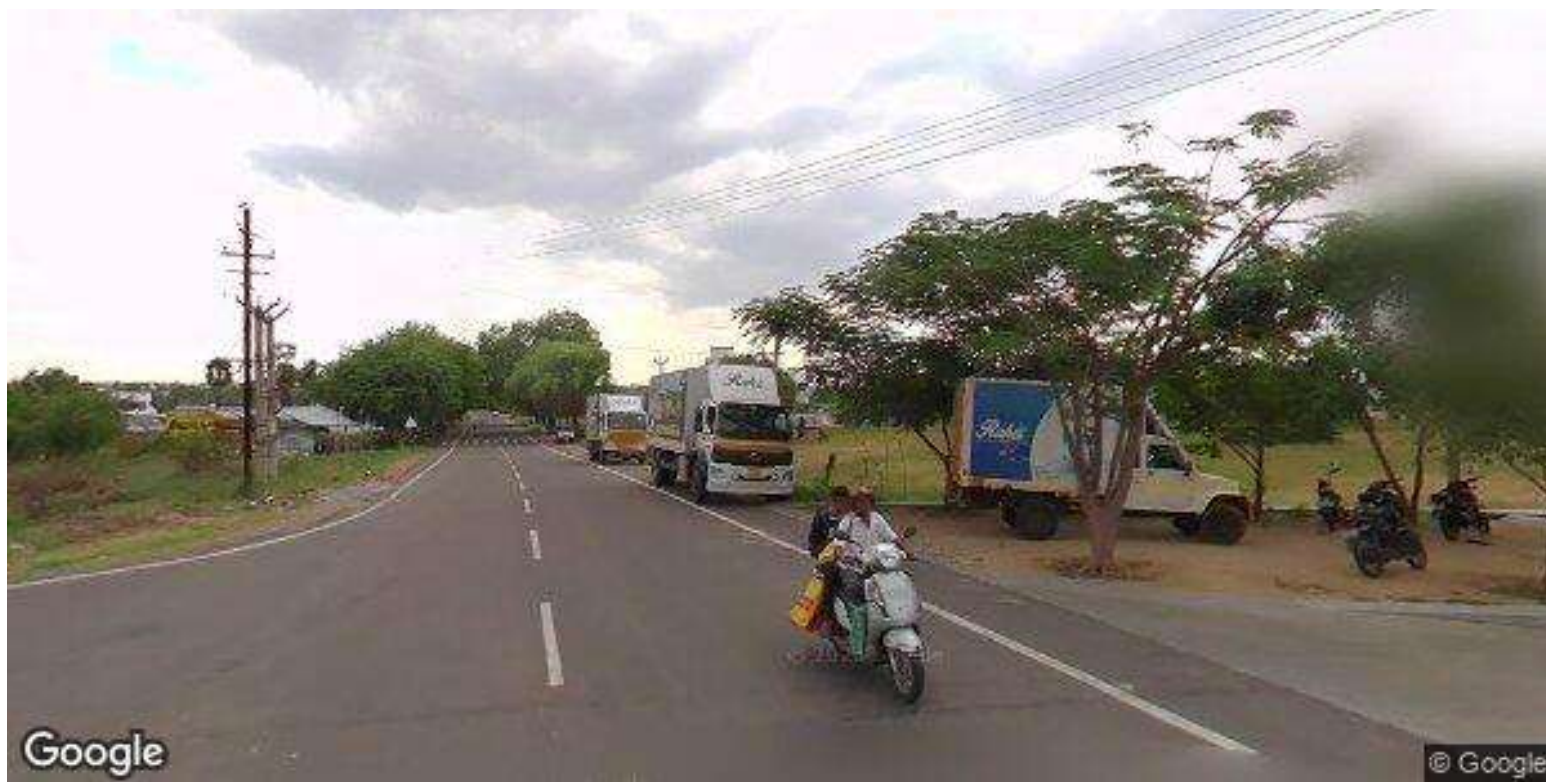
**Risk Type:** Turn

**Risk Level:** Medium

**Speed Limit:** 30 KM/Hr

**Coordinates:** 11.16243, 78.02715

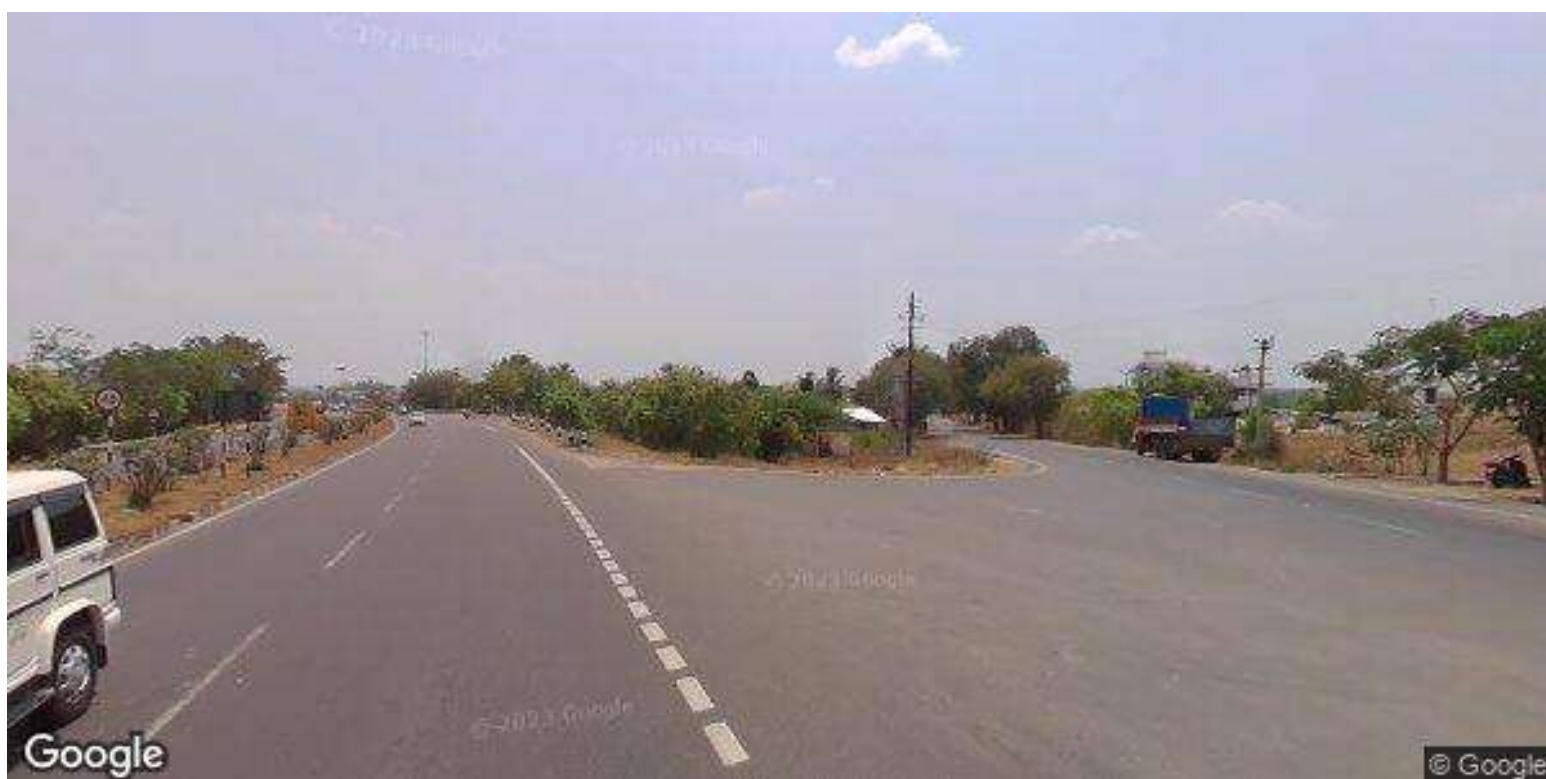
**Risk Type:** Turn

**Risk Level:** High

**Speed Limit:** 15 KM/Hr

**Coordinates:** 11.16241, 78.02729

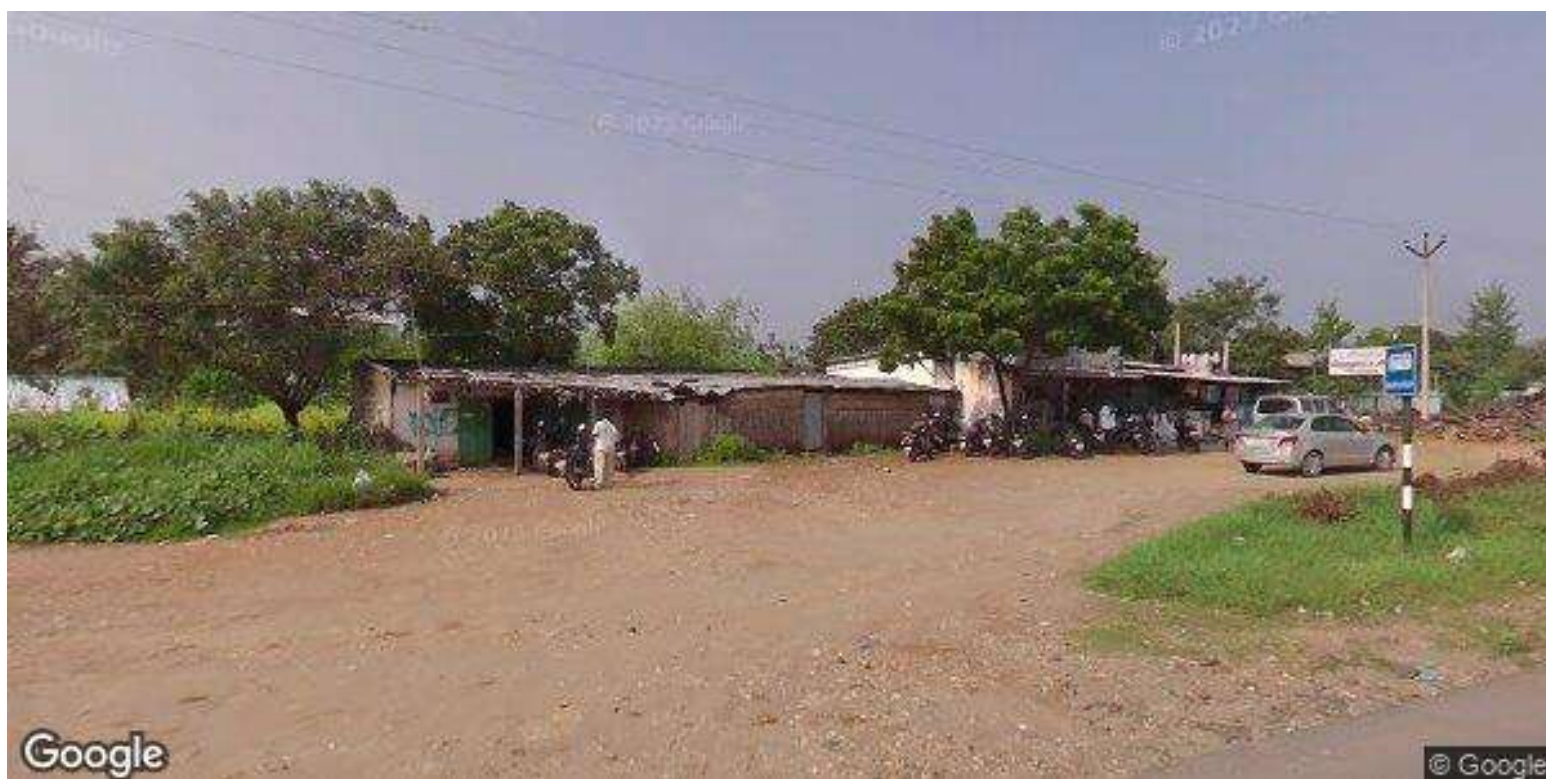
**Risk Type:** Turn  
**Risk Level:** High  
**Speed Limit:** 15 KM/Hr  
**Coordinates:** 11.17605, 78.05538

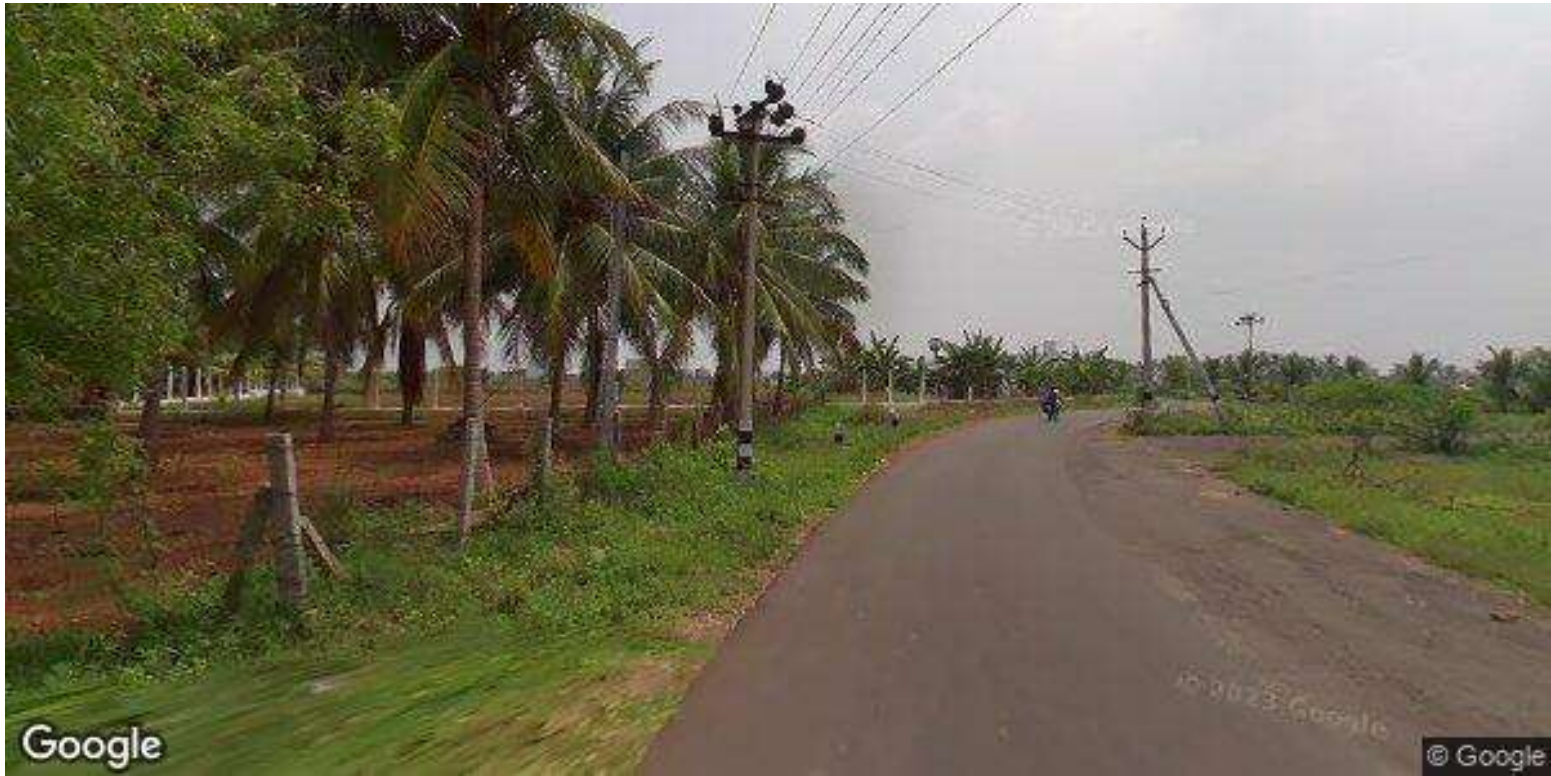
**Risk Type:** Turn  
**Risk Level:** Medium  
**Speed Limit:** 30 KM/Hr  
**Coordinates:** 11.17447, 78.05732

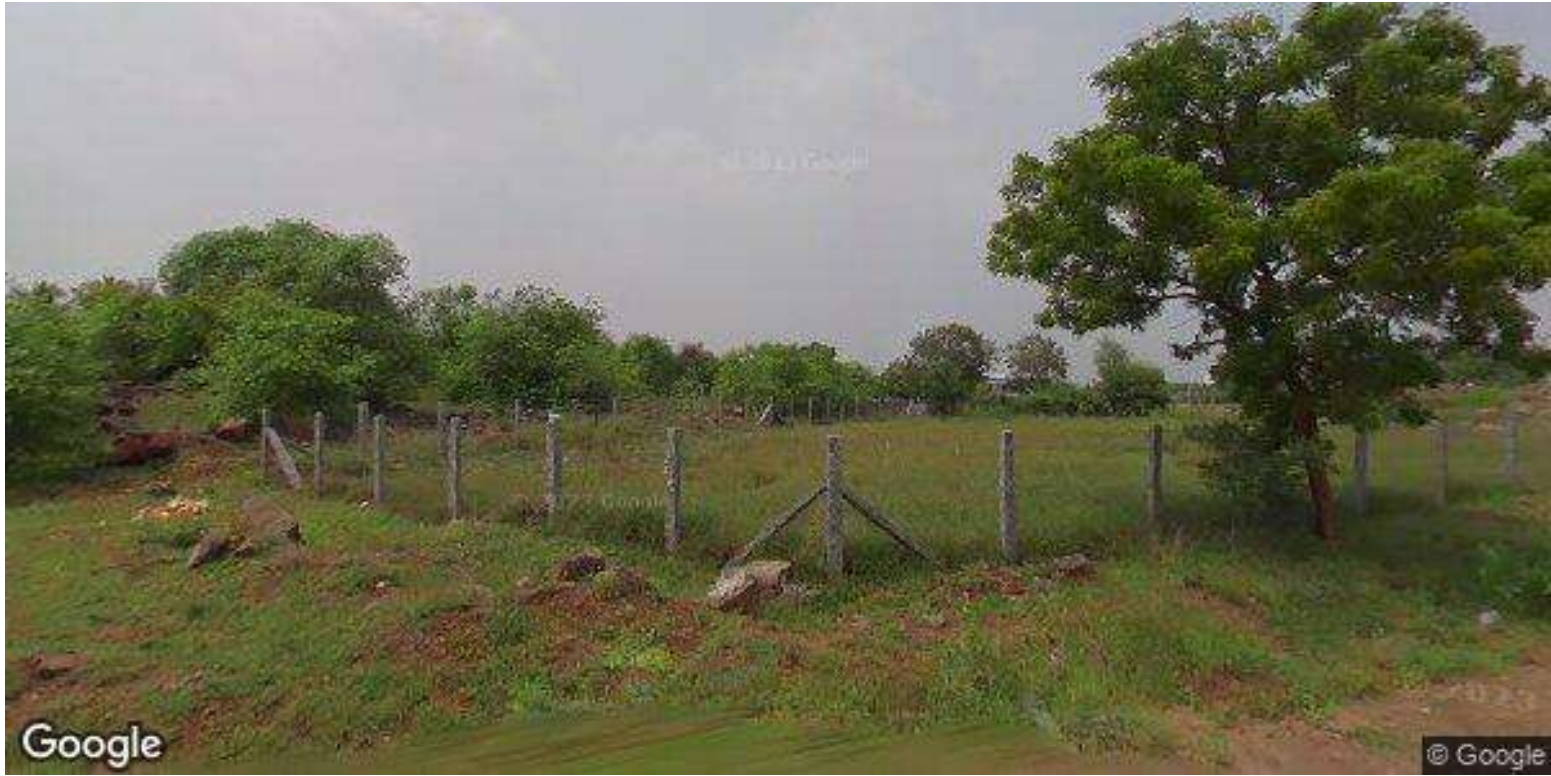
**Risk Type:** Turn  
**Risk Level:** Medium  
**Speed Limit:** 30 KM/Hr  
**Coordinates:** 11.17225, 78.05906

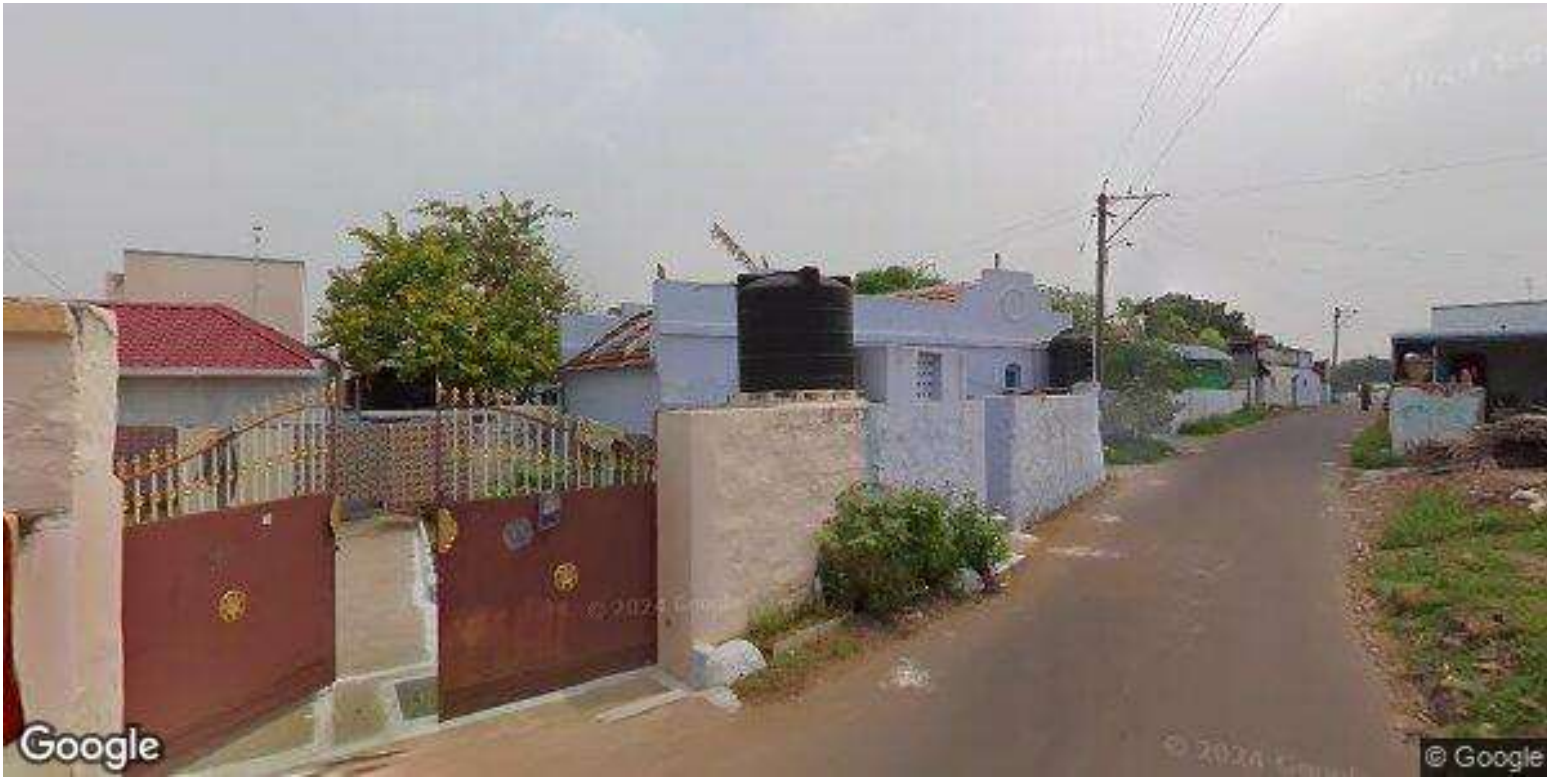
**Risk Type:** Turn  
**Risk Level:** Medium  
**Speed Limit:** 30 KM/Hr  
**Coordinates:** 11.16071, 78.06874

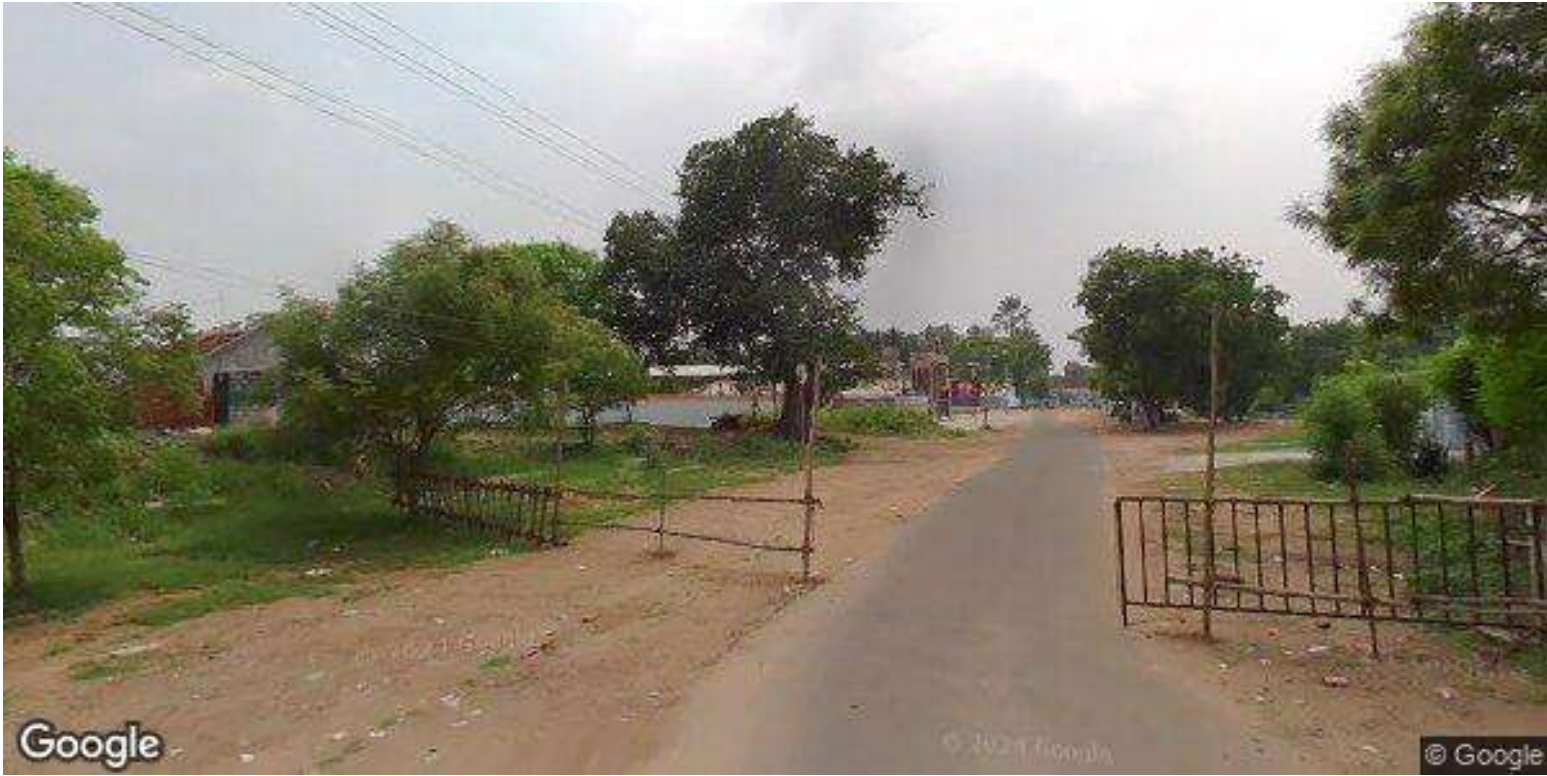
**Risk Type:** Turn  
**Risk Level:** Medium  
**Speed Limit:** 30 KM/Hr  
**Coordinates:** 11.15756, 78.07014

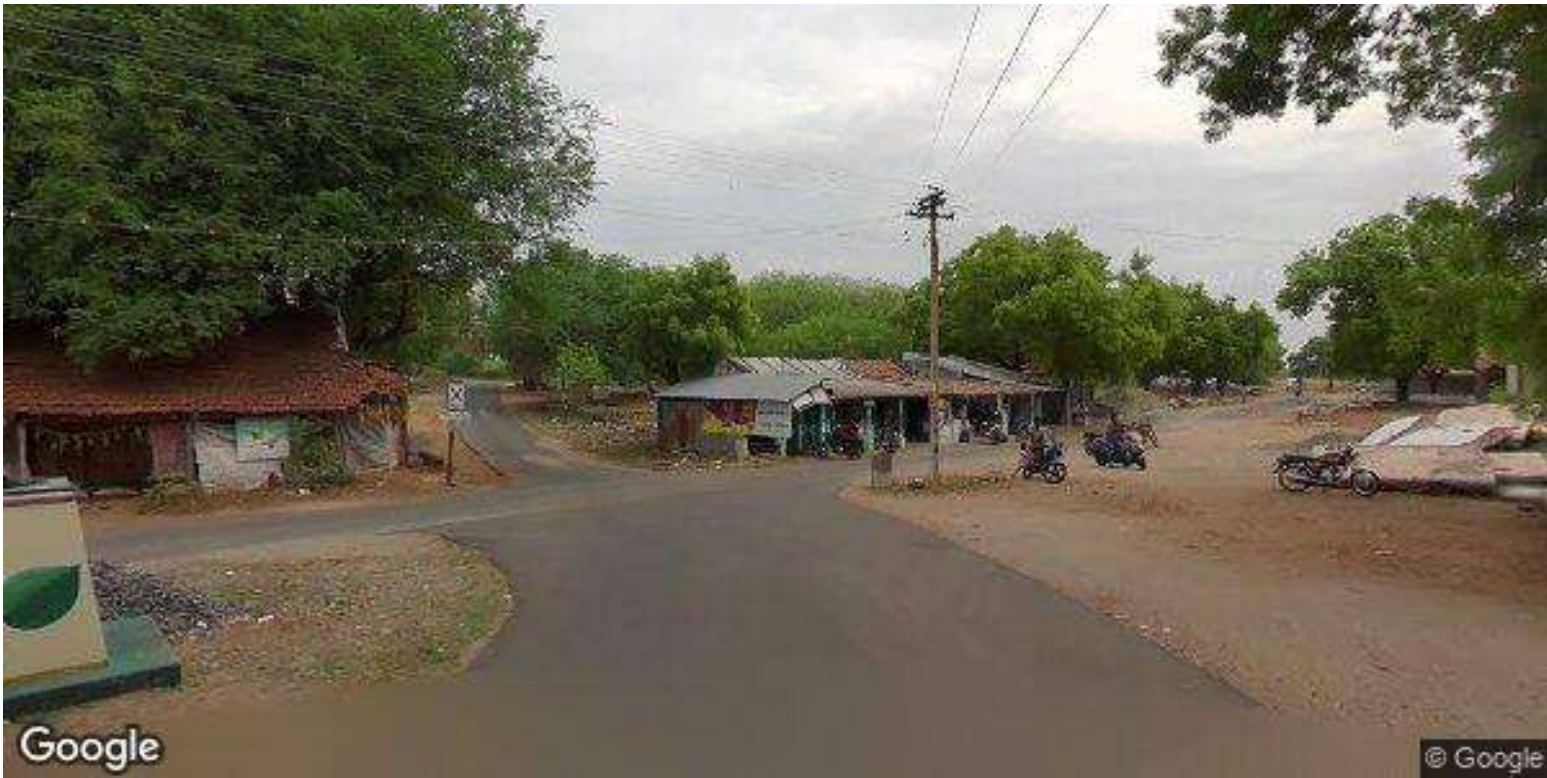
**Risk Type:** Turn  
**Risk Level:** Medium  
**Speed Limit:** 30 KM/Hr  
**Coordinates:** 11.15582, 78.07004

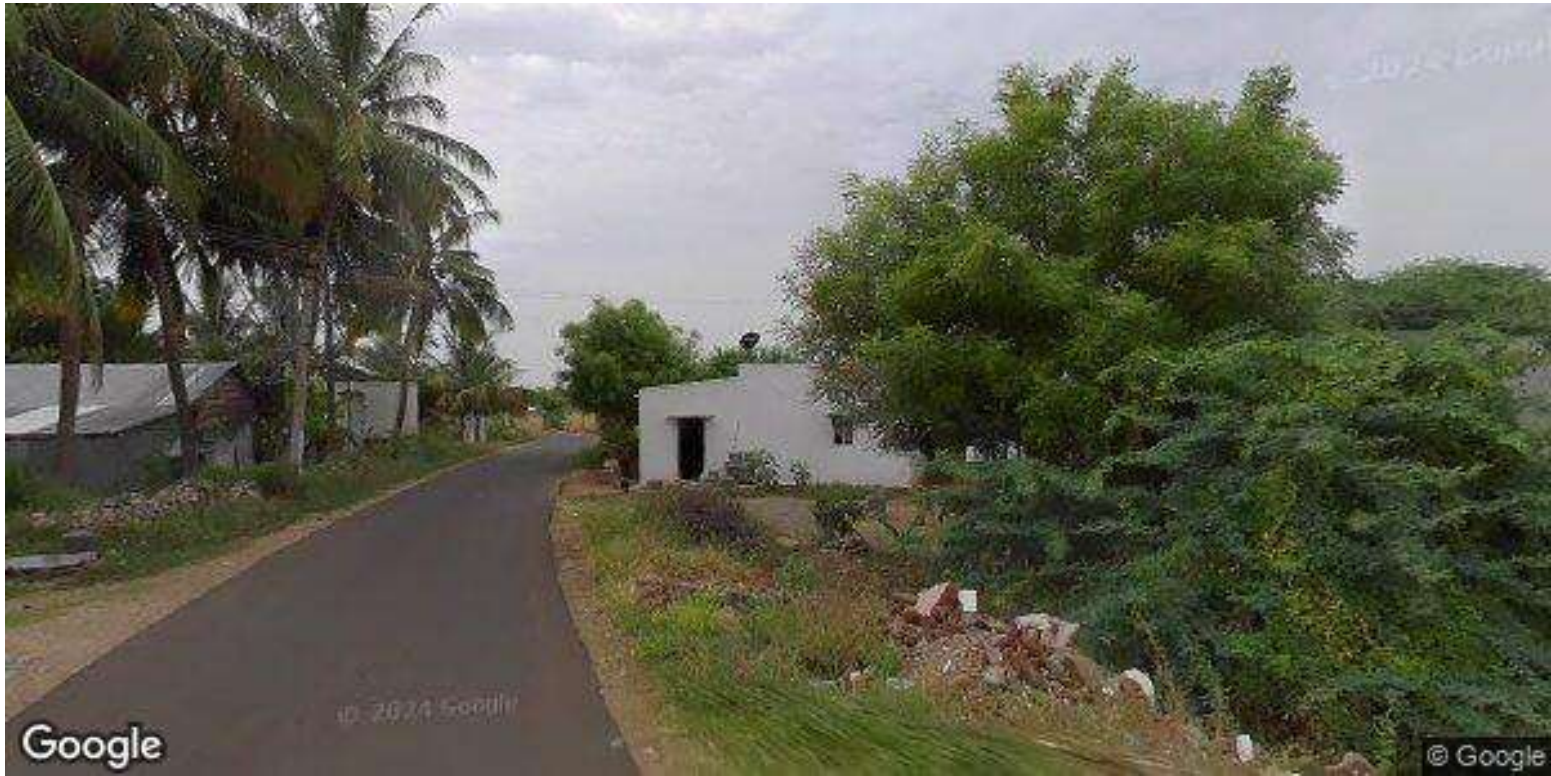
**Risk Type:** Turn  
**Risk Level:** Medium  
**Speed Limit:** 30 KM/Hr  
**Coordinates:** 11.15501, 78.07151

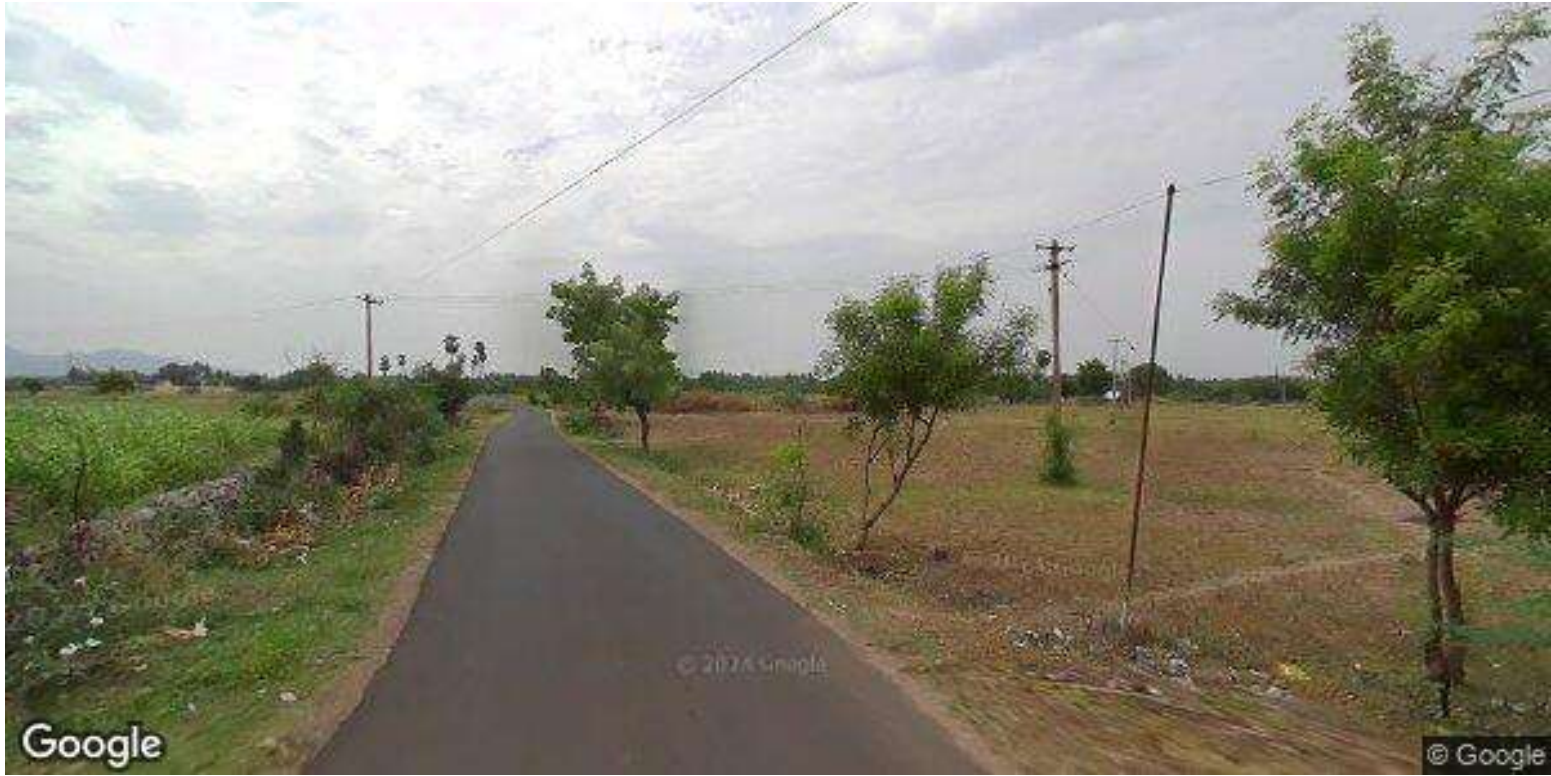
**Risk Type:** Turn  
**Risk Level:** Medium  
**Speed Limit:** 30 KM/Hr  
**Coordinates:** 11.15437, 78.07194

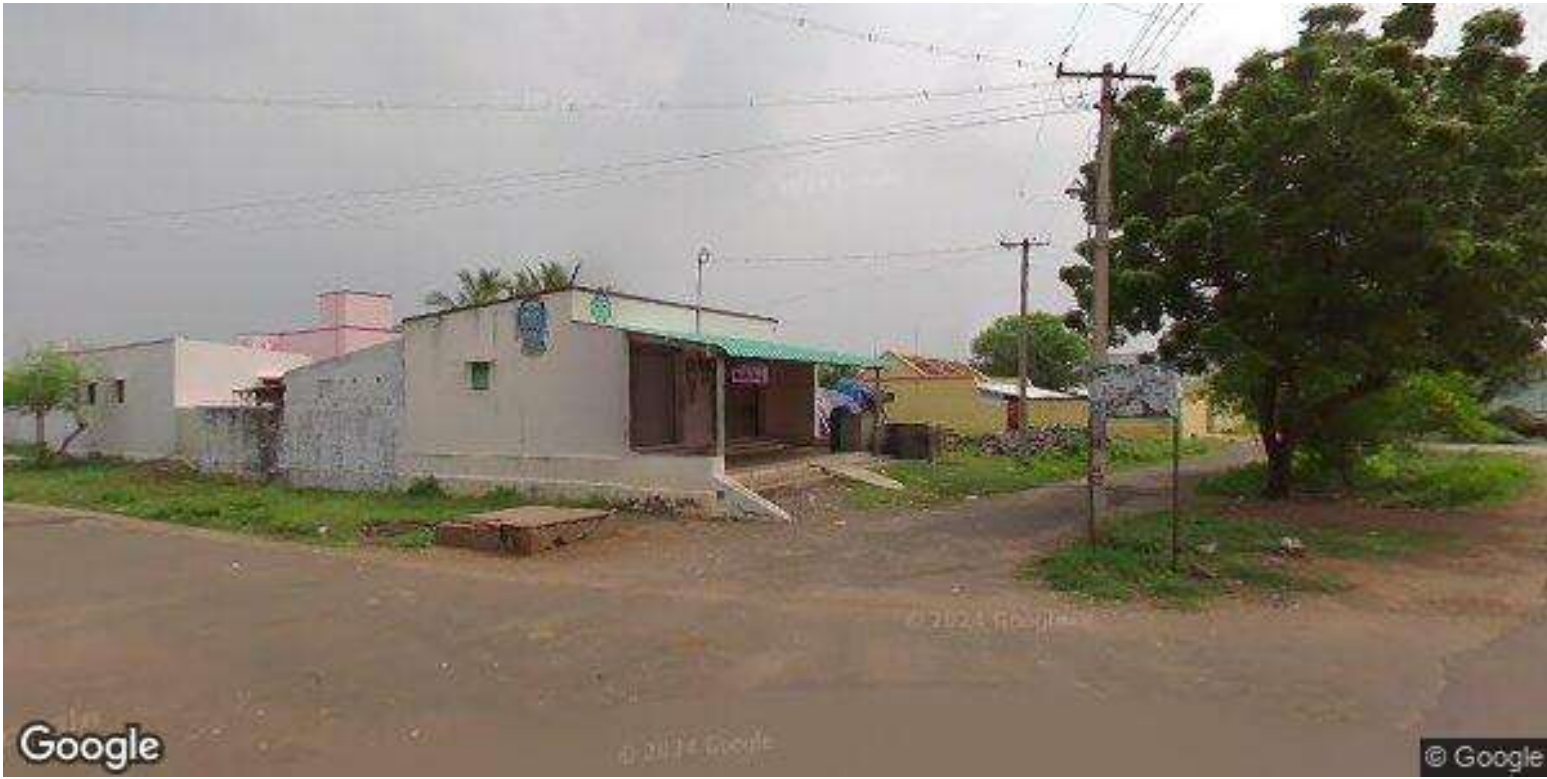
**Risk Type:** Blind Spot  
**Risk Level:** Blind Spot  
**Speed Limit:** 10 KM/Hr  
**Coordinates:** 11.15411, 78.07842

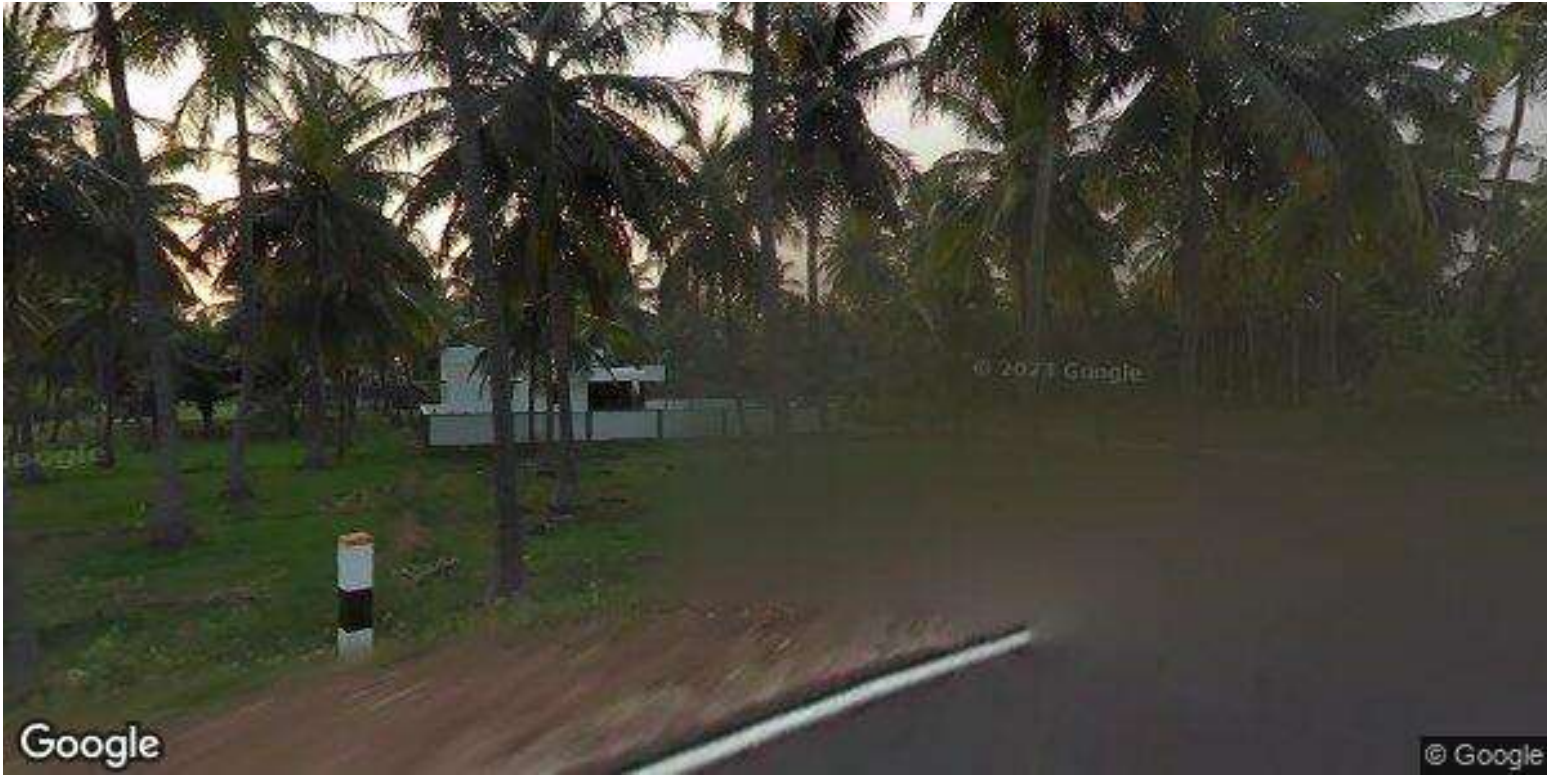
**Risk Type:** Turn  
**Risk Level:** High  
**Speed Limit:** 15 KM/Hr  
**Coordinates:** 11.14790, 78.07733

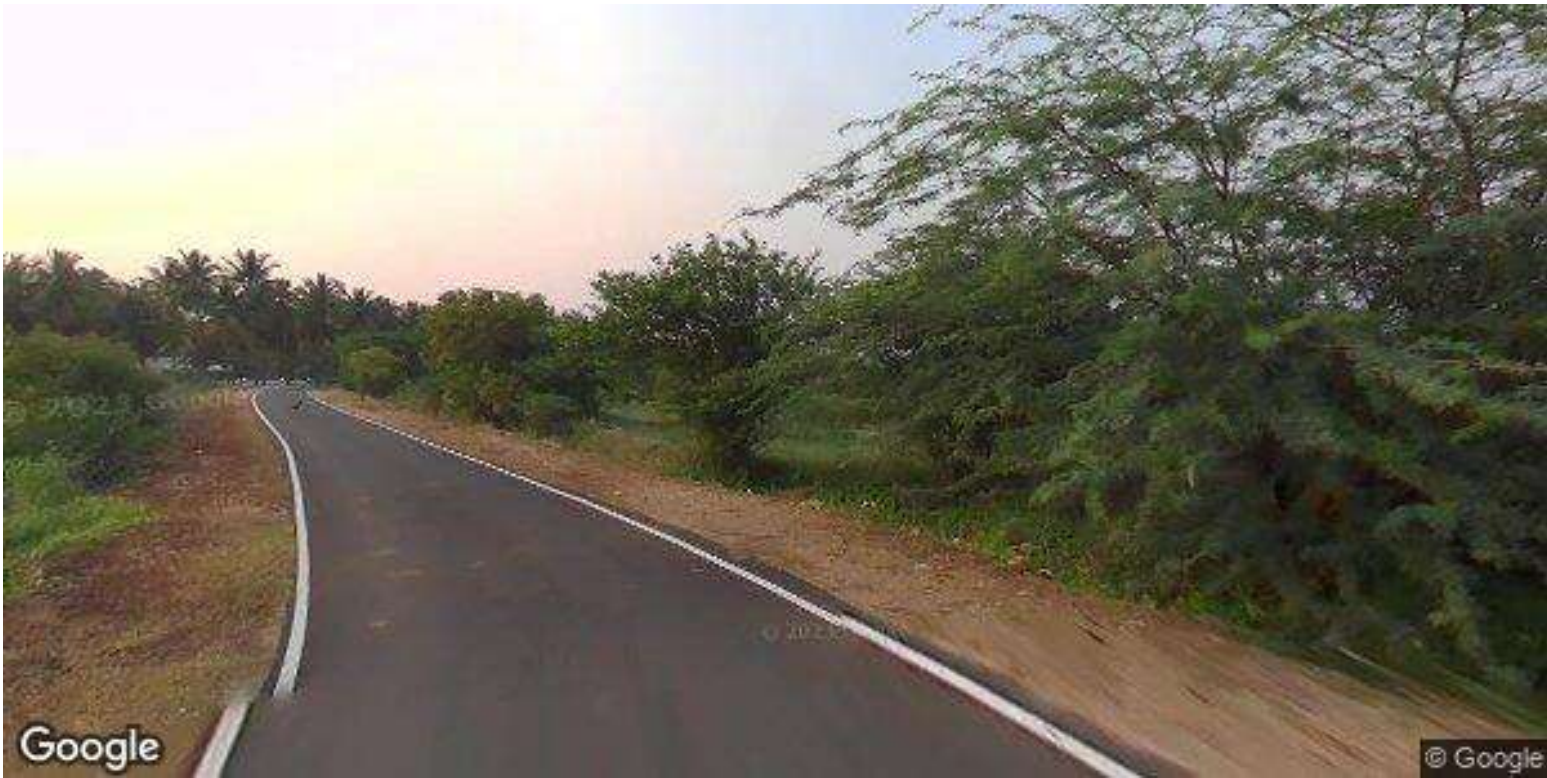
**Risk Type:** Turn  
**Risk Level:** Medium  
**Speed Limit:** 30 KM/Hr  
**Coordinates:** 11.14736, 78.07811
