## JOURNEY RISK MANAGEMENT (JRM) STUDY

### Salem Terminal TO PALKARAR K. PONNU AGENCIES

**Route Analysis from CVQF+23W, Sangagiri to 438R+HQJ, Vallipuram - Palapatti Road**

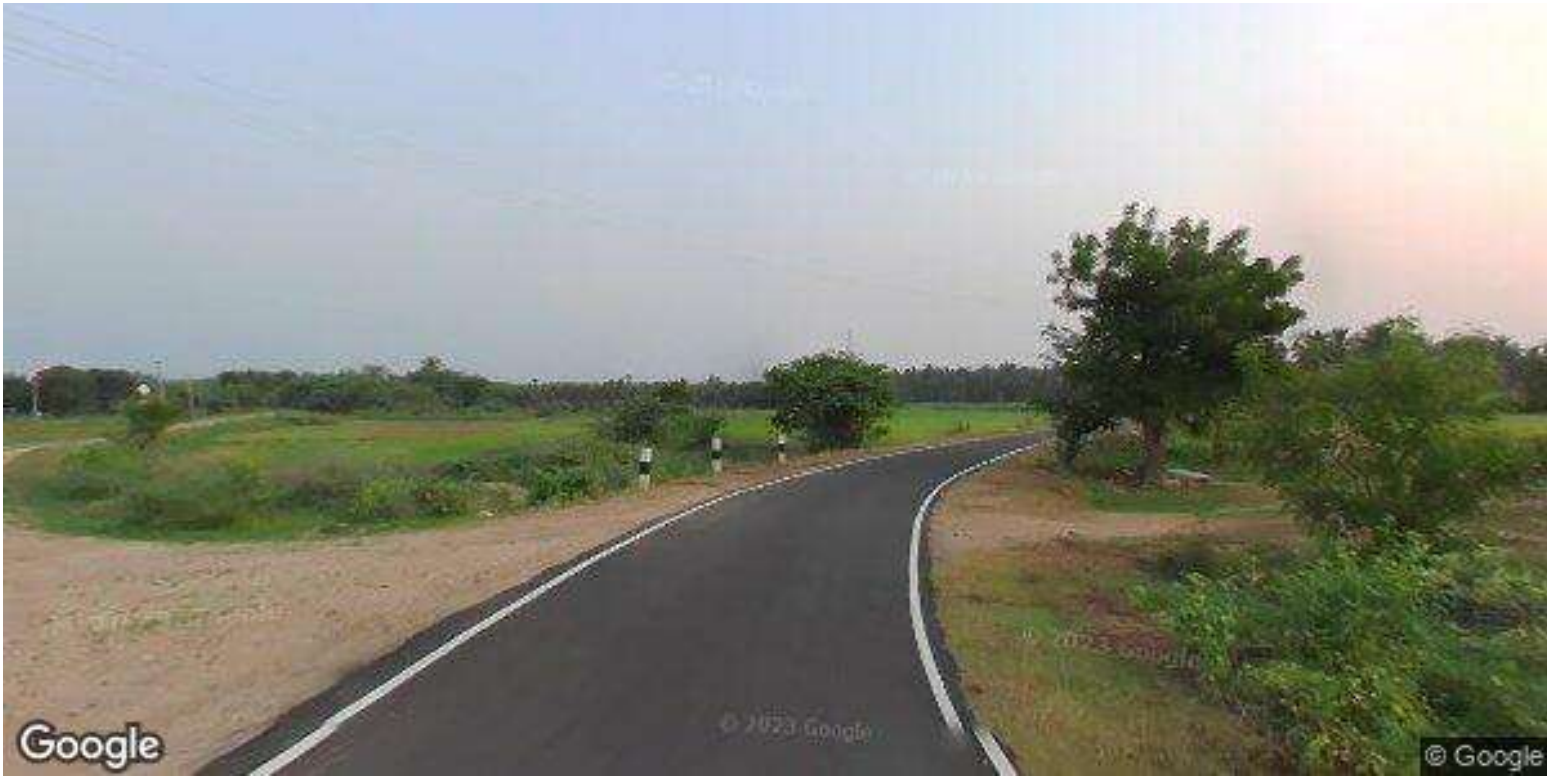
**Risk Type:** Turn  
**Risk Level:** Medium  
**Speed Limit:** 30 KM/Hr  
**Coordinates:** 11.14715, 78.07821

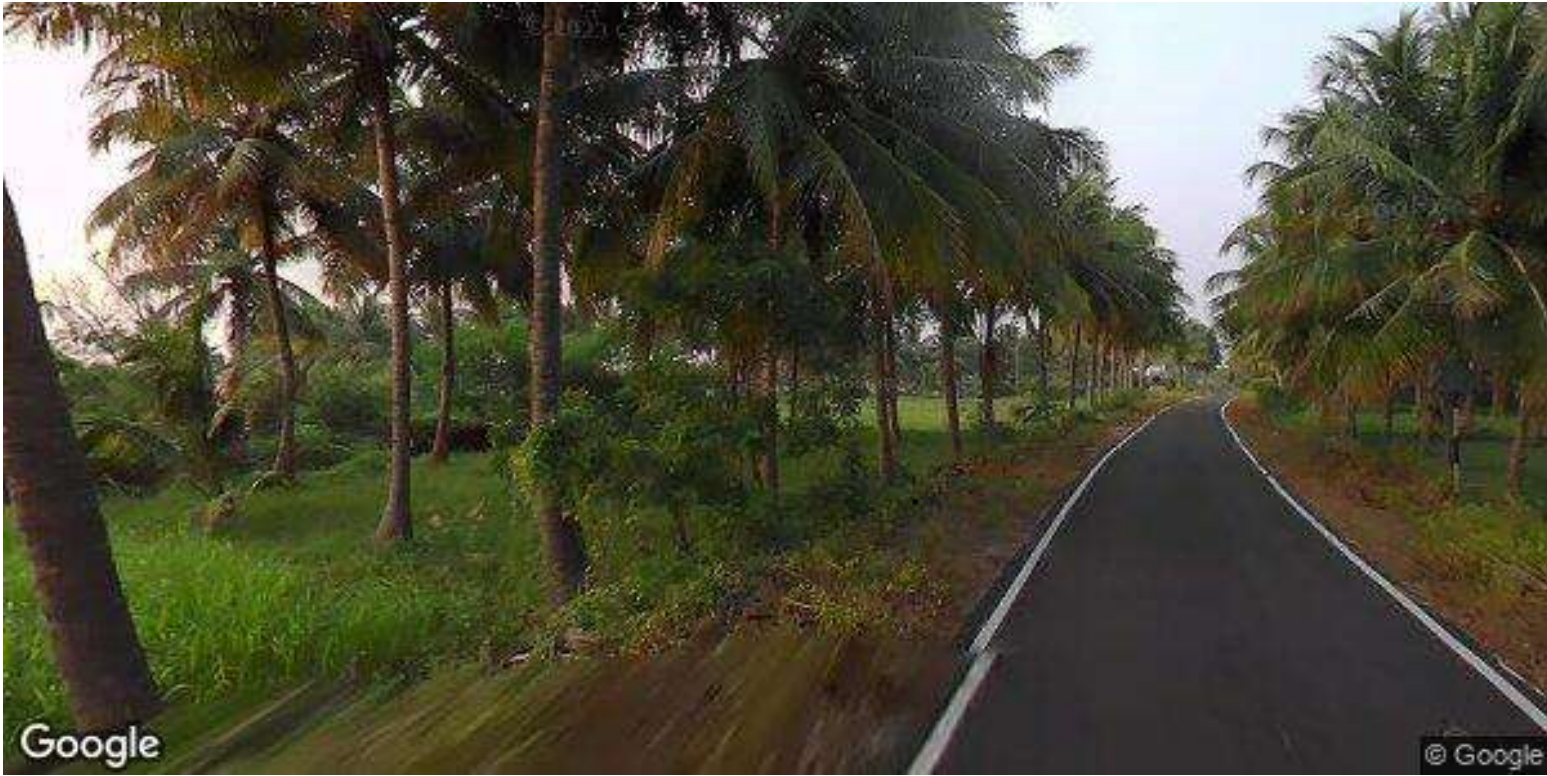
**Risk Type:** Turn  
**Risk Level:** Medium  
**Speed Limit:** 30 KM/Hr  
**Coordinates:** 11.14327, 78.07733

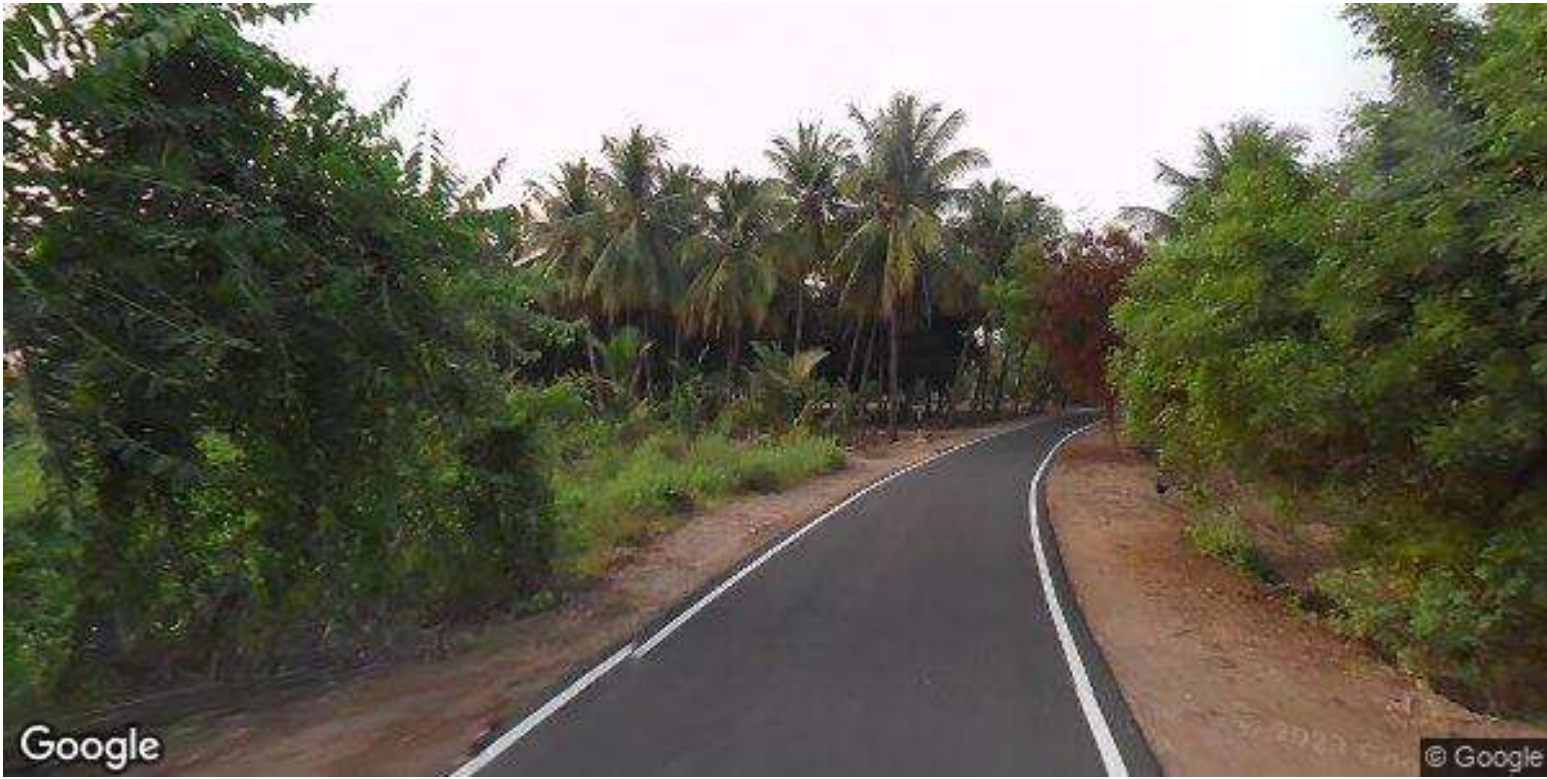
**Risk Type:** Turn  
**Risk Level:** Medium  
**Speed Limit:** 30 KM/Hr  
**Coordinates:** 11.13737, 78.07789

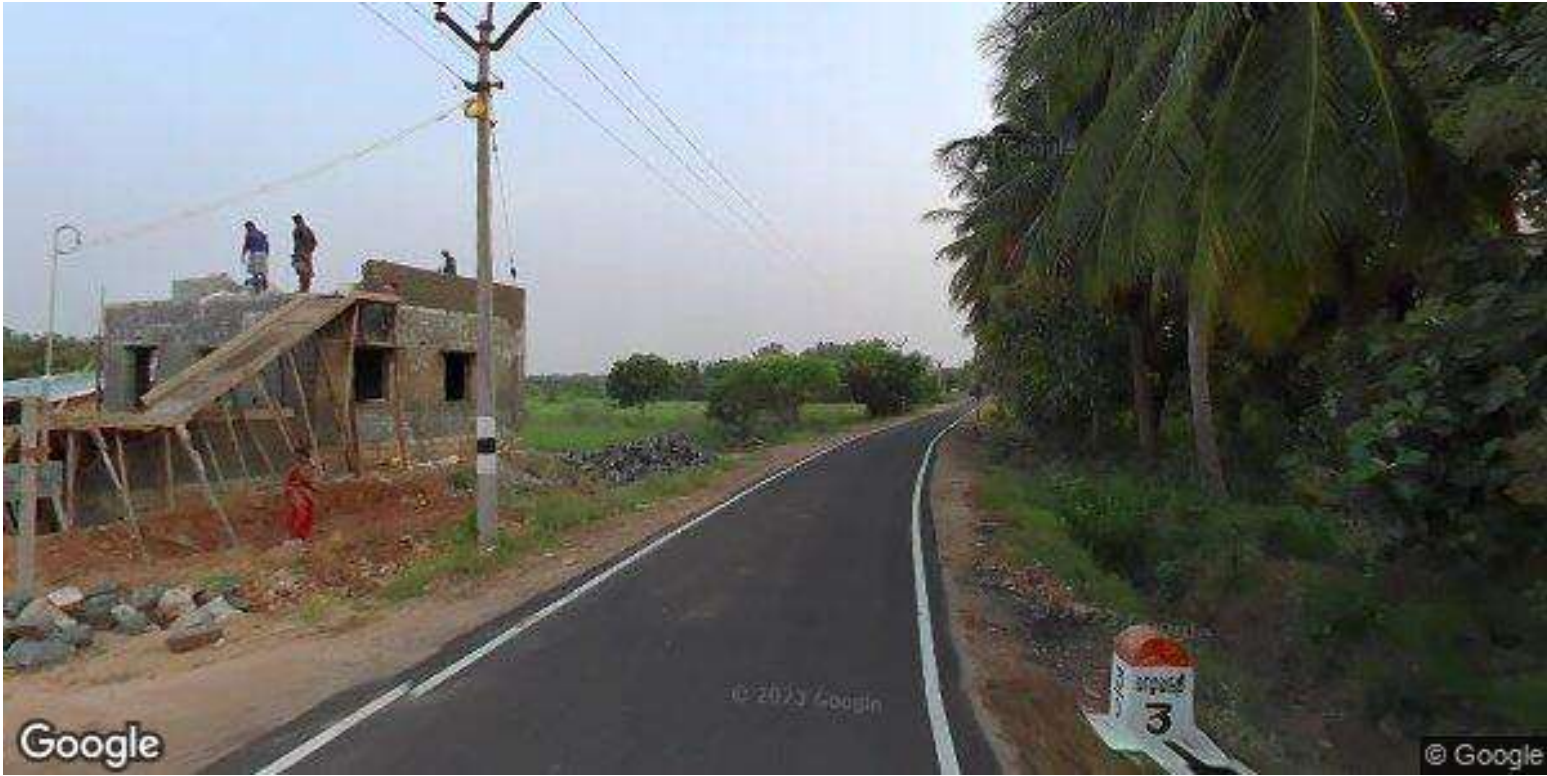
**Risk Type:** Turn  
**Risk Level:** Medium  
**Speed Limit:** 30 KM/Hr  
**Coordinates:** 11.13608, 78.07979

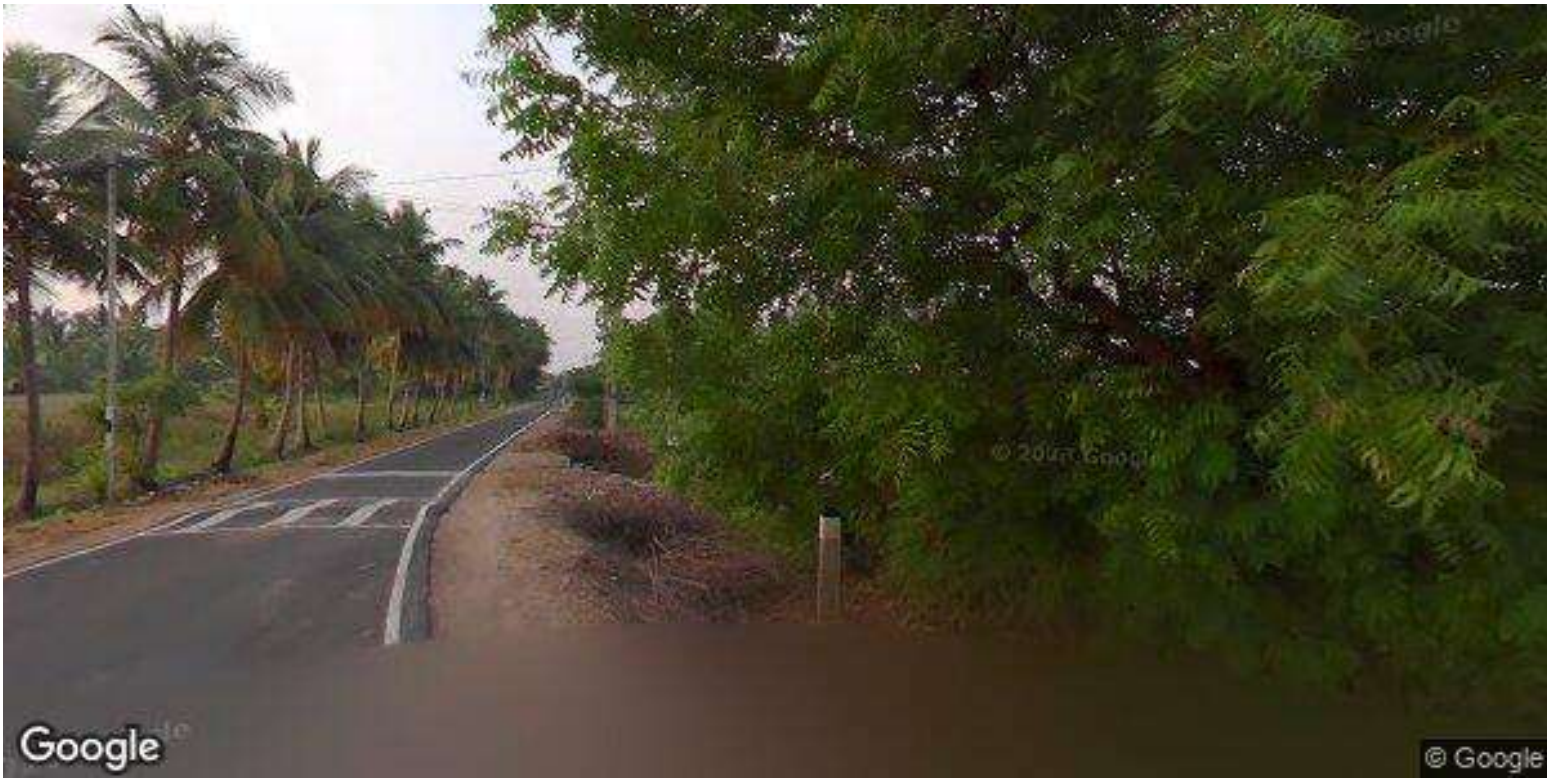
**Risk Type:** Blind Spot  
**Risk Level:** Blind Spot  
**Speed Limit:** 10 KM/Hr  
**Coordinates:** 11.13449, 78.08021

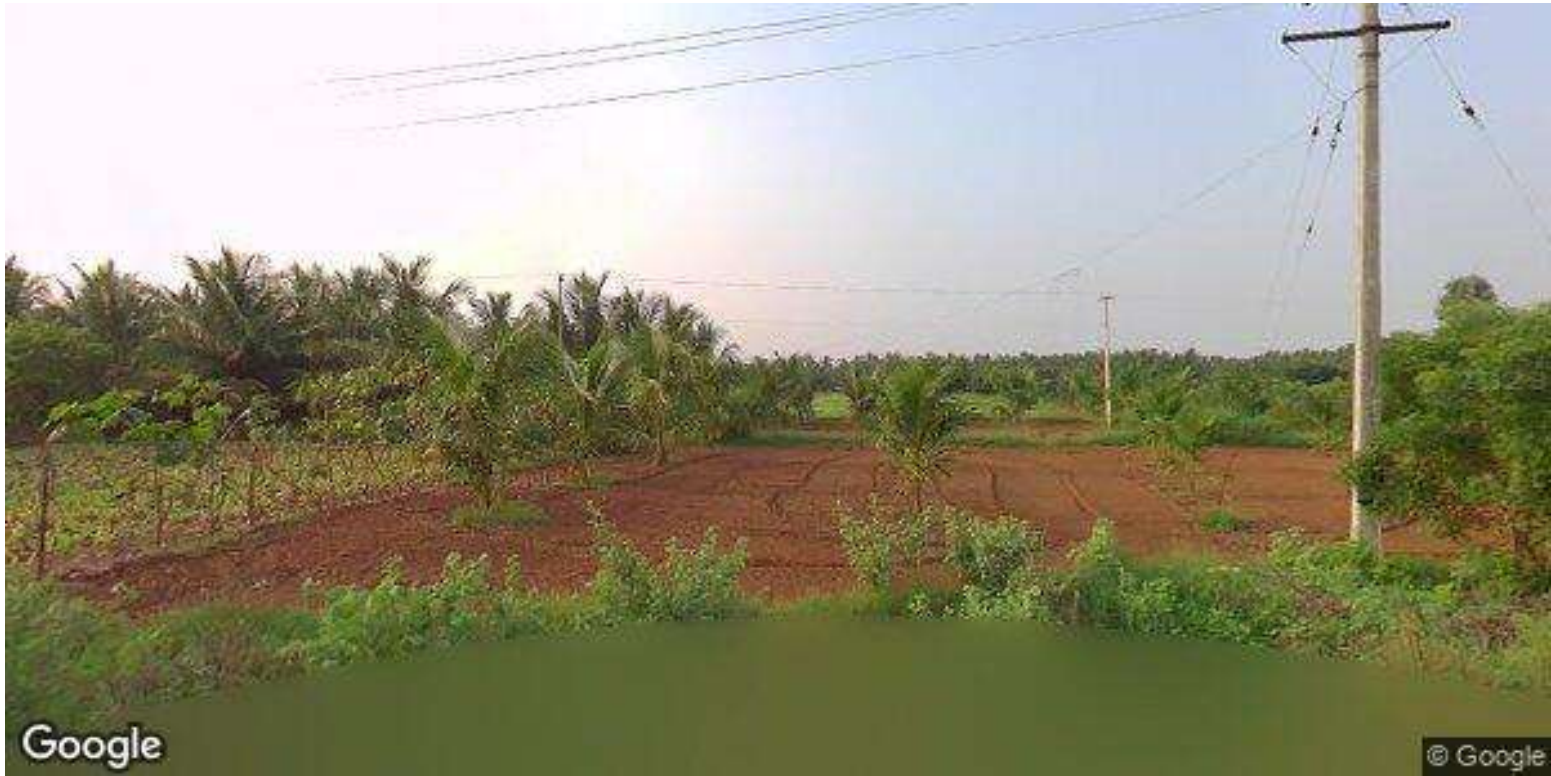
**Risk Type:** Turn  
**Risk Level:** High  
**Speed Limit:** 15 KM/Hr  
**Coordinates:** 11.13464, 78.08069

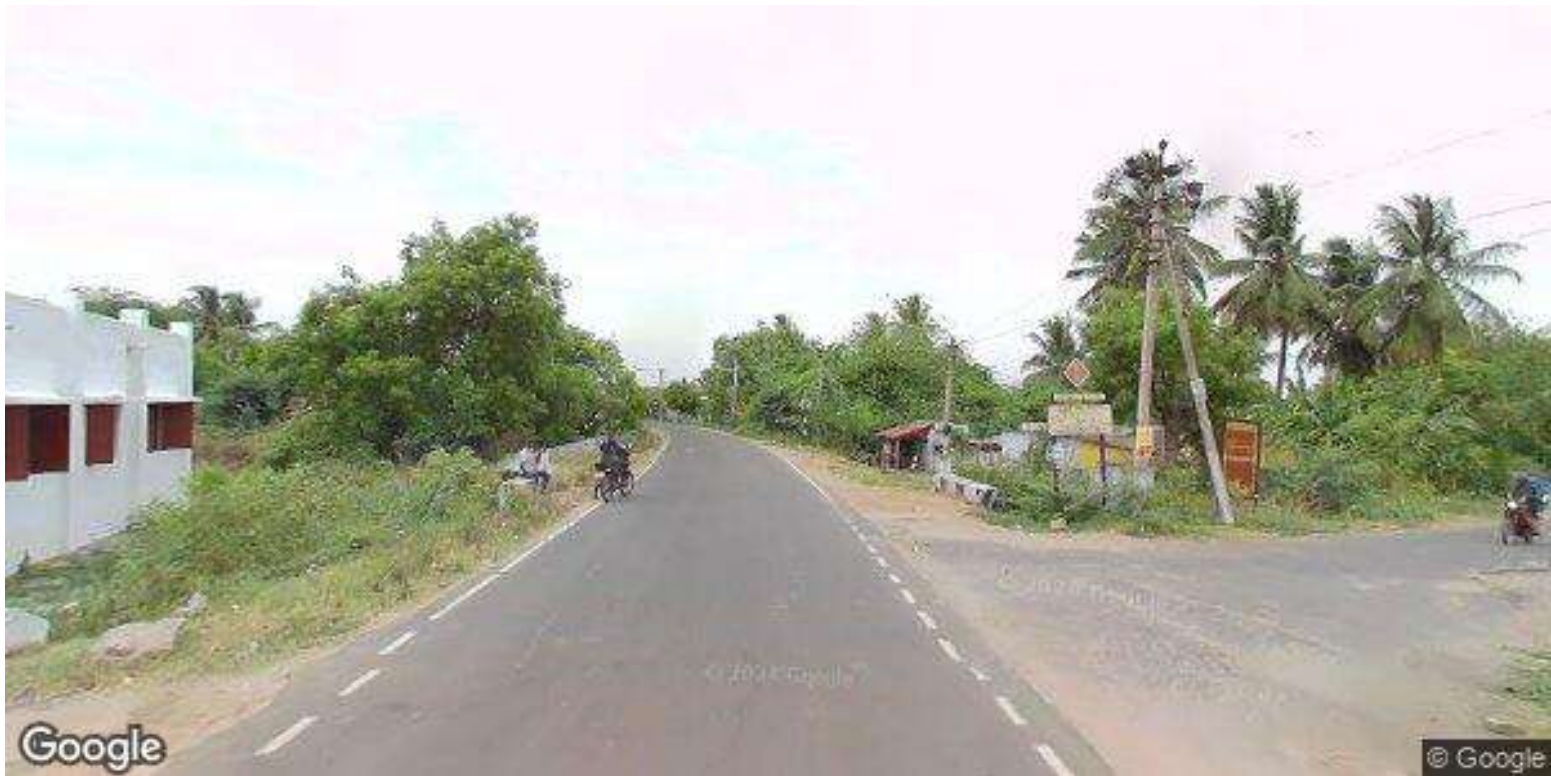
**Risk Type:** Turn  
**Risk Level:** High  
**Speed Limit:** 15 KM/Hr  
**Coordinates:** 11.11376, 78.09124

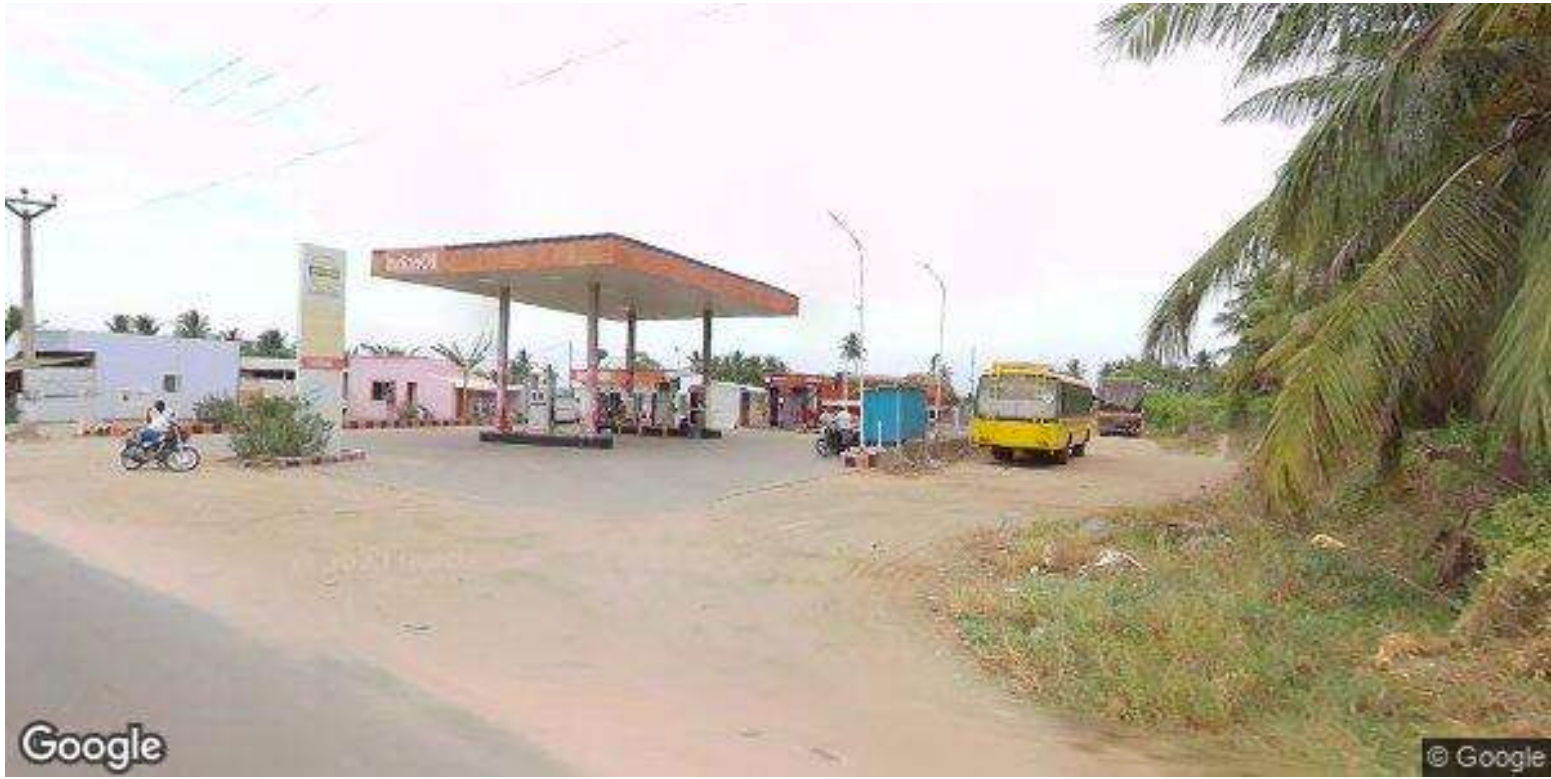
**Risk Type:** Blind Spot  
**Risk Level:** Blind Spot  
**Speed Limit:** 10 KM/Hr  
**Coordinates:** 11.11657, 78.09219
