# IndianOil

## JOURNEY RISK MANAGEMENT (JRM) STUDY

### Salem Terminal TO JEYAMMAL TRADERS

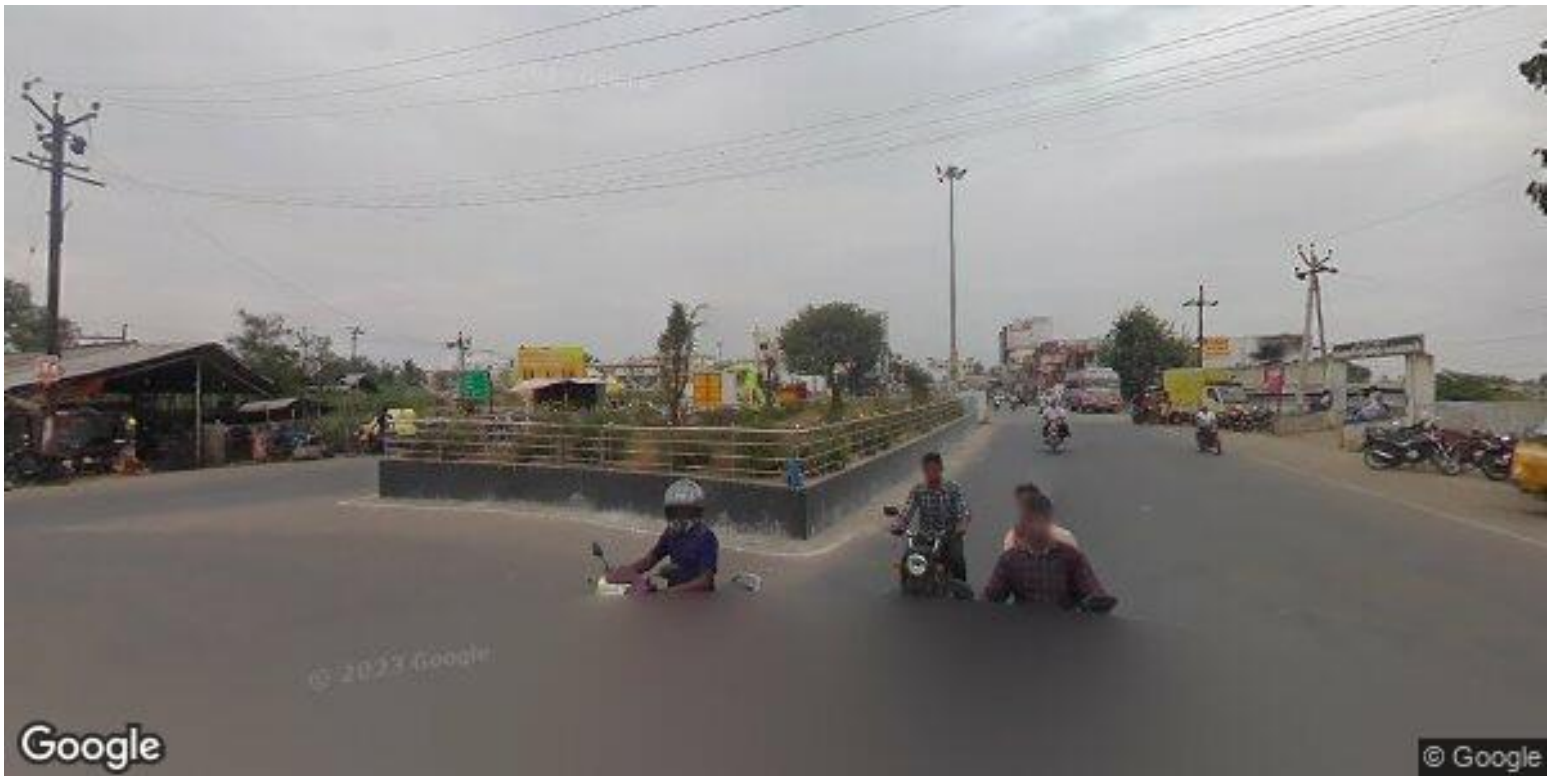
**Coordinates:** 11.58435, 77.83651

**Risk Type:** Roundabout

**Risk Level:** High

**Speed Limit:** 15 KM/Hr

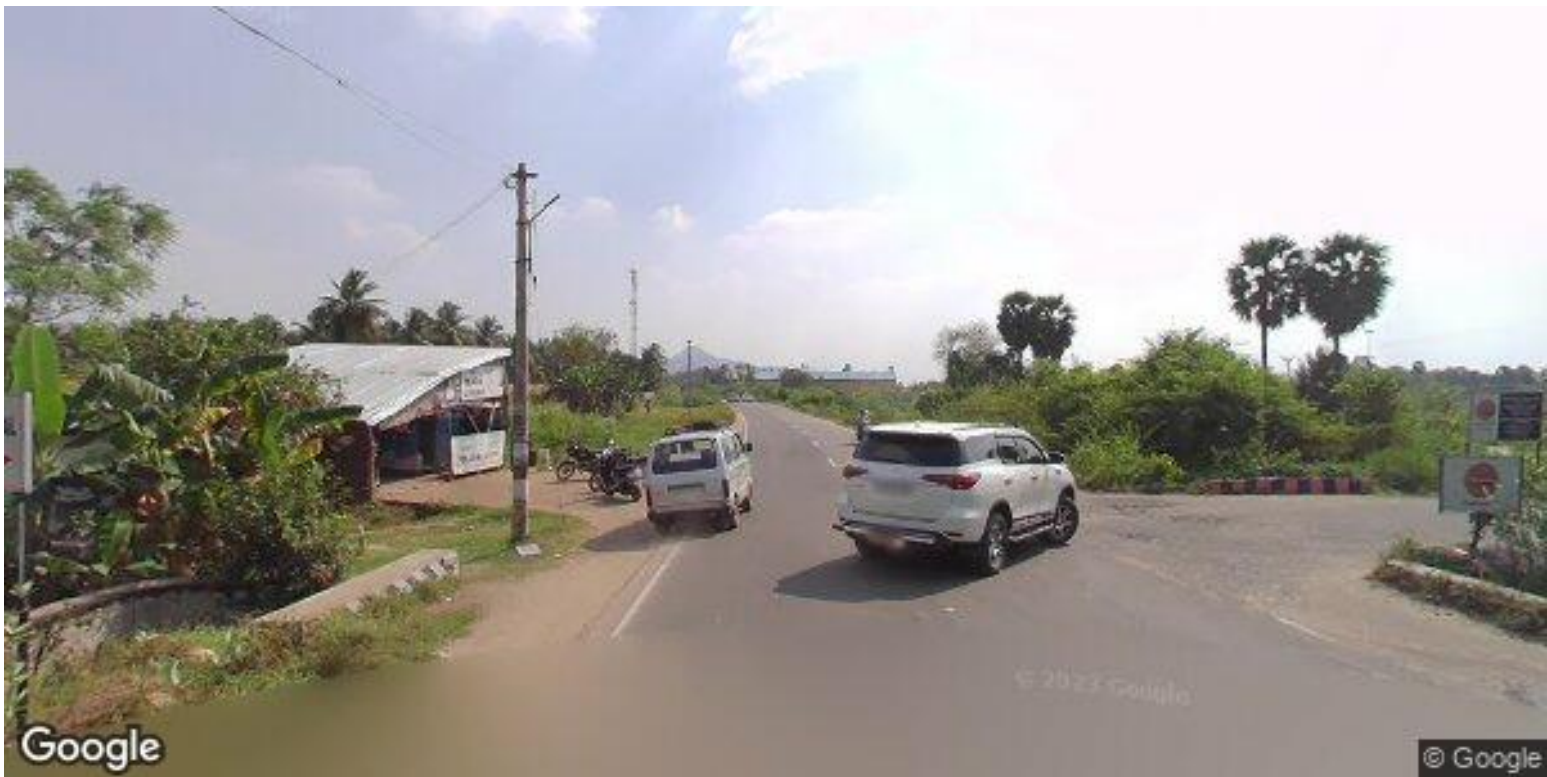
**Coordinates: 11.44029, 77.87544**

**Risk Type: Turn**

**Risk Level: High**

**Speed Limit: 15 KM/Hr**

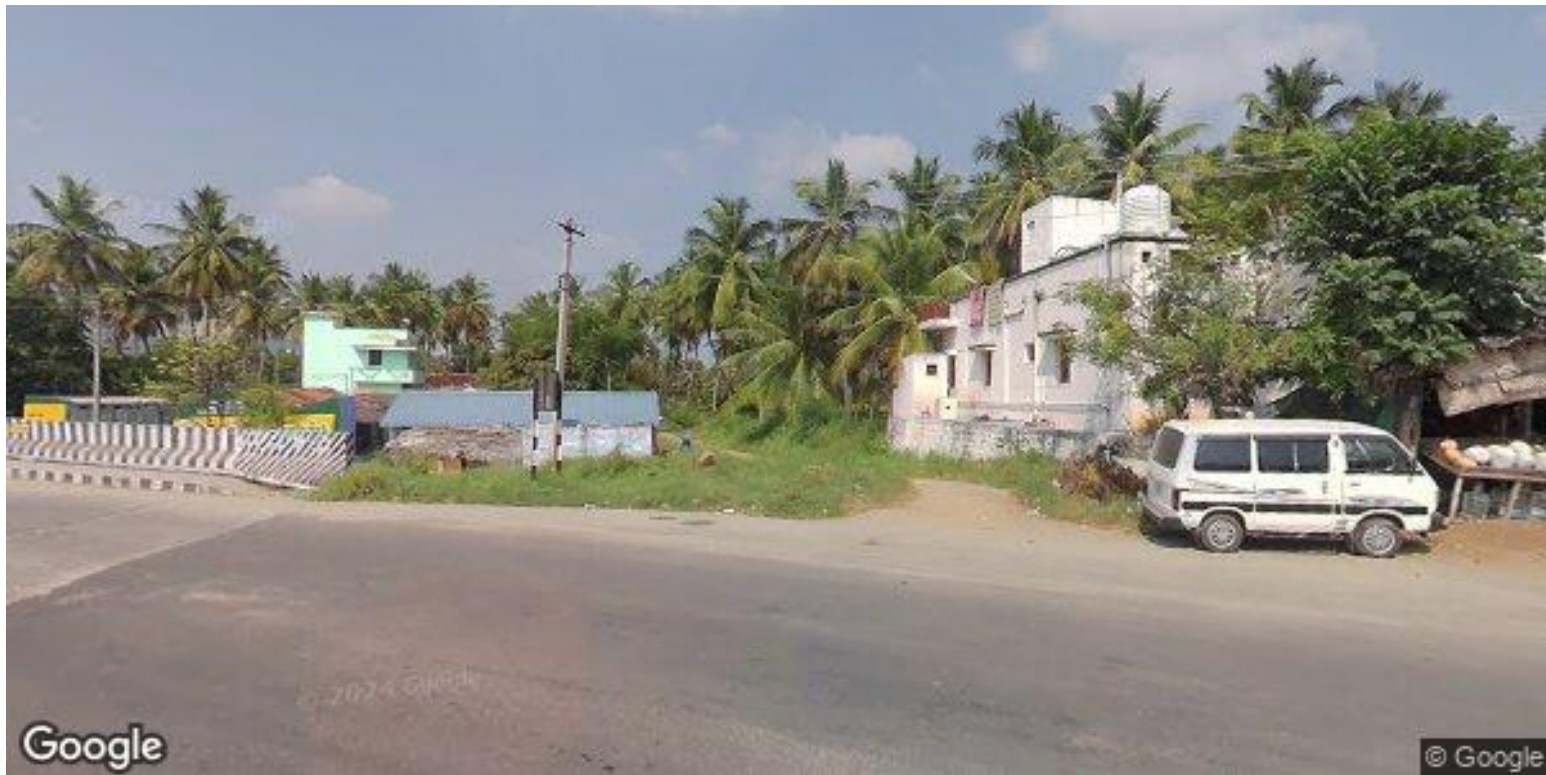
**Coordinates: 11.44898, 77.87410**

**Risk Type: Turn**

**Risk Level: Medium**

**Speed Limit: 30 KM/Hr**

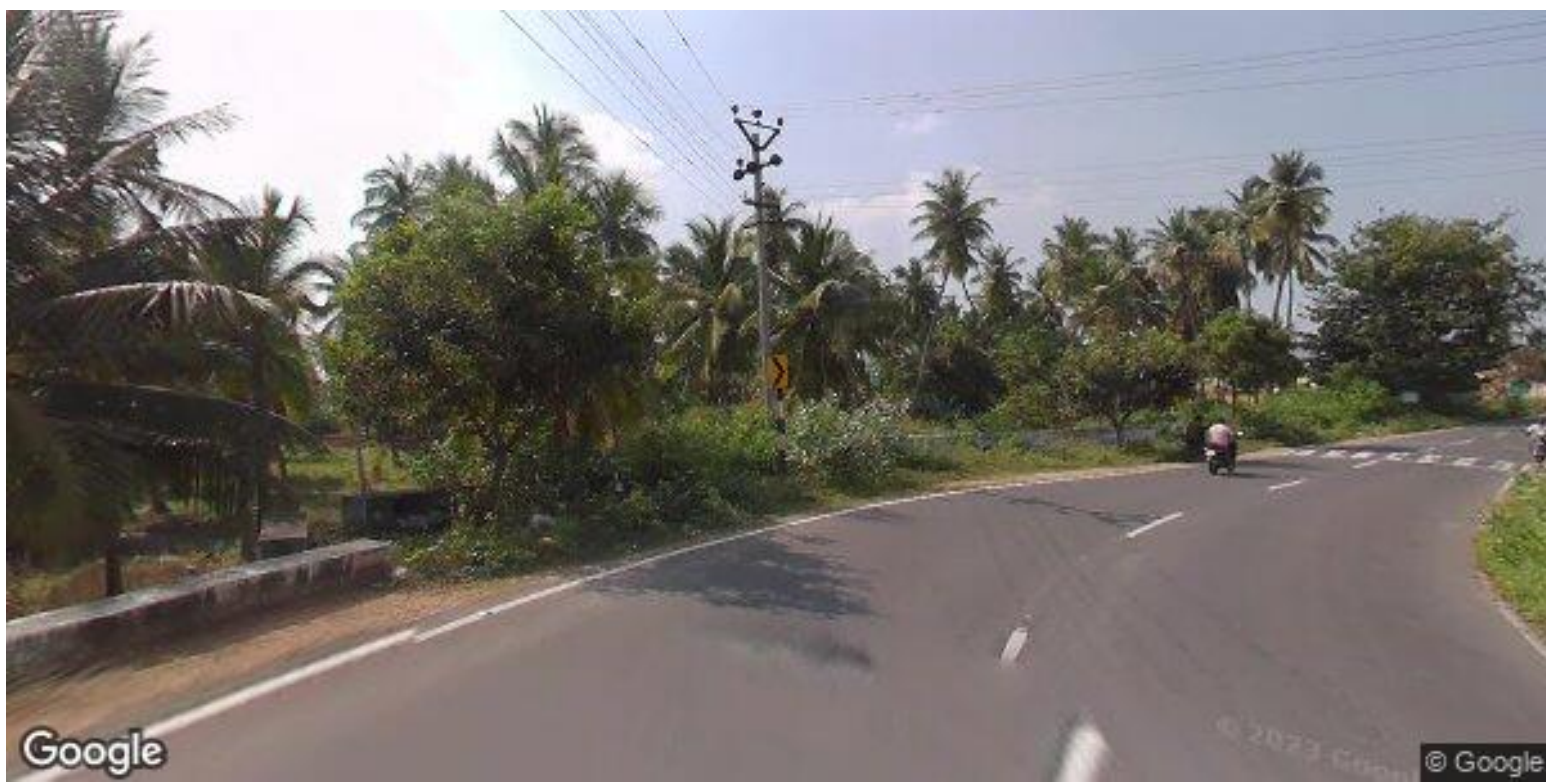
**Coordinates:** 11.45348, 77.85706

**Risk Type:** Turn

**Risk Level:** Medium

**Speed Limit:** 30 KM/Hr

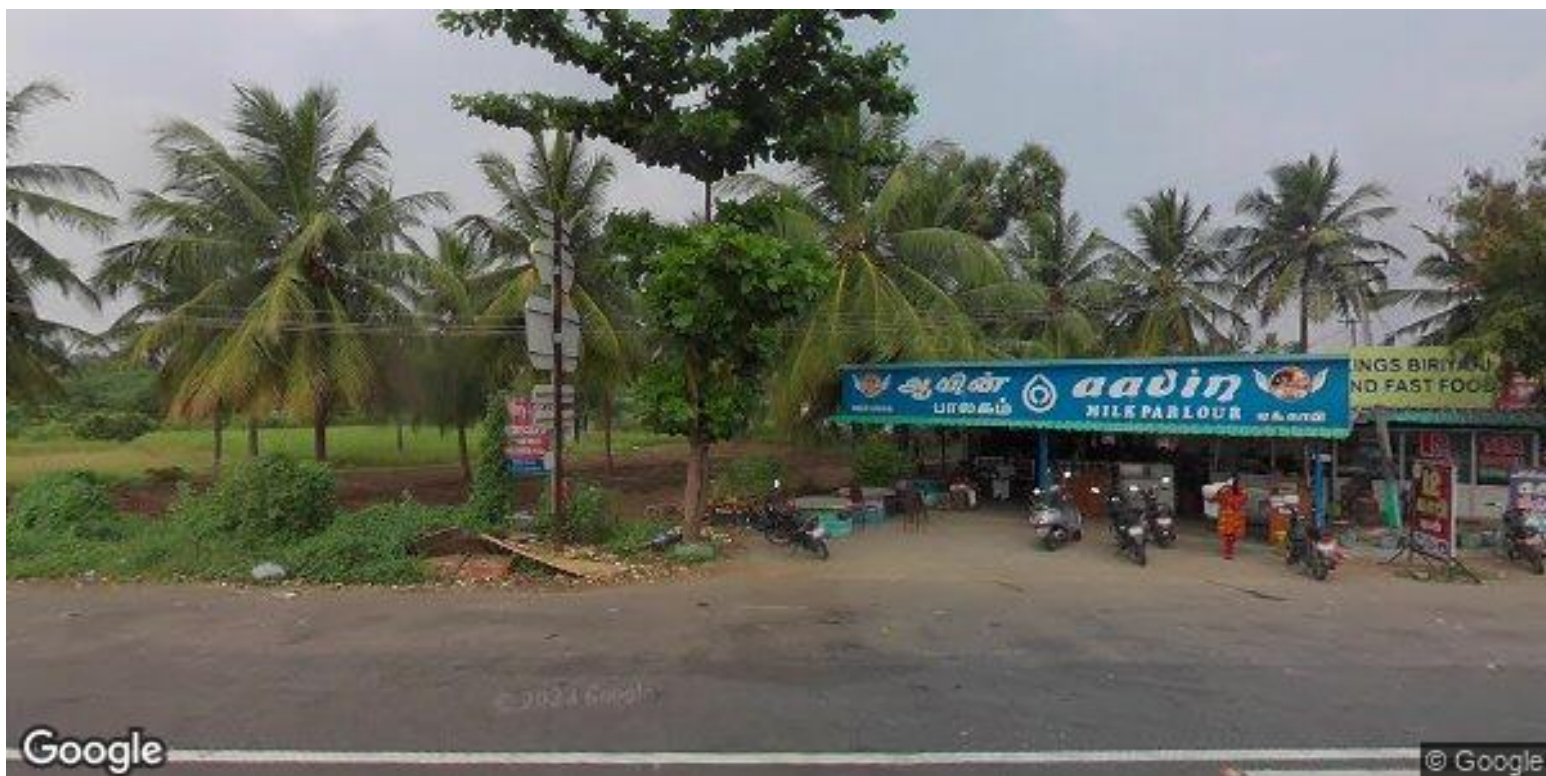
**Risk Type:** Turn  
**Risk Level:** High  
**Speed Limit:** 15 KM/Hr  
**Coordinates:** 11.45631, 77.81668

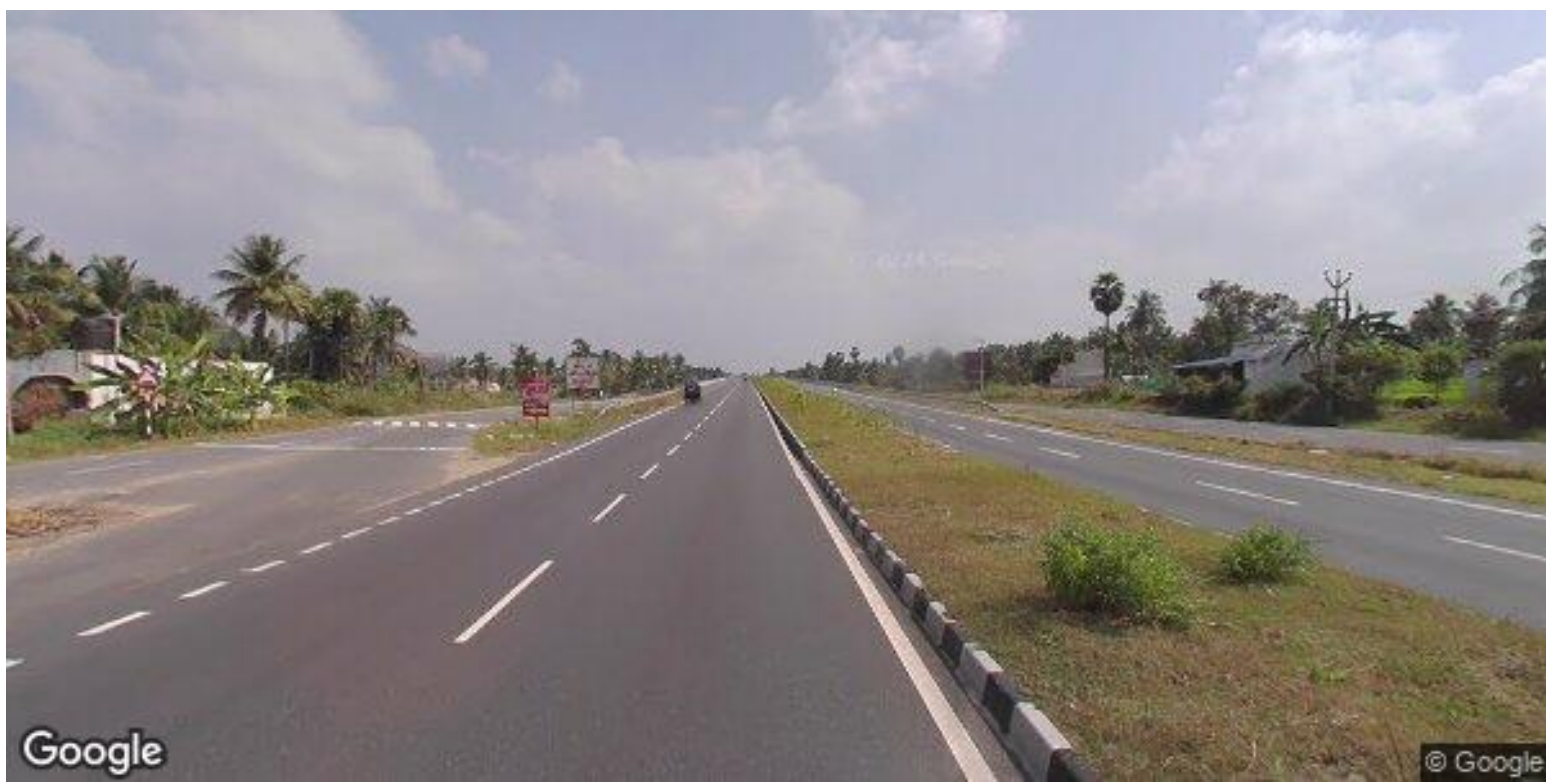
**Coordinates:** 11.49249, 77.85821

**Risk Type:** Turn

**Risk Level:** Medium

**Speed Limit:** 30 KM/Hr

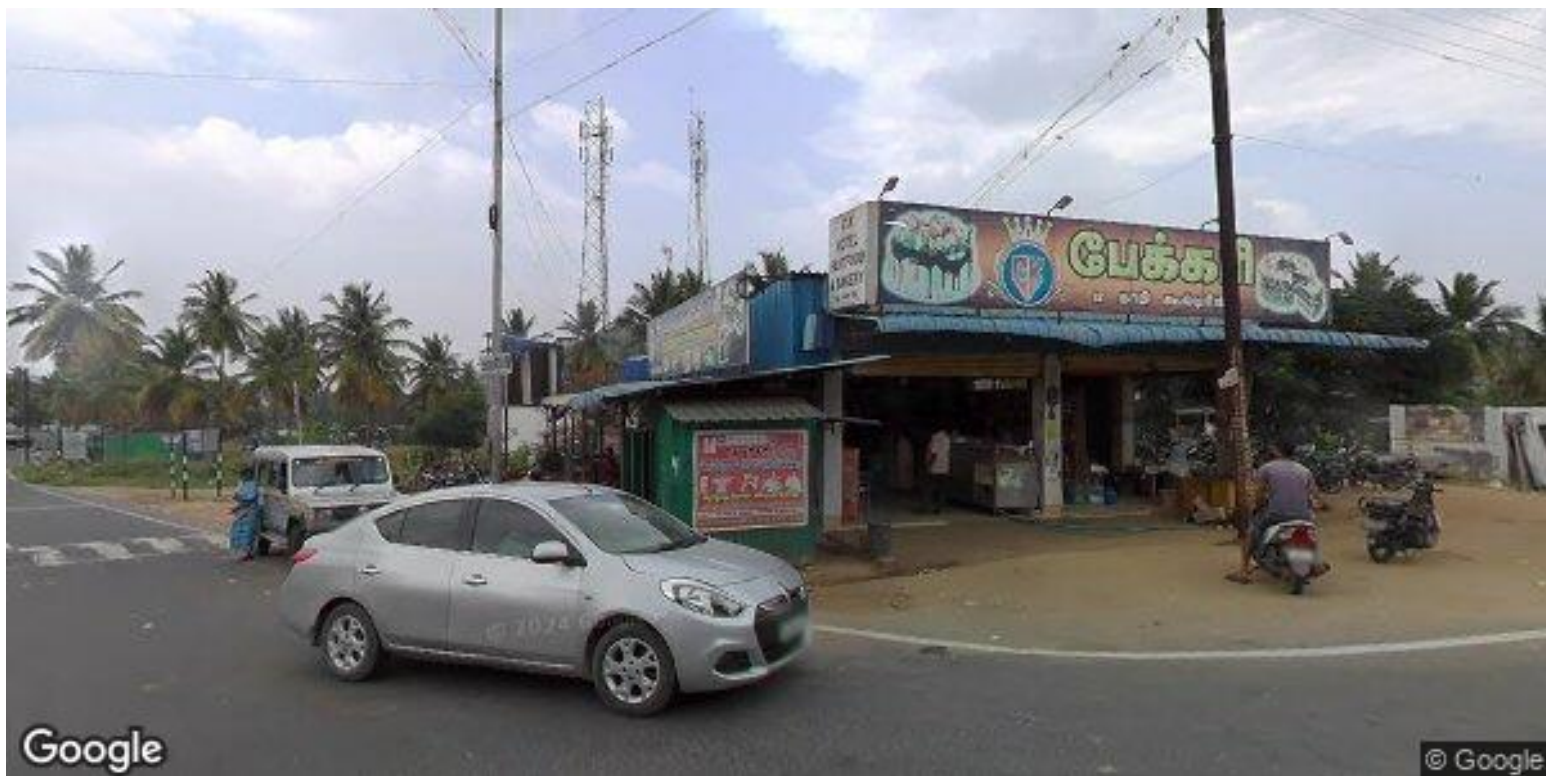
**Coordinates:** 11.49390, 77.86748

**Risk Type:** Blind Spot

**Risk Level:** Blind Spot

**Speed Limit:** 10 KM/Hr

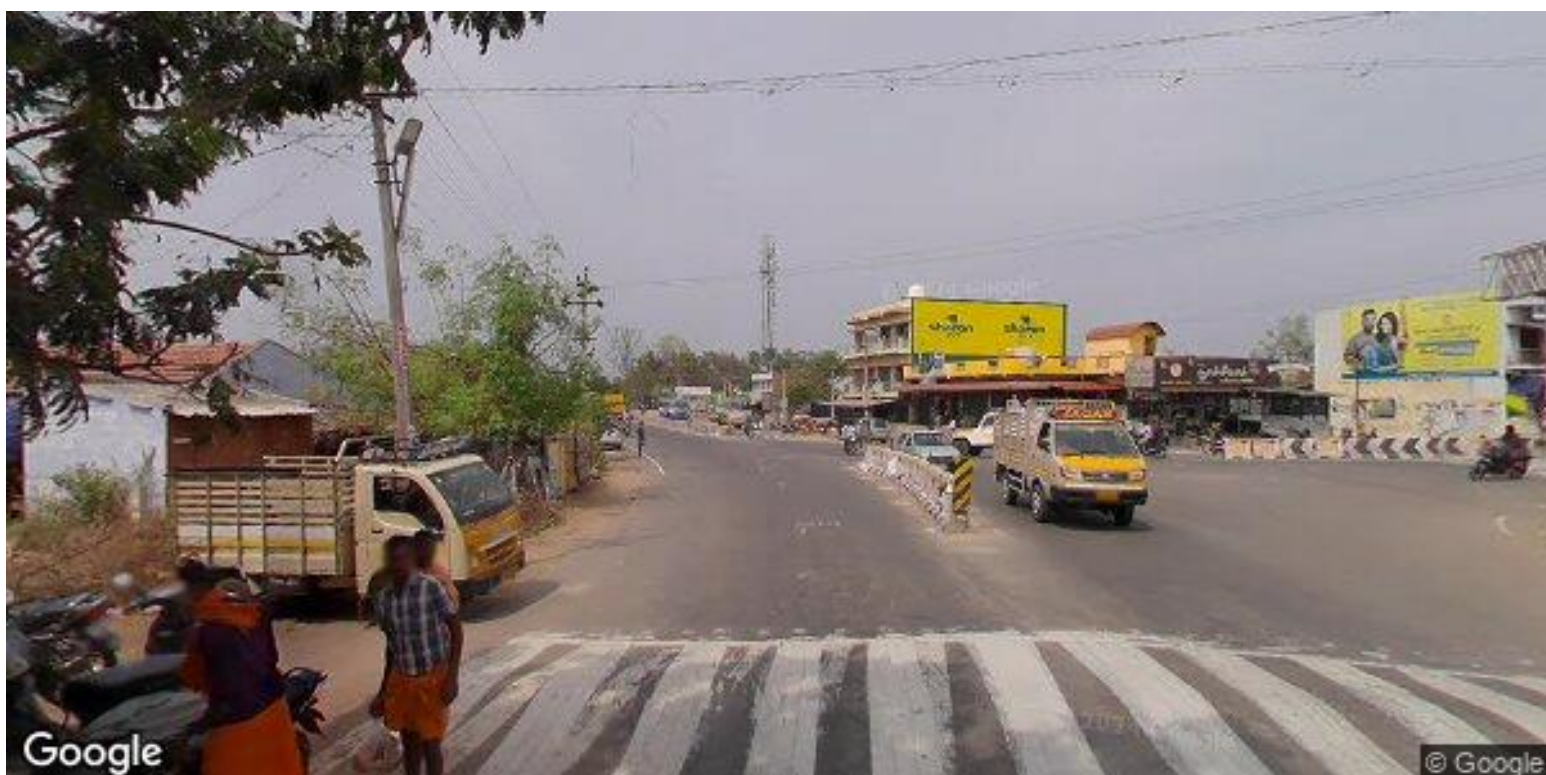
**Coordinates:** 11.58296, 77.85419

**Risk Type:** Turn

**Risk Level:** Medium

**Speed Limit:** 30 KM/Hr

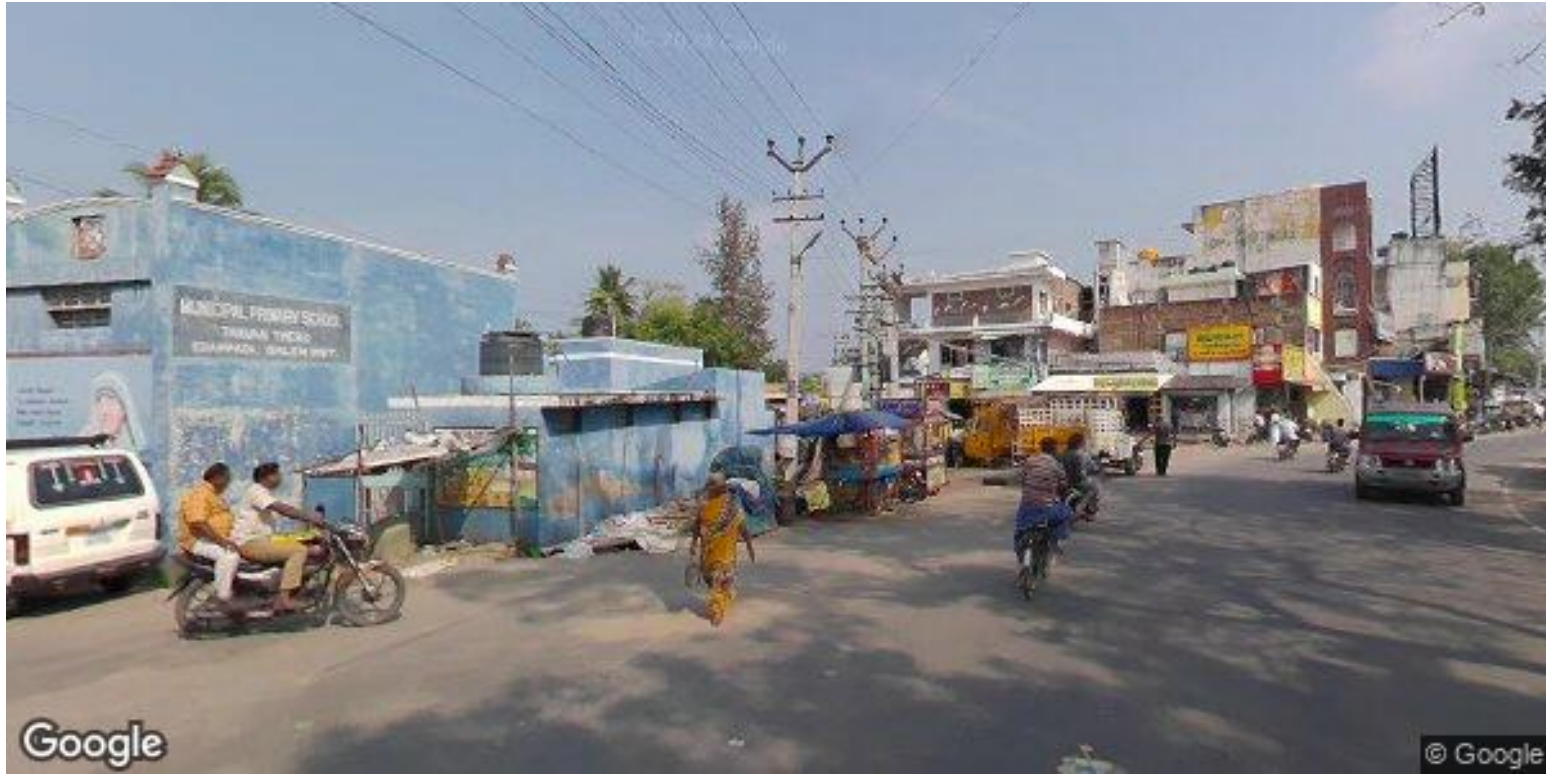
**Coordinates:** 11.58523, 77.83507

**Risk Type:** Turn

**Risk Level:** High

**Speed Limit:** 15 KM/Hr
