# IndianOil

## JOURNEY RISK MANAGEMENT (JRM) STUDY

### Salem Terminal to VANMATHI AGENCIES

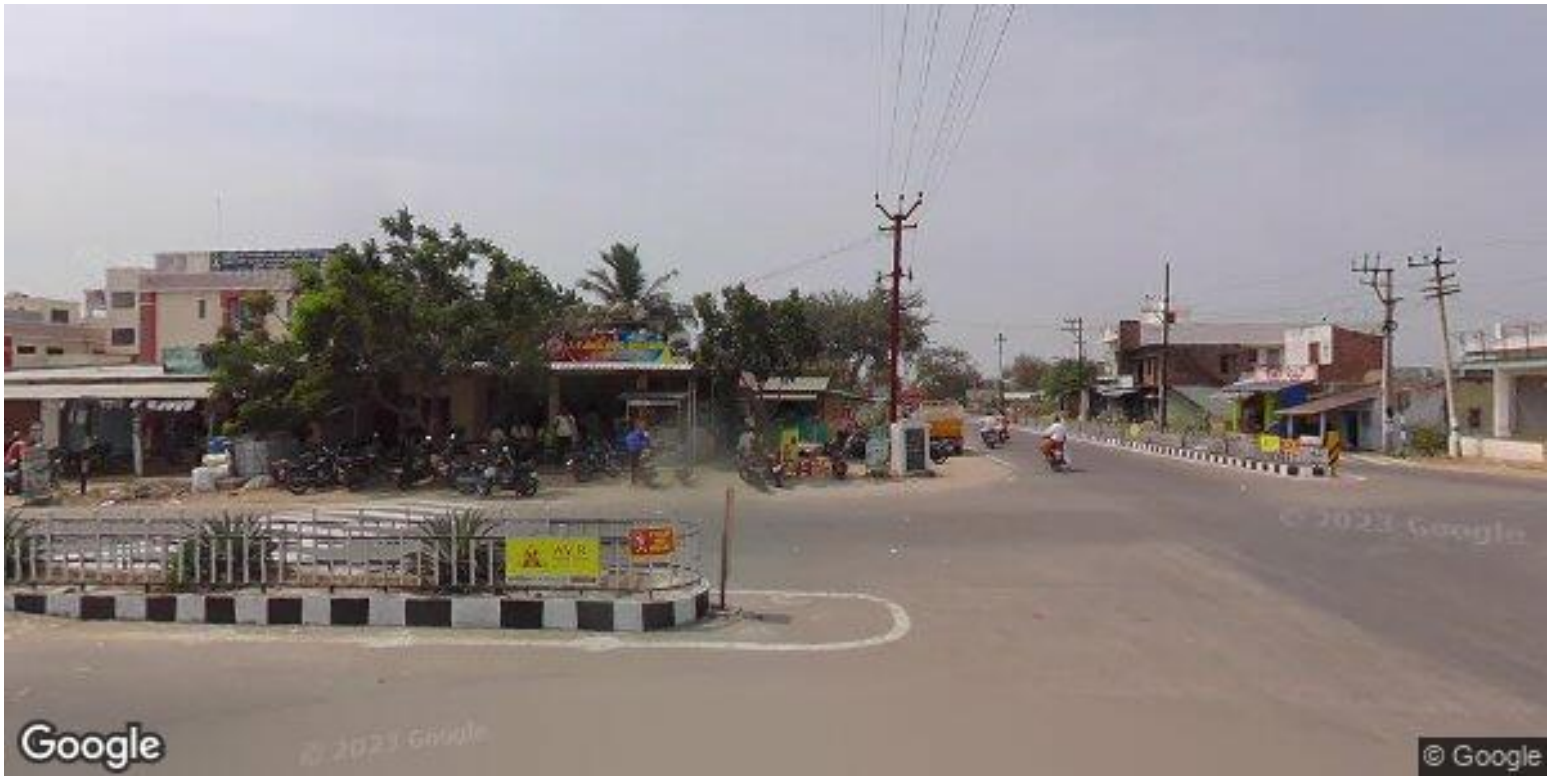
**Risk Type:** Roundabout  
**Risk Level:** High  
**Speed Limit:** 15 KM/Hr  
**Coordinates:** 11.58300, 77.85813

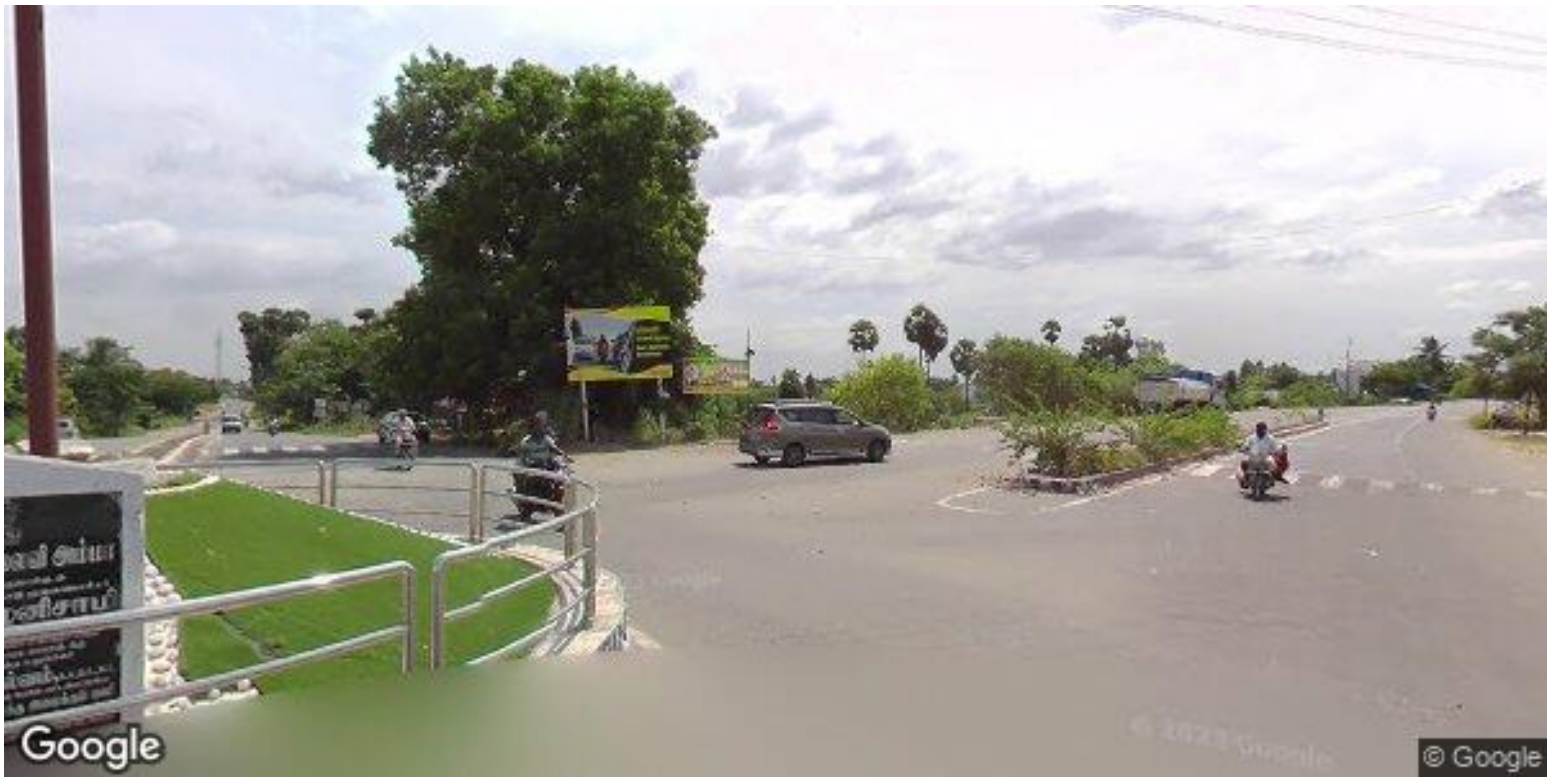
**Risk Type:** Roundabout  
**Risk Level:** High

**Speed Limit: 15 KM/Hr**  
**Coordinates: 11.60348, 77.83967**

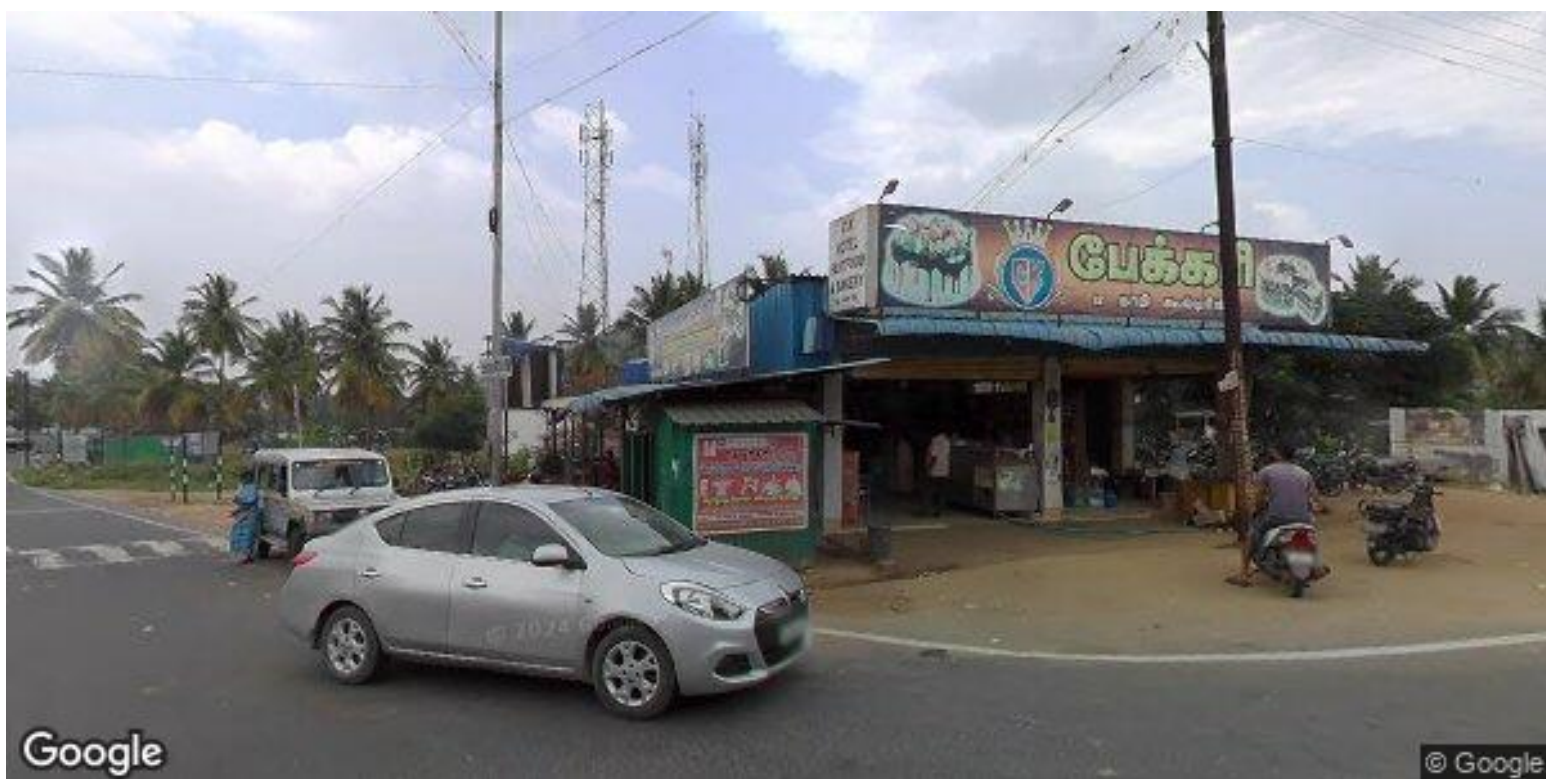
**Risk Type:** Blind Spot

**Risk Level:** Blind Spot

**Speed Limit:** 10 KM/Hr

**Coordinates:** 11.49390, 77.86748

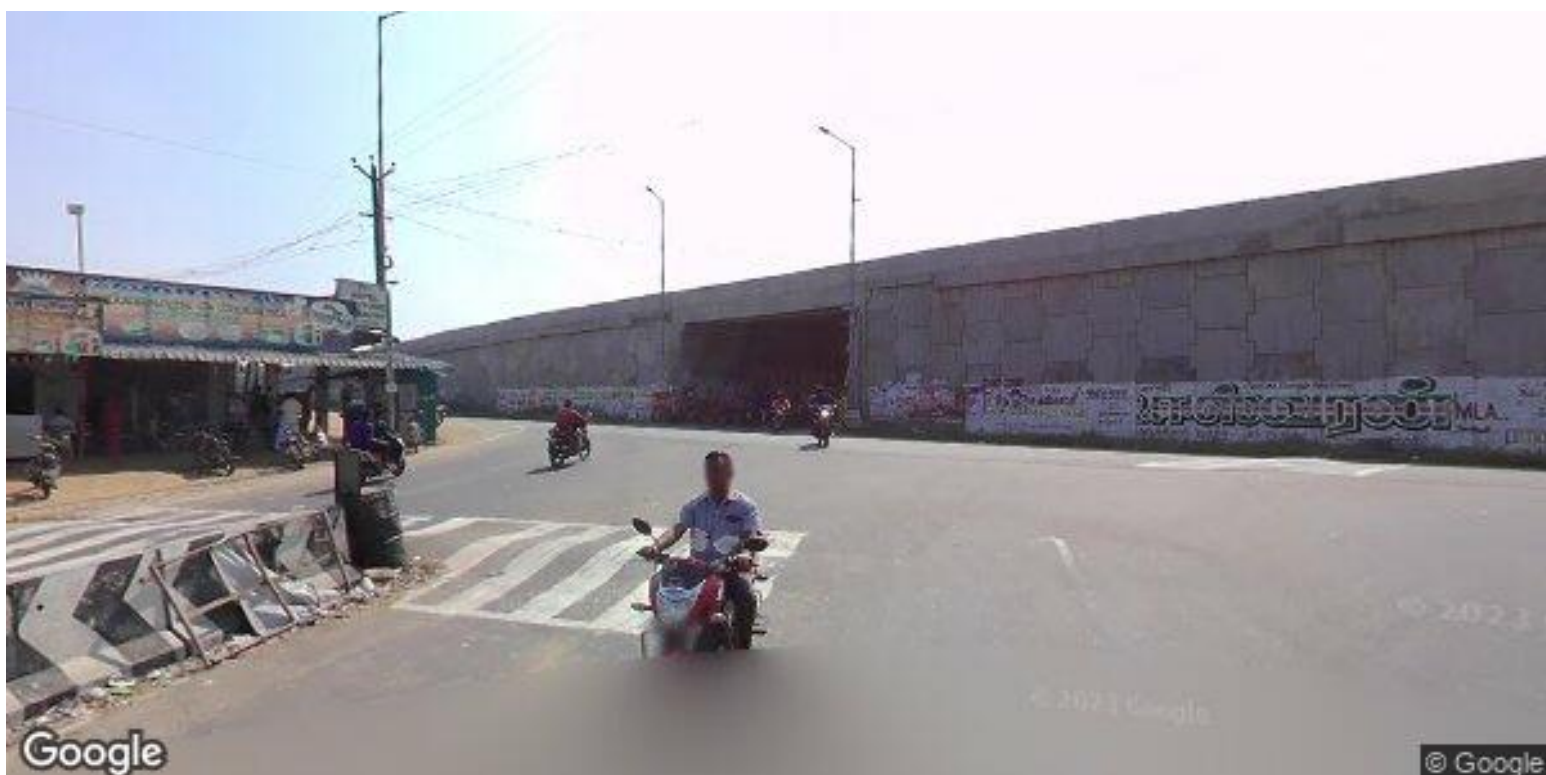
**Risk Type:** Turn

**Risk Level:** Medium

**Speed Limit:** 30 KM/Hr

**Coordinates:** 11.49404, 77.86724

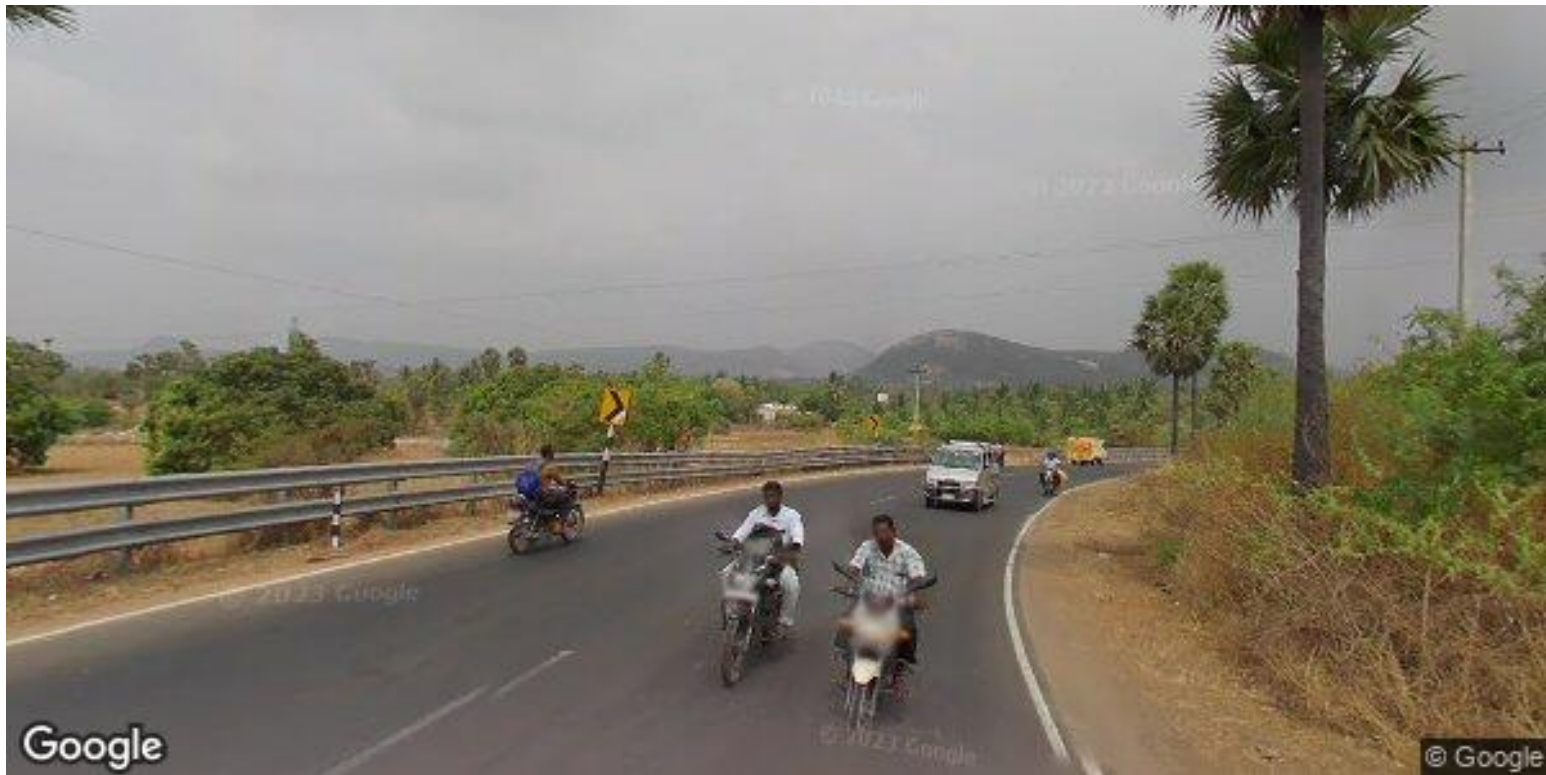
**Risk Type:** Turn

**Risk Level:** Medium

**Speed Limit:** 30 KM/Hr

**Coordinates:** 11.50866, 77.86053

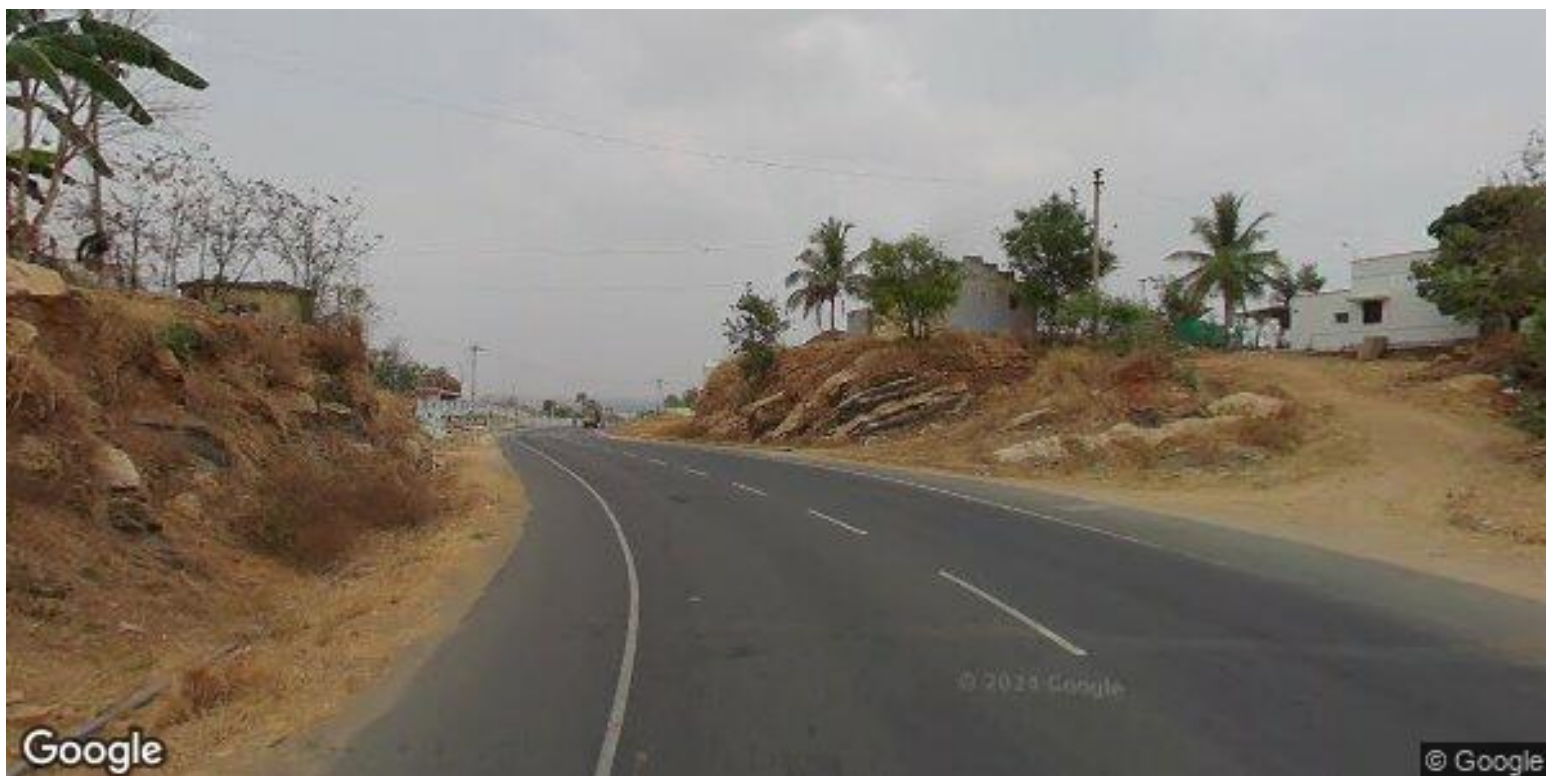
**Risk Type:** Turn

**Risk Level:** Medium

**Speed Limit:** 30 KM/Hr

**Coordinates:** 11.55039, 77.85511

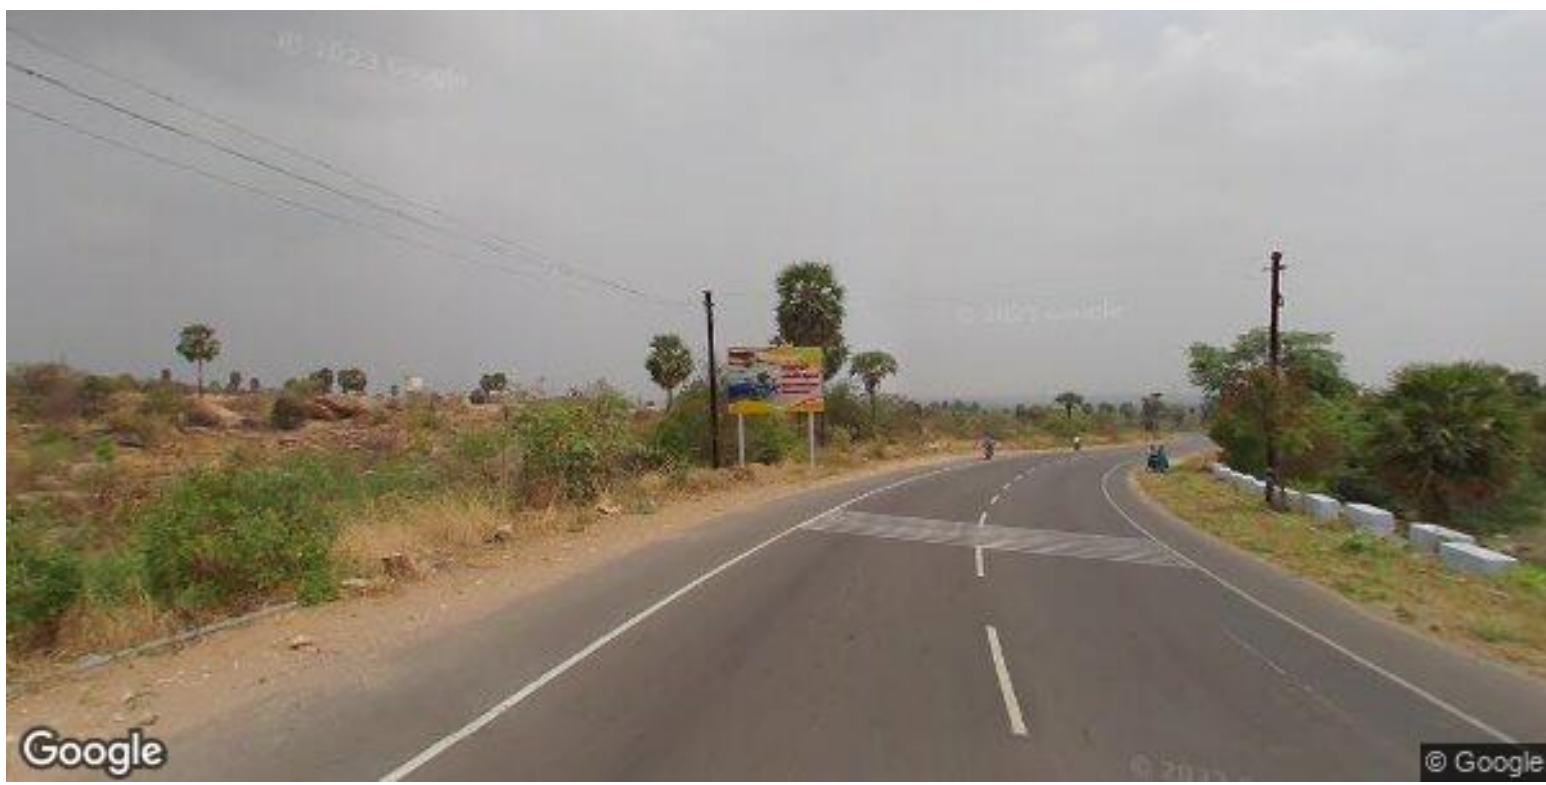
**Risk Type:** Turn

**Risk Level:** Medium

**Speed Limit:** 30 KM/Hr

**Coordinates:** 11.55460, 77.85624

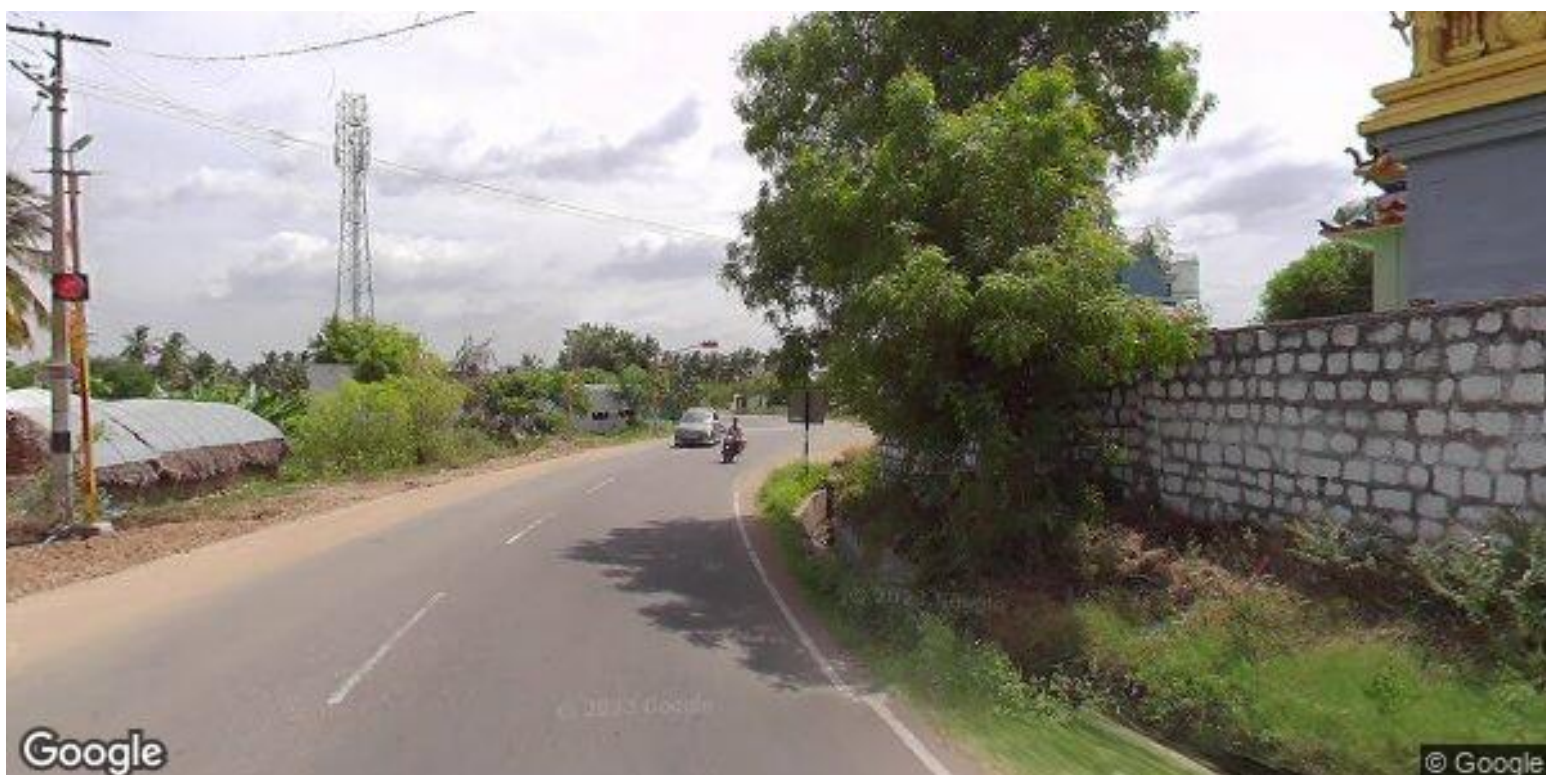
**Risk Type:** Turn

**Risk Level:** Medium

**Speed Limit:** 30 KM/Hr

**Coordinates:** 11.60727, 77.84032

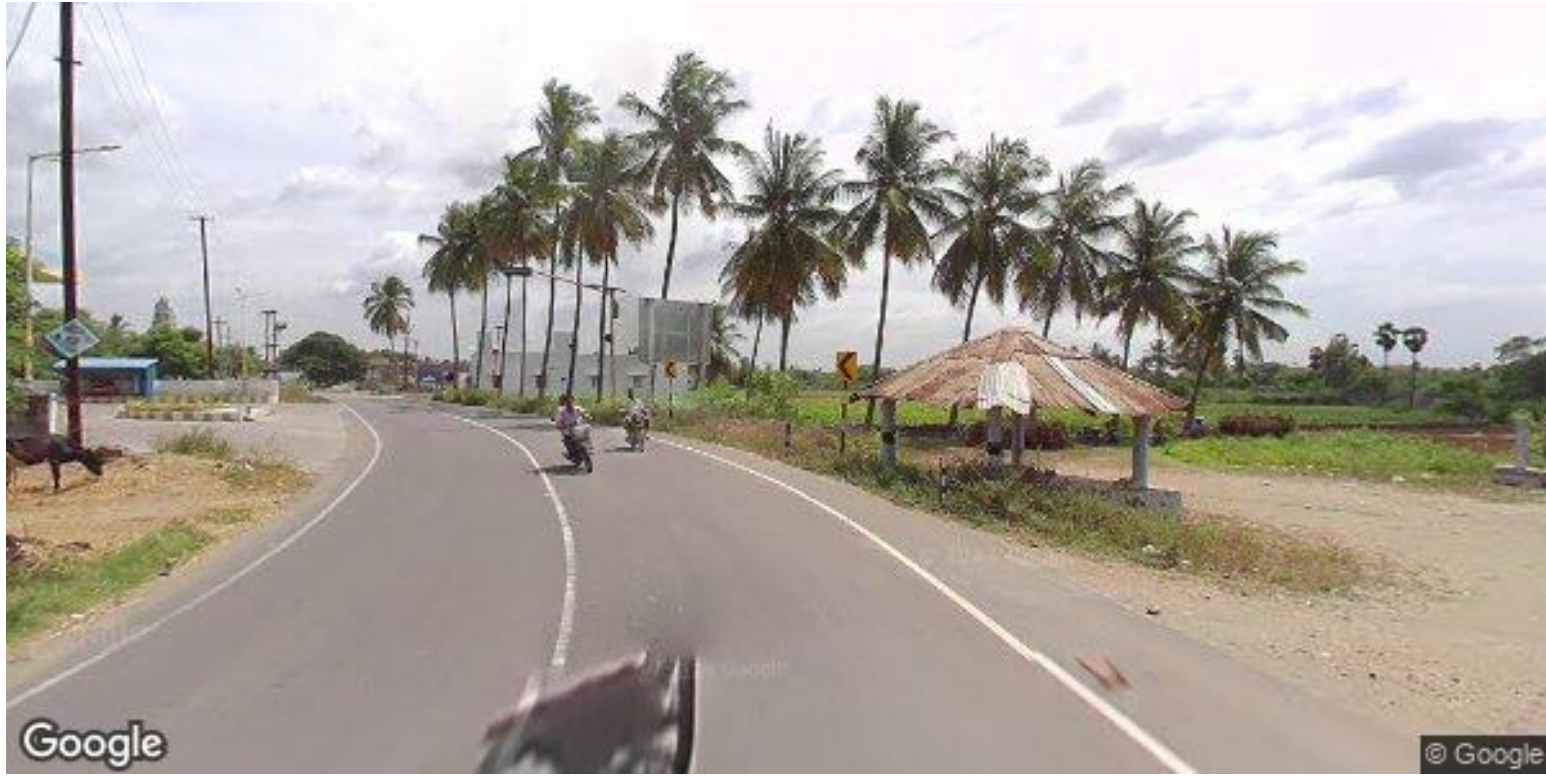
**Risk Type:** Turn

**Risk Level:** Medium

**Speed Limit:** 30 KM/Hr

**Coordinates:** 11.60972, 77.84164

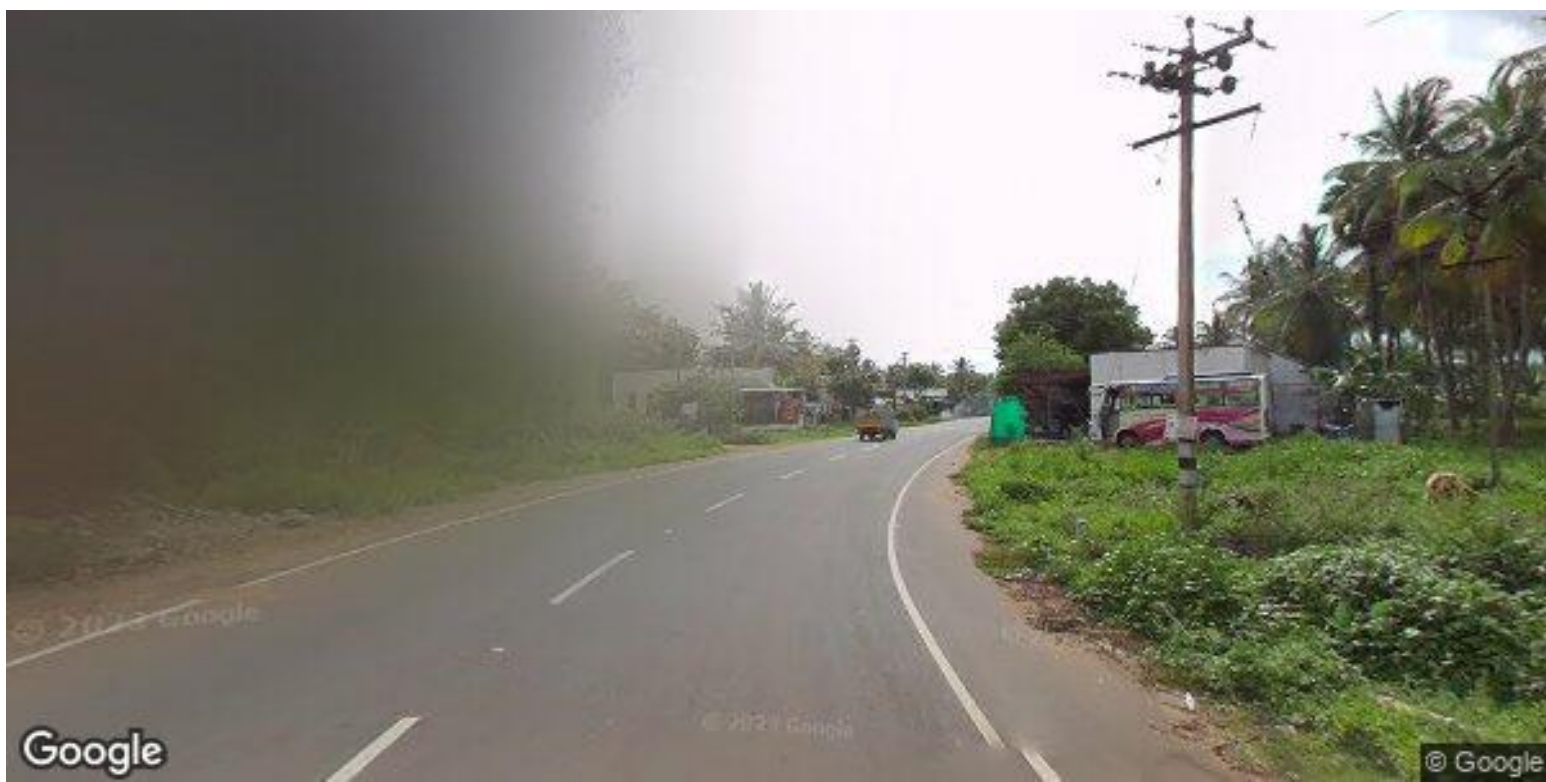
**Risk Type:** Turn

**Risk Level:** Medium

**Speed Limit:** 30 KM/Hr

**Coordinates:** 11.67373, 77.86230

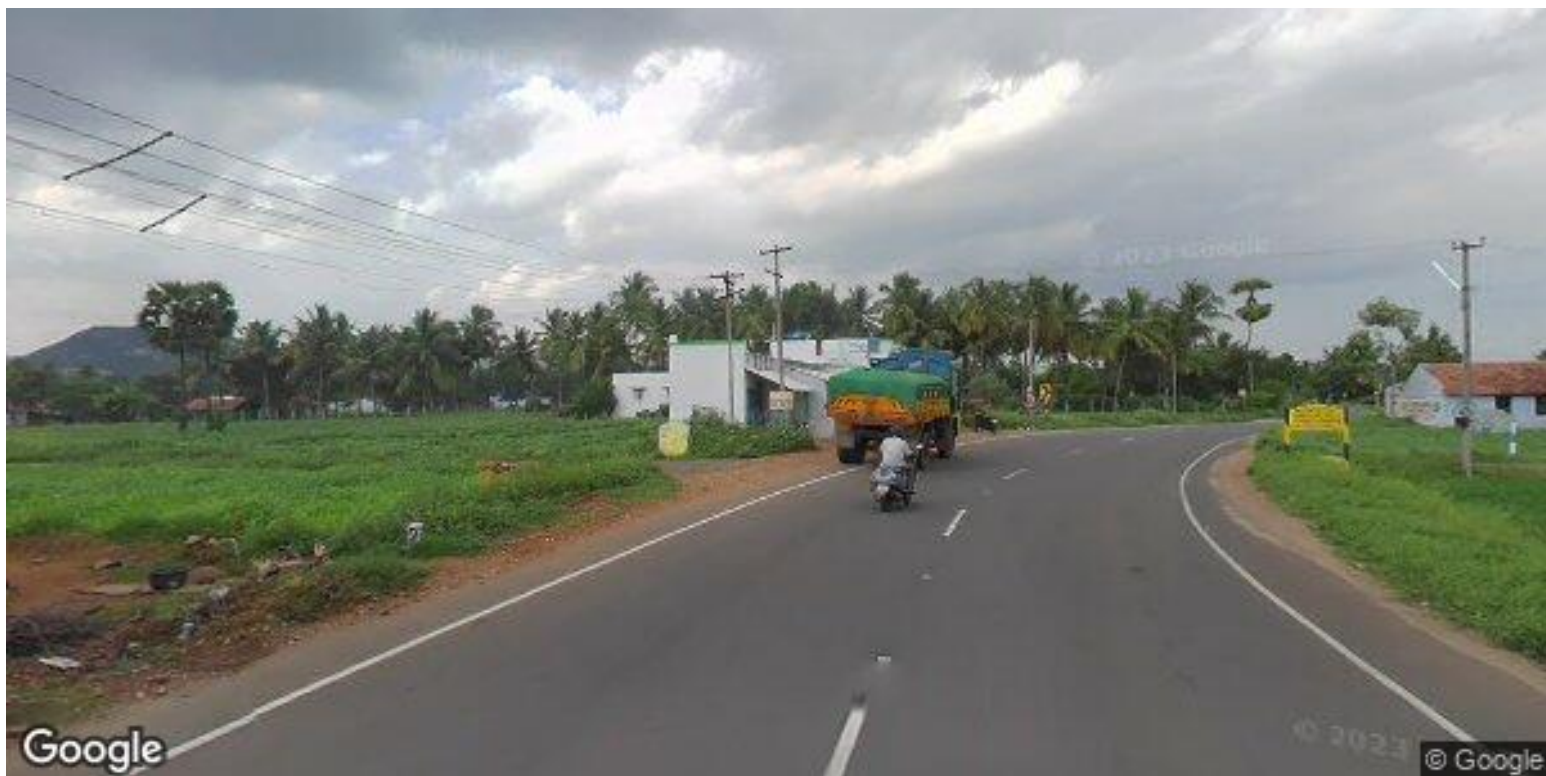
**Risk Type:** Turn

**Risk Level:** Medium

**Speed Limit:** 30 KM/Hr

**Coordinates:** 11.68171, 77.86676

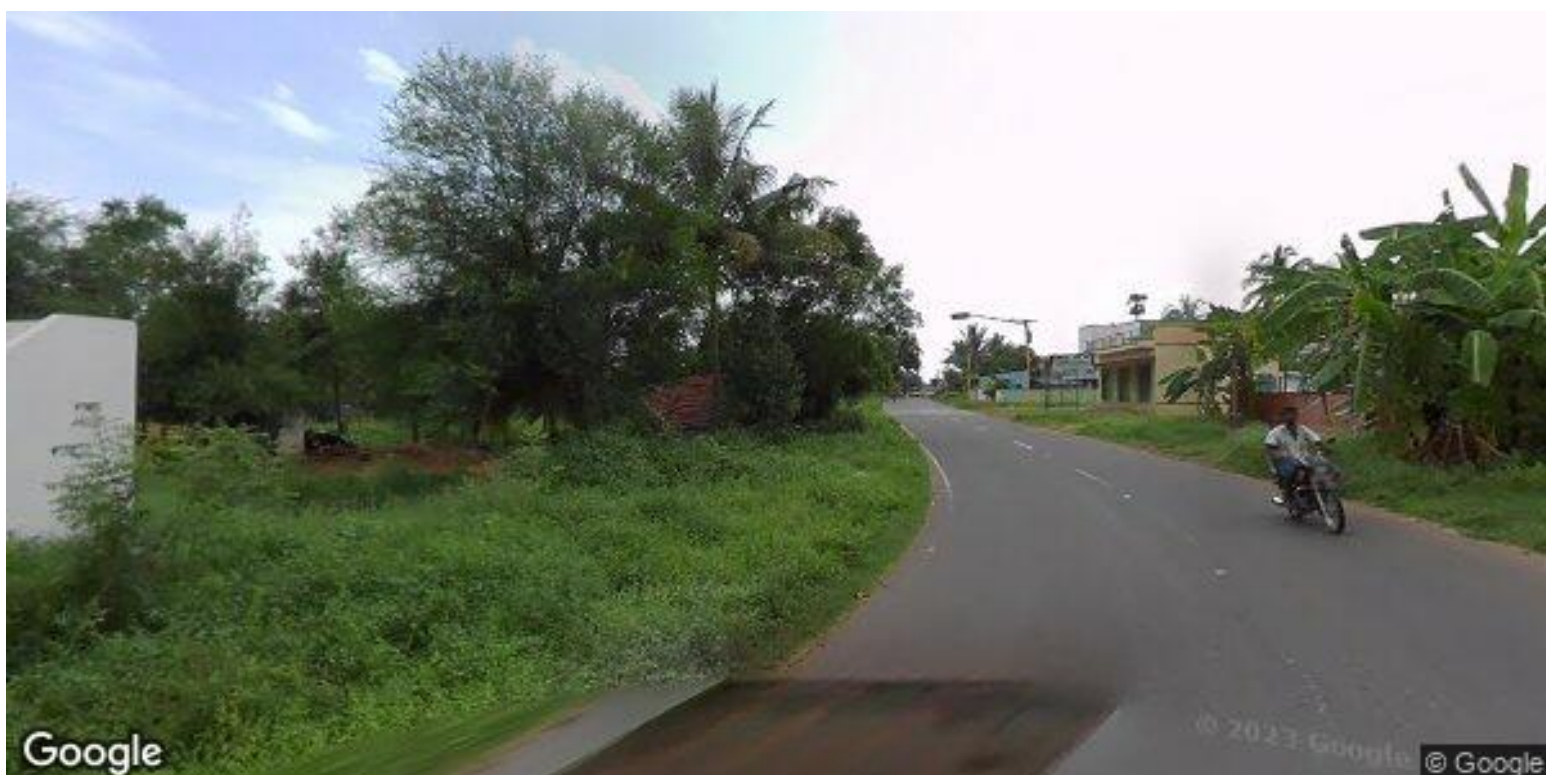
**Risk Type:** Turn

**Risk Level:** High

**Speed Limit:** 15 KM/Hr

**Coordinates:** 11.68490, 77.86893

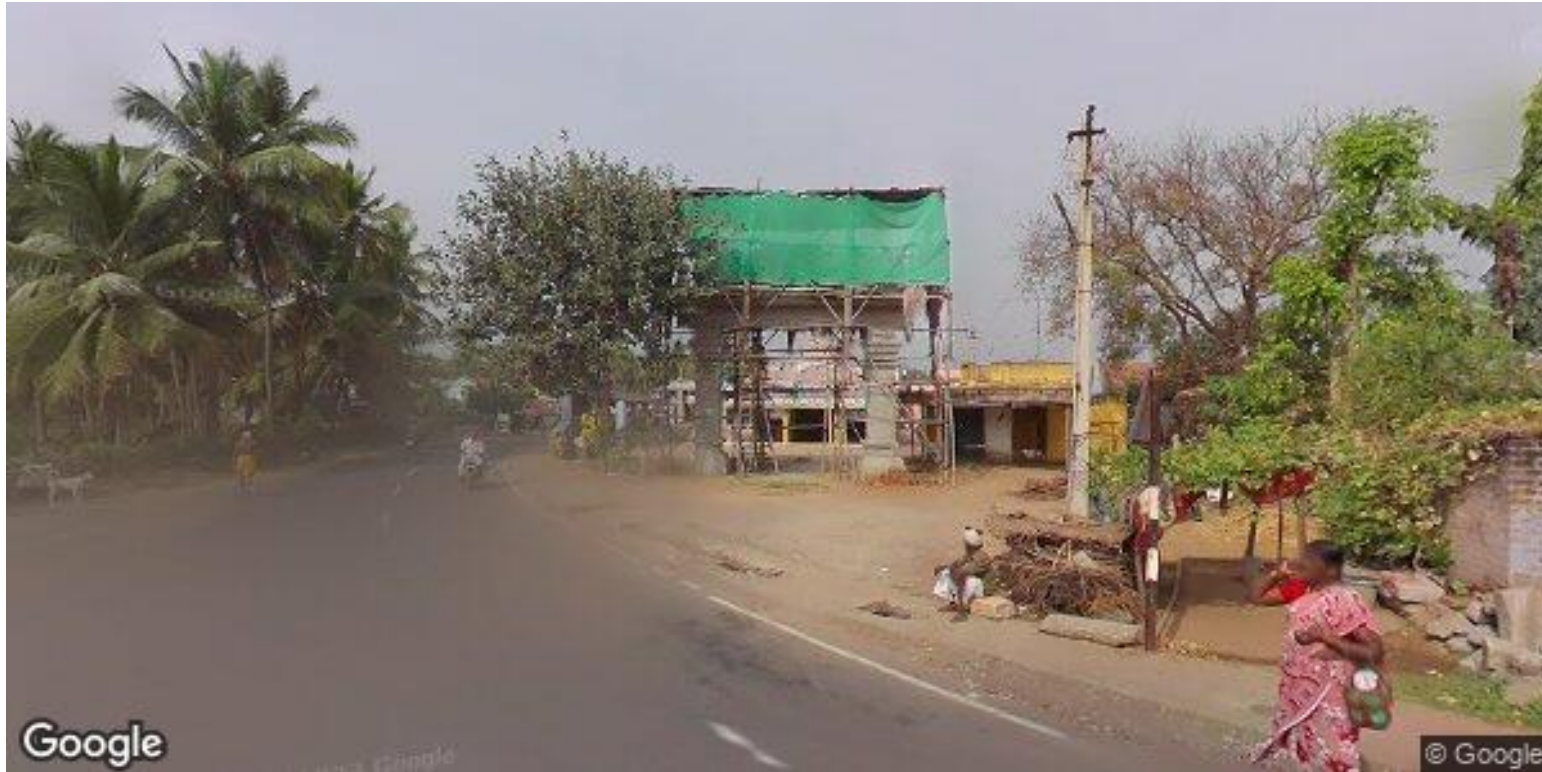
**Risk Type:** Turn

**Risk Level:** High

**Speed Limit:** 15 KM/Hr

**Coordinates:** 11.68472, 77.87281
