## **JOURNEY RISK MANAGEMENT (JRM) STUDY**

### **Salem Terminal to BAGIYALAKSHMI AGENCY**

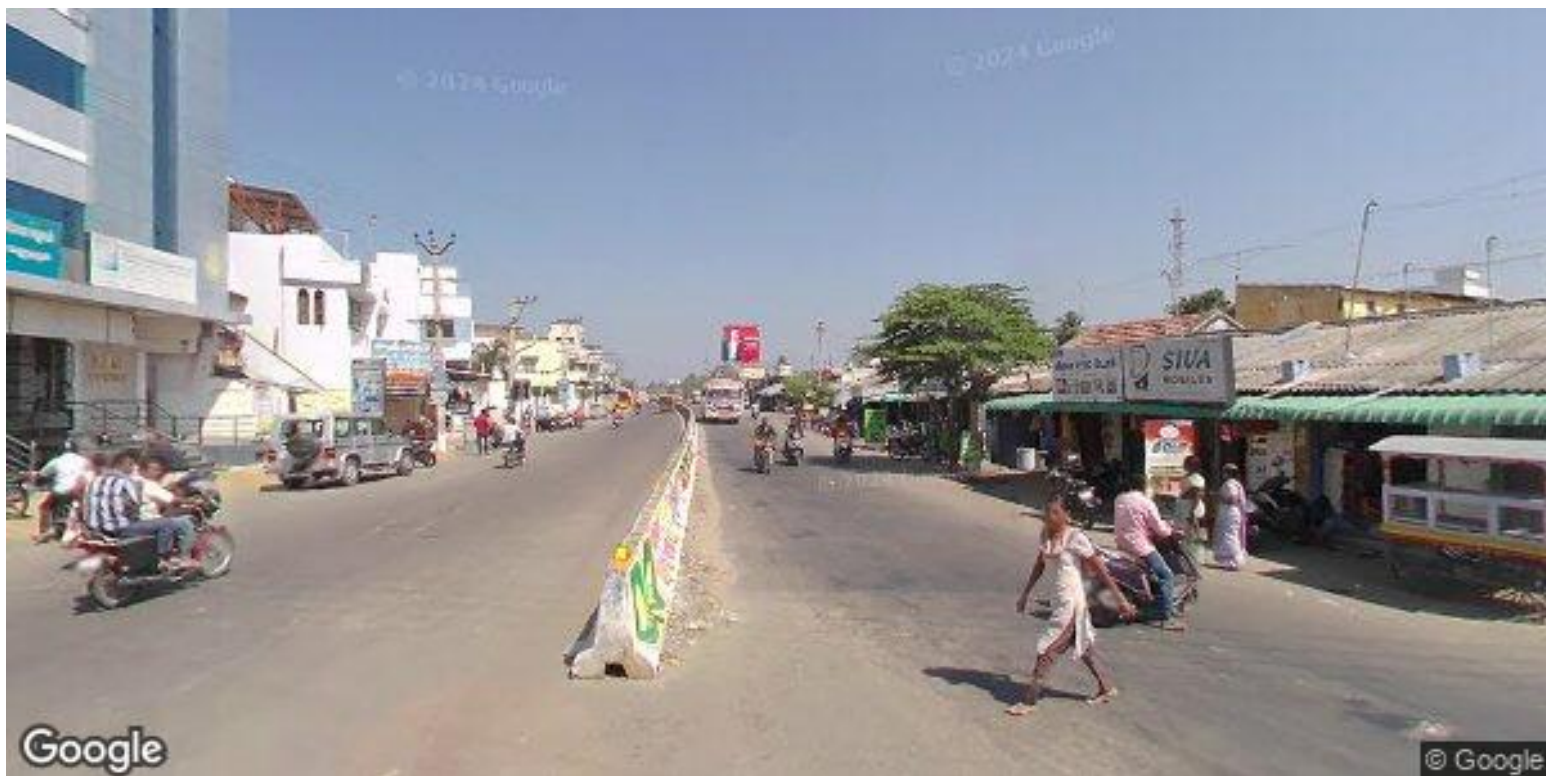
**Coordinates:** 11.37086, 77.74828

**Risk Type:** Roundabout

**Risk Level:** High

**Speed Limit:** 15 KM/Hr

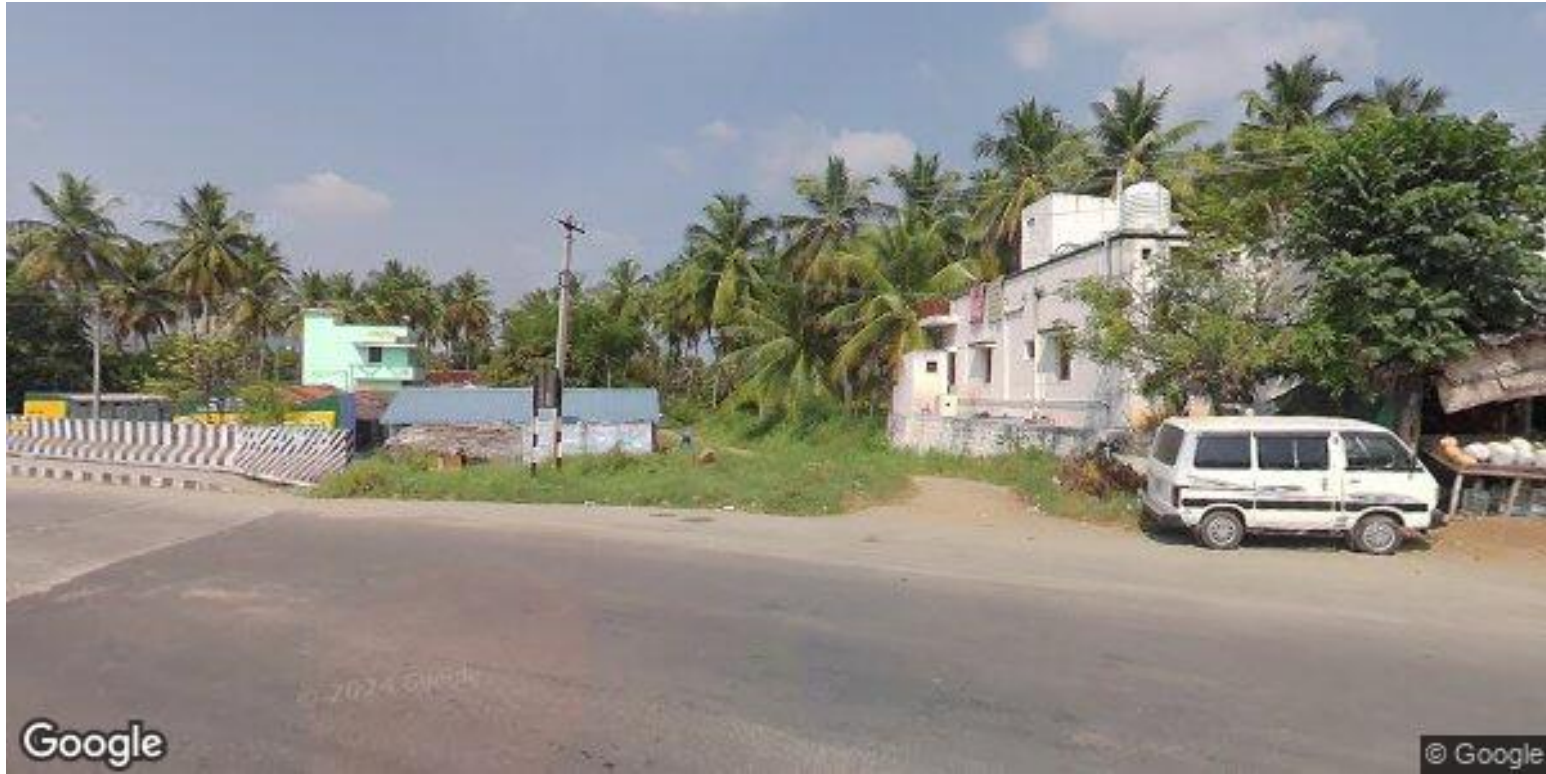
**Risk Type: Turn**  
**Risk Level: Medium**  
**Speed Limit: 30 KM/Hr**  
**Coordinates: 11.44898, 77.87410**

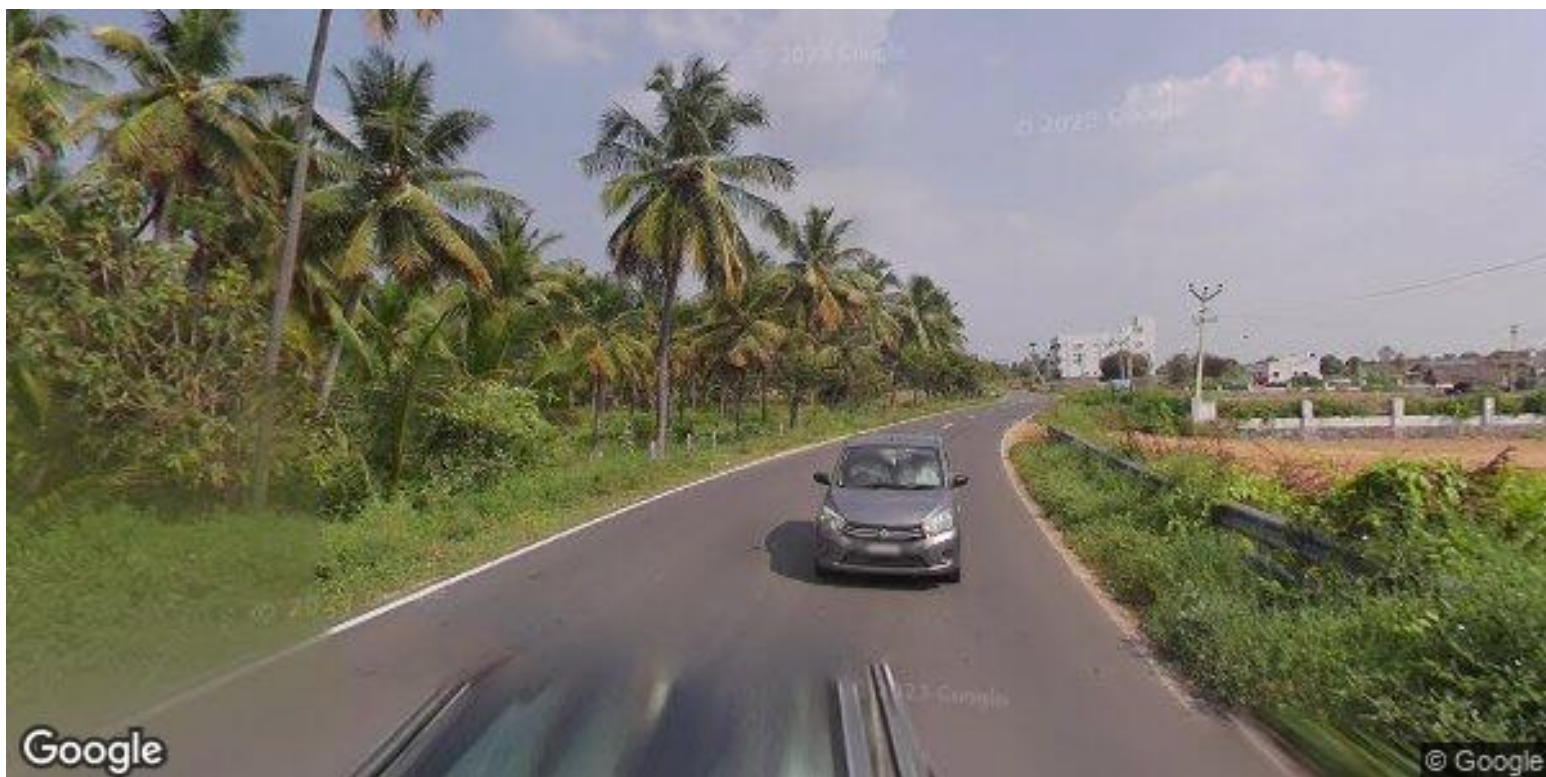
**Risk Type: Turn**  
**Risk Level: Medium**  
**Speed Limit: 30 KM/Hr**  
**Coordinates: 11.45357, 77.85789**

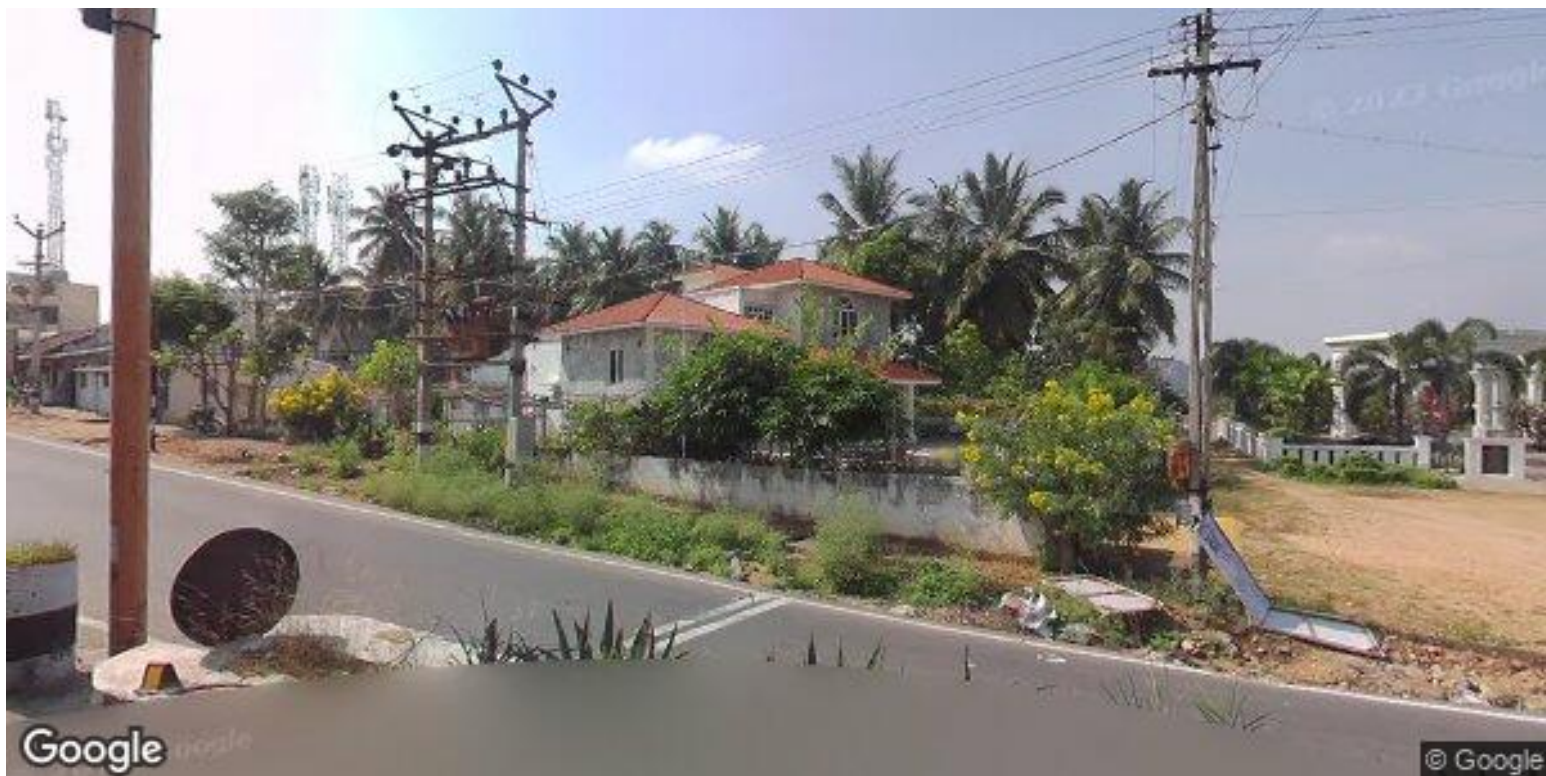
**Coordinates:** 11.46303, 77.84945

**Risk Type:** Turn

**Risk Level:** Medium

**Speed Limit:** 30 KM/Hr

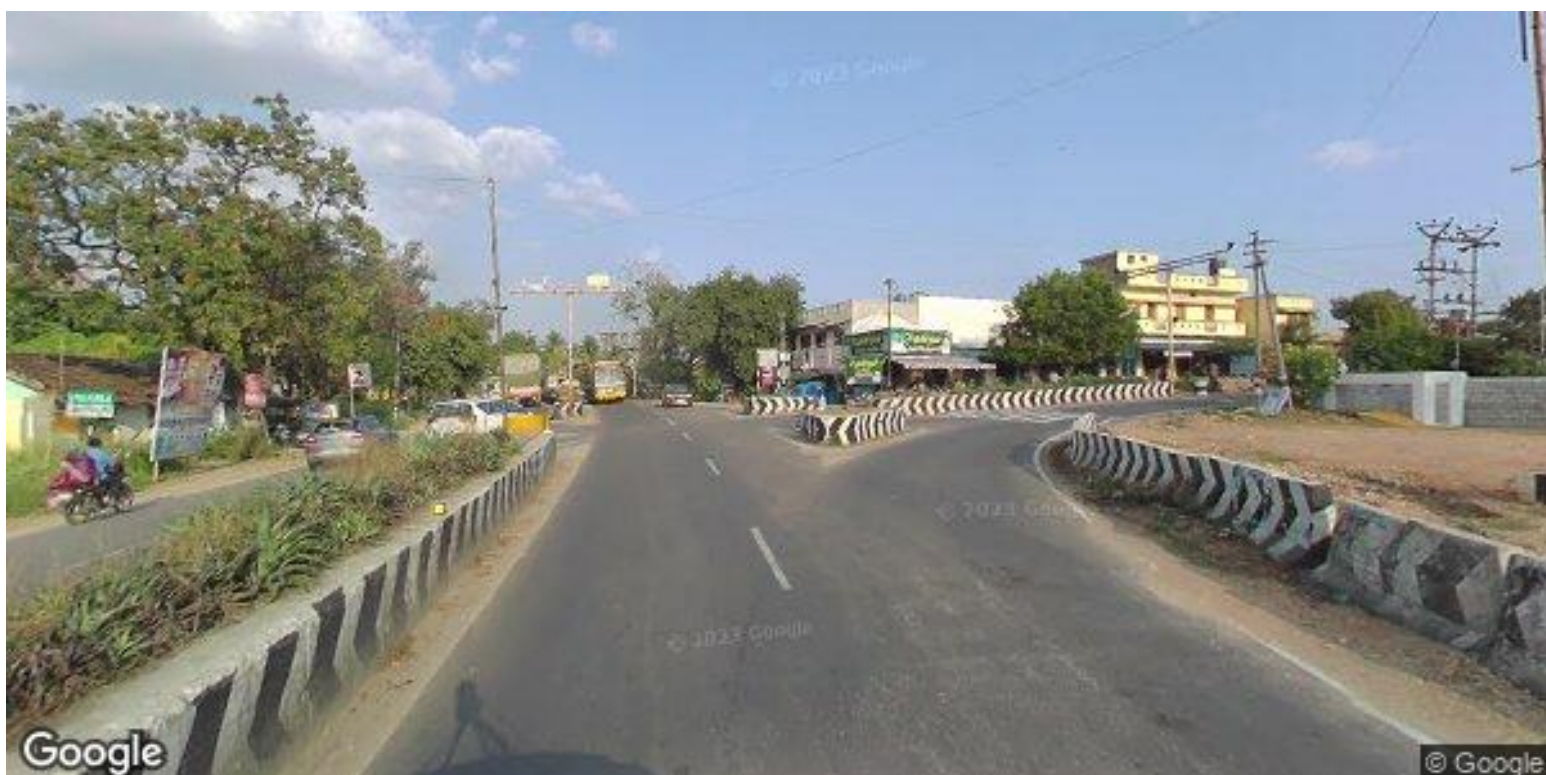
**Coordinates:** 11.46318, 77.84913

**Risk Type:** Turn

**Risk Level:** Medium

**Speed Limit:** 30 KM/Hr

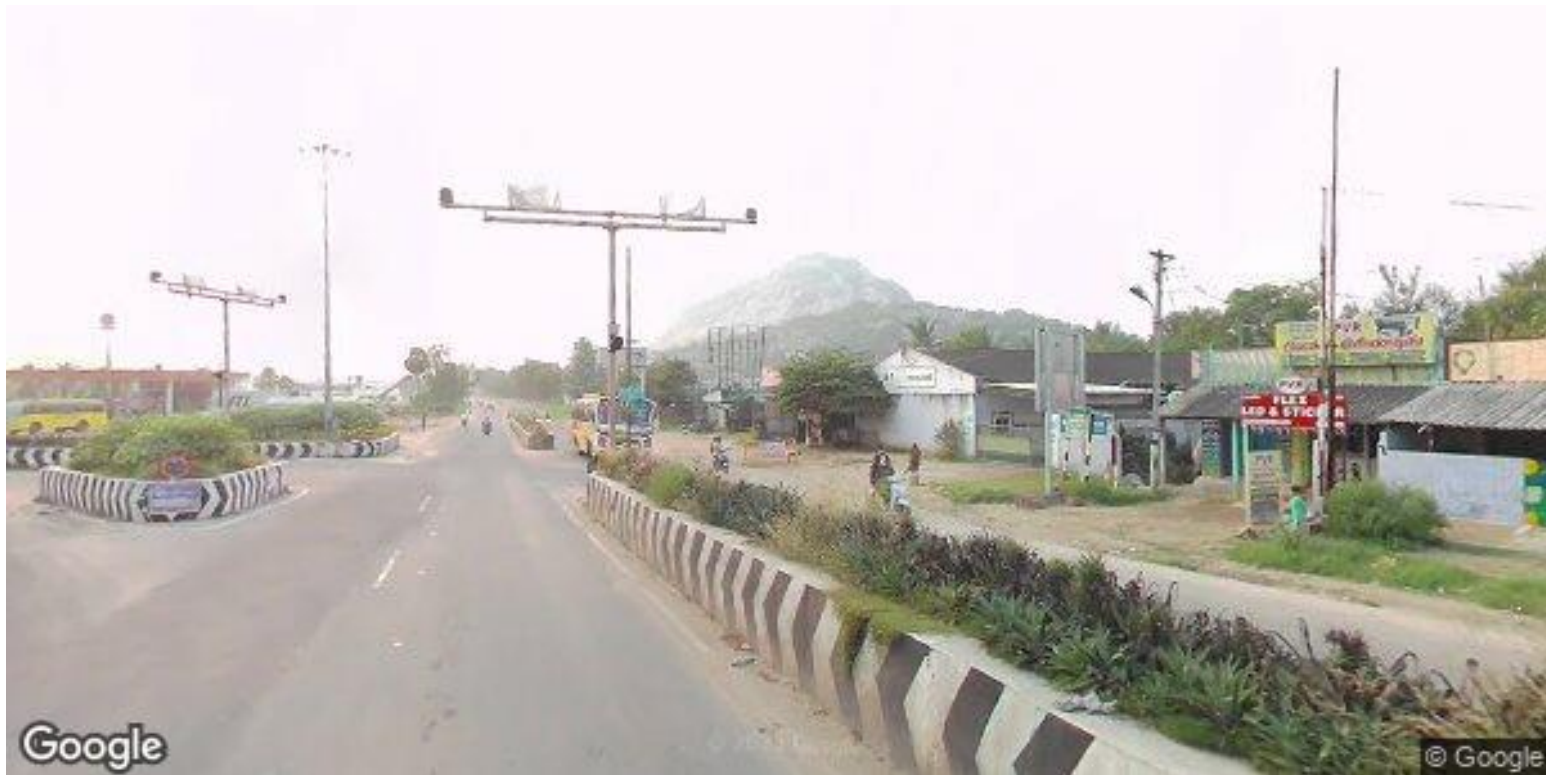
**Coordinates:** 11.46312, 77.84886

**Risk Type:** Turn

**Risk Level:** Medium

**Speed Limit:** 30 KM/Hr

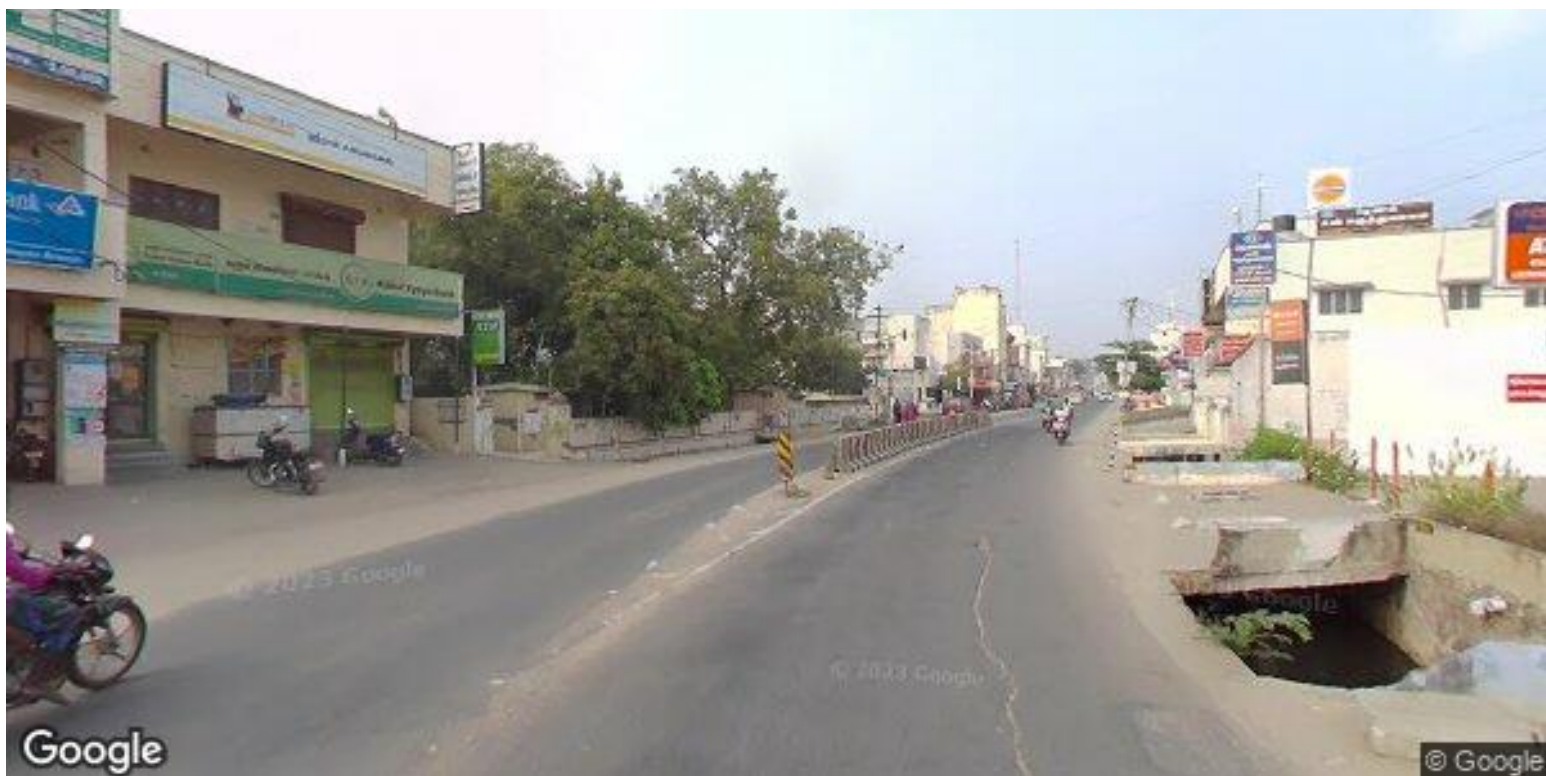
**Coordinates:** 11.36622, 77.74789

**Risk Type:** Turn

**Risk Level:** Medium

**Speed Limit:** 30 KM/Hr

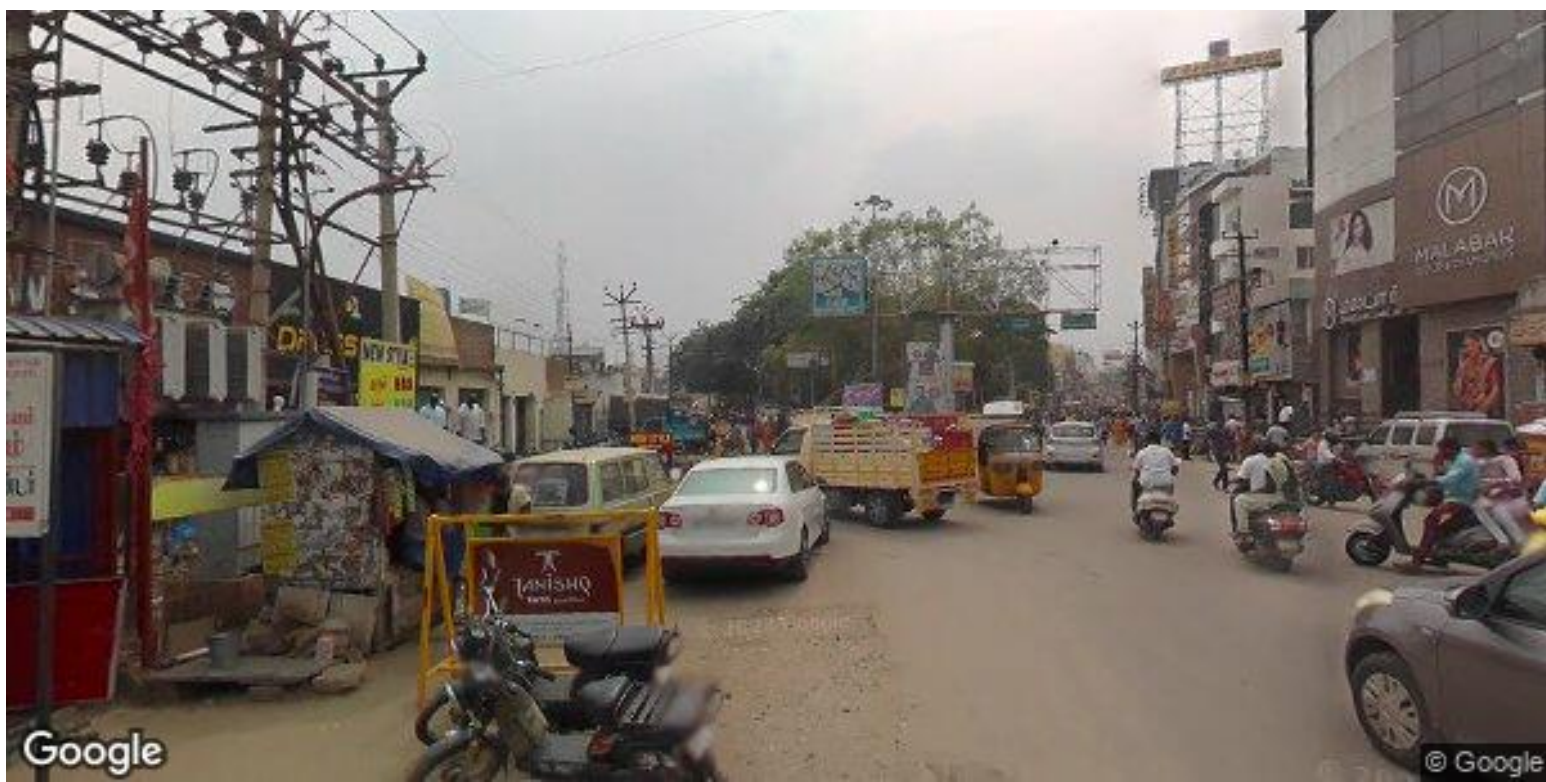
**Coordinates:** 11.34493, 77.73032

**Risk Type:** Turn

**Risk Level:** Medium

**Speed Limit:** 30 KM/Hr

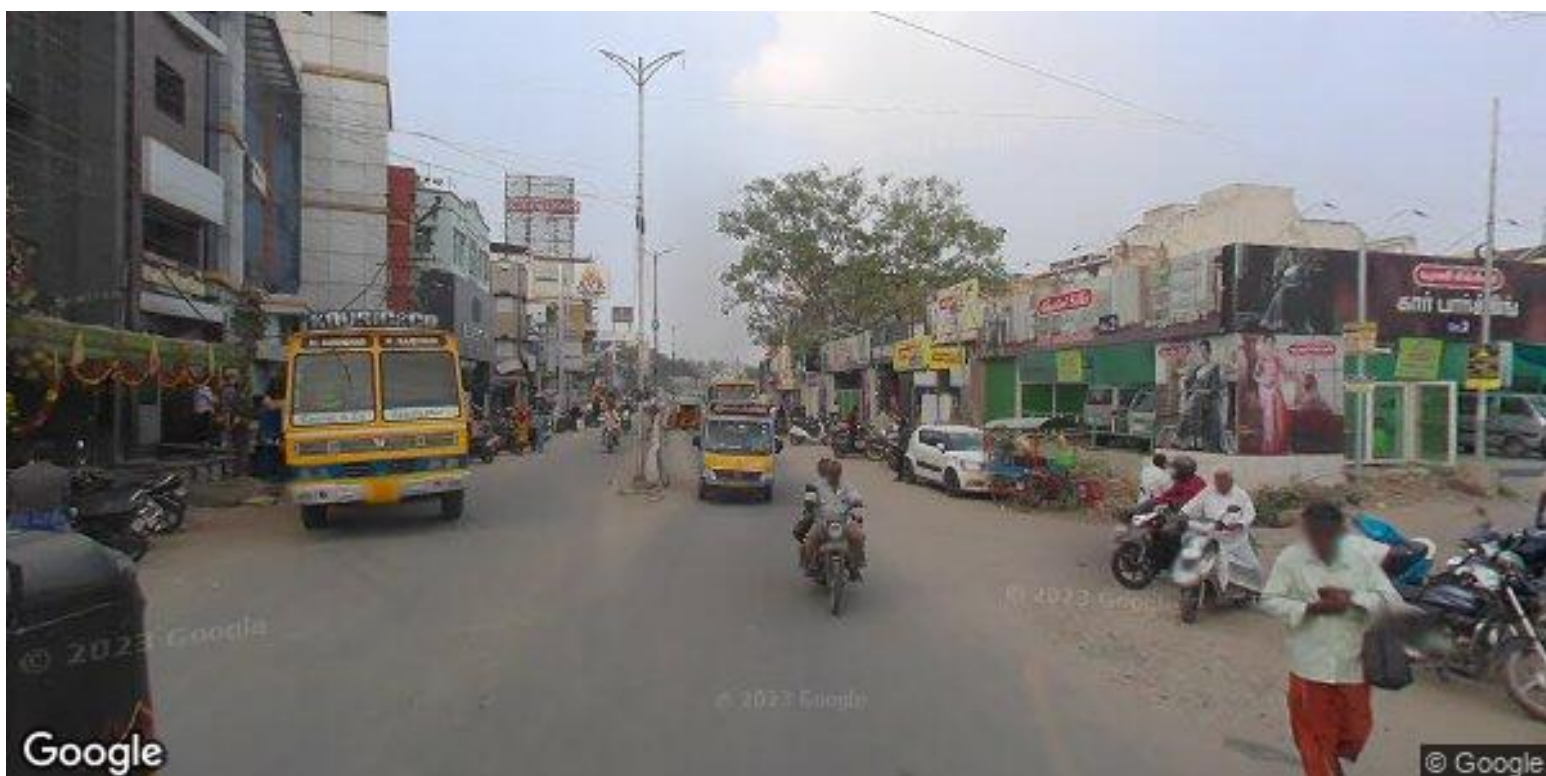
**Coordinates:** 11.34487, 77.73024

**Risk Type:** Turn

**Risk Level:** Medium

**Speed Limit:** 30 KM/Hr

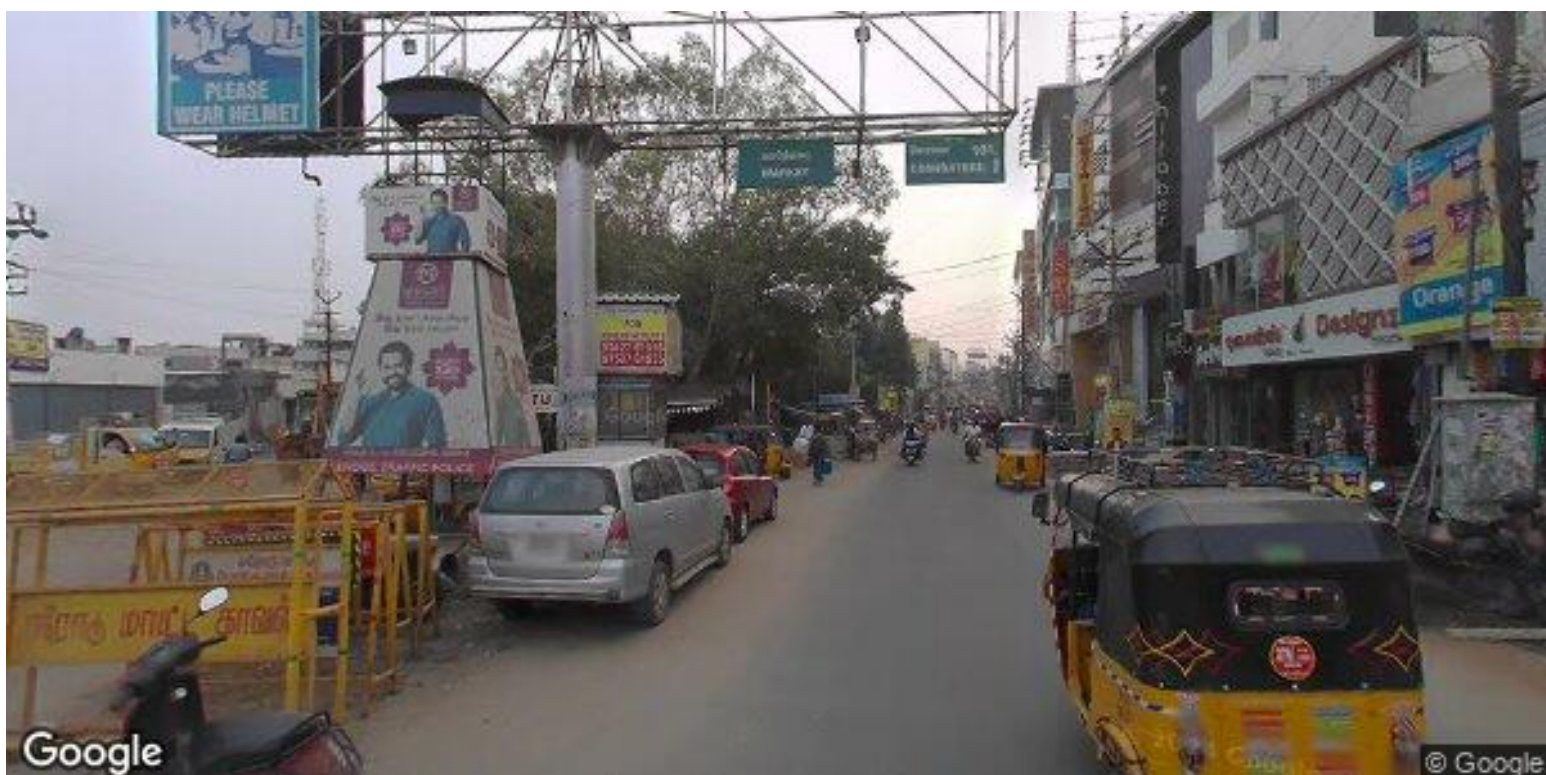
**Coordinates:** 11.34470, 77.73018

**Risk Type:** Turn

**Risk Level:** Medium

**Speed Limit:** 30 KM/Hr

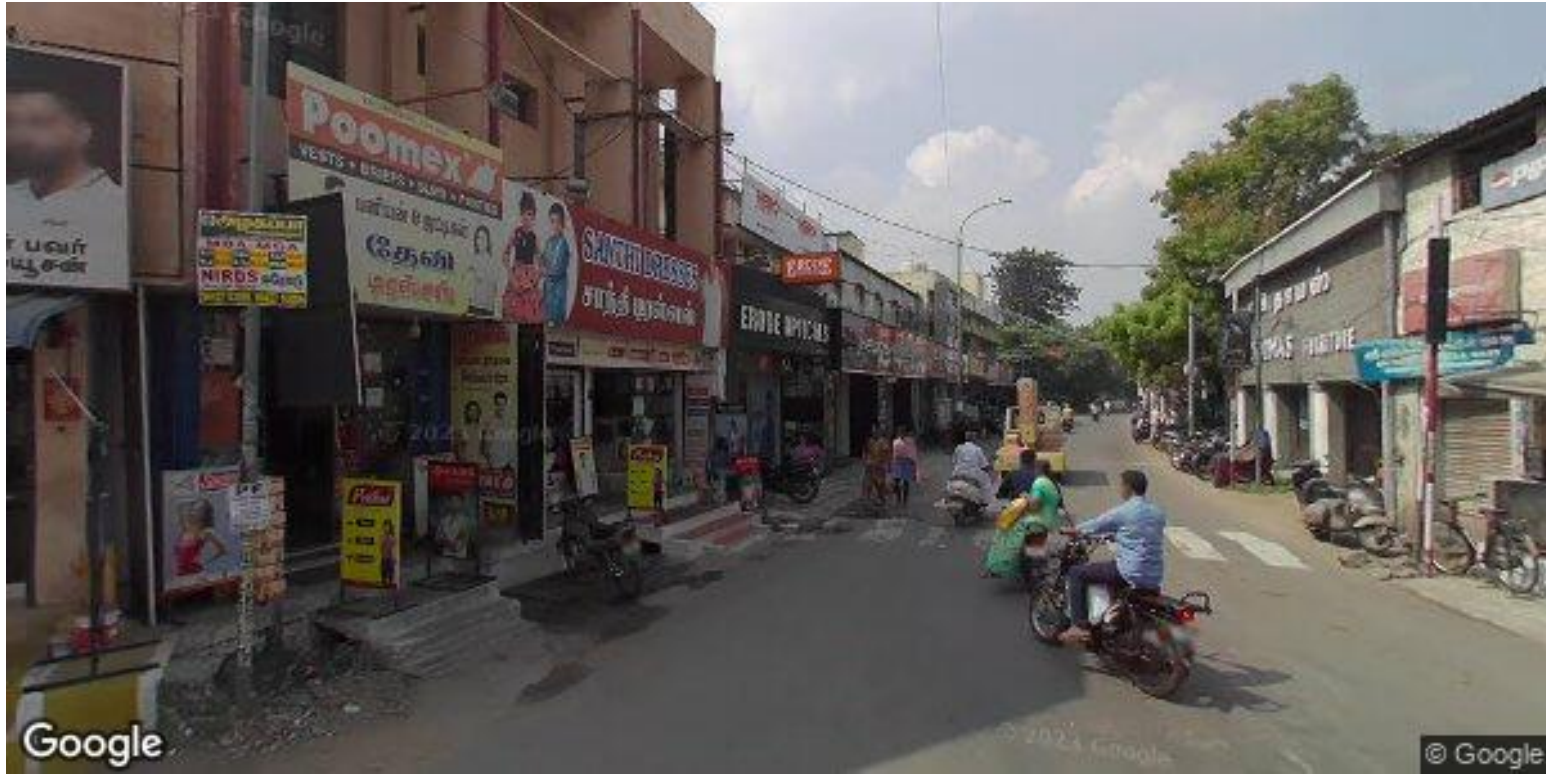
**Coordinates:** 11.33920, 77.72902

**Risk Type:** Blind Spot

**Risk Level:** Blind Spot

**Speed Limit:** 10 KM/Hr

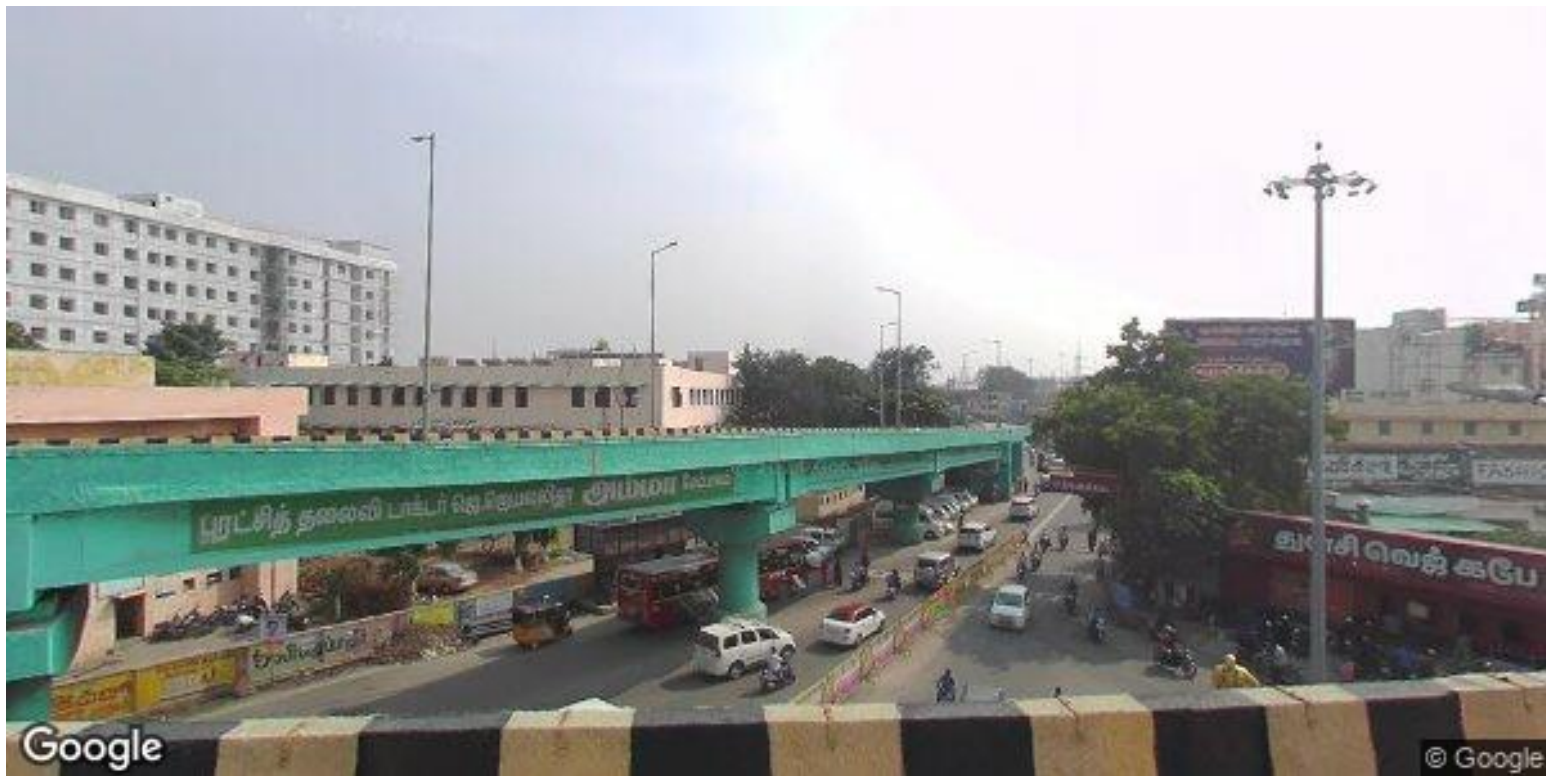
**Coordinates:** 11.34068, 77.71709

**Risk Type:** Blind Spot

**Risk Level:** Blind Spot

**Speed Limit:** 10 KM/Hr

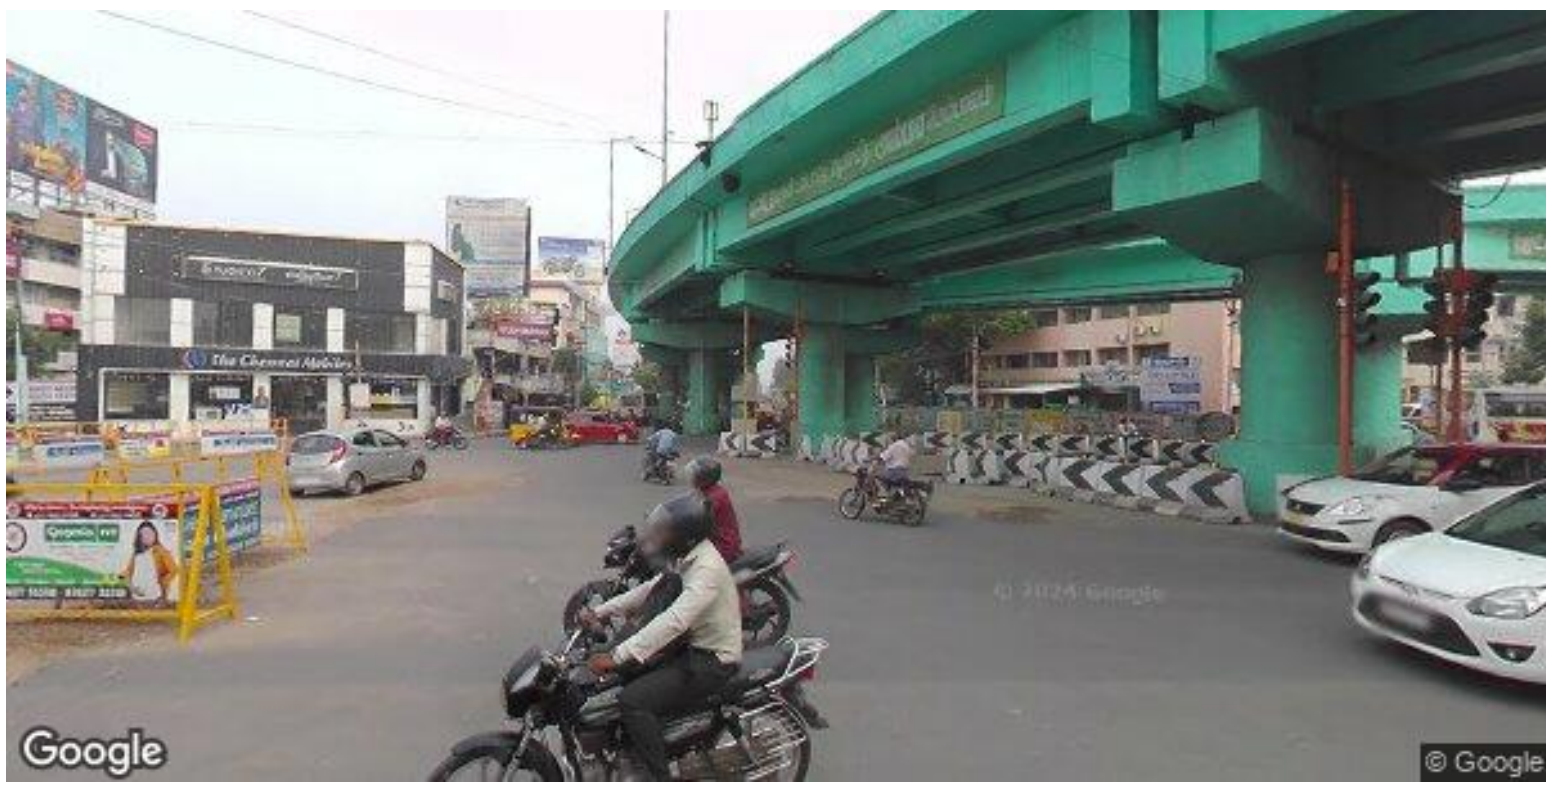
**Coordinates:** 11.34097, 77.71715

**Risk Type:** Blind Spot

**Risk Level:** Blind Spot

**Speed Limit:** 10 KM/Hr

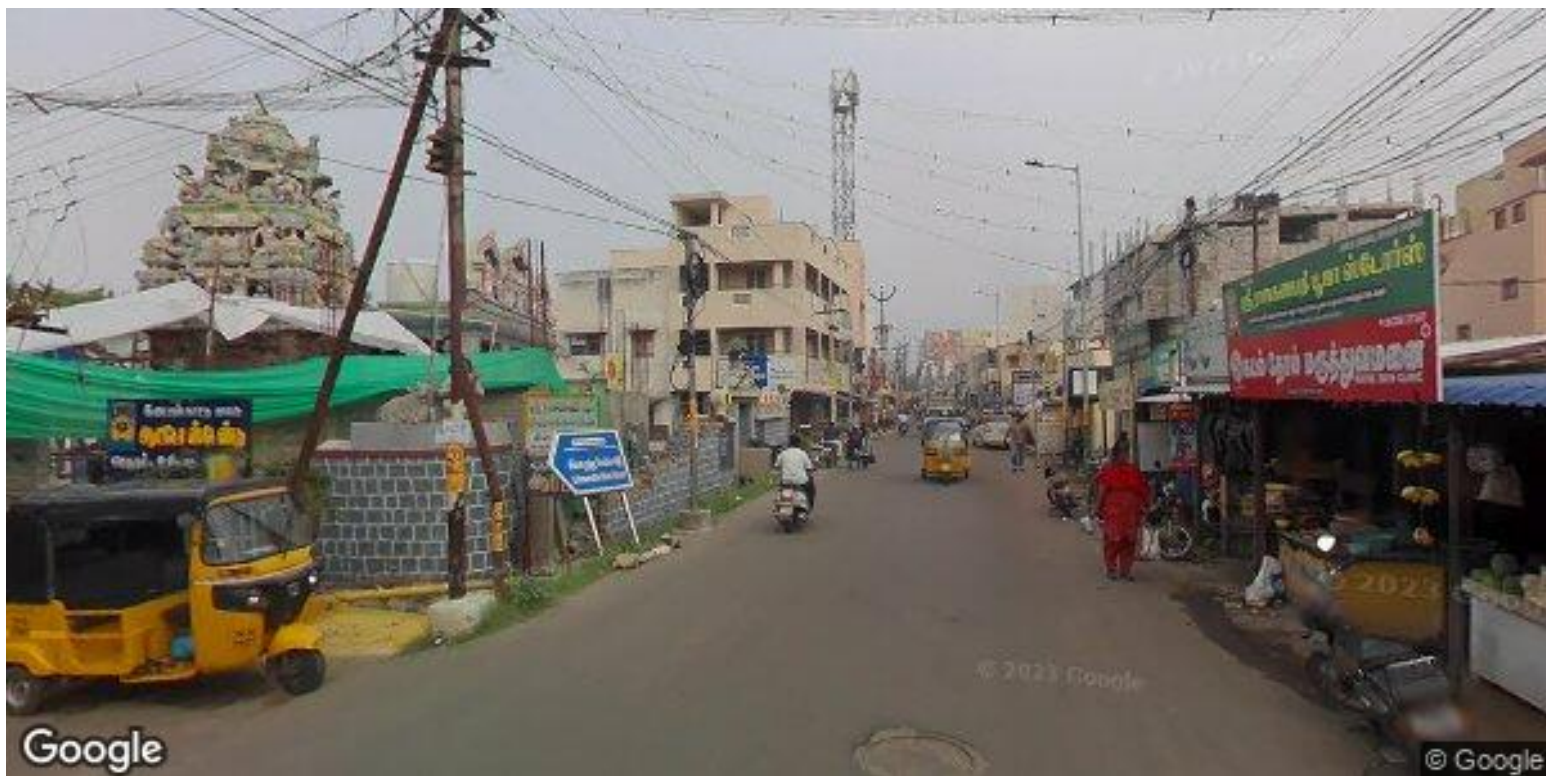
**Coordinates:** 11.34166, 77.71442

**Risk Type:** Turn

**Risk Level:** Medium

**Speed Limit:** 30 KM/Hr
