# IndianOil

## JOURNEY RISK MANAGEMENT (JRM) STUDY

### Salem Terminal TO SELVI AGENCY

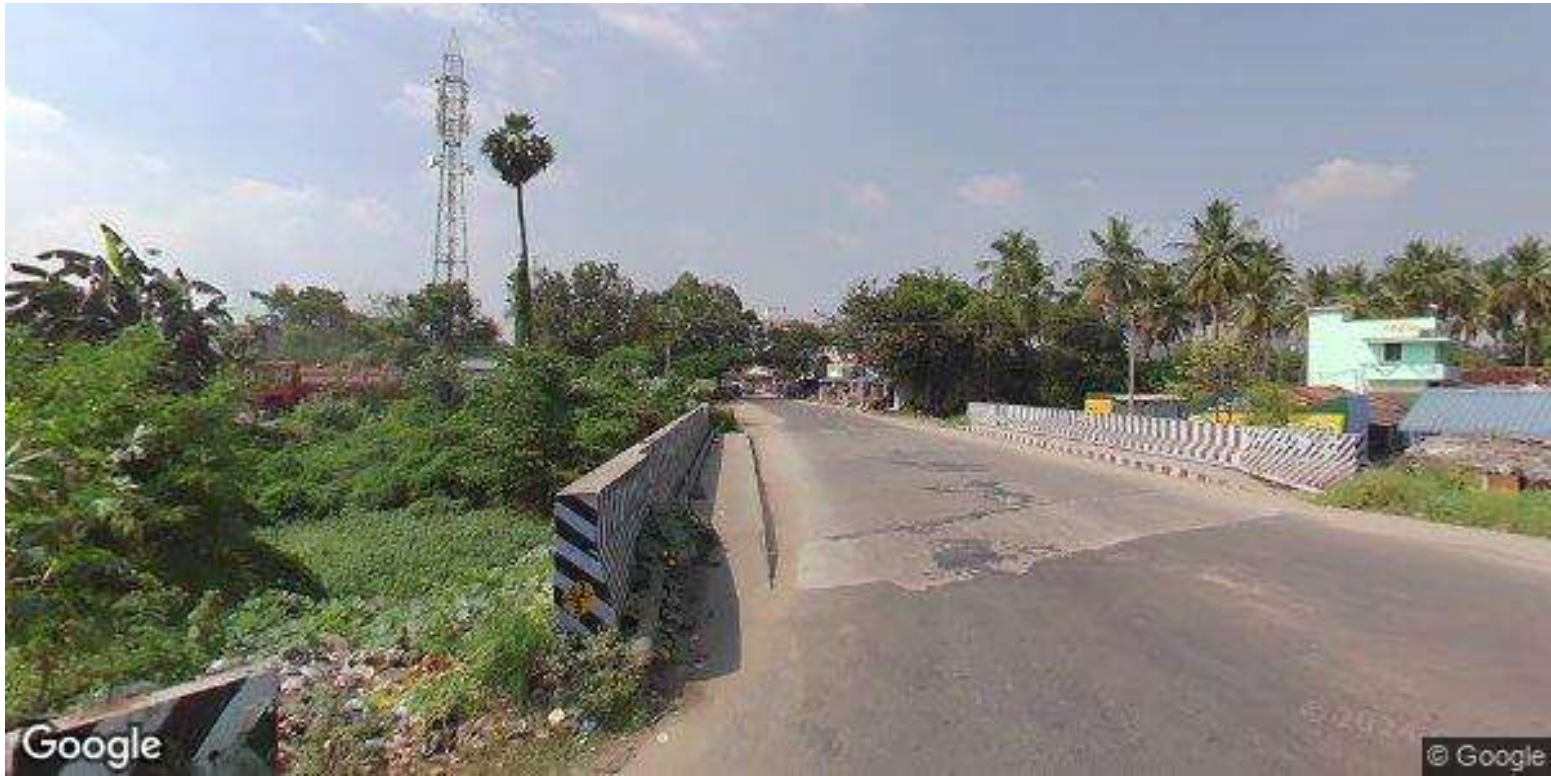
**Risk Type:** Turn  
**Risk Level:** Medium  
**Speed Limit:** 30 KM/Hr  
**Coordinates:** 11.44900, 77.87406

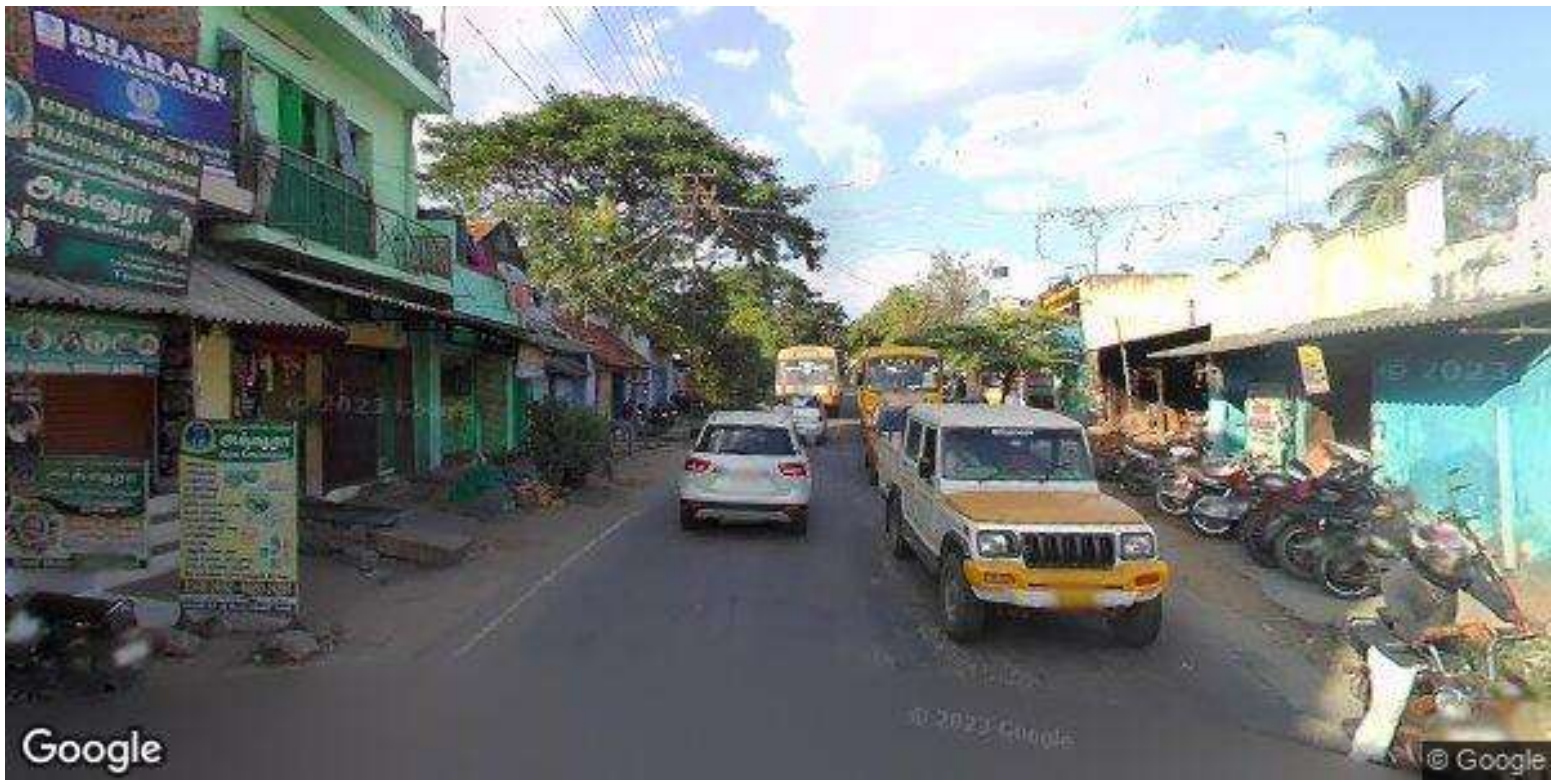
**Risk Type:** Turn

**Risk Level:** High

**Speed Limit:** 15 KM/Hr

**Coordinates:** 11.45028, 77.87202

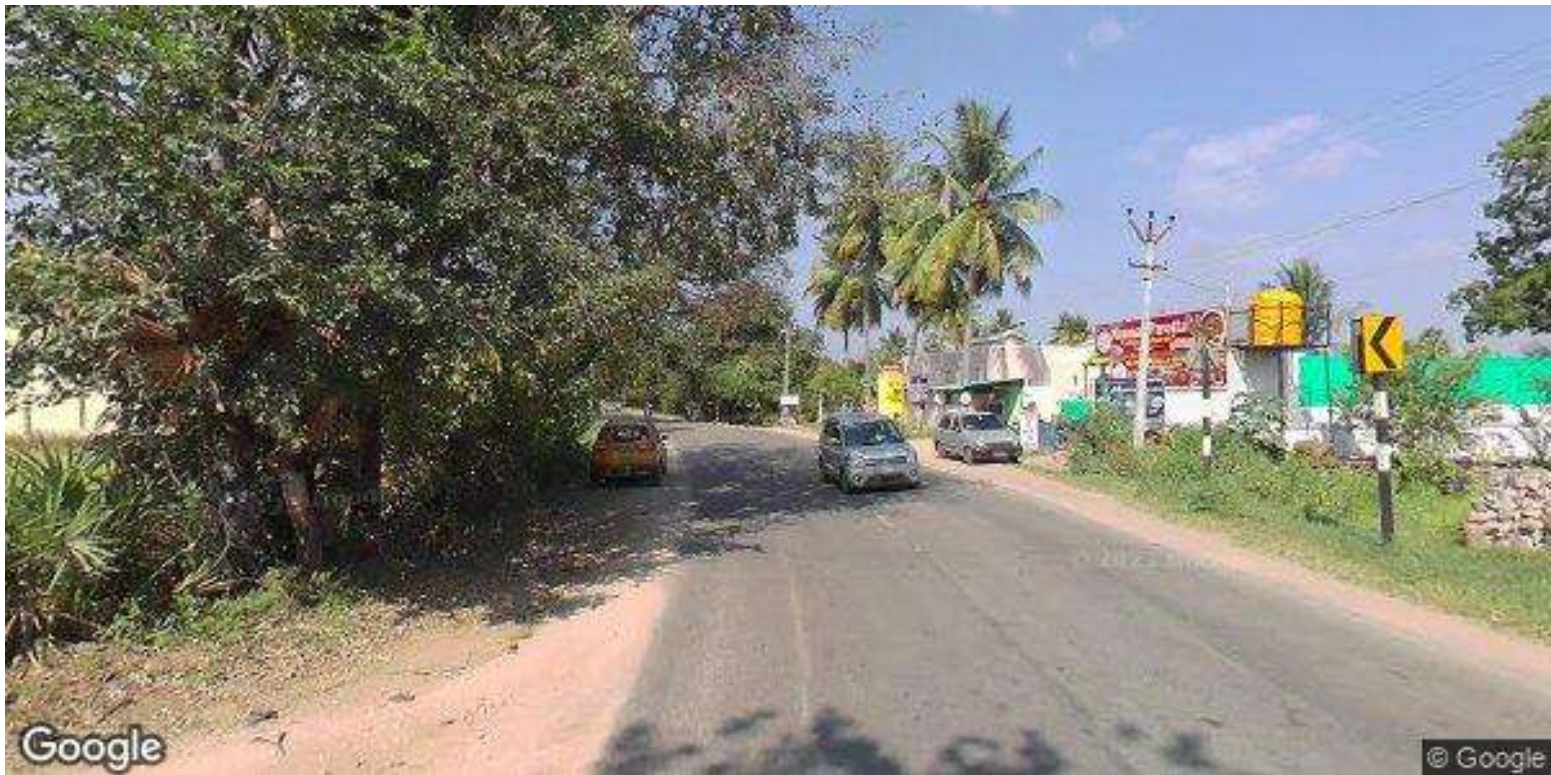
**Risk Type:** Turn

**Risk Level:** Medium

**Speed Limit:** 30 KM/Hr

**Coordinates:** 11.45309, 77.87325

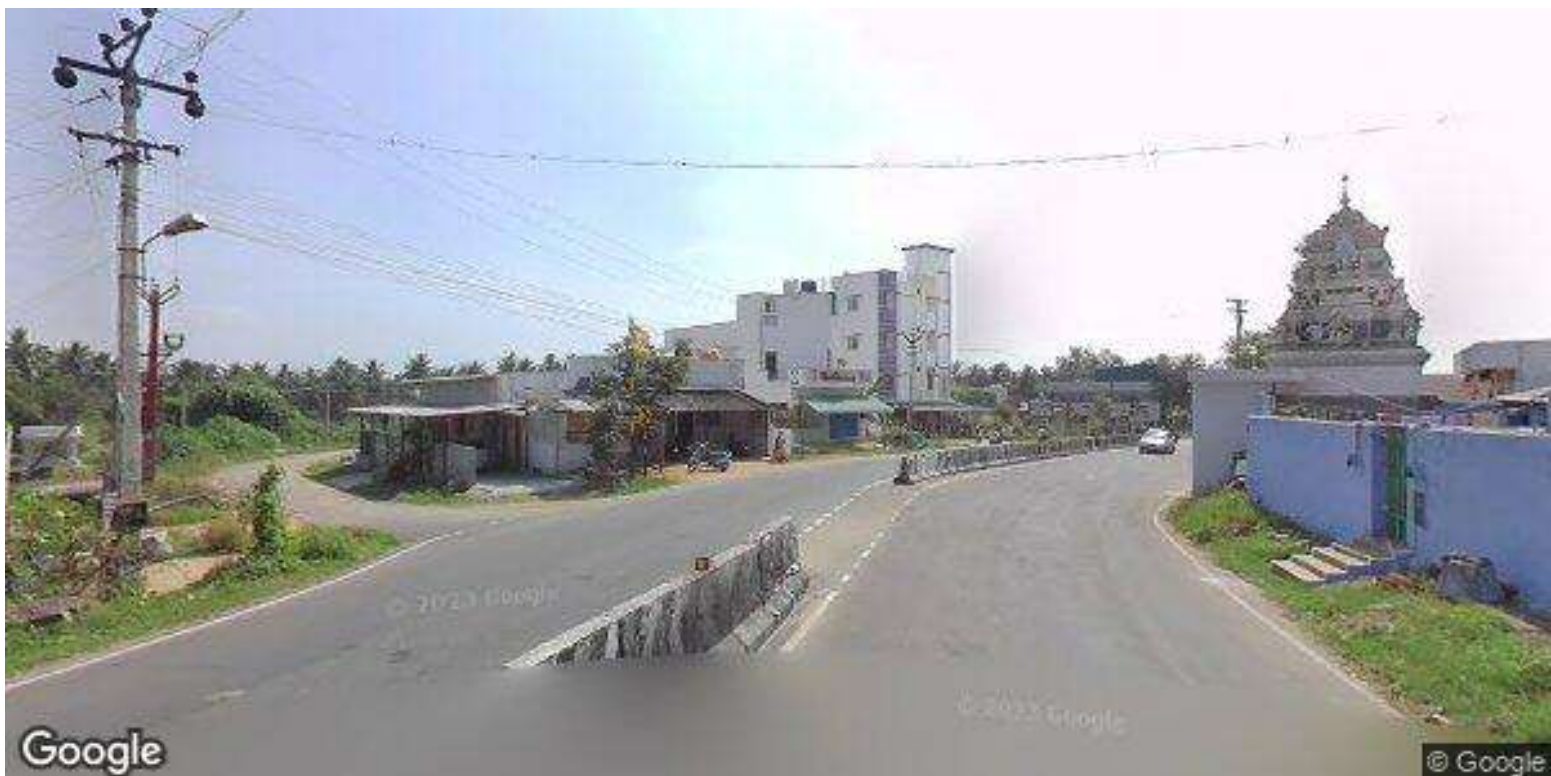
**Risk Type:** Turn  
**Risk Level:** Medium  
**Speed Limit:** 30 KM/Hr  
**Coordinates:** 11.46400, 77.87323

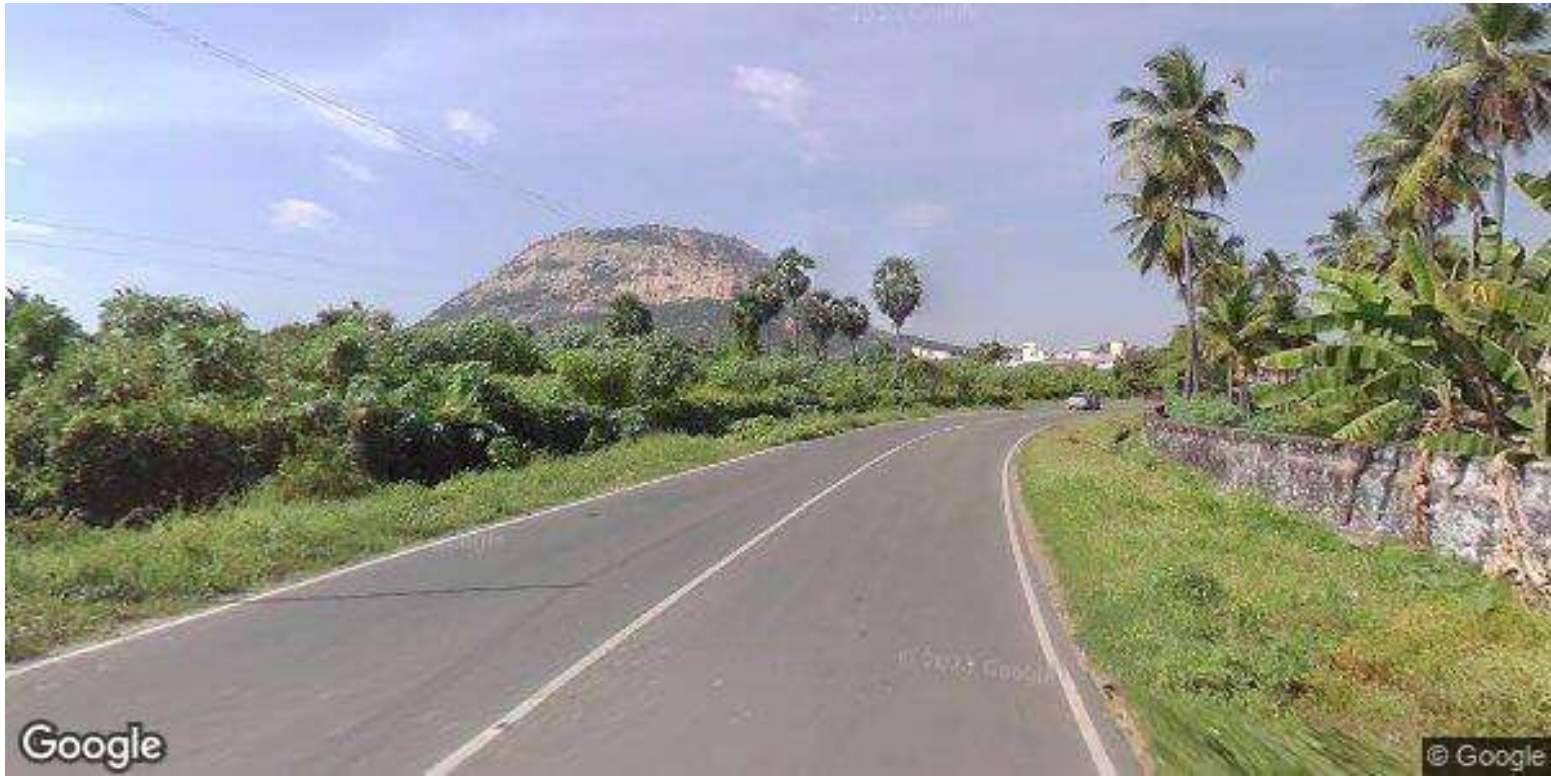
**Risk Type:** Turn  
**Risk Level:** Medium  
**Speed Limit:** 30 KM/Hr  
**Coordinates:** 11.46765, 77.87037

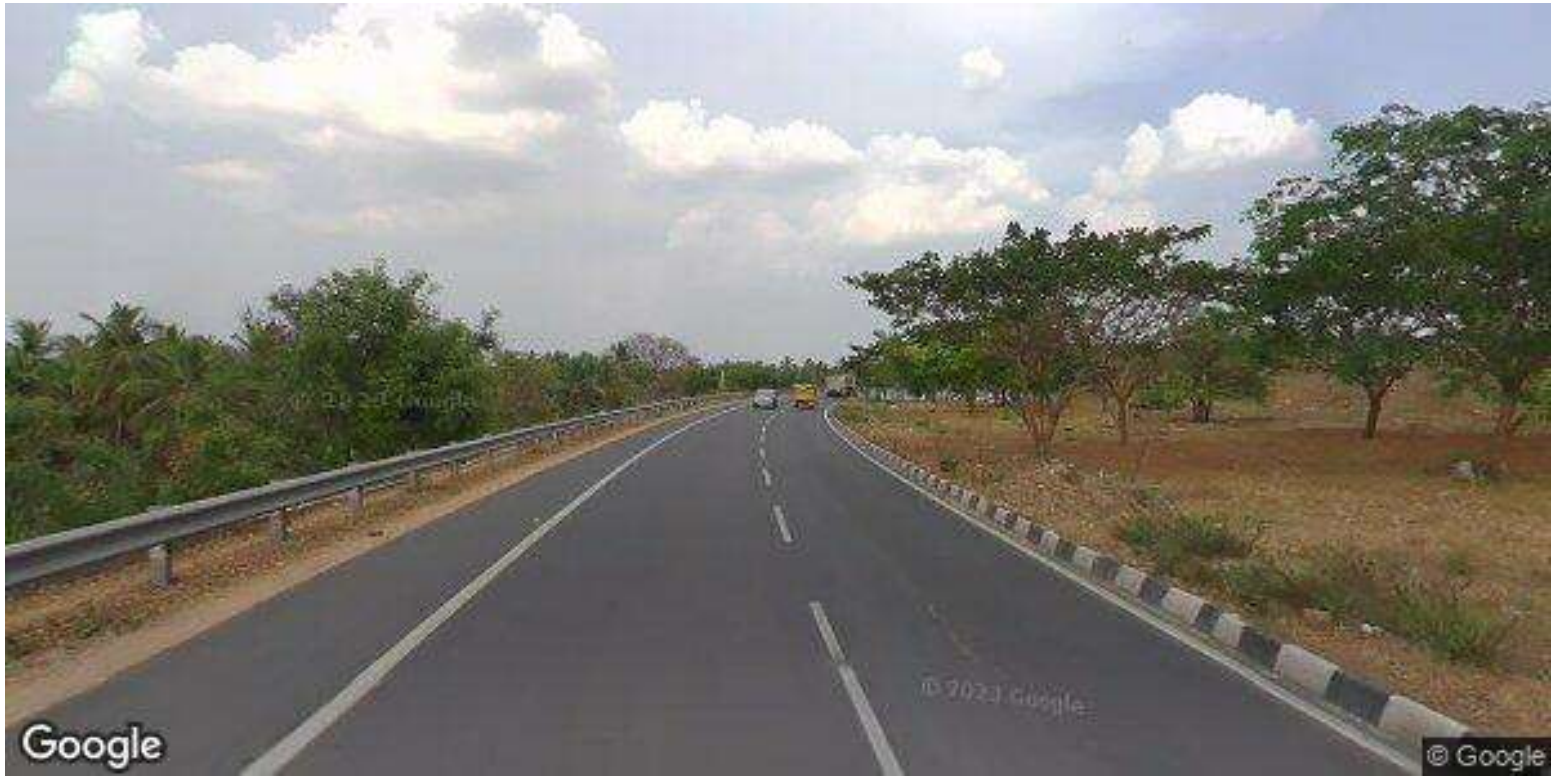
**Risk Type:** Turn  
**Risk Level:** Medium  
**Speed Limit:** 30 KM/Hr  
**Coordinates:** 11.53601, 77.95856

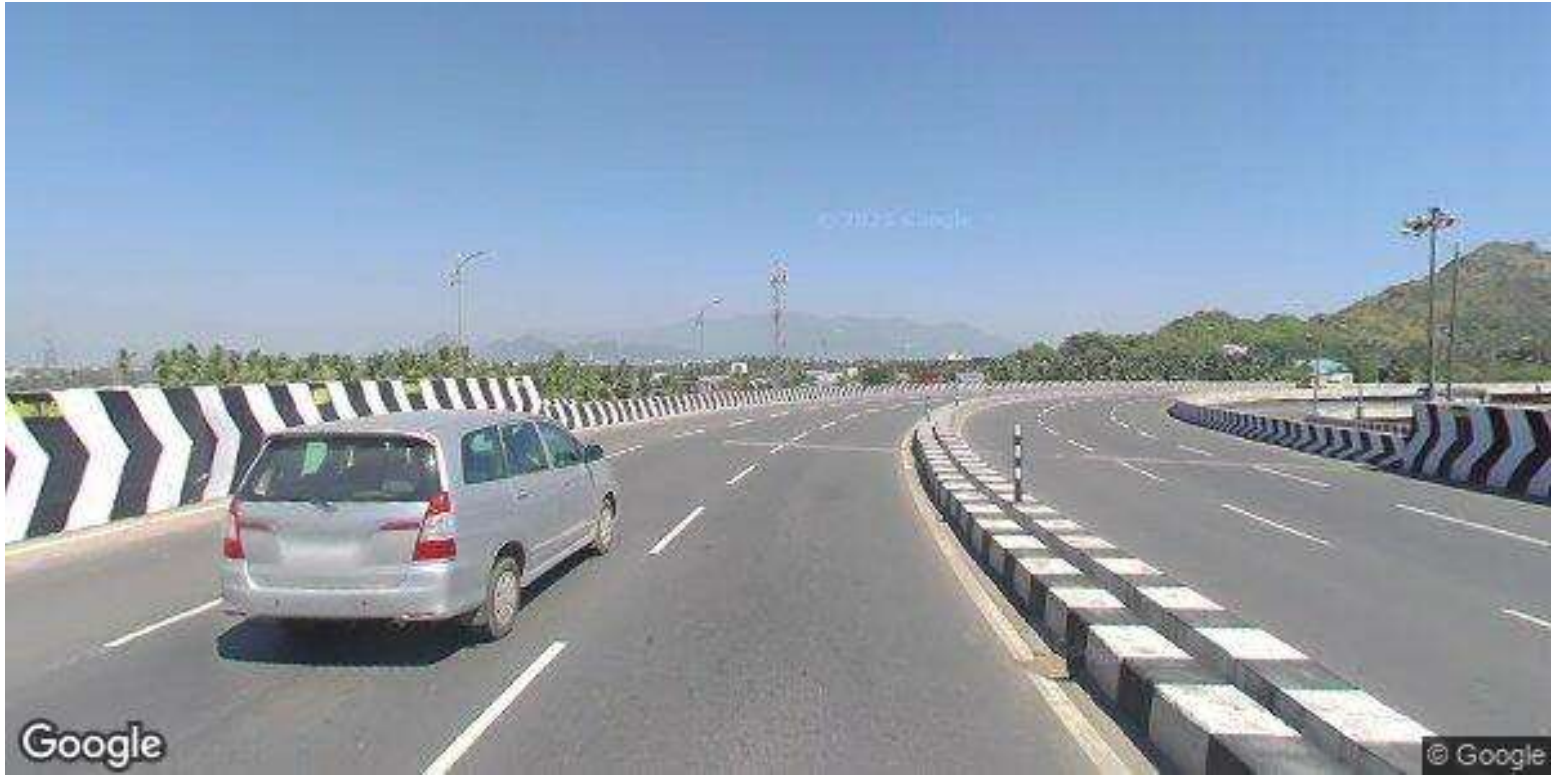
**Risk Type:** Turn  
**Risk Level:** Medium  
**Speed Limit:** 30 KM/Hr  
**Coordinates:** 11.64172, 78.11817

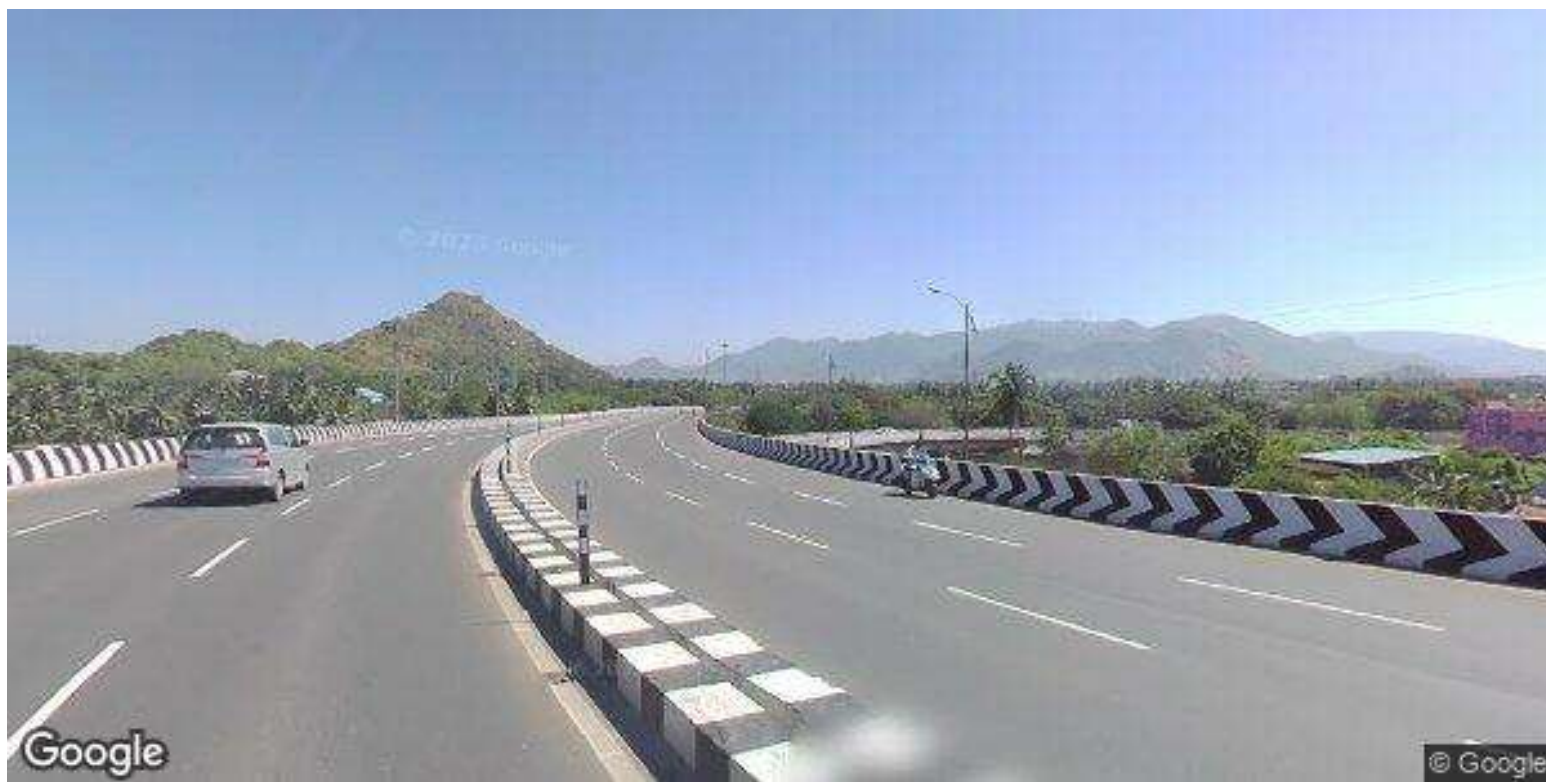
**Risk Type: Turn**

**Risk Level: Medium**

**Speed Limit: 30 KM/Hr**

**Coordinates: 11.64216, 78.11875**

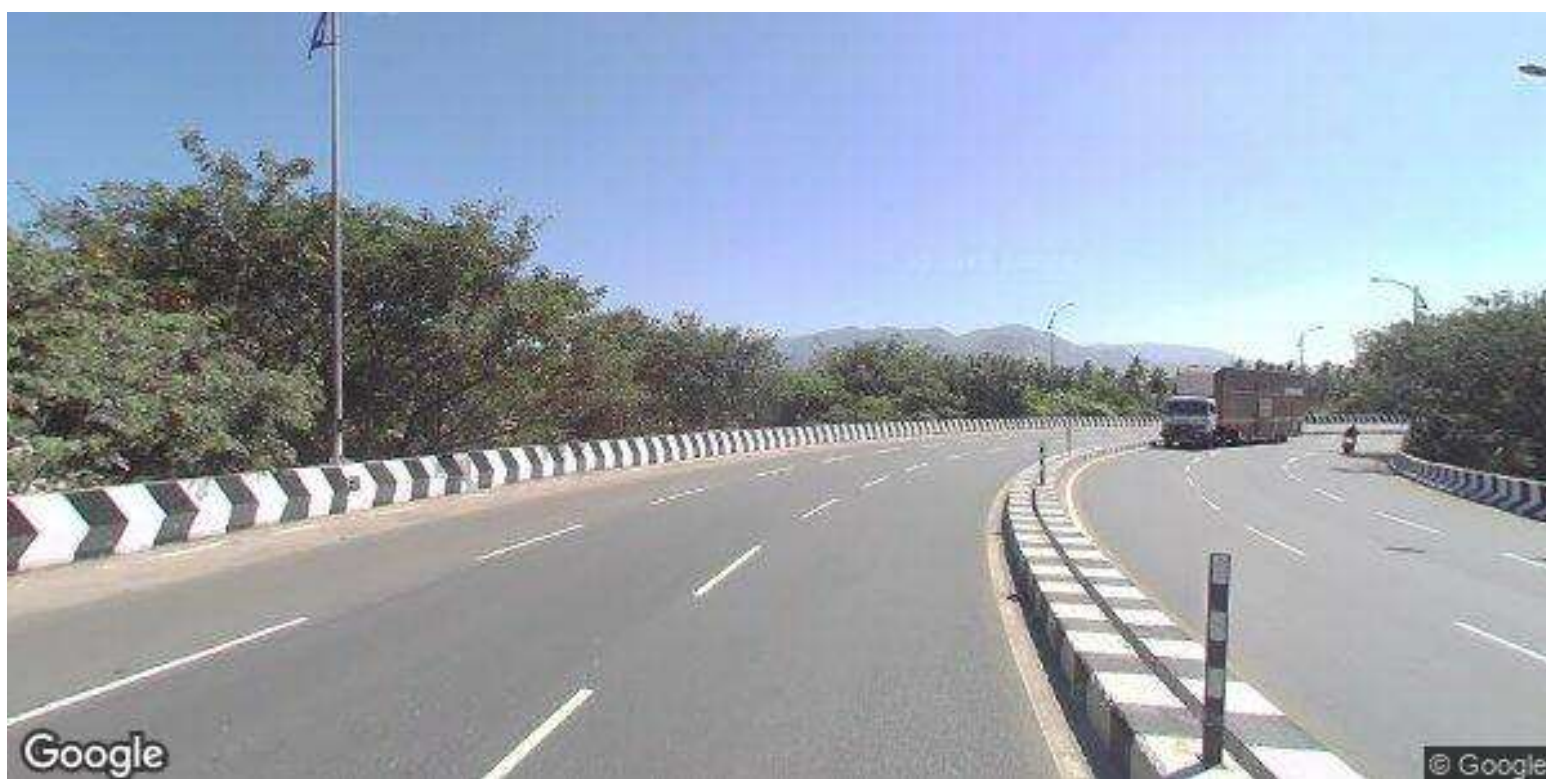
**Risk Type: Turn**

**Risk Level: High**

**Speed Limit: 15 KM/Hr**

**Coordinates: 11.64195, 78.12129**

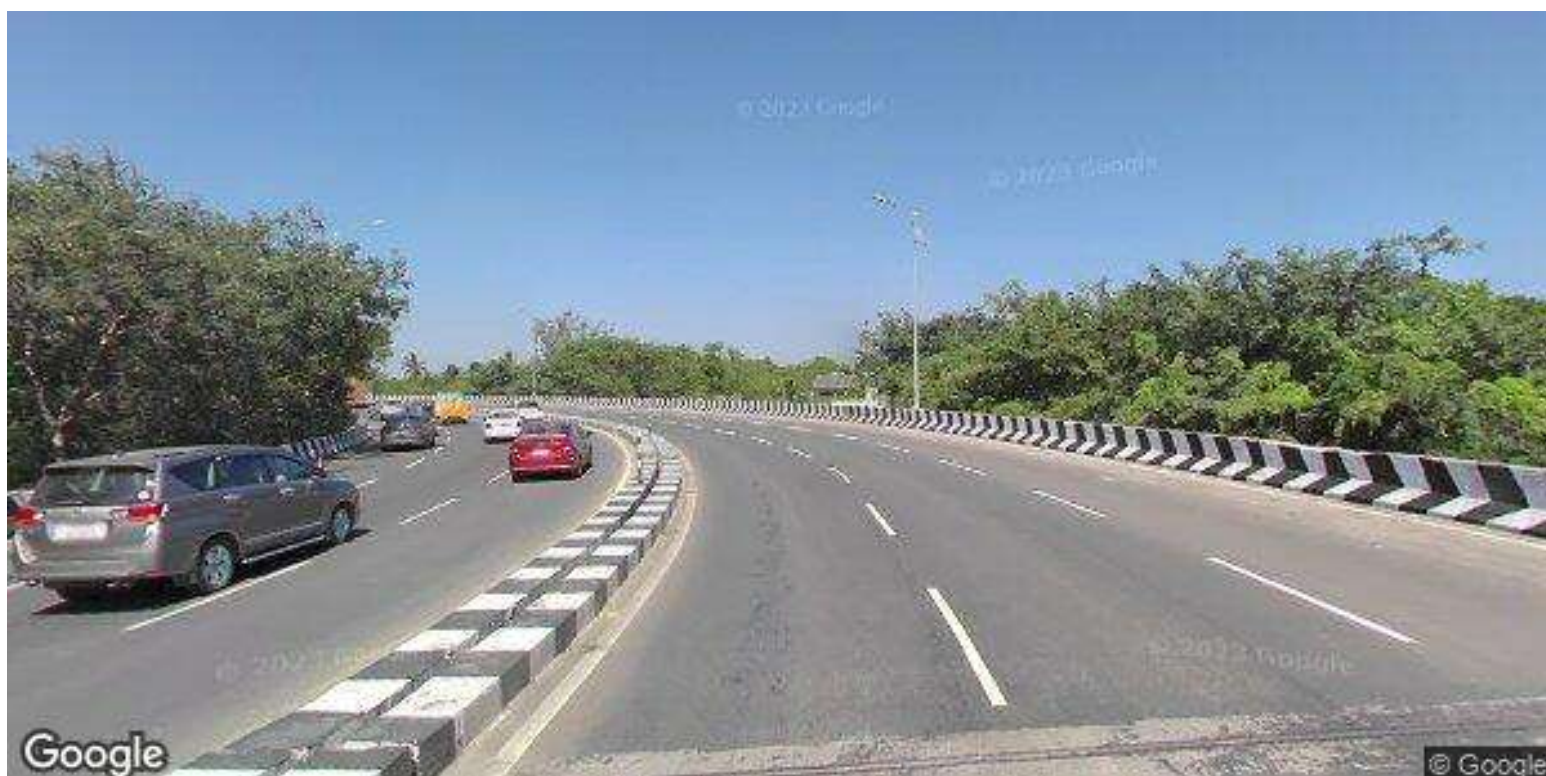
**Risk Type:** Turn  
**Risk Level:** High  
**Speed Limit:** 15 KM/Hr  
**Coordinates:** 11.64120, 78.12168

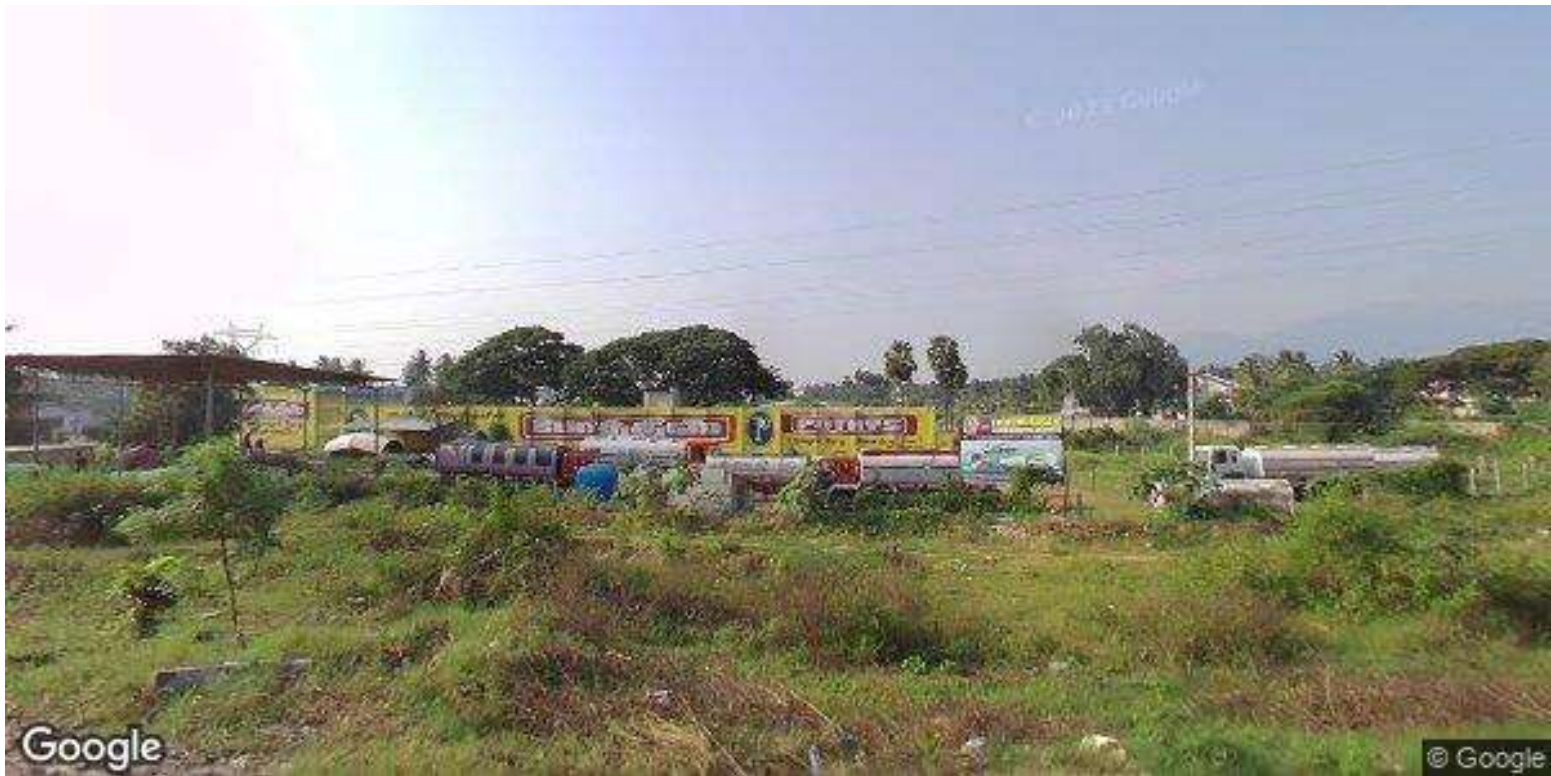
**Risk Type:** Turn  
**Risk Level:** Medium  
**Speed Limit:** 30 KM/Hr  
**Coordinates:** 11.65703, 78.20465

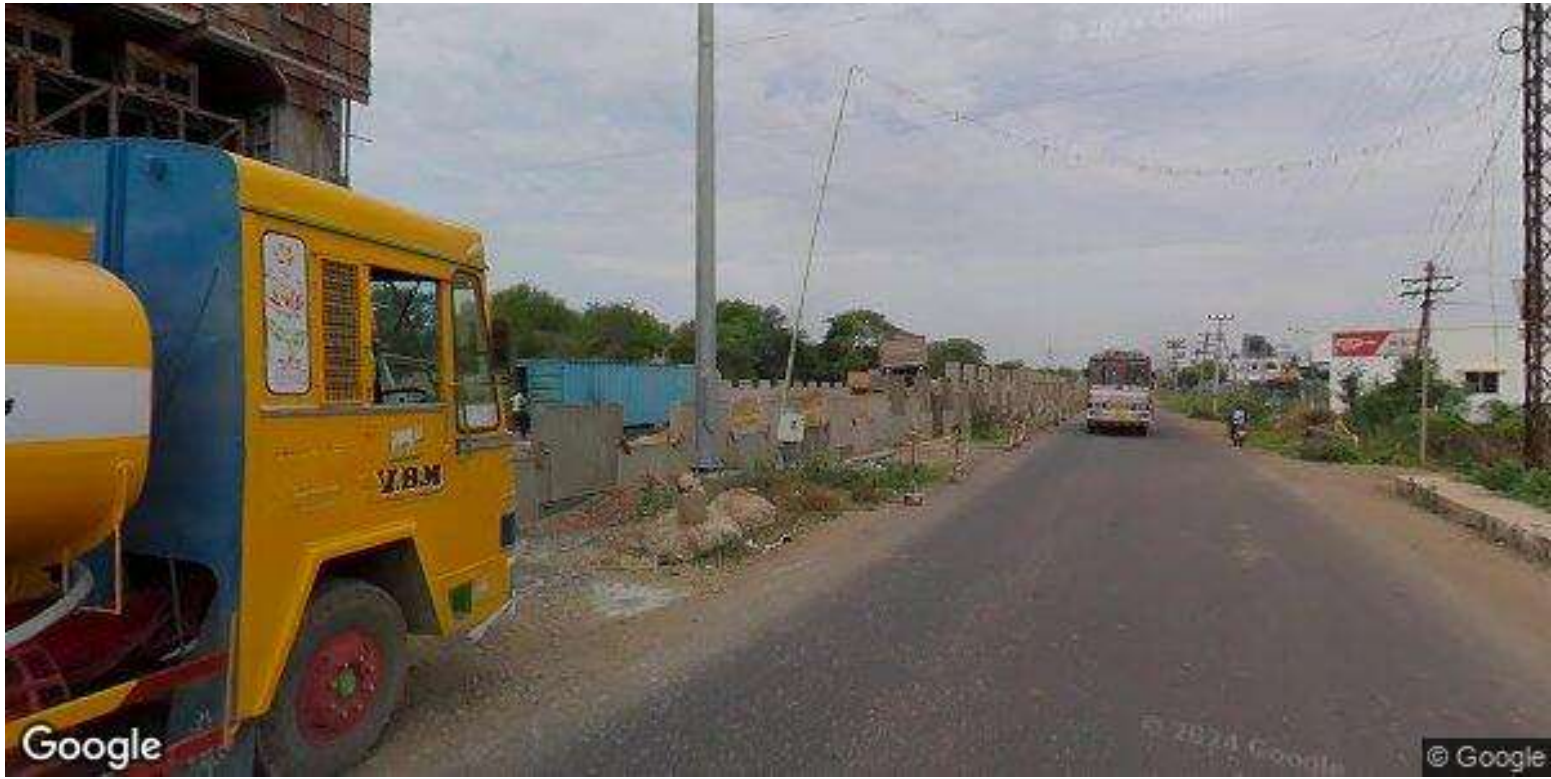
**Risk Type:** Turn  
**Risk Level:** High  
**Speed Limit:** 15 KM/Hr  
**Coordinates:** 11.58562, 78.74231

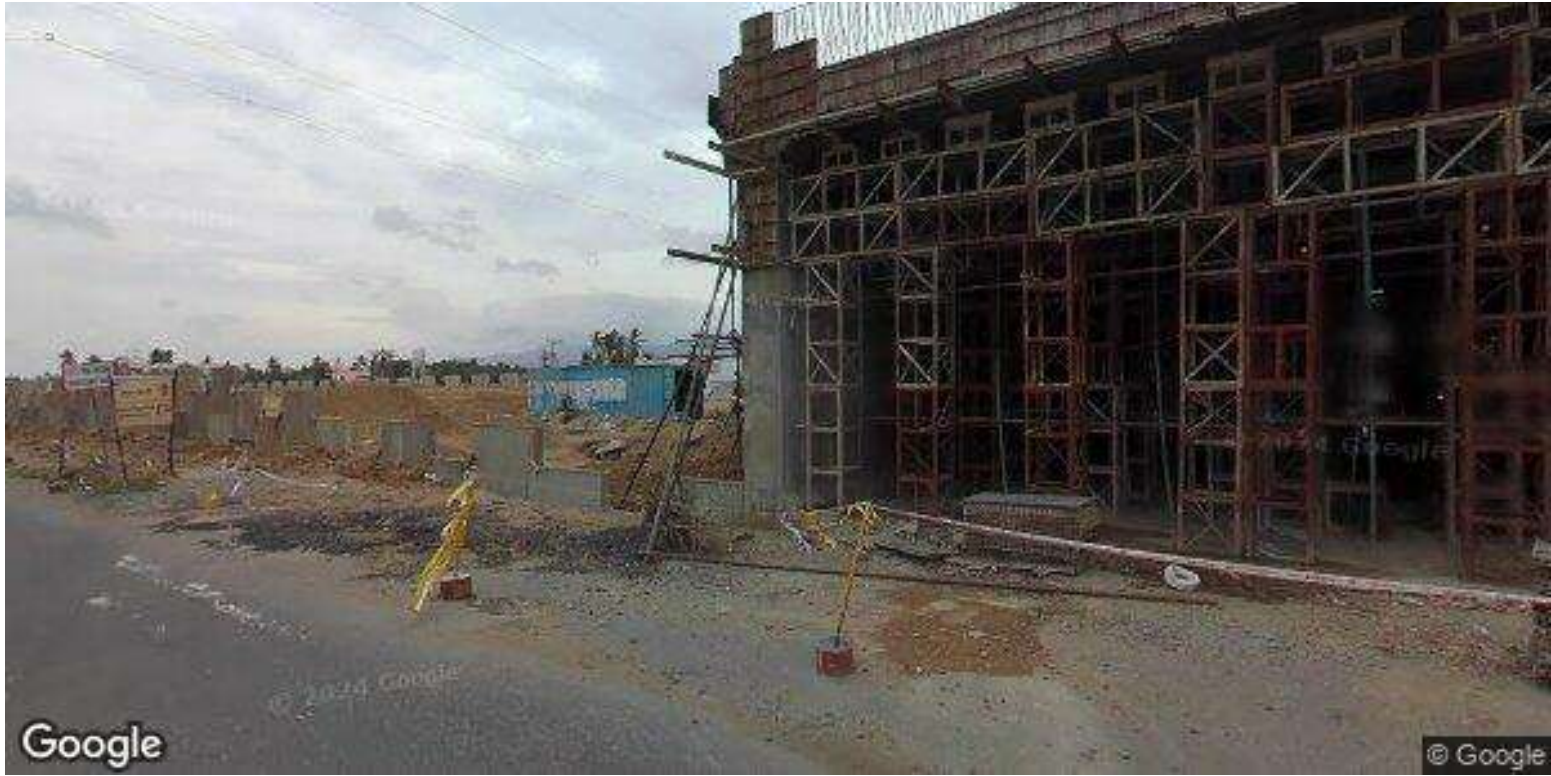
**Risk Type:** Turn  
**Risk Level:** High  
**Speed Limit:** 15 KM/Hr  
**Coordinates:** 11.58528, 78.74234

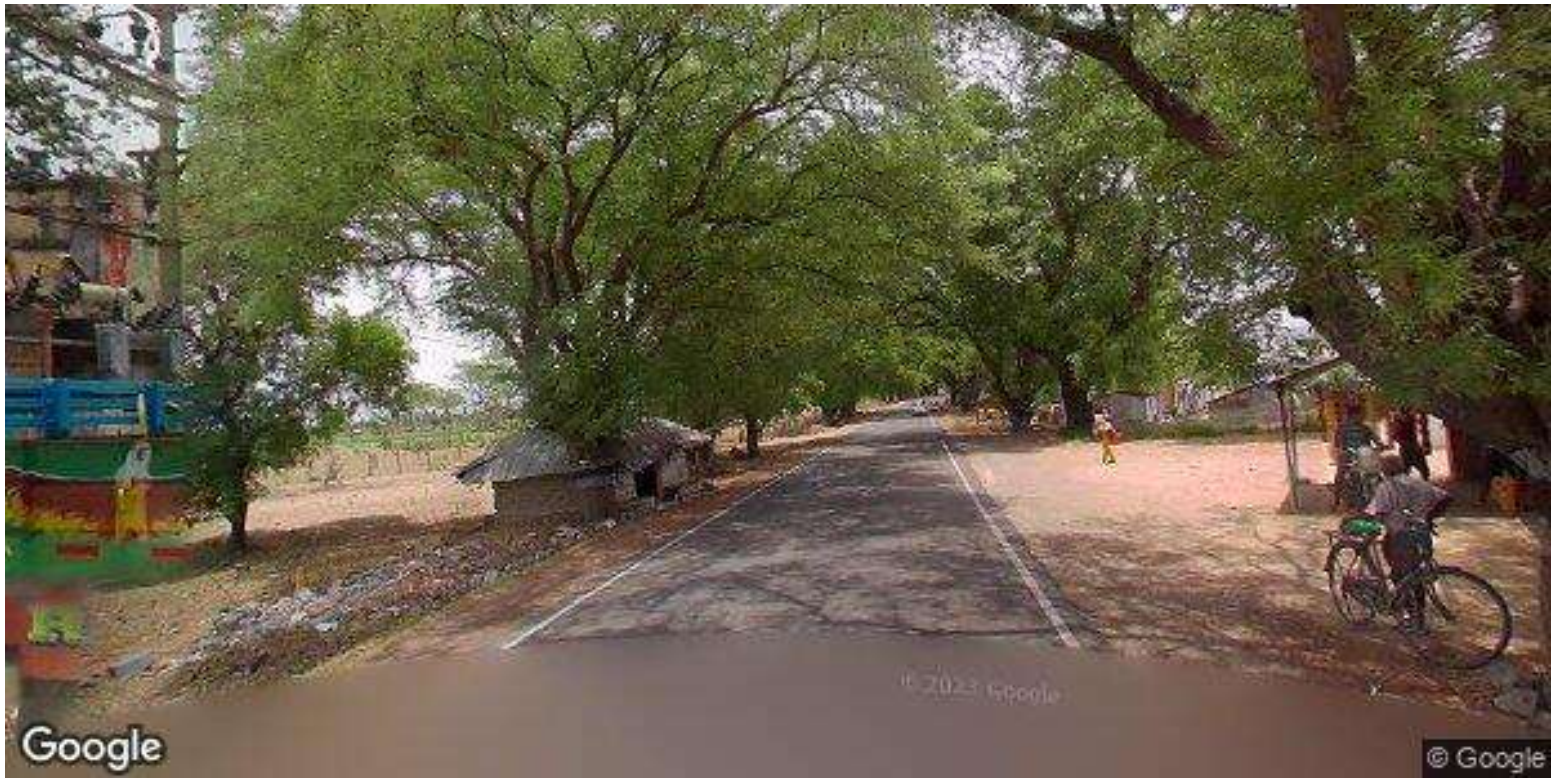
**Risk Type:** Turn

**Risk Level:** High

**Speed Limit:** 15 KM/Hr

**Coordinates:** 11.58553, 78.74952
