# IndianOil

## JOURNEY RISK MANAGEMENT (JRM) STUDY

### Salem Terminal TO KUMARAN TRADERS

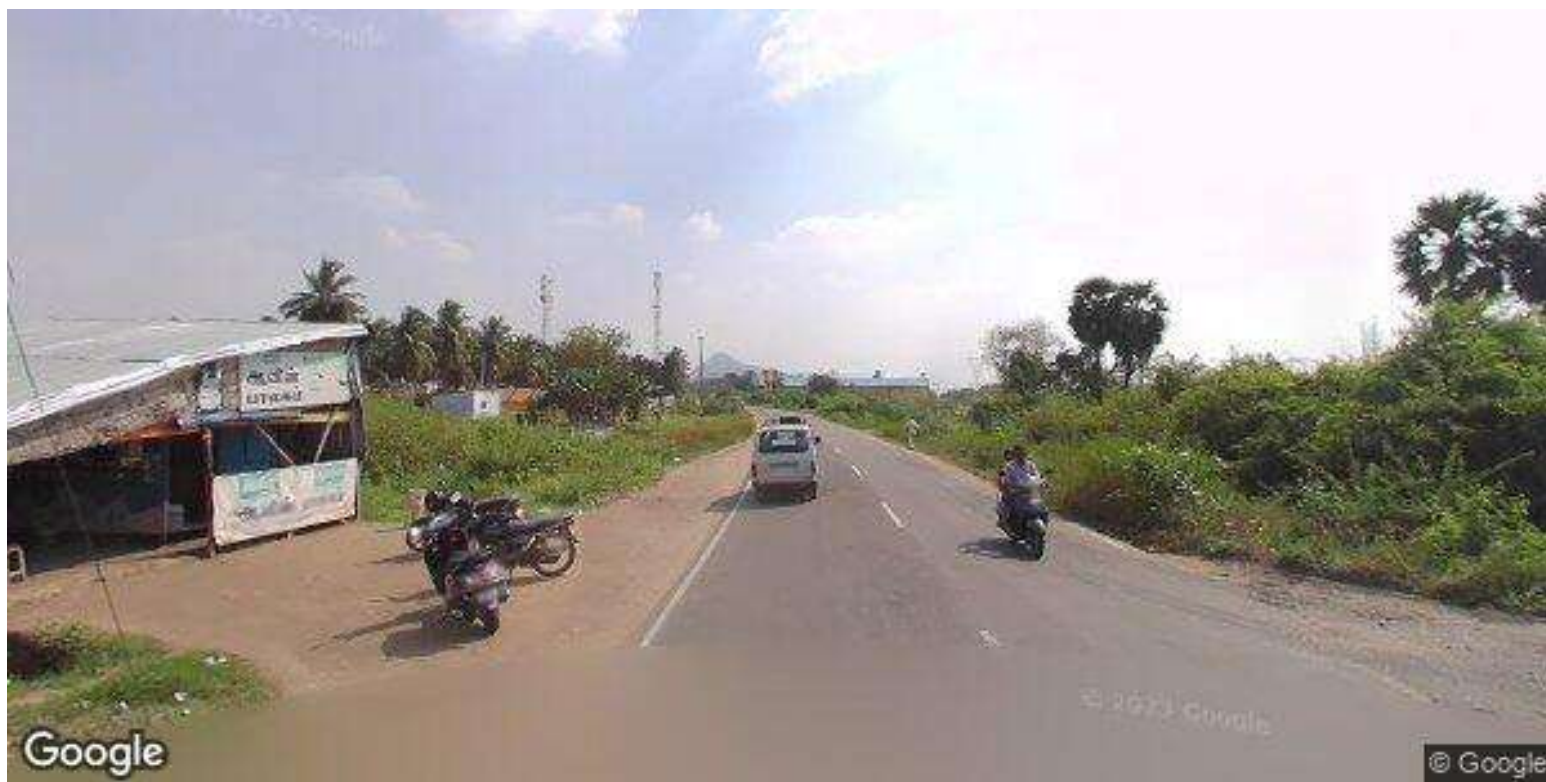
**Coordinates: 11.44022, 77.87546**

**Risk Type: Turn**

**Risk Level: High**

**Speed Limit: 15 KM/Hr**

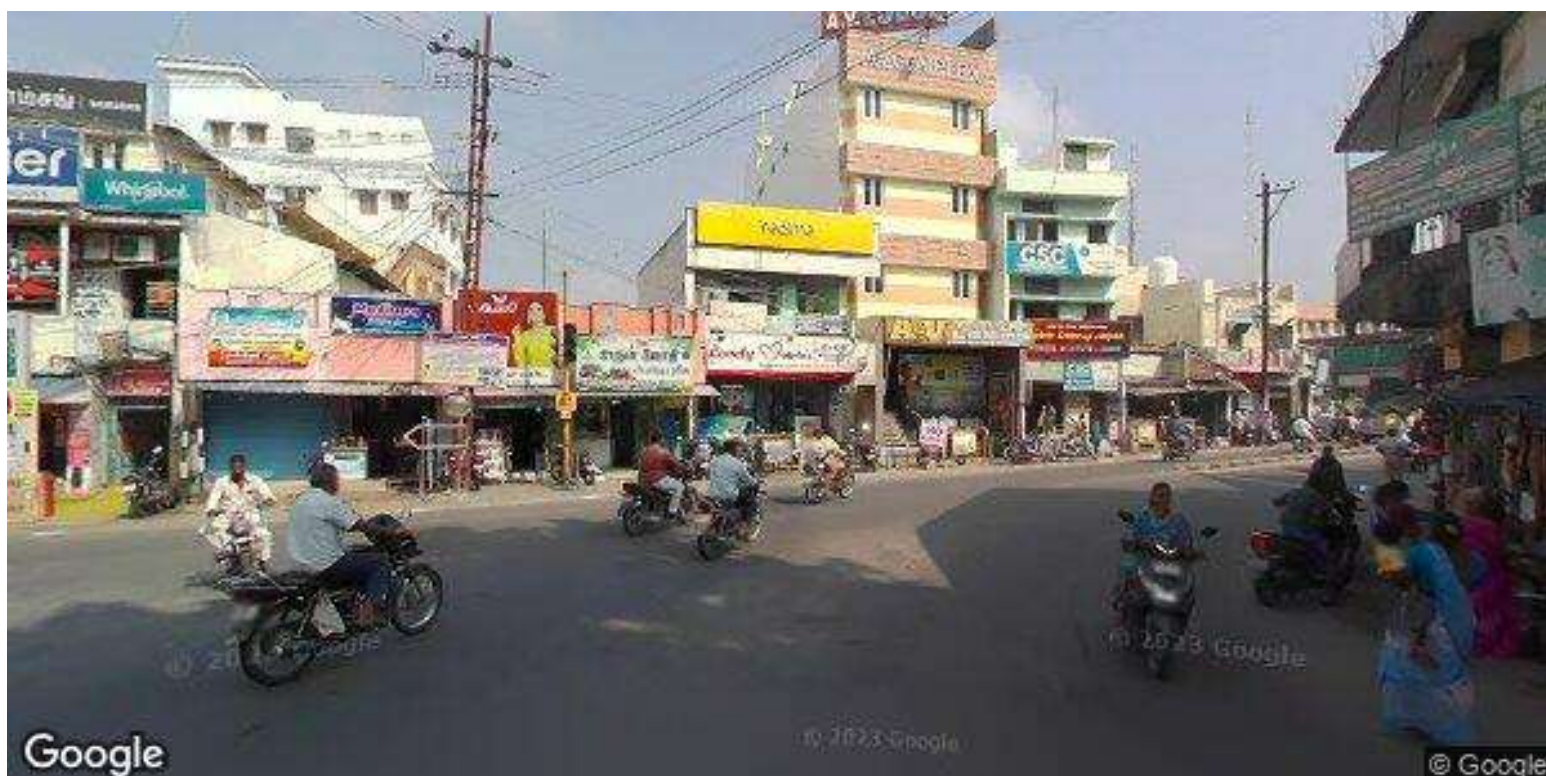
**Risk Type:** Turn  
**Risk Level:** Medium  
**Speed Limit:** 30 KM/Hr  
**Coordinates:** 11.37842, 77.89452

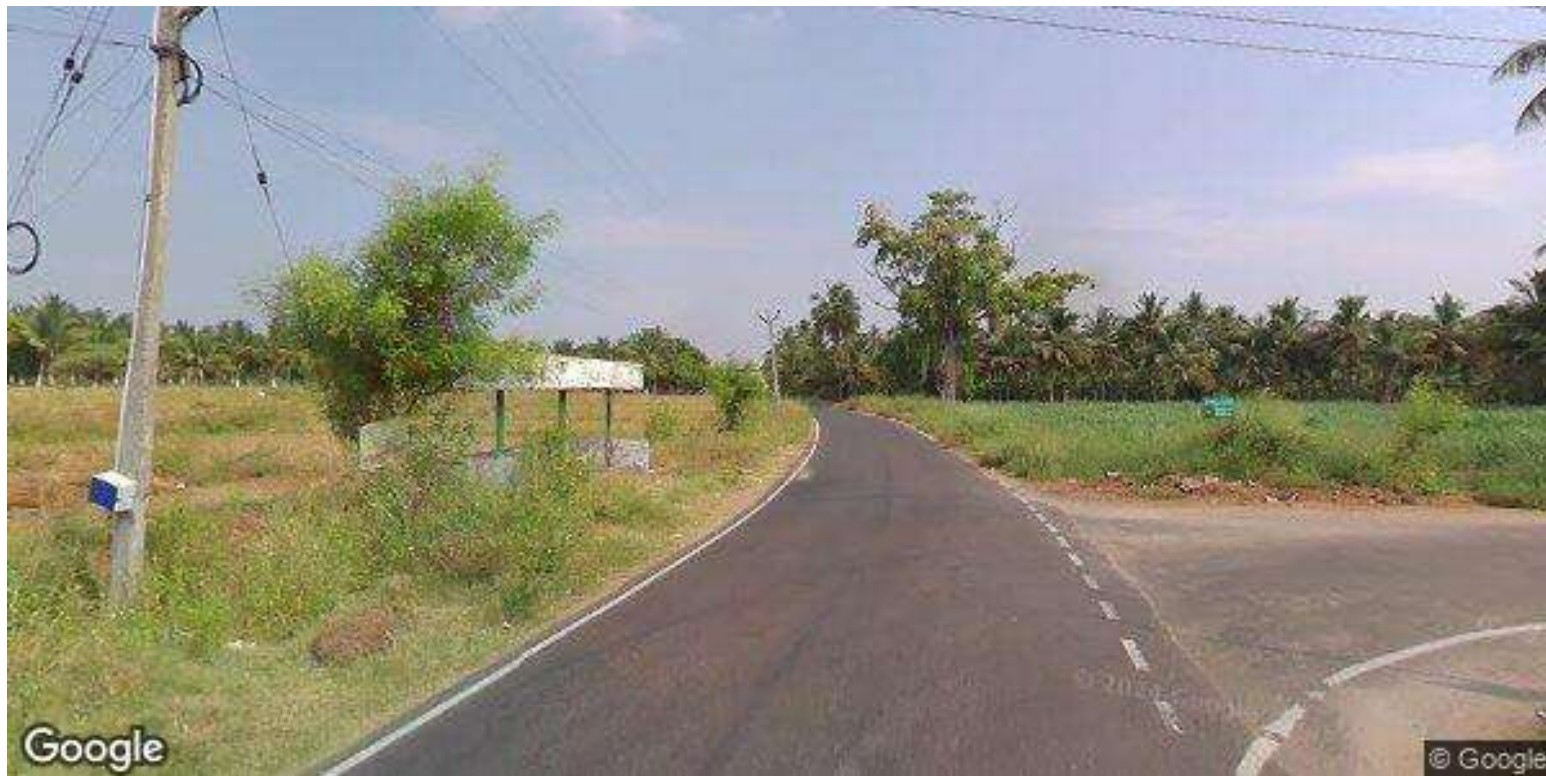
**Coordinates: 11.29141, 77.74662**

**Risk Type: Turn**

**Risk Level: High**

**Speed Limit: 15 KM/Hr**

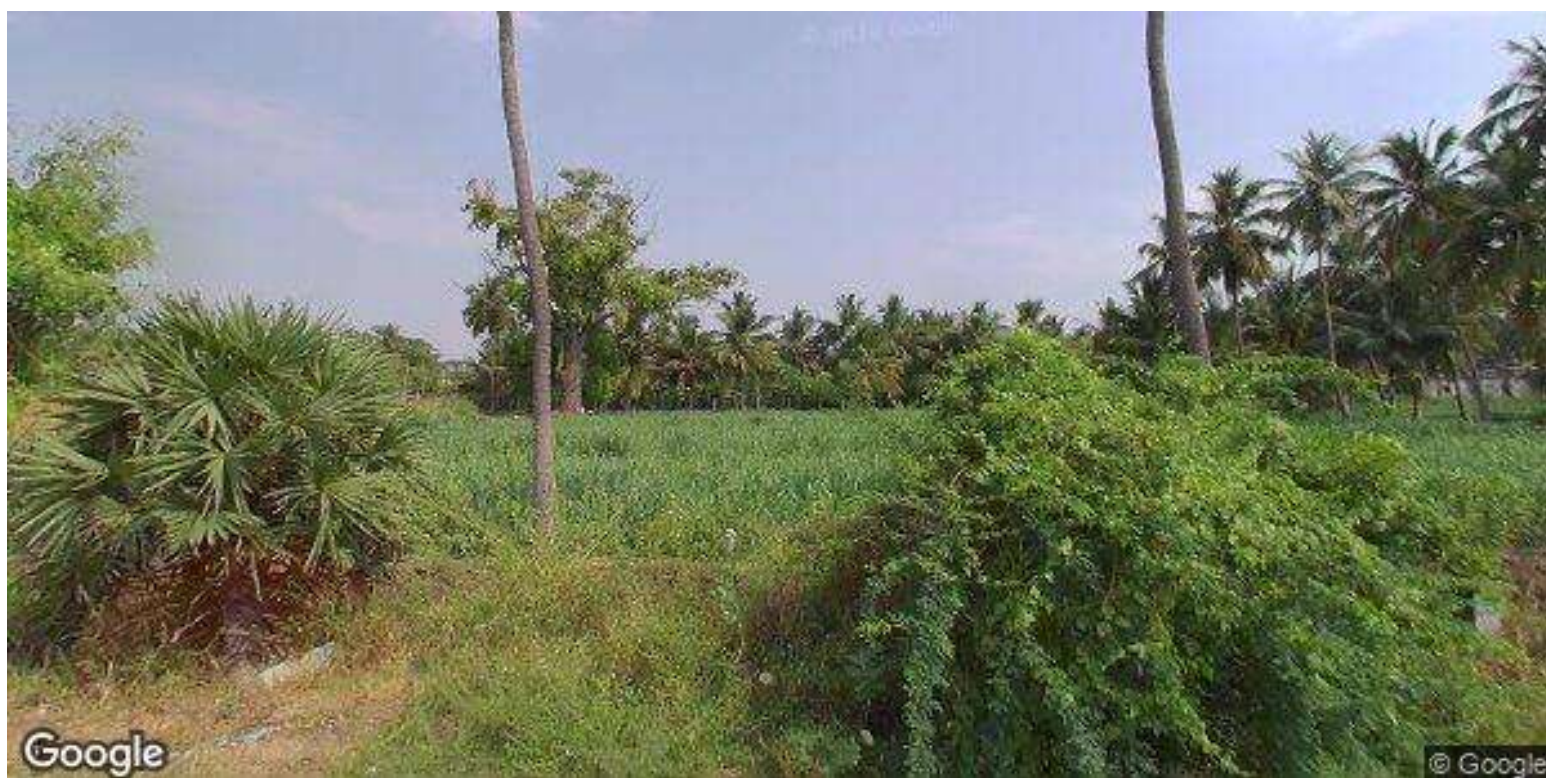
**Coordinates: 11.29125, 77.74646**

**Risk Type: Turn**

**Risk Level: Medium**

**Speed Limit: 30 KM/Hr**

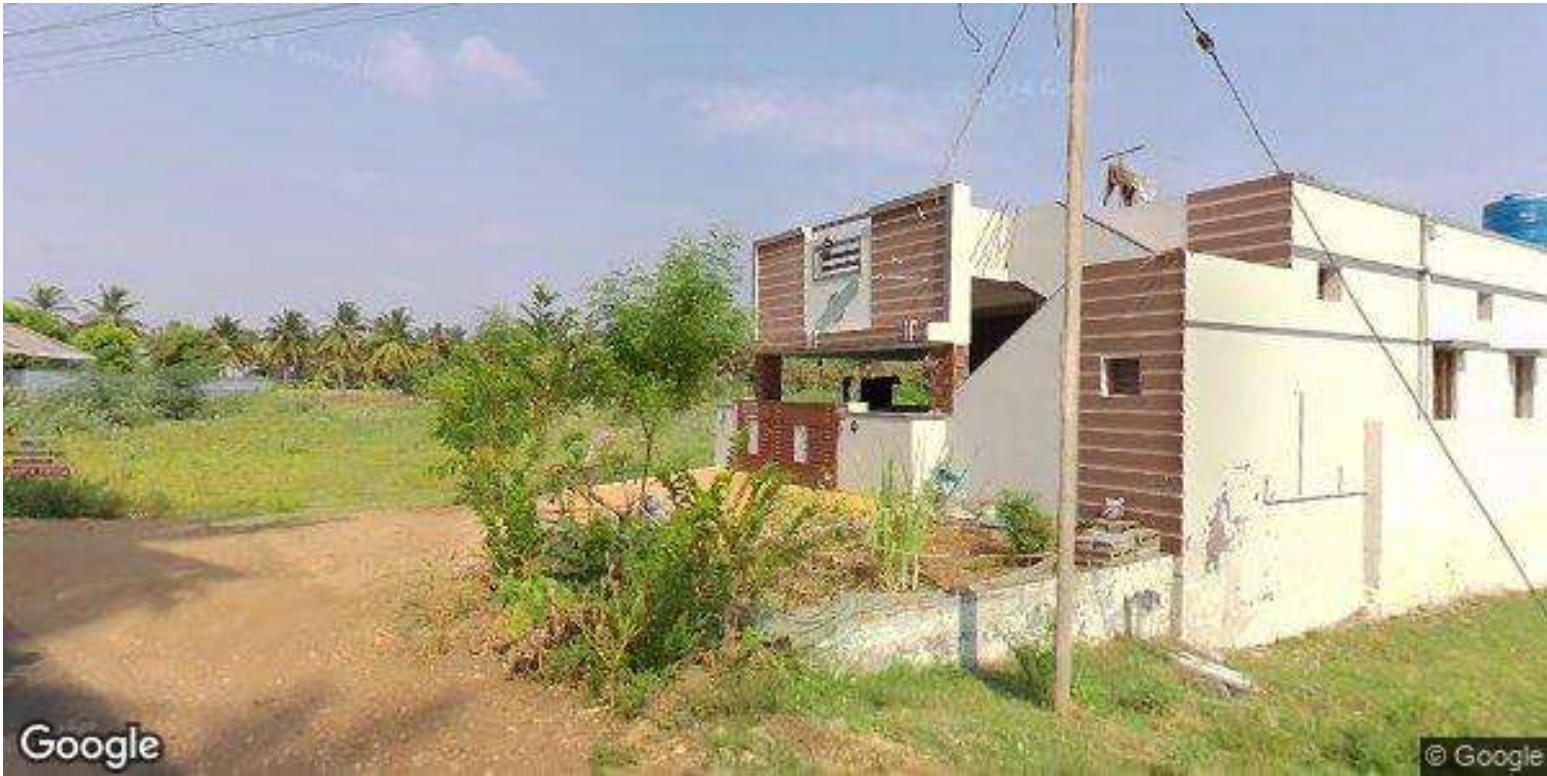
**Risk Type:** Turn  
**Risk Level:** Medium  
**Speed Limit:** 30 KM/Hr  
**Coordinates:** 11.27319, 77.72981

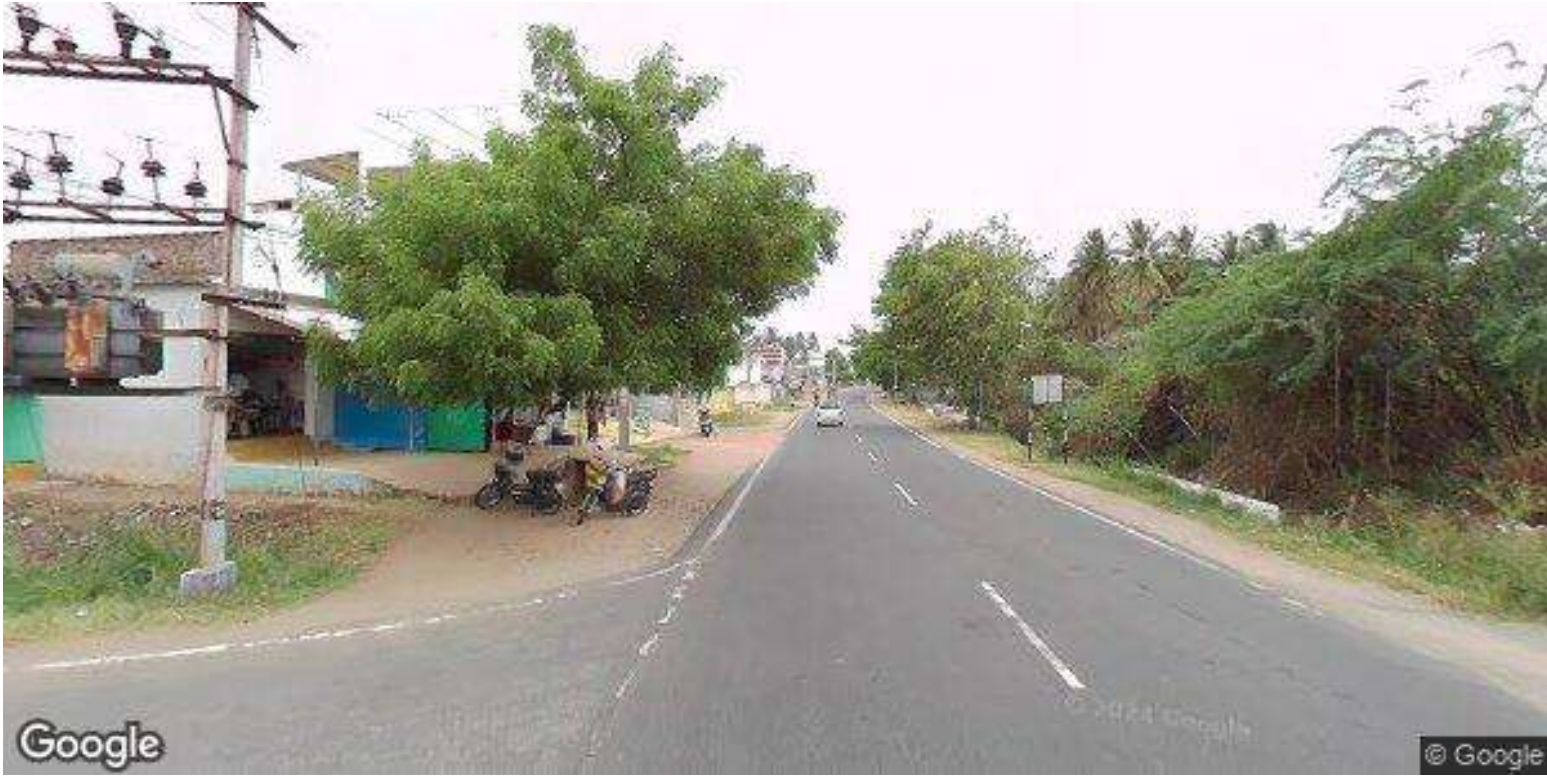
**Risk Type:** Turn  
**Risk Level:** High  
**Speed Limit:** 15 KM/Hr  
**Coordinates:** 11.27328, 77.72705

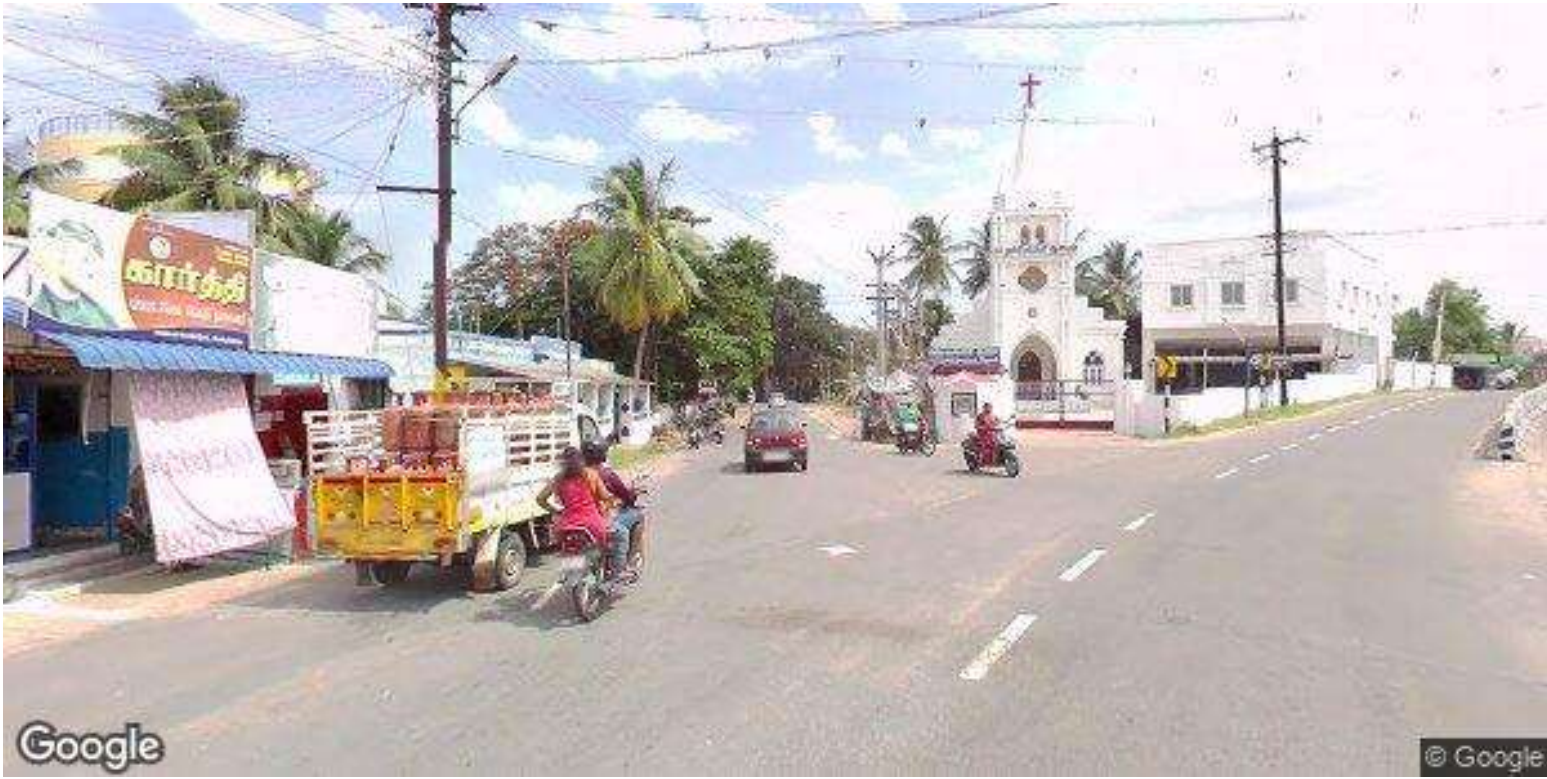
**Risk Type:** Turn  
**Risk Level:** Medium  
**Speed Limit:** 30 KM/Hr  
**Coordinates:** 11.23054, 77.71796

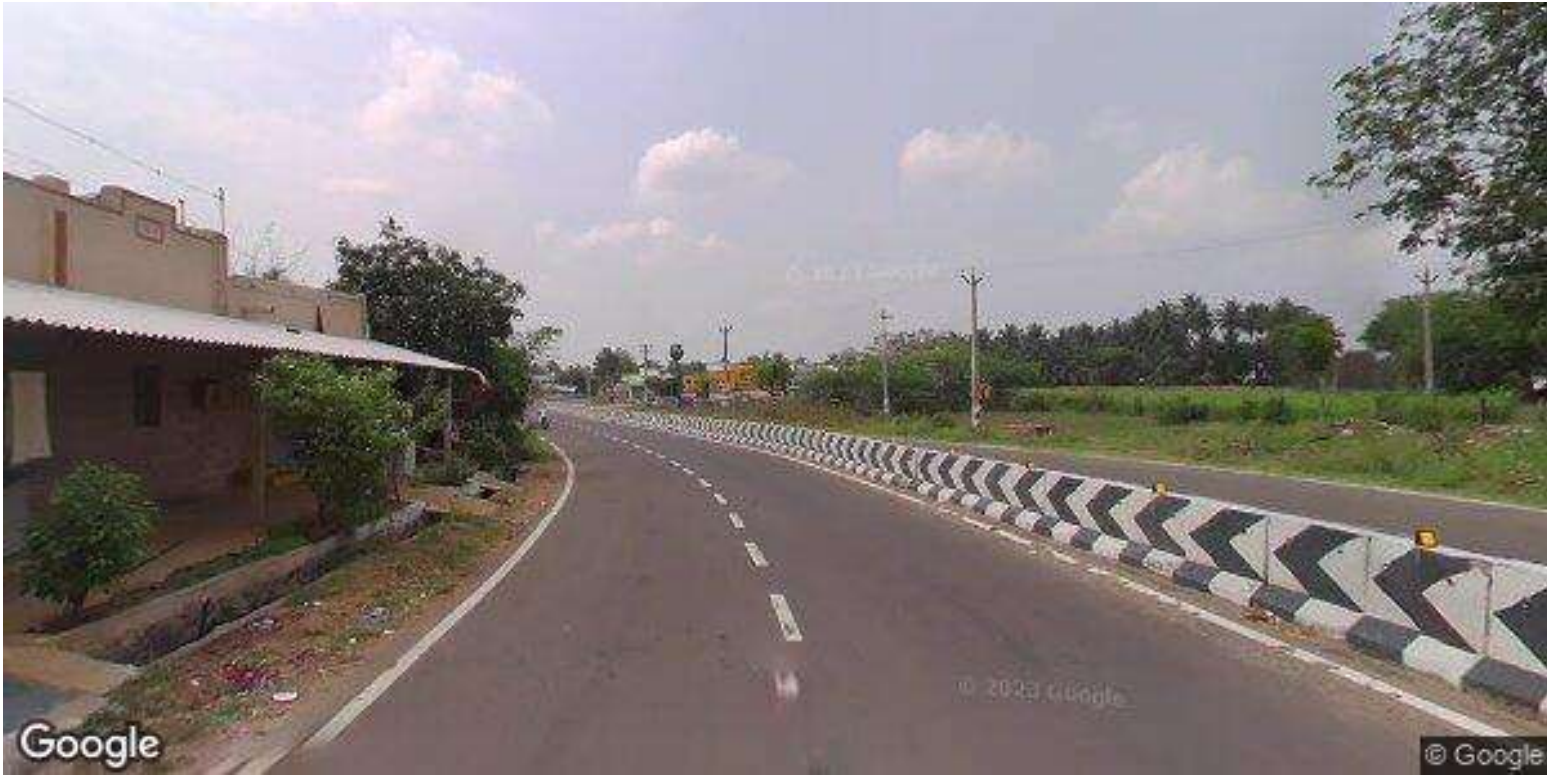
**Risk Type:** Turn  
**Risk Level:** Medium  
**Speed Limit:** 30 KM/Hr  
**Coordinates:** 11.22387, 77.71385

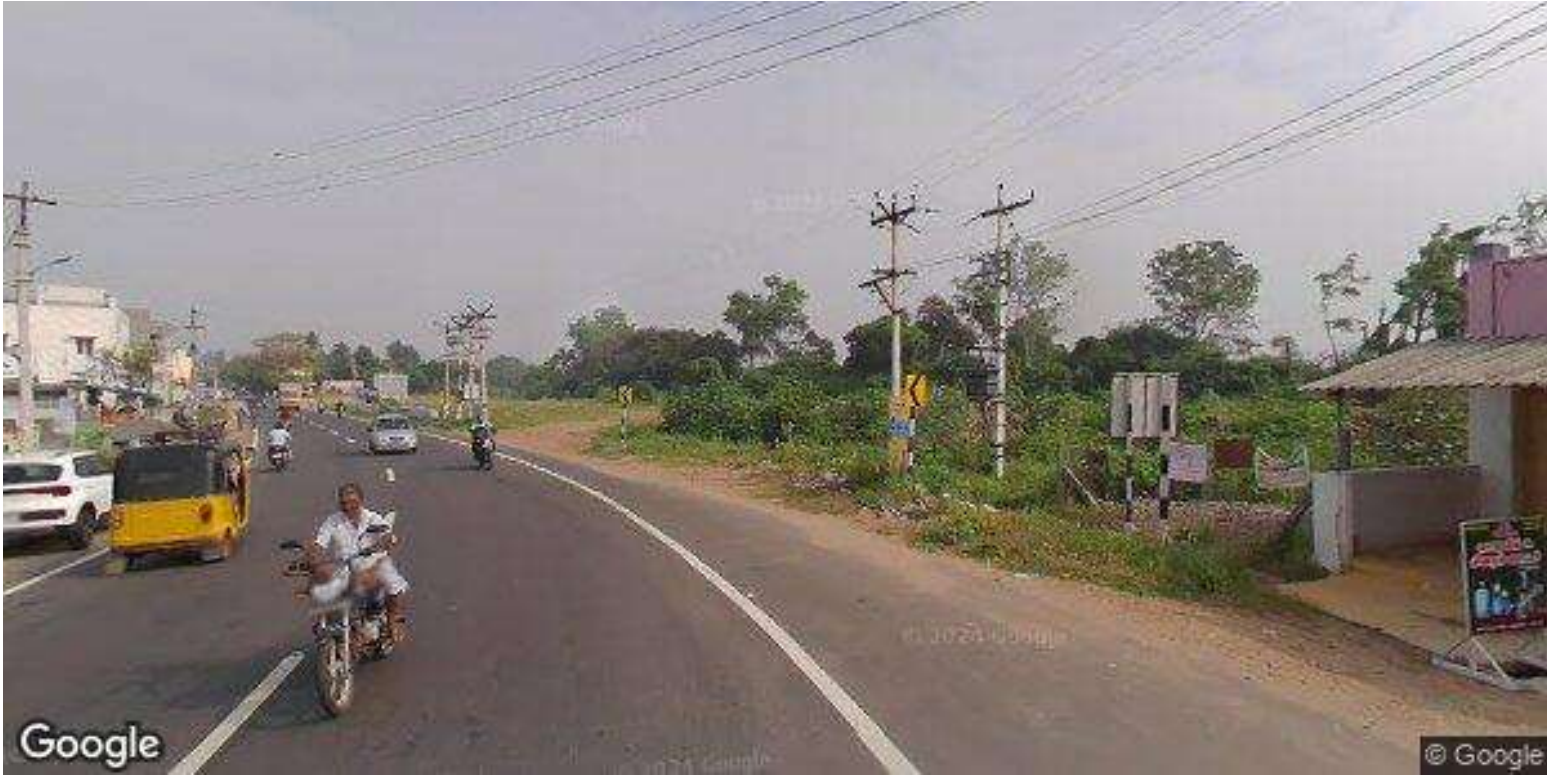
**Risk Type:** Turn  
**Risk Level:** Medium  
**Speed Limit:** 30 KM/Hr  
**Coordinates:** 11.16078, 77.70122

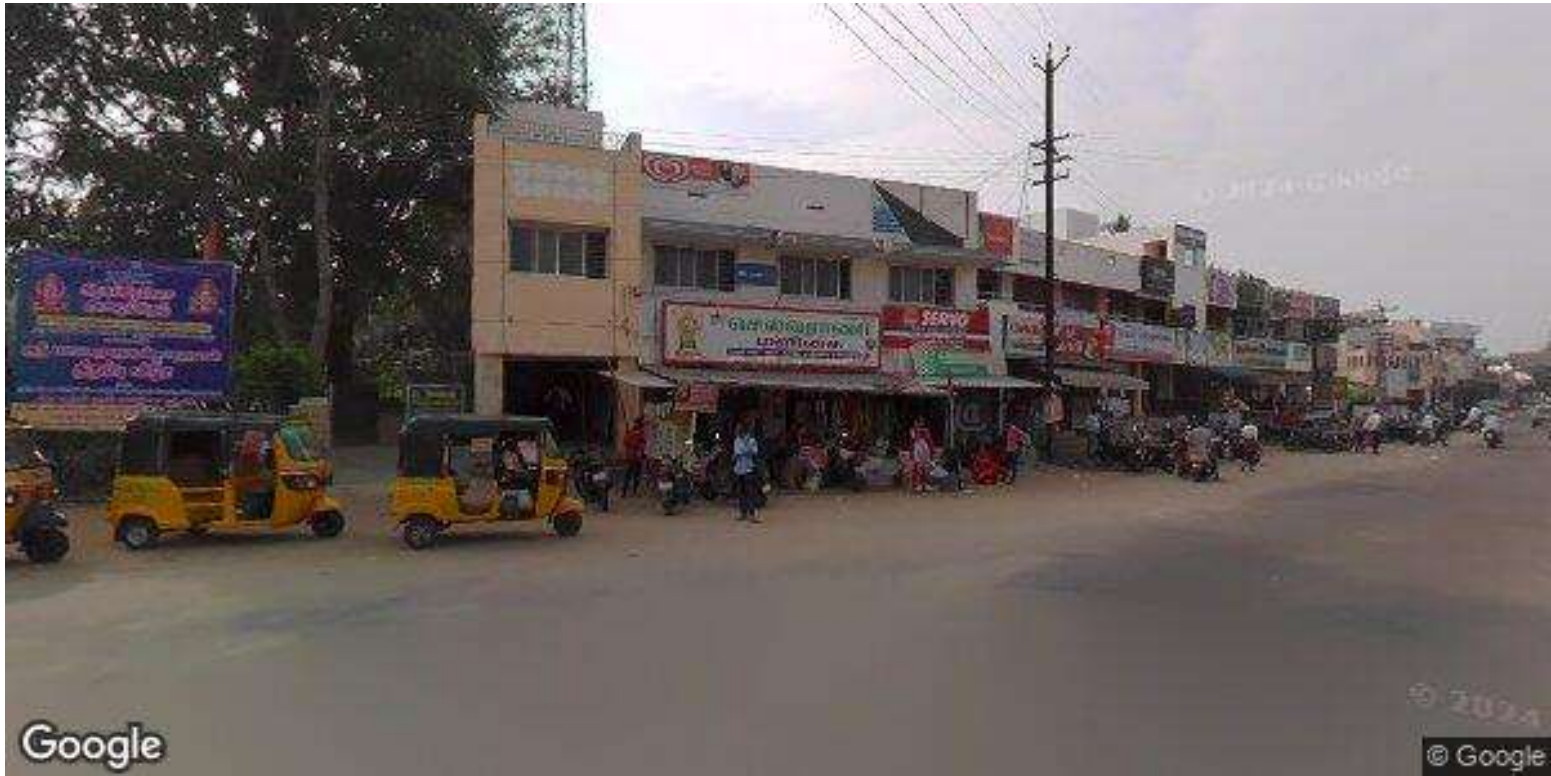
**Risk Type:** Turn  
**Risk Level:** High  
**Speed Limit:** 15 KM/Hr  
**Coordinates:** 11.15942, 77.70068

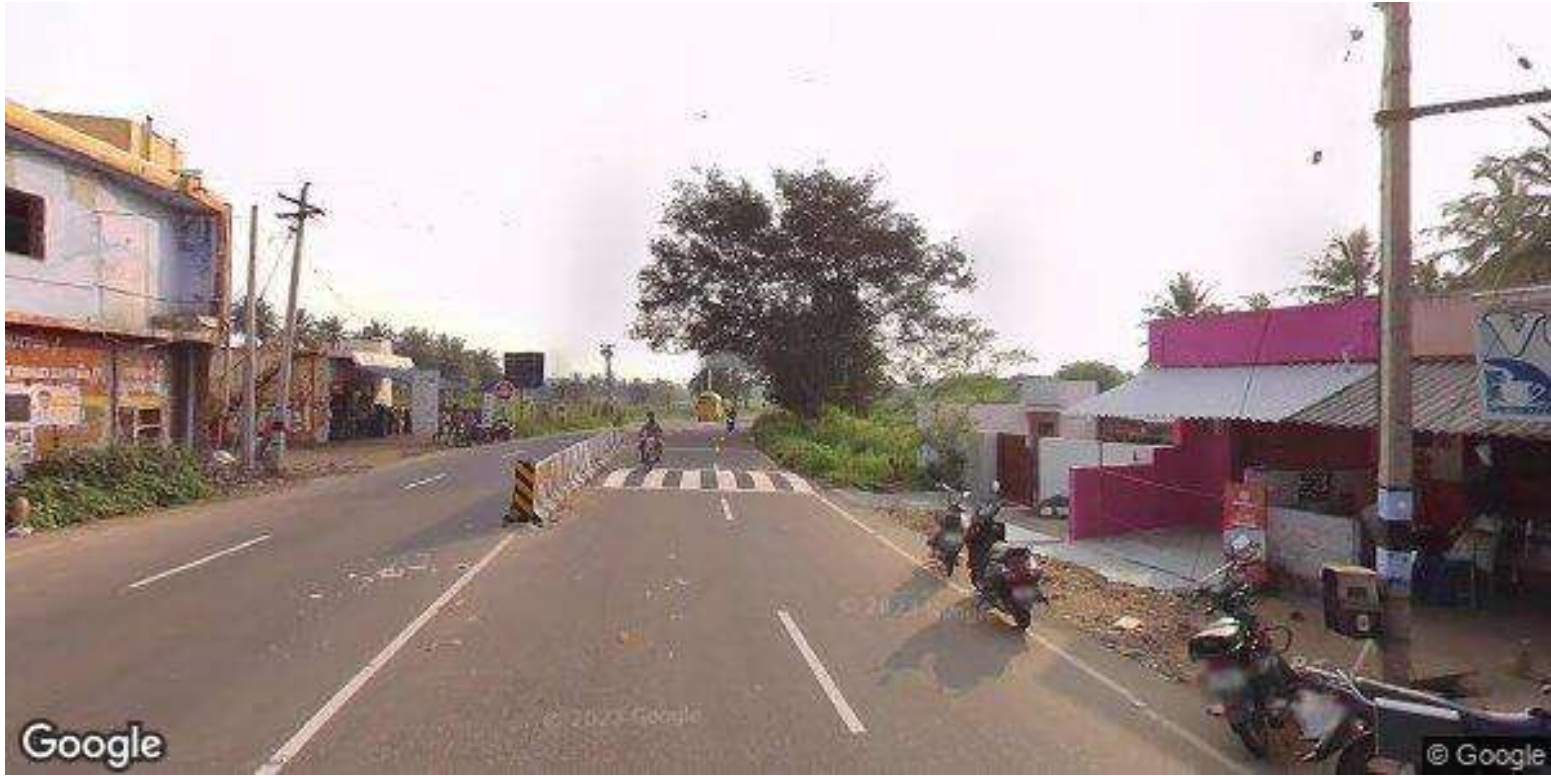
**Risk Type:** Blind Spot  
**Risk Level:** Blind Spot  
**Speed Limit:** 10 KM/Hr  
**Coordinates:** 11.12126, 77.67929
