# IndianOil

## JOURNEY RISK MANAGEMENT (JRM) STUDY

### Salem Terminal to SARADHA RANGANATHAN AGENCIES

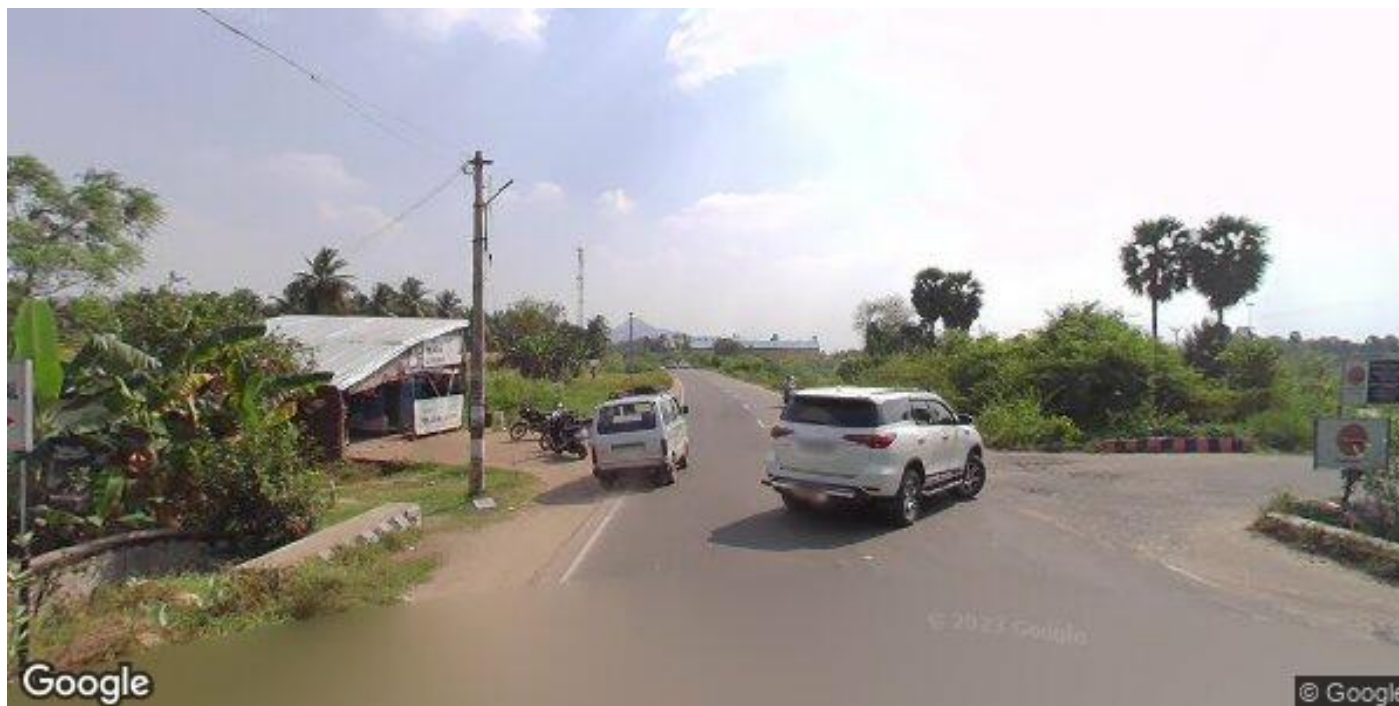
**Risk Type:** Turn  
**Risk Level:** High  
**Speed Limit:** 15 KM/Hr  
**Coordinates:** 11.44029, 77.87544

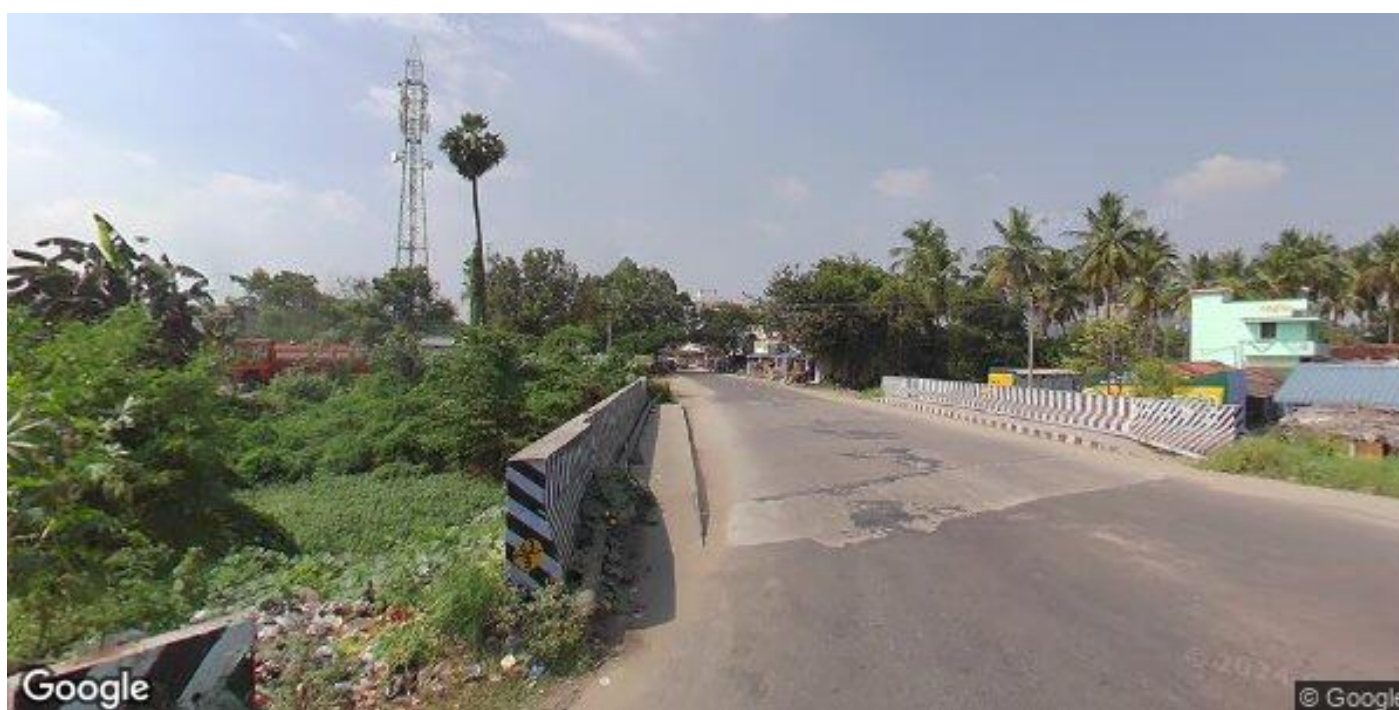
**Risk Type:** Turn  
**Risk Level:** Medium  
**Speed Limit:** 30 KM/Hr  
**Coordinates:** 11.44900, 77.87406

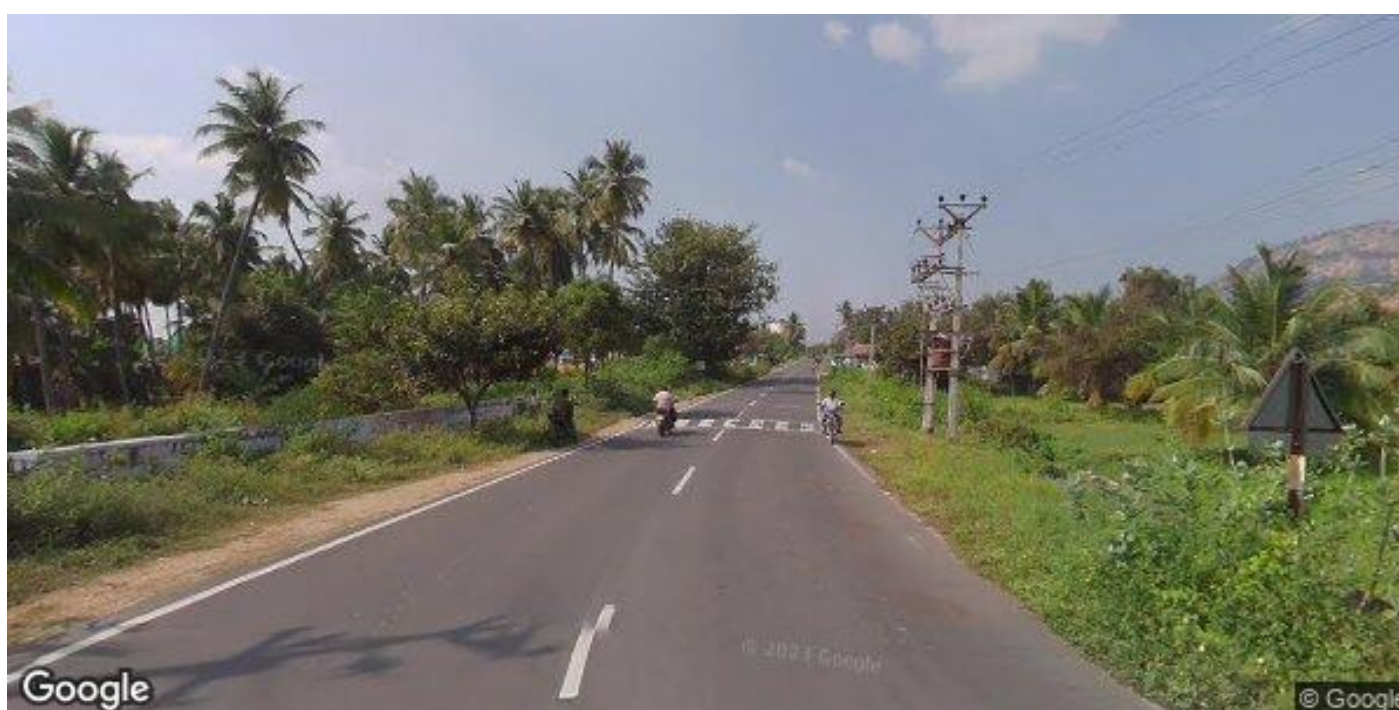
**Risk Type:** Turn  
**Risk Level:** High  
**Speed Limit:** 15 KM/Hr  
**Coordinates:** 11.45353, 77.85697

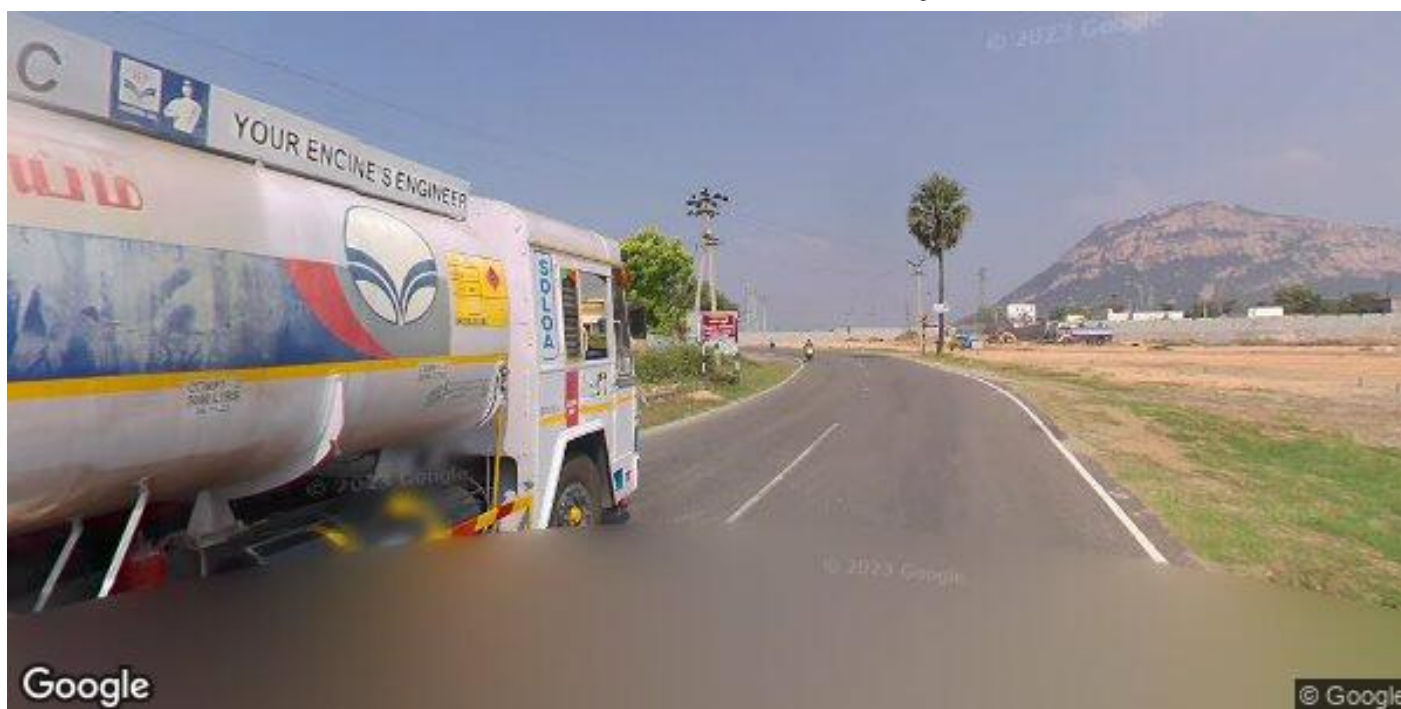
**Risk Type:** Turn  
**Risk Level:** Medium  
**Speed Limit:** 30 KM/Hr  
**Coordinates:** 11.45853, 77.85139

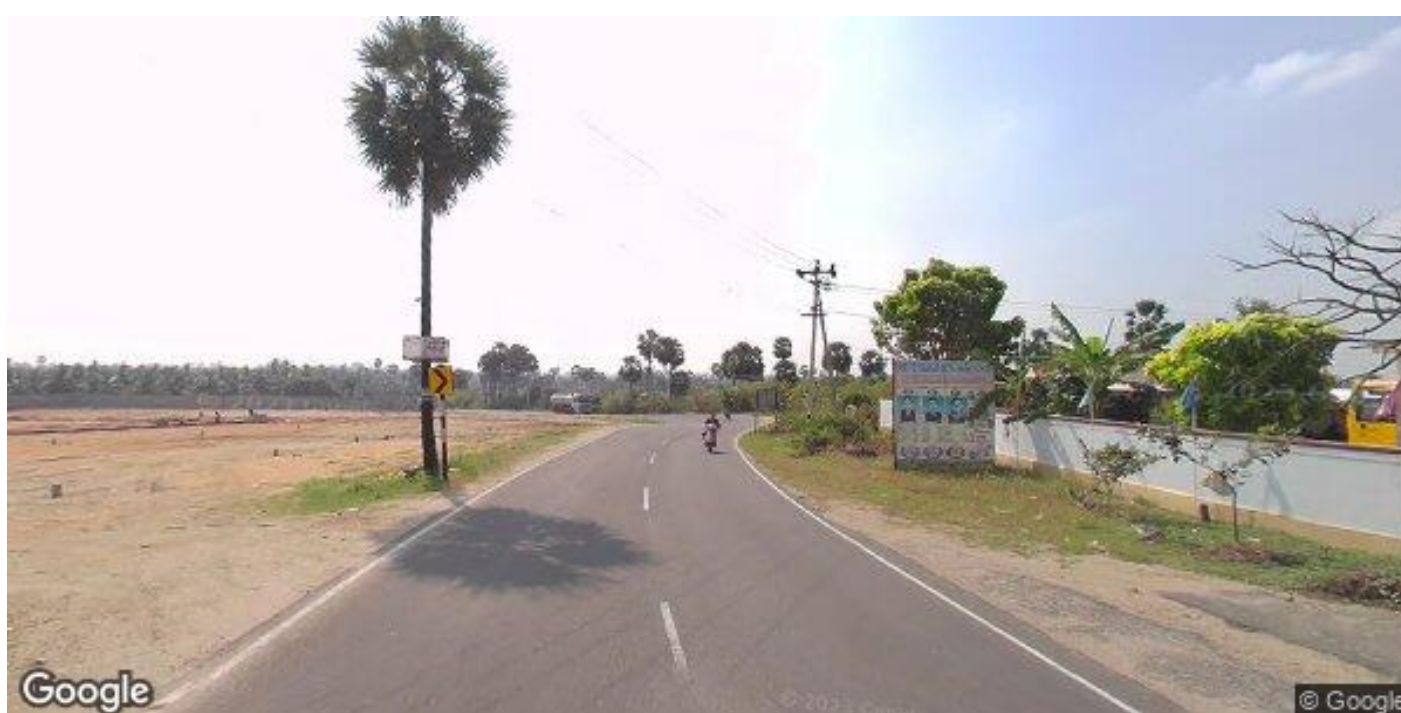
**Risk Type:** Turn  
**Risk Level:** Medium  
**Speed Limit:** 30 KM/Hr  
**Coordinates:** 11.45906, 77.85132

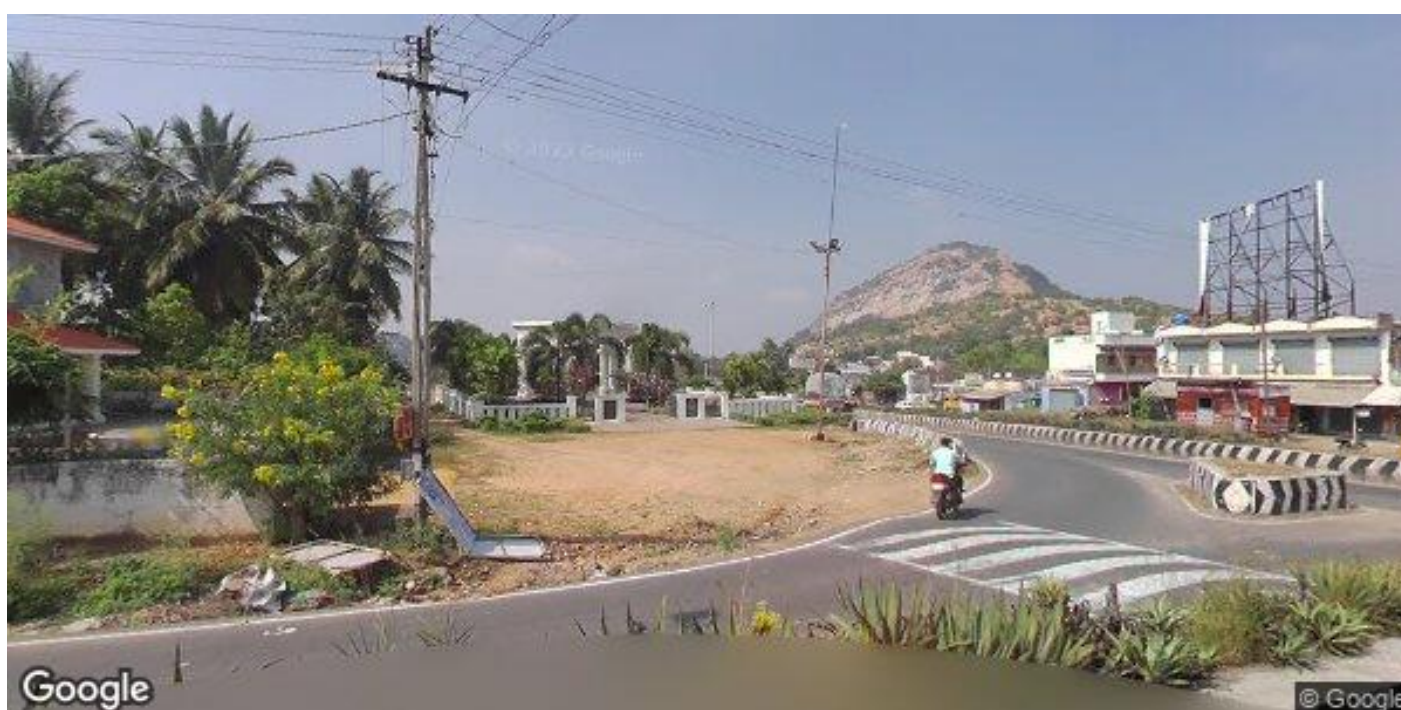
**Risk Type:** Turn  
**Risk Level:** High  
**Speed Limit:** 15 KM/Hr  
**Coordinates:** 11.46307, 77.84941

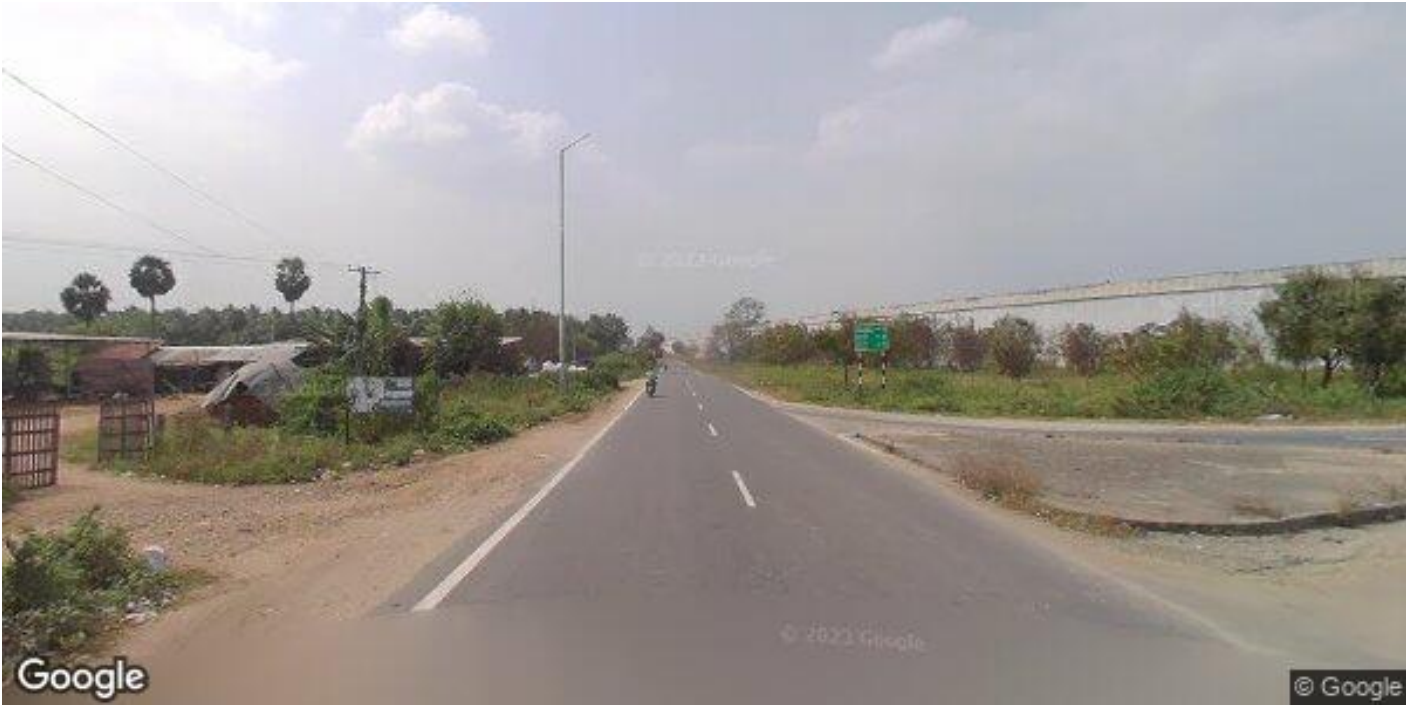
**Risk Type:** Turn  
**Risk Level:** High  
**Speed Limit:** 15 KM/Hr  
**Coordinates:** 11.45542, 77.81725

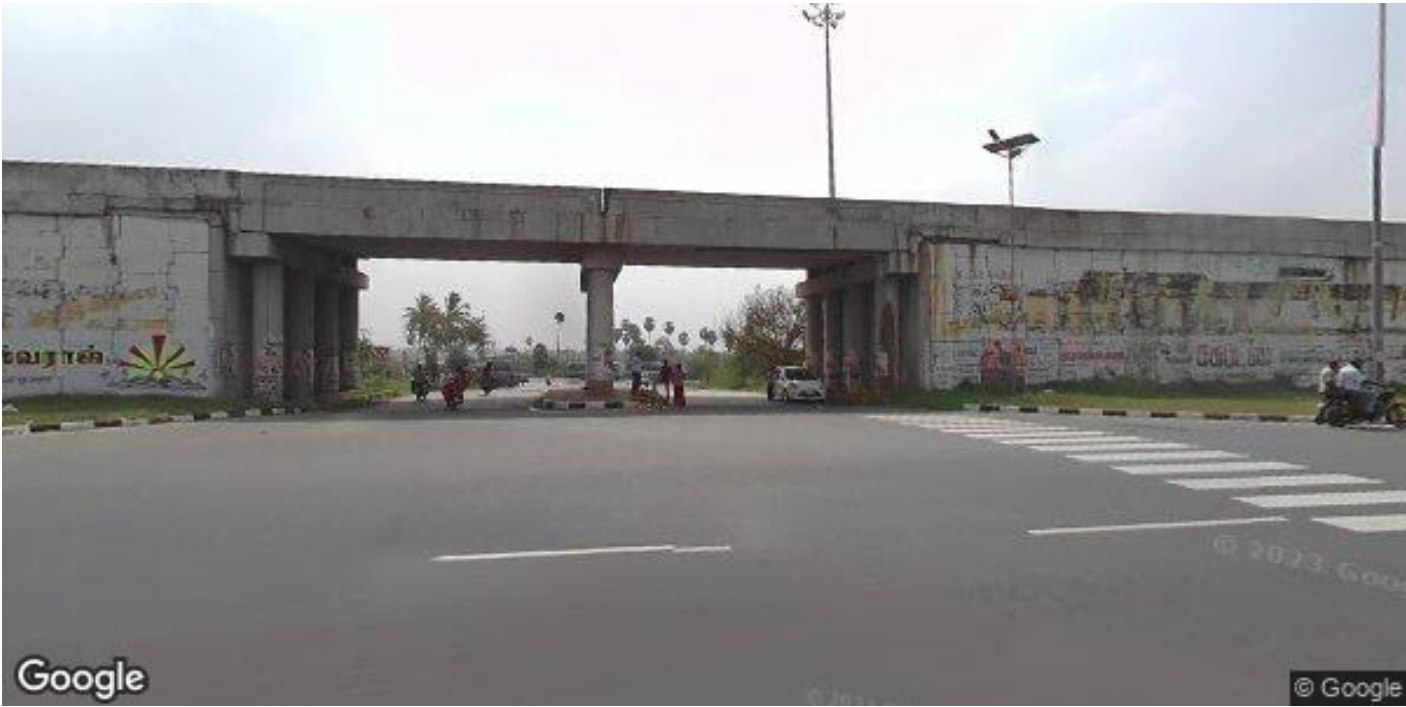
**Risk Type:** Turn  
**Risk Level:** High  
**Speed Limit:** 15 KM/Hr  
**Coordinates:** 11.45636, 77.81678

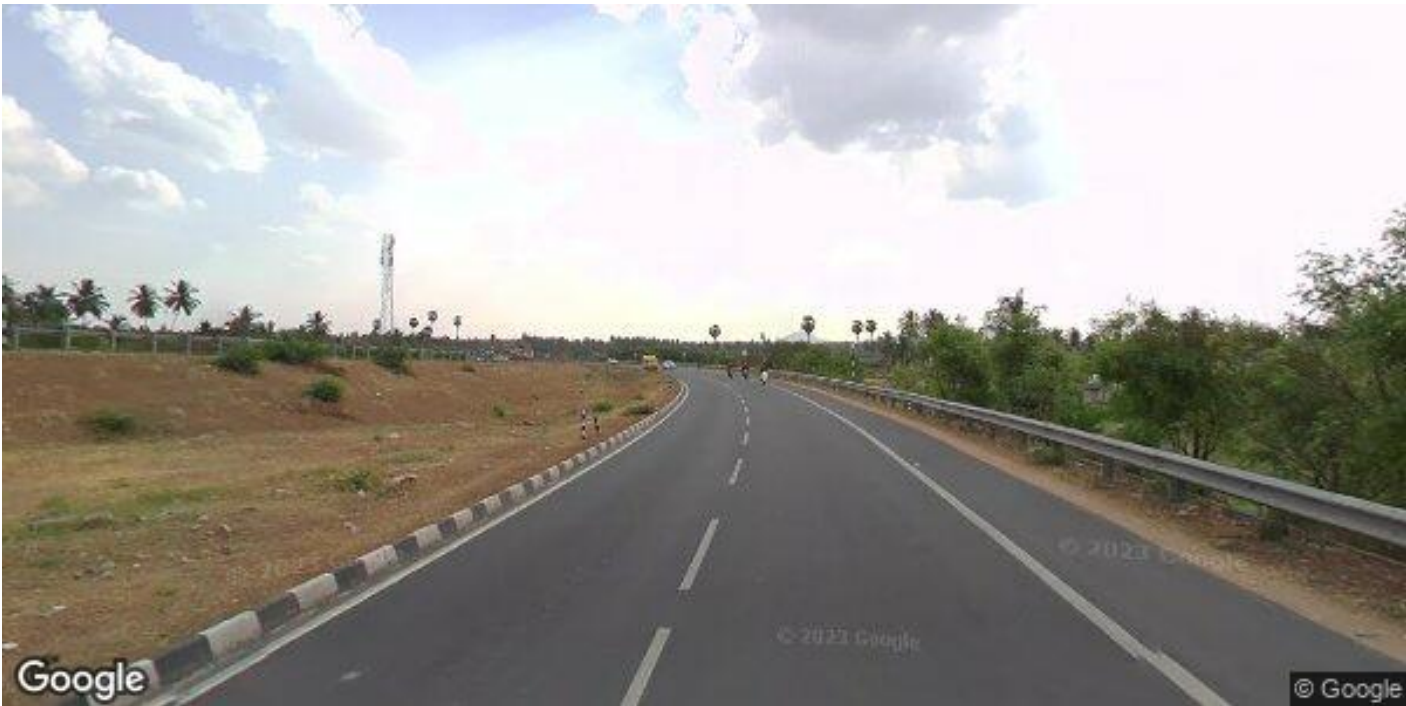
**Risk Type:** Turn  
**Risk Level:** Medium  
**Speed Limit:** 30 KM/Hr  
**Coordinates:** 11.53573, 77.95794

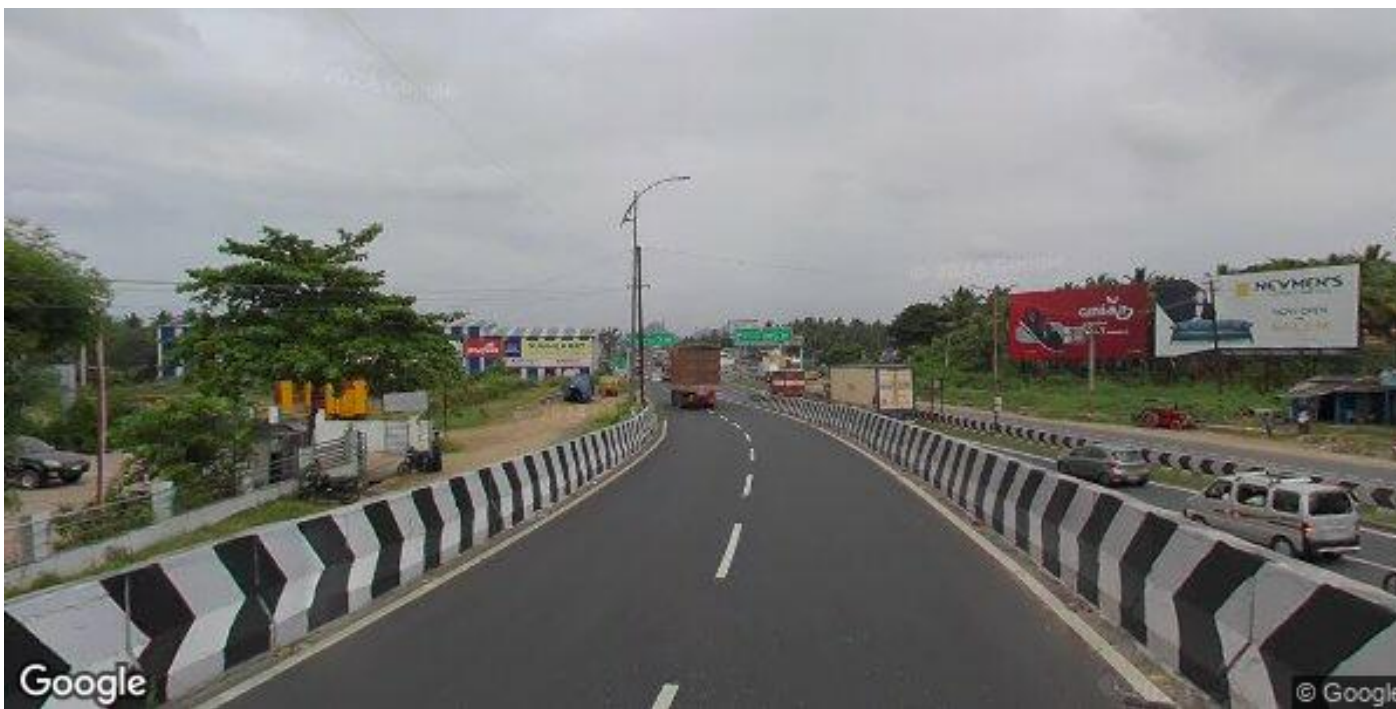
**Risk Type:** Turn  
**Risk Level:** Medium  
**Speed Limit:** 30 KM/Hr  
**Coordinates:** 11.64338, 78.11998

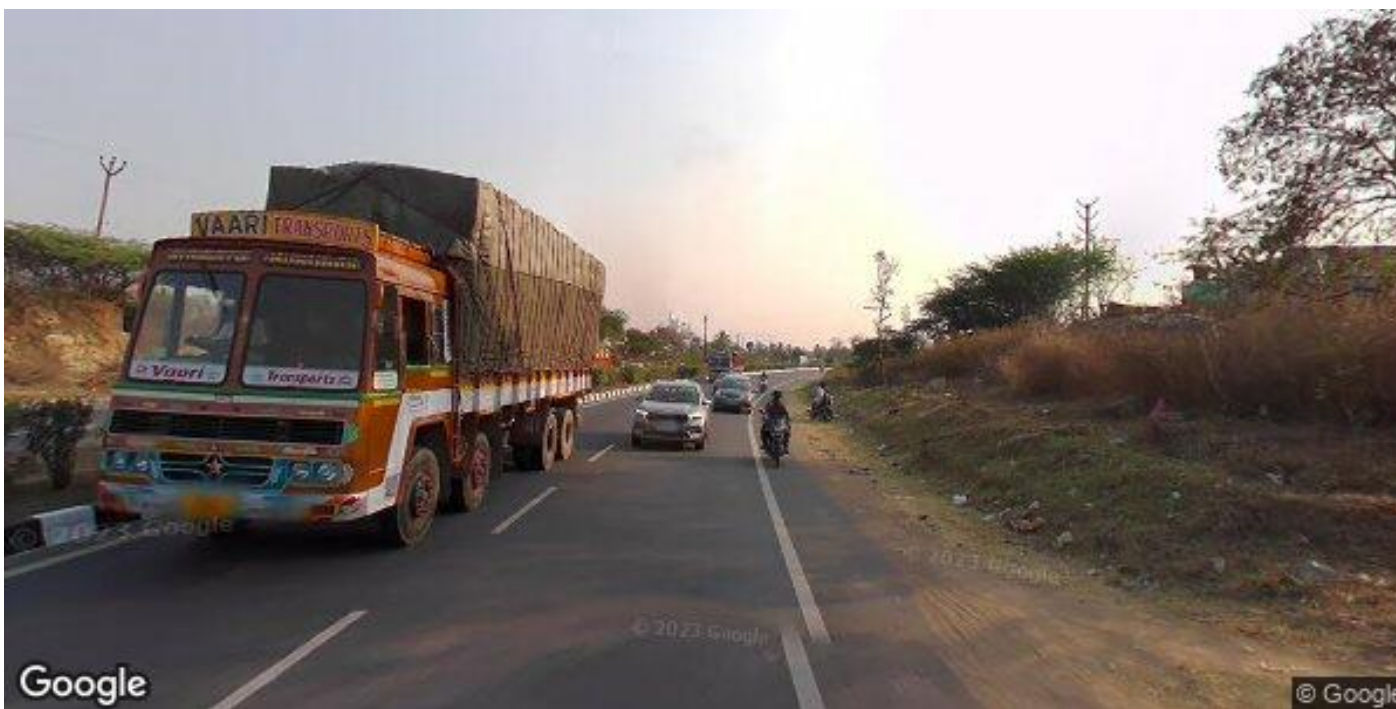
**Risk Type:** Turn  
**Risk Level:** Medium  
**Speed Limit:** 30 KM/Hr  
**Coordinates:** 11.78039, 78.05792

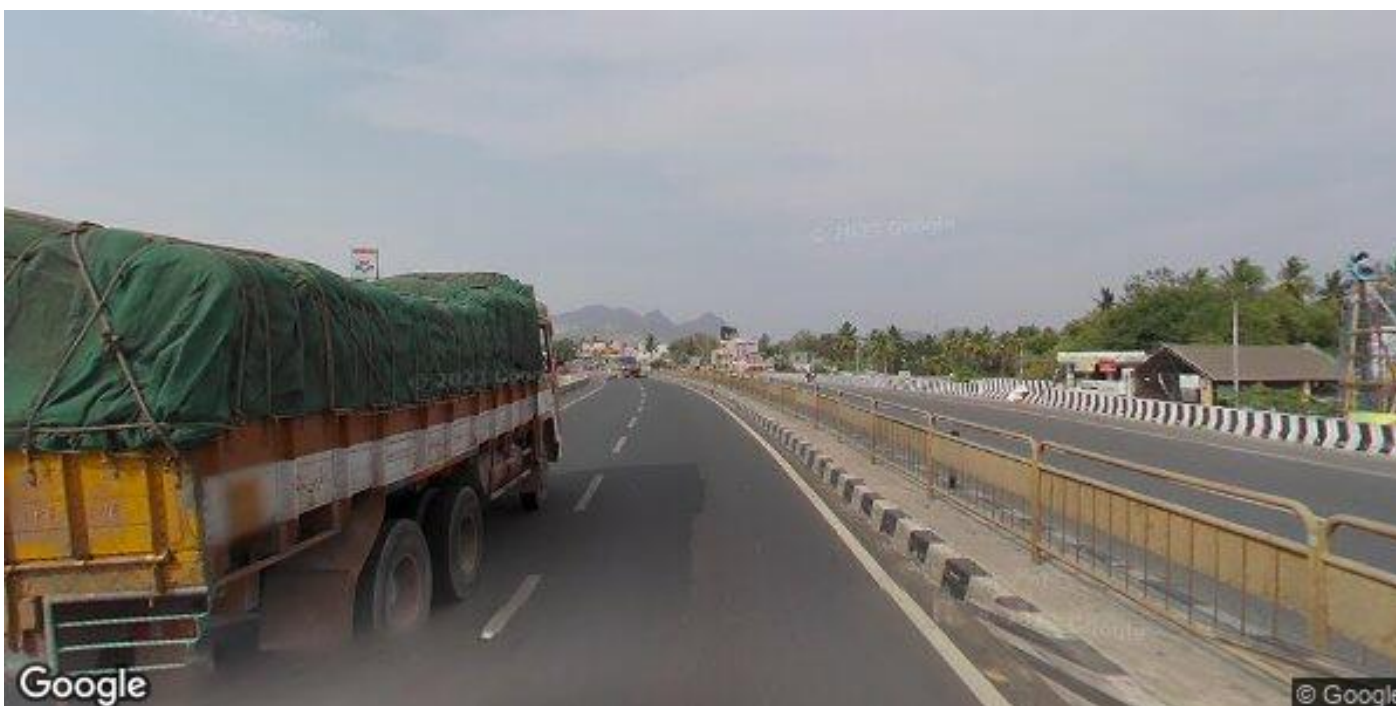
**Risk Type:** Turn  
**Risk Level:** Medium  
**Speed Limit:** 30 KM/Hr  
**Coordinates:** 11.86753, 78.08331

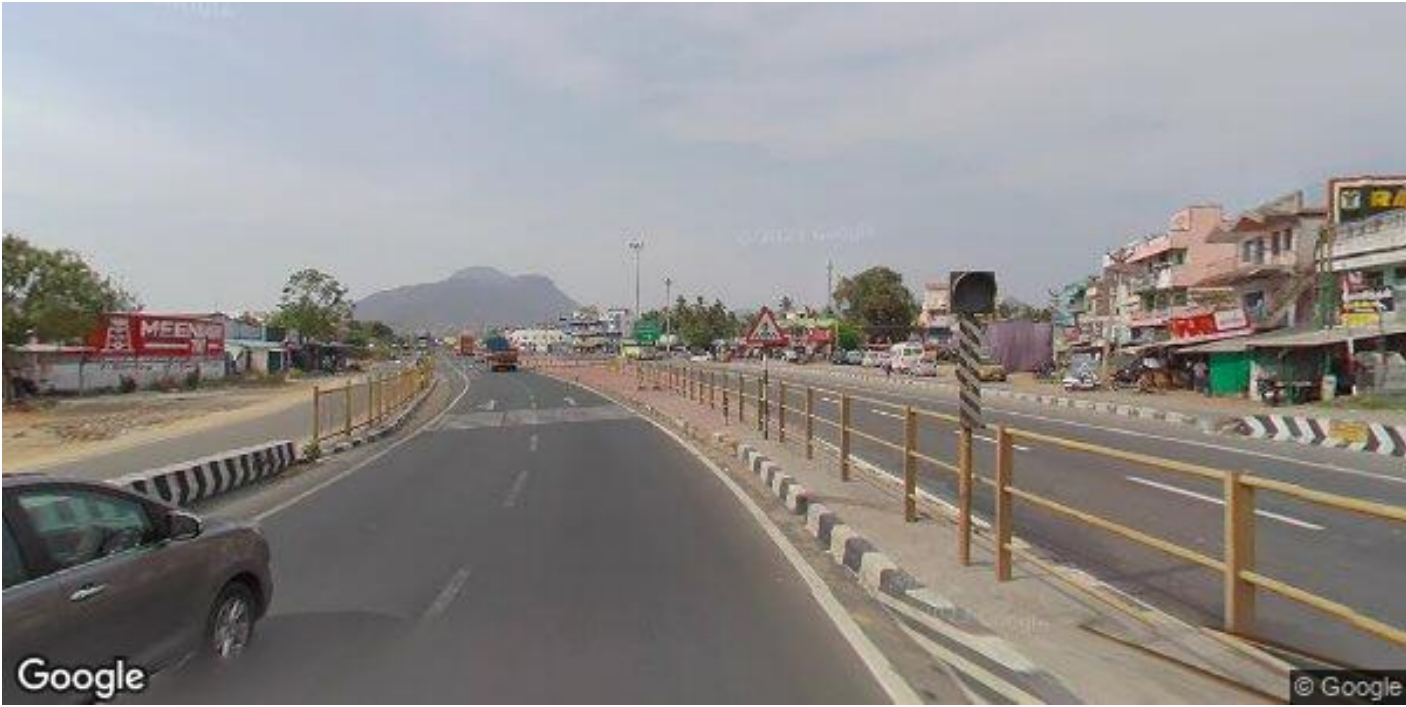
**Risk Type:** Turn  
**Risk Level:** Medium  
**Speed Limit:** 30 KM/Hr  
**Coordinates:** 11.86981, 78.08387

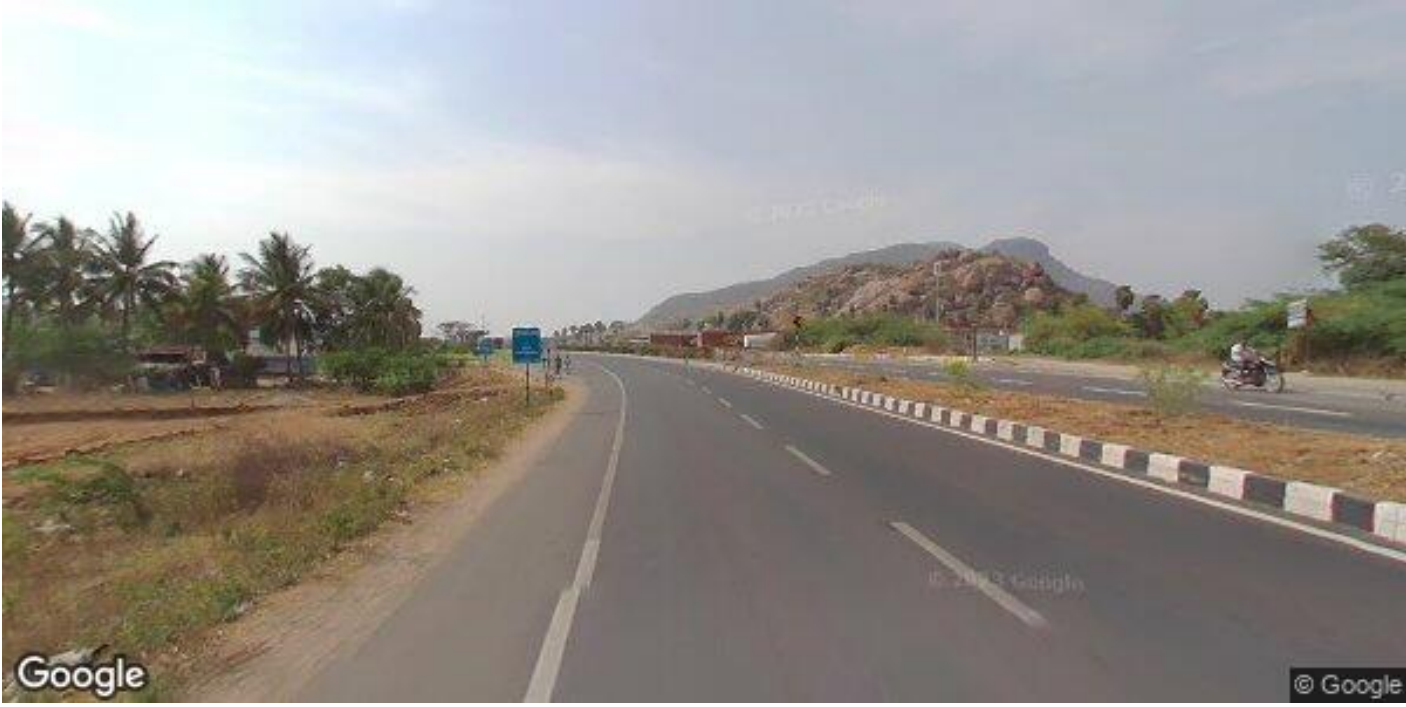
**Risk Type:** Turn  
**Risk Level:** Medium  
**Speed Limit:** 30 KM/Hr  
**Coordinates:** 11.88041, 78.08143

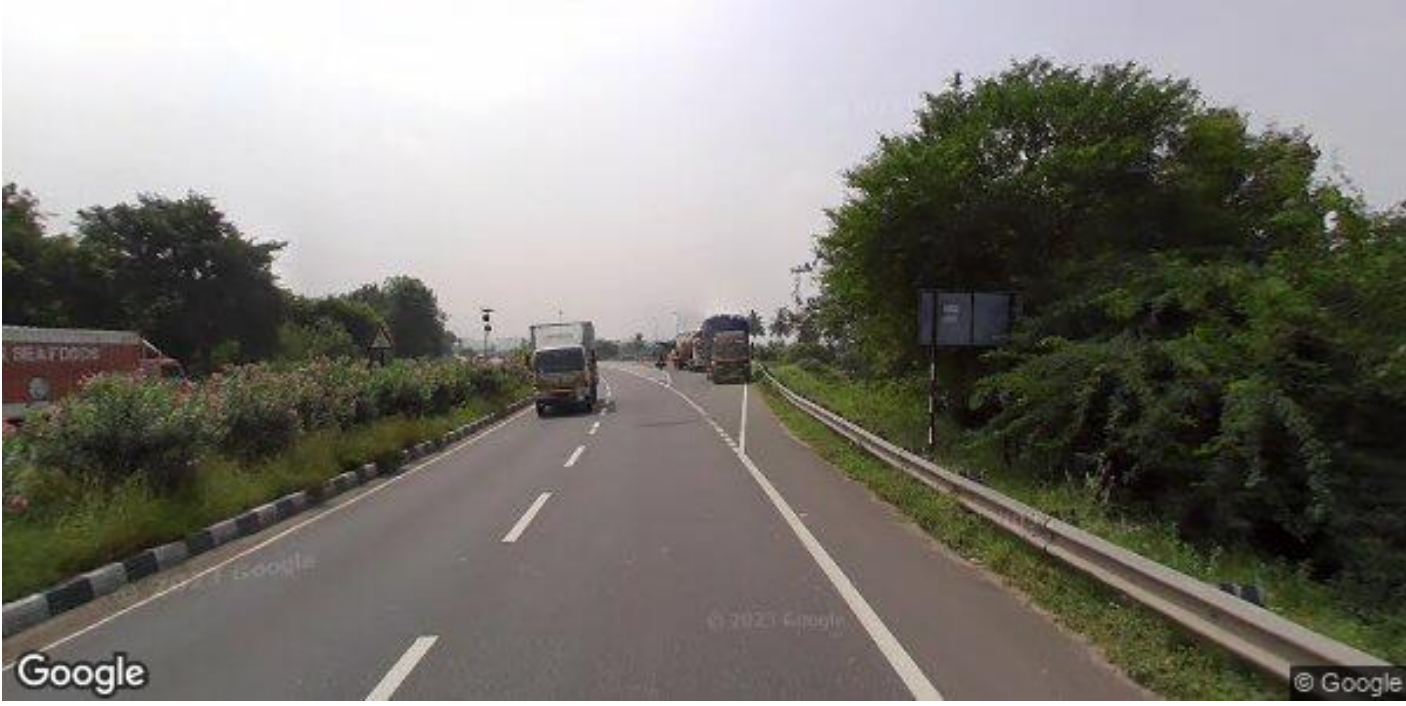
**Risk Type:** Turn  
**Risk Level:** Medium  
**Speed Limit:** 30 KM/Hr  
**Coordinates:** 11.91302, 78.05856

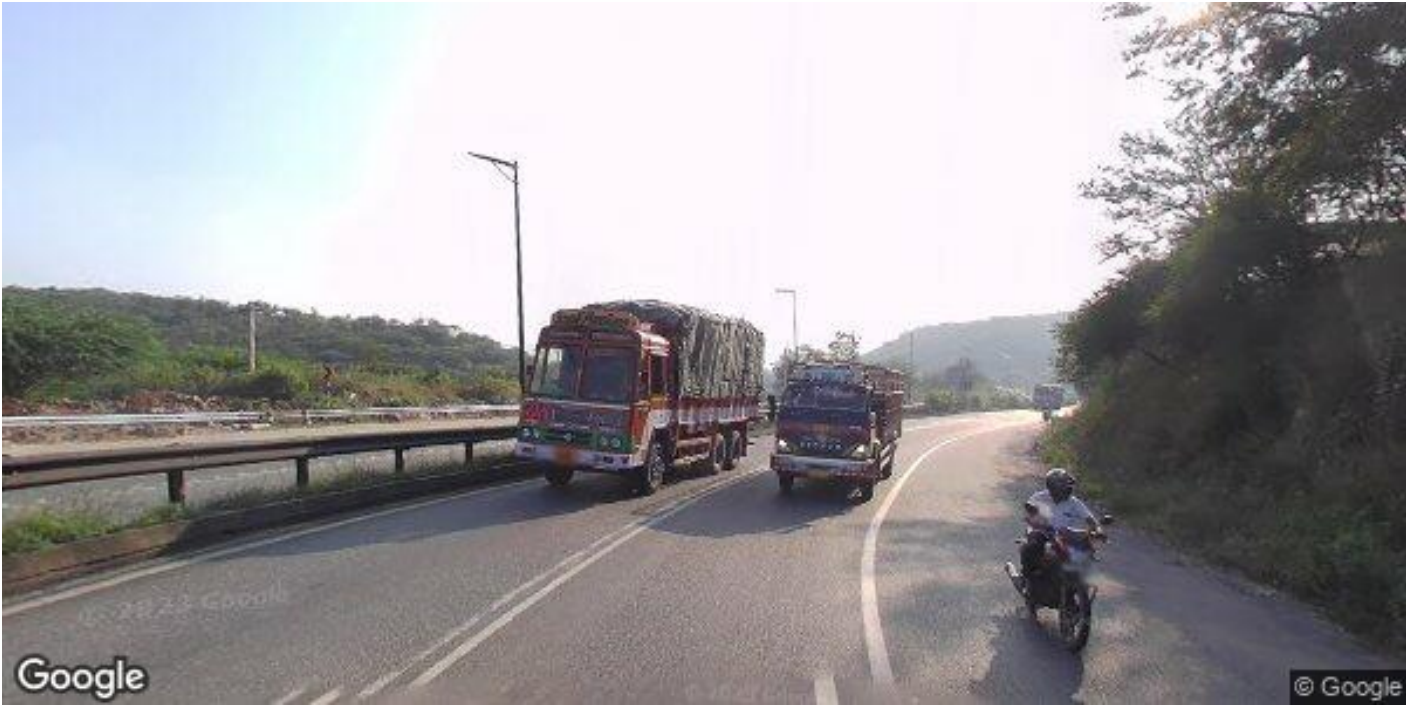
**Risk Type:** Turn  
**Risk Level:** High  
**Speed Limit:** 15 KM/Hr  
**Coordinates:** 11.95824, 78.04981

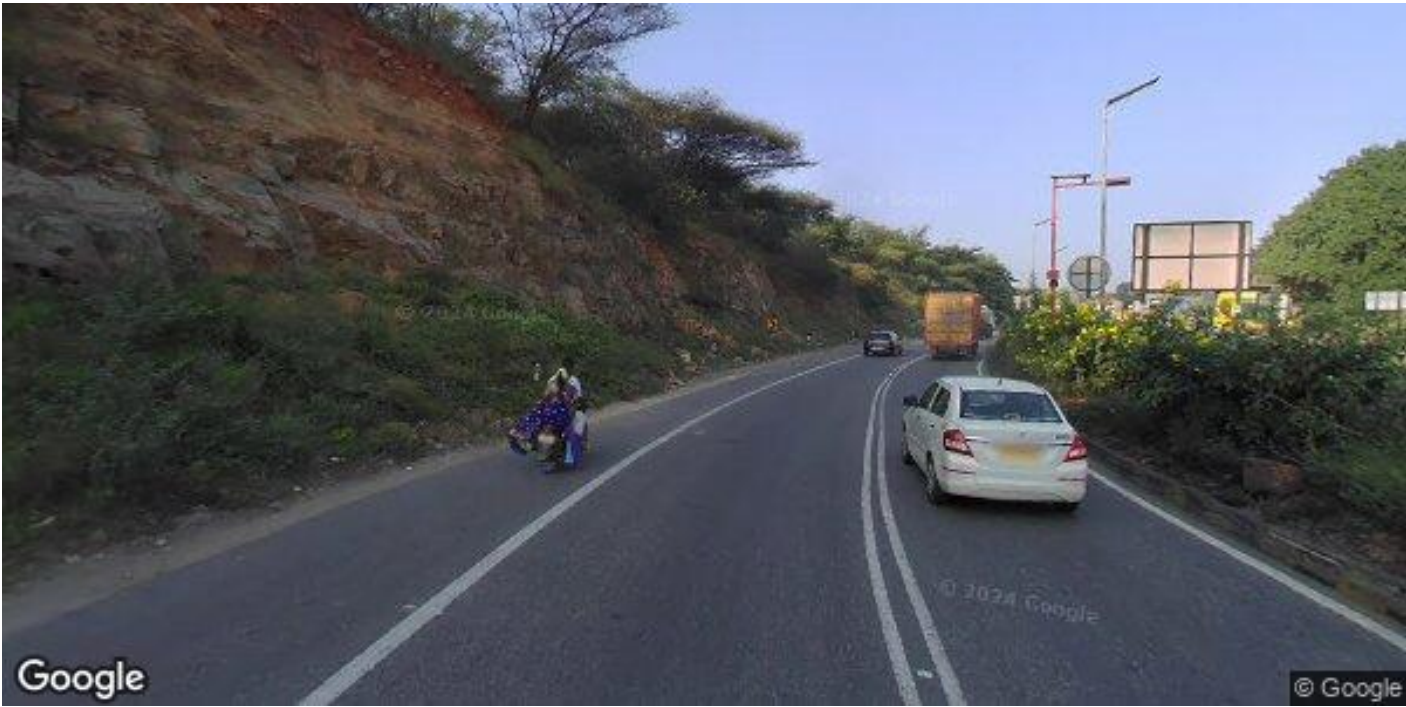
**Risk Type:** Turn  
**Risk Level:** High  
**Speed Limit:** 15 KM/Hr  
**Coordinates:** 11.96040, 78.04947

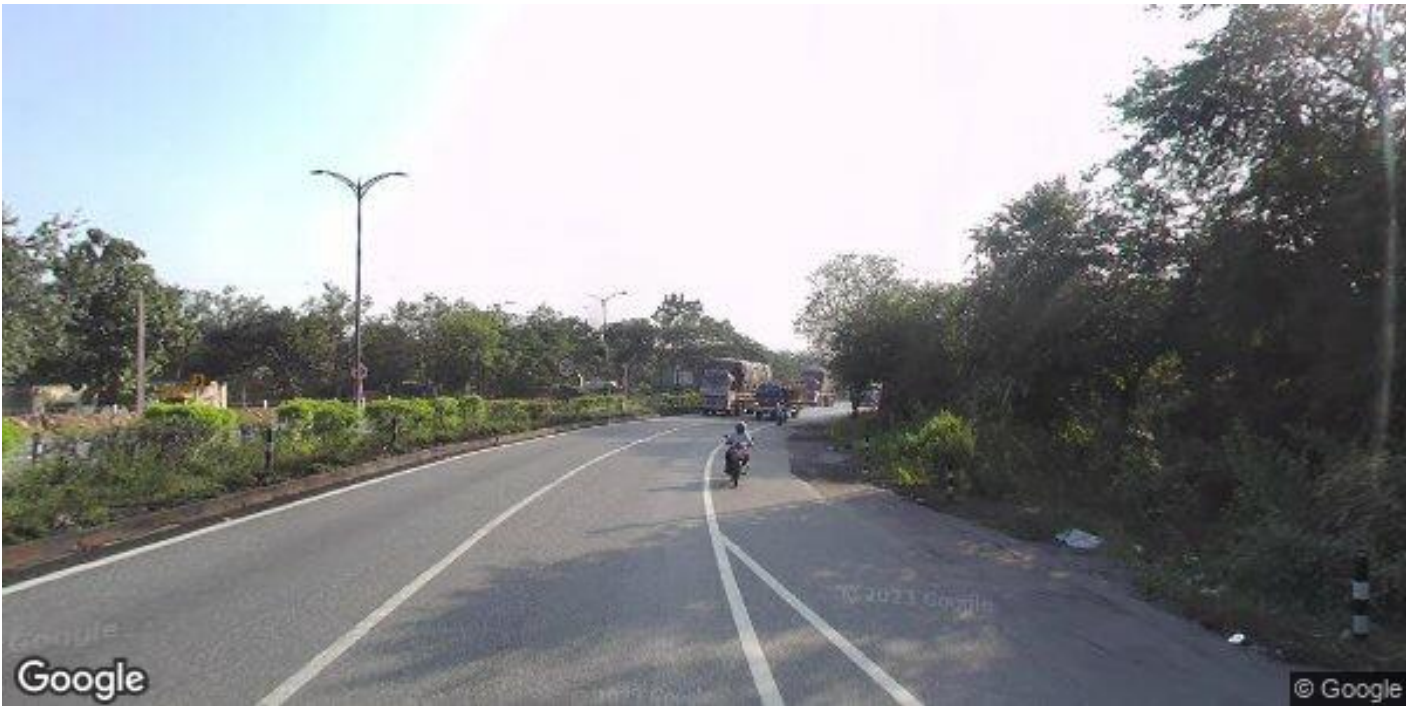
**Risk Type:** Turn  
**Risk Level:** Medium  
**Speed Limit:** 30 KM/Hr  
**Coordinates:** 11.96320, 78.05139

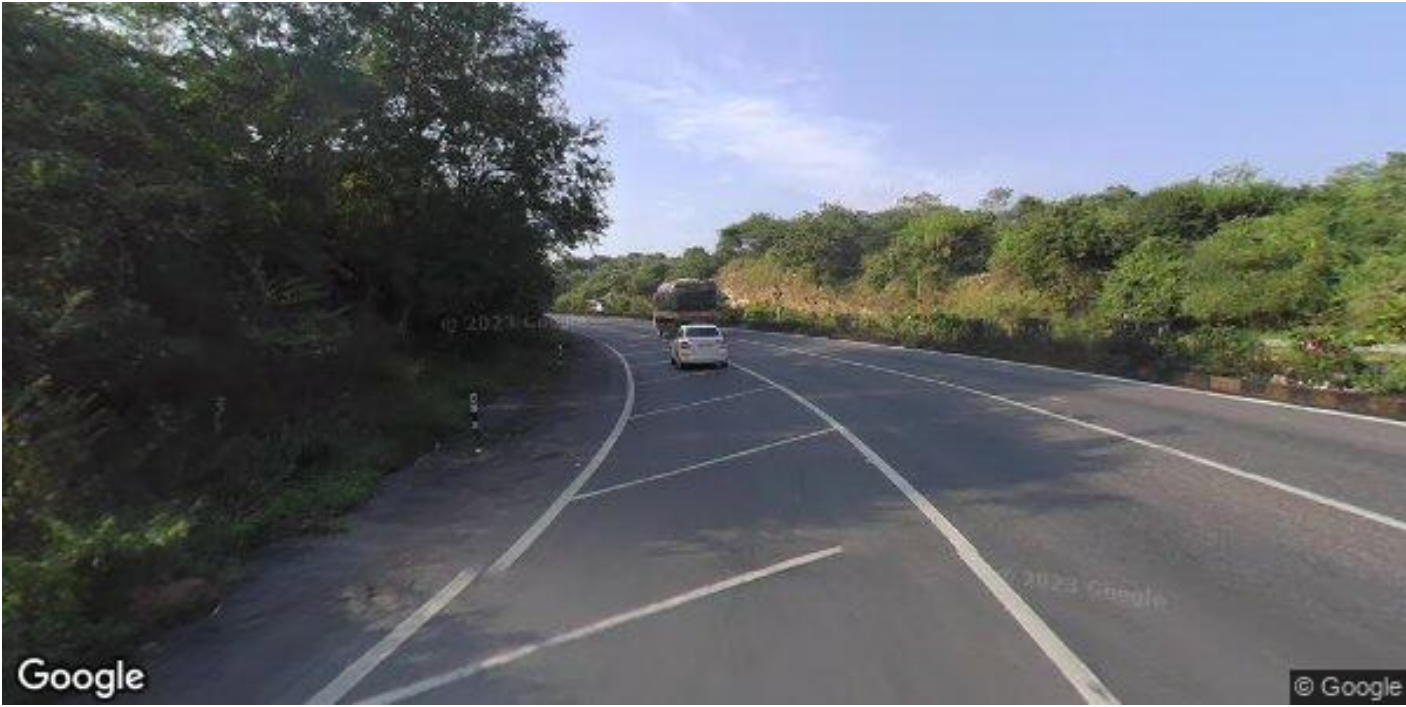
**Risk Type:** Turn  
**Risk Level:** Medium  
**Speed Limit:** 30 KM/Hr  
**Coordinates:** 11.96401, 78.05134

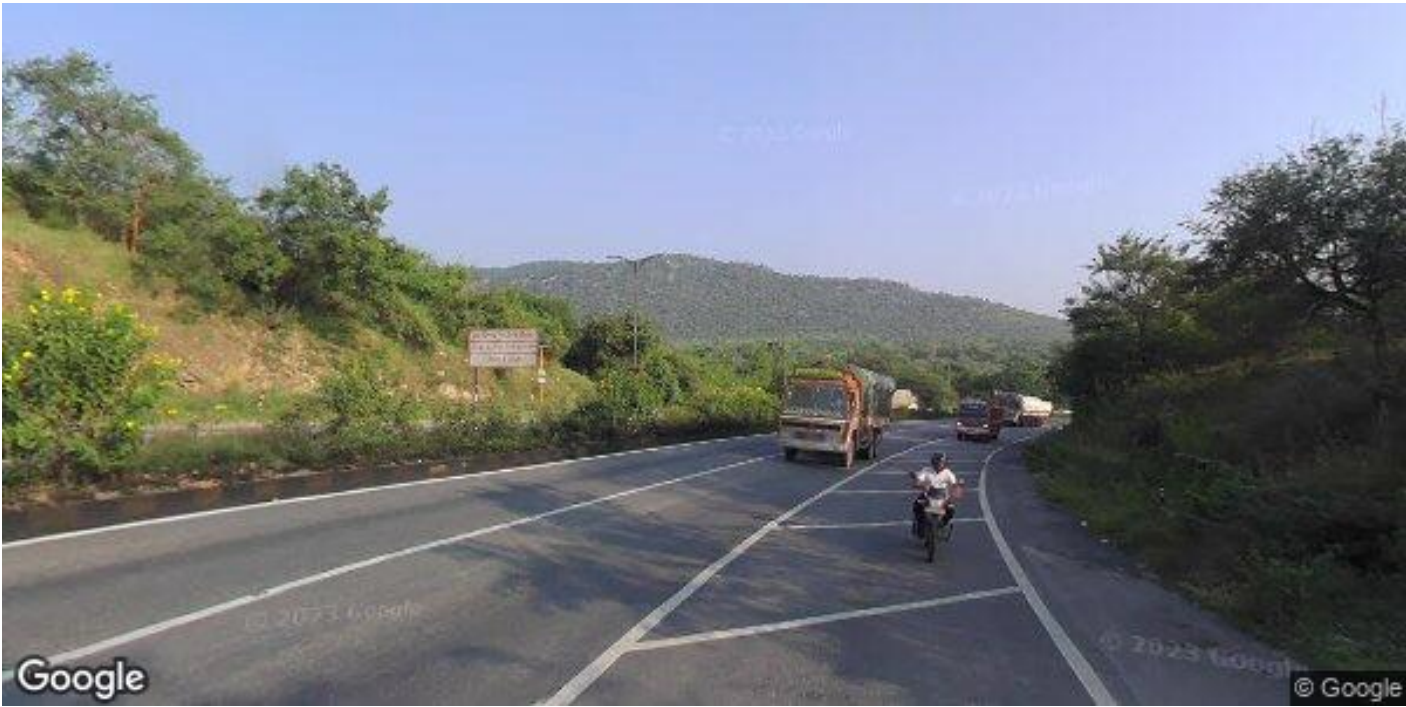
**Risk Type:** Turn  
**Risk Level:** Medium  
**Speed Limit:** 30 KM/Hr  
**Coordinates:** 11.96463, 78.05077

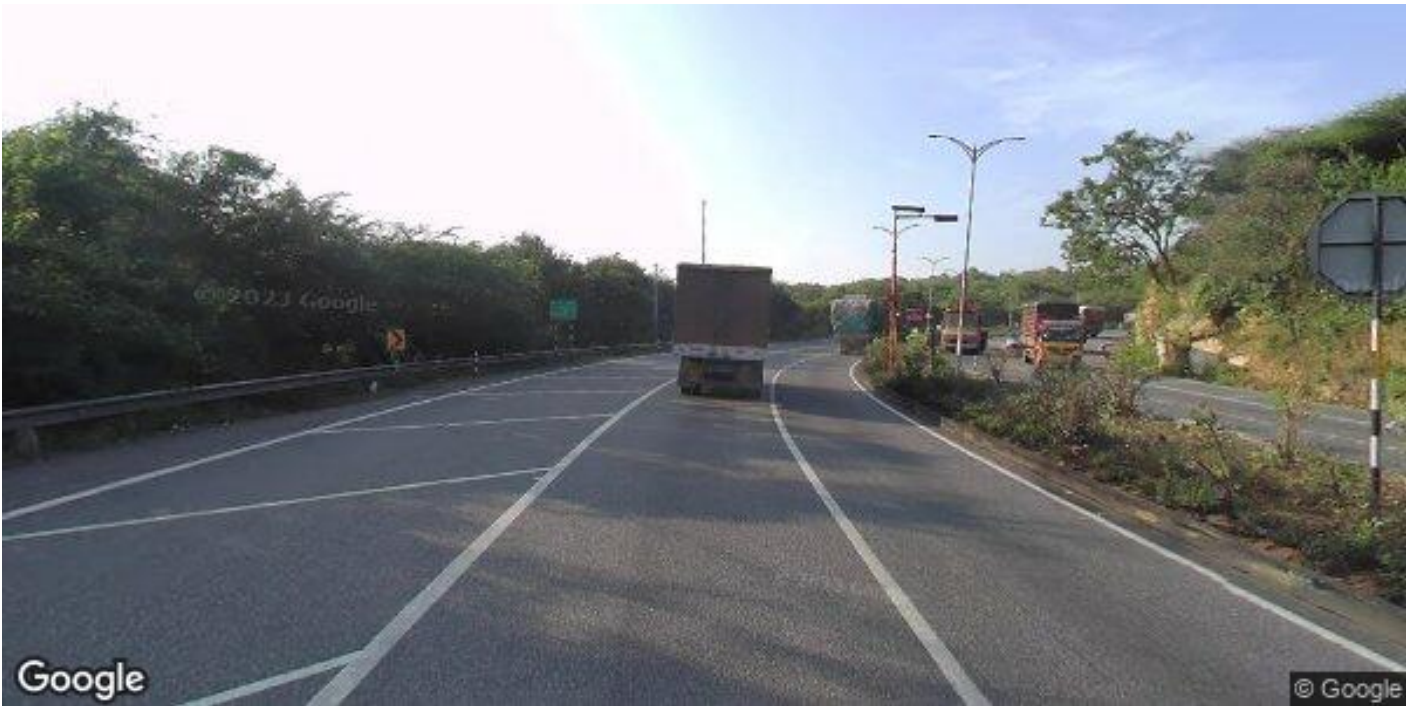
**Risk Type:** Turn  
**Risk Level:** Medium  
**Speed Limit:** 30 KM/Hr  
**Coordinates:** 11.96504, 78.04975

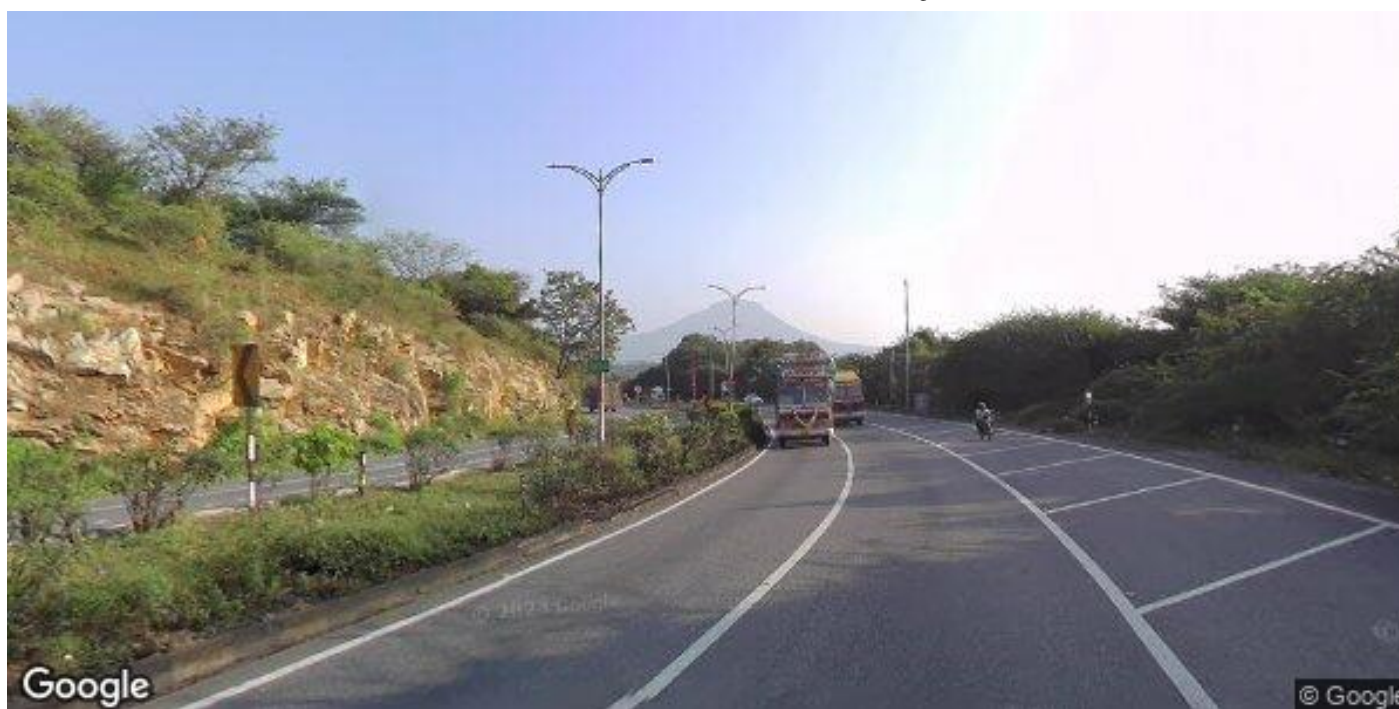
**Risk Type:** Turn  
**Risk Level:** High  
**Speed Limit:** 15 KM/Hr  
**Coordinates:** 11.96597, 78.04920
