# IndianOil

## JOURNEY RISK MANAGEMENT (JRM) STUDY

### Salem Terminal to SARADHA RANGANATHAN AGENCIES

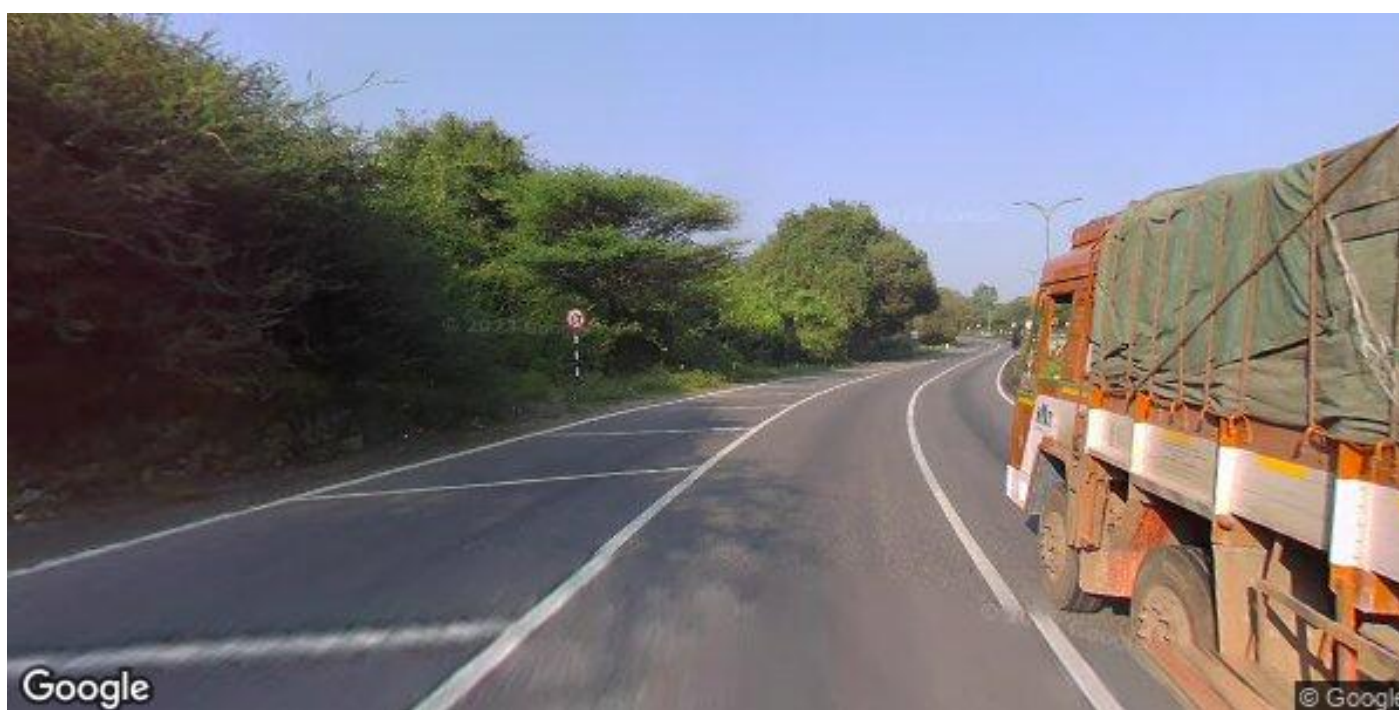
**Risk Type:** Turn  
**Risk Level:** Medium  
**Speed Limit:** 30 KM/Hr  
**Coordinates:** 11.96679, 78.04942

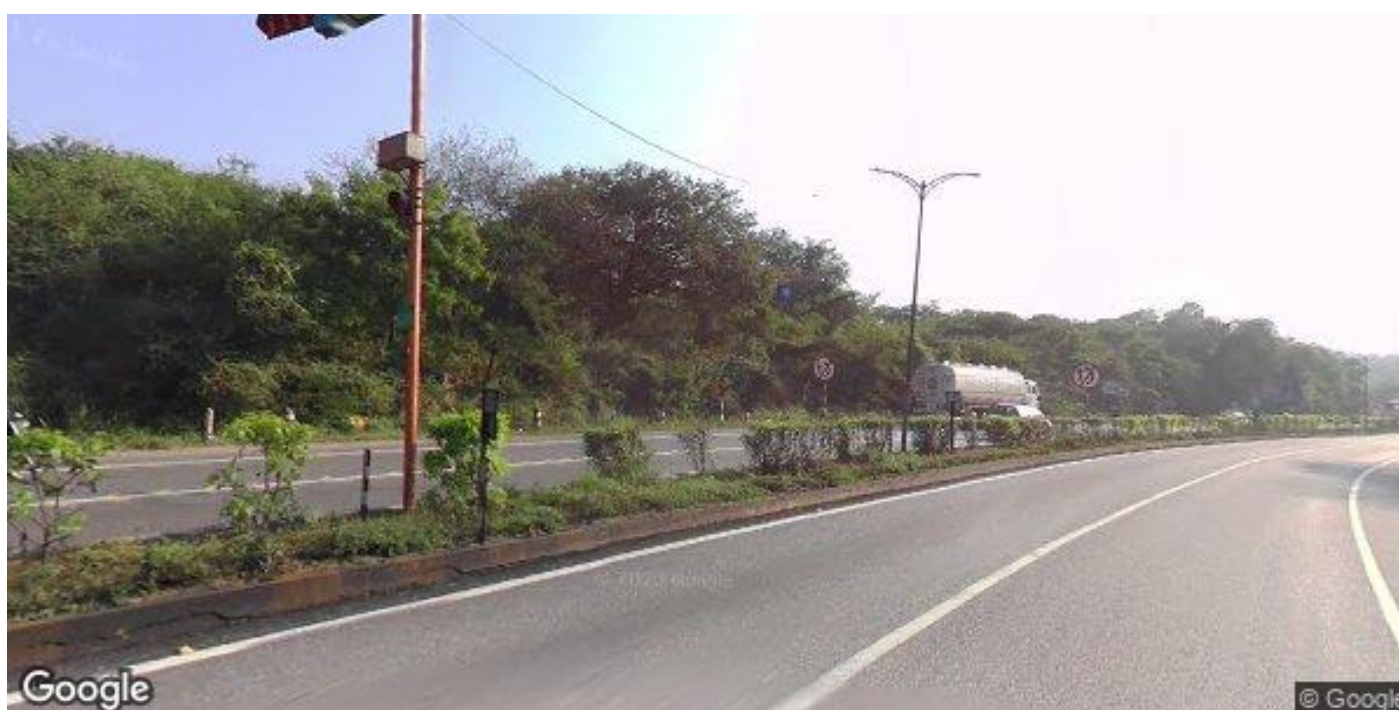
**Risk Type:** Turn  
**Risk Level:** Medium  
**Speed Limit:** 30 KM/Hr  
**Coordinates:** 11.96804, 78.05080

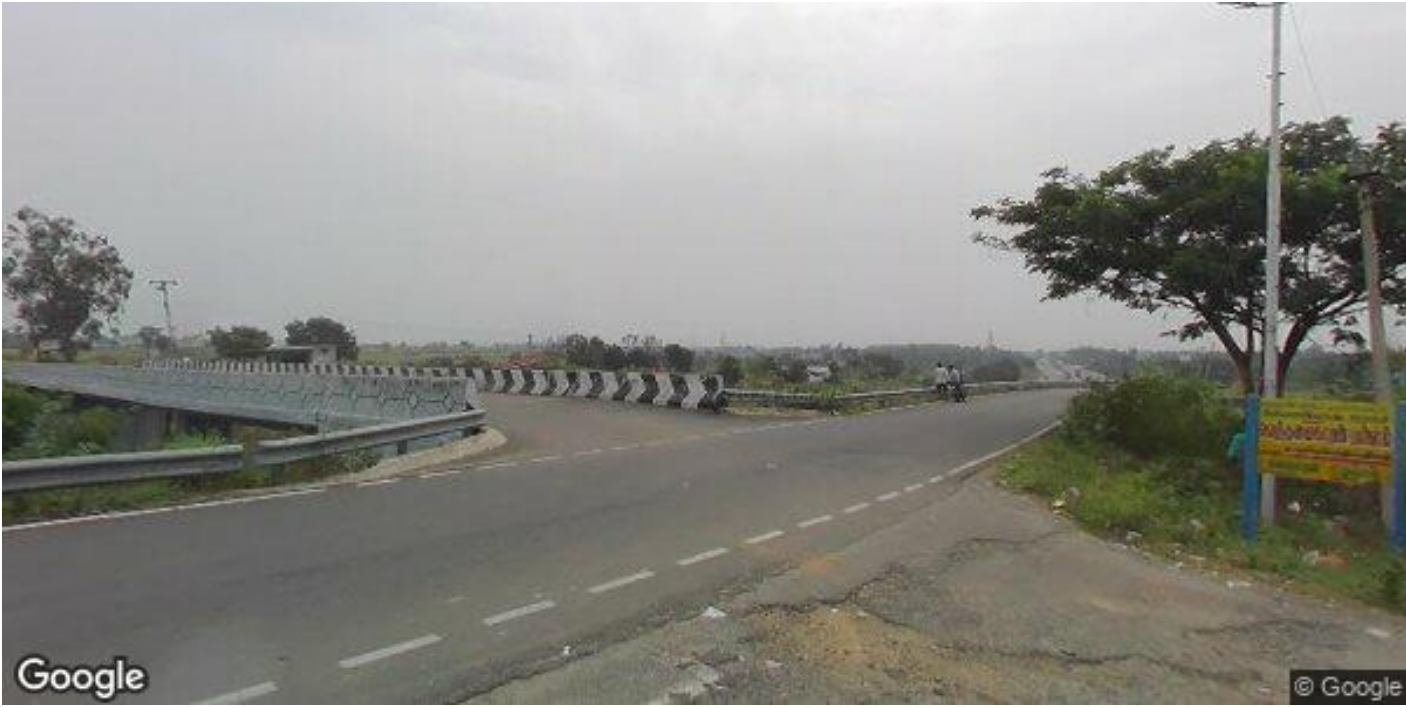
**Risk Type:** Blind Spot  
**Risk Level:** Blind Spot  
**Speed Limit:** 10 KM/Hr  
**Coordinates:** 12.09202, 78.11459

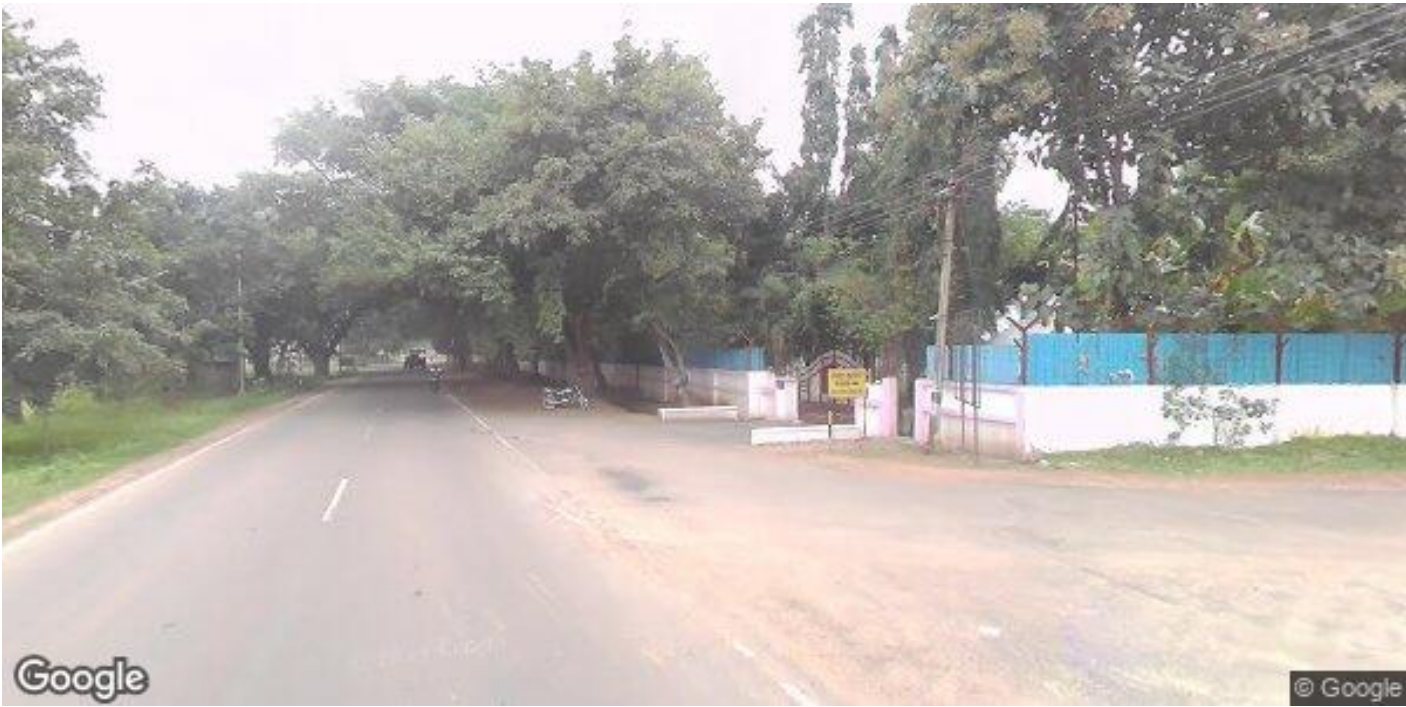
**Risk Type:** Turn  
**Risk Level:** High  
**Speed Limit:** 15 KM/Hr  
**Coordinates:** 12.08780, 78.12237

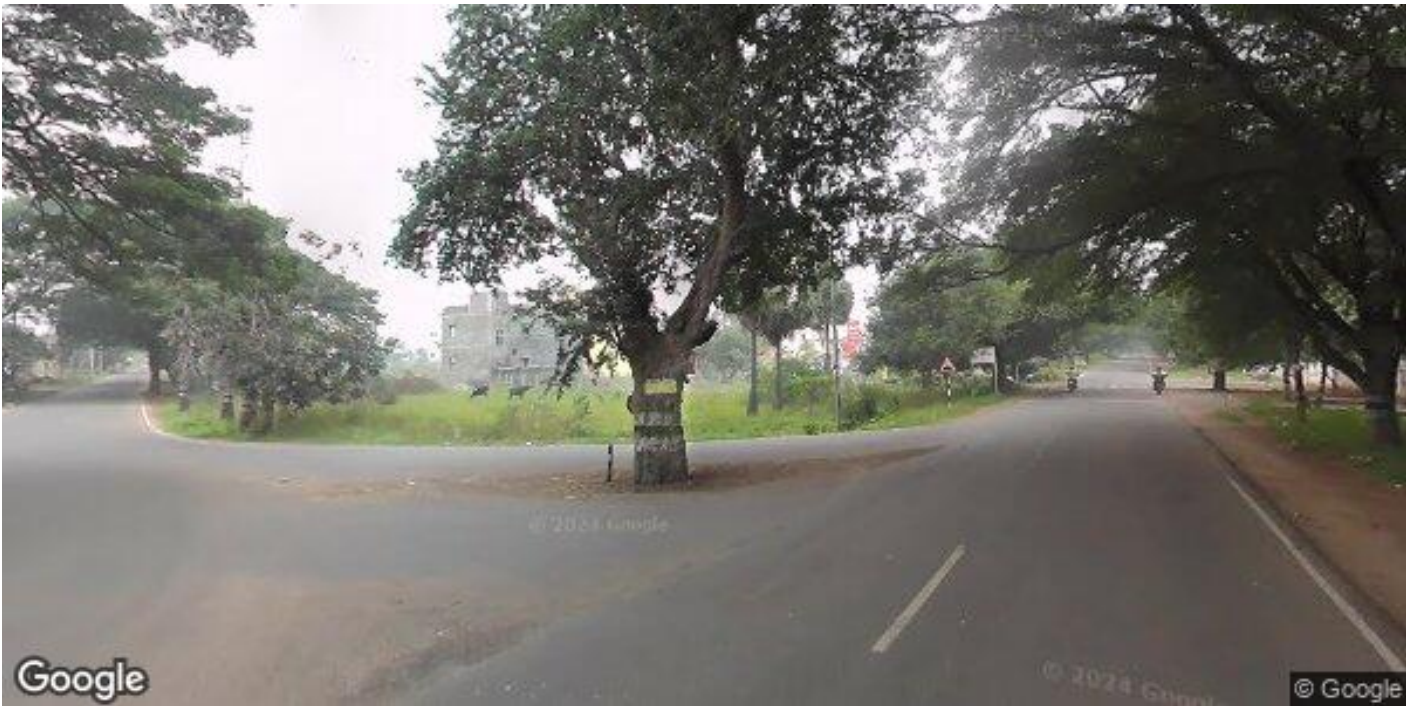
**Risk Type:** Turn  
**Risk Level:** High  
**Speed Limit:** 15 KM/Hr  
**Coordinates:** 12.08688, 78.12234

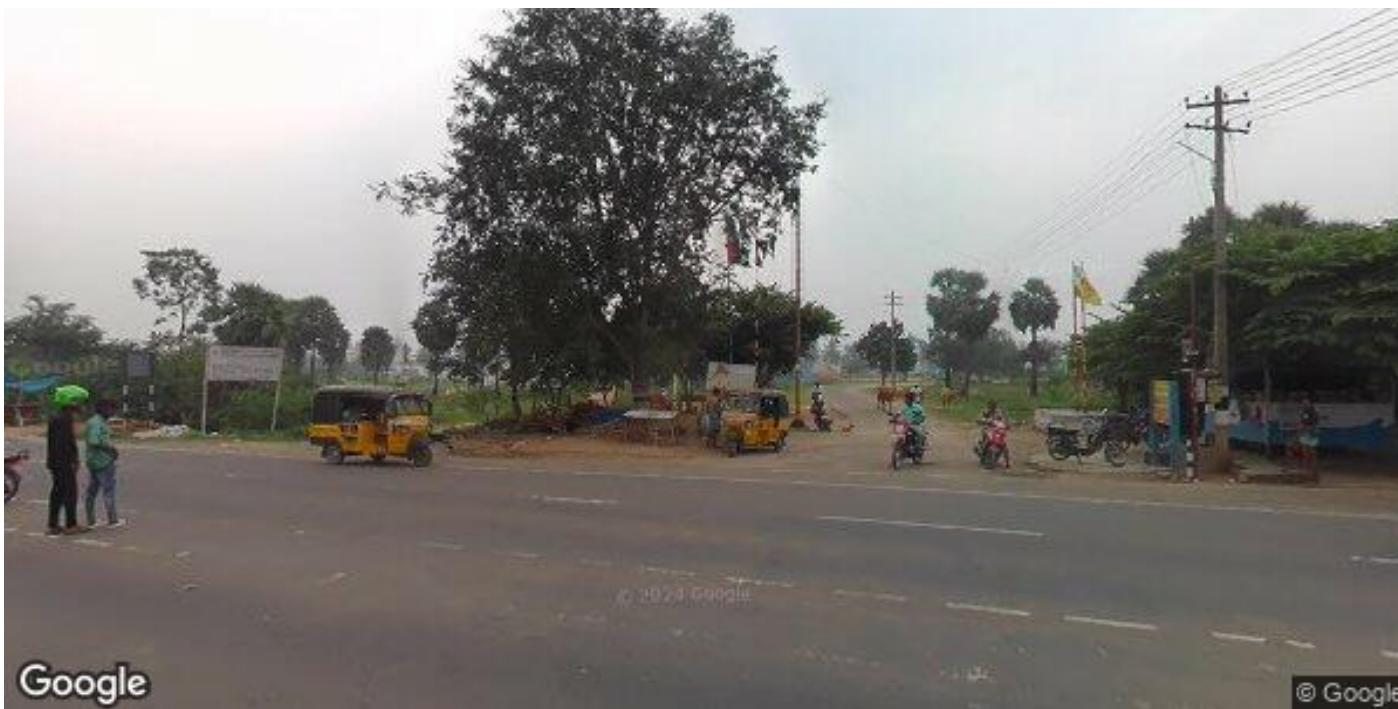
**Risk Type:** Turn  
**Risk Level:** High  
**Speed Limit:** 15 KM/Hr  
**Coordinates:** 12.08464, 78.12765

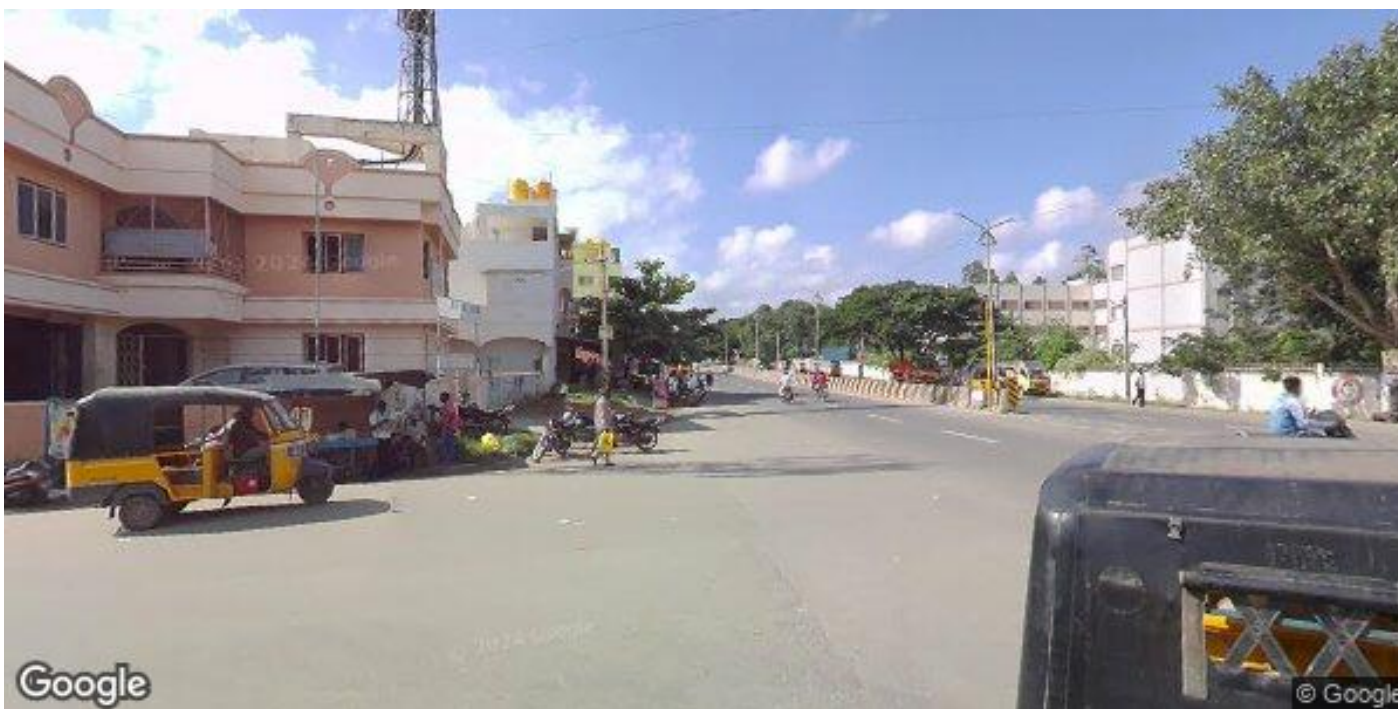
**Risk Type:** Turn  
**Risk Level:** High  
**Speed Limit:** 15 KM/Hr  
**Coordinates:** 12.10313, 78.14568

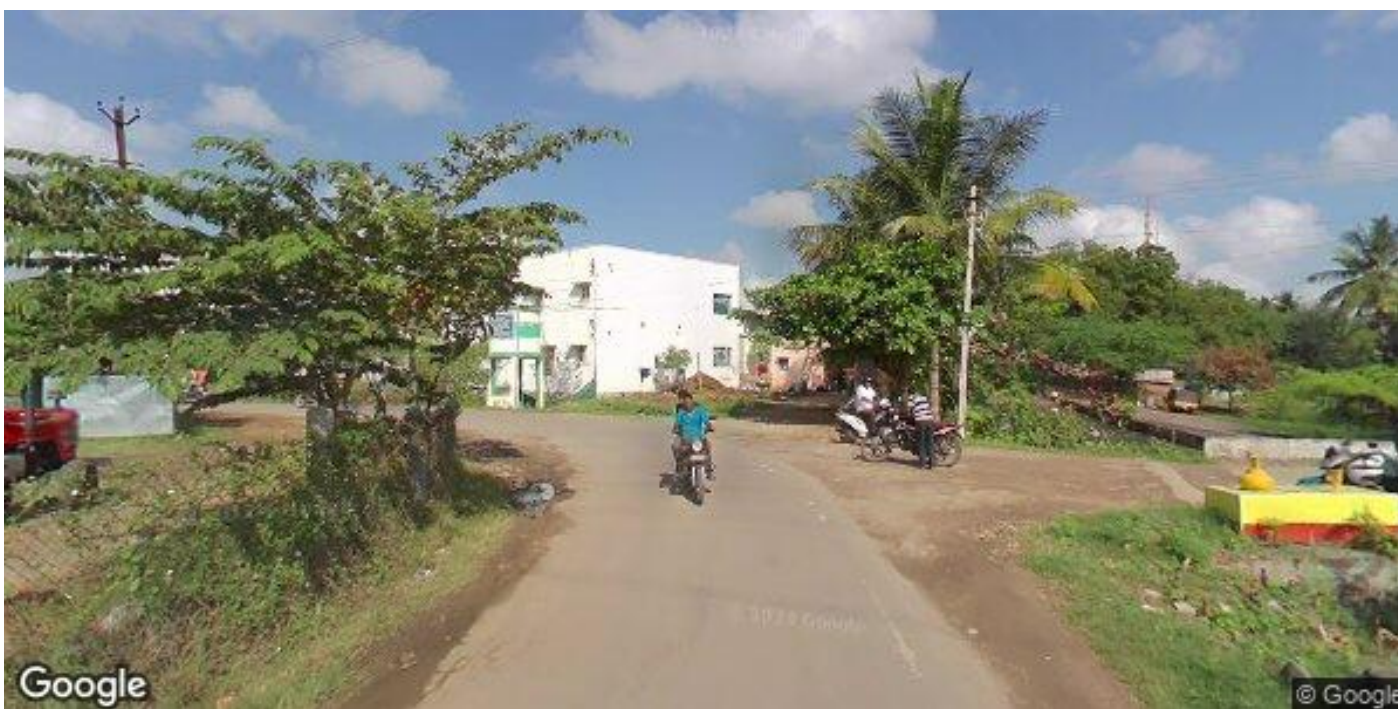
**Risk Type:** Turn  
**Risk Level:** Medium  
**Speed Limit:** 30 KM/Hr  
**Coordinates:** 12.10166, 78.14834

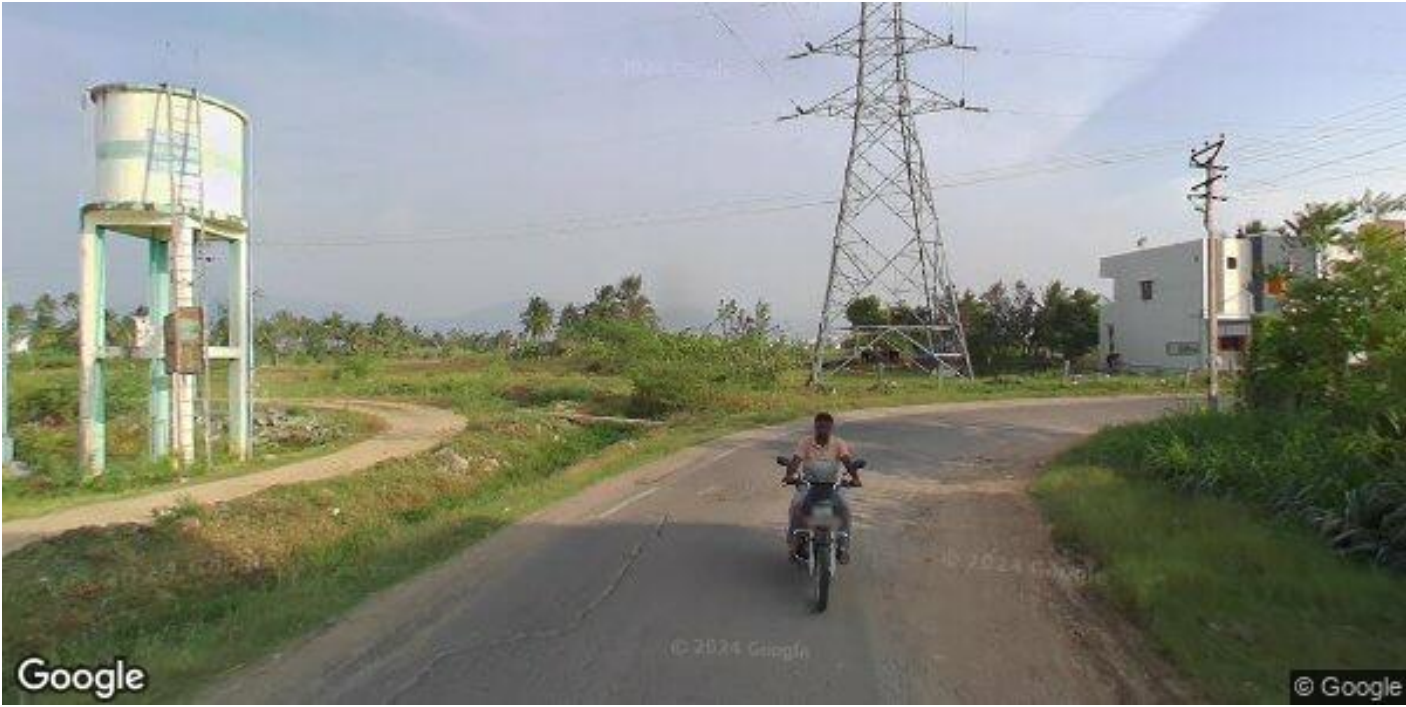
**Risk Type:** Turn  
**Risk Level:** High  
**Speed Limit:** 15 KM/Hr  
**Coordinates:** 12.09975, 78.14984

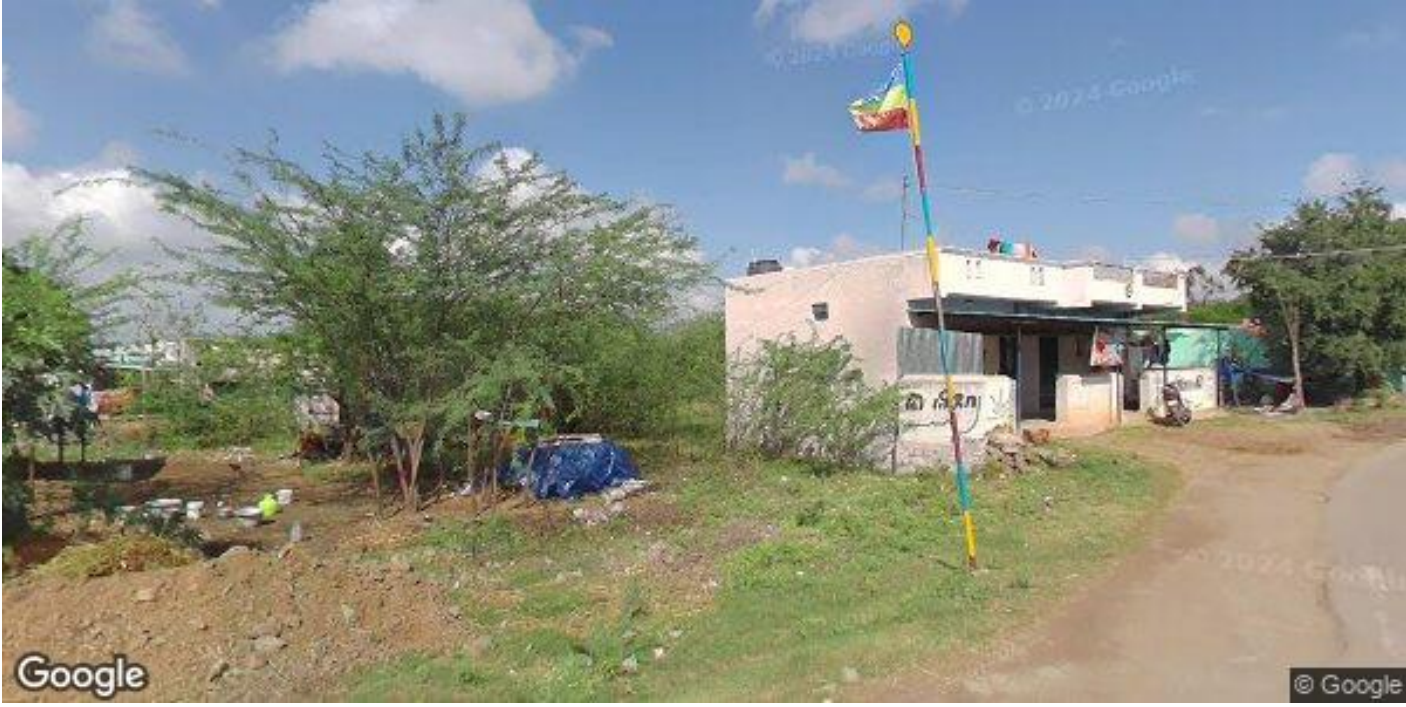
**Risk Type:** Turn  
**Risk Level:** High  
**Speed Limit:** 15 KM/Hr  
**Coordinates:** 12.09643, 78.14897
