# IndianOil

## JOURNEY RISK MANAGEMENT (JRM) STUDY

### Salem Terminal to S.P. SAMY AGENCIES

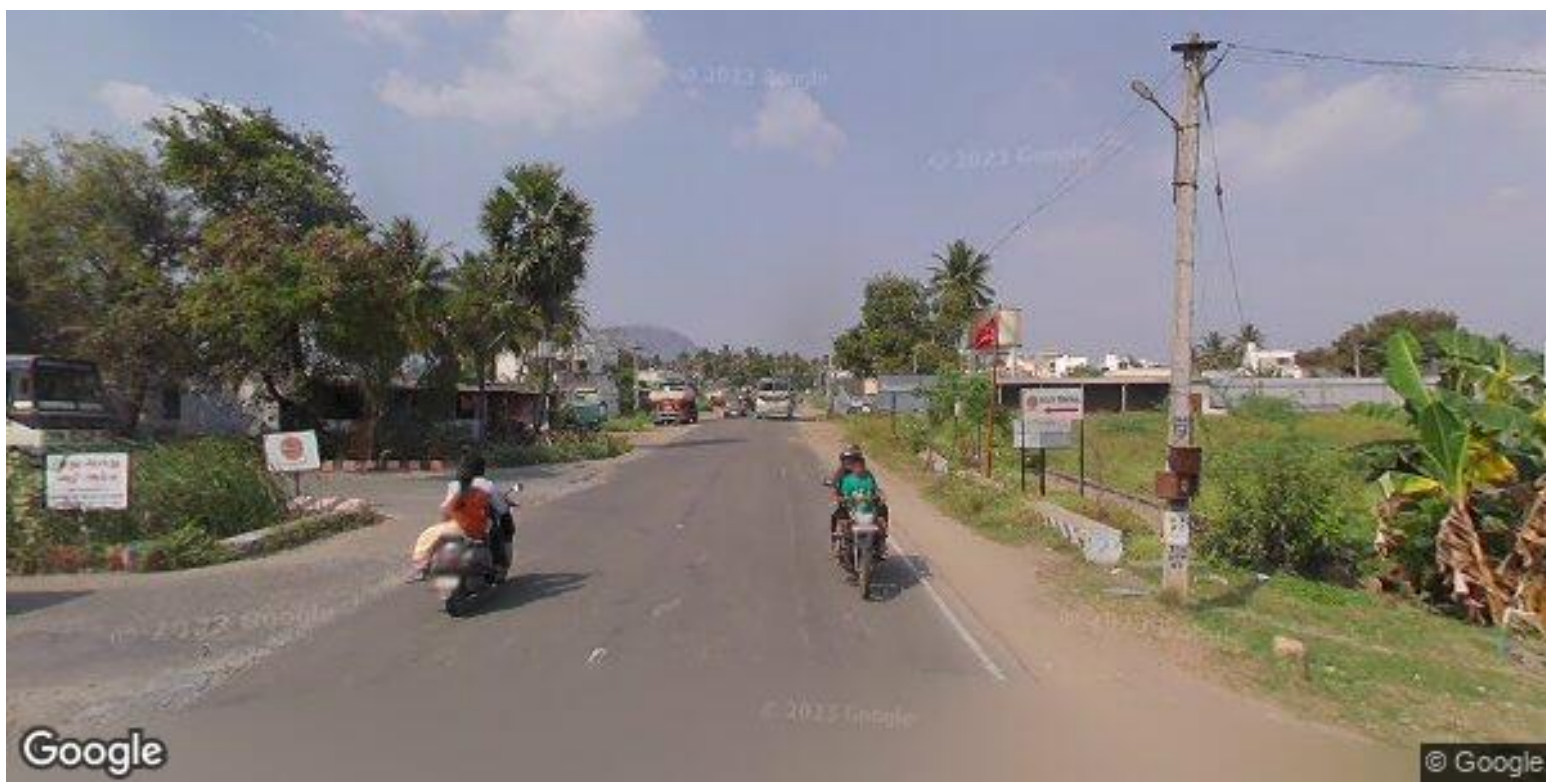
**Coordinates:** 11.44019, 77.87547

**Risk Type:** Turn

**Risk Level:** High

**Speed Limit:** 15 KM/Hr

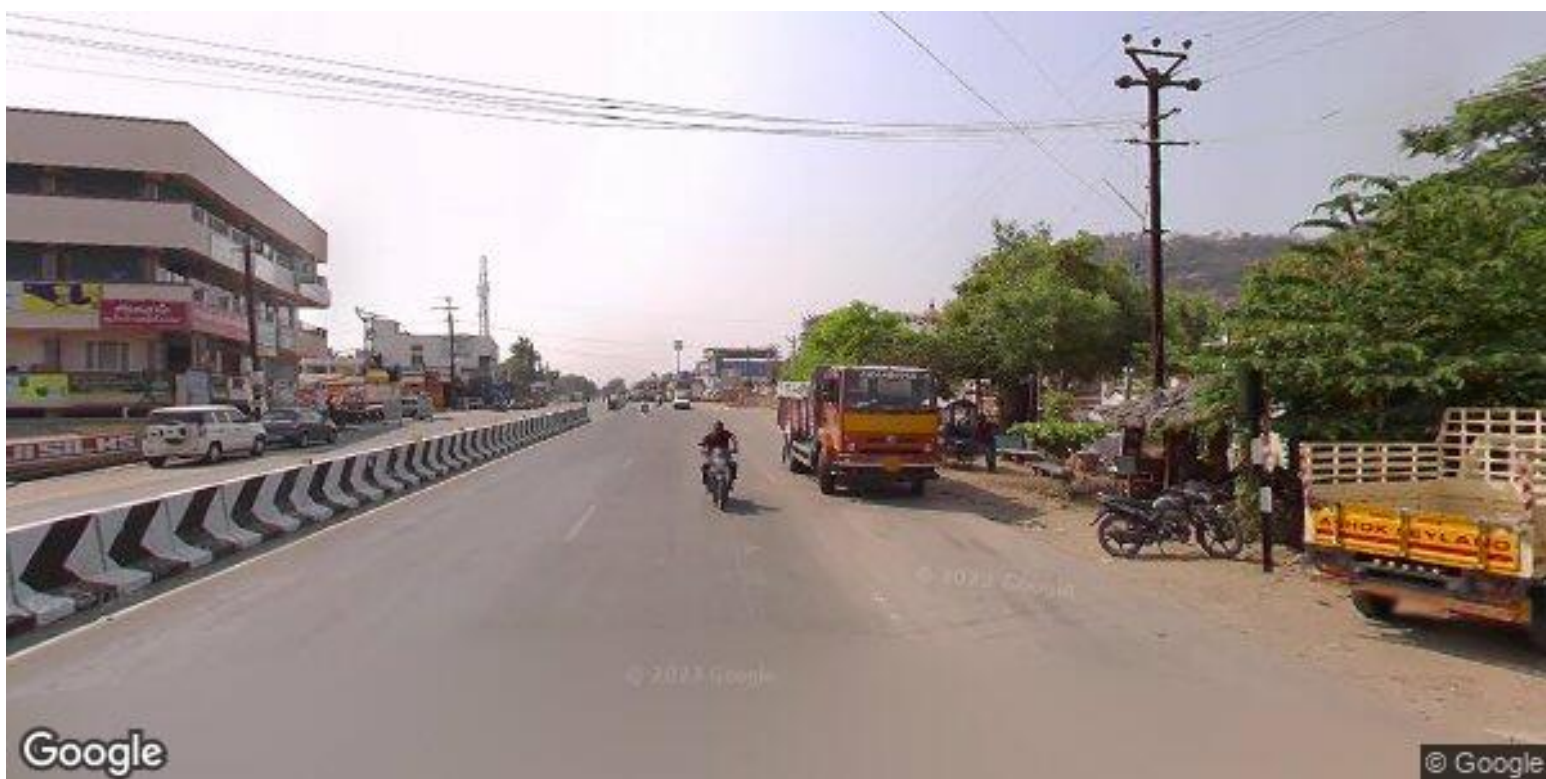
**Coordinates:** 11.39685, 77.88861

**Risk Type:** Turn

**Risk Level:** Medium

**Speed Limit:** 30 KM/Hr

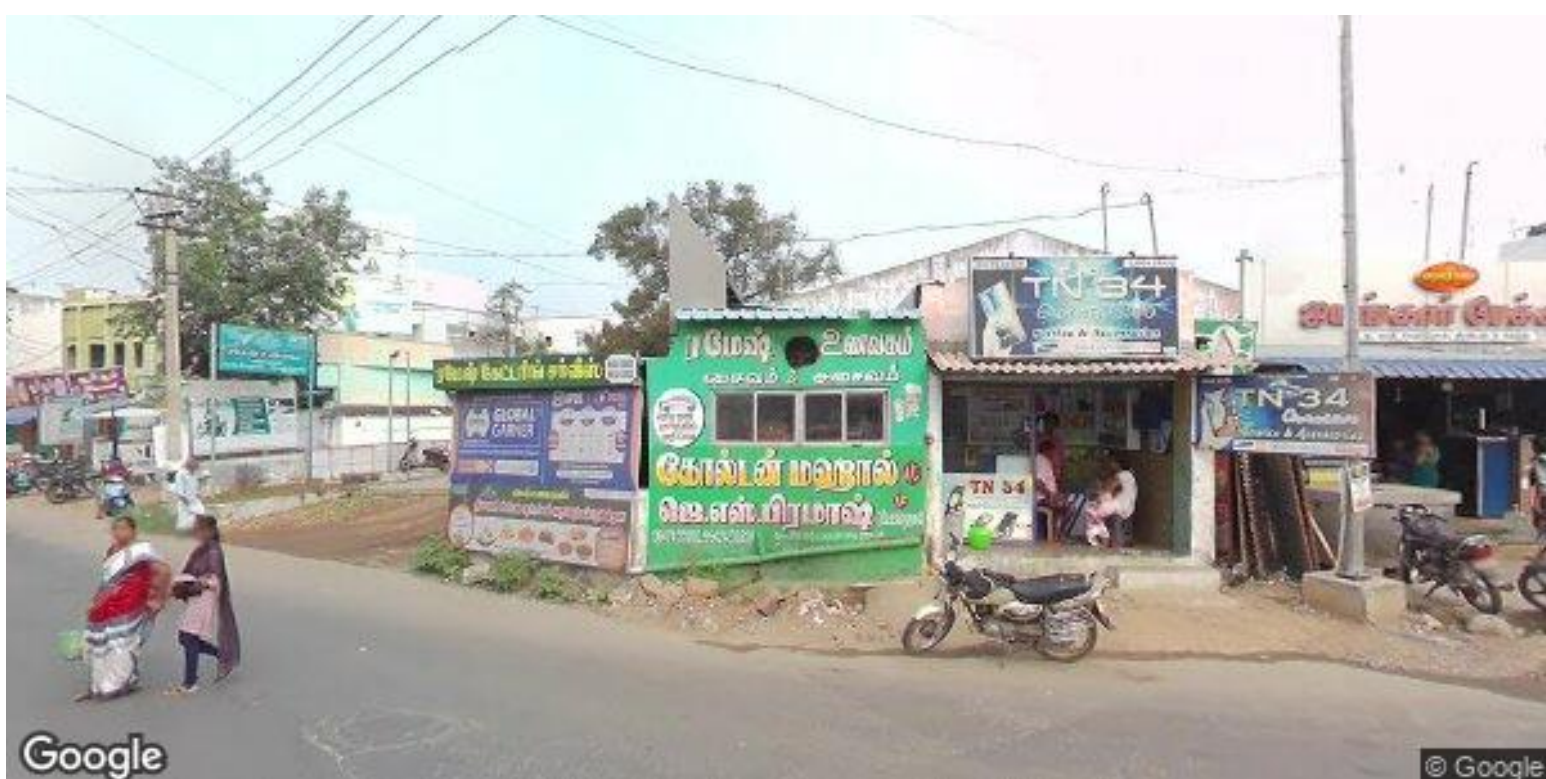
**Coordinates: 11.38346, 77.89975**

**Risk Type: Turn**

**Risk Level: Medium**

**Speed Limit: 30 KM/Hr**

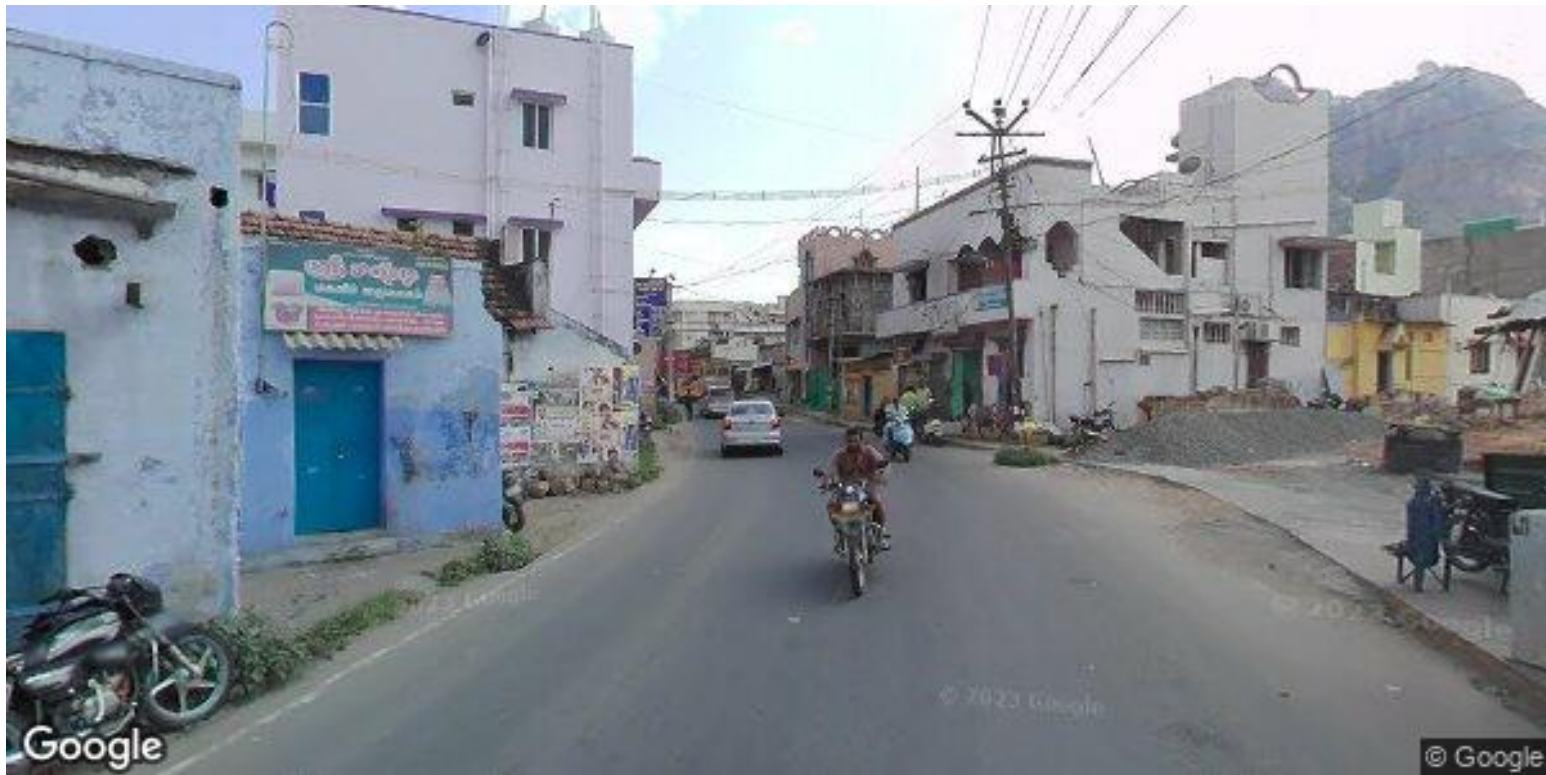
**Coordinates: 11.38302, 77.89995**

**Risk Type: Turn**

**Risk Level: Medium**

**Speed Limit: 30 KM/Hr**

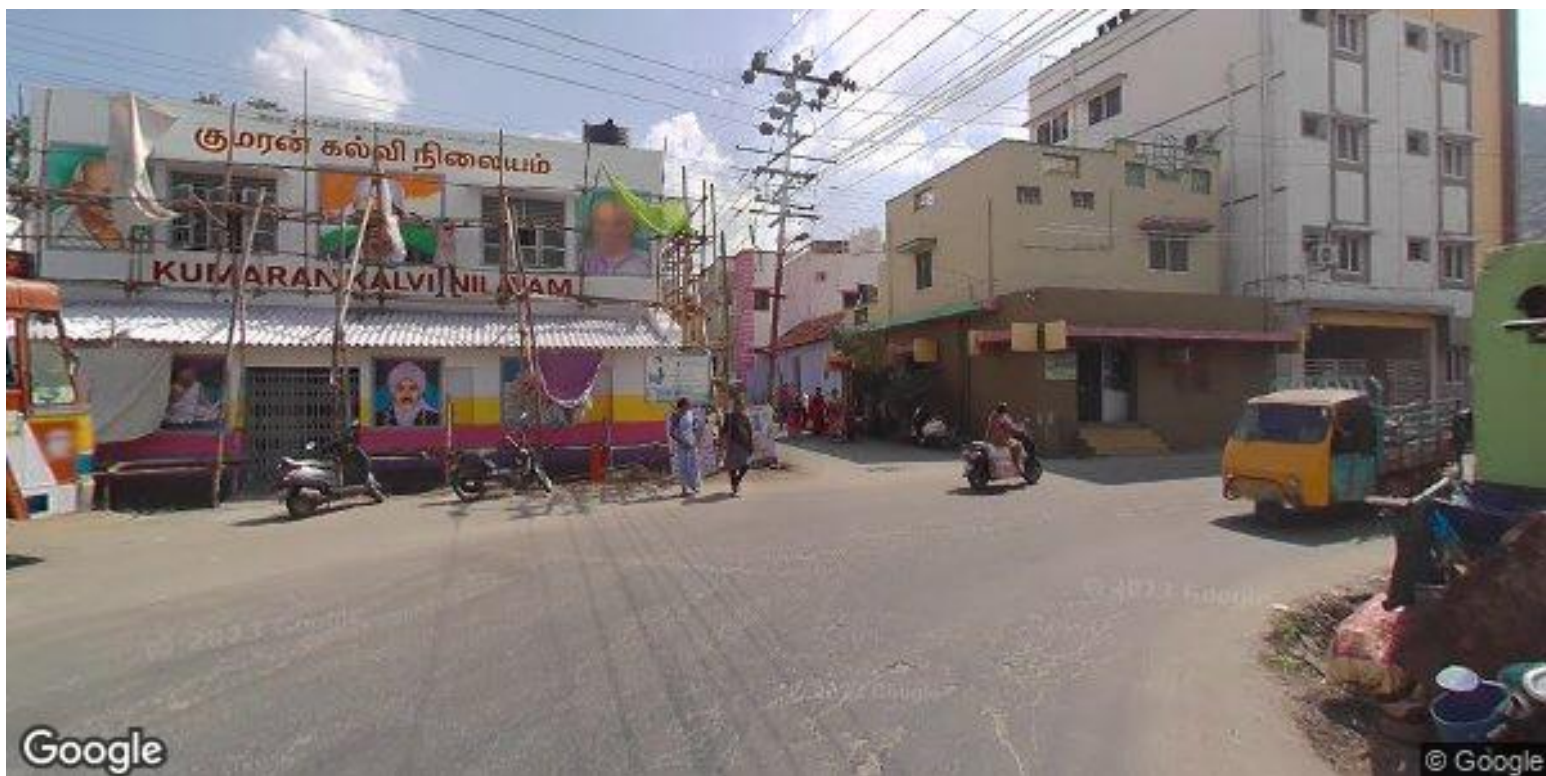
**Coordinates: 11.38188, 77.90257**

**Risk Type: Turn**

**Risk Level: High**

**Speed Limit: 15 KM/Hr**

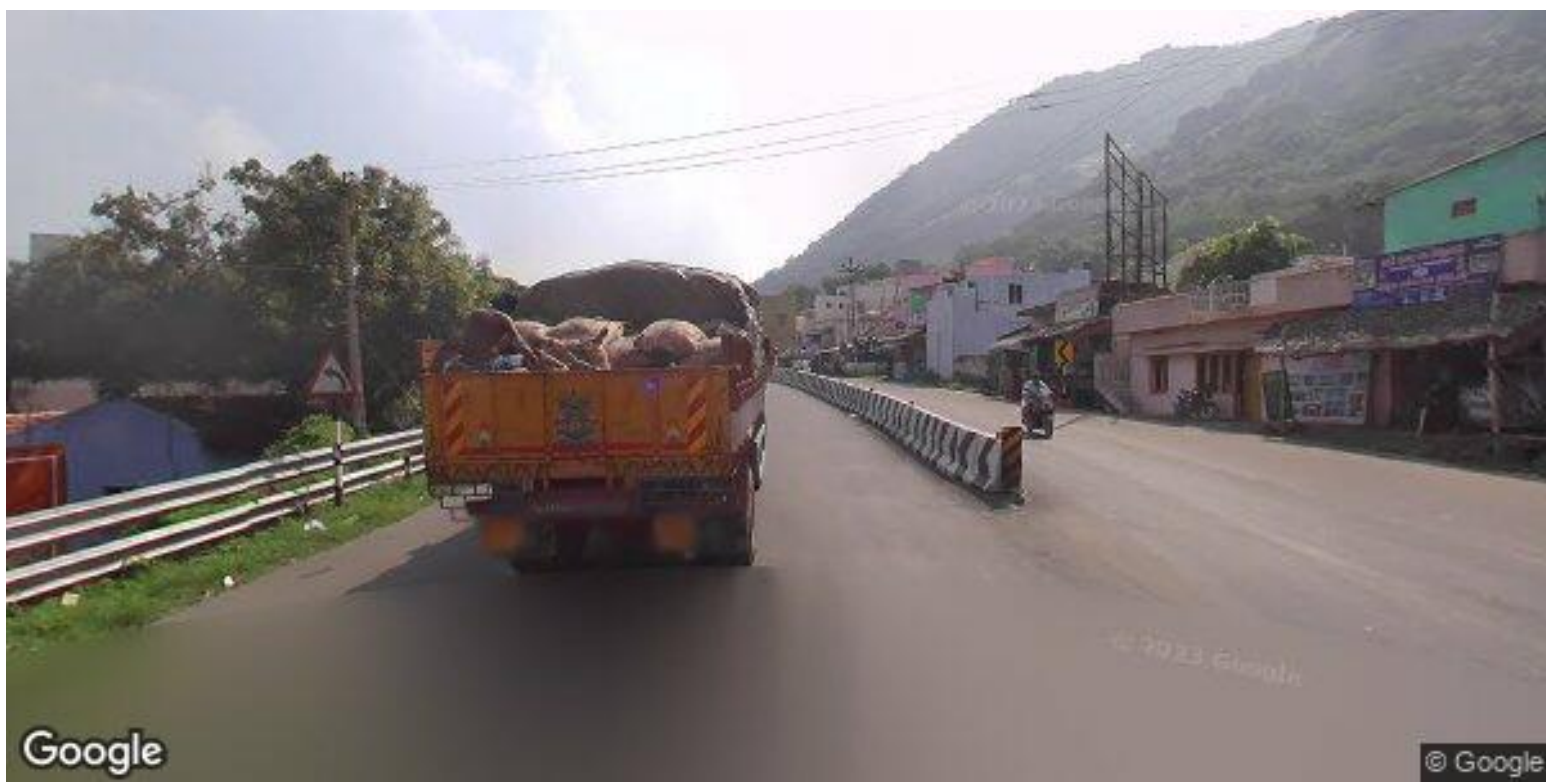
**Coordinates:** 11.37830, 77.90160

**Risk Type:** Turn

**Risk Level:** High

**Speed Limit:** 15 KM/Hr

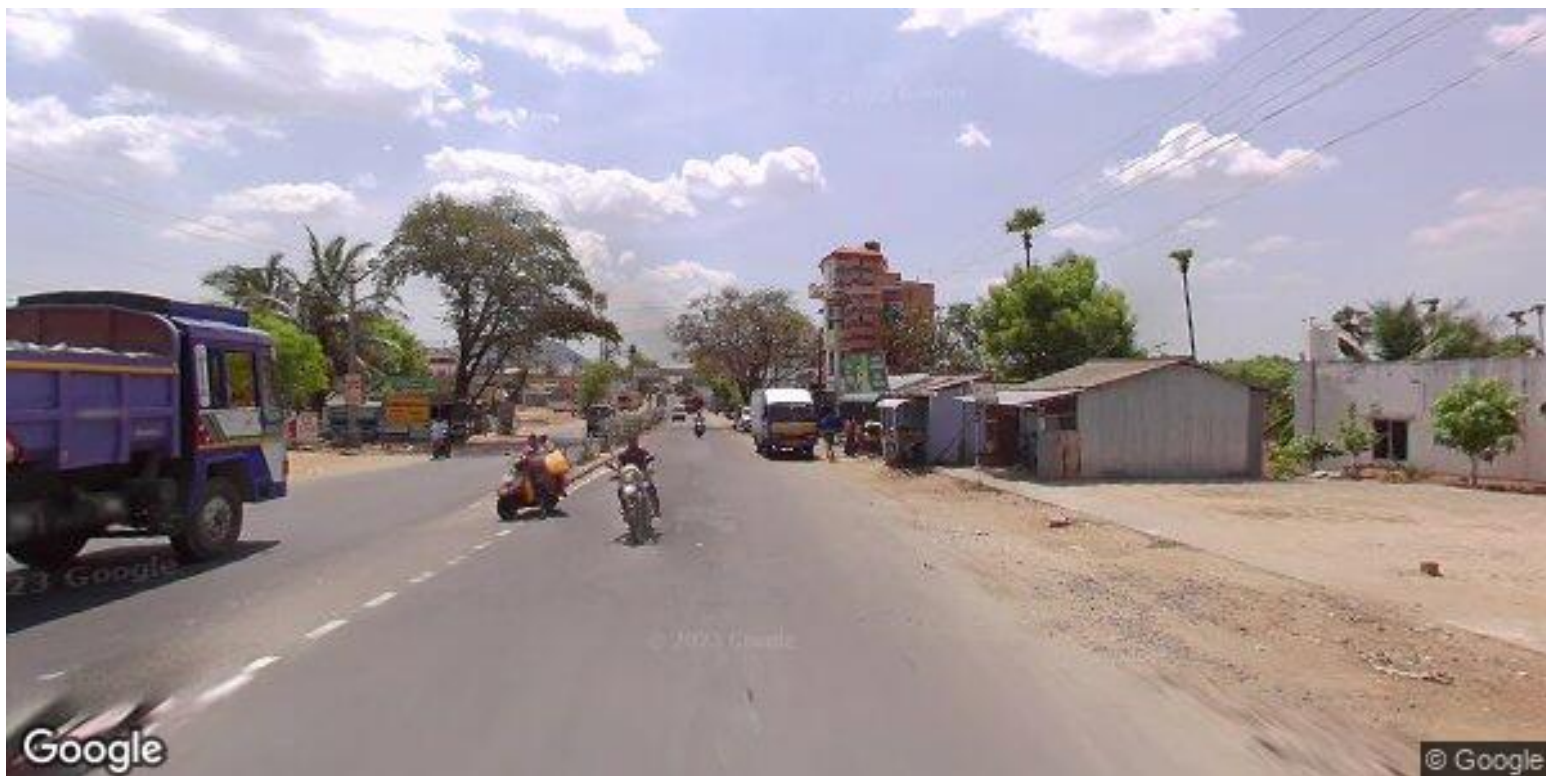
**Coordinates:** 11.36754, 77.93919

**Risk Type:** Turn

**Risk Level:** Medium

**Speed Limit:** 30 KM/Hr

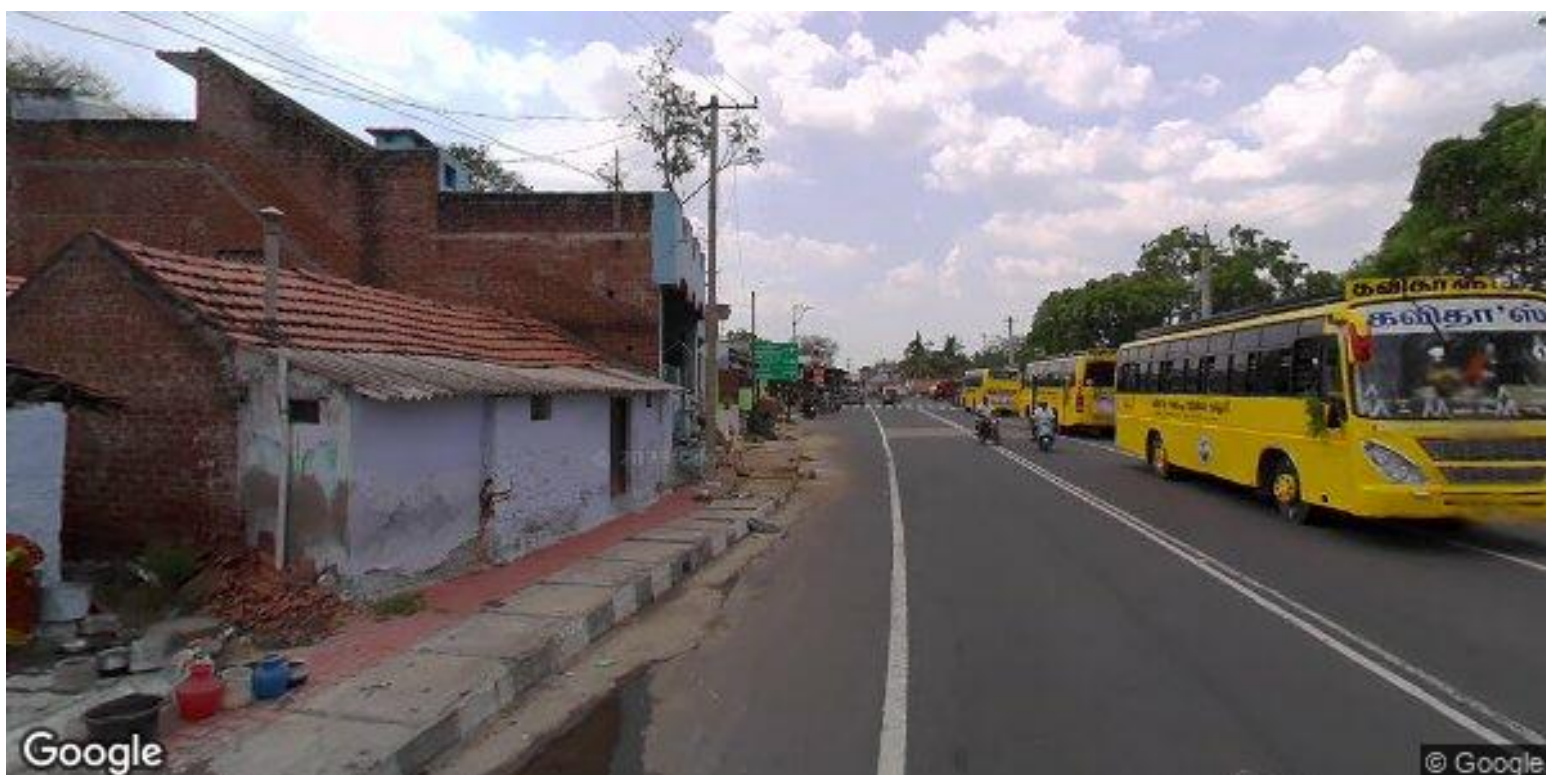
**Risk Type:** Turn  
**Risk Level:** Medium  
**Speed Limit:** 30 KM/Hr  
**Coordinates:** 11.41361, 78.08073

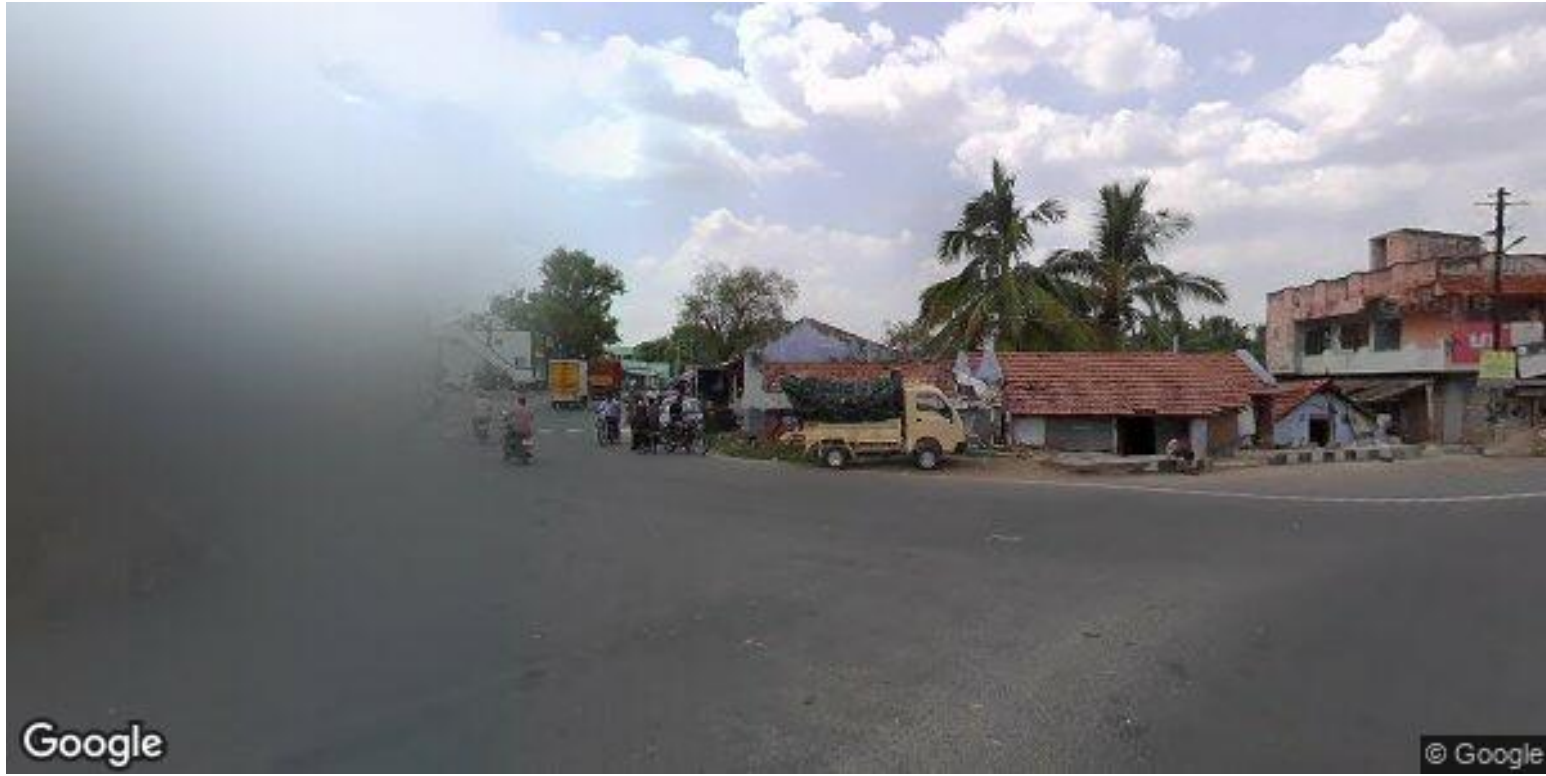
**Risk Type:** Turn  
**Risk Level:** High  
**Speed Limit:** 15 KM/Hr  
**Coordinates:** 11.41453, 78.08062

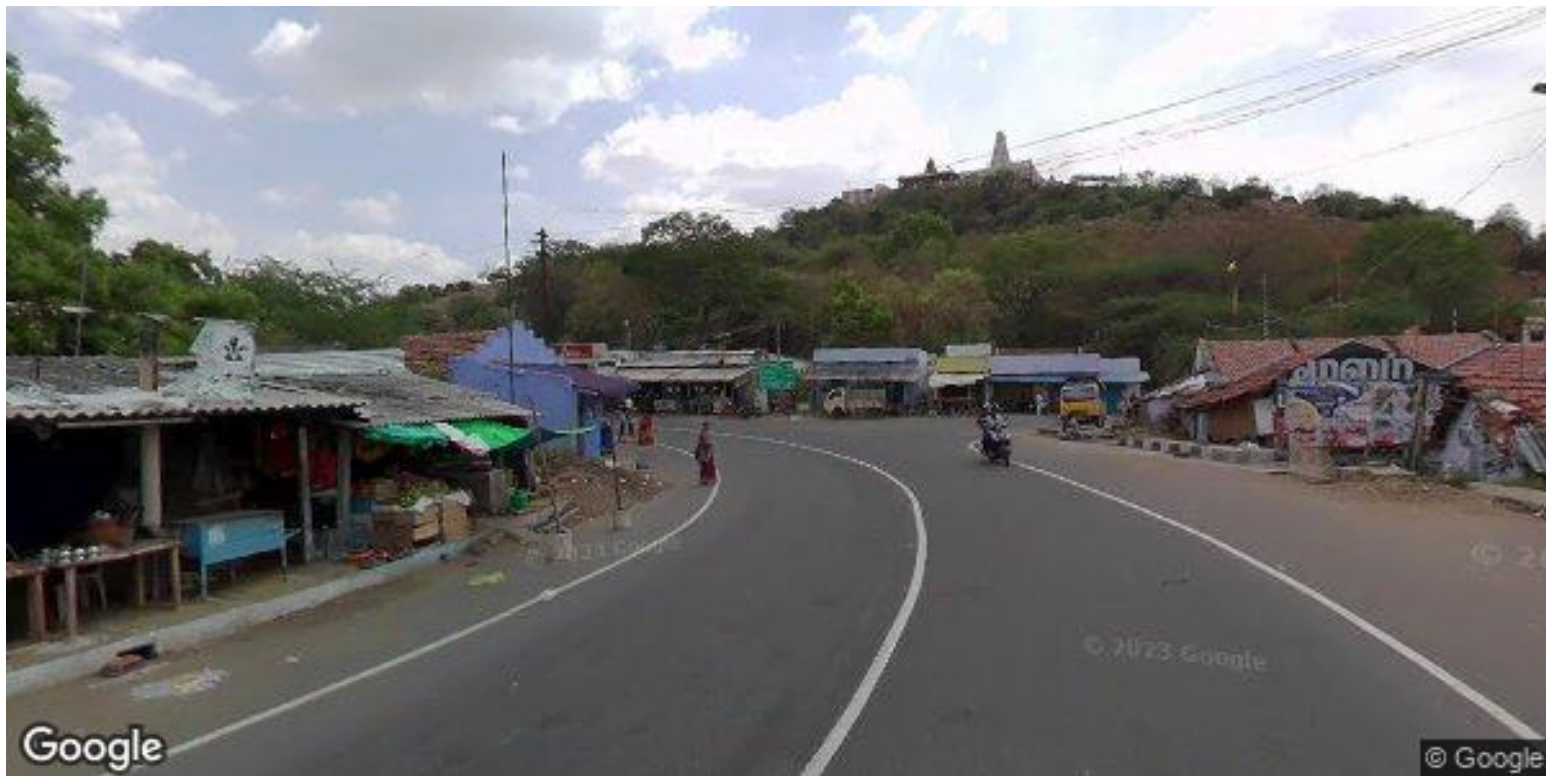
**Risk Type:** Turn  
**Risk Level:** Medium  
**Speed Limit:** 30 KM/Hr  
**Coordinates:** 11.41476, 78.08094

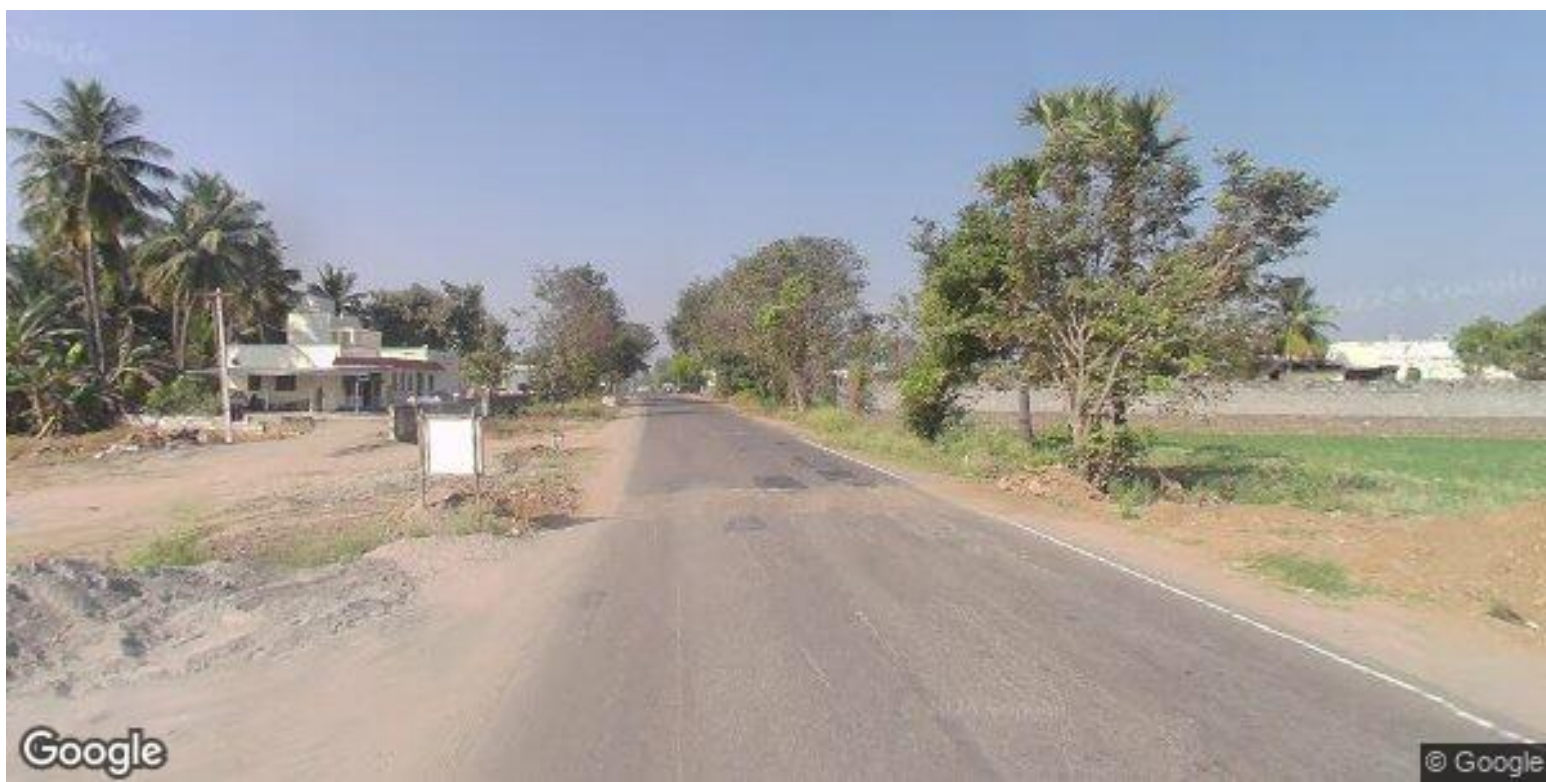
**Coordinates:** 11.42956, 78.11590

**Risk Type:** Turn

**Risk Level:** High

**Speed Limit:** 15 KM/Hr

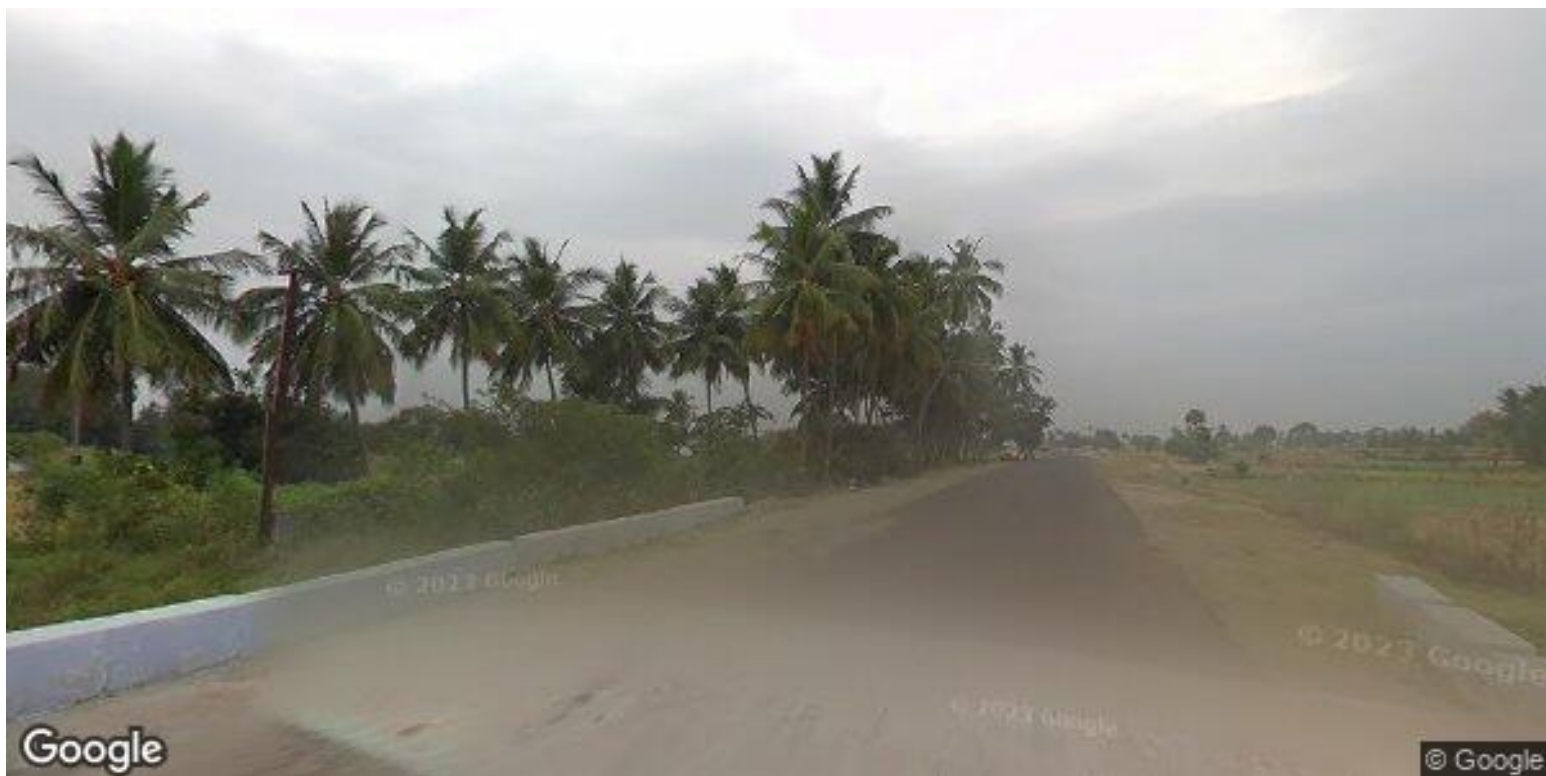
**Coordinates:** 11.42450, 78.15278

**Risk Type:** Turn

**Risk Level:** Medium

**Speed Limit:** 30 KM/Hr

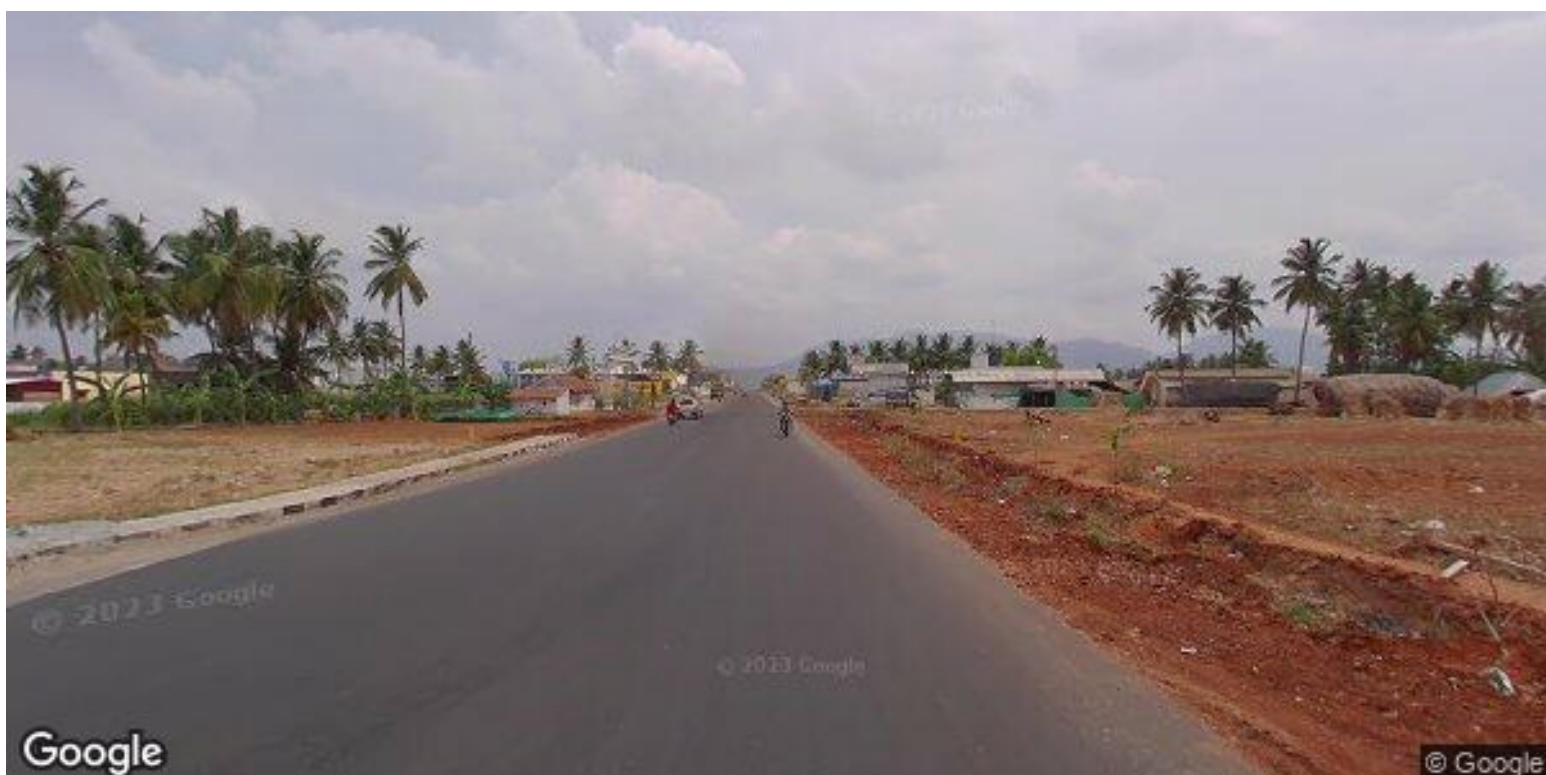
**Risk Type:** Turn  
**Risk Level:** High  
**Speed Limit:** 15 KM/Hr  
**Coordinates:** 11.43542, 78.20754

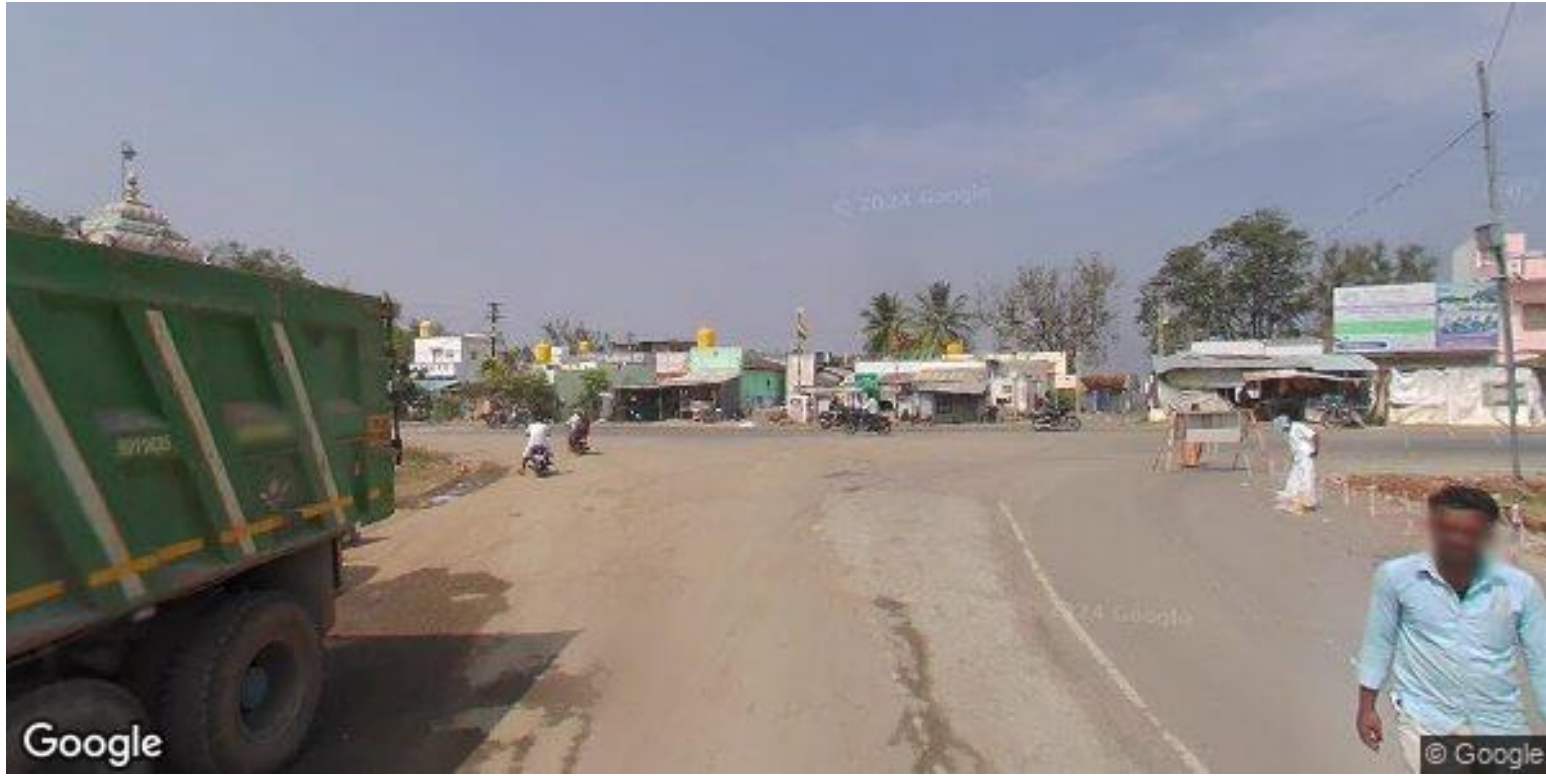
**Risk Type:** Turn  
**Risk Level:** Medium  
**Speed Limit:** 30 KM/Hr  
**Coordinates:** 11.45075, 78.20391

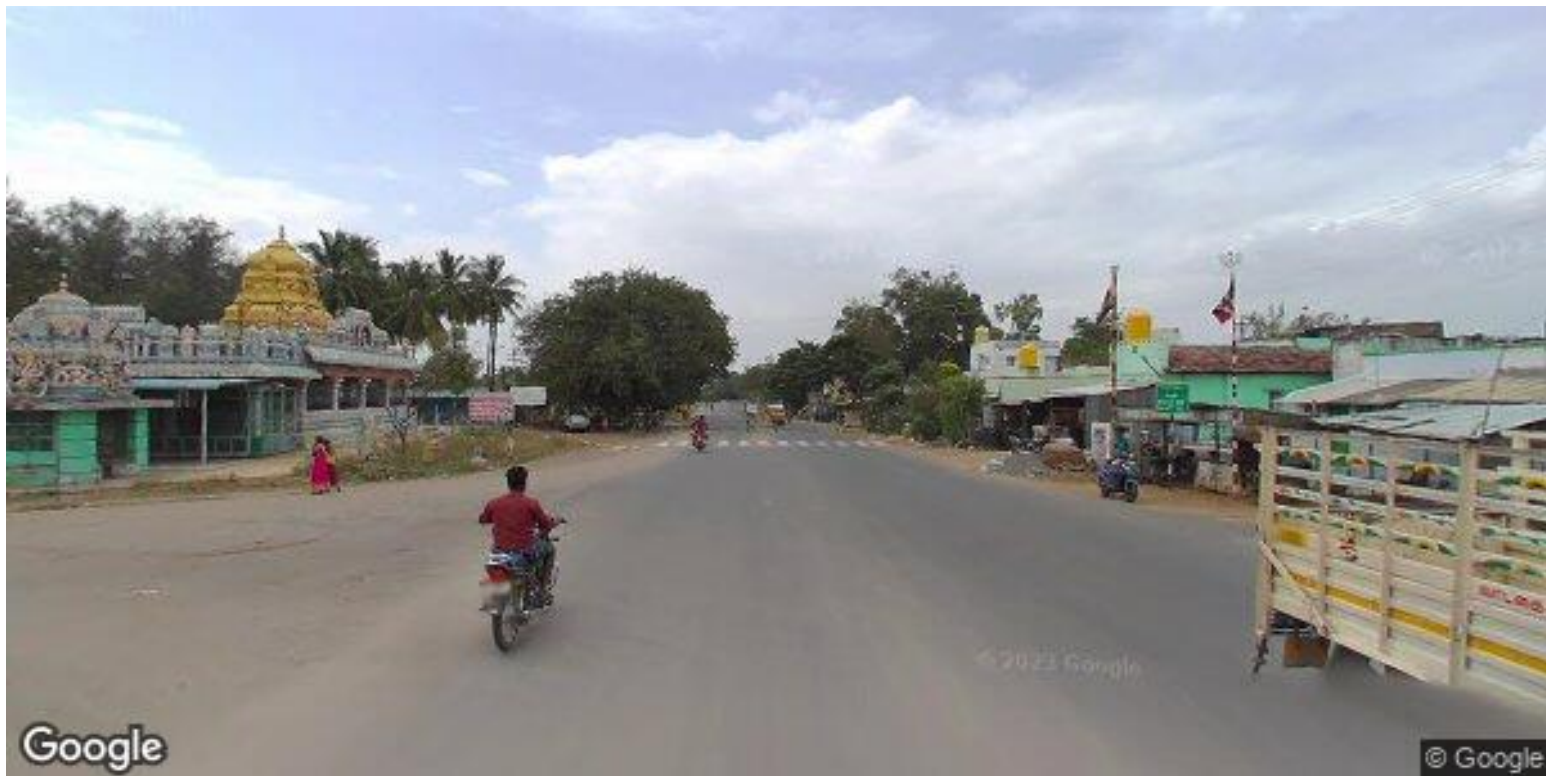
**Risk Type:** Turn  
**Risk Level:** High  
**Speed Limit:** 15 KM/Hr  
**Coordinates:** 11.45099, 78.20397

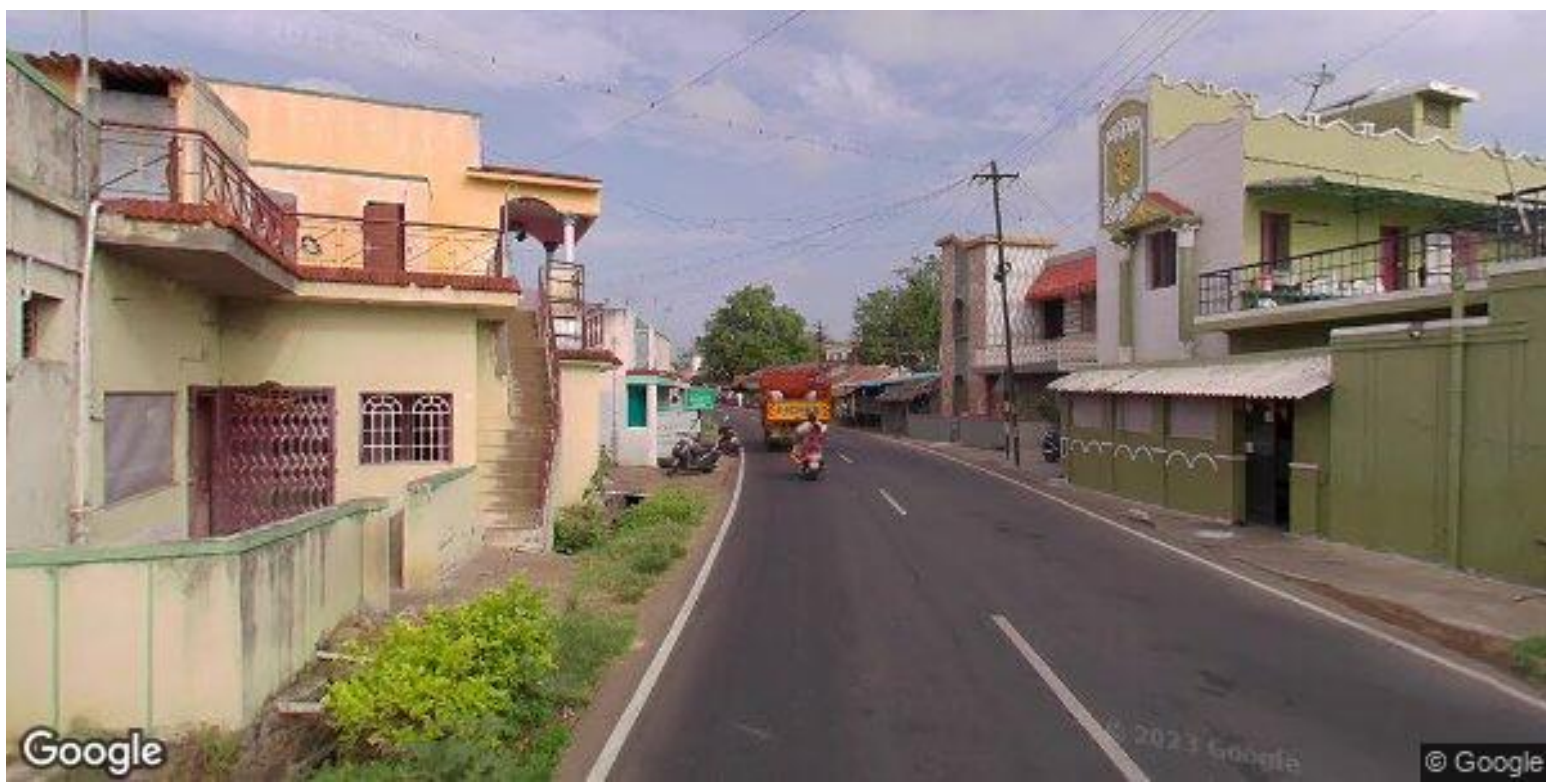
**Coordinates:** 11.44946, 78.22270

**Risk Type:** Turn

**Risk Level:** High

**Speed Limit:** 15 KM/Hr

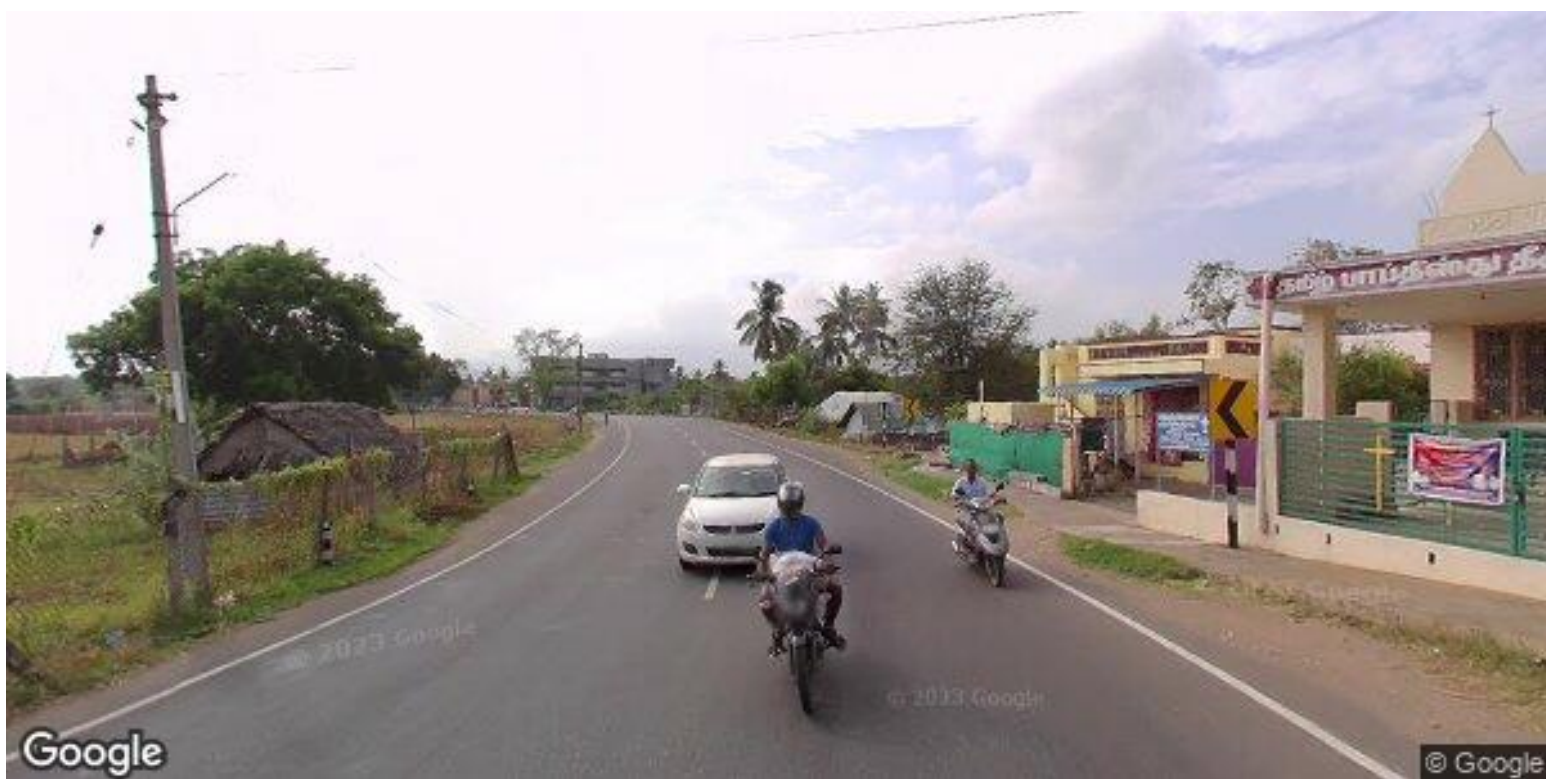
**Coordinates:** 11.44793, 78.22320

**Risk Type:** Turn

**Risk Level:** High

**Speed Limit:** 15 KM/Hr

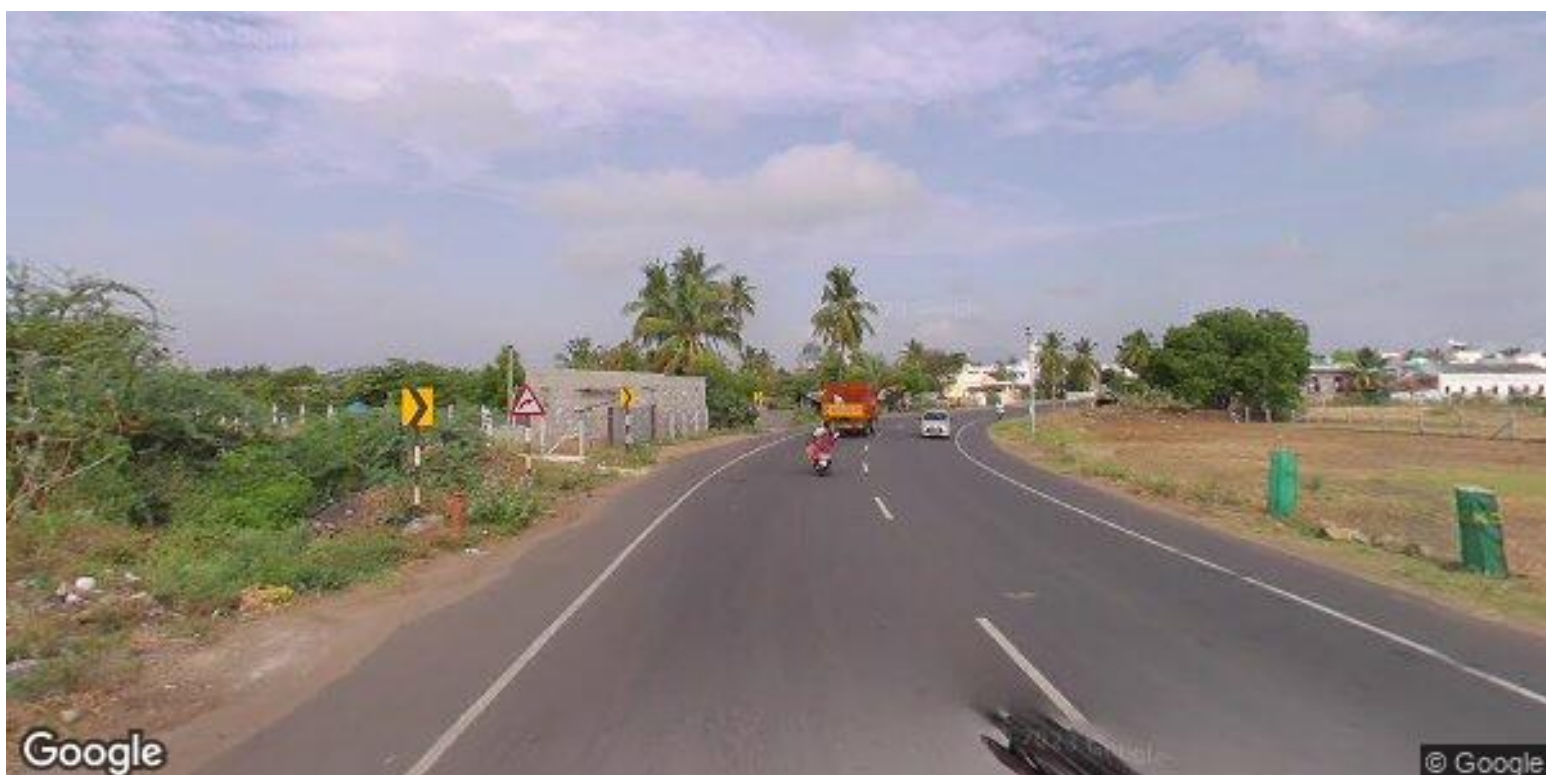
**Coordinates:** 11.44753, 78.22443

**Risk Type:** Turn

**Risk Level:** Medium

**Speed Limit:** 30 KM/Hr

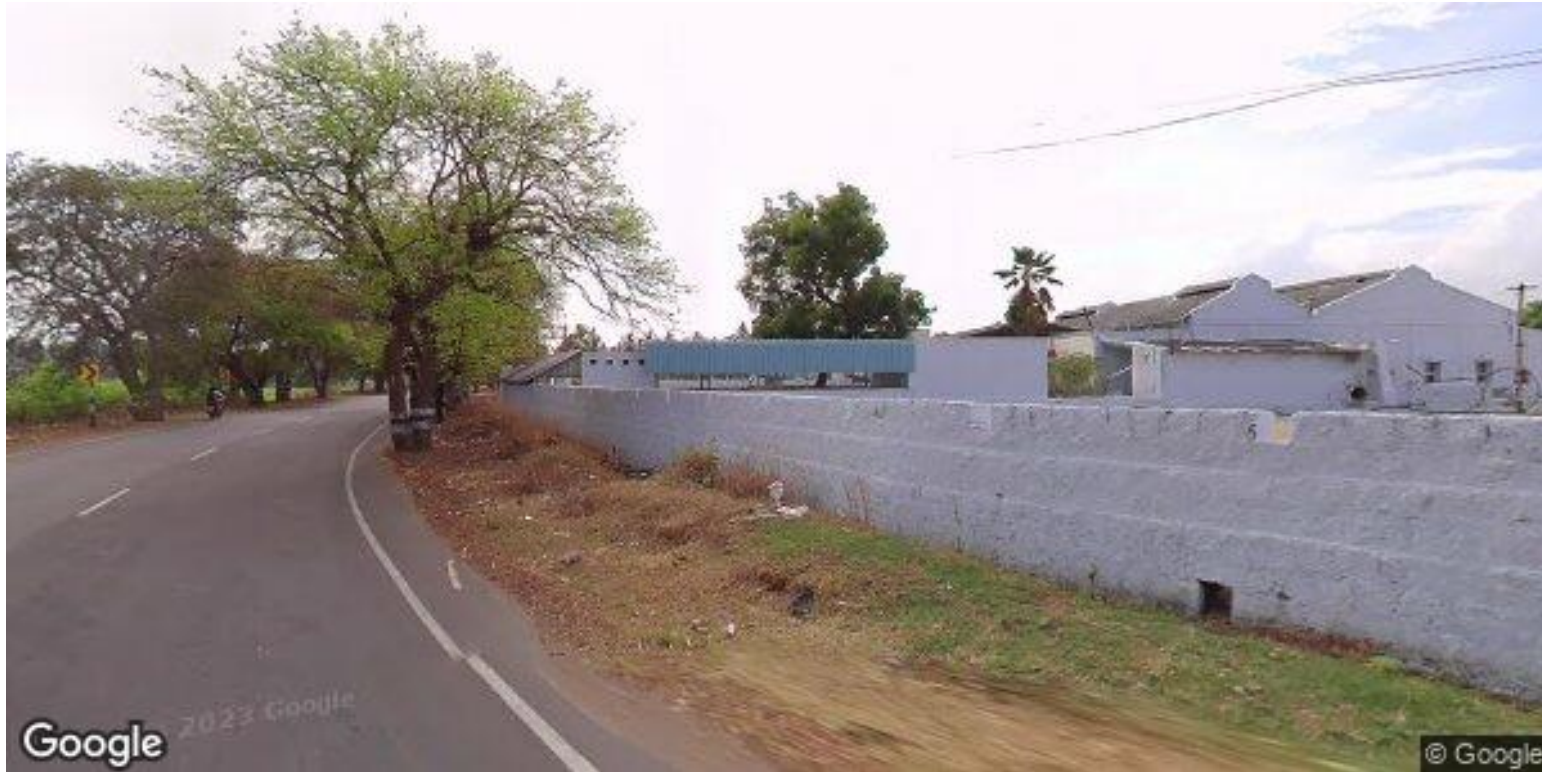
**Coordinates:** 11.45361, 78.23597

**Risk Type:** Turn

**Risk Level:** Medium

**Speed Limit:** 30 KM/Hr
