# IndianOil

## JOURNEY RISK MANAGEMENT (JRM) STUDY

### Salem Terminal to S.P. SAMY AGENCIES

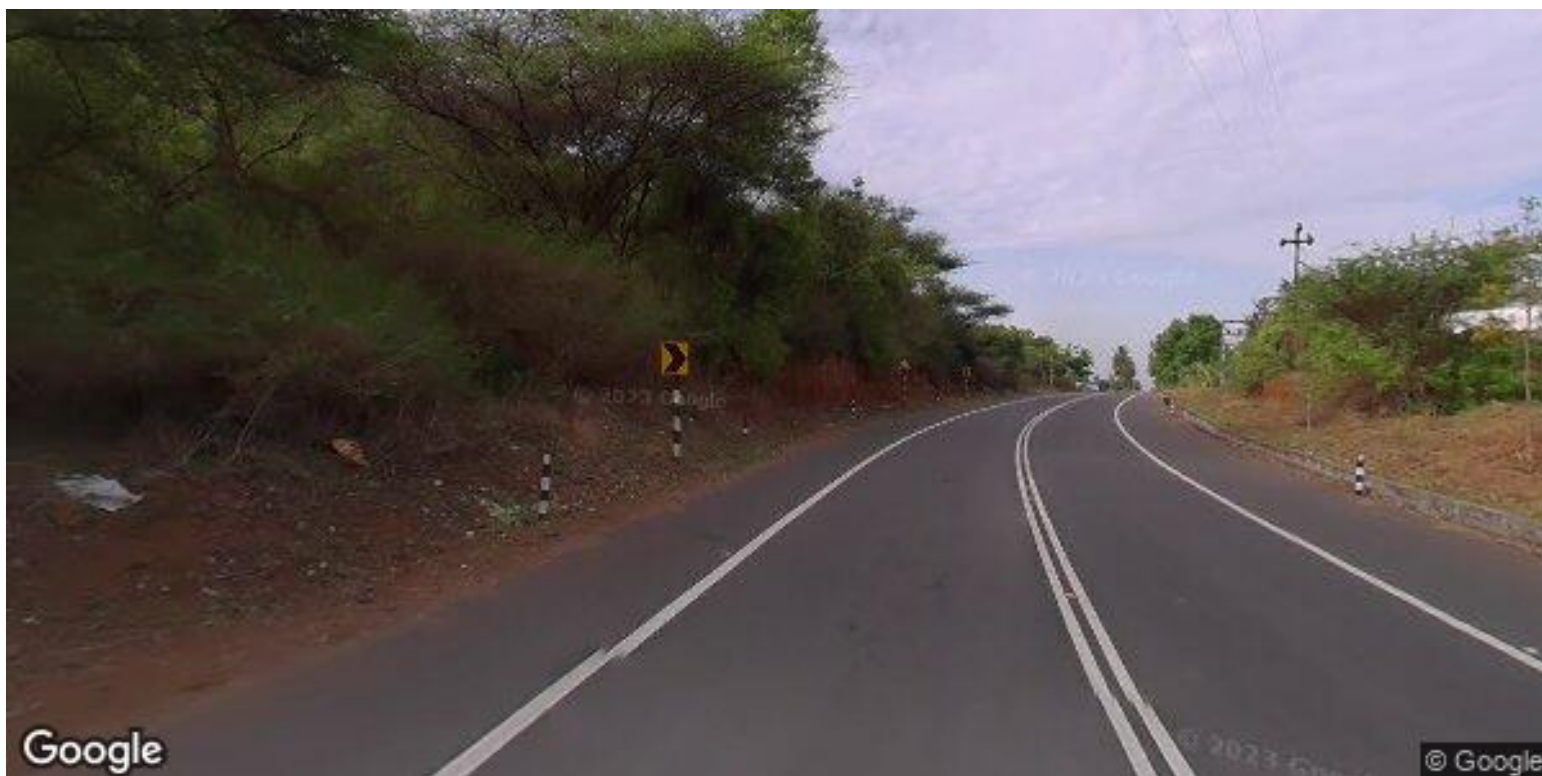
**Coordinates:** 11.49628, 78.32342

**Risk Type:** Turn

**Risk Level:** Medium

**Speed Limit:** 30 KM/Hr

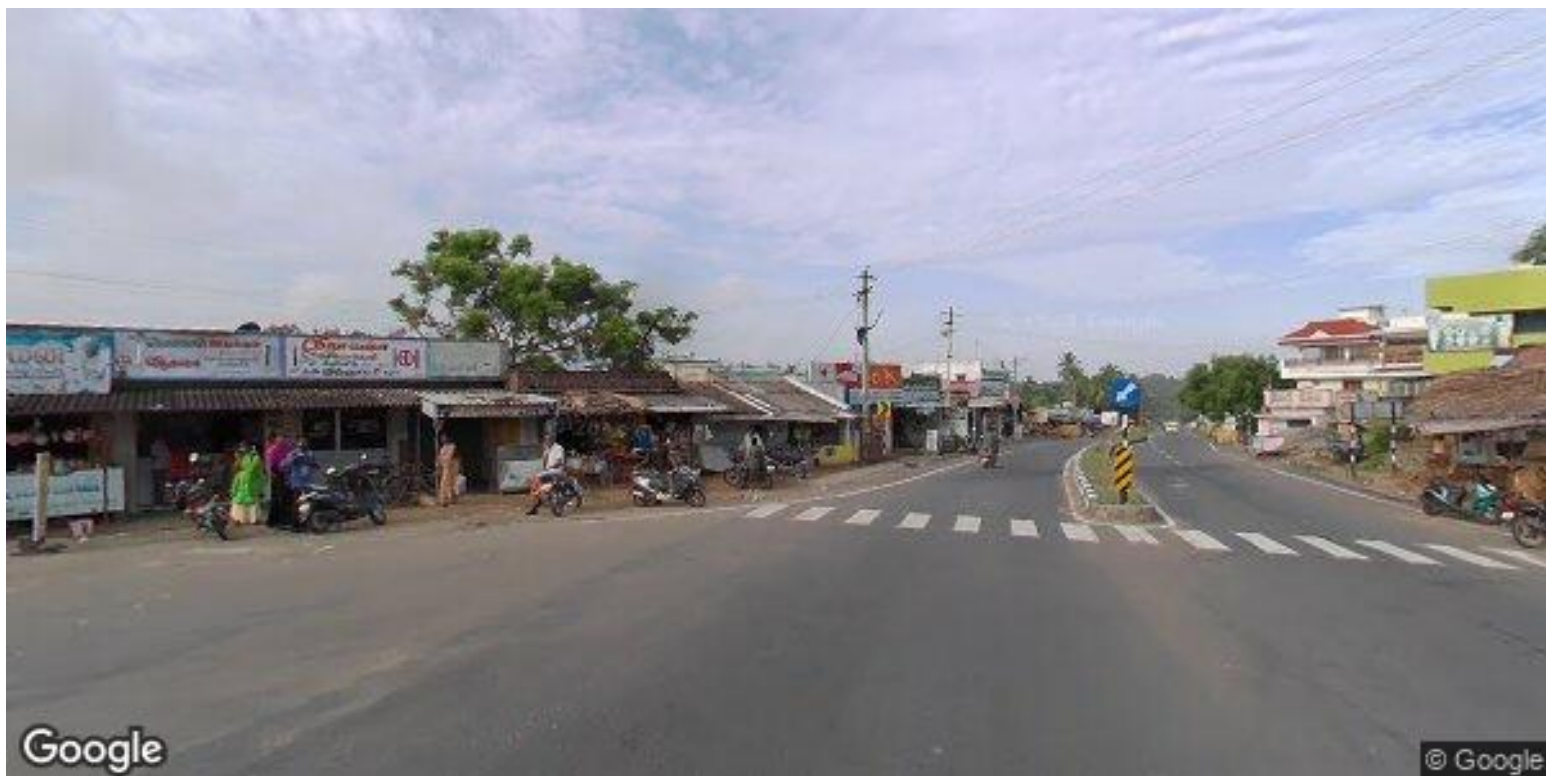
**Coordinates:** 11.51180, 78.34422

**Risk Type:** Turn

**Risk Level:** High

**Speed Limit:** 15 KM/Hr

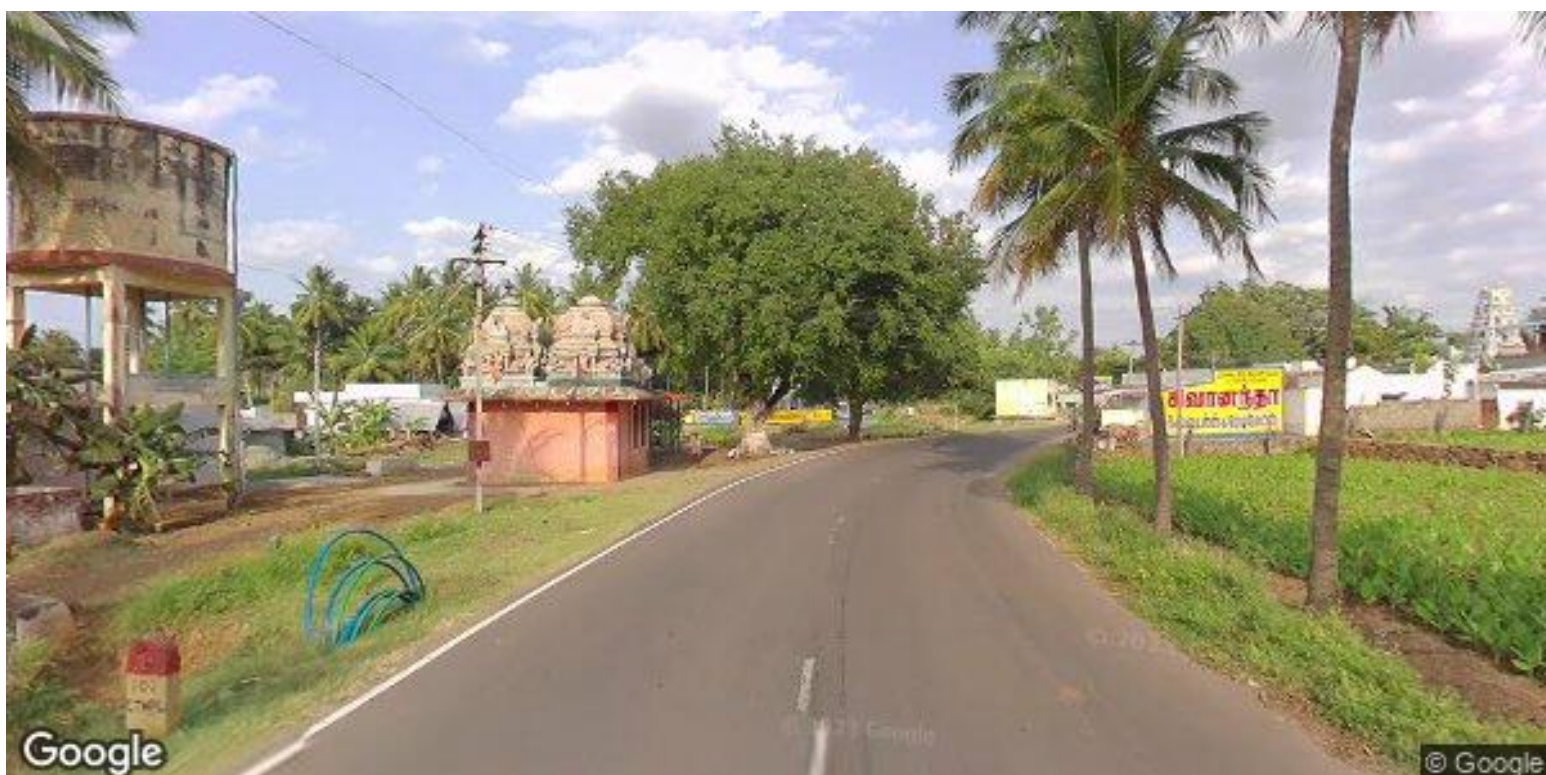
**Coordinates:** 11.51040, 78.34875

**Risk Type:** Turn

**Risk Level:** Medium

**Speed Limit:** 30 KM/Hr

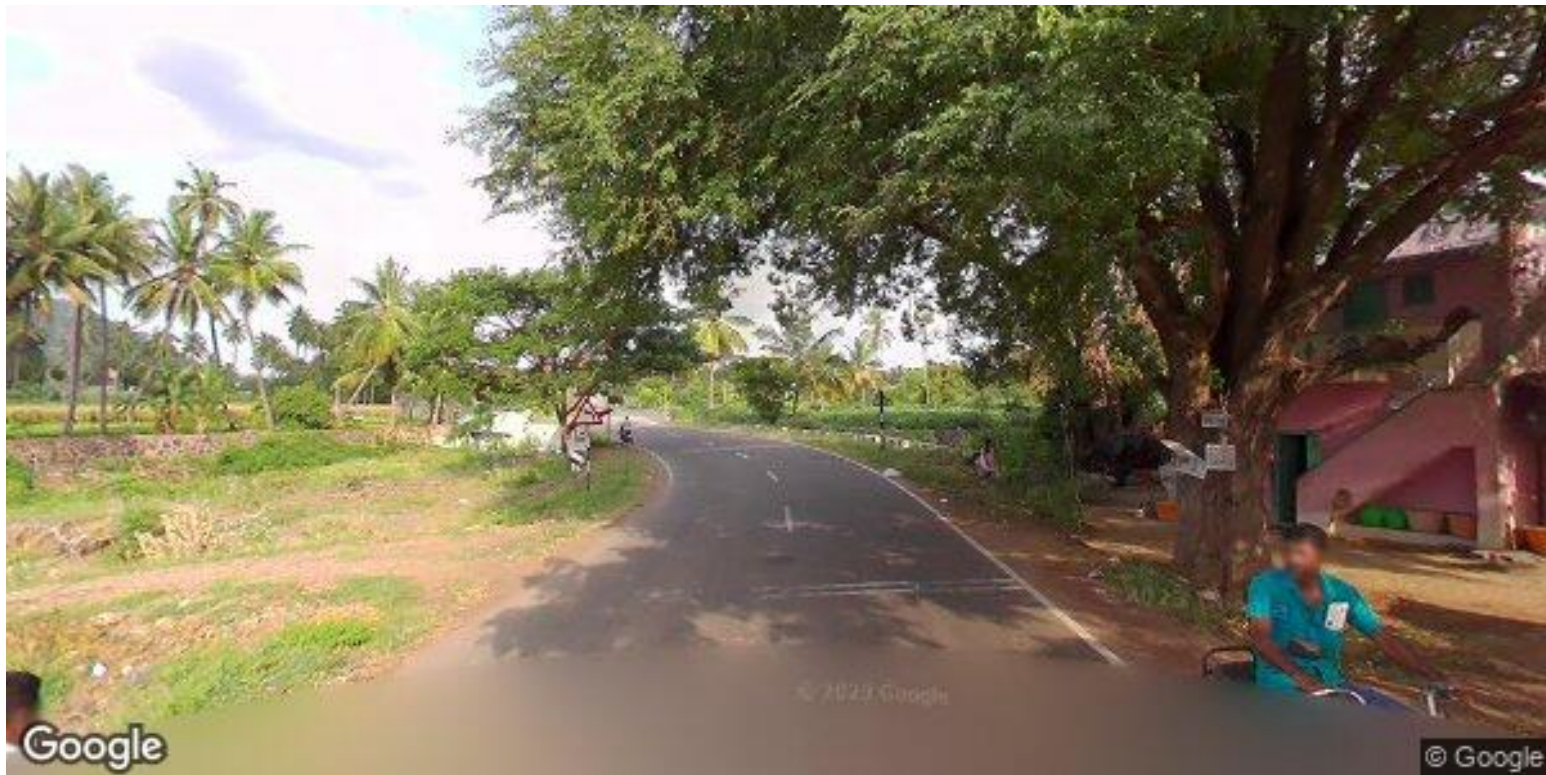
**Coordinates:** 11.50969, 78.34967

**Risk Type:** Turn

**Risk Level:** Medium

**Speed Limit:** 30 KM/Hr

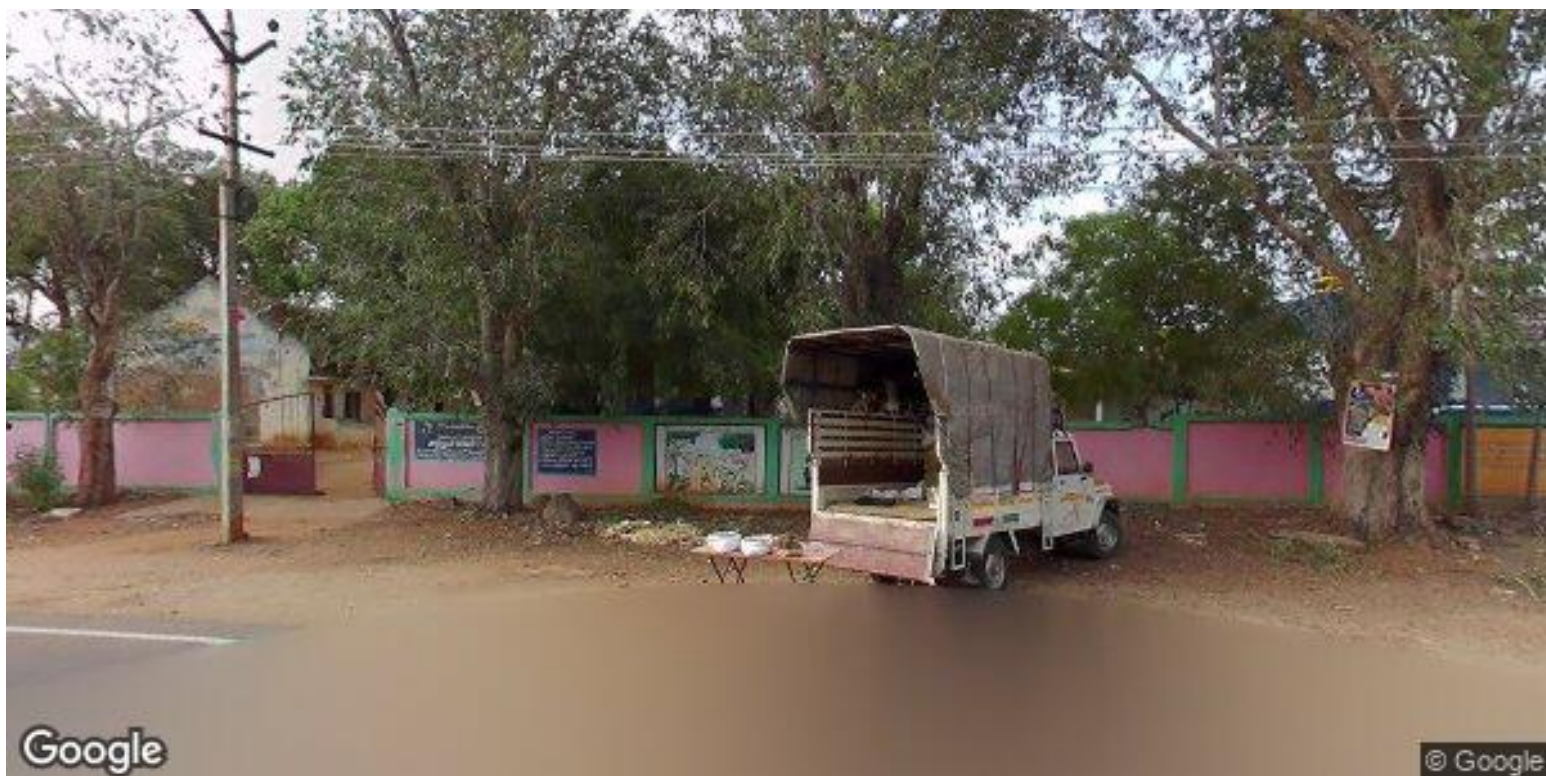
**Coordinates:** 11.50905, 78.35285

**Risk Type:** Turn

**Risk Level:** Medium

**Speed Limit:** 30 KM/Hr

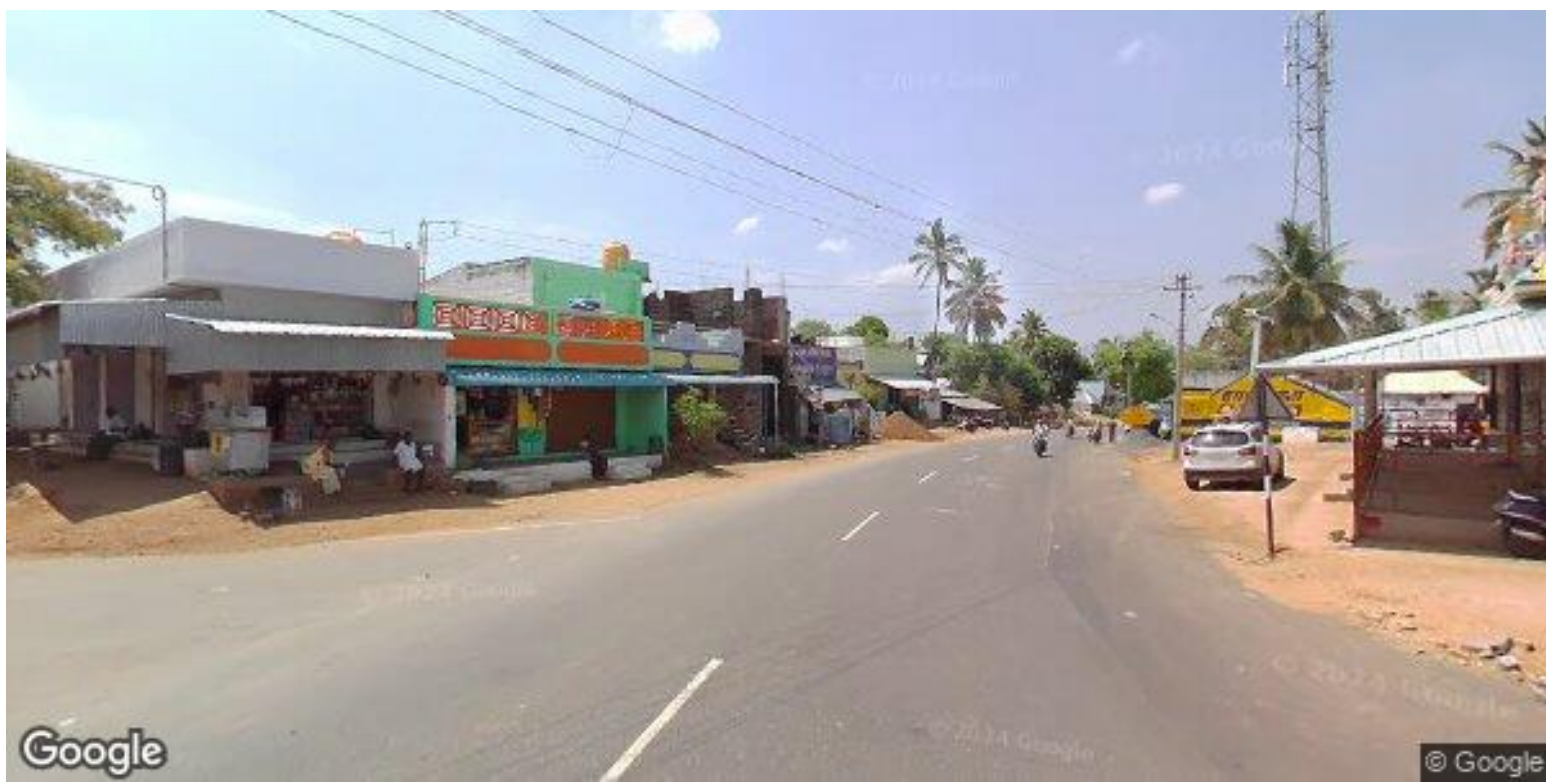
**Coordinates:** 11.47977, 78.38044

**Risk Type:** Turn

**Risk Level:** Medium

**Speed Limit:** 30 KM/Hr

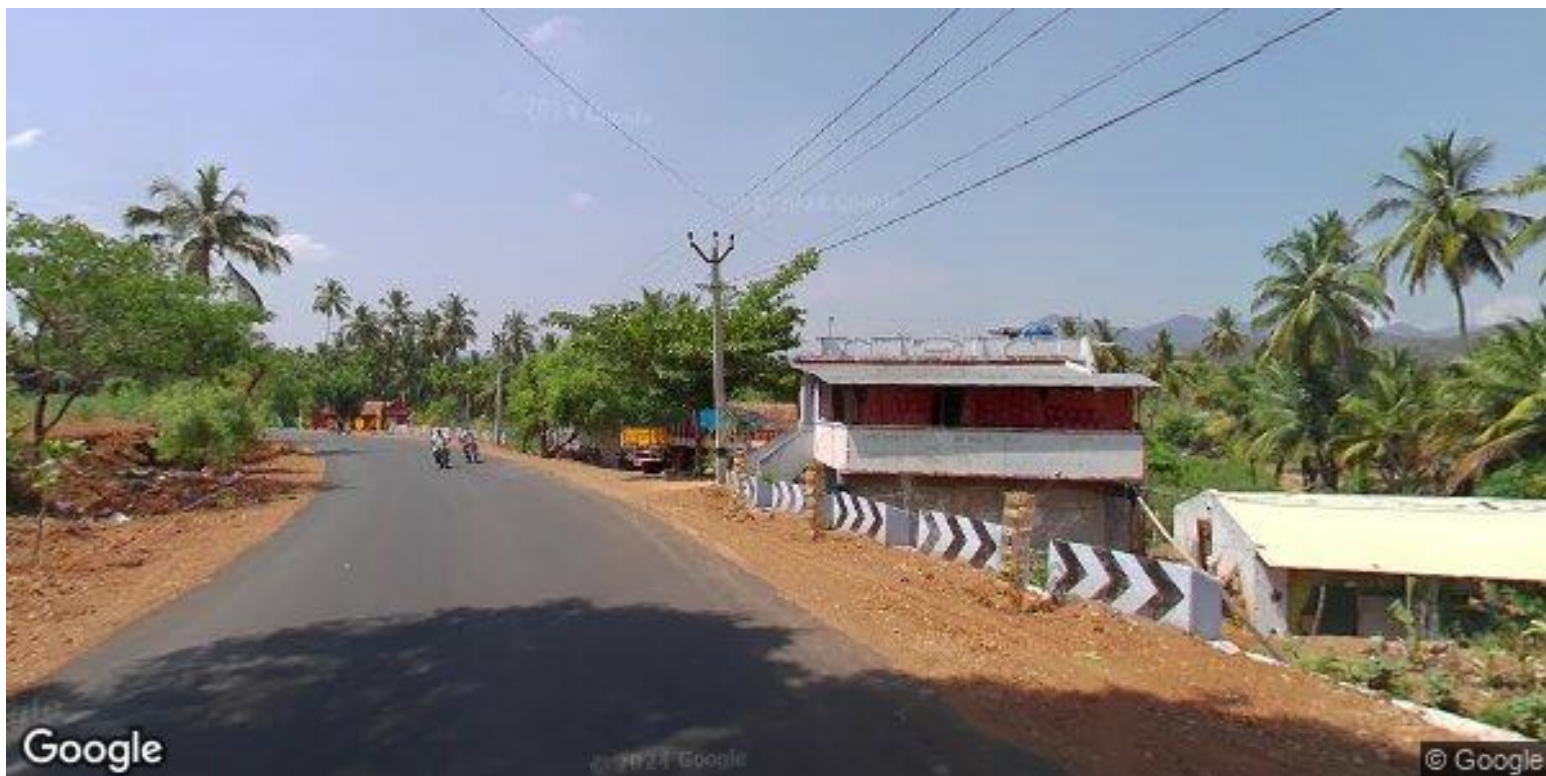
**Coordinates:** 11.47754, 78.38114

**Risk Type:** Turn

**Risk Level:** Medium

**Speed Limit:** 30 KM/Hr

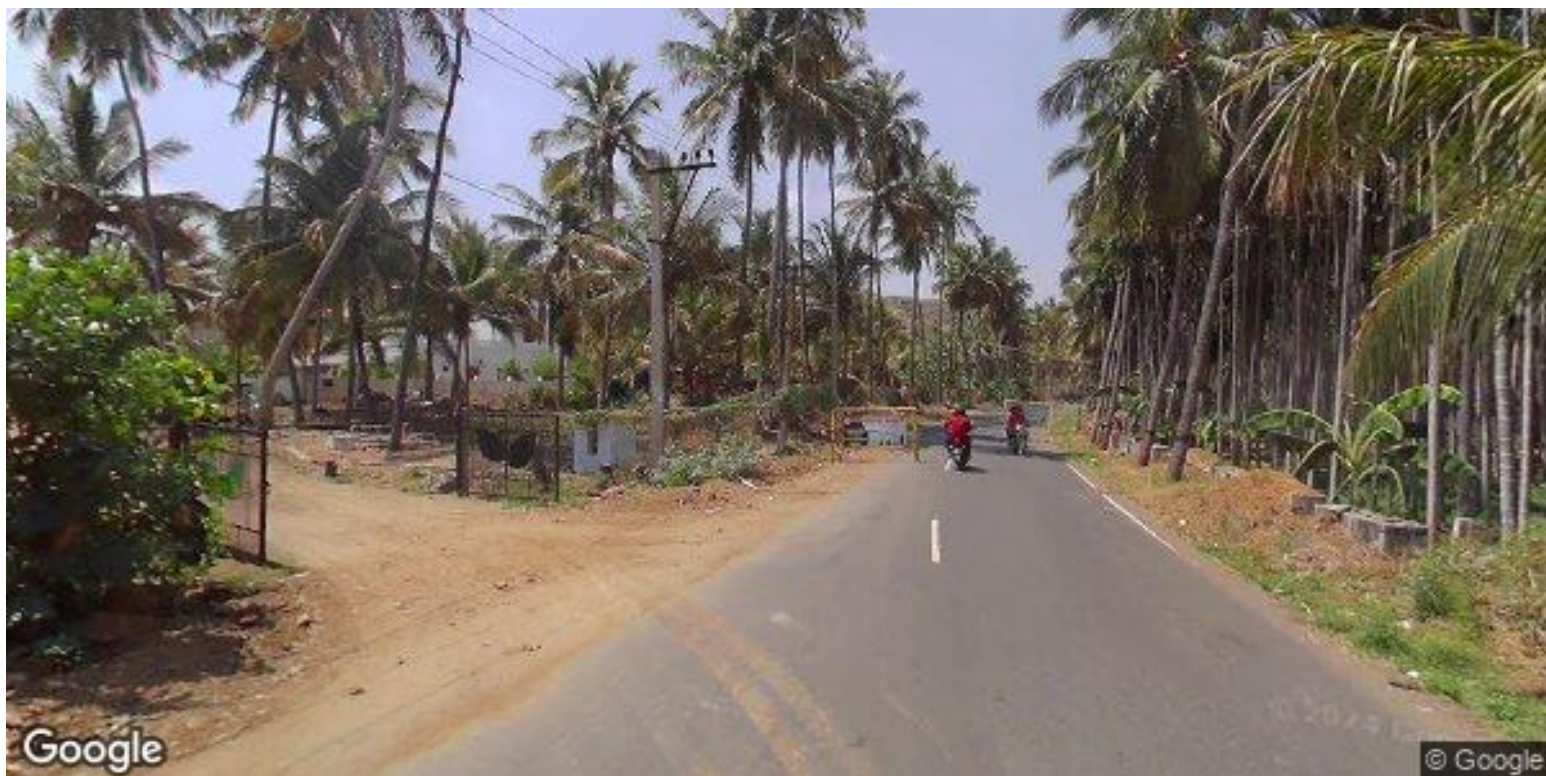
**Coordinates: 11.46956, 78.39365**

**Risk Type: Turn**

**Risk Level: Medium**

**Speed Limit: 30 KM/Hr**

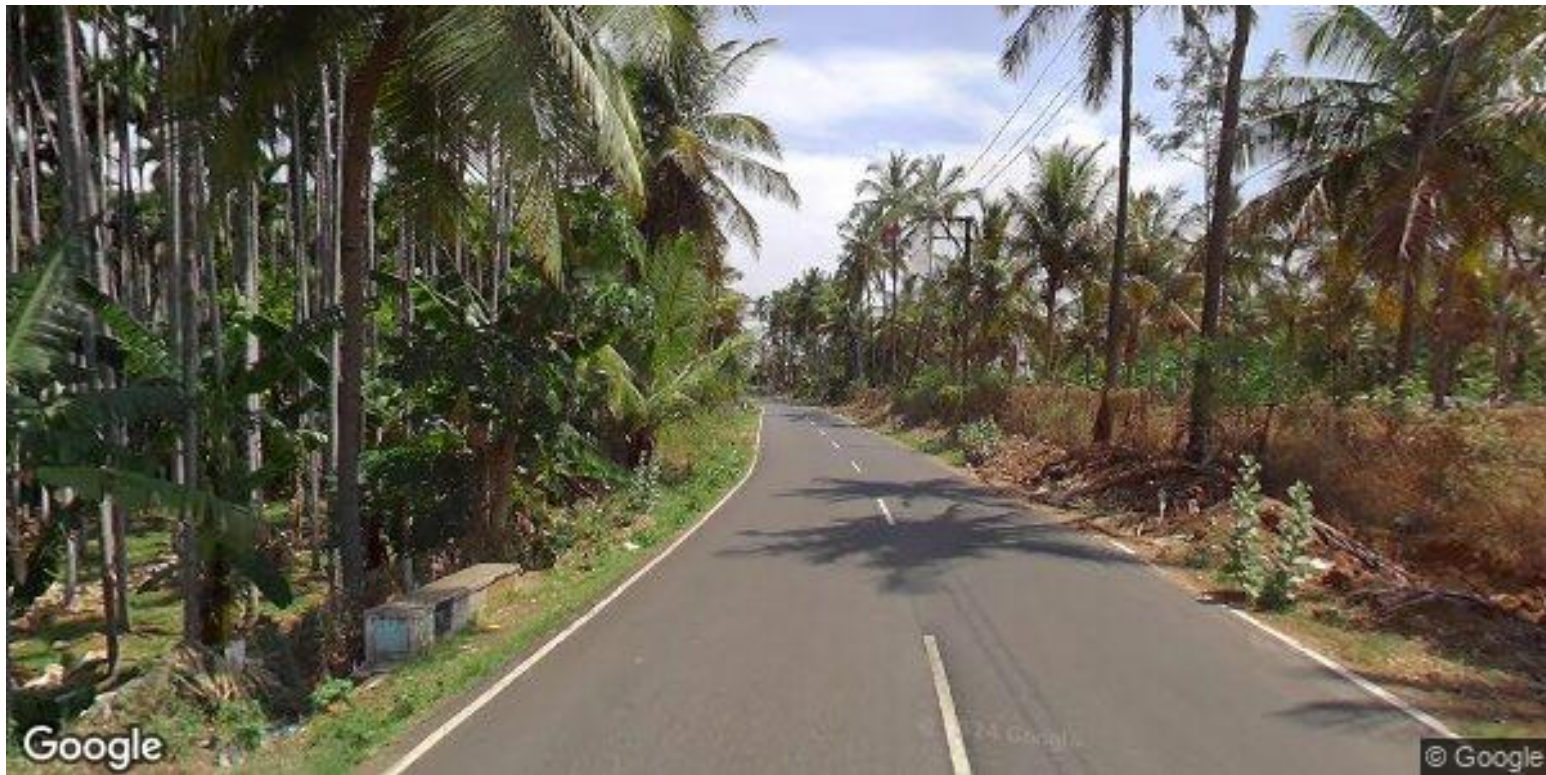
**Coordinates: 11.46783, 78.39421**

**Risk Type: Turn**

**Risk Level: Medium**

**Speed Limit: 30 KM/Hr**

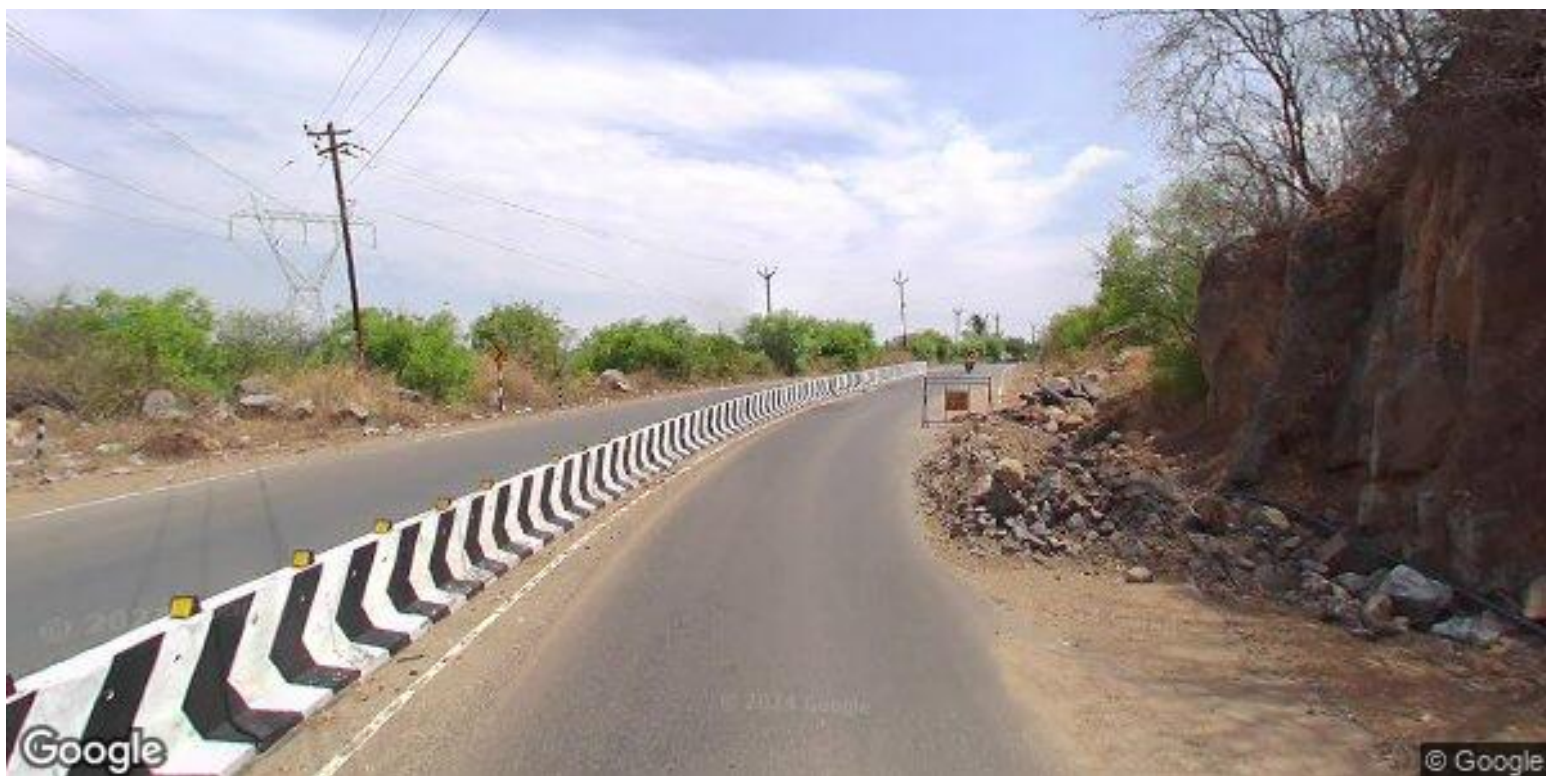
**Coordinates: 11.46455, 78.39289**

**Risk Type: Turn**

**Risk Level: High**

**Speed Limit: 15 KM/Hr**

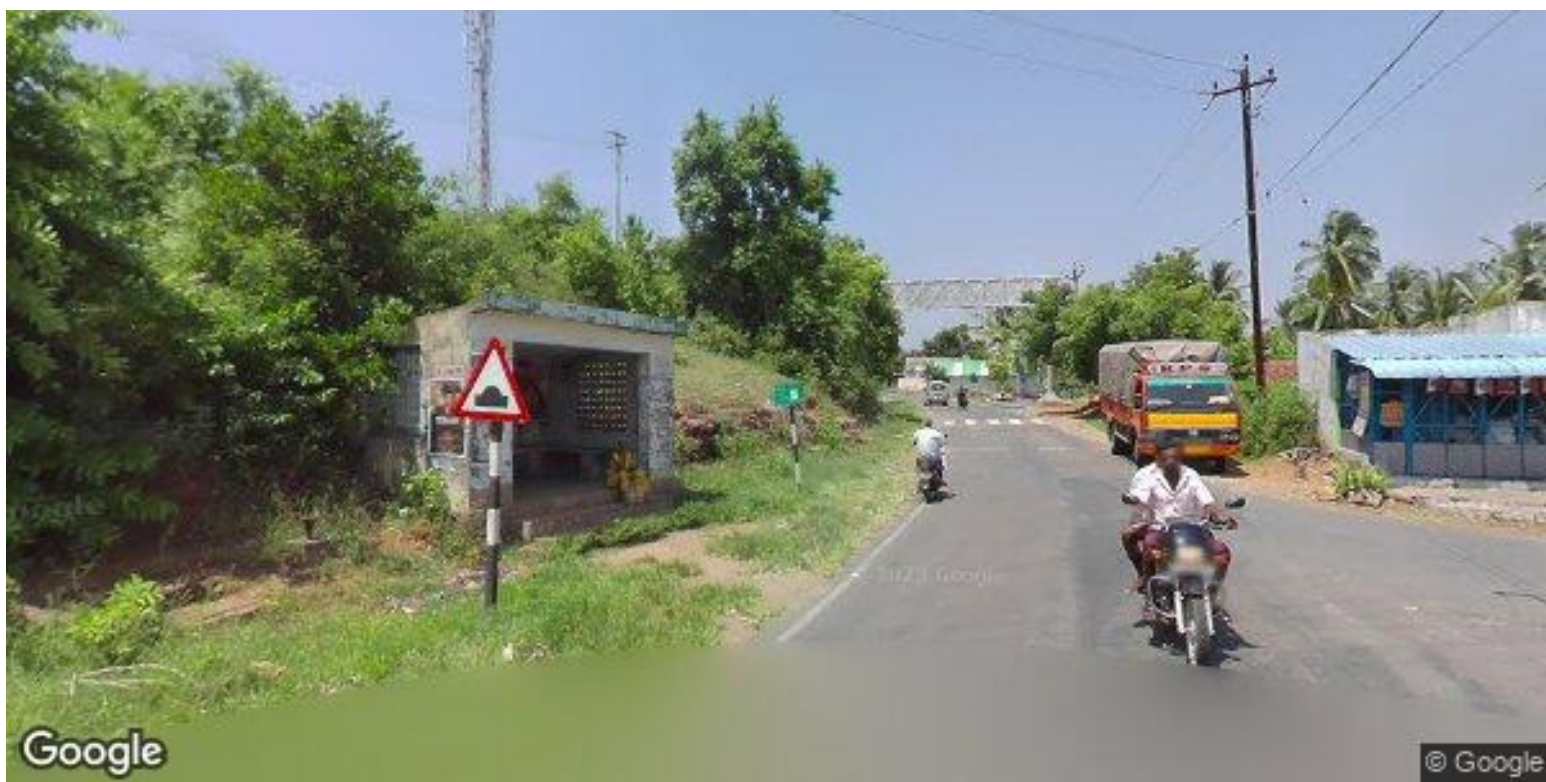
**Coordinates:** 11.45614, 78.40096

**Risk Type:** Turn

**Risk Level:** High

**Speed Limit:** 15 KM/Hr

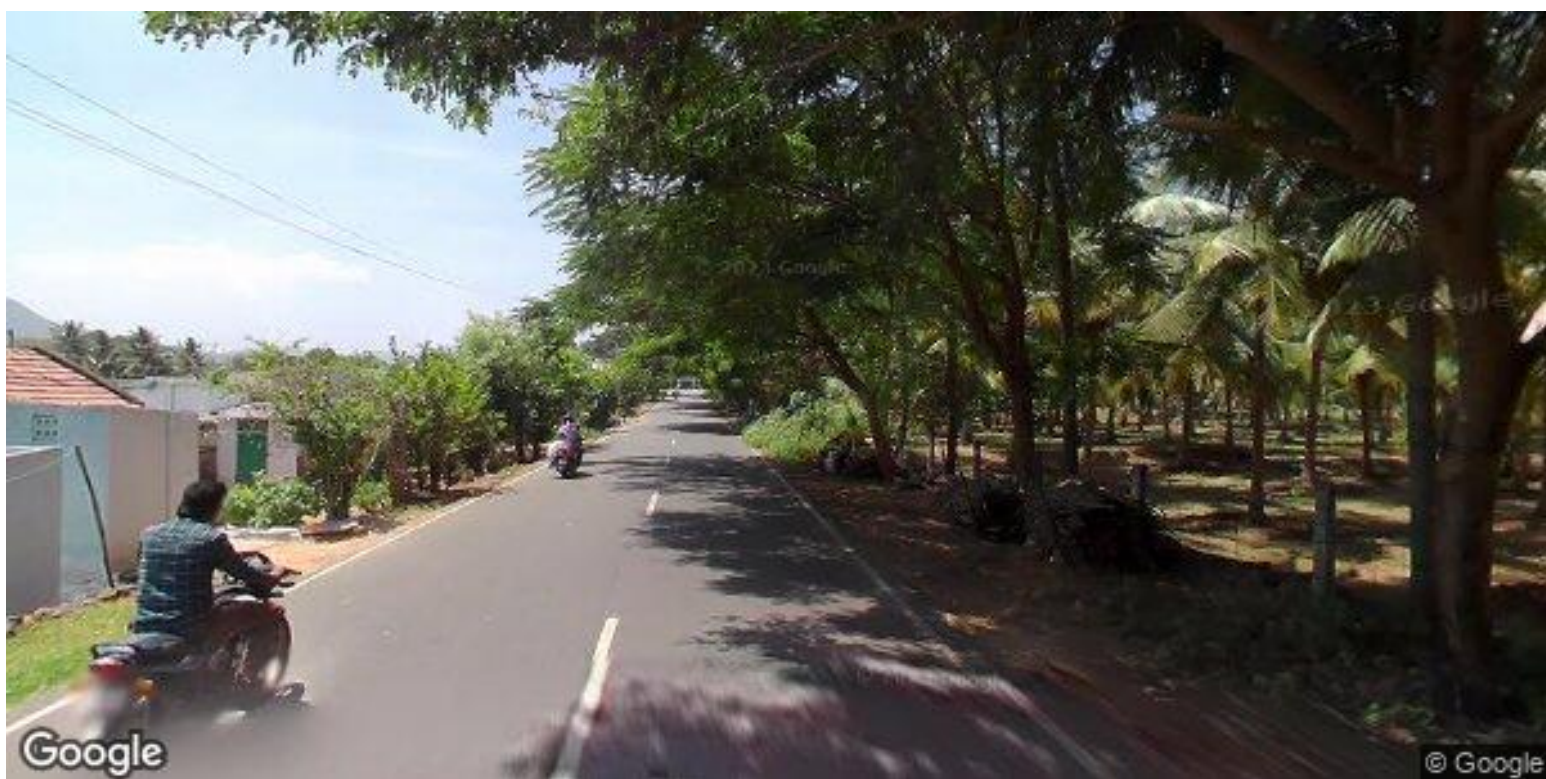
**Coordinates:** 11.45560, 78.40272

**Risk Type:** Turn

**Risk Level:** Medium

**Speed Limit:** 30 KM/Hr

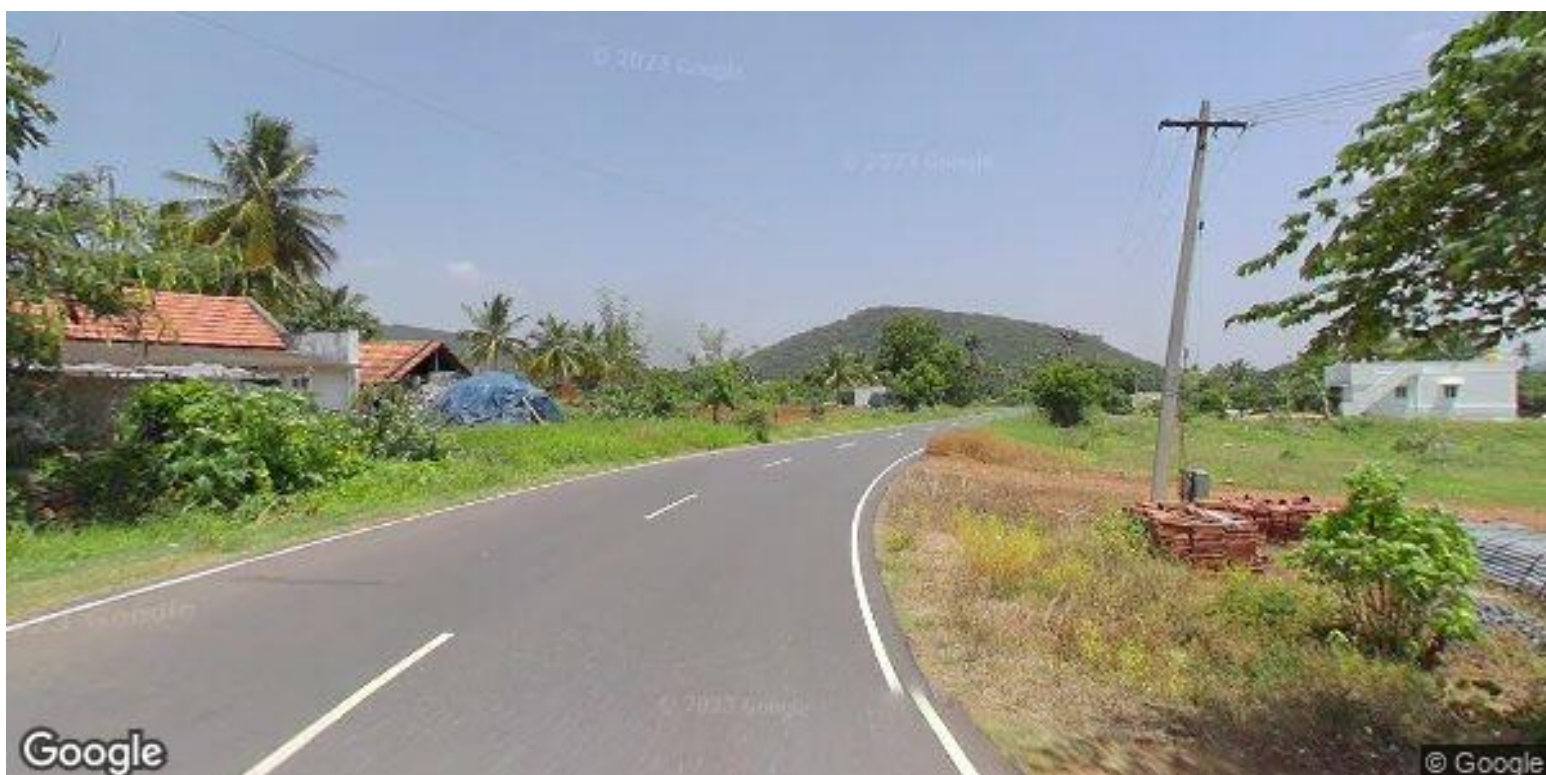
**Risk Type:** Turn  
**Risk Level:** Medium  
**Speed Limit:** 30 KM/Hr  
**Coordinates:** 11.45658, 78.40442

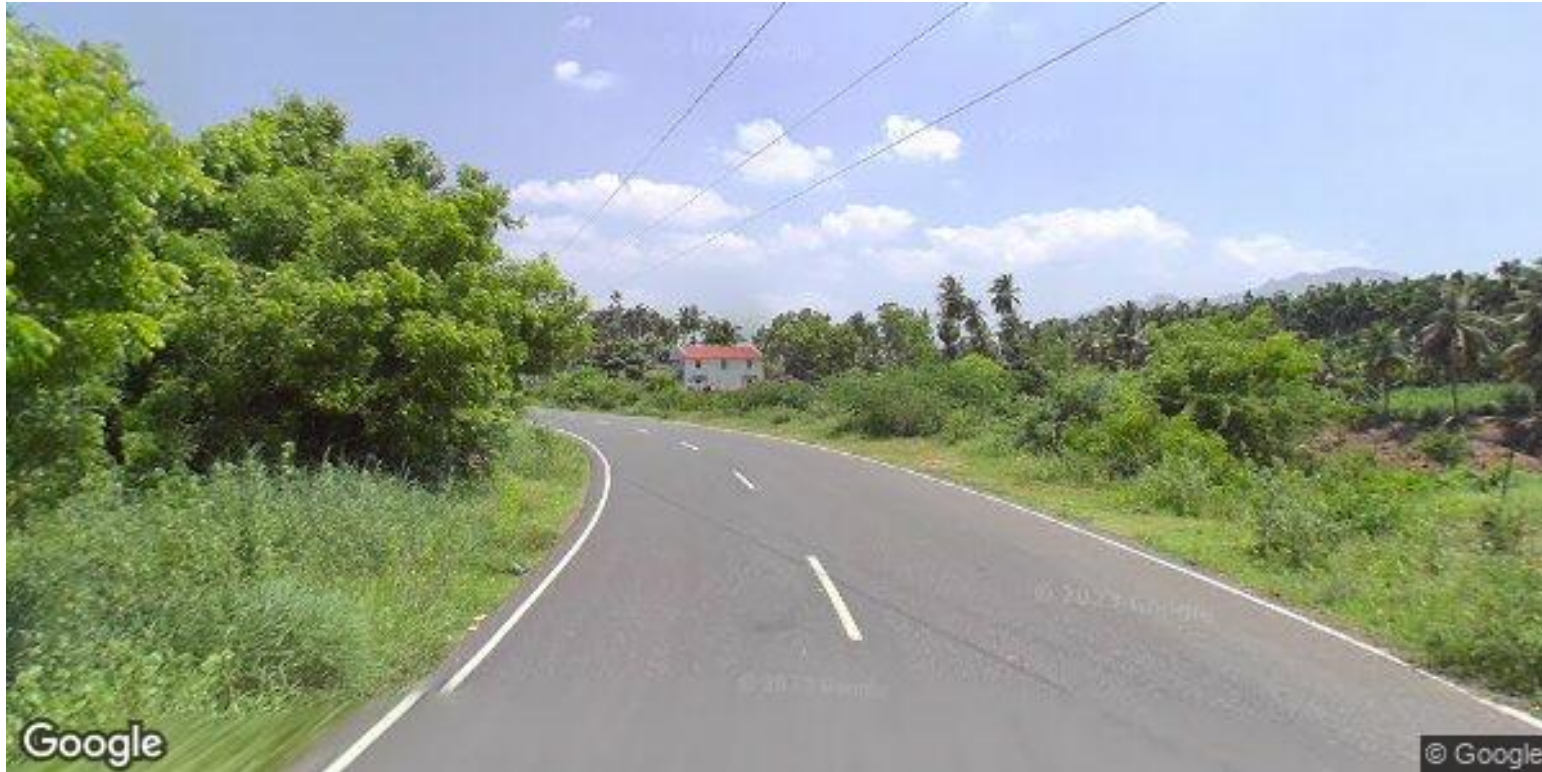
**Risk Type:** Turn  
**Risk Level:** Medium  
**Speed Limit:** 30 KM/Hr  
**Coordinates:** 11.45483, 78.40829

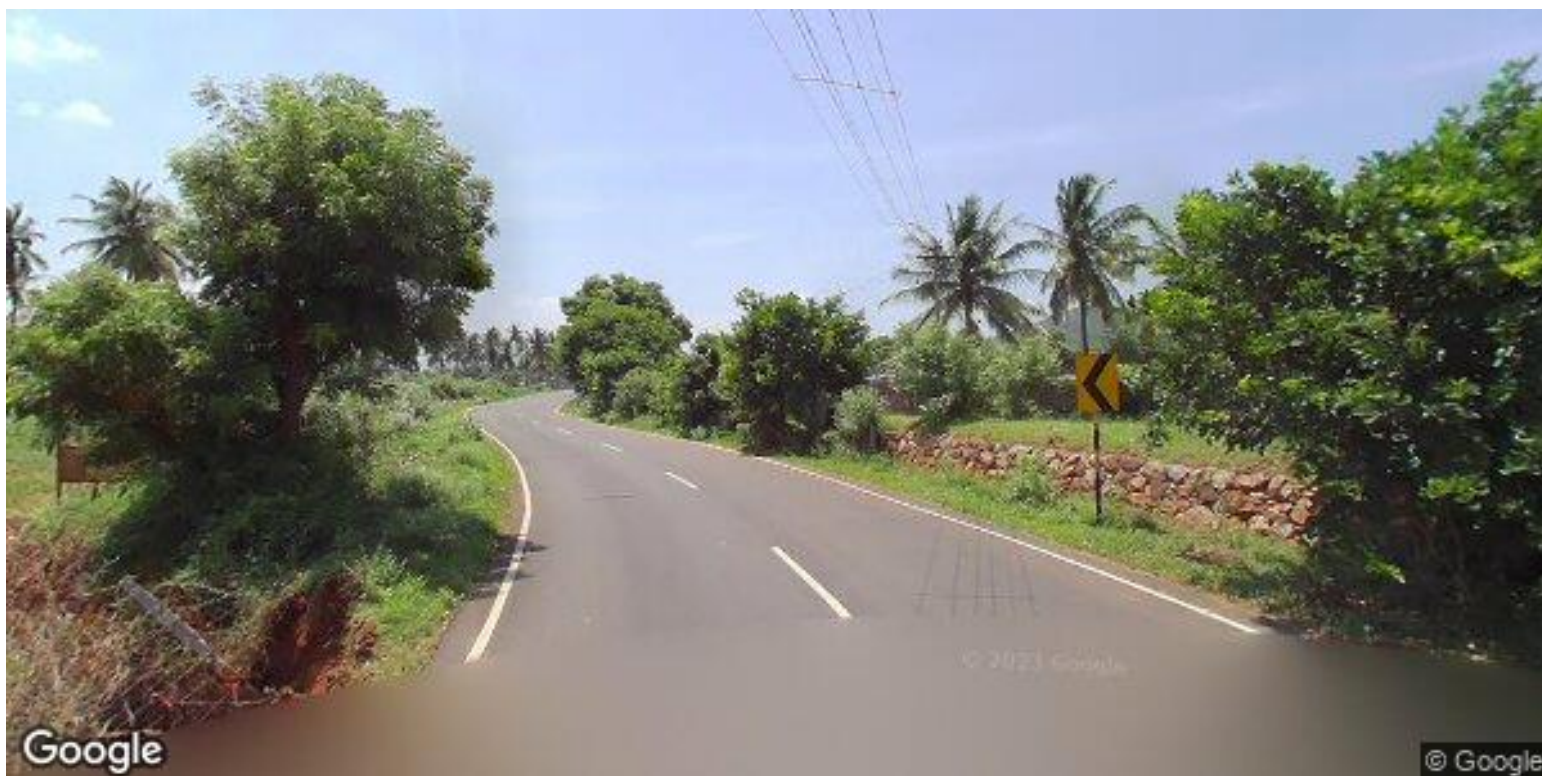
**Risk Type:** Turn  
**Risk Level:** Medium  
**Speed Limit:** 30 KM/Hr  
**Coordinates:** 11.46741, 78.45087

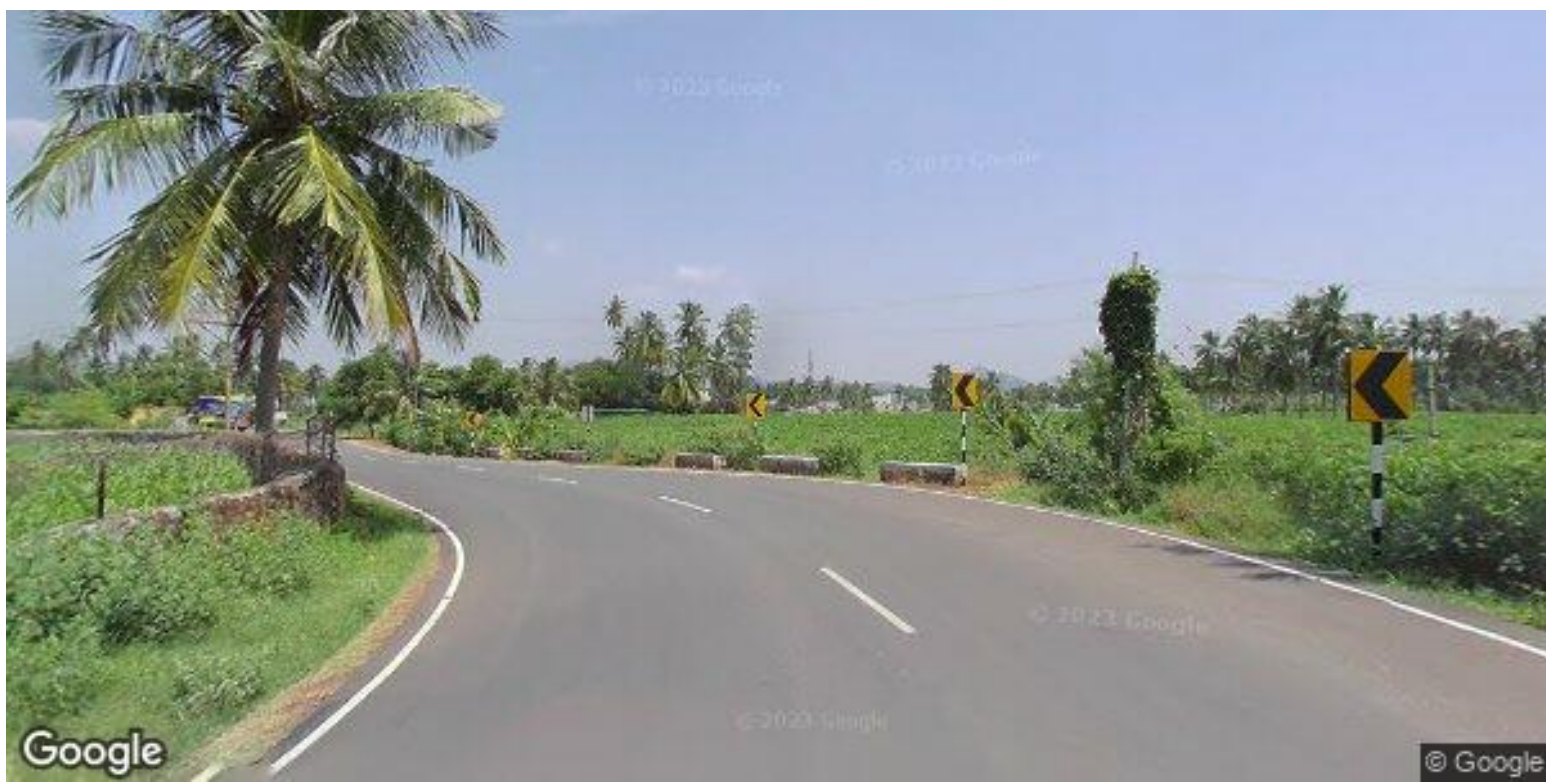
**Coordinates:** 11.46729, 78.45447

**Risk Type:** Turn

**Risk Level:** High

**Speed Limit:** 15 KM/Hr

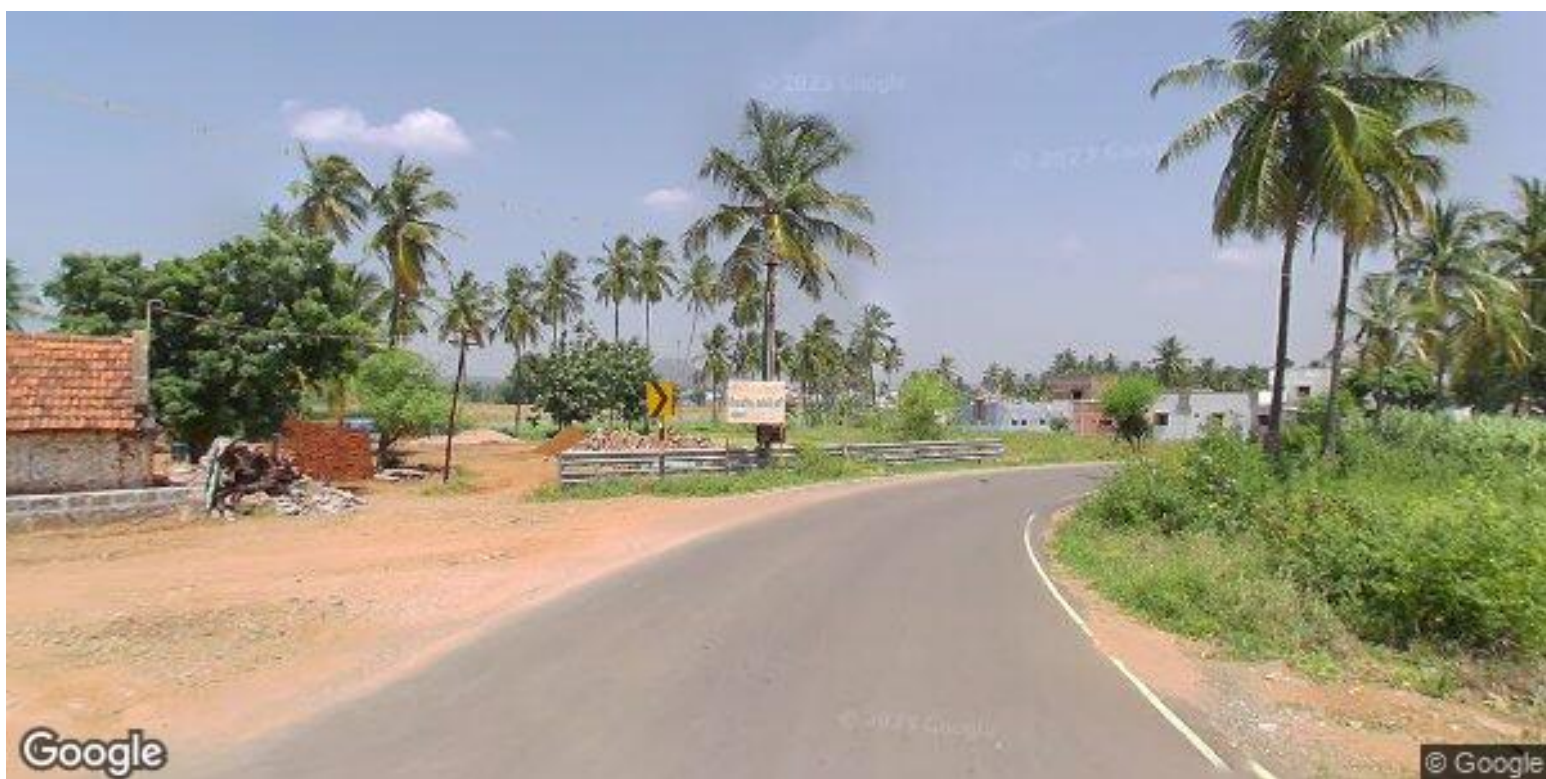
**Coordinates:** 11.46808, 78.45535

**Risk Type:** Turn

**Risk Level:** Medium

**Speed Limit:** 30 KM/Hr

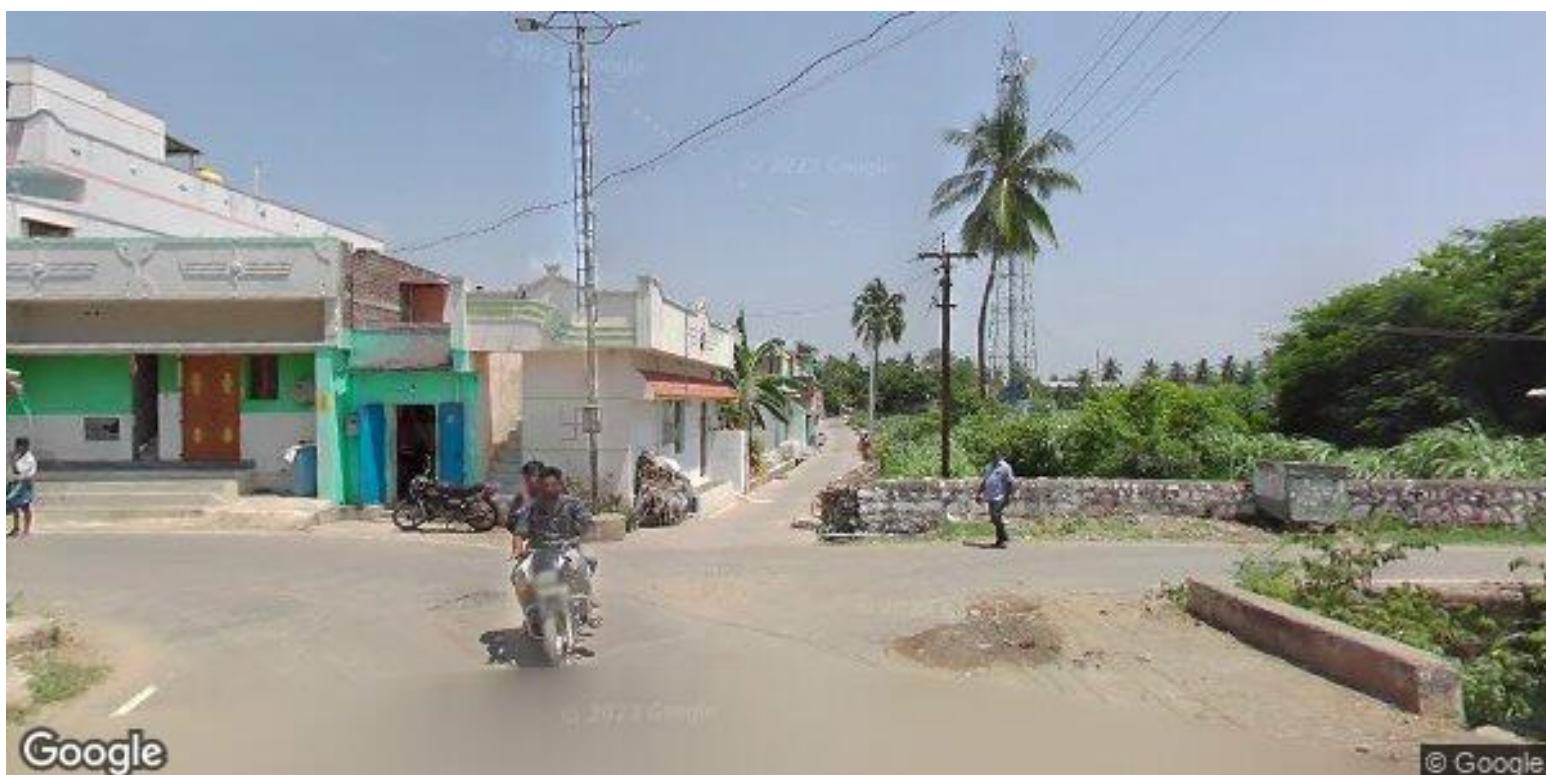
**Risk Type:** Blind Spot  
**Risk Level:** Blind Spot  
**Speed Limit:** 10 KM/Hr  
**Coordinates:** 11.46798, 78.45844

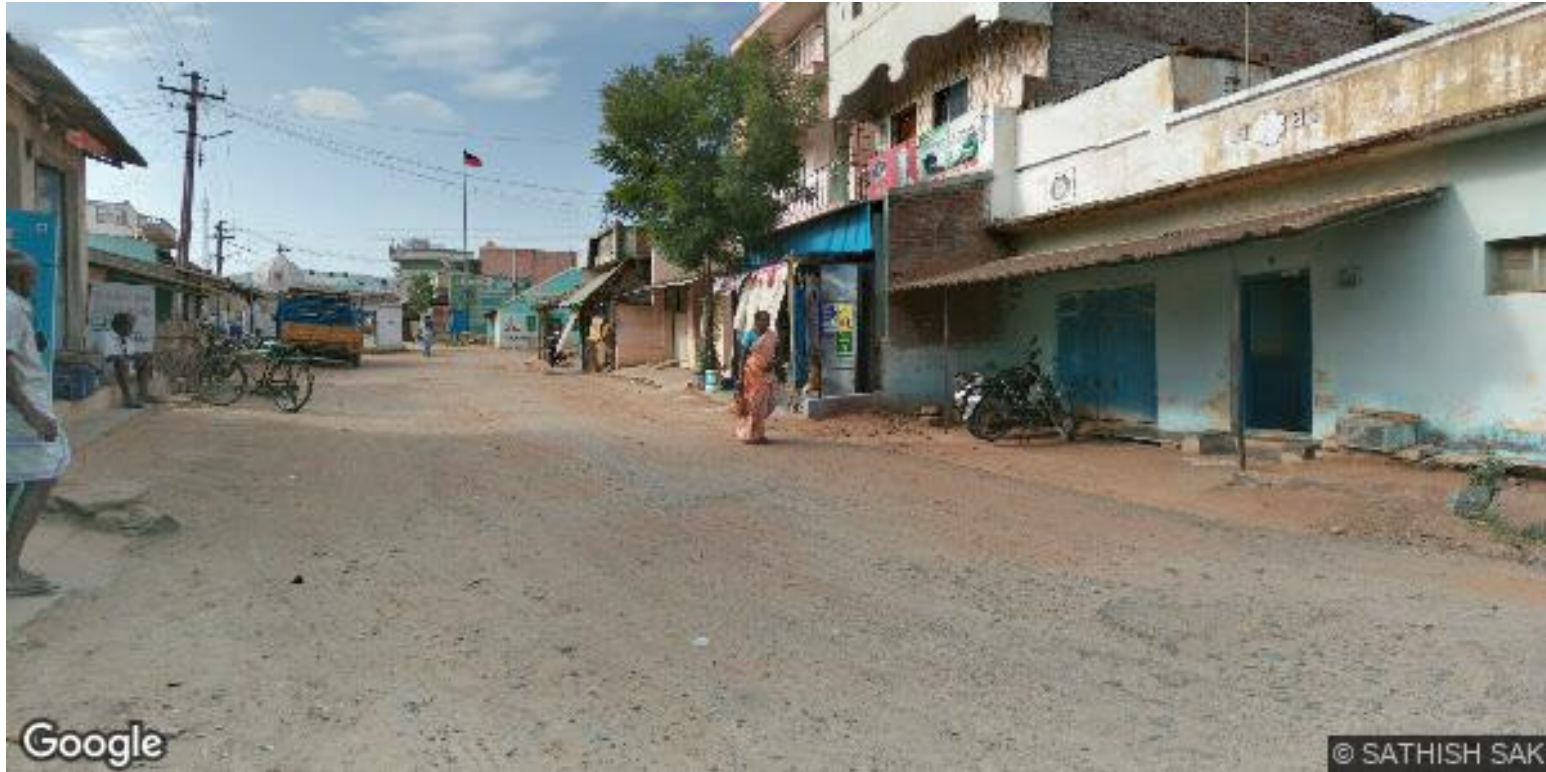
**Risk Type:** Blind Spot  
**Risk Level:** Blind Spot  
**Speed Limit:** 10 KM/Hr  
**Coordinates:** 11.46857, 78.45844
