# IndianOil

## JOURNEY RISK MANAGEMENT (JRM) STUDY

### Salem Terminal to S.P. SAMY AGENCIES

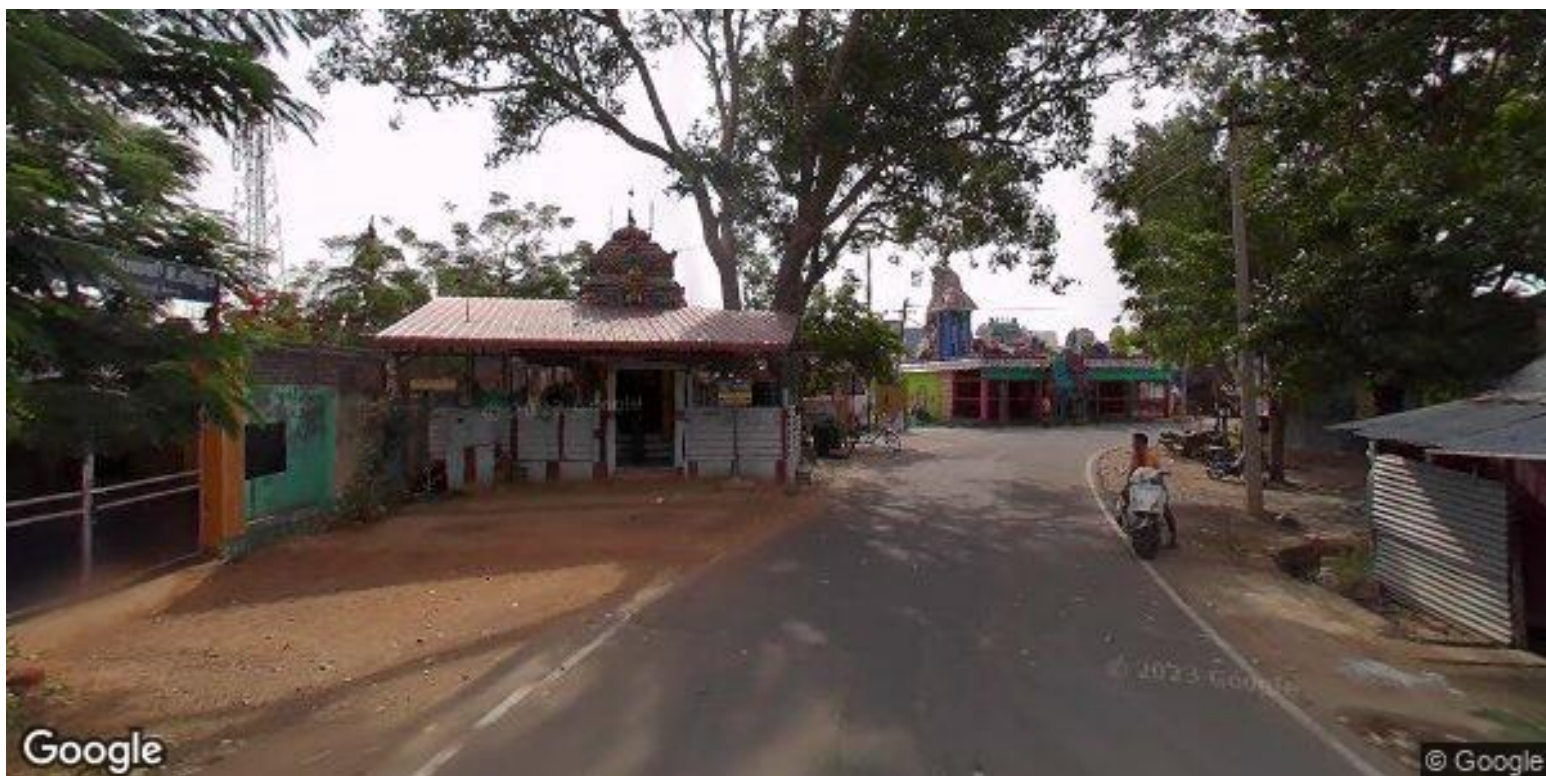
**Risk Type:** Turn  
**Risk Level:** High  
**Speed Limit:** 15 KM/Hr  
**Coordinates:** 11.46799, 78.45992

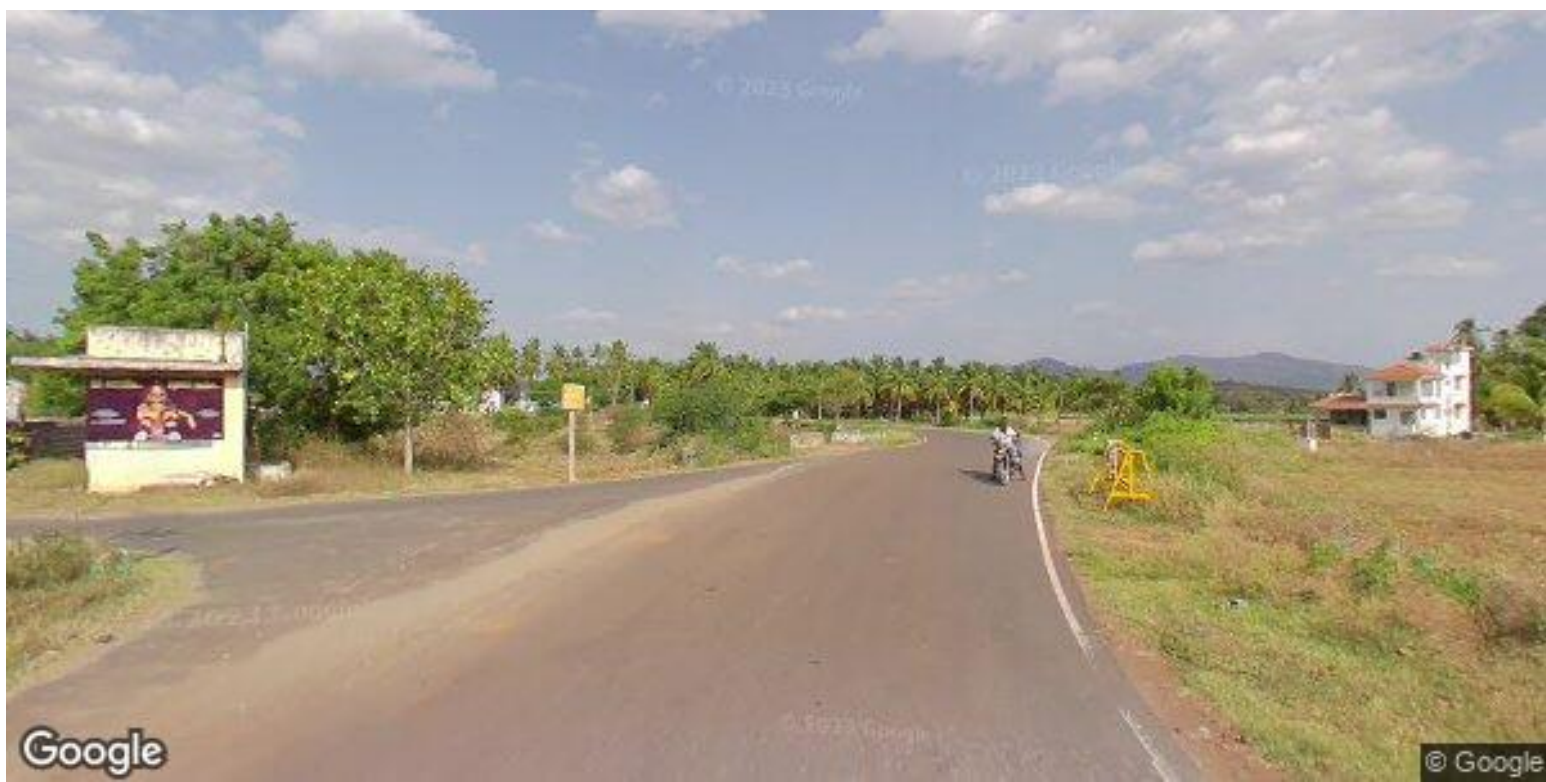
**Coordinates:** 11.46458, 78.47401

**Risk Type:** Turn

**Risk Level:** Medium

**Speed Limit:** 30 KM/Hr

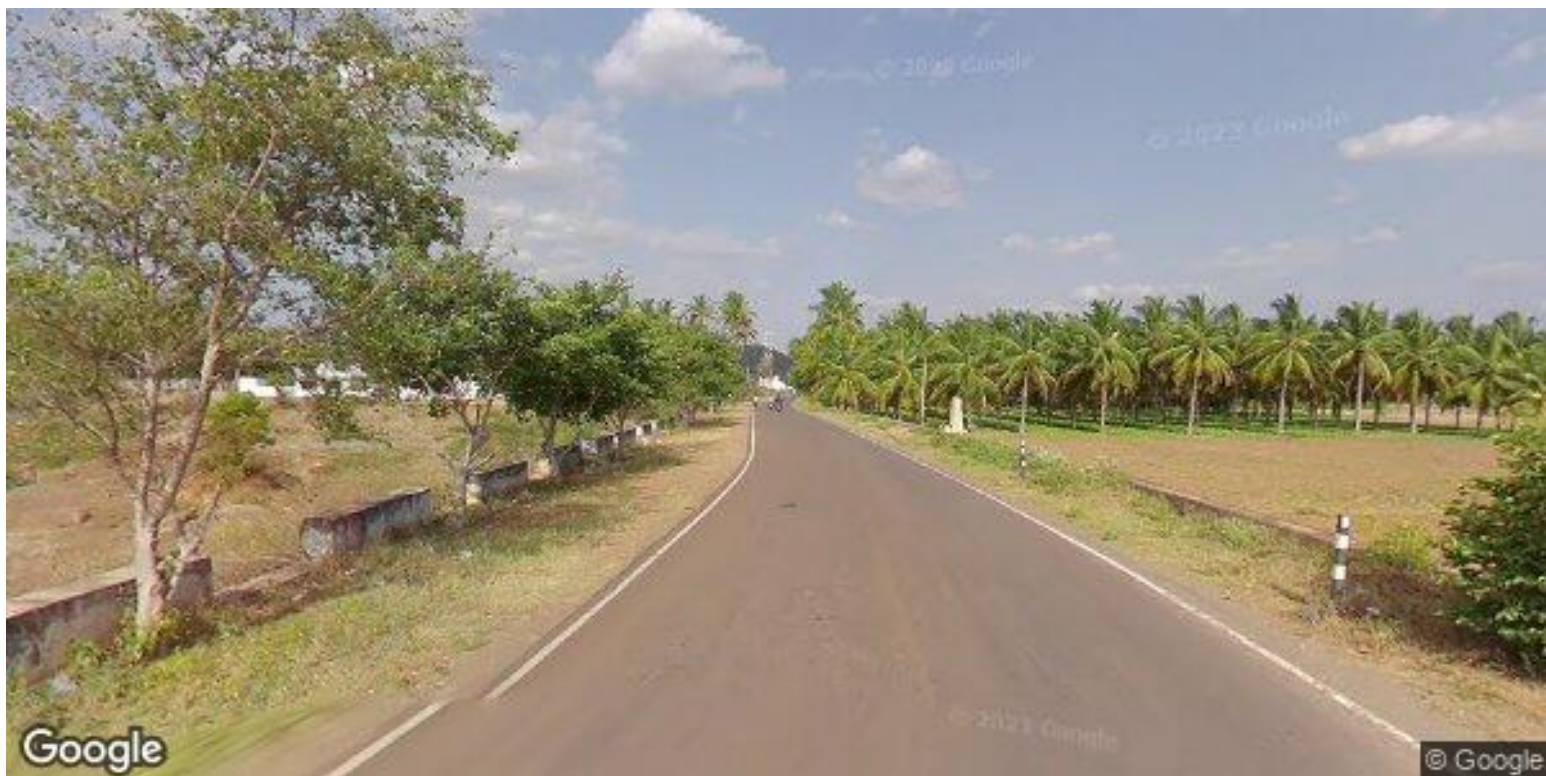
**Coordinates:** 11.46418, 78.47451

**Risk Type:** Turn

**Risk Level:** Medium

**Speed Limit:** 30 KM/Hr

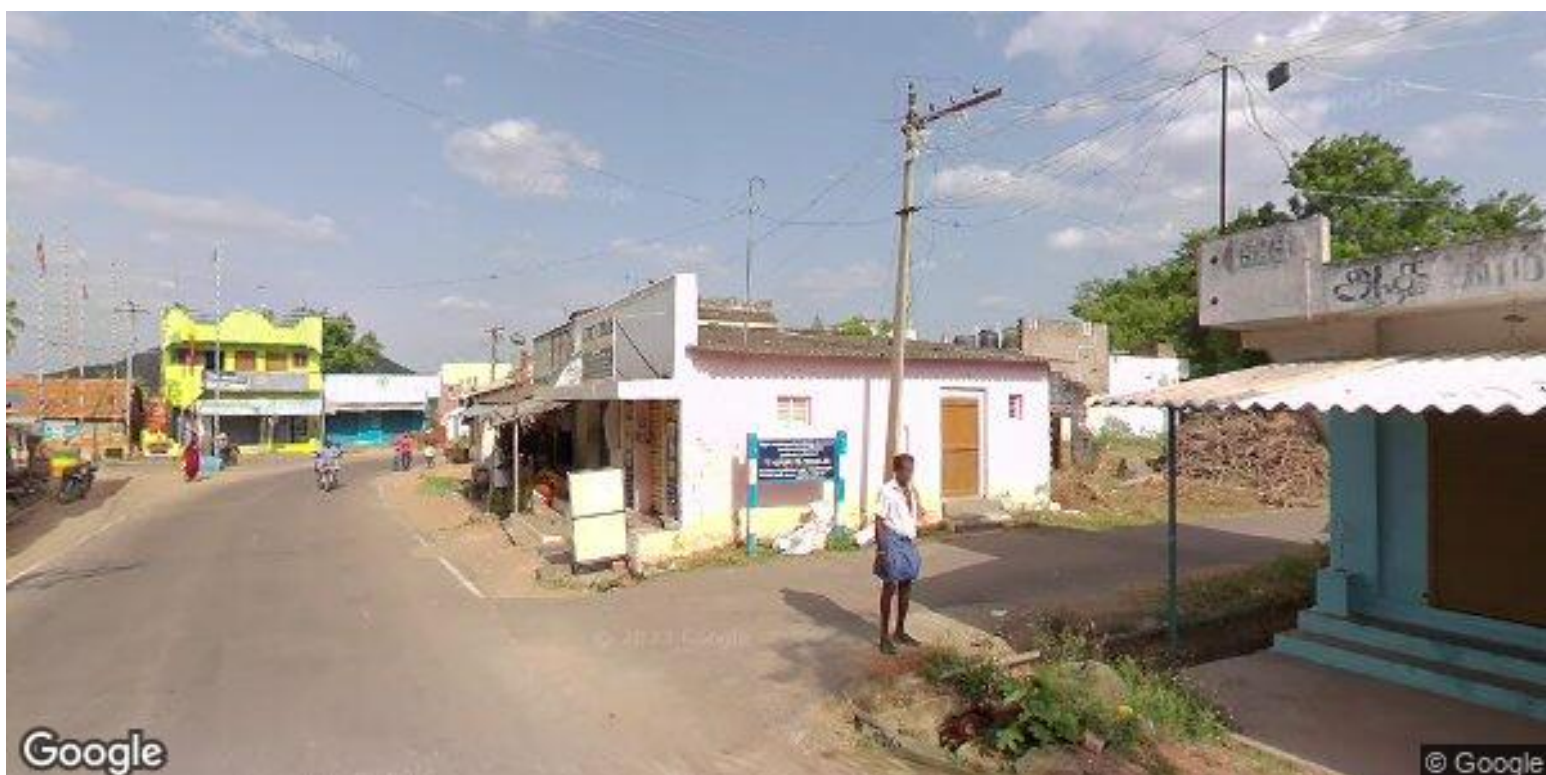
**Risk Type:** Turn  
**Risk Level:** Medium  
**Speed Limit:** 30 KM/Hr  
**Coordinates:** 11.46333, 78.48024

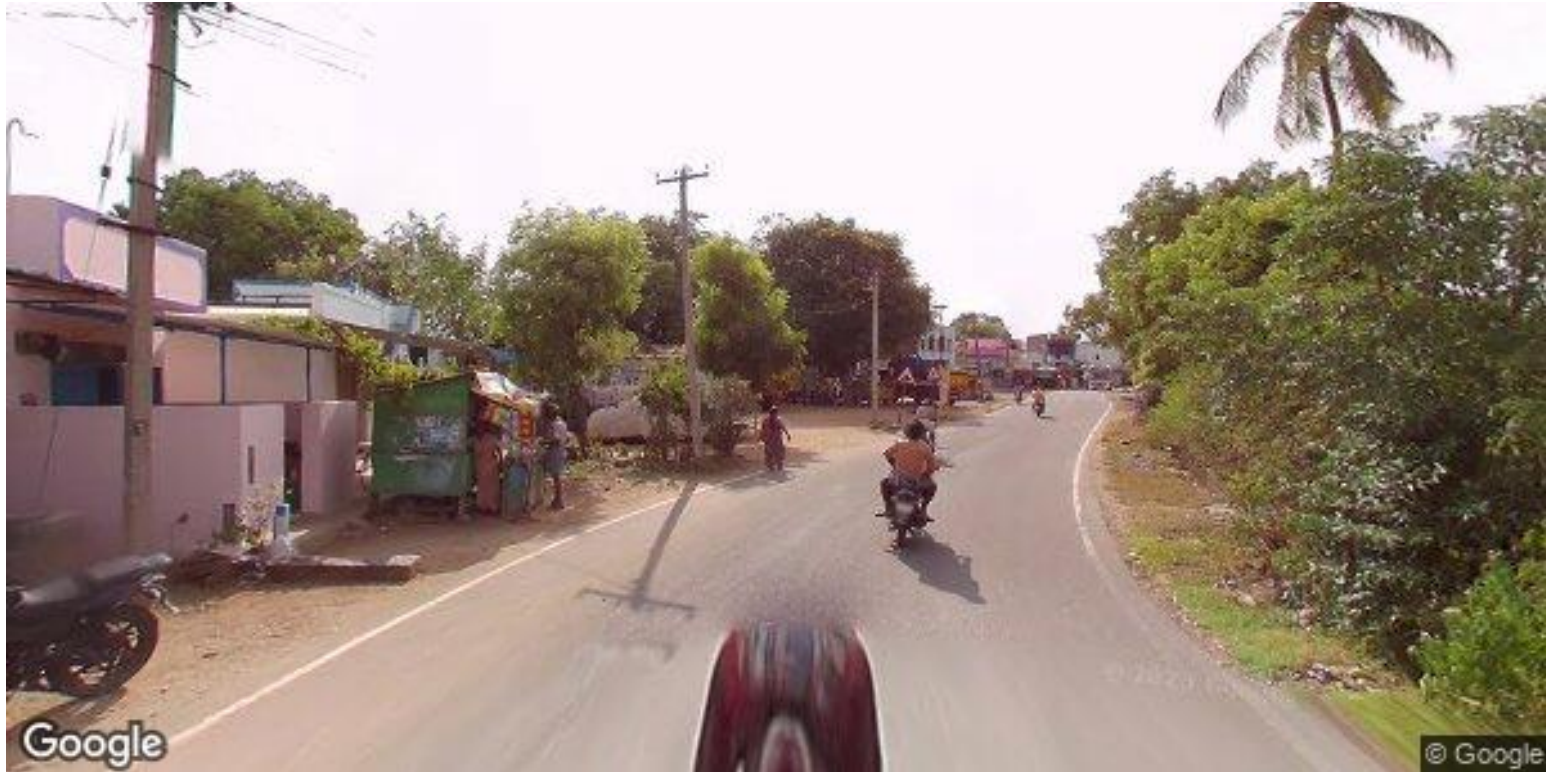
**Risk Type:** Turn  
**Risk Level:** Medium  
**Speed Limit:** 30 KM/Hr  
**Coordinates:** 11.46211, 78.48159

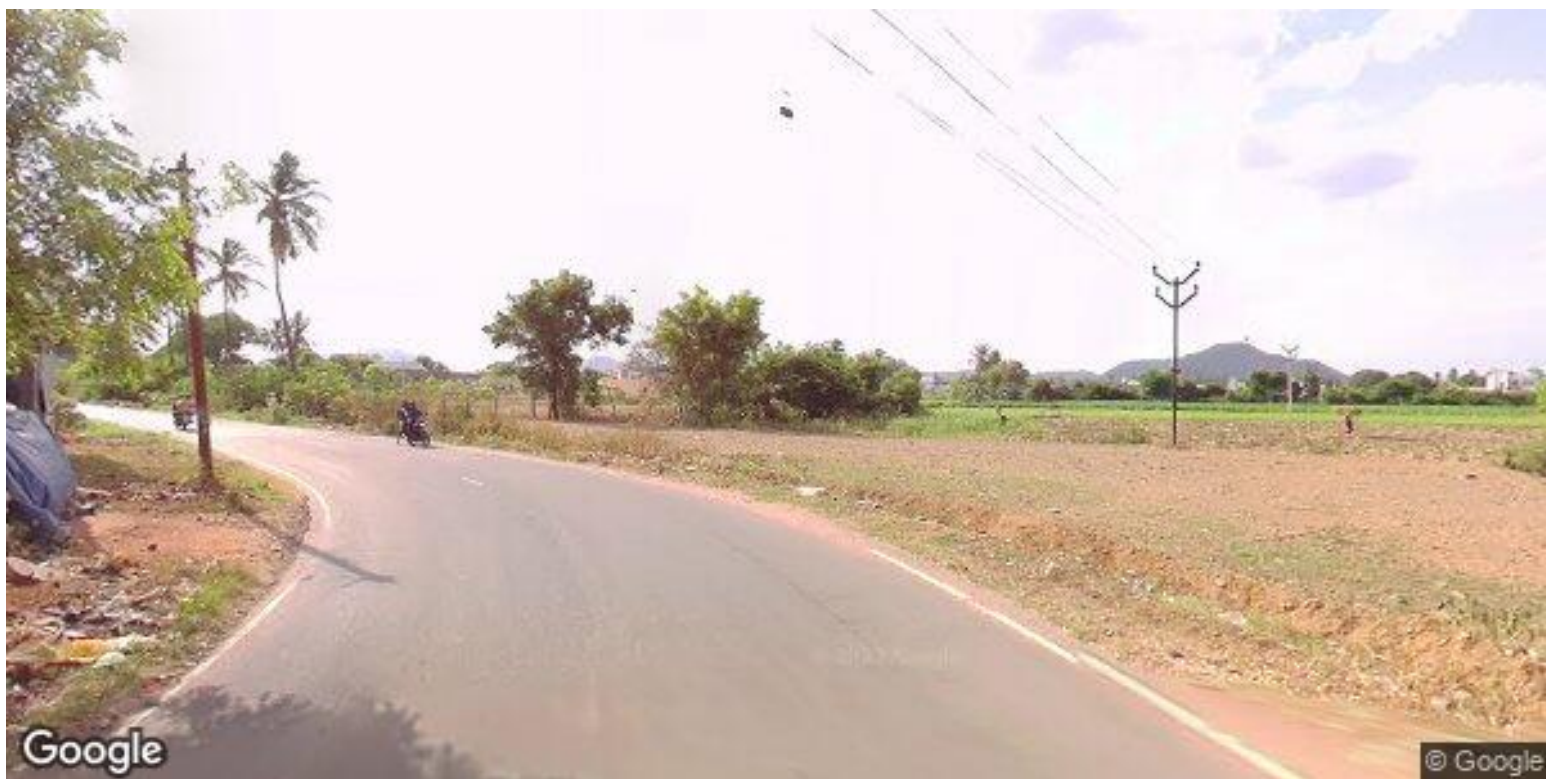
**Risk Type:** Turn  
**Risk Level:** Medium  
**Speed Limit:** 30 KM/Hr  
**Coordinates:** 11.46177, 78.48277

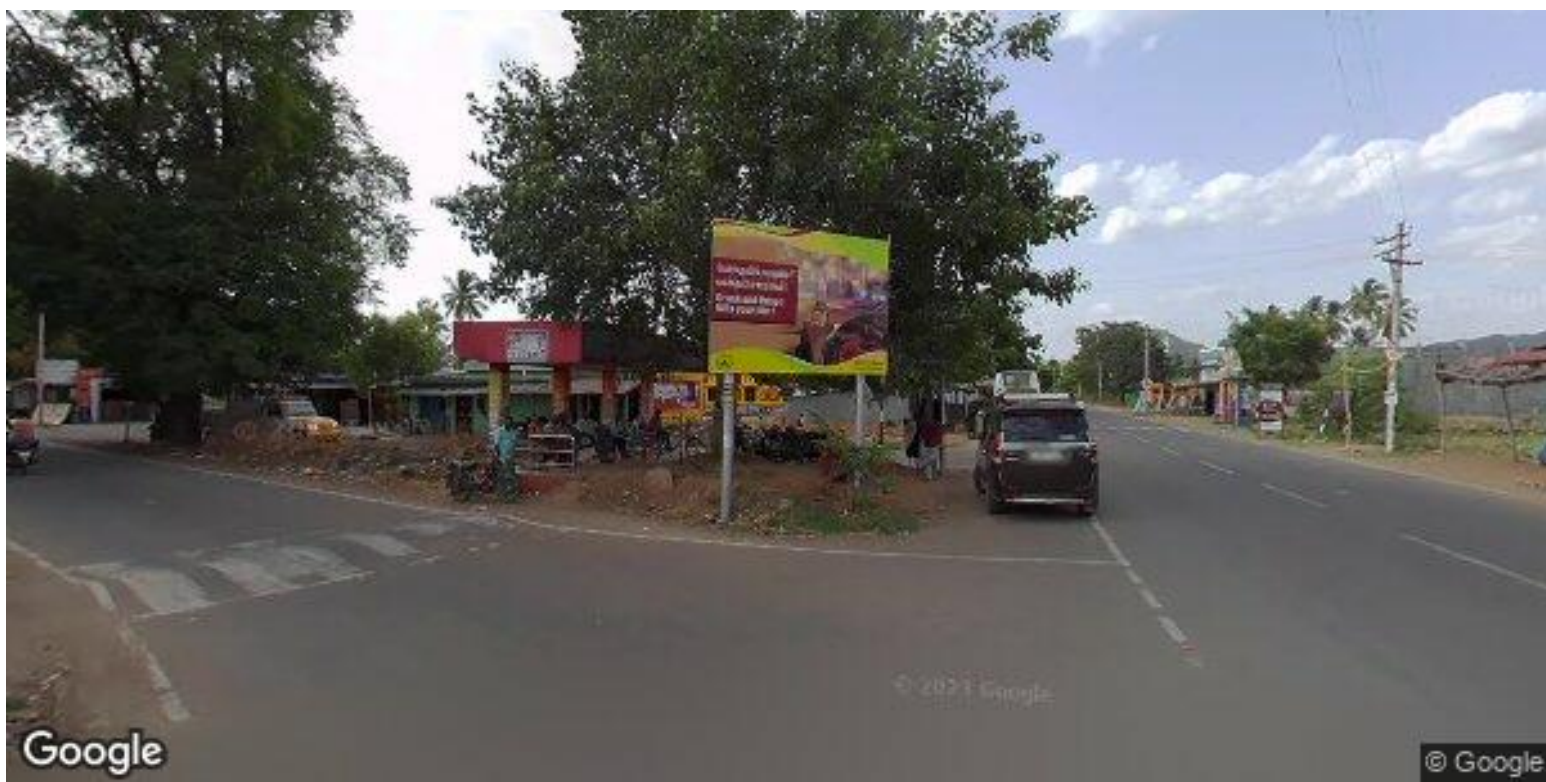
**Coordinates:** 11.46097, 78.48362

**Risk Type:** Turn

**Risk Level:** High

**Speed Limit:** 15 KM/Hr

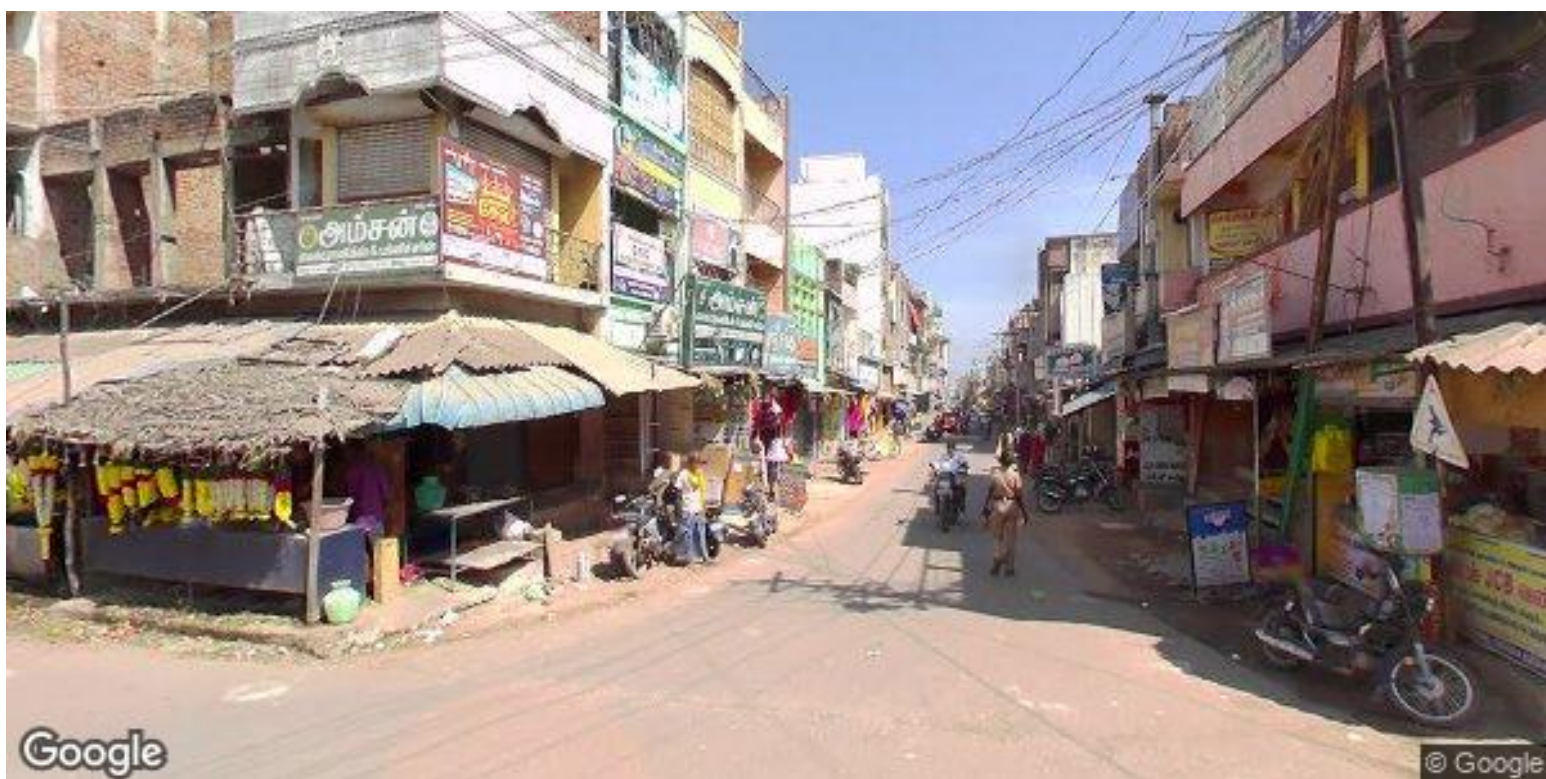
**Coordinates:** 11.44226, 78.48592

**Risk Type:** Blind Spot

**Risk Level:** Blind Spot

**Speed Limit:** 10 KM/Hr

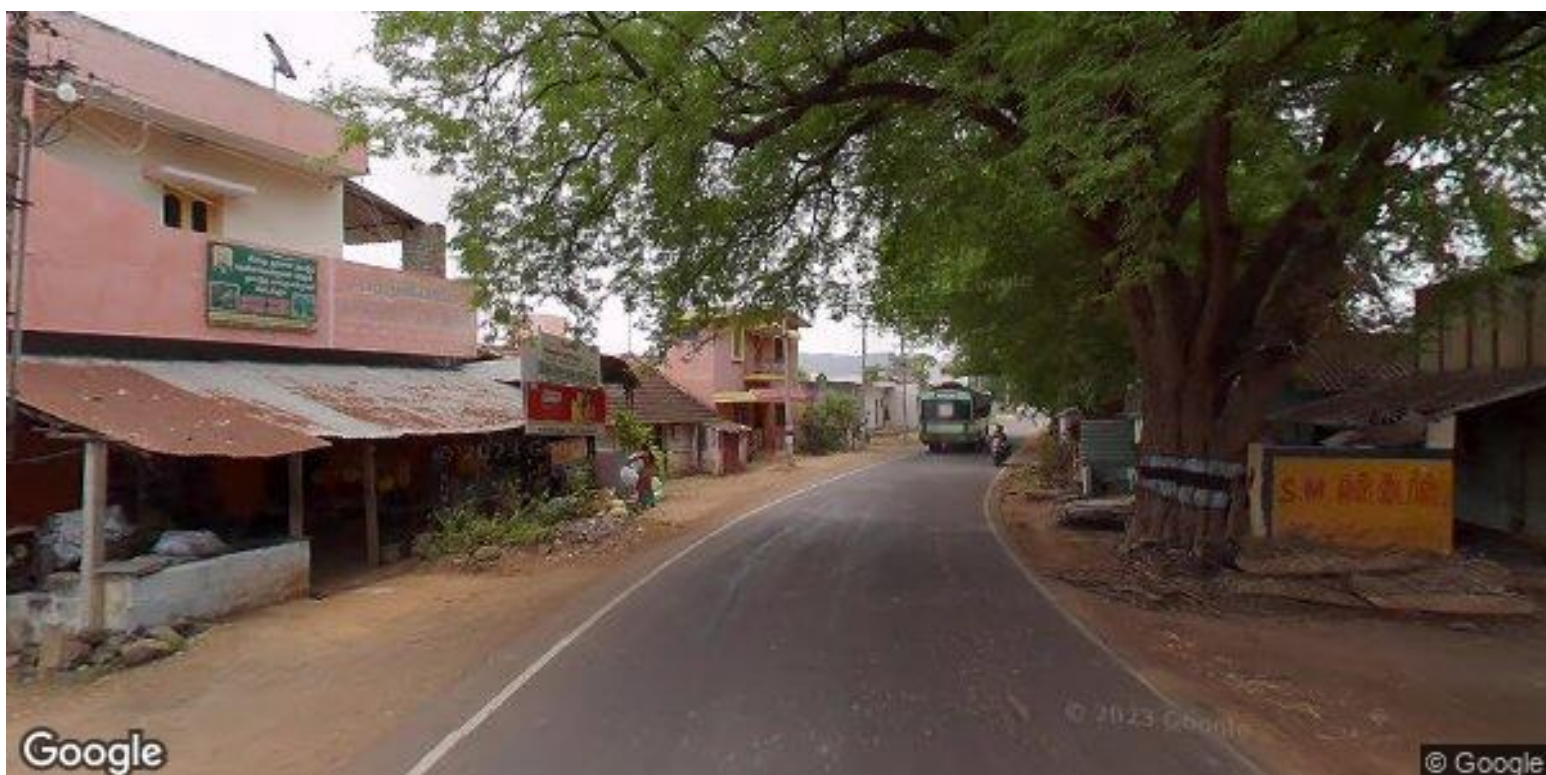
**Coordinates:** 11.45575, 78.52476

**Risk Type:** Turn

**Risk Level:** Medium

**Speed Limit:** 30 KM/Hr

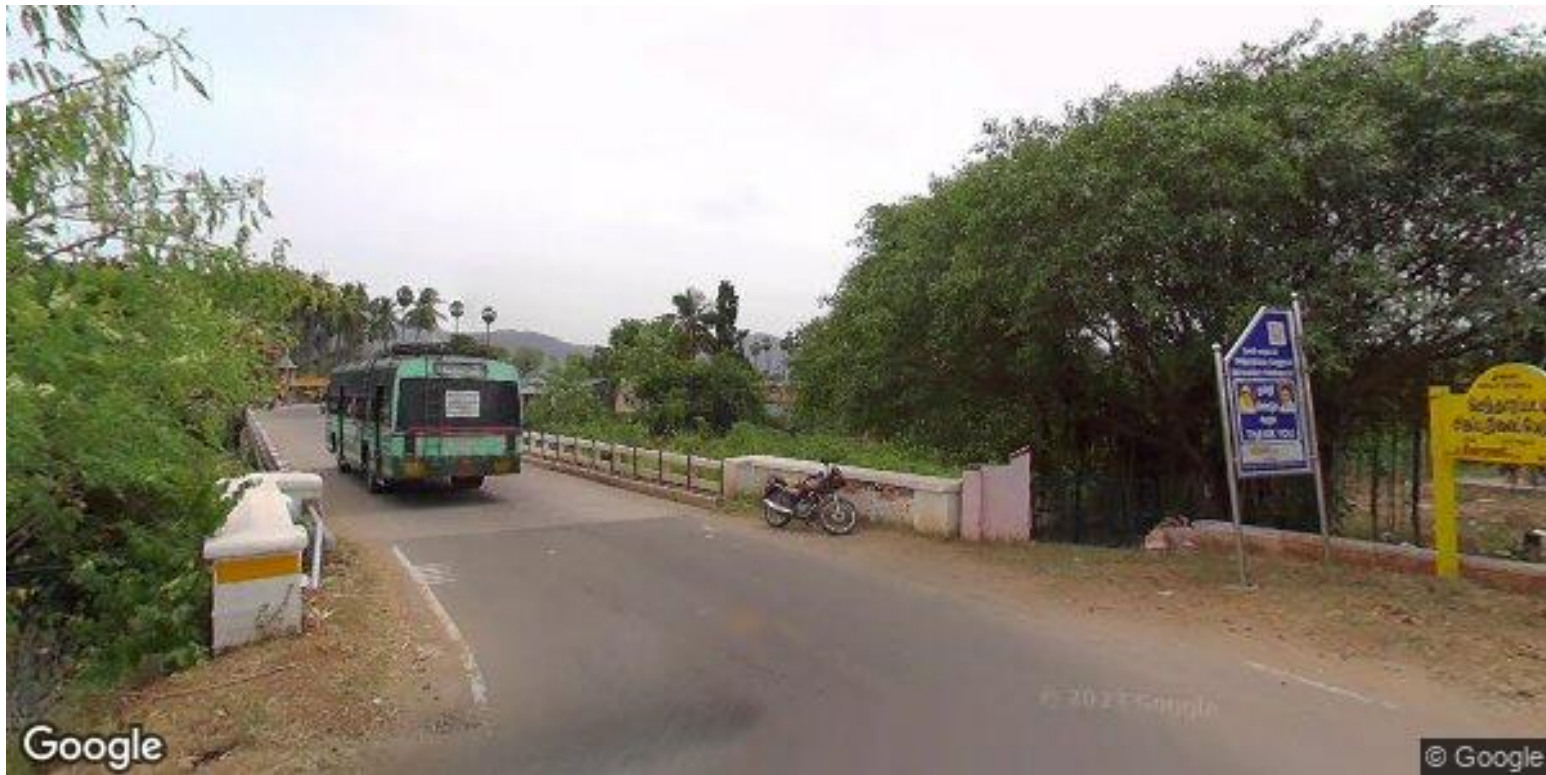
**Coordinates:** 11.45633, 78.52755

**Risk Type:** Turn

**Risk Level:** High

**Speed Limit:** 15 KM/Hr

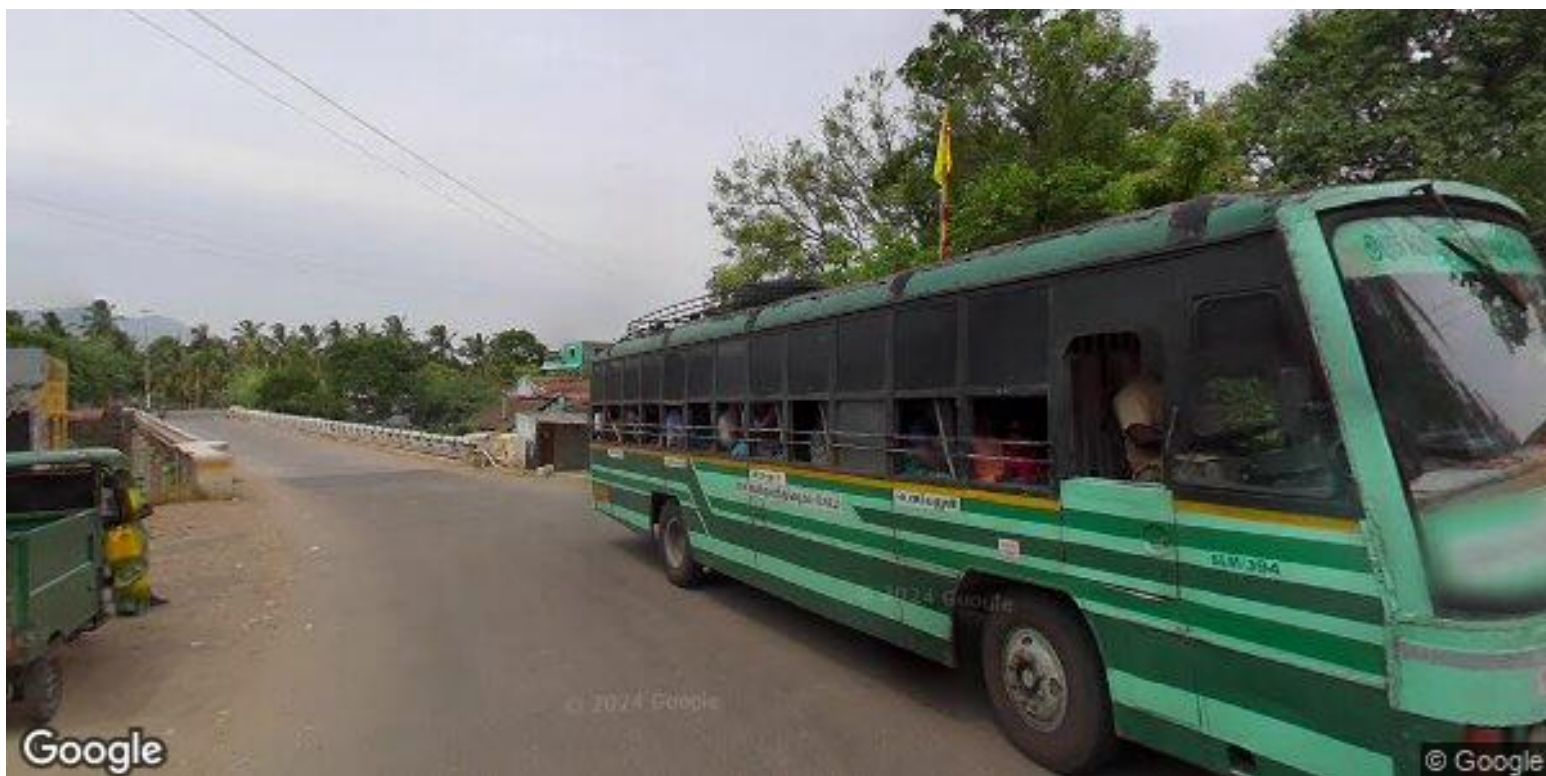
**Coordinates:** 11.45724, 78.52761

**Risk Type:** Turn

**Risk Level:** High

**Speed Limit:** 15 KM/Hr
