# IndianOil

## JOURNEY RISK MANAGEMENT (JRM) STUDY

### Salem Terminal TO THELEEPAN FUELS

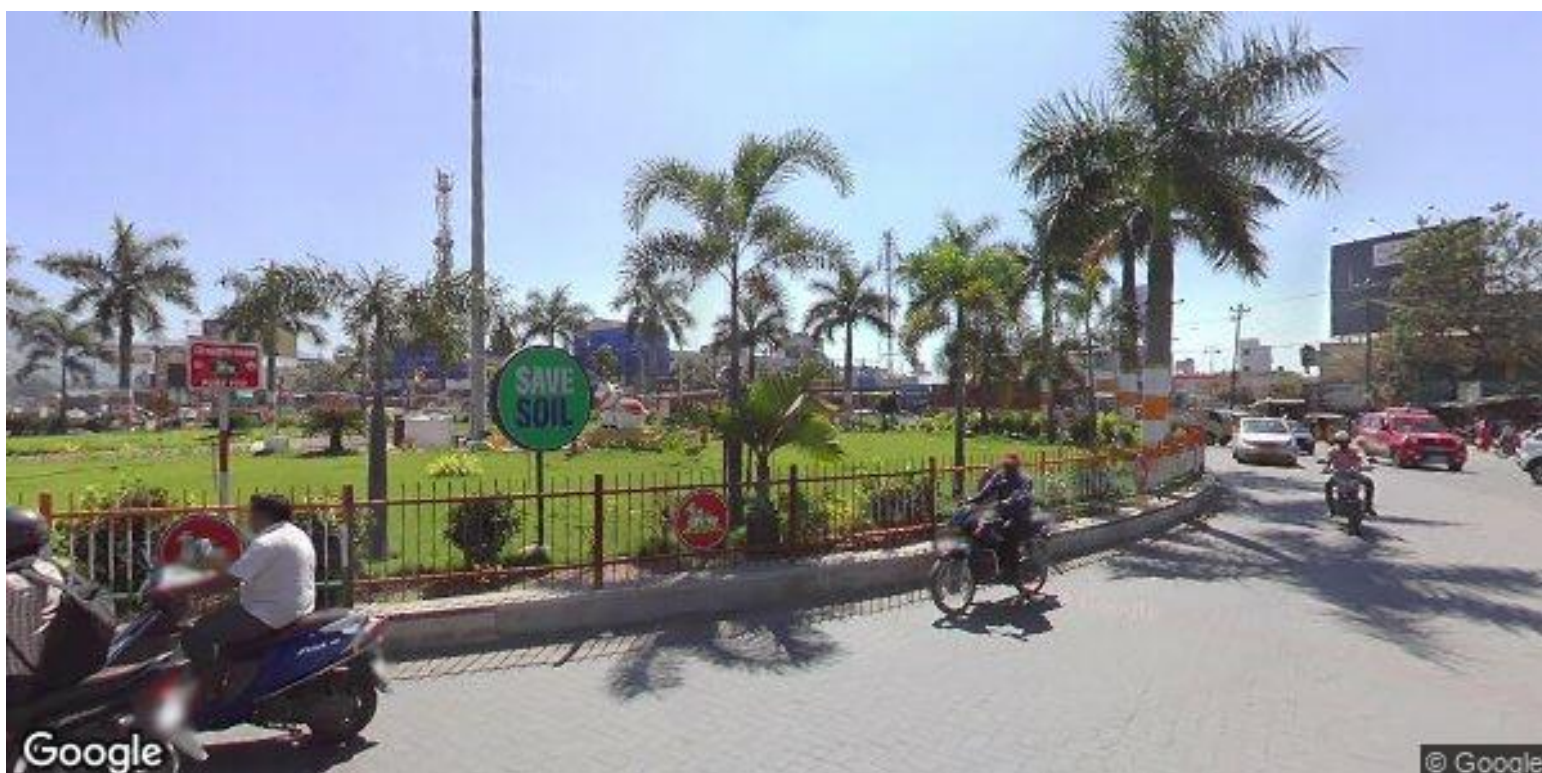
**Risk Type:** Roundabout

**Risk Level:** High

**Speed Limit: 15 KM/Hr**  
**Coordinates: 11.63303, 78.12713**

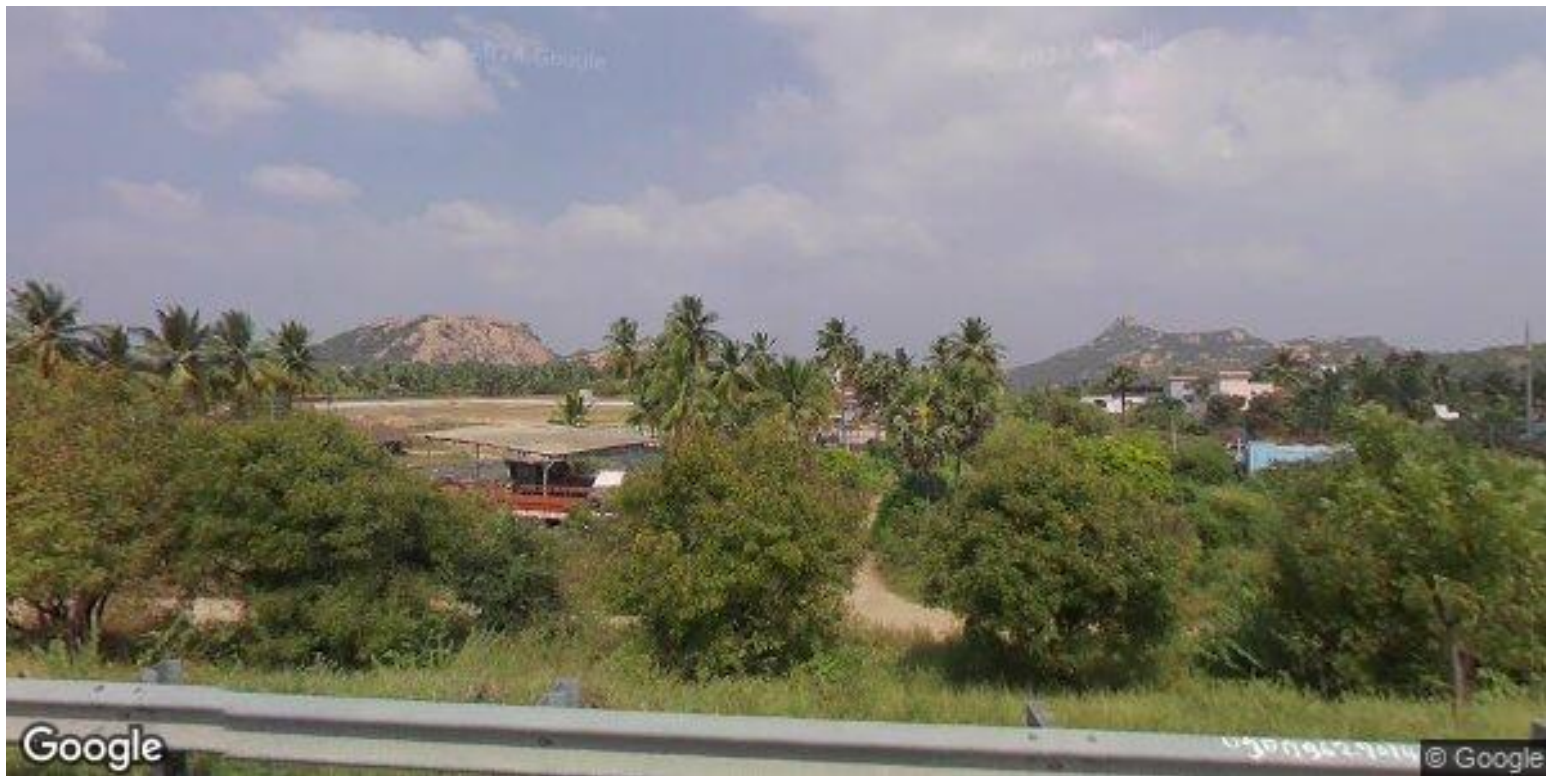
**Risk Type:** Turn  
**Risk Level:** High  
**Speed Limit:** 15 KM/Hr  
**Coordinates:** 11.49383, 77.88442

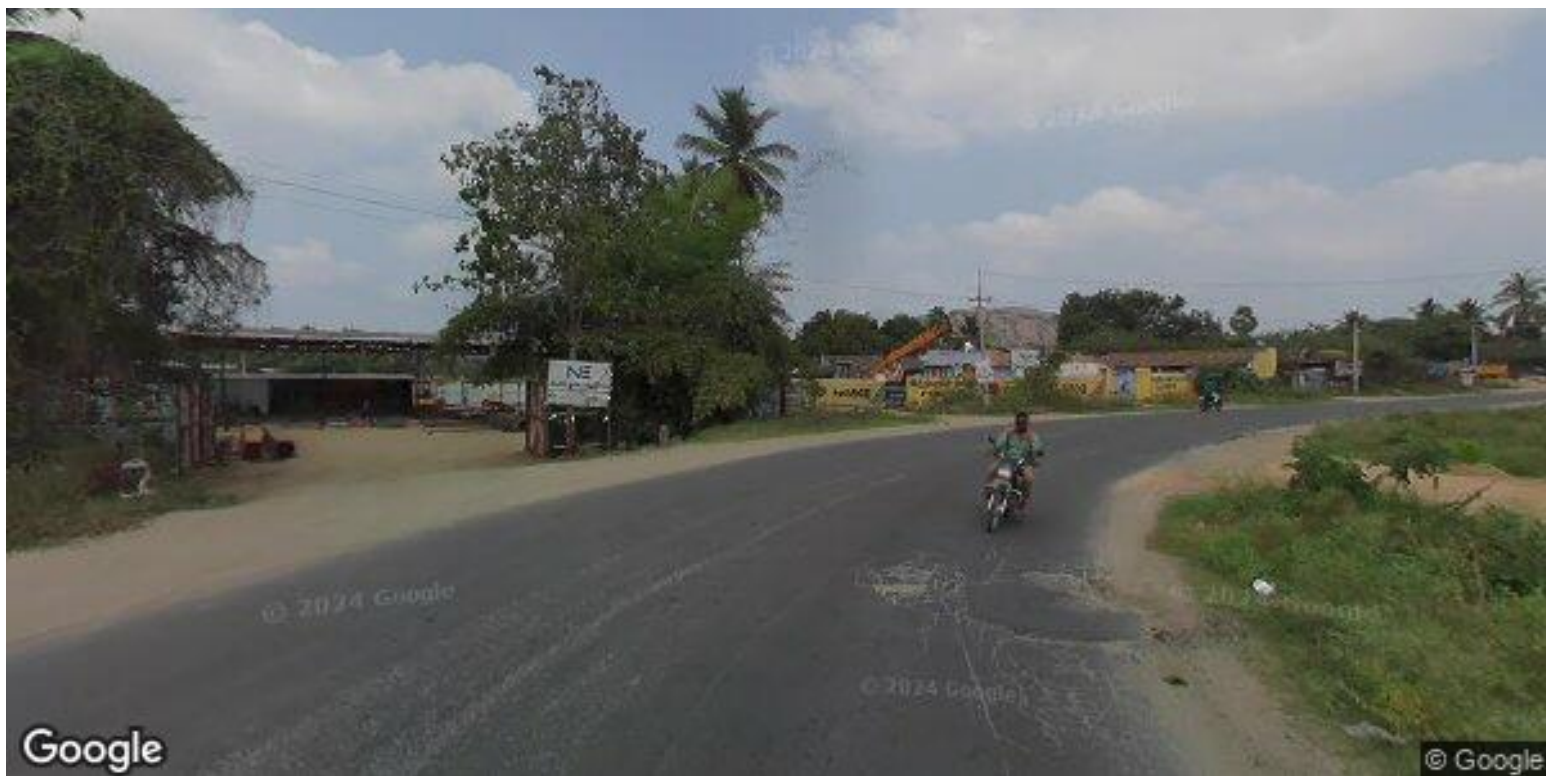
**Risk Type:** Turn

**Risk Level:** High

**Speed Limit:** 15 KM/Hr

**Coordinates:** 11.49444, 77.88492

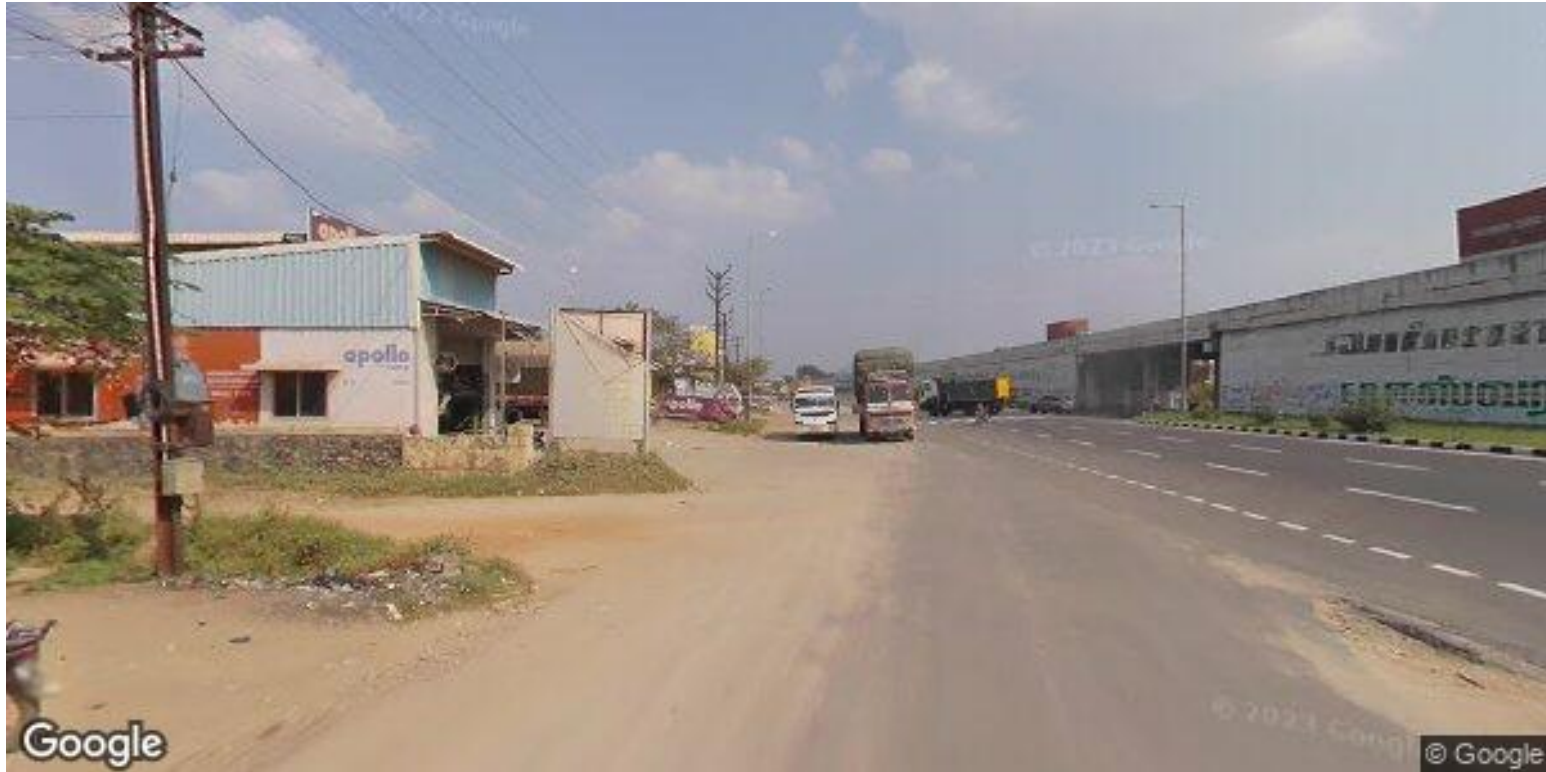
**Risk Type:** Turn  
**Risk Level:** High  
**Speed Limit:** 15 KM/Hr  
**Coordinates:** 11.49236, 77.89552

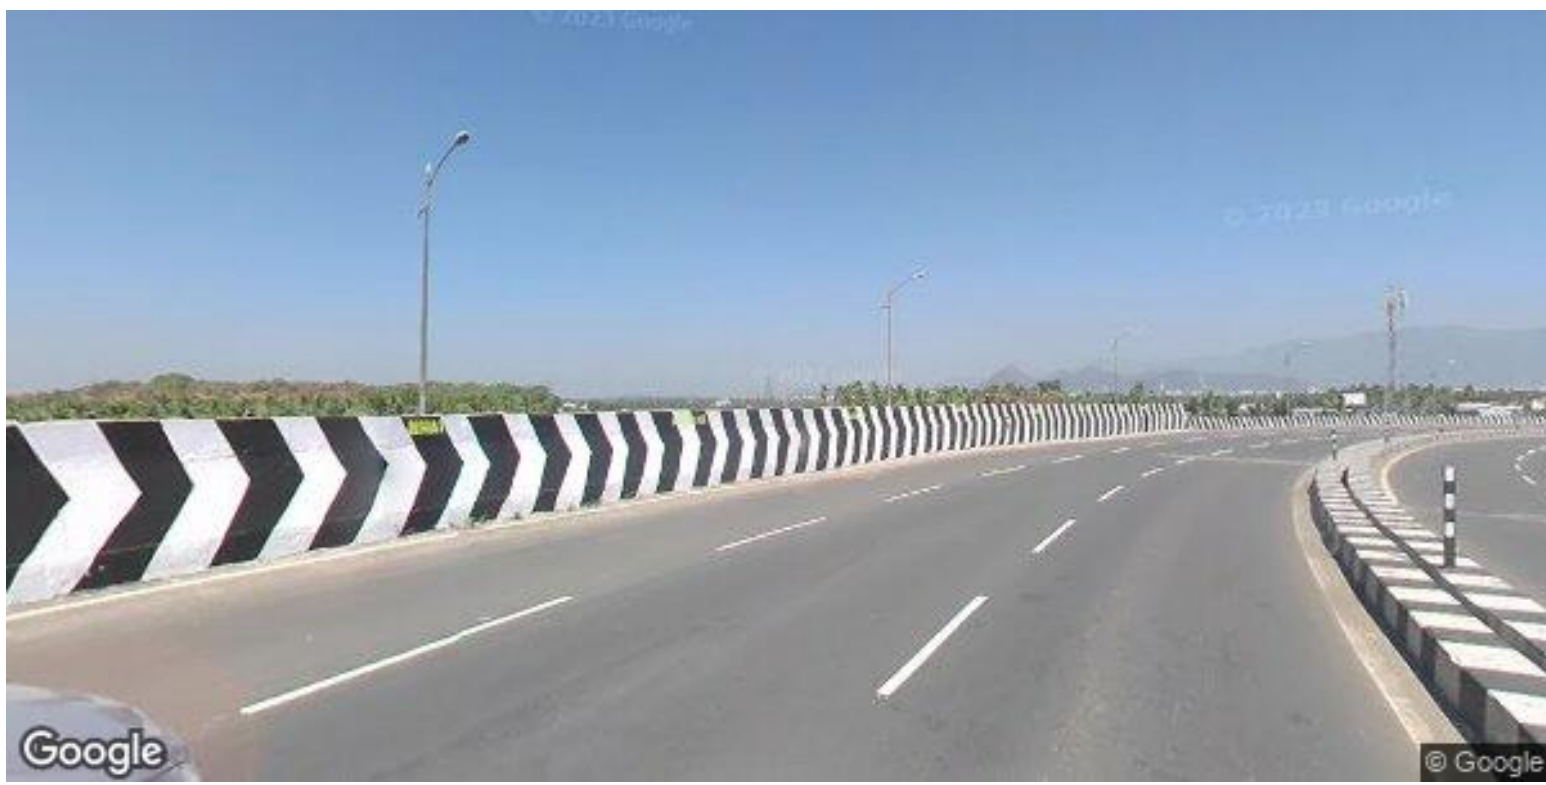
**Risk Type:** Turn

**Risk Level:** Medium

**Speed Limit:** 30 KM/Hr

**Coordinates:** 11.64144, 78.11803

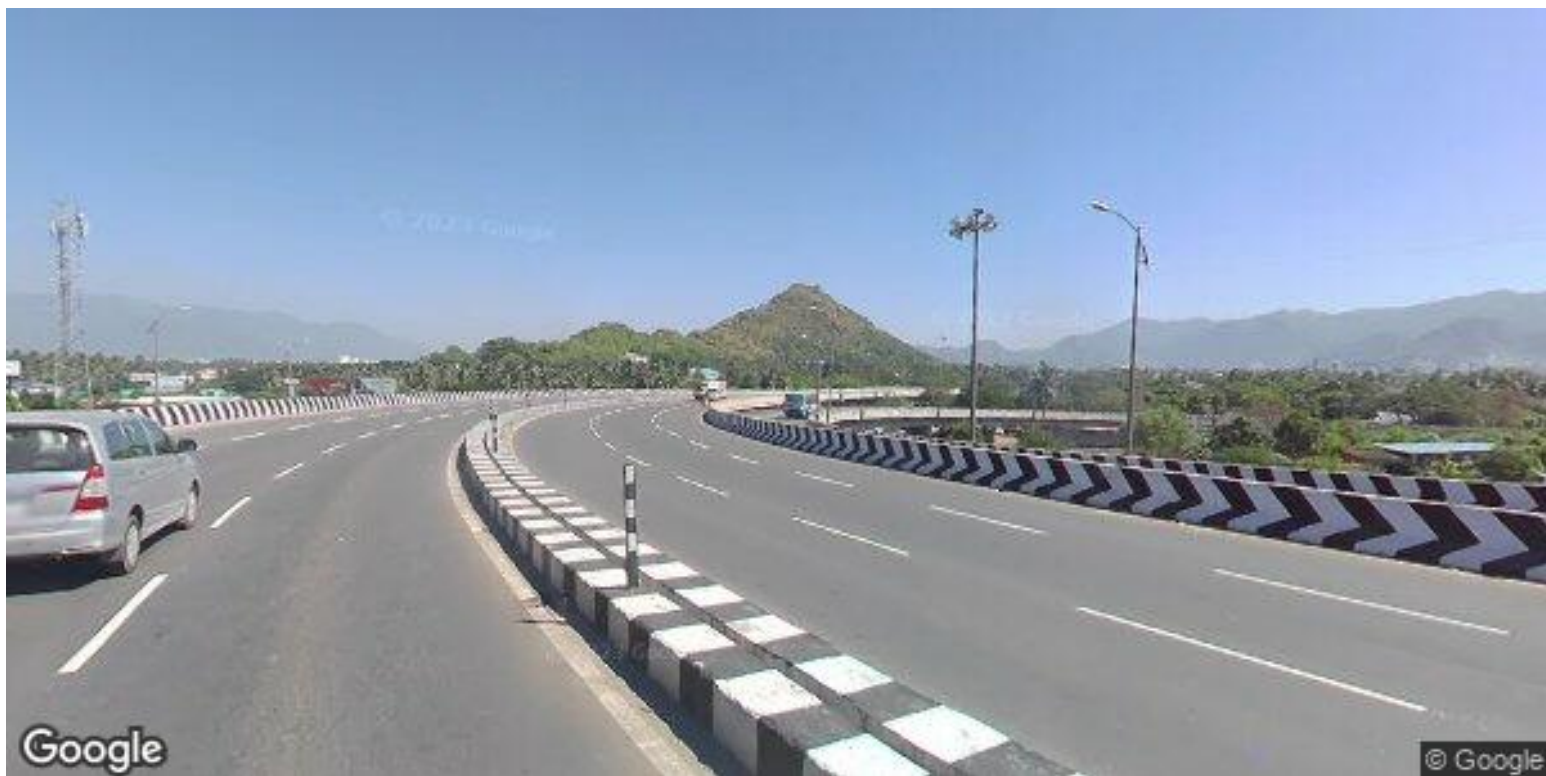
**Risk Type:** Turn

**Risk Level:** Medium

**Speed Limit:** 30 KM/Hr

**Coordinates:** 11.64186, 78.11829

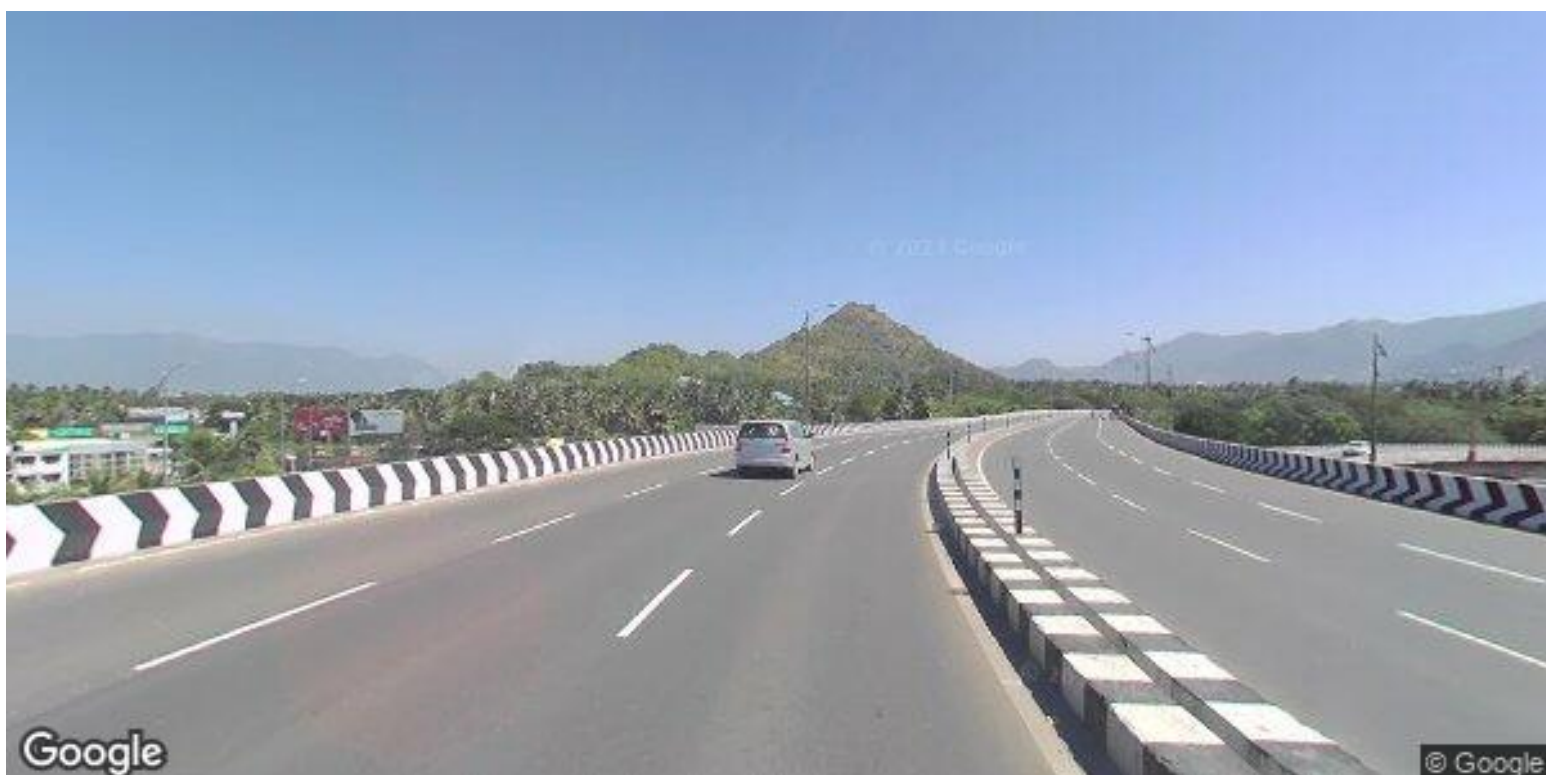
**Risk Type:** Turn  
**Risk Level:** Medium  
**Speed Limit:** 30 KM/Hr  
**Coordinates:** 11.64220, 78.11887

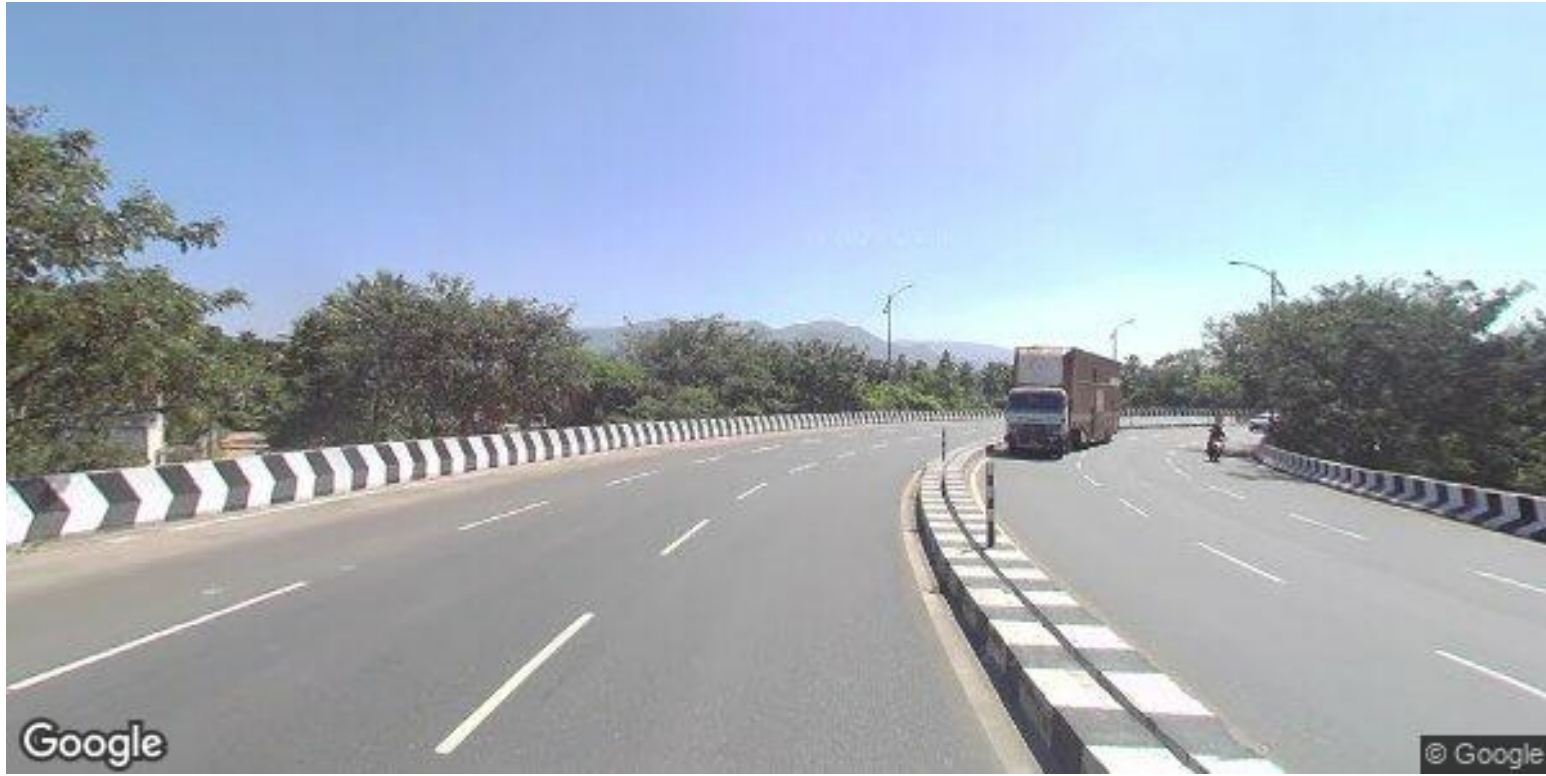
**Risk Type:** Turn  
**Risk Level:** Medium  
**Speed Limit:** 30 KM/Hr  
**Coordinates:** 11.64189, 78.12137

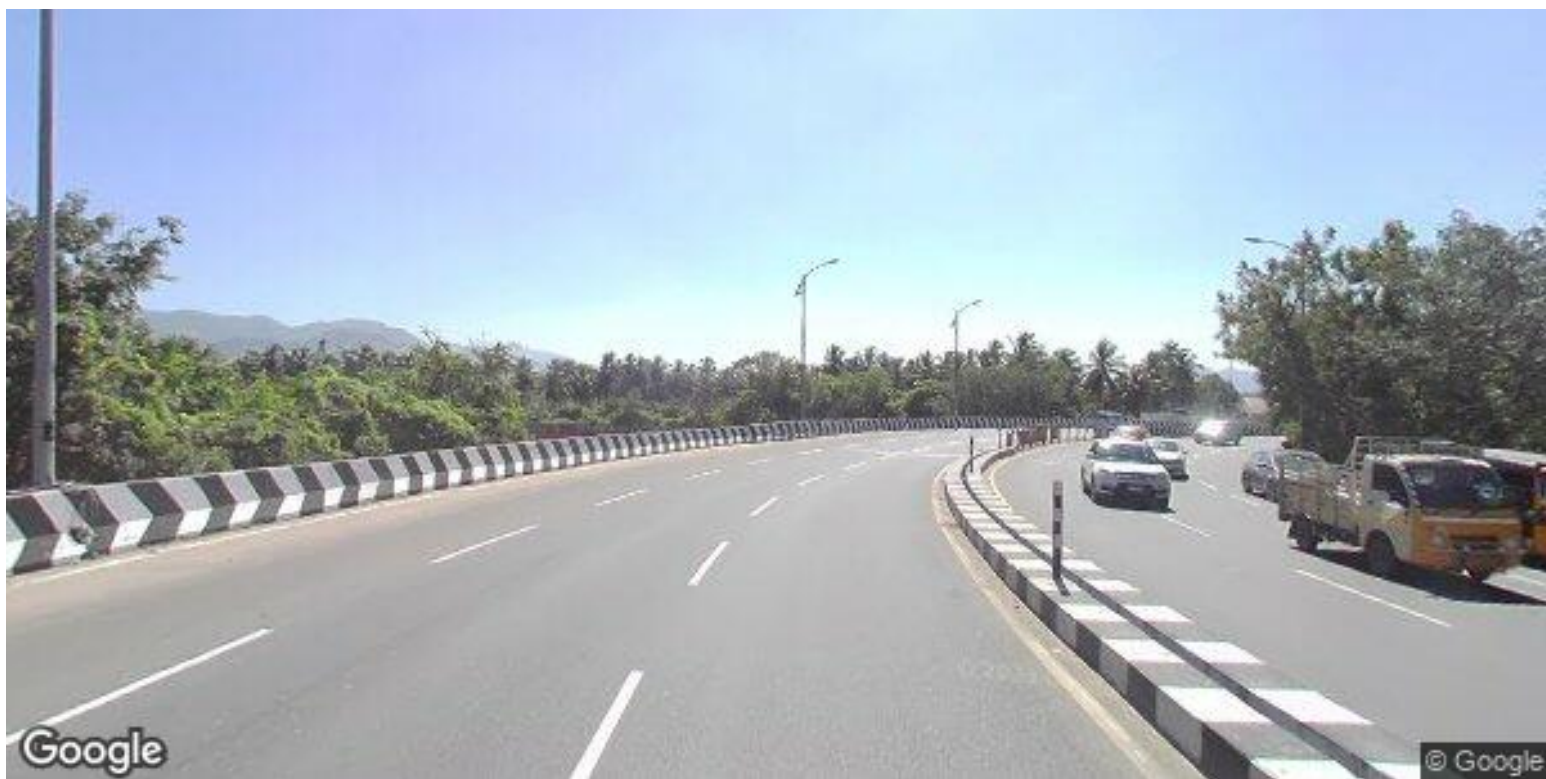
**Risk Type:** Turn  
**Risk Level:** Medium  
**Speed Limit:** 30 KM/Hr  
**Coordinates:** 11.64152, 78.12164

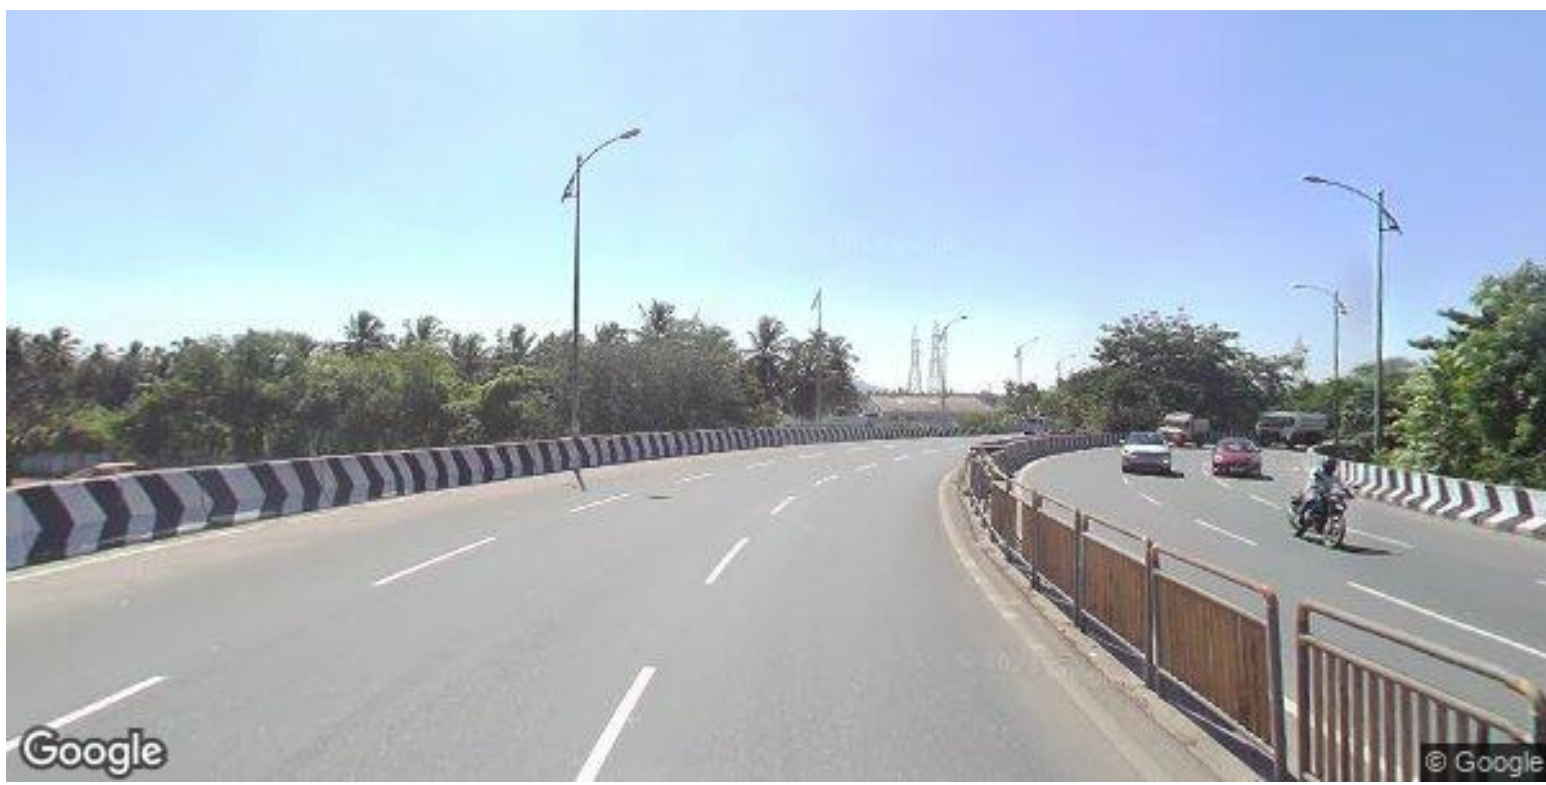
**Risk Type:** Turn

**Risk Level:** Medium

**Speed Limit:** 30 KM/Hr

**Coordinates:** 11.64111, 78.12167

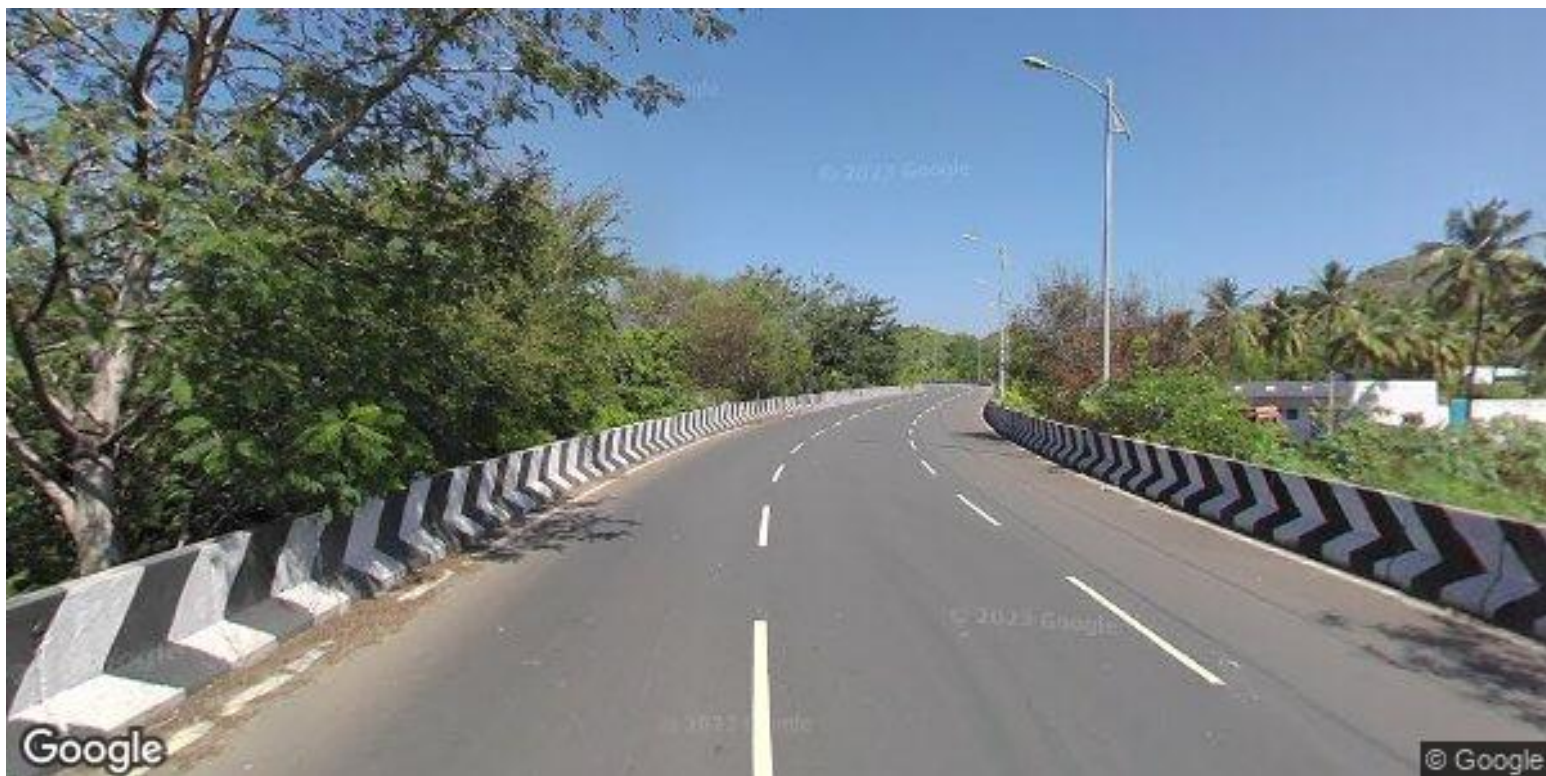
**Risk Type:** Turn

**Risk Level:** Medium

**Speed Limit:** 30 KM/Hr

**Coordinates:** 11.64000, 78.12092

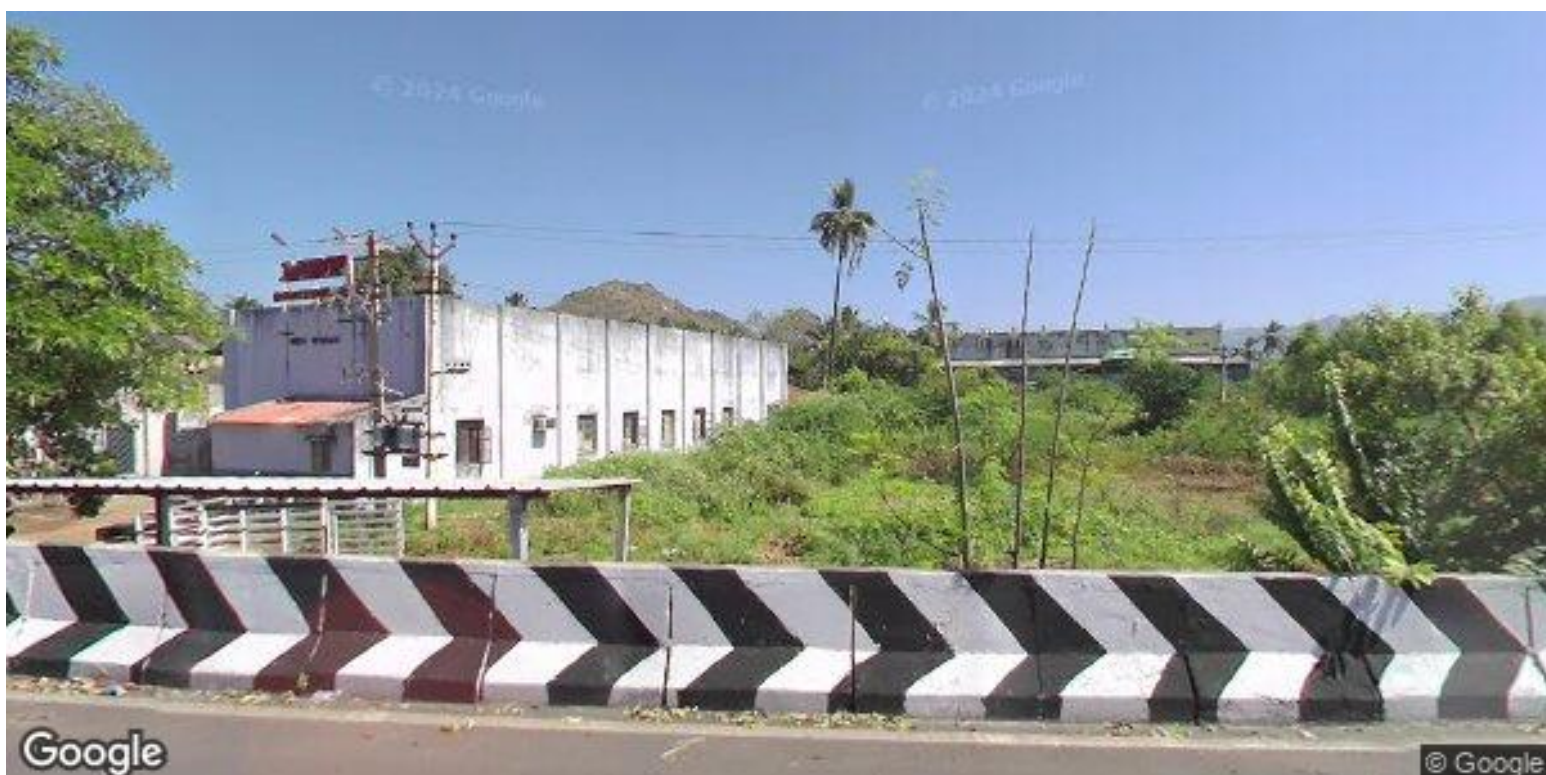
**Risk Type:** Turn

**Risk Level:** Medium

**Speed Limit:** 30 KM/Hr

**Coordinates:** 11.63917, 78.12086

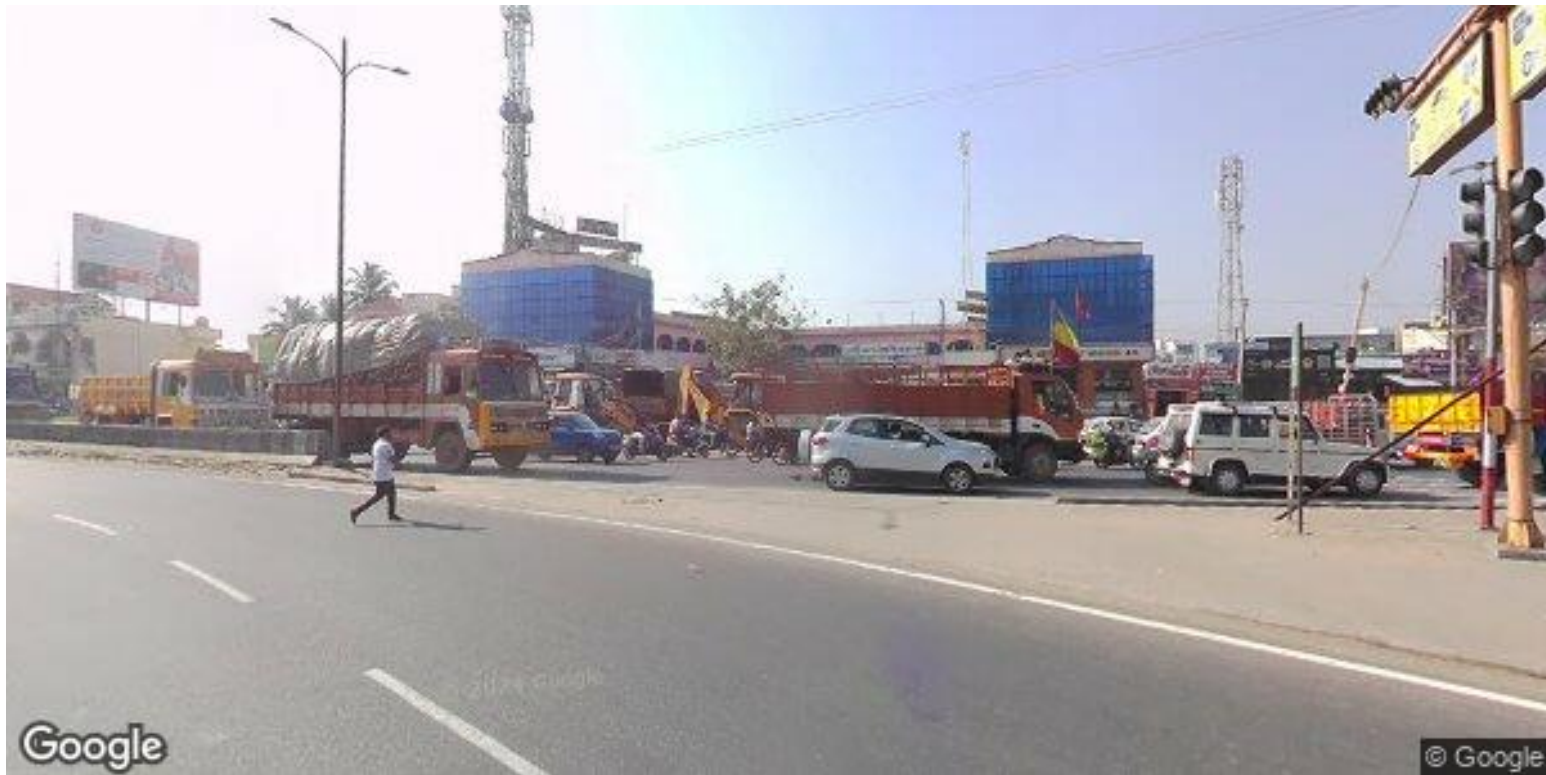
**Risk Type:** Turn

**Risk Level:** Medium

**Speed Limit:** 30 KM/Hr

**Coordinates:** 11.63254, 78.12770

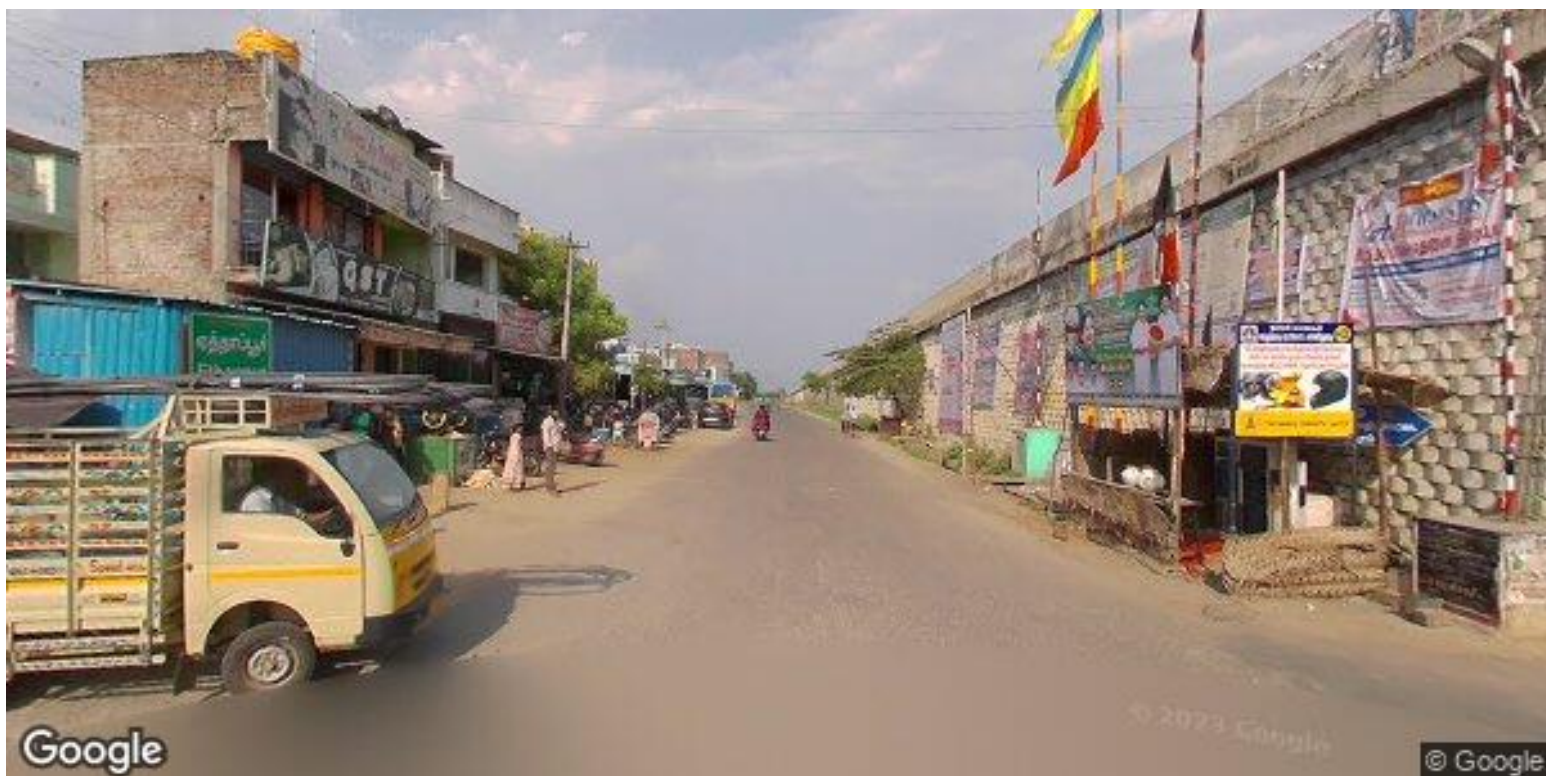
**Risk Type:** Turn

**Risk Level:** High

**Speed Limit:** 15 KM/Hr

**Coordinates:** 11.65111, 78.47828

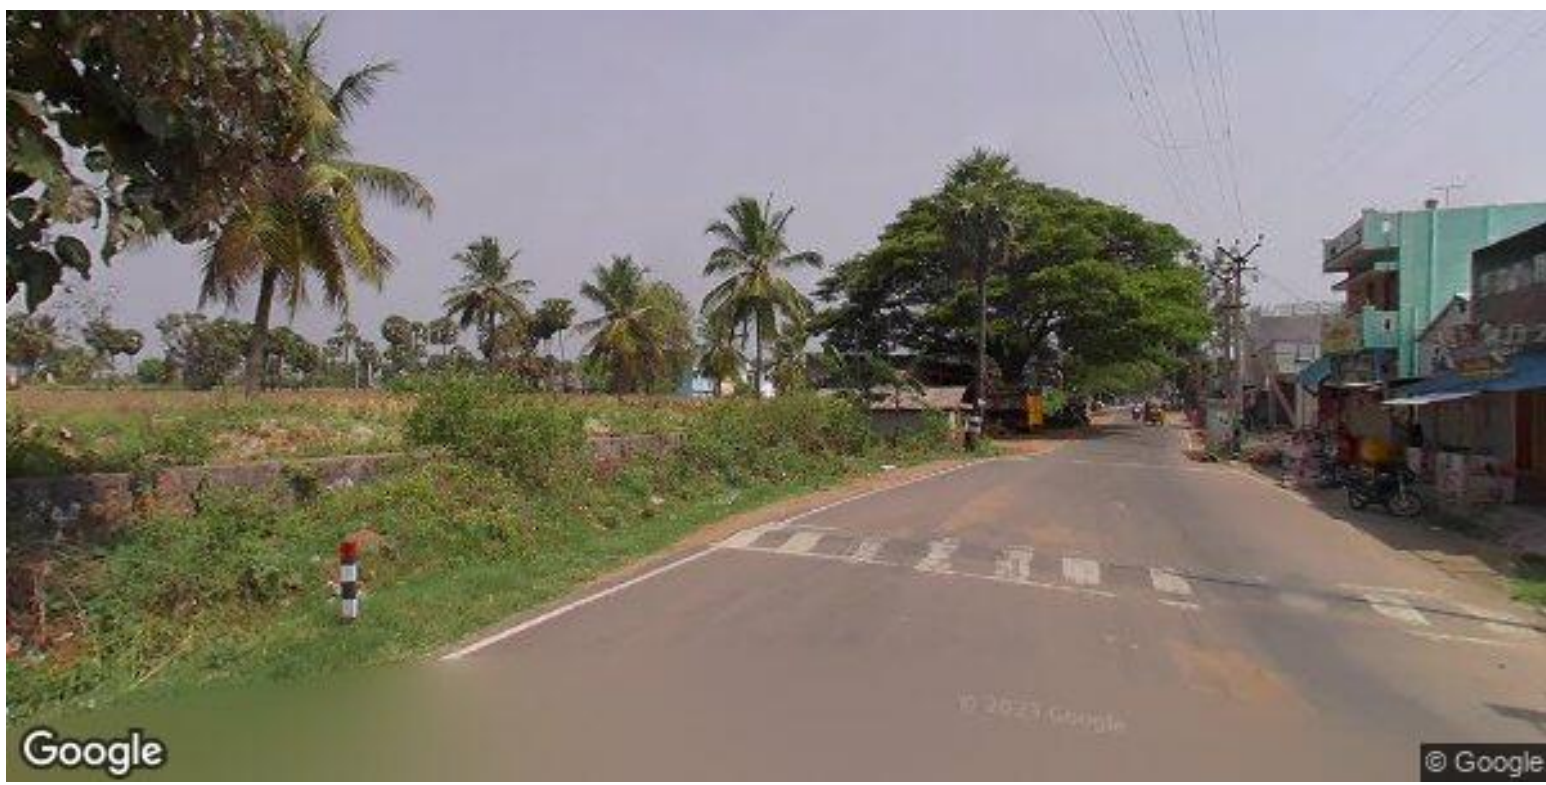
**Risk Type:** Turn

**Risk Level:** High

**Speed Limit:** 15 KM/Hr

**Coordinates:** 11.65786, 78.48011
