## JOURNEY RISK MANAGEMENT (JRM) STUDY

### Salem Terminal TO KARTHIK FUELS IOC DEALER

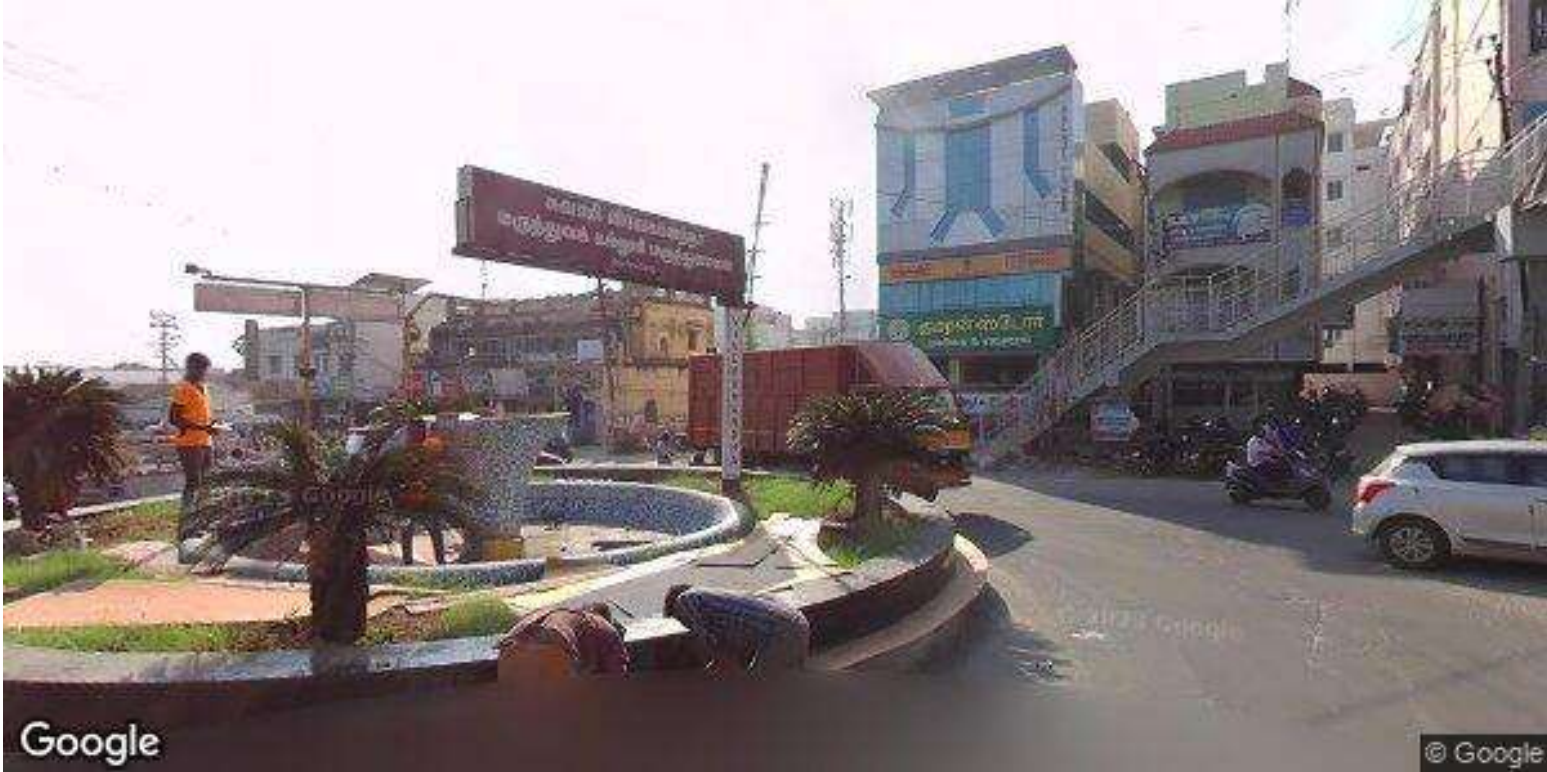
Risk Type: Roundabout  
Risk Level: High  
Speed Limit: 15 KM/Hr  
Coordinates: 11.38395, 77.89480

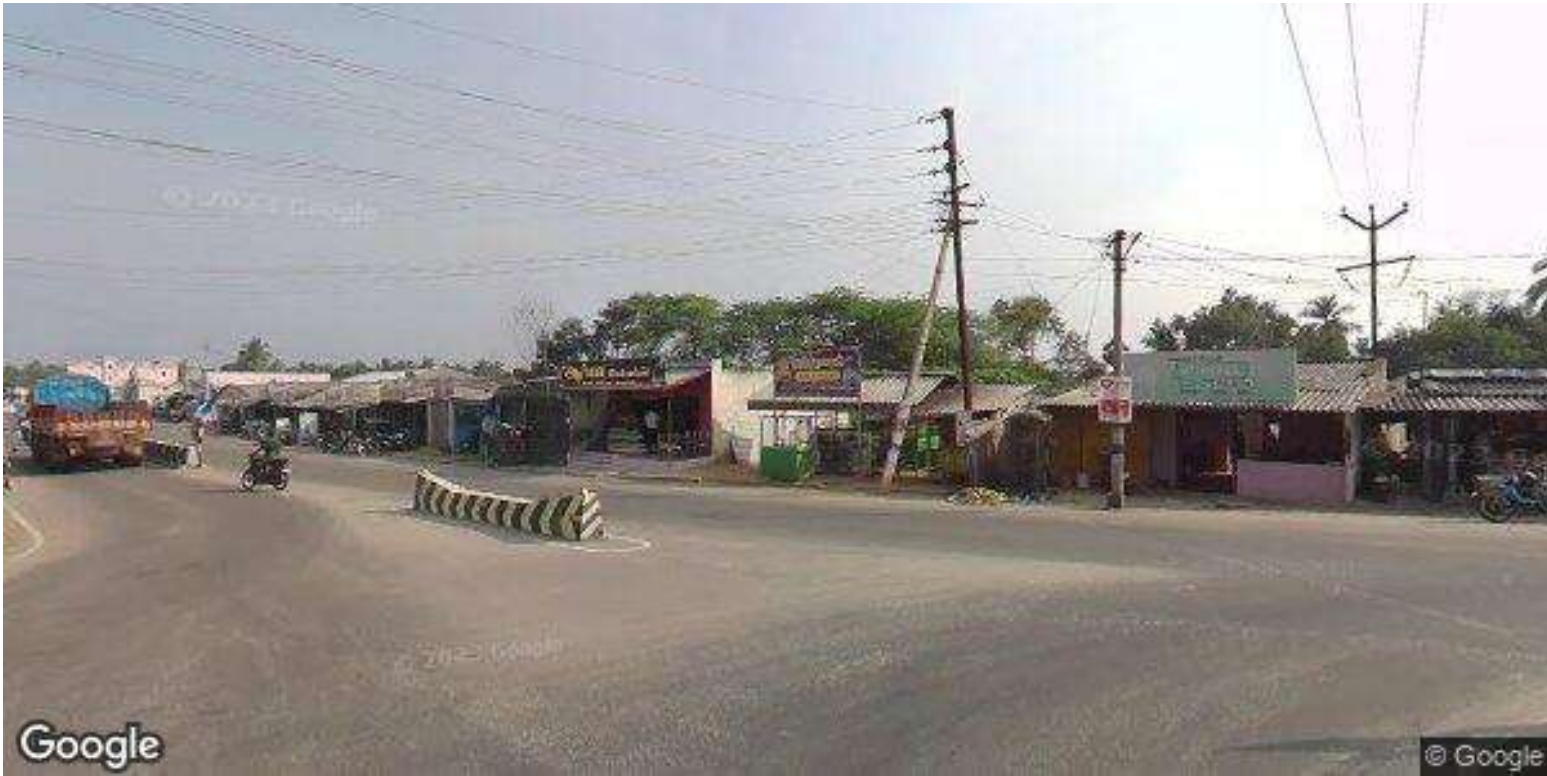
**Risk Type: Roundabout**

**Risk Level: High**

**Speed Limit: 15 KM/Hr**

**Coordinates: 11.04637, 77.73761**

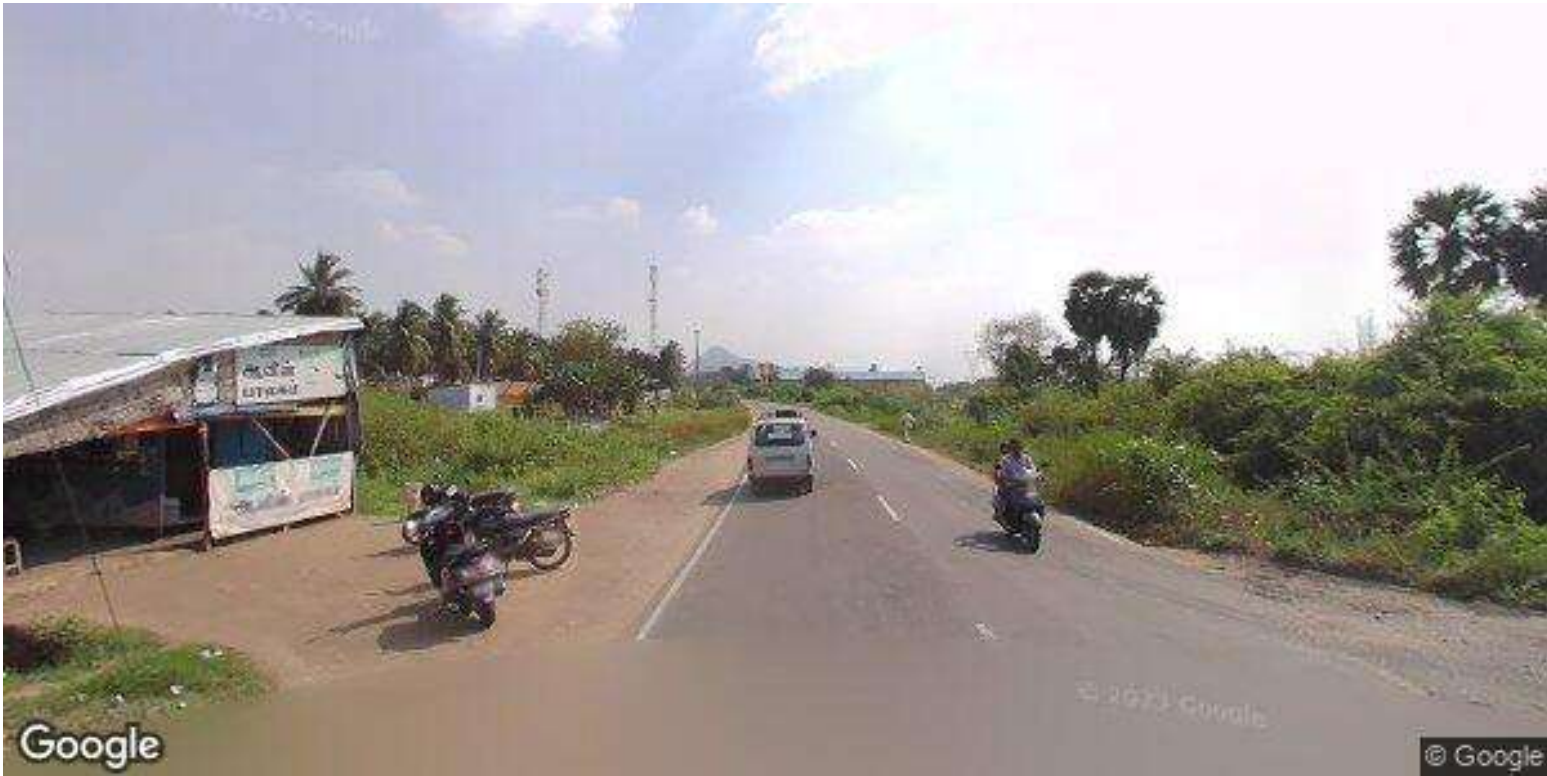
**Risk Type: Turn**

**Risk Level: High**

**Speed Limit: 15 KM/Hr**

**Coordinates: 11.44022, 77.87546**

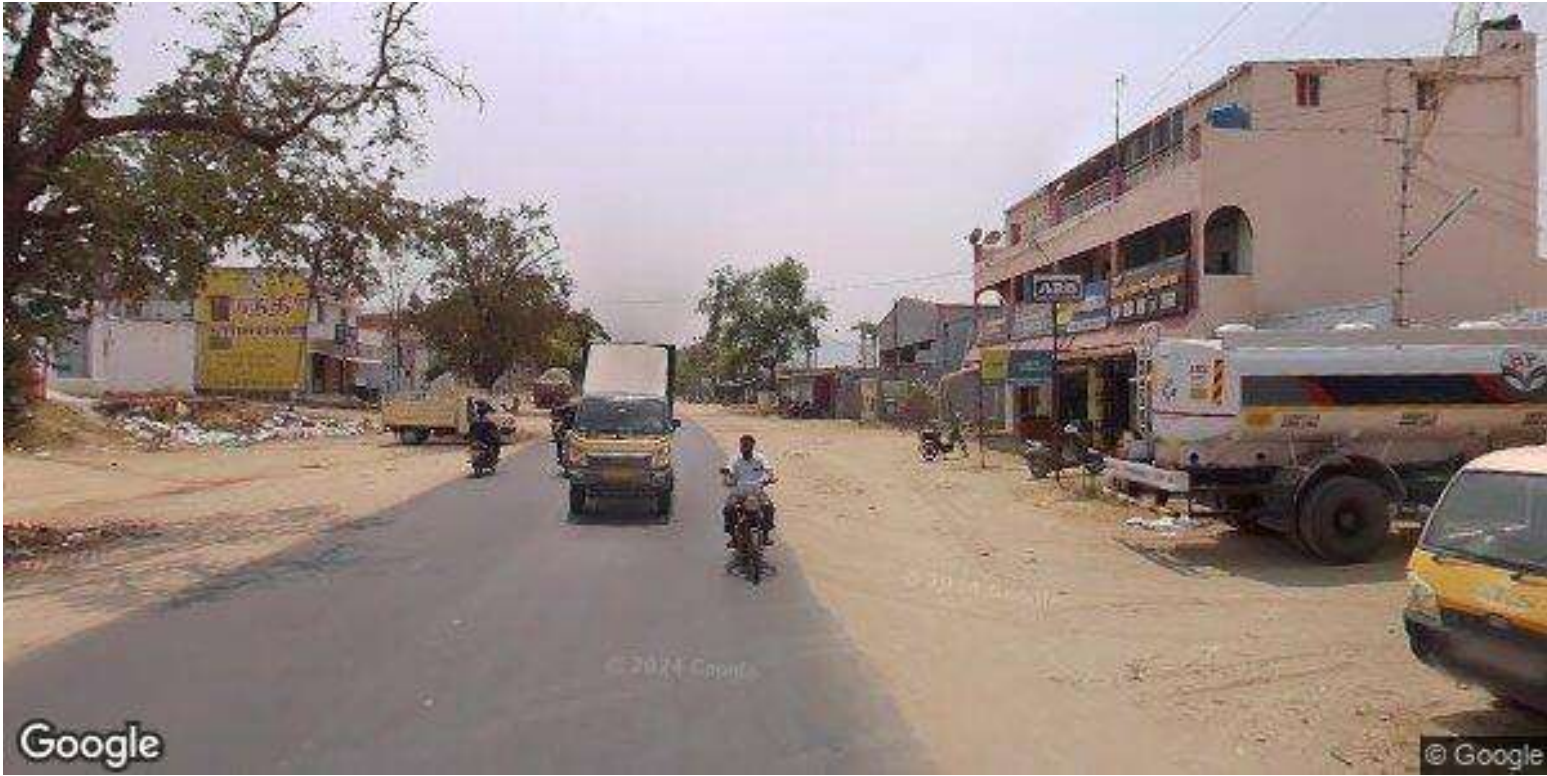
**Risk Type: Turn**

**Risk Level: Medium**

**Speed Limit: 30 KM/Hr**

**Coordinates: 11.39976, 77.88382**

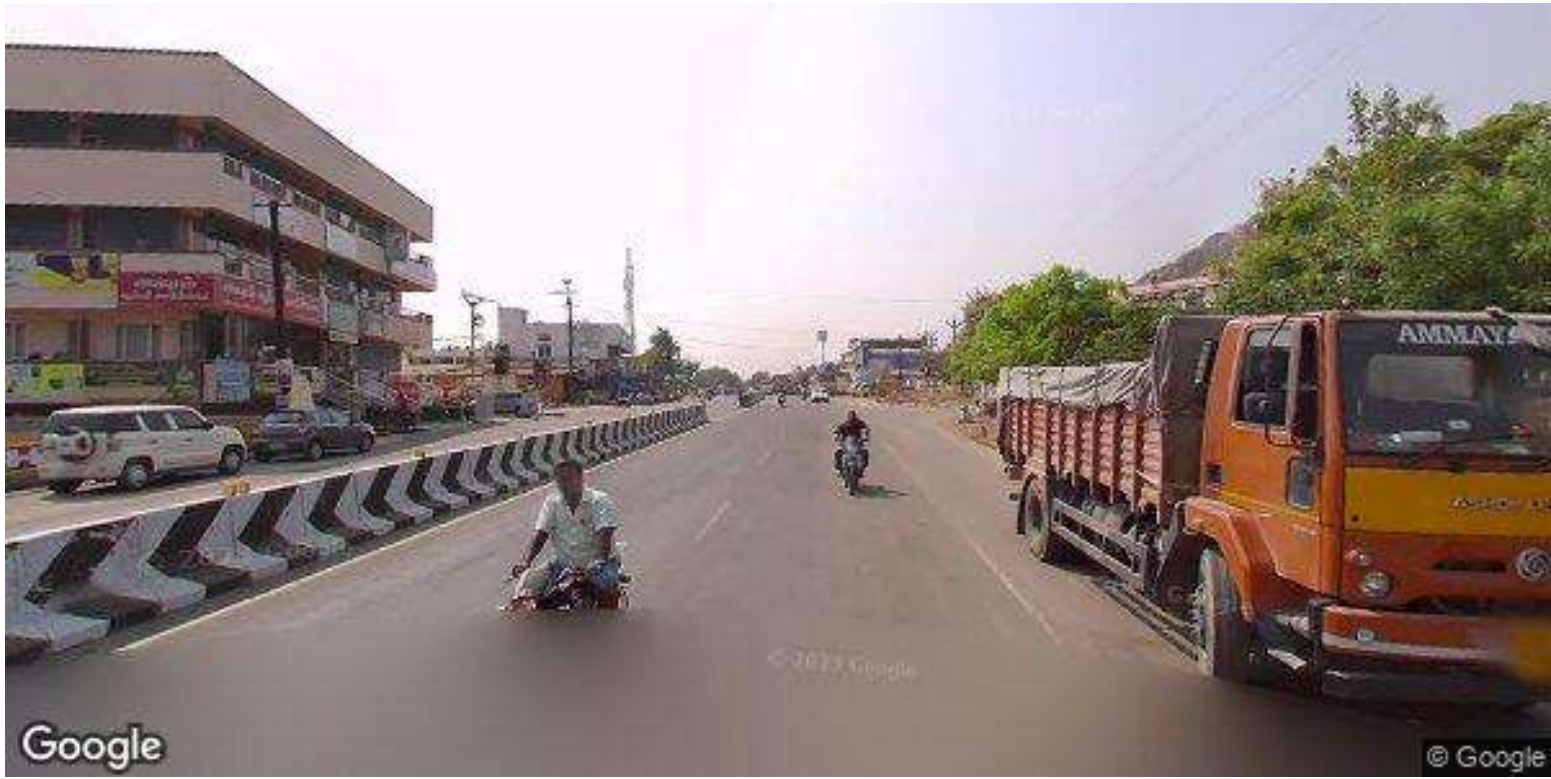
**Risk Type:** Turn  
**Risk Level:** Medium  
**Speed Limit:** 30 KM/Hr  
**Coordinates:** 11.39690, 77.88852

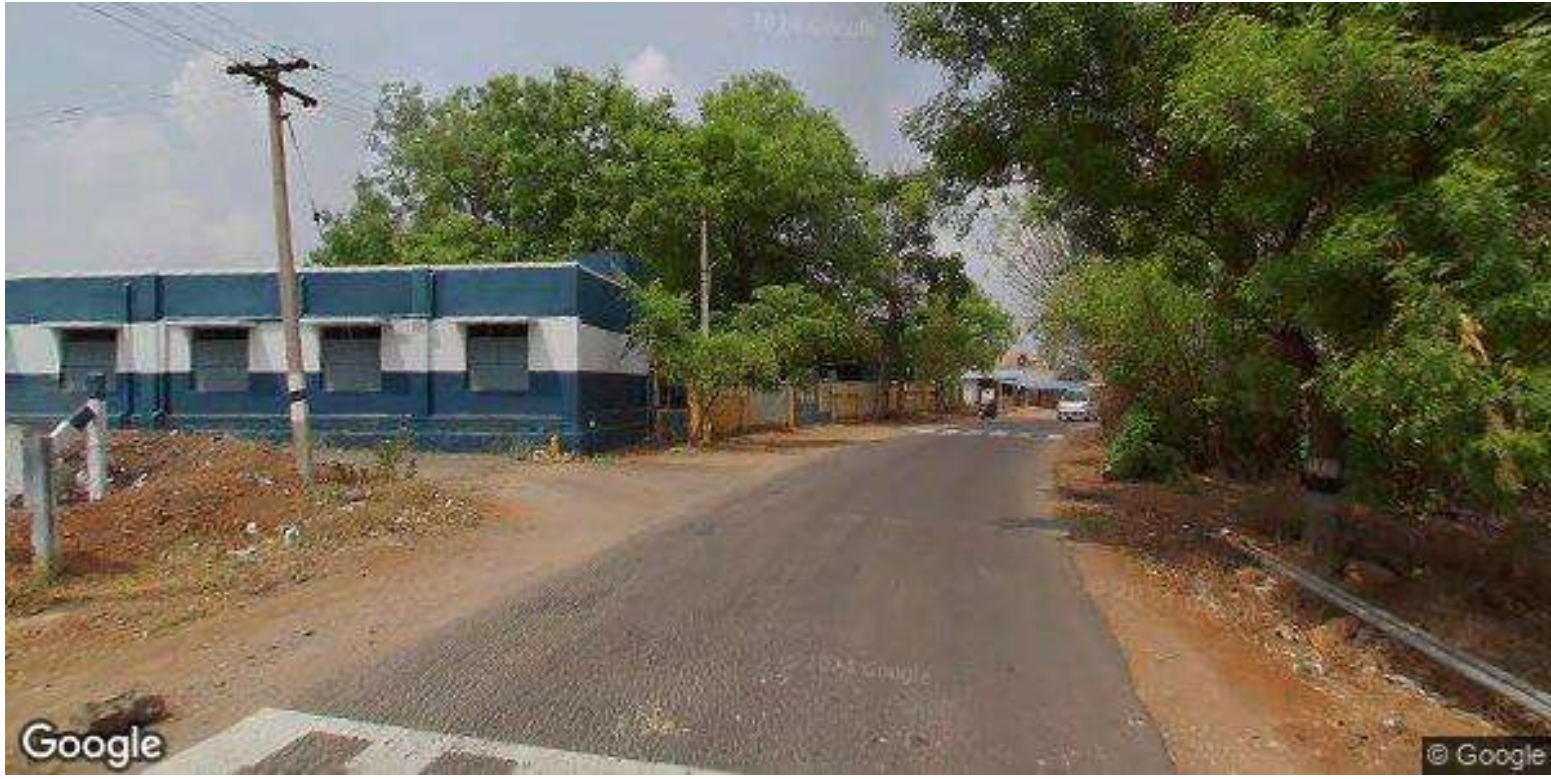
**Risk Type:** Turn  
**Risk Level:** High  
**Speed Limit:** 15 KM/Hr  
**Coordinates:** 11.33268, 77.88827

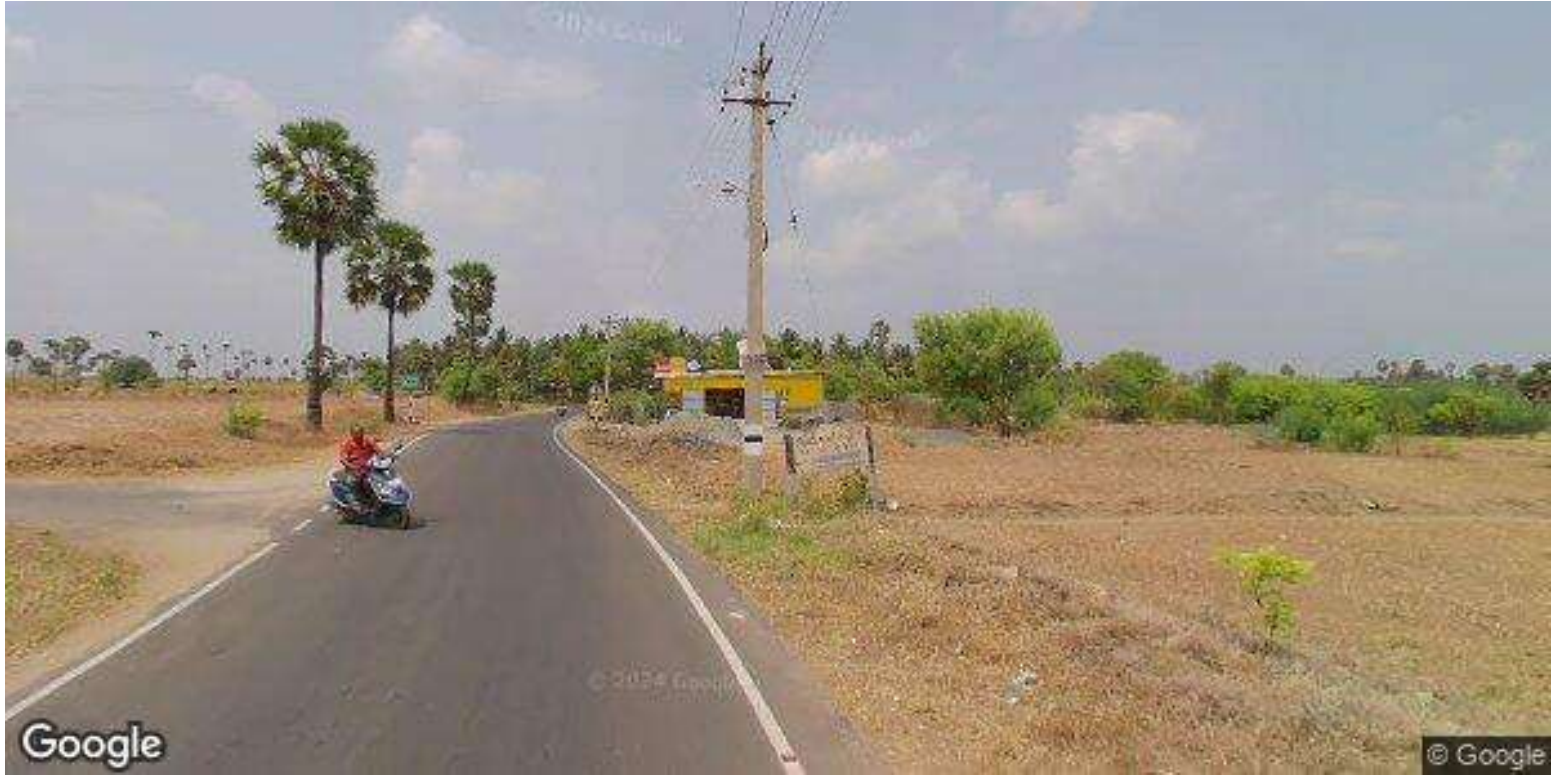
**Risk Type:** Turn  
**Risk Level:** Medium  
**Speed Limit:** 30 KM/Hr  
**Coordinates:** 11.33165, 77.88697

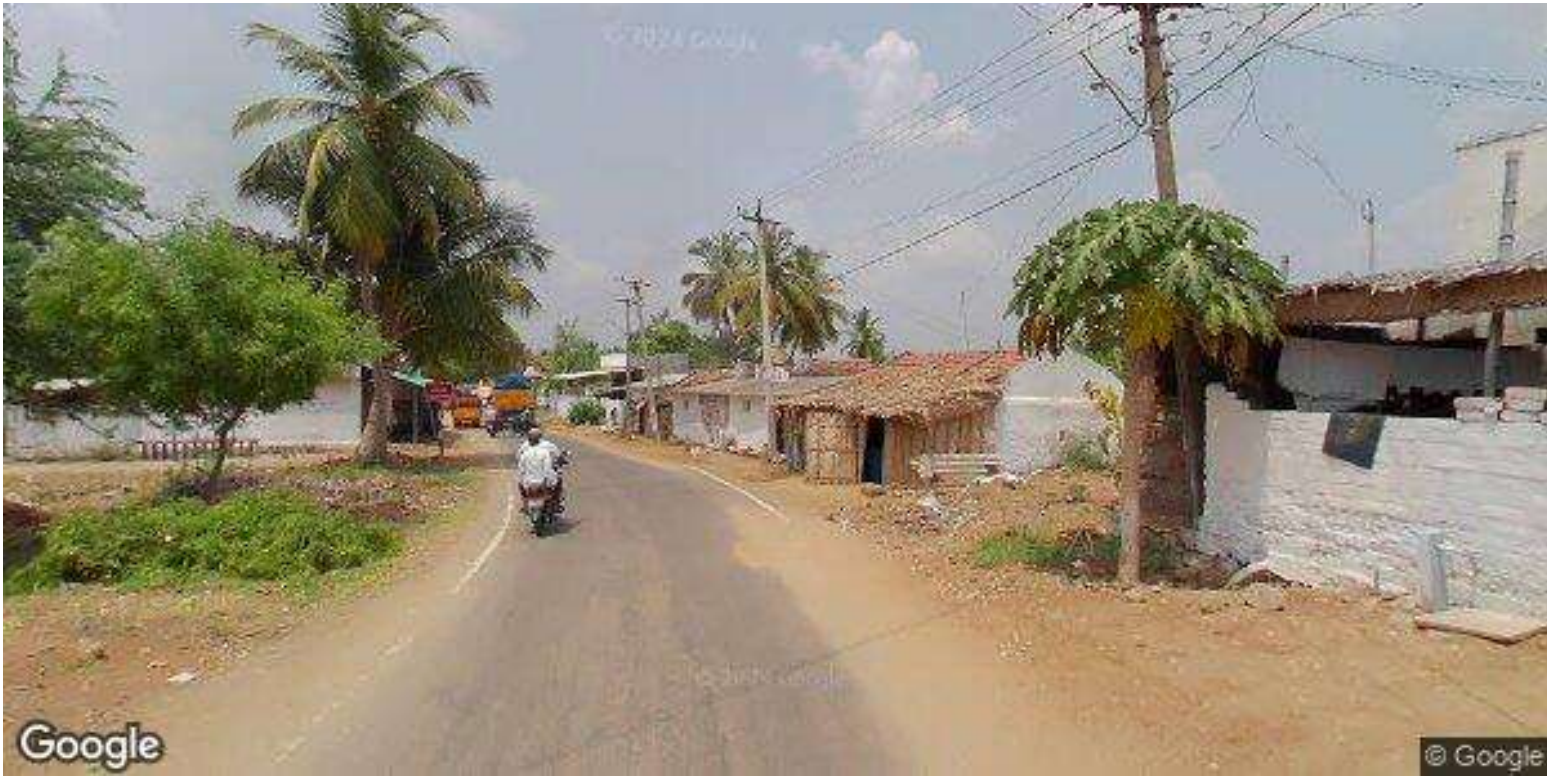
**Risk Type:** Turn  
**Risk Level:** Medium  
**Speed Limit:** 30 KM/Hr  
**Coordinates:** 11.30625, 77.87776

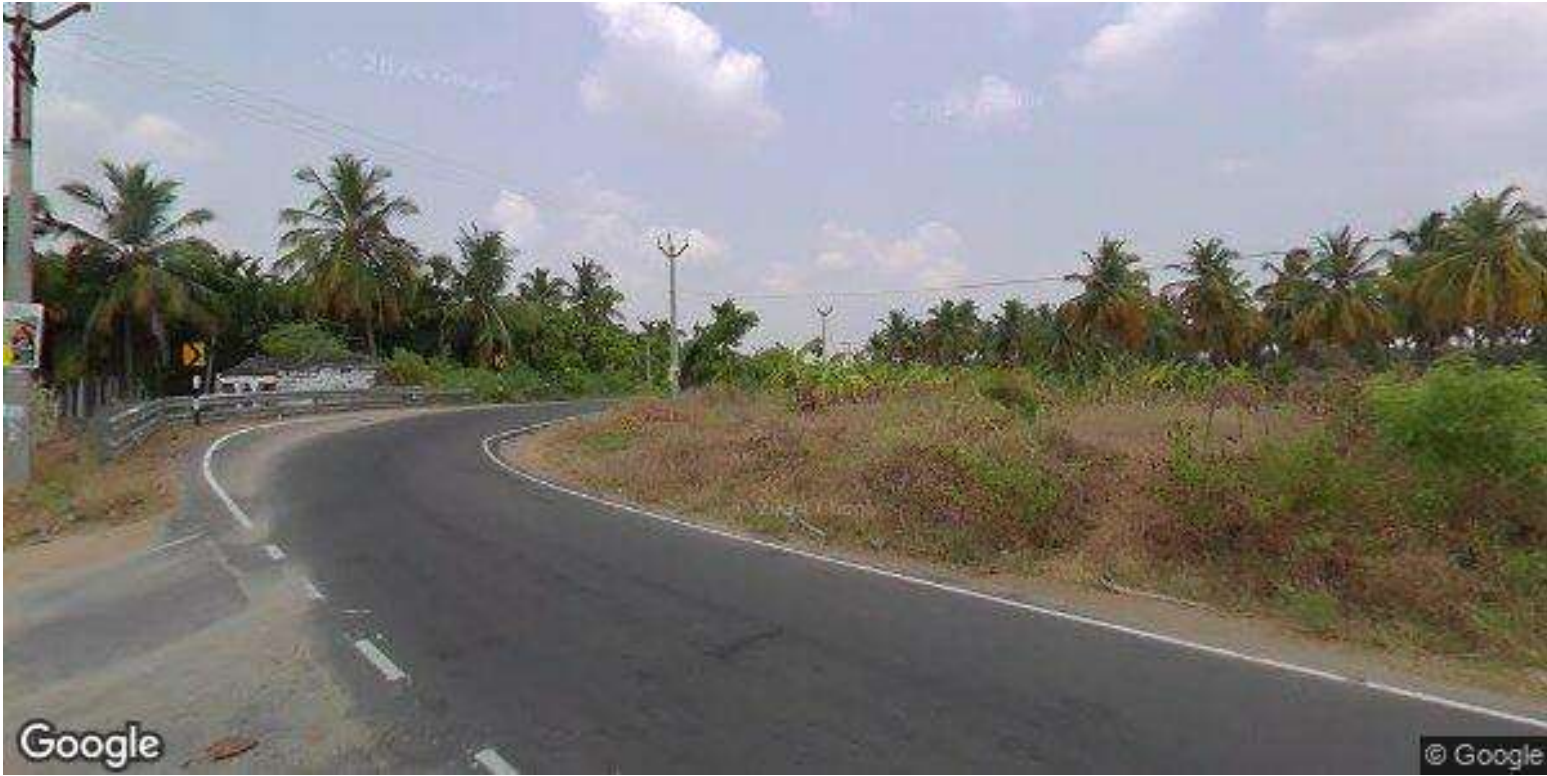
**Risk Type:** Turn  
**Risk Level:** High  
**Speed Limit:** 15 KM/Hr  
**Coordinates:** 11.29763, 77.87710

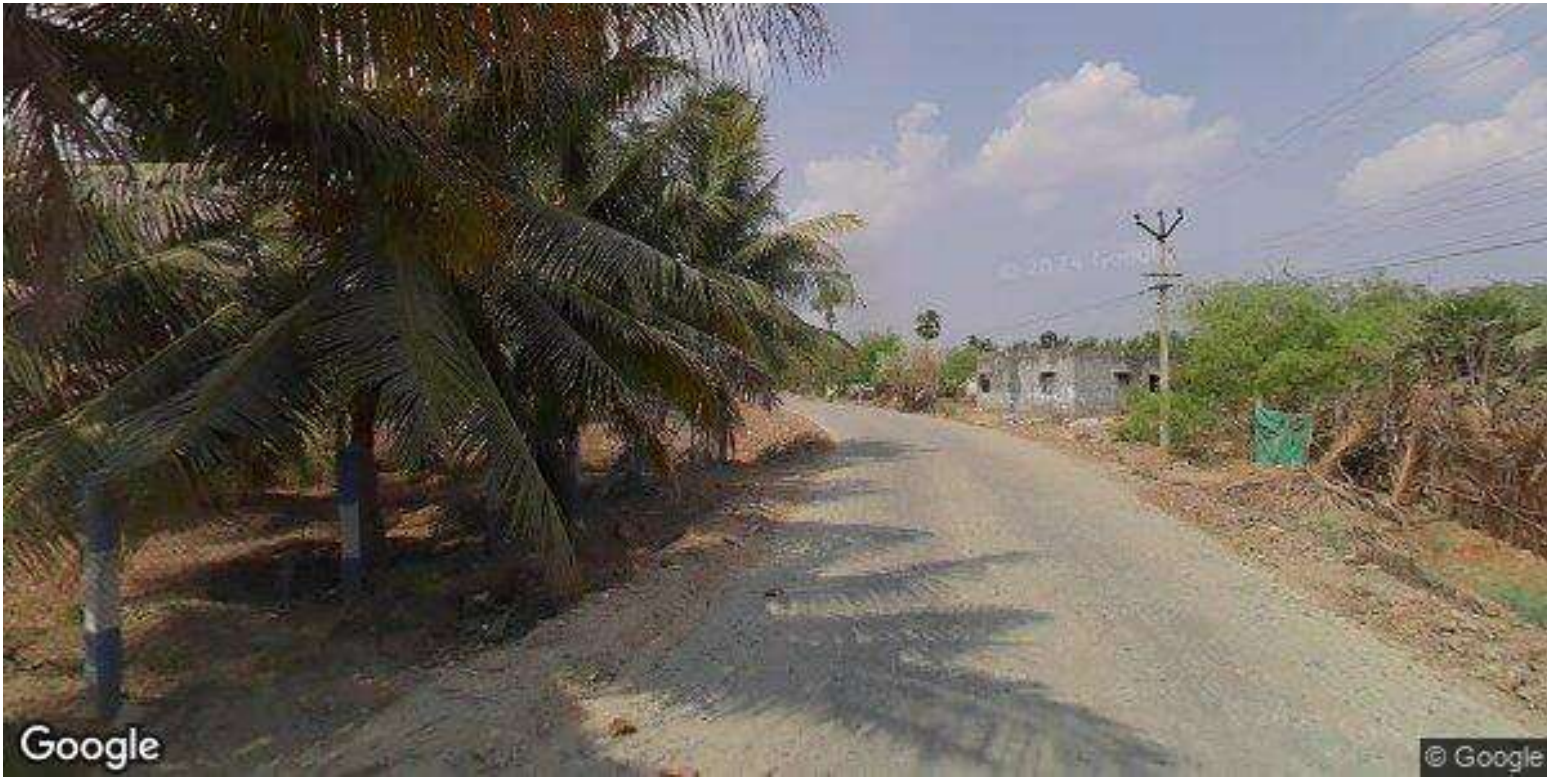
**Risk Type:** Turn  
**Risk Level:** Medium  
**Speed Limit:** 30 KM/Hr  
**Coordinates:** 11.27096, 77.87034

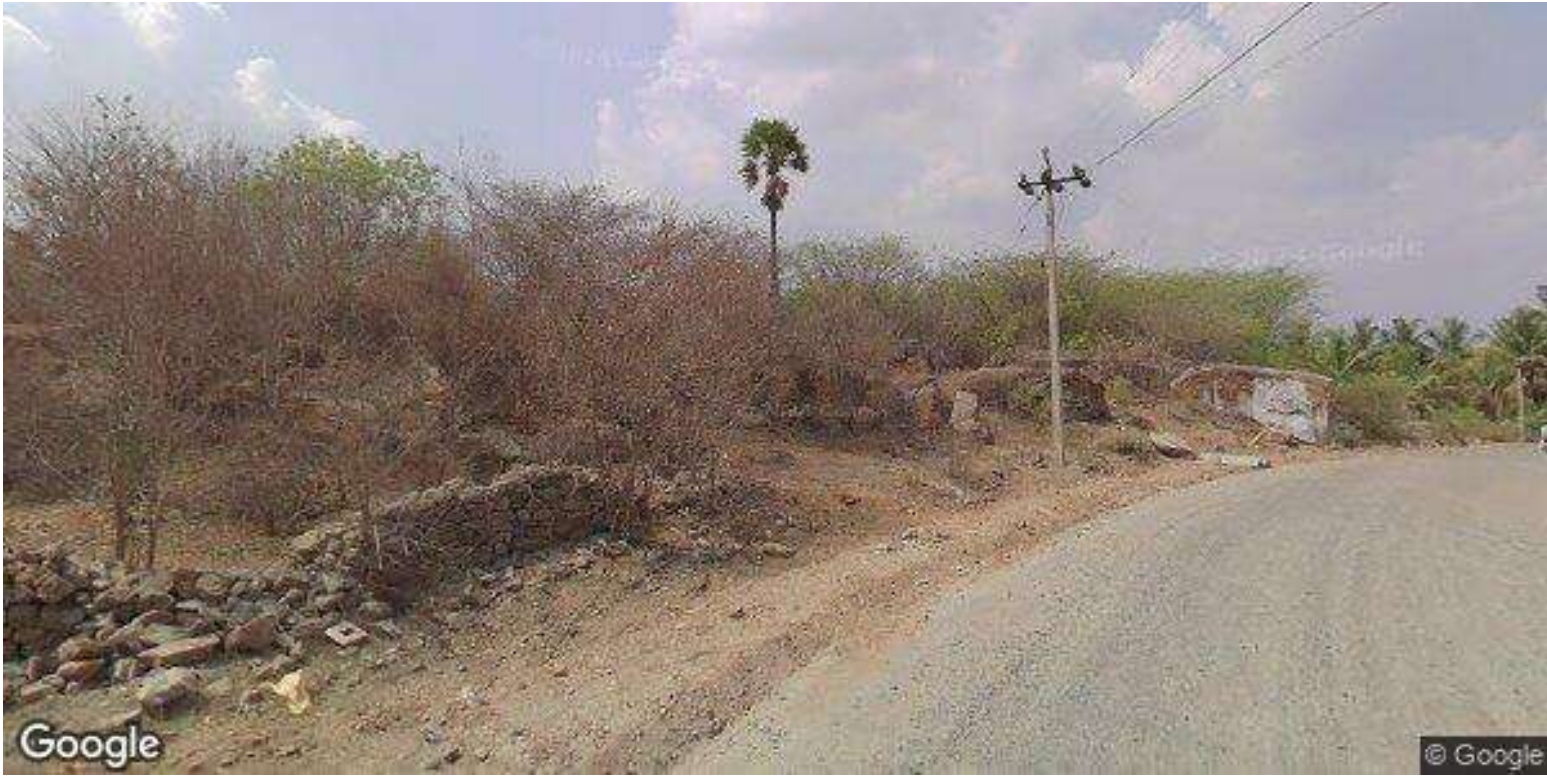
**Risk Type:** Turn  
**Risk Level:** Medium  
**Speed Limit:** 30 KM/Hr  
**Coordinates:** 11.27057, 77.86827

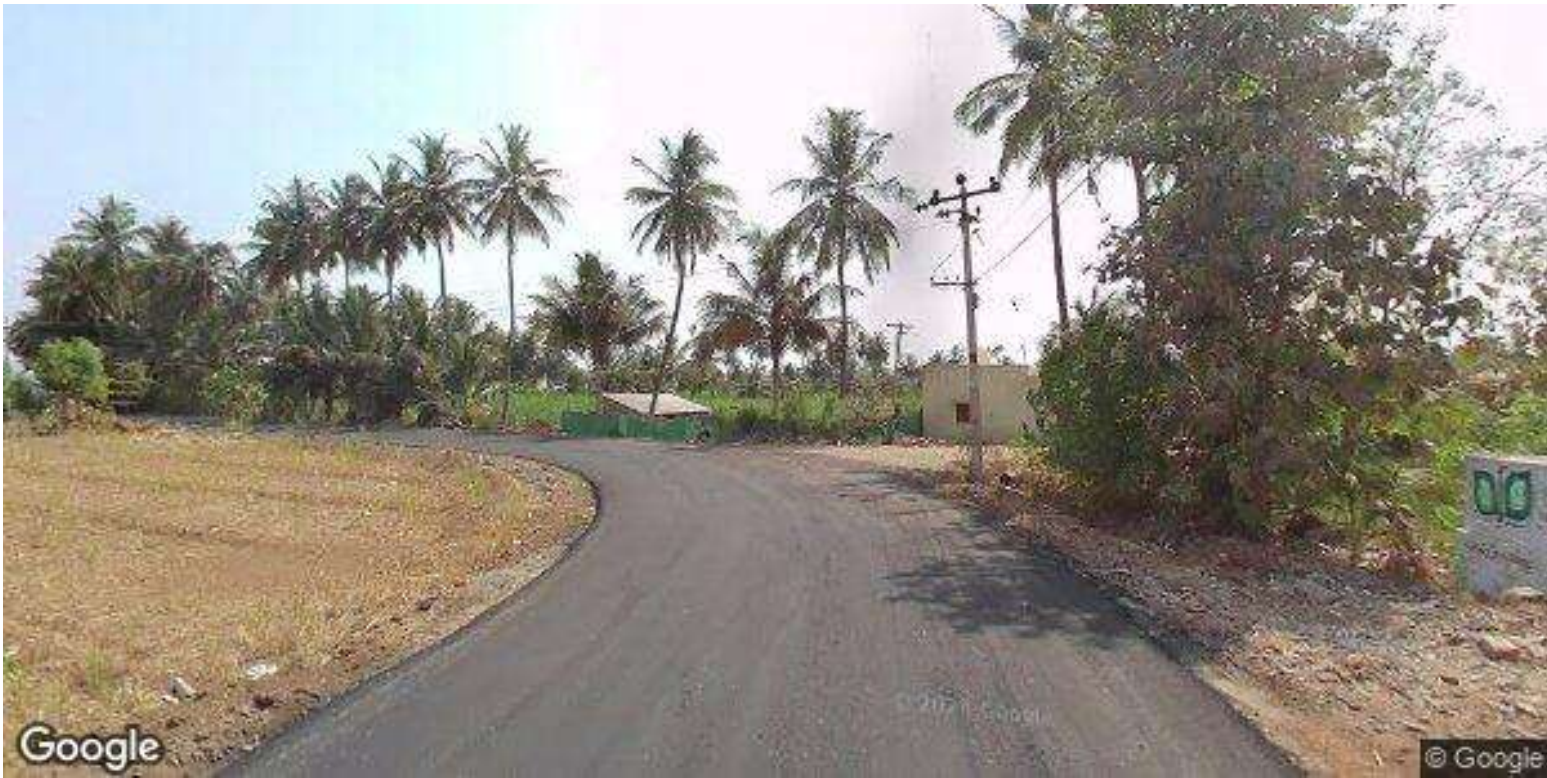
**Risk Type:** Turn  
**Risk Level:** High  
**Speed Limit:** 15 KM/Hr  
**Coordinates:** 11.26028, 77.85633

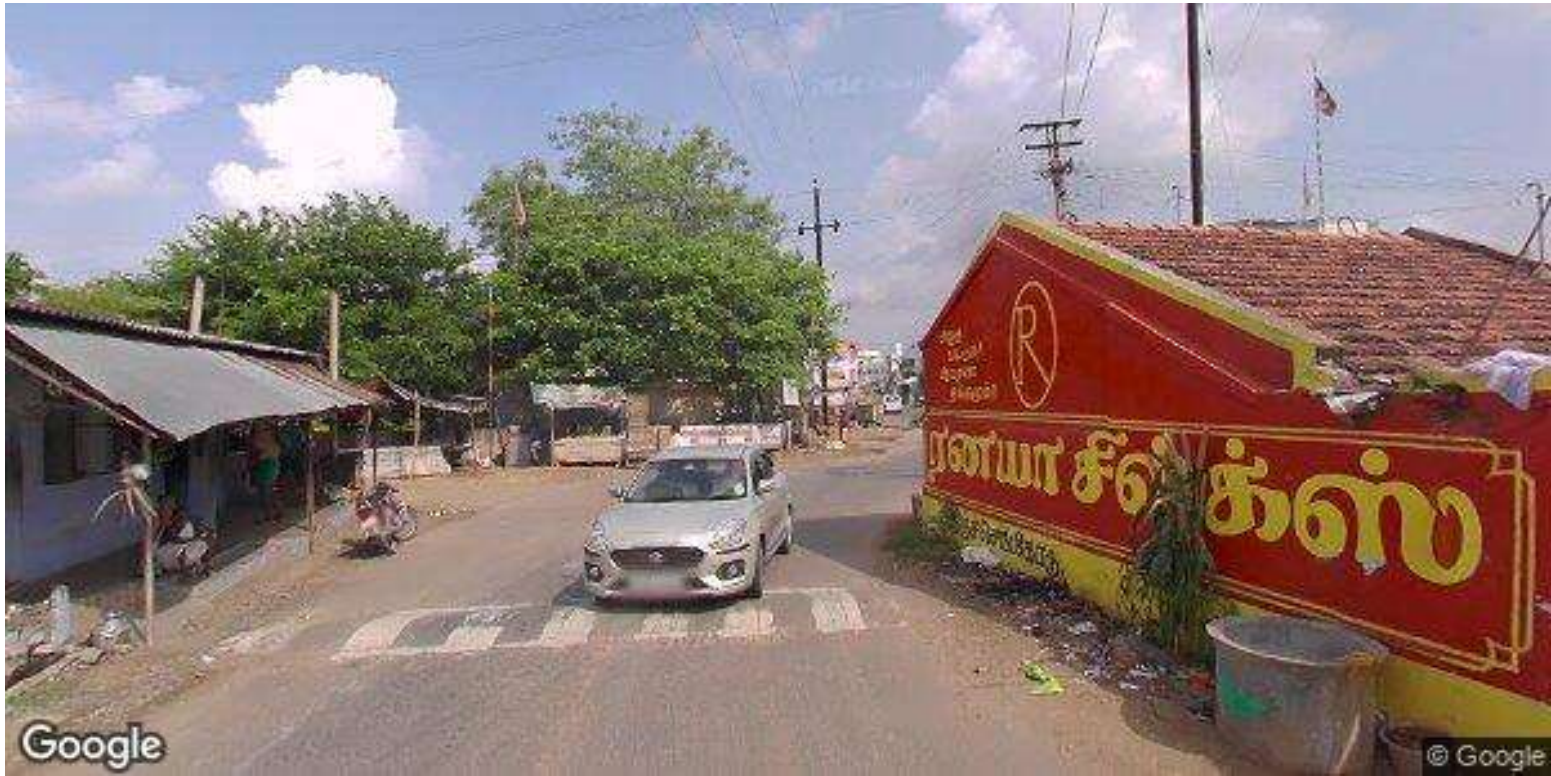
**Risk Type:** Turn  
**Risk Level:** High  
**Speed Limit:** 15 KM/Hr  
**Coordinates:** 11.25791, 77.85522

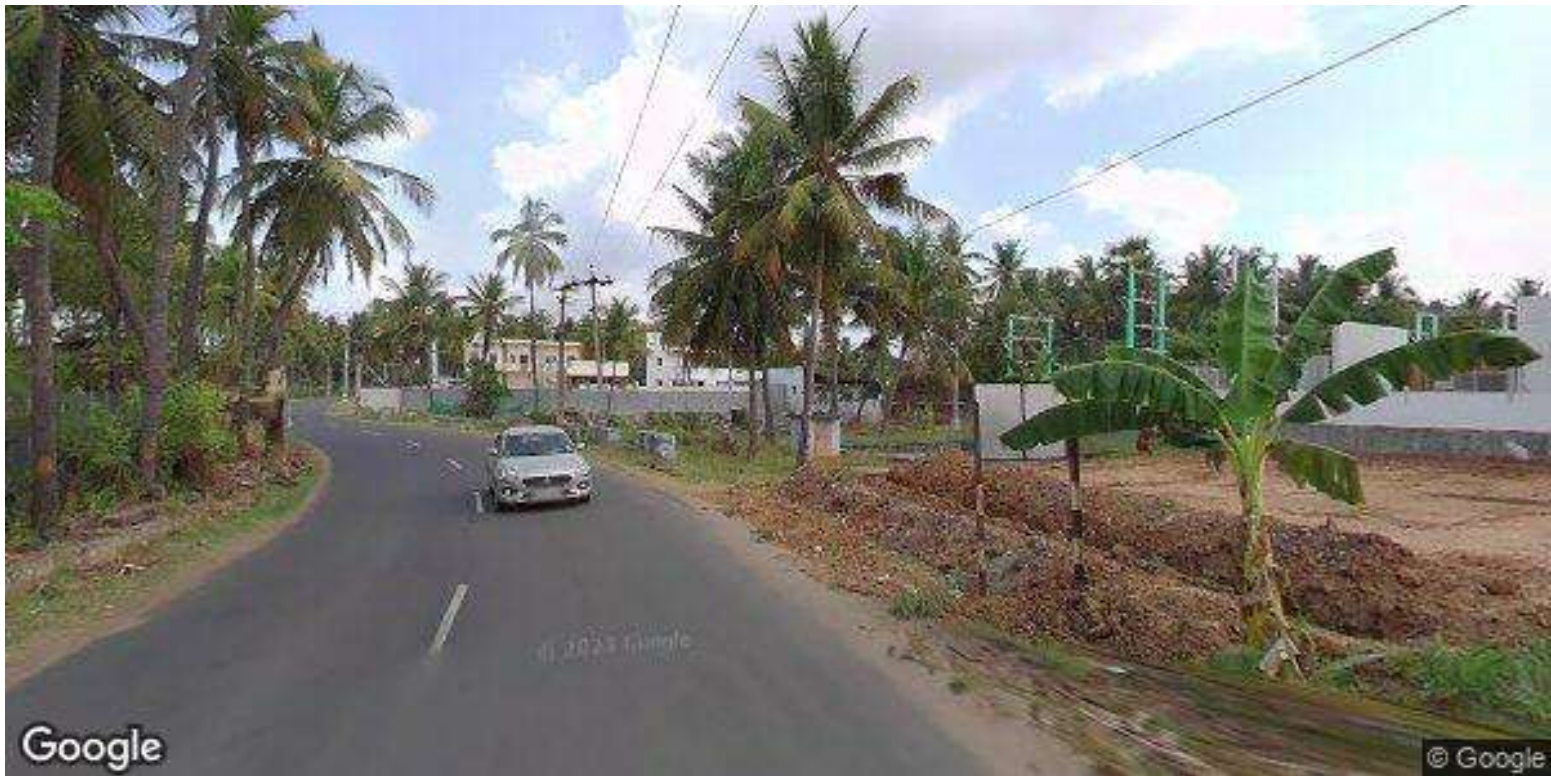
**Risk Type:** Turn  
**Risk Level:** Medium  
**Speed Limit:** 30 KM/Hr  
**Coordinates:** 11.25287, 77.86220

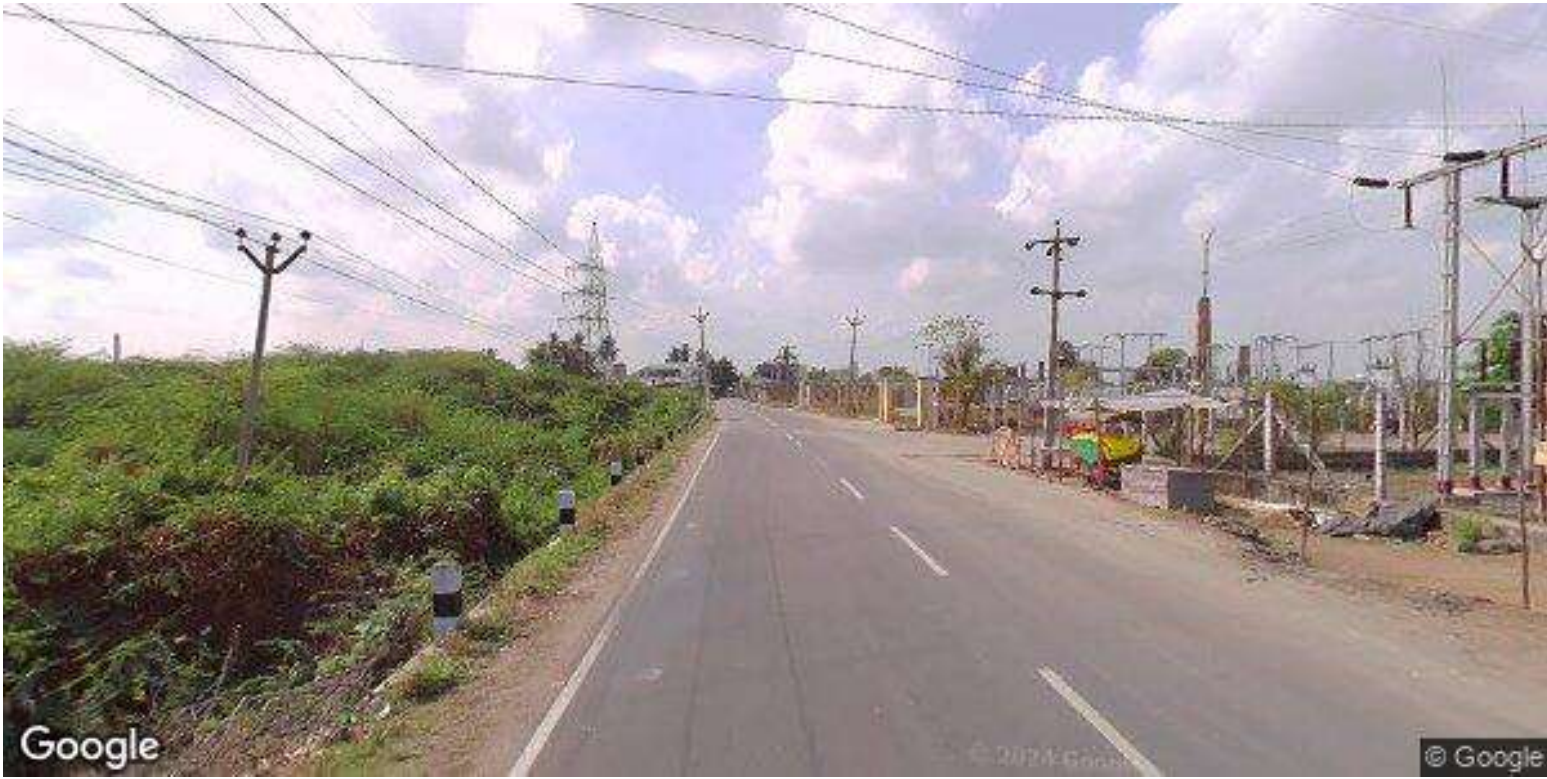
**Risk Type:** Turn  
**Risk Level:** Medium  
**Speed Limit:** 30 KM/Hr  
**Coordinates:** 11.24410, 77.86671

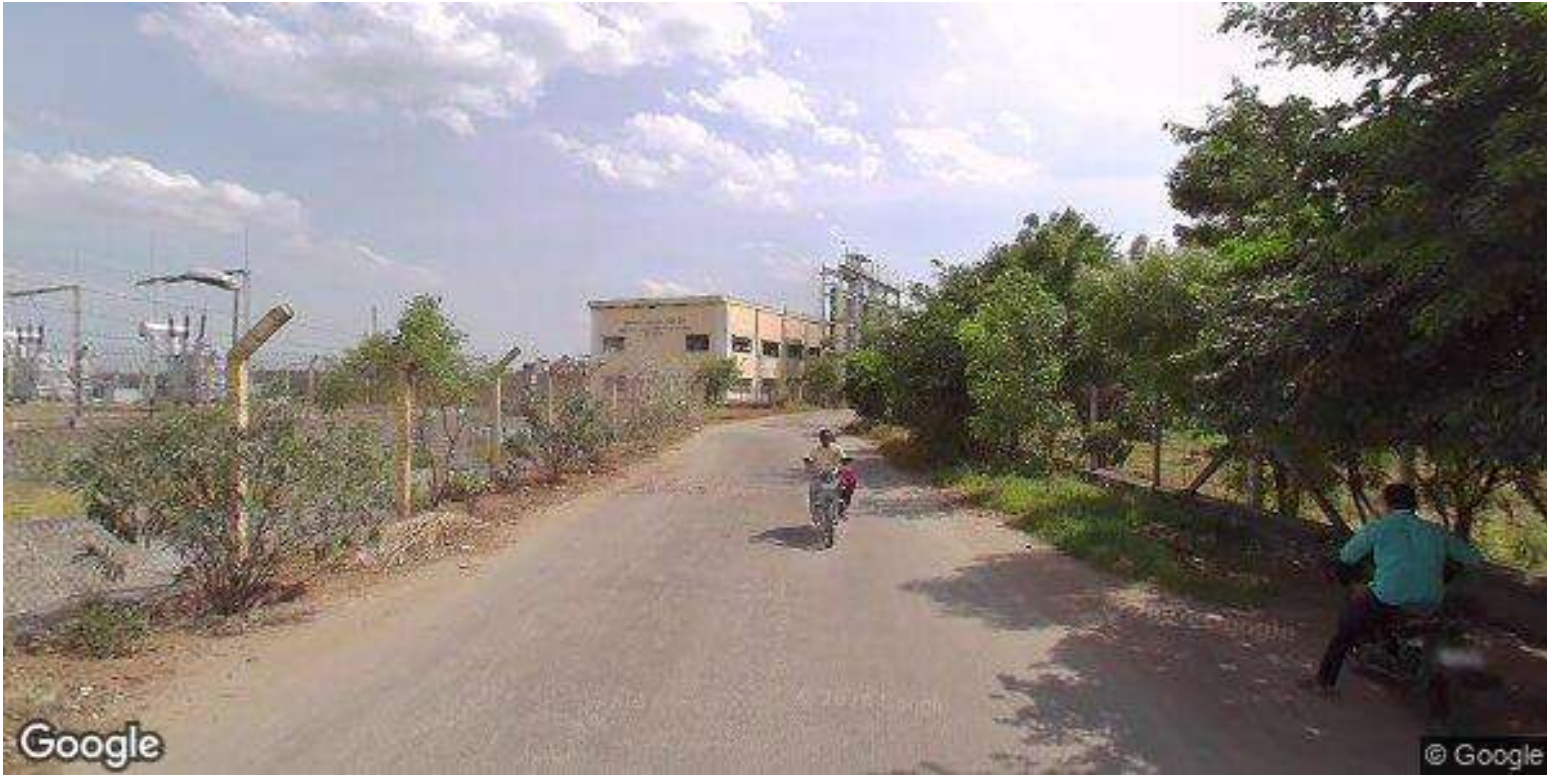
**Risk Type:** Turn  
**Risk Level:** High  
**Speed Limit:** 15 KM/Hr  
**Coordinates:** 11.24365, 77.86668

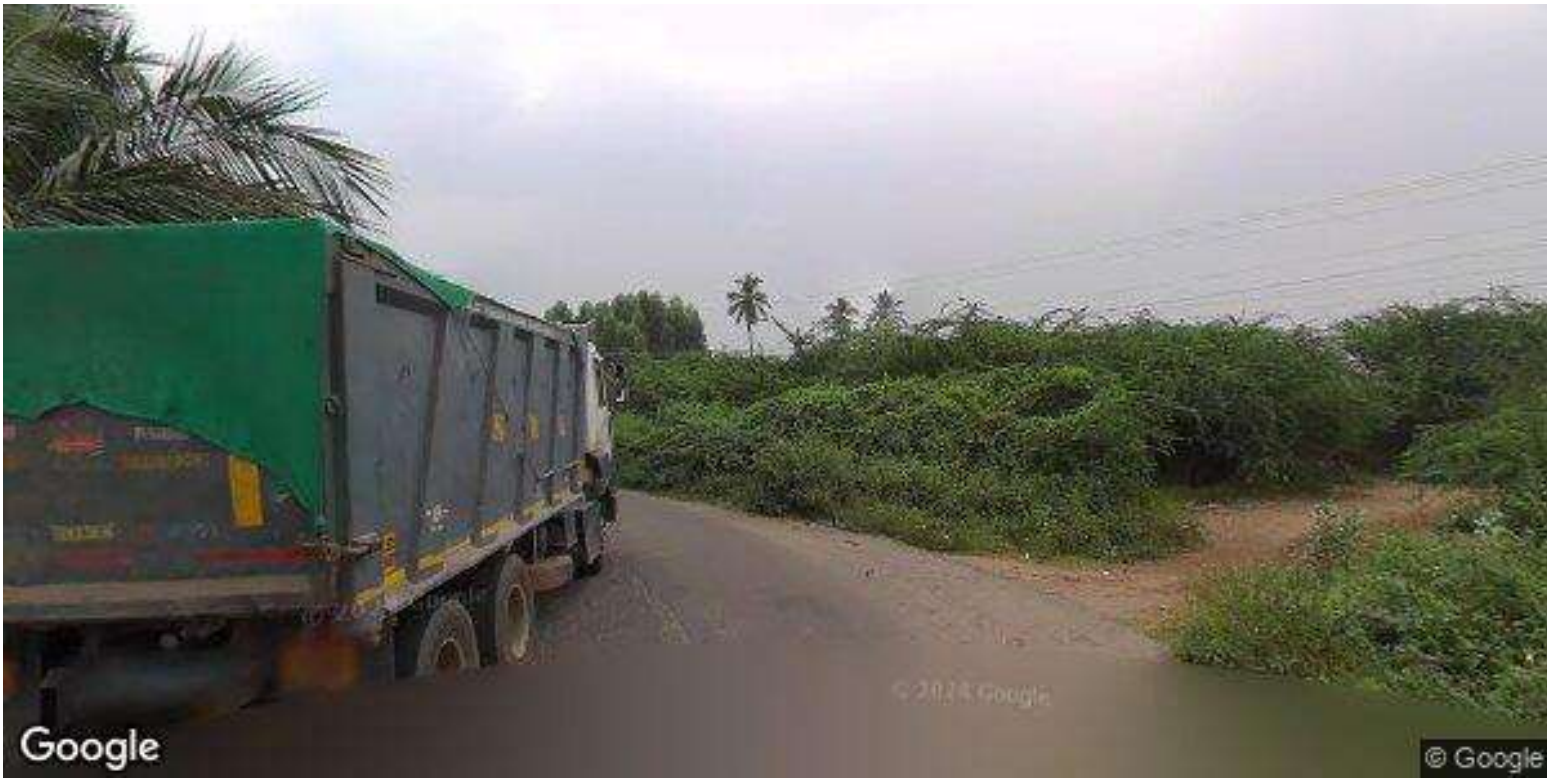
**Risk Type:** Turn  
**Risk Level:** High  
**Speed Limit:** 15 KM/Hr  
**Coordinates:** 11.24100, 77.86030

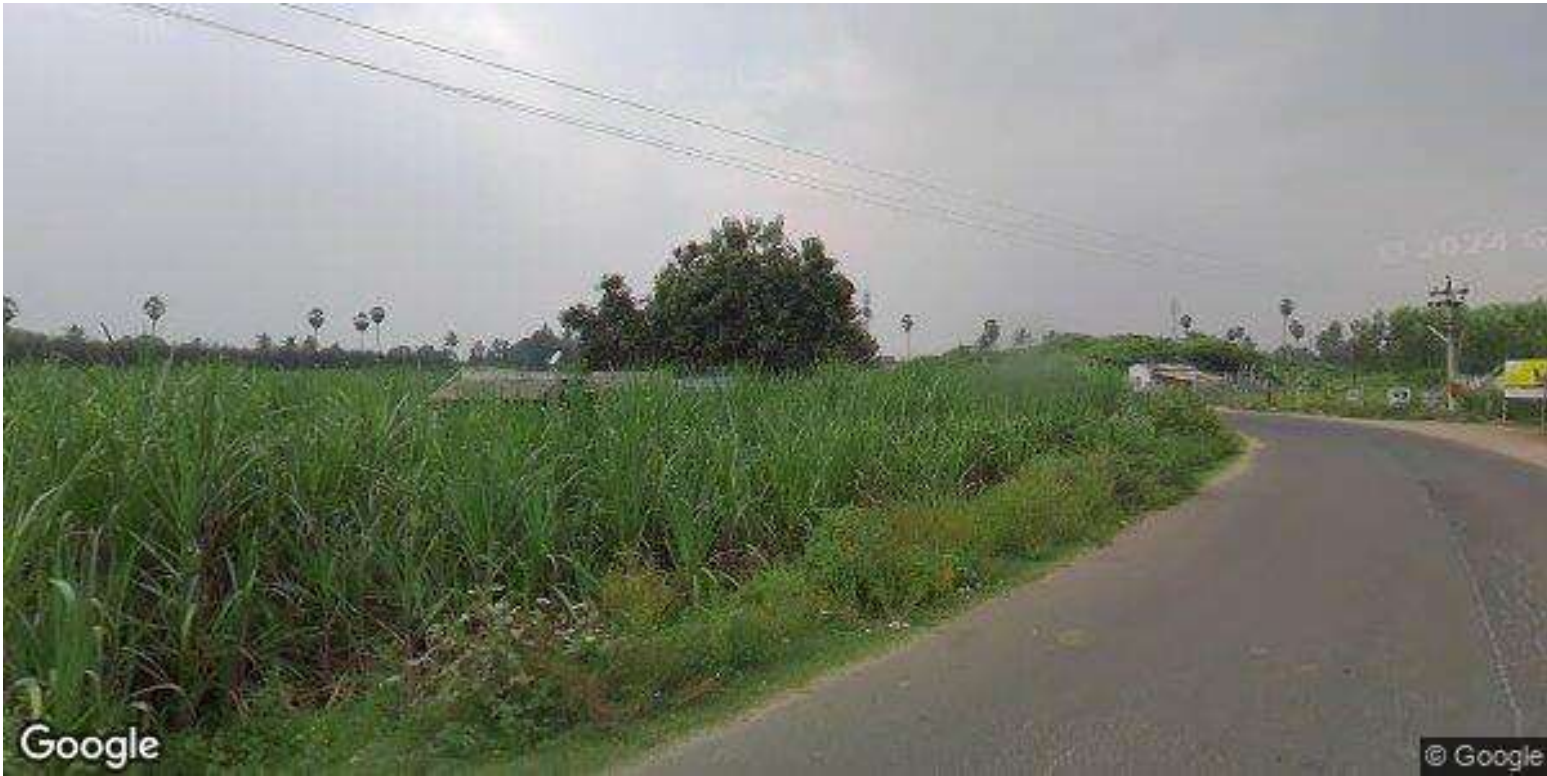
**Risk Type:** Turn  
**Risk Level:** Medium  
**Speed Limit:** 30 KM/Hr  
**Coordinates:** 11.24196, 77.85902
