## JOURNEY RISK MANAGEMENT (JRM) STUDY

### Salem Terminal TO KARTHIK FUELS IOC DEALER

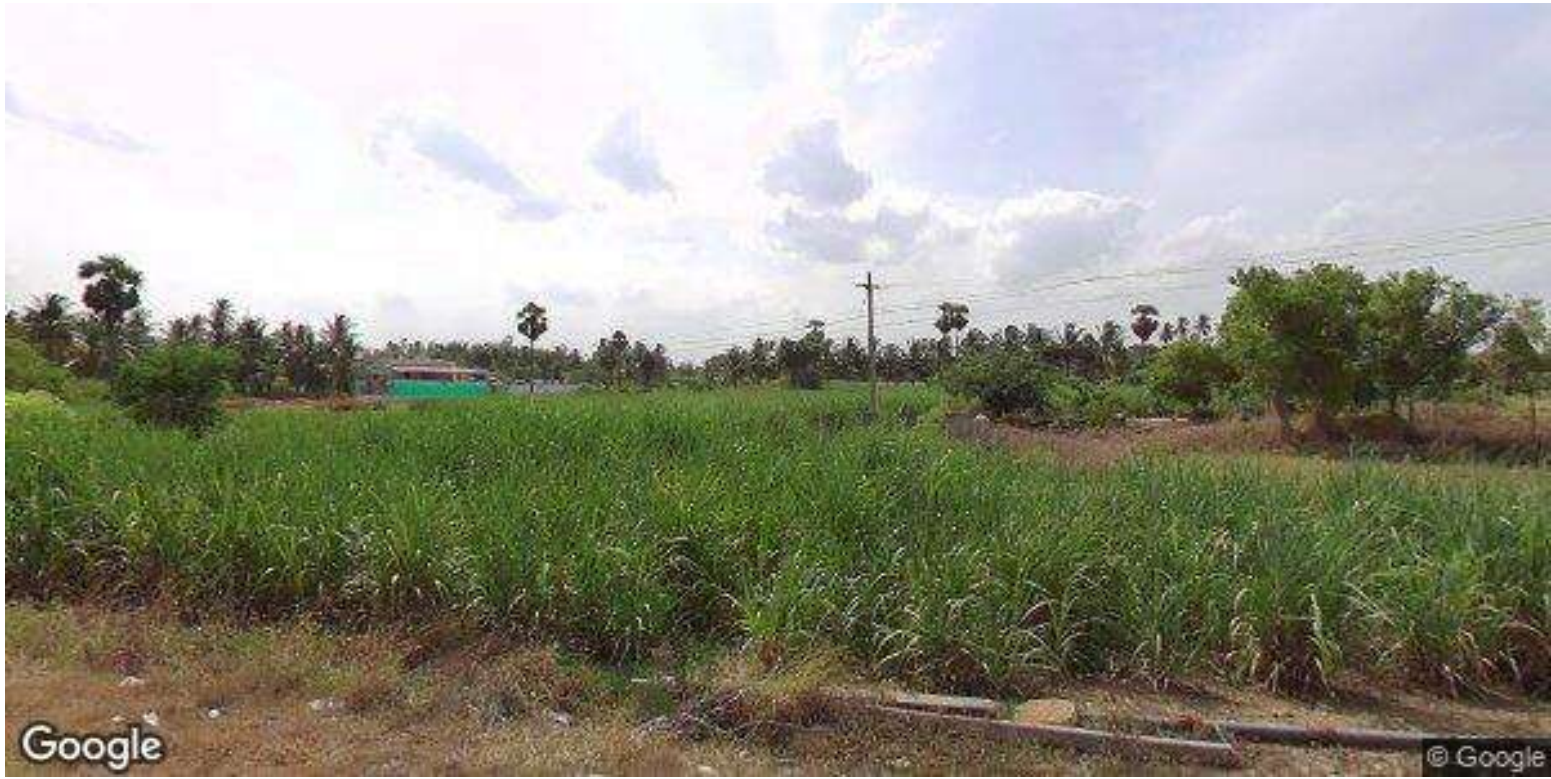
**Risk Type:** Turn  
**Risk Level:** Medium  
**Speed Limit:** 30 KM/Hr  
**Coordinates:** 11.22478, 77.84241

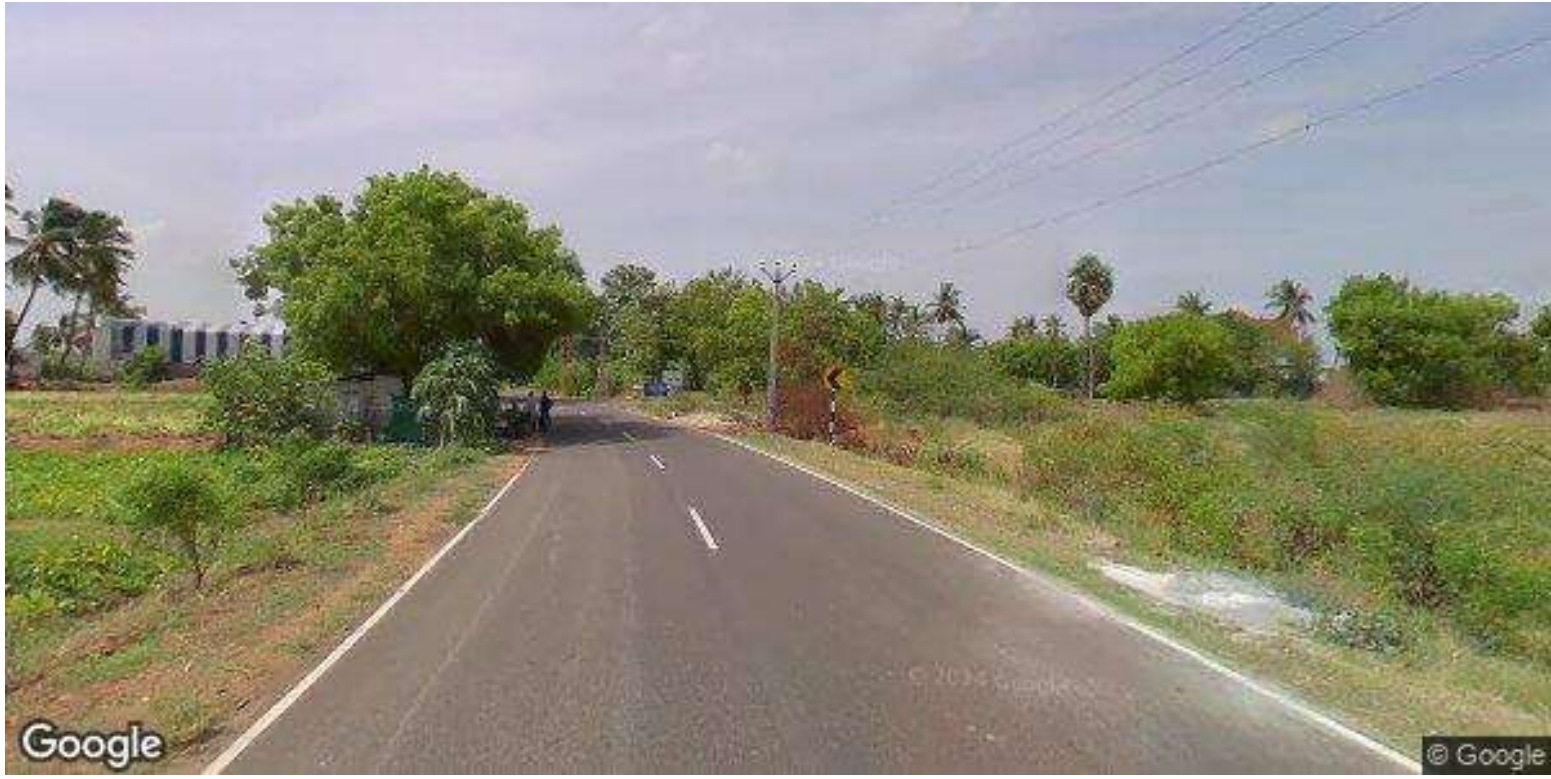
**Risk Type:** Turn  
**Risk Level:** Medium  
**Speed Limit:** 30 KM/Hr  
**Coordinates:** 11.20949, 77.81173

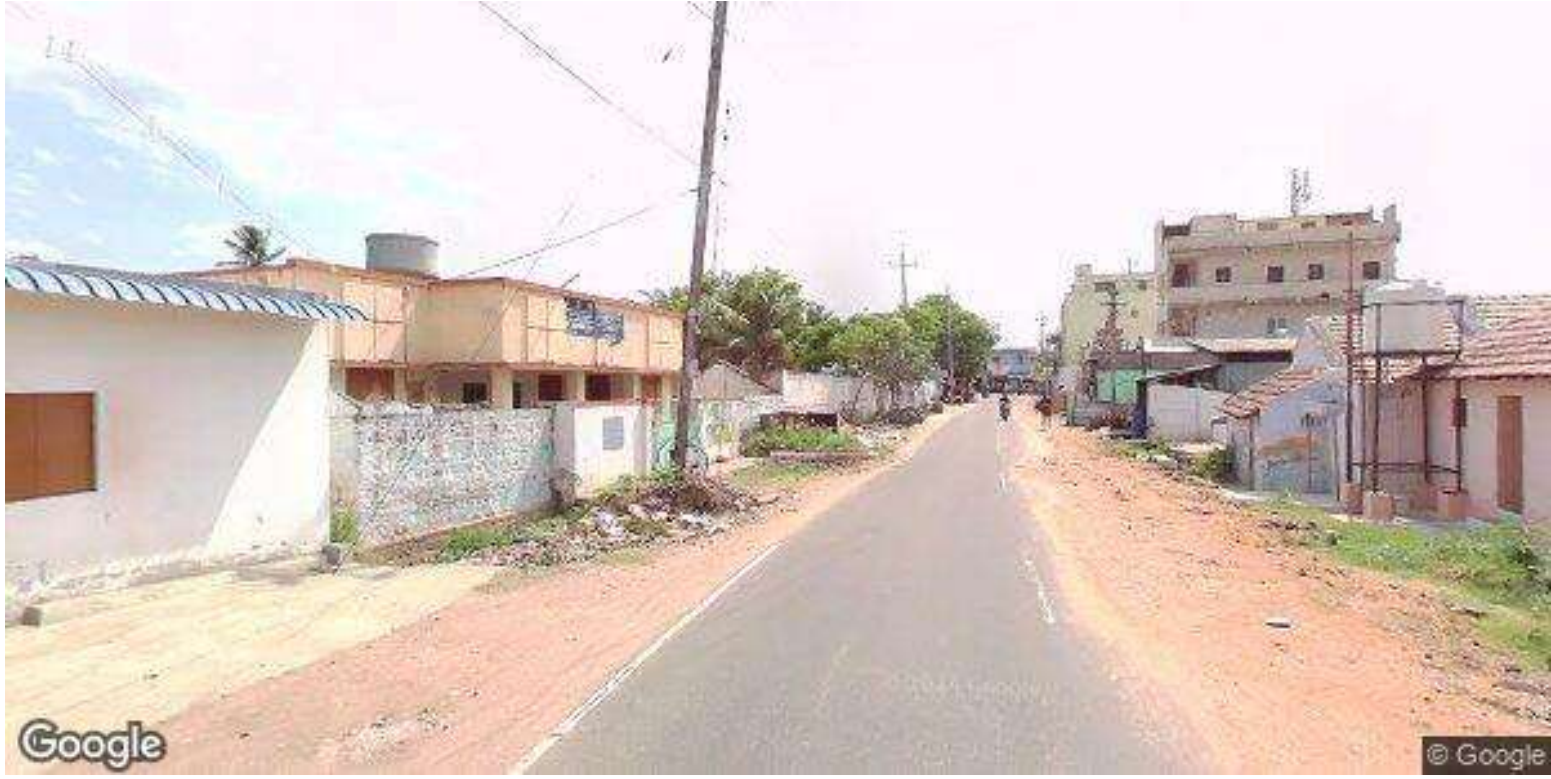
**Risk Type:** Turn  
**Risk Level:** Medium  
**Speed Limit:** 30 KM/Hr  
**Coordinates:** 11.18875, 77.77206

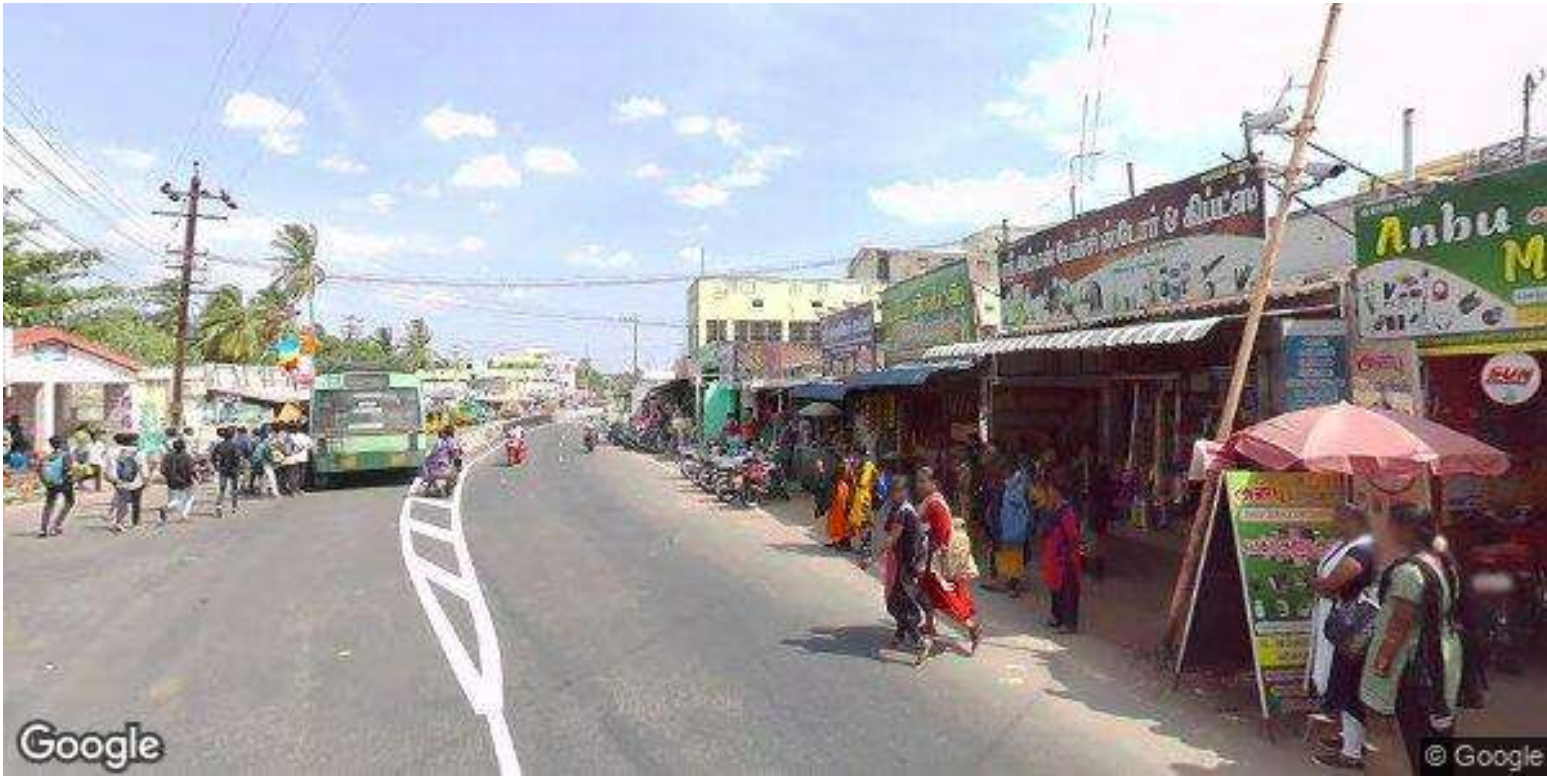
**Risk Type:** Blind Spot  
**Risk Level:** Blind Spot  
**Speed Limit:** 10 KM/Hr  
**Coordinates:** 11.18861, 77.77108

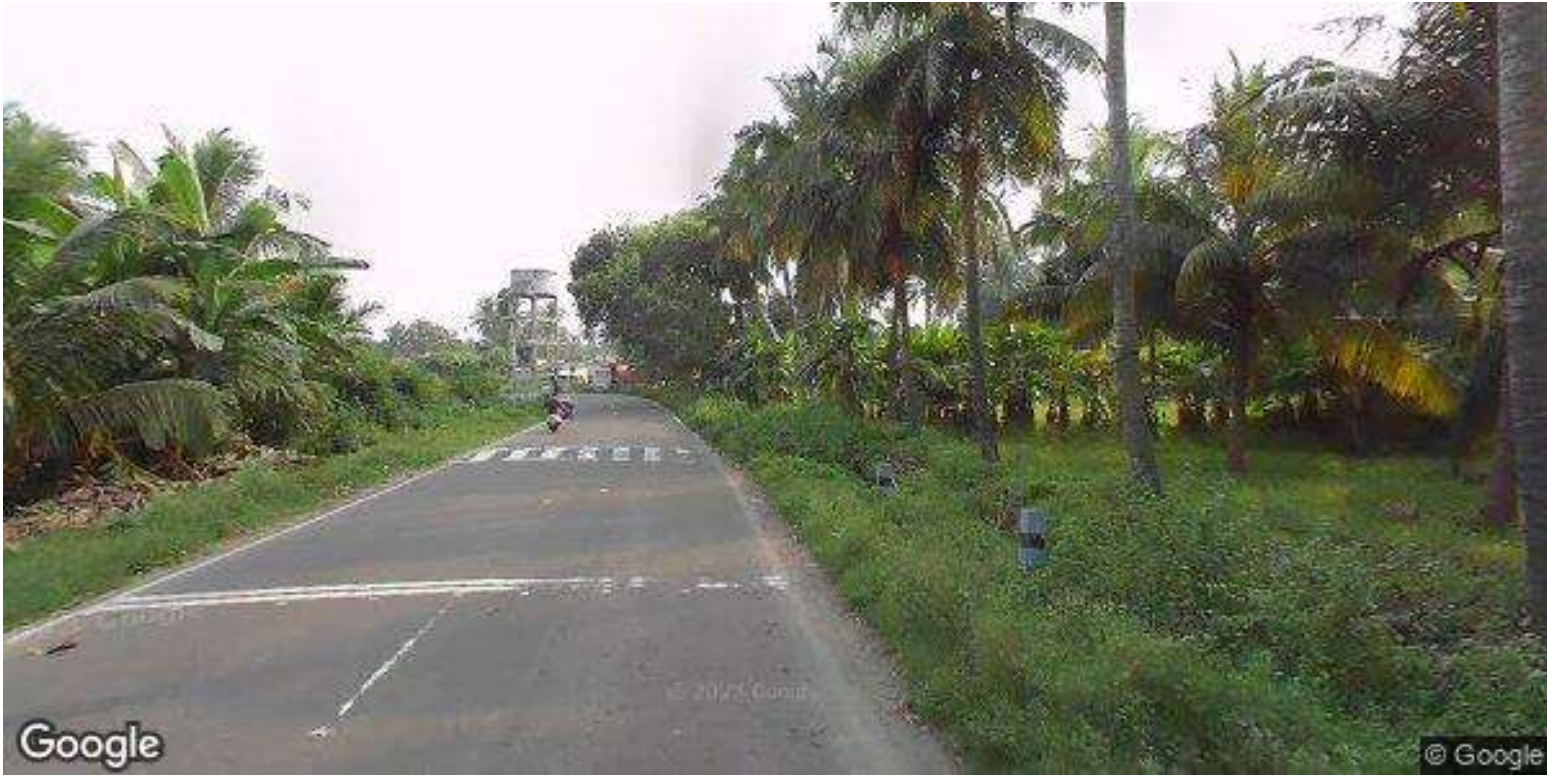
**Risk Type:** Turn  
**Risk Level:** Medium  
**Speed Limit:** 30 KM/Hr  
**Coordinates:** 11.16466, 77.77354

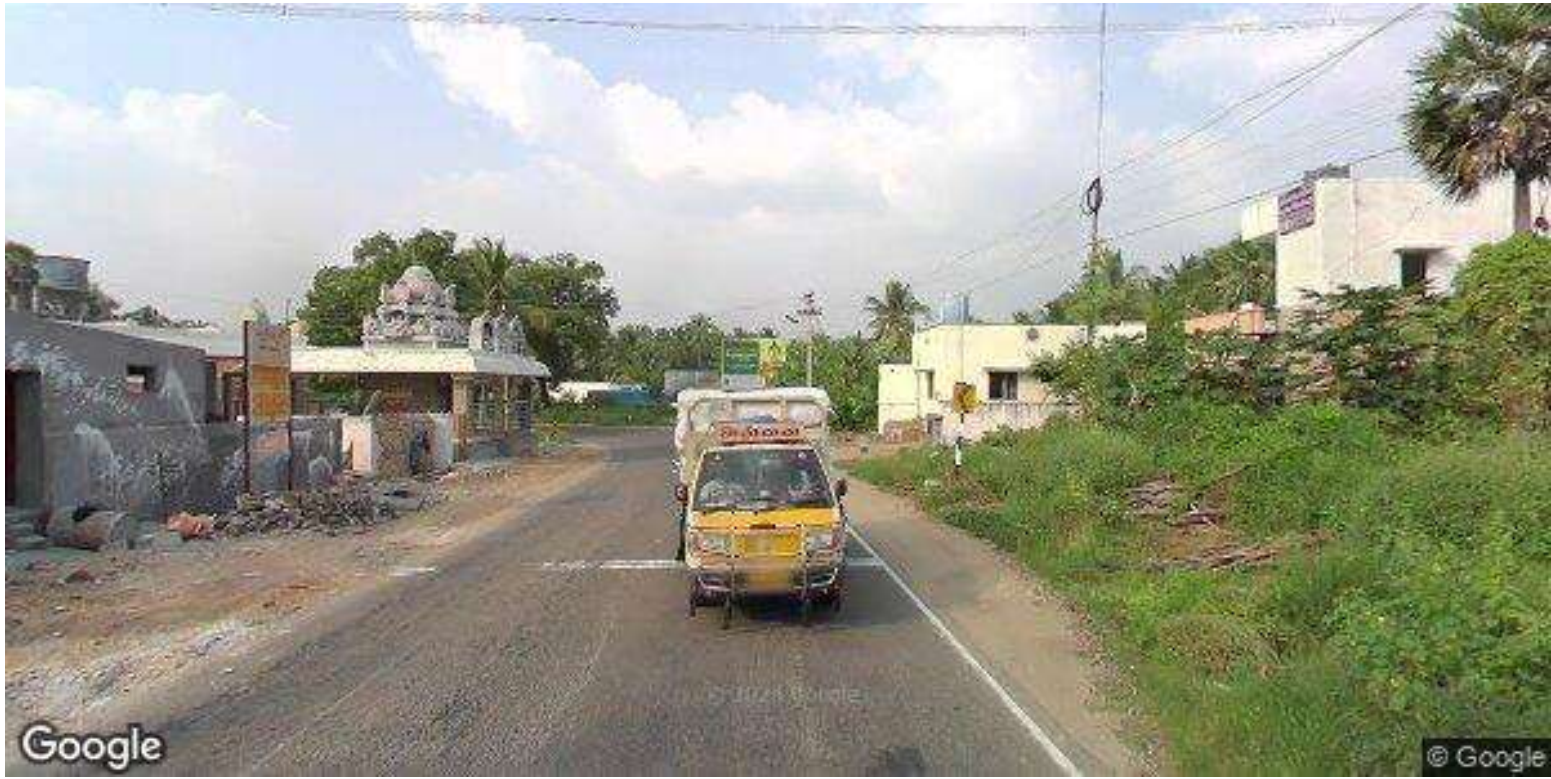
**Risk Type:** Turn  
**Risk Level:** Medium  
**Speed Limit:** 30 KM/Hr  
**Coordinates:** 11.16321, 77.77438

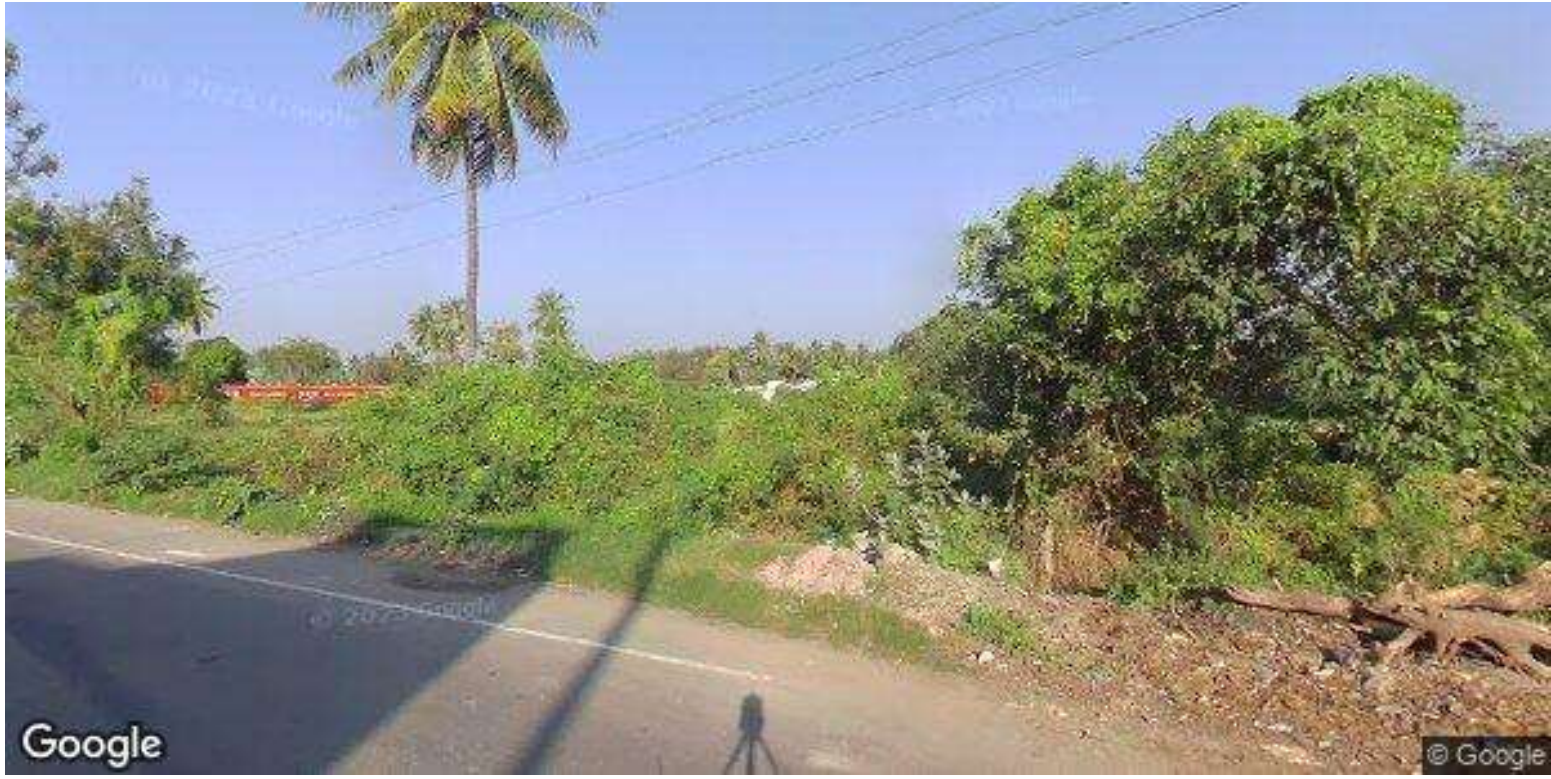
**Risk Type:** Turn  
**Risk Level:** Medium  
**Speed Limit:** 30 KM/Hr  
**Coordinates:** 11.13693, 77.76539

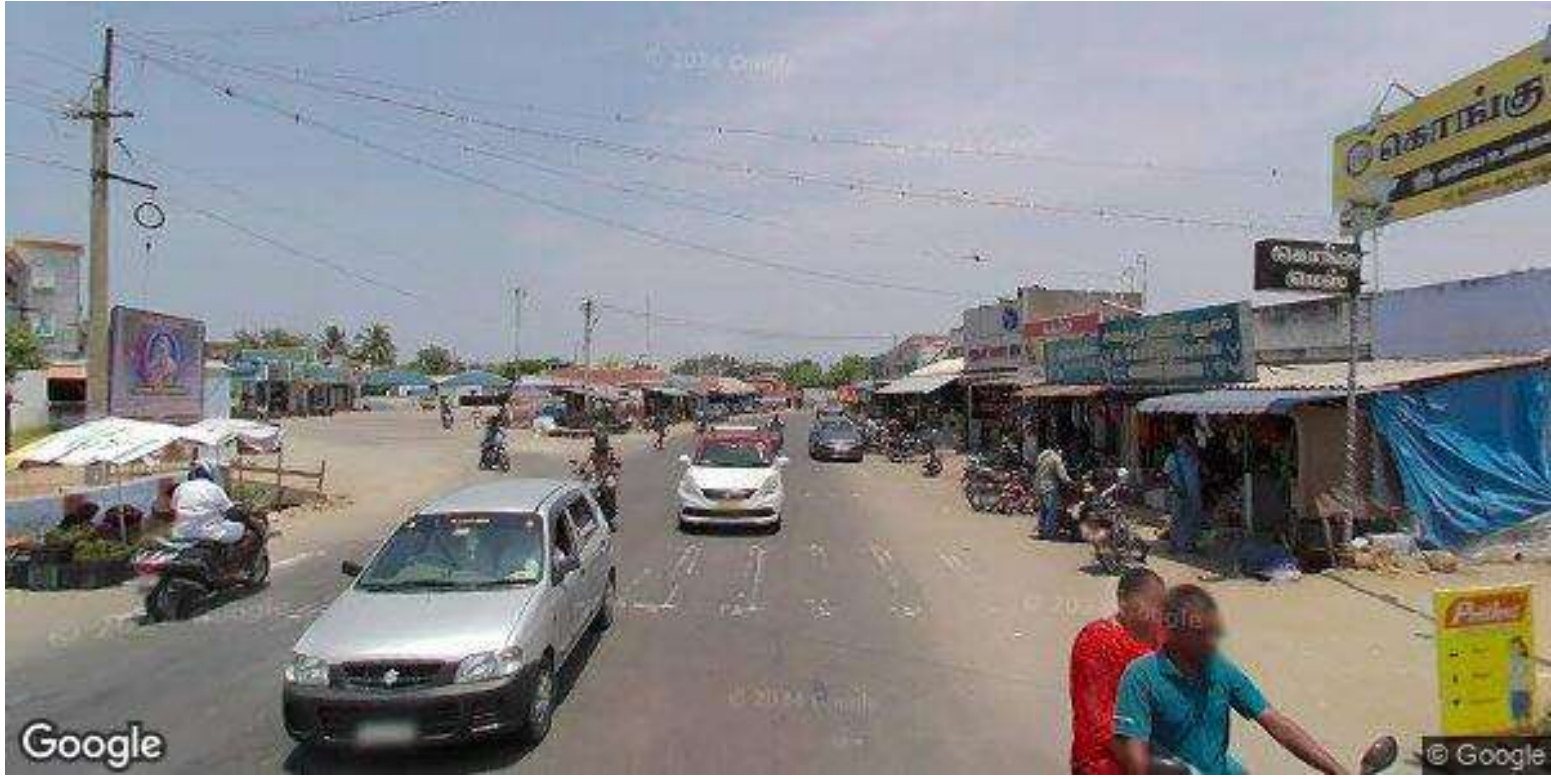
**Risk Type:** Turn  
**Risk Level:** High  
**Speed Limit:** 15 KM/Hr  
**Coordinates:** 11.04545, 77.73638

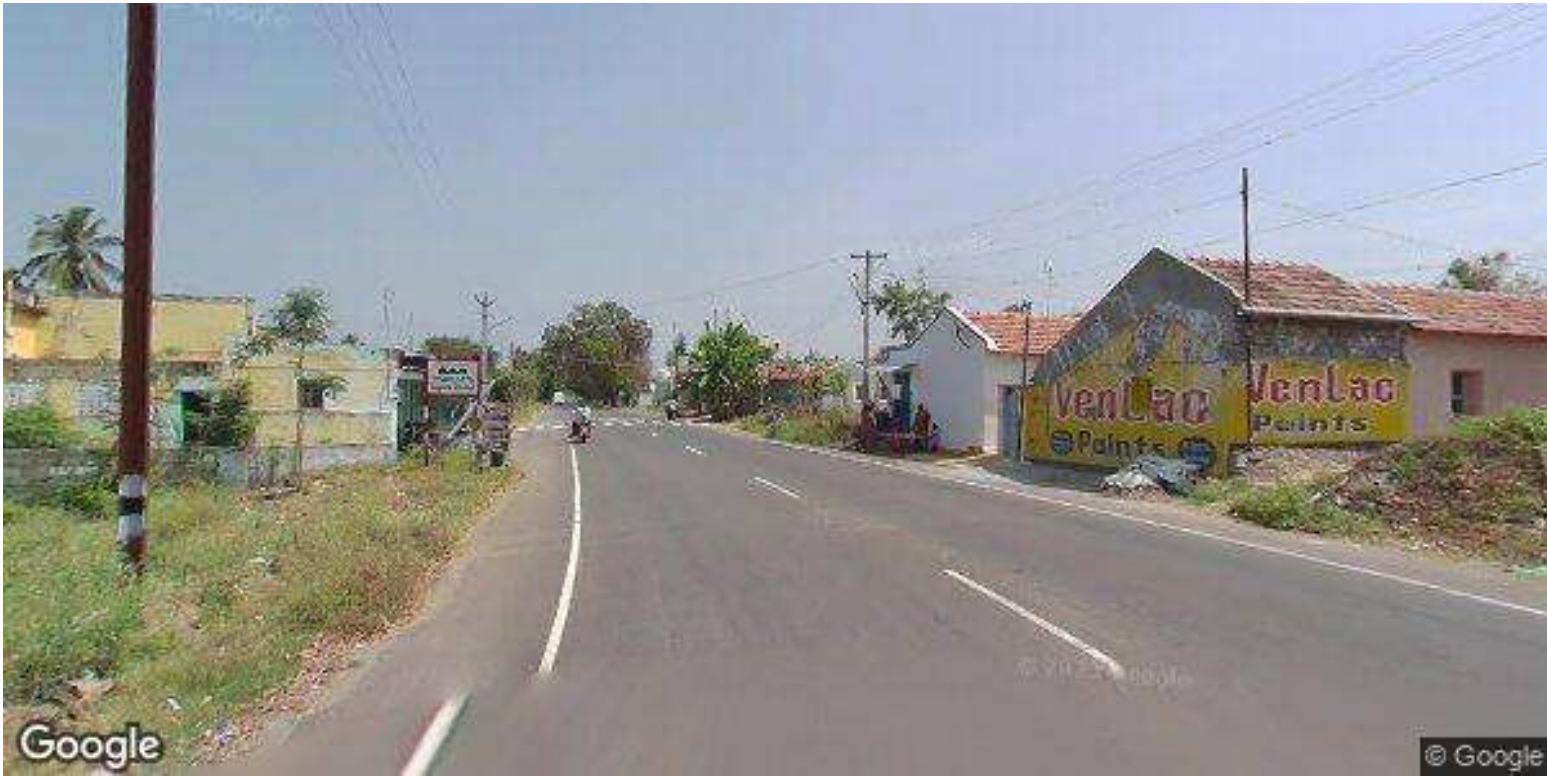
**Risk Type:** Turn  
**Risk Level:** High  
**Speed Limit:** 15 KM/Hr  
**Coordinates:** 10.99038, 77.72518

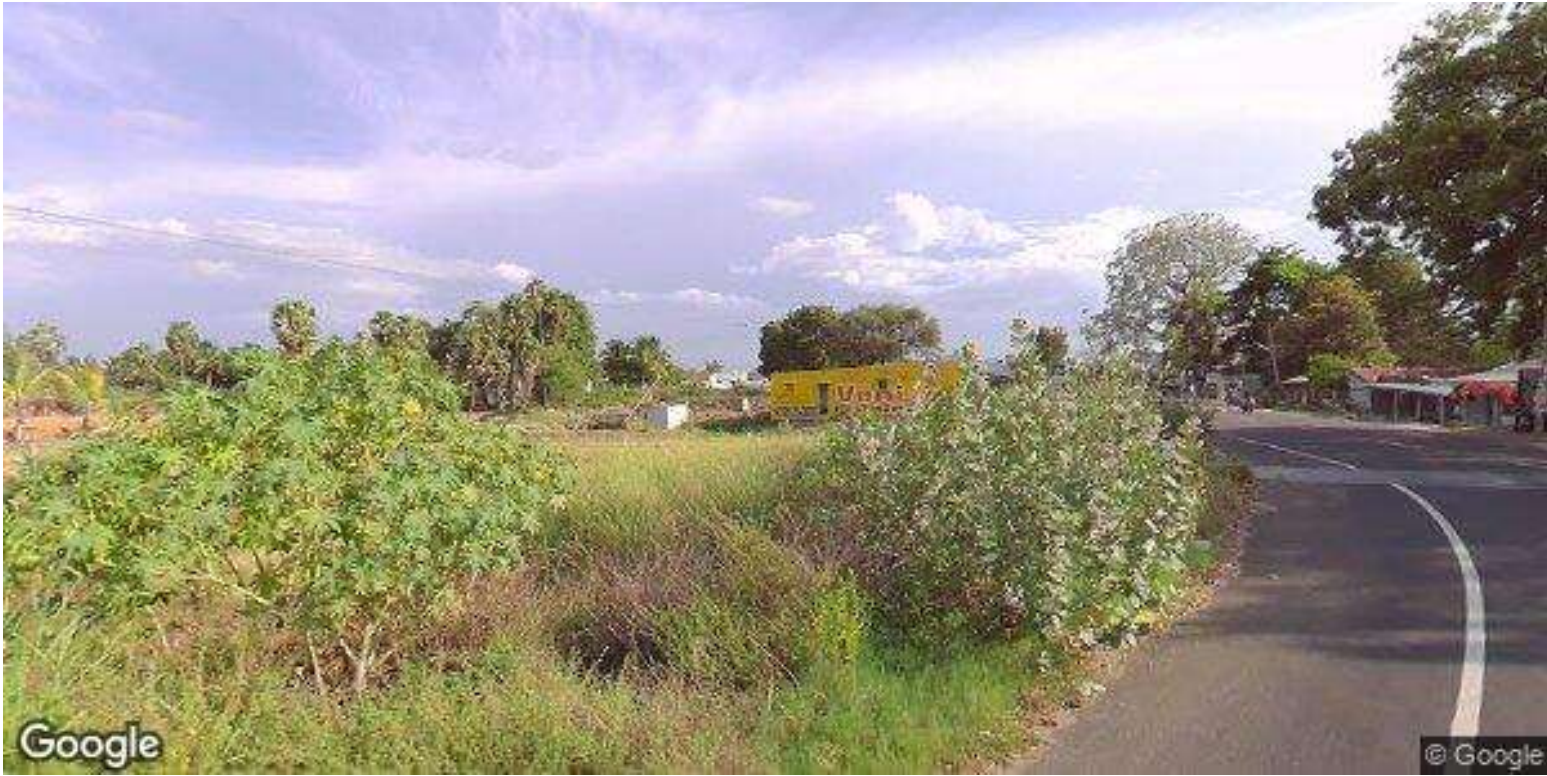
**Risk Type:** Turn  
**Risk Level:** High  
**Speed Limit:** 15 KM/Hr  
**Coordinates:** 10.98970, 77.72385

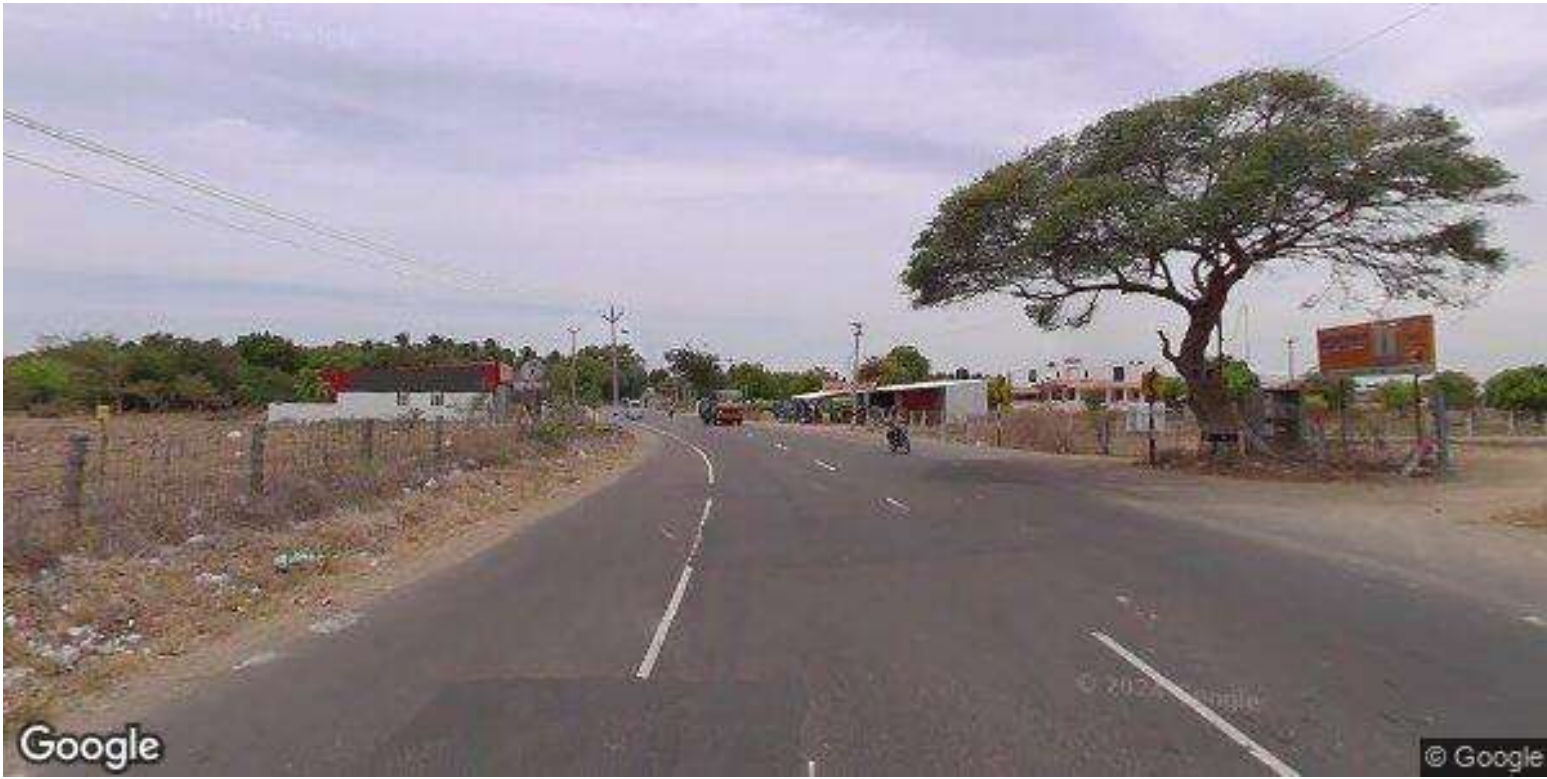
**Risk Type:** Turn  
**Risk Level:** Medium  
**Speed Limit:** 30 KM/Hr  
**Coordinates:** 10.96614, 77.71685

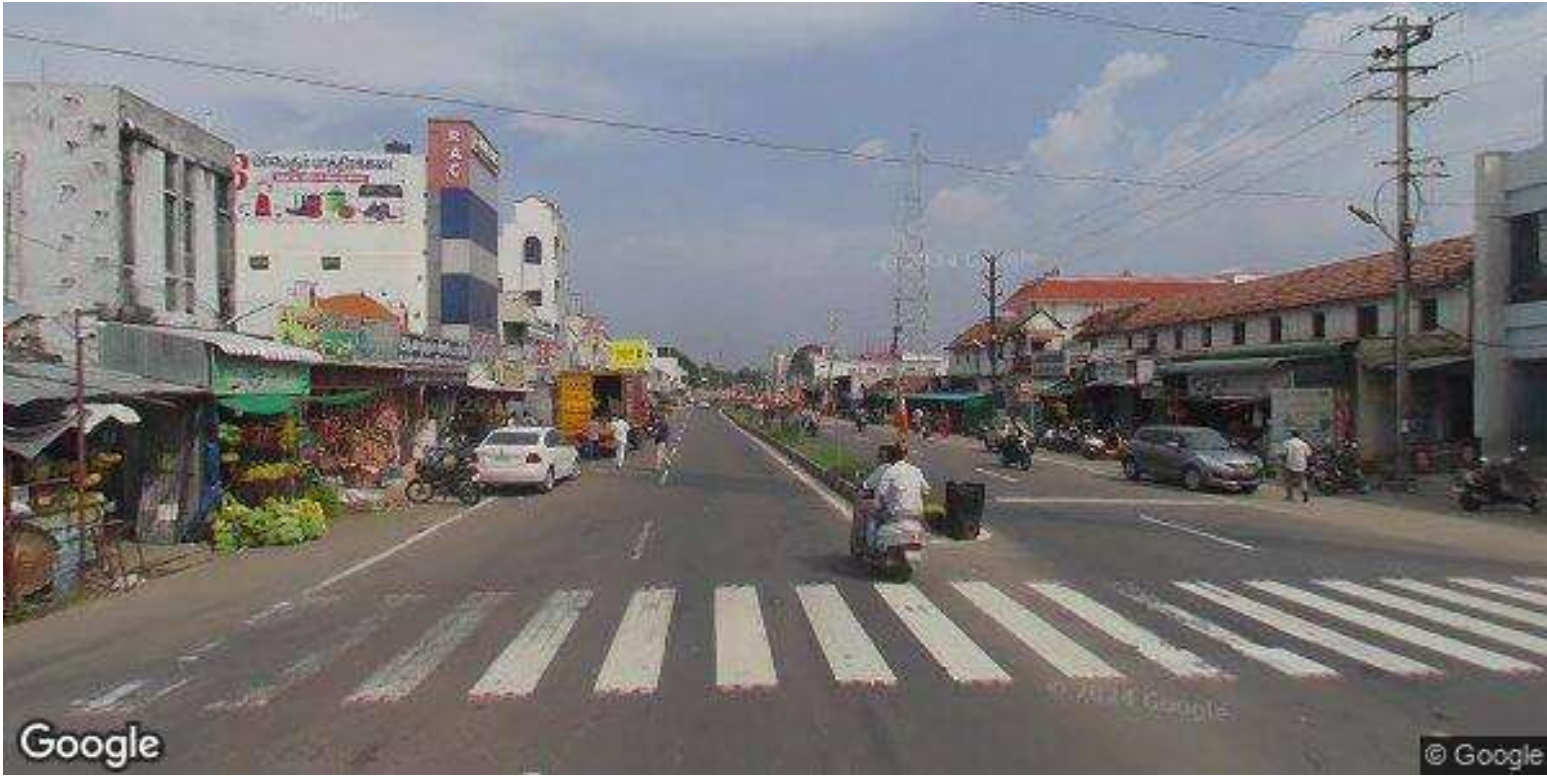
**Risk Type:** Turn  
**Risk Level:** High  
**Speed Limit:** 15 KM/Hr  
**Coordinates:** 10.94597, 77.71319

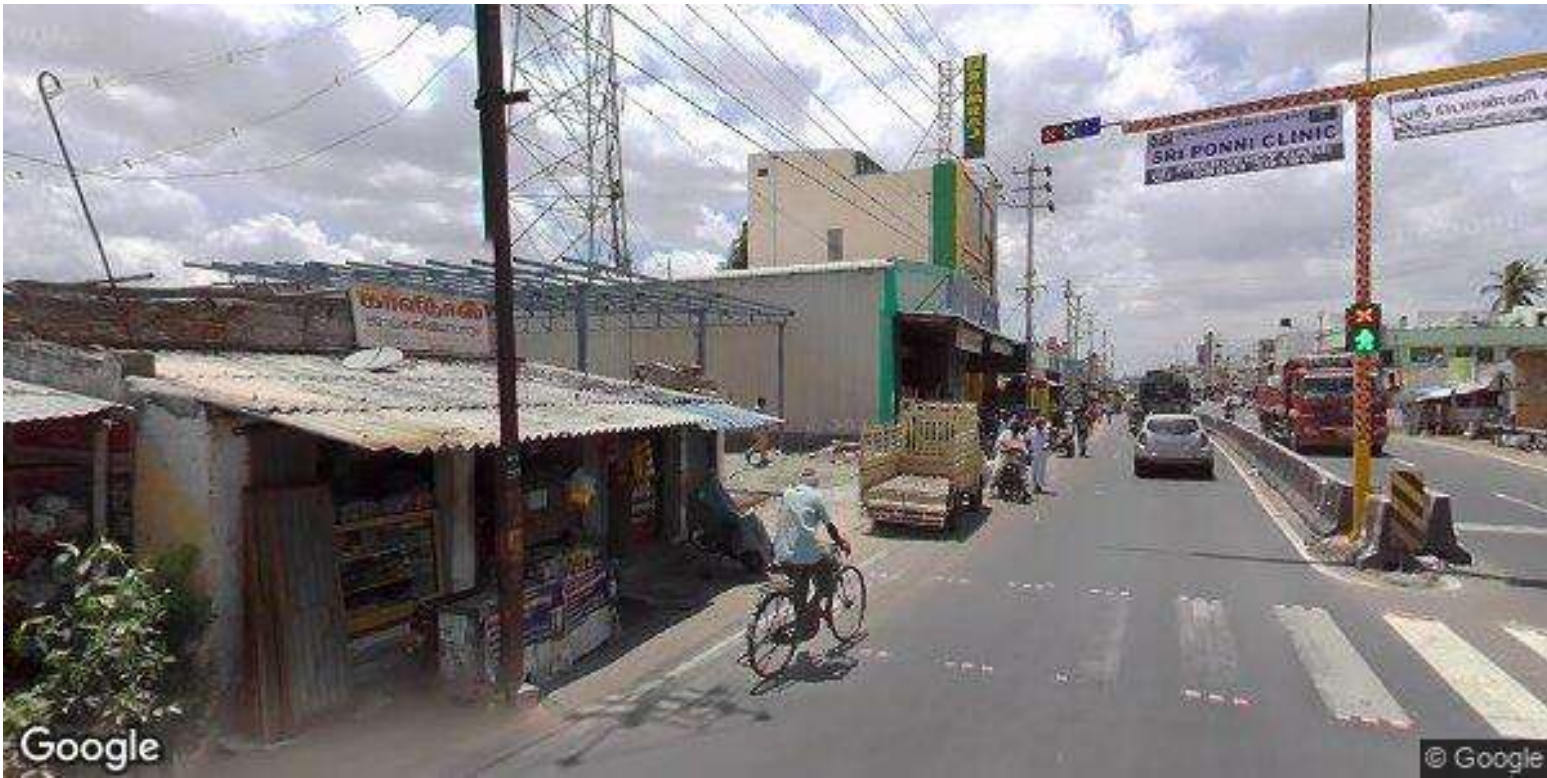
**Risk Type:** Turn  
**Risk Level:** High  
**Speed Limit:** 15 KM/Hr  
**Coordinates:** 10.94563, 77.71574

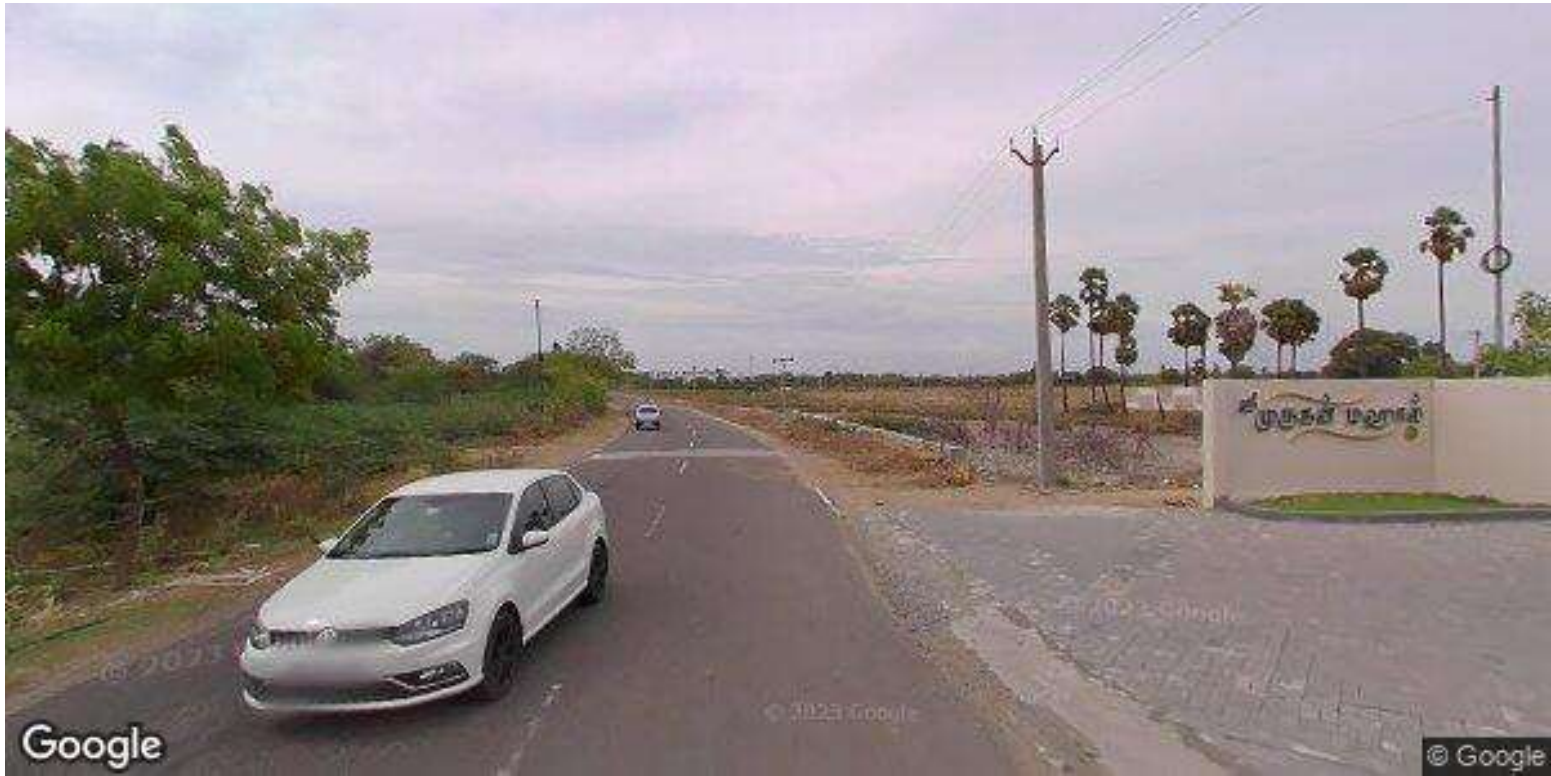
**Risk Type:** Turn  
**Risk Level:** Medium  
**Speed Limit:** 30 KM/Hr  
**Coordinates:** 10.92228, 77.72392

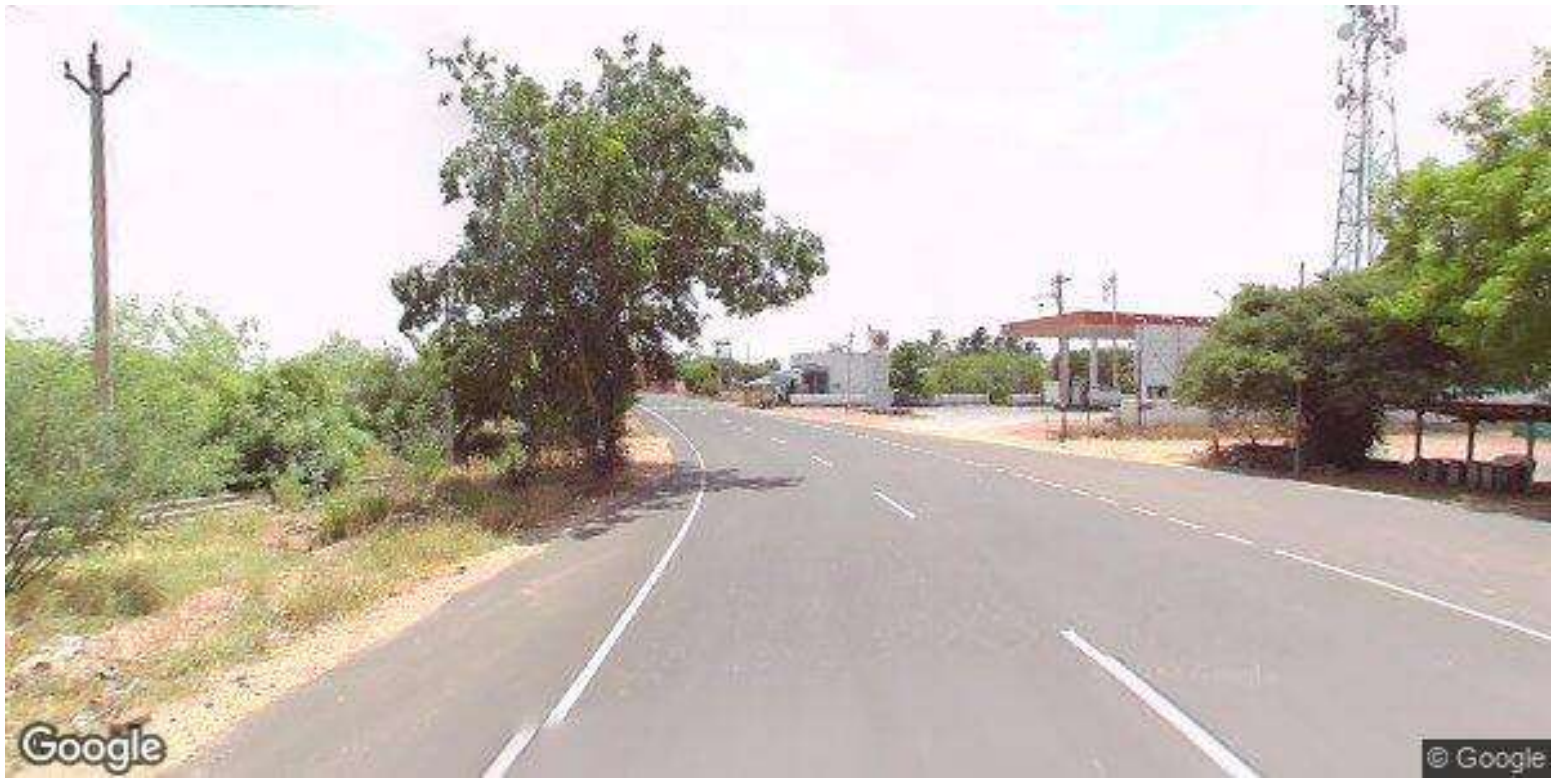
**Risk Type:** Turn  
**Risk Level:** Medium  
**Speed Limit:** 30 KM/Hr  
**Coordinates:** 10.86278, 77.72143

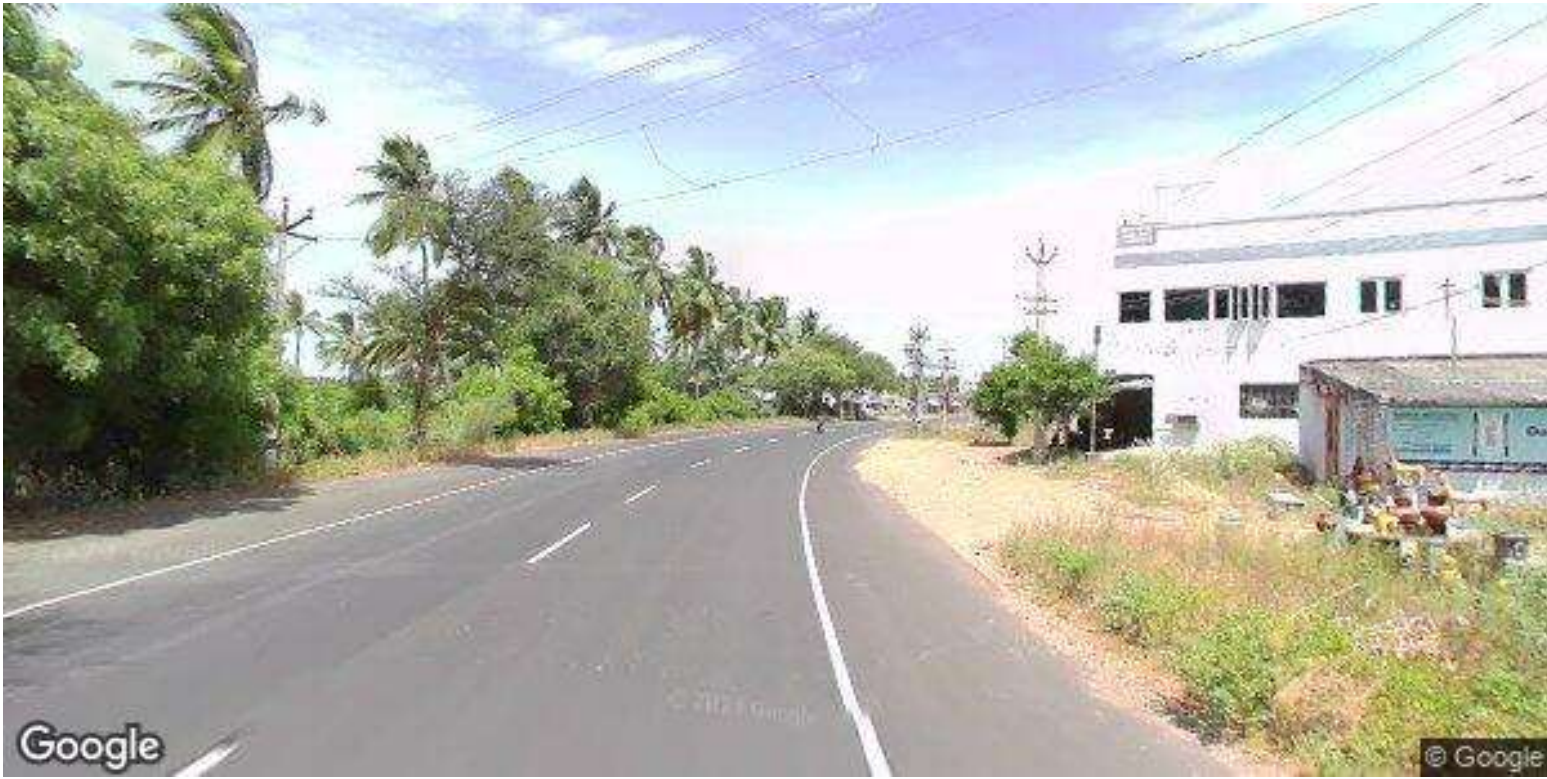
**Risk Type:** Turn  
**Risk Level:** Medium  
**Speed Limit:** 30 KM/Hr  
**Coordinates:** 10.86222, 77.72089

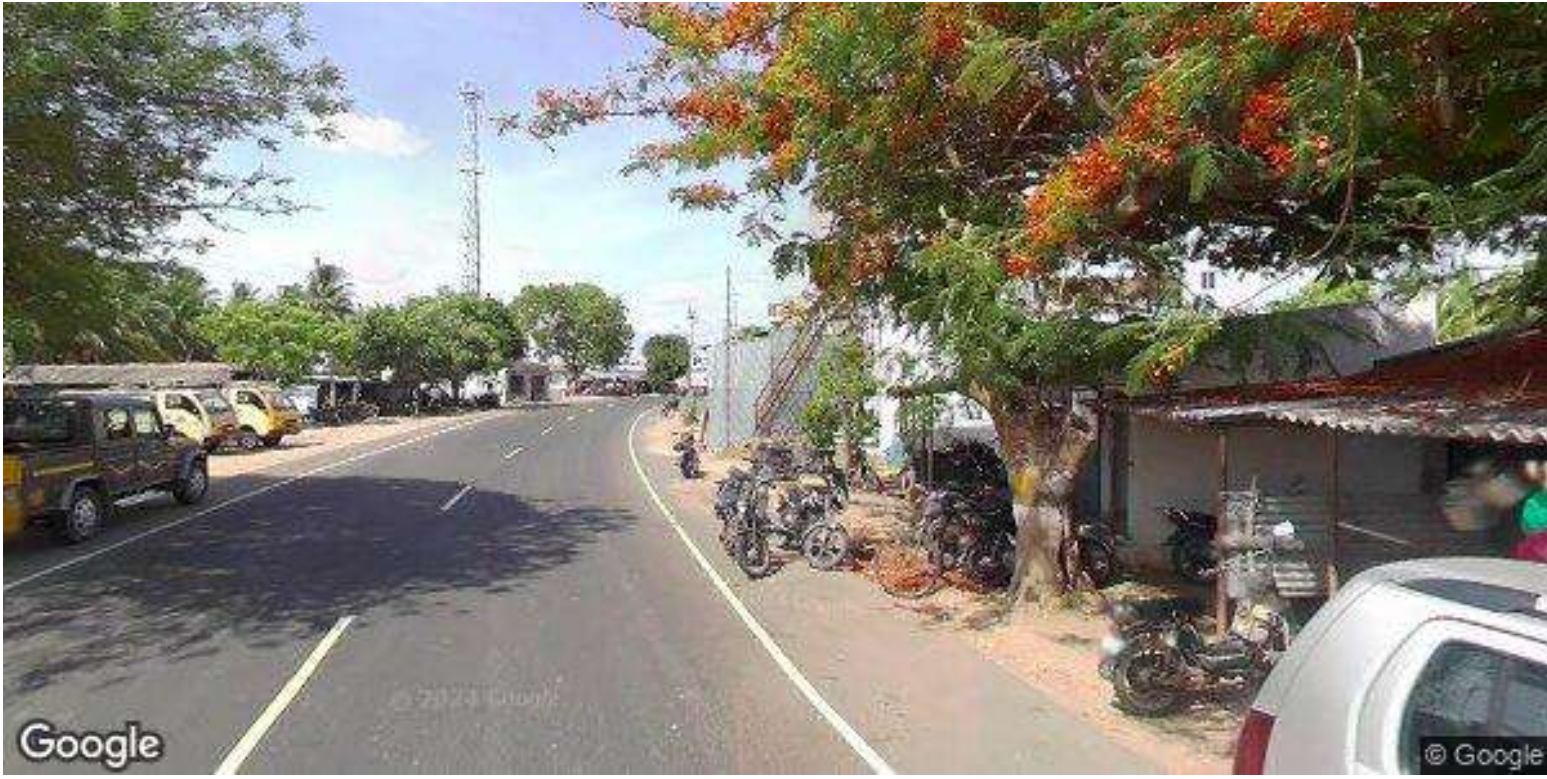
**Risk Type:** Turn  
**Risk Level:** High  
**Speed Limit:** 15 KM/Hr  
**Coordinates:** 10.86158, 77.71764

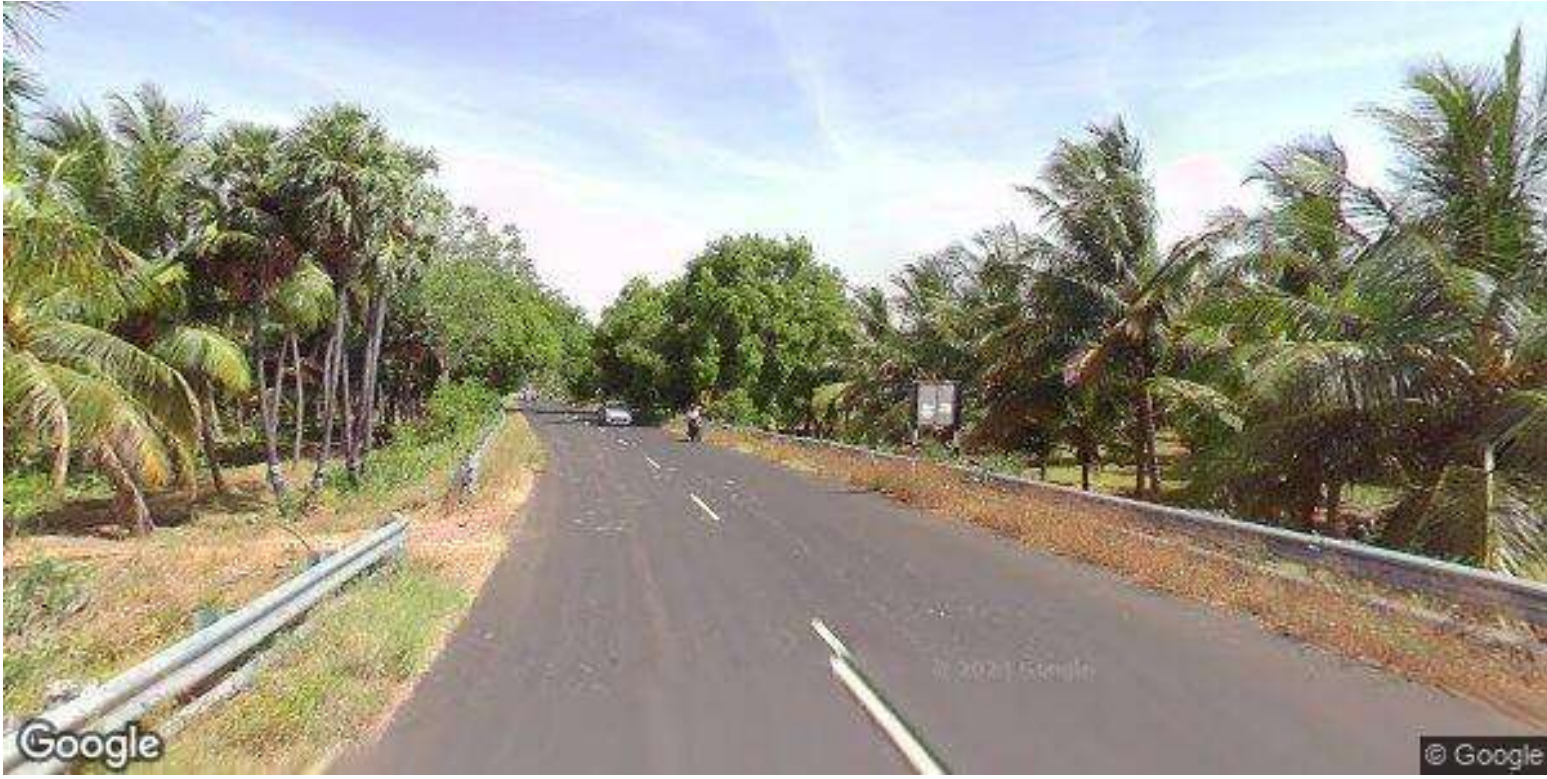
**Risk Type:** Turn  
**Risk Level:** Medium  
**Speed Limit:** 30 KM/Hr  
**Coordinates:** 10.86061, 77.71708
