## JOURNEY RISK MANAGEMENT (JRM) STUDY

### Salem Terminal TO KARTHIK FUELS IOC DEALER

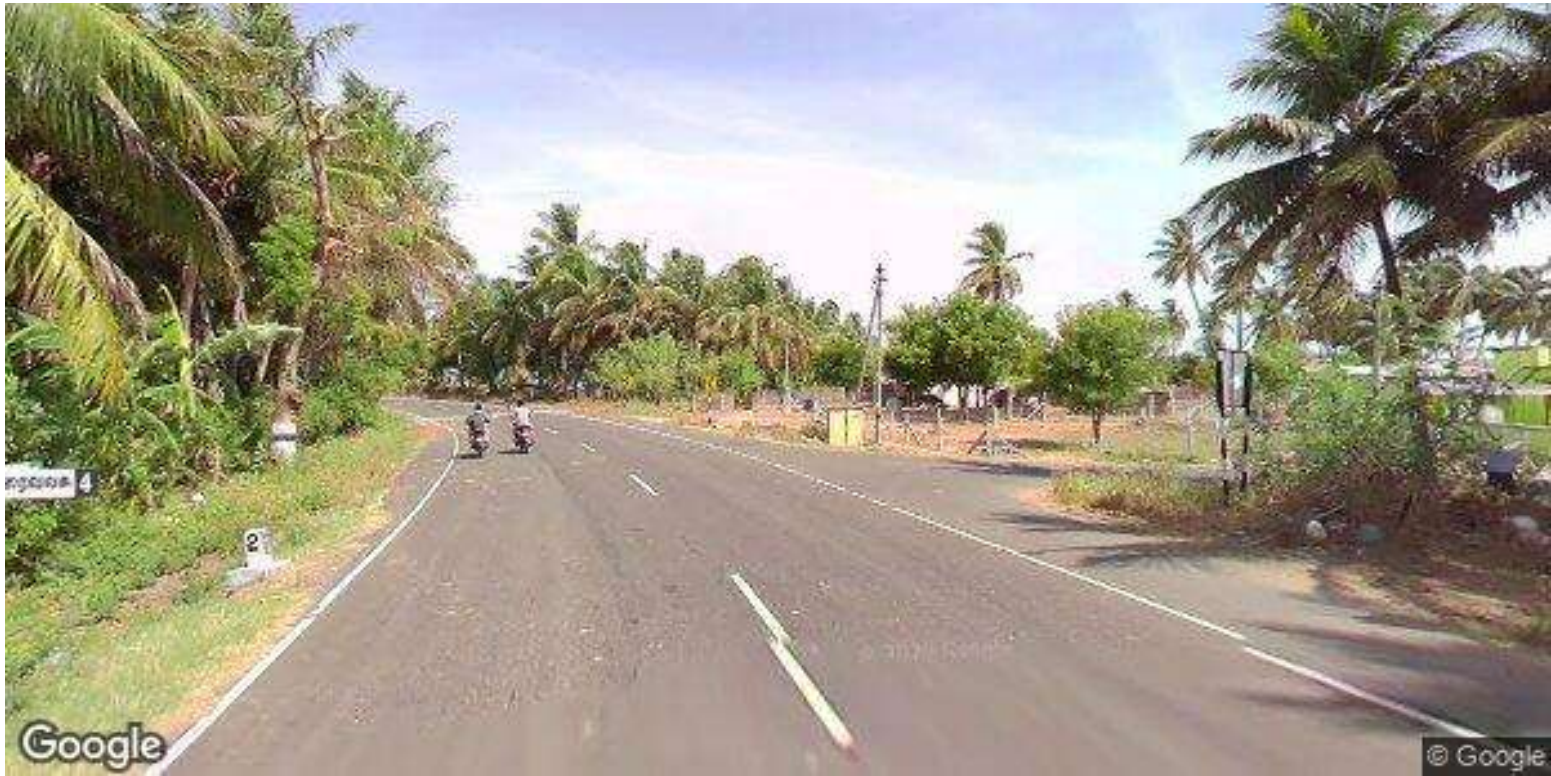
**Risk Type:** Turn  
**Risk Level:** Medium  
**Speed Limit:** 30 KM/Hr  
**Coordinates:** 10.85657, 77.71762

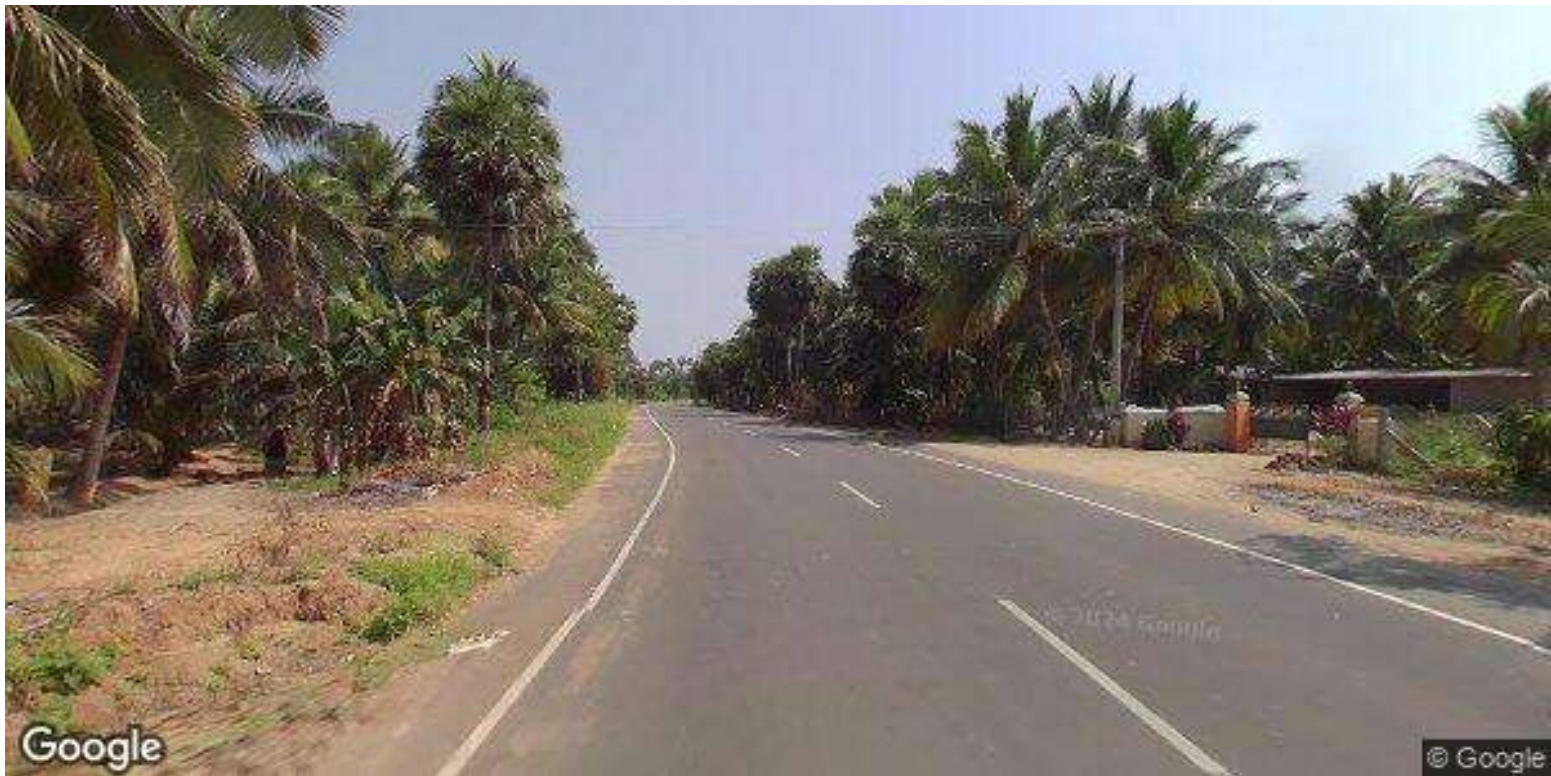
**Risk Type:** Turn  
**Risk Level:** Medium  
**Speed Limit:** 30 KM/Hr  
**Coordinates:** 10.85577, 77.71832

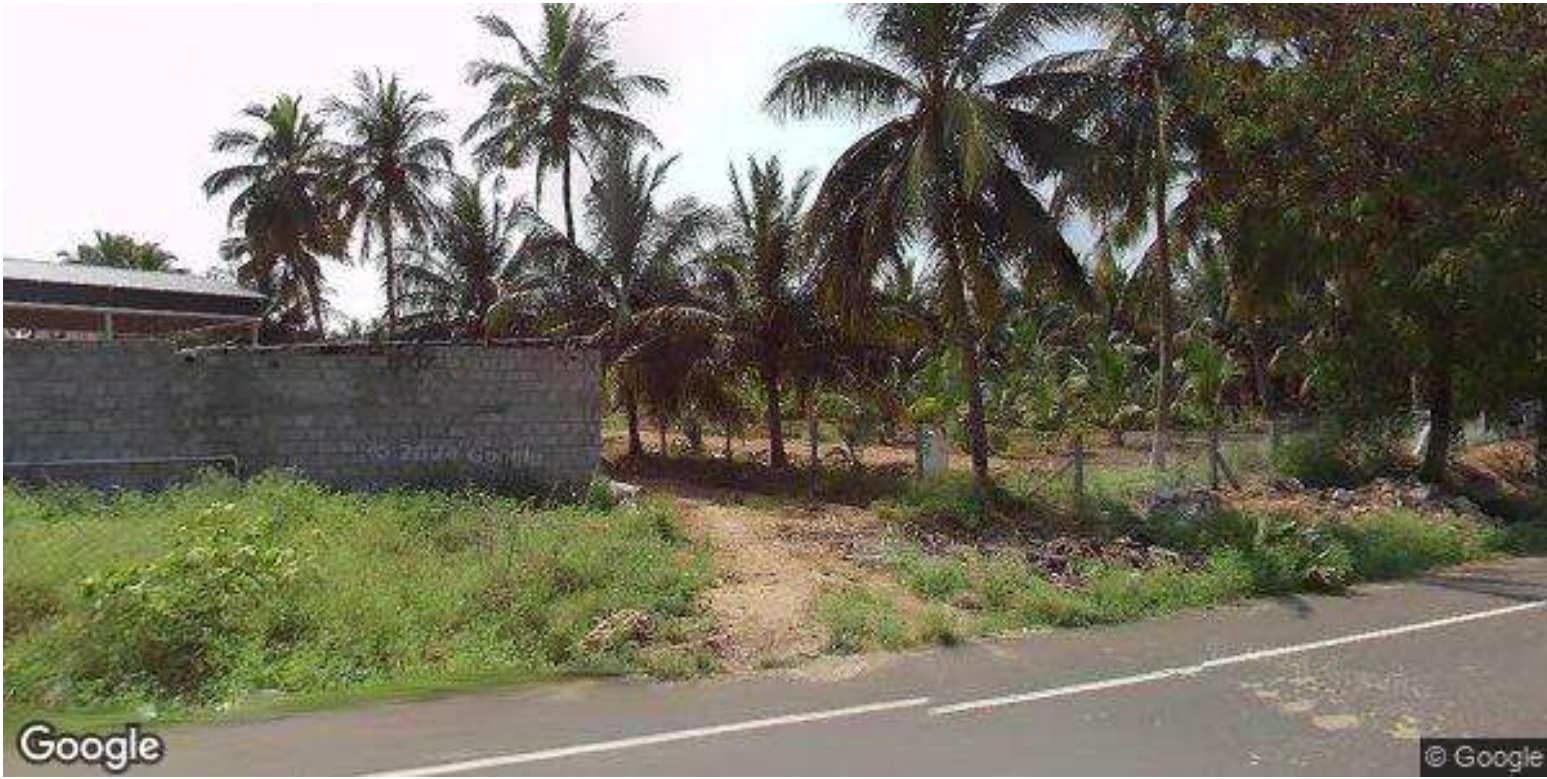
**Risk Type:** Turn  
**Risk Level:** Medium  
**Speed Limit:** 30 KM/Hr  
**Coordinates:** 10.85507, 77.72021

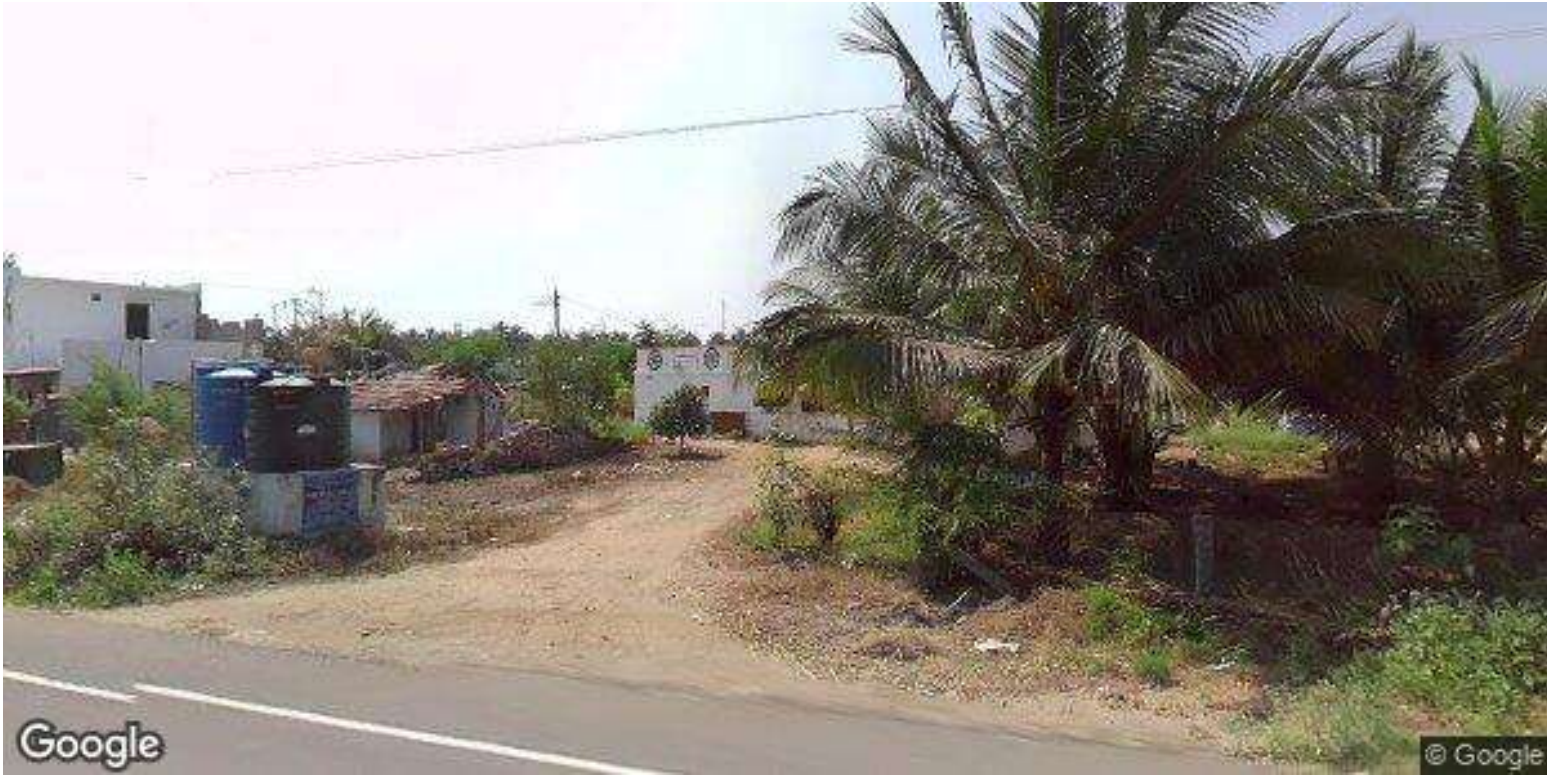
**Risk Type:** Turn  
**Risk Level:** Medium  
**Speed Limit:** 30 KM/Hr  
**Coordinates:** 10.85412, 77.72083

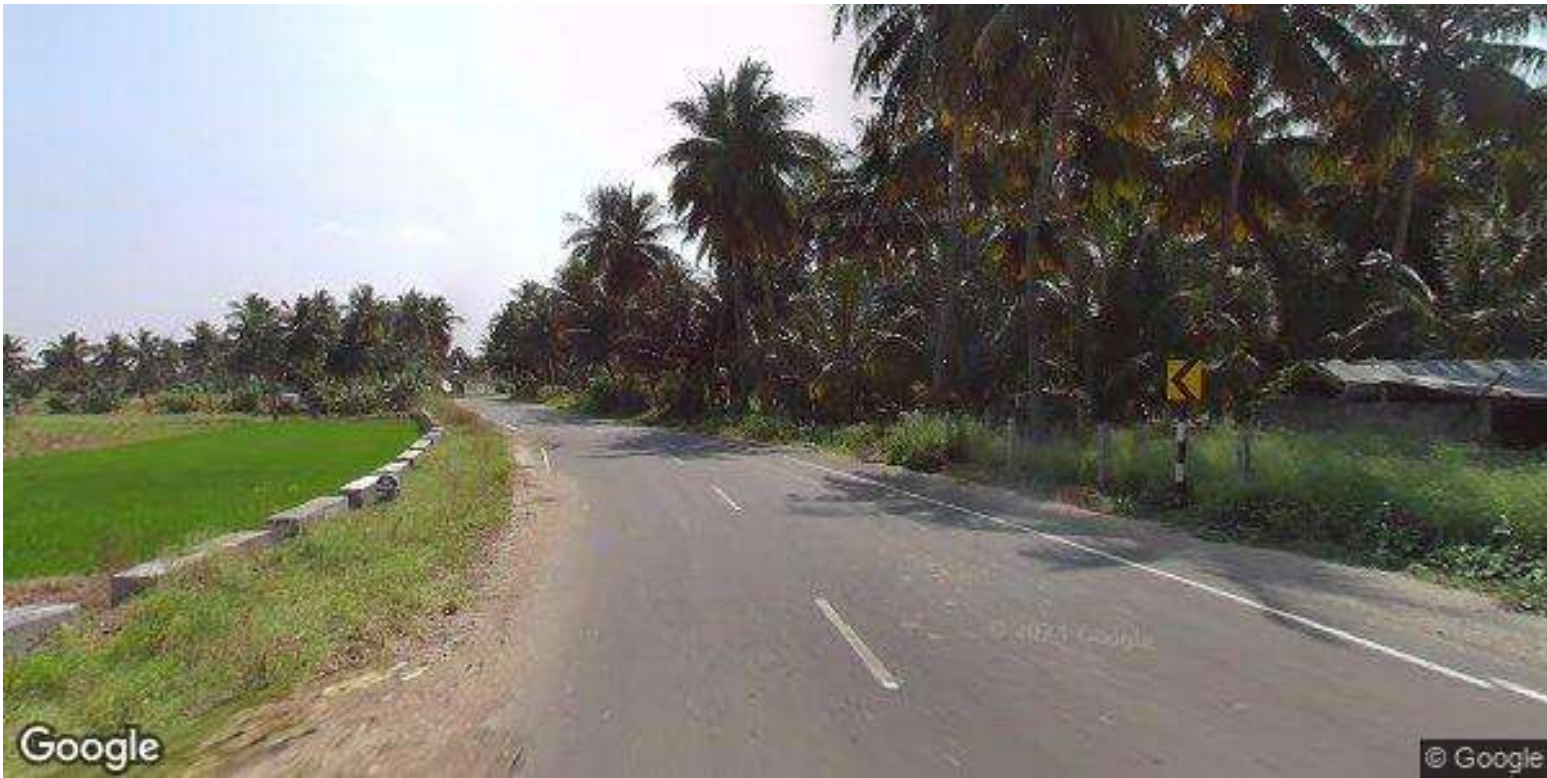
**Risk Type:** Turn  
**Risk Level:** Medium  
**Speed Limit:** 30 KM/Hr  
**Coordinates:** 10.85112, 77.72068

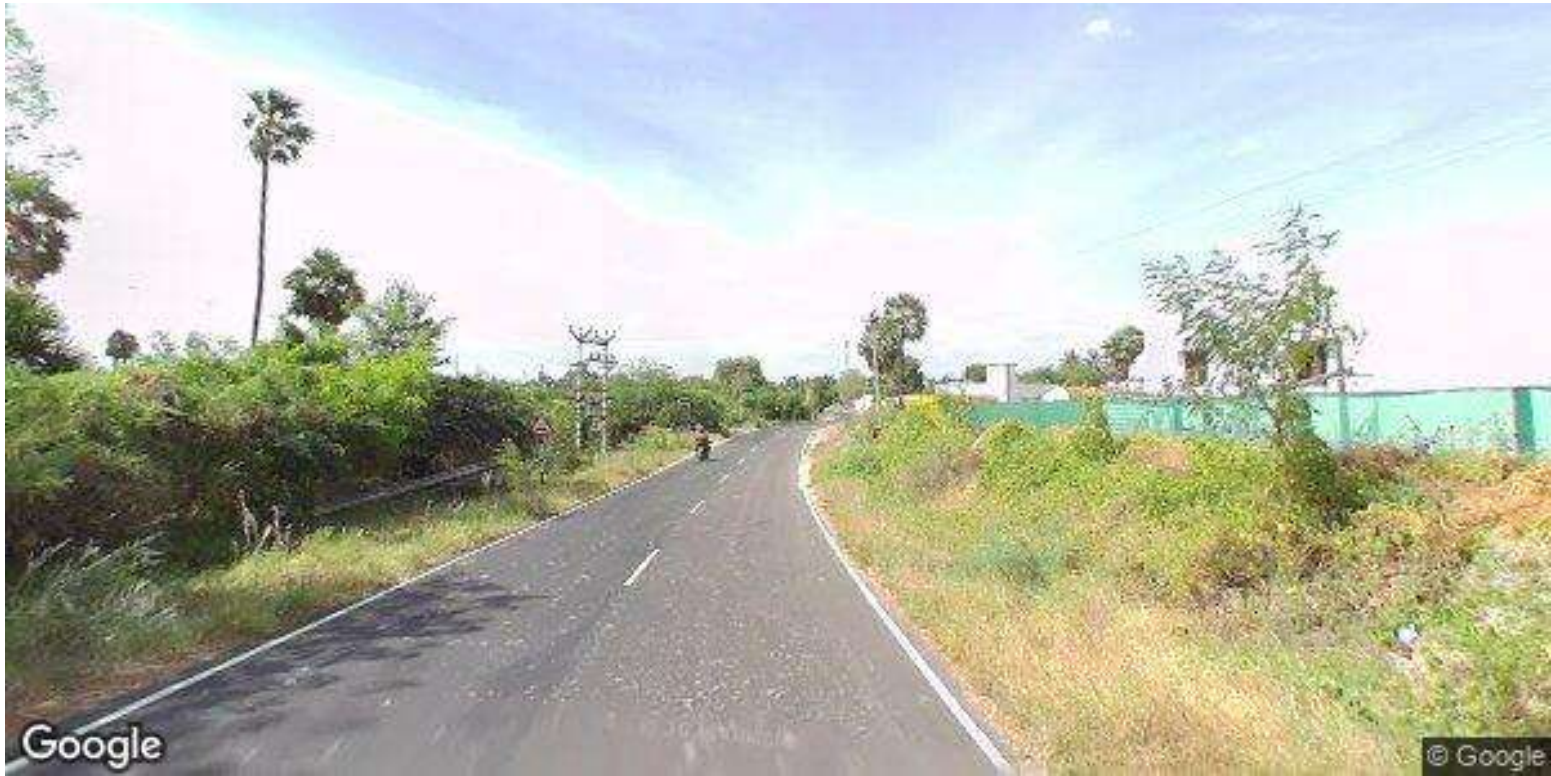
**Risk Type:** Turn  
**Risk Level:** Medium  
**Speed Limit:** 30 KM/Hr  
**Coordinates:** 10.82112, 77.71888

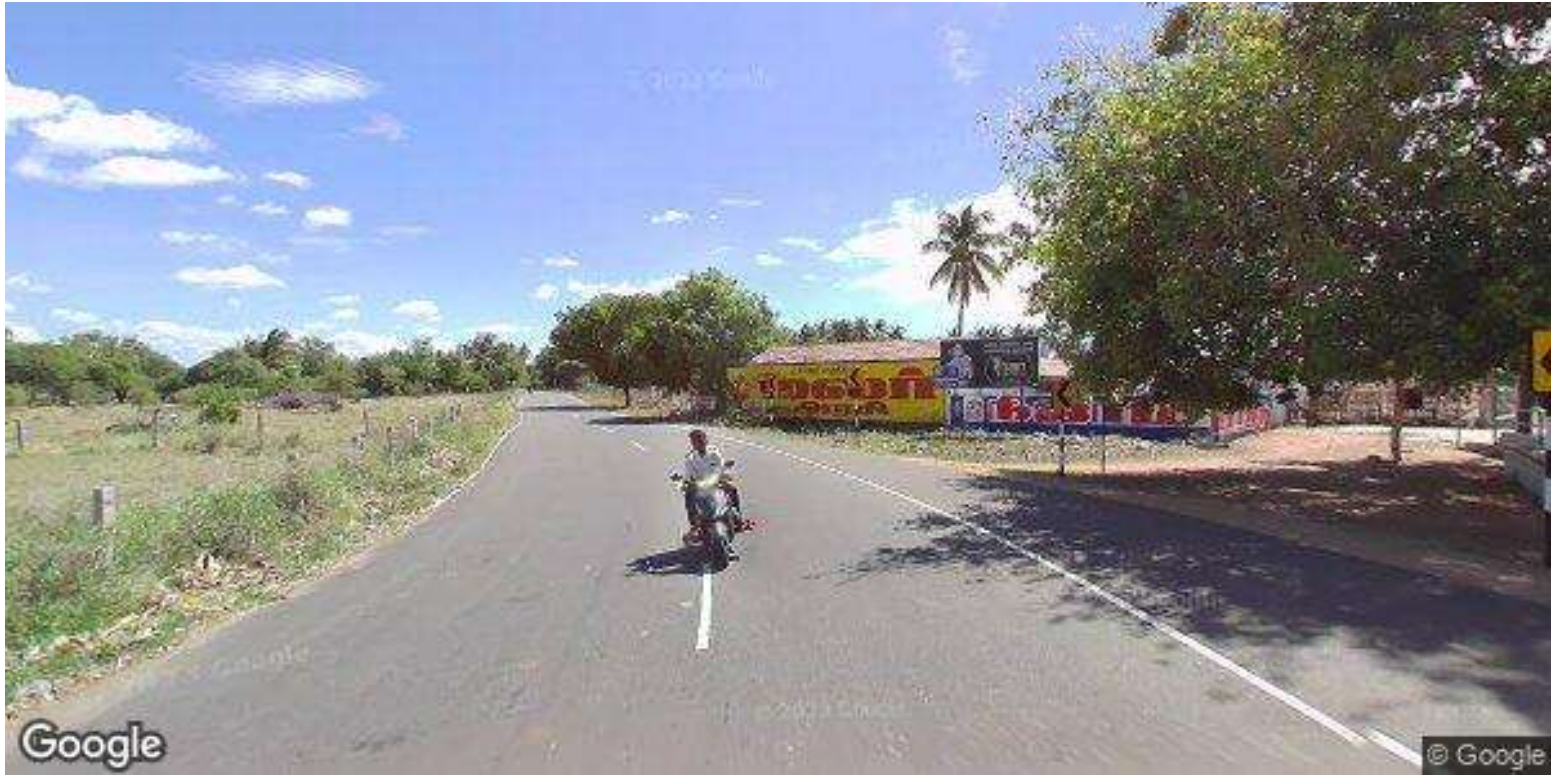
**Risk Type:** Turn  
**Risk Level:** Medium  
**Speed Limit:** 30 KM/Hr  
**Coordinates:** 10.80306, 77.71465
