# IndianOil

## **JOURNEY RISK MANAGEMENT (JRM) STUDY**

### **Salem Terminal TO SURYA FUEL AGENCIES**

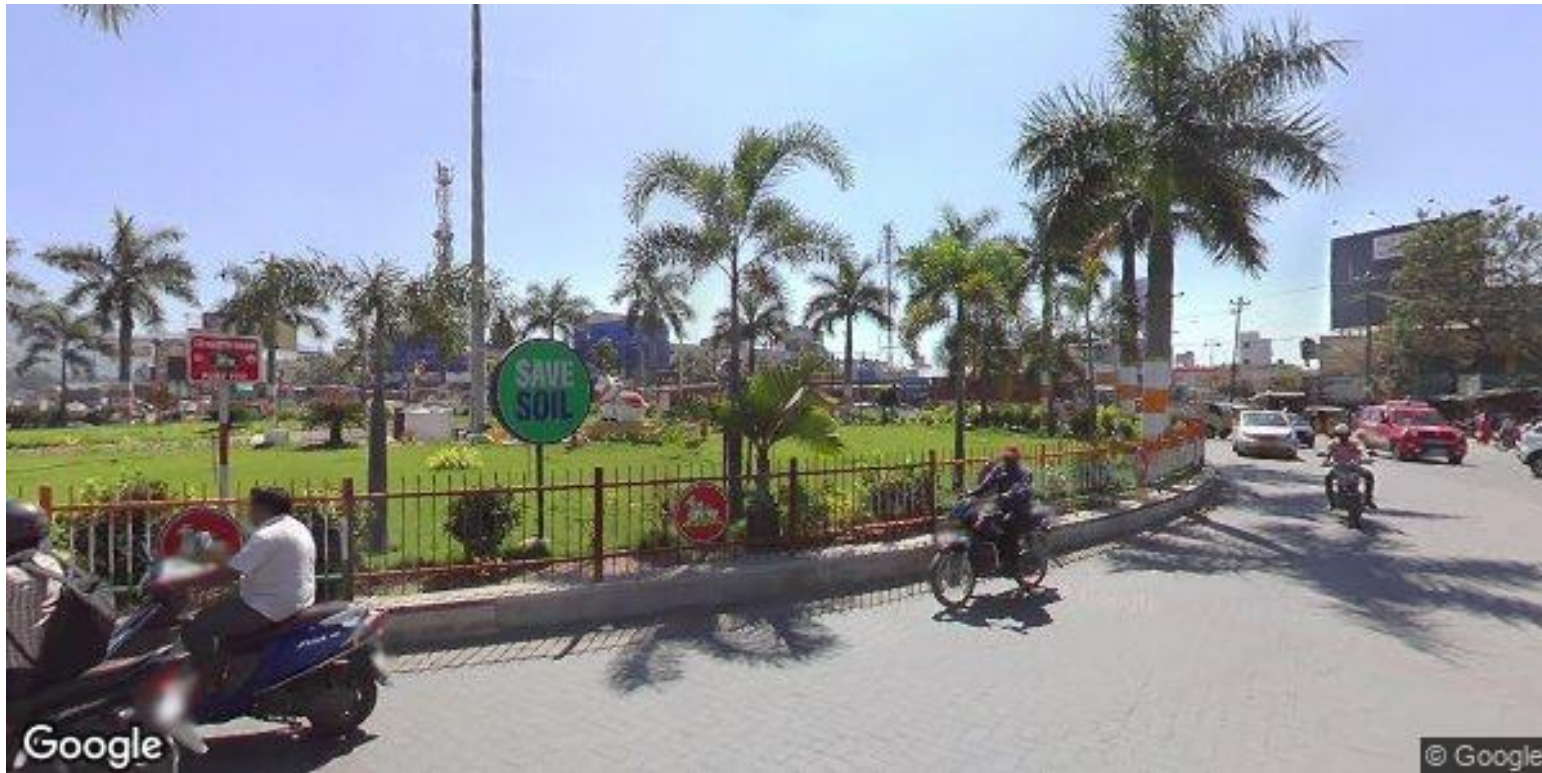
**Coordinates:** 11.63303, 78.12713

**Risk Type:** Roundabout

**Risk Level:** High

**Speed Limit:** 15 KM/Hr

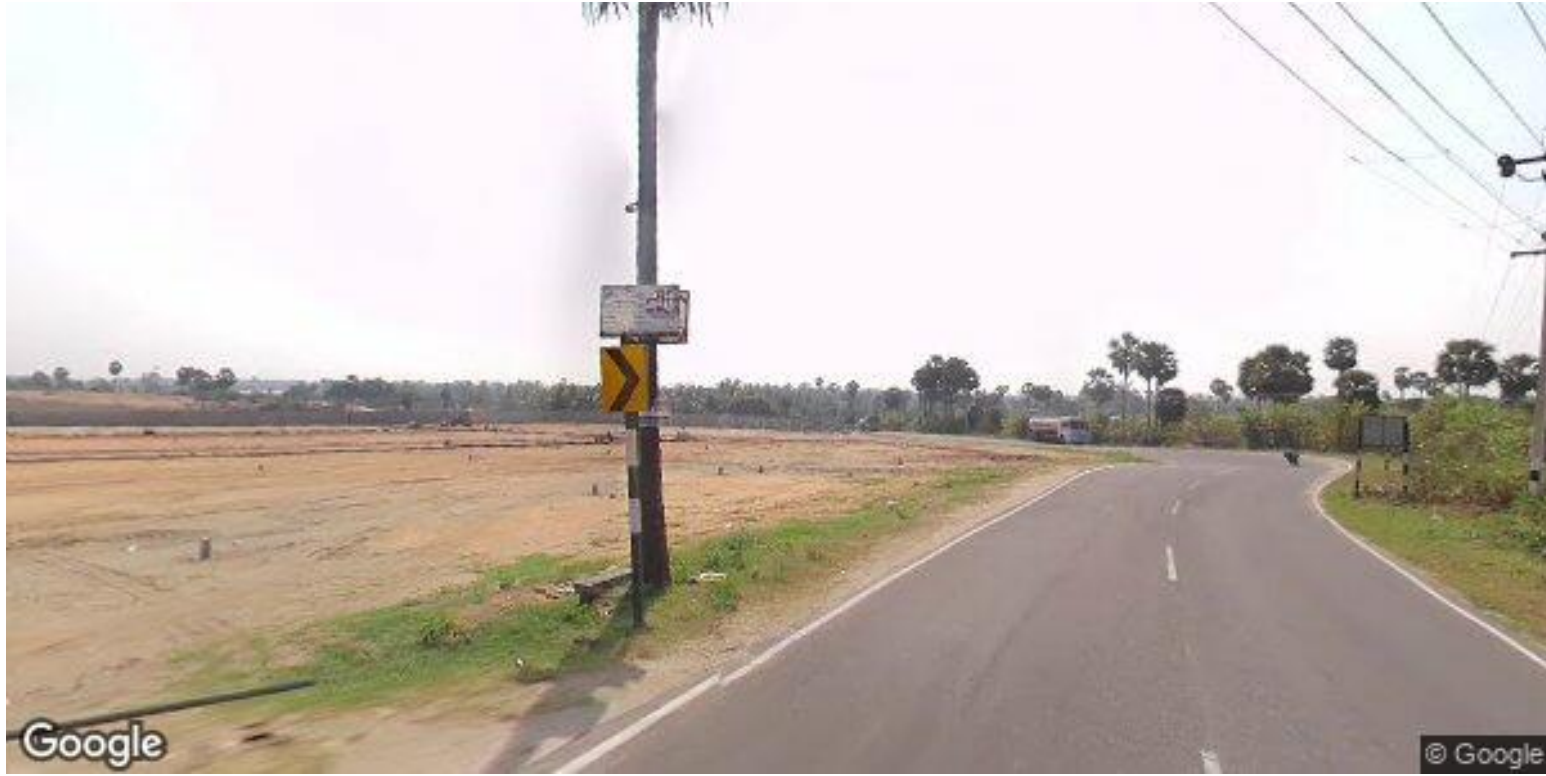
**Risk Type:** Turn  
**Risk Level:** Medium  
**Speed Limit:** 30 KM/Hr  
**Coordinates:** 11.45898, 77.85135

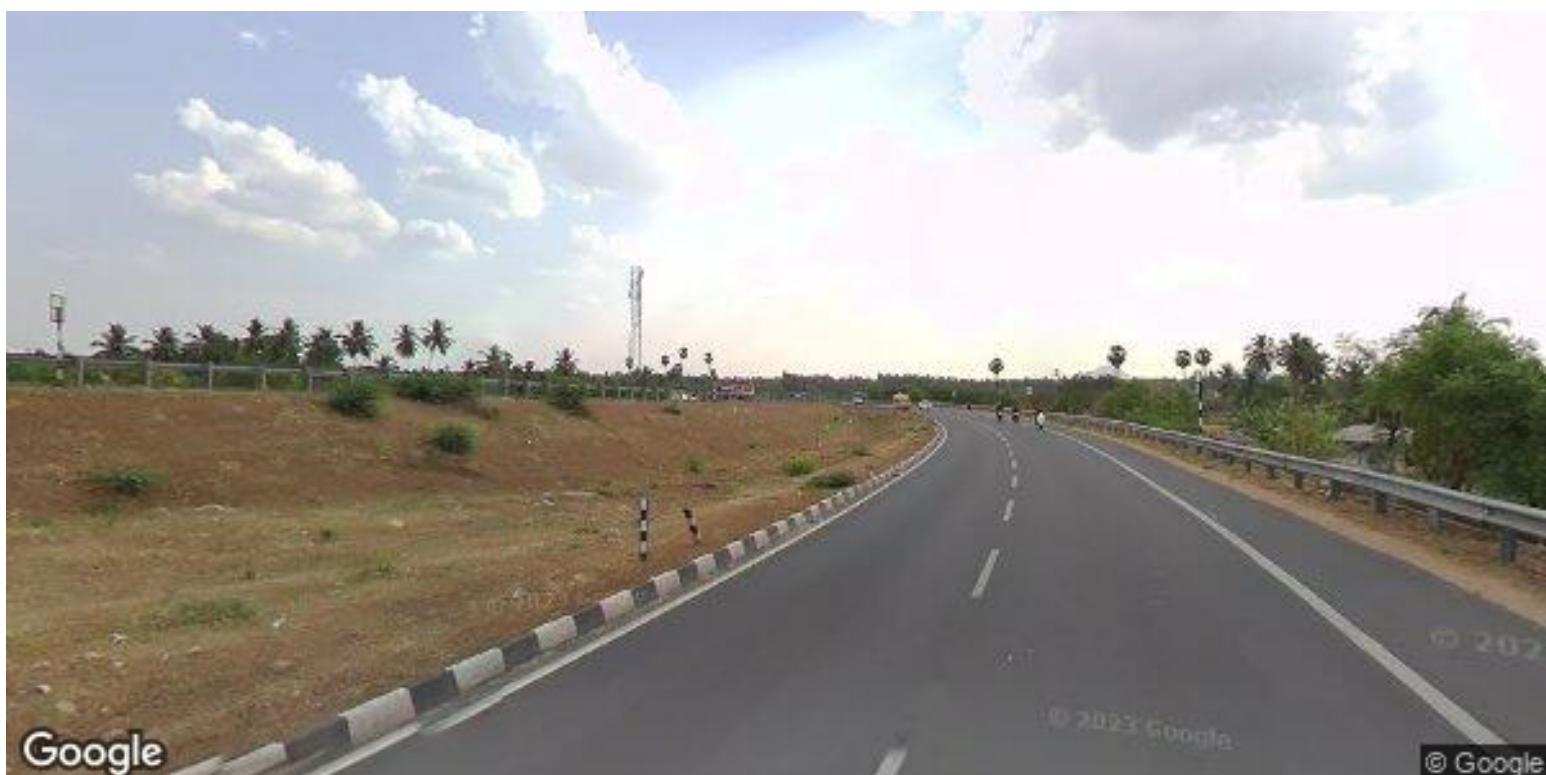
**Risk Type:** Turn  
**Risk Level:** Medium  
**Speed Limit:** 30 KM/Hr  
**Coordinates:** 11.53569, 77.95787

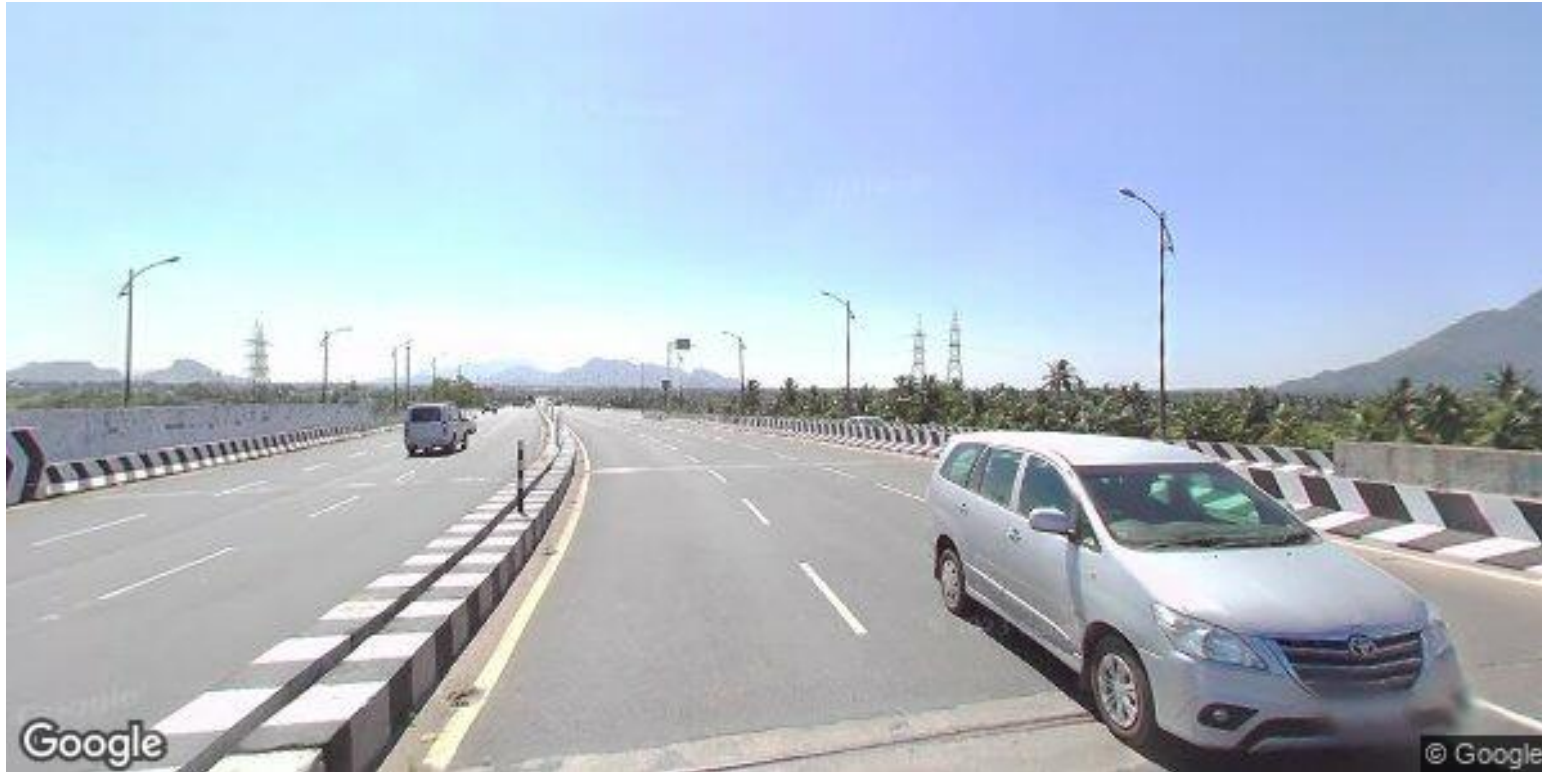
**Risk Type:** Turn  
**Risk Level:** Medium  
**Speed Limit:** 30 KM/Hr  
**Coordinates:** 11.64120, 78.11797

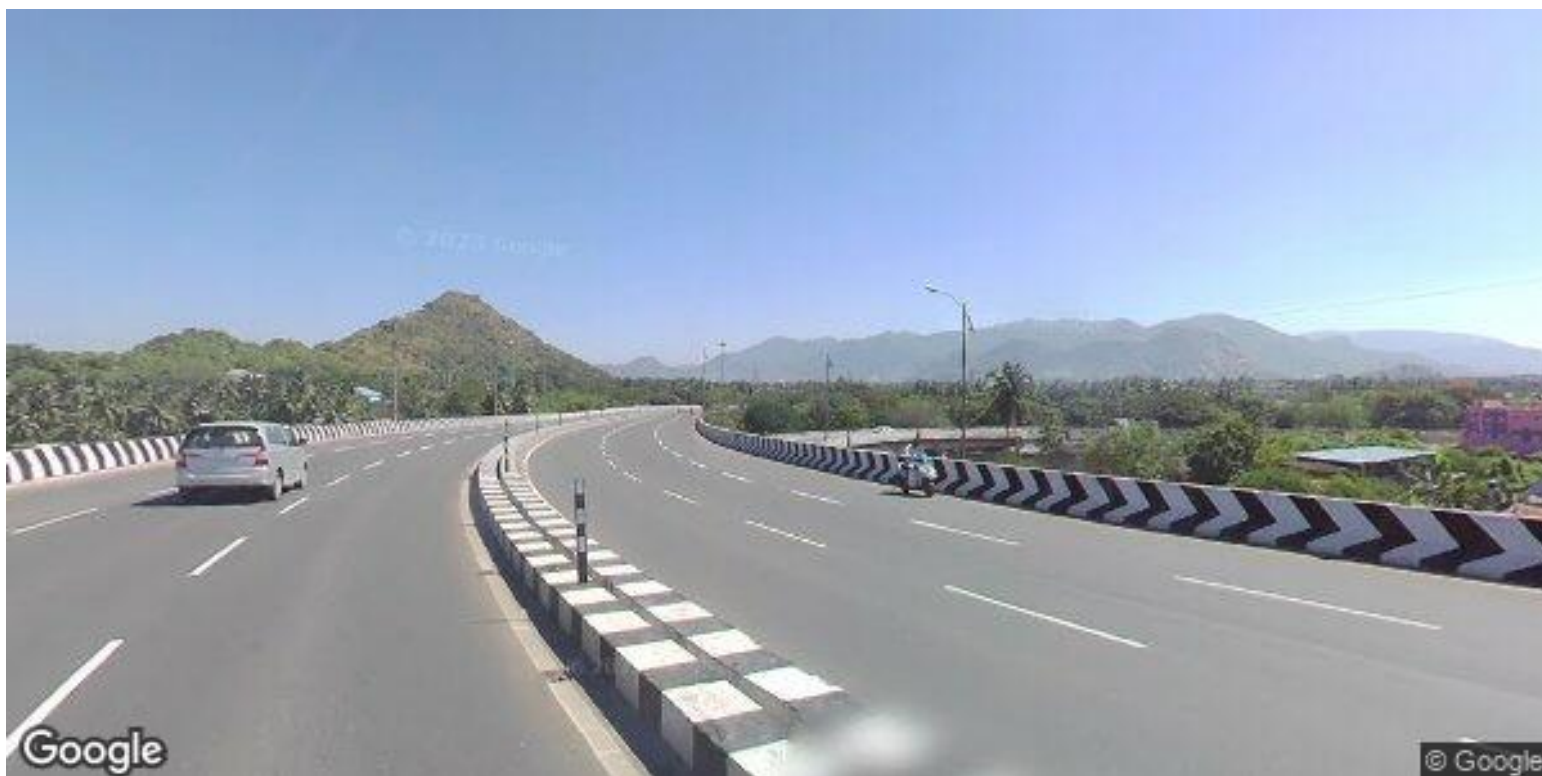
**Risk Type:** Turn  
**Risk Level:** High  
**Speed Limit:** 15 KM/Hr  
**Coordinates:** 11.64216, 78.11875

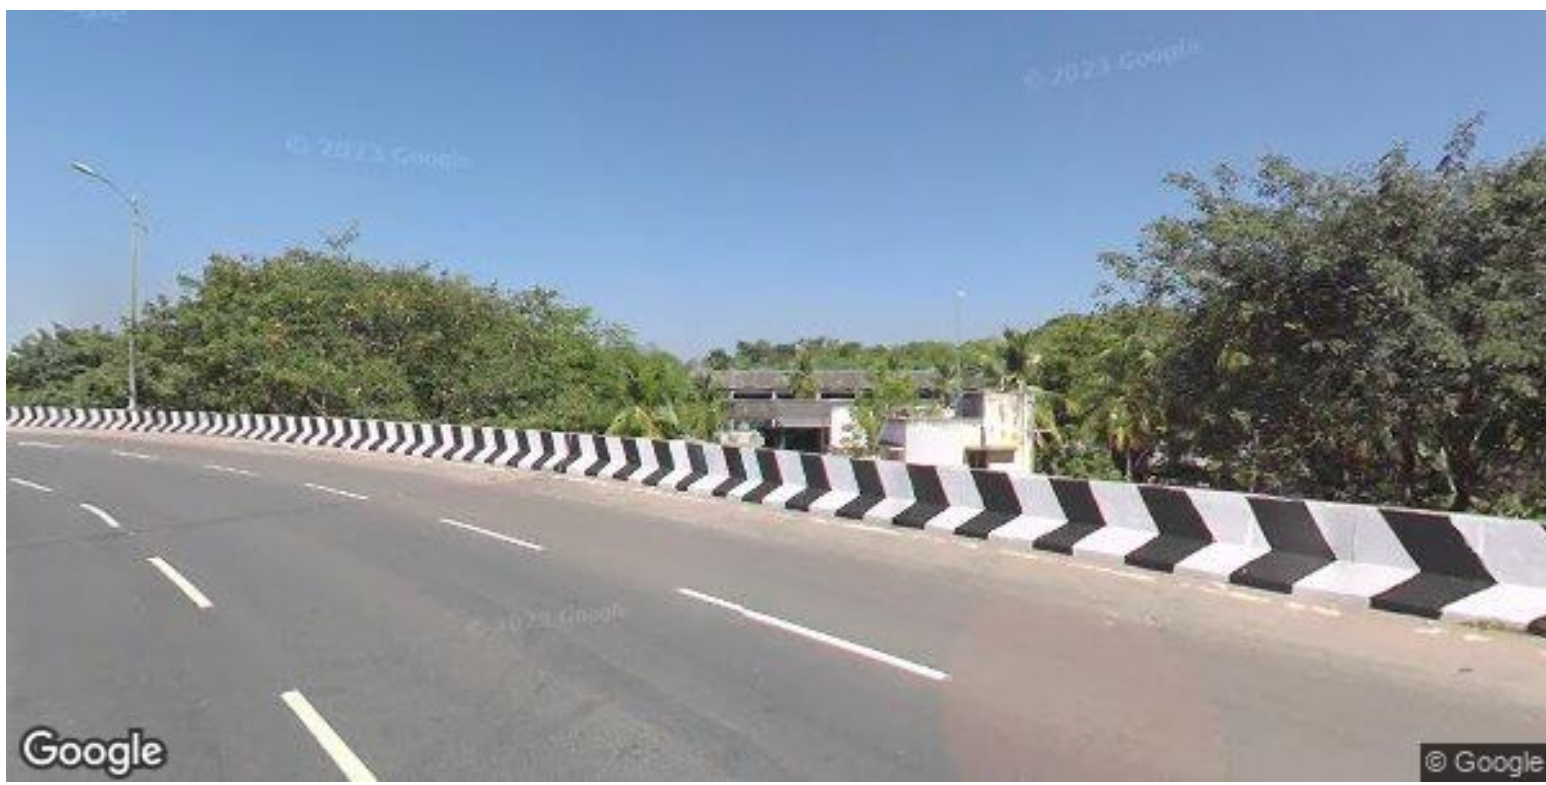
**Coordinates:** 11.64162, 78.12160

**Risk Type:** Turn

**Risk Level:** High

**Speed Limit:** 15 KM/Hr

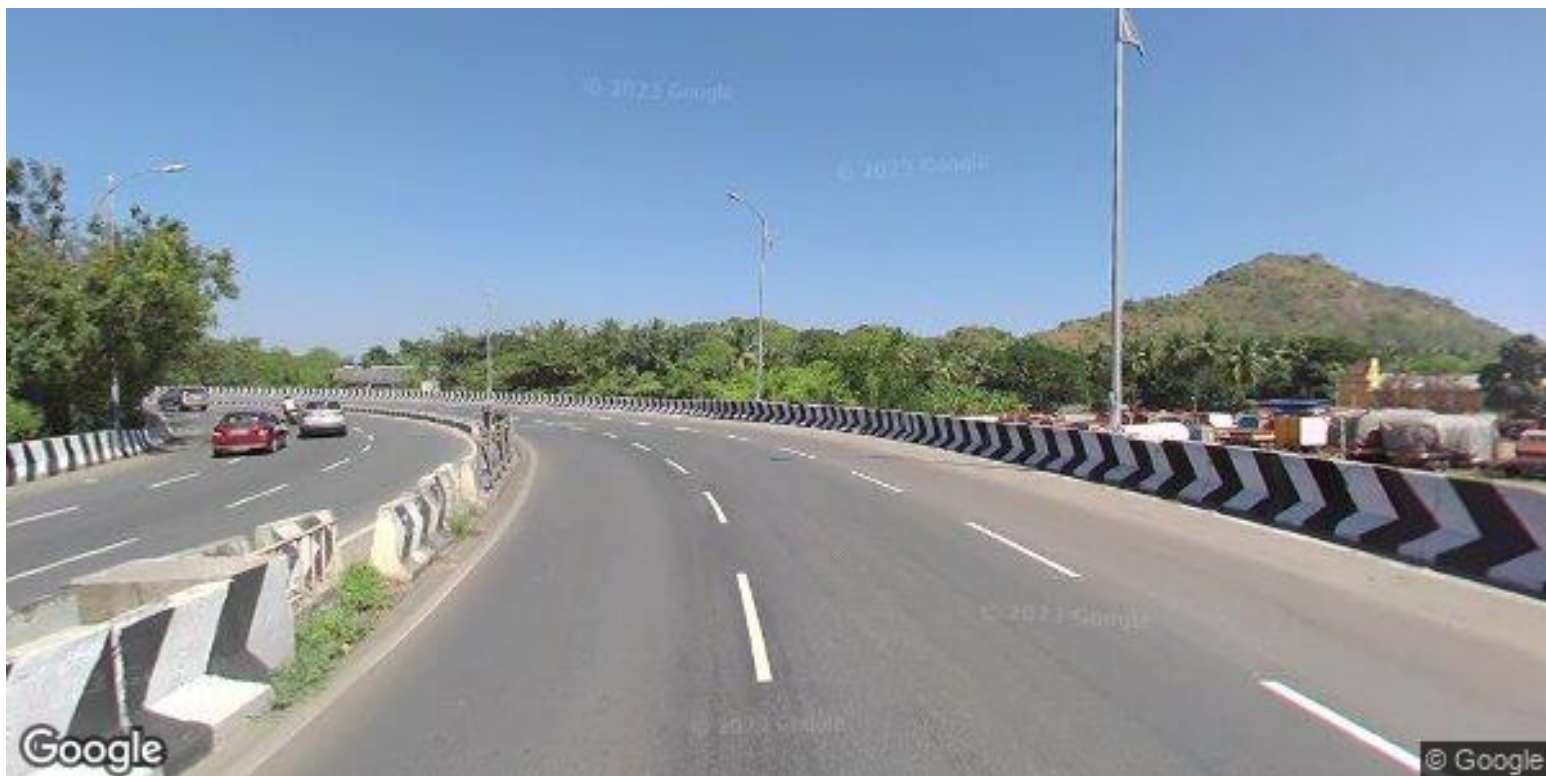
**Coordinates:** 11.64087, 78.12157

**Risk Type:** Turn

**Risk Level:** Medium

**Speed Limit:** 30 KM/Hr

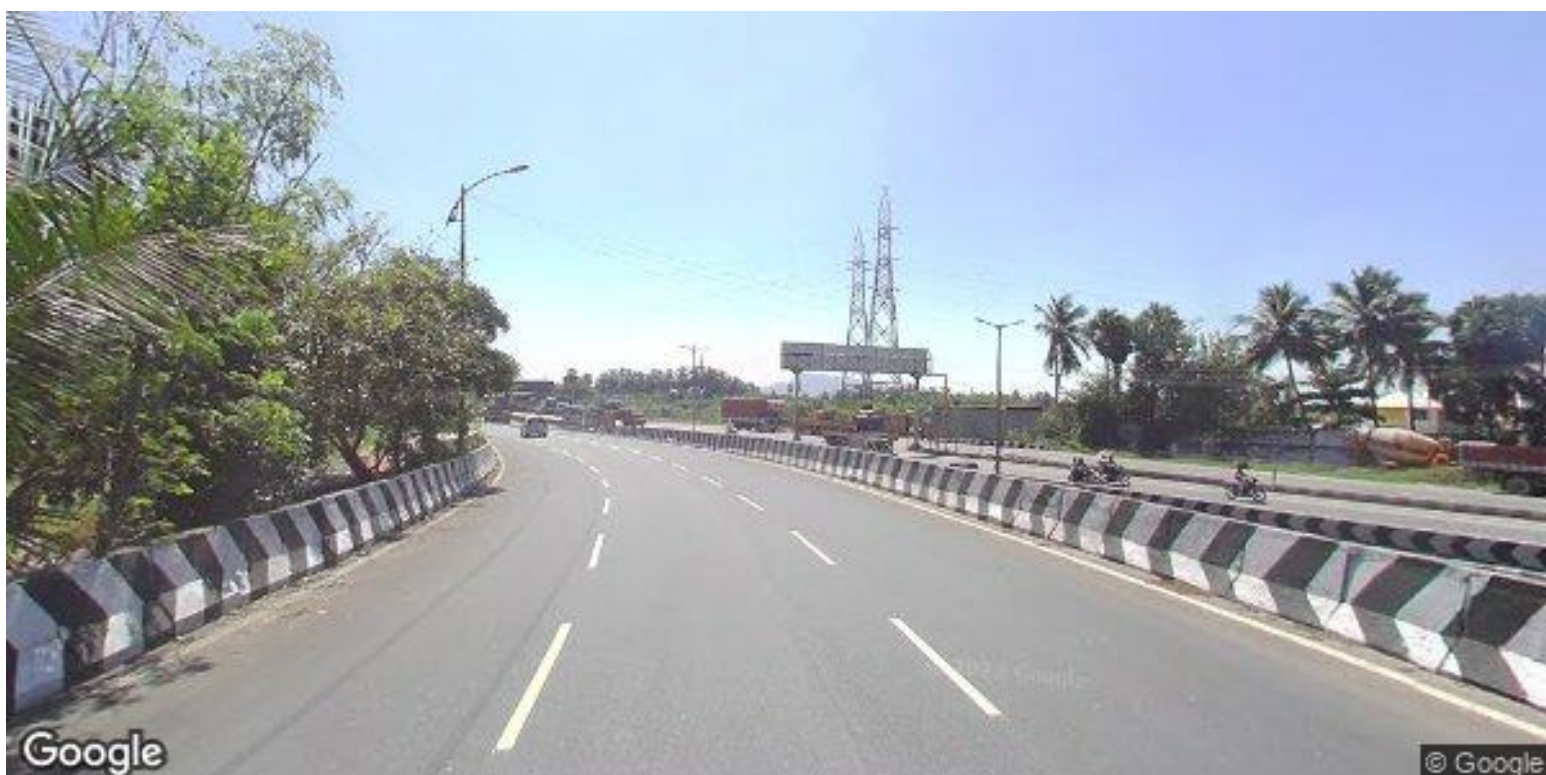
**Risk Type:** Turn  
**Risk Level:** High  
**Speed Limit:** 15 KM/Hr  
**Coordinates:** 11.63948, 78.12081

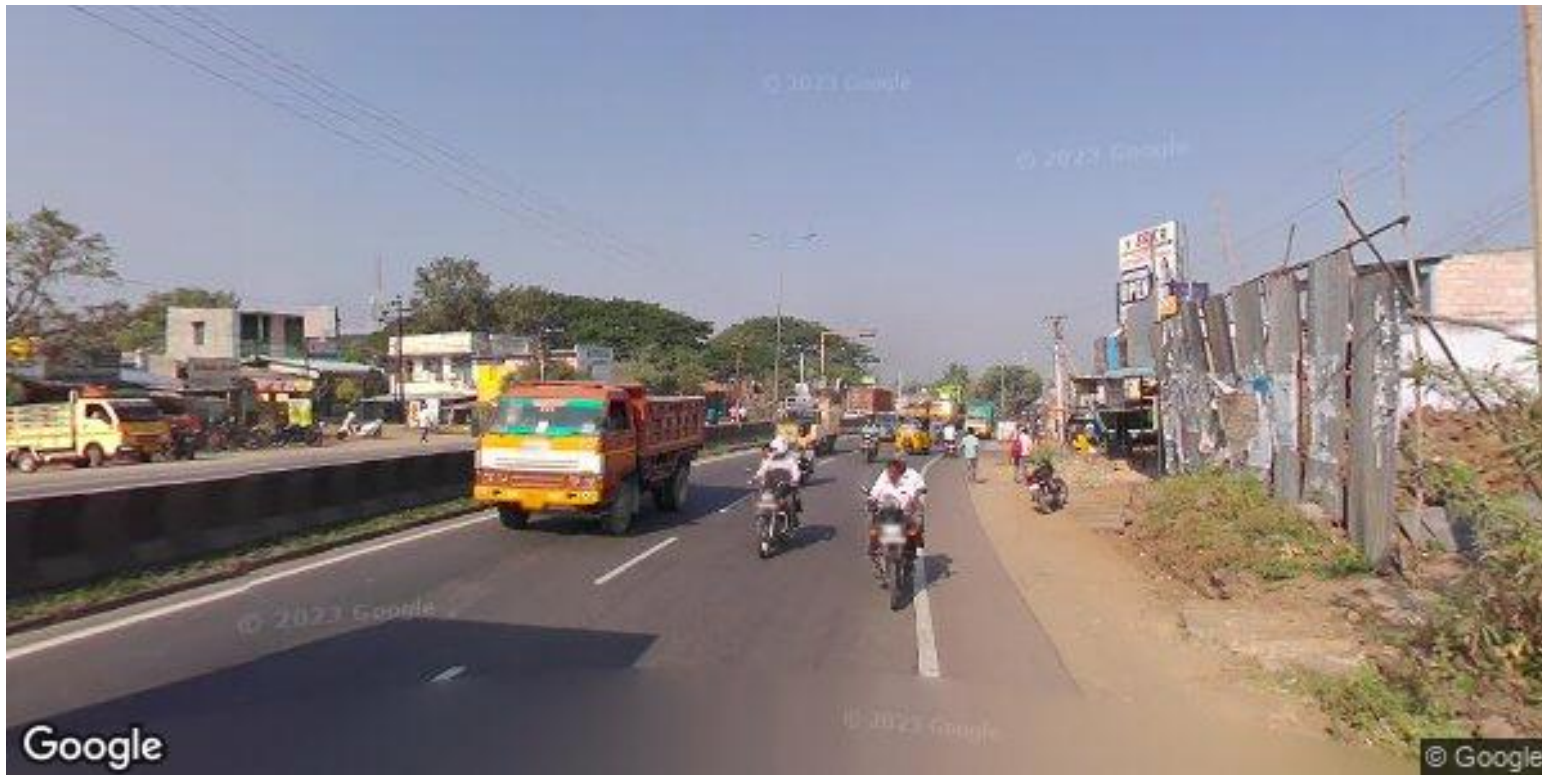
**Risk Type:** Turn  
**Risk Level:** Medium  
**Speed Limit:** 30 KM/Hr  
**Coordinates:** 11.62821, 78.13348

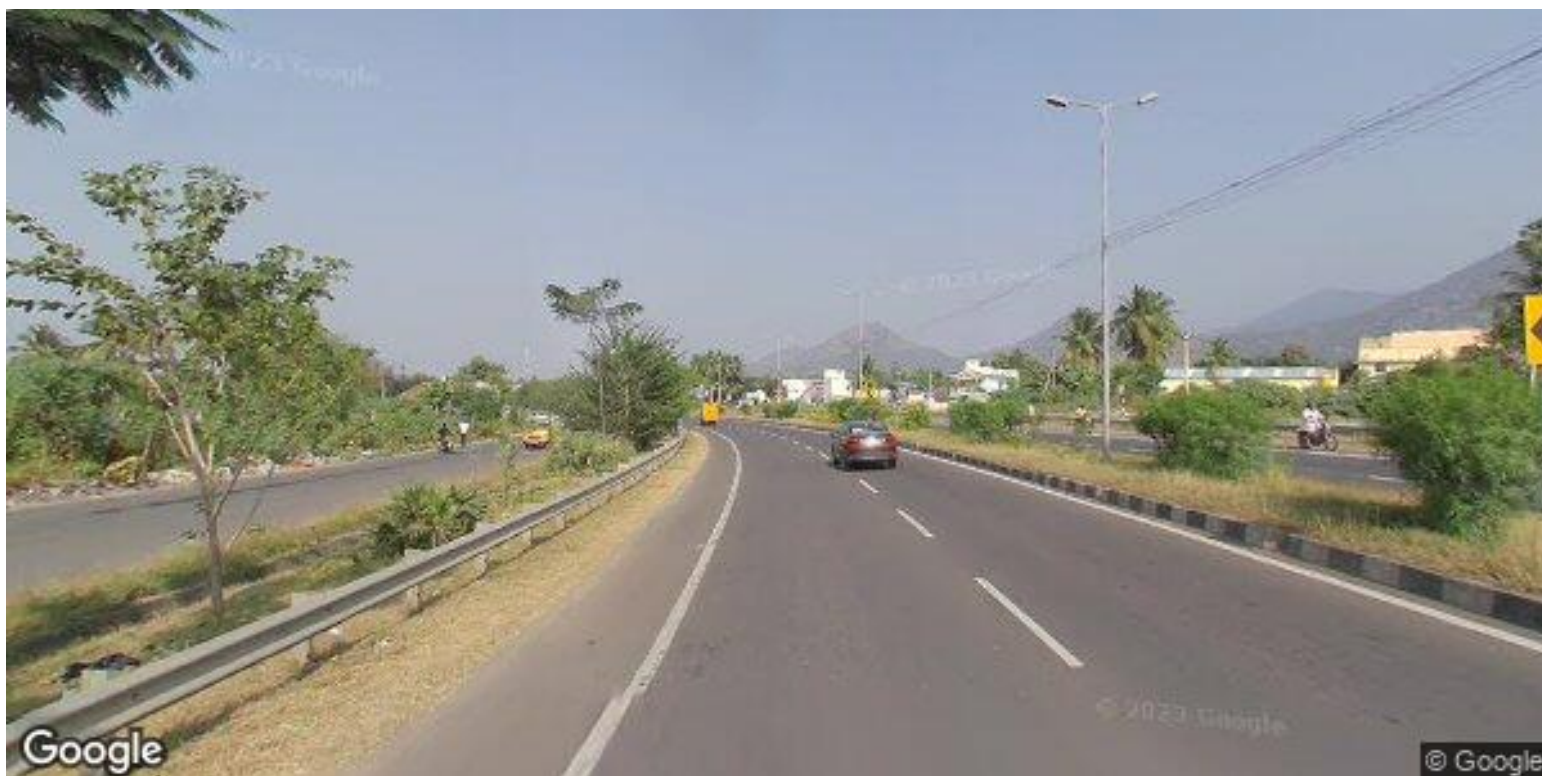
**Risk Type:** Turn  
**Risk Level:** Medium  
**Speed Limit:** 30 KM/Hr  
**Coordinates:** 11.62836, 78.16483

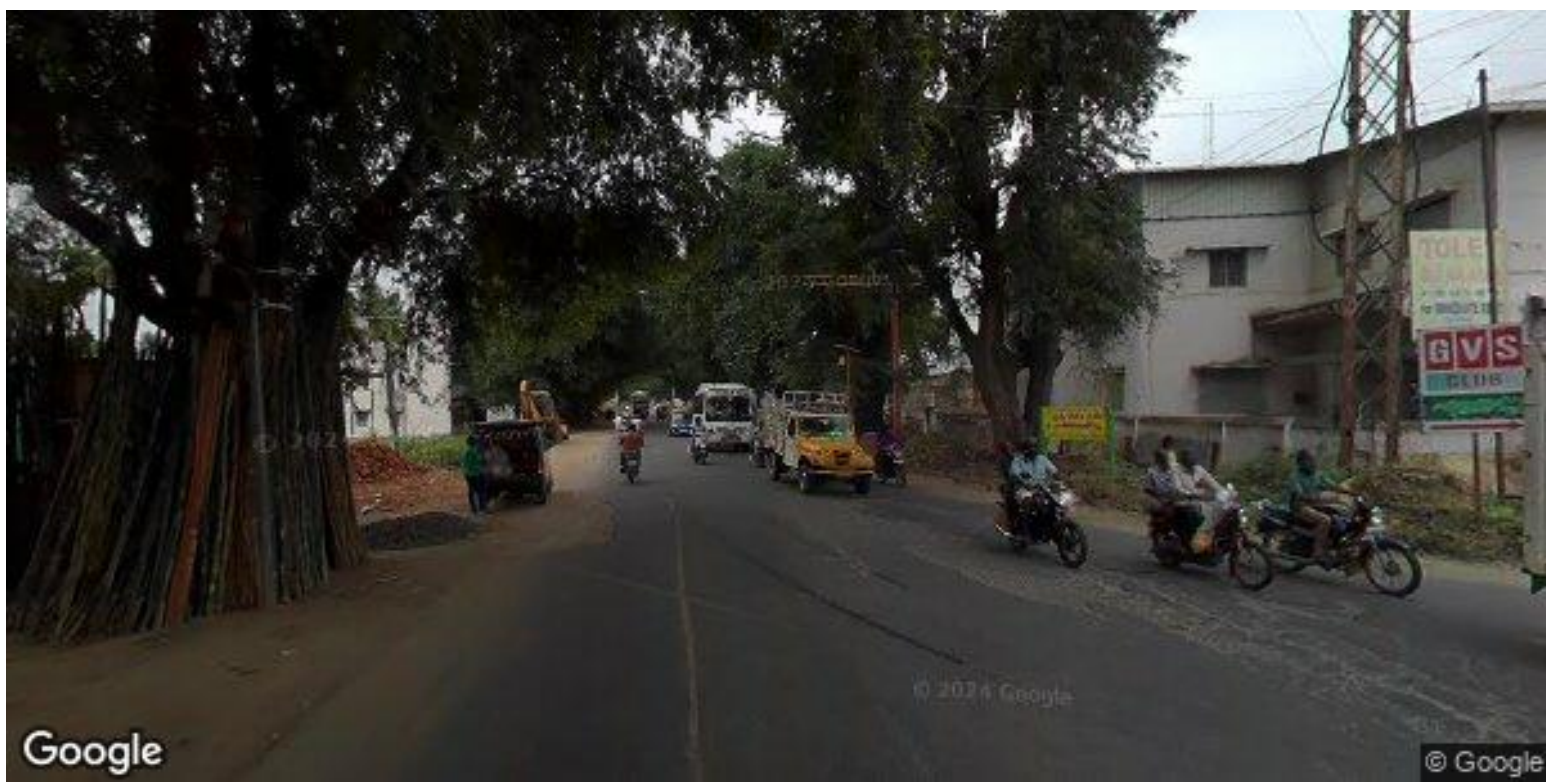
**Coordinates:** 11.66380, 78.20648

**Risk Type:** Turn

**Risk Level:** High

**Speed Limit:** 15 KM/Hr

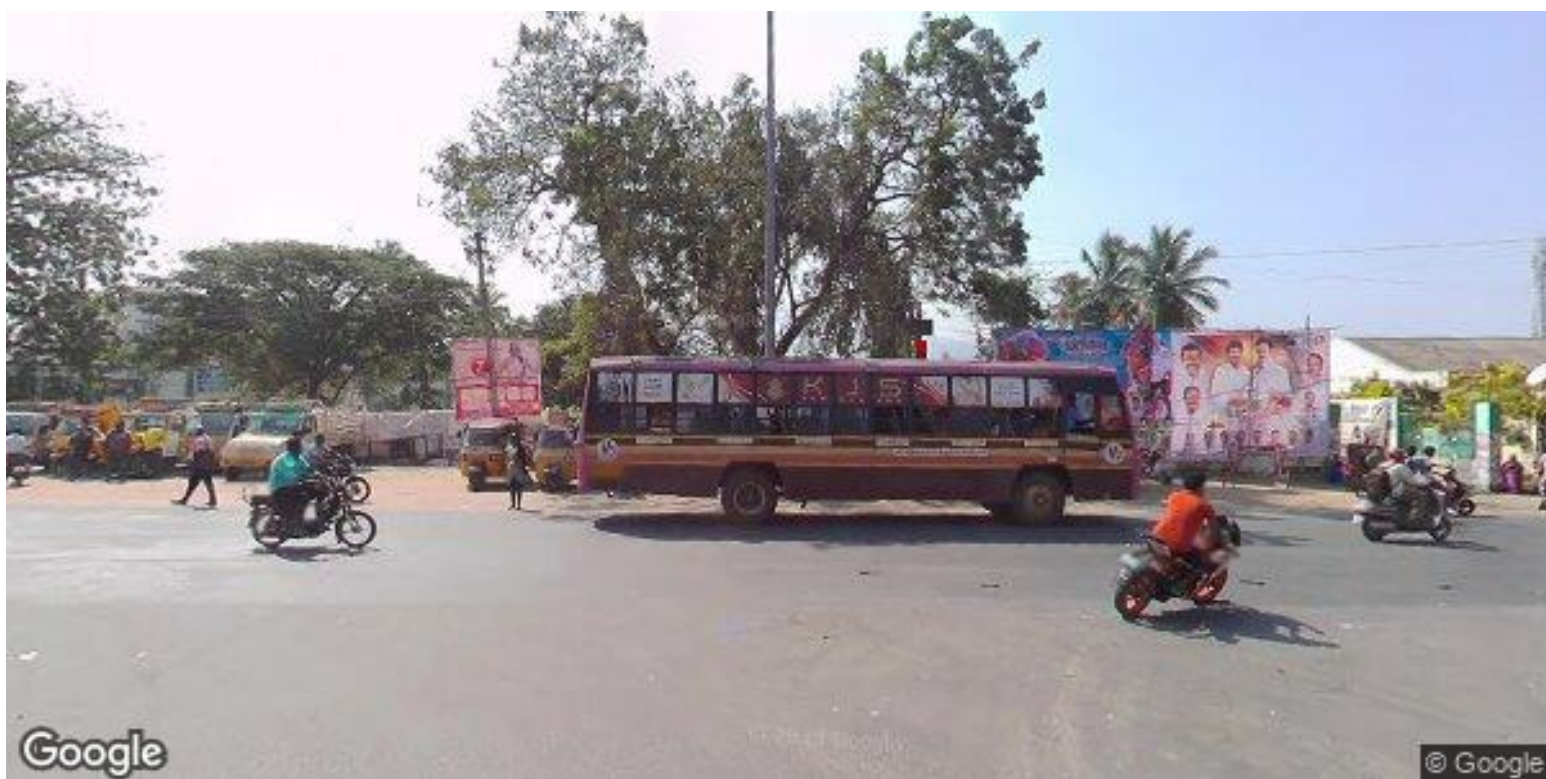
**Coordinates:** 11.67120, 78.23136

**Risk Type:** Turn

**Risk Level:** High

**Speed Limit:** 15 KM/Hr

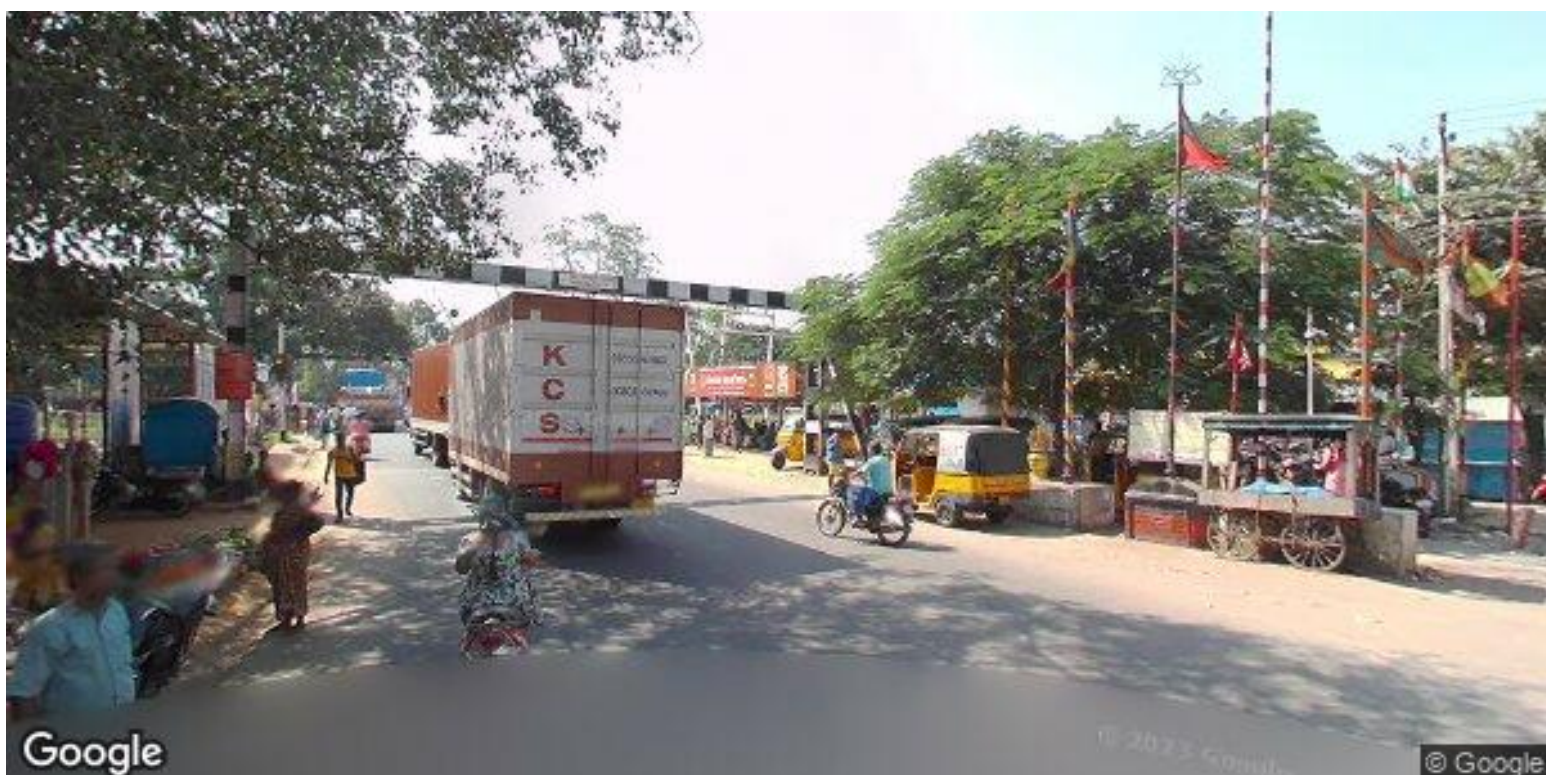
**Coordinates:** 11.67190, 78.23144

**Risk Type:** Turn

**Risk Level:** High

**Speed Limit:** 15 KM/Hr

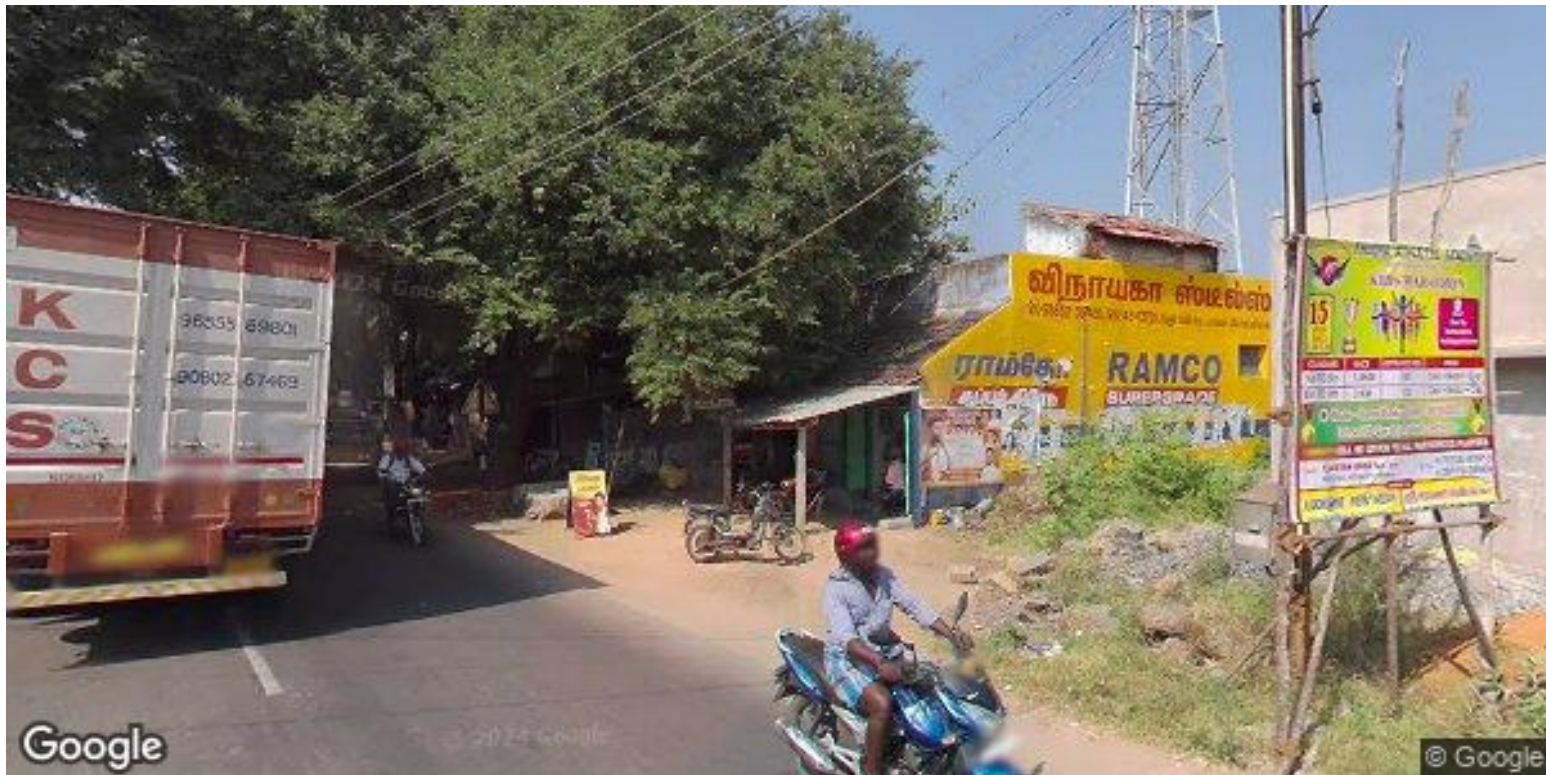
**Coordinates:** 11.67429, 78.23896

**Risk Type:** Turn

**Risk Level:** Medium

**Speed Limit:** 30 KM/Hr

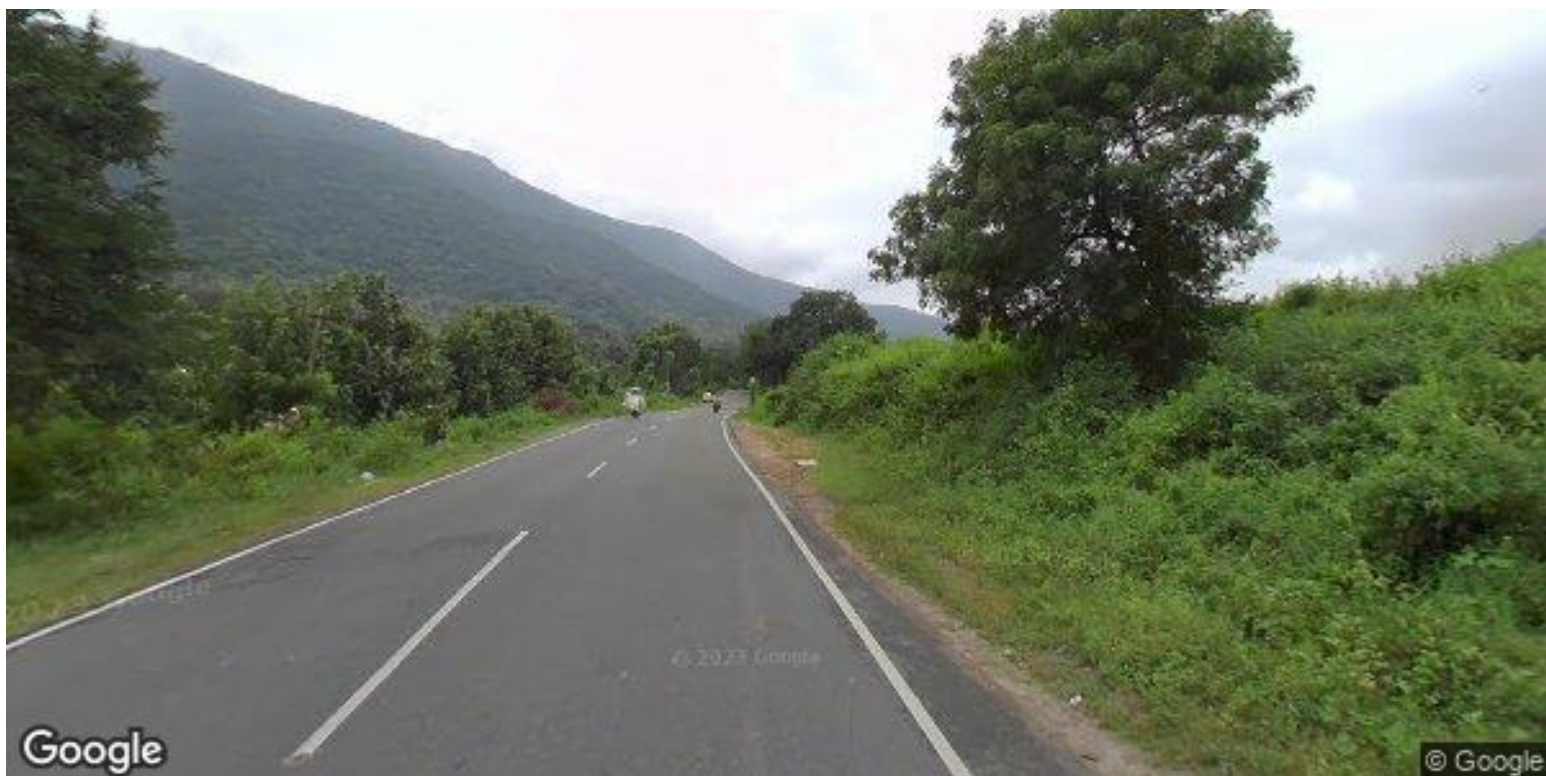
**Coordinates:** 11.80416, 78.33319

**Risk Type:** Turn

**Risk Level:** Medium

**Speed Limit:** 30 KM/Hr

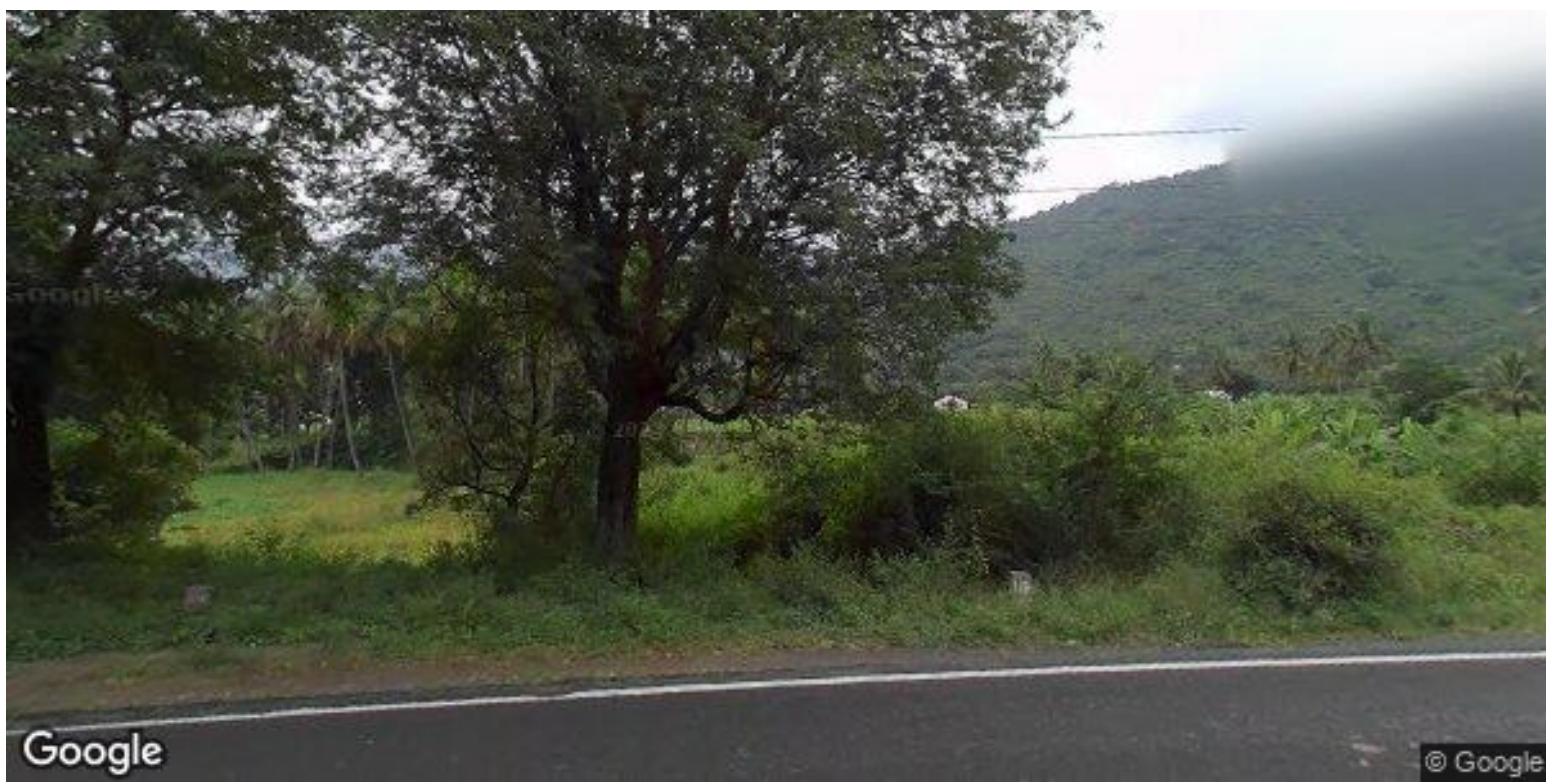
**Coordinates:** 11.81219, 78.34077

**Risk Type:** Turn

**Risk Level:** Medium

**Speed Limit:** 30 KM/Hr

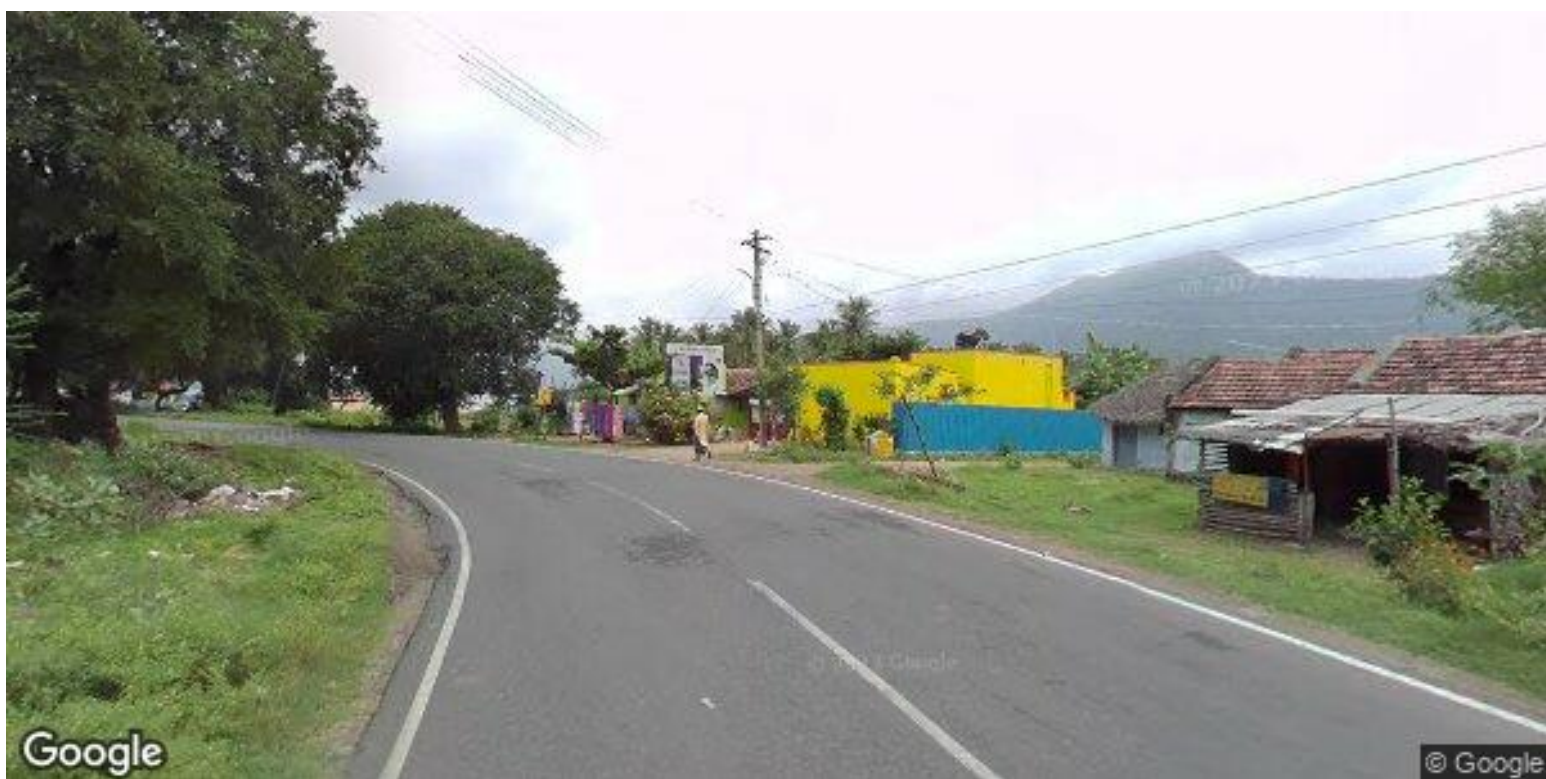
**Coordinates:** 11.83472, 78.35285

**Risk Type:** Turn

**Risk Level:** Medium

**Speed Limit:** 30 KM/Hr

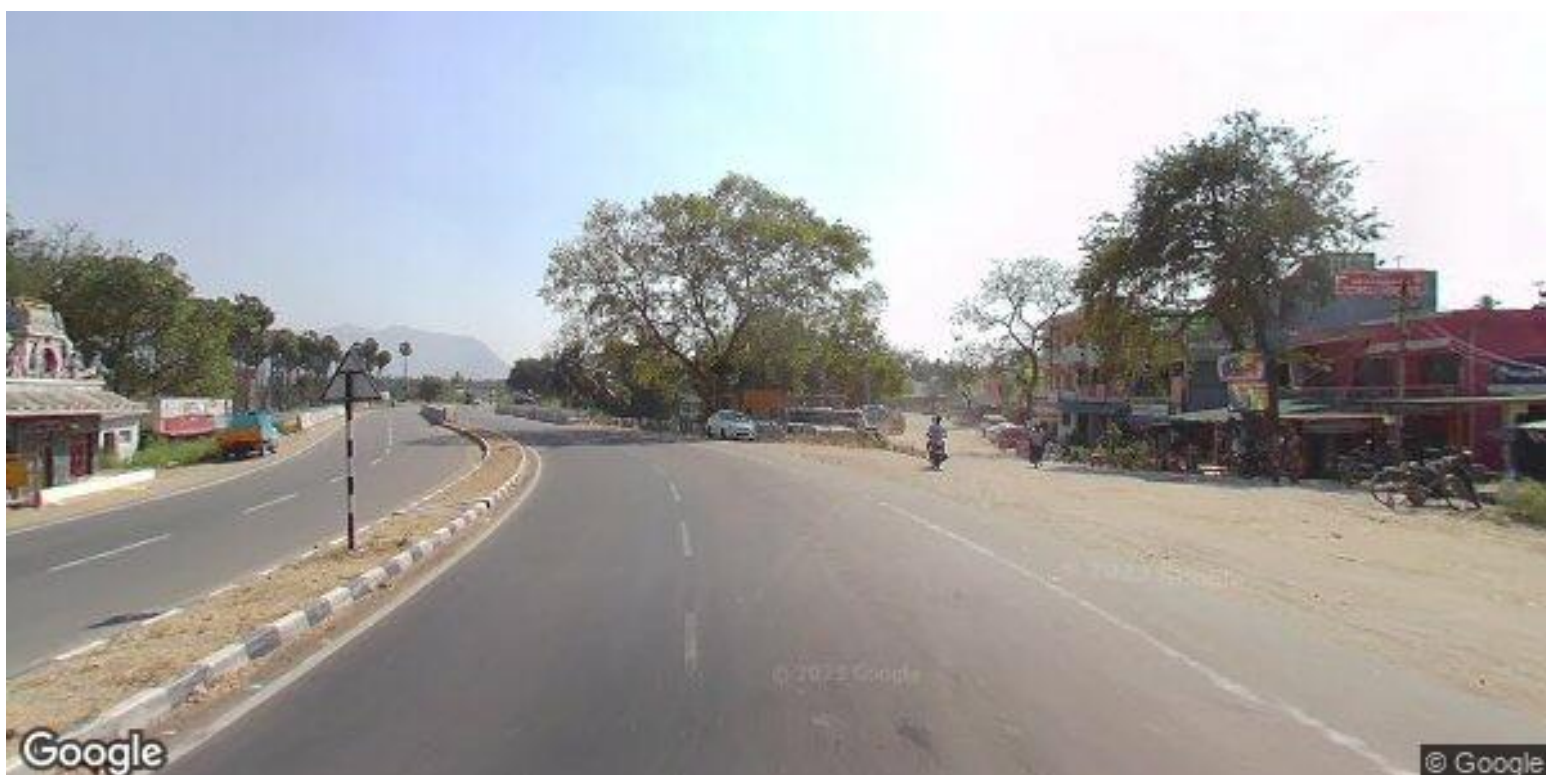
**Risk Type:** Turn  
**Risk Level:** Medium  
**Speed Limit:** 30 KM/Hr  
**Coordinates:** 11.99572, 78.44559

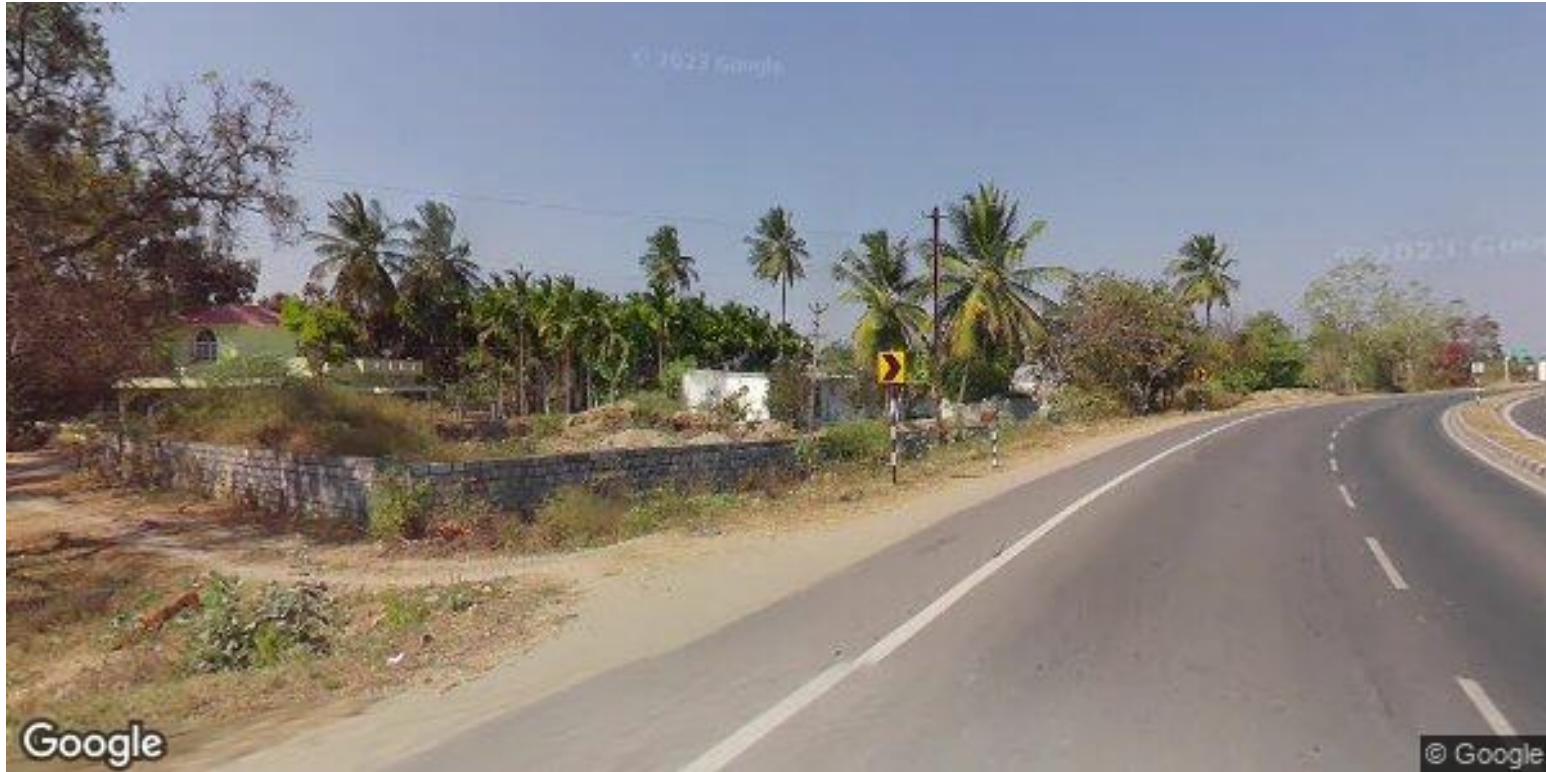
**Risk Type:** Turn  
**Risk Level:** Medium  
**Speed Limit:** 30 KM/Hr  
**Coordinates:** 12.01548, 78.45650
