# IndianOil

## **JOURNEY RISK MANAGEMENT (JRM) STUDY**

### **Salem Terminal TO SURYA FUEL AGENCIES**

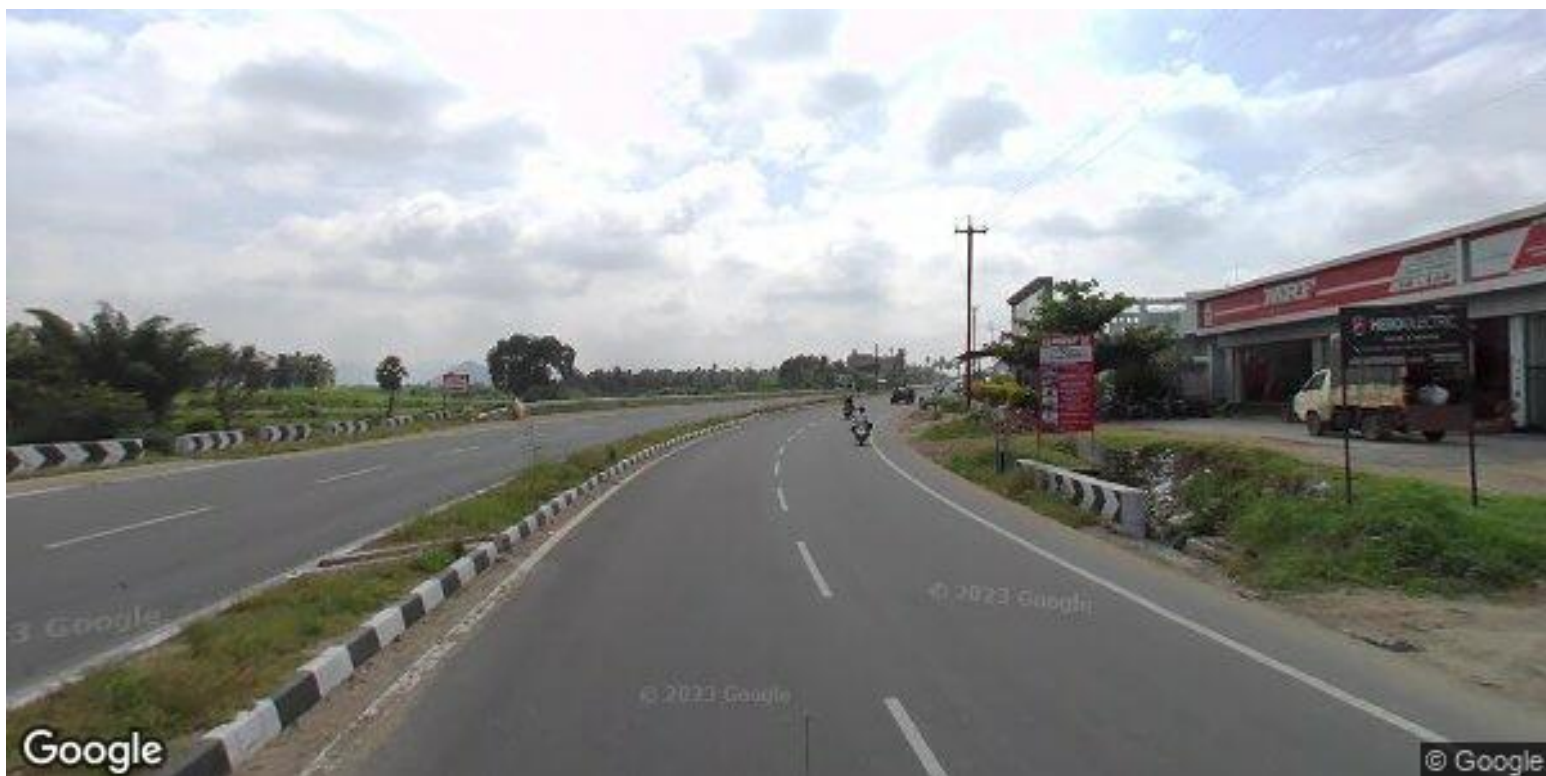
**Risk Type:** Turn  
**Risk Level:** Medium  
**Speed Limit:** 30 KM/Hr  
**Coordinates:** 12.04309, 78.48361

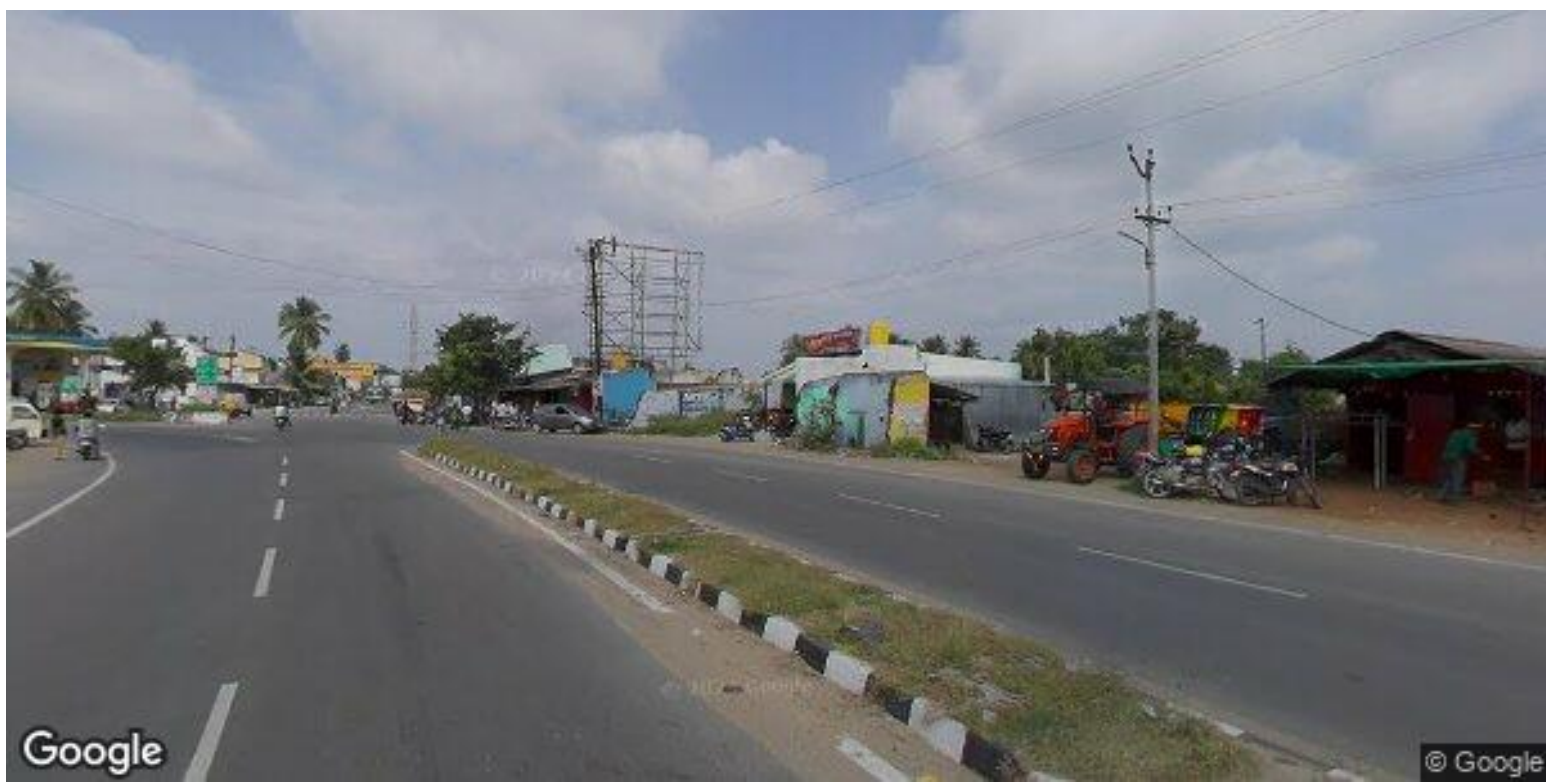
**Coordinates:** 12.04429, 78.48380

**Risk Type:** Turn

**Risk Level:** Medium

**Speed Limit:** 30 KM/Hr

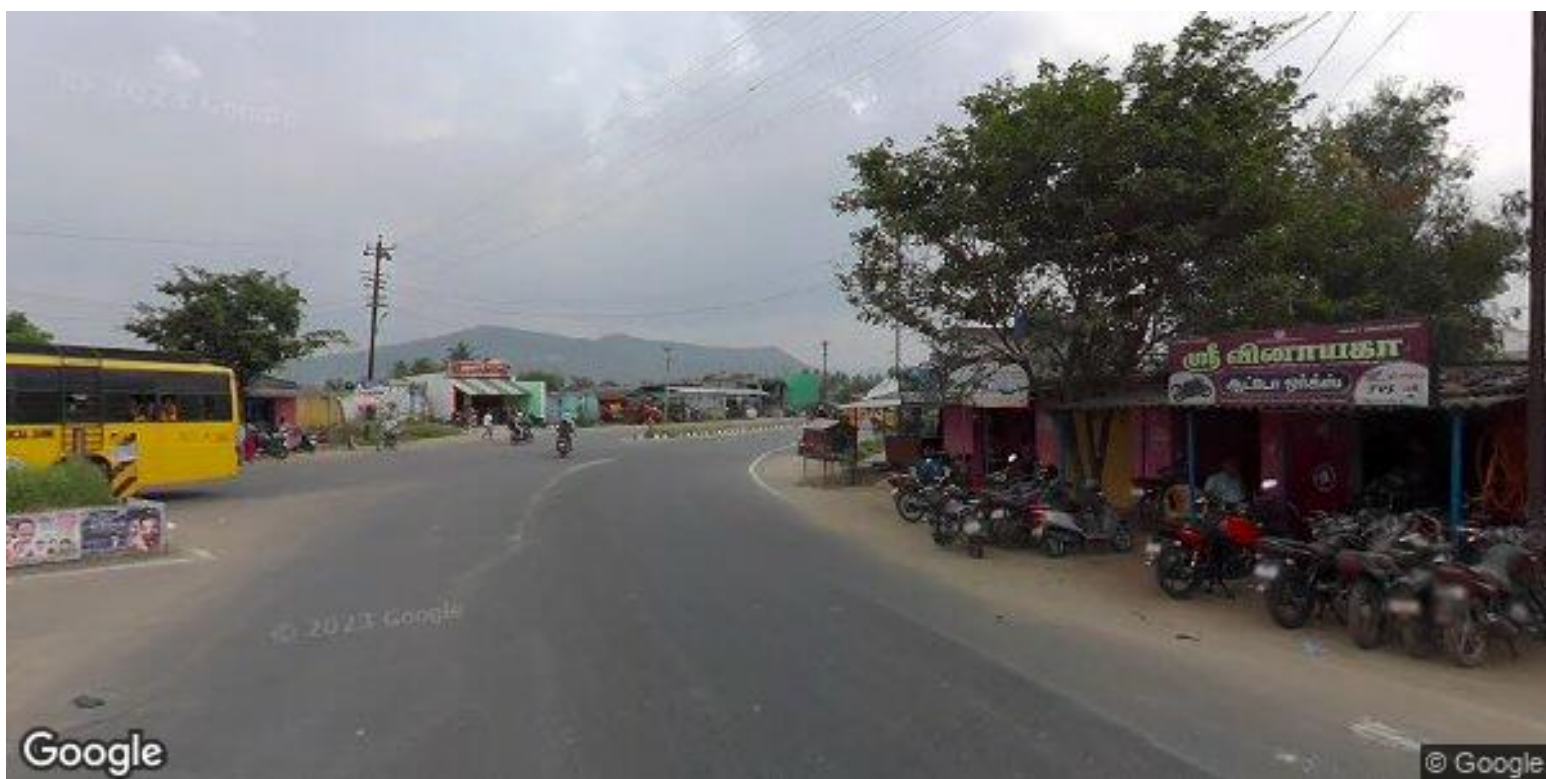
**Coordinates:** 12.04490, 78.48355

**Risk Type:** Turn

**Risk Level:** Medium

**Speed Limit:** 30 KM/Hr

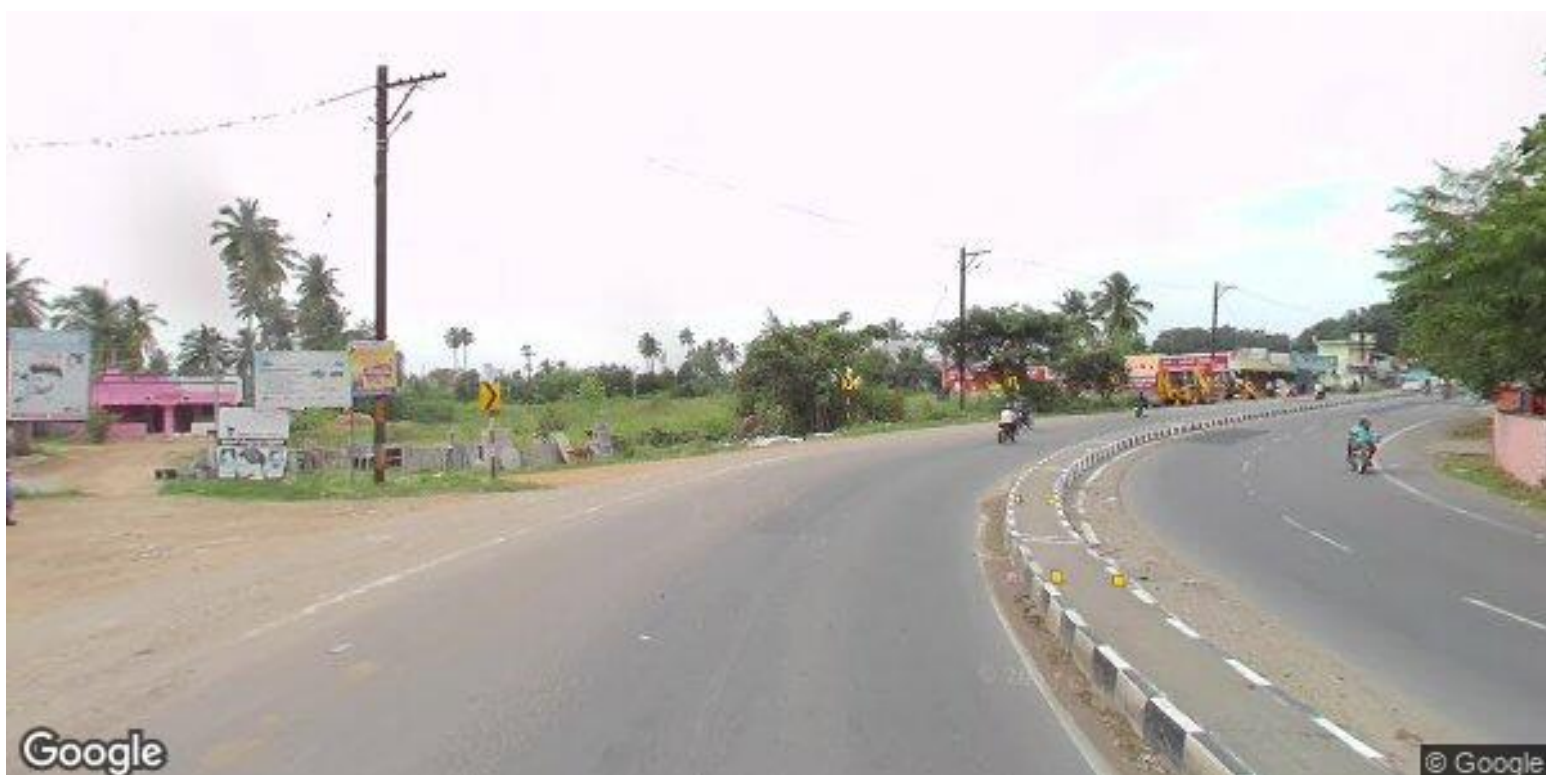
**Risk Type:** Turn  
**Risk Level:** High  
**Speed Limit:** 15 KM/Hr  
**Coordinates:** 12.04984, 78.47480

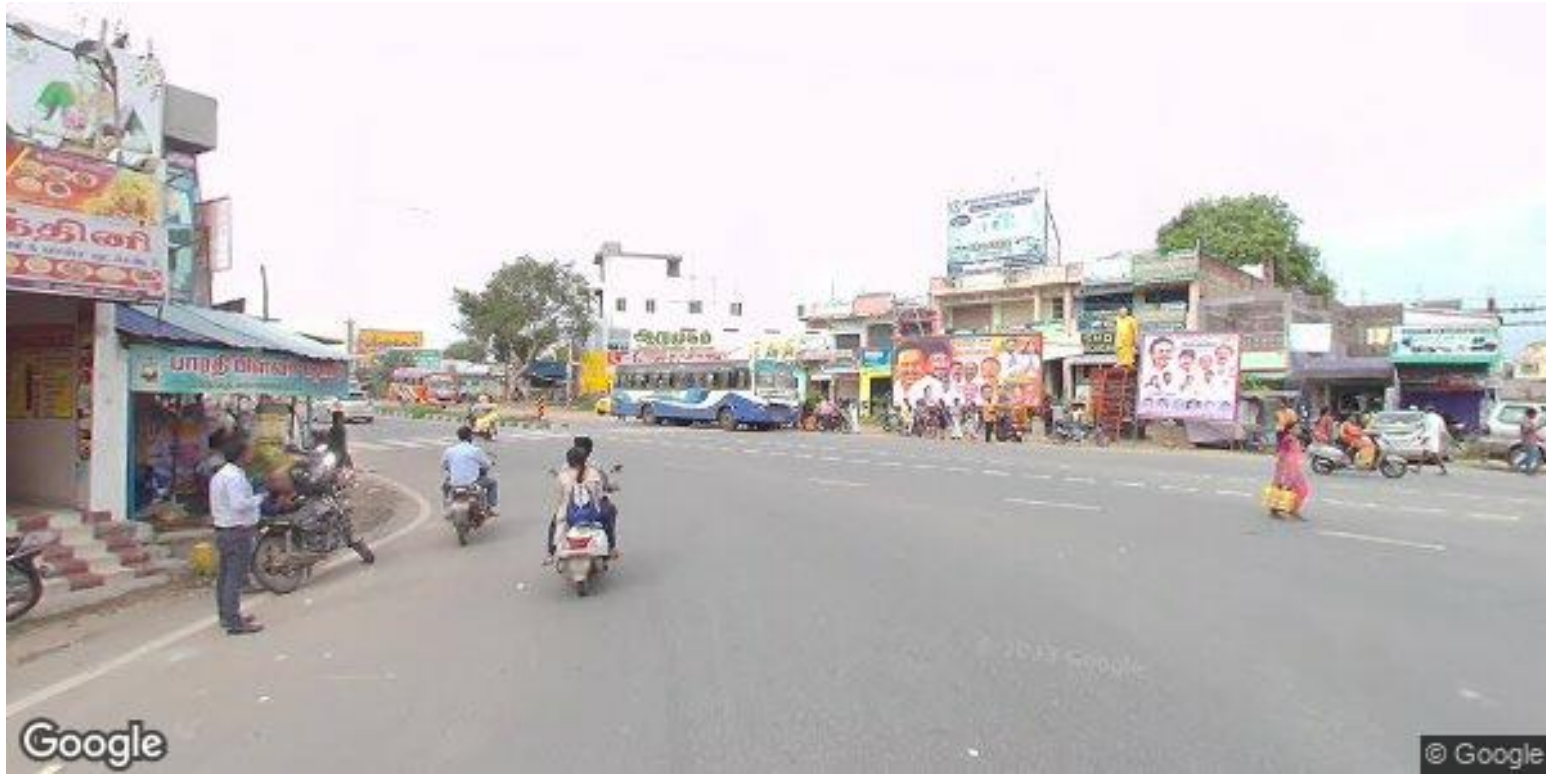
**Risk Type:** Turn  
**Risk Level:** High  
**Speed Limit:** 15 KM/Hr  
**Coordinates:** 12.06014, 78.47787

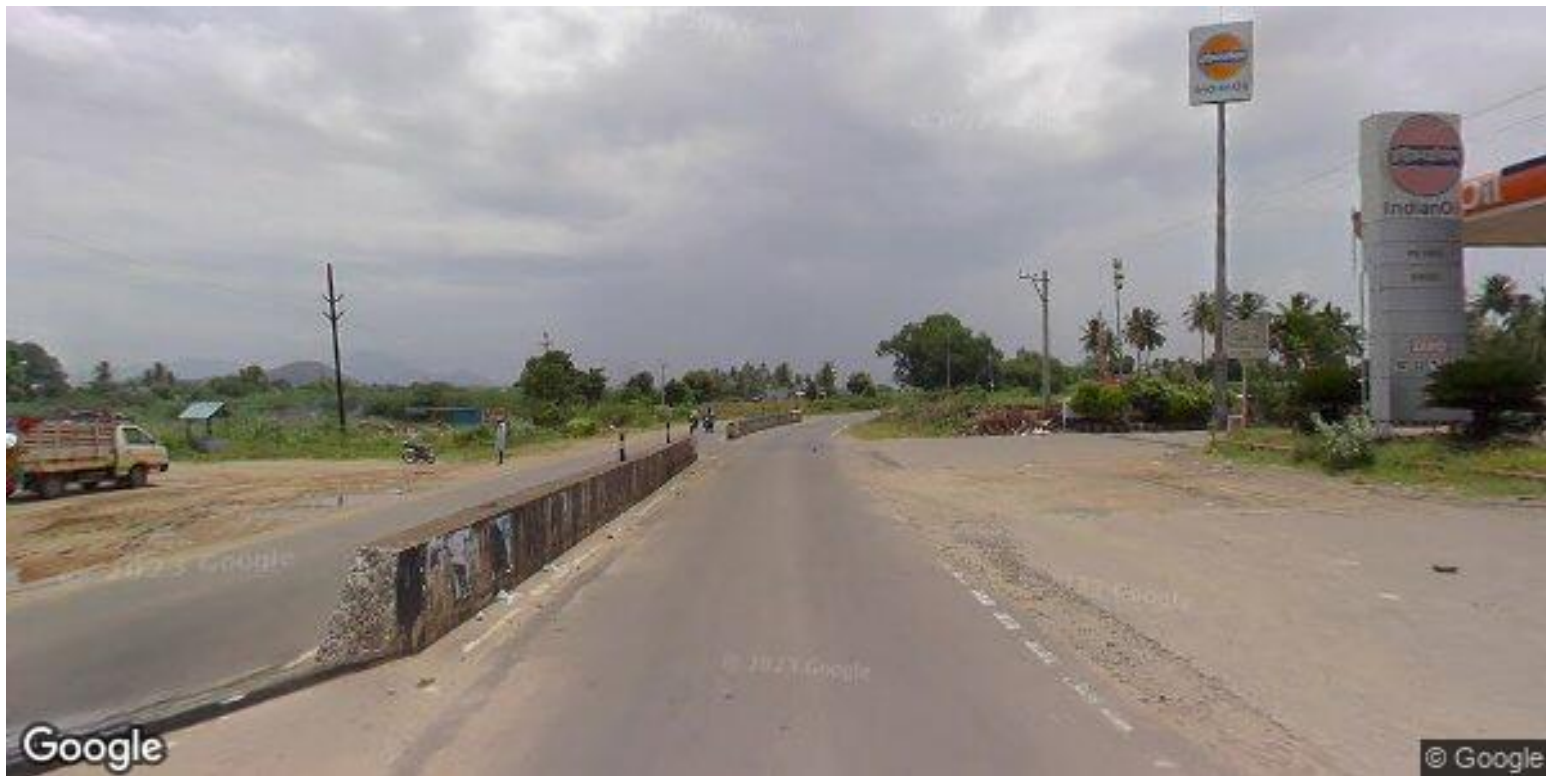
**Risk Type:** Turn  
**Risk Level:** High  
**Speed Limit:** 15 KM/Hr  
**Coordinates:** 12.11584, 78.40337
