# IndianOil

## JOURNEY RISK MANAGEMENT (JRM) STUDY

### Salem Terminal to ASHWIN AUTOMOBILES

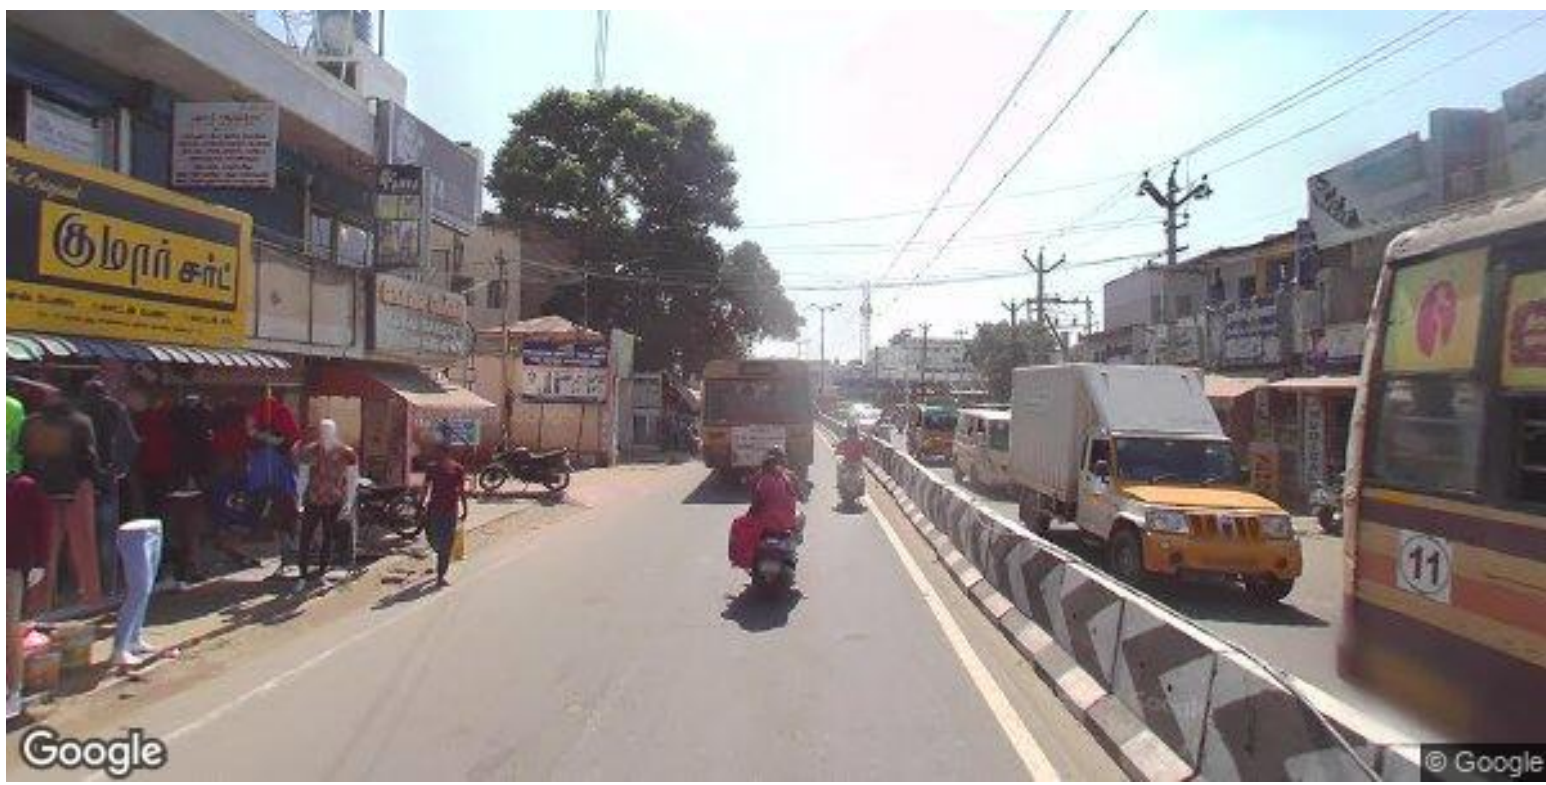
**Coordinates:** 11.1328729, 77.3421741

**Risk Type:** U-Turn

**Risk Level:** High

**Speed Limit:** 10 KM/Hr

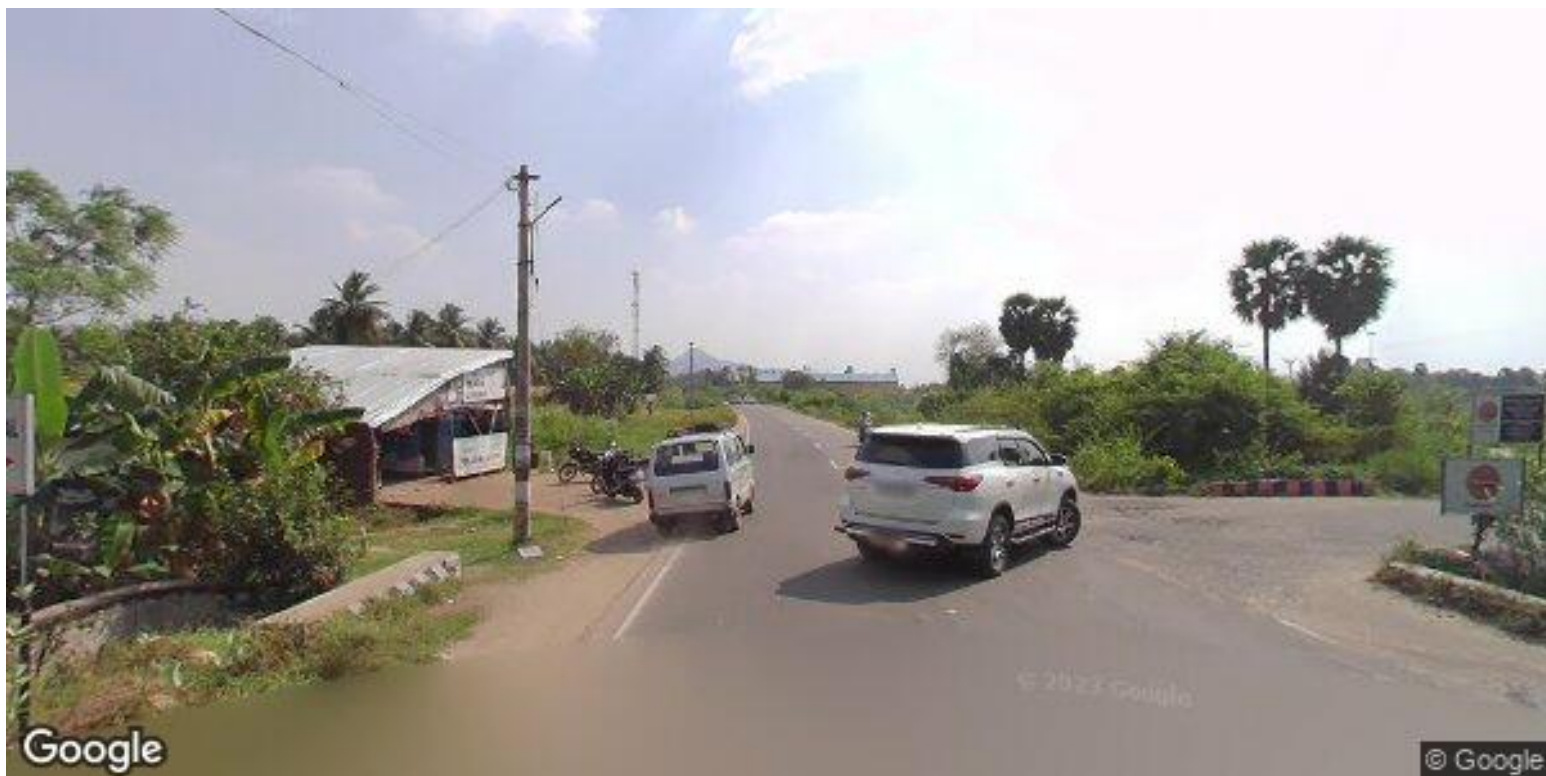
**Coordinates:** 11.44029, 77.87544

**Risk Type:** Turn

**Risk Level:** High

**Speed Limit:** 15 KM/Hr

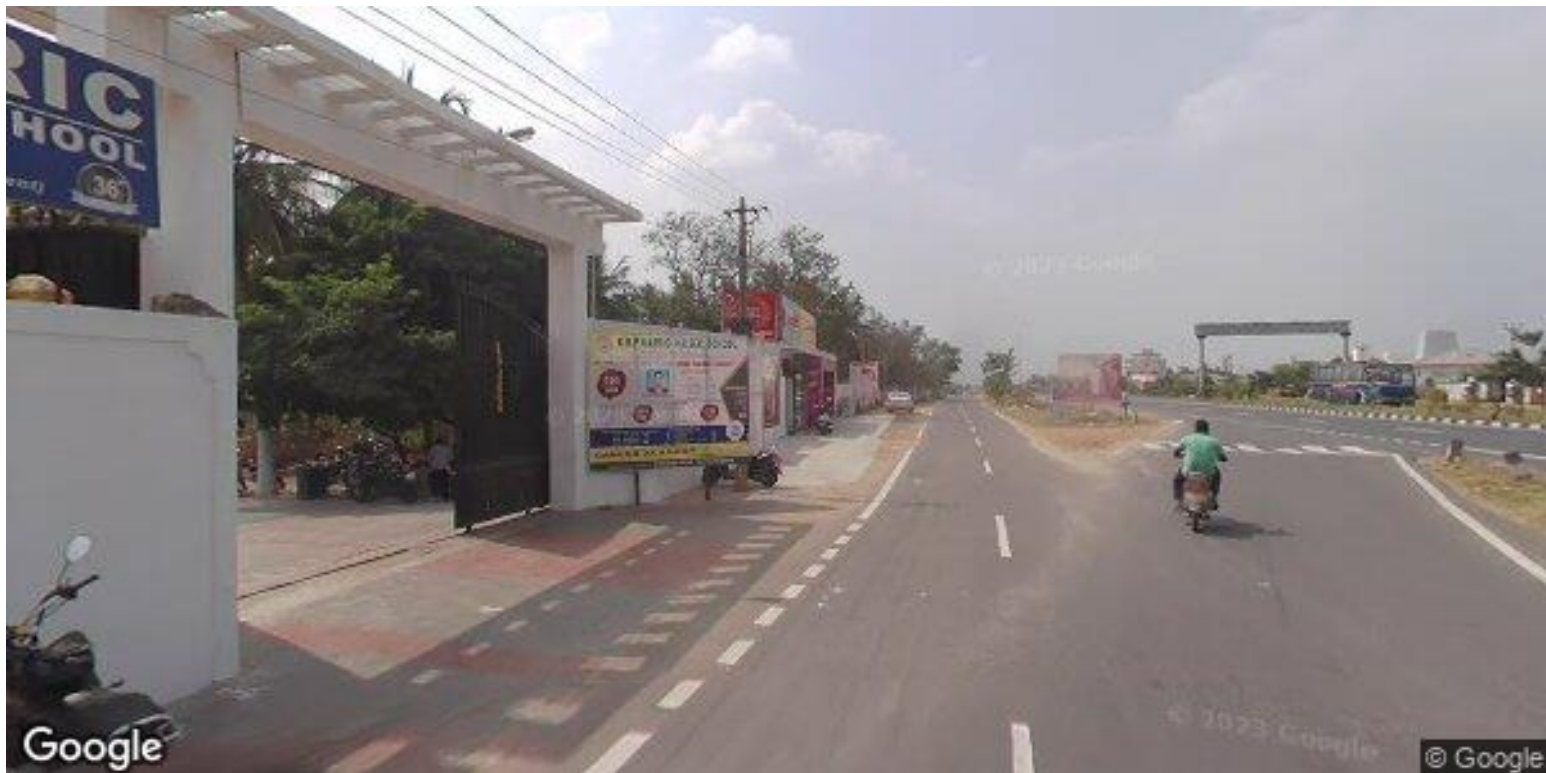
**Coordinates:** 11.45509, 77.81383

**Risk Type:** Turn

**Risk Level:** Medium

**Speed Limit:** 30 KM/Hr
