# IndianOil

## JOURNEY RISK MANAGEMENT (JRM) STUDY

### Salem Terminal to AANJANEYA FUELS

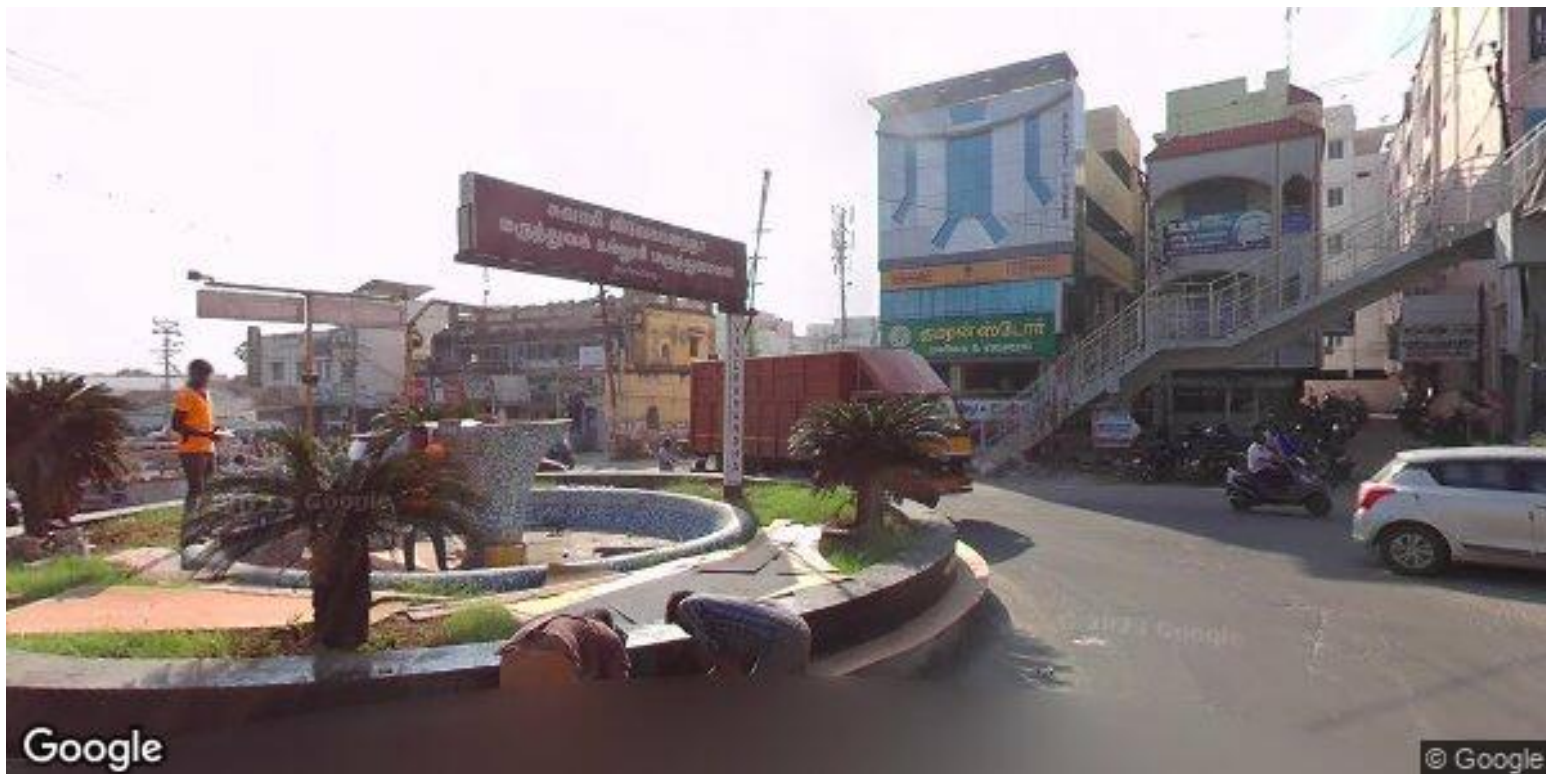
**Coordinates:** 11.38395, 77.89480

**Risk Type:** Roundabout

**Risk Level:** High

**Speed Limit:** 15 KM/Hr

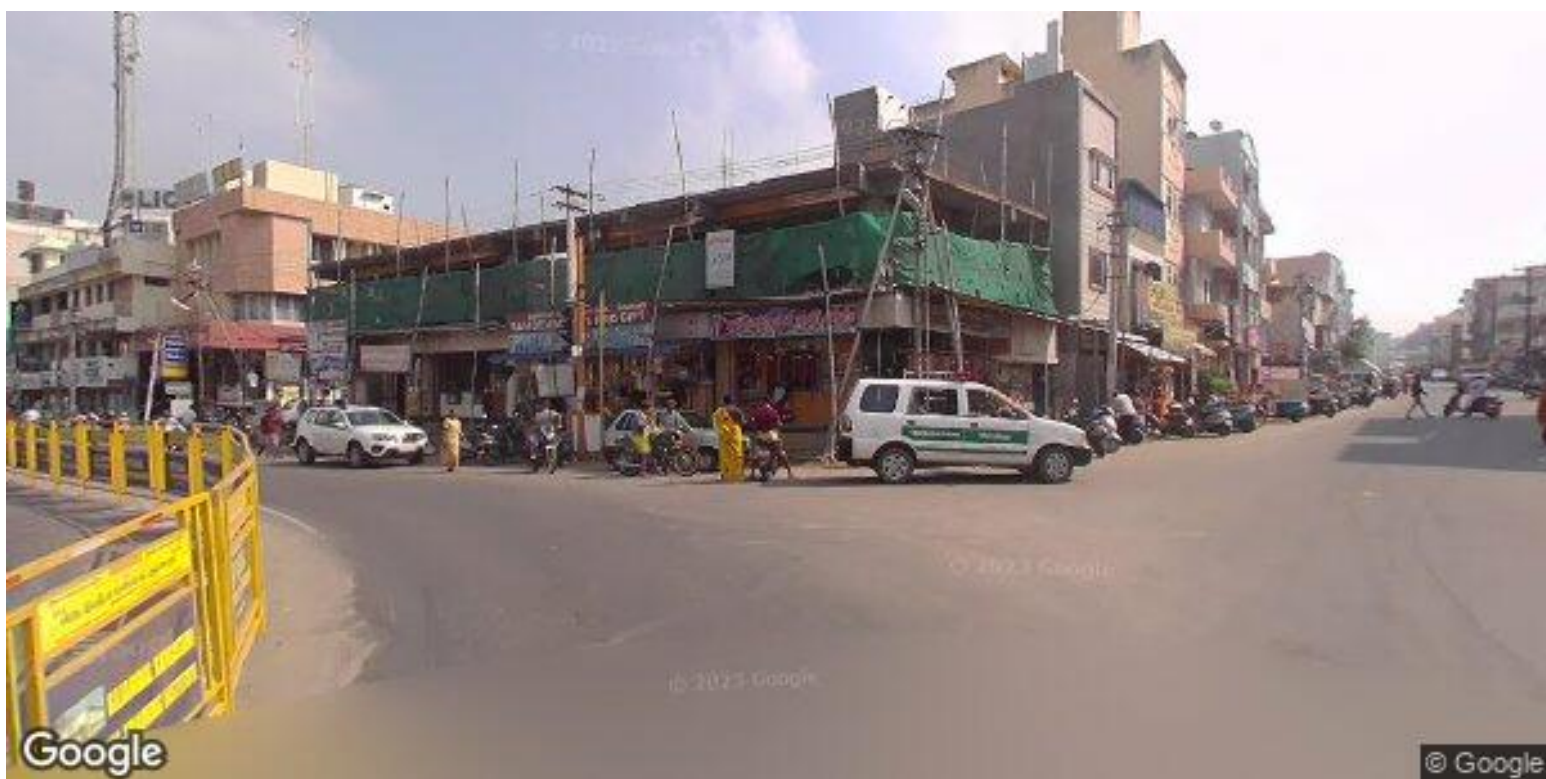
**Coordinates:** 11.37868, 77.89498

**Risk Type:** Turn

**Risk Level:** High

**Speed Limit:** 15 KM/Hr

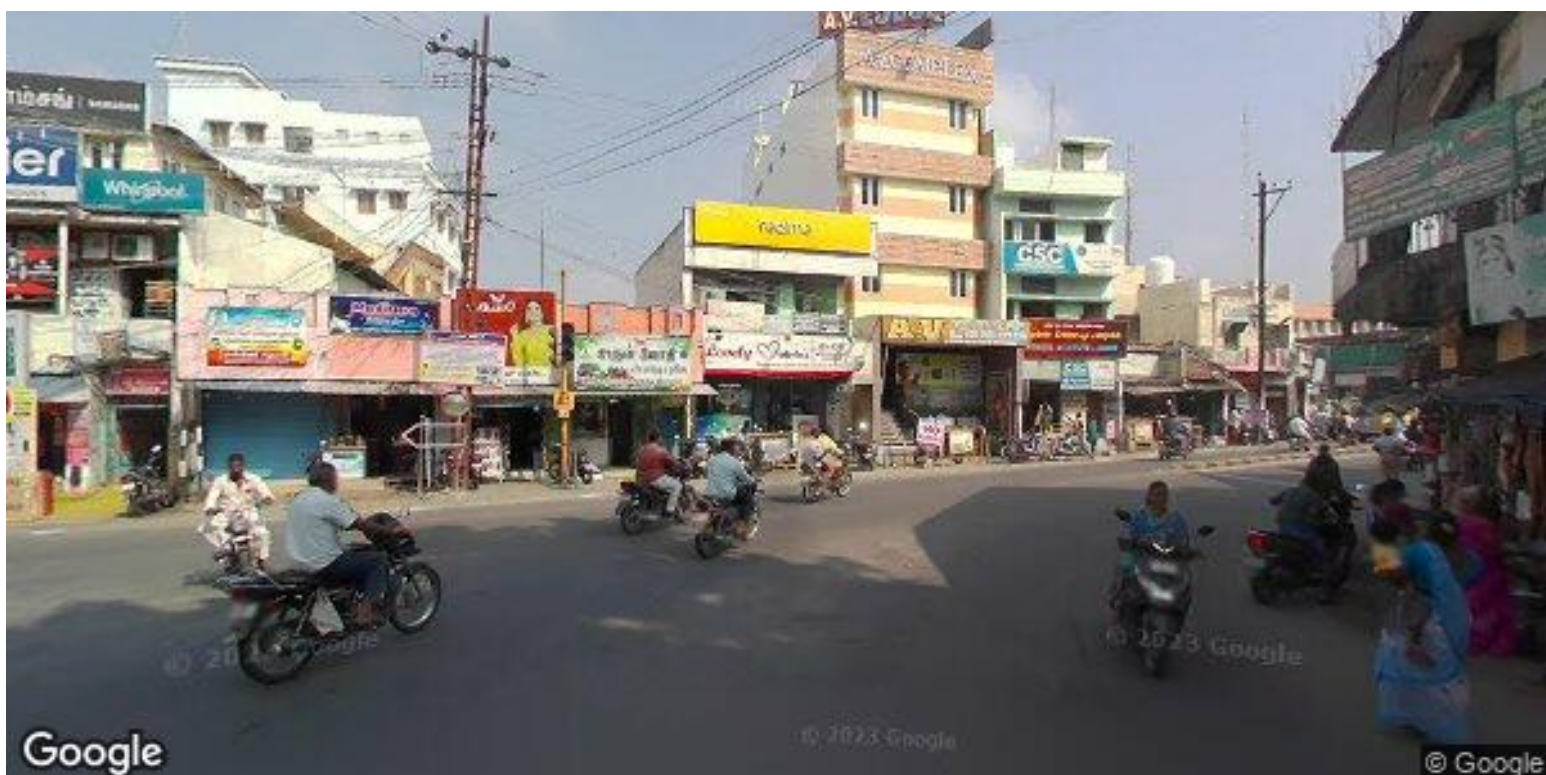
**Coordinates:** 11.37842, 77.89452

**Risk Type:** Turn

**Risk Level:** Medium

**Speed Limit:** 30 KM/Hr

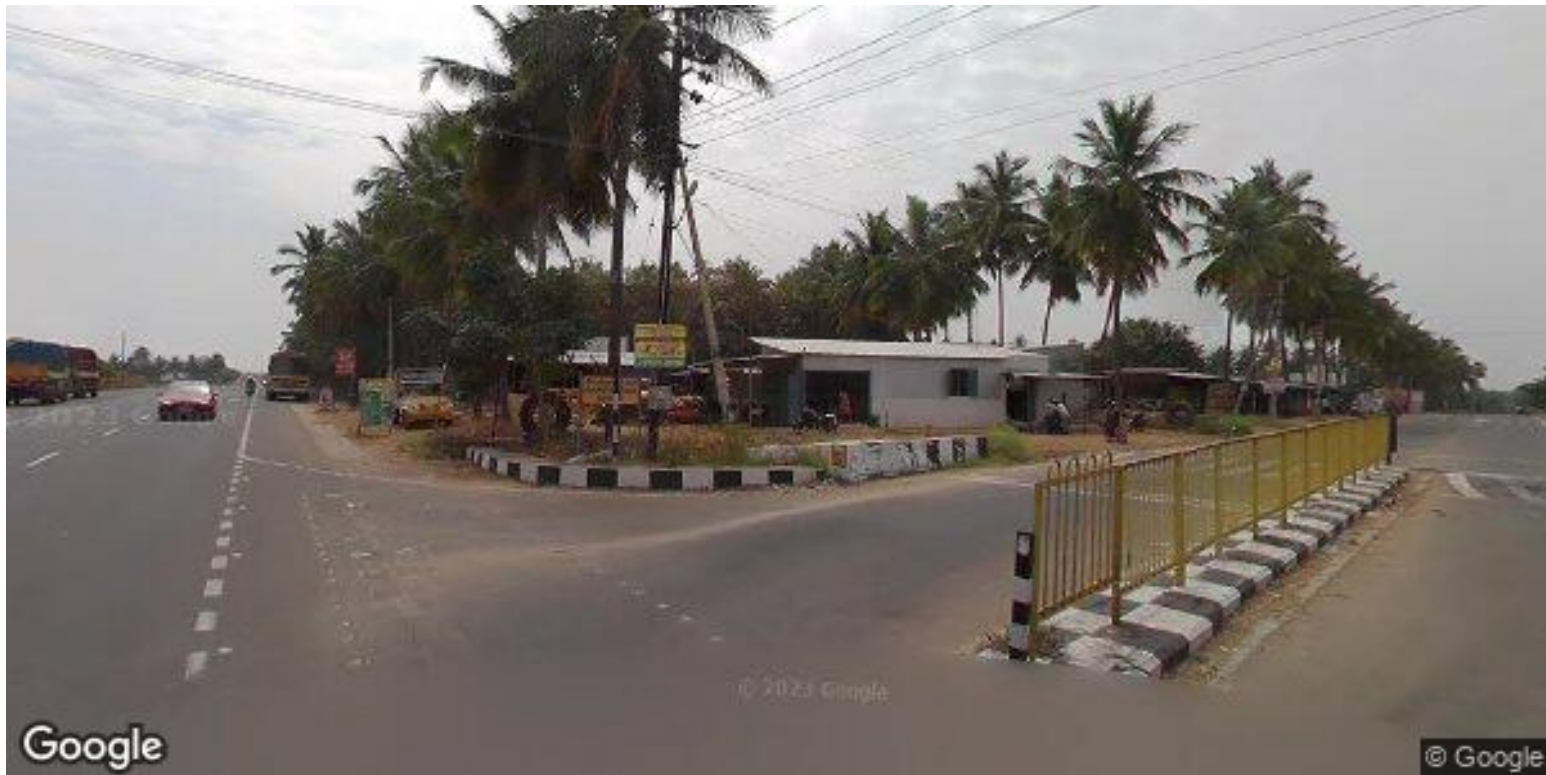
**Coordinates:** 11.30859, 77.92918

**Risk Type:** Turn

**Risk Level:** High

**Speed Limit:** 15 KM/Hr

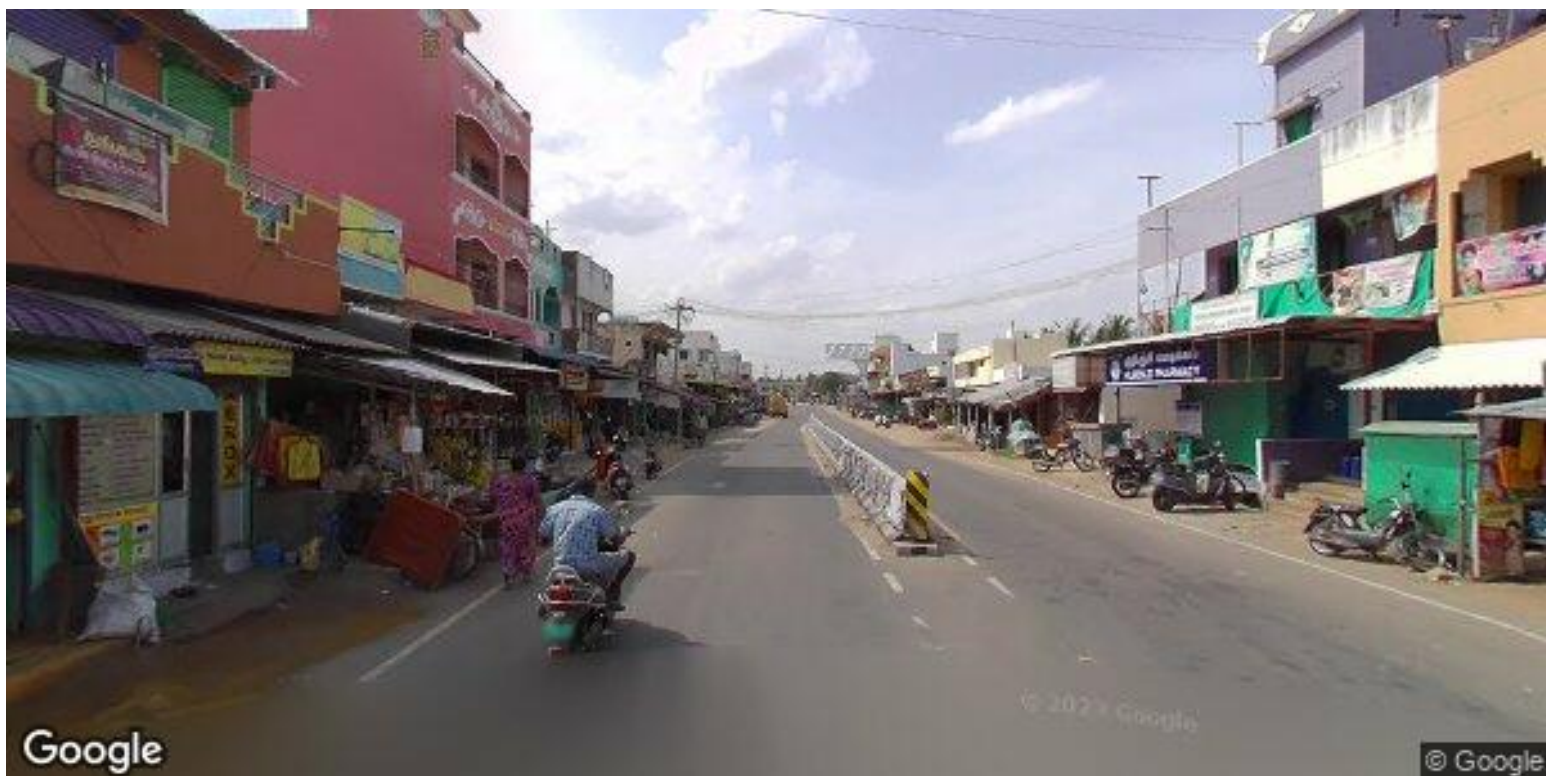
**Coordinates:** 11.24000, 77.87363

**Risk Type:** Turn

**Risk Level:** High

**Speed Limit:** 15 KM/Hr

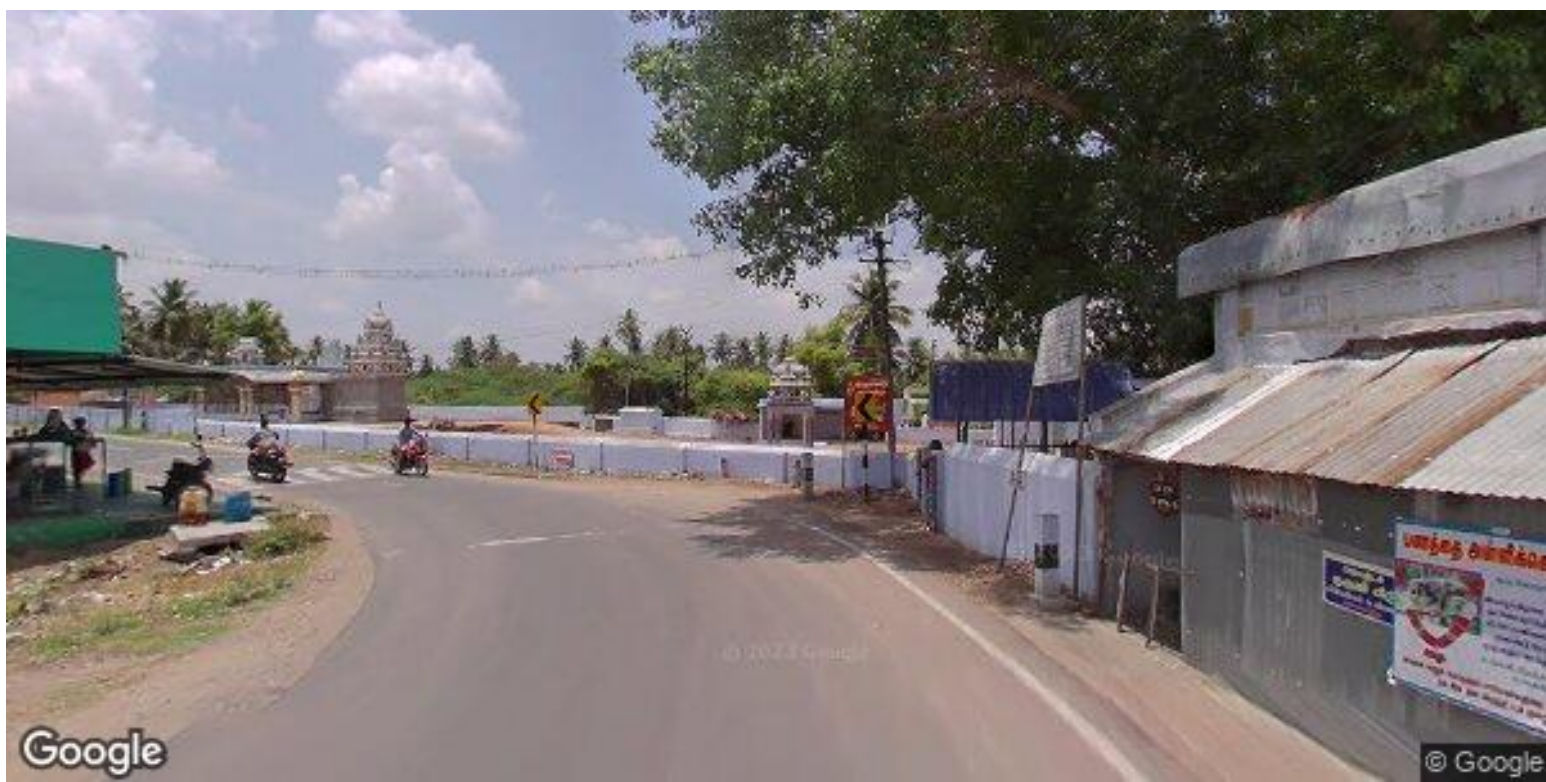
**Coordinates:** 11.24053, 77.86902

**Risk Type:** Turn

**Risk Level:** Medium

**Speed Limit:** 30 KM/Hr

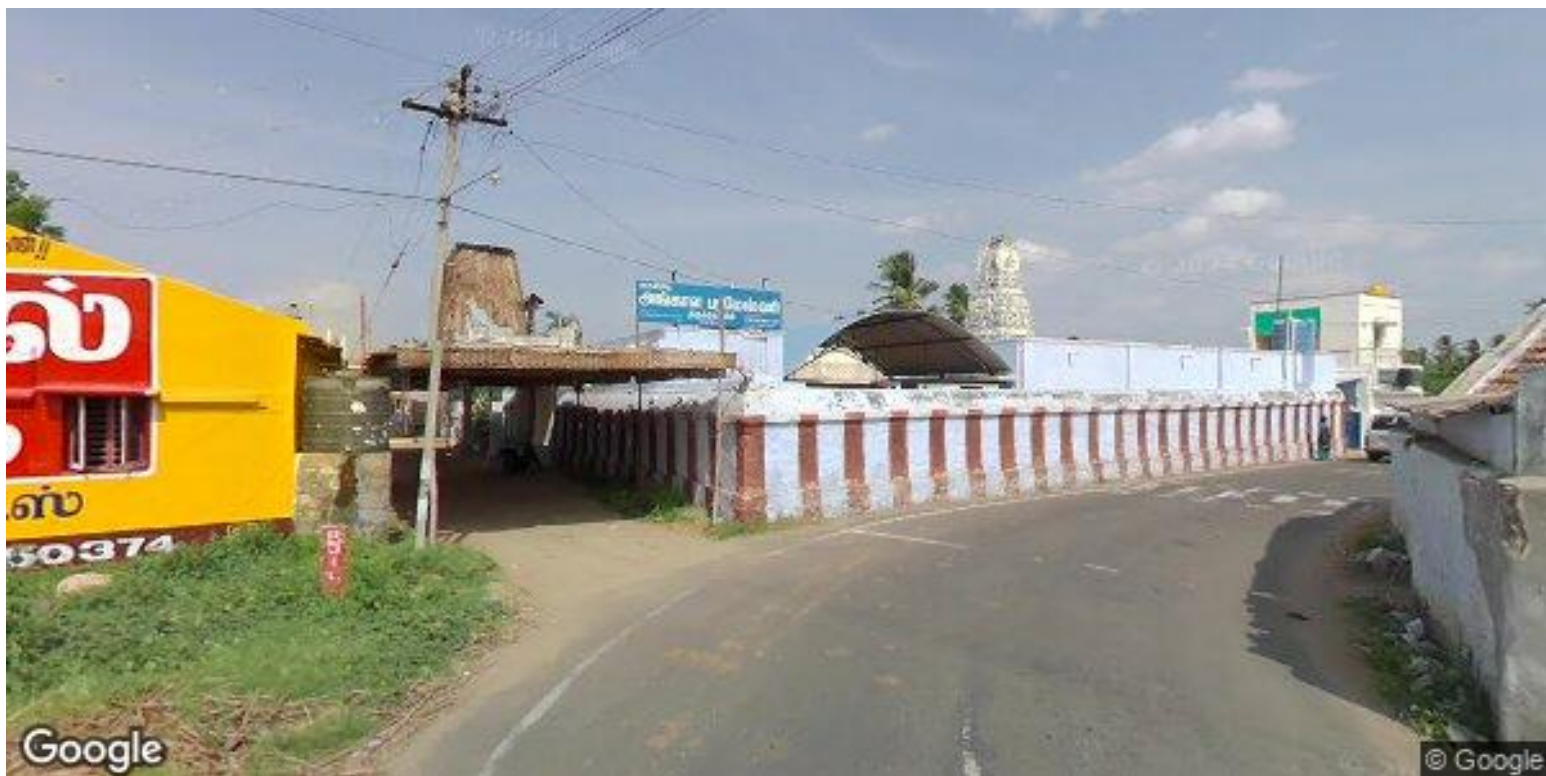
**Coordinates:** 11.24115, 77.86891

**Risk Type:** Turn

**Risk Level:** Medium

**Speed Limit:** 30 KM/Hr

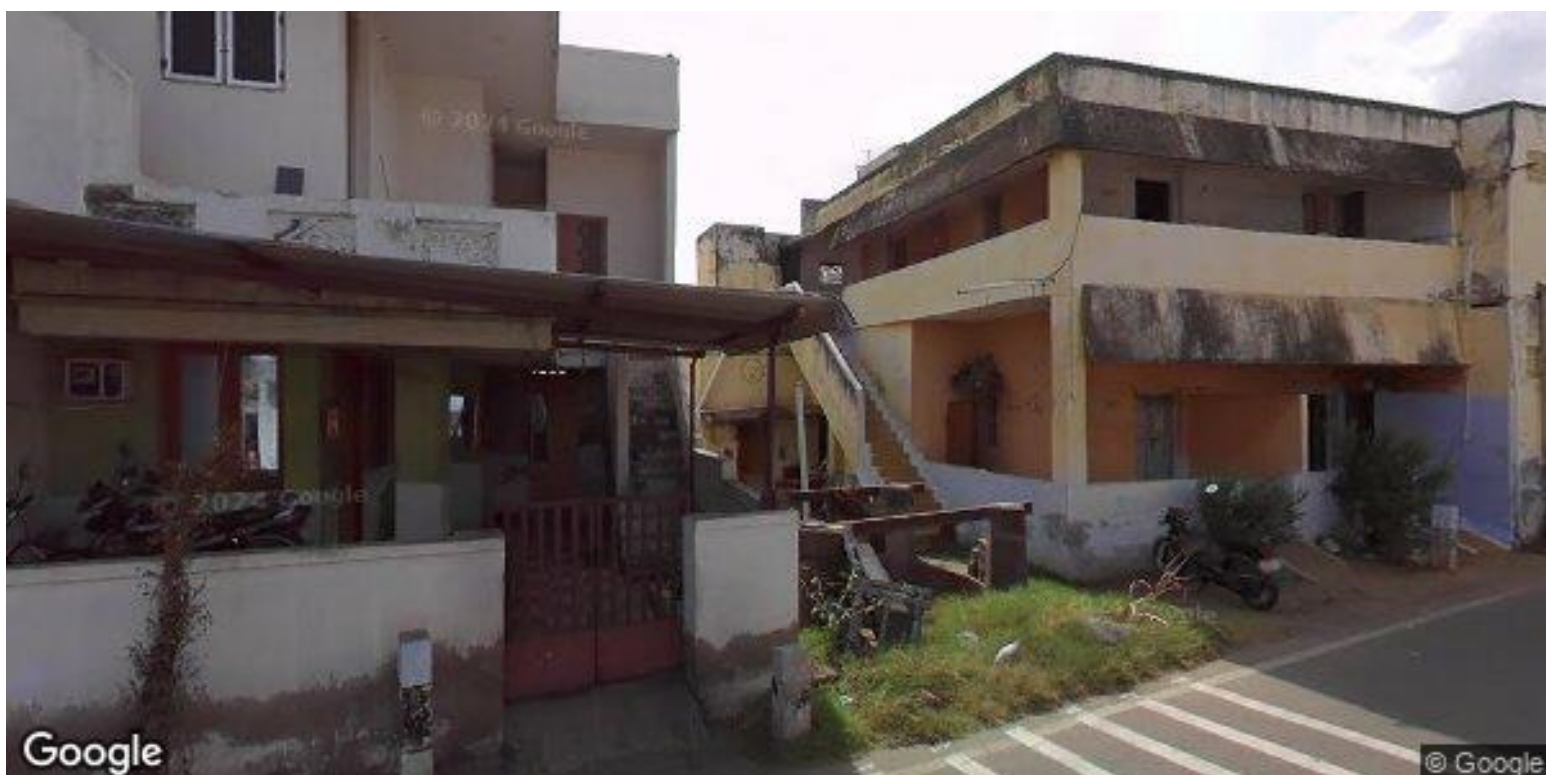
**Coordinates: 11.24122, 77.86883**

**Risk Type: Turn**

**Risk Level: Medium**

**Speed Limit: 30 KM/Hr**

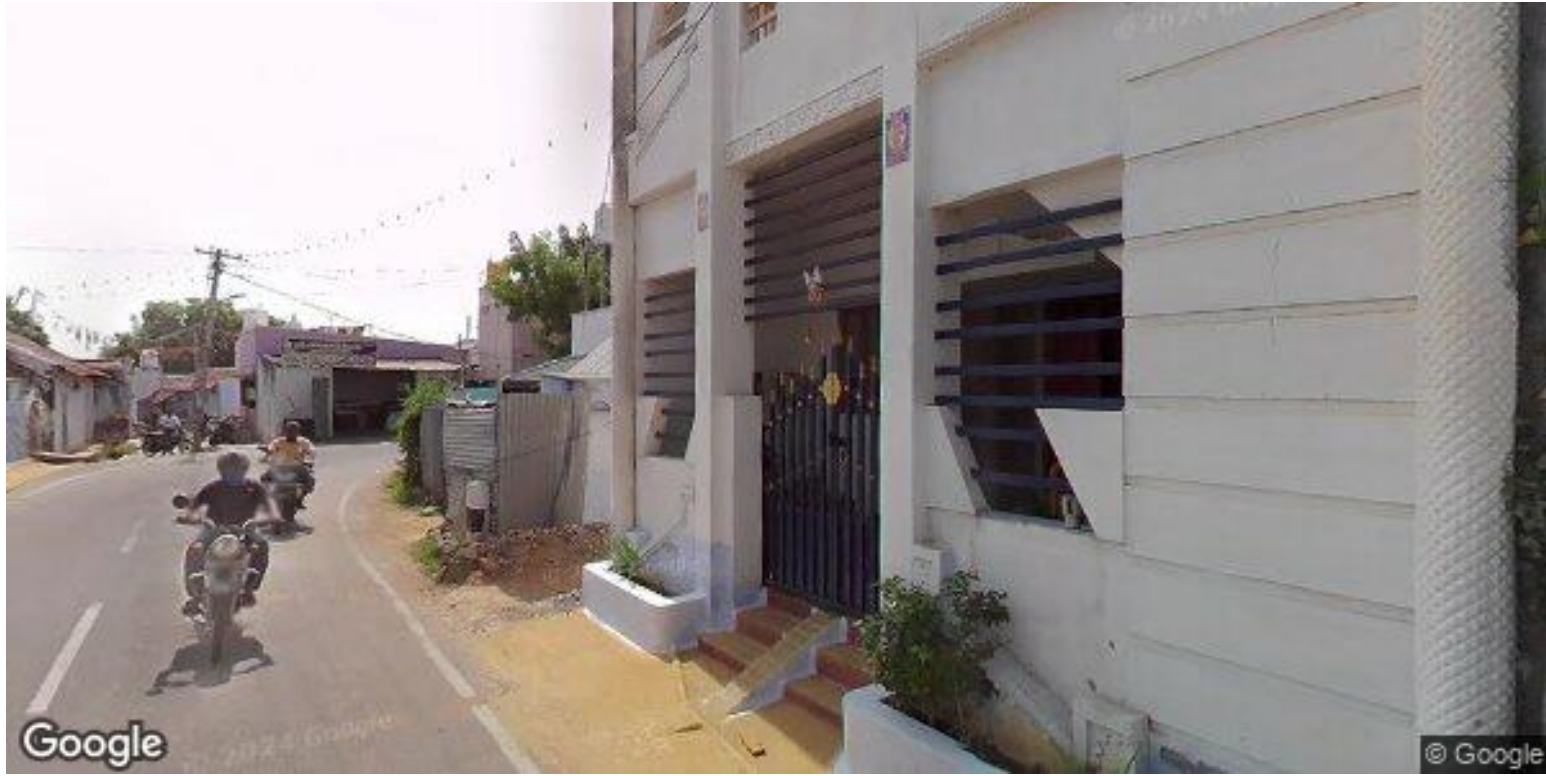
**Coordinates: 11.24159, 77.86874**

**Risk Type: Turn**

**Risk Level: High**

**Speed Limit: 15 KM/Hr**

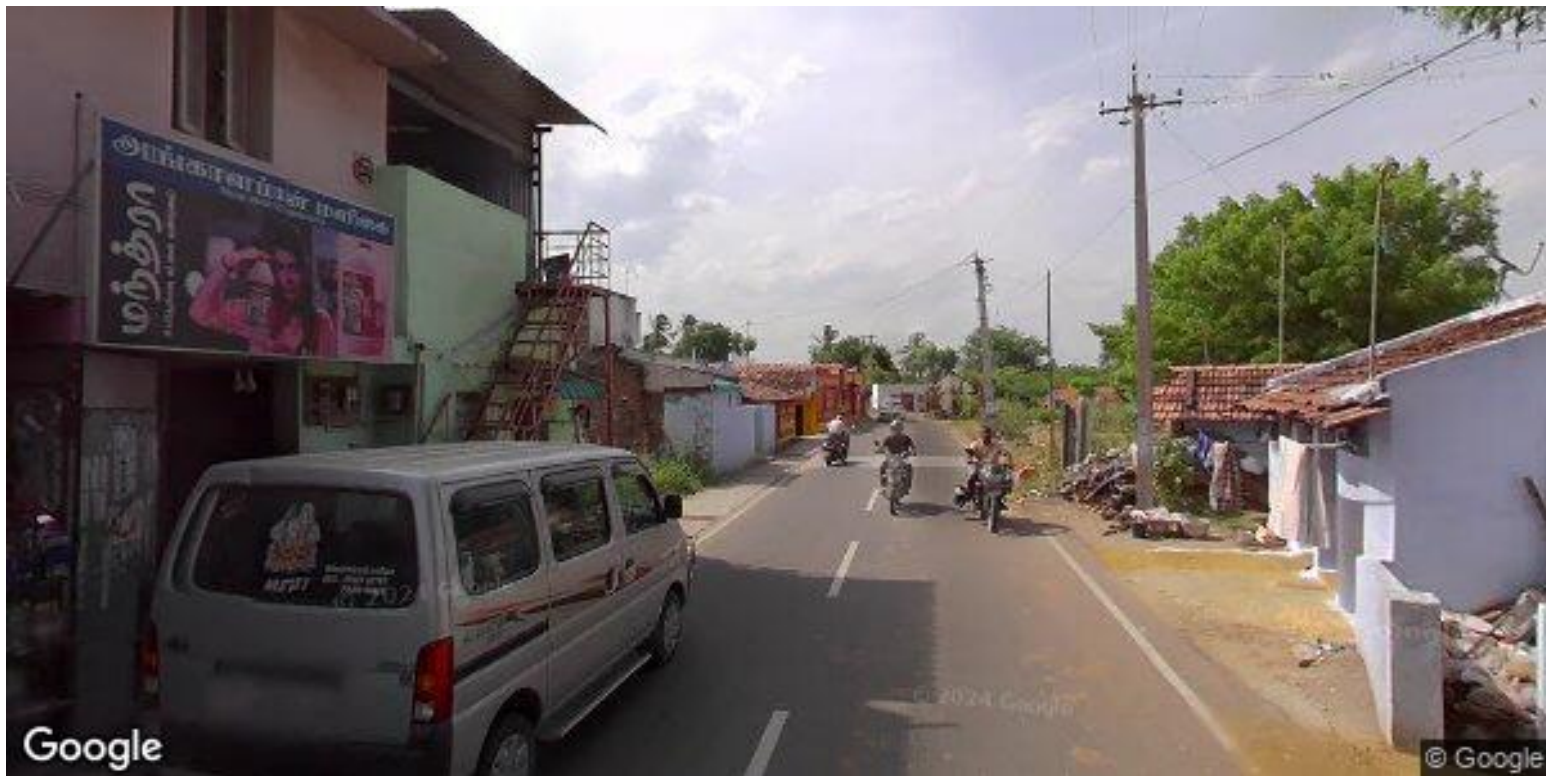
**Coordinates: 11.24170, 77.86842**

**Risk Type: Turn**

**Risk Level: High**

**Speed Limit: 15 KM/Hr**

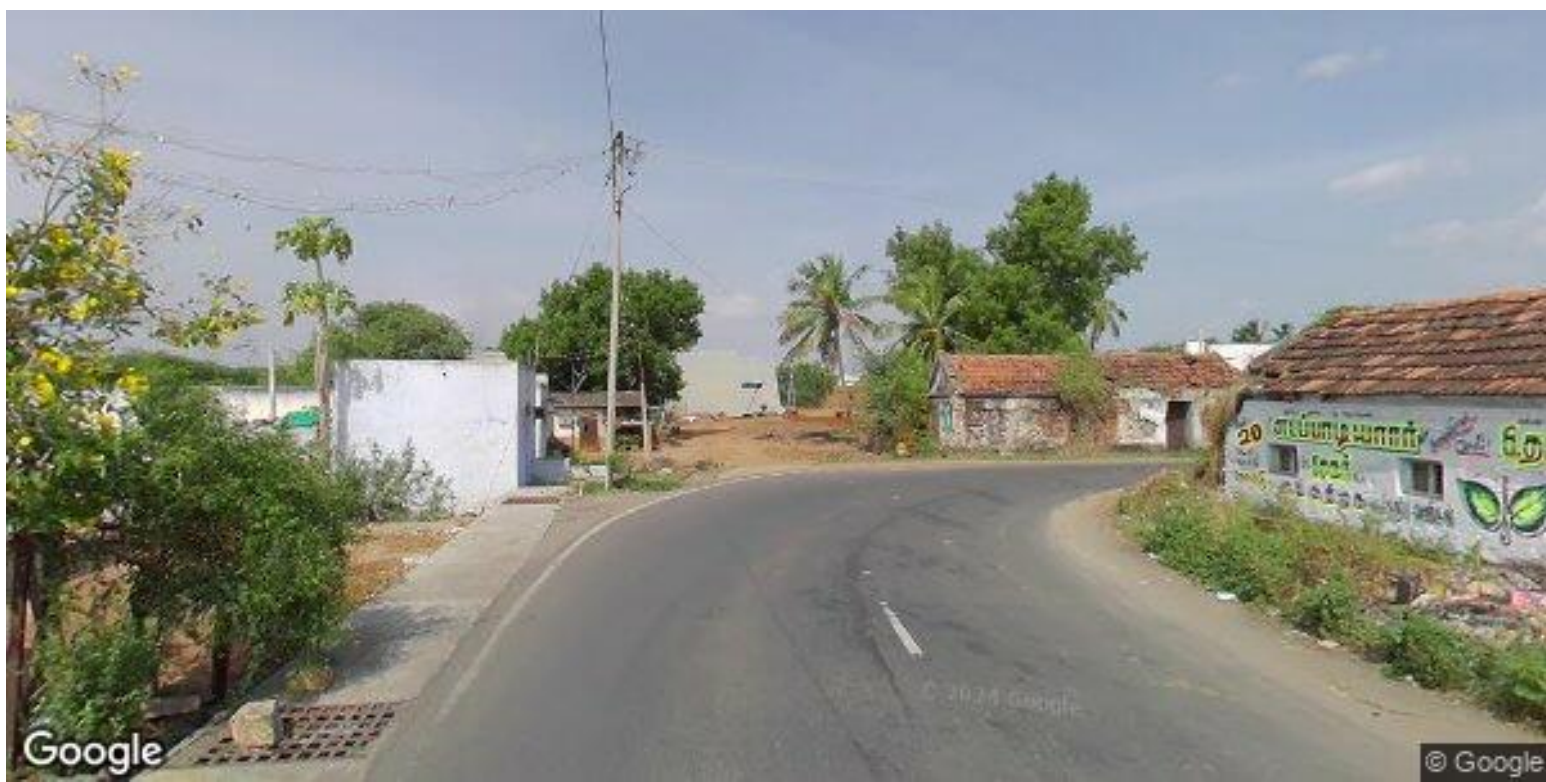
**Coordinates:** 11.24248, 77.86829

**Risk Type:** Turn

**Risk Level:** High

**Speed Limit:** 15 KM/Hr

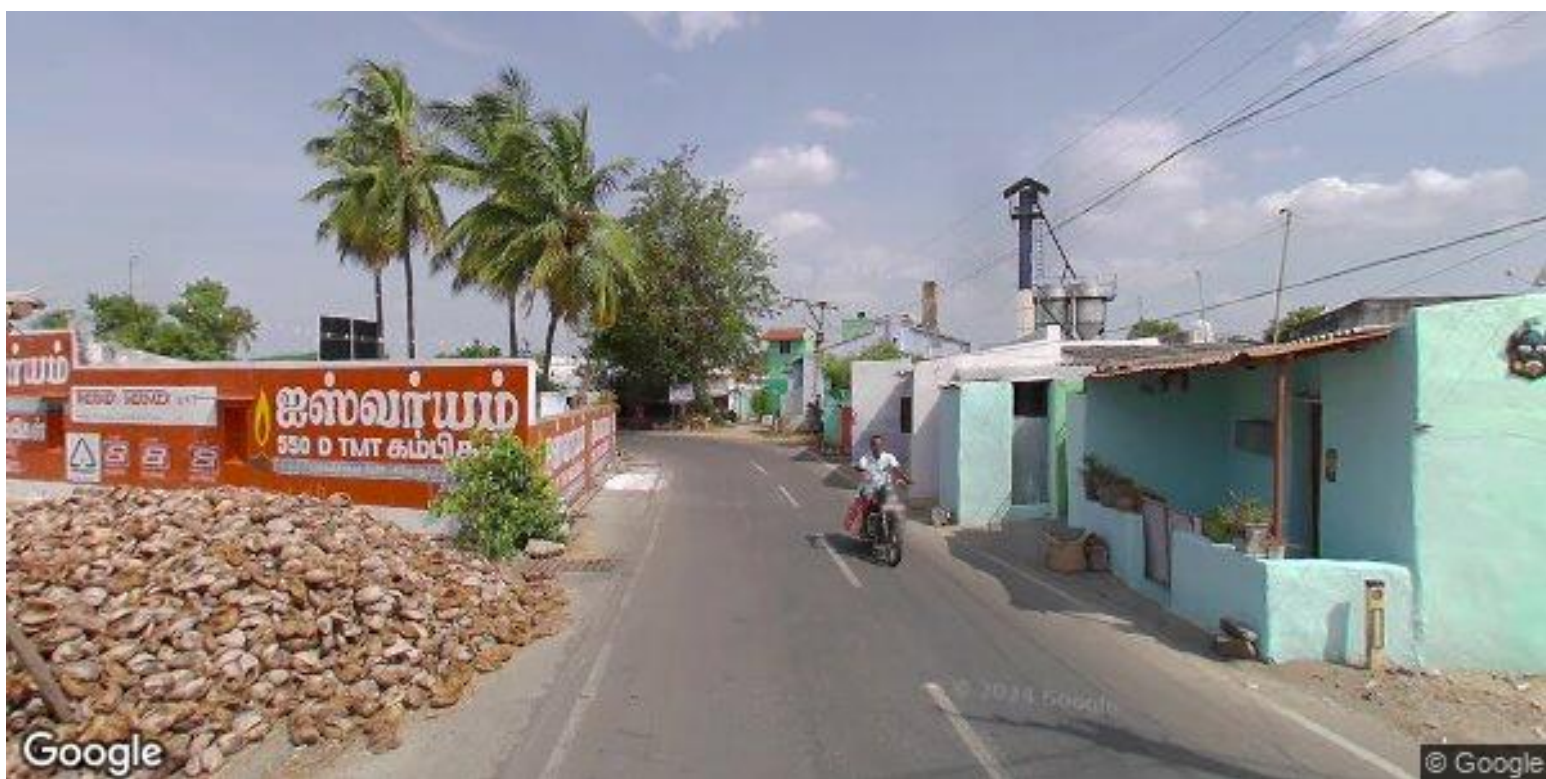
**Coordinates:** 11.24257, 77.86776

**Risk Type:** Turn

**Risk Level:** Medium

**Speed Limit:** 30 KM/Hr

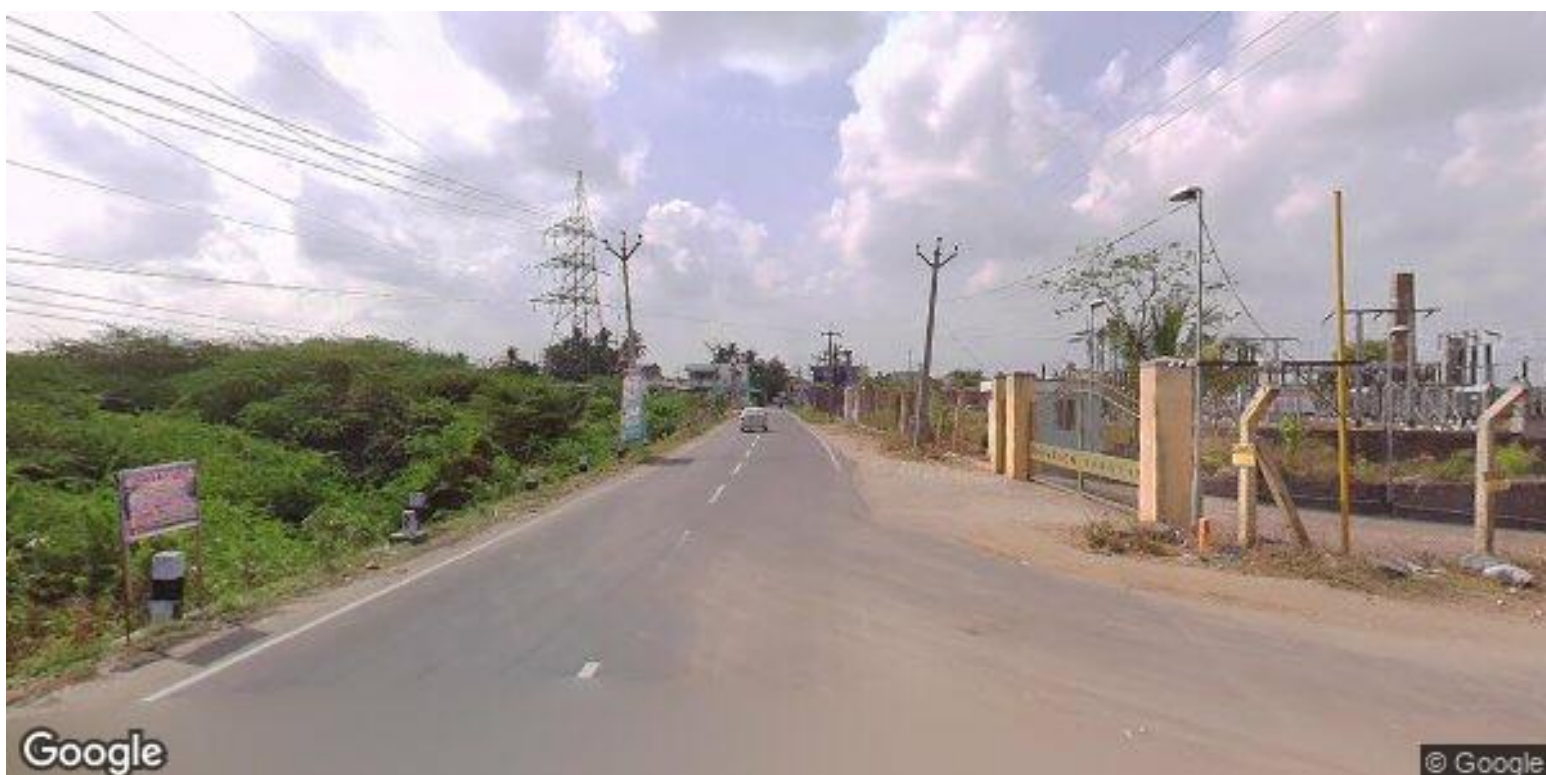
**Risk Type:** Blind Spot  
**Risk Level:** Blind Spot  
**Speed Limit:** 10 KM/Hr  
**Coordinates:** 11.24384, 77.86689

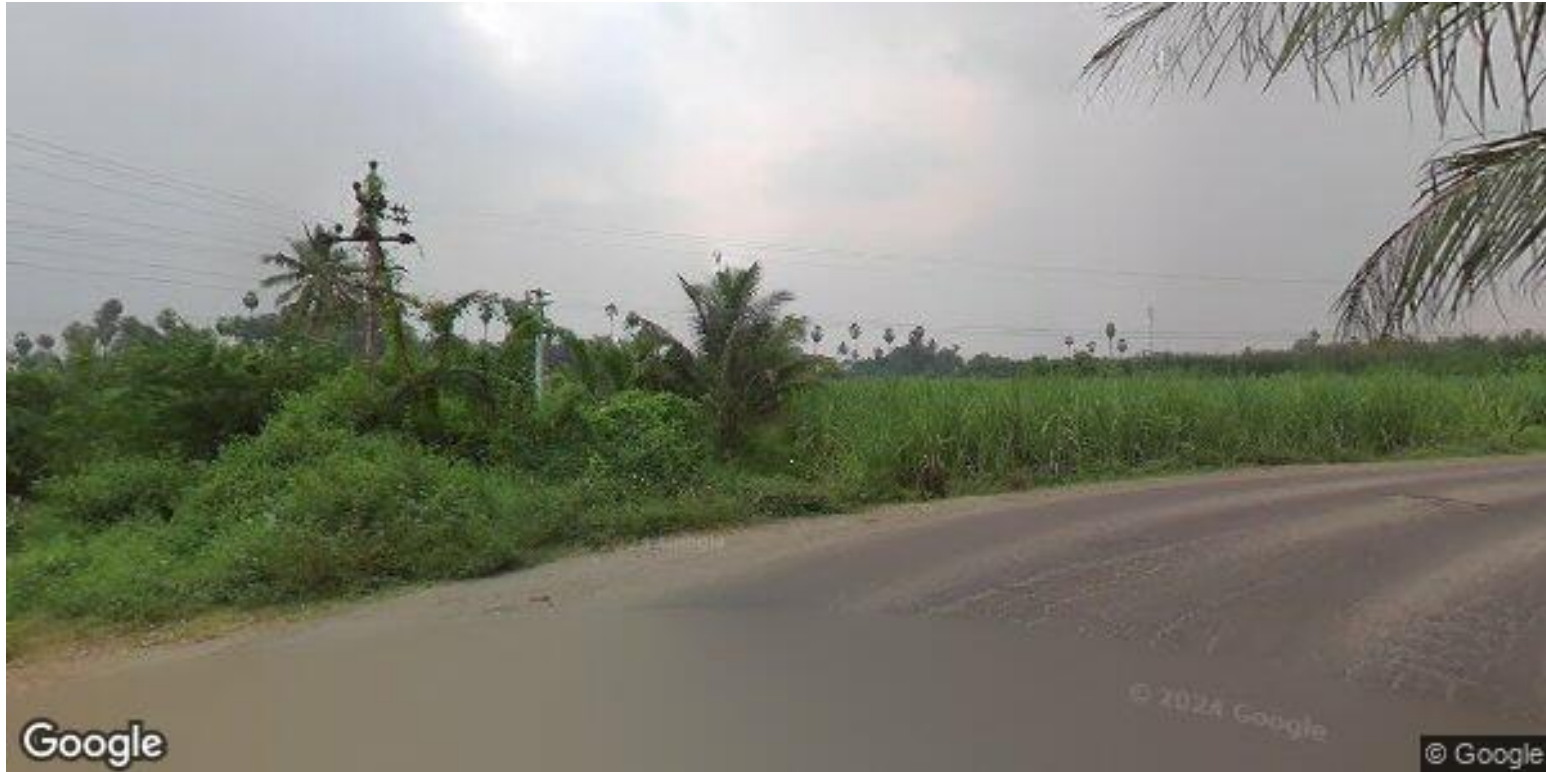
**Risk Type:** Turn  
**Risk Level:** Medium  
**Speed Limit:** 30 KM/Hr  
**Coordinates:** 11.24101, 77.86034

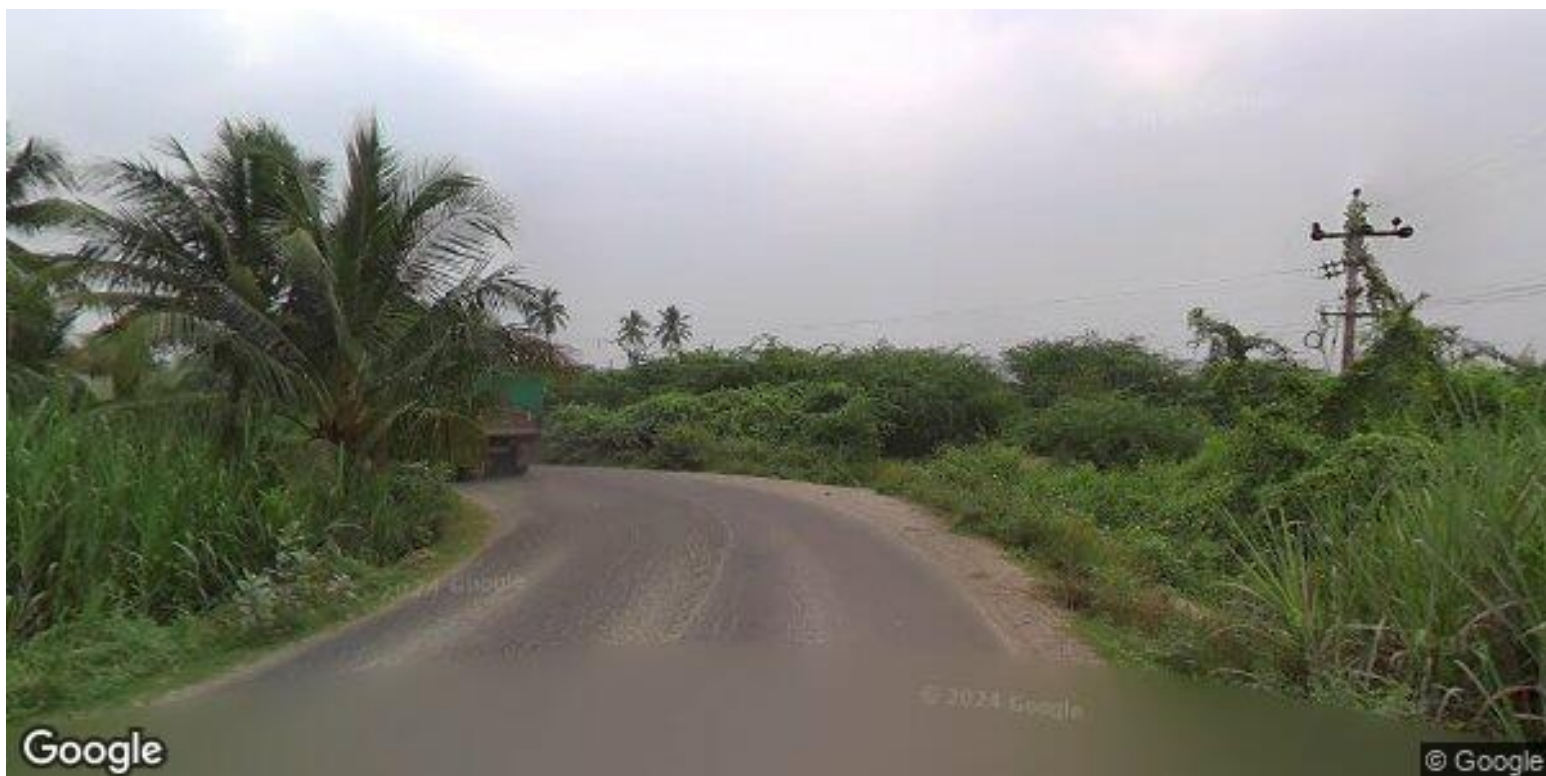
**Risk Type:** Turn  
**Risk Level:** Medium  
**Speed Limit:** 30 KM/Hr  
**Coordinates:** 11.24103, 77.86020

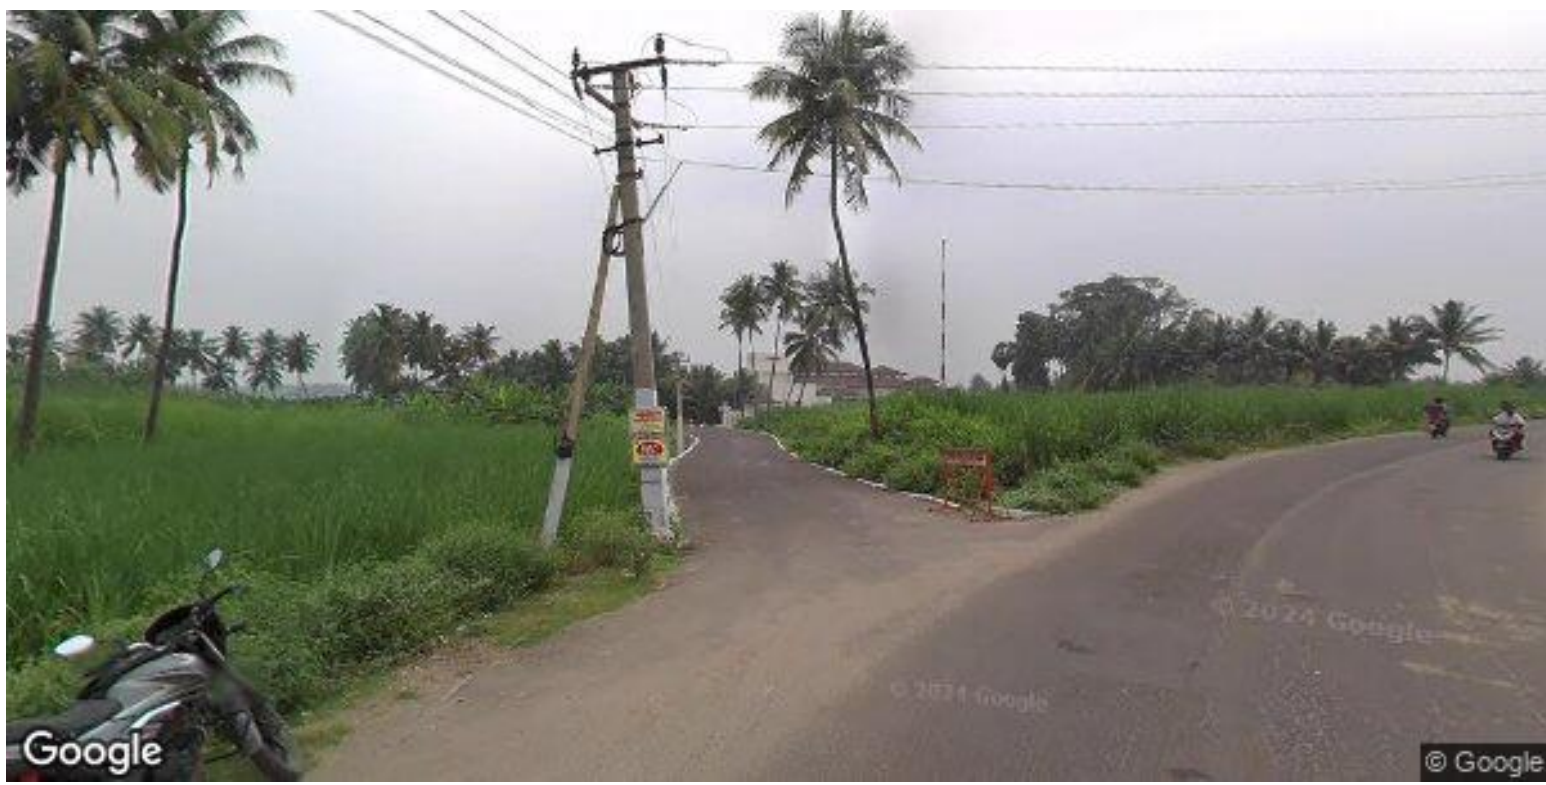
**Coordinates:** 11.24197, 77.85905

**Risk Type:** Turn

**Risk Level:** Medium

**Speed Limit:** 30 KM/Hr

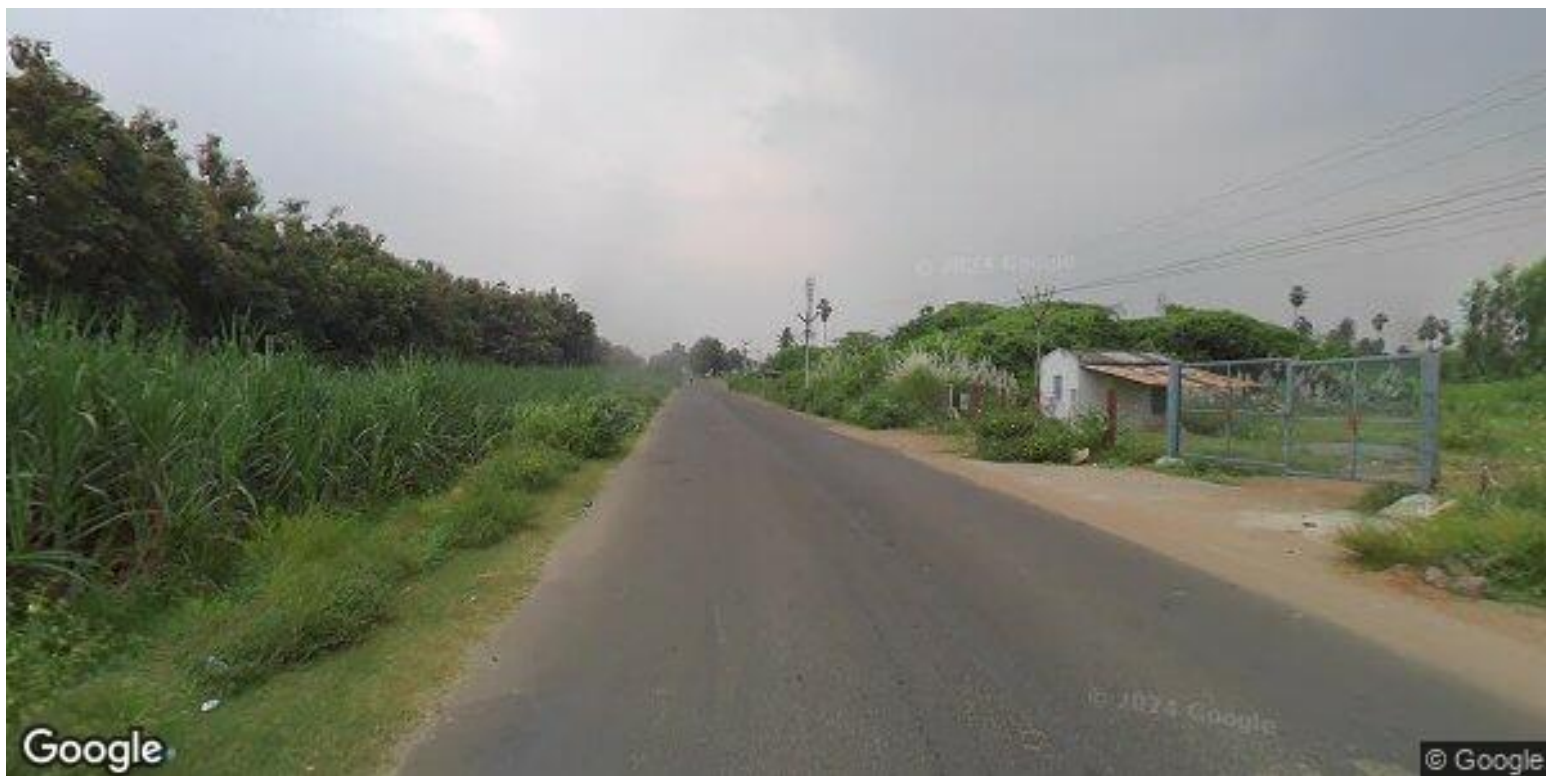
**Coordinates:** 11.24196, 77.85856

**Risk Type:** Turn

**Risk Level:** Medium

**Speed Limit:** 30 KM/Hr

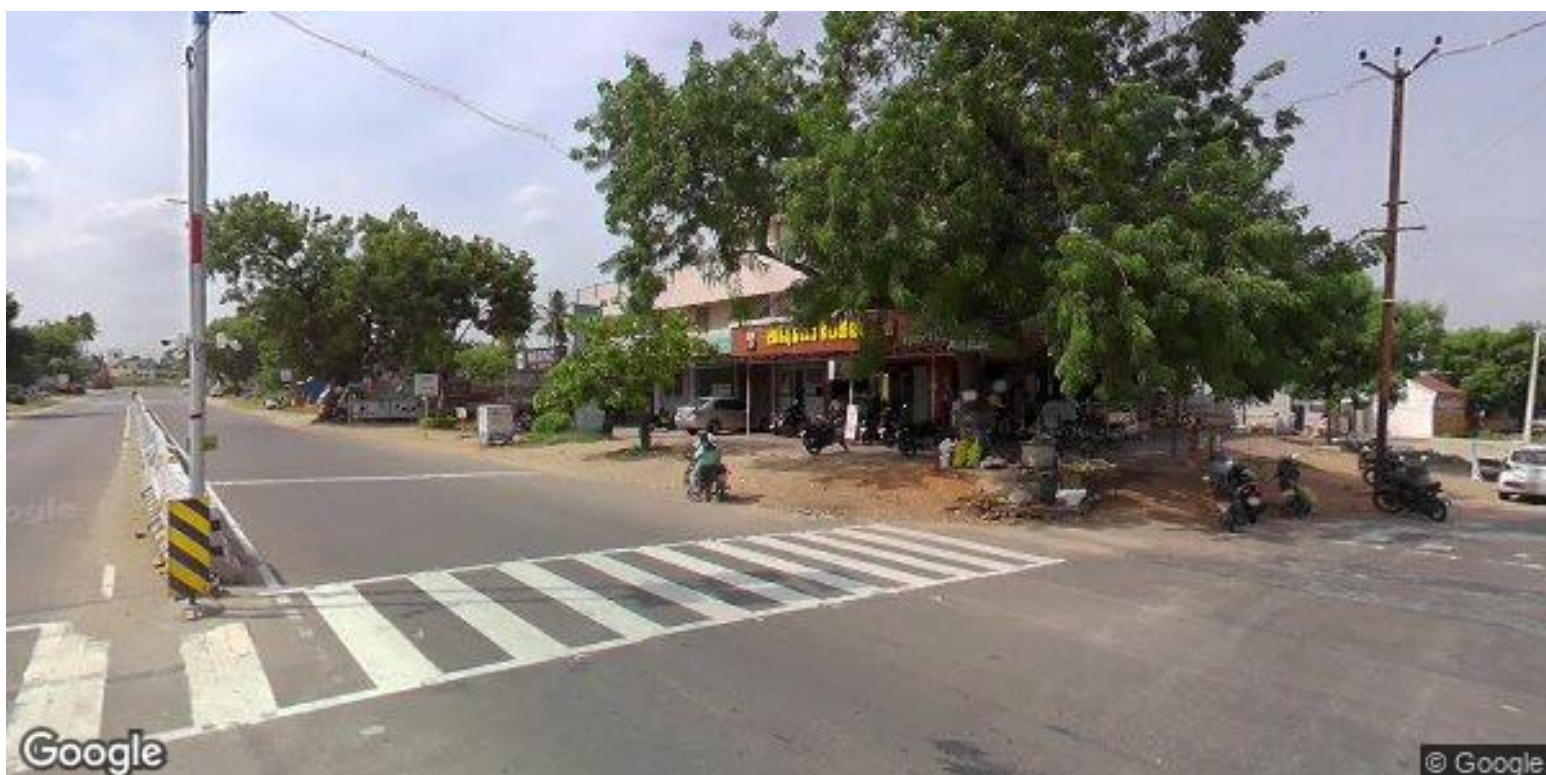
**Coordinates:** 11.22377, 77.83980

**Risk Type:** Turn

**Risk Level:** High

**Speed Limit:** 15 KM/Hr

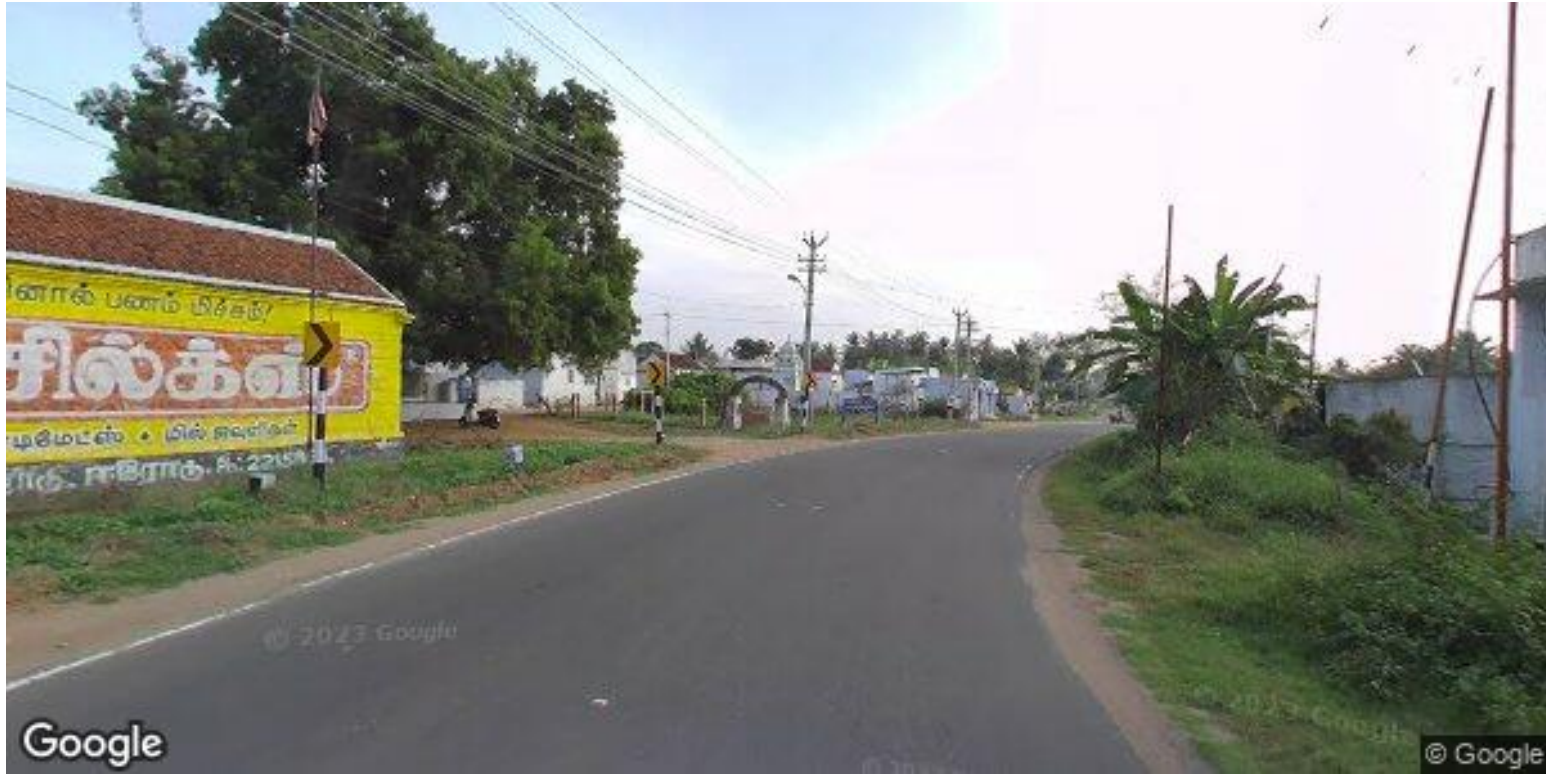
**Coordinates:** 11.14839, 77.84954

**Risk Type:** Turn

**Risk Level:** Medium

**Speed Limit:** 30 KM/Hr
