# IndianOil

## JOURNEY RISK MANAGEMENT (JRM) STUDY

### Salem Terminal TO VADIVELAN AGENCIES

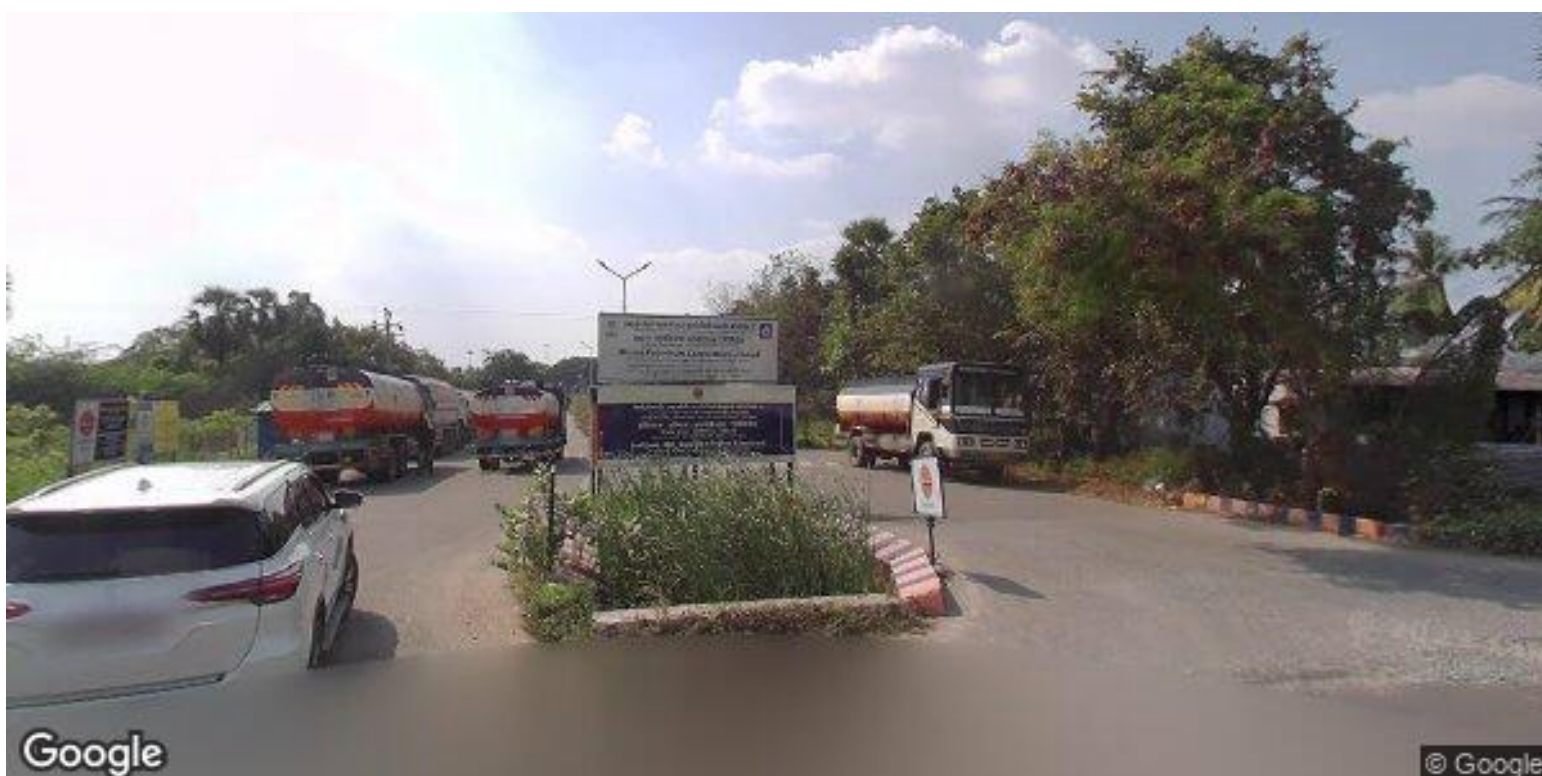
**Coordinates:** 11.44024, 77.87528

**Risk Type:** Turn

**Risk Level:** High

**Speed Limit:** 15 KM/Hr

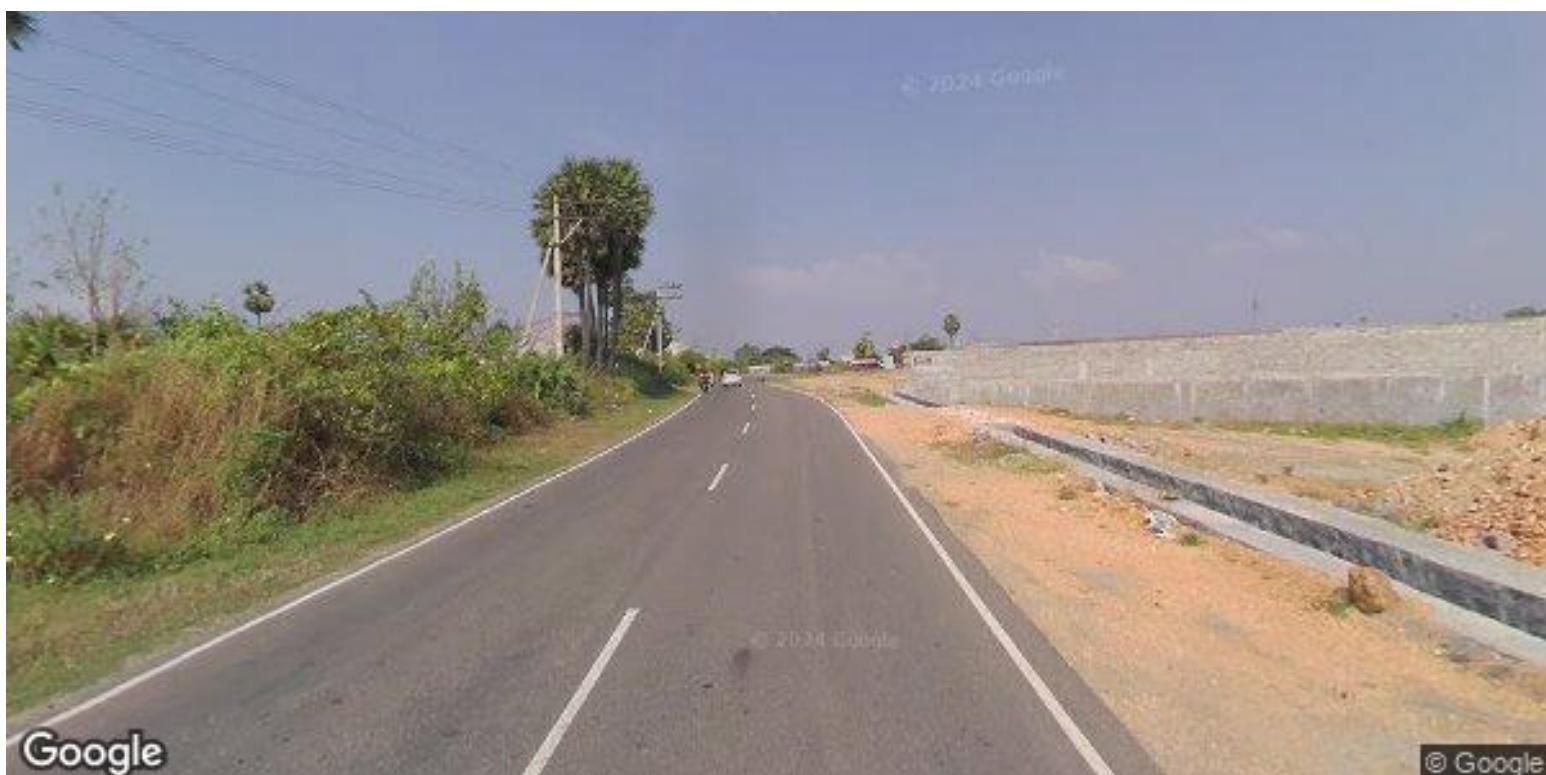
**Coordinates: 11.45764, 77.85219**

**Risk Type: Turn**

**Risk Level: Medium**

**Speed Limit: 30 KM/Hr**

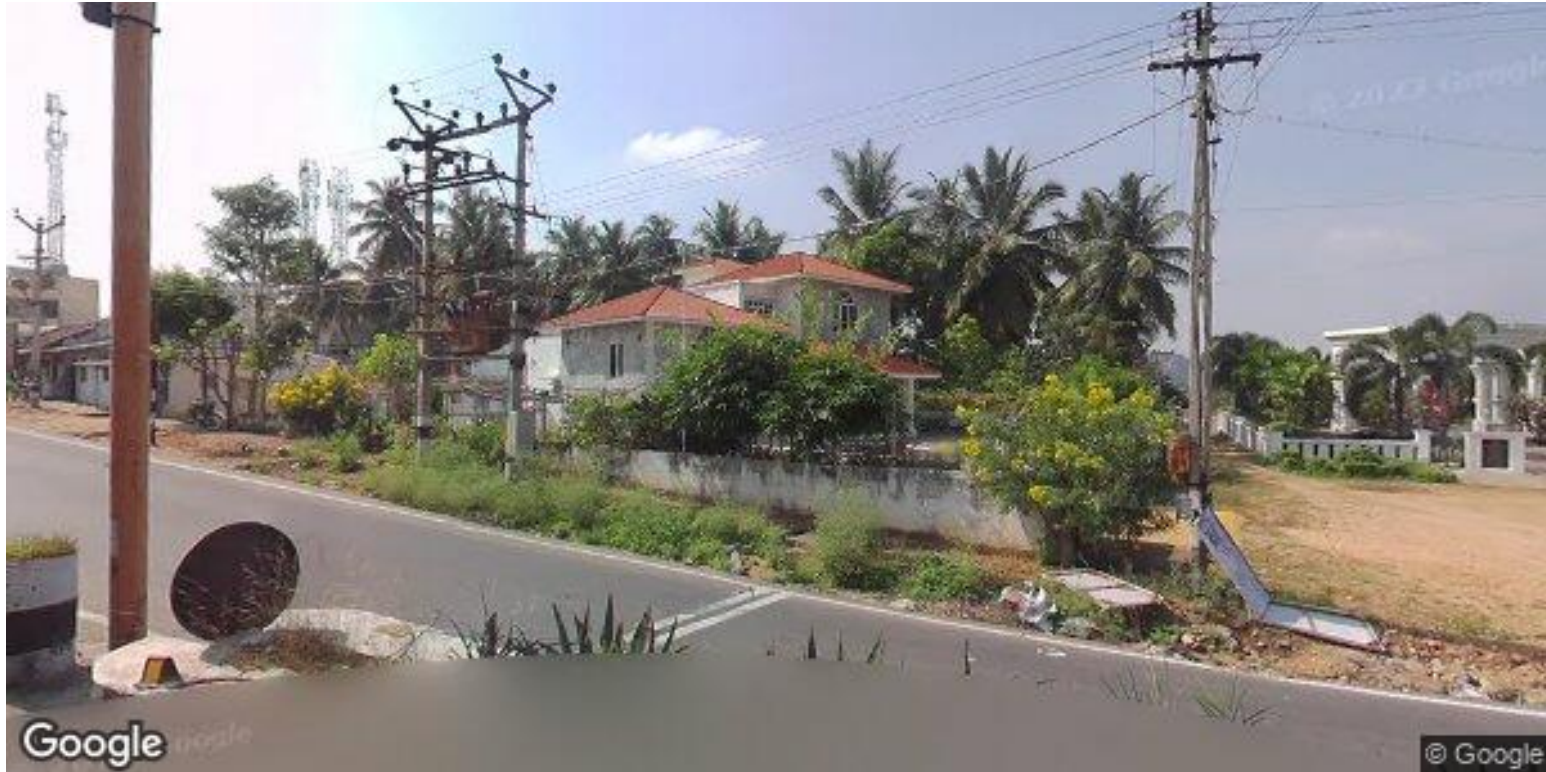
**Coordinates: 11.46303, 77.84945**

**Risk Type: Turn**

**Risk Level: High**

**Speed Limit: 15 KM/Hr**

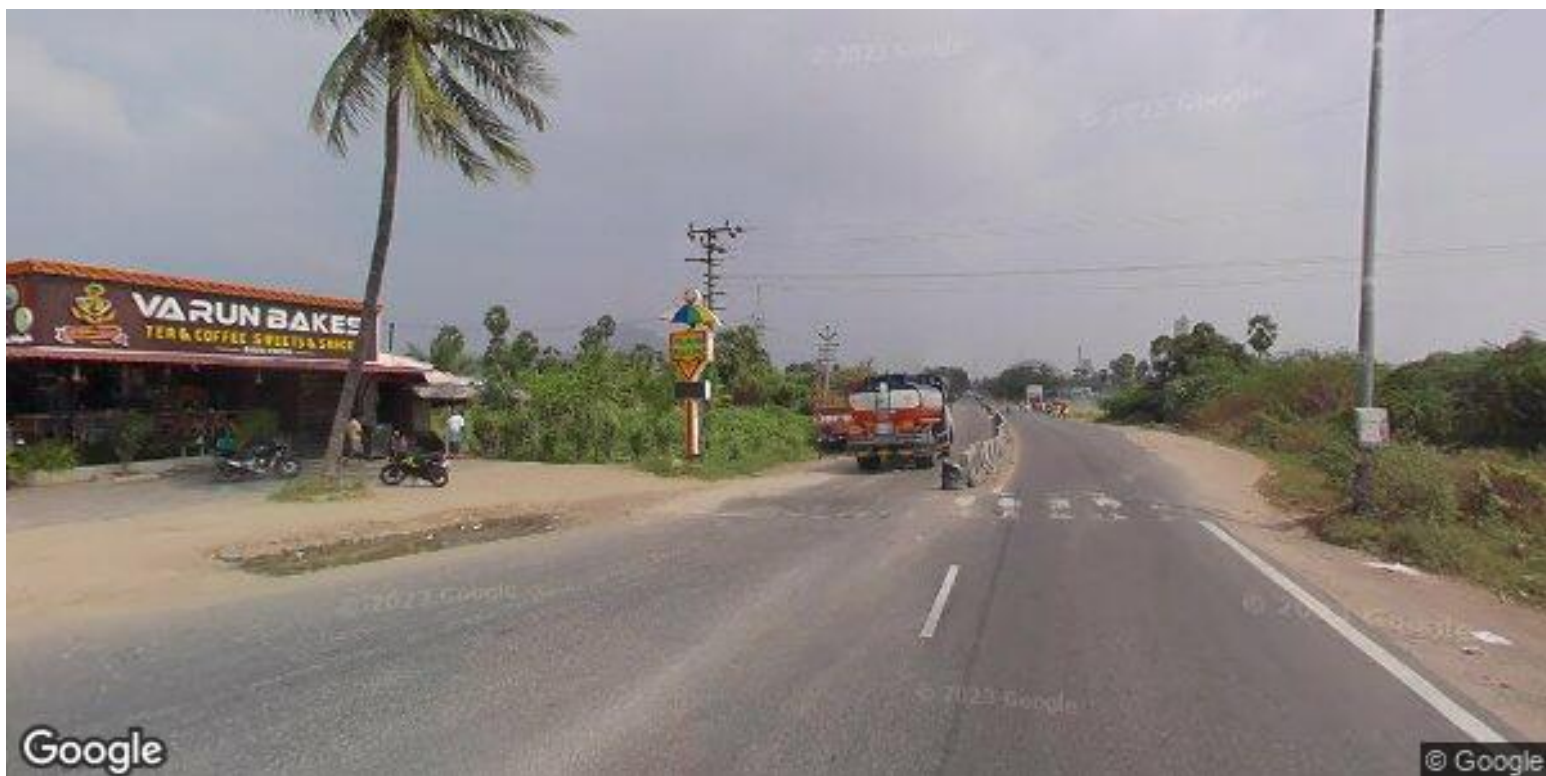
**Coordinates: 11.45543, 77.81740**

**Risk Type: Turn**

**Risk Level: Medium**

**Speed Limit: 30 KM/Hr**

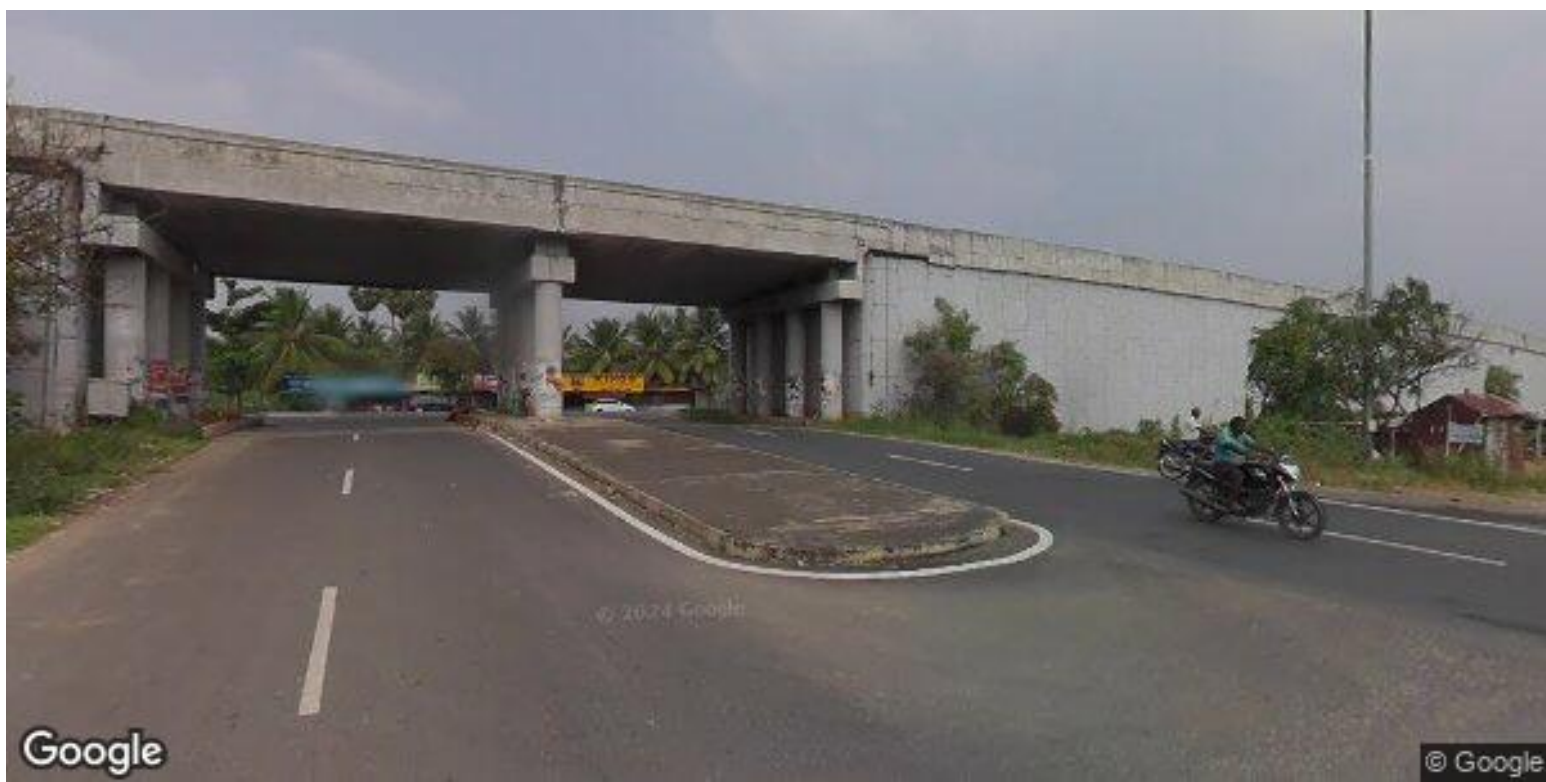
**Coordinates:** 11.45584, 77.81695

**Risk Type:** Turn

**Risk Level:** High

**Speed Limit:** 15 KM/Hr

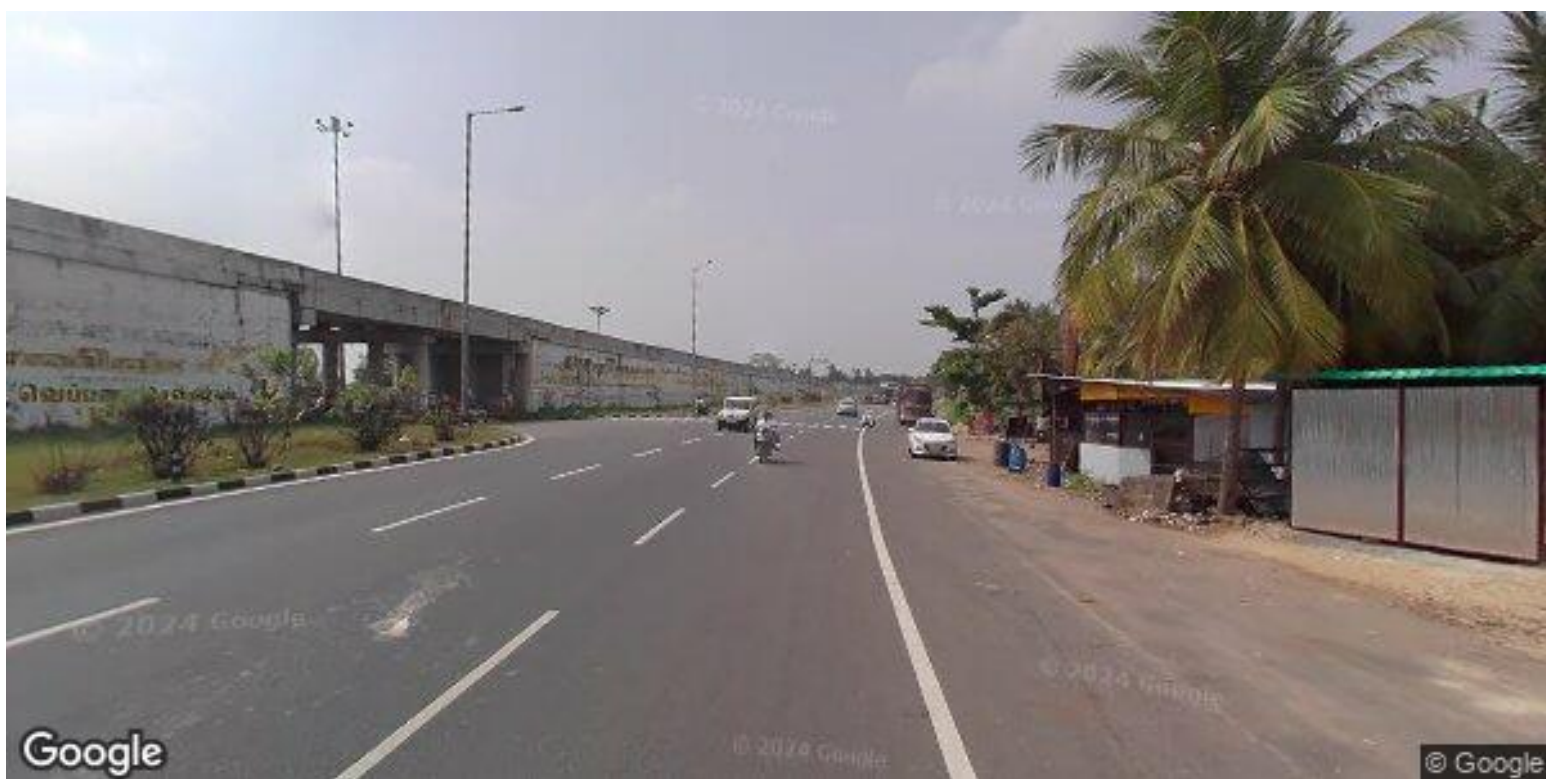
**Coordinates:** 11.45656, 77.81709

**Risk Type:** Turn

**Risk Level:** Medium

**Speed Limit:** 30 KM/Hr

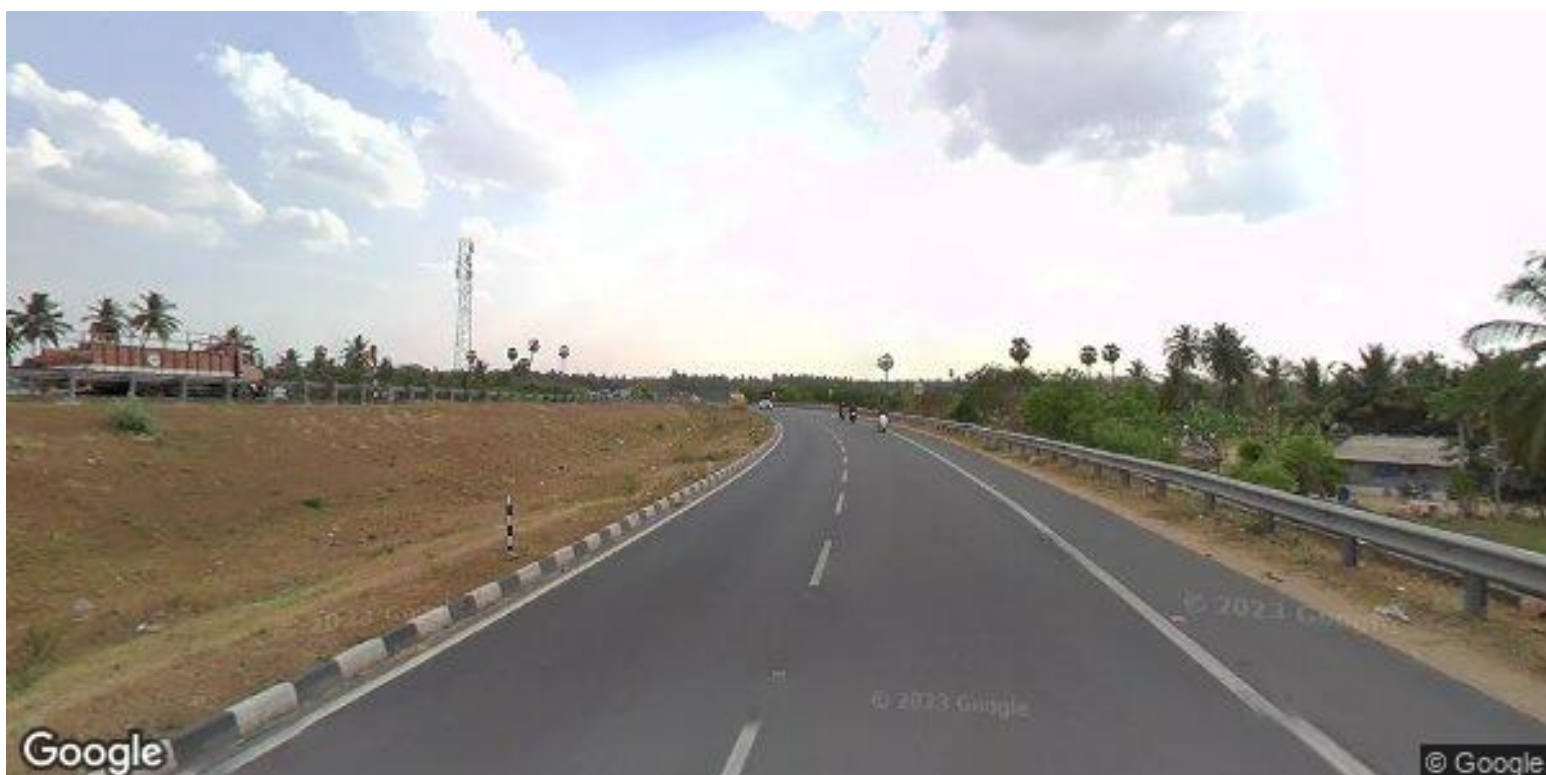
**Risk Type:** Turn  
**Risk Level:** Medium  
**Speed Limit:** 30 KM/Hr  
**Coordinates:** 11.53552, 77.95763

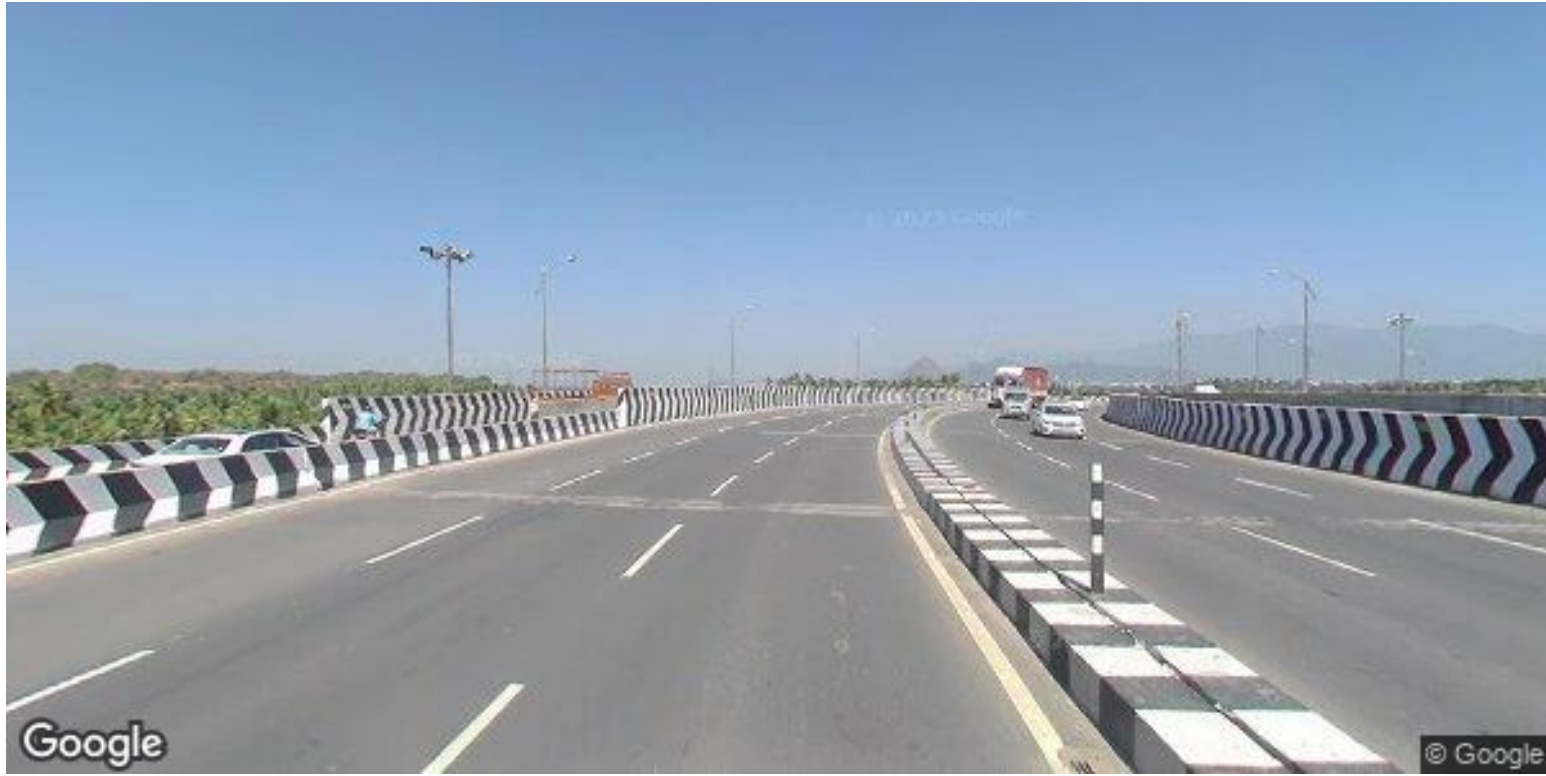
**Risk Type:** Turn  
**Risk Level:** Medium  
**Speed Limit:** 30 KM/Hr  
**Coordinates:** 11.64096, 78.11795

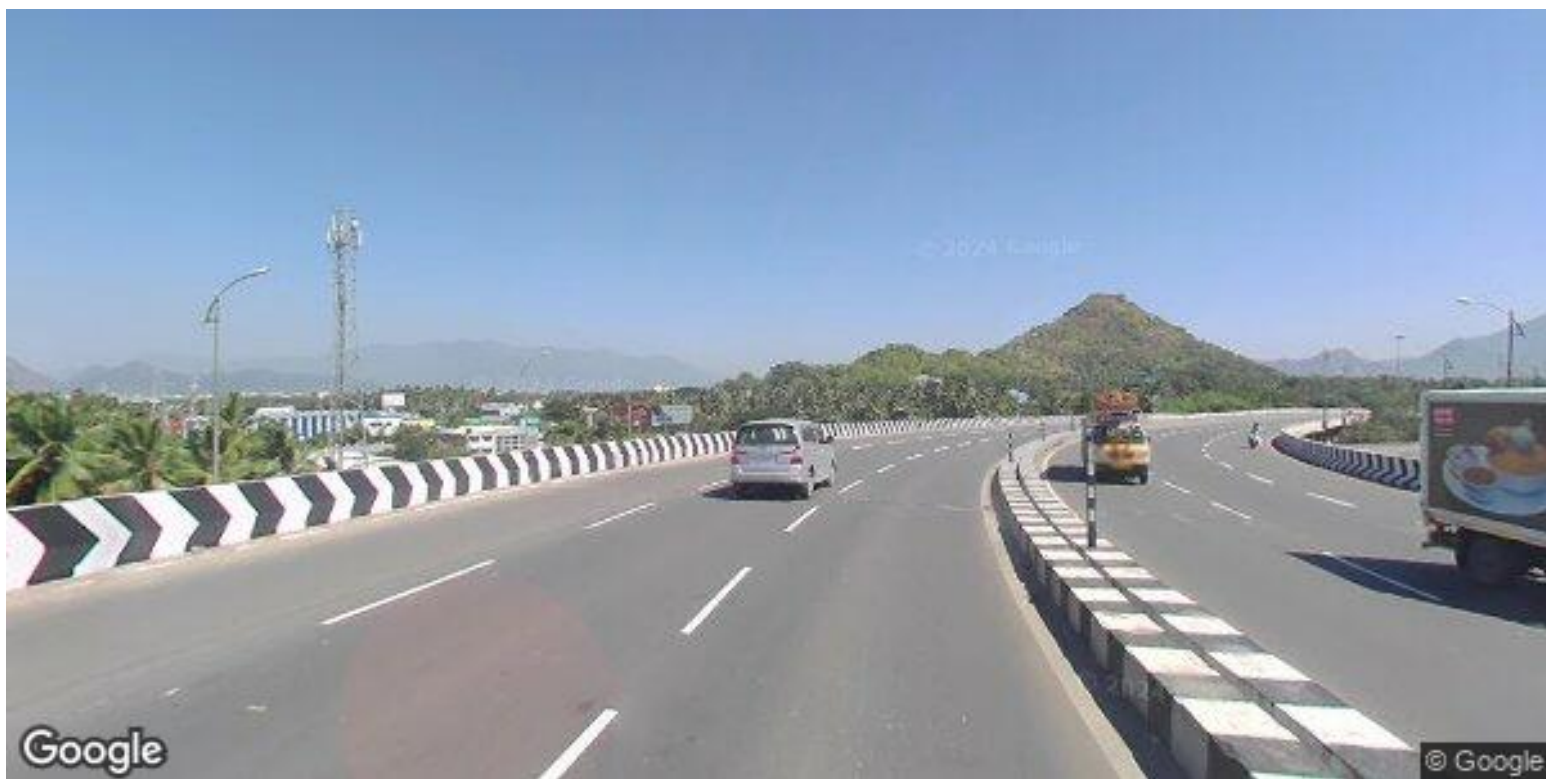
**Risk Type:** Turn  
**Risk Level:** High  
**Speed Limit:** 15 KM/Hr  
**Coordinates:** 11.64210, 78.11860

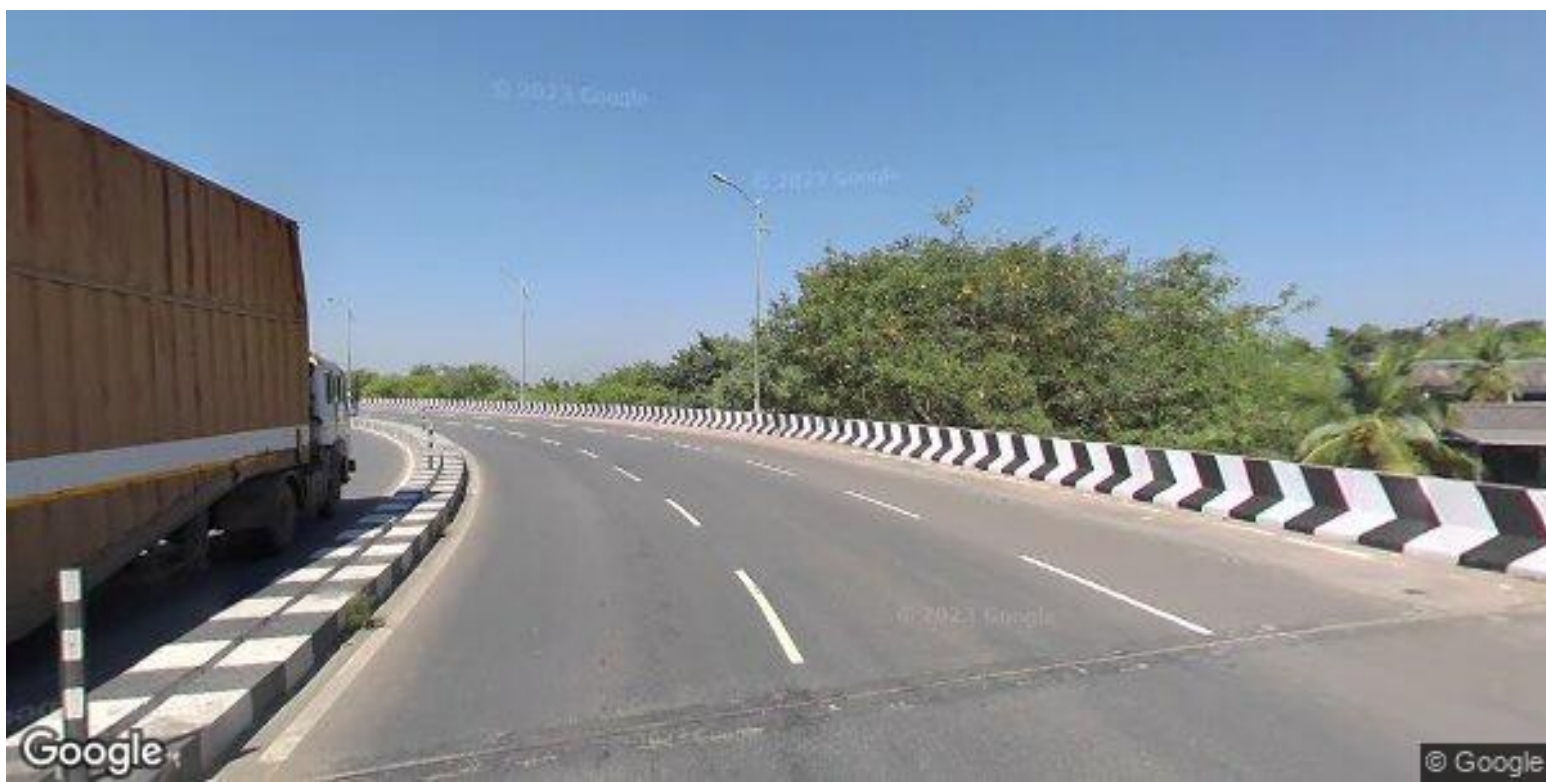
**Coordinates:** 11.64172, 78.12154

**Risk Type:** Turn

**Risk Level:** High

**Speed Limit:** 15 KM/Hr

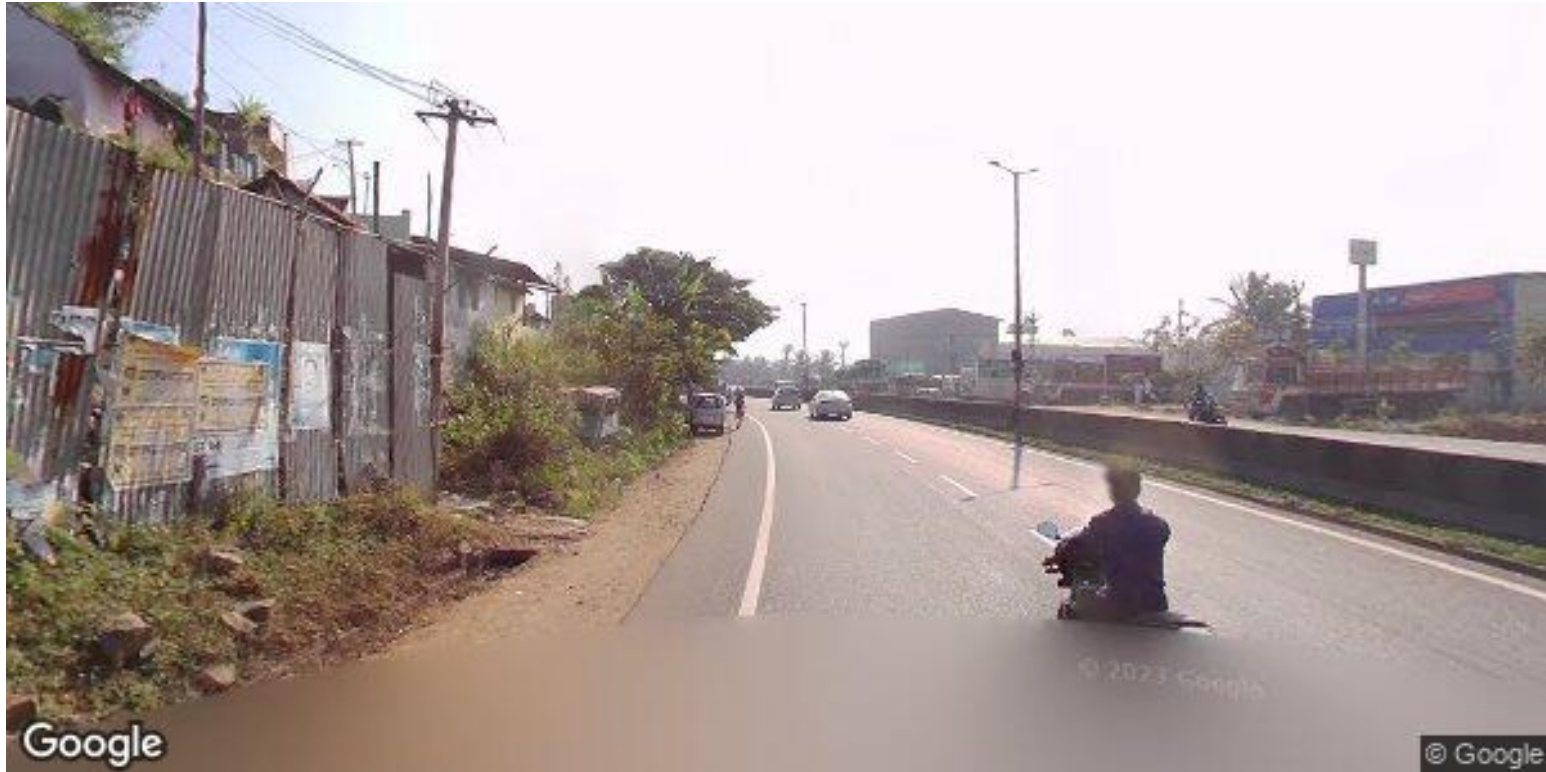
**Risk Type:** Turn  
**Risk Level:** Medium  
**Speed Limit:** 30 KM/Hr  
**Coordinates:** 11.62826, 78.13337

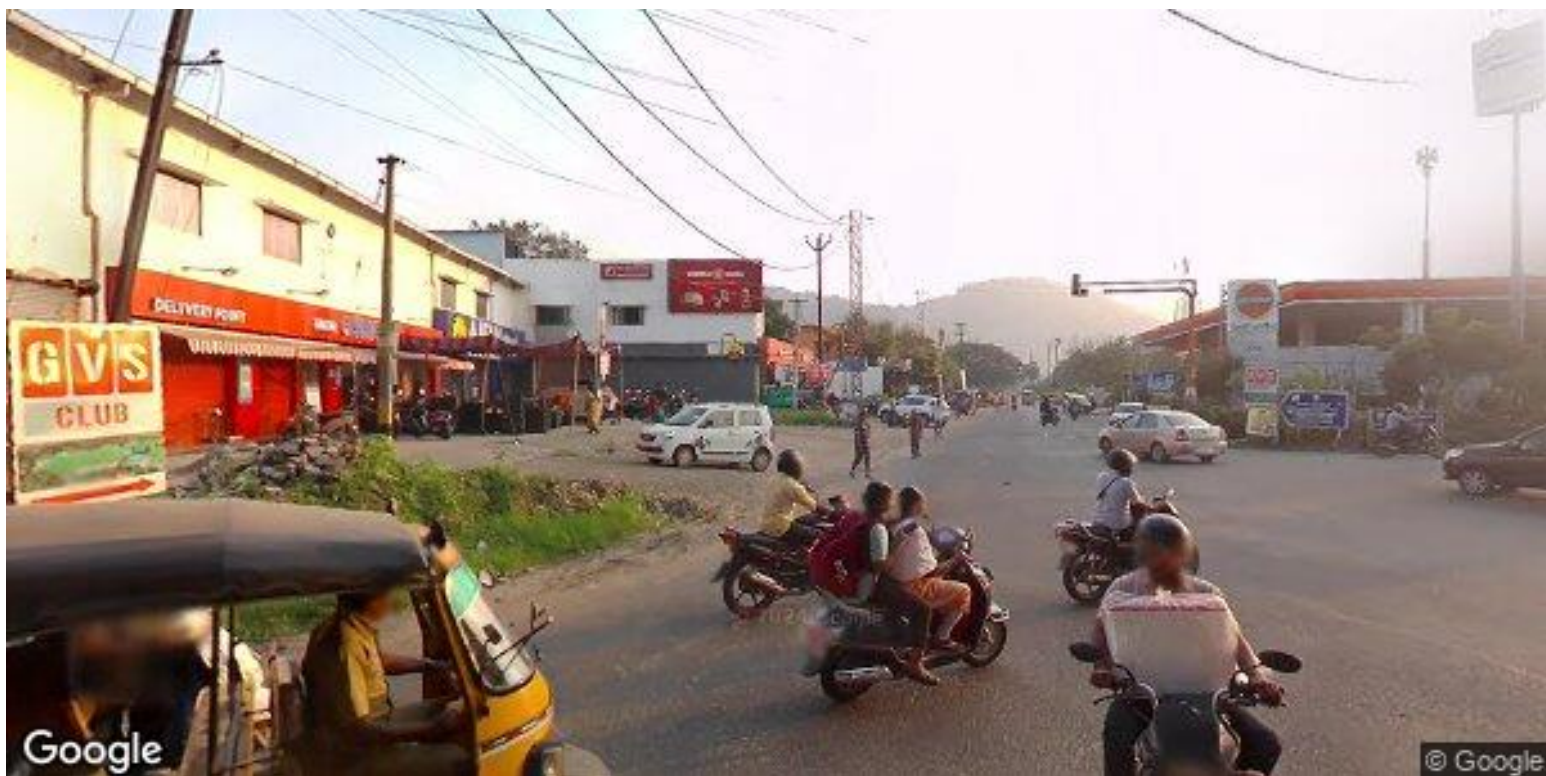
**Risk Type:** Turn  
**Risk Level:** High  
**Speed Limit:** 15 KM/Hr  
**Coordinates:** 11.66372, 78.20649

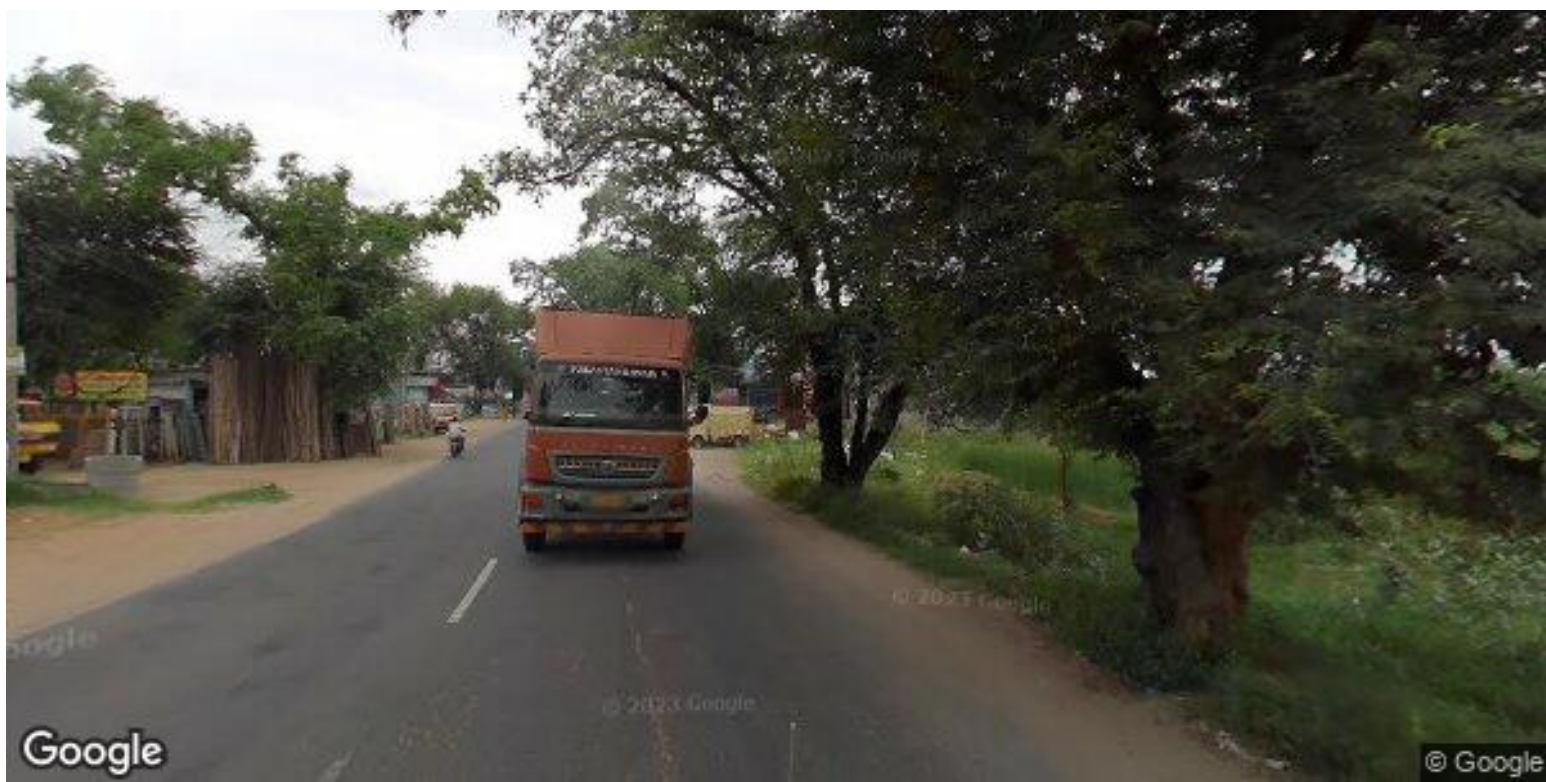
**Coordinates:** 11.67124, 78.22961

**Risk Type:** Turn

**Risk Level:** Medium

**Speed Limit:** 30 KM/Hr

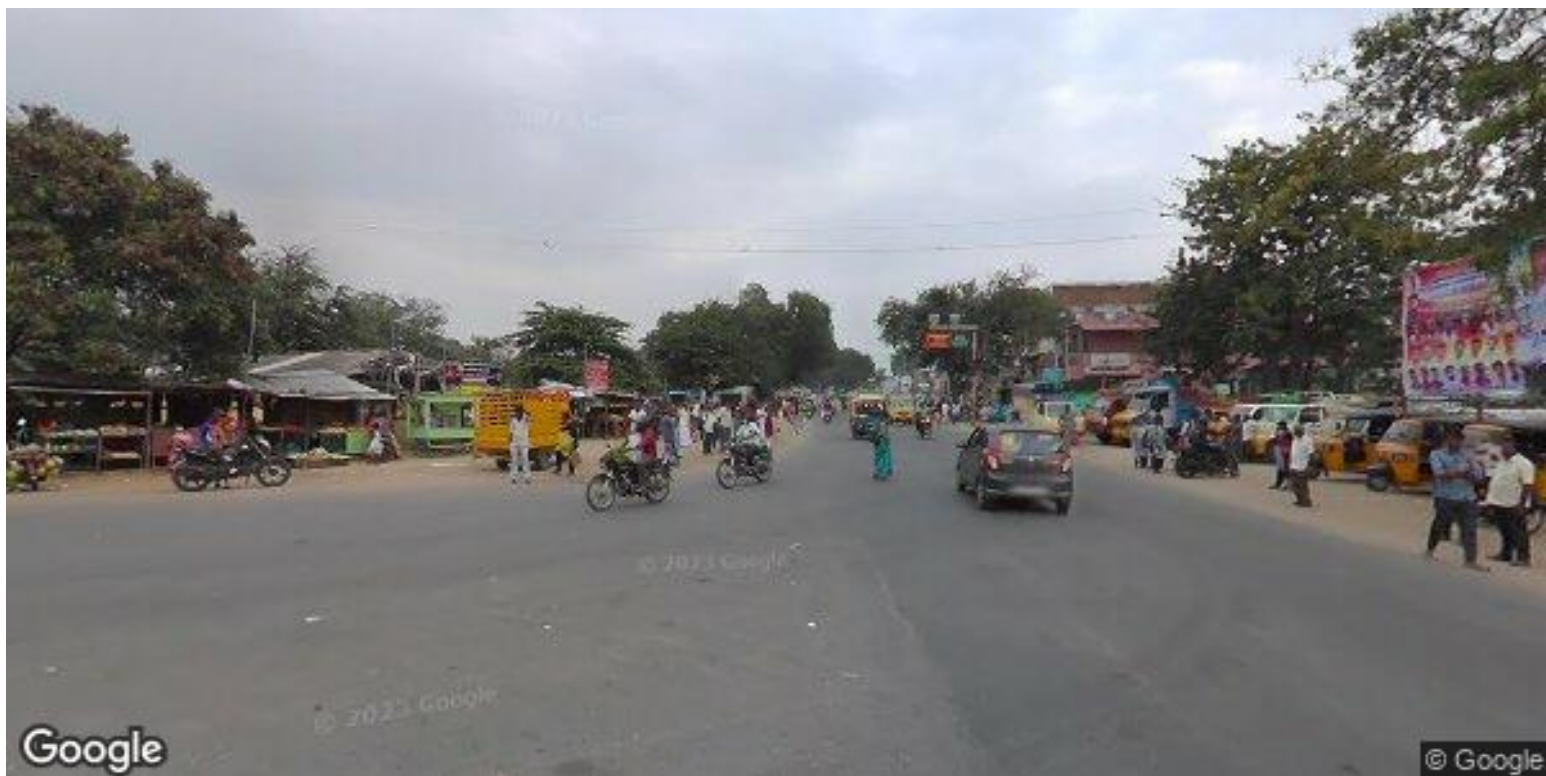
**Coordinates:** 11.67111, 78.23134

**Risk Type:** Turn

**Risk Level:** High

**Speed Limit:** 15 KM/Hr

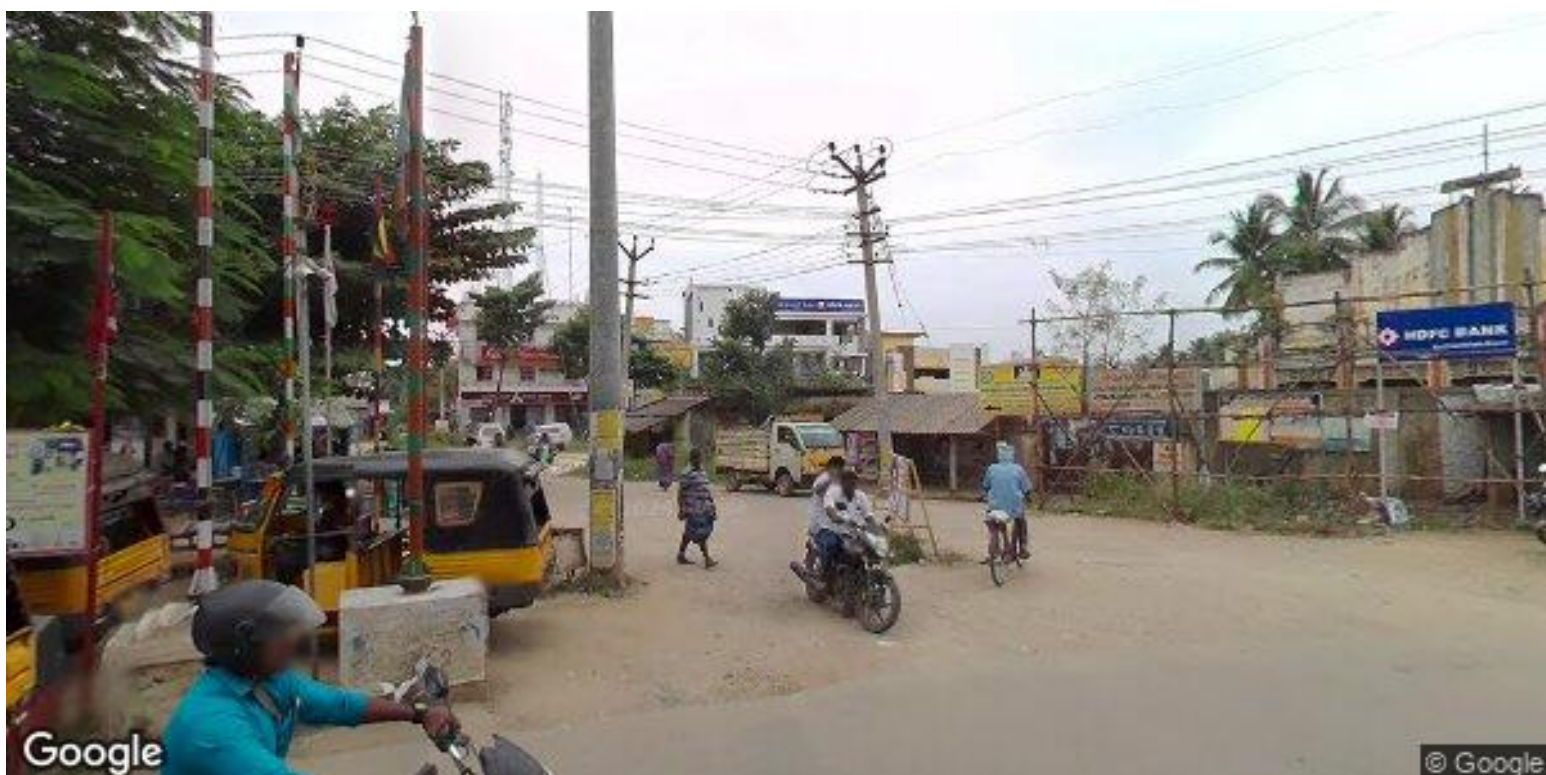
**Risk Type:** Turn  
**Risk Level:** High  
**Speed Limit:** 15 KM/Hr  
**Coordinates:** 11.67187, 78.23142

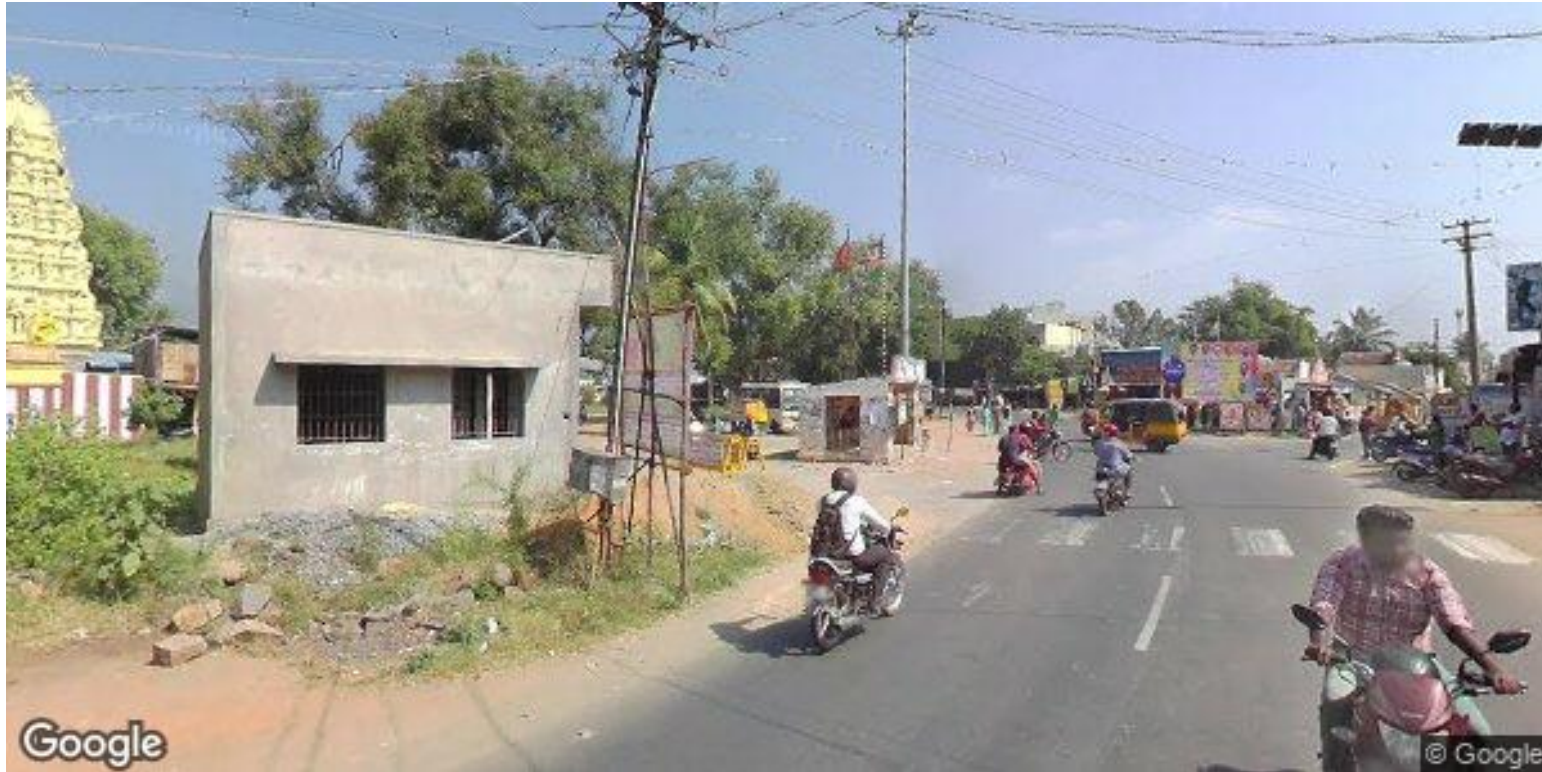
**Risk Type:** Turn  
**Risk Level:** Medium  
**Speed Limit:** 30 KM/Hr  
**Coordinates:** 11.67427, 78.23892

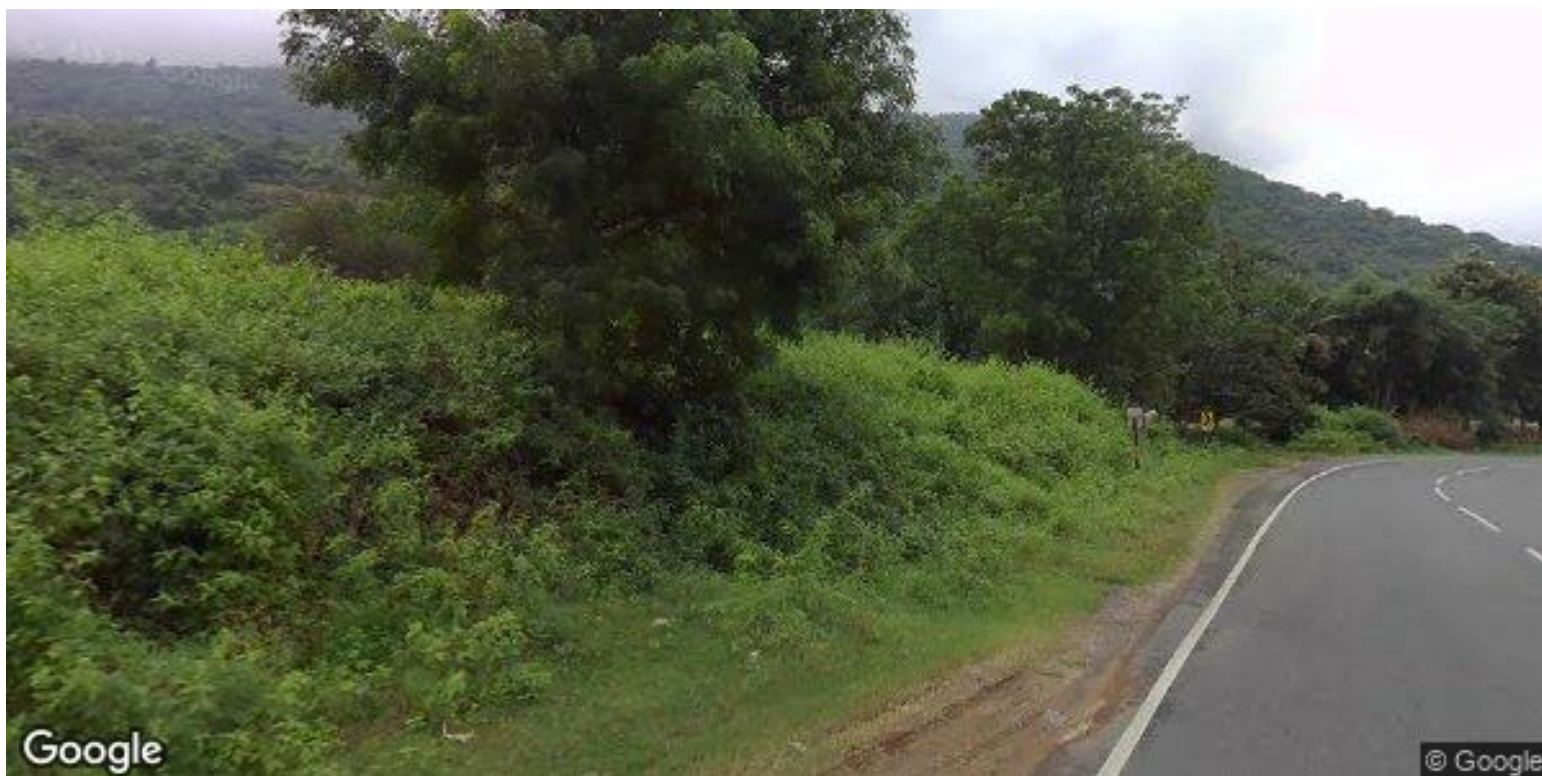
**Risk Type:** Turn  
**Risk Level:** Medium  
**Speed Limit:** 30 KM/Hr  
**Coordinates:** 11.80401, 78.33316

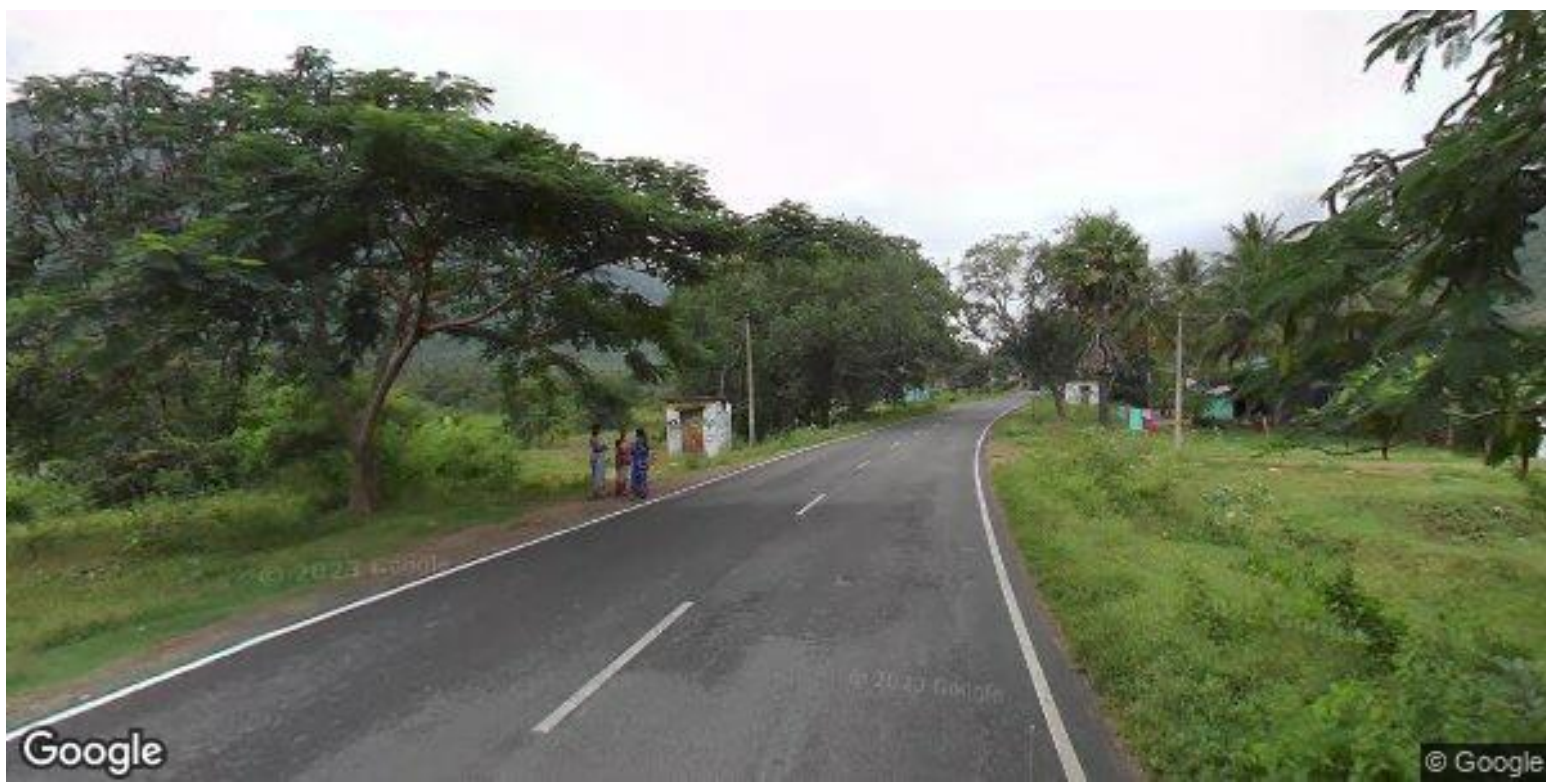
**Coordinates:** 11.81208, 78.34071

**Risk Type:** Turn

**Risk Level:** Medium

**Speed Limit:** 30 KM/Hr

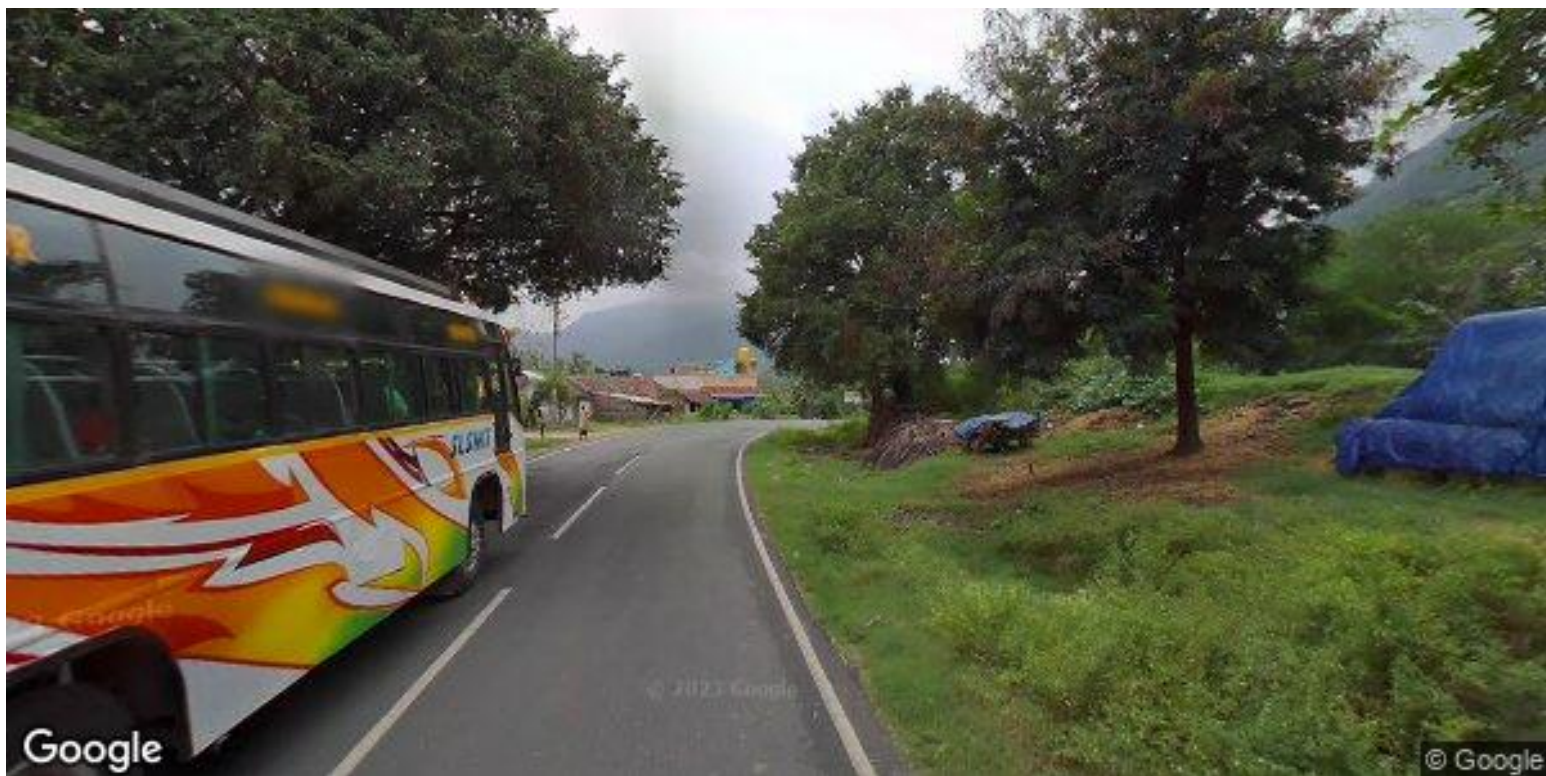
**Coordinates:** 11.83518, 78.35305

**Risk Type:** Turn

**Risk Level:** Medium

**Speed Limit:** 30 KM/Hr
